APPENDIX 5.
RECORDS OF BRIDGE SURVEY

1. Visual inspection survey

4.1 Kanchpur Bridge

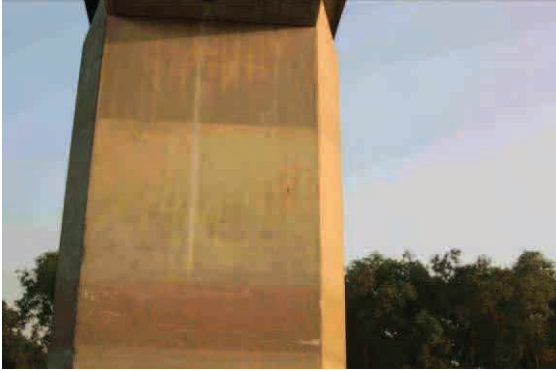
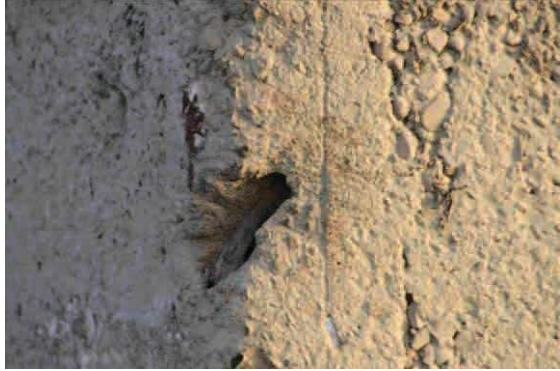
Pier 10	
Damage: Not exist	Damage: Not exist

No damage	No damage in reinforcement

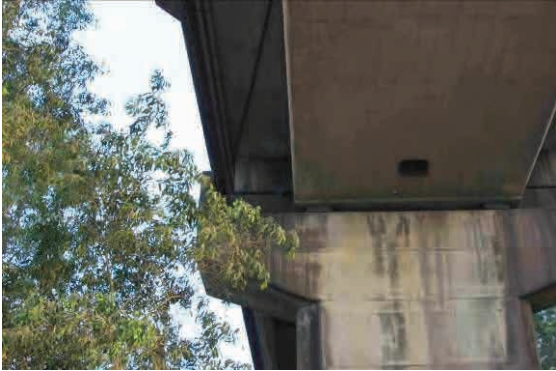
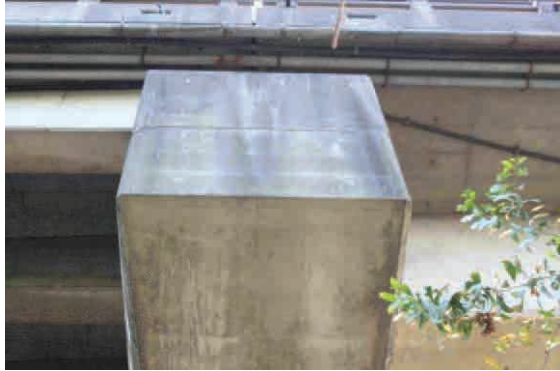
Pier 11	
Damage: Not exist	Damage: Not exist

No damage	No damage

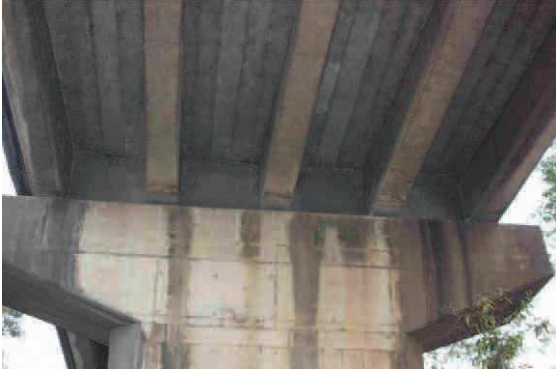
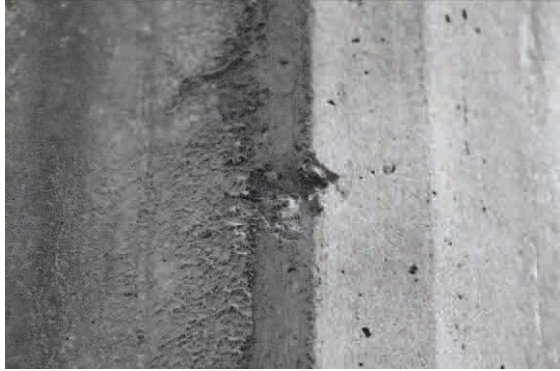
Pier 12	
Damage: Not exist	Damage: Not exist

No damage	No damage in reinforcement

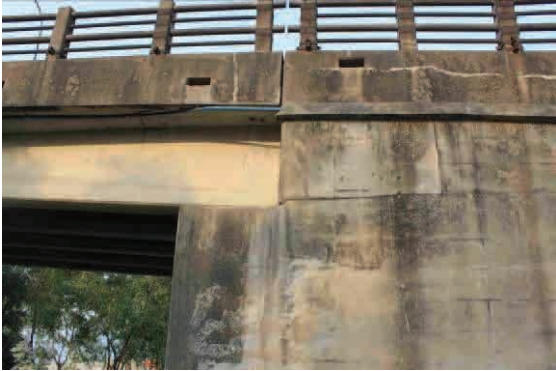
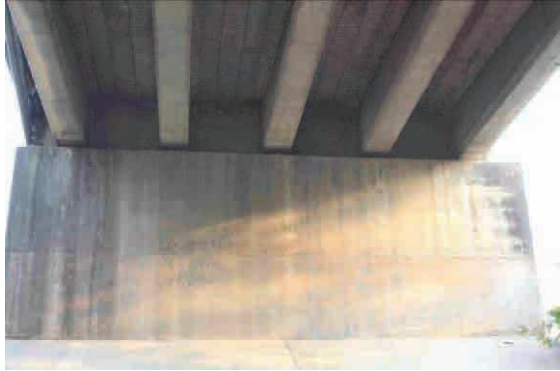
Abutment 02	
Damage: Not exist	Damage: Not exist

No damage	No damage

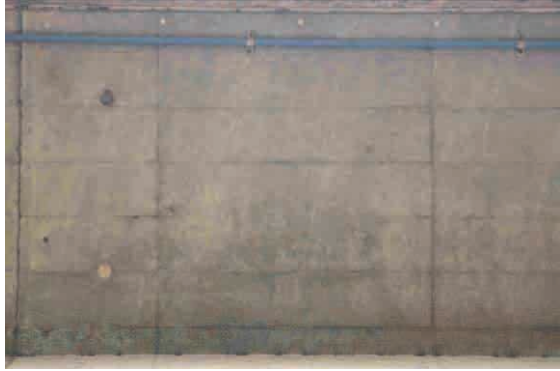
Superstructure P1	
Damage: Not exist	Damage: Not exist

No damage	No damage

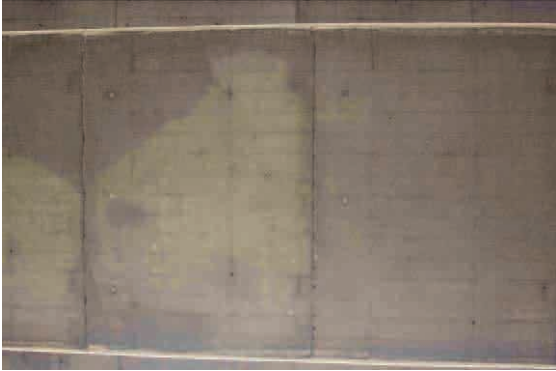
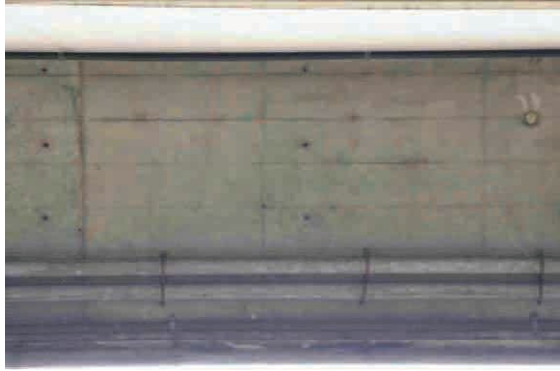
Superstructure P2	
Damage: Not exist	Damage: Not exist

No damage	No damage

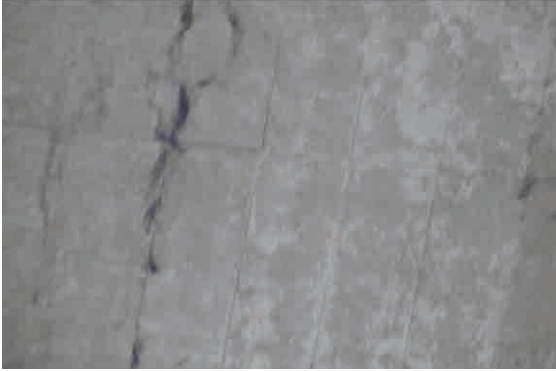
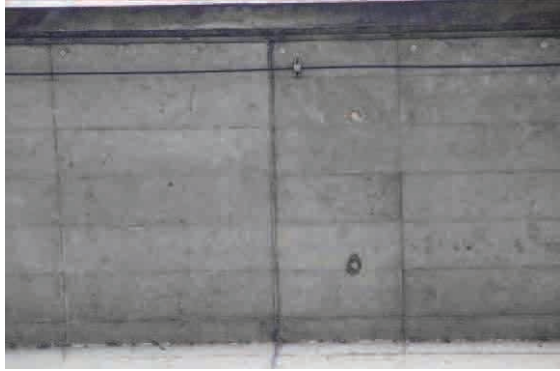
Superstructure P3	
Damage: Not exist	Damage: Not exist

No damage	No damage

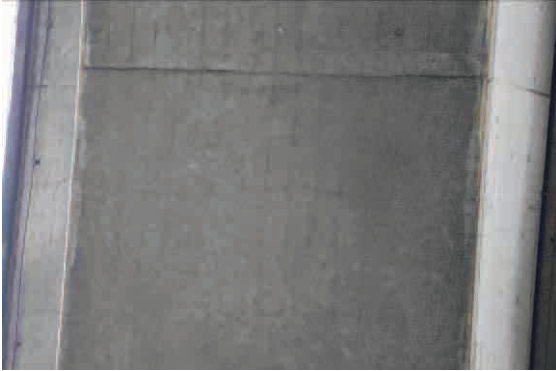
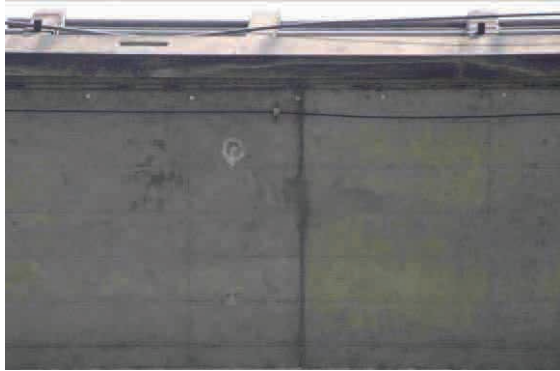
Superstructure P4	
Damage: Not exist	Damage: Not exist

No damage	No damage

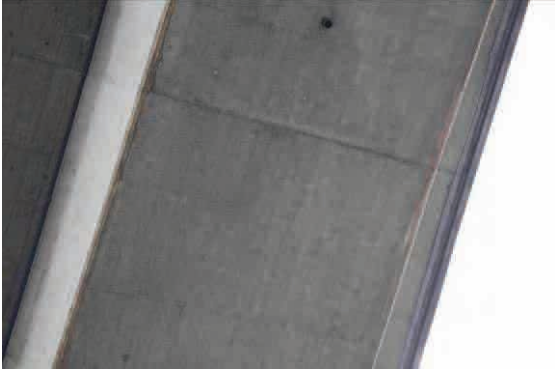
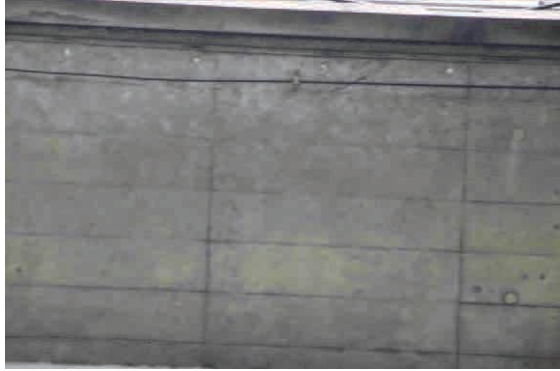
Superstructure P5	
Damage: Not exist	Damage: Not exist

No damage	No damage

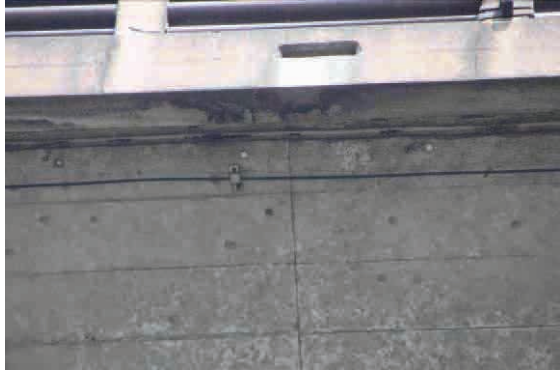
Superstructure P6	
Damage: Not exist	Damage: Not exist

No damage	No damage

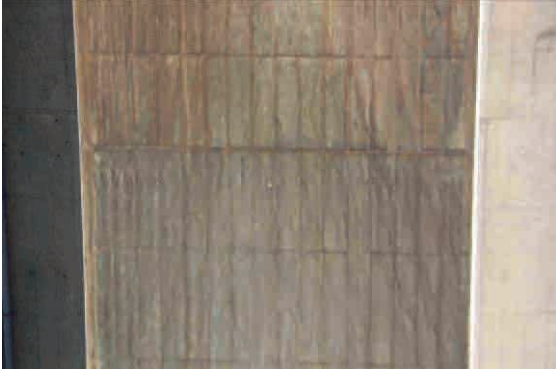
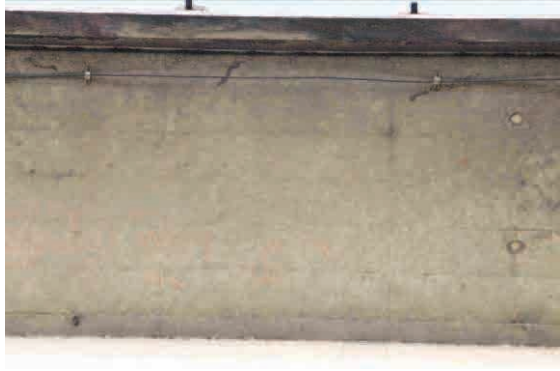
Superstructure P7	
Damage: Not exist	Damage: Not exist

No damage	No damage

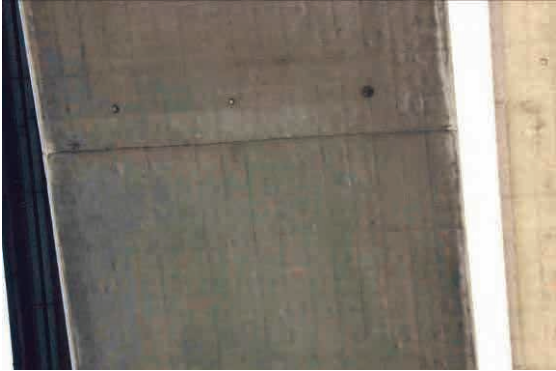
Superstructure P8	
Damage: Not exist	Damage: Not exist

No damage	No damage

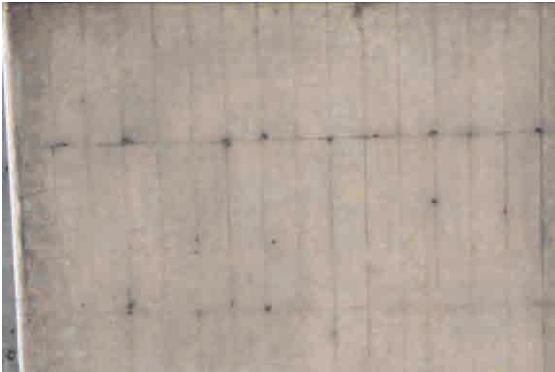
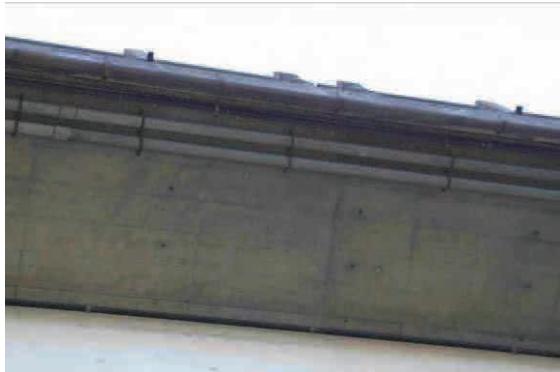
Superstructure P10	
Damage: Not exist	Damage: Not exist

No damage	No damage

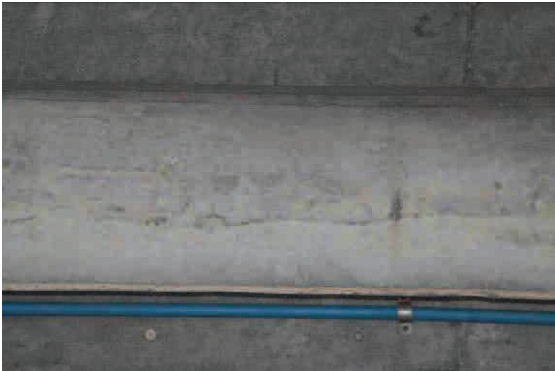
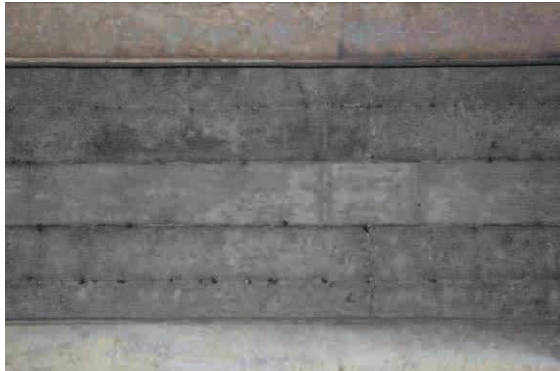
Superstructure P11-P12	
Damage: Not exist	Damage: Not exist

No damage	No damage

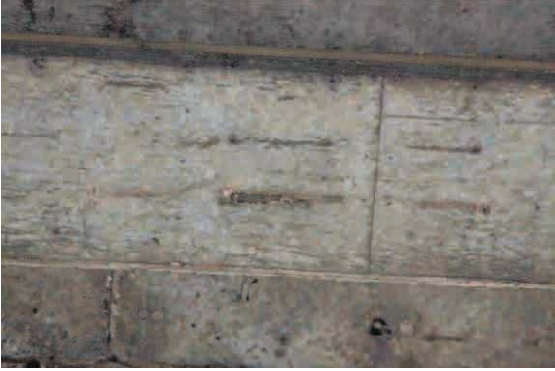
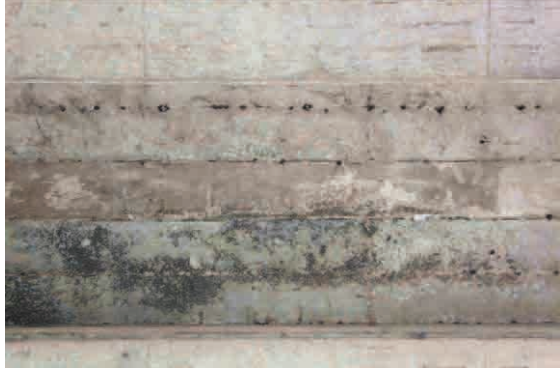
Superstructure P12-A2	
Damage: Exist	Damage: Not exist

<p>Small area Corrosion in reinforcement</p>	<p>No damage</p>

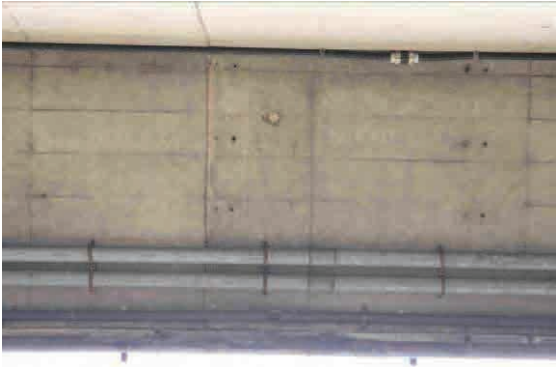
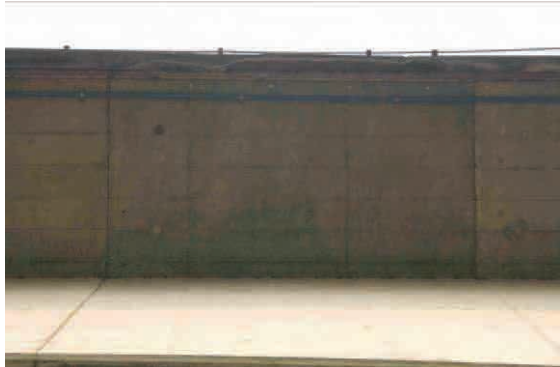
Slab P1	
Damage: Not exist	Damage: a

No damage	No crack

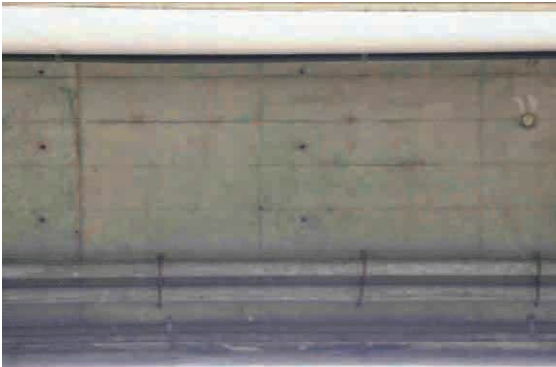
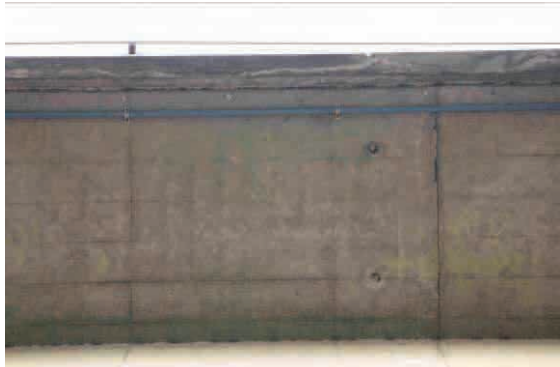
Slab P2	
Damage: Not exist	Damage: a

No damage	No crack

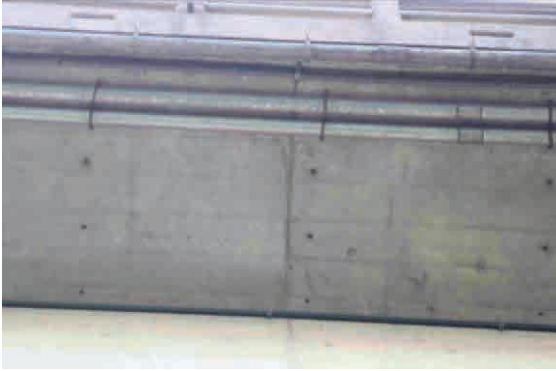
Slab P3	
Damage: Not exist	Damage: a

No damage	No crack

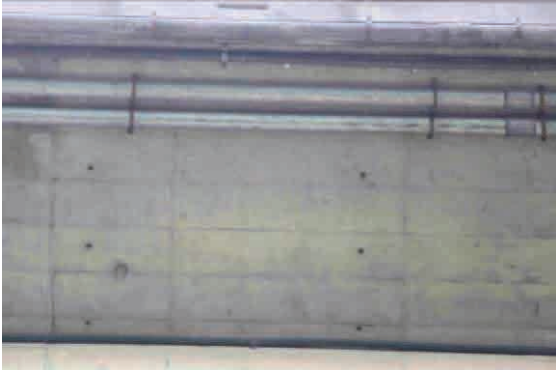
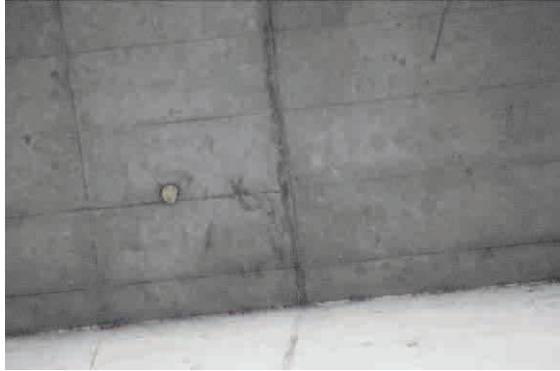
Slab P4	
Damage: Not exist	Damage: a

No damage	No crack

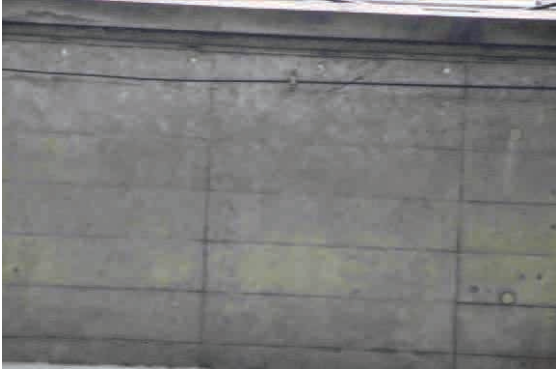
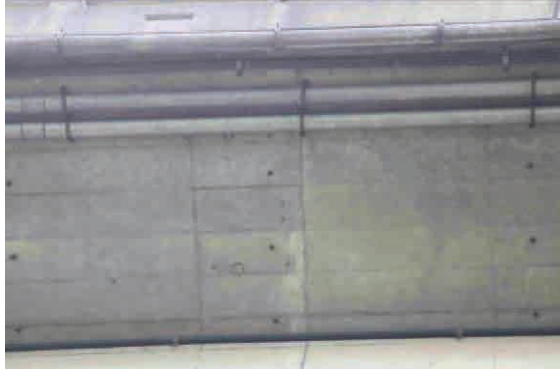
Slab P5	
Damage: Not exist	Damage: a

No damage	No crack

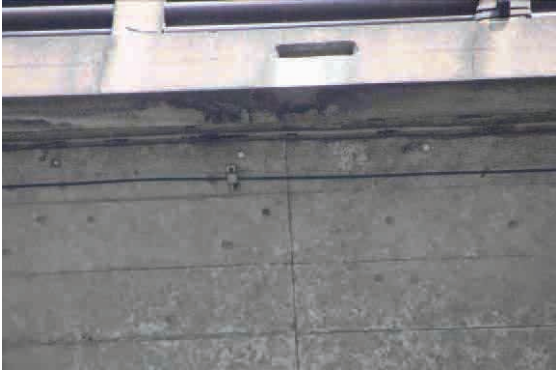
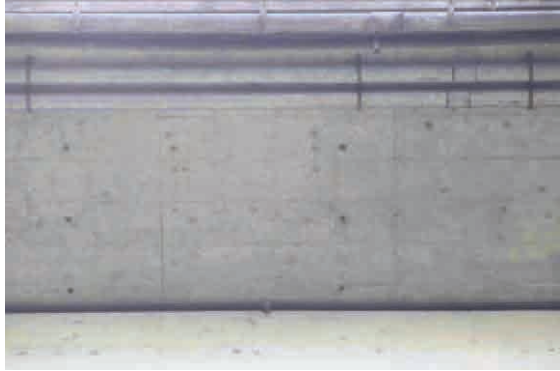
Slab P6	
Damage: Not exist	Damage: a

No damage	No crack

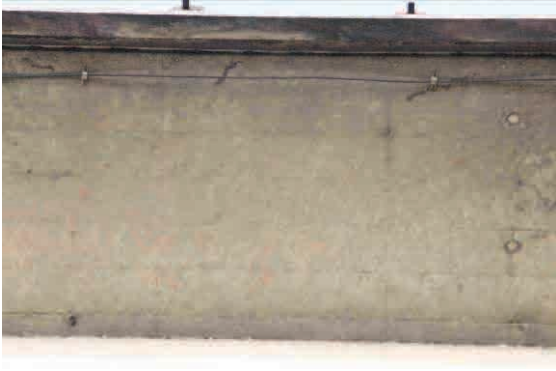
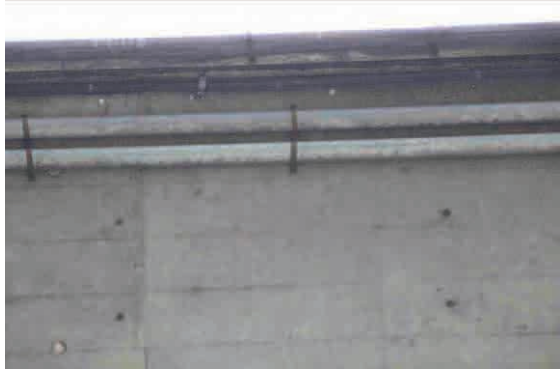
Slab P7	
Damage: Not exist	Damage: a

No damage	No crack

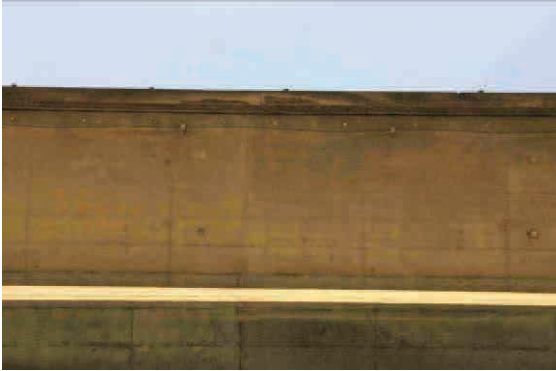
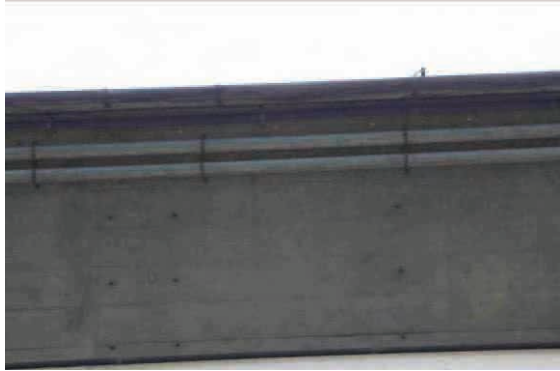
Slab P8	
Damage: Not exist	Damage: a

No damage	No crack

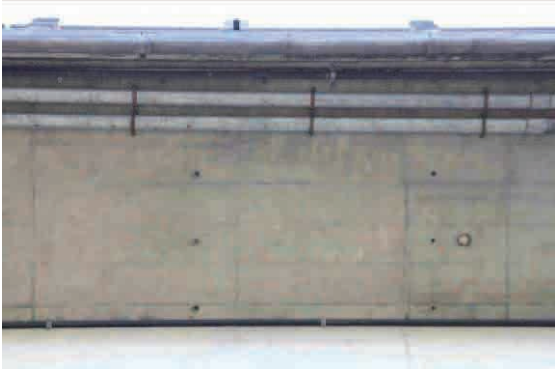
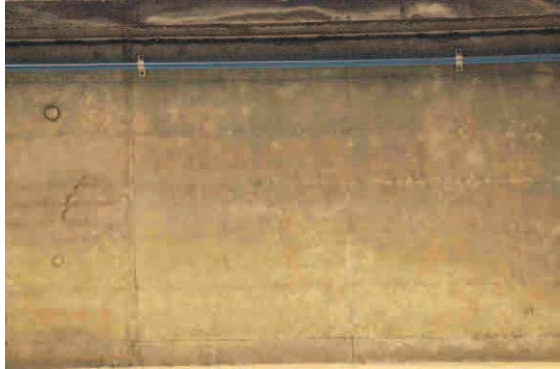
Slab P10	
Damage: Not exist	Damage: a

No damage	No crack

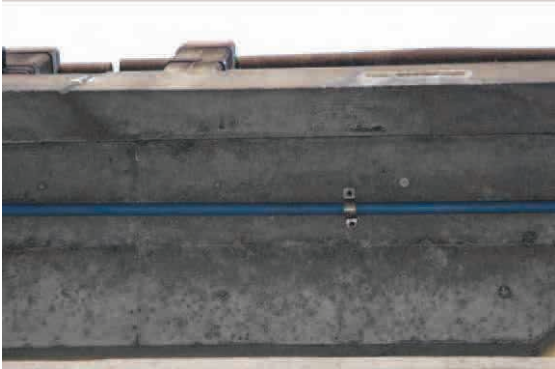
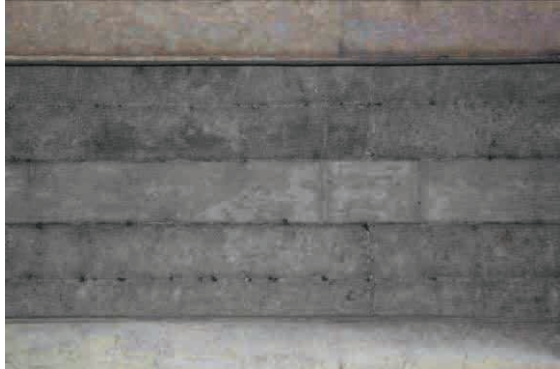
Slab P11-P12	
Damage: Not exist	Damage: a

No damage	No crack

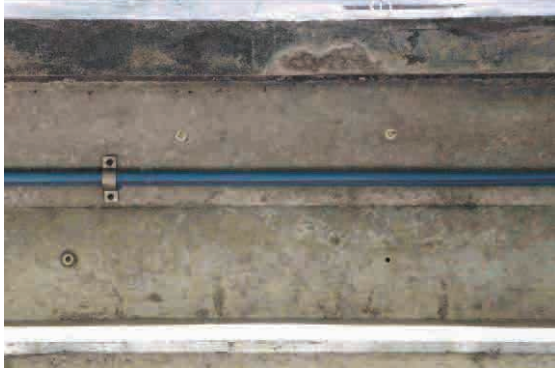
Slab P12-A2

Damage: Not exist

No damage

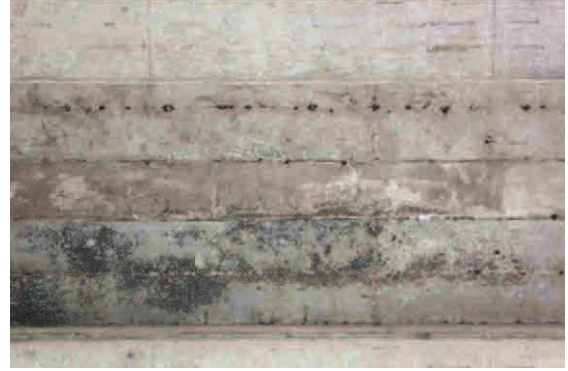
Damage: a

No crack

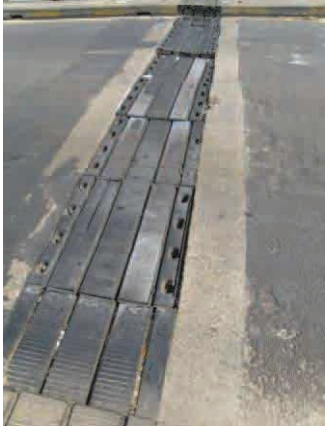
Surface	
Damage: Exist	Damage: Exist

Uneven more than 20mm	Uneven more than 20mm

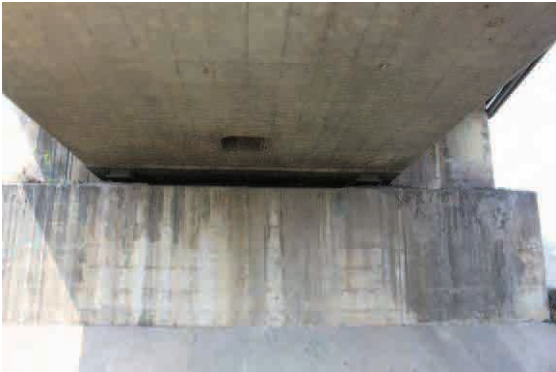
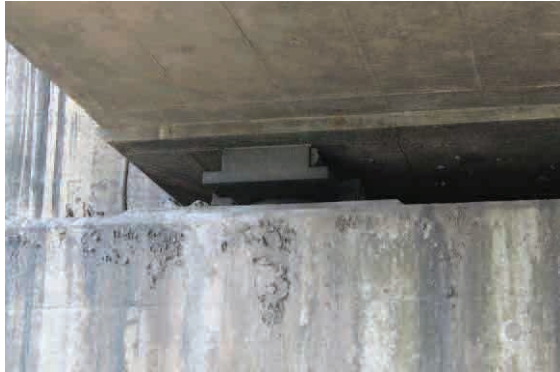
Abutment 01	
Damage: a	Damage: a

No crack	No crack

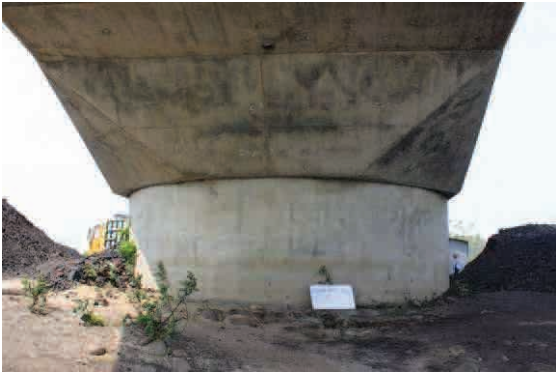
Pier 01	
Damage: a	Damage: b

No crack	Crack width less 0.2mm

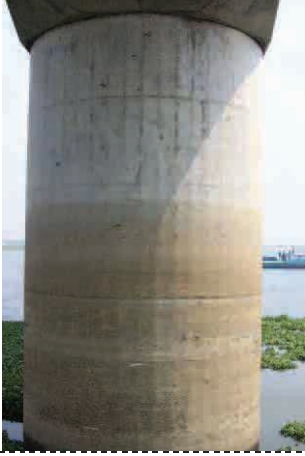
Pier 02	
Damage: a	Damage: c

No crack	Crack width over 0.2mm

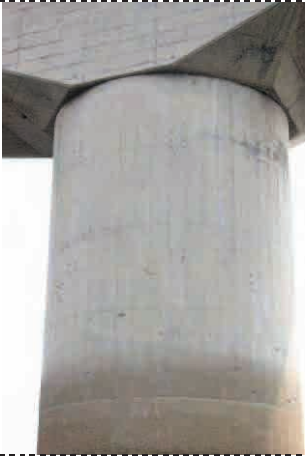
Pier 03	
Damage: a	Damage: c

No crack	Crack width over 0.2mm

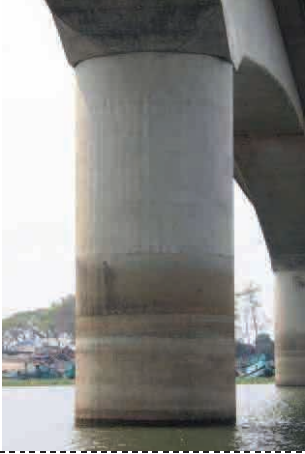
Pier 04	
Damage: a	Damage: c

No crack	Crack width over 0.2mm

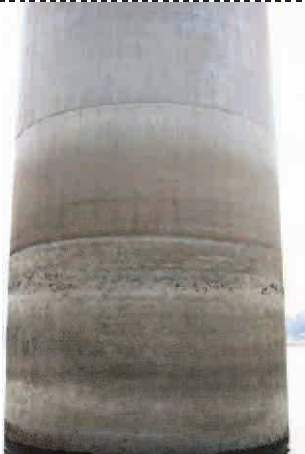
Pier 05	
Damage: a	Damage: c

No crack	Crack width over 0.2mm

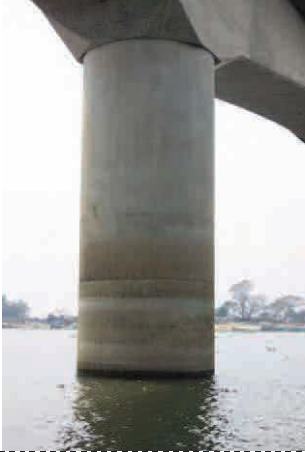
Pier 06	
Damage: a	Damage: c

No crack	Crack width over 0.2mm

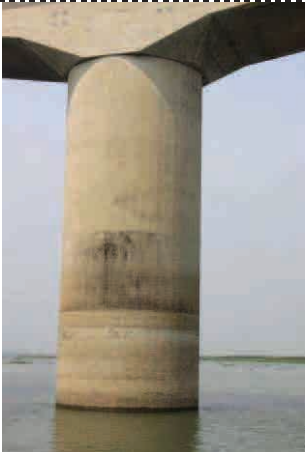
Pier 07	
Damage: a	Damage: c

No crack	Crack width over 0.2mm

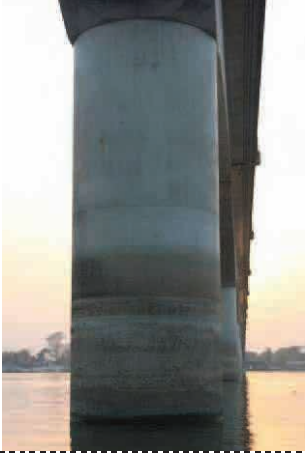
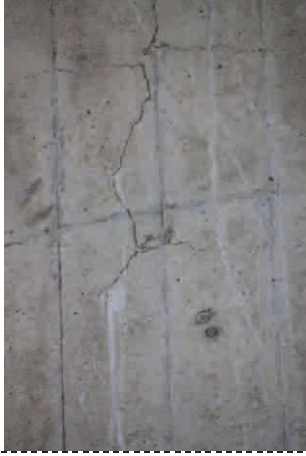
Pier 08	
Damage: a	Damage: c

No crack	Crack width over 0.2mm

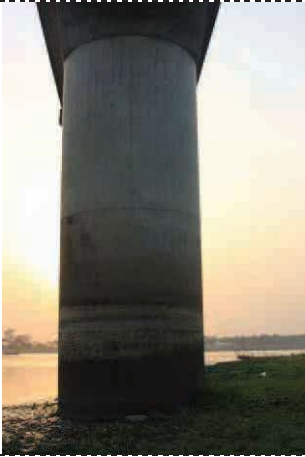
Pier 09	
Damage: a	Damage: c

No crack	Crack width over 0.2mm

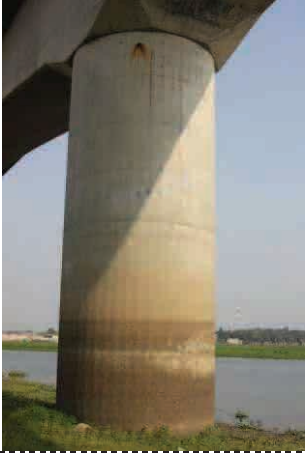
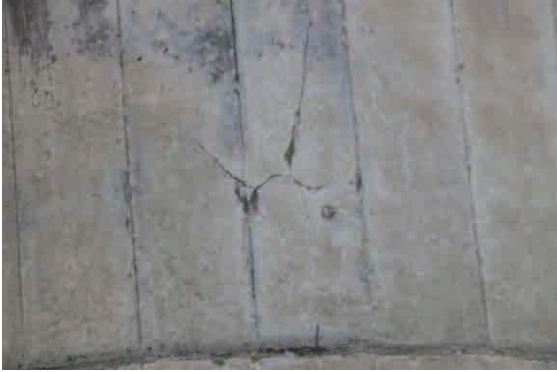
Pier 10	
Damage: a	Damage: c

No crack	Crack width over 0.2mm

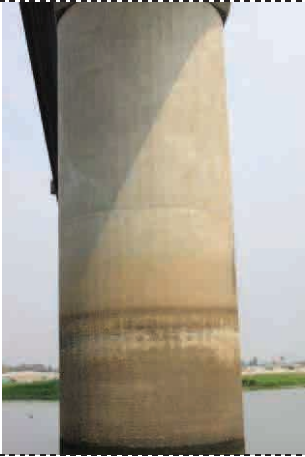
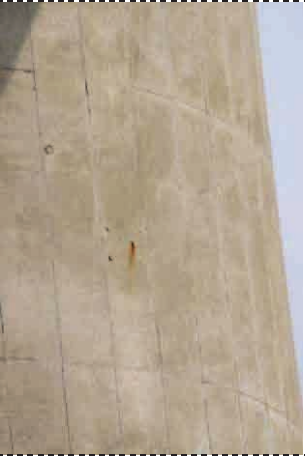
Pier 11	
Damage: a	Damage: a

No crack	No crack

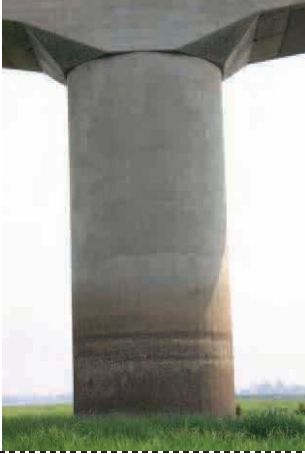
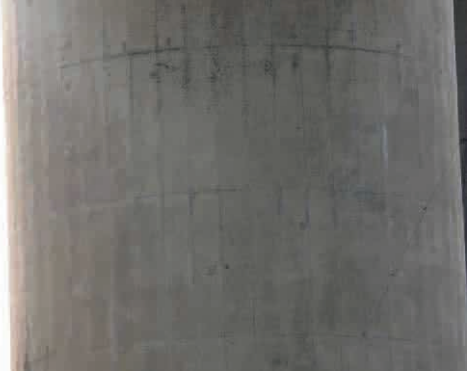
Pier 12	
Damage: a	Damage: a

No crack	No crack

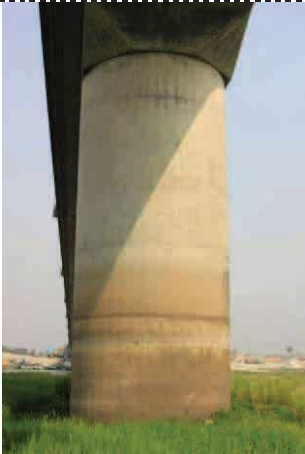
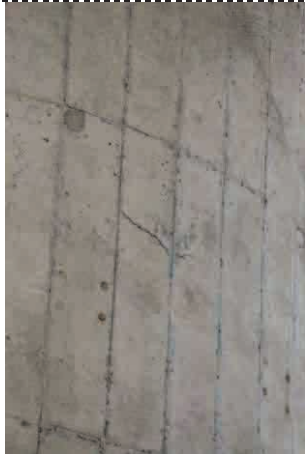
Pier 13	
Damage: a	Damage: c

No crack	Crack width over 0.2mm

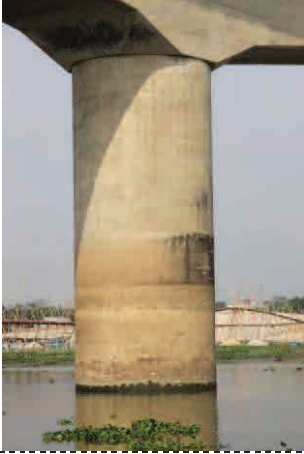
Pier 14	
Damage: a	Damage: d

No crack	Crack width over 0.2mm Water leakage only

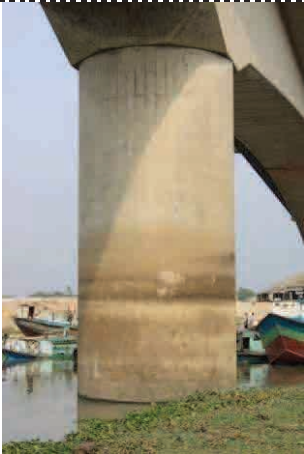
Pier 15	
Damage: a	Damage: c

No crack	Crack width over 0.2mm

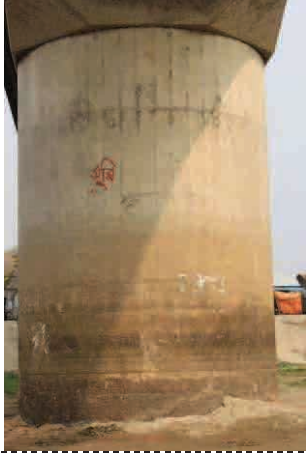
Pier 16	
Damage: a	Damage: d

No crack	Crack width over 0.2mm Water leakage only

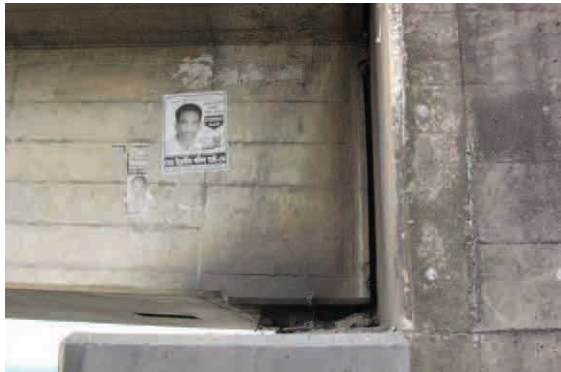
Abutment 02	
Damage: a	Damage: a

No crack	No crack

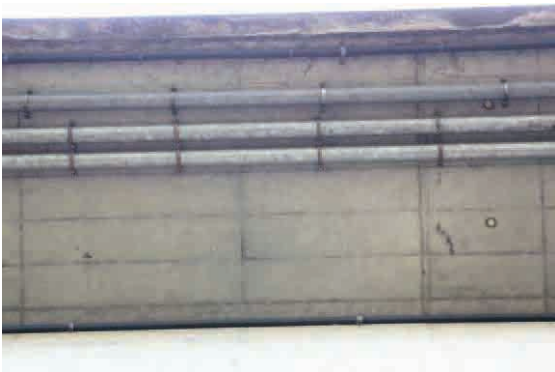
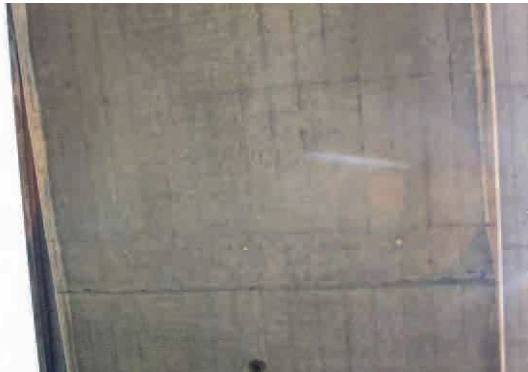
Superstructure P2	
Damage: a	Damage: a

No crack	No crack

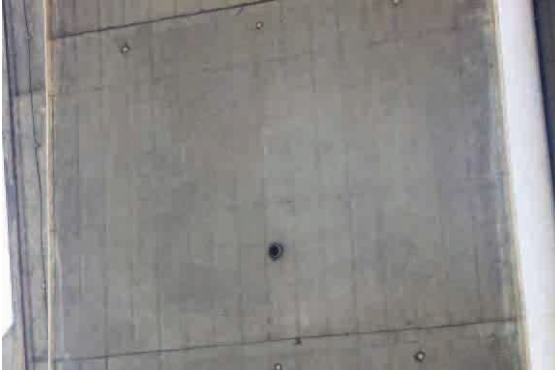
Superstructure P3	
Damage: a	Damage: a

No crack	No crack

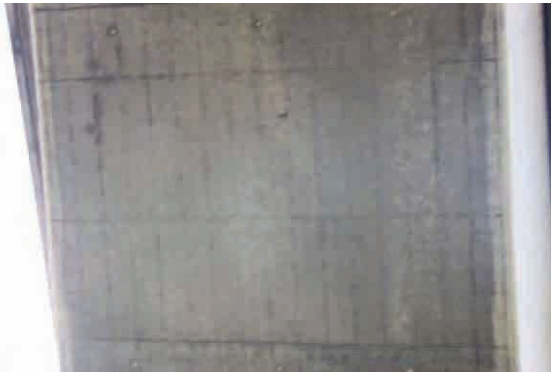
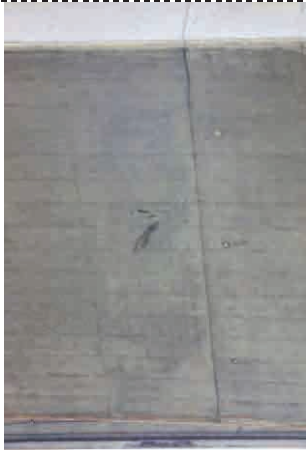
Superstructure P4	
Damage: a	Damage: a

No crack	No crack

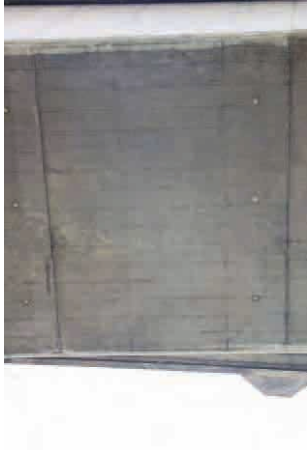
Superstructure P5	
Damage: a	Damage: d

No crack	Crack width over 0.2mm Water leakage only

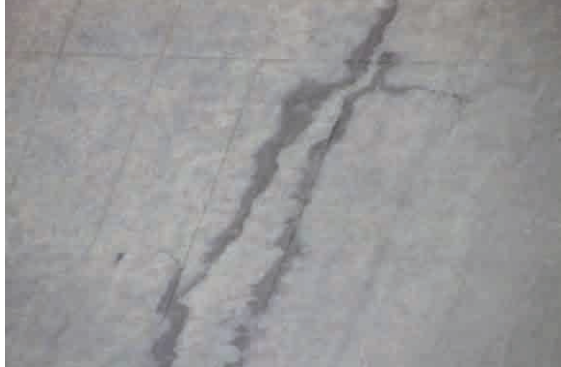
Superstructure P6	
Damage: a	Damage: d

No crack	Crack width over 0.2mm Water leakage only

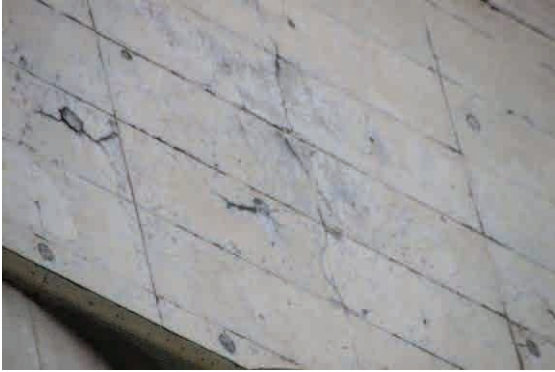
Superstructure P7	
Damage: c	Damage: d

Crack width over 0.2mm	Crack width over 0.2mm Water leakage only

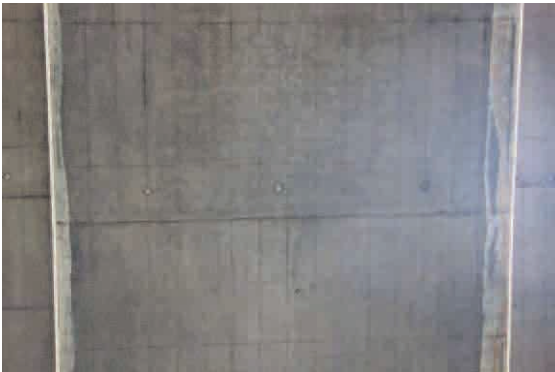
Superstructure P8	
Damage: a	Damage: a

No crack	No crack

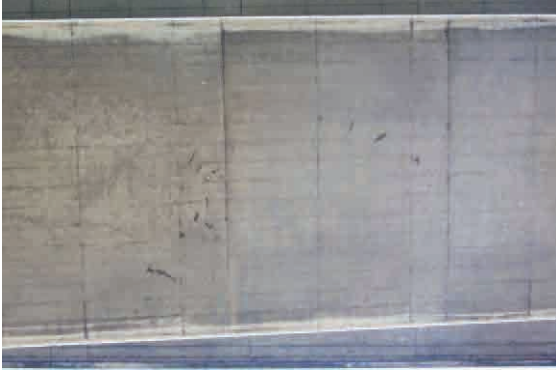
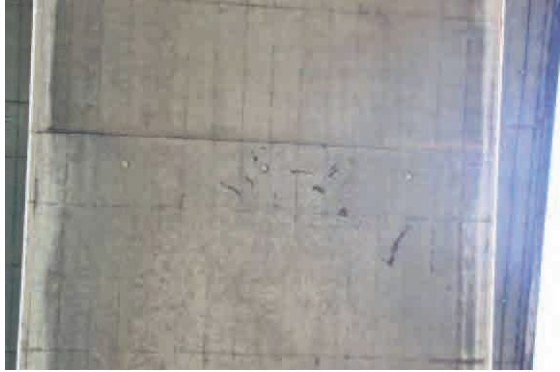
Superstructure P9	
Damage: a	Damage: a

No crack	No crack

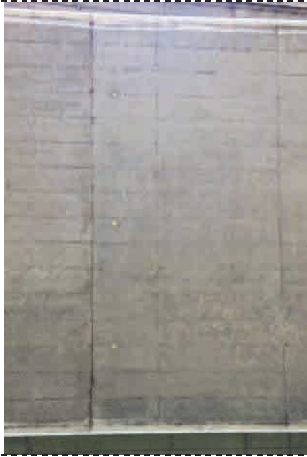
Superstructure P10	
Damage: a	Damage: d

No crack	Crack width over 0.2mm Water leakage only

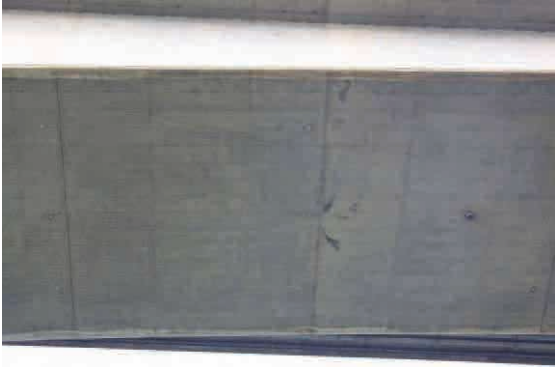
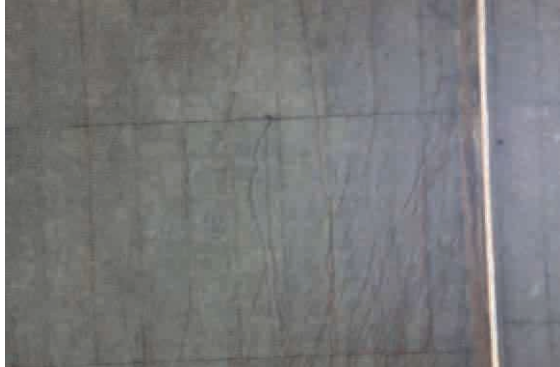
Superstructure P11	
Damage: a	Damage: a

No crack	No crack

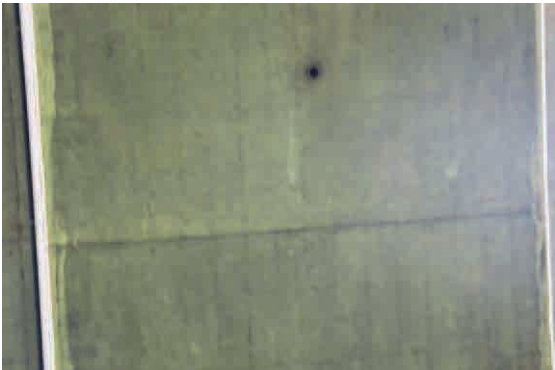
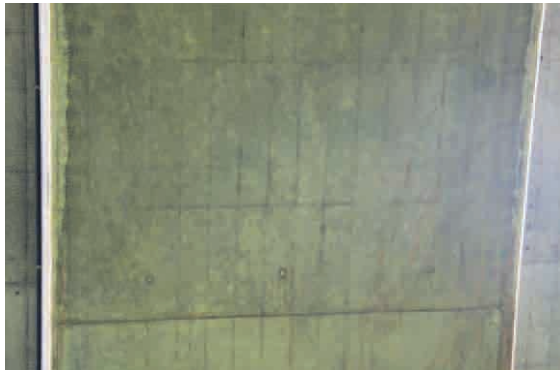
Superstructure P12	
Damage: a	Damage: a

No crack	No crack

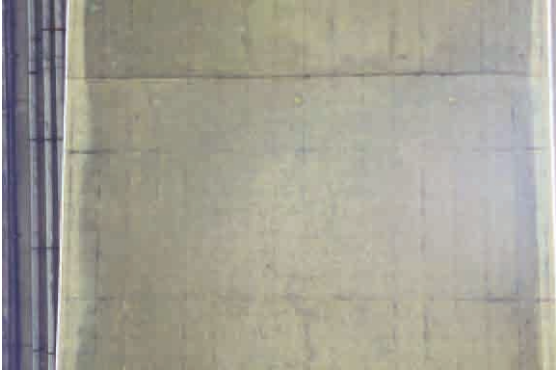
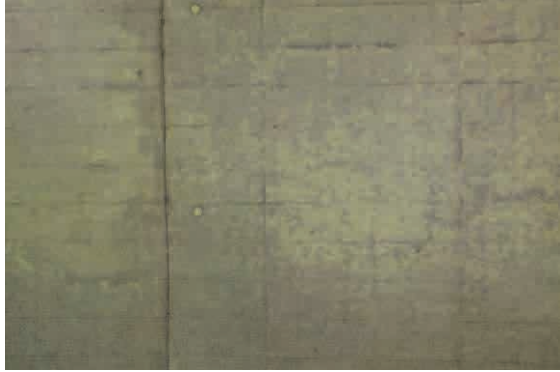
Superstructure P13	
Damage: a	Damage: a

No crack	No crack

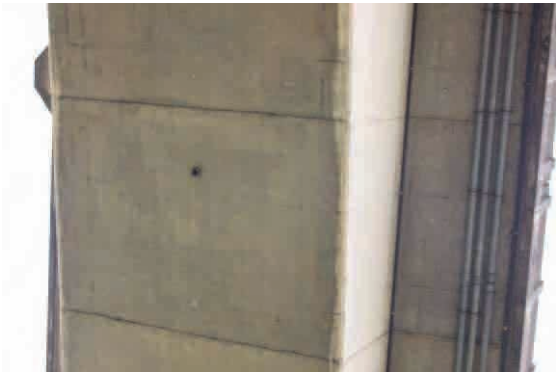
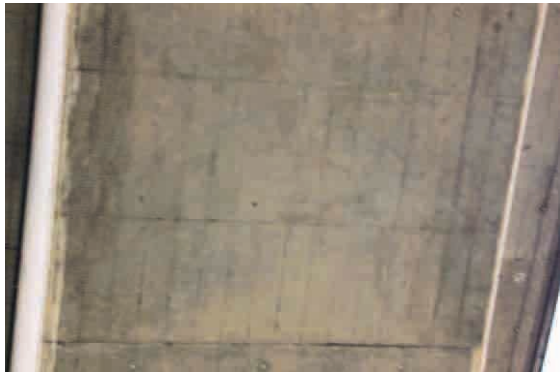
Superstructure P14	
Damage: a	Damage: a

No crack	No crack

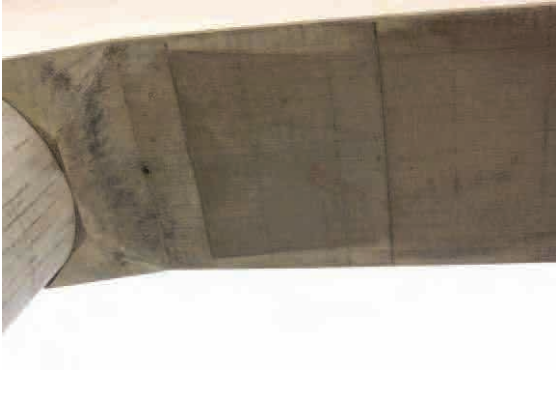
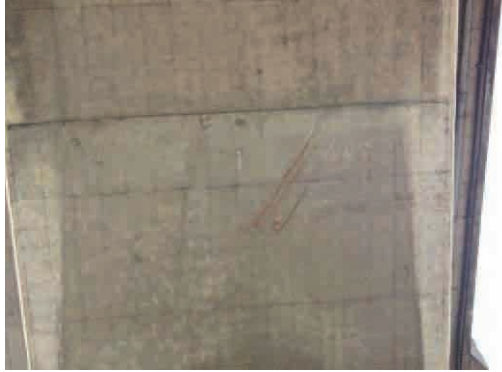
Superstructure P15	
Damage: a	Damage: a

No crack	No crack

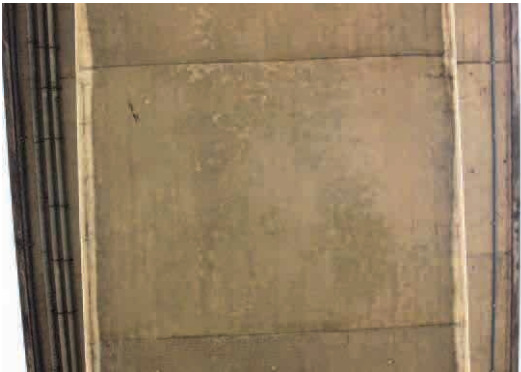
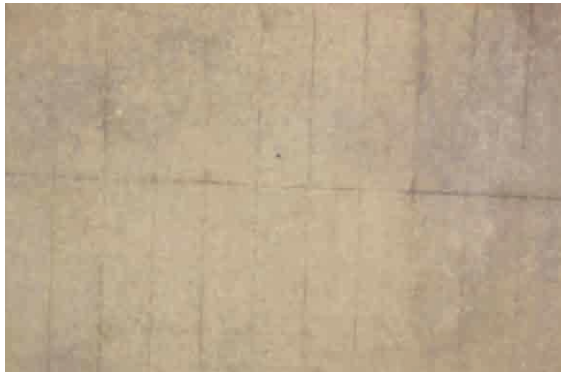
Superstructure P16	
Damage: a	Damage: a

No crack	No crack
