**THE PREPARATORY SURVEY (2)  
ON  
THE PROJECT  
FOR  
REHABILITATION OF BALUCHAUNG NO.2  
HYDROPOWER PLANT  
IN  
REPUBLIC OF THE UNION OF MYANMAR**

**Final Report  
(Annex)**

**March 2013**

### **CHECK LIST OF SITE INSPECTION**

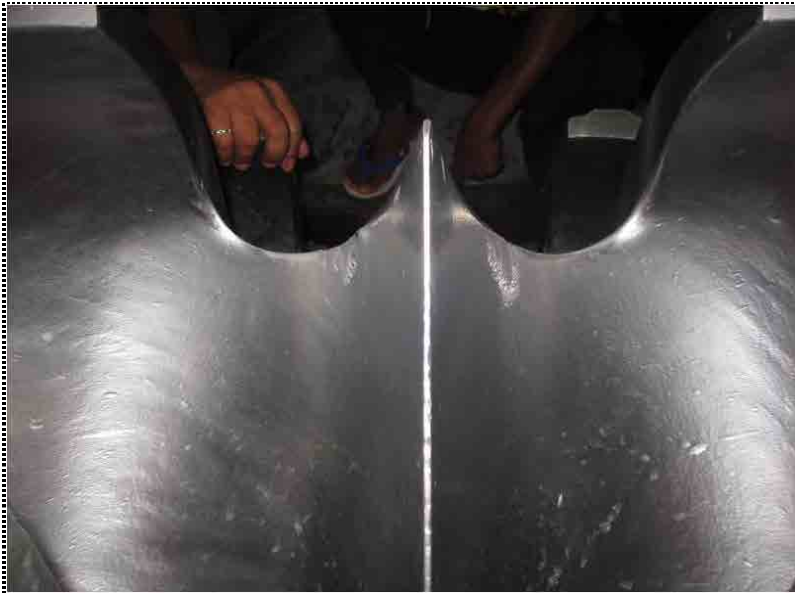
No 7

Near the inlet edge top of the action surface of Bucket No.9, light cavitation is observed.

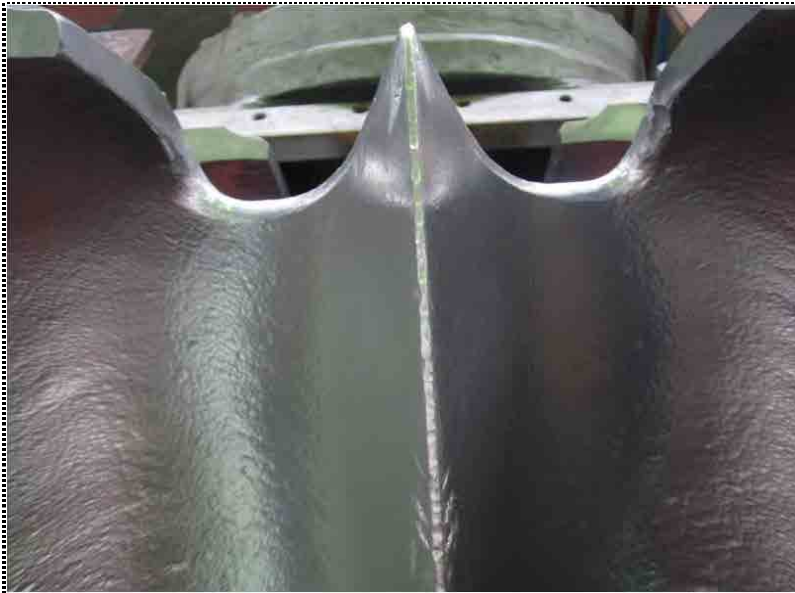
No 25

Light cavitation pitting at the leading edge of the action side of Bucket No. 19 and erosion at the stream surface of the bucket is observed.

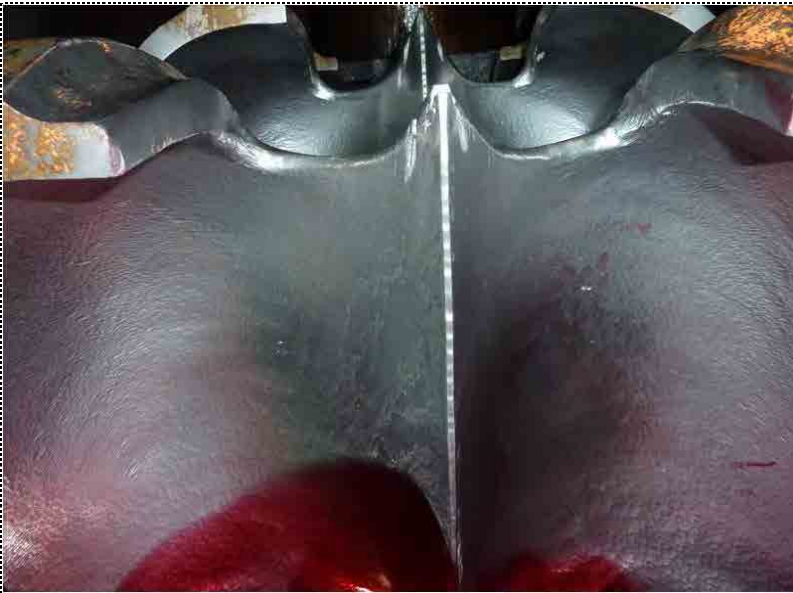
No 34

Rather light cavitation pitting is observed at the leading edge of the action side of Bucket No. 5

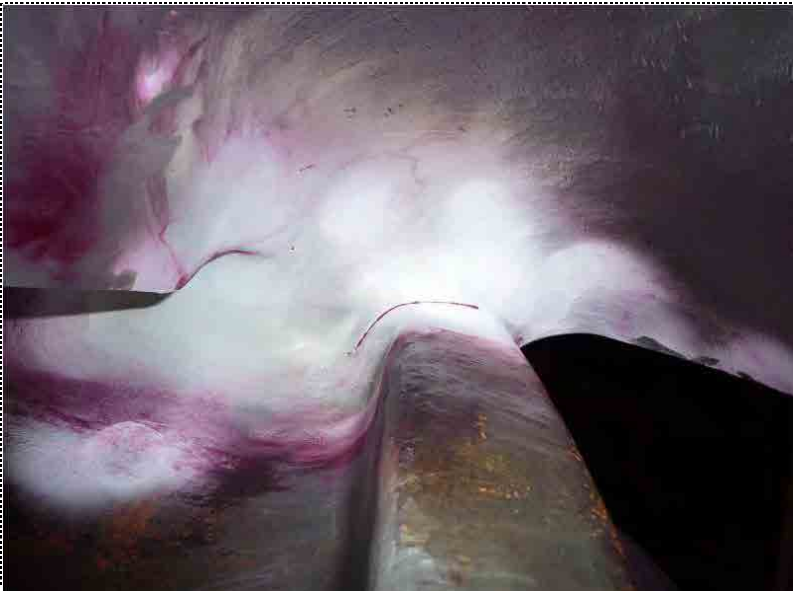
SideB No.14 bucket crack

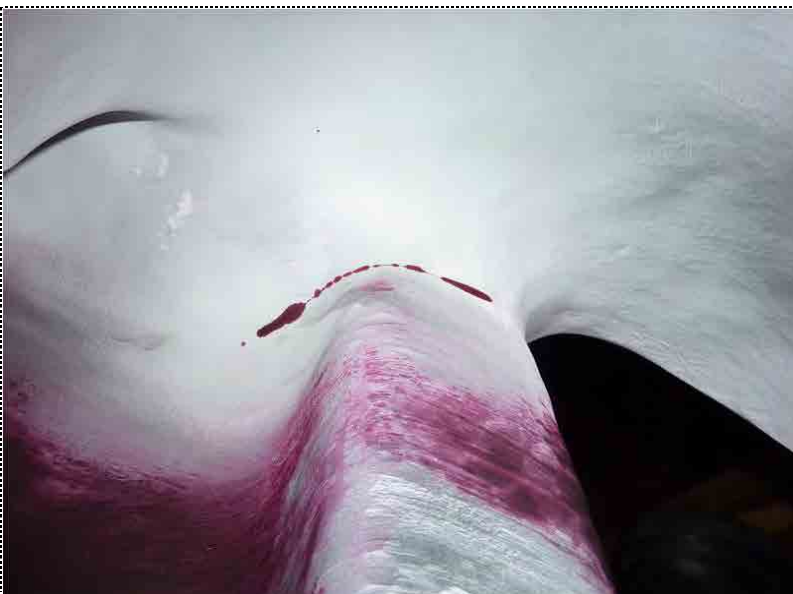
SideB No.17 bucket crack

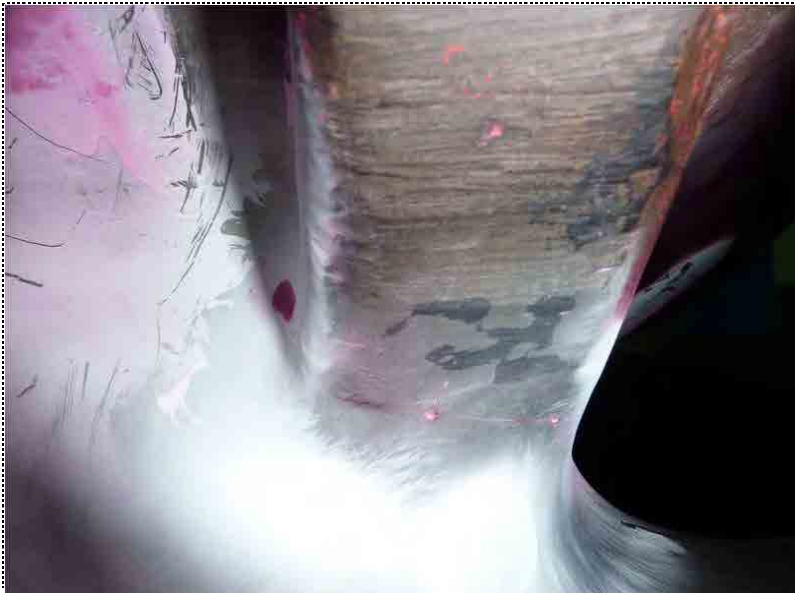
SideB No.19 bucket crack

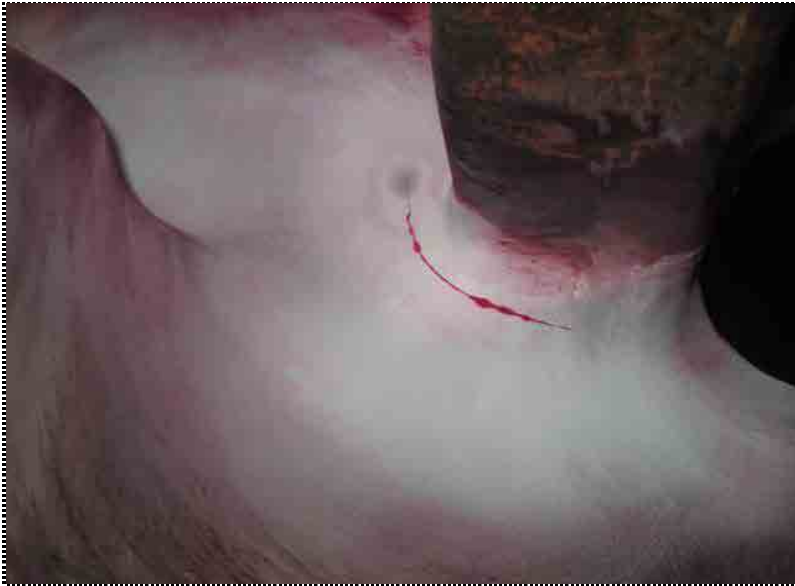
SideA No.9 bucket crack

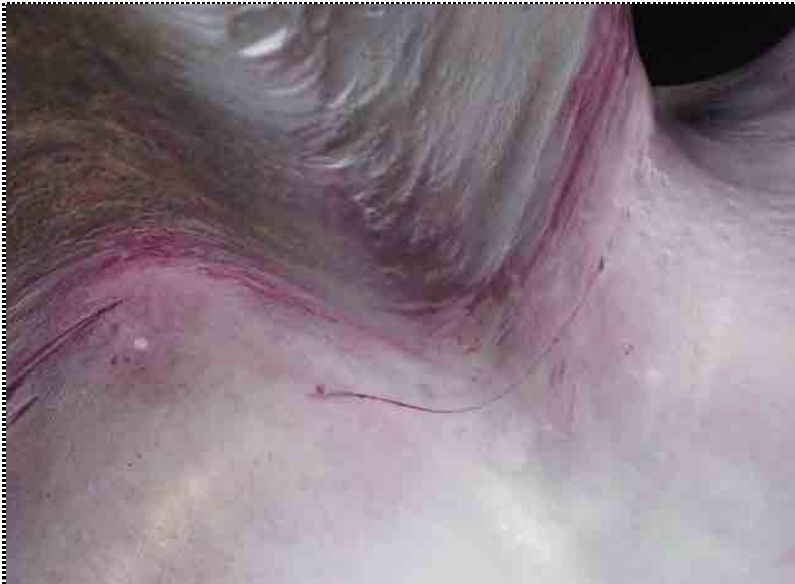
SideA No.10 bucket crack

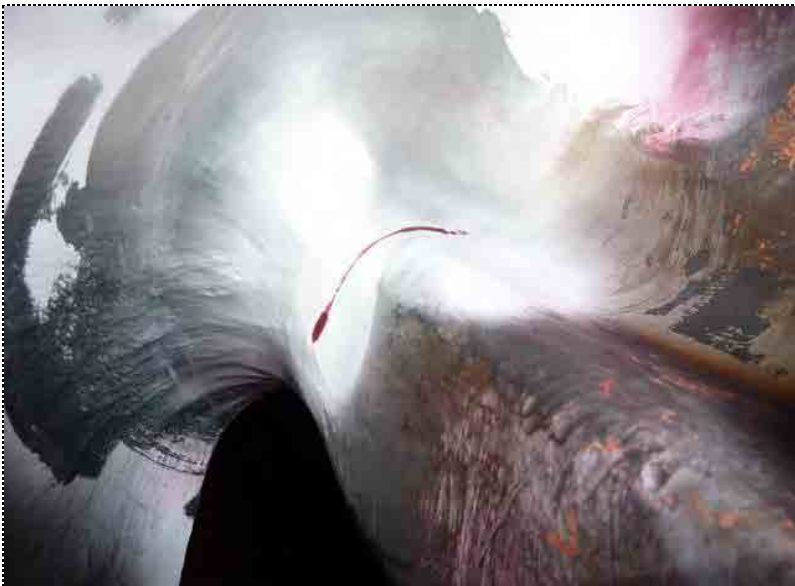
SideB No.7 bucket crack

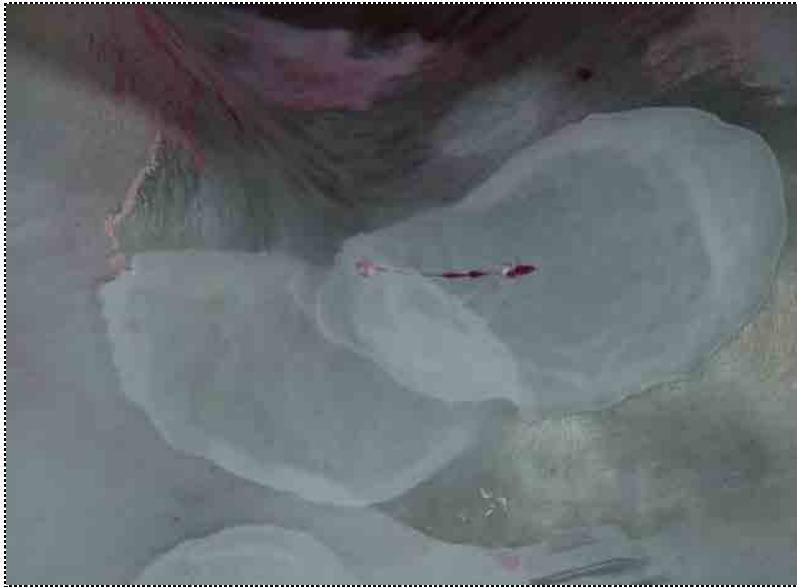
SideB No.8 bucket crack

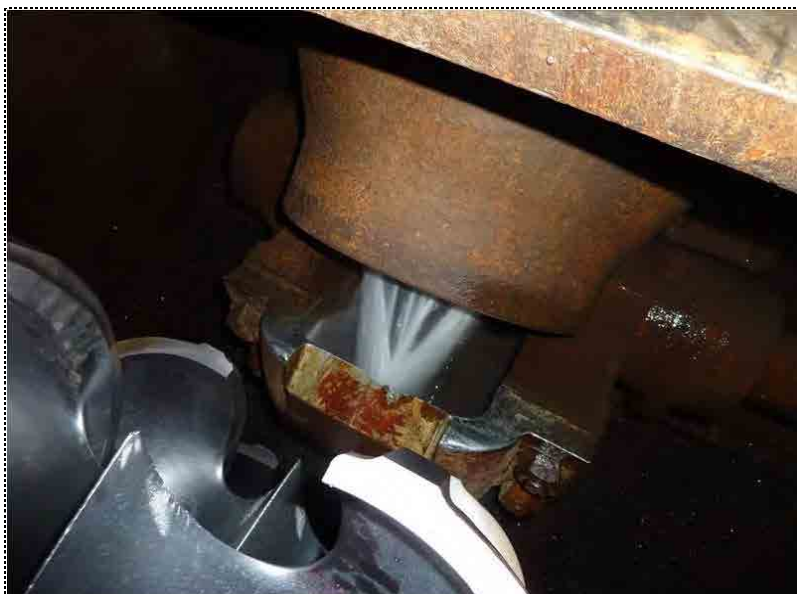
No T-001

Unit No. 1 A Upper Needle, Leakage

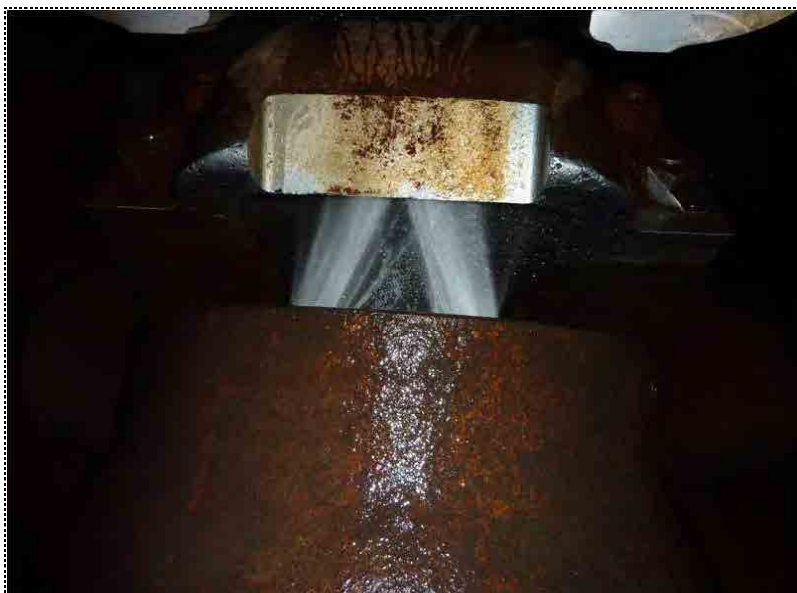
No T-002

Unit No. 1 B Upper Needle, Leakage

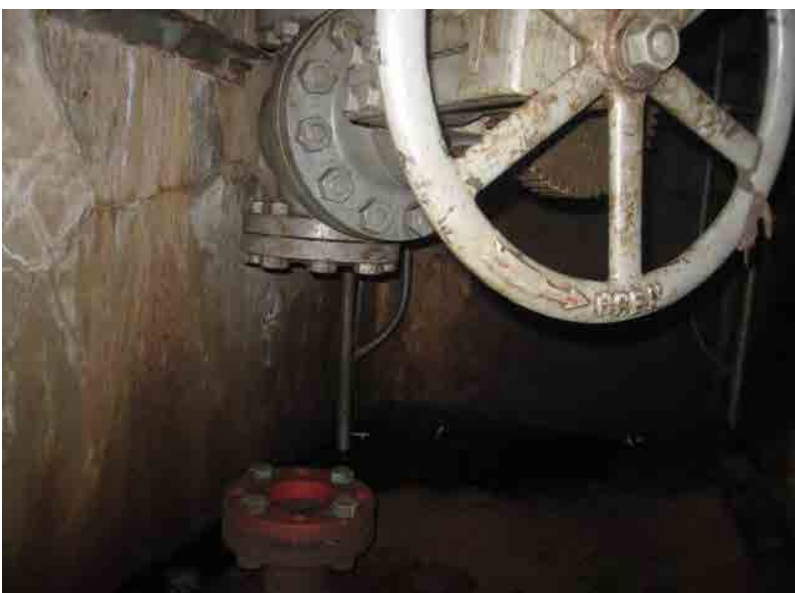
No T-006

Unit No. 1A Penstock Drain Valve

This valve is permanently closed with blind cover.

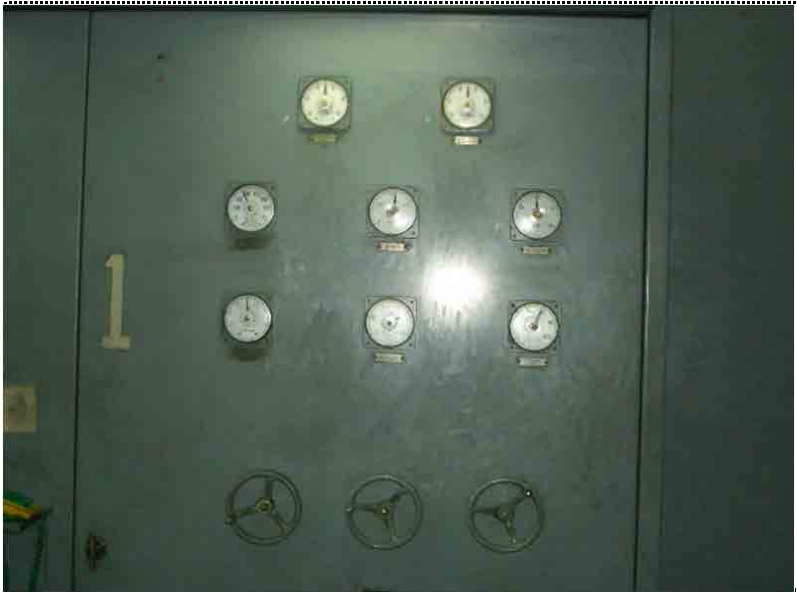
No T-007

Unit No. 1 Governor Cabinet and Damaged Dial Indicators

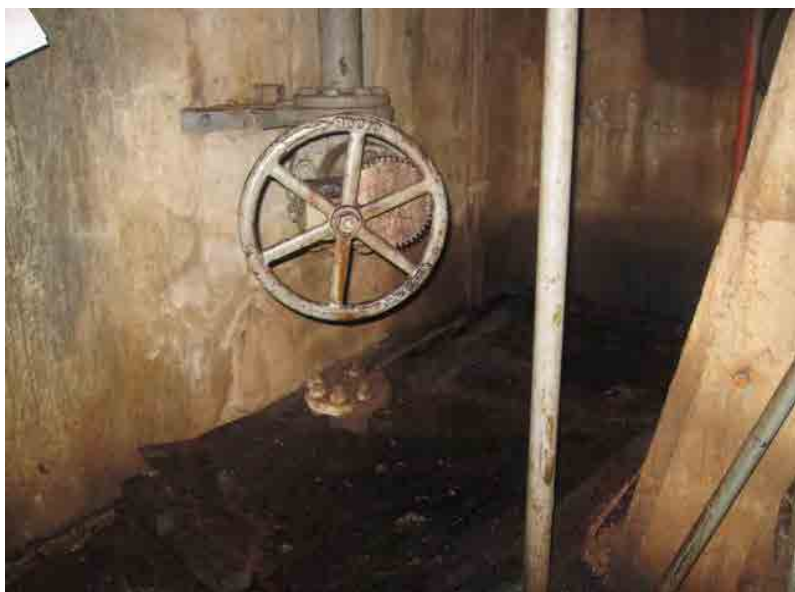
No T-004

Unit No. 2 A Penstock Drain Line

Downstream flange of penstock drain valve is closed with blind cover.

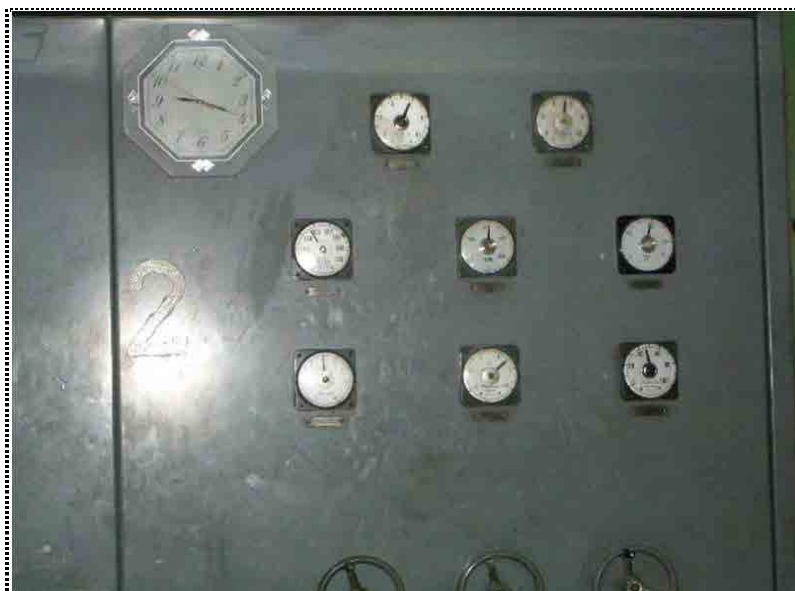
No T-005

Unit No. 2 Governor Cabinet

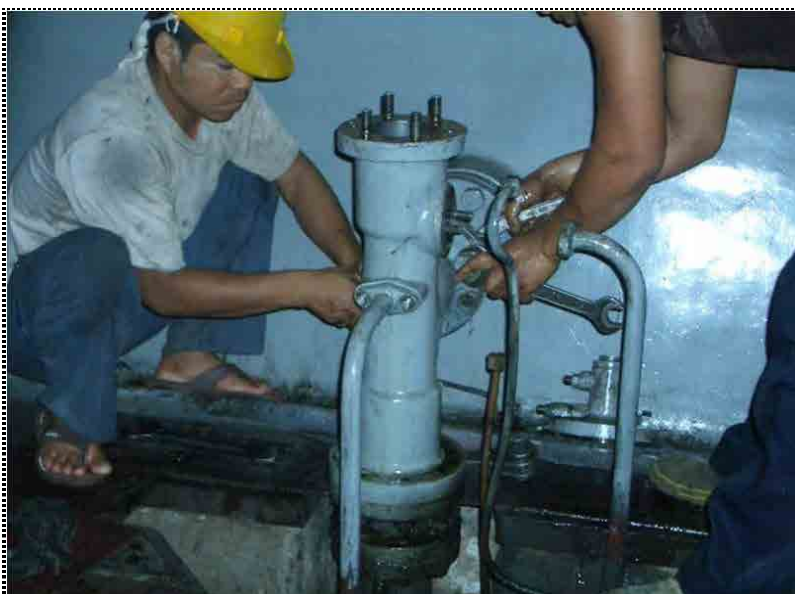
No T-003

Unit No. 3 A Needle Shaft Drain

The drain valve handle is removed.

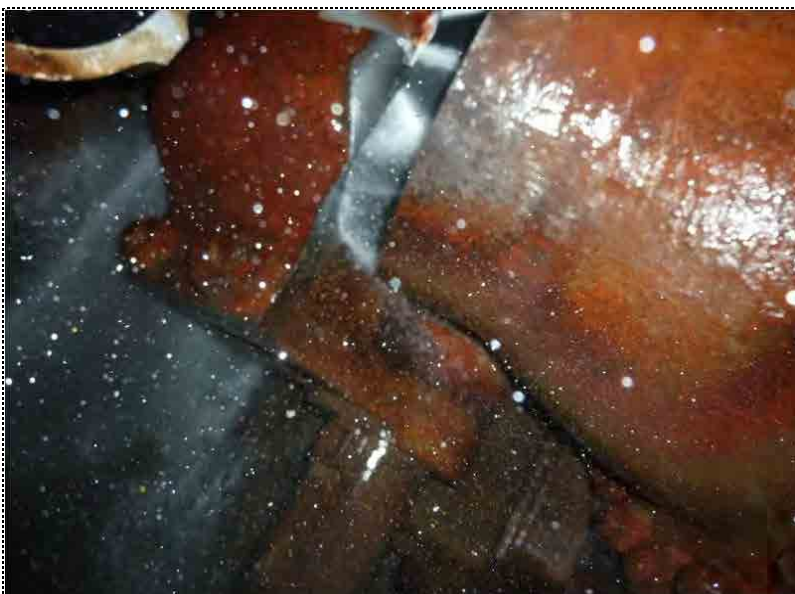
No T-001

Unit No. 4 A Upper Needle Water Leakage

Large water leakage from 4A needle nozzle is observed.

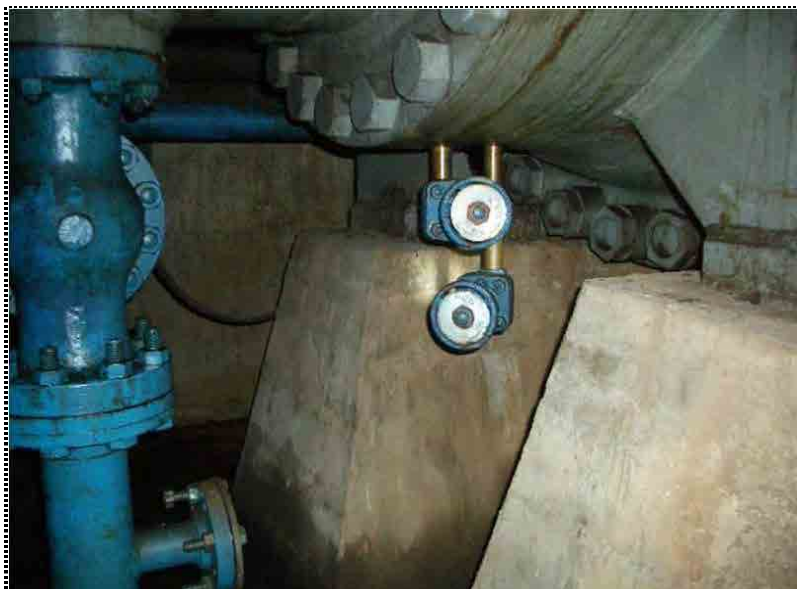
No T-005

Unit No. 4 A Water Drain Piping of  
Downstream Seal is Removed

Downstream seal supply and drain line is no  
longer used.

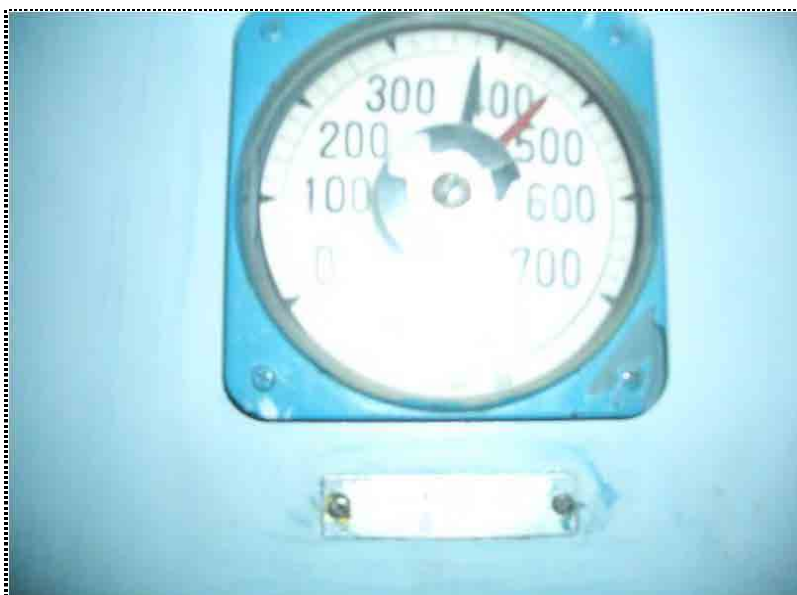
No T-015

Unit No. 4 Governor Tank Level Gauge

Sight level gauge is discolored.

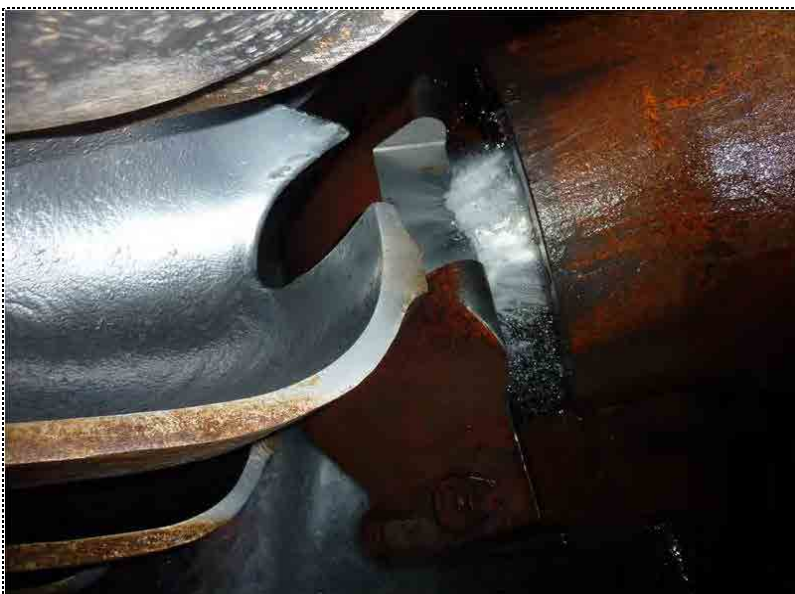
No T-001

Unit No. 5 A Upper Needle Nozzle Leakage

Due to heavy water leakage, details of needle tip surface cannot be inspected.

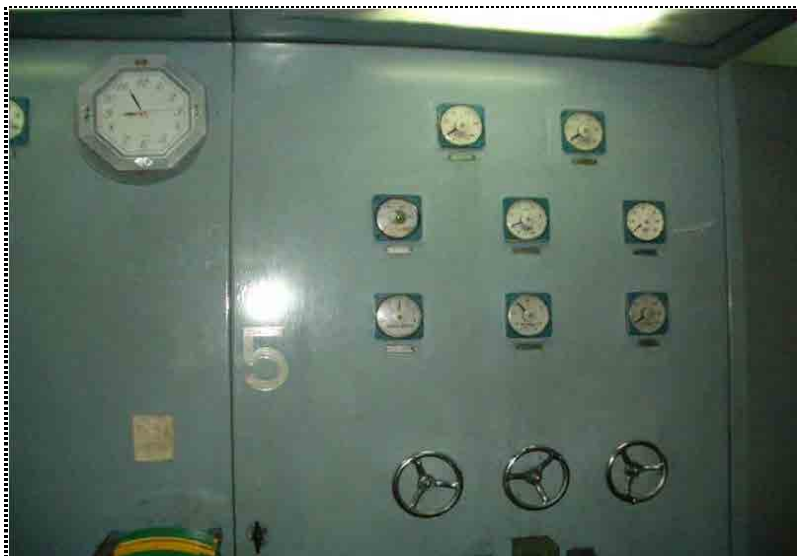
No T-008

Unit No. 5 B Inlet Valve Servomotor

Too much grease is supplied to inlet valve stem.

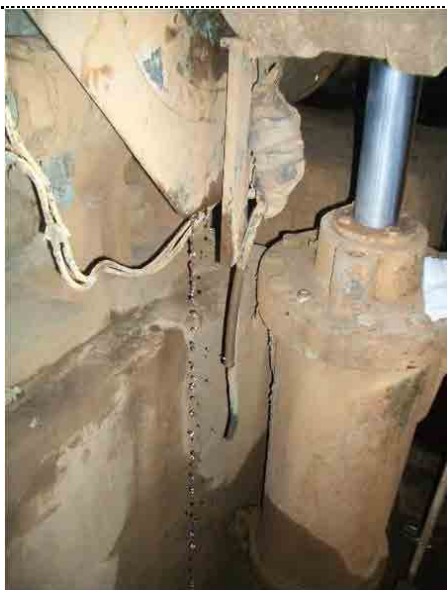
No T-007

Plugged Grease Line for Inlet Valve Stem

Grease supply line to inlet valve stem is plugged.

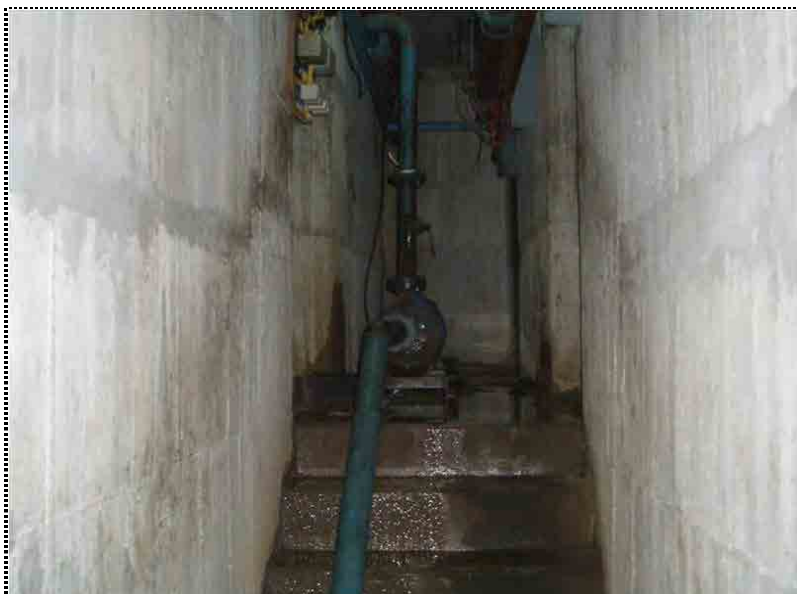
No AU-001

Temporary House Drainage Pump Unit

The existing drainage pumping units are no longer used, and temporary pump unit is installed. This pump unit does not have enough capacity to drain water.

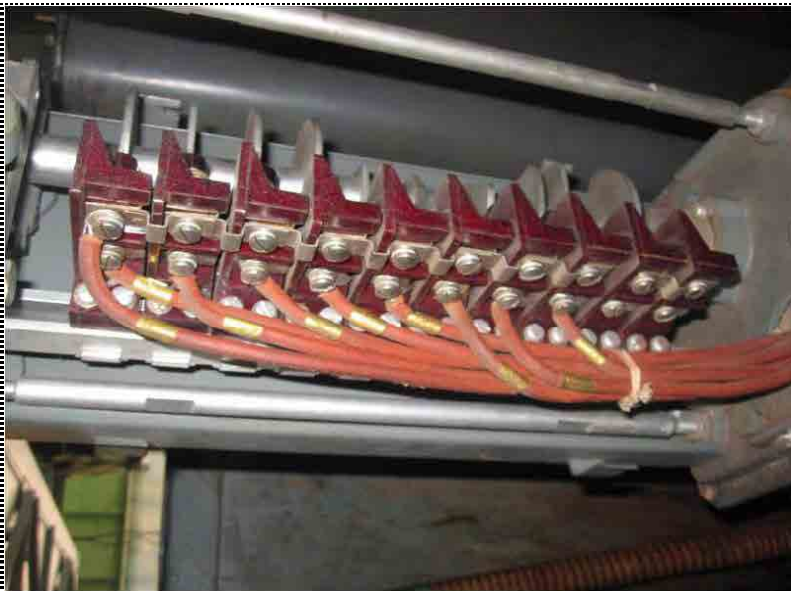
No C-002

Overall View of Master Controller for  
Travelling

Only one speed (the lowest speed) is  
available to move right side direction

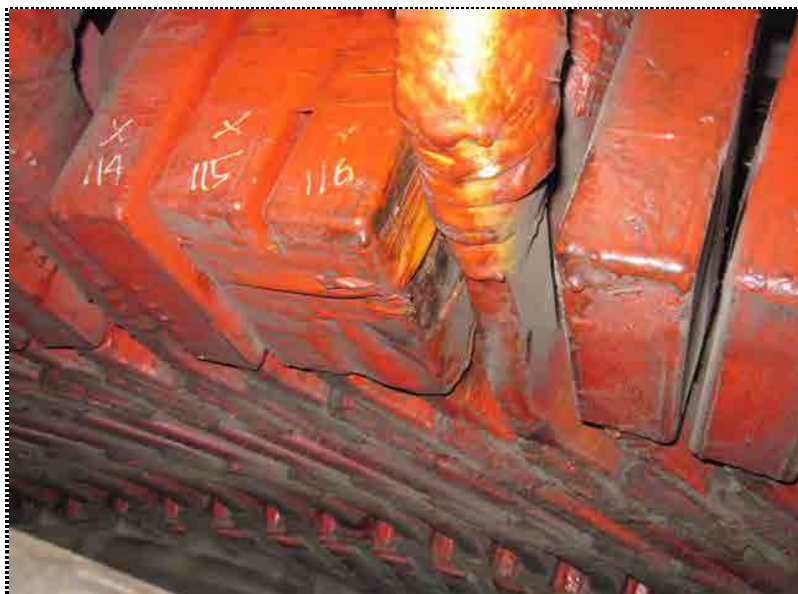
No 1

- 1) Coil cover was damaged by repair work.
- 2) No Discoloration, no powder occurrence
- 3) Contamination by oil and carbon particles
- 4) A part of core duct at the upper side of stator came down by 5mm.
- 5) See the attached. The value of the polarity index was decreased due to high humidity.

Stator Coil

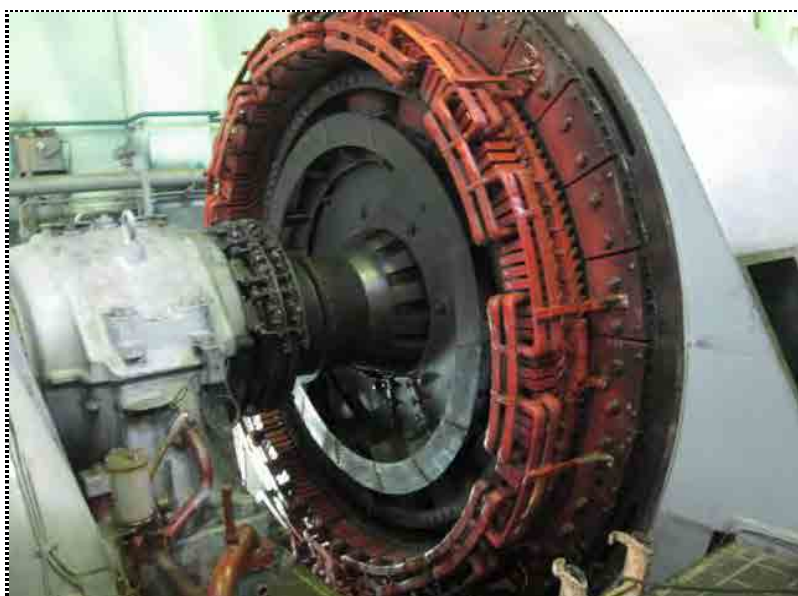
No 2

Stator Coil

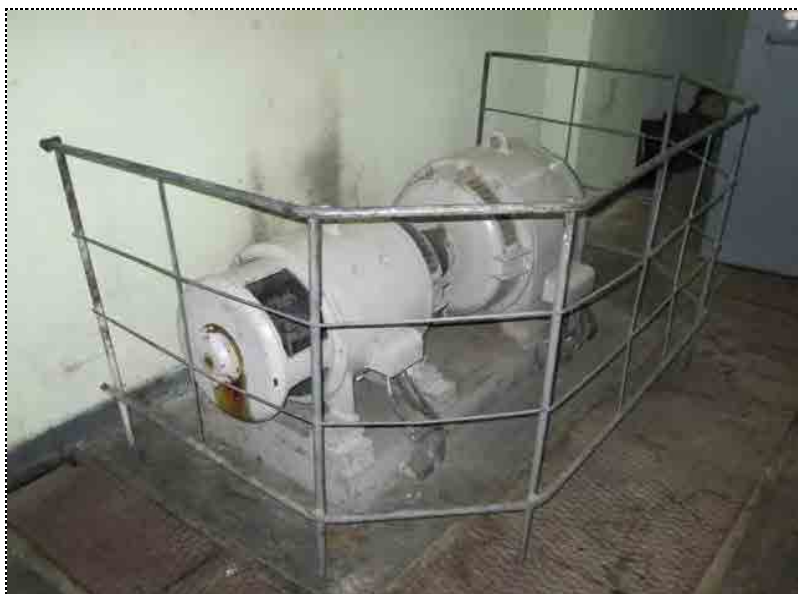
No 10

- 1) Discoloration of the commutator was observed.
- 2) Overall deterioration was observed.

HTD

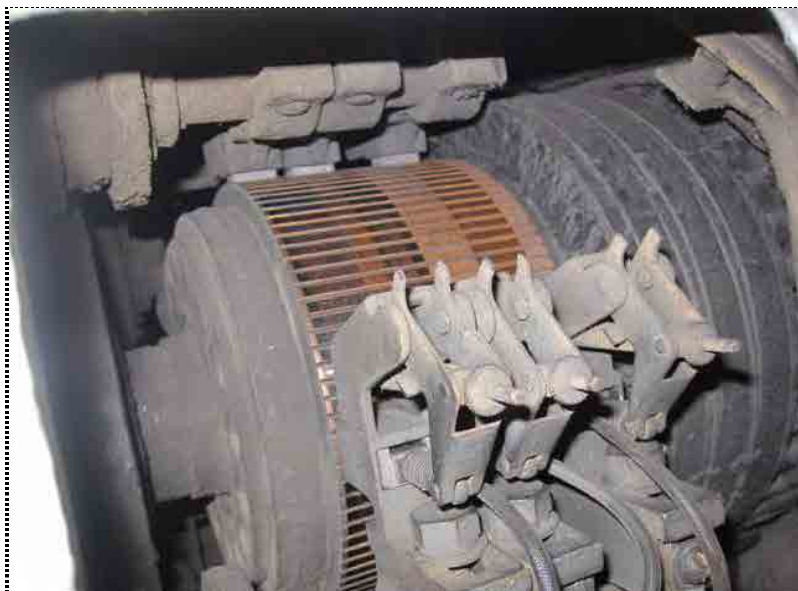
No 11

HTD

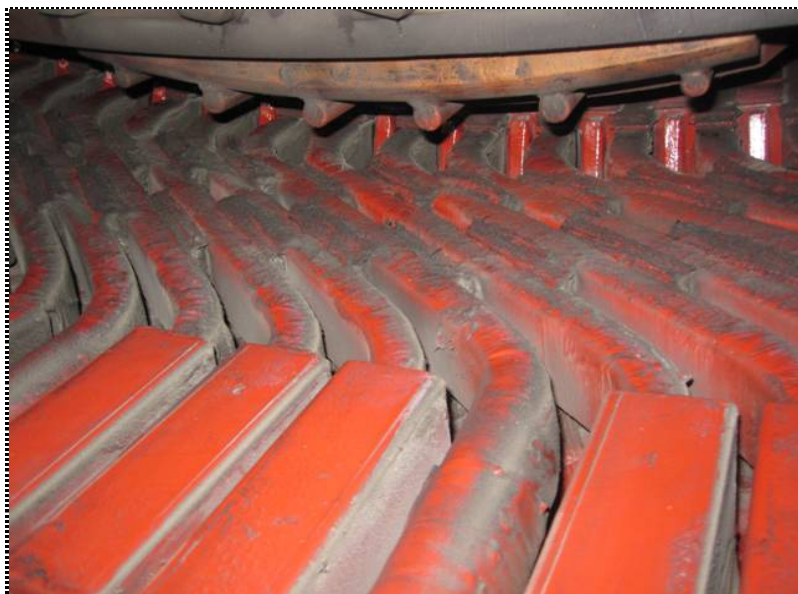
No 1

- 1) No Discoloration, no powder occurrence
- 2) The insulation resistance value of stator windings for U, V, W and N measured by 500V Meggar was 0.05 MΩ. It is supposed that the value of the insulation resistance was decreased since the terminals absorbed moisture in the pit.

Stator Coil

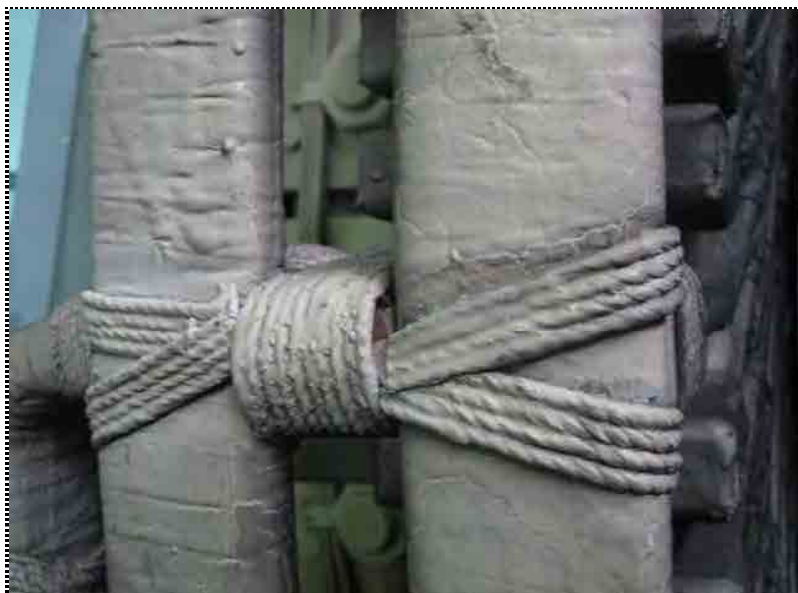
No 2

Stator Coil

Coil Binding

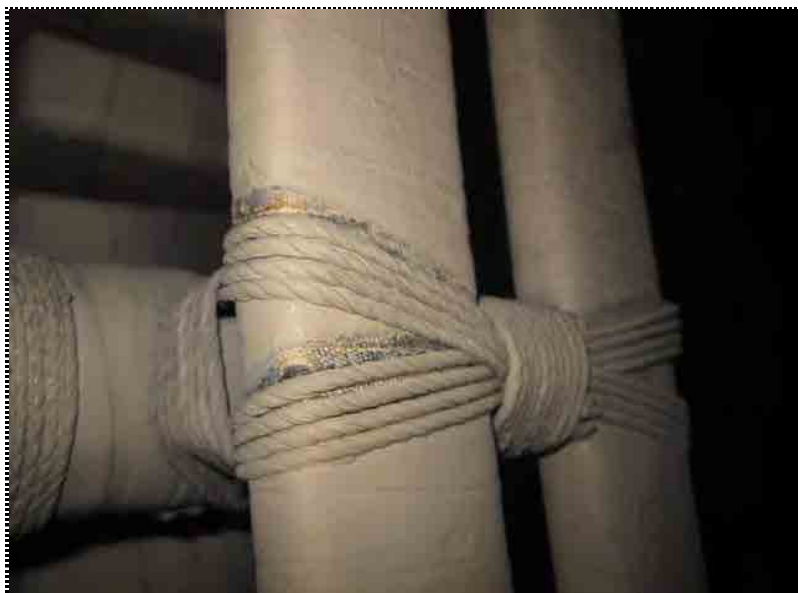
No 2

Stator Coil

Coil Binding

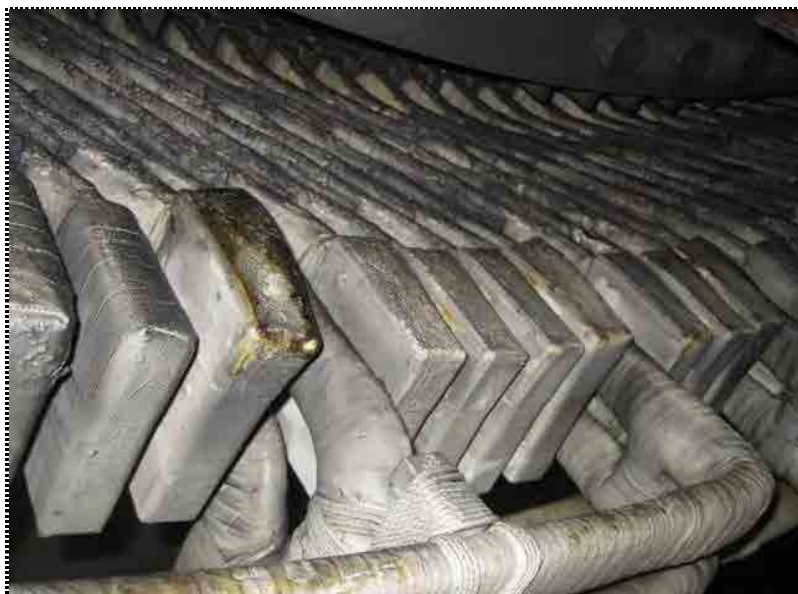
No 1

Stator Coil

Discoloration and Deformation of Coil Cover

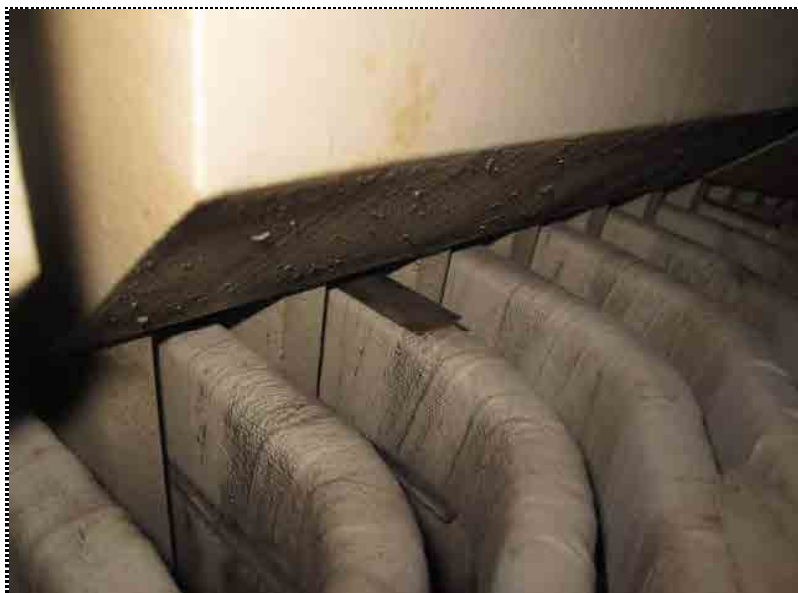
No 2

Stator Coil

A spacer for stator coil is coming off

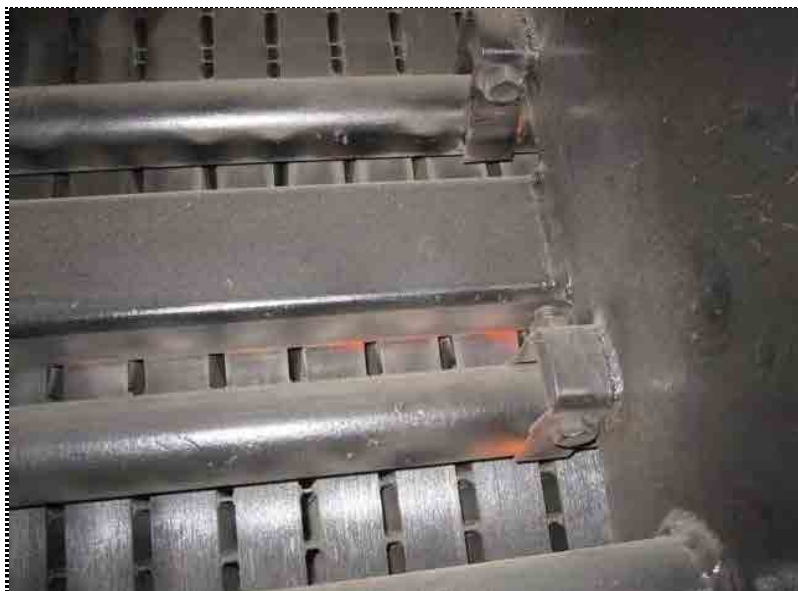
No 5

Stator Coil

a drop of the wedge

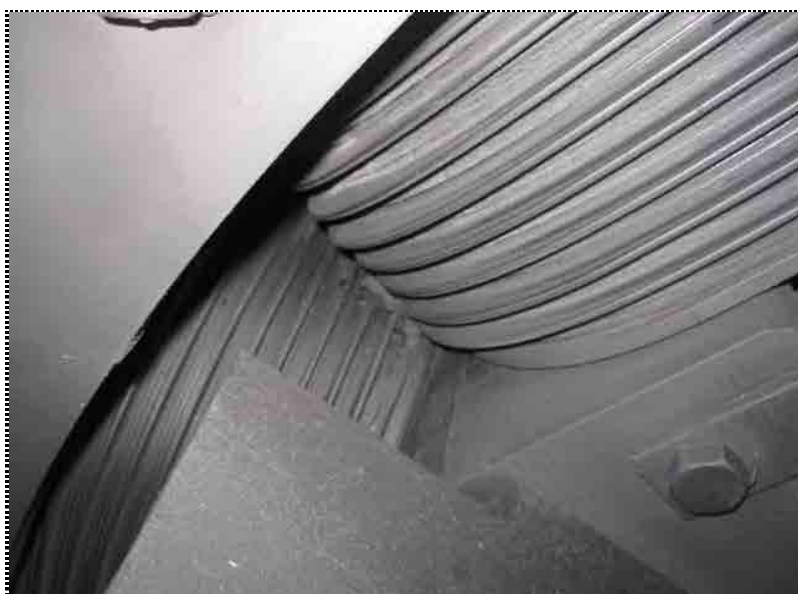
No 6

Stator Core

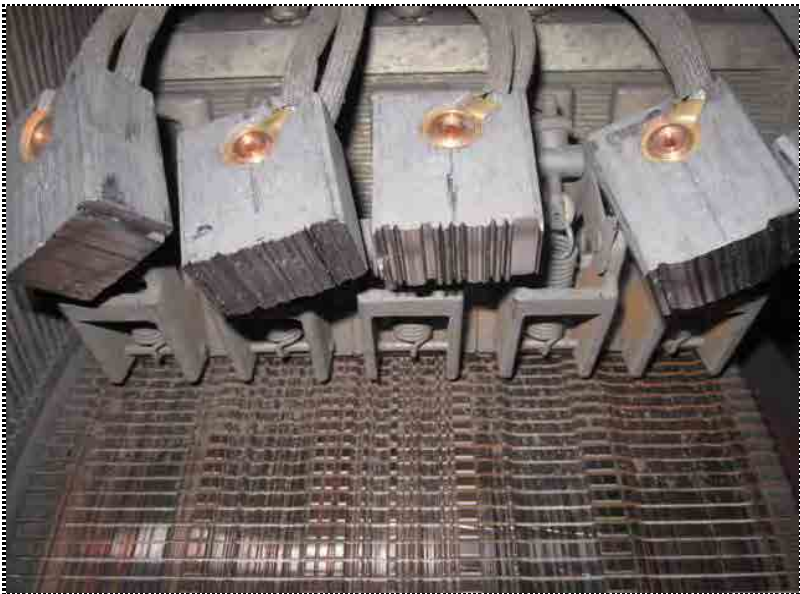
No 7

Rotor Winding

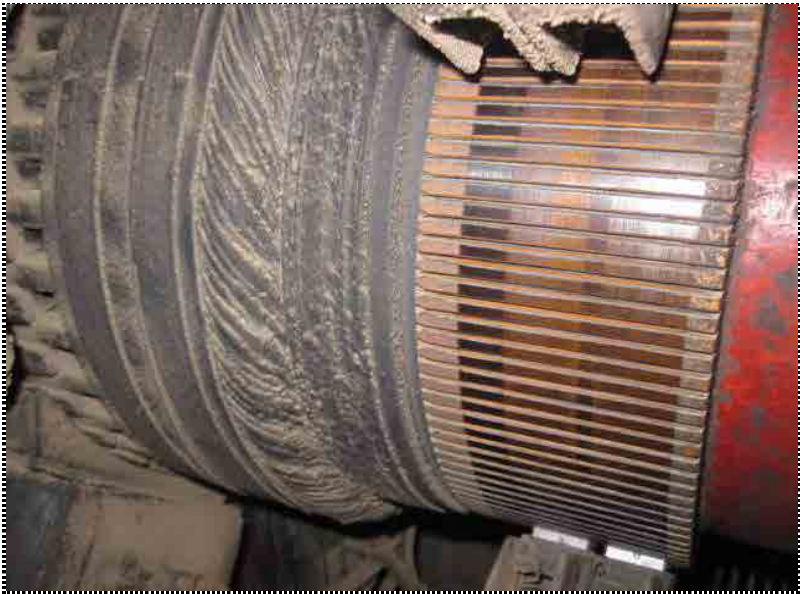
No 8

DC Exciter

Commutator and Brush

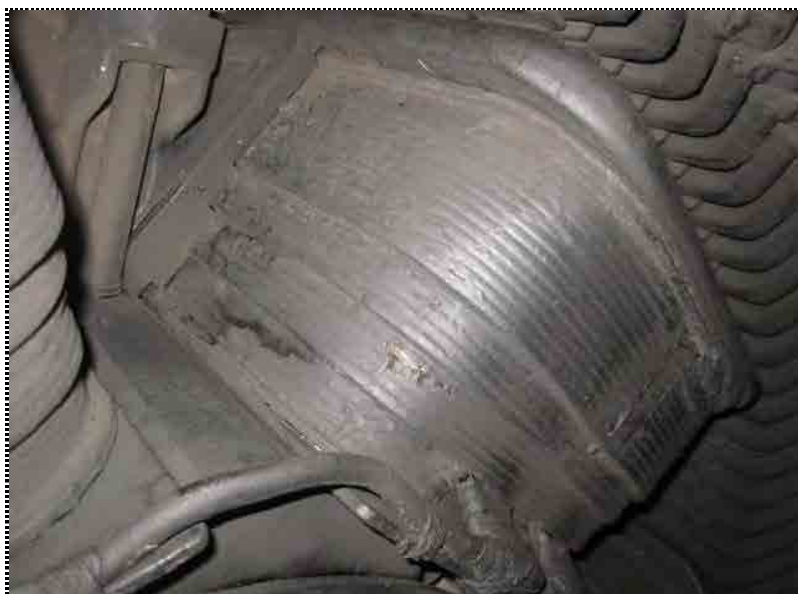
No 4

Items		Result	Photo No.
1	Condition of Connecting Conductor	○	
2	Condition of Fan	○	
3	Condition of Coil Insulation Material	△ <sup>(1)</sup>	4
4	Pollution on Rotor Coils and Collector Ring	○	
5	Abrasion Damage of Commutator, Collector Ring	○	5
6	Insulation resistance	—

- 1) Damage of coil insulation material was observed.

Stator Core

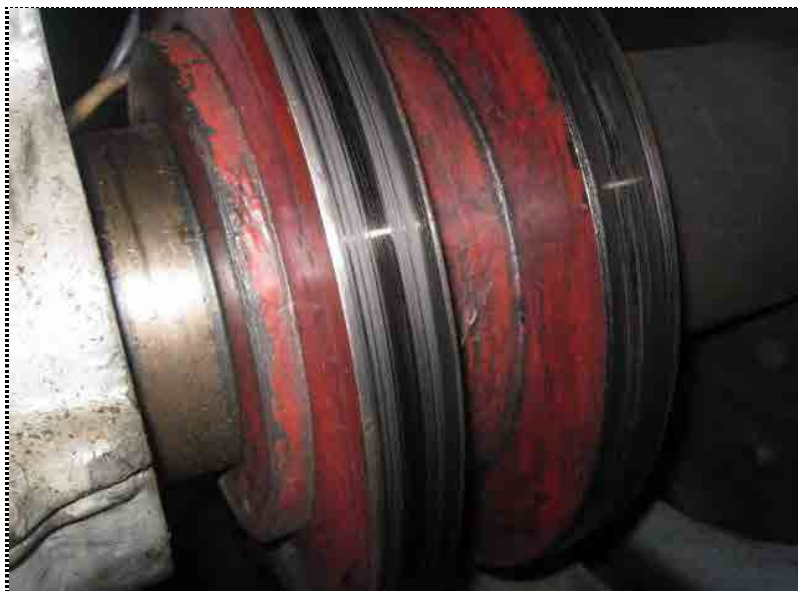
No 5

Rotor Winding

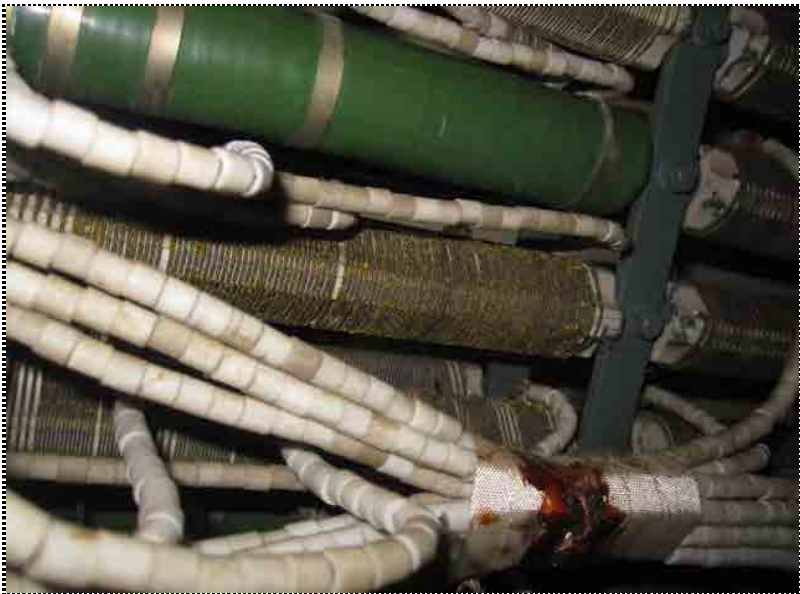
No 7

Items		Result	Photo No.
1	Condition of Exciter	○	6
2	Condition of HTD	—	
3	Condition of Excitation control cubicle	△ <sup>(1)</sup>	7, 8

- 1) Overall deterioration was observed.

Commutator

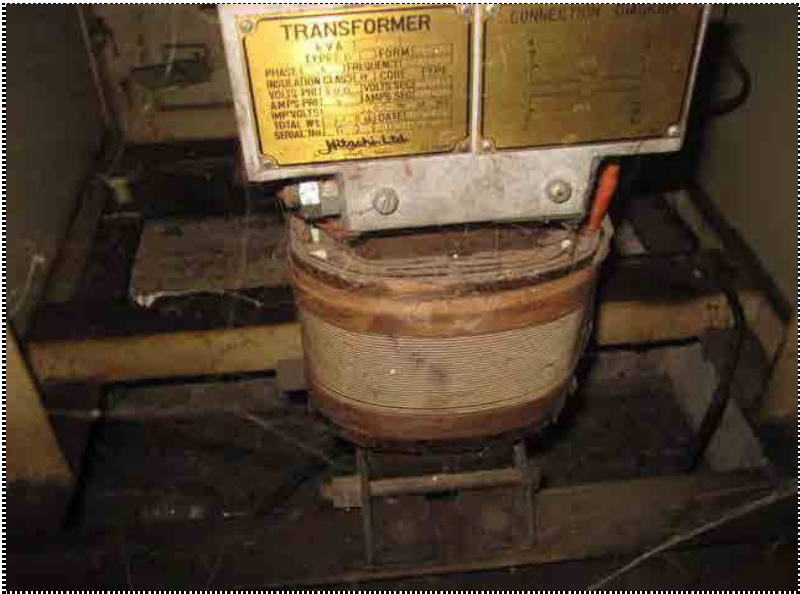
No 8

Excitation System

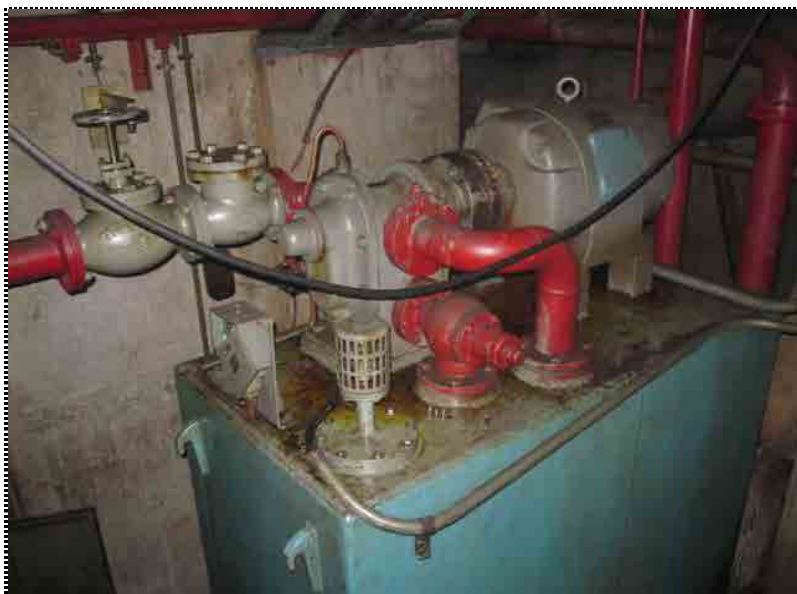
No 1

- 1) Pumps / motors and control panels have been used since commissioning. Heavy oil leakage and aged deterioration was observed for Unit 1 to 3. Relevant relays for Unit 1 to 6 were also deteriorated.
- 2) Bearing metals for Unit 4 to 6 were damaged at the accident in 2011 and replaced with spare ones. There are not any necessary spare ones.
- 3) The oil lifter cannot be operated automatically due to the malfunction of the timer relays on the control panel for Unit 4 to 6.
- 4) All spare parts for the air cooler were damage and it was observed that 20% of piping for spare one was closed due to water leakage.
- 5) A part of the gear for the speed detector of Unit 4 was damaged.

Lubricating oil system

Pump / motor for Unit 1

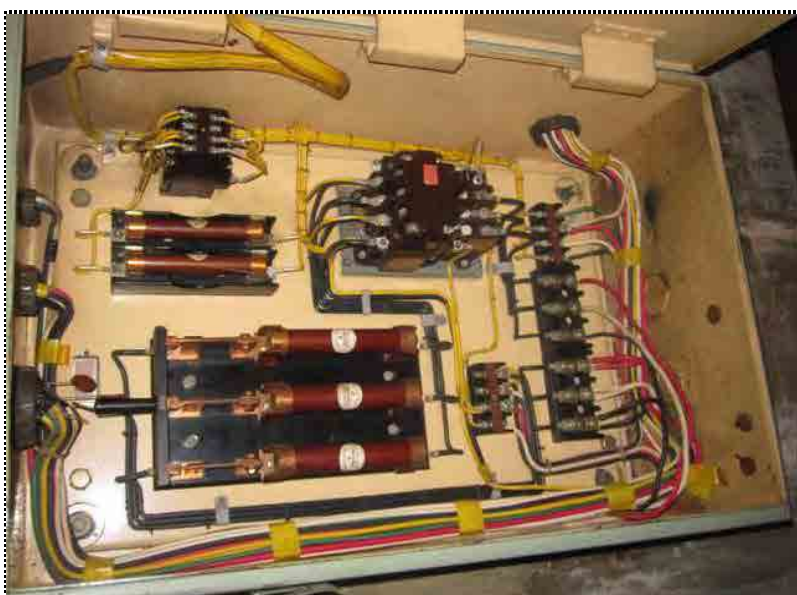
No 2

Lubricating oil system

Control Panel
