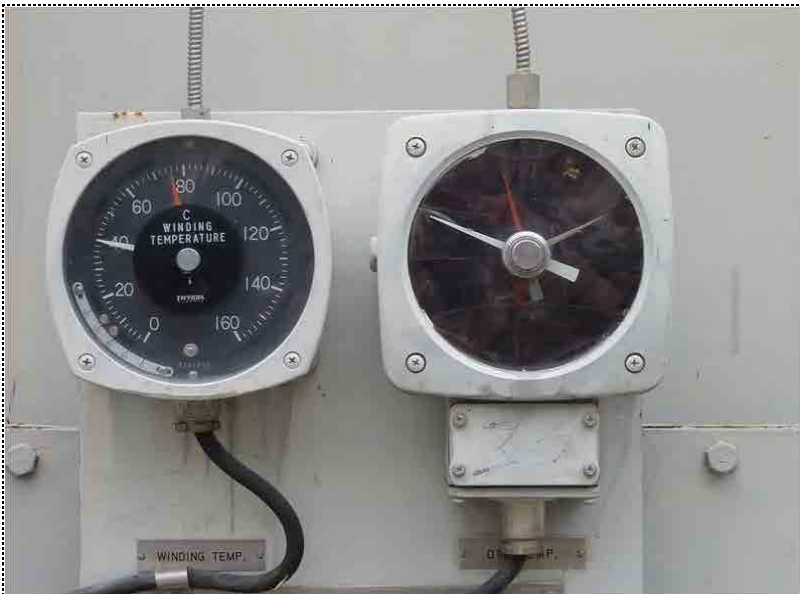
No 324

Booster Transformer 2

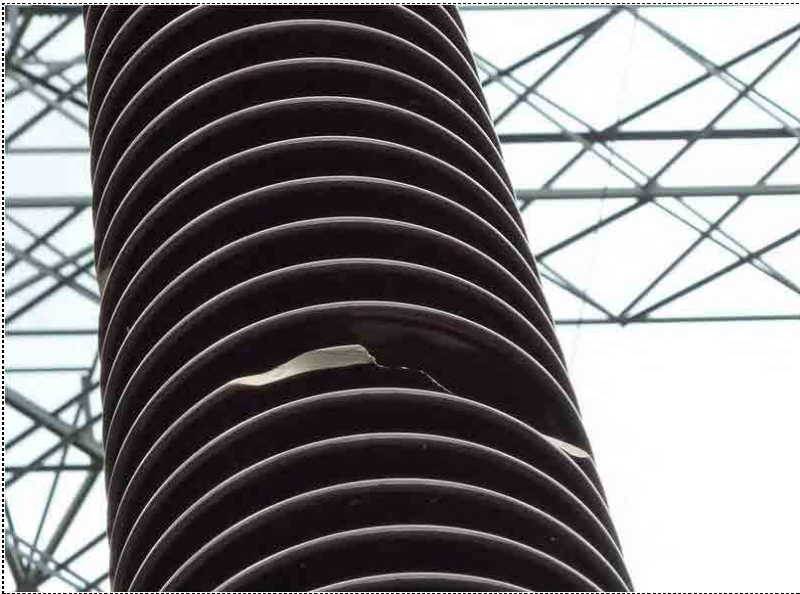
No 325

Booster Transformer 2 (phase A)

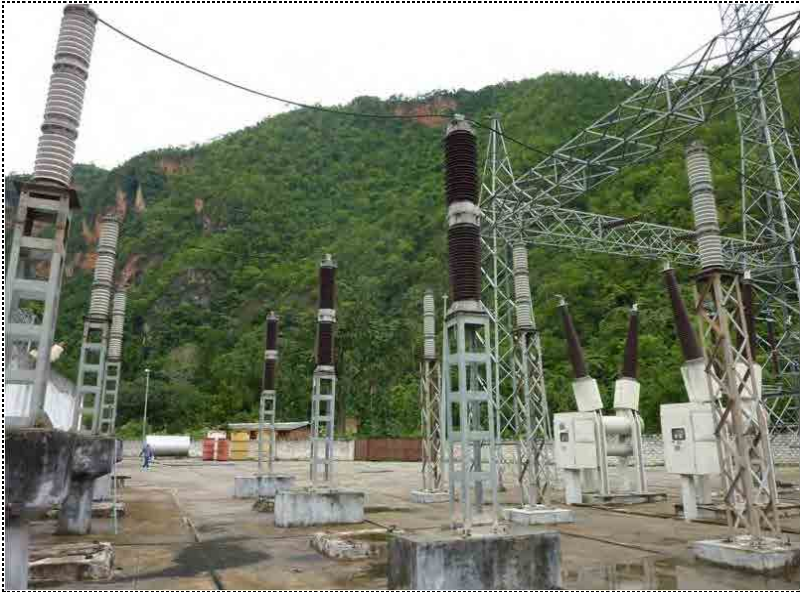
No 326

230kV Arrester (LA2)

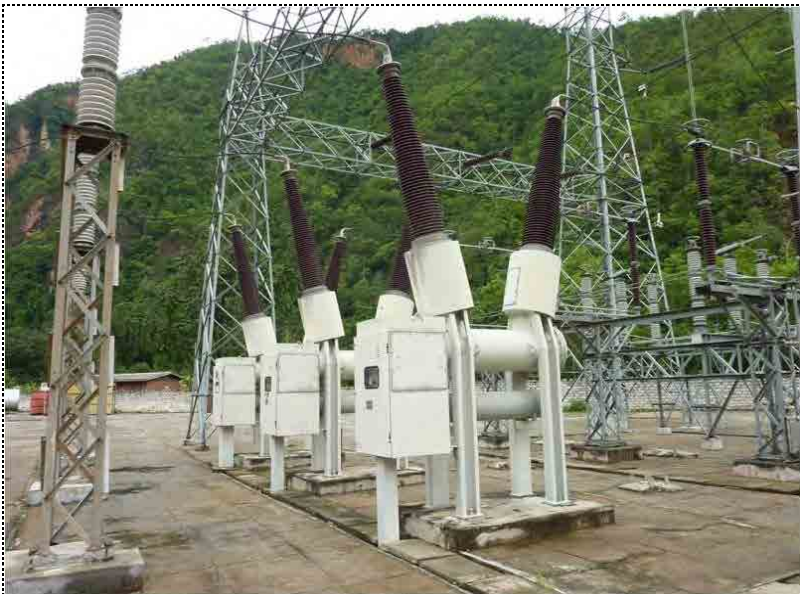
No 327

230kV Circuit Breaker (152-B2)

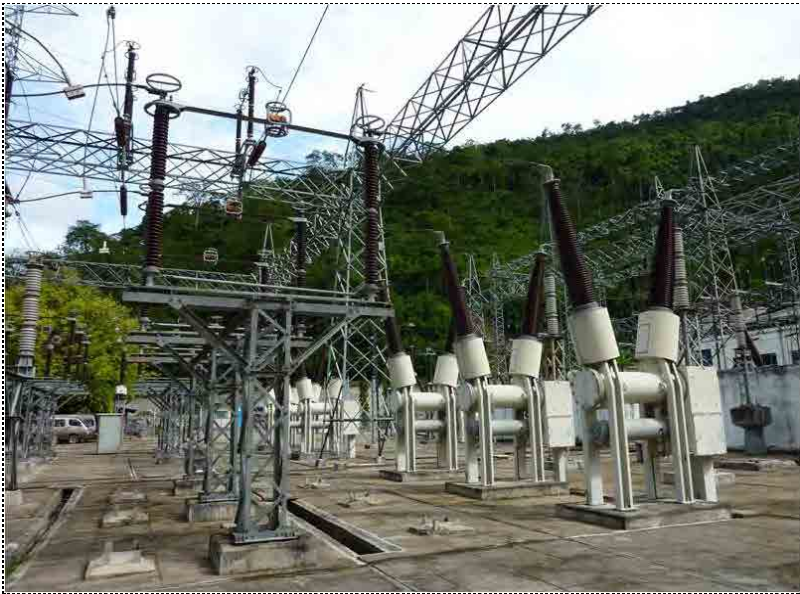
No 328

230kV Disconnecting Switch (189-B2)

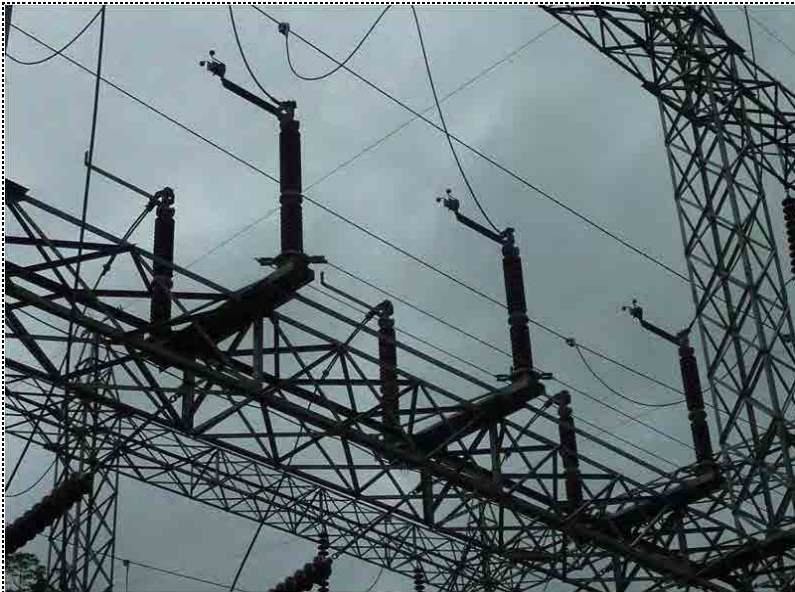
No 401

132kV Disconnecting Switch (128-3)

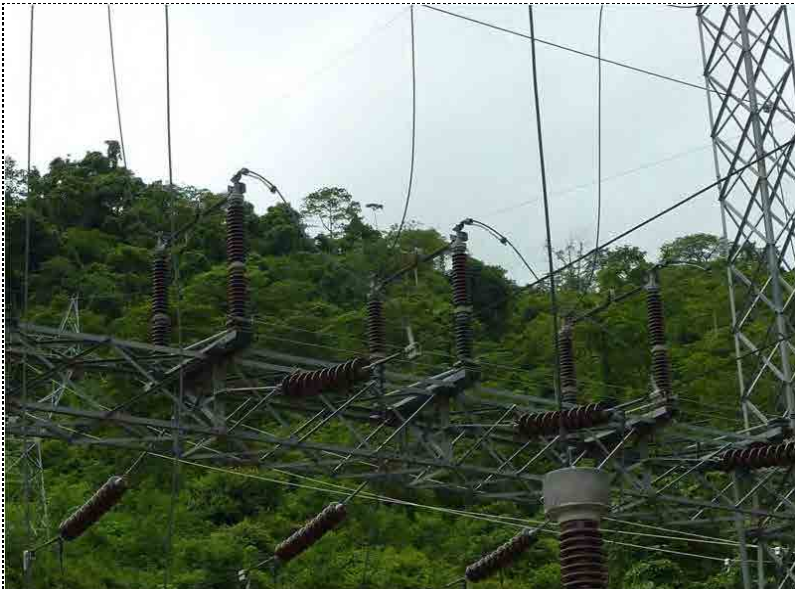
No 402

132kV Disconnecting Switch (128-3)

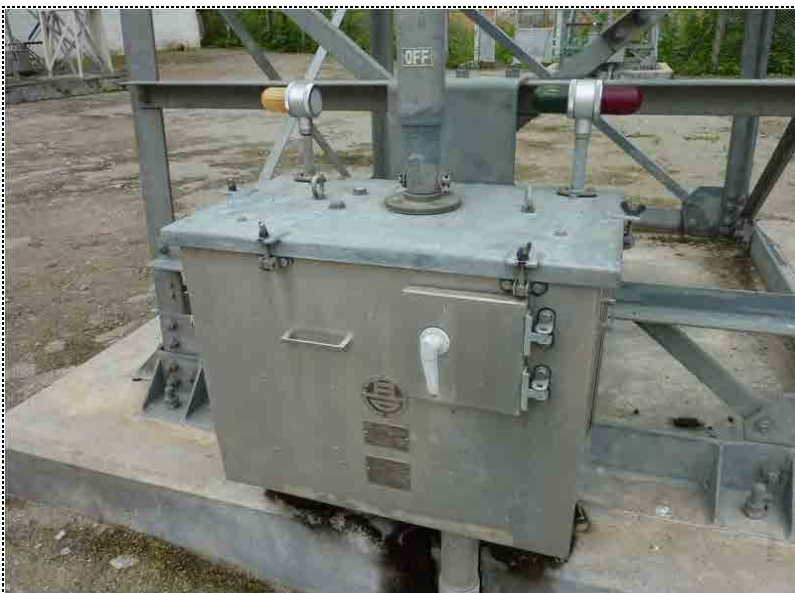
No 403

132kV Disconnecting Switch (228-3)

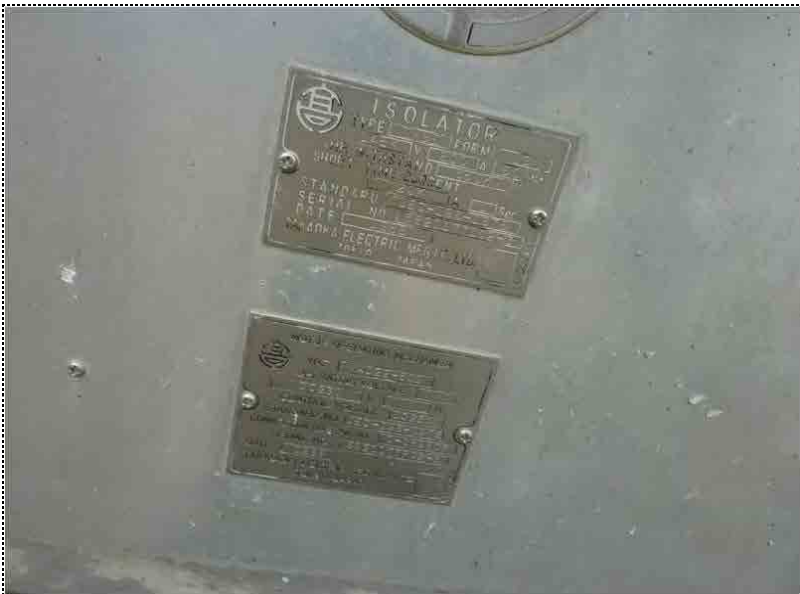
No 401

132kV Disconnecting Switch (228-3)

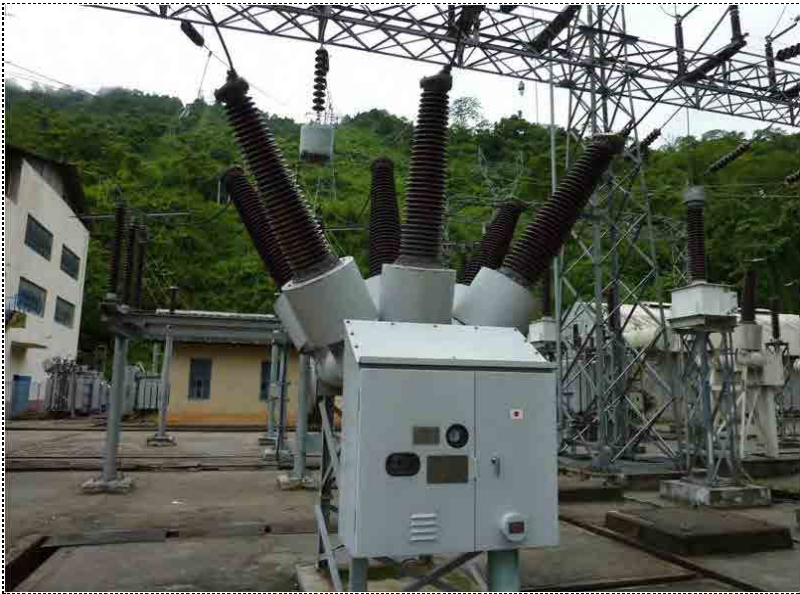
No 402

Circuit Breaker (152-3)

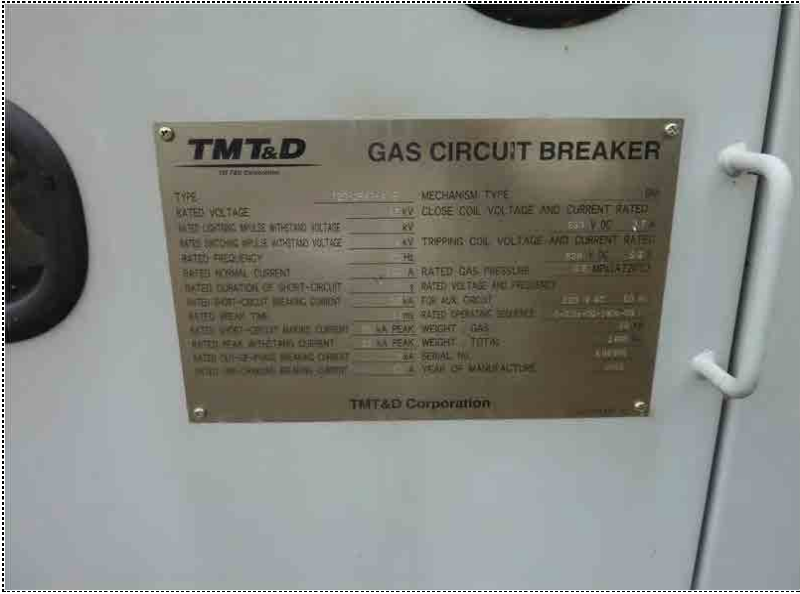
No 403

Circuit Breaker (152-3)

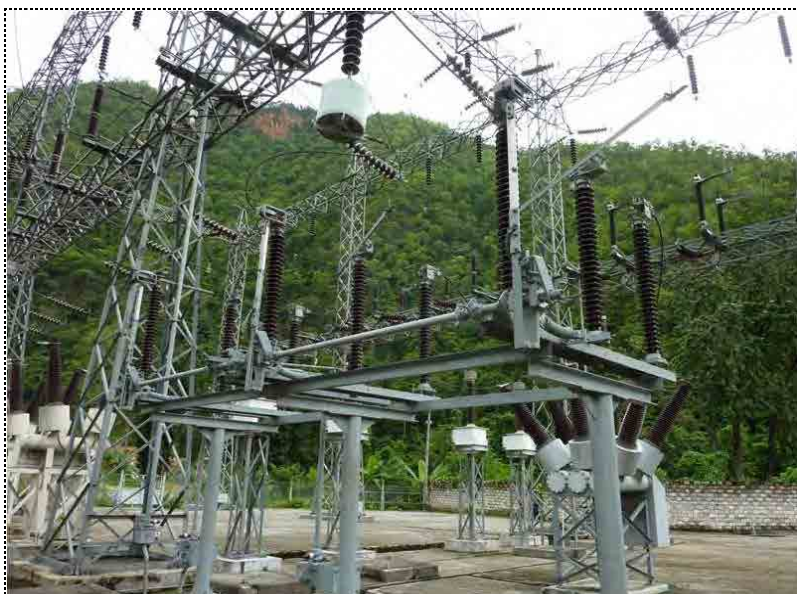
No 404

Disconnecting Switch (289-3)

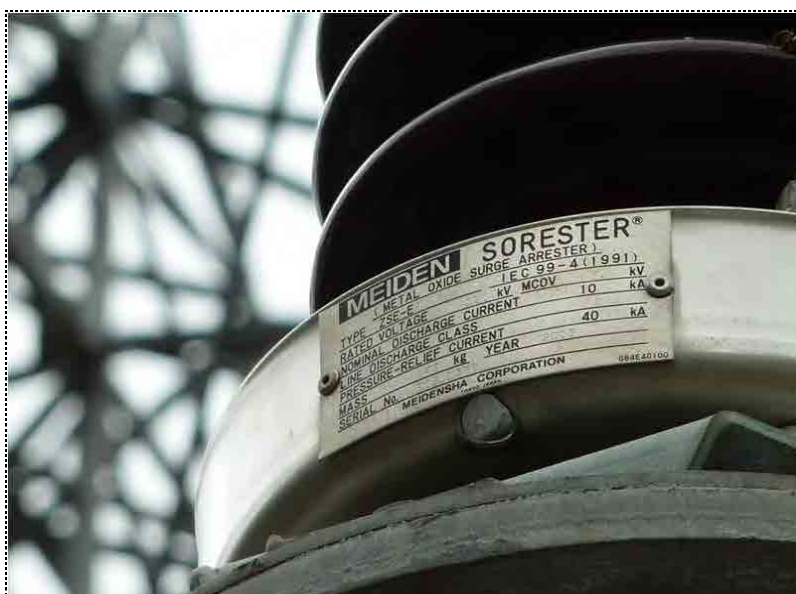
No 409

Arrester (LA)

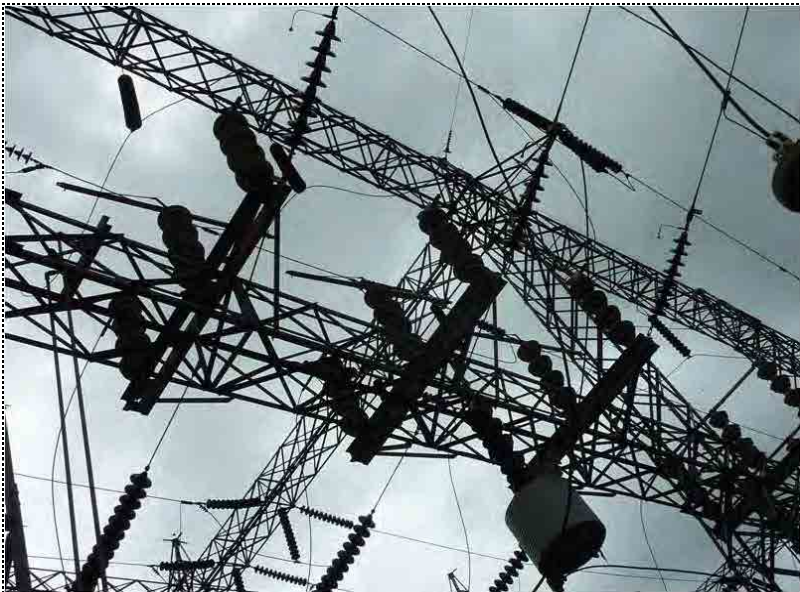
No 503

132kV Disconnecting Switch (228)

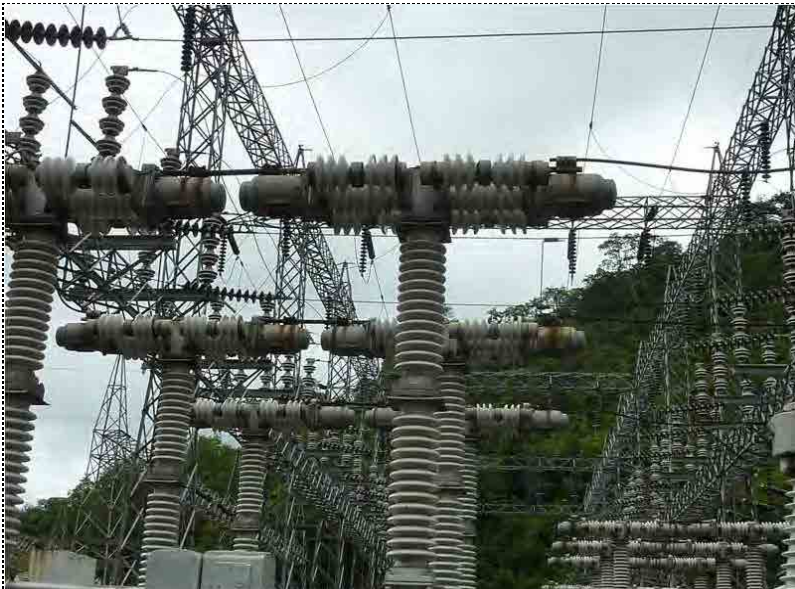
No 505

132kV Circuit Breaker (152-1)

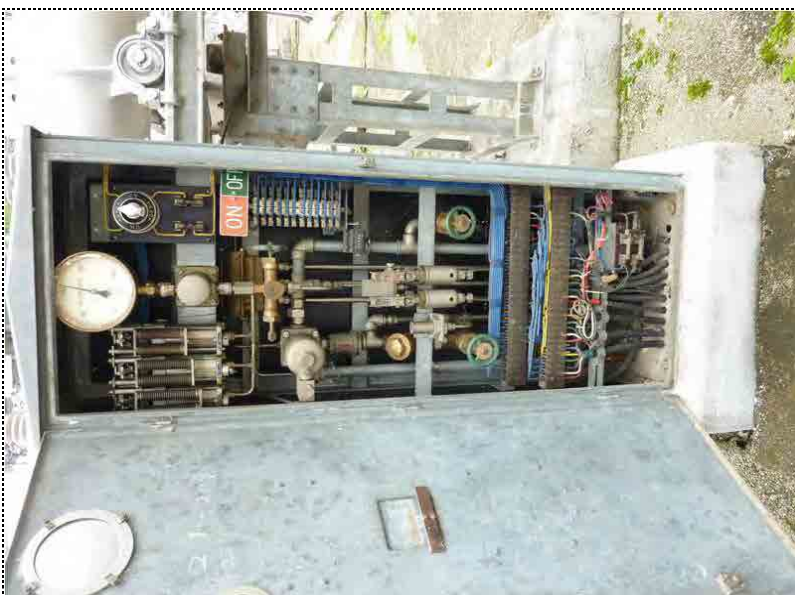
No 506

132kV Circuit Breaker (152-1)

Control panel

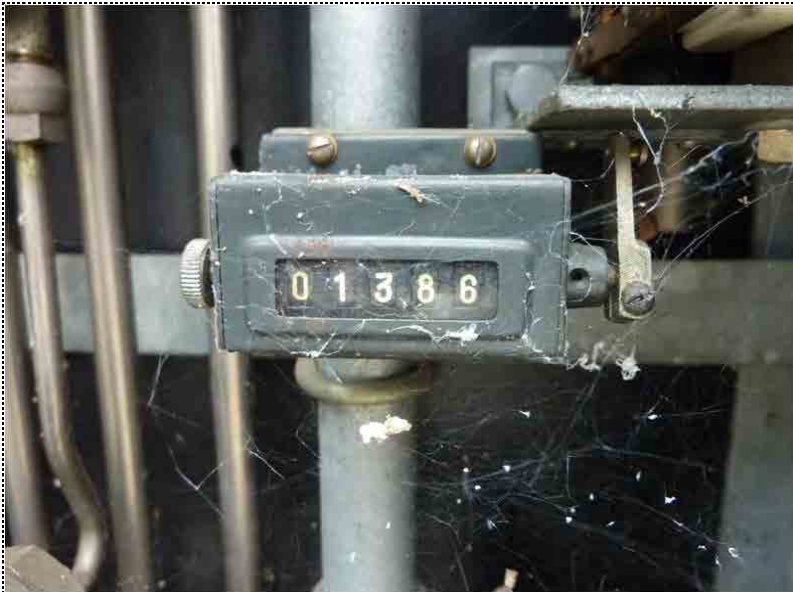
No 507

132kV Circuit Breaker (152-1)

Counter

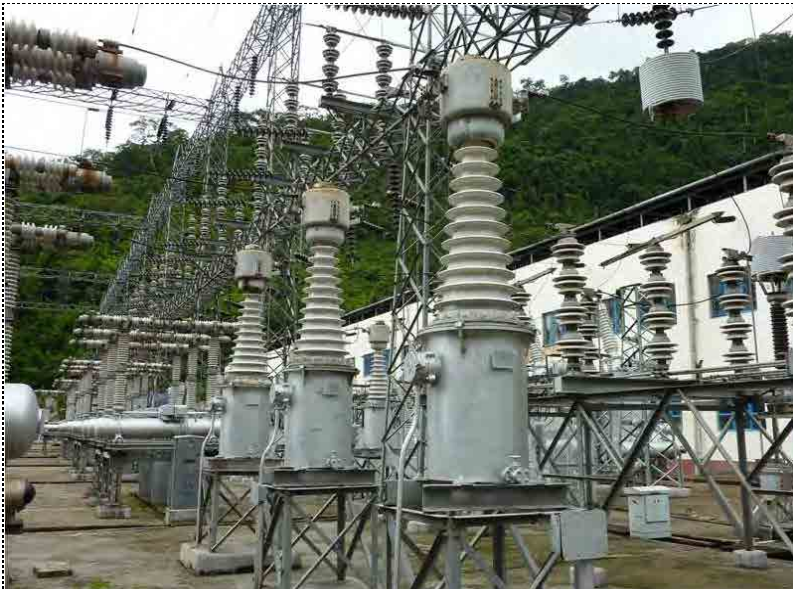
No 508

132kV Current Transformer

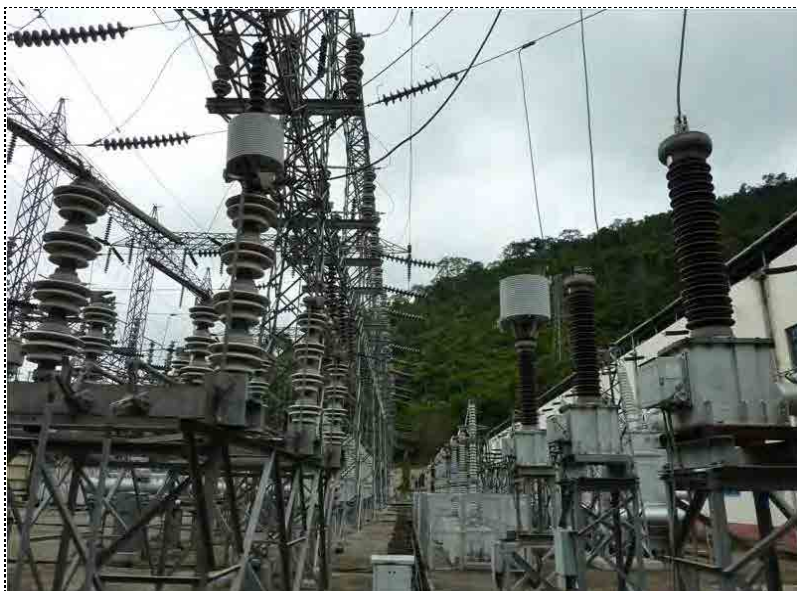
No 511

132kV Capacitor Voltage Transformer

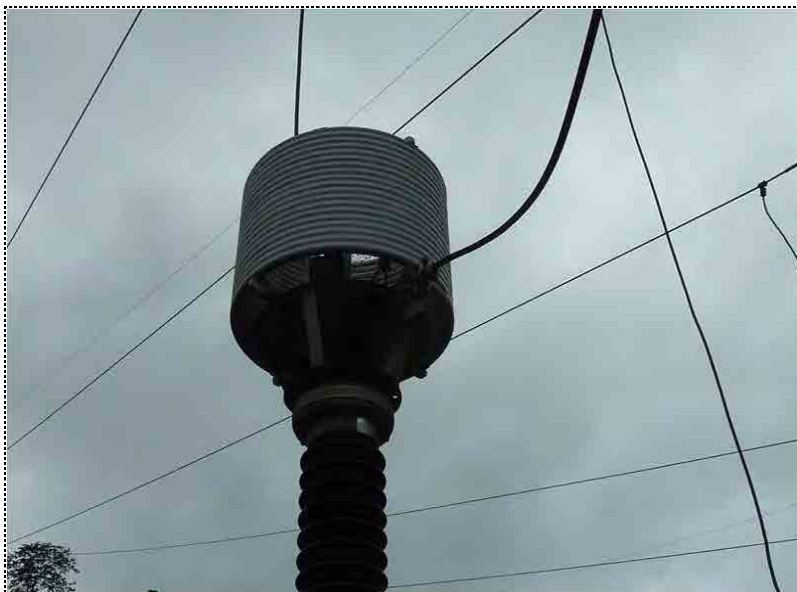
No 513

132kV Capacitor Voltage Transformer
Phase A

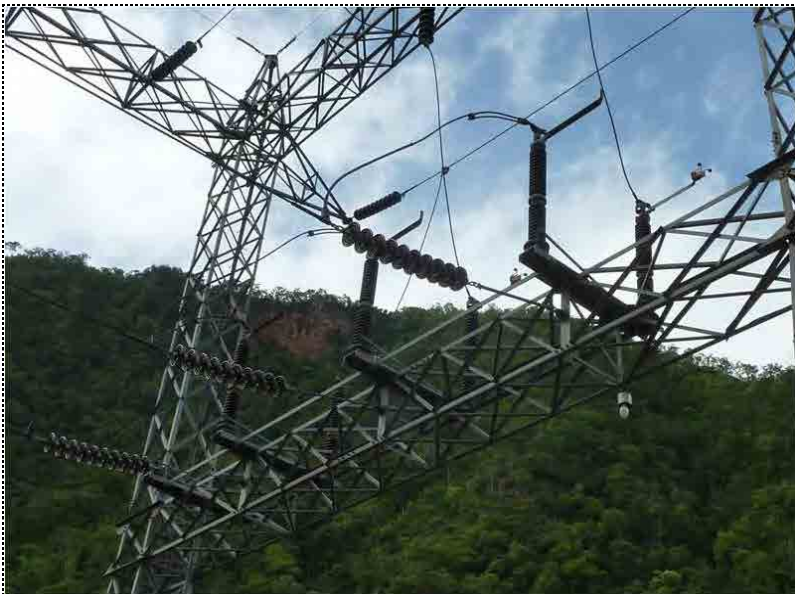
No 601

132kV Disconnecting Switch

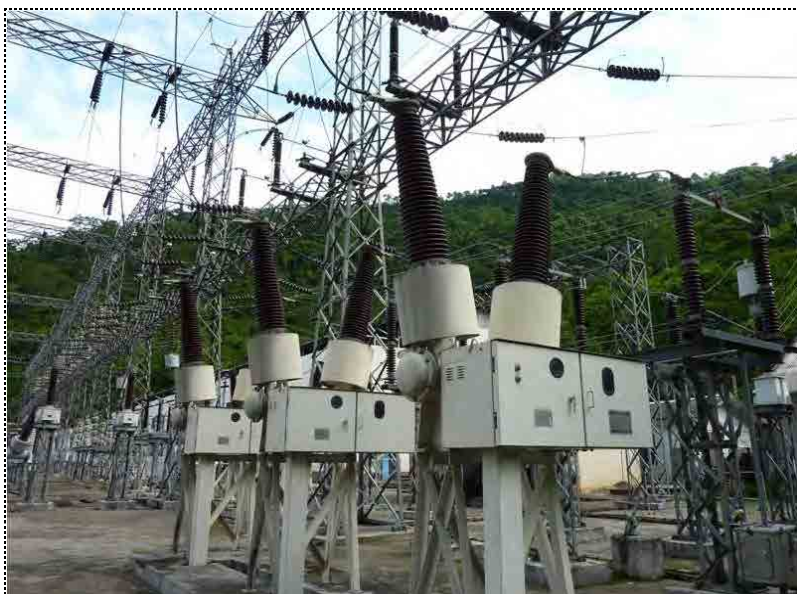
No 604

132kV Circuit Breaker

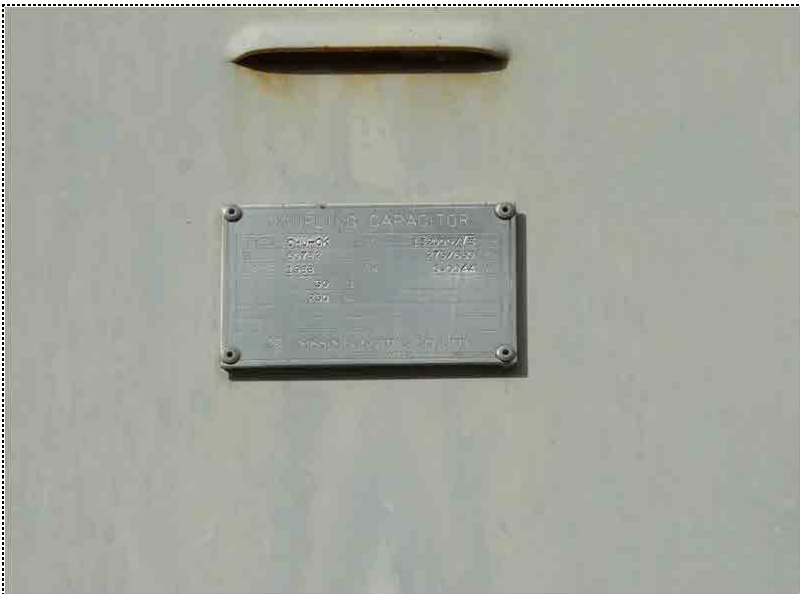
No 610

132kV Coupling capacitor

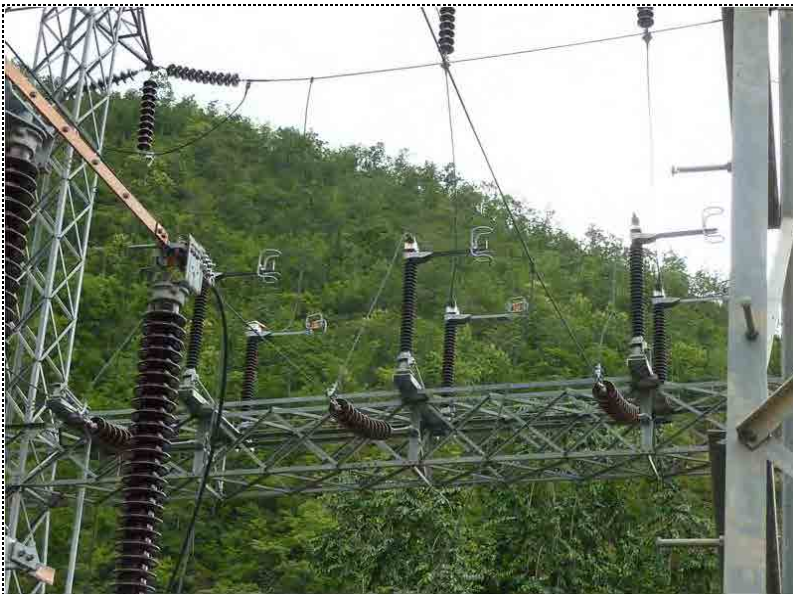
No 701

132kV Disconnecting Switch

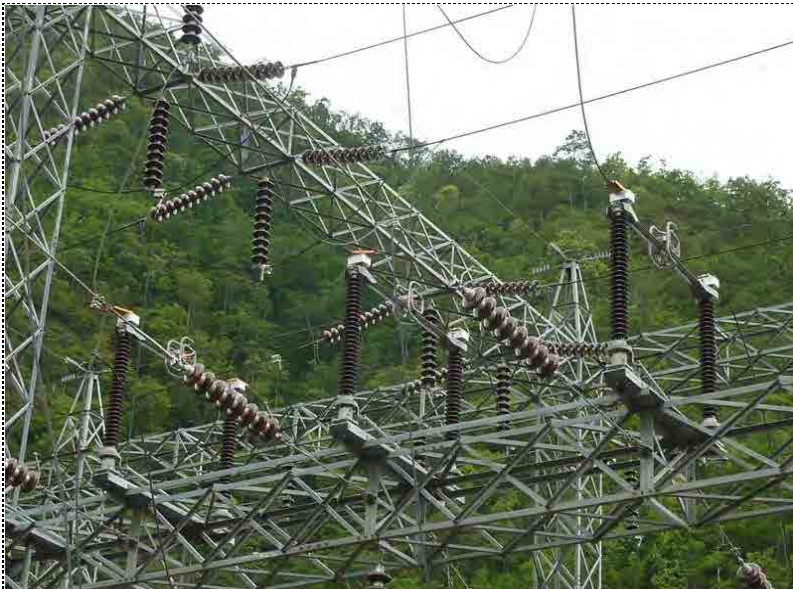
No 702

132kV Disconnecting Switch

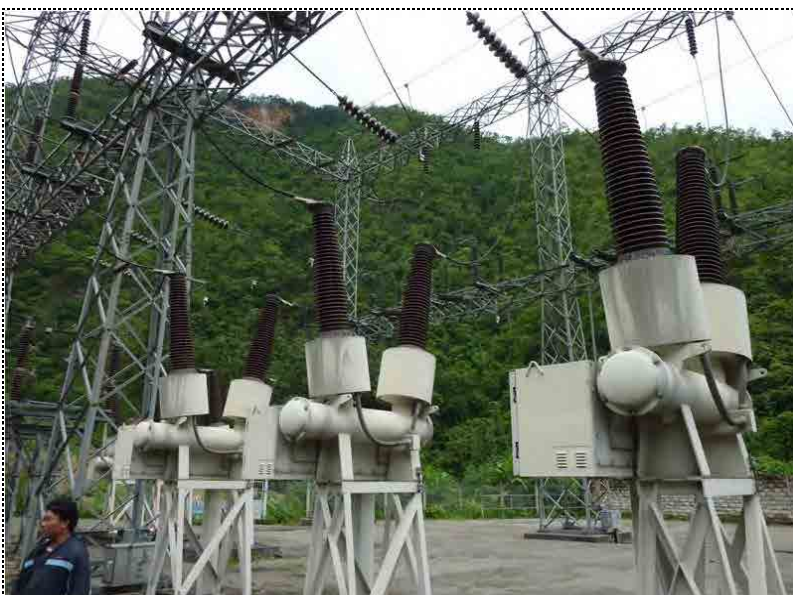
No 703

132kV Circuit Breaker

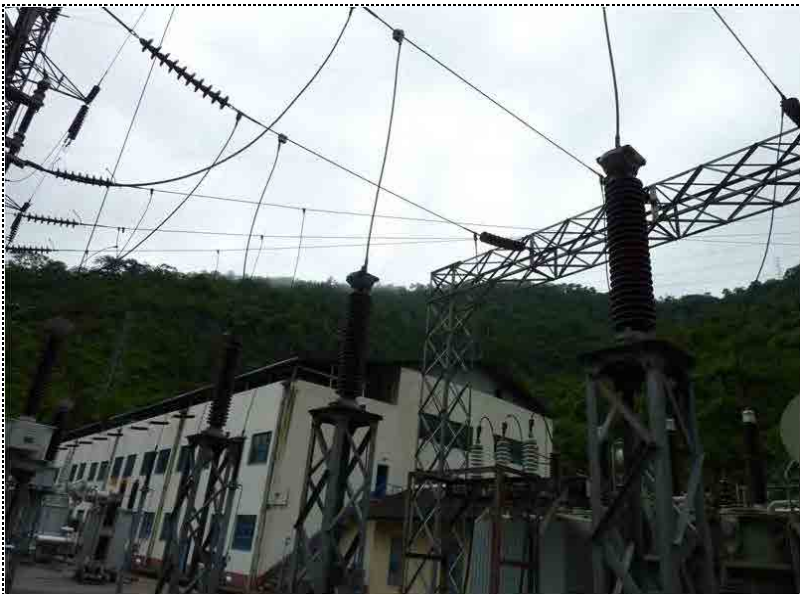
No 704

132kV Arrester (LA)

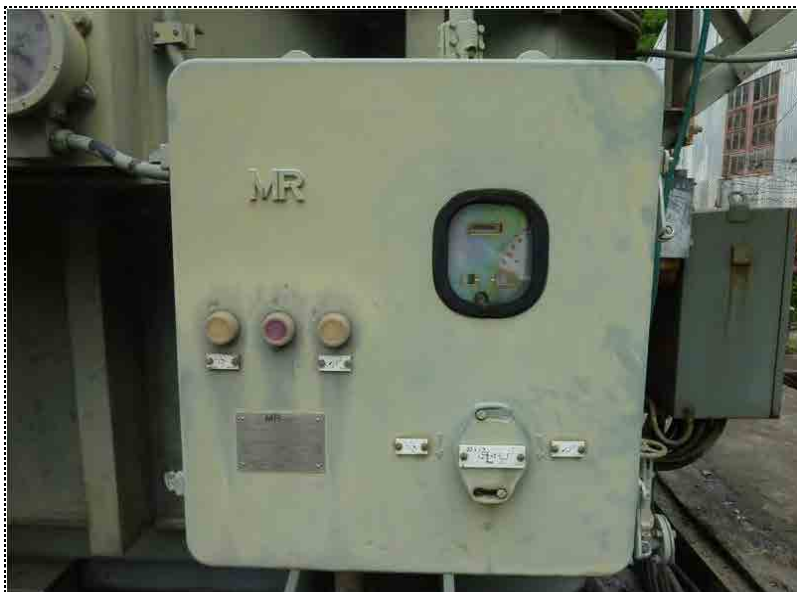
No 707

The INTERBUS transformer was equipped with LTC.

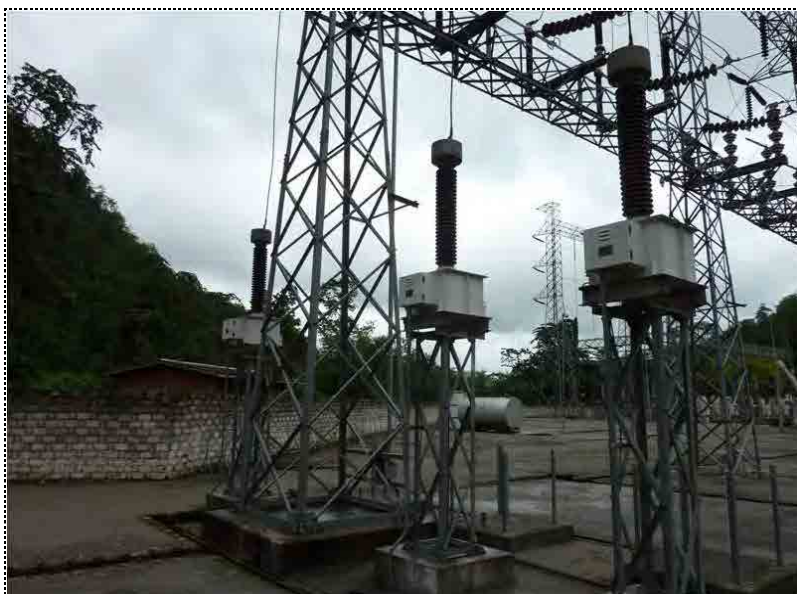
No 801

132kV Capacitor Voltage Transformer
for BUS-A

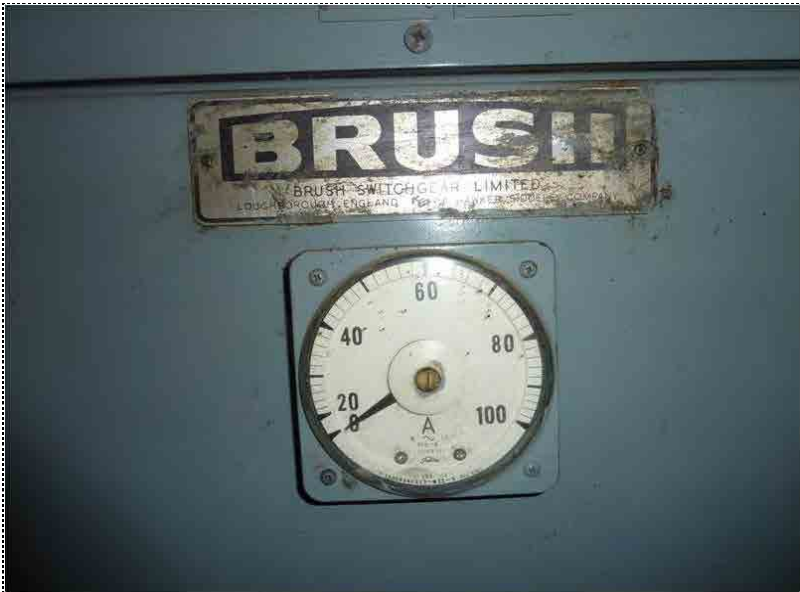
No 914

Specification cannot be confirmed because of no nameplate.

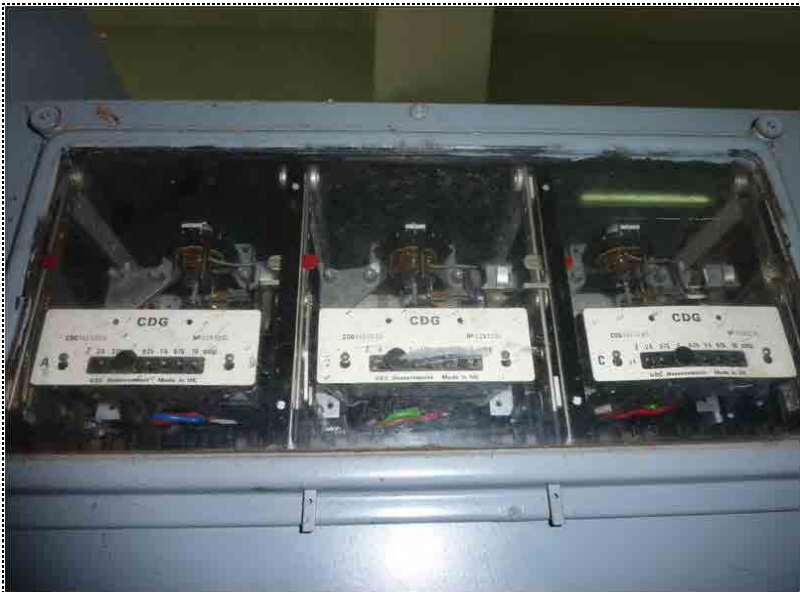
No 915

These relays seem to be OC relay.

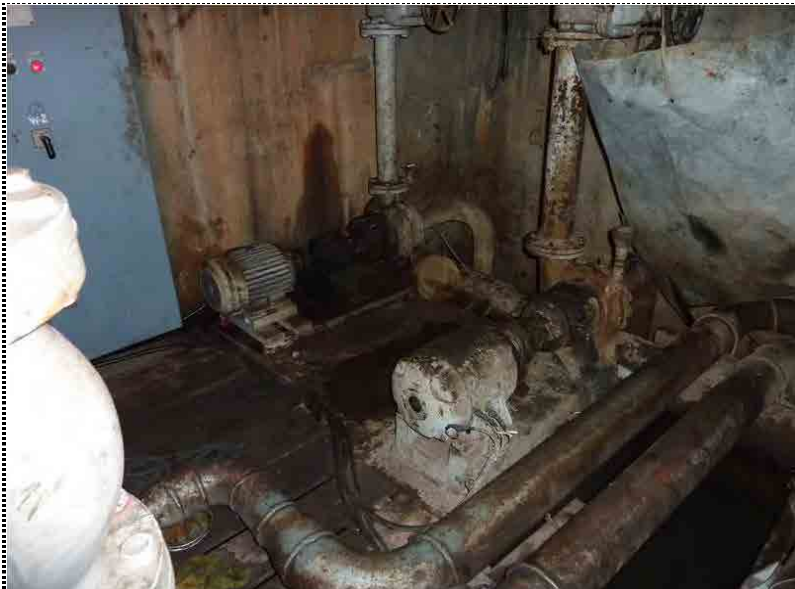
No 1002

Cooling pump system for Booster Tr.

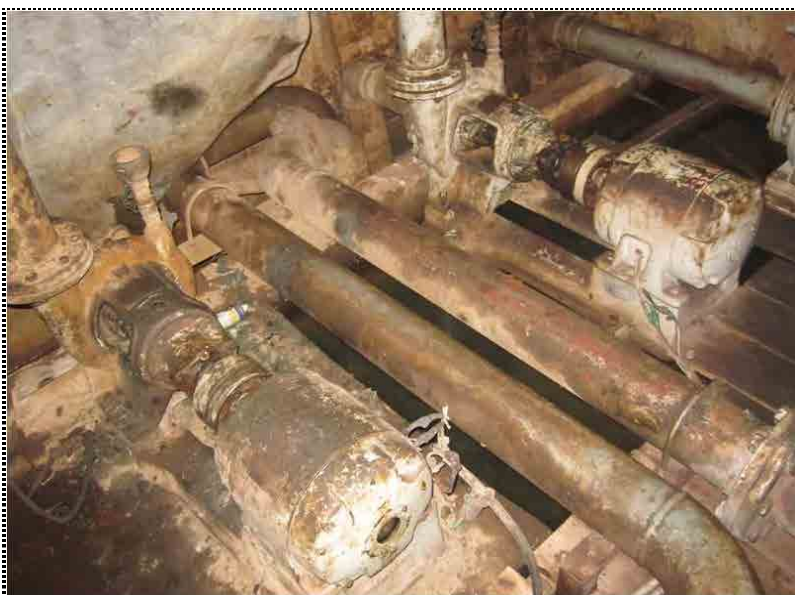
No 1003

Cooling pump system for Booster Tr.

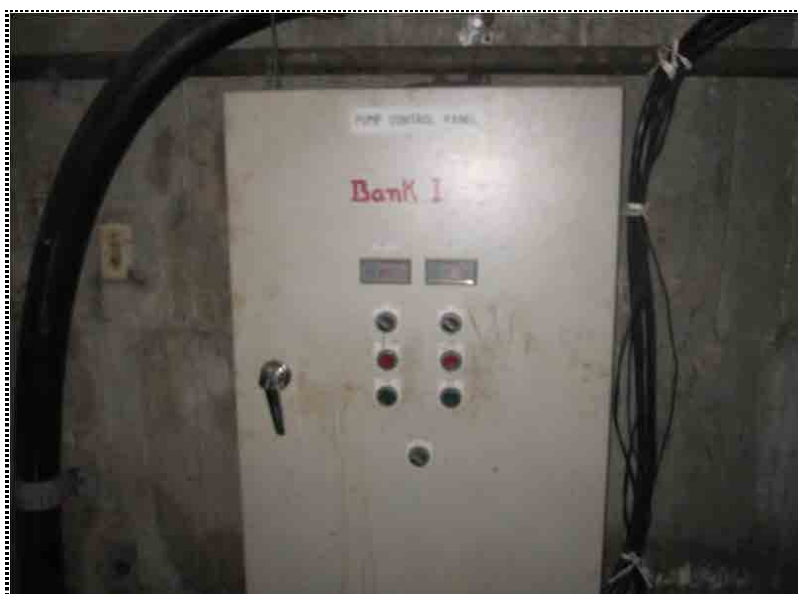
No 1006

Control panel of Cooling pump

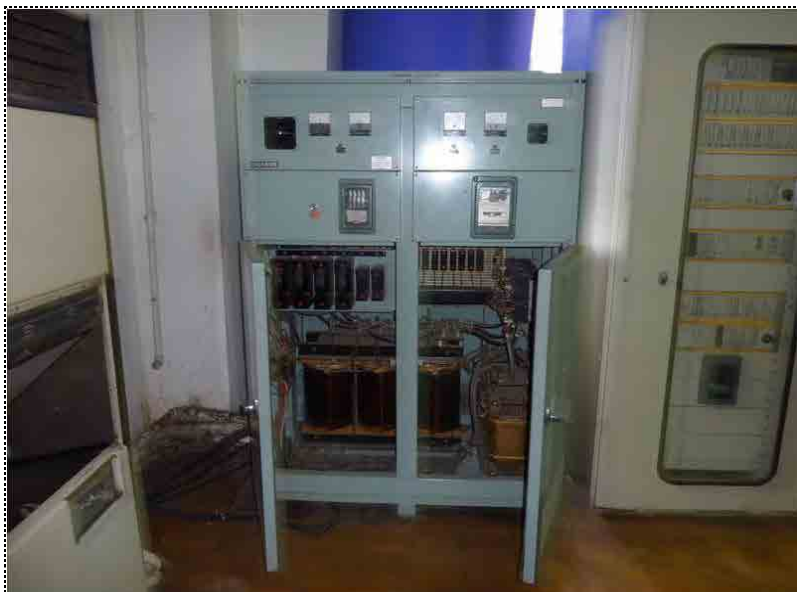
No 1007

Rectifier panel (Left side)

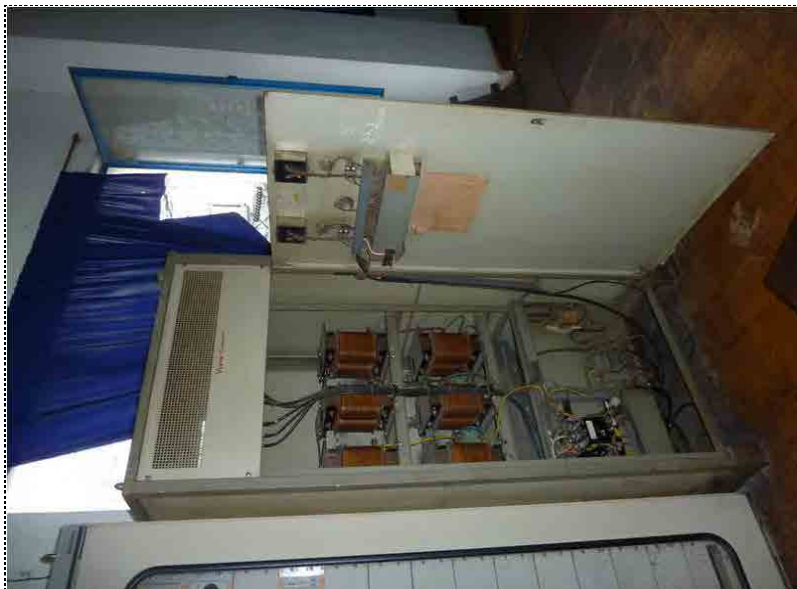
No 1008

Another Rectifier panel (Right side)

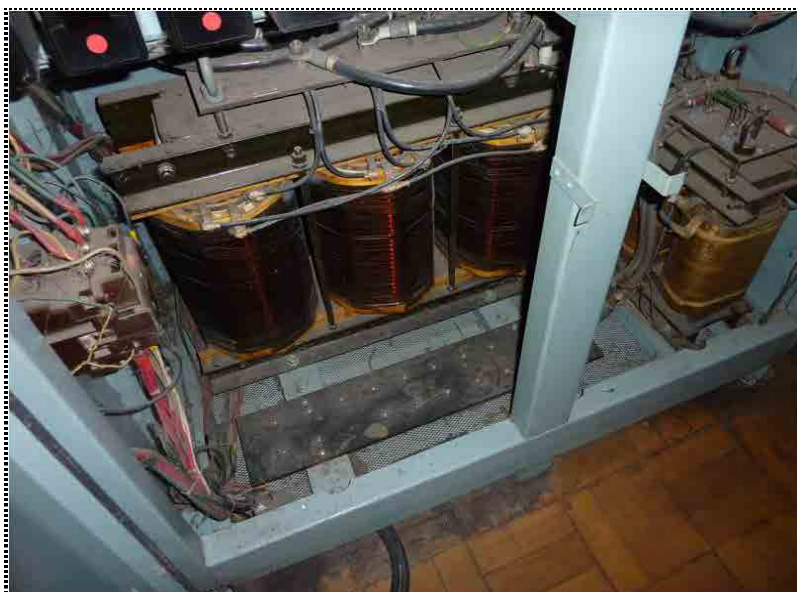
No 1009

Rectifier panel (Left side)

Some parts were removed.

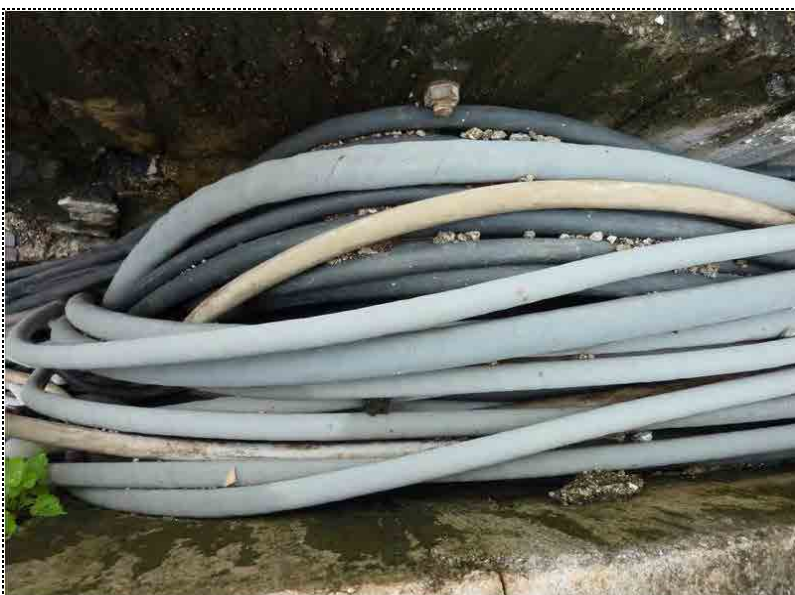
No 1015

Control cables
near the 230kV Booster Transformer
Cable sheathing was deteriorated.

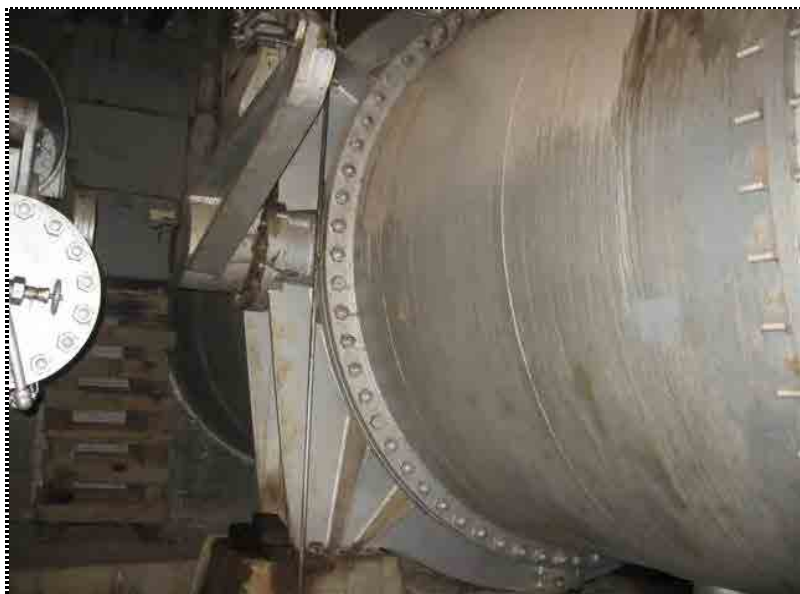
No 1

Butterfly valve fo LPPL No.1

Situation of the outside condition
(view from the downstream of the right side)

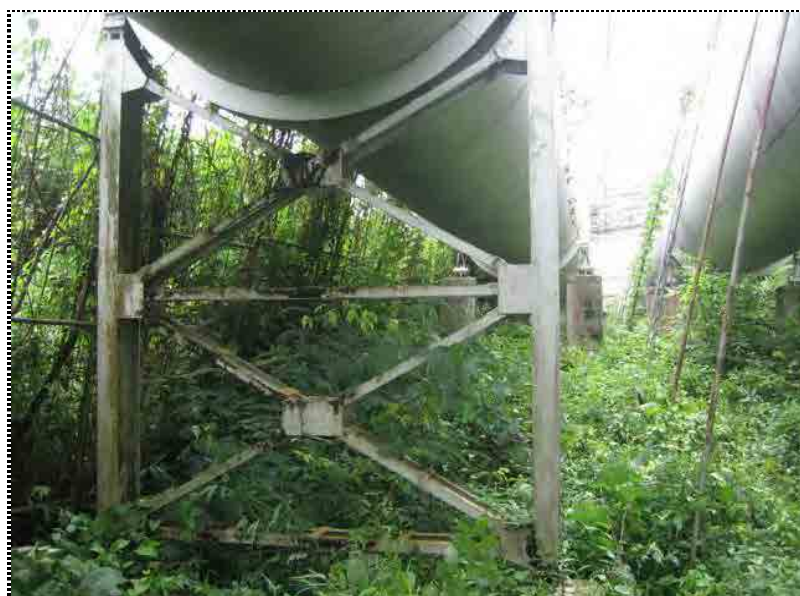
No 12

Items		Results	Photo No.
1	Rocker support No.	S49	-
2	Right side condition	Movement to the upstream	10
3	Left side condition	Movement to the upstream	11
4	Past repair record	None	-
5	Others	The upstream rocker support of S48 is structural steel type. Measurement for the repair	12

Situation of damaged rocker support "S49"

This is the left side of rocker support, which is moved to the upstream.
(view from the left side)

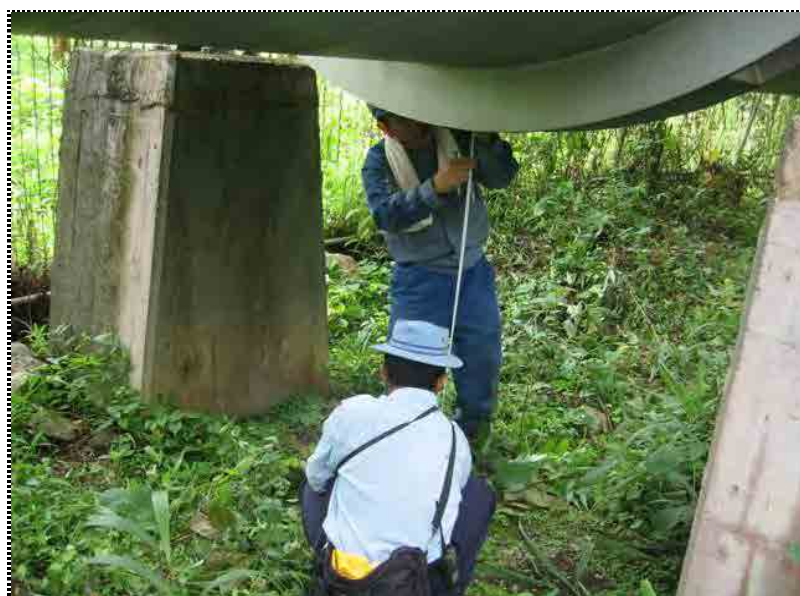
No 21

Items		Results	Photo No.
1	Rocker support No.	S55	-
2	Right side condition	None	-
3	Left side condition	Movement to the downstream	20
4	Past repair record	None	-
5	Others	Measurement for the repair	21

Situation of damaged rocker support "S55"

This is the left side of rocker support, which is moved to the downstream.
(view from the left side)

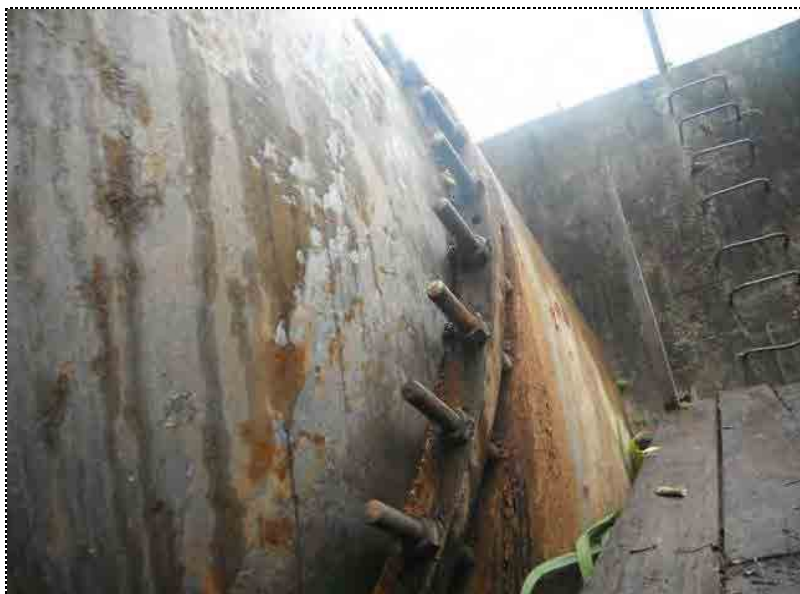
No 28

Items		Results	Photo No.
1	Rocker support No.	S74	-
2	Right side condition	Movement to the downstream	27
3	Left side condition	None	-
4	Past repair record	None	-
5	Others	Measurement for the repair	-

Situation of damaged rocker support "S74"
This is the right side of rocker support, which is moved to the downstream.
(view from the right side)

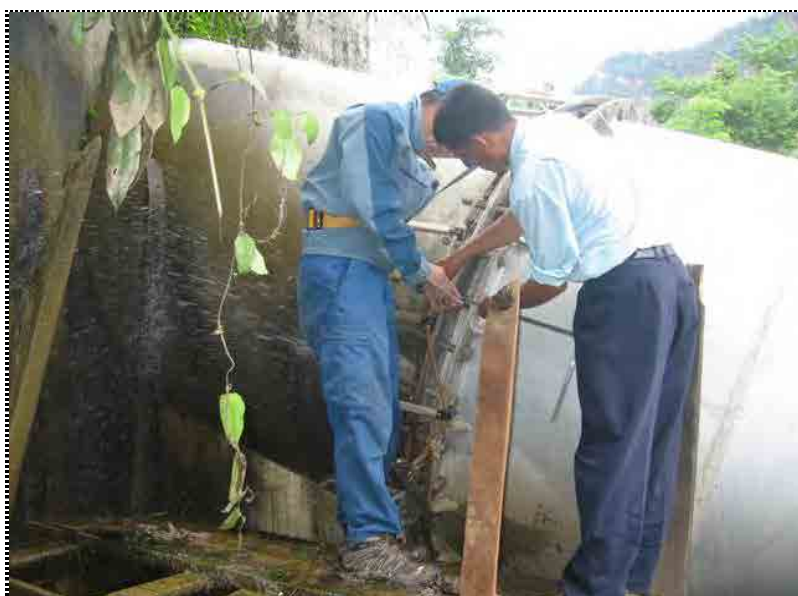
No 39

Items	Results	Photo No.
1 Water leakage	×	37&38
2 Difference between upper pipe and lower pipe (thickness of packing)	×	39
3 Past repair record	Damaged packing was removed and replaced with new one four (4) times in the past fifteen (15) years 1) 13&14 June, 1998 2) 13&14 August 2005 3) 27 August 2006 4) 10 September 2011 According to the photo before repair in 10 September 2011, the water leakage was heavier than the present.	42
4 Others	Measurement for the rehabilitation planning Under base concrete of No.7 anchor block (Unit No.5 & 6) of penstock pipe line No.2, which is located in the upstream of the expansion joint, is eroded by continuous the water leakage.	40&41

Expansion joint near No.7 anchor block
(Unit No.5 & 6) of penstock No.2

Enlarged the above
(view from the right side)

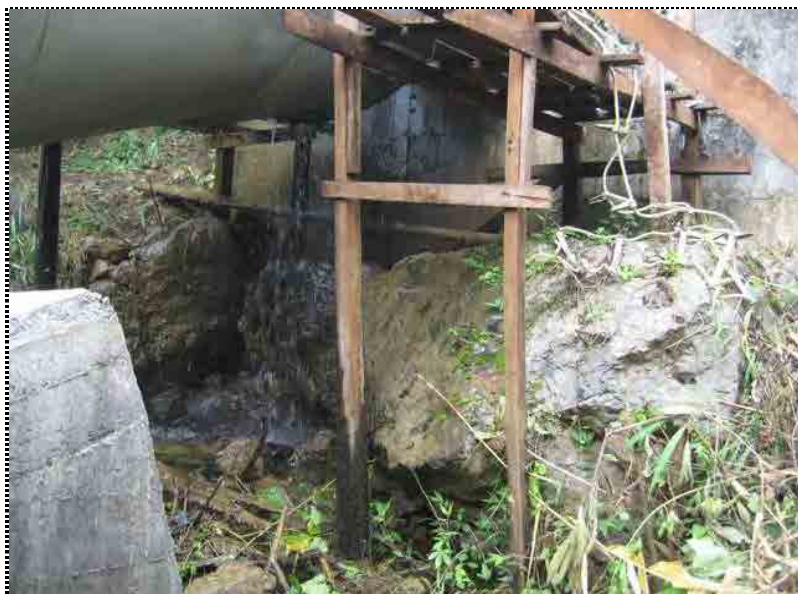
No 40

Situation of measurement for rehabilitation
planning
(view from the right side)

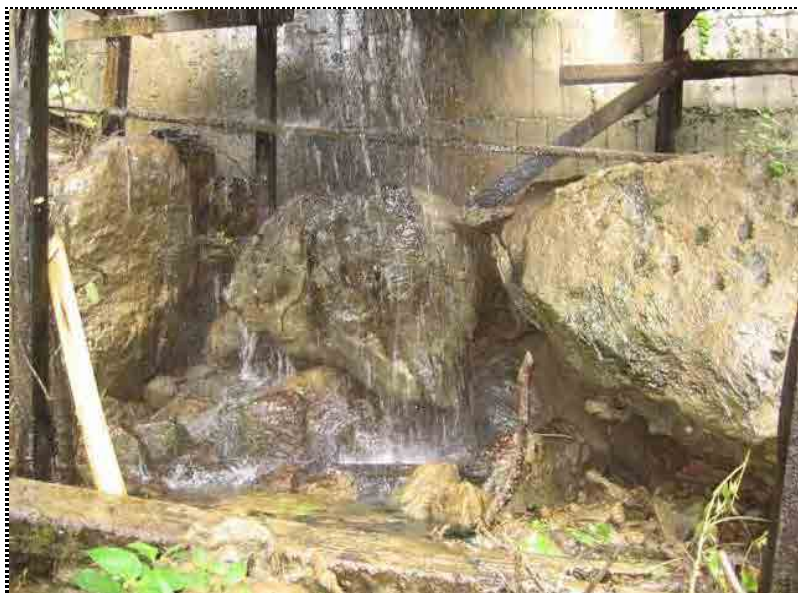
No 41

Situation of the erosion under base concrete
of No.7 anchor block (Unit No.5 & 6)
(view from the downstream of the left side)
