Appendix 3-2 Slope inspection sheets for Rank C and B

General Information Sheet

Management office	Ratnapura										
Management number	A004-134	Route No	A004	Location(m)	134/15	to	134	Distance	200	m	
Disaster	Rock fall	Name of Road		Landmark		latitude	N 06°37'20.18"	longitude	E 080°39'32.17"		
Schematic sketch				Reporter's name :	M. Enokida

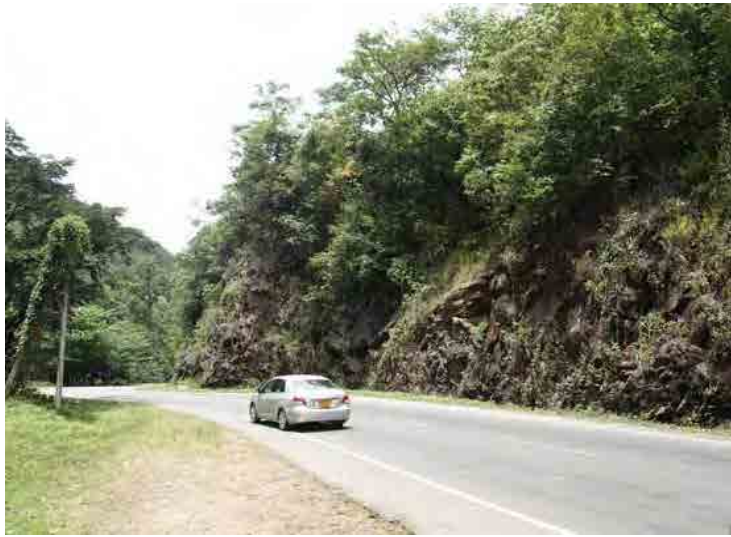
Full view of the slope at the beginning side

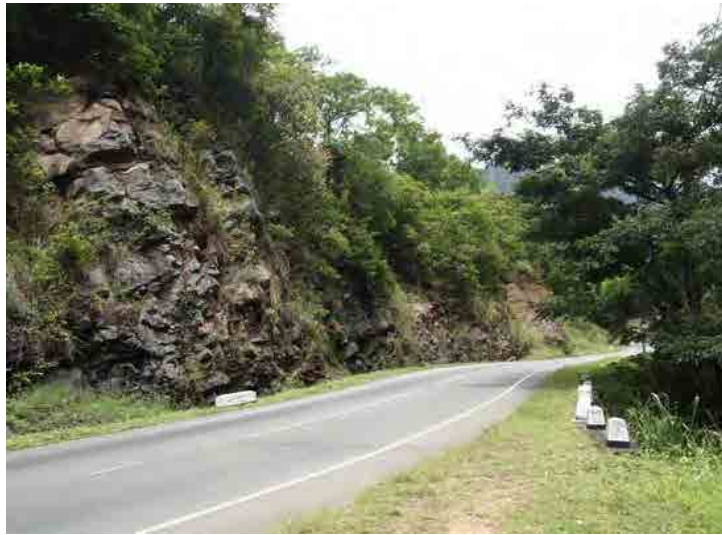
Full view of the slope at the ending side

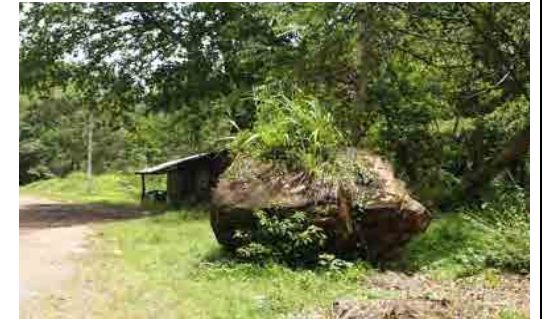
Old falling rock

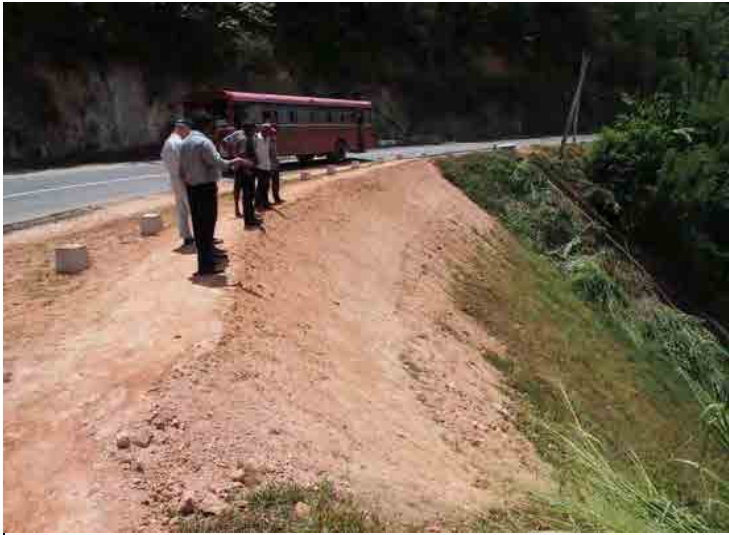
Full view of the slope at the beginning side

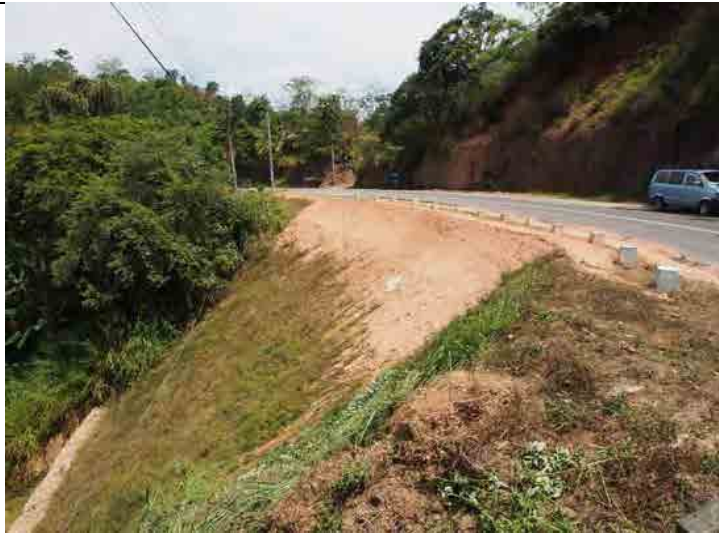
Full view of the slope at the ending side

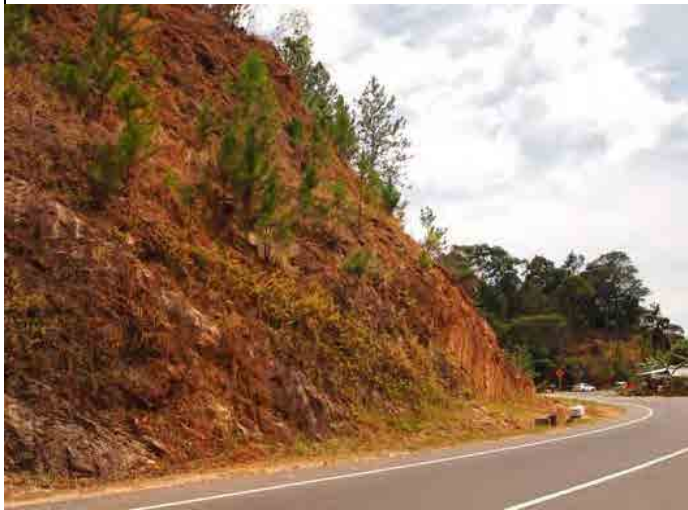
Full view of the slope from strat side

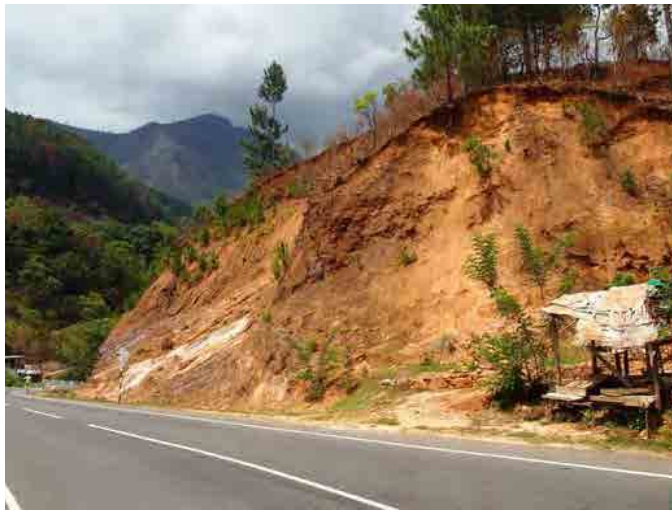
Full view of the slope from end side

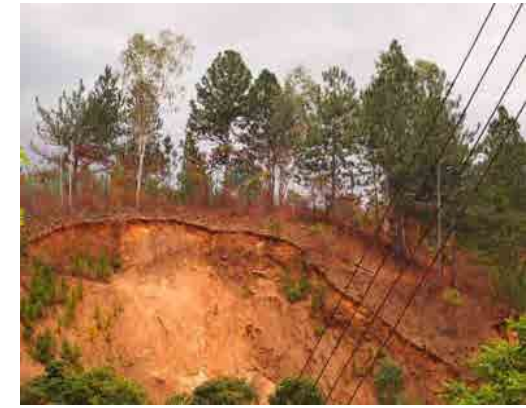
Situation of slope head

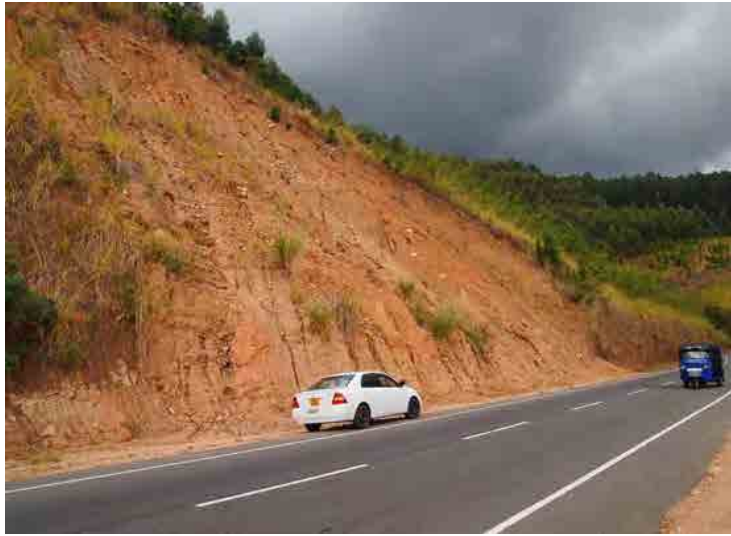
Full view of the slope from strat side

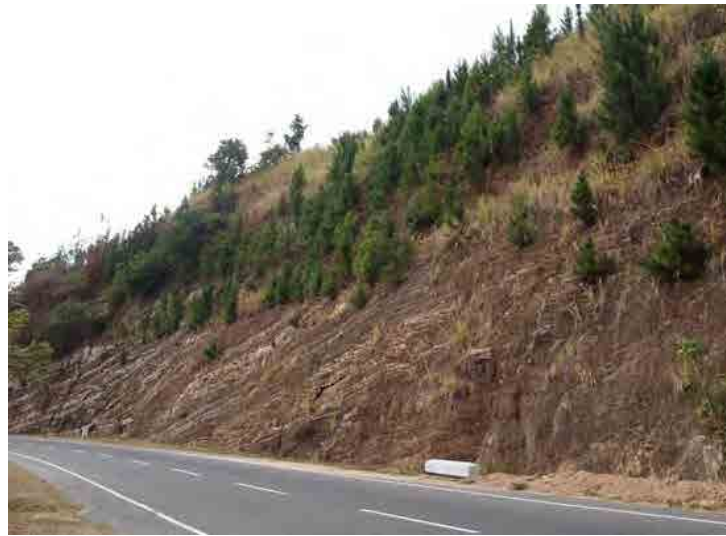
Full view of the slope from end side

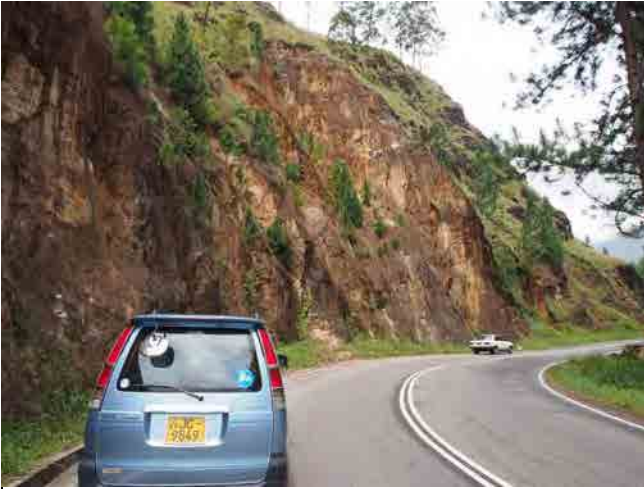
Full view of the slope at the ending side

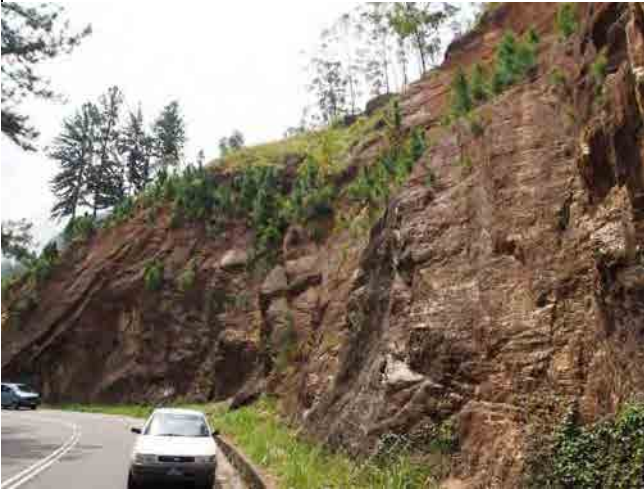
Full view of the slope at the beginning side

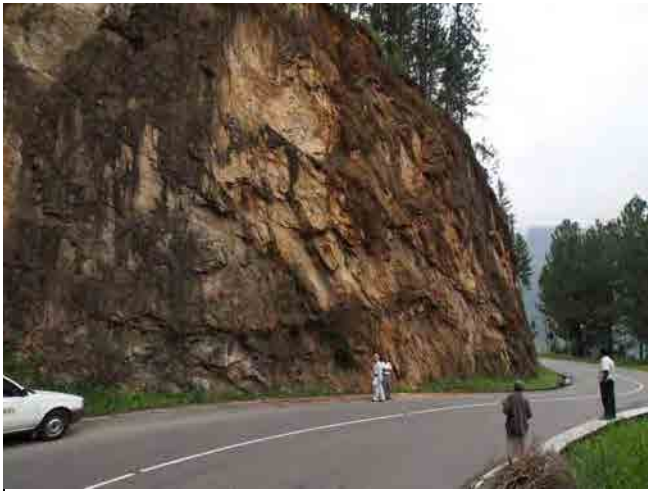
Full view of the slope at the ending side

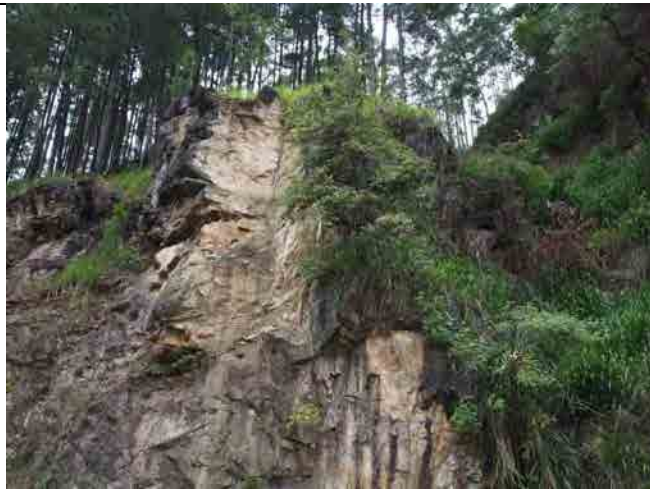
Traces of rock slides

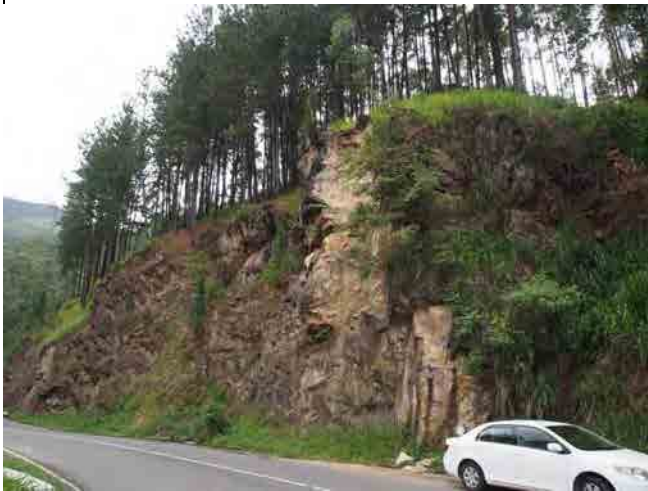
Full view of the slope at the beginning side

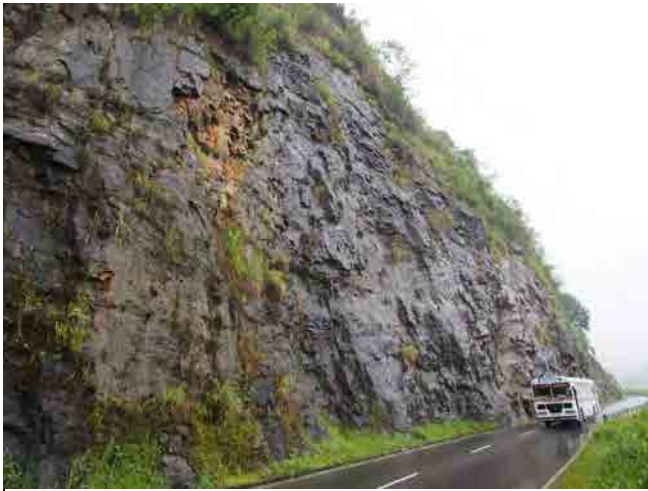
Full view of the slope at the beginning side

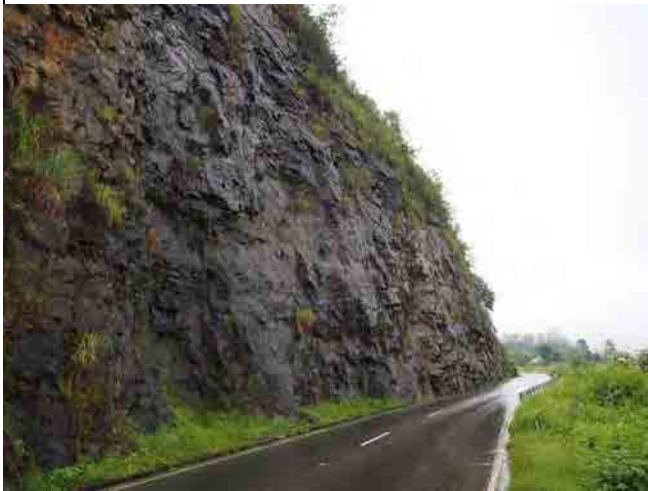
Full view of the slope at the ending side

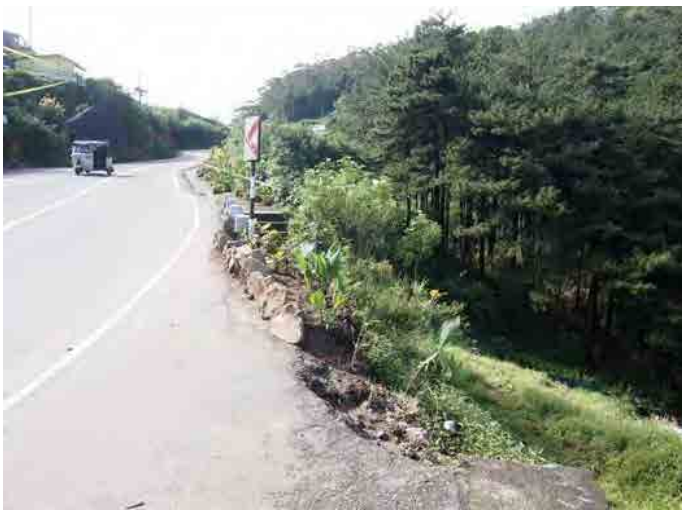
Full view of the slope from end side

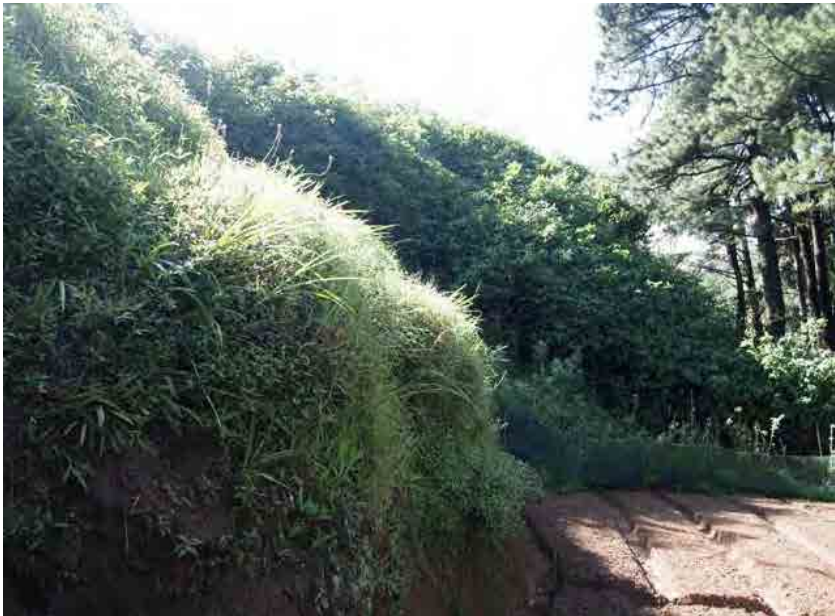
Condition of slope, state of road lower slope

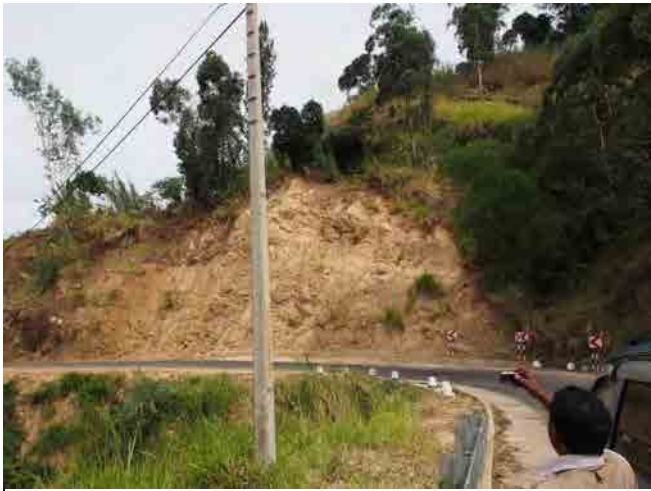
Full view of the site

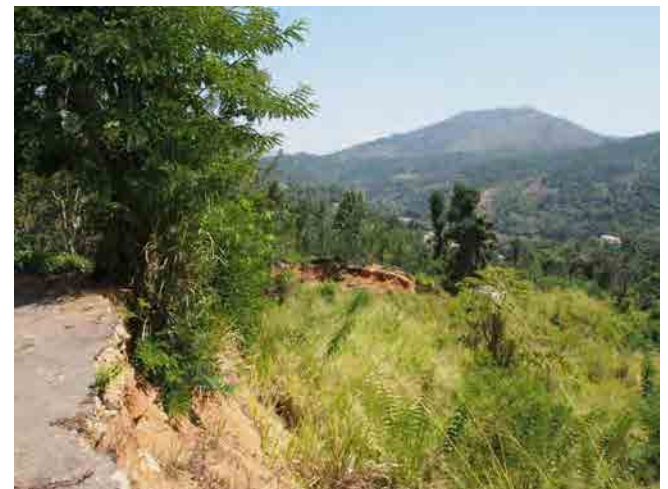
EscarPMENT of a divided landslide.

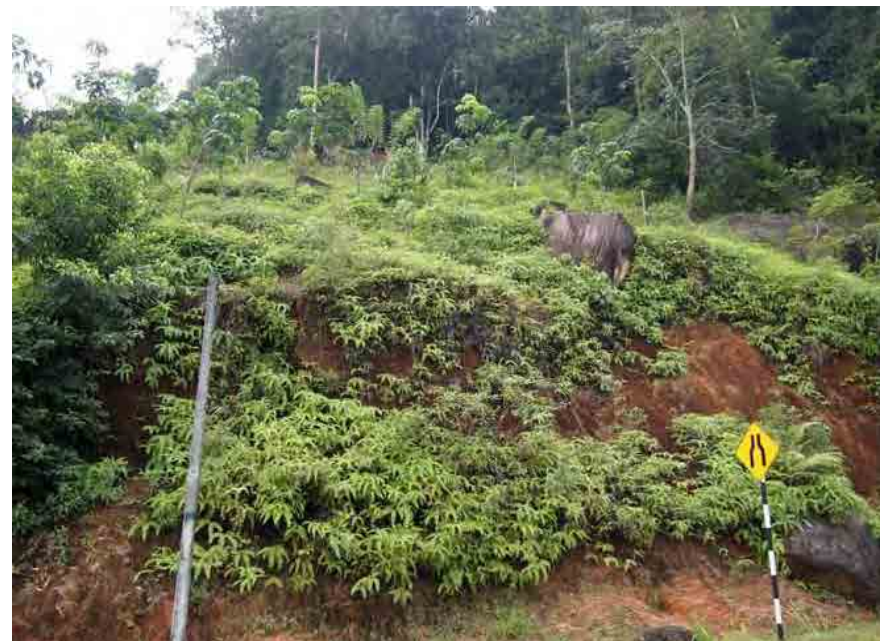
Condition of slope, state of road upper slope

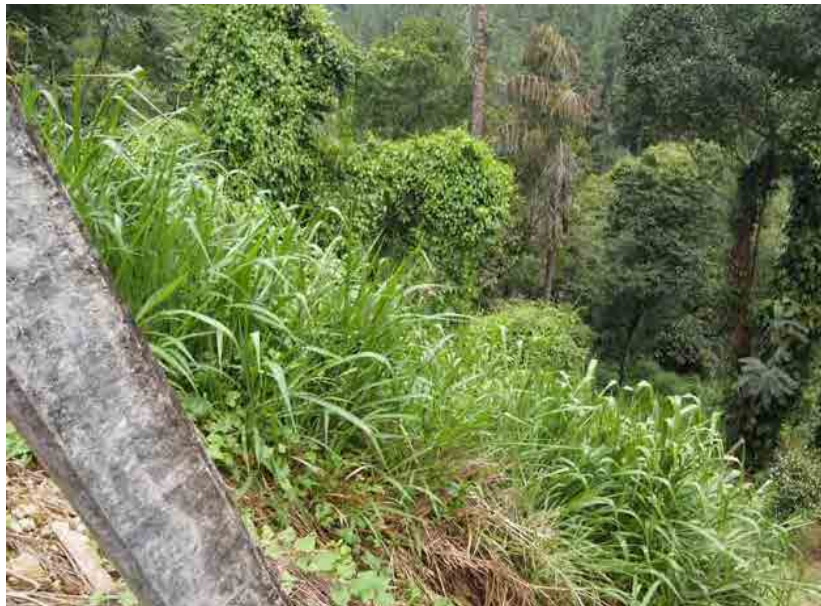
Condition of slope, state of road lower slope

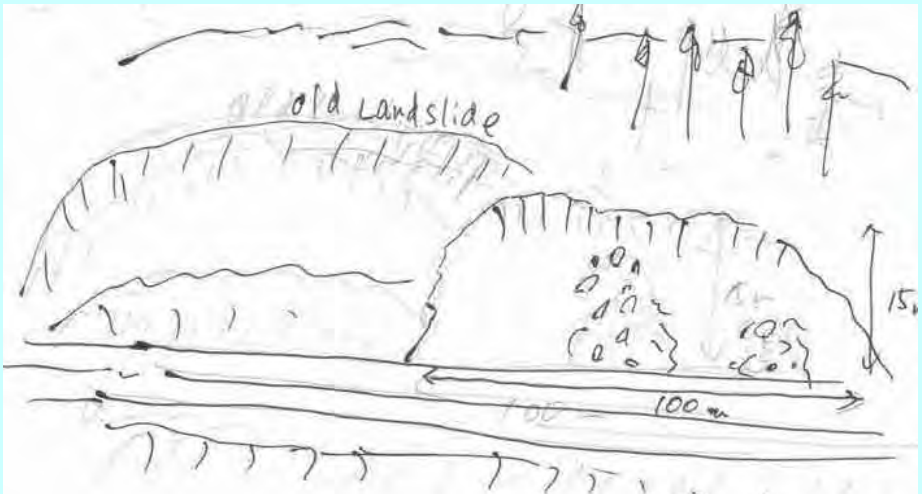
<p>Reporter's name : M. Enokida</p> <p>Date of report : 25-Sep-12</p> <p>Description</p> <p>Recorded Disaster : Debris provided from the slope failure closed the road.</p> <p>Failure Type: Slope failure in residual soil and weathered rock.</p> <p>Geological Condition: Residual soil and weathered gneiss rich in cracks. Vertical cracks attract the attention.</p> <p>Trigger of Failure: (Supposed) Rainfall, erosion, and steeper gradient of slope.</p> <p>Featured Points: Springs were confirmed in the middle of the slope at the beginning side.</p> <p>Supposed countermeasures: Further investigation is required to set up appropriate countermeasures. Based on the site situation, however, draiange system and grating cribs with ground anchors can be amongst the supposed.</p> <p>Histrory</p> <p style="text-align: center;">New failure Movement/extension</p> <p>Estimated disaster volume</p>

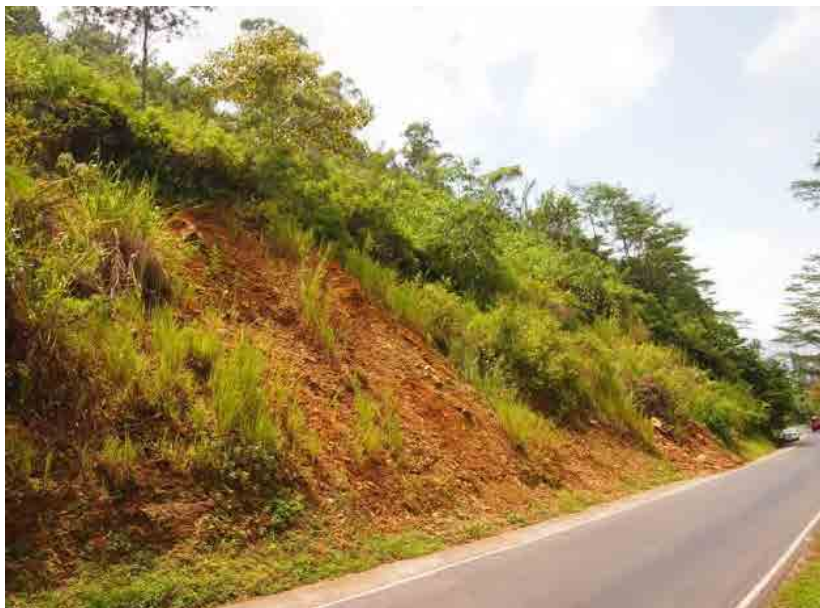
Condition of slope, state of road upper slope

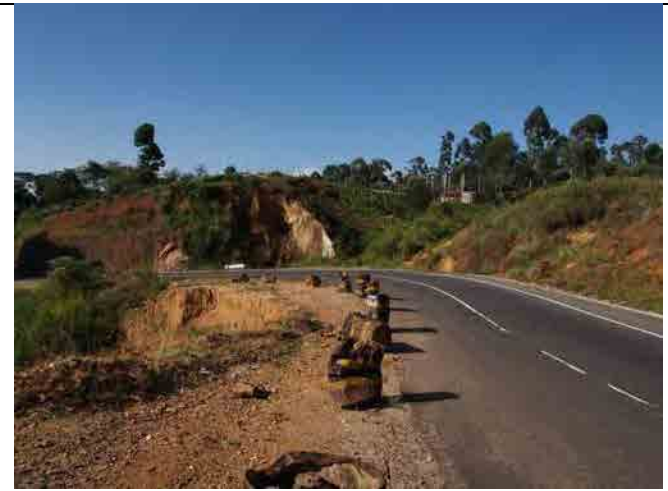
Condition of the road around the head scarp at the ending side.

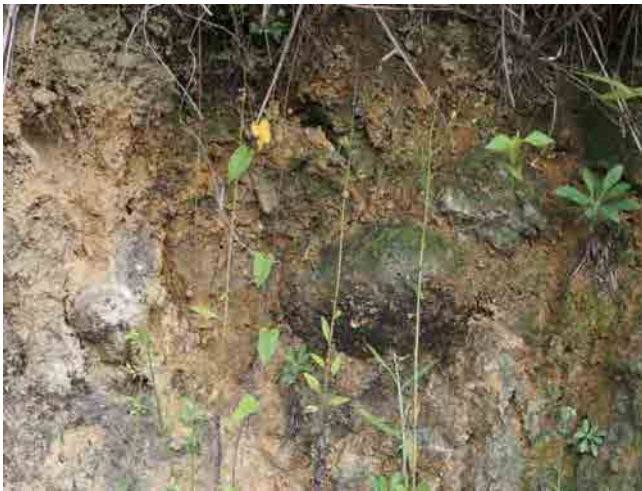
Colluvium is distributed in the site.

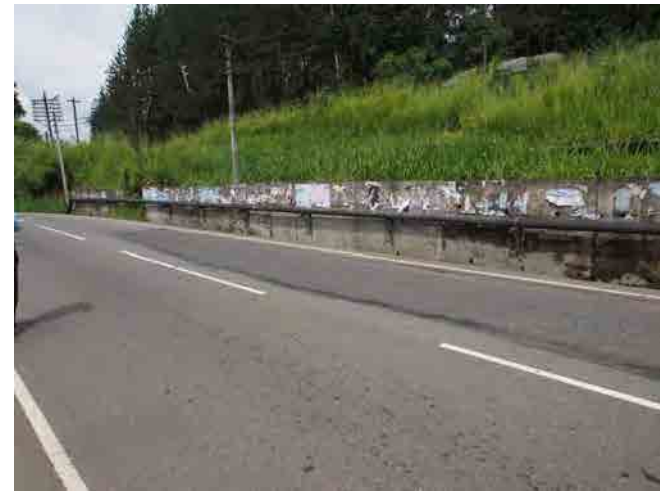
Retaining wall along the road. After the construction of this retaining wall, landslide of upper slope was said to be eased.
