Appendix 3-2 Slope inspection sheets for Rank C and B

General Information Sheet

Management office	Ratnapura												
Management number	A004-134	Route No	A004	Location(m)	134/15	to	134	Distance	200	m			
Disaster	Rock fall	Name of Road		Landmark		latitude	N 06°37'20.18"	longitude	E 080°39'32.17"				
Schematic sketch				Reporter's name :	M. Enokida

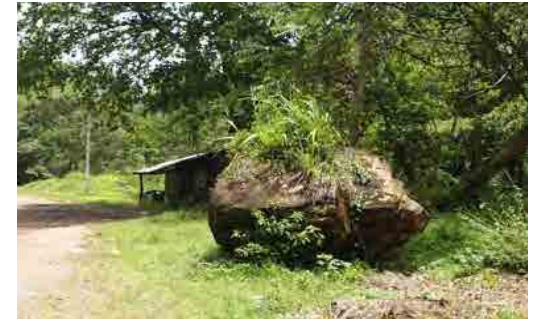
Old falling rock

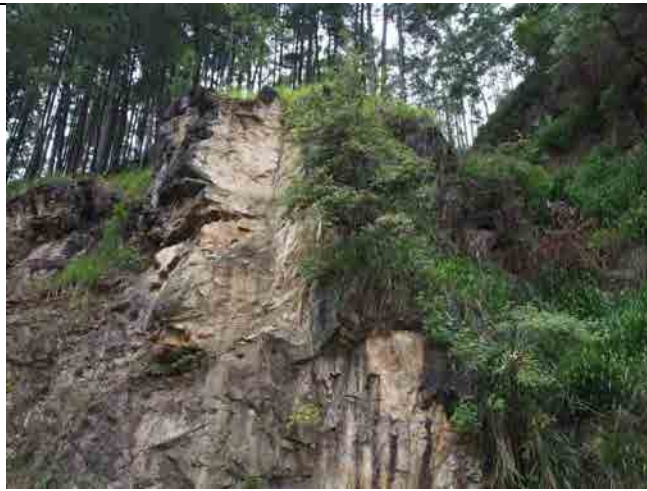
Traces of rock slides

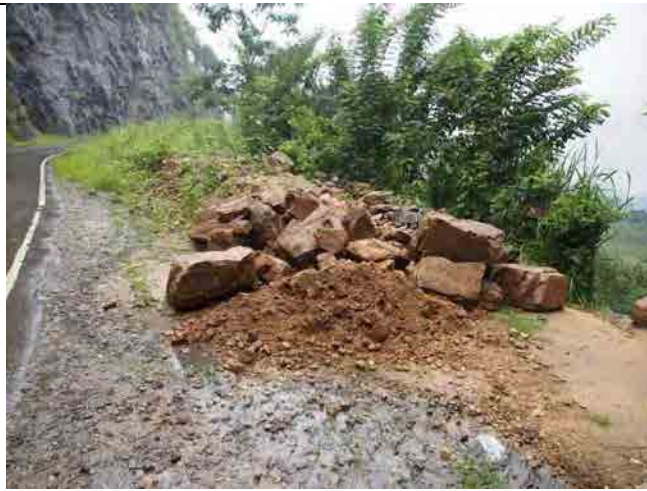
Debris cleared up to the shoulder of the road

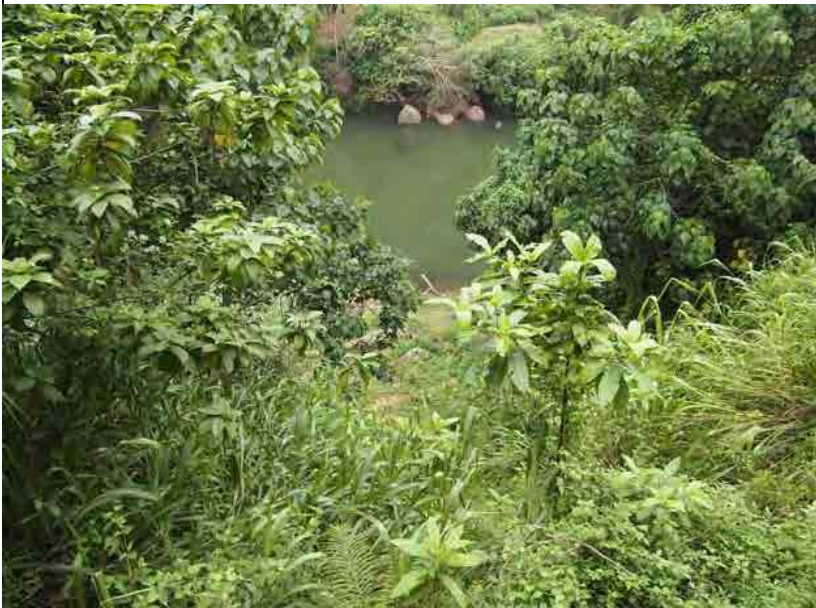
Condition of slope, state of road lower slope

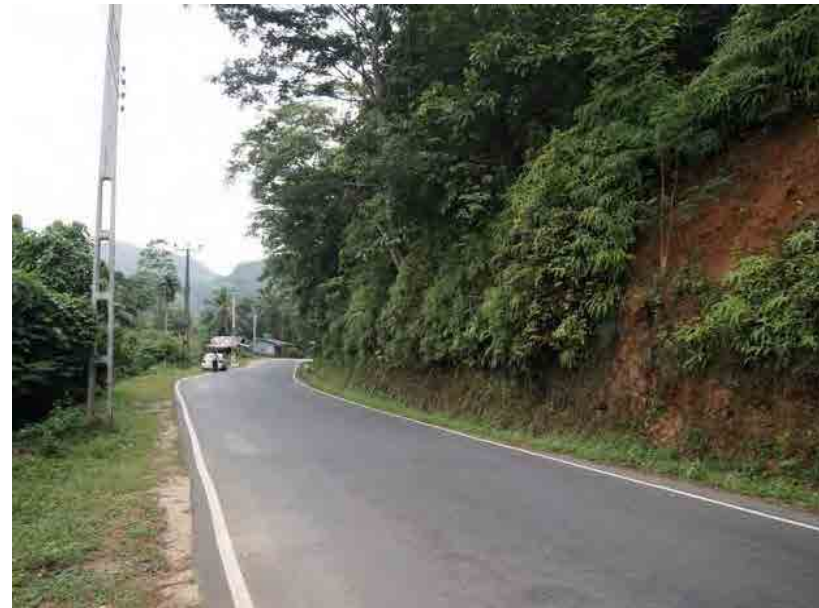
Condition of slope, state of road upper slope

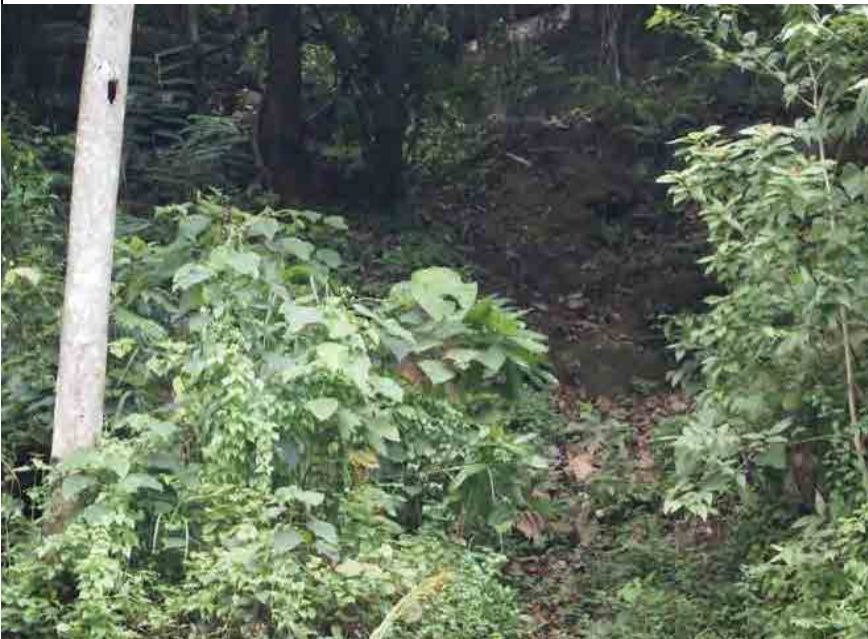
Condition of slope, state of road upper slope

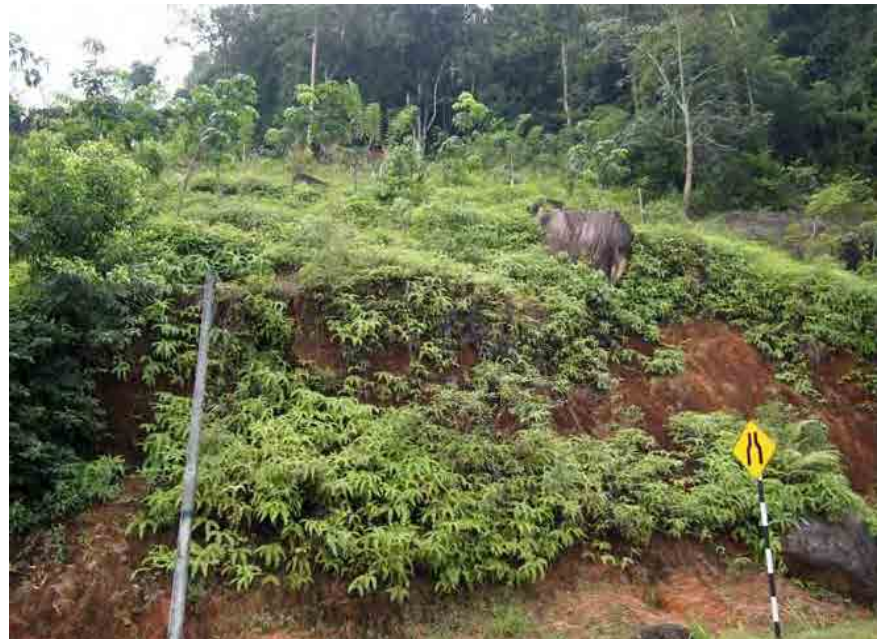
Condition of slope, state of road upper slope

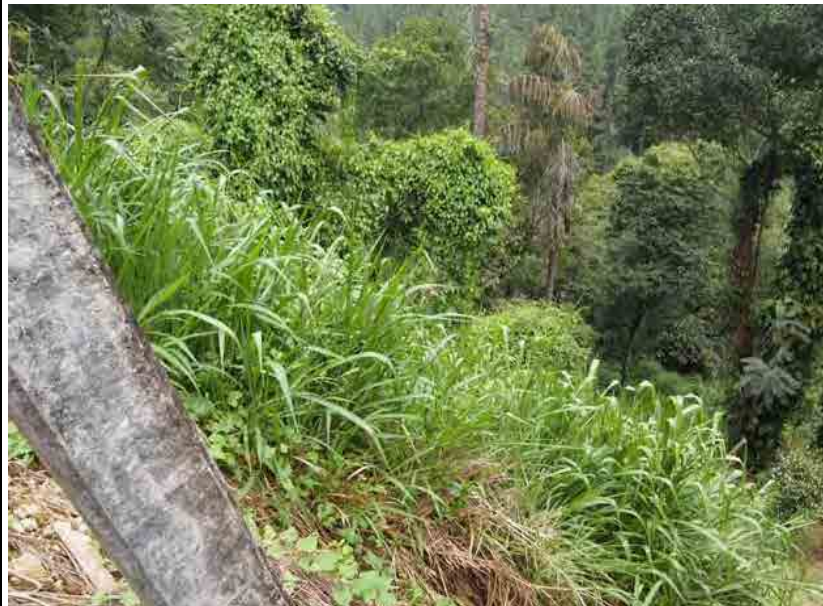
Condition of slope, state of road lower slope

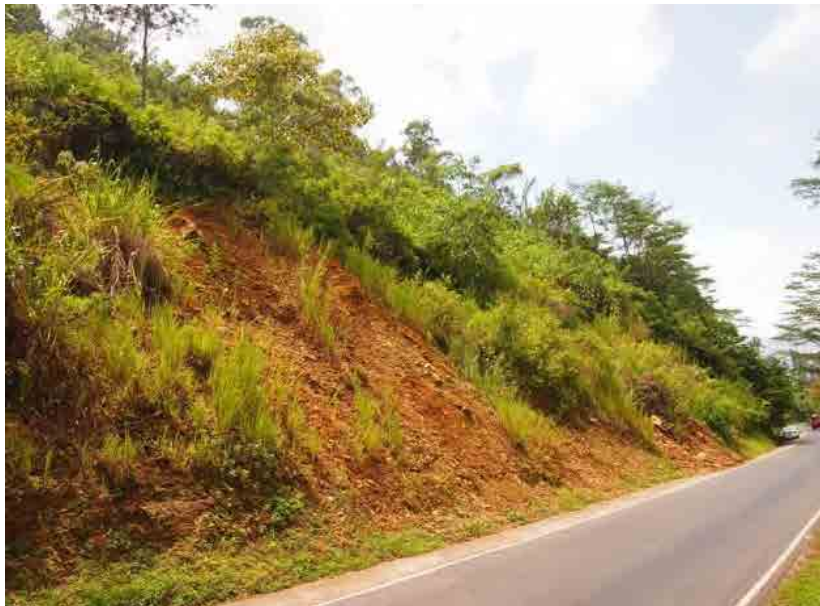
Condition of slope, state of road upper slope

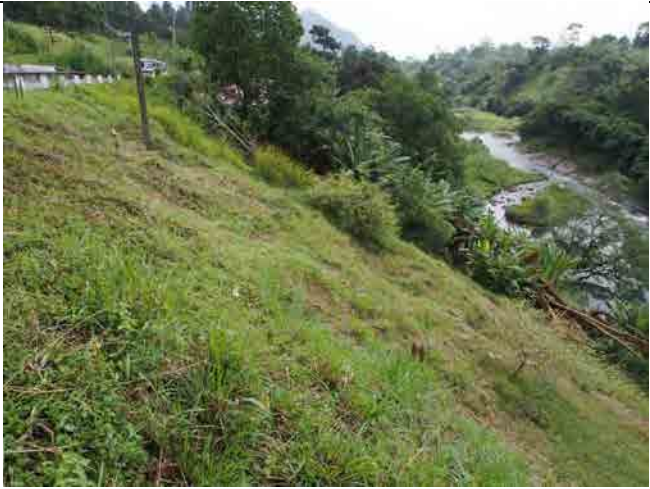
Condition of the lower part of the landslide.
