**REPORT**  
**FOR**  
**THE FOLLOW-UP PROGRAMME**  
**ON**  
**THE PROJECT FOR**  
**IMPROVEMENT OF WATER**  
**QUALITY IN LOCAL AREAS**  
**IN**  
**THE REPUBLIC OF THE**  
**PHILIPPINES**

**SEPTEMBER 2011**

**Japan International Cooperation Agency**

**Japan Techno Co., Ltd.**

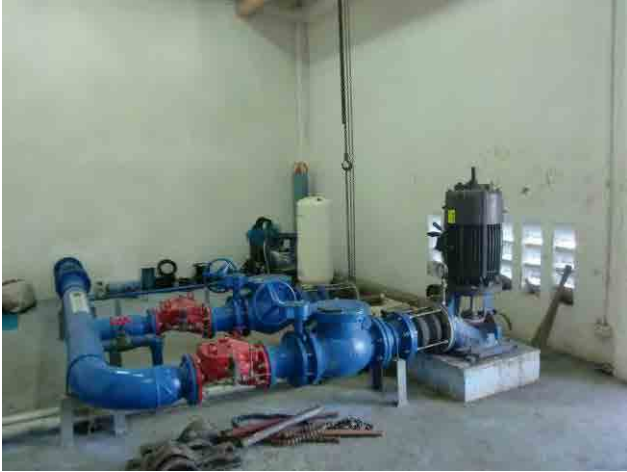
Transmission pump: pump No.2 is not in use due to a malfunction of the shaft. The motor has no problem. Currently pump No.1 and the surface-wash pump are operating alternatively.

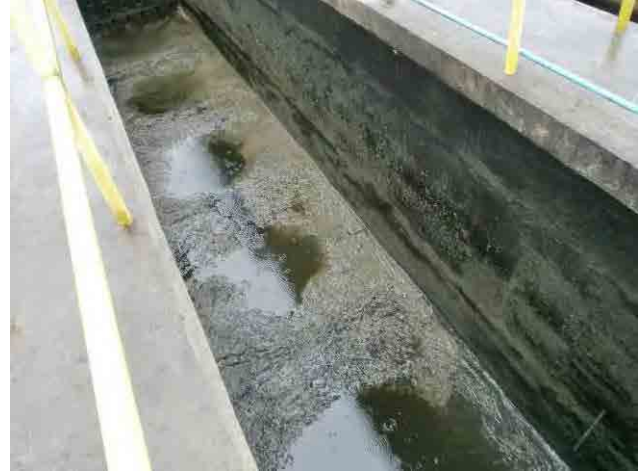
Sedimentation basin: Sludge is removed only three times since the operation started. Therefore, the sludge is accumulated considerably.

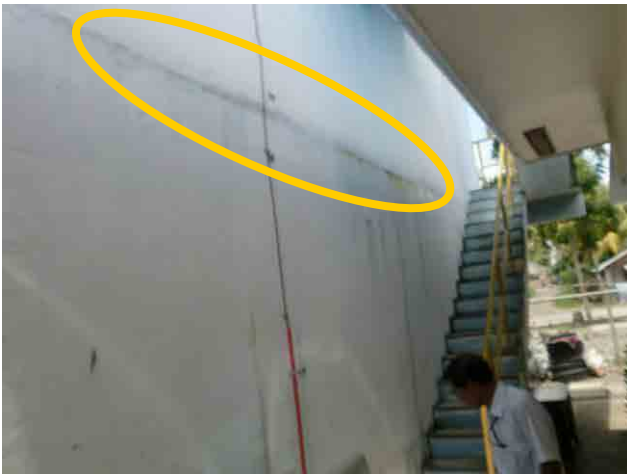
Aeration Tower: Leakage from the concrete joint.
