**IMPLEMENTATION REVIEW STUDY REPORT  
ON  
THE PROJECT FOR THE REHABILITATION OF  
THE EAST DEMERARA WATER  
CONSERVANCY( II )  
IN  
THE REPUBLIC OF GUYANA**

**October 2013**

**JAPAN INTERNATIONAL COOPERATION AGENCY**

**SANYU CONSULTANTS INC.**

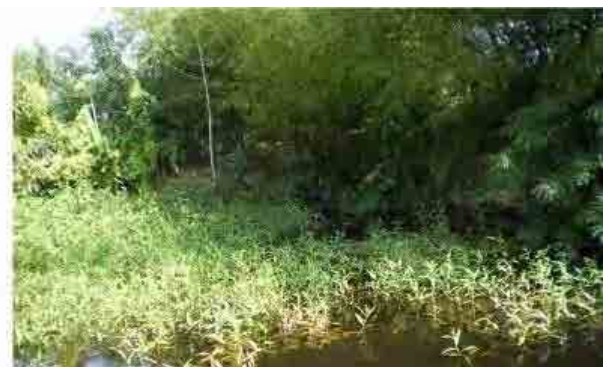
Part	Conditions
Main body	At present, normally functioning without problems (see PH 2-1-10)
Wooden pile revetment	The wooden pile revetment can be hardly seen at the upstream side, and the slope looks stabilized by the natural vegetation (see PH 2-1-11). At the downstream side, tall concrete retaining walls are installed (see PH 2-1-12). Surrounding portions consist of a stable ground slope covered by vegetation (see PH 2-1-13).
Surrounding embankment	No symptom of sliding is seen on the embankment slopes (see PH 2-1-11).
Operation	The gate is operated 4 times a year by Guyana Sugar Corporation (at the beginning of the dry season and the rainy season). Small amount of leakage comes out through an opening of the gate, which is utilized by farmers cultivating cash crops.

PH2-1-13 Ground slope covered by vegetation
