VOLUME 3

RESULTS OF EXISTING CONDITION  
SURVEY

## APPENDIX 3-B

# DETAILED RESULTS FOR FIRST SCREENING OF CANDIDATE BRIDGES

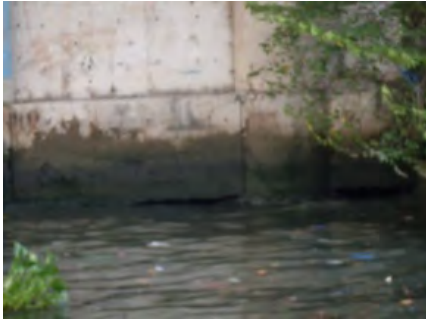
Many vertical clacks are observed.
Piers	Cracking concrete

A few vertical cracks are observed on concrete wall between pier columns
Curb and Railing (Secondary)	Cracking

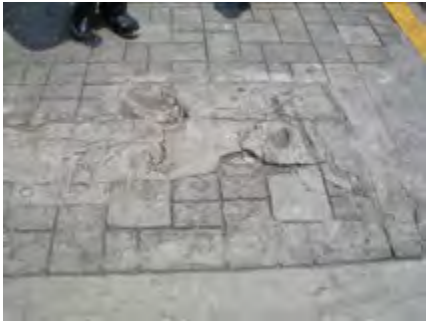
Many cracks are occurred on newly repaired walkway.

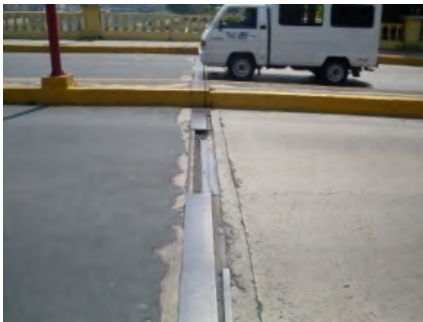
Cover of expansion joint is displaced.

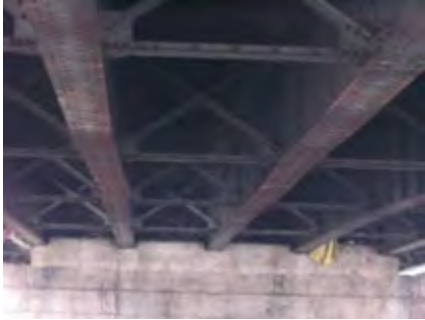
Lower flange of Plate girder is deformed due to impact of ship.
	Paint Peel off

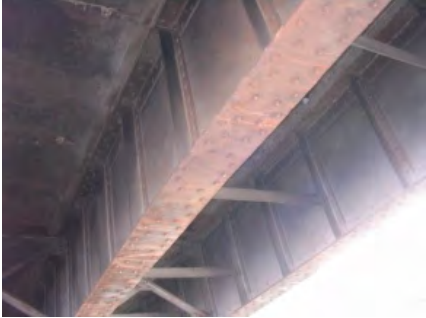
Paint peel off is entirely observed on the steel plate girders. (Poor Condition)

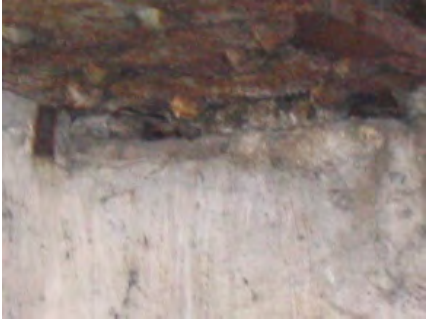
Some of steel bearings are displaced abnormally.
Abutments	Cracking concrete

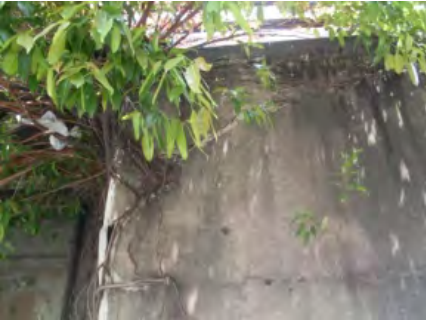
Several long cracks with width more than 1mm are observed horizontally.
	Honeycomb

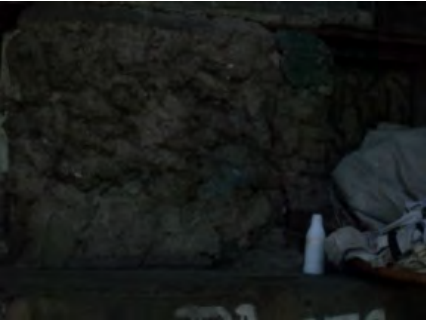
A few honeycombs caused by unskilled workman ship are observed.

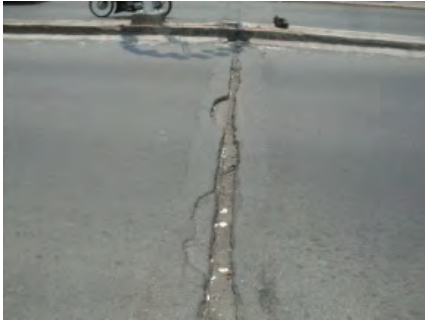
Expansion joints are displaced.
Painting Cond. (Primary)	Discoloration

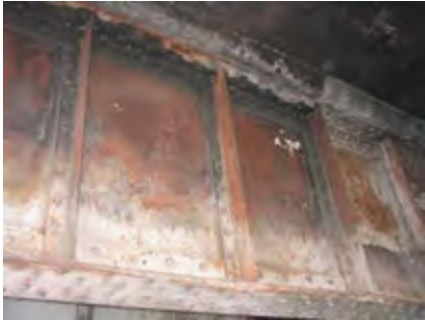
Discoloration due to paint peel off is observed.
	Rust

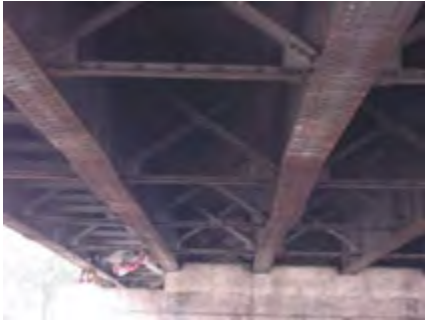
After Paint peel off, rusting is starting on the steel plate girders.

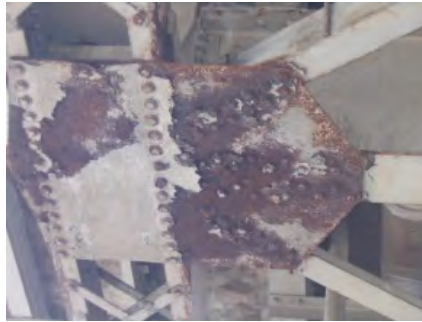
Many gusset plates are corroded but members of arch bridge are good condition.

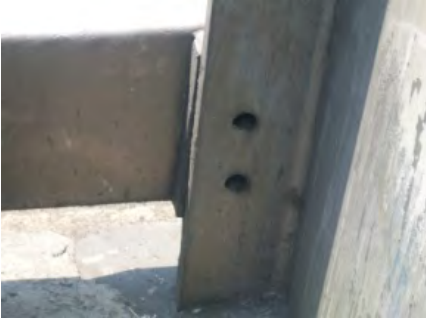
Some bolts are missing and losing connection.
	Paint Peel off

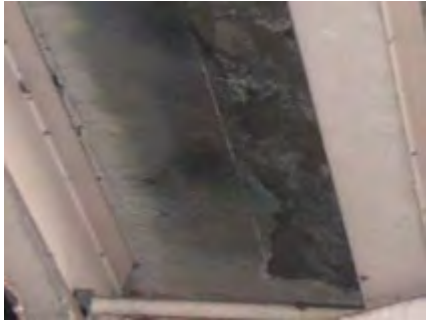
Component/ Material/ Classification	Type of Damages	Picture of the Damage	Reasoning for the Evaluation
Deck Slab (Primary)	Cracking

Many cracks with width less than 0.3mm are observed on deck slab.
	Scaling/Spalling

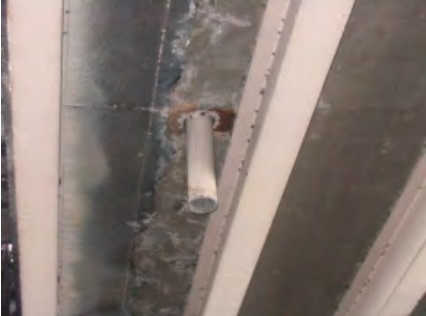
Some portion of deck slab, cracks are combined with water leaking
Steel Beam/ Truss Member (Bracings, etc.) (Primary)	Corrosion

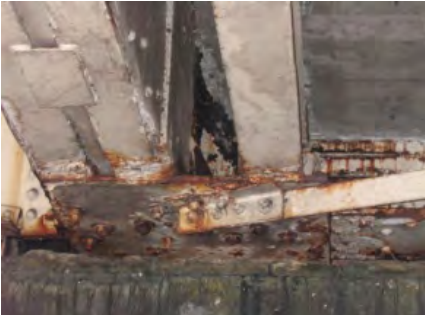
Joints and bracing members are severely corroded and main truss members are also progressing corrosion.

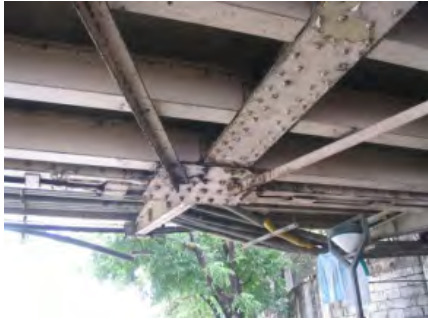
Bracing members are fractured or cracking or missing due to impact of ship, especially flooring system.
	Deformation/Buckling

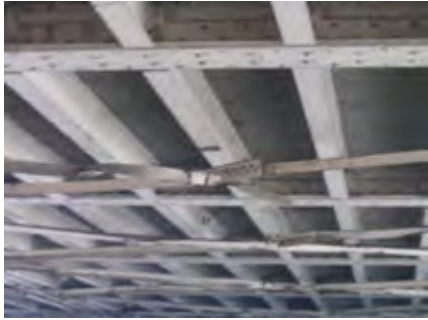
Many bracing members are deformed due to impact of ship.
	Loose Connection

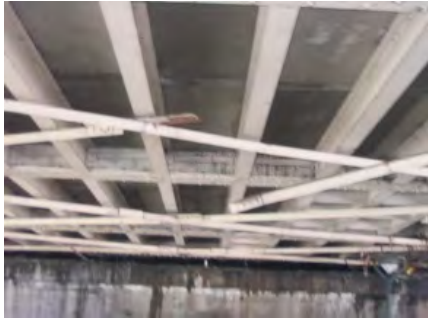
Same bracing members are missing due to loose connection or broken by impact of ship.
	Paint Peel off

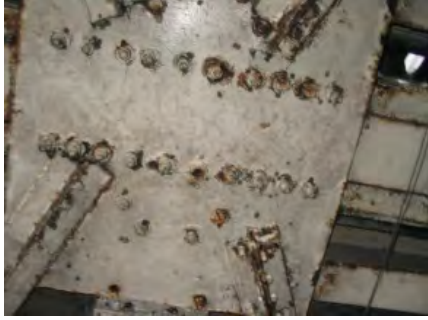
Paint of steel truss members are progressing peel off entirely.

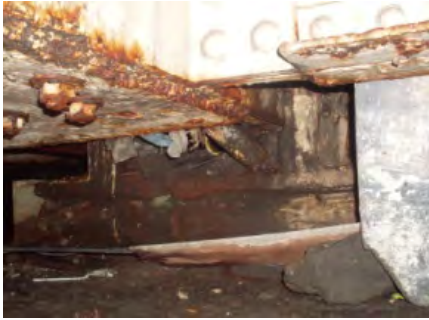
Steel bearings, especially base plate and connection to truss members are severely corroded.
	Displacement

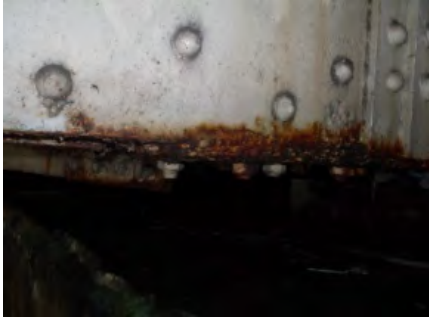
Slightly displacement of steel bearing is observed horizontally.
Abutments	Spalling, Scaling,Disintegration

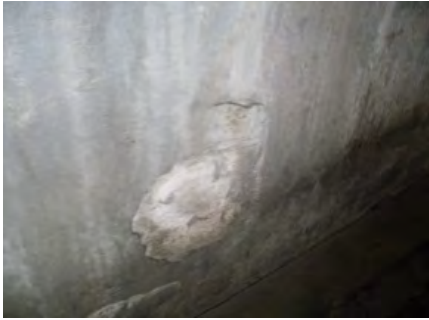
Many spillings or scalings are observed on abutment.
	Cracking concrete

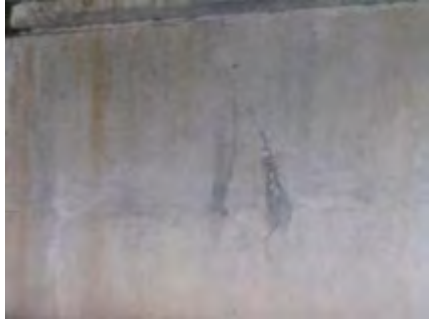
Many cracks with width less than 1mm are observed vertically and horizontally.

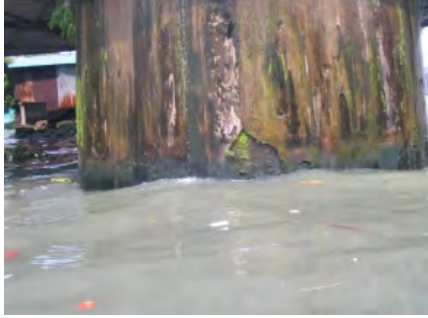
Large spillings/ disintegrations are observed on pier and degrade of concrete strength is predicted.
	Cracking concrete

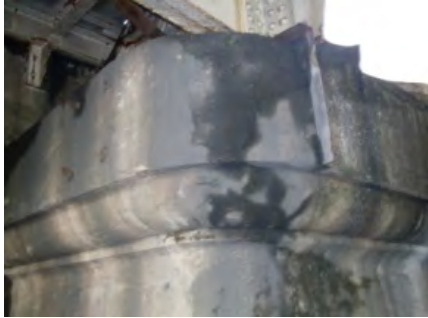
Same cracks with width more than 1mm are observed vertically but crack is a little crack entirely.

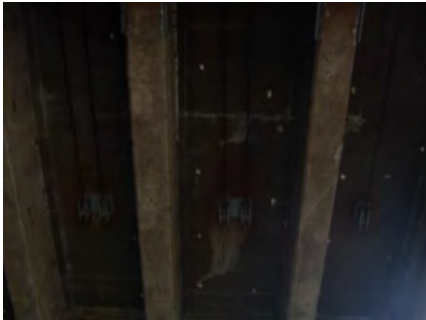
Most of cracks are less than width 0.3mm but several cracks are long and more than 1mm are observed.
	Waterleaking

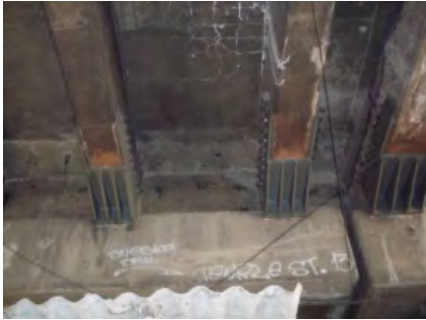
Waterleaking are observed at some parts of cracks at end of deck slab.
Concrete Beam/ Girder (Primary)	Cracking

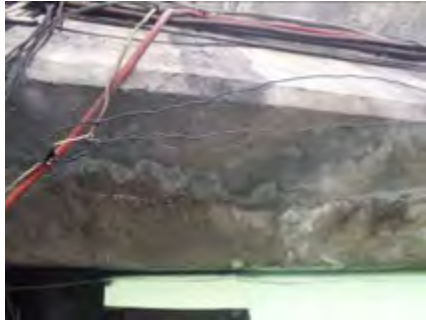
Cracks with width less than 1mm are observed on half of girders.
	Spalling, Scaling, Disintegration

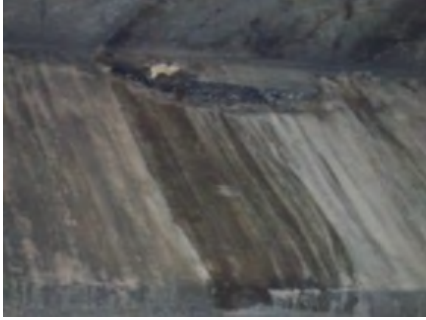
Spalling is observed at the connection between concrete girder and slab.

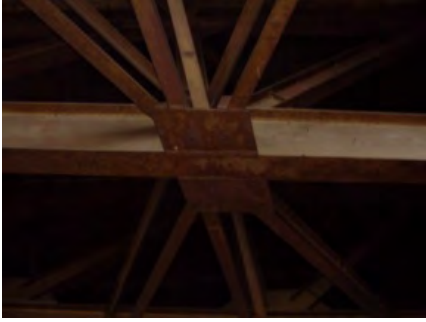
After paint peel off, some parts are corroded especially gusset plates.
	Paint Peel off

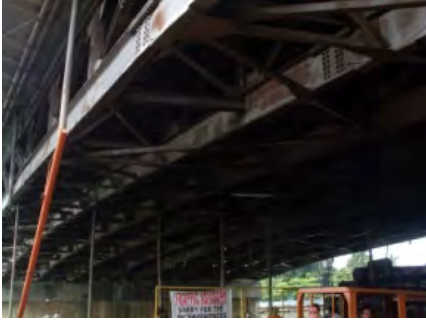
Paint peel off is observed overall steel truss members.
Shoe/Bearing	Corrosion

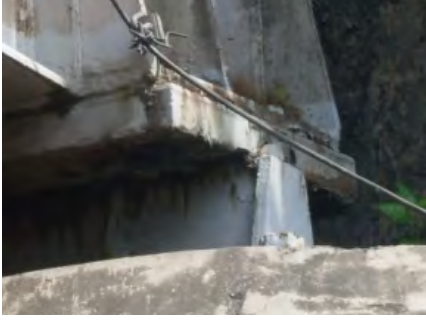
Steel bearing is slightly corroded.

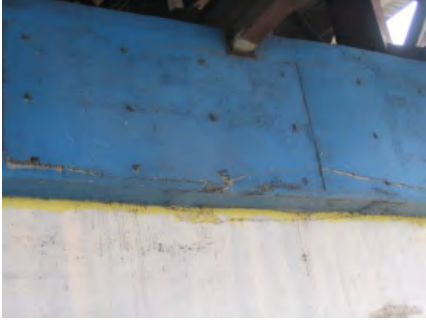
Several cracks with width less than 1mm are observed.
	Spalling, Scaling,Disinte gration

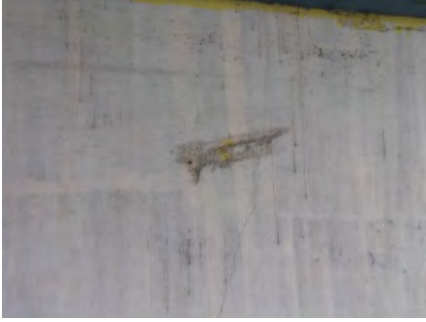
Some spallings are detected on pier.
	Exposure/Corro sion of Reinf.

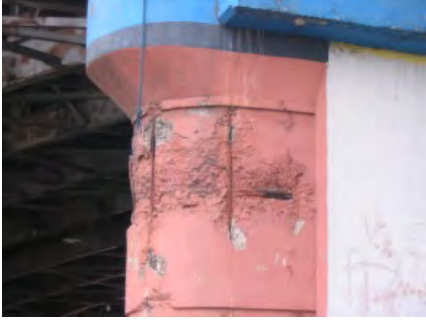
Exposure of rebars due to scaling are observed pier wall.
Expansion Joint (Primary)	Water leaking

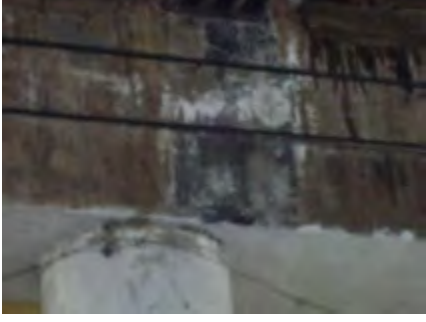
Water leaking from expansion joint at pier is observed.

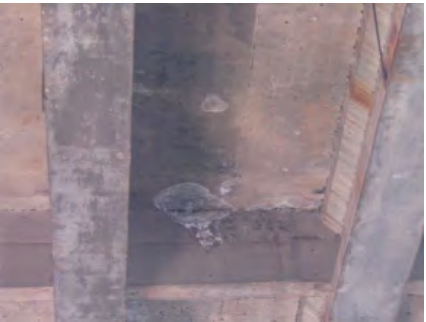
A few spallings are observed on deck slab.
	Water leaking

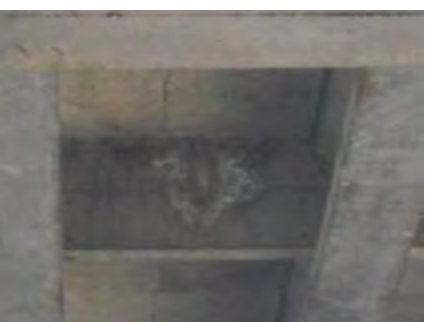
At some parts of cracks, water leaking are observed
Concrete Beam/ Girder (Primary)	Cracking

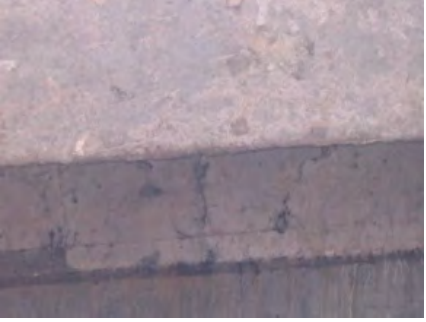
A few Cracks with width less than 0.3mm are observed.

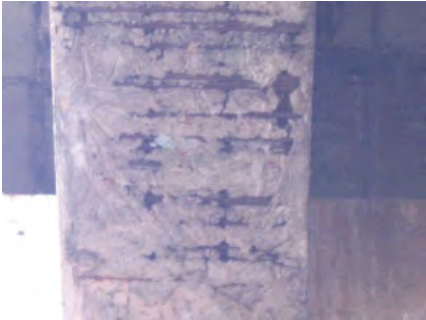
Exposure/Corrosion of Rebars caused by unskilled workmanship is observed.
Abutments	Cracking concrete

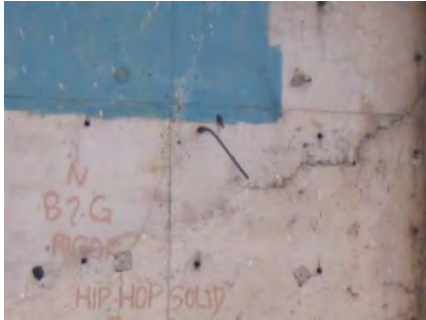
Shear crack is observed on pier wall.
	Exposure/Corro sion of Reinf.

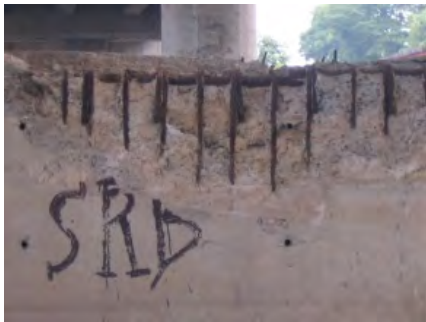
Exposure/Corrosion of Rebars due to impact of ship is detected at pile cap.
Expansion Joint (Primary)	Waterleaking

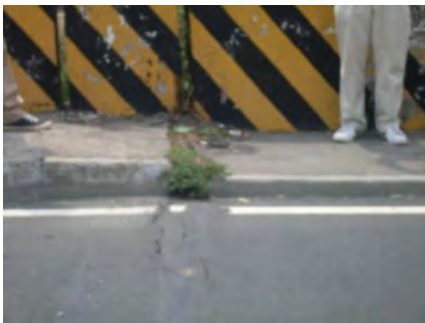
Difference in elevation is occurred between bridge and approach slab.

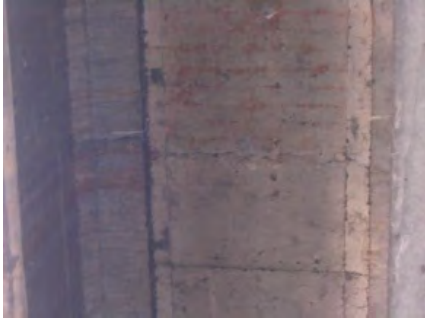
<p>Cracks on deck slab of PC girder are mostly observed on bottom side.</p> <p>Cracks are not serious but developing on entire deck slab.</p>
	Water leaking

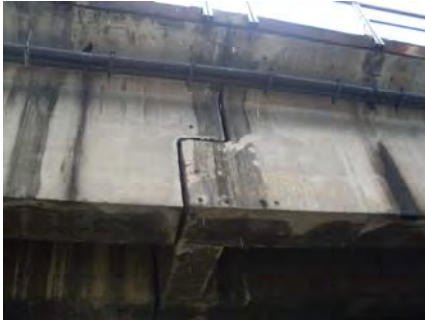
<p>Many cracks are observed on the outside girder. Especially, On the all hinge portion, shear cracks are observed that are considered to be fatal cracks</p>
	Spalling, Scaling,Disinte gration

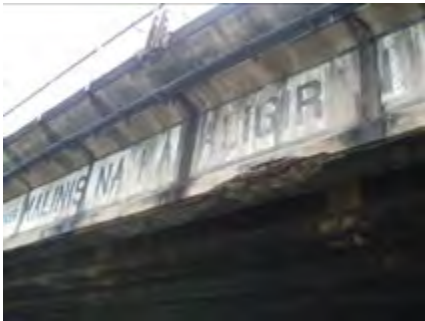
<p>A few spallings caused by collision by ship are observed. The damage is serious.</p>

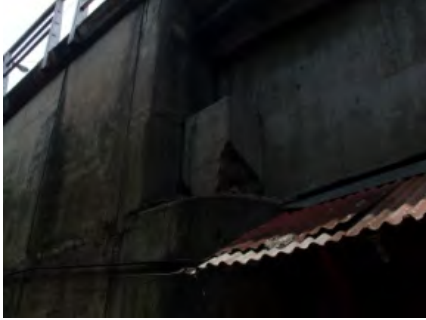
A few spillings are observed at shear key block.
	Cracking concrete

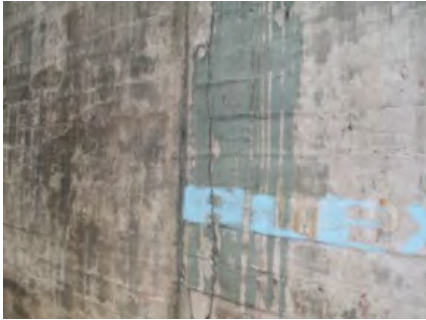
Many vertical clacks are observed near the joint between wing wall and retaining wall.
Pier	Spalling, Scaling,Disi ntegration

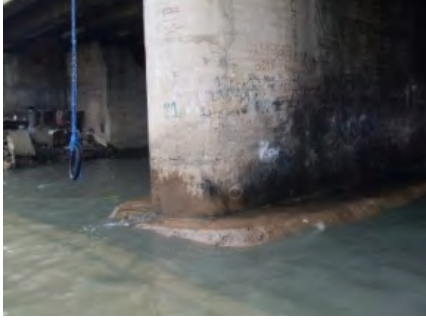
Scaling on surface of concrete is scraped due to ship.

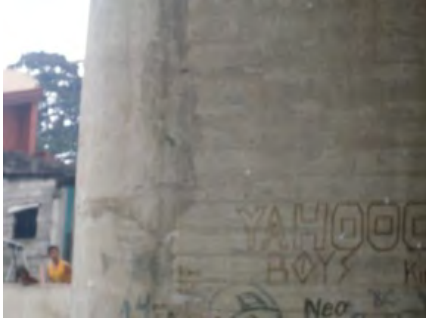
Many cracks with less than 0.3mm observed horizontally and vertically.
Curb and Railing (Secondary)	Cracking/Corrosion

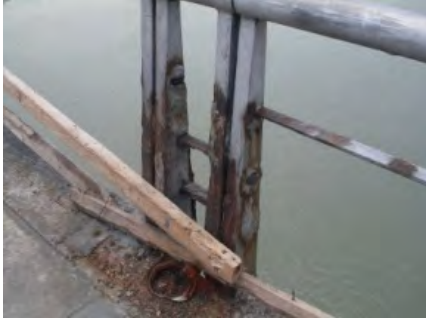
Severe corrosion is occurred on steel railing.
Expansion Joint (Primary)	Water leaking

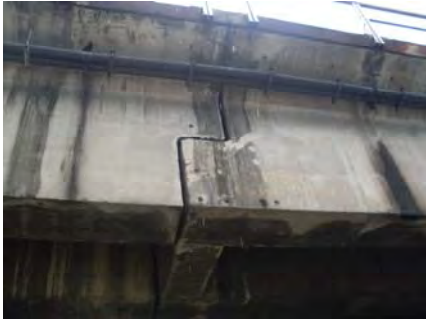
Water leaking is observed at all expansion of hinge joints.
	Difference in elevation

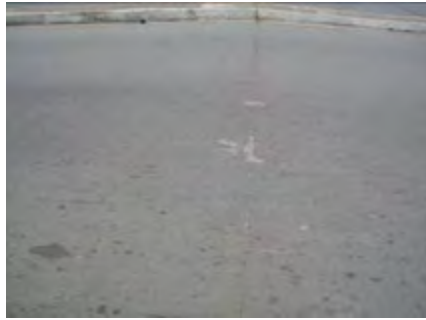
Difference in elevation is observed between girders and approach slab.

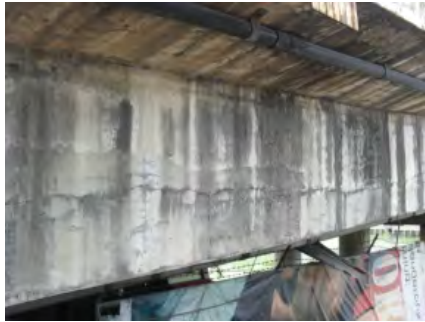
Many cracks on concrete surface of both sides of box girder are observed. Especially at the end box girders cracks are severely developed.
	Exposure/Corrosion of Rebars

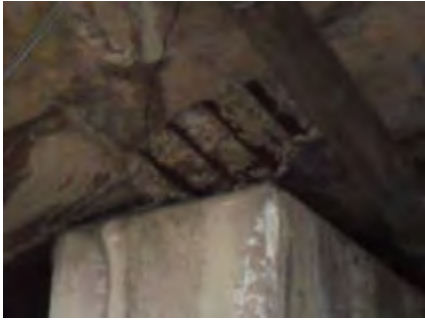
A few exposure/Corrosion of rebar is observed due to delamination.
	Spalling, Scaling,Disintegration

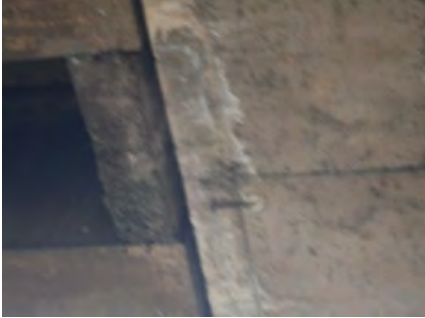
Several honeycombs caused by unskilled workmanship are observed.
Shoe Bearing (Primary)	Corrosion

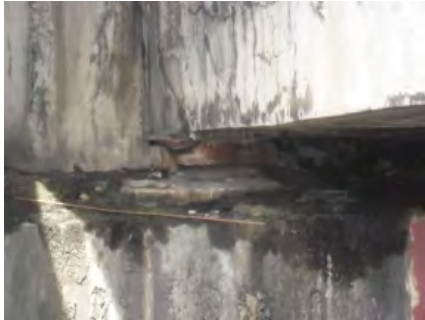
Steel bearing plates are severely corroded by waterleaking from expansion joint.
	Abnormal Displacement

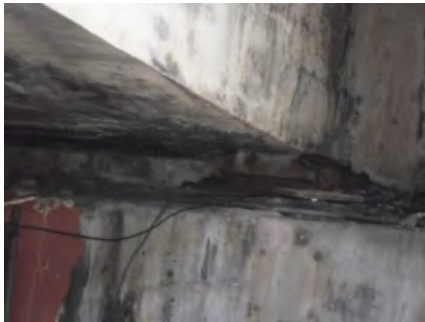
Steel bearings located at curved section are displaced outward.
	Bulging/Rupture

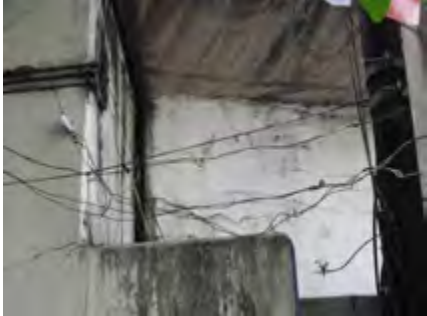
Several cracks are observed on abutment.
Pier	Spalling, Scaling,Disinte gration

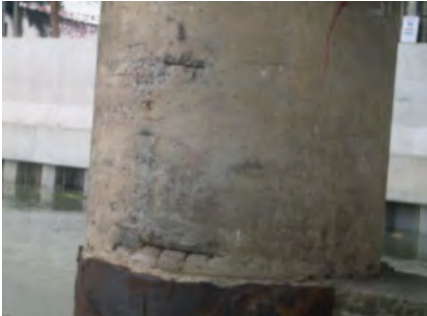
Spalling and scaling caused by ship are observed on piers in the river.
	Cracking concrete

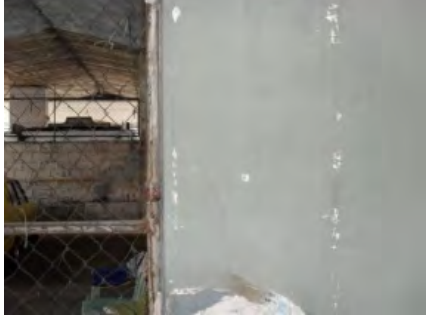
Many cracks with less than 0.3mm are observed but covered by painting.
	Exposure/Corr osion of Reinf.

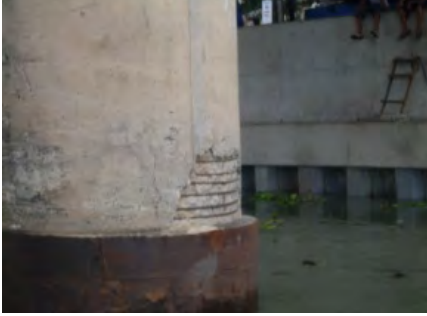
A few Exposure/Corrosion of Rebars are observed on piers, which caused by ship.

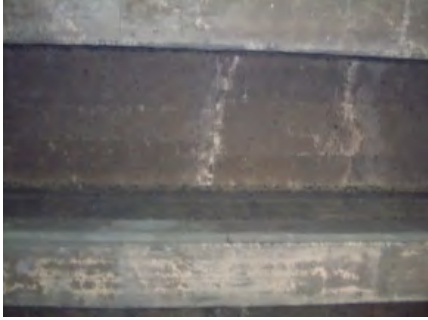
Cracks on deck slab of PC girder are mostly observed on bottom side.
	Water leaking

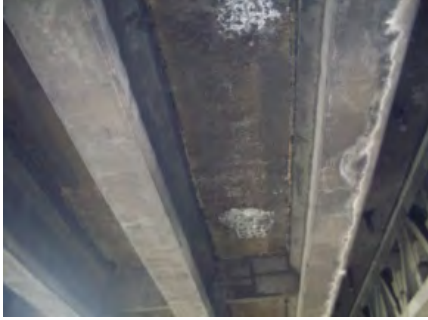
At some parts of cracks, water leaking are observed.
Concrete Beam/ Girder (Primary)	Cracking

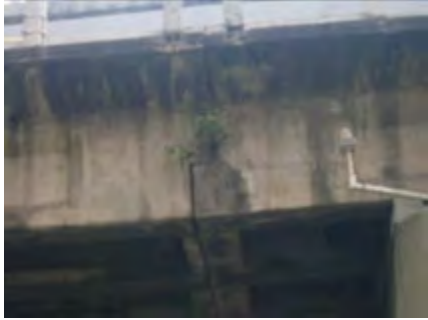
Many cracks are observed on the outside girder. Especially, On the all hinge portion, shear cracks are observed that are considered to be fatal cracks
	Delamination

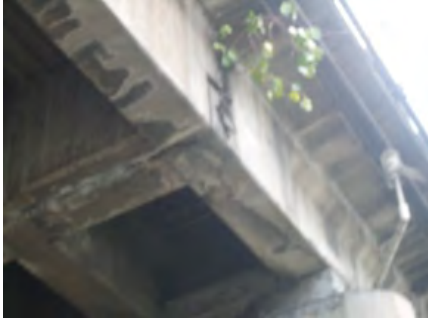
A few delaminations are observed on bottom of girders.

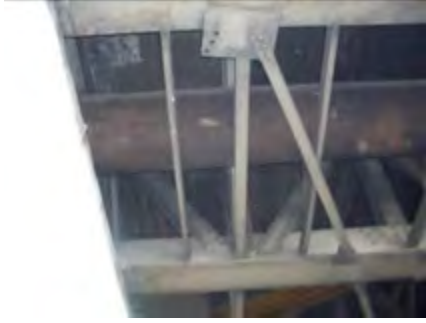
A few missing steel bracings are observed.
	Paint Peel off

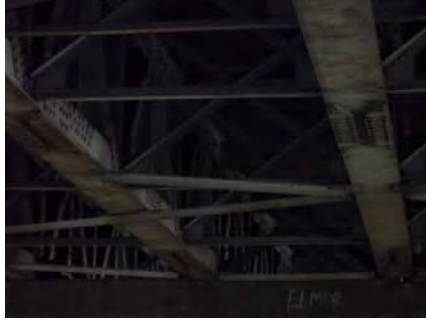
Paints of Steel truss bridge is quite good condition but paint peel off is observed at some places.
Abutments	Delamination

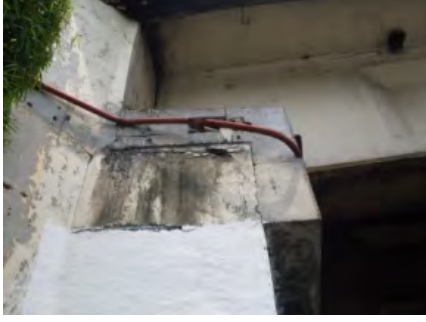
A few delaminations are observed on abutment.
	Cracking concrete

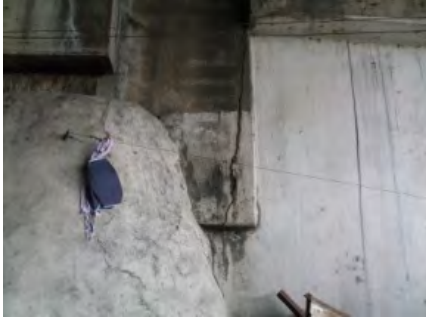
A few cracks are observed on abutment.

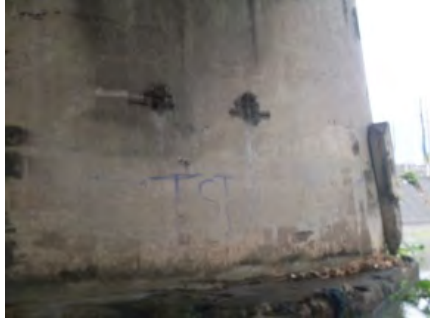
Many spillings and scaling due to impact of ships are observed.
	Cracking concrete

River course is slightly bent so ships are often hit pier body. Strong protects are necessary.

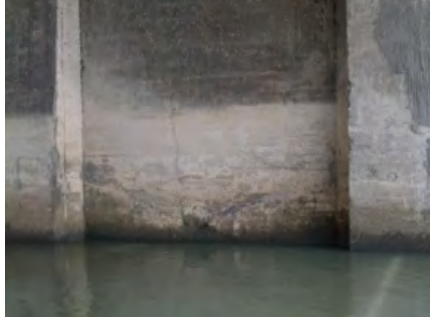
Cracks are occurred on wall concrete between rectangular piles
	Exposure/Corro sion of Reinf.

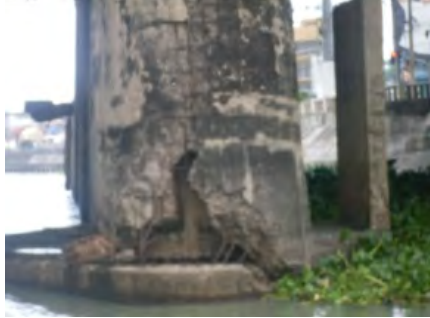
Many exposure /corrosion of rebars due to impact of ships are observed.
Curb and Railing (Secondary)	Cracking

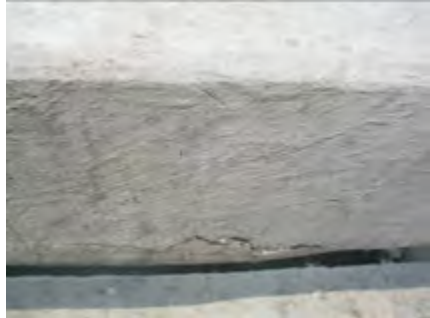
Cracks on railing are observed.

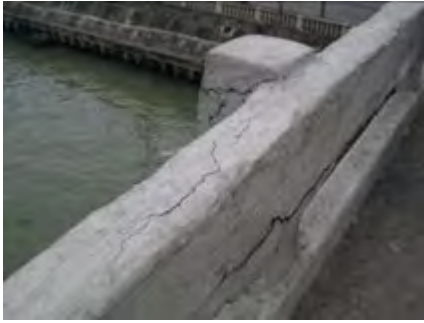
Several spalling and delamination are observed.
Expansion Joint	Water leaking

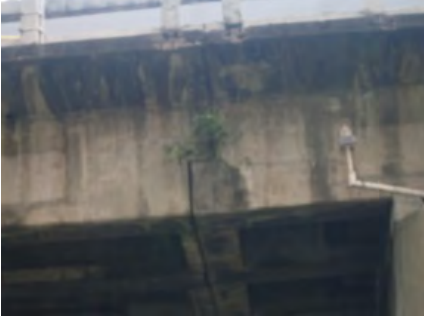
Water leaking is observed at all expansion of hinge joints.
	Abnormal Space/Noise

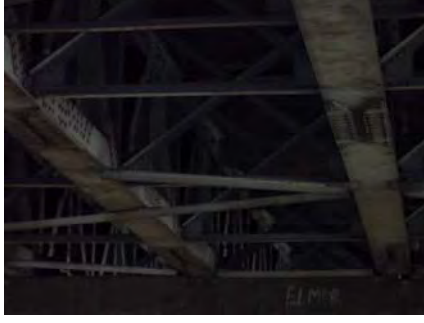
Discoloration is entirely progressing.

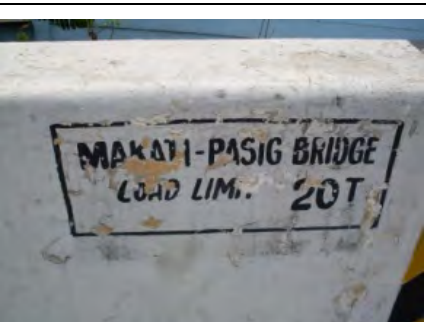
<p>10. no load limit id</p>

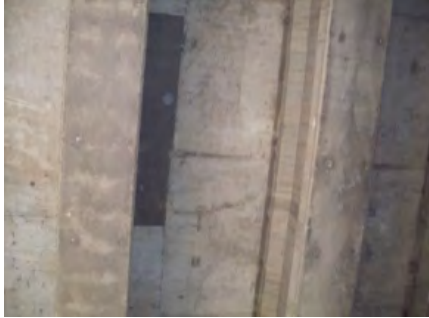
Crackings width less than 0.3mm is observed on some part.
	Water leaking

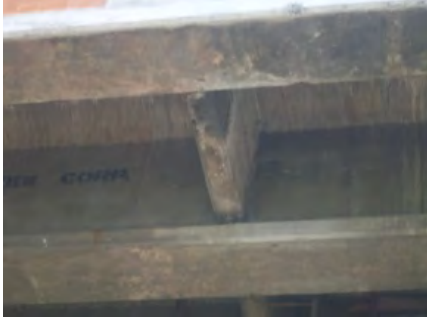
Few honeycombs are observed on cross beams.
Piers (Primary)	Spalling, Scaling,Disintegration

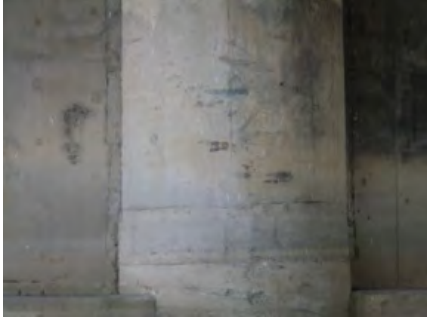
Spalling and scaling are observed on pier concrete due to intentionally impact
	Cracking concrete

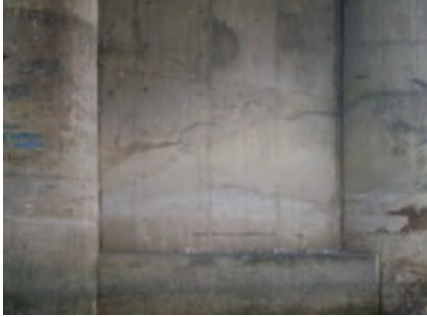
Some Cracks less than 1mm are observed on interval wall between Circular piles at several piers.
Curb and Railing (Secondary)	Cracking

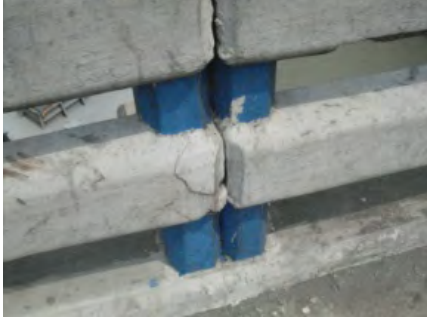
Small cracks are observed on end post of railings.

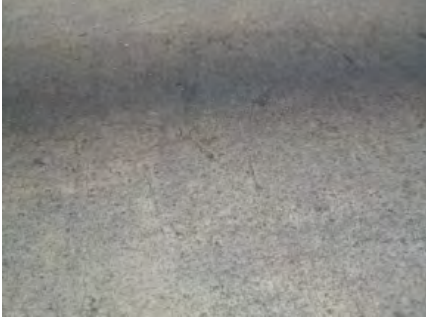
Cracking width about 1mm on slab is covered with 30%.
	Scaling/Spalling

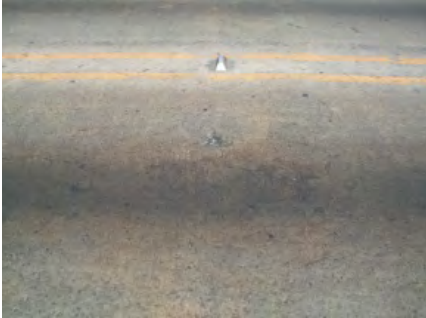
Scaling on the deck slab is observed entirely but its condition is not bad.
Concrete Beam/ Girder (Primary)	Exposure/Corrosion of Rebars

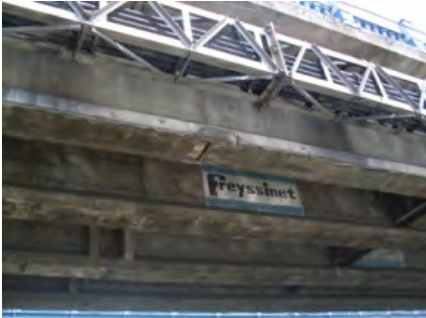
Few Exposure/Corrosion of rebars are observed on concrete girders.
	Spalling, Scaling, Disintegration

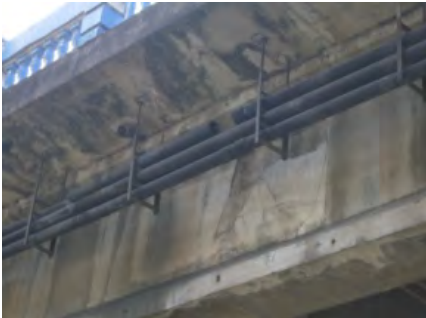
Few spalling and scaling are observed on concrete girders.

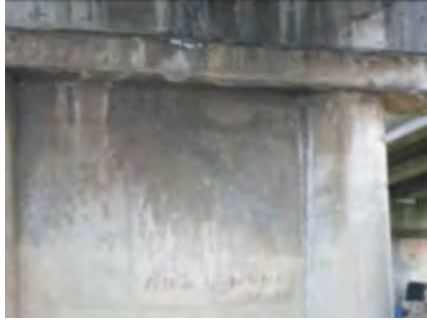
Some vertical cracks are visible but maintain good condition.

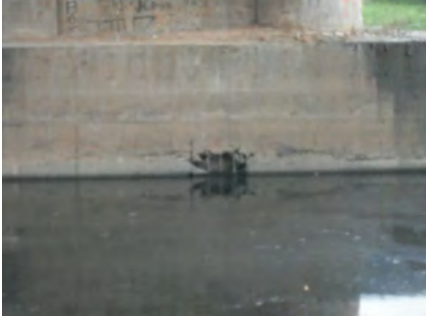
Only one Exposure/Corrosion of Rebars is observed at pile cap.
Expansion Joint (Primary)	Water leaking

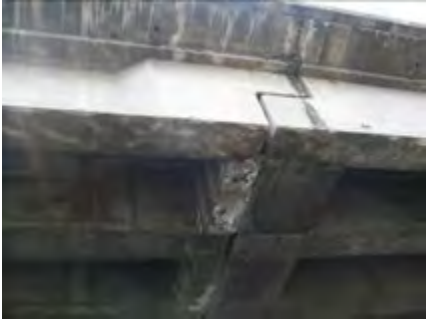
Water leaking from expansion joint is observed.
Slope Protection	Material Loss

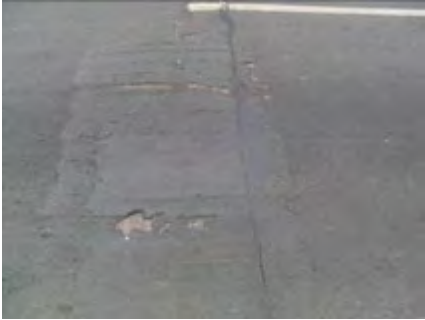
Many pot-holes are observed on approach road.

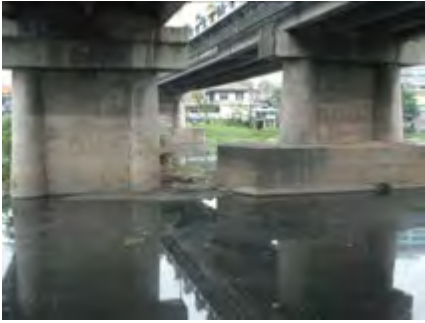
A few local scouring around piers is observed.

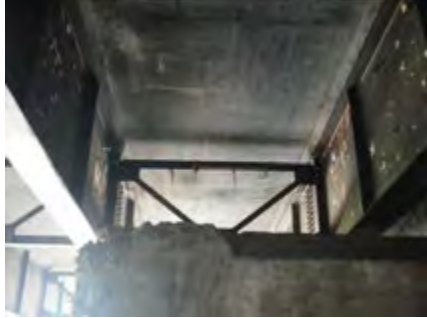
Cracks with width less than 1mm are observed on a half of deck slab.
	Water leaking

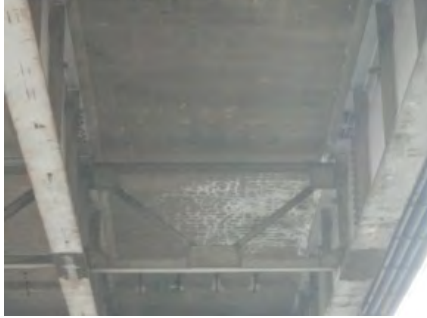
Water leaking are observed from the cracks with width more than 1mm.
Steel Beam/ Truss Member (Bracings, etc.) (Primary)	Corrosion

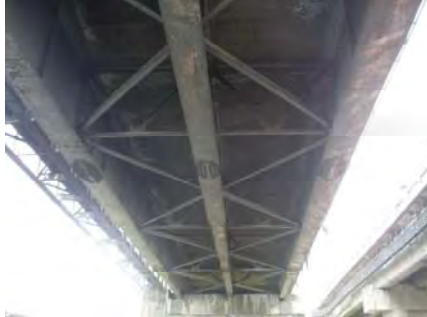
Lower flanges of steel I-girders are corroded but corrosion is limited.
	Loose Connection

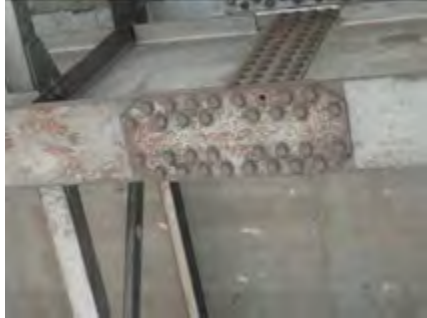
Some H.T.Bolts are missing or loose connection.

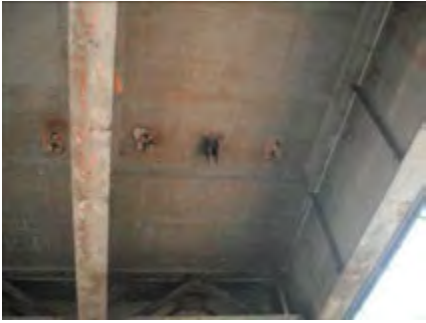
Paint peel off is progressing entirely steel plates.
Pier	Cracking concrete

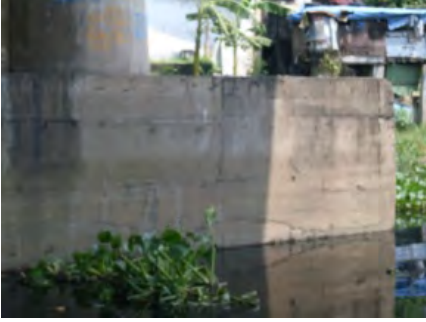
Some cracks with width more than 1mm are observed on bottom of pile cap.
Slope Protection (Secondary)	Erosion	 	Slope protection is scoured by flood and approximately a half of protection is damaged.
Approach Road	others

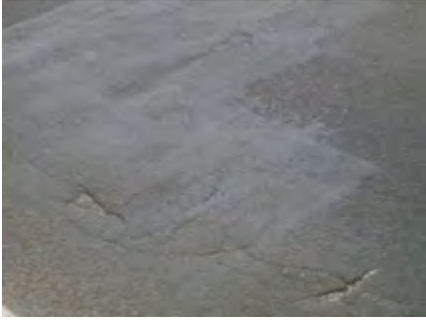
Many pot-holes are observed on approach road.

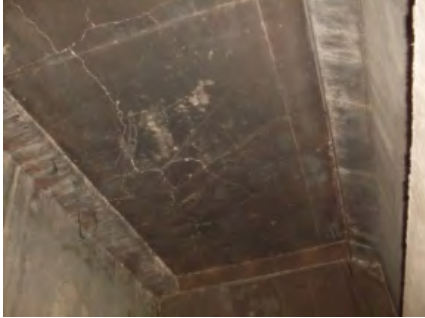
Component/ Material/ Classification	Type of Damages	Picture of the Damage	Reasoning for the Evaluation
Deck Slab (Primary)	Cracking

Cracks with width less than 1mm observed entirely on deck slab. Some cracks are over 1mm.
	Exposure/Corrosion of Rebars

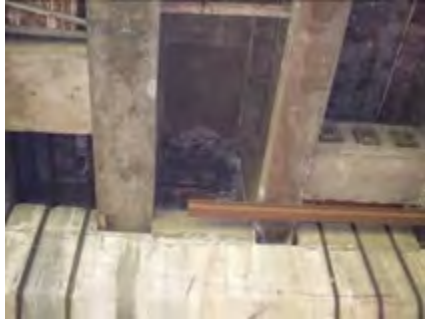
At end of deck slab, Exposure/Corrosion of Rebars due to spalling is detected.
	Scaling/Spalling

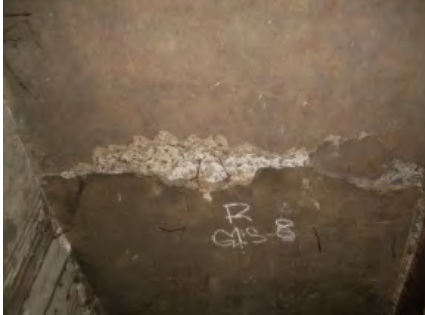
Several spallings are observed on the bottom of deck slab.
Concrete Beam/ Girder (Primary)	Cracking

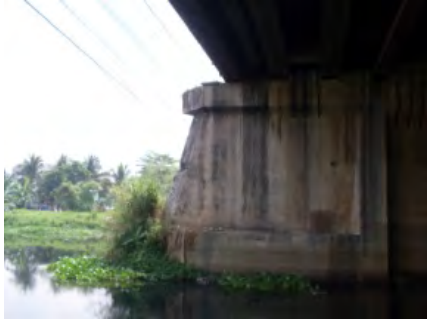
At a few piers, Exposure/Corrosion of Rebars due to impact of ship is observed.
Curb and Railing (Secondary)	Impact Damaged

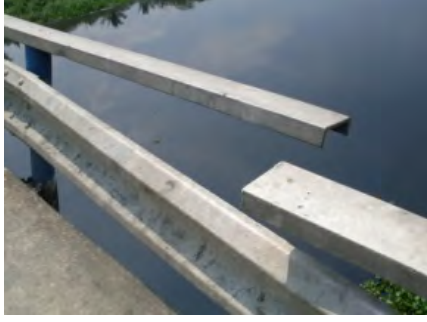
Railing is damaged due to impact of traffic.
Expansion Joint (Primary)	Water leaking

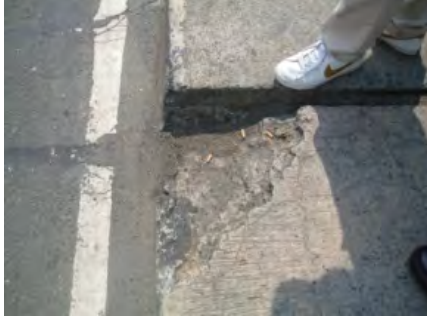
Difference in elevation at expansion joint is occurred due to displacement of girders.
	Displacement

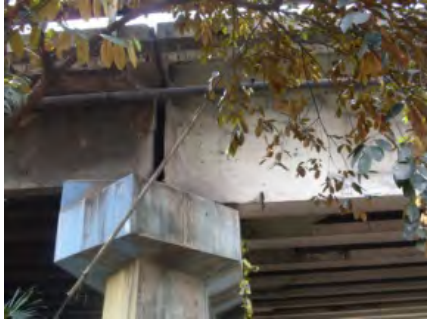
Due to displacement of girders, portion of expansion joint is closed and bottom of girders are opened.
Slope Protection	Erosion

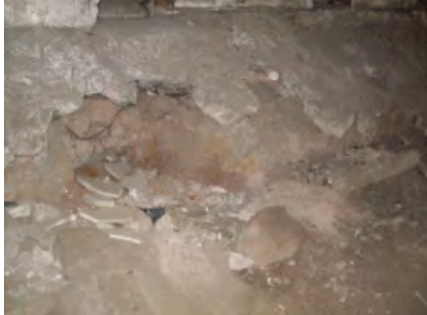
At Abutment A1, erosion of slope protection is observed.
	Material Loss

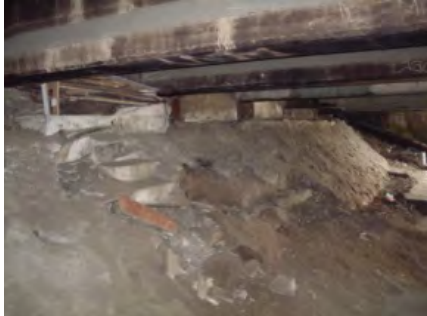
At abutment A2, material losses are observed.

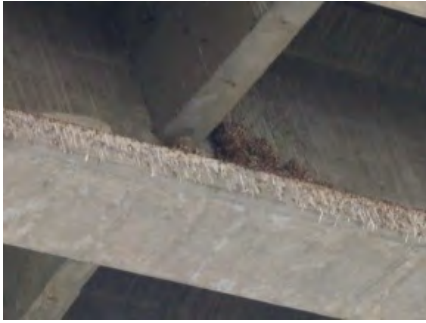
A few honeycombs caused by unskilled workmanship are observed.
Shoe/Bearing	Bulging/Rupture

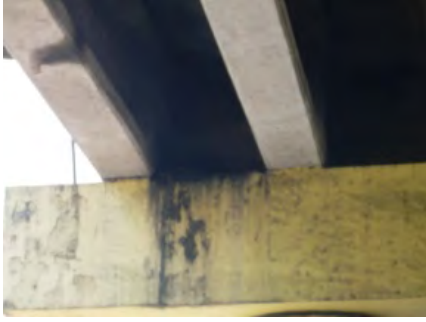
Several spallings are observed on piers.
	Cracking concrete

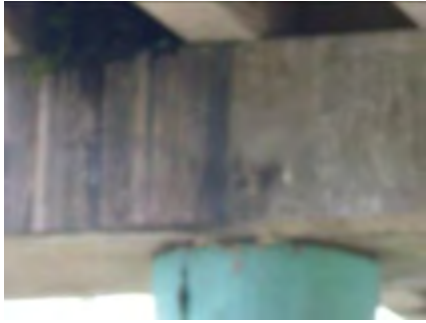
Water leaking is observed from expansion joints.
	Displacement

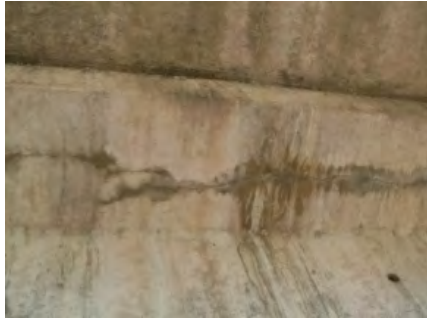
Component/ Material/ Classification	Type of Damages	Picture of the Damage	Reasoning for the Evaluation
Concrete Beam/ Girder (Primary)	Cracking

Crack with width more than 1mm is detected o flange of PC T-girder. Length is approximately 3m.
	Spalling, Scaling,Disinte gration

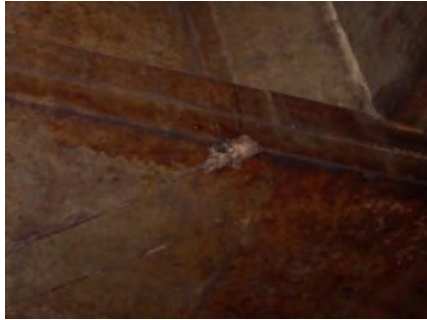
Several small spallings are observed.
Shoe/Bearing	Corrosion

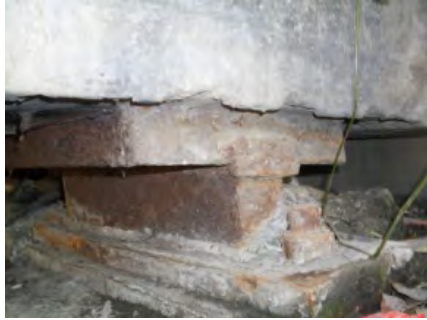
Steel bearings are severely corroded but not yet section loss.
	Loose Connection

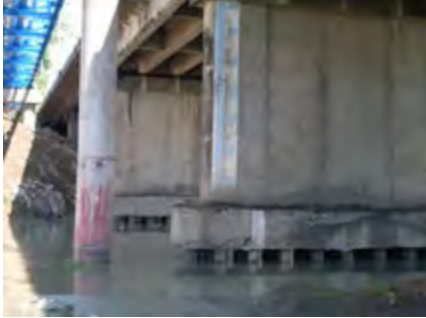
Component/ Material/ Classification	Type of Damages	Picture of the Damage	Reasoning for the Evaluation
Pier	Delamination

Delamination of concrete may be occurred at pile cap.
	Spalling, Scaling, Disintegration

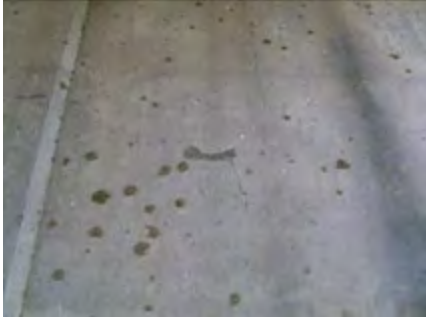
Small spallings are observed on pier concrete.
	Cracking concrete

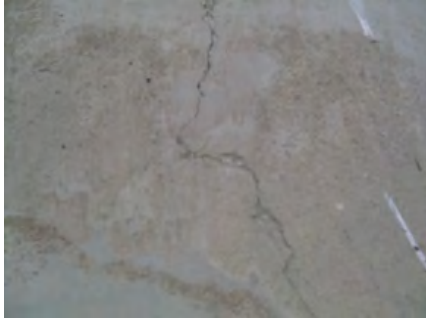
A few vertical cracks with width more than 1mm are observed on each pier.
Expansion Joint (Primary)	Water leaking

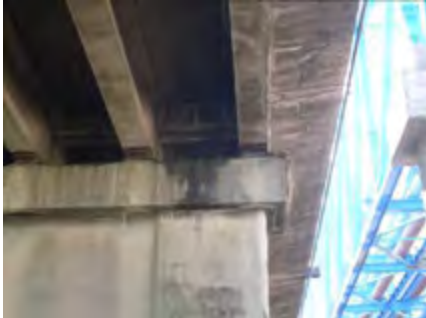
Water leaking is observed from expansion joints.

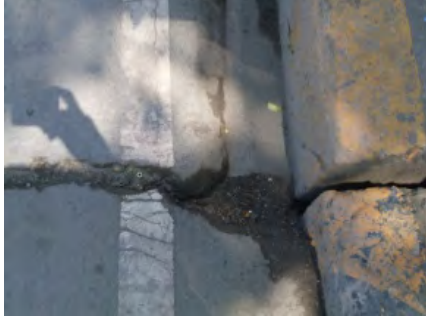
Component/ Material/ Classification	Type of Damages	Picture of the Damage	Reasoning for the Evaluation
Expansion Joint (Primary)	Abnormal Space/Noise

Space of expansion joints are closed abnormally.
Drainage Pipe	Clogged

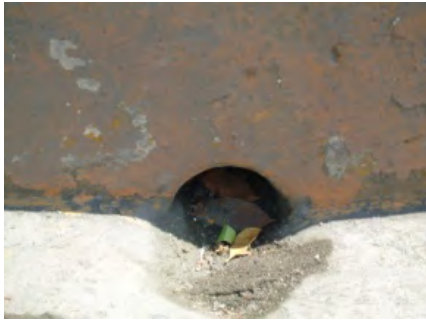
Drainage pipes are completely clogged with dusts and sand.
River Condition (Secondary)	Scouring

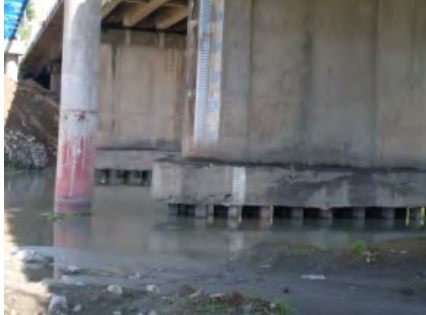
Pile foundations are exposed by local scoring and its piles are projected.
