(2) Package C

1) Badiwan Bridge

BRIDGE SEISMIC INVENTORY DATA									
A. GENERAL									
(1) Bridge Name:		<i>Badiwan Bridge</i>				(2) Posted Load Limit		<i>15</i>	tons
(3) Location:	km.: <i>276+885</i>	Route:	<i>Marcos Highway</i>			Prov./ City	<i>CAR, Baguio City</i>

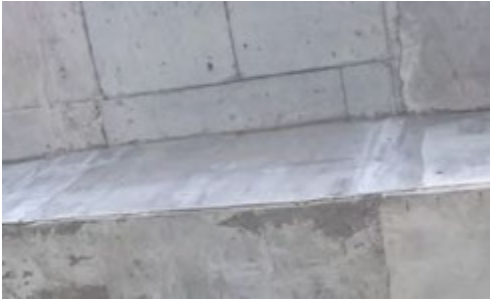
Minor cracks are observed at the part of overhanging deck slab.
Concrete Beam/ Girder (Primary)	Exposure /corrosion of rebars

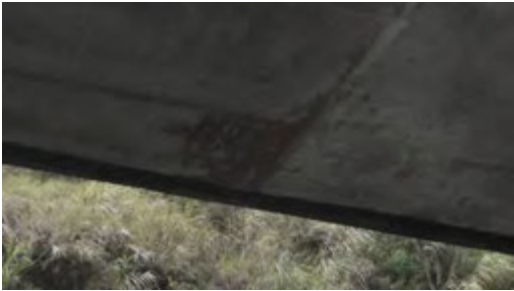
Corrosion of rebars is observed at the part of concrete box girder.
	Honeycomb

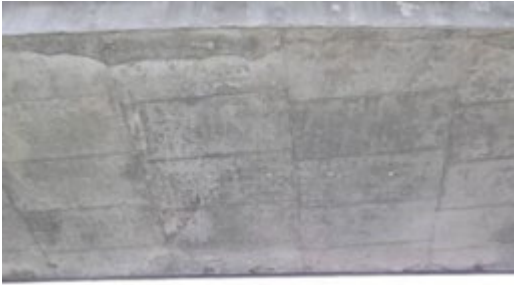
Honeycomb is observed at the part of concrete box girder.
	Black stain by fire

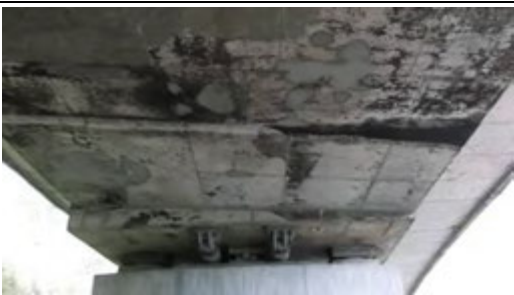
Black stain by fire is observed at the concrete box girder between P12 and A2.
Shoe/Bearing (Primary)	Corrosion

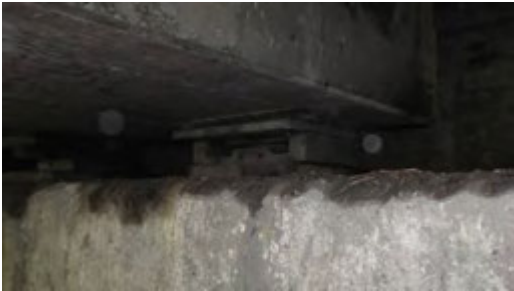
Corrosion at the steel bearings is observed at abutments.

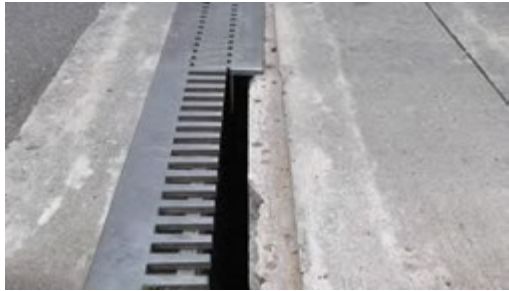
Water leaking due to section loss is observed at expansion joints.
Drainage Pipe (Secondary)	Clogged

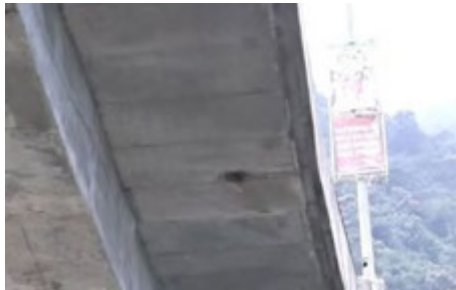
Clogged drain is observed at drainage pipes
River Condition (Secondary)	Sedimentation

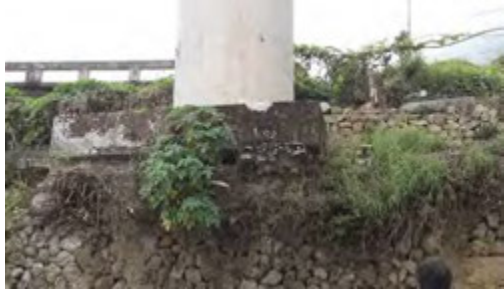
Debris flow is observed between P1 and P2, and between P5 and P6.

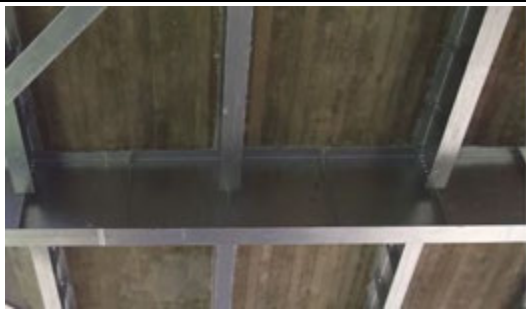
Minor cracks are observed at the part of the deck slab.
	Water leaking/ Free lime

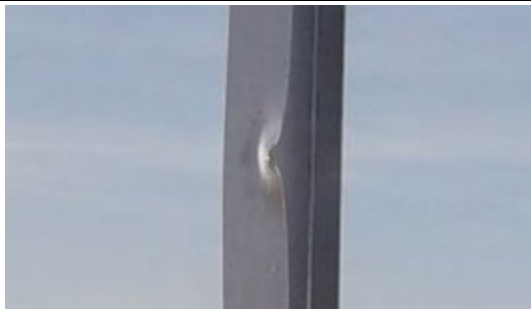
Deformation is observed at part of the primary steel member.
	Abnormal Vibrations

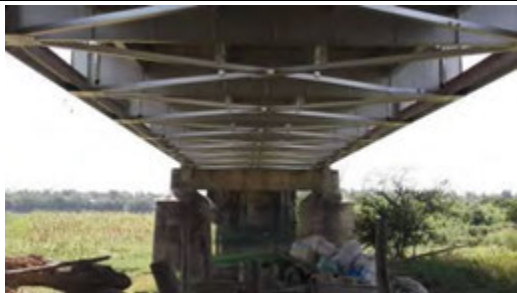
Abnormal vibration of secondary steel members (bracings) is observed.
Shoe/Bearing (Primary)	Displacement

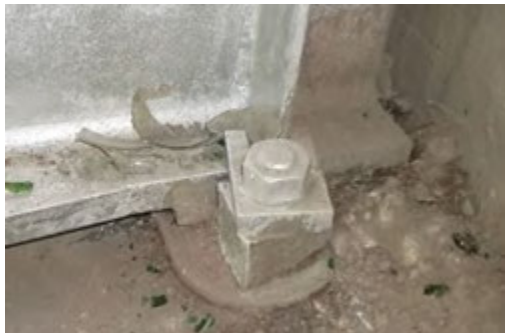
Abnormal displacement is observed at Movable bearings

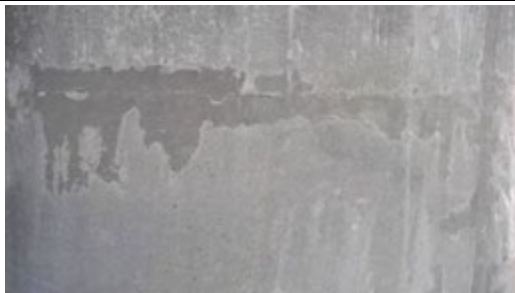
Cracks are observed at piers.
	Scouring

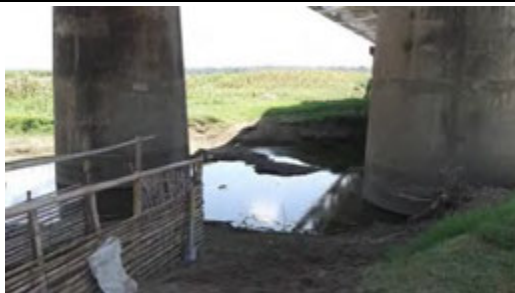
Scouring is observed at P4.
Expansion Joint (Secondary)	Water leaking

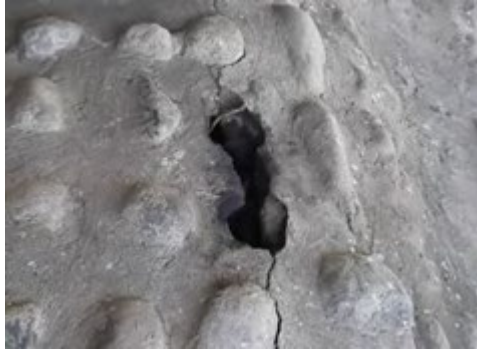
Pot-holes and cracks are observed at the slope protection of A2.

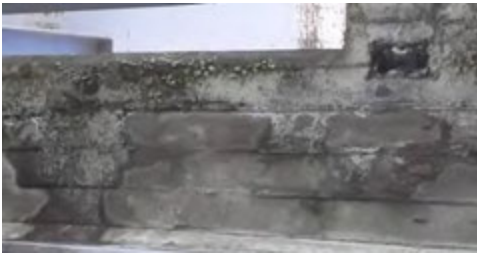
Component/ Material/ Classification	Type of Damages	Picture of the Damage	Reasoning for the Evaluation
Deck Slab (Primary)	Hanycomb/ Water leaking

Hanycomb and water leaking are observed at the part of overhanging deck slab.
	Scaling/Spalling

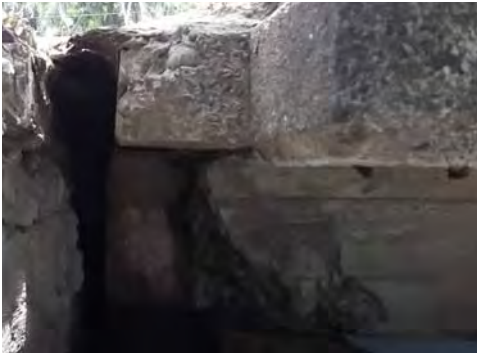
Spalling is observed at the end of deck slab.
Steel Beam/ Truss Members (Bracings, etc.) (Primary)	Corrosion/ Paint Peel Off

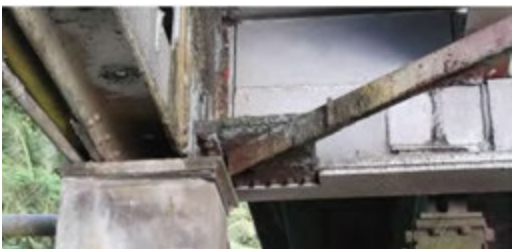
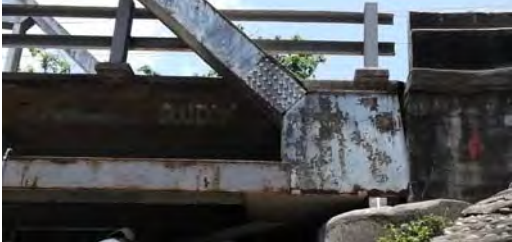
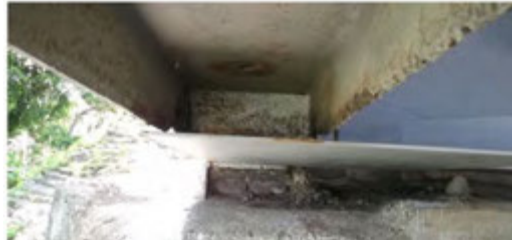
Corrosion and Paint Peel Off are observed at steel members.
Shoe/Bearing (Primary)	Corrosion

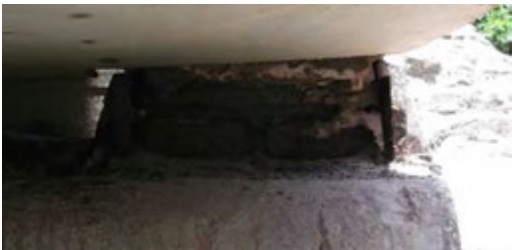
Corrosion is observed at bearings.

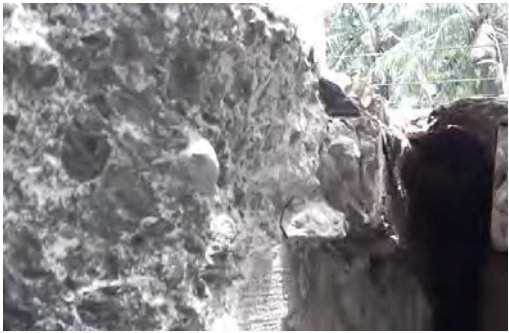
Spalling due to hanycomb is observed at A1.
Curb and Railing (Secondary)	Cracking (Loose Connection)

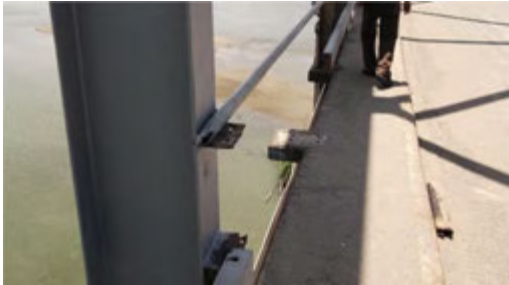
Loose connection due to cracking is observed at the railing.
Expansion Joint (Secondary)	Water leaking

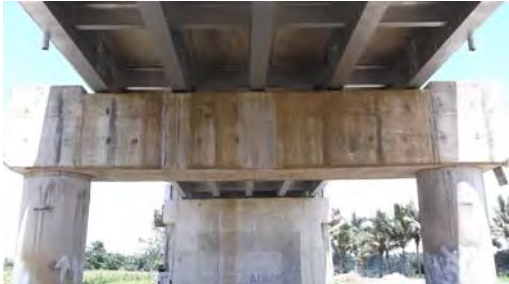
Water leaking is observed at expansion joints.
	Abnormal Space/Noise

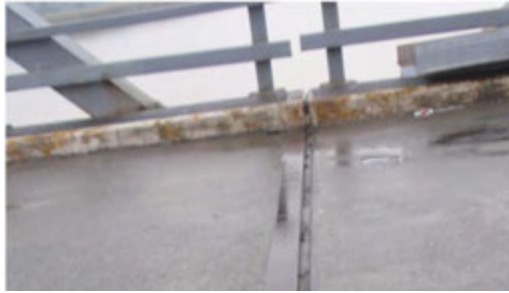
Abnormal space/noise is observed at expansion joints.
Slope Protection (Secondary)	Material Loss

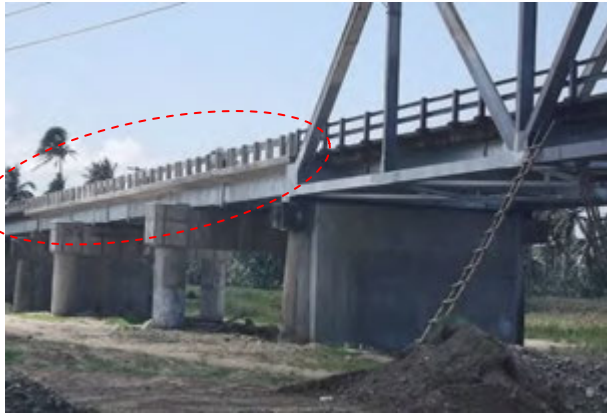
The 7th span is already replaced.

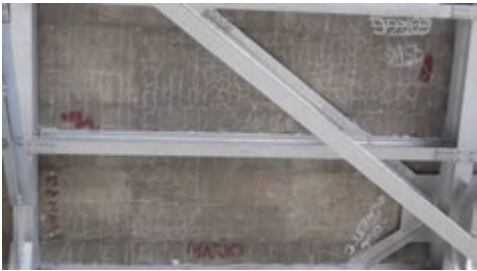
Cracks are observed at the part of the deck slab.
Steel Beam/ Truss Members (Bracings, etc.) (Primary)	Corrosion

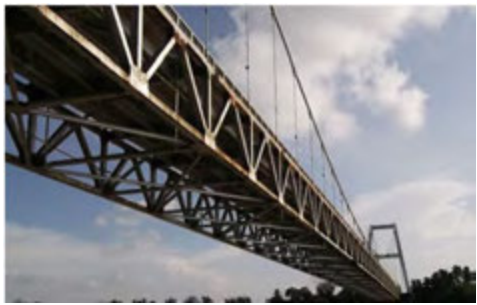
Corrosion is observed at the part of steel members.
	Loose connection

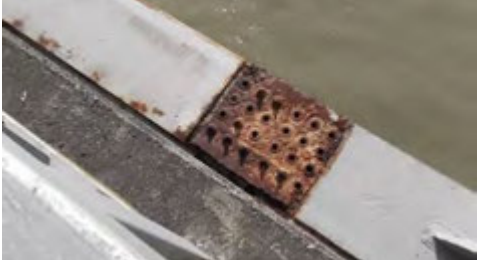
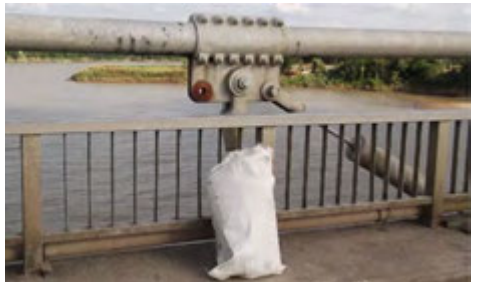
<p>Loose connection due to lack of bolts is observed at splices of steel members.</p> <p>Also, loose connection due to lack of damper cables is observed at steel members.</p>
	Paint peel off

Repair of loose connection at steel member

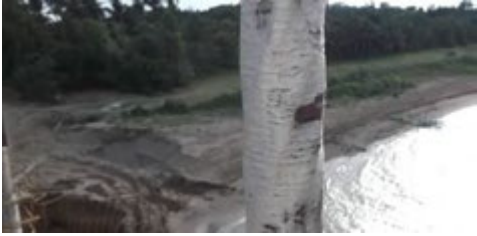
Paint peel off is observed at steel members & the suspension member.
Shoe/Bearing (Primary)	Abnormal displacement

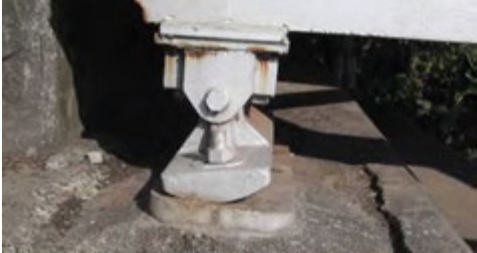
Abnormal displacement is observed at A1.

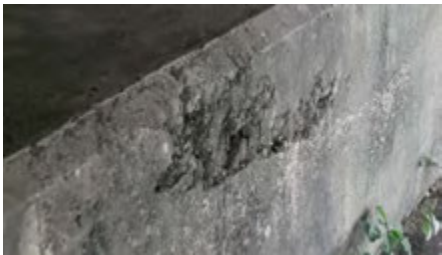
Hanycomnb is observed at A2.
Curb and Railing (Secondary)	Loose connection

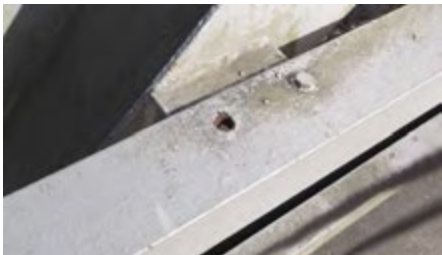
Loose connection due to lack of bolts is observed at the railing.
Expansion Joint (Primary)	Water leaking

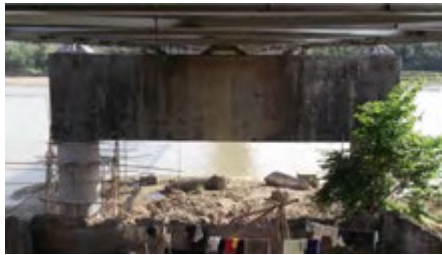
Water leaking is observed under expansion joints.
Slope Protection (Secondary)	Cracking

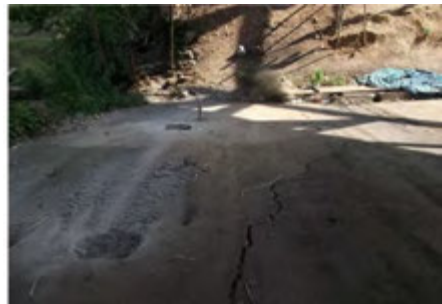
Major cracks are observed at A2.

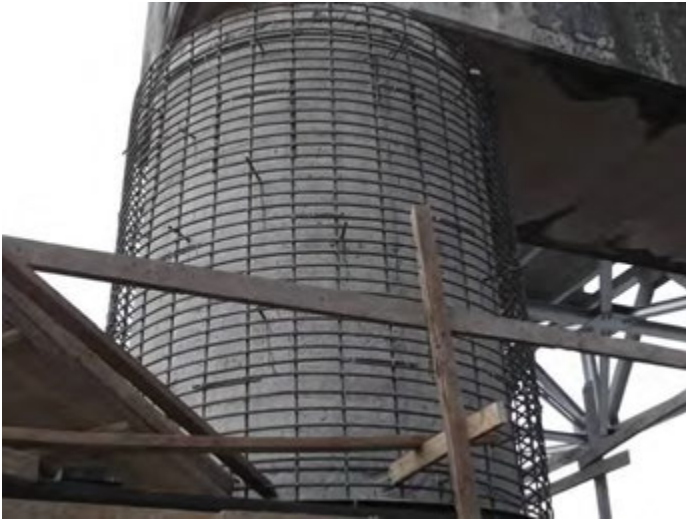
RC-jacketing on piers

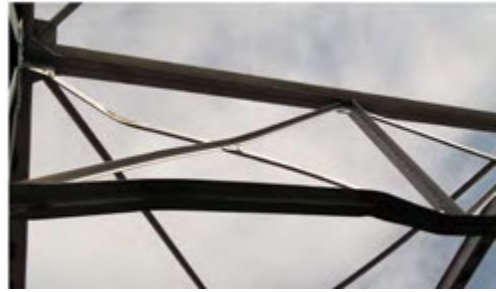
Deformation is observed at the part of secondary steel members.
	Abnormal vibration/noise

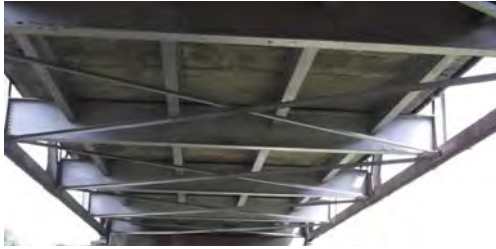
Abnormal vibration of secondary steel members (bracings) is observed.
	Corrosion Paint peel off

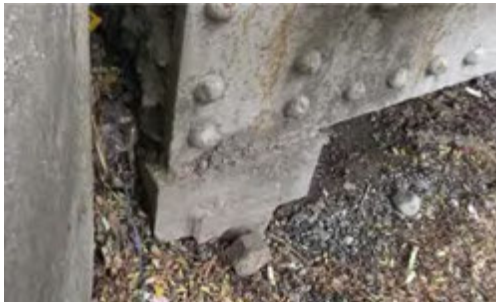
Debris flow around bearings of A2 is observed.

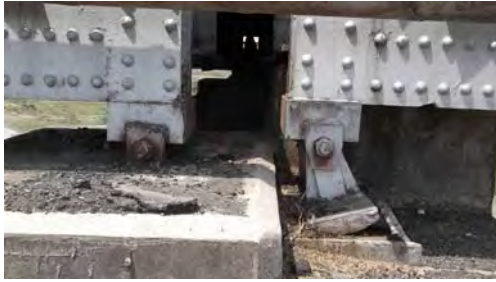
Abnormal displacement is observed at the bearings.
Abutments (Primary)	Cracking

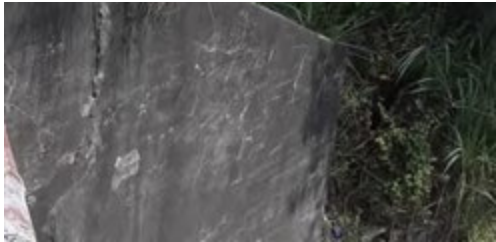
Major cracks (over 1mm in width) are observed at A1.
	Scouring

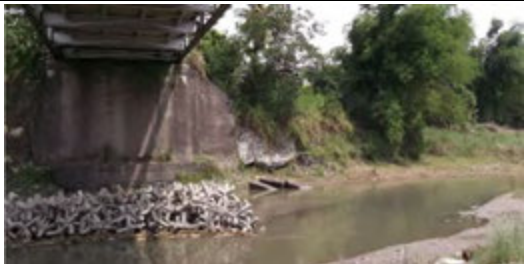
Scouring is observed at A1.
Curb and Railing (Secondary)	Impact Damaged

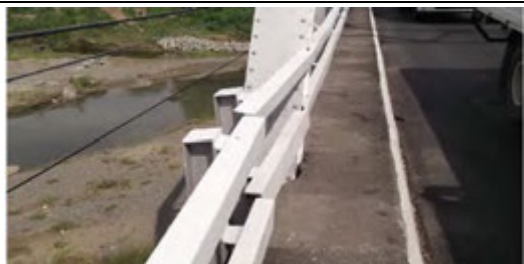
Impact damage is observed at the part of the railing.
	Loose connection

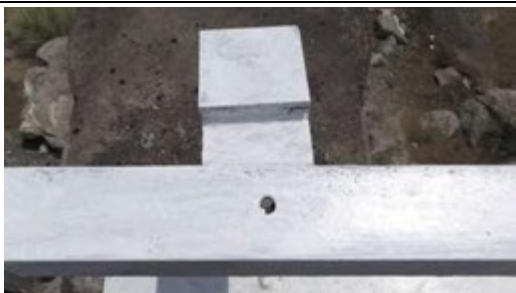
Loose connection due to lack of bolts is observed at the railing.
Expansion Joint (Primary)	Water leaking

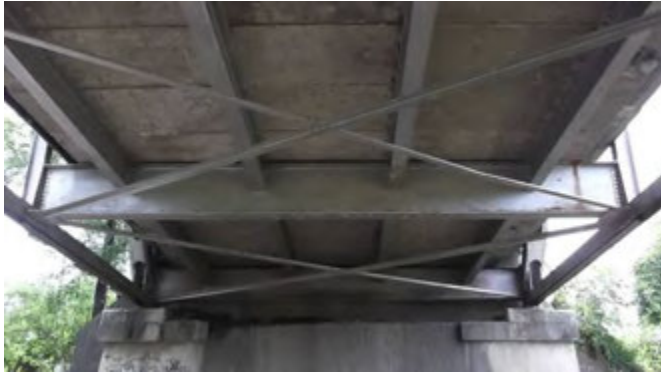
Replacement of the deck slab with the precast deck slab at carriageway

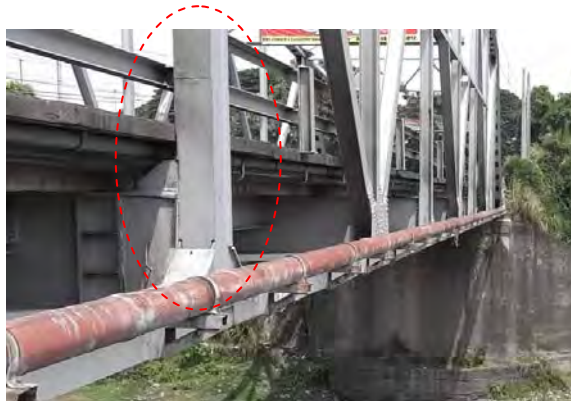
Reinforcement of primary steel members with steel plates

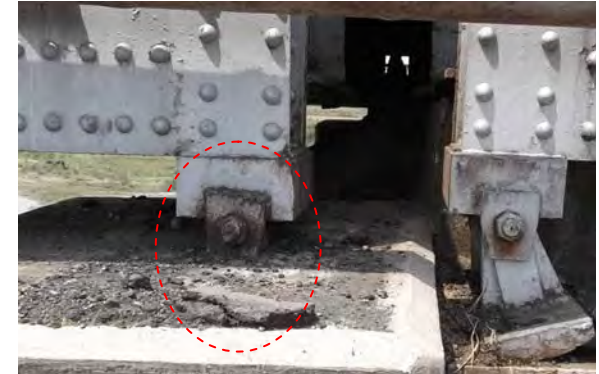
Reinforcement of bearings with concrete

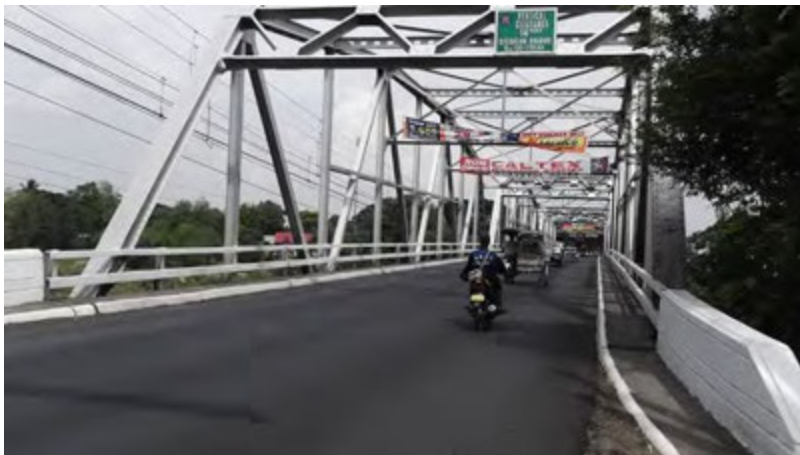
Asphalt pavement overlay

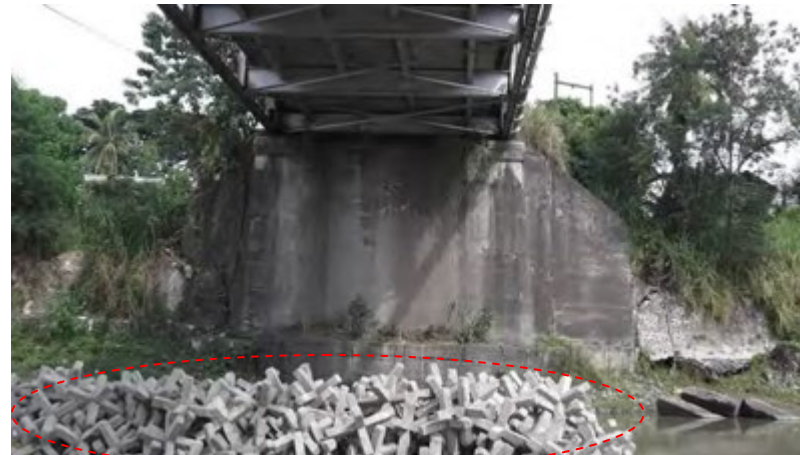
Head regulator on A1 side

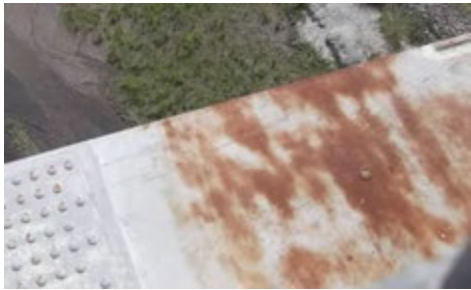
Corrosion is observed at the part of primary steel members
Abutment (Primary)	Cracking

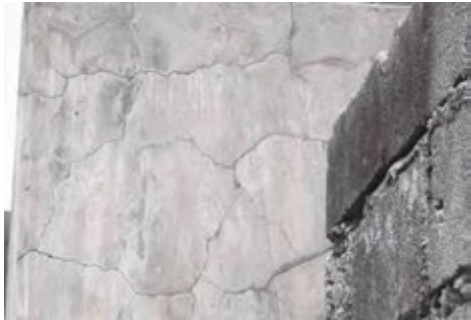
Cracks are observed at abutments. The width of cracks is over 1mm, but those are considered to be only superficial cracks.
Steel Beam/Truss Members (Bracings, etc.) (Primary)	Loose Connection (Material Loss)

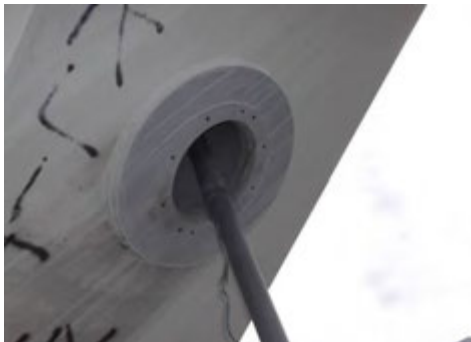
Lack of most of hand hole covers at primary steel members
Curb and Railing (Secondary)	Impact damaged

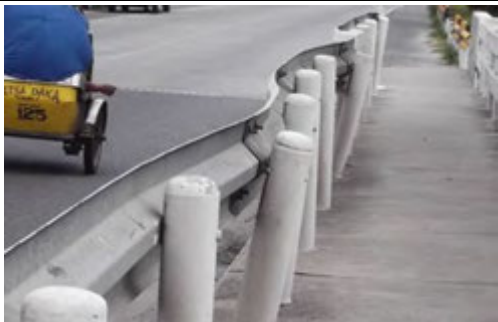
Impact damage is observed at the part of the railing.
Fall-prevention Cable

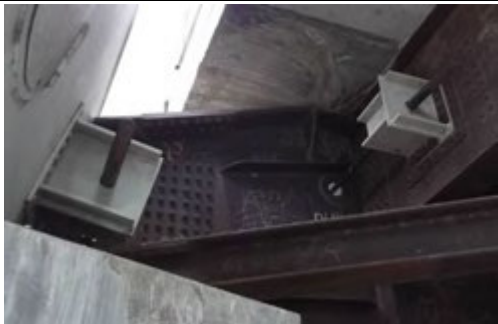
Lack of covers and bolts is observed at fall-prevention cables of A2.

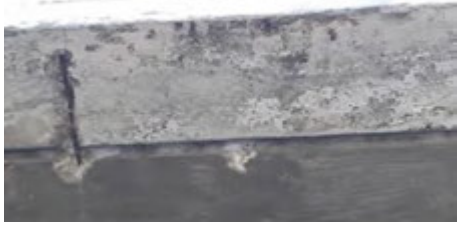
Exposure of rebar due to spalling is observed at the part of overhanging deck slab on A2 side.
	Water leaking

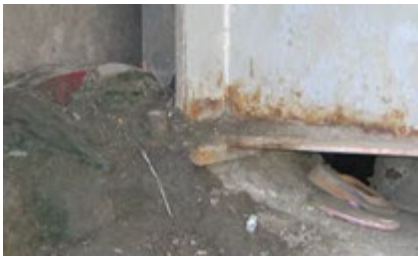
Accumulated dirt is observed at bearings of A2
Abutments (Primary)	Cracking

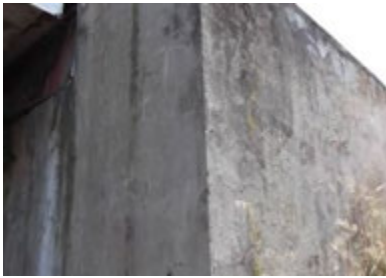
Cracking is observed at overall A1.
Piers (Primary)	Exposure/Corrosion of Reinf.

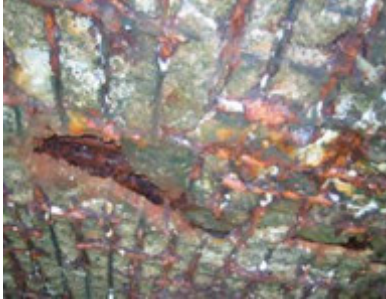
Major exposure/corrosion of reinf. is observed at the bottom of pile caps
	Scouring

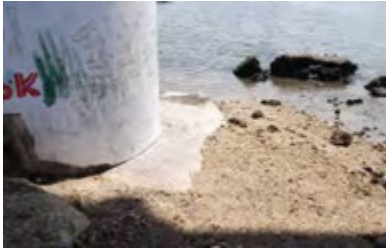
Scouring is observed at P10.
Expansion Joint (Primary)	Water leaking

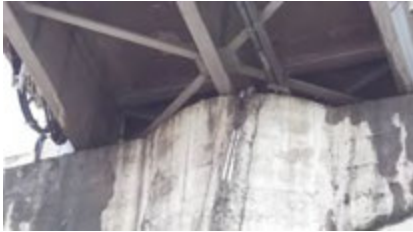
Water leaking is observed under expansion joints.
Curb and Railing (Secondary)	Section loss

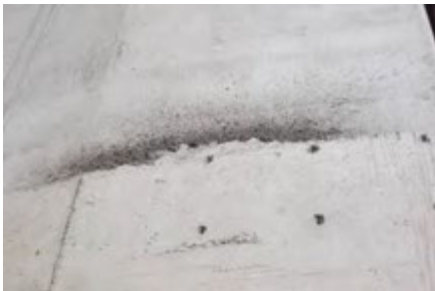
Hanycomb and cracks are observed at piers.
	Spalling/ Cracking

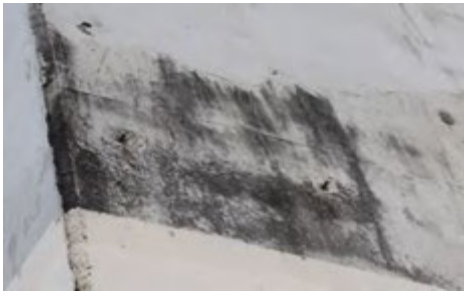
Spalling and cracks are observed at piers.
	Cracking

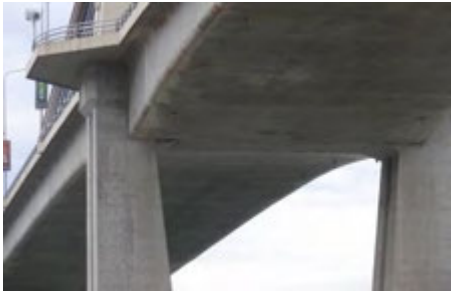
Cracks are observed at pylons. Cracks are considered to be due to <u>alkali - aggregate reaction</u> .
Expansion Joint (Primary)	Water leaking/ Abnormal noise

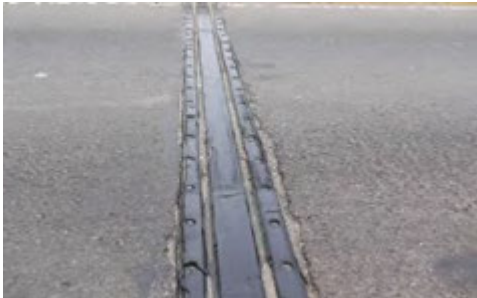
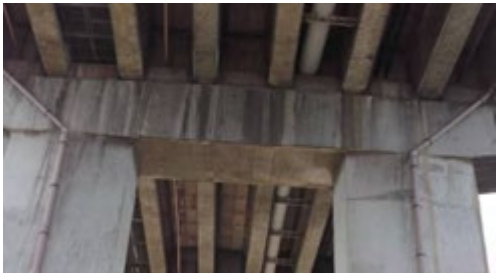
Water leaking and abnormal noise are observed under expansion joints. Some of expansion joints are heavily deteriorated.

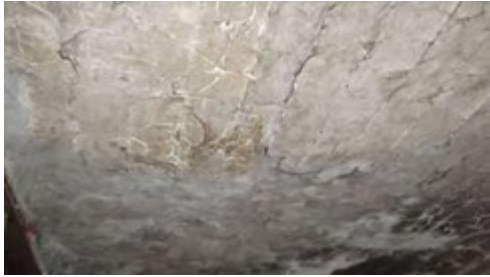
Major cracks and free lime are observed at the deck slab.
	Water leaking

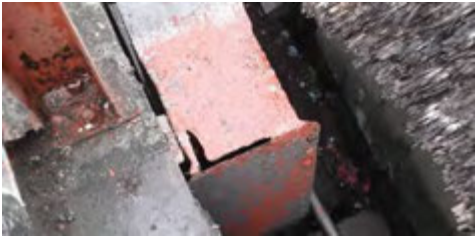
Section loss is observed at the part of steel members.
	Deformation/ Buckling

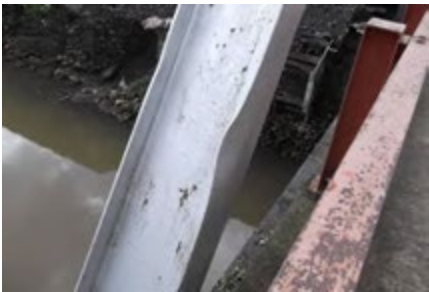
Deformation is observed at the part of primary steel members.
Shoe/Bearing (Primary)	Corrosion

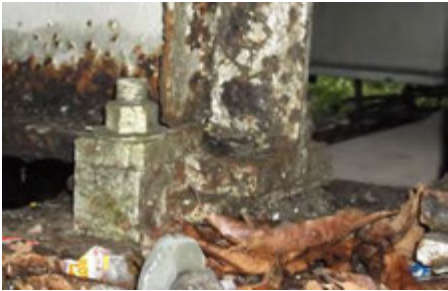
Corrosion at steel bearings is observed.
Expansion Joint (Primary)	Water leaking

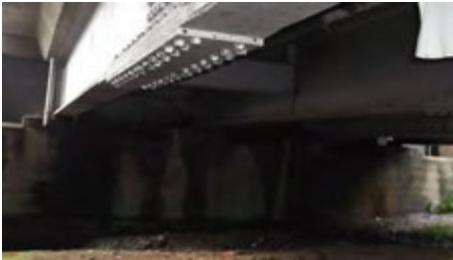
Water leaking is observed under expansion joints.

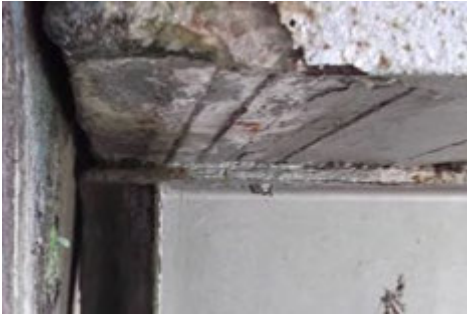
Section loss due to spalling is observed at the end of deck slab.
Steel Beam/Truss Members (Bracings, etc.) (Primary)	Corrosion

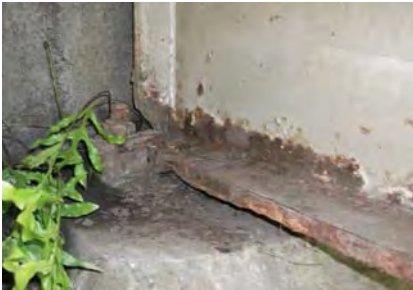
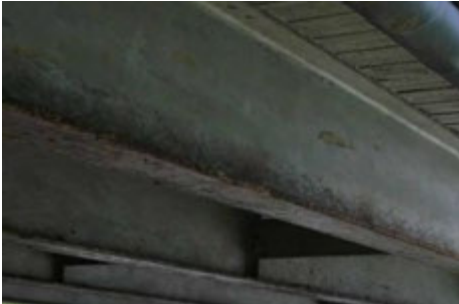
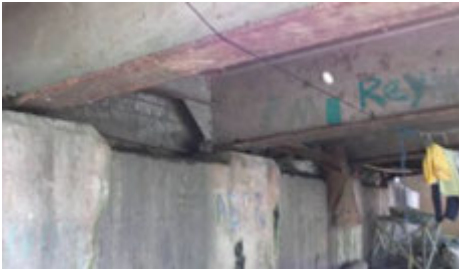
Corrosion is observed at bottom flanges of steel members.
Abutments (Primary)	Hanycomb

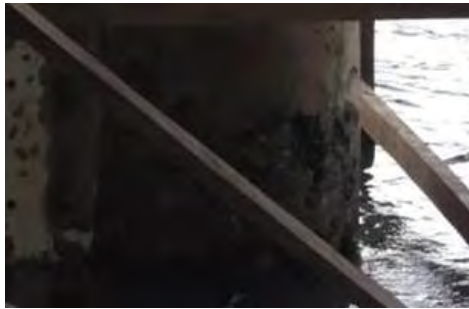
Spalling is observed at piers.
Curb and Railing (Secondary)	Section loss

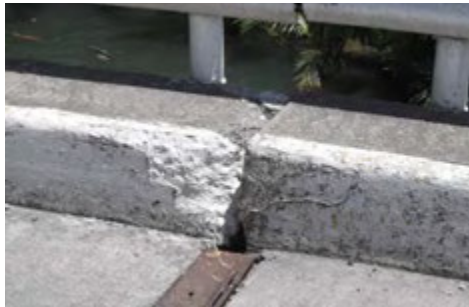
Section loss is observed at the part of curbstone.
Expansion Joint (Primary)	Water leaking

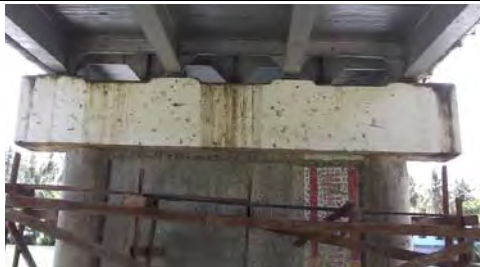
Water leaking is observed under expansion joints.
	Cracking/ Rupture

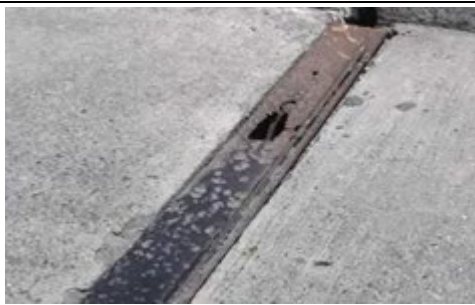
Section loss due to cracking is observed at some of expansion joints.
Slope Protection (Secondary)	Material loss

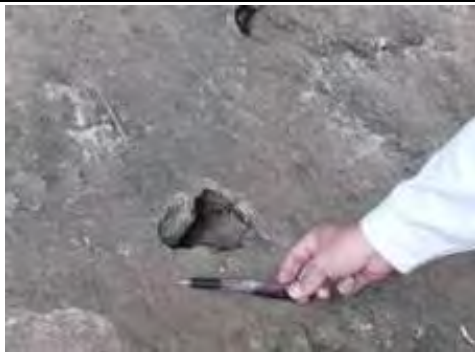
Pot-holes are observed at the slope protection of A1.

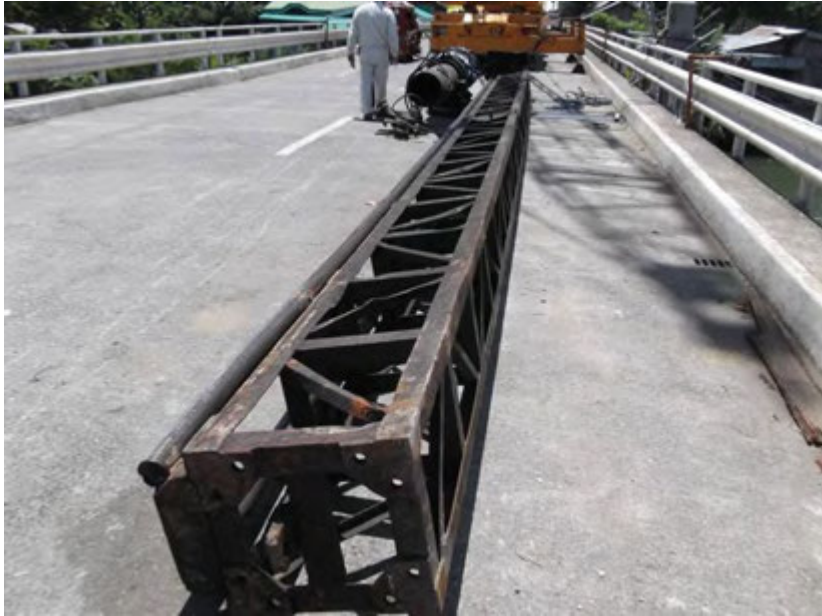
Under construction of additional driven piles

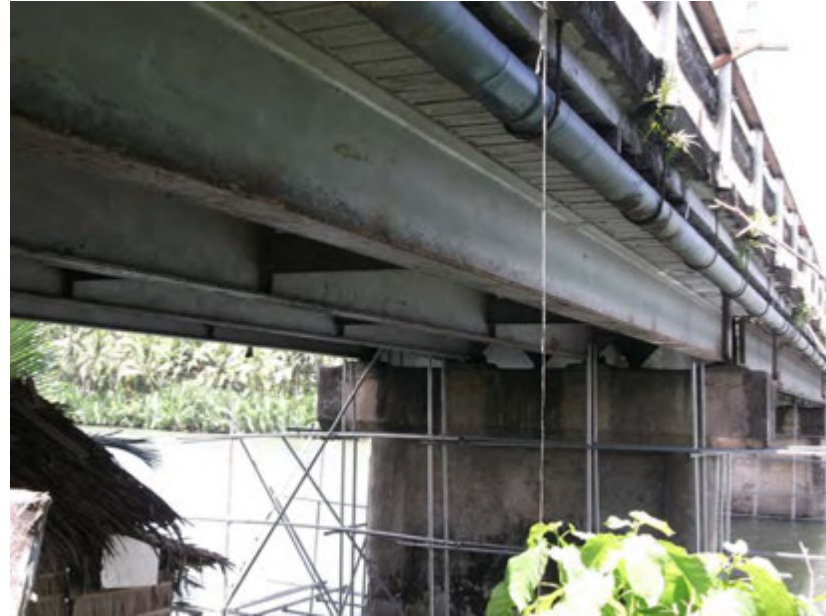
Under repair work of substructures

- Additional driven piles
- RC-jacketing on piers
- Repair of retaining walls & slope protection
- Replacement of bolts at steel members
- Repair of the deck slab with steel plates

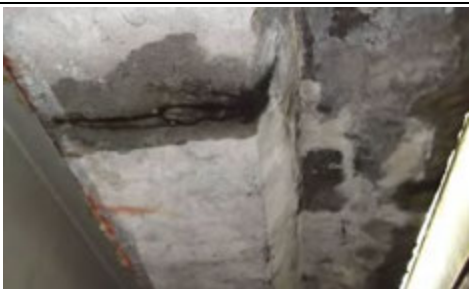
Water leaking is observed at the part of the deck slab.

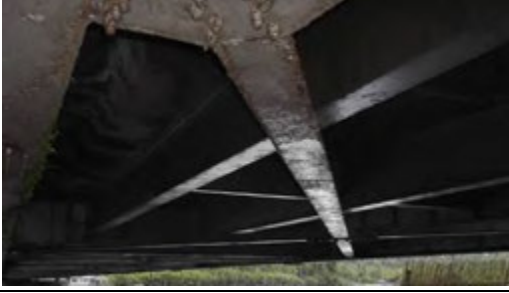
Abnormal vibration of secondary steel members (bracings) is observed.
Curb and Railing (Secondary)	Corrosion/ Impact damaged

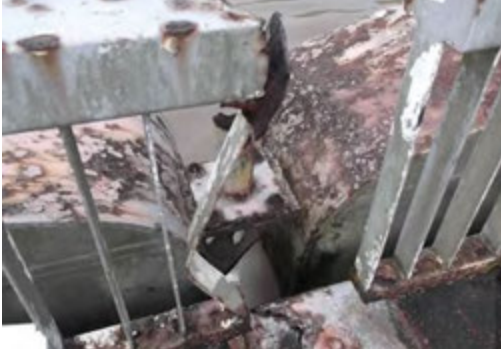
Impact damage is observed at the part of the railing.

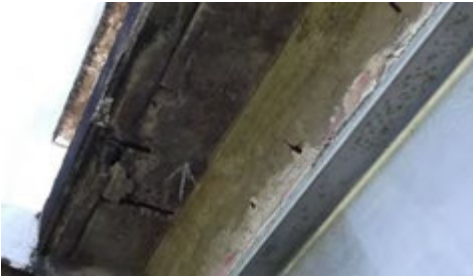
Exposure of rebar due to spalling is observed at the part of overhanging deck slab.
	Hanycomb

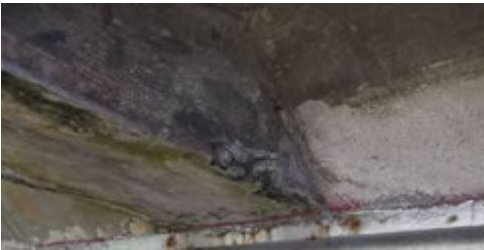
Hanycomb is observed at the part of the deck slab.
	Water leaking/ Free lime

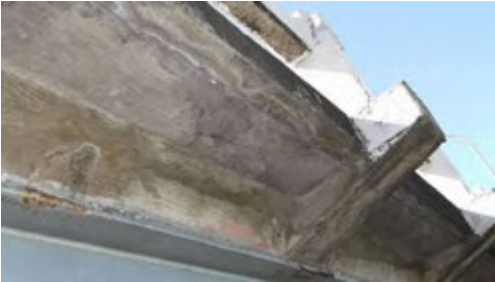
Water leaking and free lime are observed at the overhanging deck slab.
Steel Beam/ Truss Members (Bracings, etc.) (Primary)	Corrosion

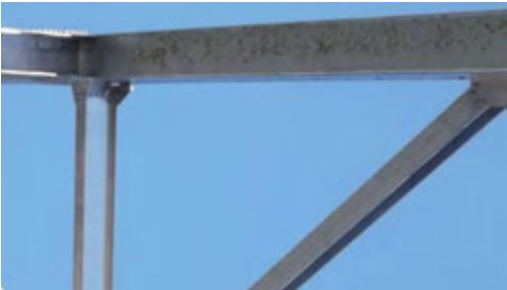
Corrosion is observed at the part of steel members. Especially, Bottoms of I girders are corroded.

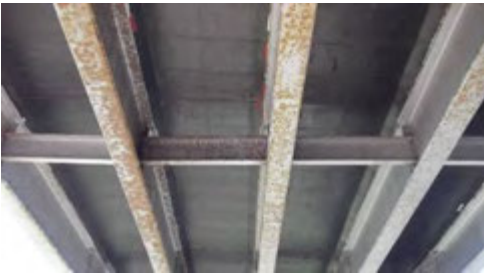
Deformation is observed at part of the primary steel member. The steel member is considered to be damaged during its installation.
Shoe/Bearing (Primary)	Corrosion

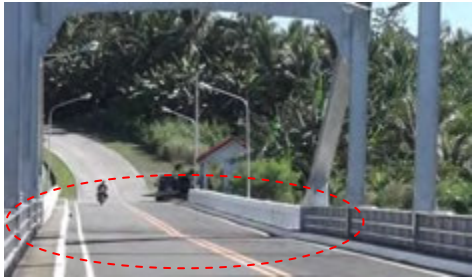
Settlement is observed at P3.

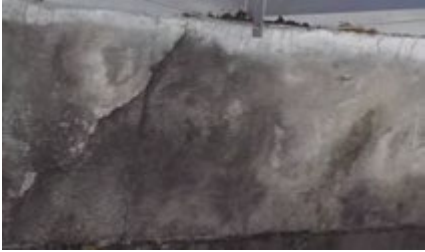
Cracking is observed at the part of overhanging deck slab.
	Hanycomb

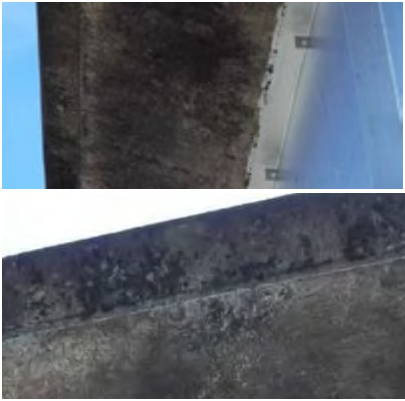
Hanycomb is observed at the part of overhanging deck slab.
	Water leaking

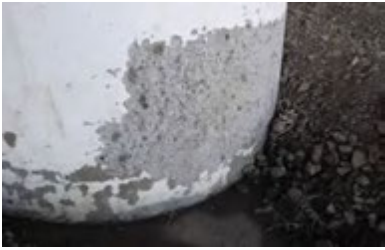
Spalling, is observed at piers near sea water.
Expansion Joint (Primary)	Water leaking

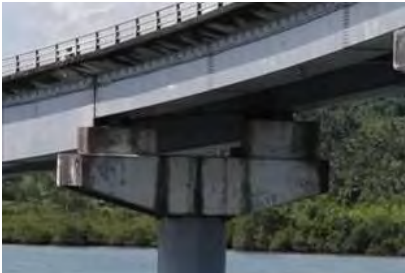
Water leaking is observed under expansion joints.

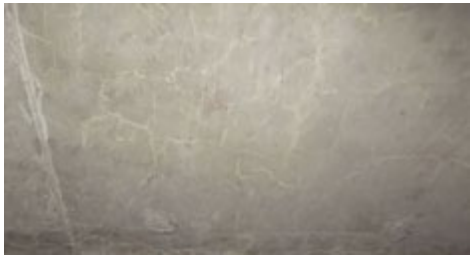
Cracks are observed at the part of the deck slab.
	Hanycomb

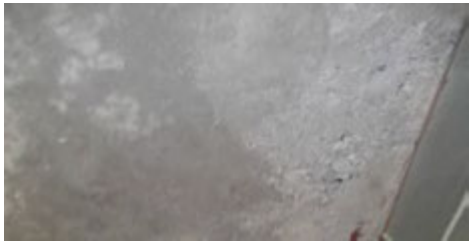
Hanycomb is observed at the part of the deck slab.
	Water leaking

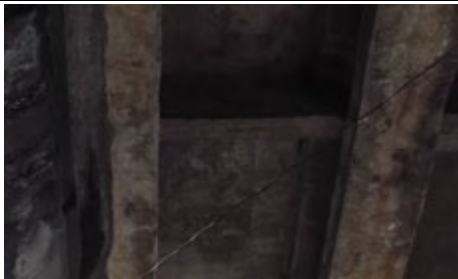
Water leaking & free lime are observed at concrete girders.
Steel Beam/ Truss Members (Bracings, etc.) (Primary)	Corrosion

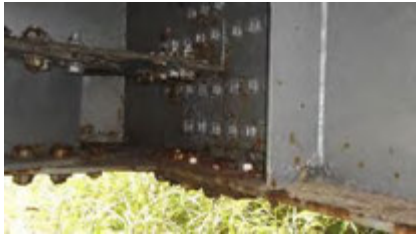
Corrosion is observed at primary steel members.
	Loose Connection

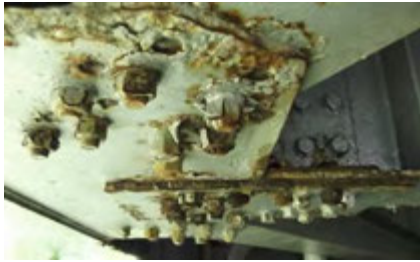
Loose connection due to lack of bolts is observed at splices of steel members.
Shoe/Bearing (Primary)	Corrosion

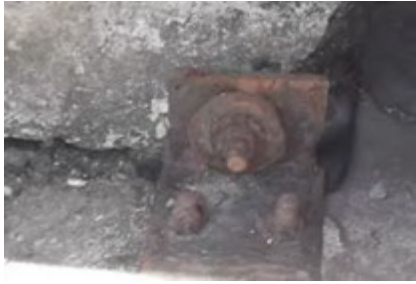
Corrosion is observed at bearings.
	Abnormal Displacement

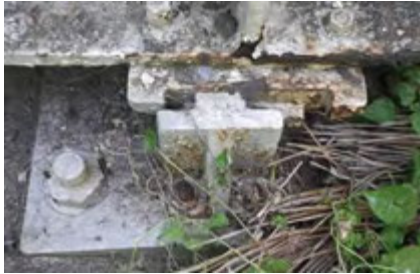
Abnormal deformation is observed at the movable bearings
Abutments (Primary)	Spalling, Scaling, Disintegration

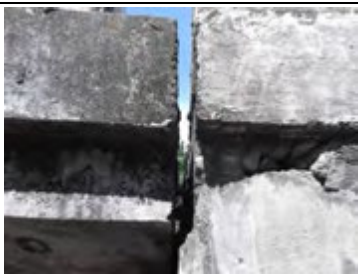
Section loss due to disintegration is observed at A2.
Piers (Primary)	Cracking concrete

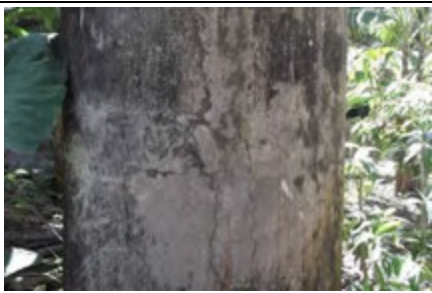
Major cracks are observed at some piers. The width of cracks is over 1mm.

RC-jacketing on piers (in 2007)

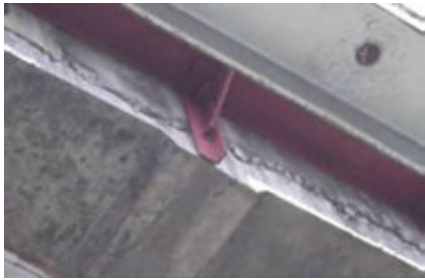
Major cracks are observed at the side of the deck slab.
	Hanycomb/ Spalling/ Water leaking

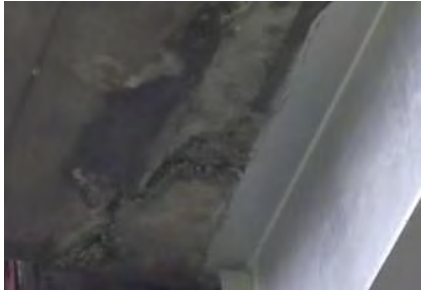
Hanycomb, spalling, and water leaking is observed at the part of the deck slab.
	Water leaking

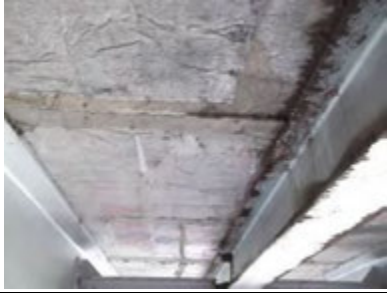
Water leaking is observed along the center steel I girder.
	Abnormal vibration

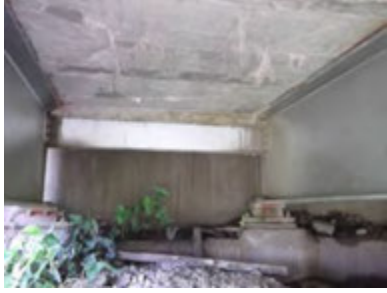
Abnormal vibration is observed at the deck slab on the A1 side.
Steel Beam/ Truss Members (Bracings, etc.) (Primary)	Corrosion

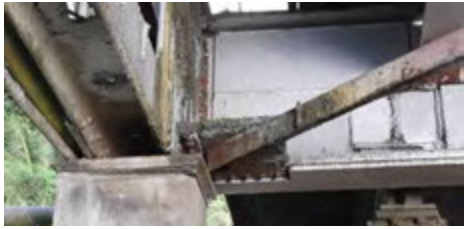
Corrosion is observed at the part of steel members.
	Deformation

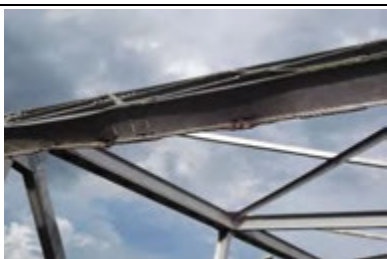
Deformation due to impact damage is observed at the secondary steel members (cross beams).

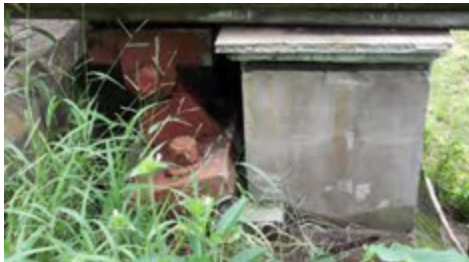
Abnormal displacement is observed at Movable bearings.
Curb and Railing (Secondary)	Loose connection

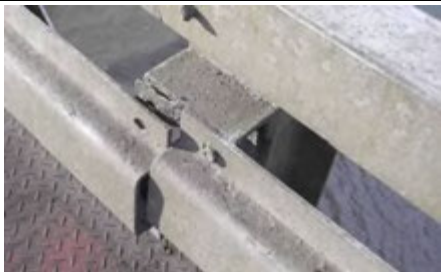
Loose connection due to lack of bolts is observed at the railing.
	Impact damaged

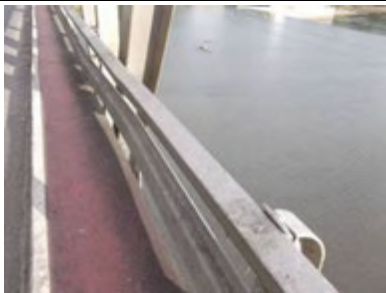
Impact damage is observed at the part of the railing.
Expansion Joint (Primary)	Water leaking

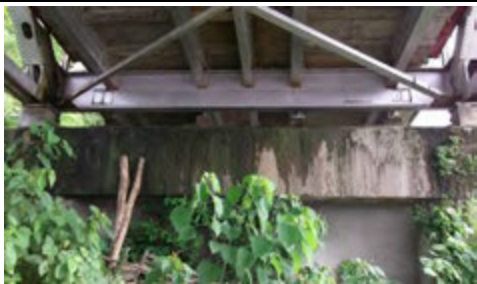
Water leaking is observed under expansion joints.

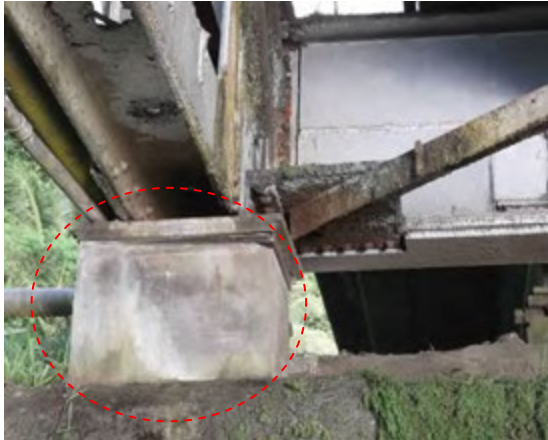
Additional bearing support at A2

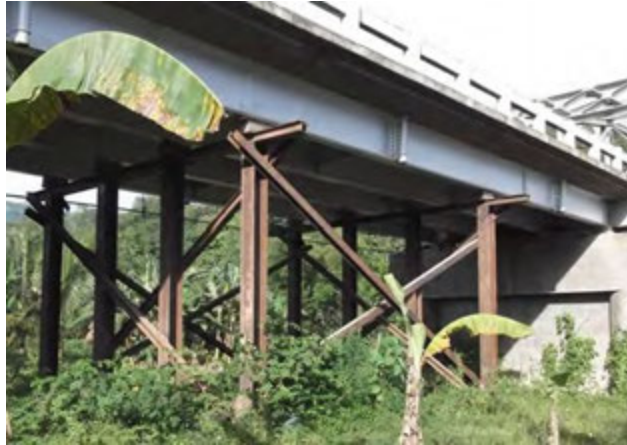
Temporary supports at the center of side spans (in 2011)

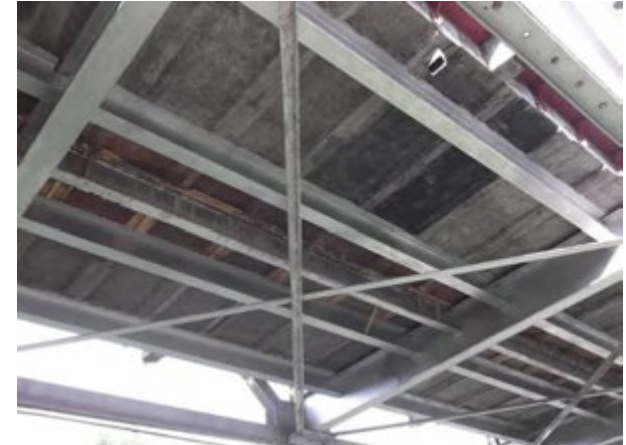
Replacement of the deck slab with the precast deck slab at carriageway

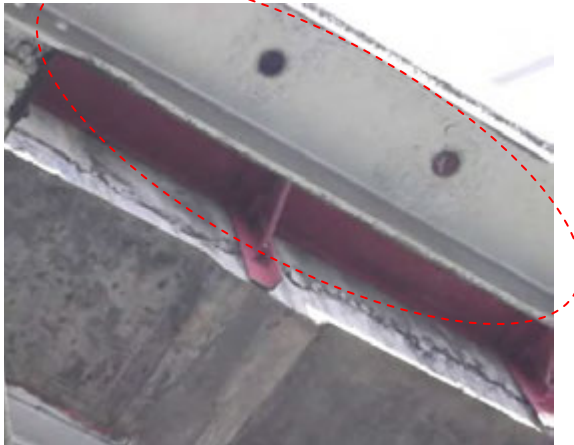
Replacement of the deck slab with the steel plates at sidewalks

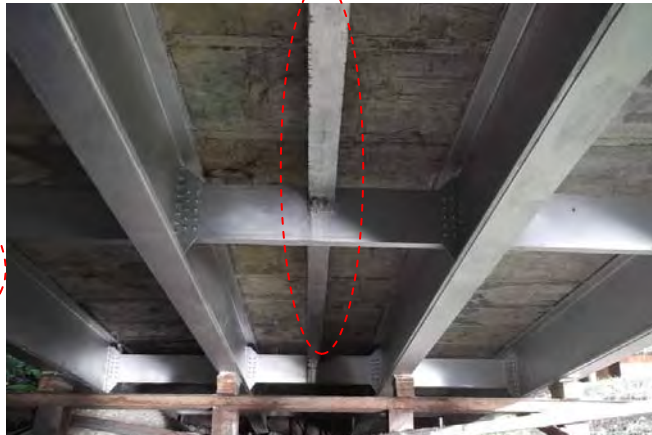
Reinforcement of the deck slab with steel I-girders

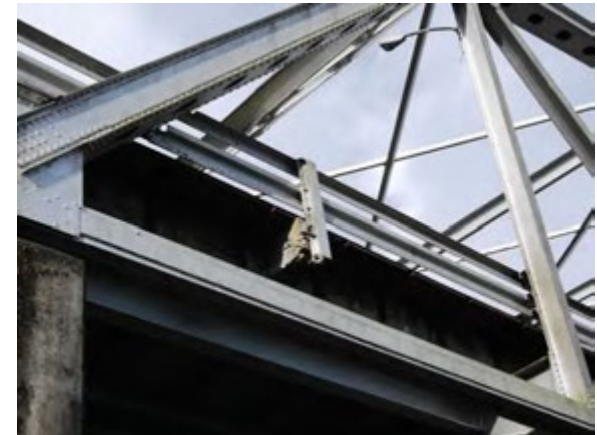
Repaint of steel members

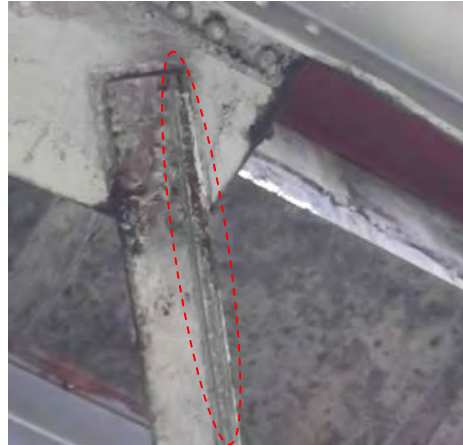
Reinforcement of secondary steel members with steel plates

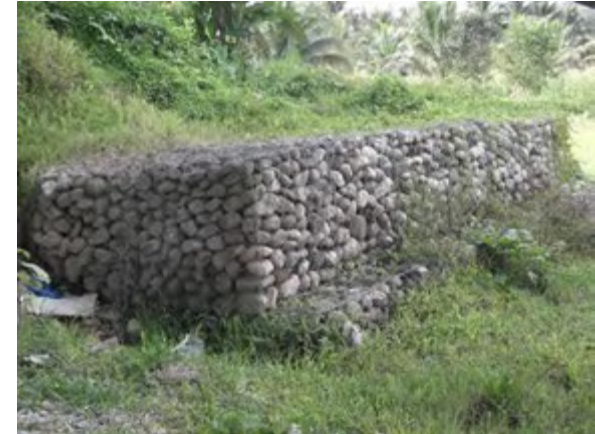
Reinforcement of the river bank protection with gabions

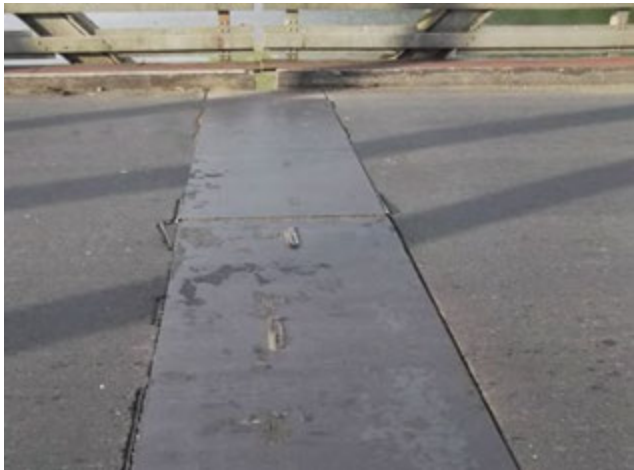
Steel plate cover over the expansion joint

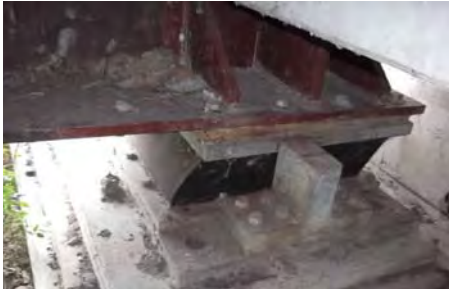
Deformation of rubber bearings is observed at abutments and nearby piers.
Expansion Joint (Primary)	Water leaking

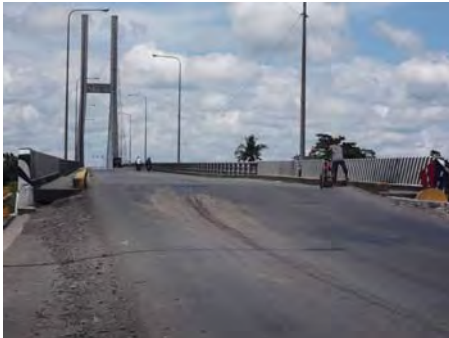
Settlement of approach road is observed on A2 side. The amount of settlement is about 20cm.

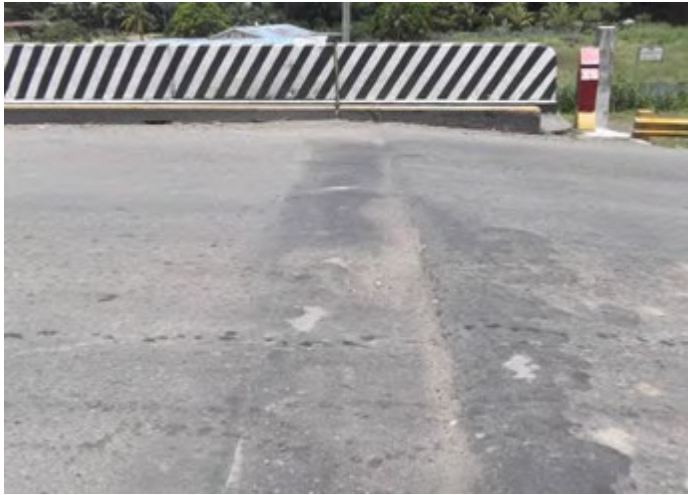
Asphalt pavement overlay at the approach road on A2 side
