(2) Package C

1) Badiwan Bridge

BRIDGE SEISMIC INVENTORY DATA									
A. GENERAL									
(1) Bridge Name:		<i>Badiwan Bridge</i>				(2) Posted Load Limit		<i>15</i>	tons
(3) Location:	km.: <i>276+885</i>	Route:	<i>Marcos Highway</i>			Prov./ City	<i>CAR, Baguio City</i>

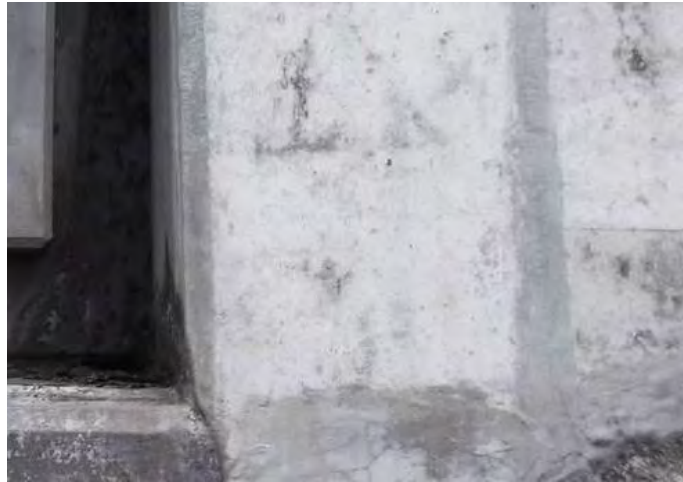
Repair of concrete cracking with mortar at A2

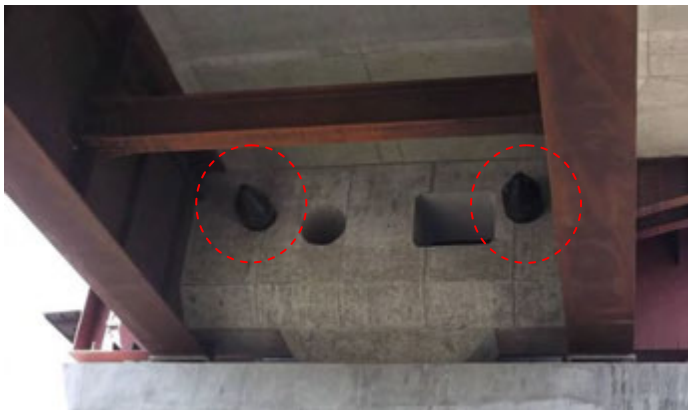
Fall-down prevention systems at discontinuous point

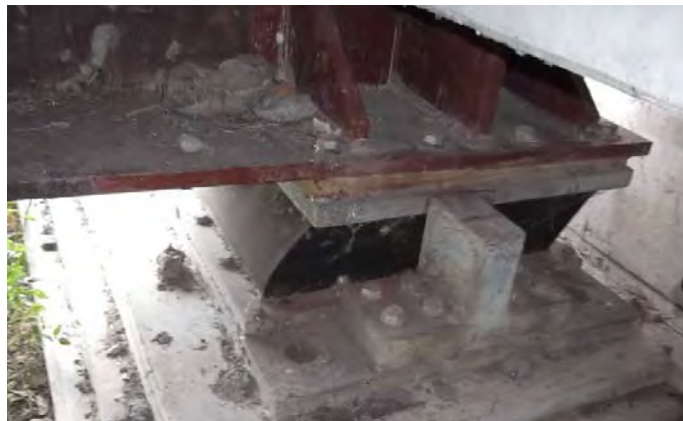
Elastomeric rubber bearing
