橋梁の目視点検結果

Bridge Survey Record (1/8)

Bridge No.	1	Location (State)	Assam
Bridge Name	Jia-Bharali Bridge	Road Name	NH 15 (old NH 52)
Station	Km166	Road Category	National Highway
GPS Data	N 26 ° 48 ' 36.0 "	Management Authority	State PWD
	E 092 ° 52 ' 23.6 "	Year of Construction	1962

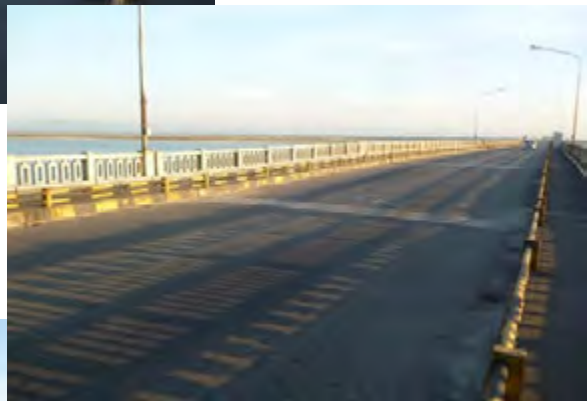
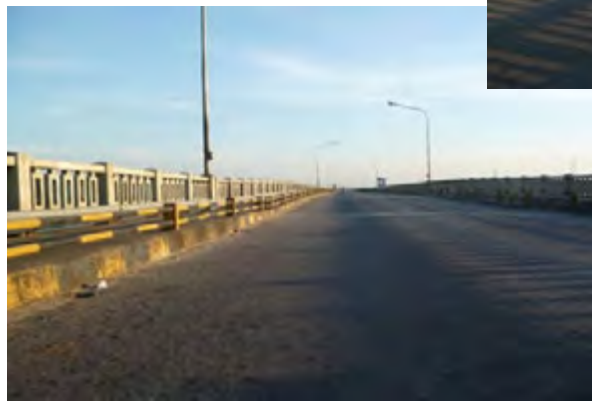
Object Member	Gerber Girder (at some spans)
Kind of Damage	Unequal level in deck slab of Gerber Girder in some spans
Sketch or Photo

1	Traffic Demand	Moderate
2	Distance of Detour Route	None (approx. 327km)
3	Project Effects for Japanese Companies	Low
4	Damage Level of the Bridges	Need repairing for removing of level difference at Gerber girder
5	Application of Japanese Technology	Applicable (replacement by Steel girder for Gerber portions)
6	Duplication with Other Projects by Donor's or Local	None
7	Importance of the Bridge on Surrounding Society and Economy	Very high
8	Impacts on the Environment	Minimal

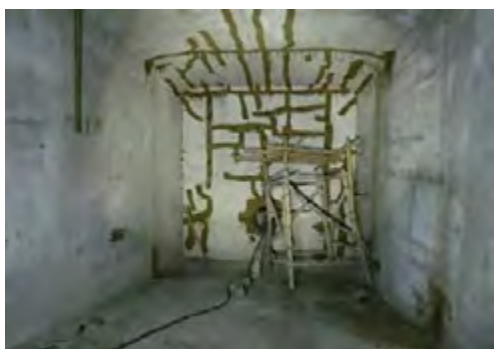
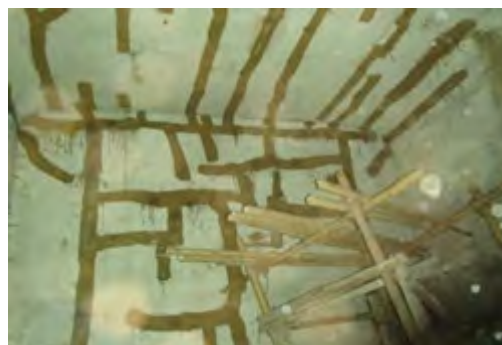
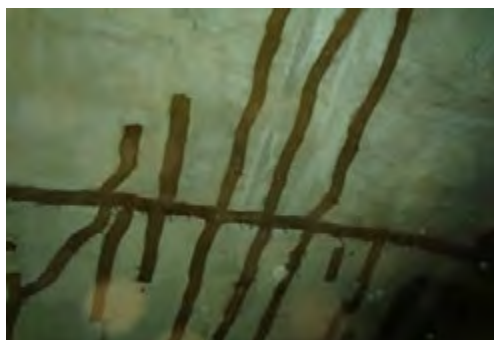
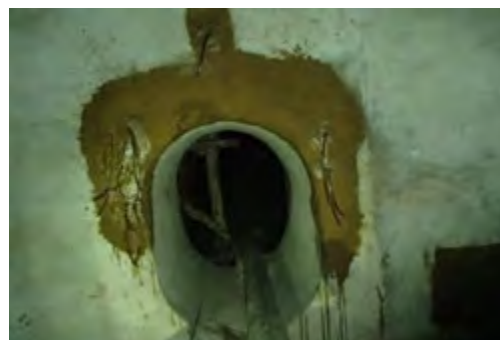
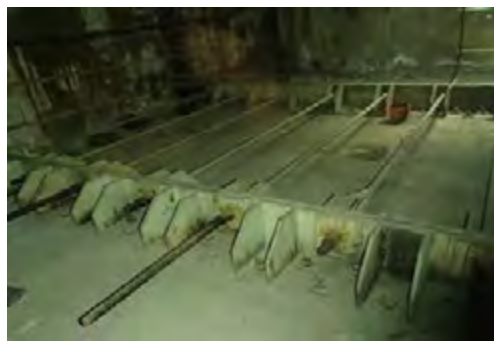
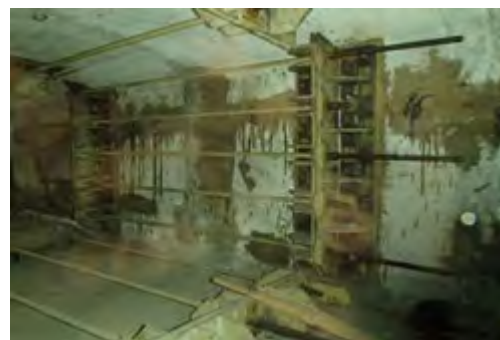
Object Member	Main Bridge Girder
Kind of Damage	Some cracks have been repaired in 1990. Further cracks are observed.
Sketch or Photo

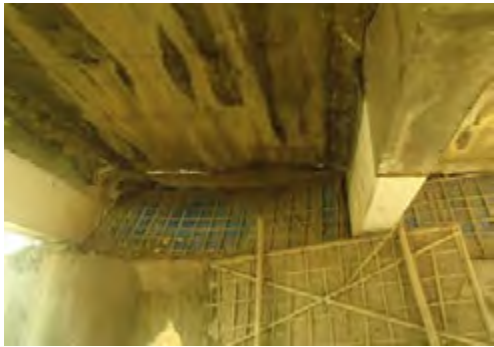
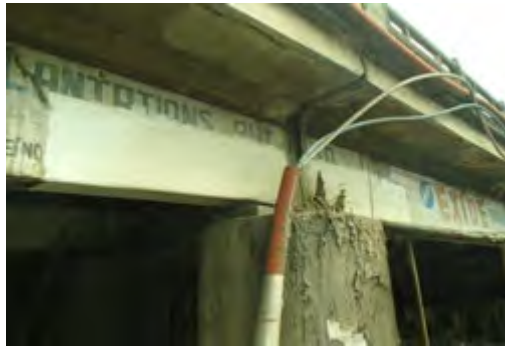
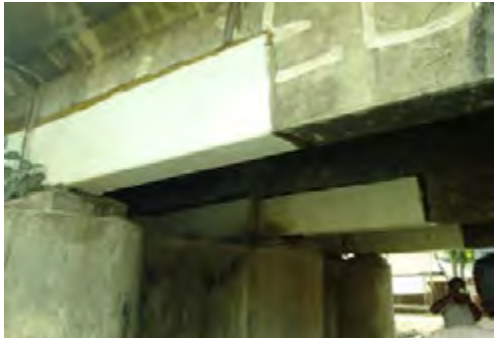
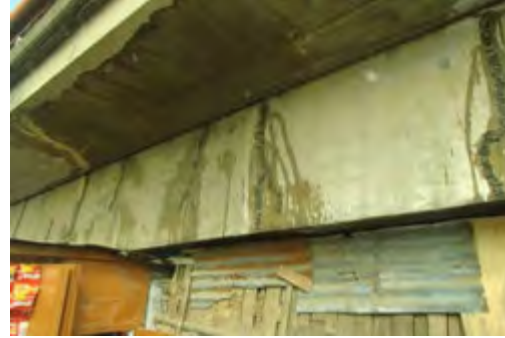
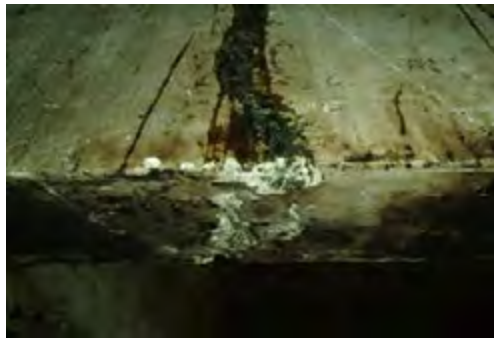
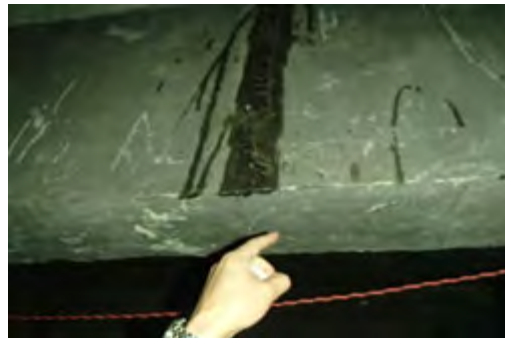
Object Member	Approach Bridge Girder
Kind of Damage	Some cracks have been repaired in 1990. Further cracks are observed.
Sketch or Photo

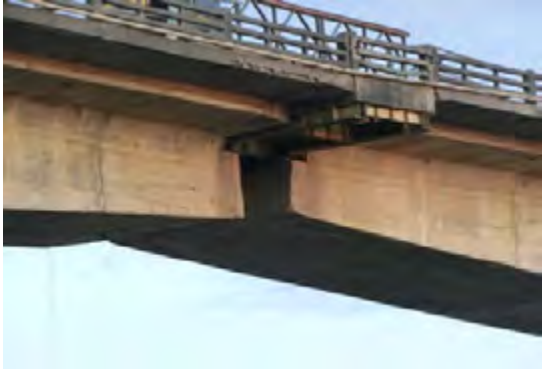
Object Member	Centre Hinge (P1-P2)
Kind of Damage	End point of girders damaged. Abnormal deflection, and 10m span steel bridge are provided over the centre hinge.
Sketch or Photo

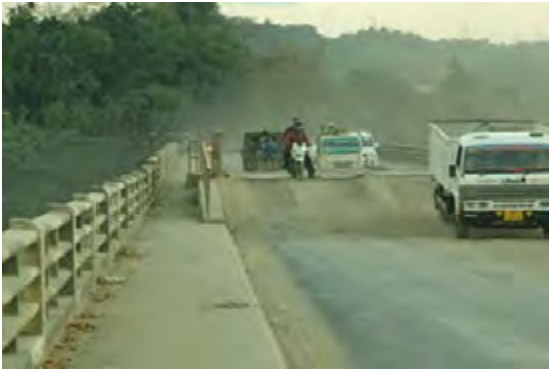
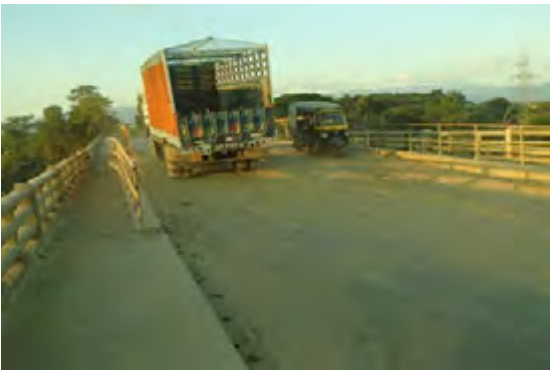
Object Member	Centre Hinge (P1-P2)
Kind of Damage	End point of girders damaged. Abnormal deflection, and 10m span steel bridge are provided over the centre hinge.
Sketch or Photo

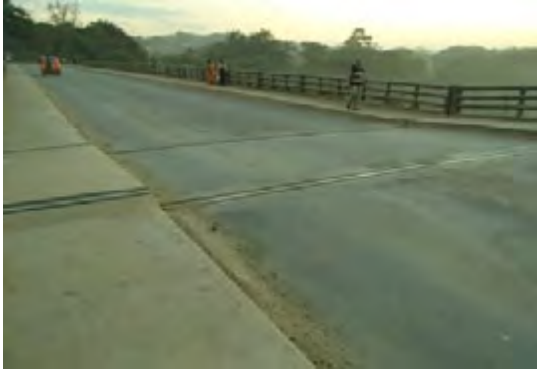
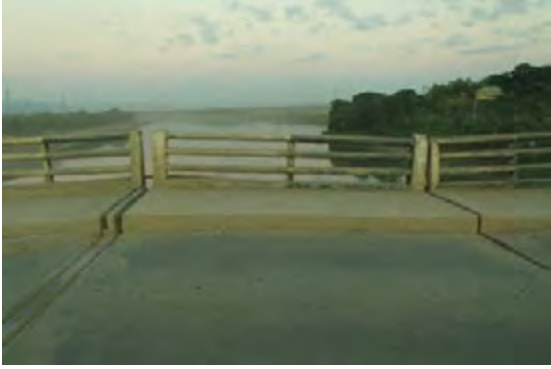
Object Member	Centre Hinge (P2-P3)
Kind of Damage	Level difference
Sketch or Photo

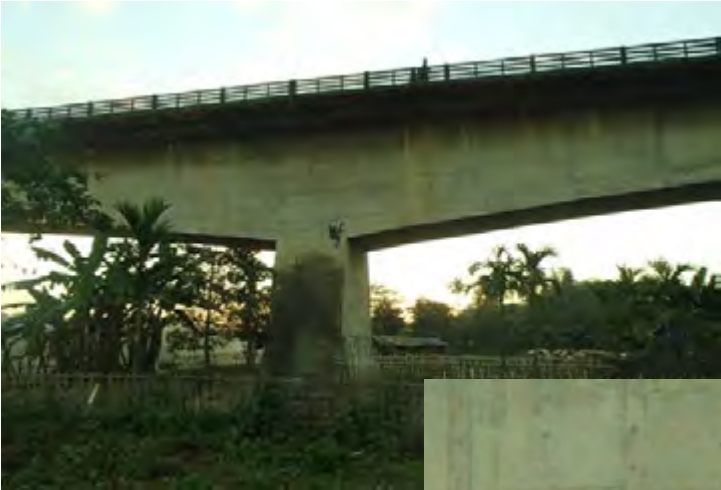
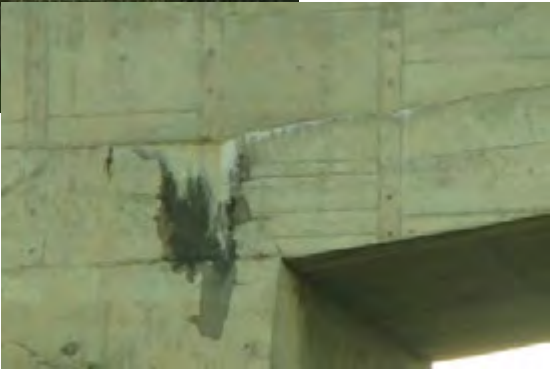
Object Member	Girder (P1, downstream side)
Kind of Damage	Cracks
Sketch or Photo

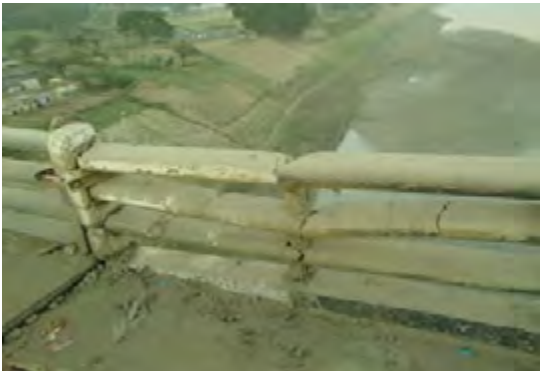
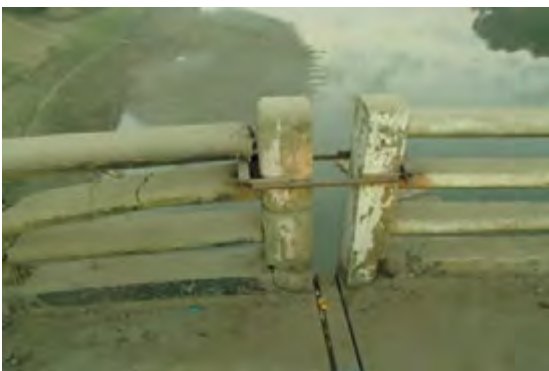
Object Member	Handrail (P1-P2)
Kind of Damage	Level difference and uneven gap
Sketch or Photo	<div style="text-align: center; margin-bottom: 10px;">

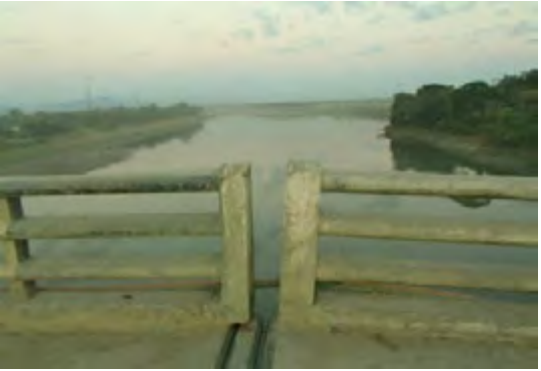
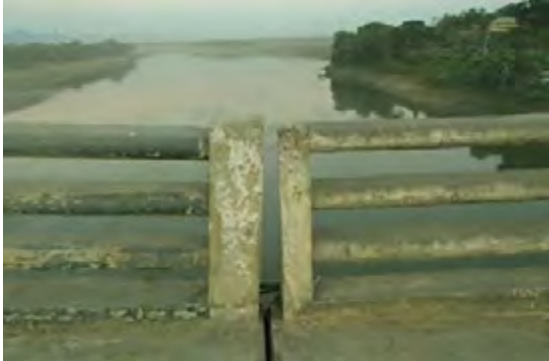
Object Member	Handrail (P2-P3)
Kind of Damage	Level difference and uneven gap
Sketch or Photo	<div style="text-align: center; margin-bottom: 10px;">

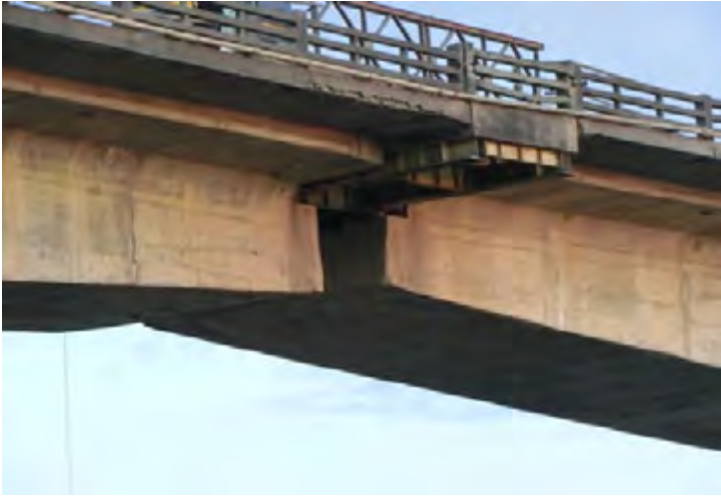
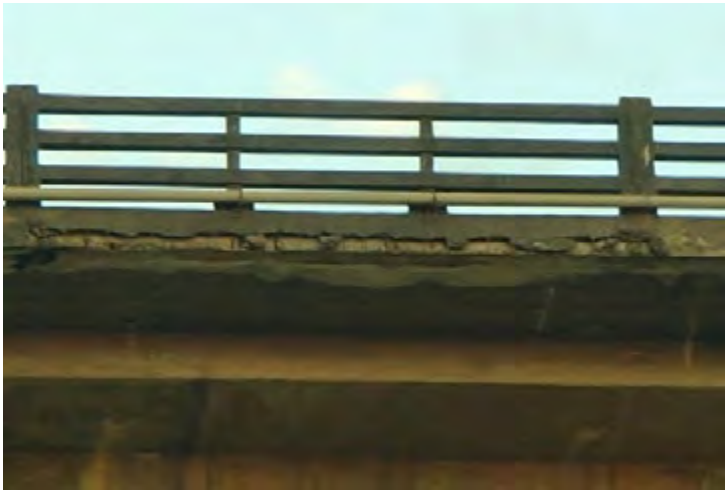
Object Member	Kerb
Kind of Damage	Peeling off finishing layer
Sketch or Photo	<div style="text-align: center; margin-bottom: 20px;">

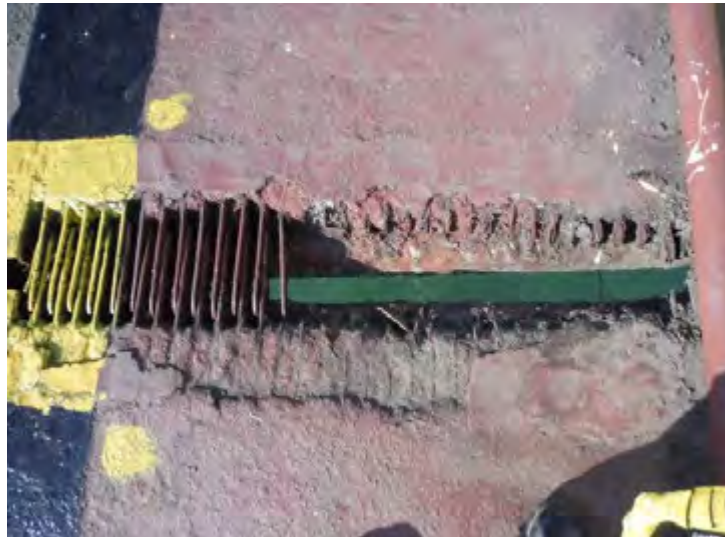
Object Member	EXP Joint (P7)
Kind of Damage	Broken
Sketch or Photo

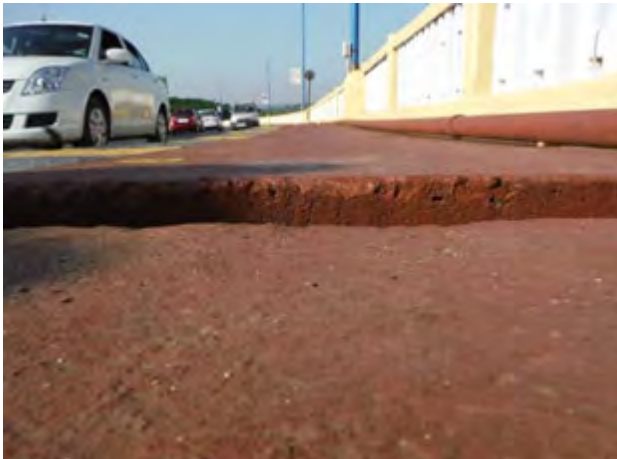
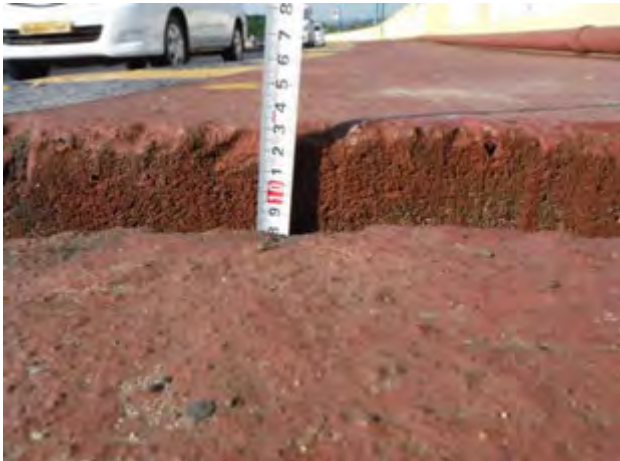
Object Member	Exp. Joint (V5)
Kind of Damage	Level difference
Sketch or Photo	<div style="text-align: center; margin-bottom: 10px;">↓ RIVER FLOW</div>

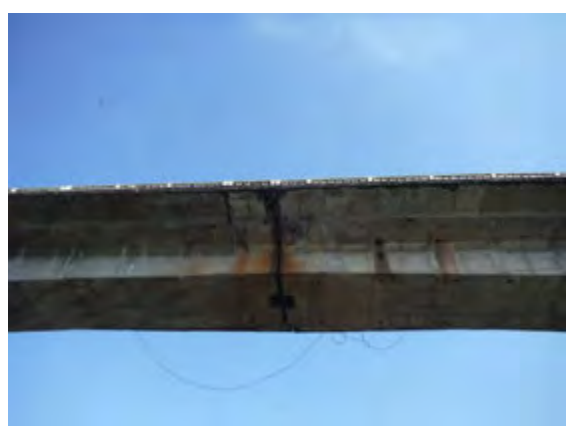
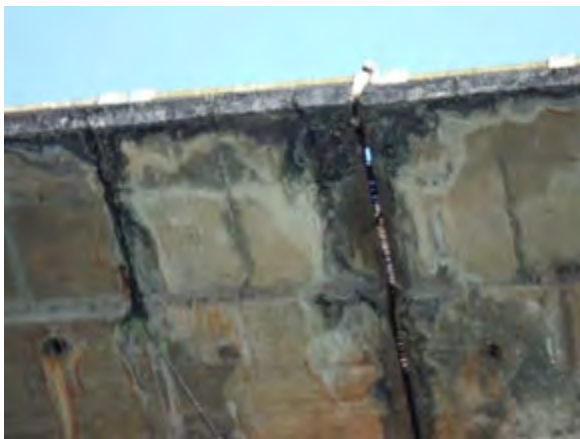
Object Member	EXP Joint (P1P2)
Kind of Damage	Corrosion
Sketch or Photo	<p>↓ RIVER FLOW</p>

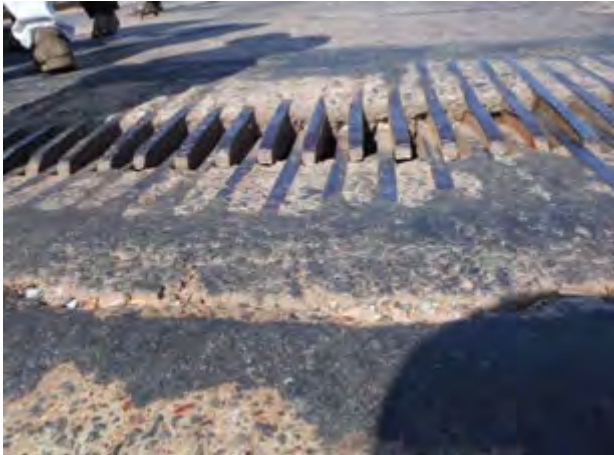
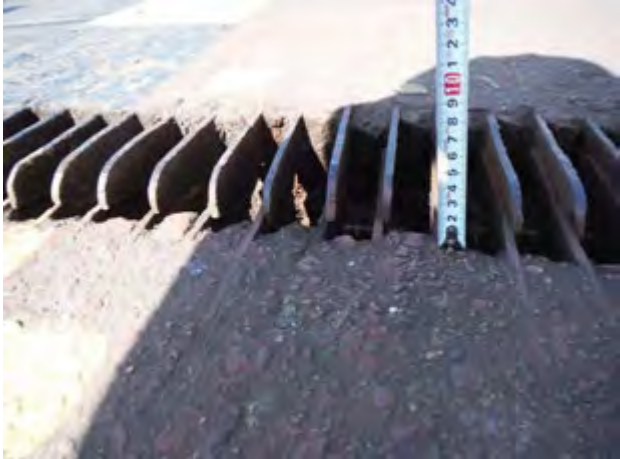
Object Member	EXP Joint (P1P2)
Kind of Damage	Level difference
Sketch or Photo	<p>↓ RIVER FLOW</p>

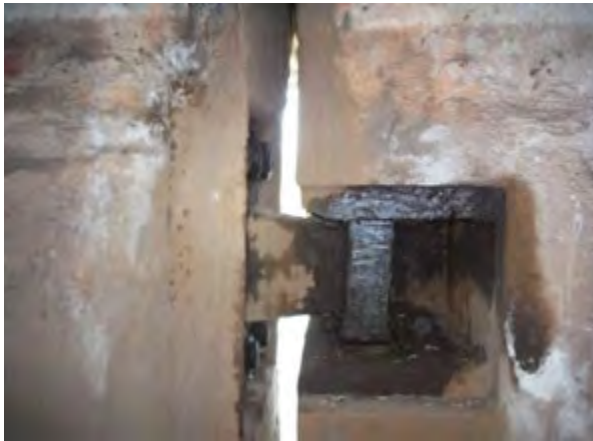
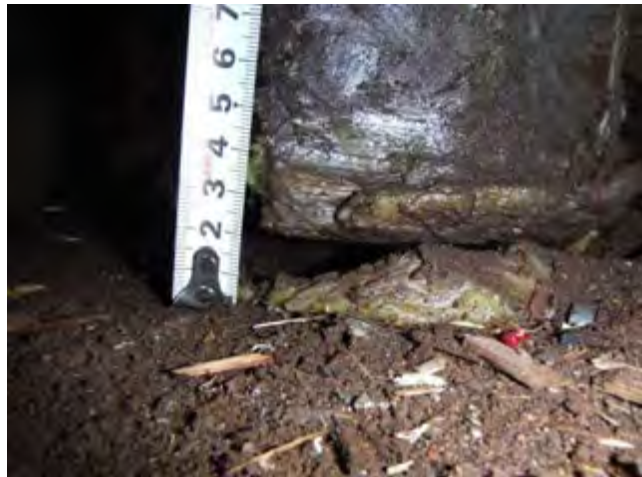
Object Member	Girder (P1P2)
Kind of Damage	There are some level difference at centre hinge
Sketch or Photo

1	Traffic Demand	High
2	Distance of Detour Route	Approx. 48 km
3	Project Effects for Japanese Companies	Moderate
4	Damage Level of the Bridges	Need repairing at centre hinge
5	Application of Japanese Technology	Applicable (centre hinge connection)
6	Duplication with Other Projects by Donor's or Local	None
7	Importance of the Bridge on Surrounding Society and Economy	Very high
8	Impacts on the Environment	Minimal

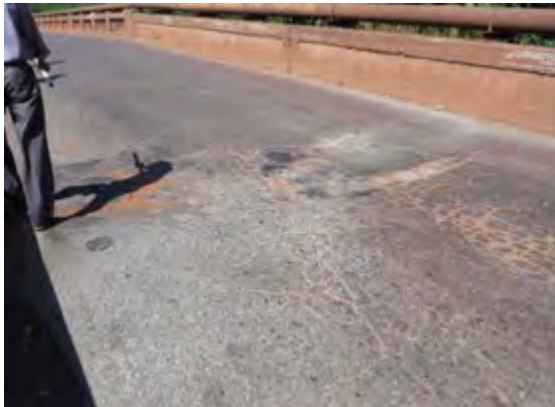
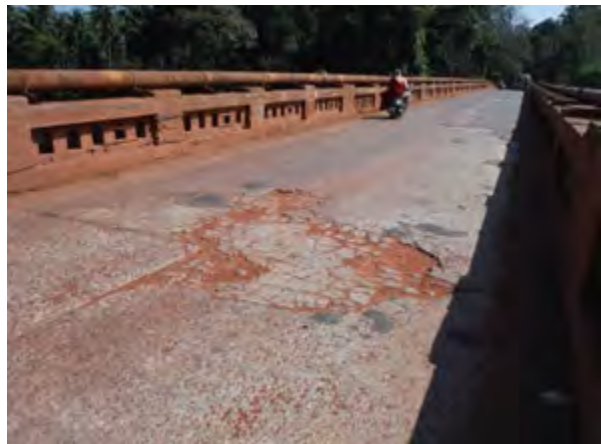
Object Member	Pavement
Kind of Damage	Cracking
Sketch or Photo

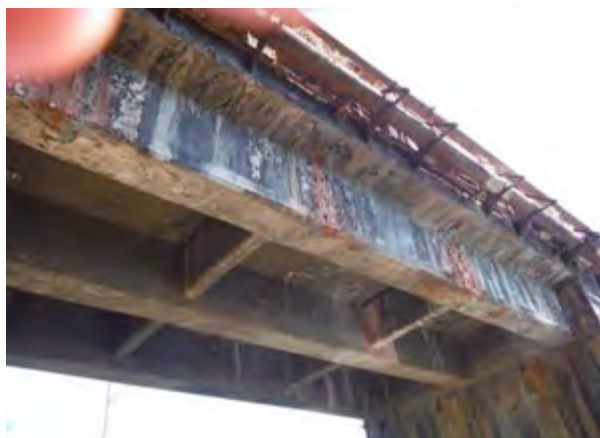
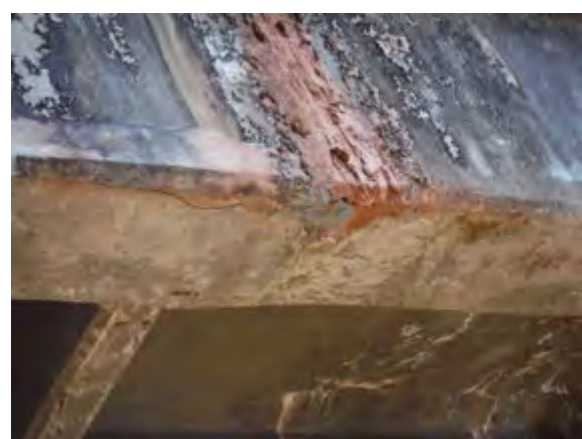
Object Member	RC T Girder (P1P2)
Kind of Damage	Cracking
Sketch or Photo	<div style="text-align: center; margin-bottom: 20px;"> <p>↓ RIVER FLOW</p>

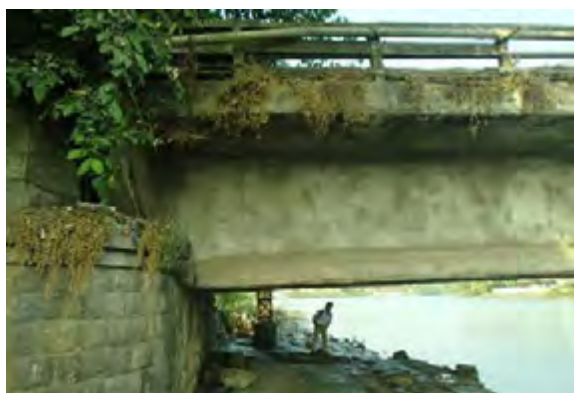
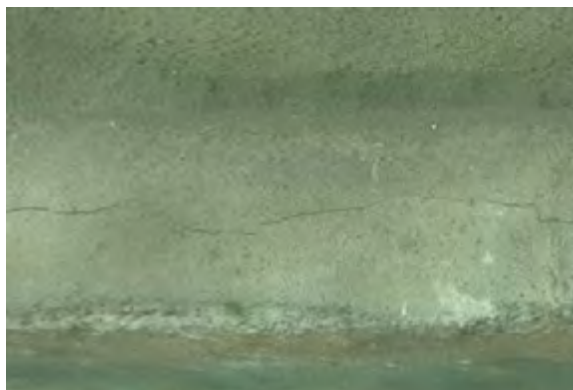
Object Member	Girder (A1-P1)
Kind of Damage	Cracks on web
Sketch or Photo

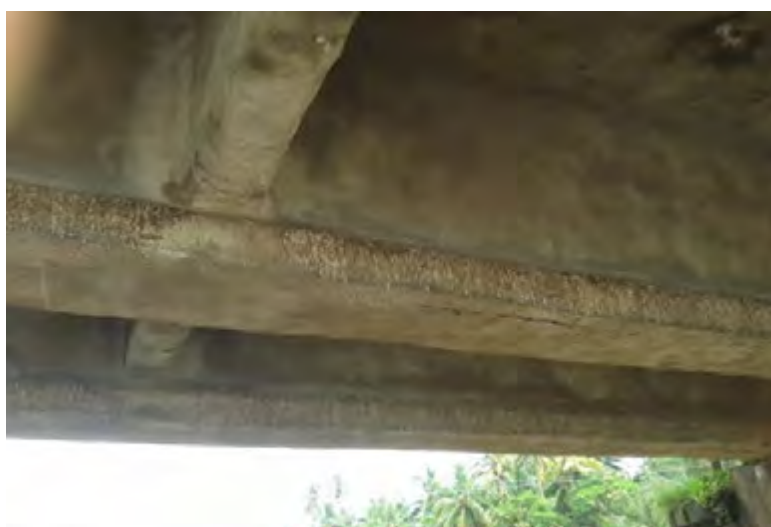
Object Member	Girder
Kind of Damage	Cracks on lower flange (P4-A2)
Sketch or Photo

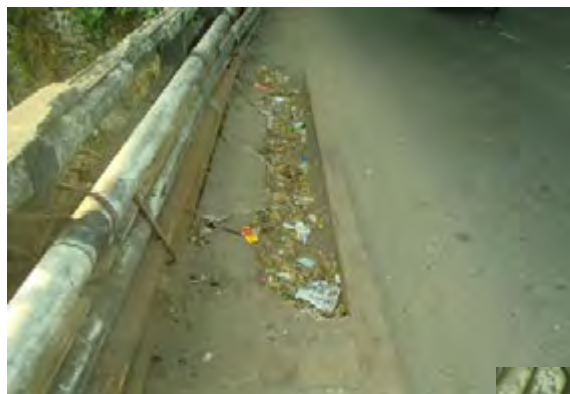
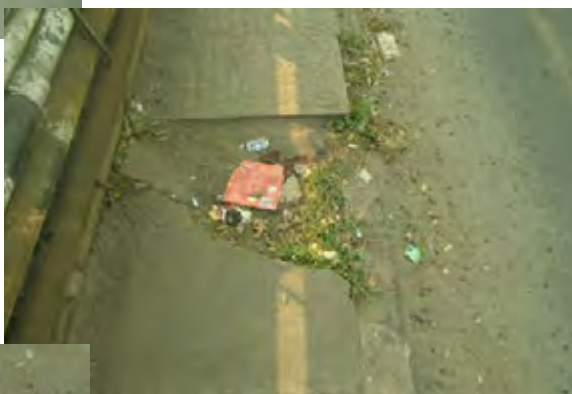
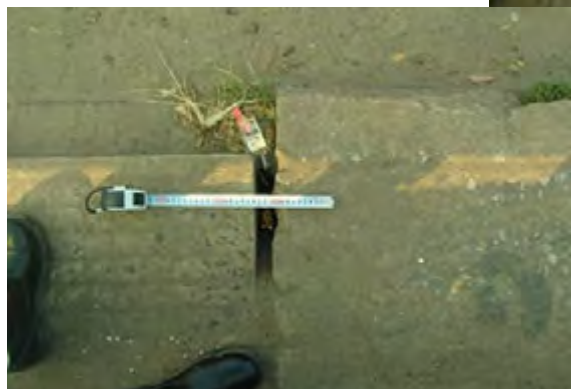
Object Member	Footpath
Kind of Damage	Kerb stone and footpath broken
Sketch or Photo

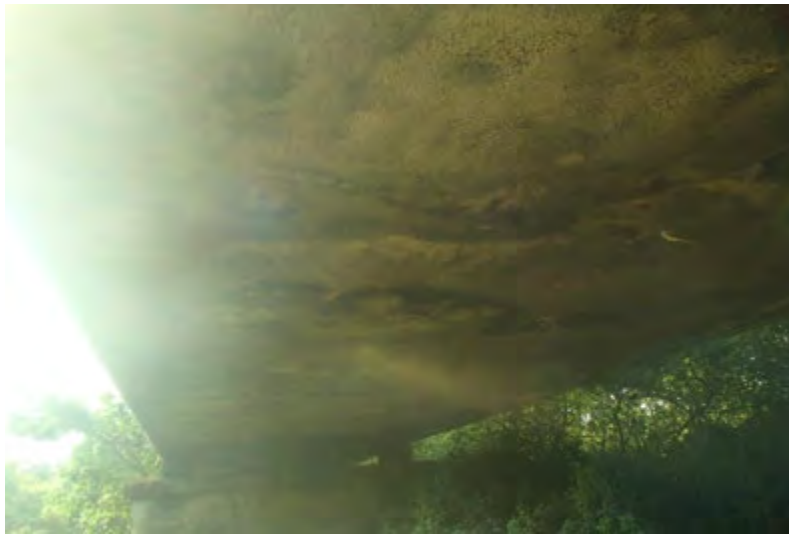
Object Member	Deck Slab (P3-P4)
Kind of Damage	Some cracks and efflorescences are observed in the bottom of the deck slab
Sketch or Photo

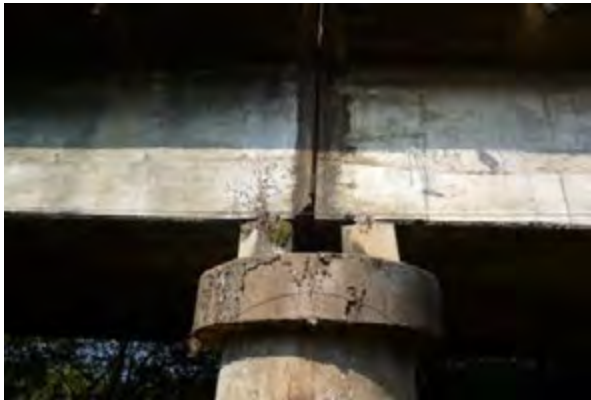
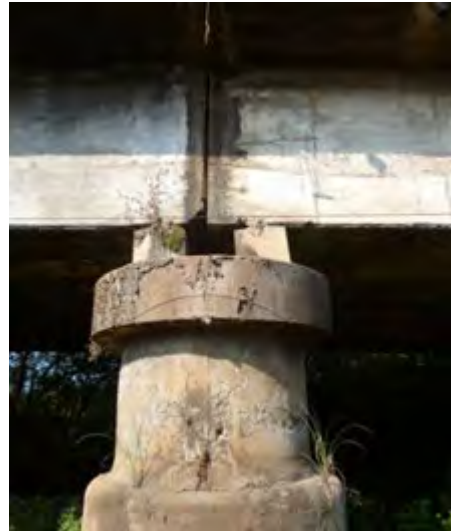
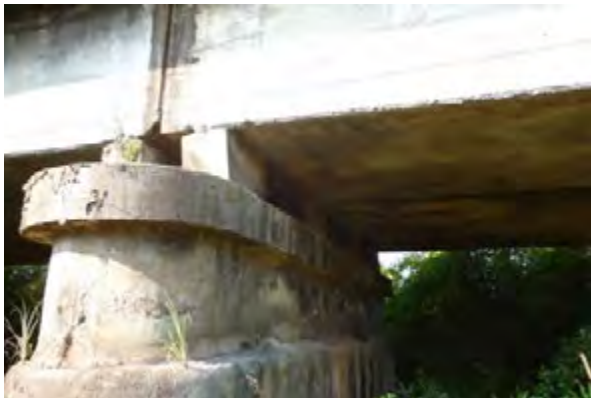
Object Member	Bearing Shoe (P3 upstream side)
Kind of Damage	Inclination
Sketch or Photo

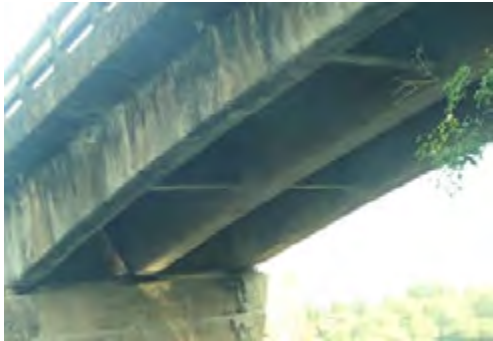
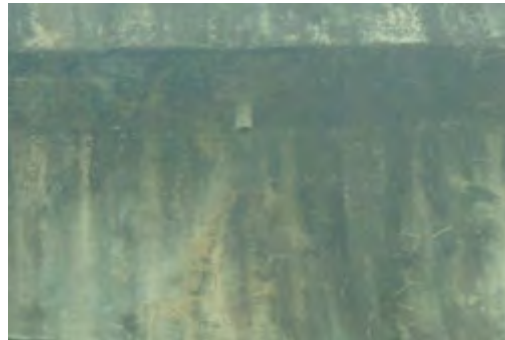
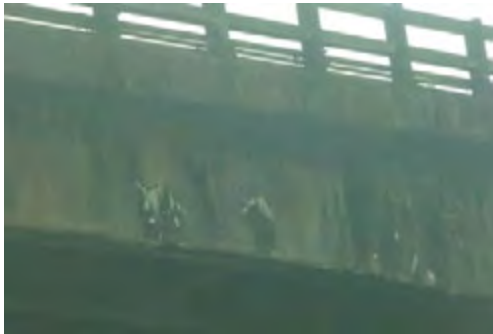
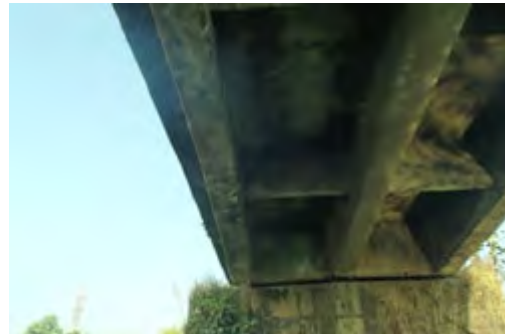
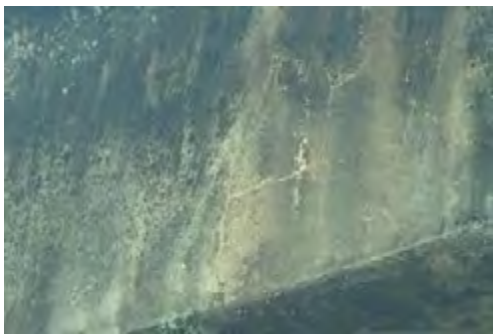
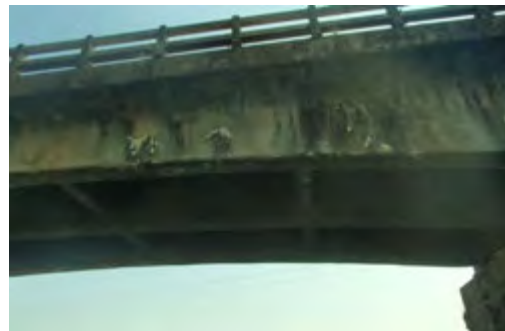
Member	Kind of the Damage
	Ex. Concrete : Cracking, Spalling, etc. Steel : Cracking, Rusting, Fracture, etc.
1. Superstructure	
(1) Concrete Member	
- Girder	There are some cracks and efflorescence on web.

Object Member	Girder (all spans)
Kind of Damage	Many cracks and efflorescence are observed on the girder web.
Sketch or Photo

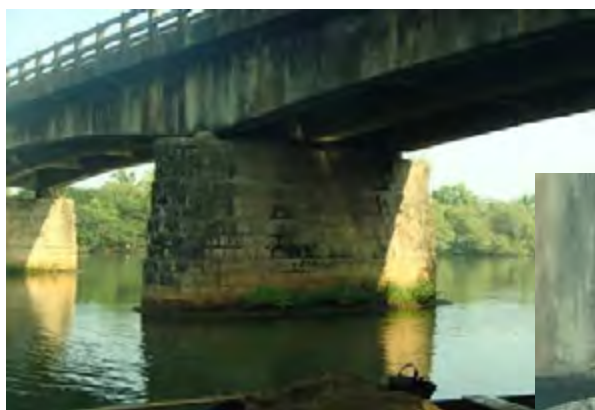
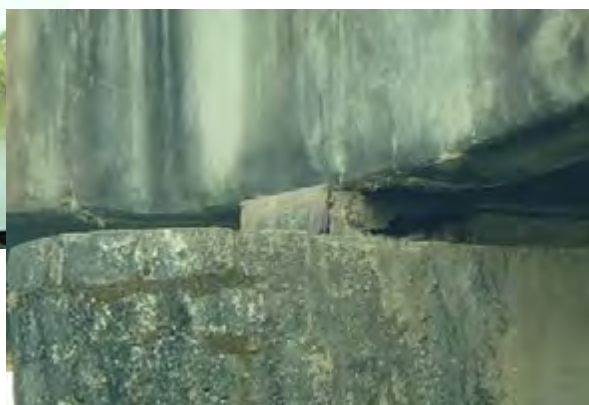
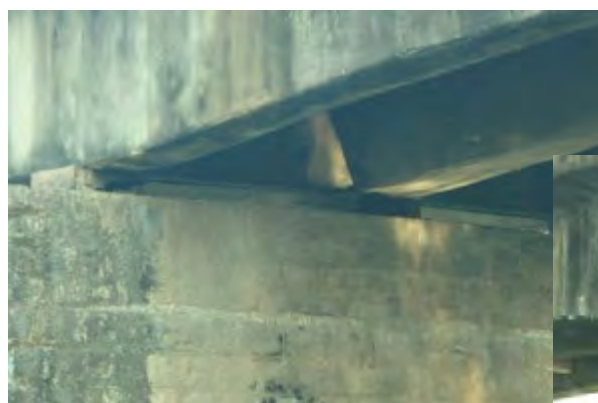
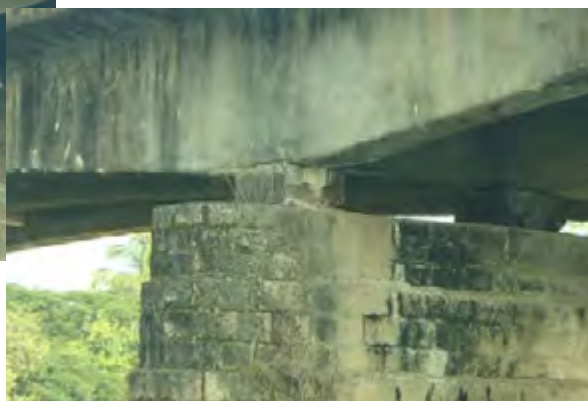
- Cross Beam	N/A
- Sway Bracing	N/A
(3) Bearing Shoe	Void in bearing block of P6
(4) EXP Joint	All covered by asphalt and not functioning properly. Some cracks.

Object Member	Bearing Block (P6)
Kind of Damage	Void in bearing block
Sketch or Photo

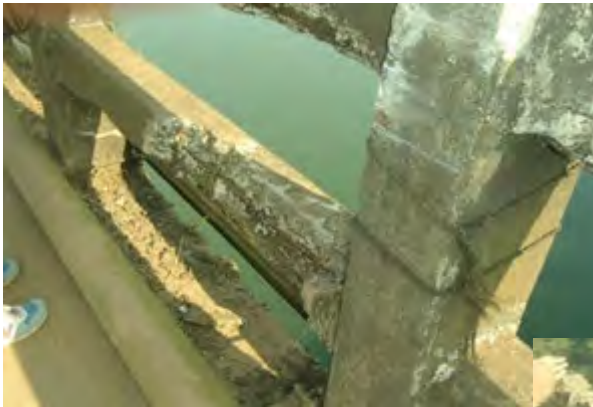
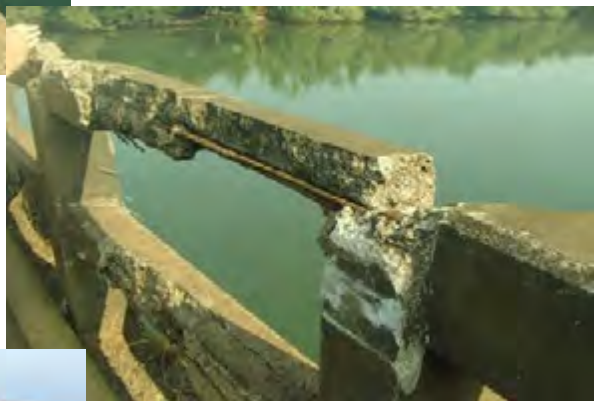
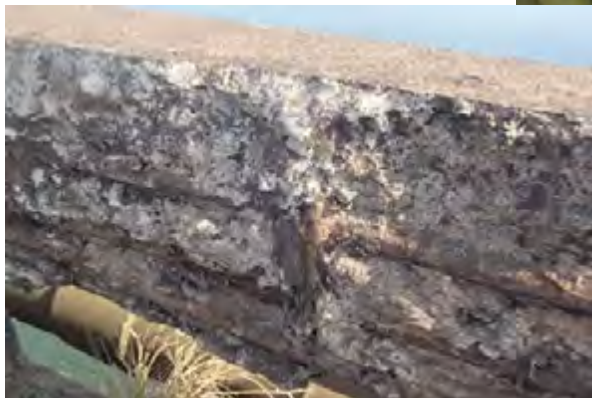
(5) Handrail	CC peeling and corroded re-bar exposed
(6) Kerb	Nil
(7) Drainage Pipe	Nil
(8) Others	It is assumed that there are many damages on superstructure although cracks were covered by guniting work and it is difficult to observe them.

Object Member	Handrail
Kind of Damage	CC peeling and corroded re-bar exposed
Sketch or Photo

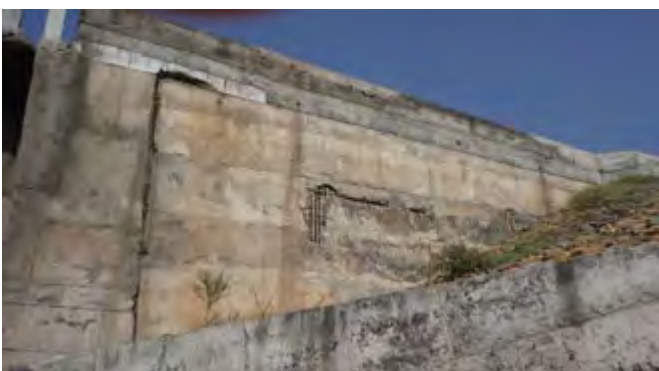
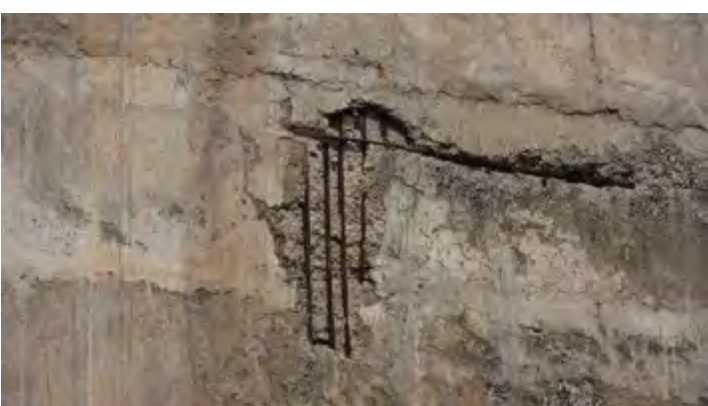
Object Member	Wing Wall (A1)
Kind of Damage	Spalling
Sketch or Photo	<p style="margin-bottom: 10px;">↓ RIVER FLOW</p>

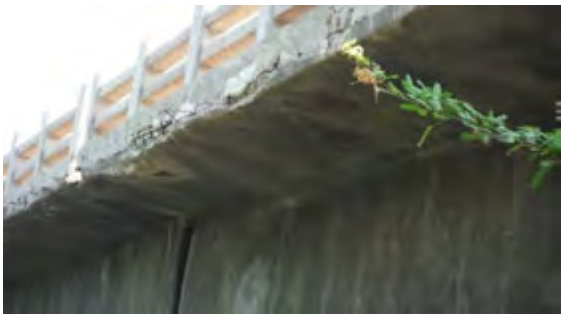
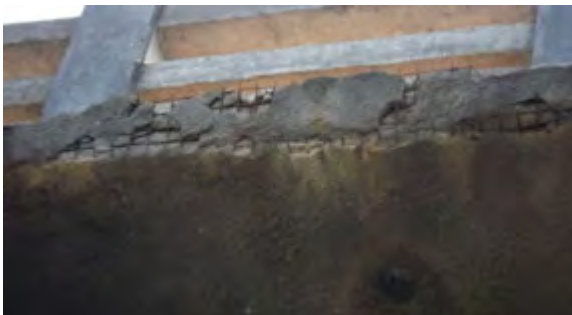
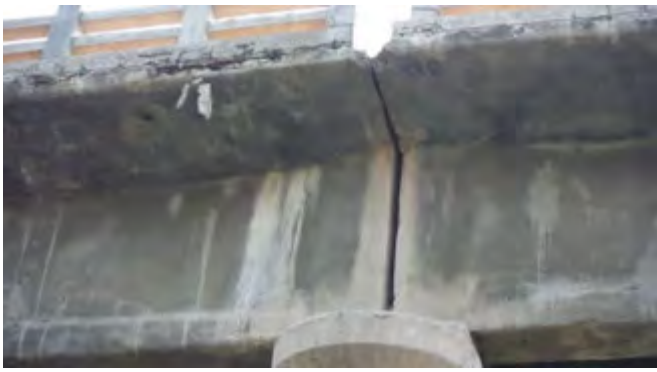
Member	Kind of the Damage
	Ex. Concrete : Cracking, Spalling, etc. Steel : Cracking, Rusting, Fracture, etc.
1. Superstructure	
(1) Concrete Member	
- Girder	There are many spalling
- Cross Beam	Nil
- Slab	Nil
(2) Steel Member	
- Girder	N/A
- Vertical Girder (stringer)	N/A
- Cross Beam	N/A
- Sway Bracing	N/A
(3) Bearing Shoe	Nil
(4) EXP Joint	Nil
(5) Handrail	Nil
(6) Kerb	N/A
(7) Drainage Pipe	Nil
(8) Others	
2. Substructure	
- Pier	Nil
- Abutment	Nil
- Wing Wall	There are many spalling
3. Miscellaneous	
- Approach Road Condition	Nil
- Obstruction	Nil
- Scouring	Nil
4. Evaluation	See Sheet 8

Object Member	RC T Girder
Kind of Damage	Spaliing
Sketch or Photo	<div style="text-align: center; margin-bottom: 10px;"> <p>↓ RIVER FLOW</p>

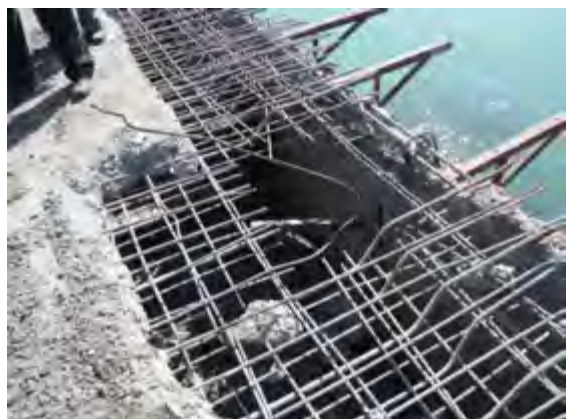
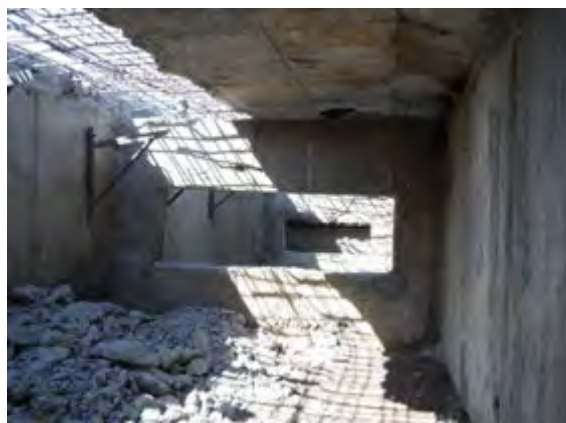
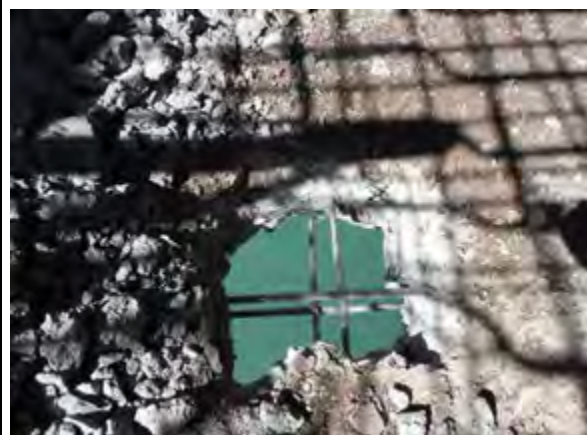
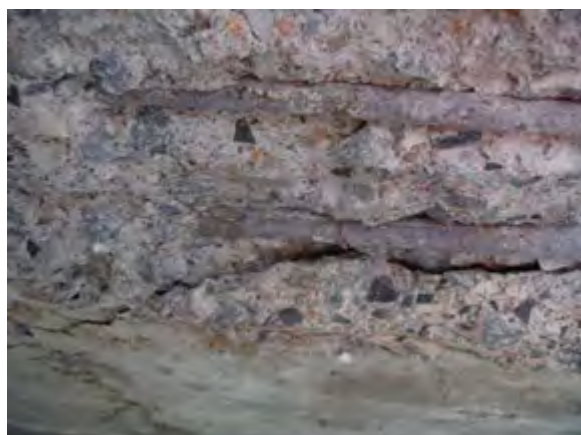
Object Member	RC Box Girder
Kind of Damage	Under Repairing
Sketch or Photo

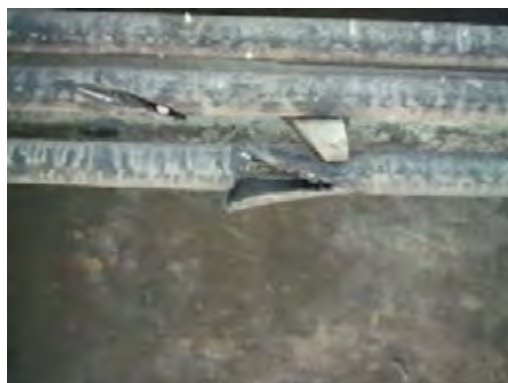
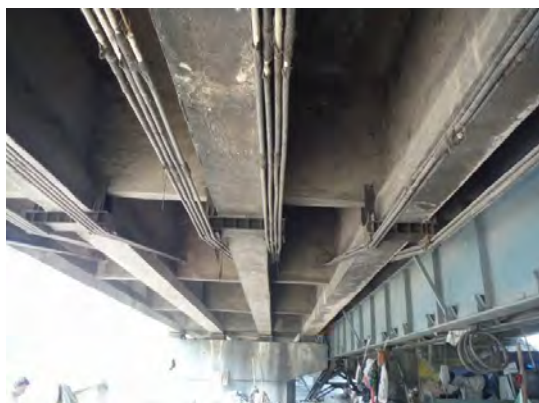
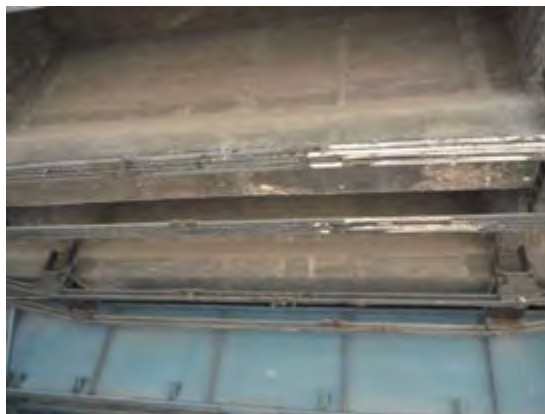
Object Member	Girder outcable (P1P2)
Kind of Damage	Boroken
Sketch or Photo

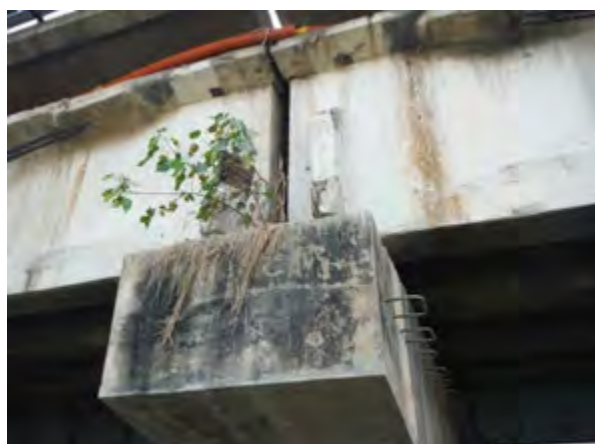
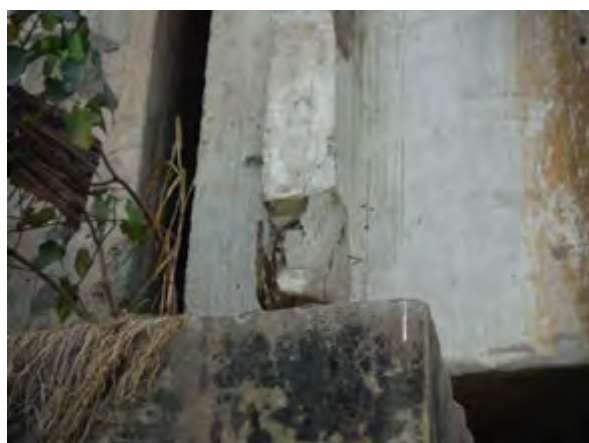
Object Member	PC T Girder (P3)
Kind of Damage	Spalling
Sketch or Photo

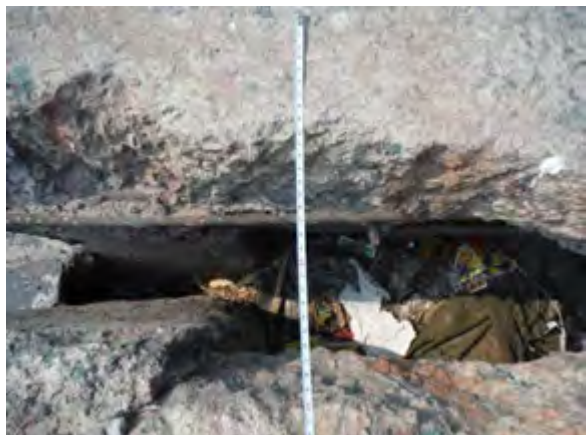
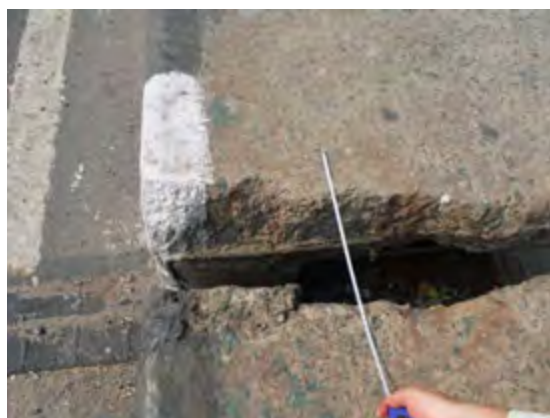
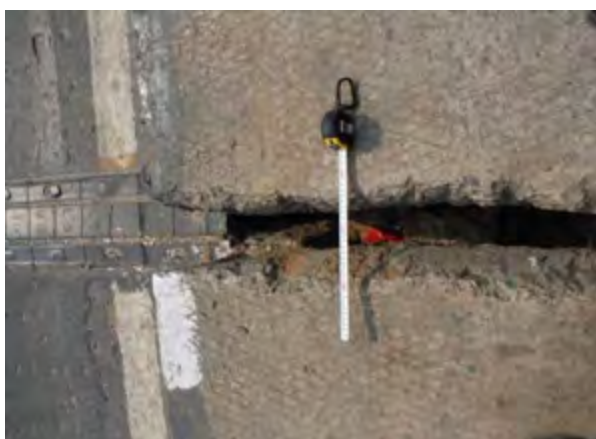
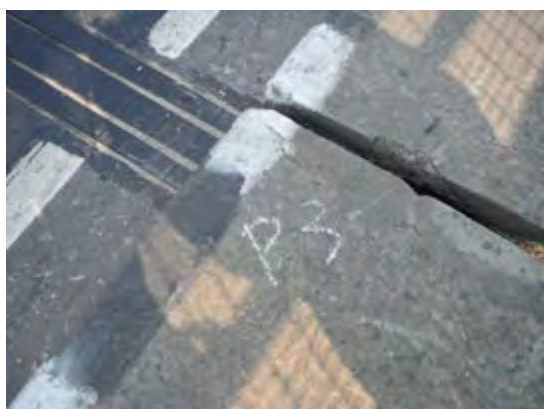
Object Member	All Joint
Kind of Damage	Clogging & Gap
Sketch or Photo

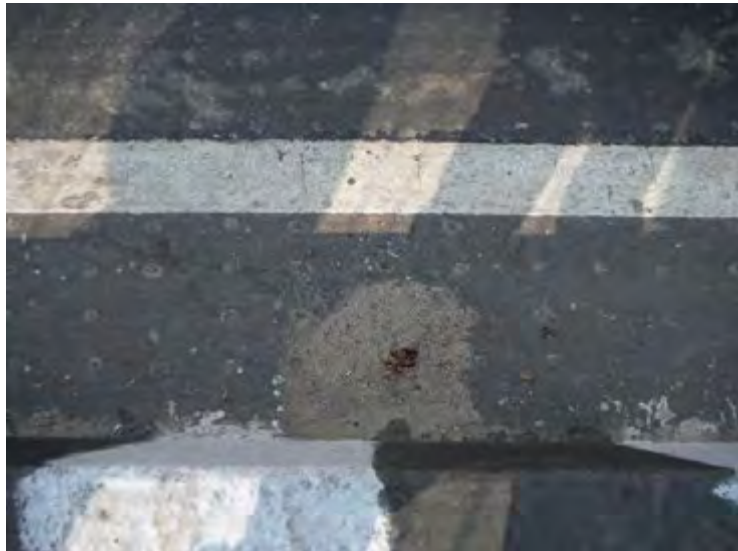
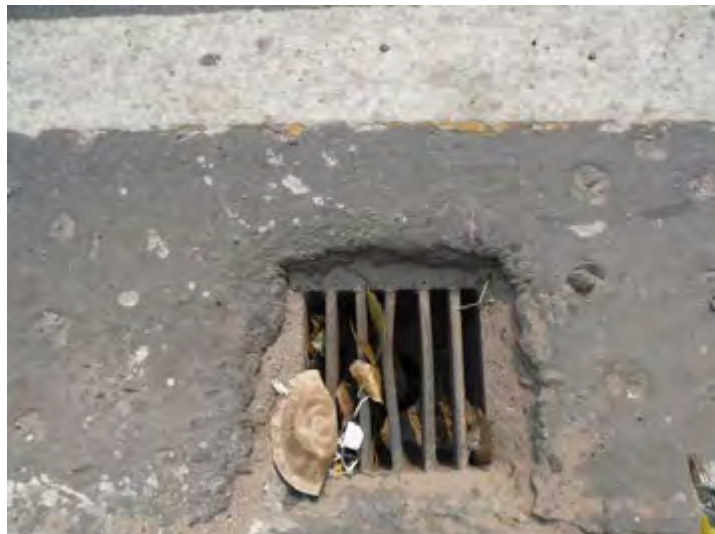
Object Member	Drainage Pipe
Kind of Damage	filling
Sketch or Photo

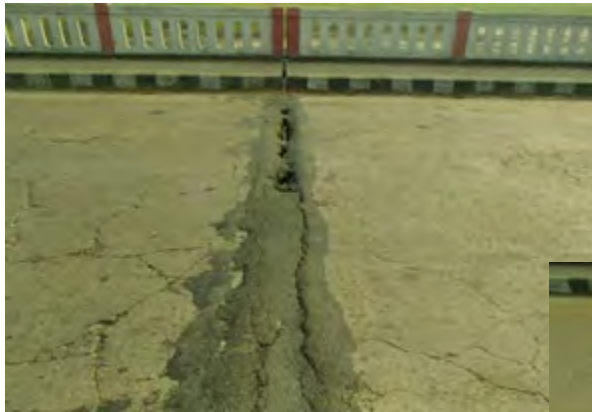
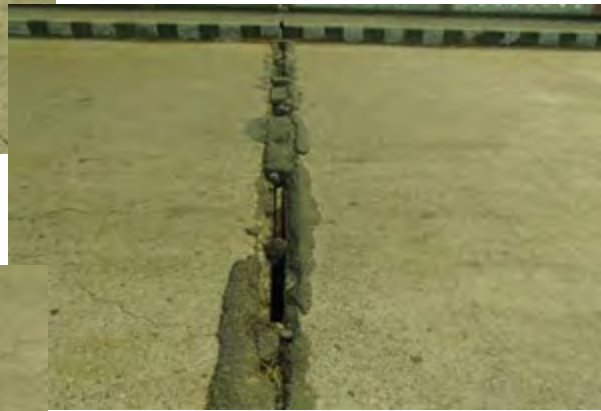
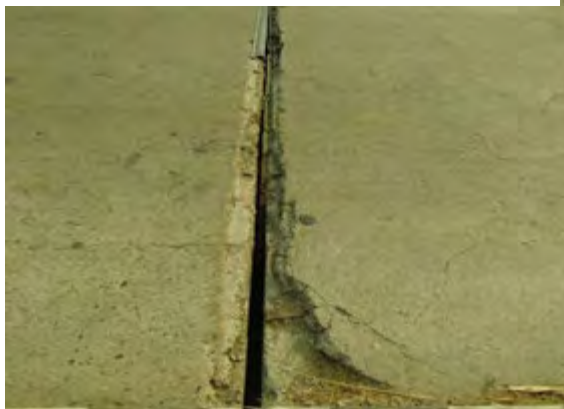
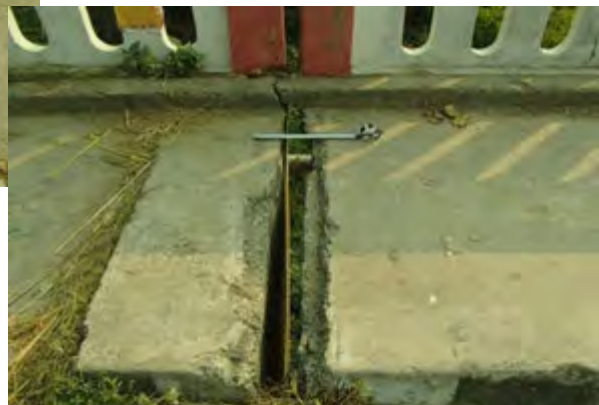
Object Member	All EXP joint
Kind of Damage	Uneven gap, broken and/or peeling
Sketch or Photo

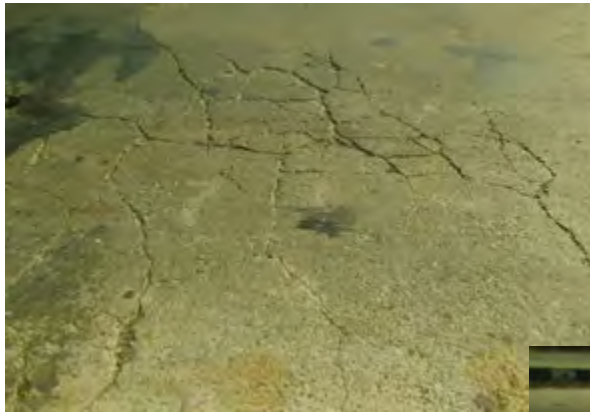
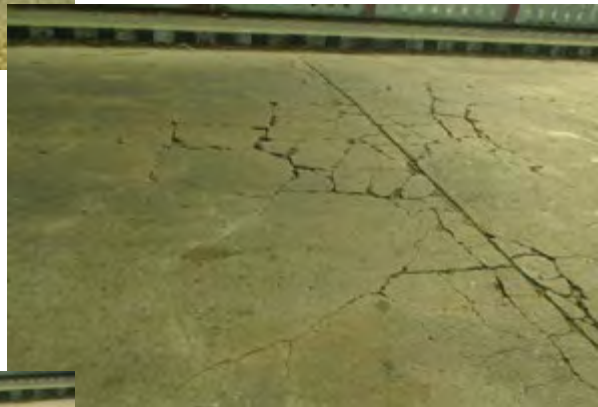
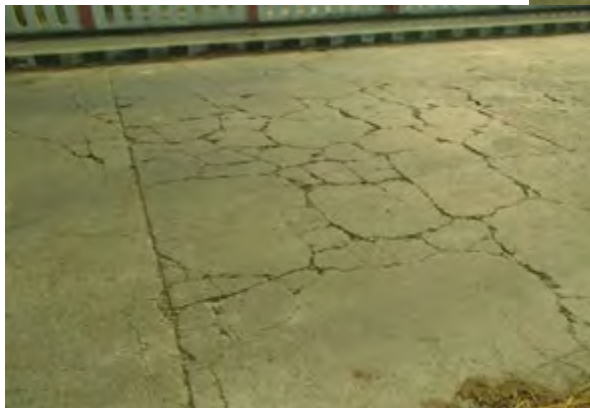
Object Member	Pavement (all portions)
Kind of Damage	Many cracks on concrete pavement
Sketch or Photo
