橋梁の目視点検結果

Bridge Survey Record (1/8)

Bridge No.	1	Location (State)	Assam
Bridge Name	Jia-Bharali Bridge	Road Name	NH 15 (old NH 52)
Station	Km166	Road Category	National Highway
GPS Data	N 26 ° 48 ' 36.0 "	Management Authority	State PWD
	E 092 ° 52 ' 23.6 "	Year of Construction	1962

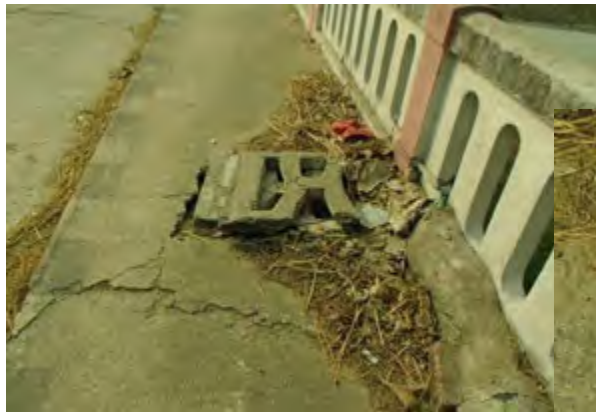
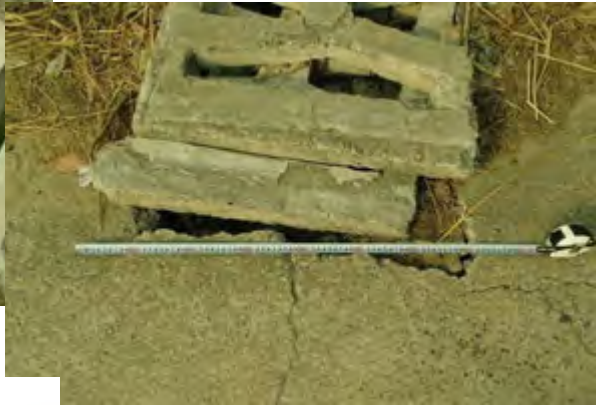
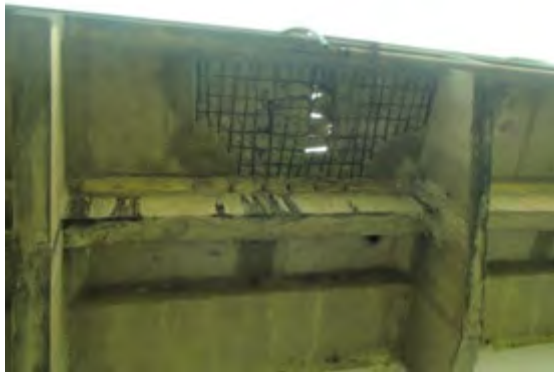
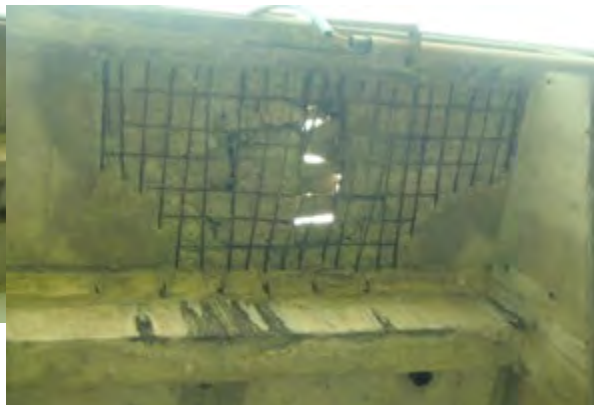
Object Member	Footway slab (P10-A2)
Kind of Damage	Falling out of footway slab
Sketch or Photo

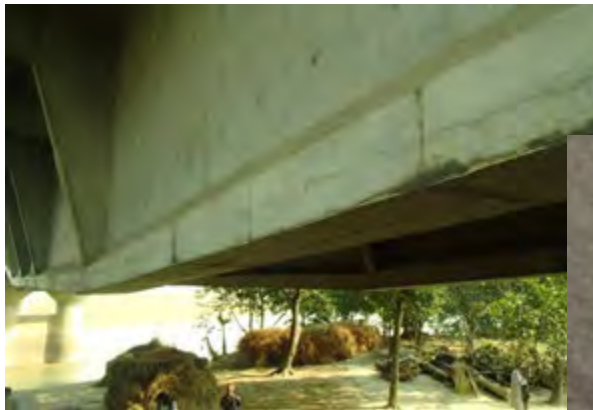
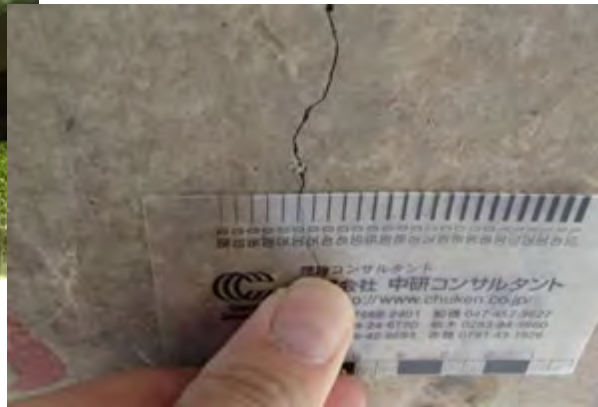
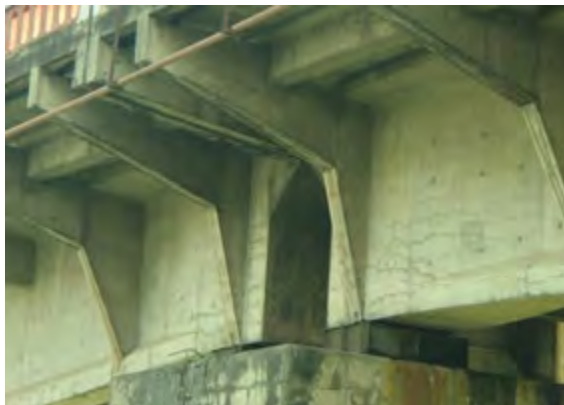
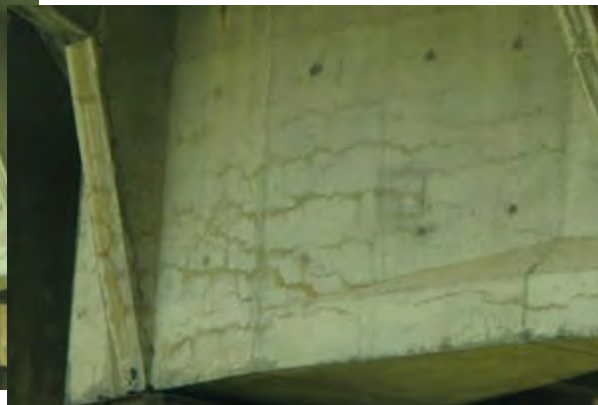
Object Member	Girder end
Kind of Damage	Small cracks on web. Some of them were already repaired in 1986
Sketch or Photo

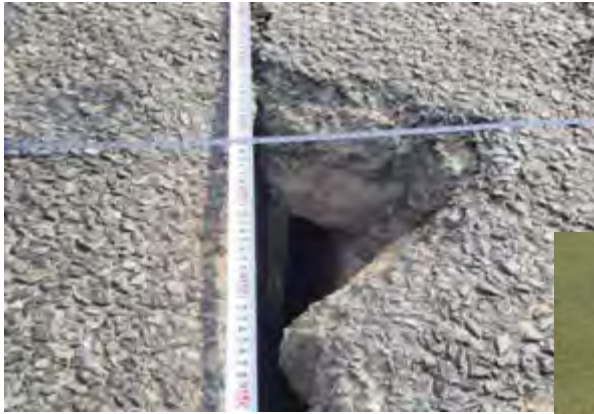
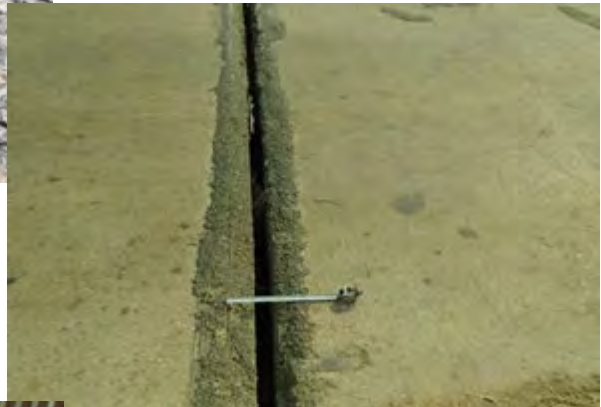
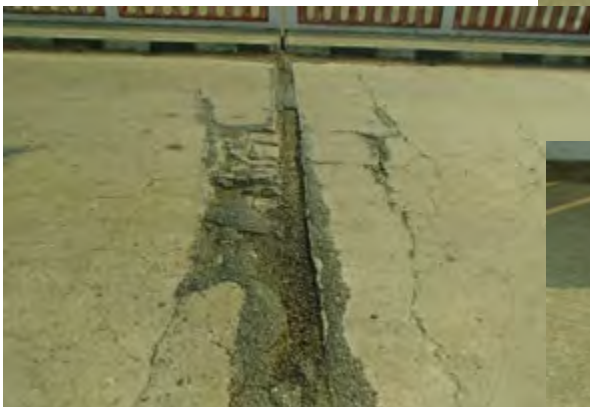
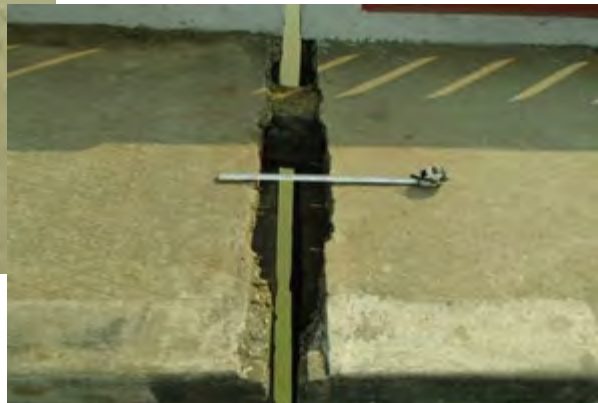
Object Member	All EXP joint
Kind of Damage	Uneven gap, broken and/or peeling
Sketch or Photo

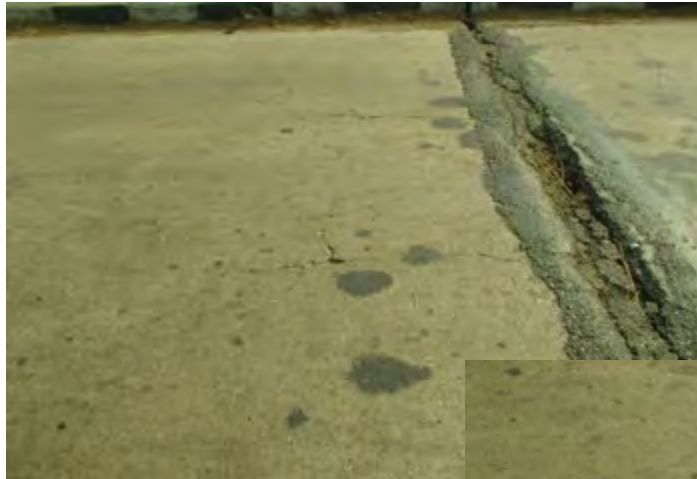
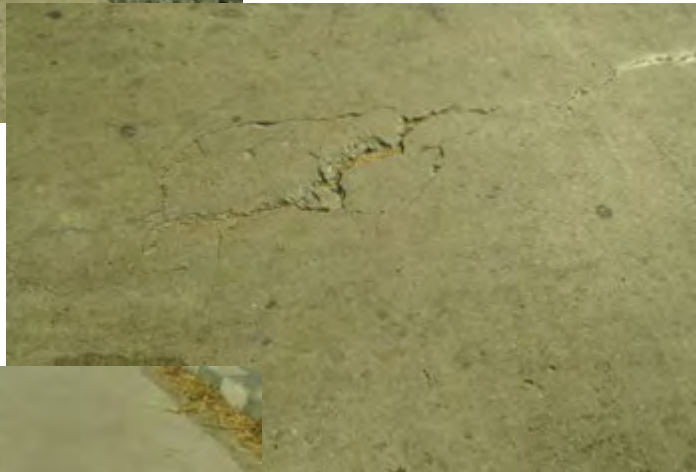
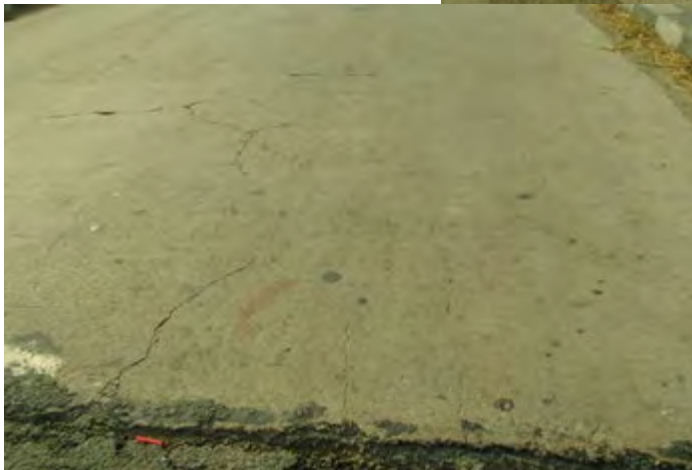
Object Member	Pvemet (all portions)
Kind of Damage	Many cracks on concrete pavement
Sketch or Photo

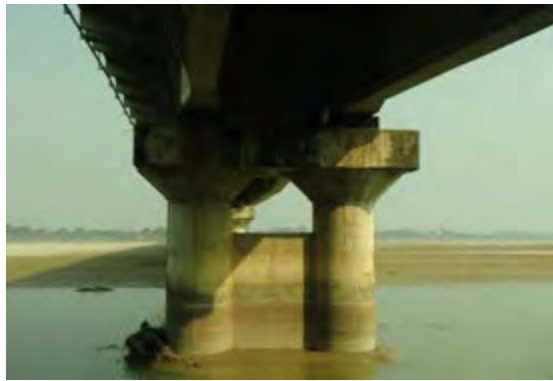
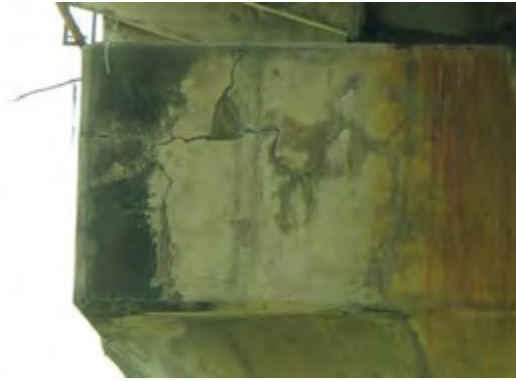
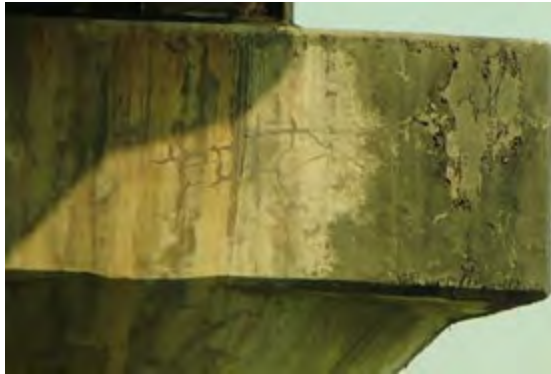
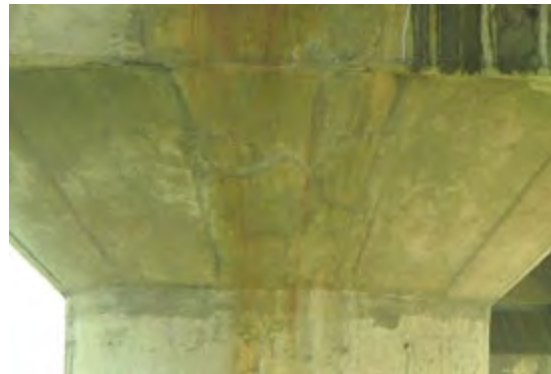
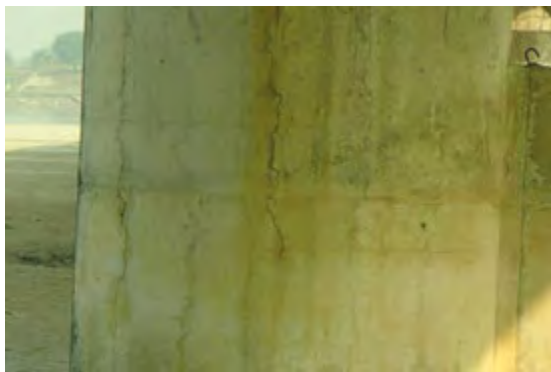
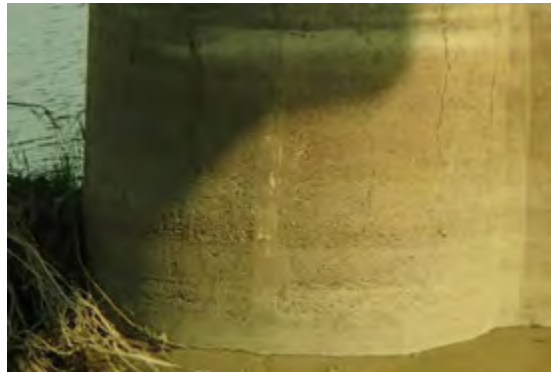
Object Member	All Piers
Kind of Damage	Cracks on pier cap and column
Sketch or Photo

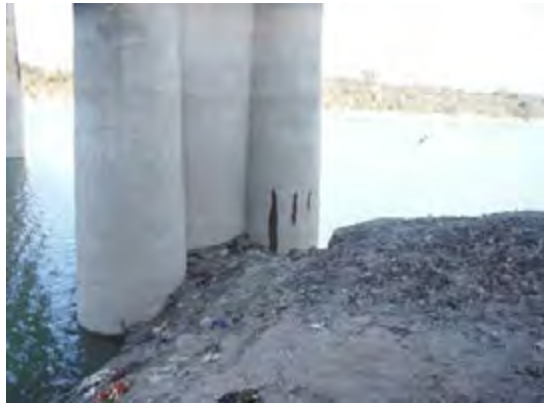
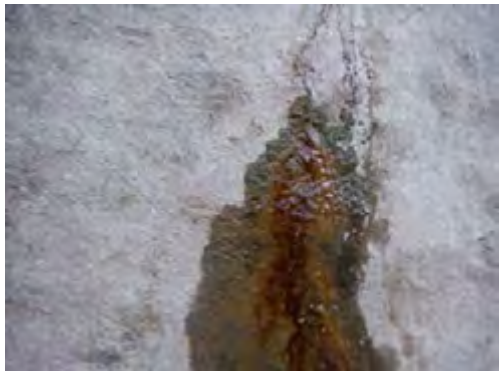
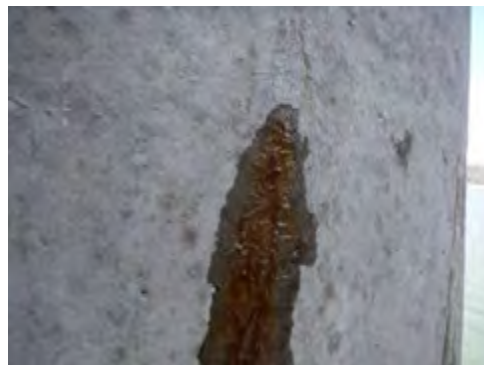
Object Member	P2
Kind of Damage	Leaking of water
Sketch or Photo

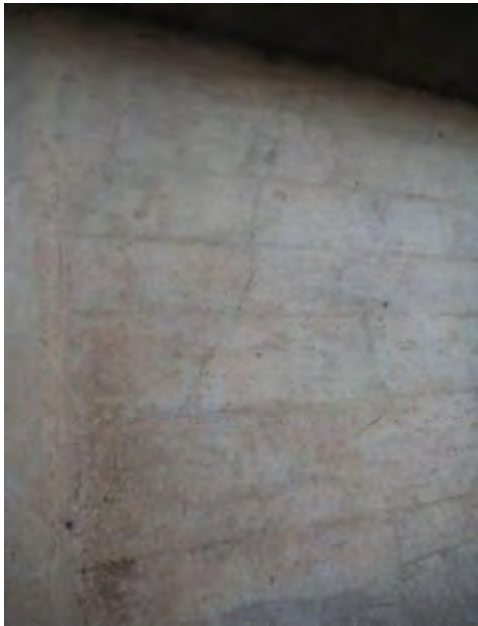
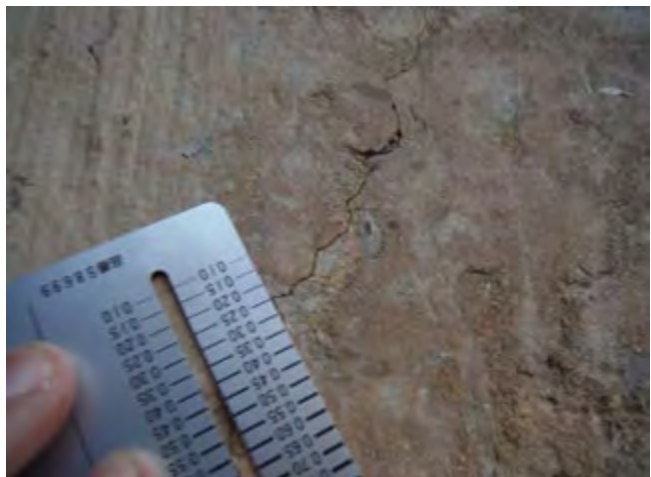
Object Member	PC T Girder (A1P1)
Kind of Damage	Cracking on web
Sketch or Photo

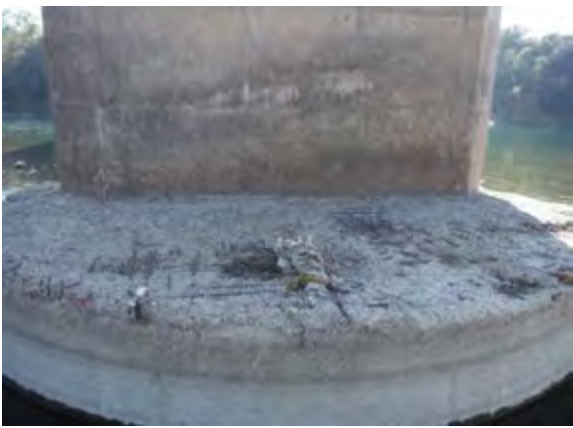
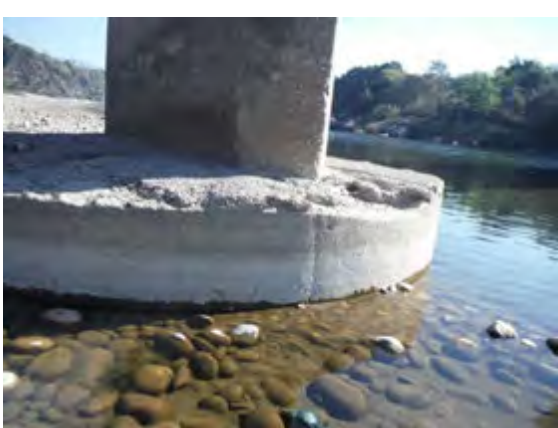
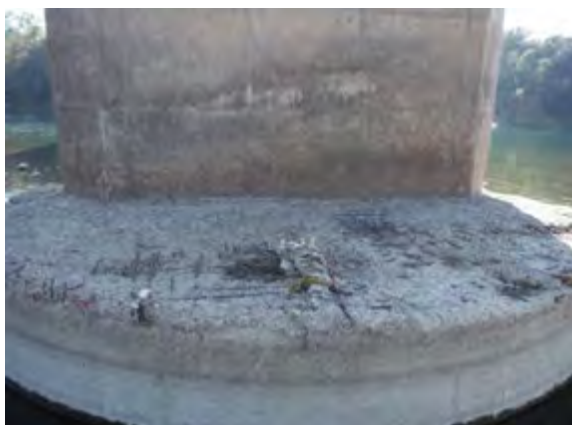
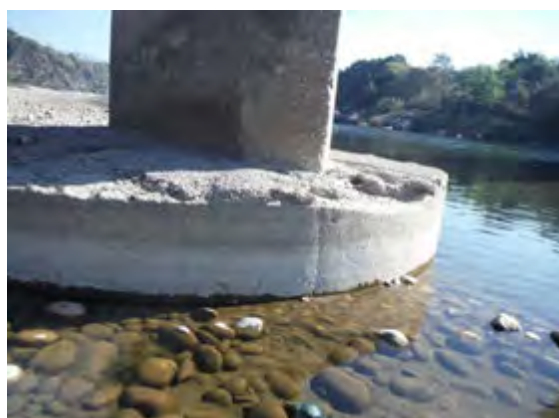
Object Member	P2
Kind of Damage	Scouring
Sketch or Photo	<div style="text-align: center; margin-bottom: 20px;"> <p>↓ RIVER FLOW</p>

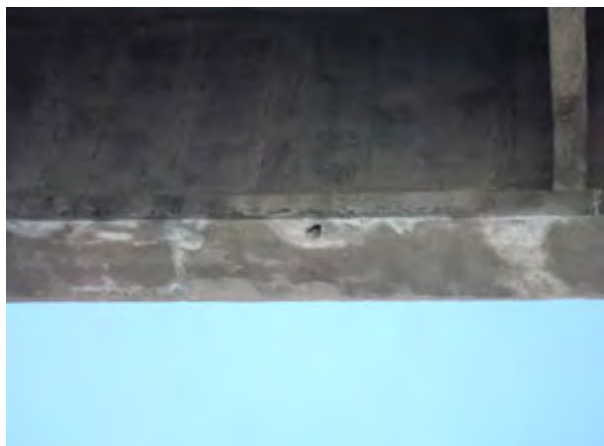
Object Member	PC T Girder (P1P2)
Kind of Damage	Honeycomb
Sketch or Photo

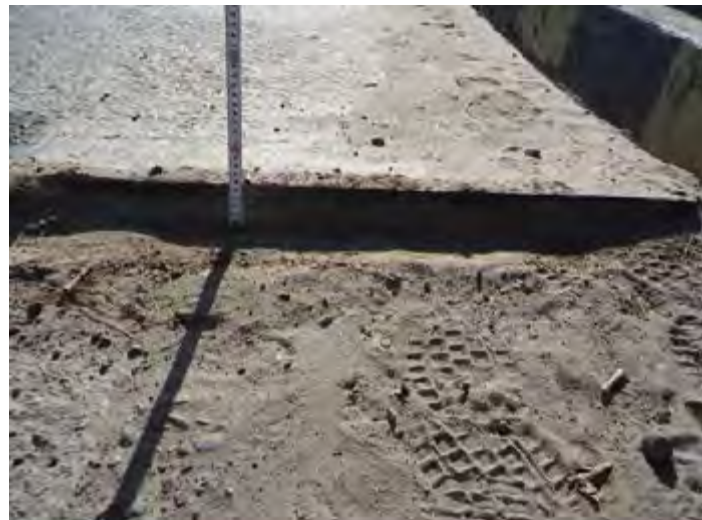
Object Member	Joint of Pavement (P6)
Kind of Damage	Level difference
Sketch or Photo

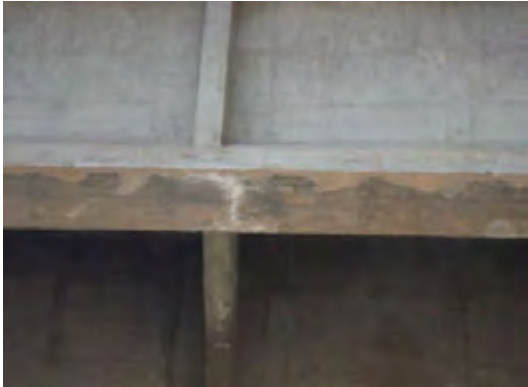
Object Member	PC T Girder (P5P6)
Kind of Damage	Efflorescence
Sketch or Photo	<div style="text-align: center; margin-bottom: 20px;"> <p>↓ RIVER FLOW</p>

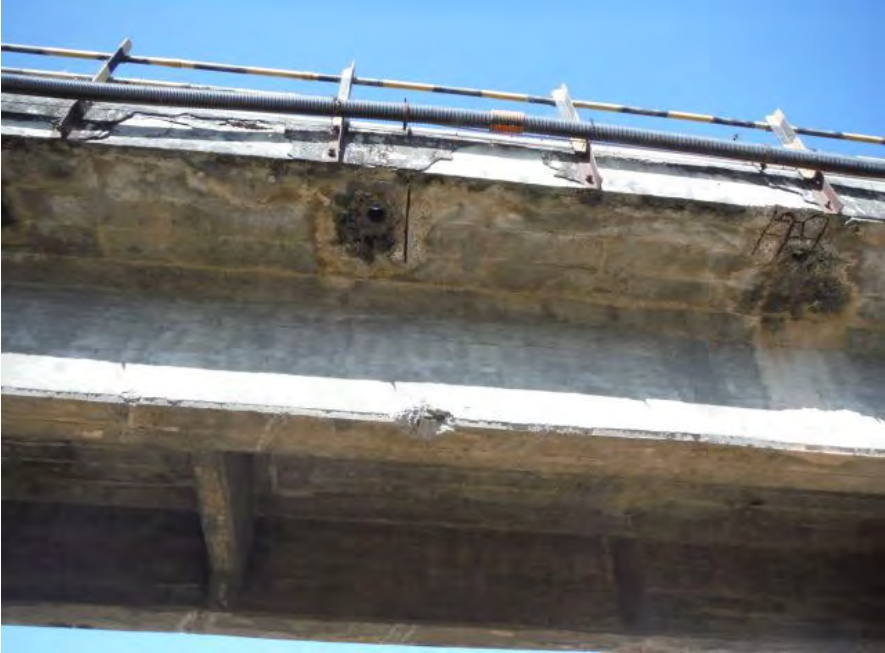
Object Member	RC T Girder
Kind of Damage	Re-bar exposed and corroded
Sketch or Photo	<div style="text-align: center; margin-bottom: 20px;"> <p>↓ RIVER FLOW</p>

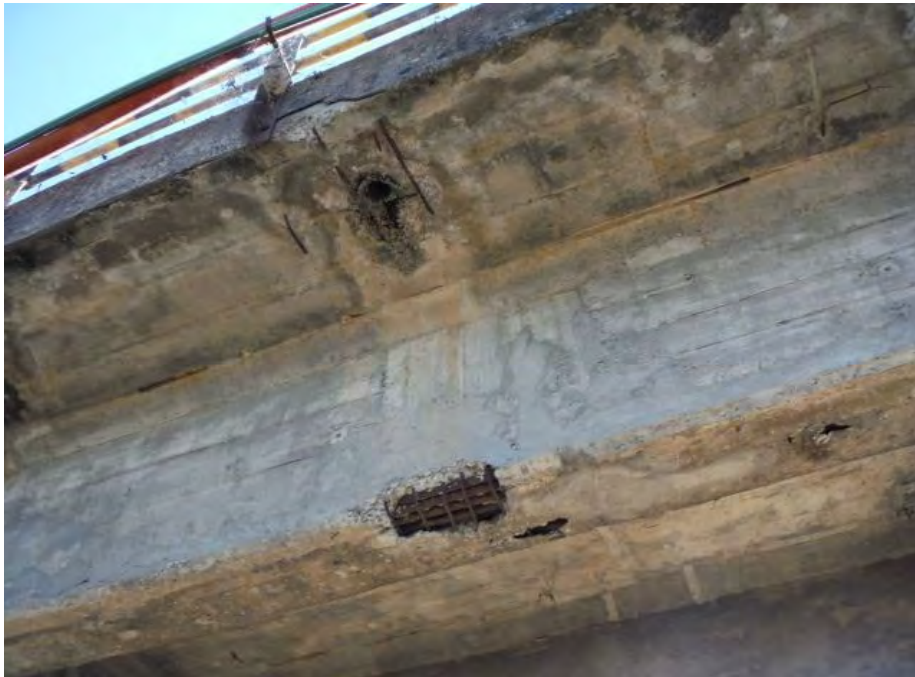
Object Member	RC T Girder
Kind of Damage	Re-bar exposed and corroded
Sketch or Photo

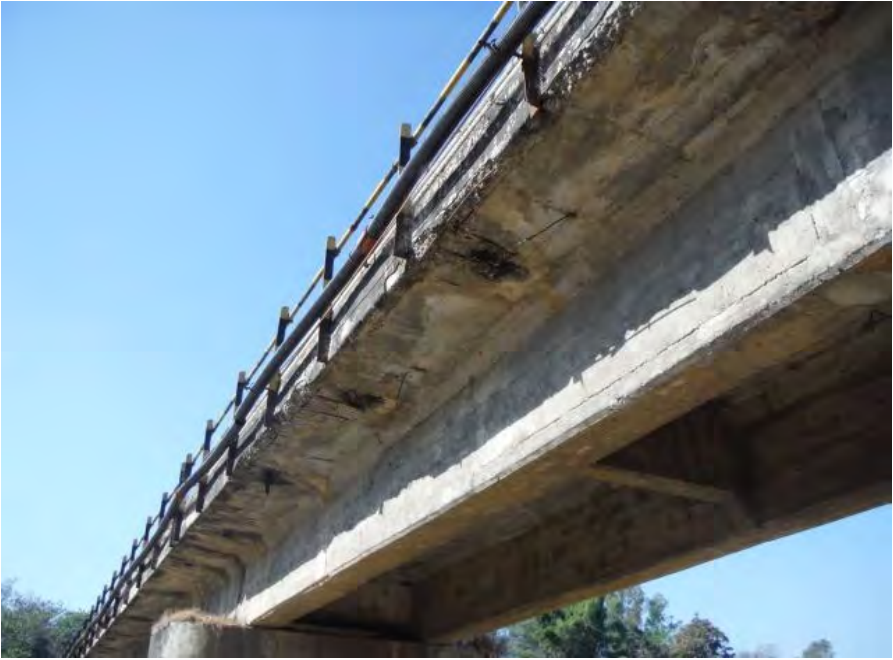
Object Member	RC T Girder
Kind of Damage	Re-bar exposed and corroded
Sketch or Photo	<div style="text-align: center; margin-bottom: 10px;"> <p>↓ RIVER FLOW</p>

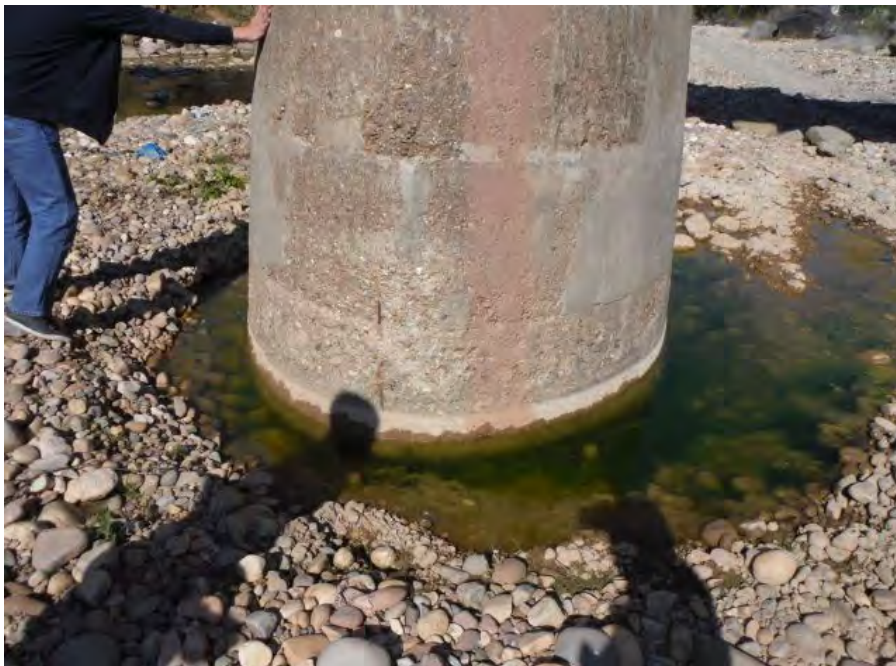
Object Member	P2
Kind of Damage	Scouring
Sketch or Photo

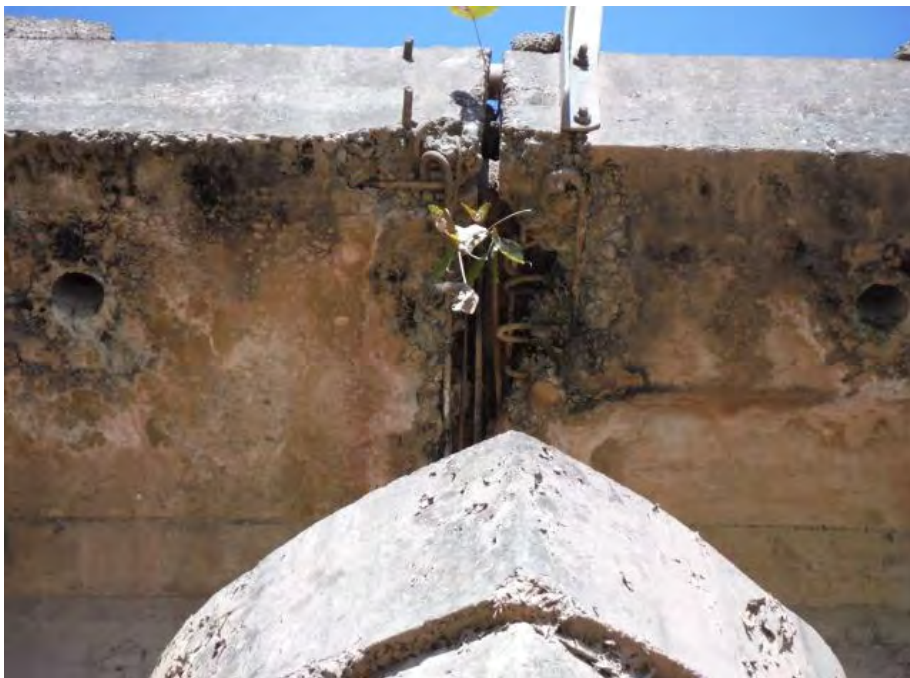
Object Member	RCT Girder (P2)
Kind of Damage	Corrosion & Spalling
Sketch or Photo

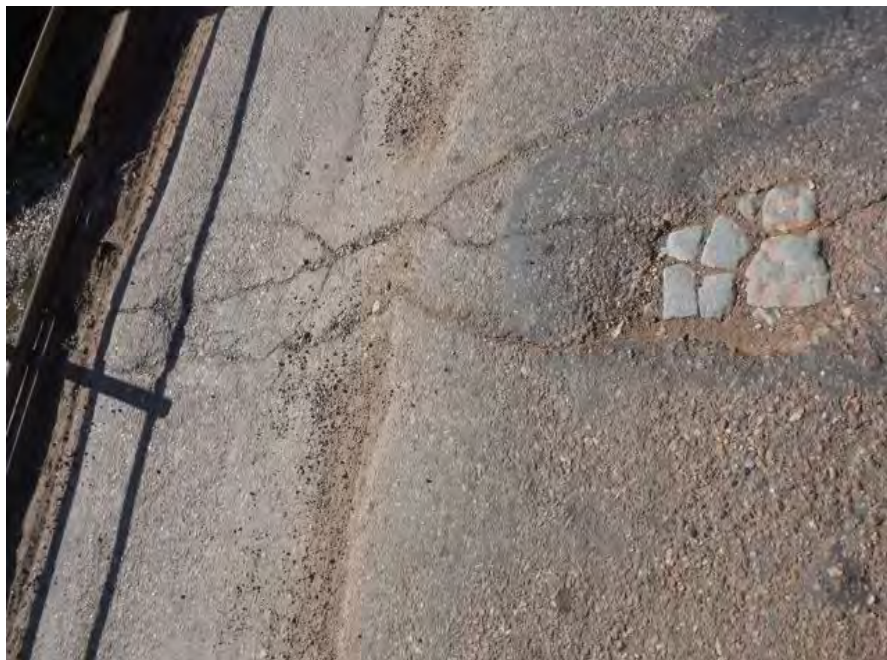
Object Member	Pavement
Kind of Damage	Cracking
Sketch or Photo

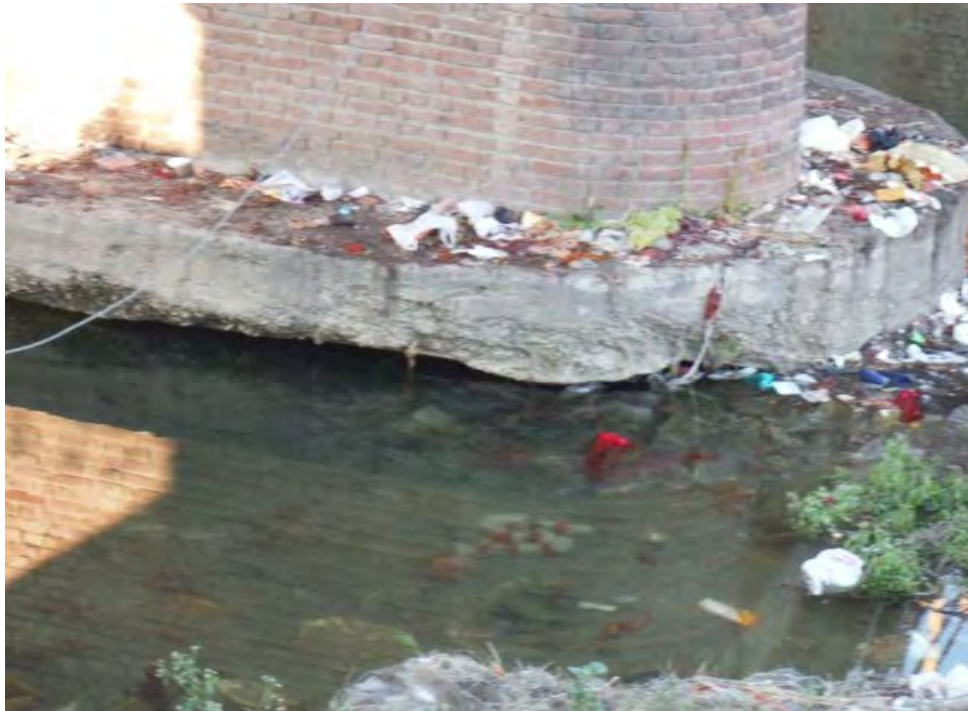
Object Member	P2
Kind of Damage	Scouring
Sketch or Photo

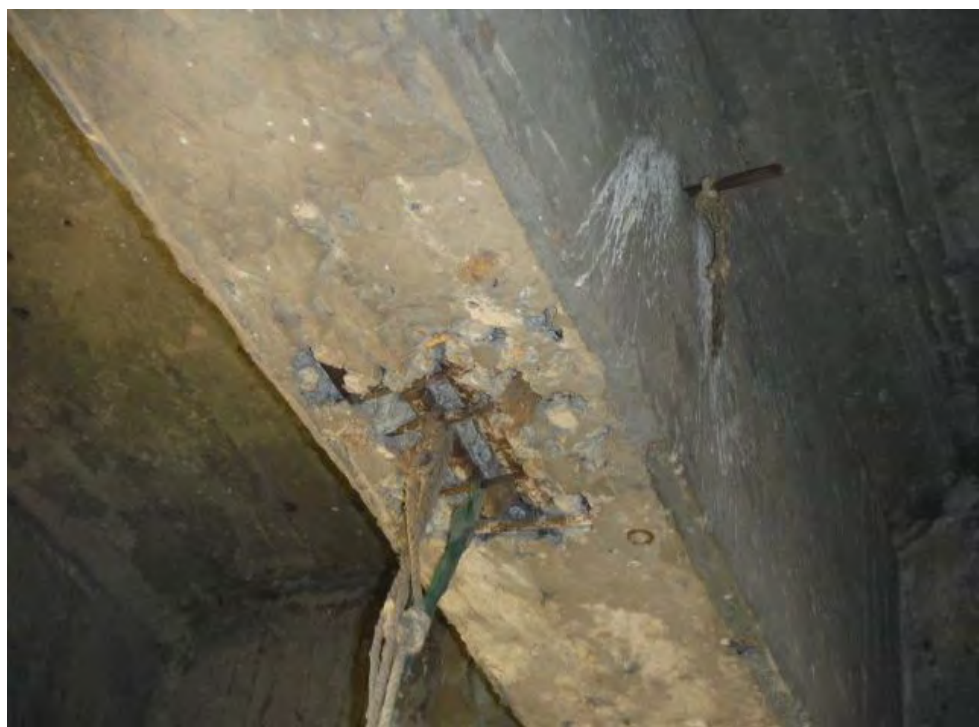
Object Member	RC T Girder
Kind of Damage	Spalling on lower web
Sketch or Photo

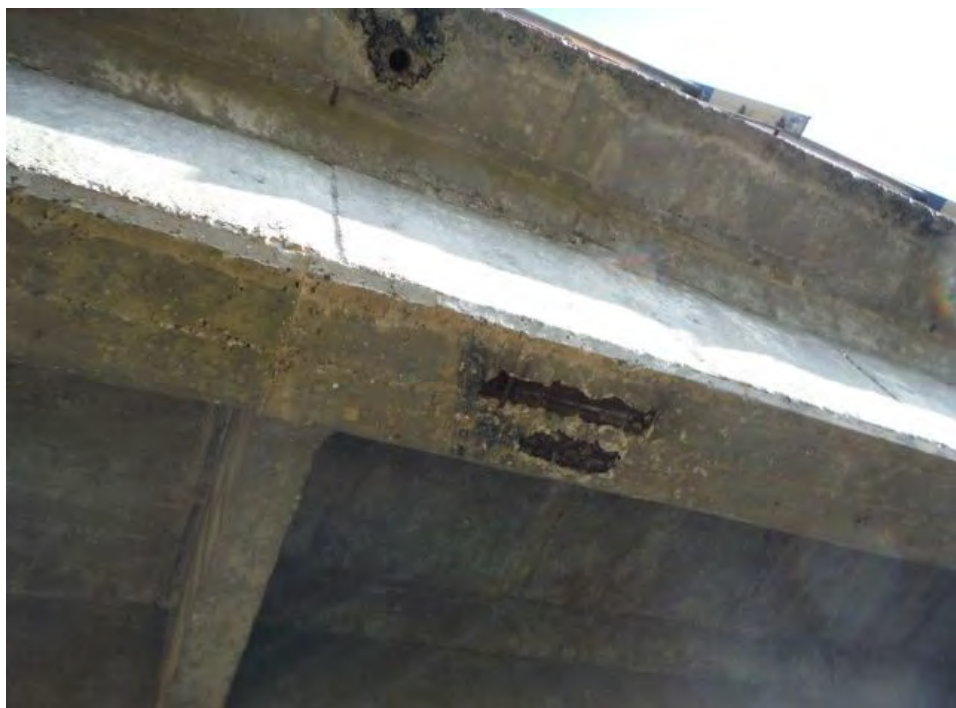
Object Member	RC T Girder
Kind of Damage	Spalling on lower web
Sketch or Photo

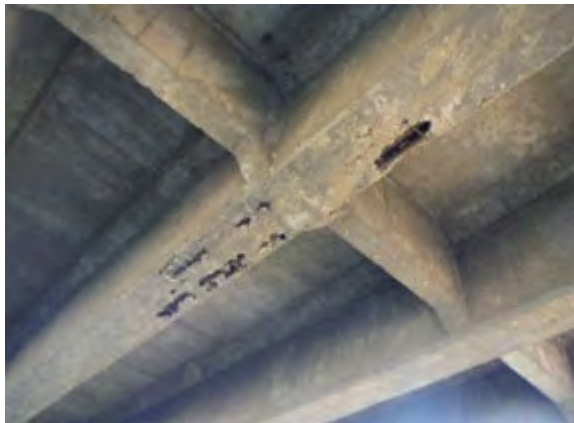
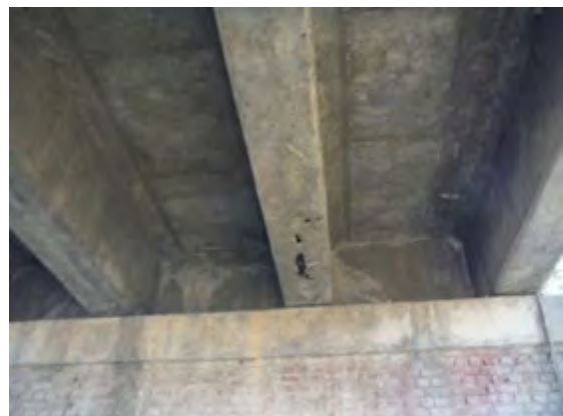
Object Member	RC T Girder
Kind of Damage	Spalling on lower web
Sketch or Photo

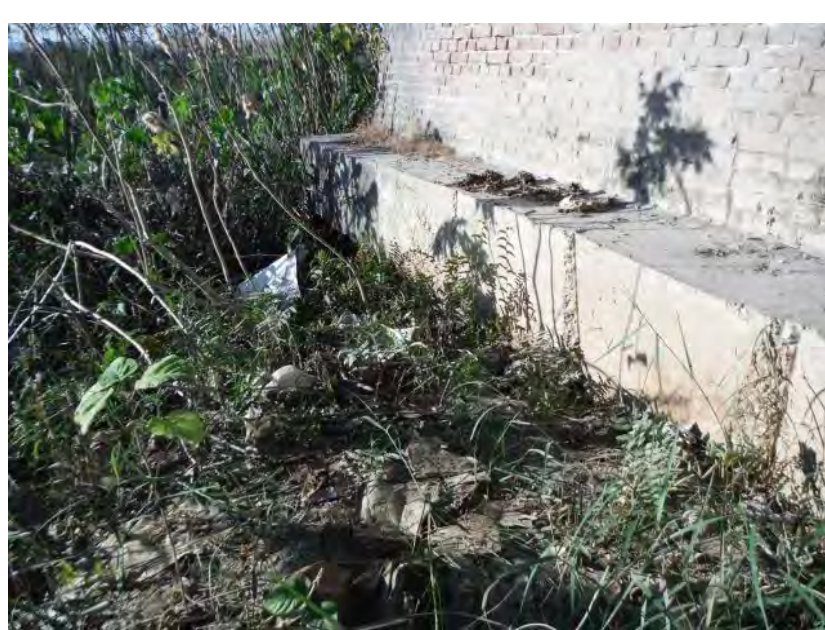
Object Member	A2
Kind of Damage	Scouring
Sketch or Photo	<div style="text-align: center; margin-bottom: 20px;"> <p>↓ RIVER FLOW</p>

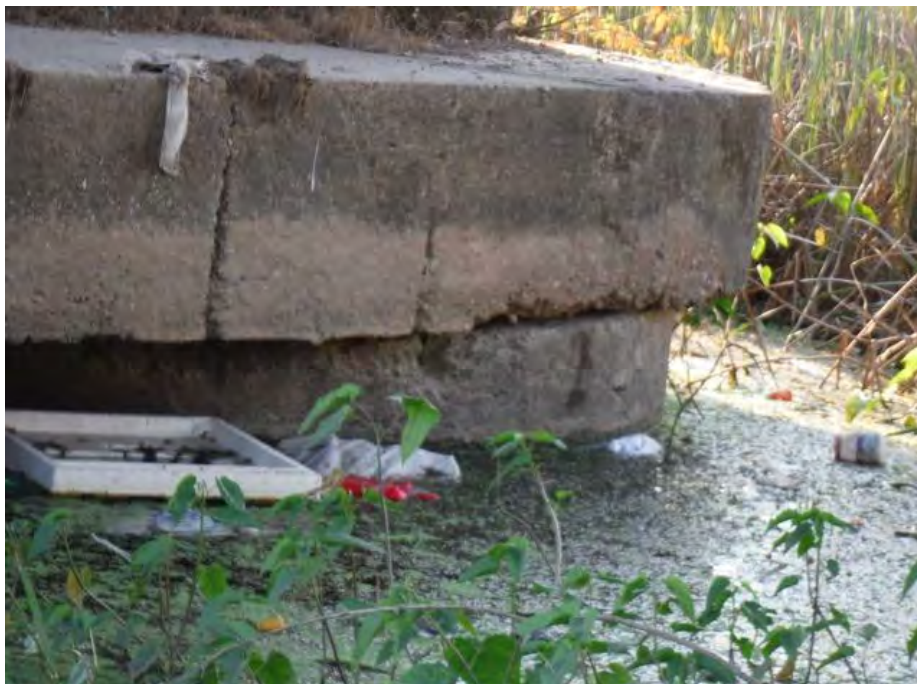
Object Member	P2
Kind of Damage	Scouring
Sketch or Photo

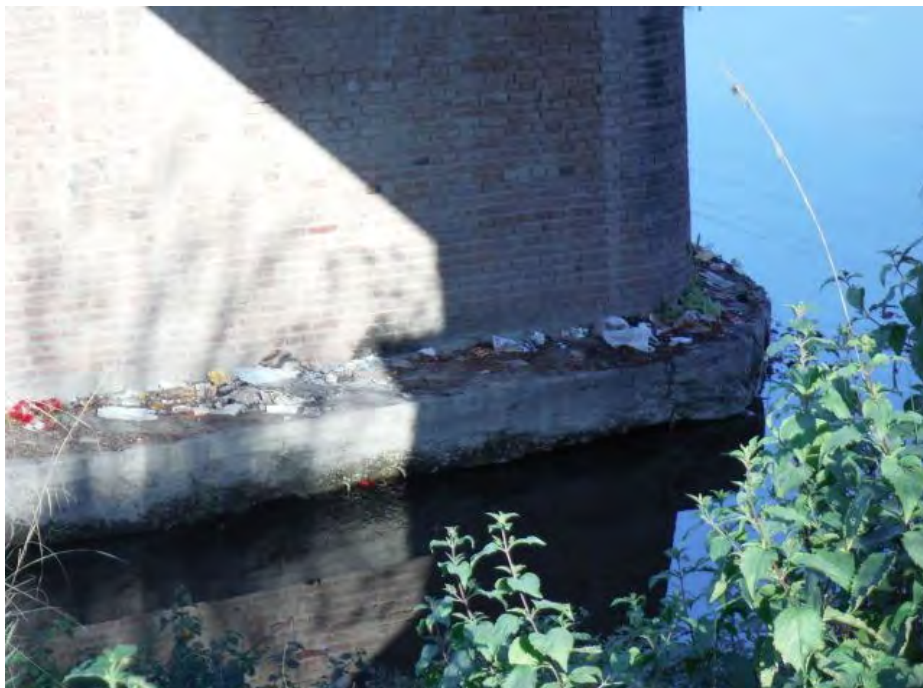
Object Member	P1
Kind of Damage	Scouring
Sketch or Photo
