APPENDIX

Bridge Survey Record by Visual Inspection

Bridge No.	1	Location (State)	Assam
Bridge Name	Jia-Bharali Bridge	Road Name	NH 15 (old NH 52)
Station	Km166	Road Category	National Highway
GPS Data	N 26 ° 48 ' 36.0 "	Management Authority	State PWD
	E 092 ° 52 ' 23.6 "	Year of Construction	1962

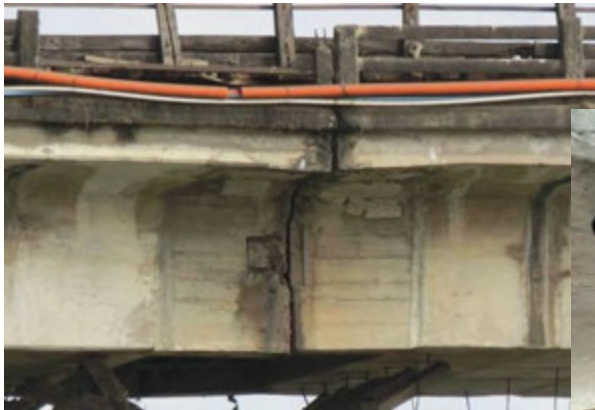
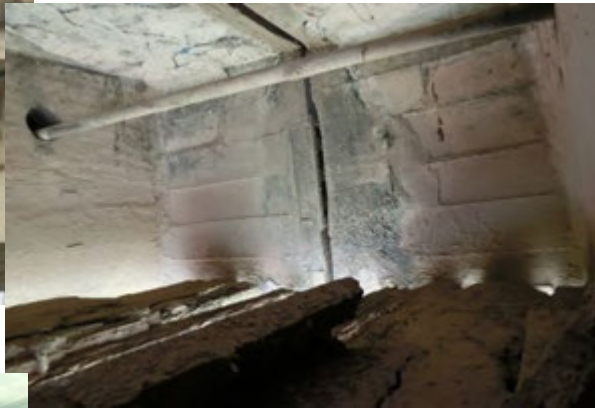
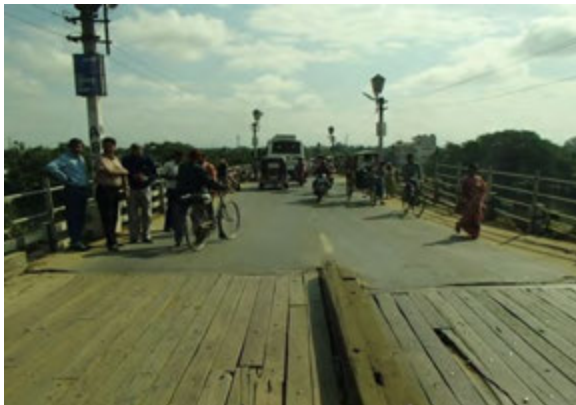
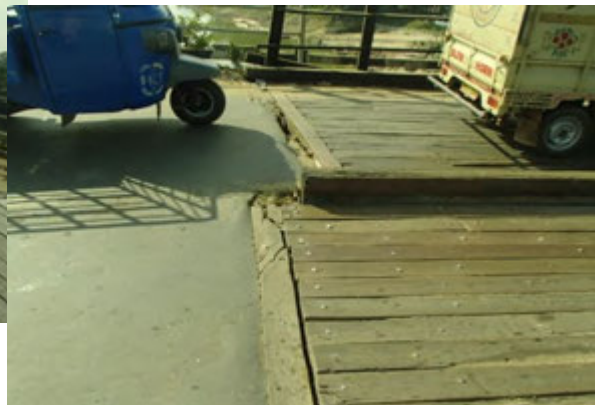
Object Member	Main Girder (at centre hinge)
Kind of Damage	End point of girders damaged at several locations. Abnormal deflection at center hinge, and 10m span timber bridge are provided over the centre hinge.
Sketch or Photo

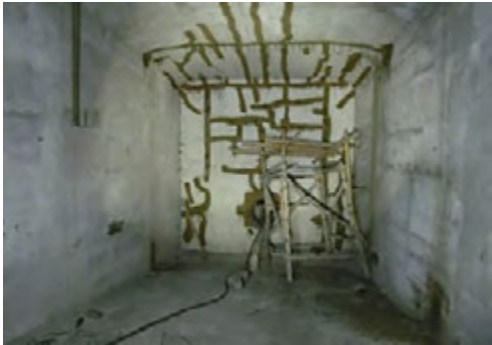
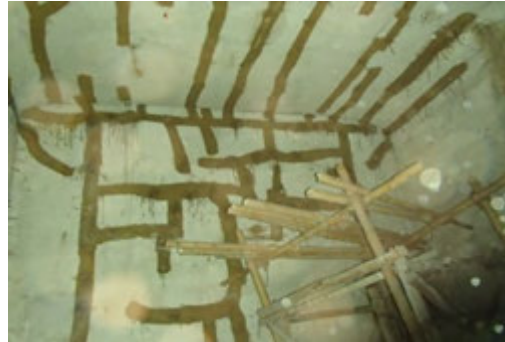
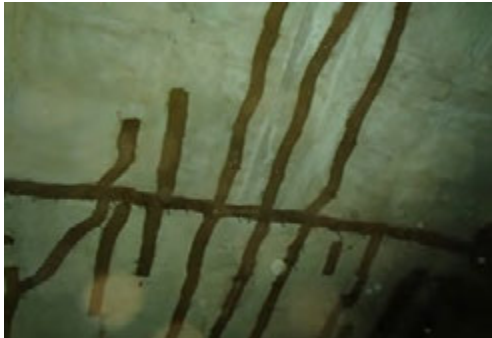
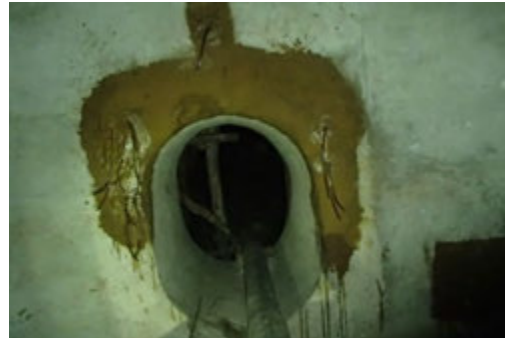
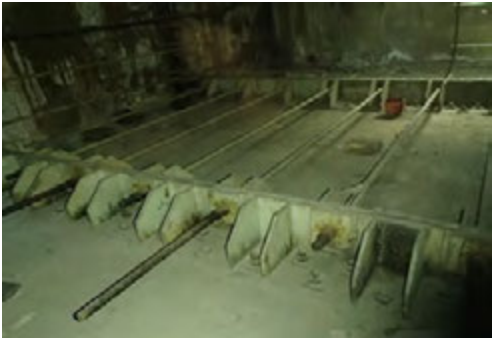
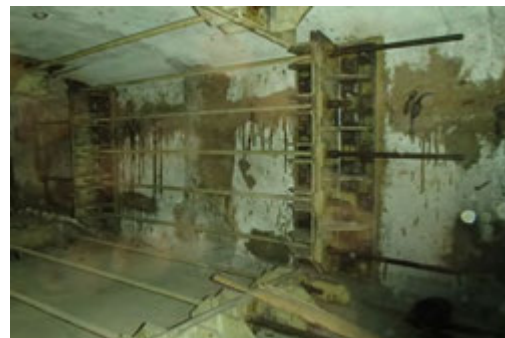
Bridge Survey Record (7/8) -2

Object Member	Main Bridge Girder
Kind of Damage	Some cracks have been repaired in 1990. Further cracks are observed.
Sketch or Photo

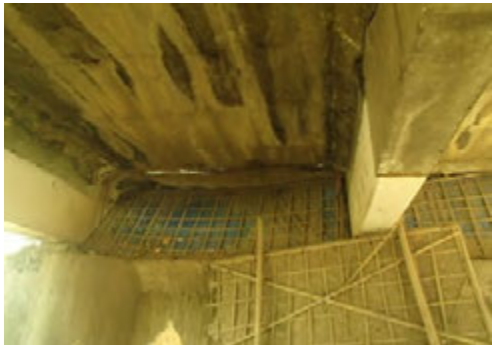
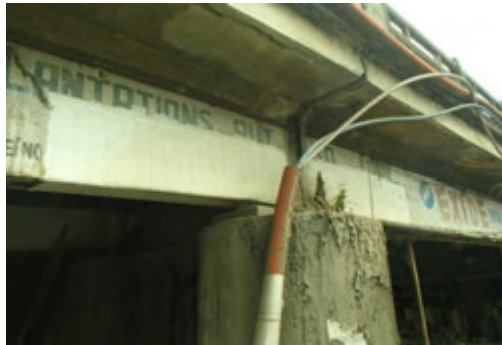
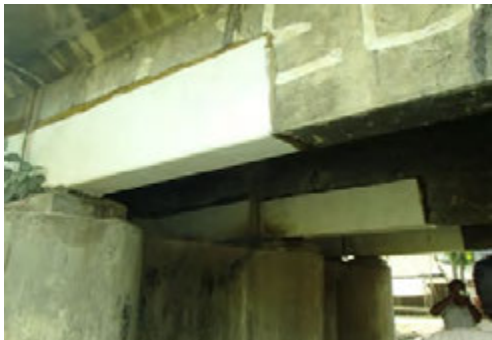
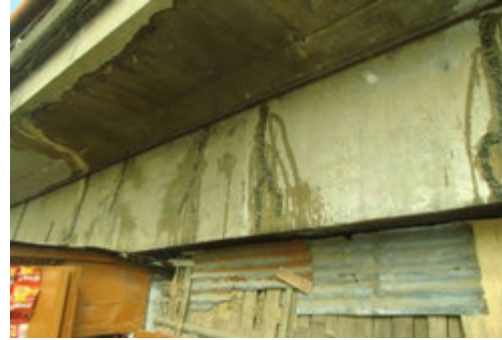
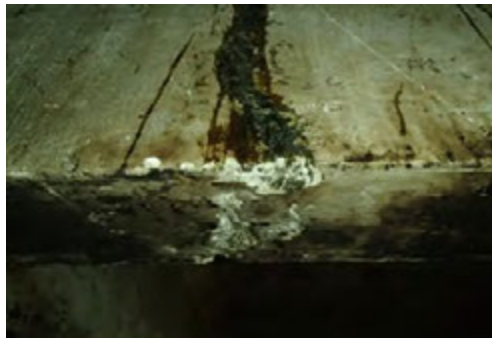
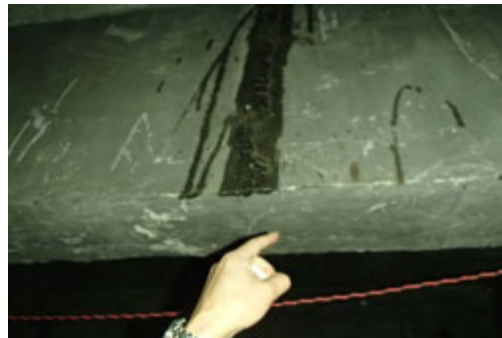
Bridge Survey Record (7/8) -3

Object Member	Approach Bridge Girder
Kind of Damage	Some cracks have been repaired in 1990. Further cracks are observed.
Sketch or Photo

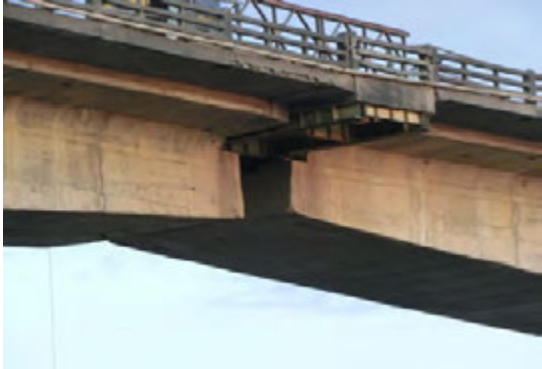
Object Member	Centre Hinge (P1-P2)
Kind of Damage	End point of girders damaged. Abnormal deflection, and 10m span steel bridge are provided over the centre hinge.
Sketch or Photo

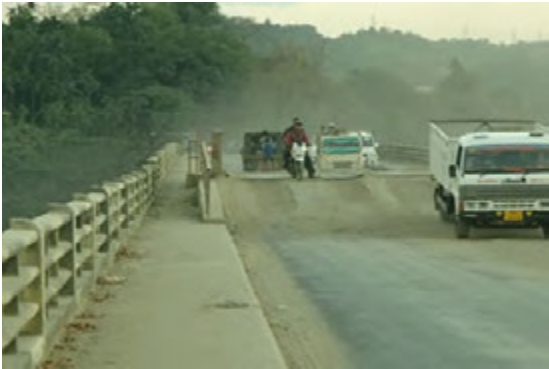
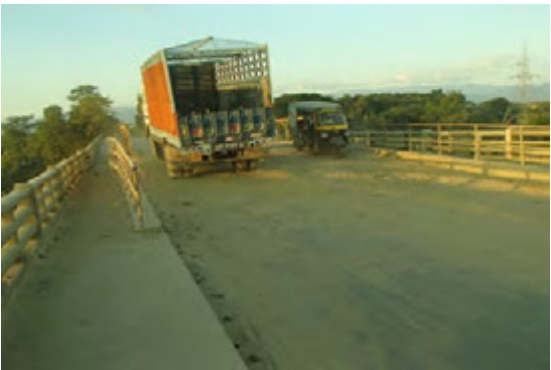
Bridge Survey Record (7/8) -2

Object Member	Centre Hinge (P1-P2)
Kind of Damage	End point of girders damaged. Abnormal deflection, and 10m span steel bridge are provided over the centre hinge.
Sketch or Photo

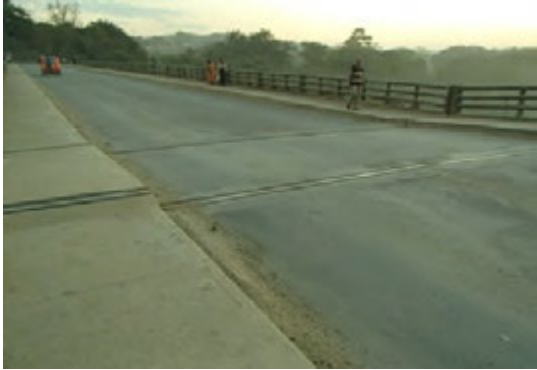
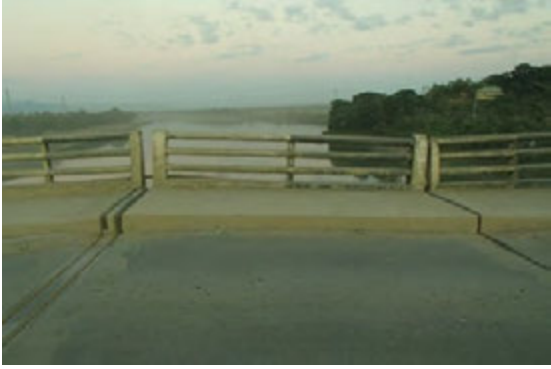
Bridge Survey Record (7/8) -3

Object Member	Centre Hinge (P2-P3)
Kind of Damage	Level difference
Sketch or Photo	<div style="text-align: center; margin-bottom: 20px;">

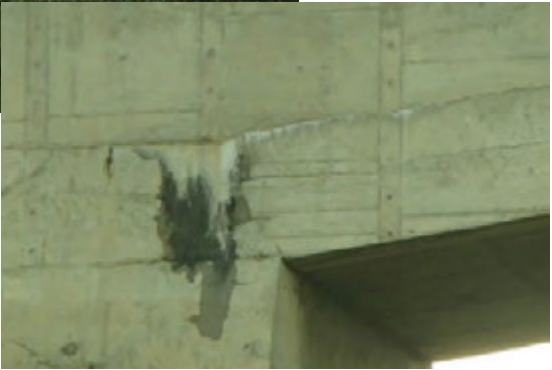
Bridge Survey Record (7/8) -4

Object Member	Girder (P1, downstream side)
Kind of Damage	Cracks
Sketch or Photo

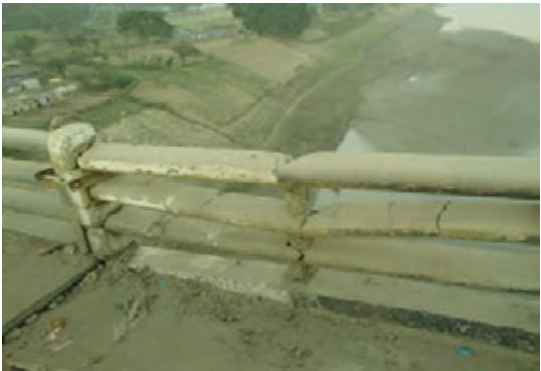
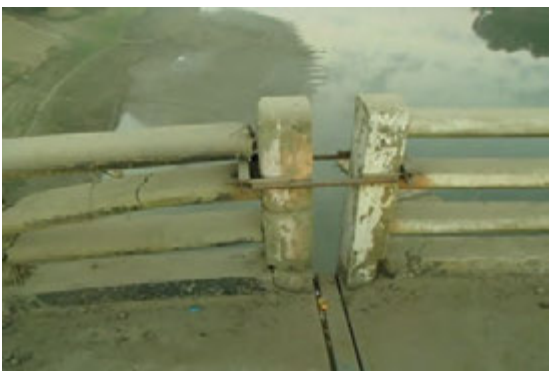
Bridge Survey Record (7/8) -5

Object Member	Handrail (P1-P2)
Kind of Damage	Level difference and uneven gap
Sketch or Photo	<div style="text-align: center; margin-bottom: 10px;">

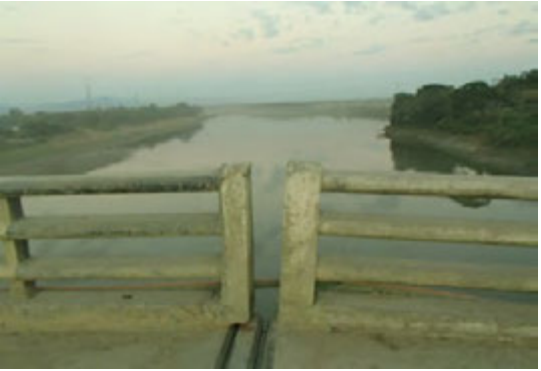
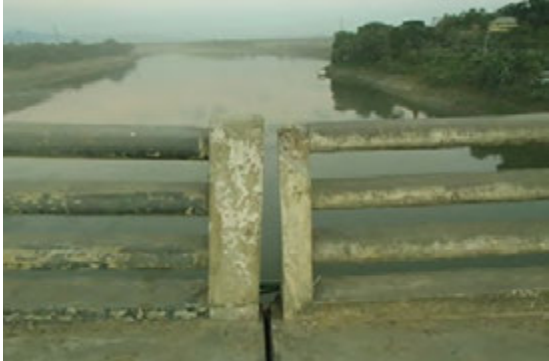
Bridge Survey Record (7/8) -6

Object Member	Handrail (P2-P3)
Kind of Damage	Level difference and uneven gap
Sketch or Photo

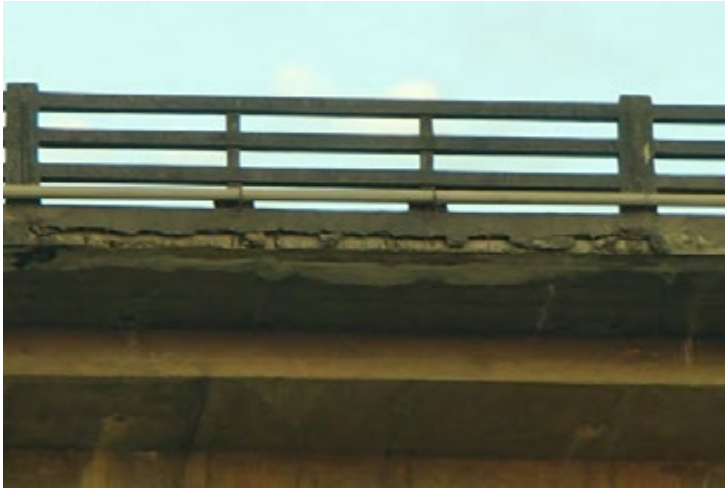
Bridge Survey Record (7/8) -7

Object Member	Kerb
Kind of Damage	Peeling off finishing layer
Sketch or Photo	<div style="text-align: center;">

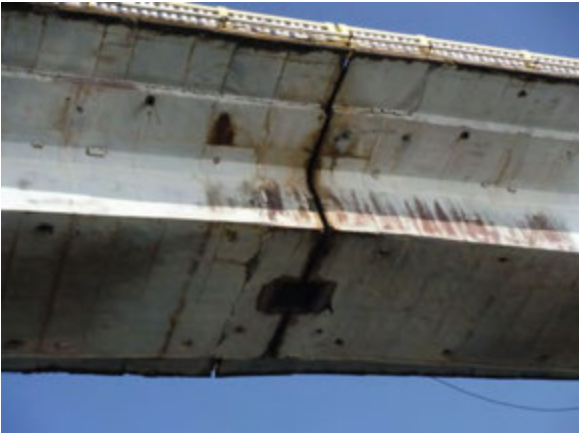
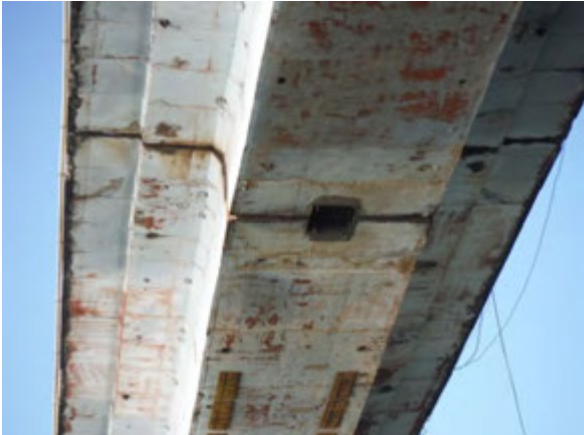
Object Member	EXP Joint P4P5 P5P6
Kind of Damage	Corrossion
Sketch or Photo	<p style="text-align: center;">↓ RIVER FLOW</p>

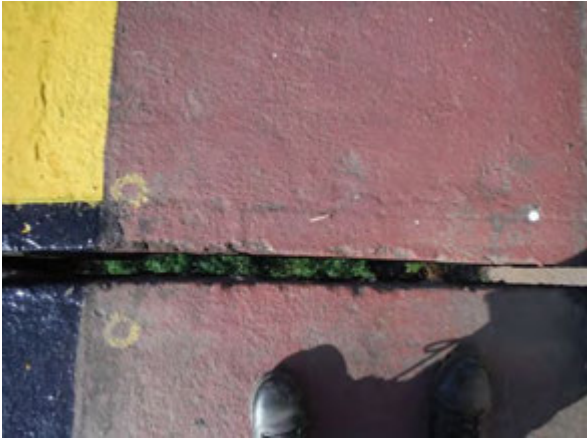
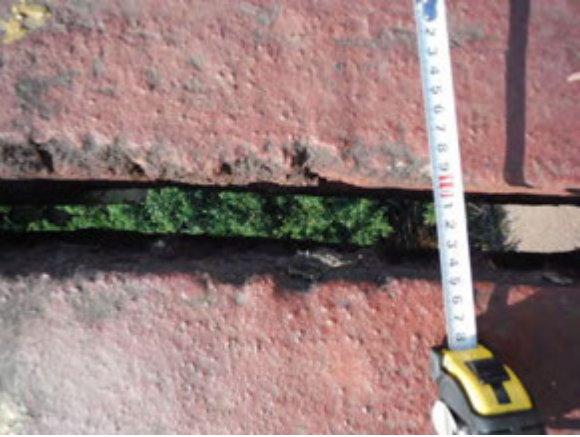
Object Member	Exp. Joint (V4)
Kind of Damage	Gap
Sketch or Photo	<p style="text-align: center;">↓ RIVER FLOW</p>

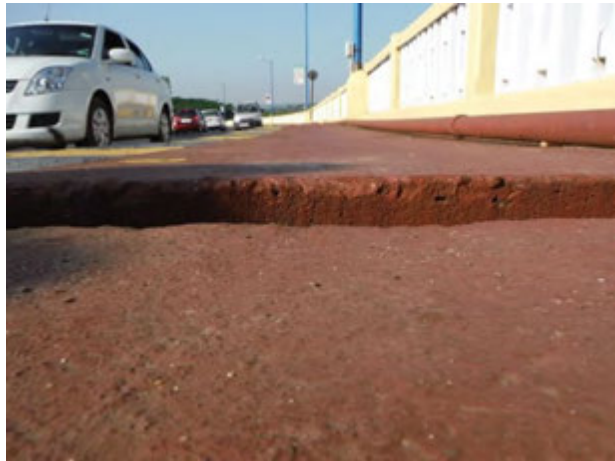
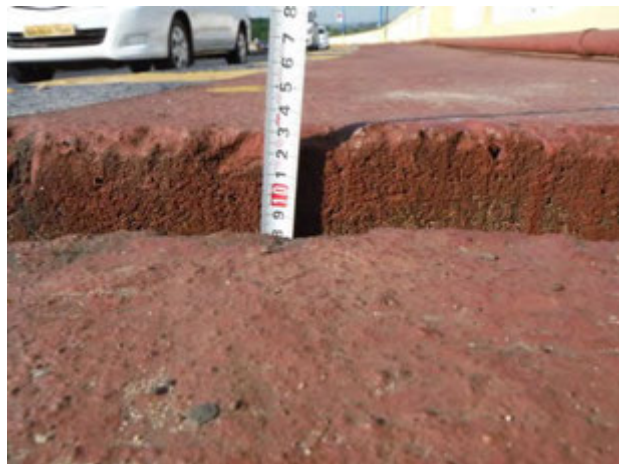
Object Member	Exp. Joint (V5)
Kind of Damage	Level difference
Sketch or Photo

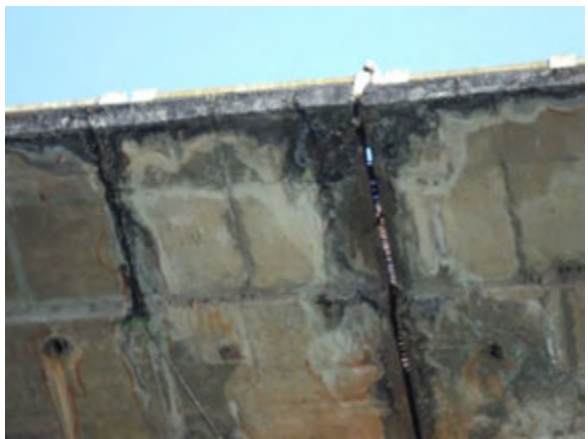
Object Member	EXP Joint (P1P2)
Kind of Damage	Corrosion
Sketch or Photo	<p>↓ RIVER FLOW</p>

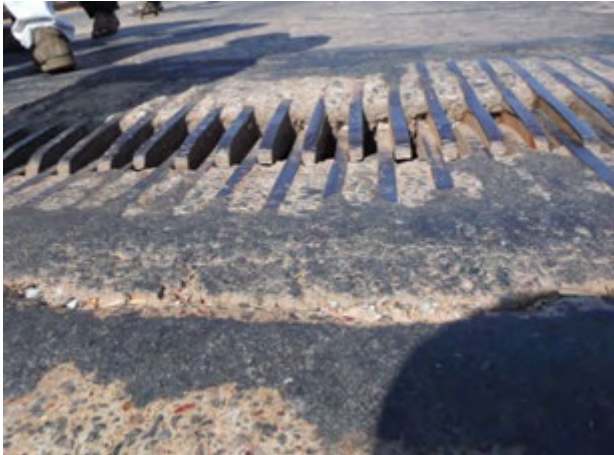
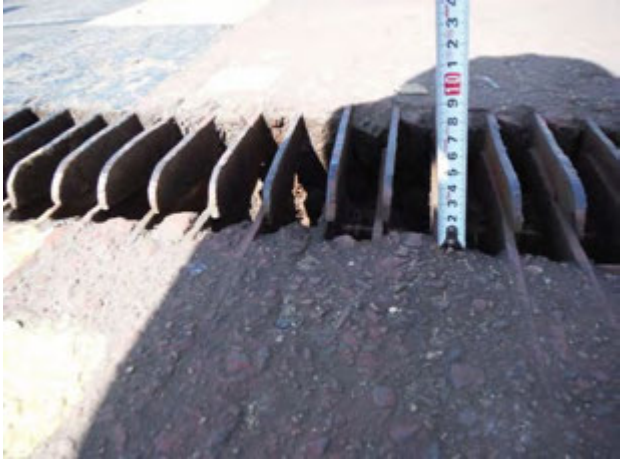
Object Member	EXP Joint (P1P2)
Kind of Damage	Level difference
Sketch or Photo	<p>↓ RIVER FLOW</p>

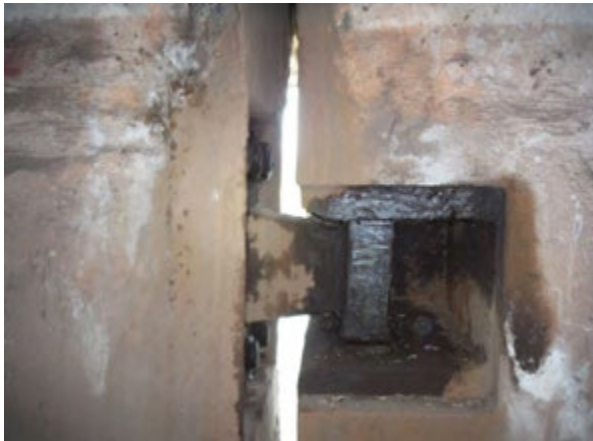
Member	Kind of the Damage
	Ex. Concrete : Cracking, Spalling, etc. Steel : Cracking, Rusting, Fracture, etc.
1. Superstructure	
(1) Concrete Member	
- Girder	There is some level difference at centre hinge
- Cross Beam	N/A
- Slab	Nil
(2) Steel Member	
- Girder	N/A
- Vertical Girder (stringer)	N/A
- Cross Beam	N/A
- Sway Bracing	N/A
(3) Bearing Shoe	Nil
(4) EXP Joint	Corrosion & Gap (P1P2)
(5) Handrail	Nil
(6) Kerb	Nil
(7) Drainage Pipe	Nil
(8) Others	Nil
2. Substructure	
- Pier	Nil
- Abutment	Nil
- Wing Wall	Nil
3. Miscellaneous	
- Approach Road Condition	Nil
- Obstruction	Nil
- Scouring	Nil
4. Evaluation	See Sheet 8

Object Member	Girder (P1P2)
Kind of Damage	There are some level difference at centre hinge
Sketch or Photo

1	Traffic Demand	High
2	Distance of Detour Route	Approx. 48 km
3	Project Effects for Japanese Companies	Moderate
4	Damage Level of the Bridges	Need repairing at centre hinge
5	Application of Japanese Technology	Applicable (centre hinge connection)
6	Duplication with Other Projects by Donor's or Local	None
7	Importance of the Bridge on Surrounding Society and Economy	Very high
8	Impacts on the Environment	Minimal

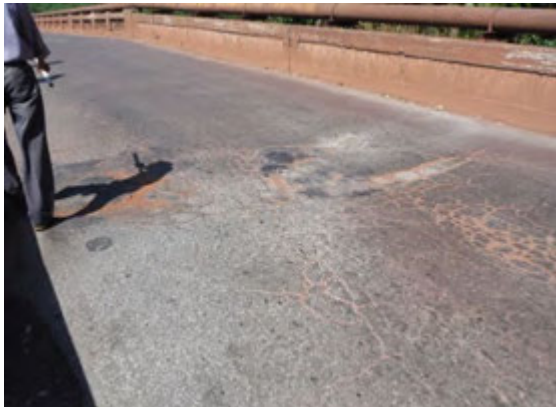
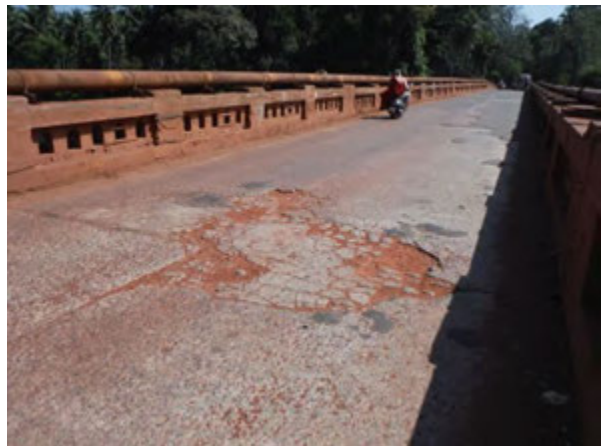
Object Member	Pavement
Kind of Damage	Cracking
Sketch or Photo

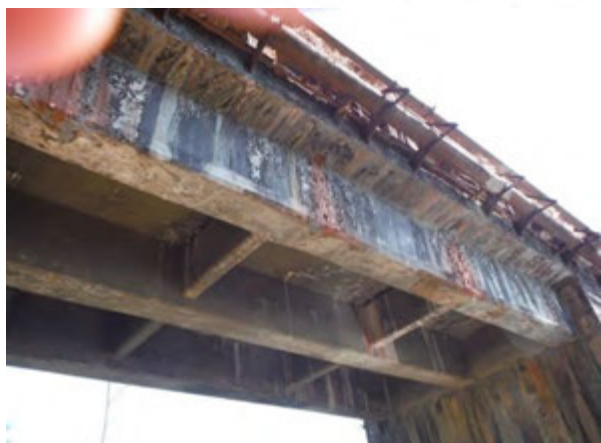
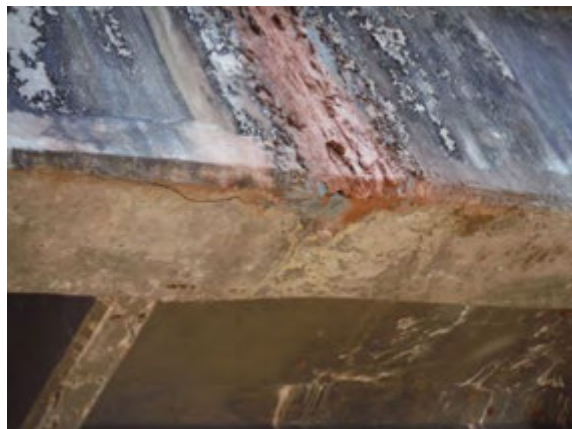
Member	Kind of the Damage
	Ex. Concrete : Cracking, Spalling, etc. Steel : Cracking, Rusting, Fracture, etc.
1. Superstructure	
(1) Concrete Member	
- Girder	Cracking on lower flange (P1P2)
- Cross Beam	Nil
- Slab	Nil
(2) Steel Member	
- Girder	N/A
- Vertical Girder (stringer)	N/A
- Cross Beam	N/A
- Sway Bracing	N/A
(3) Bearing Shoe	Nil
(4) EXP Joint	Nil
(5) Handrail	Nil
(6) Kerb	N/A
(7) Drainage Pipe	Filling
(8) Others	
2. Substructure	
- Pier	Nil
- Abutment	Nil
- Wing Wall	Nil
3. Miscellaneous	
- Approach Road Condition	Nil
- Obstruction	Nil
- Scouring	Nil
4. Evaluation	See Sheet 8

Object Member	RC T Girder (P1P2)
Kind of Damage	Cracking
Sketch or Photo

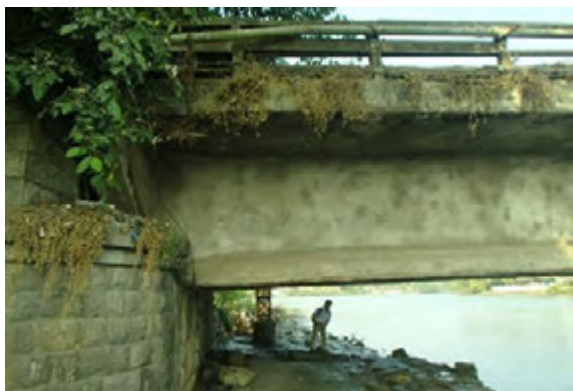
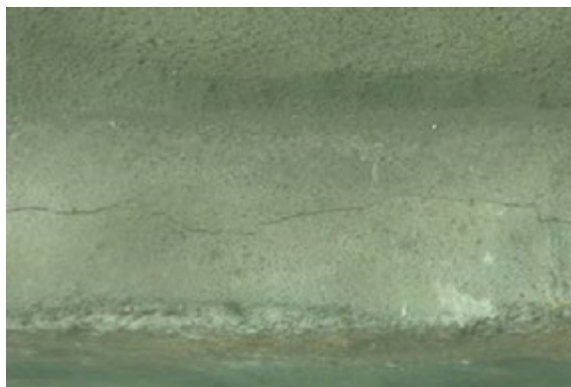
Object Member	Girder (A1-P1)
Kind of Damage	Cracks on web
Sketch or Photo

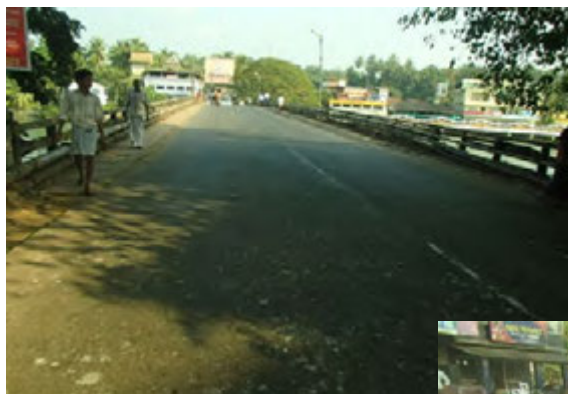
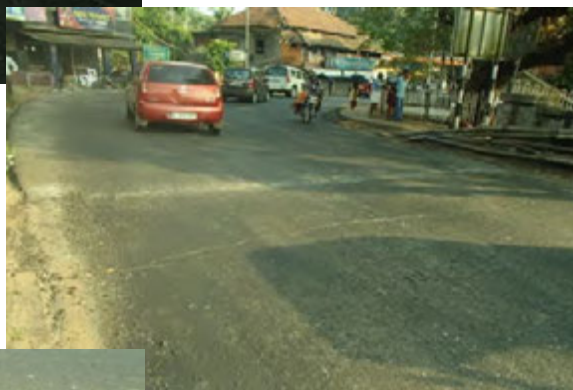
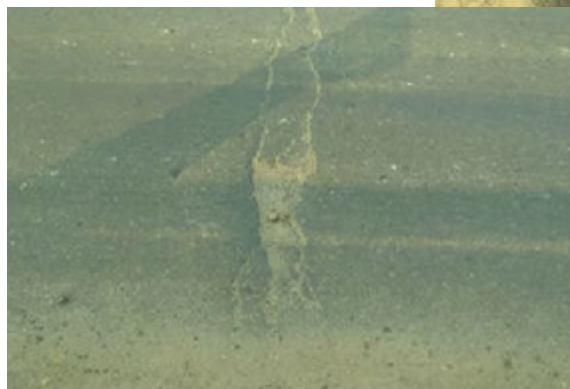
Object Member	All EXP joints
Kind of Damage	EXP joints are plugged with asphalt or bituminous material
Sketch or Photo

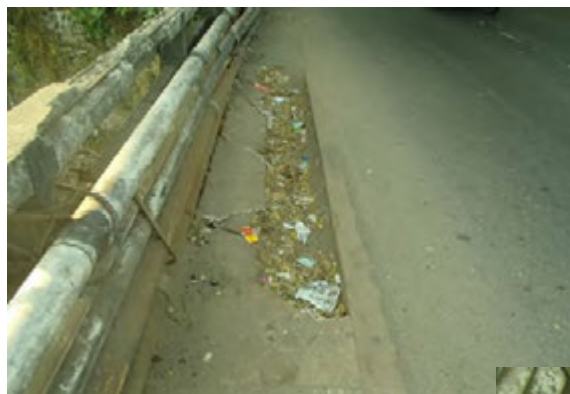
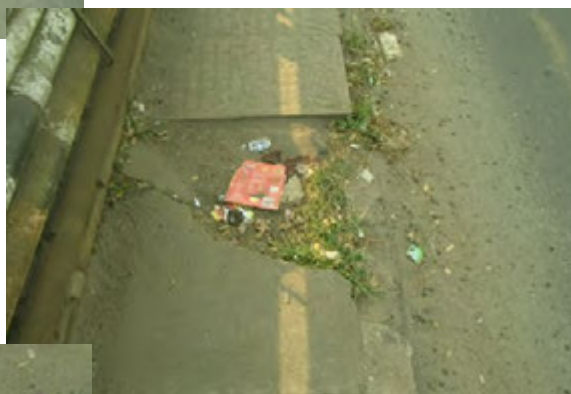
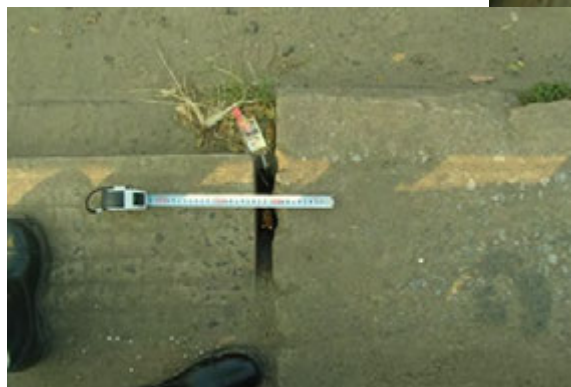
Object Member	Footpath
Kind of Damage	Kerb stone and footpath broken
Sketch or Photo

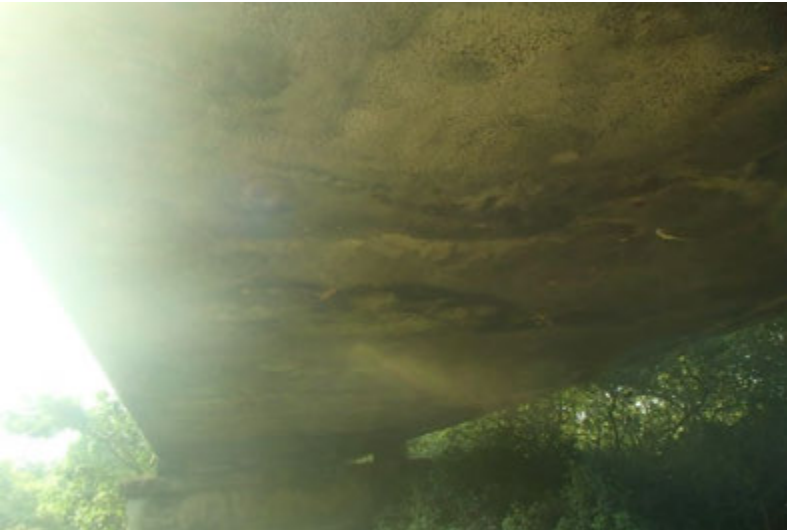
Object Member	Deck Slab (P3-P4)
Kind of Damage	Some cracks and efflorescences are observed in the bottom of the deck slab
Sketch or Photo	<div style="text-align: center; margin-bottom: 10px;">

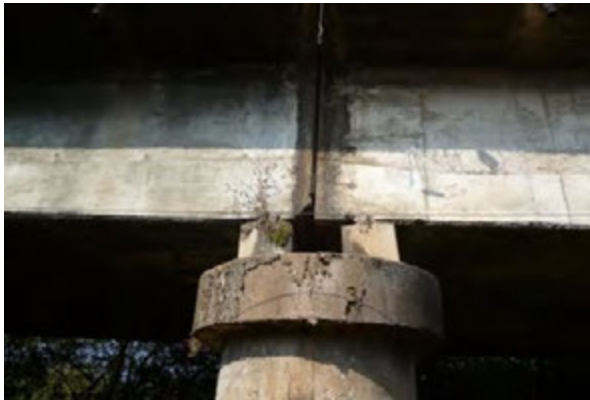
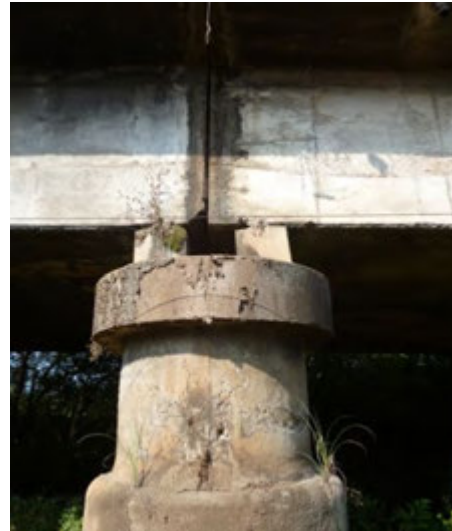
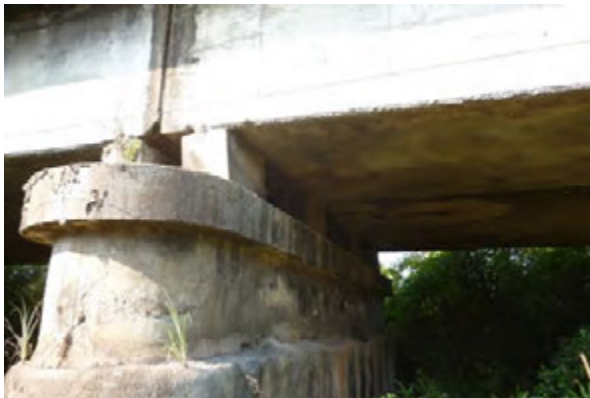
Object Member	Bearing Shoe (P3 upstream side)
Kind of Damage	Inclination
Sketch or Photo

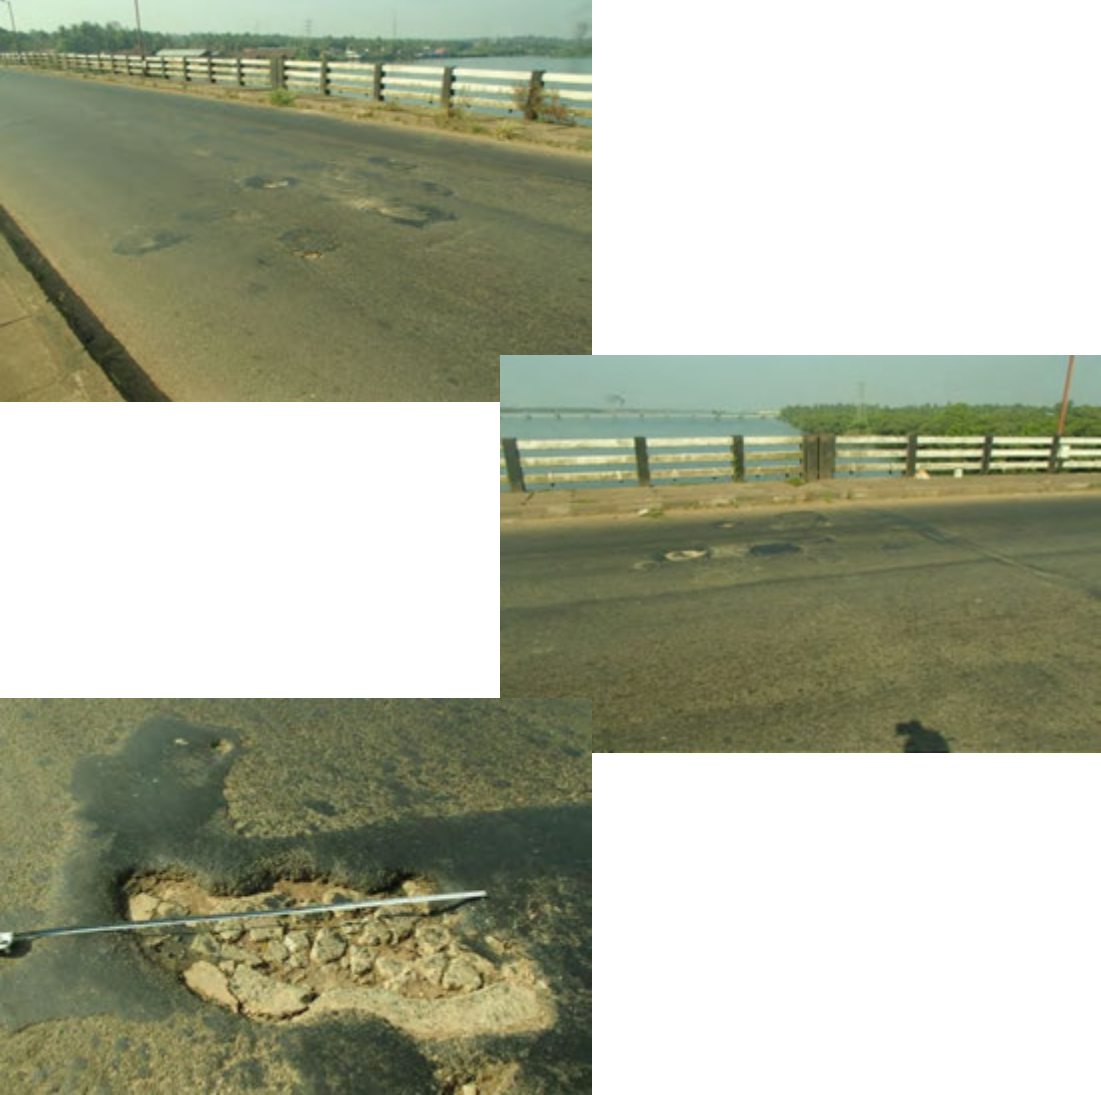
Object Member	Pavement
Kind of Damage	Mamy potholes
Sketch or Photo

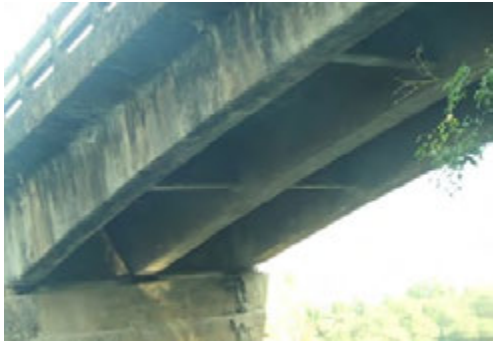
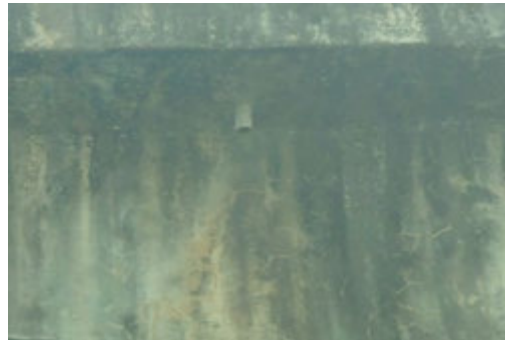
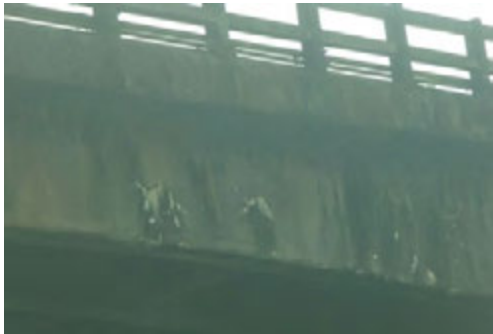
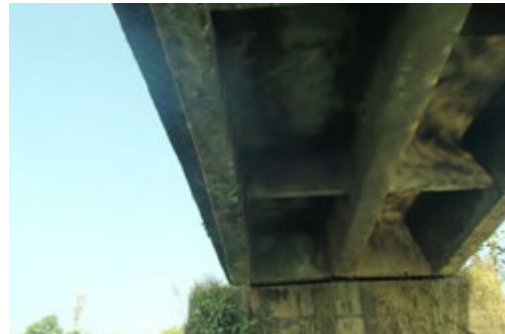
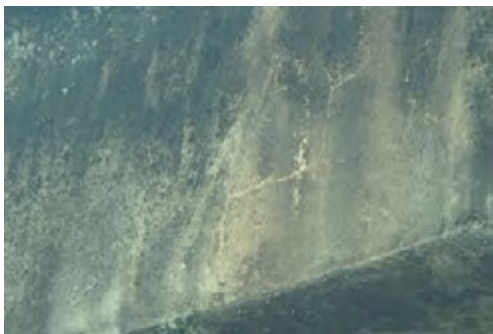
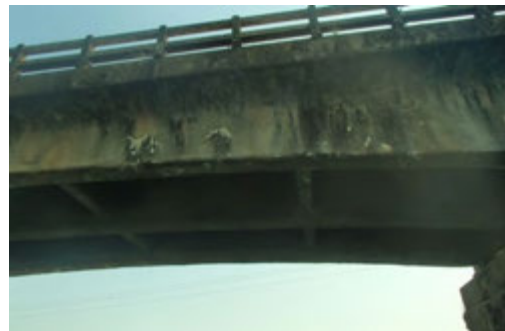
Member	Kind of the Damage
	Ex. Concrete : Cracking, Spalling, etc. Steel : Cracking, Rusting, Fracture, etc.
1. Superstructure	
(1) Concrete Member	
- Girder	There are some cracks and efflorescence on web.

Object Member	Girder (all spans)
Kind of Damage	Many cracks and efflorescence are observed on the girder web.
Sketch or Photo

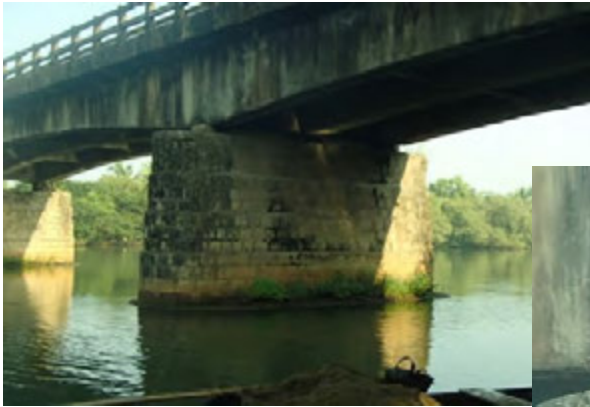
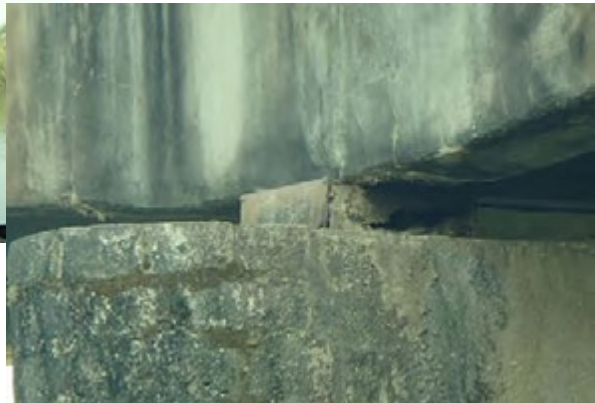
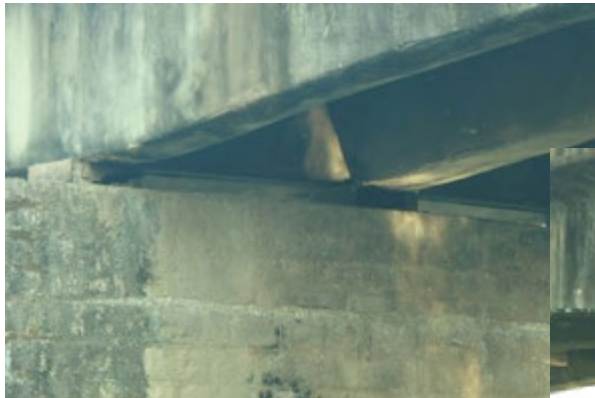
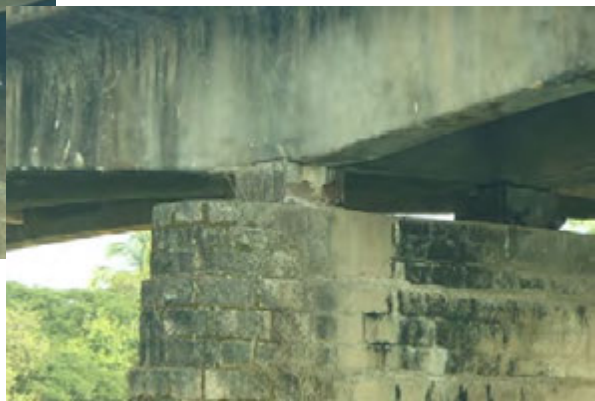
- Cross Beam	N/A
- Sway Bracing	N/A
(3) Bearing Shoe	Void in bearing block of P6
(4) EXP Joint	All covered by asphalt and not functioning properly. Some cracks.

Object Member	Bearing Block (P6)
Kind of Damage	Void in bearing block
Sketch or Photo

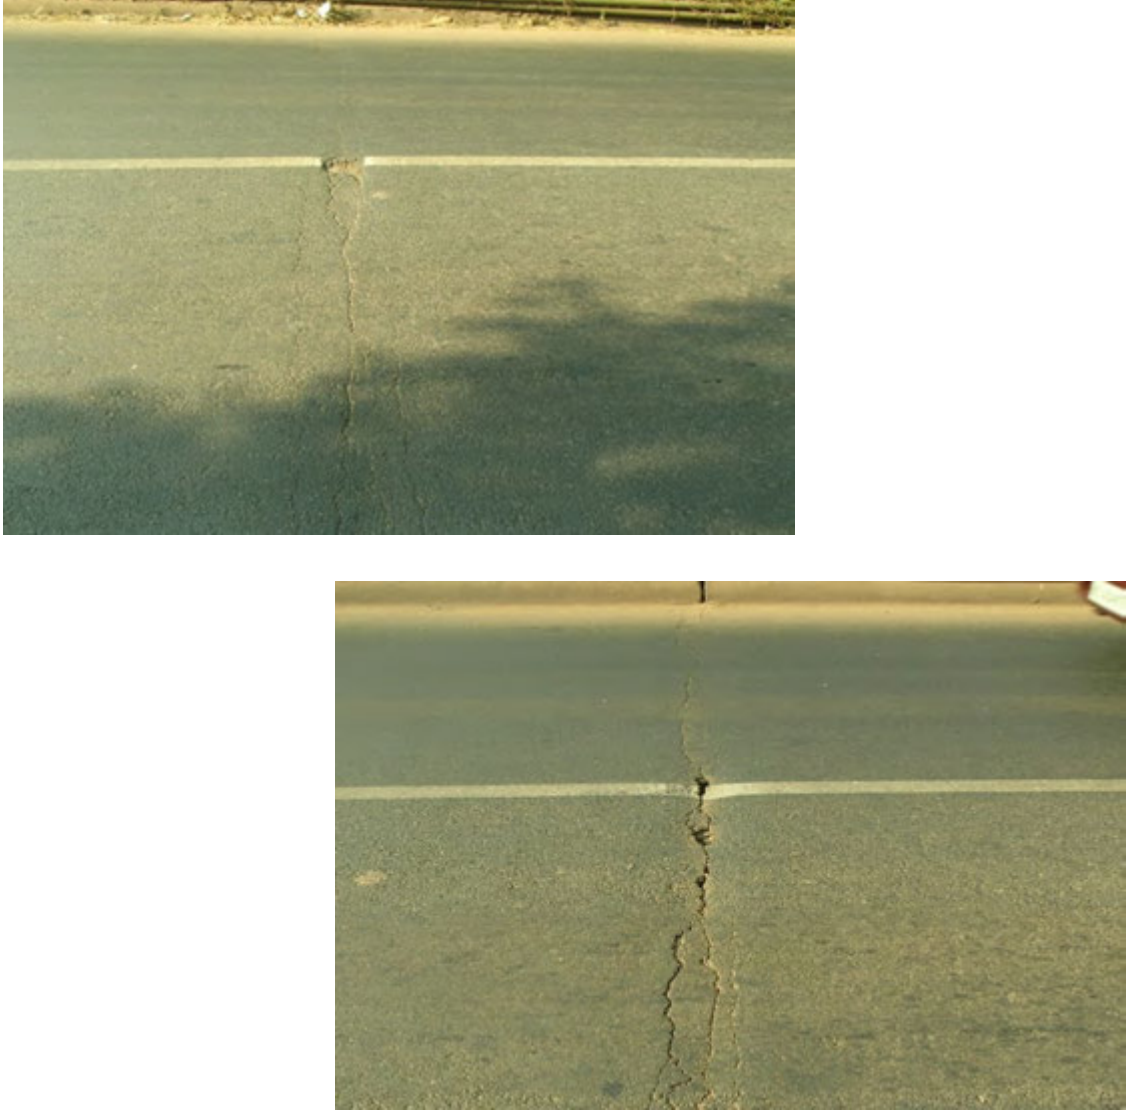
Object Member	EXP Joints
Kind of Damage	EXP Joints are plugged and non functional
Sketch or Photo

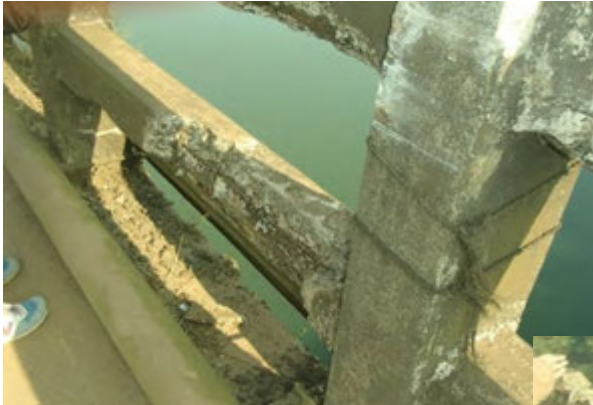
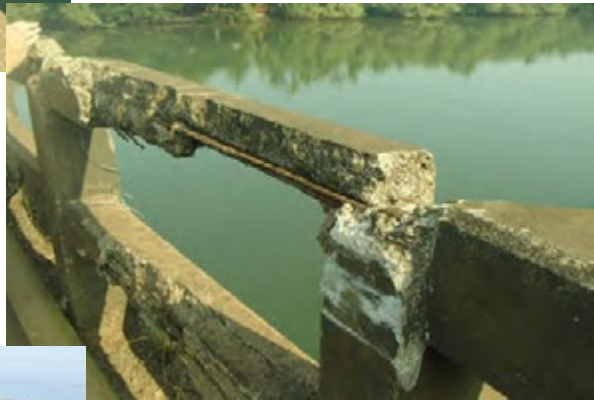
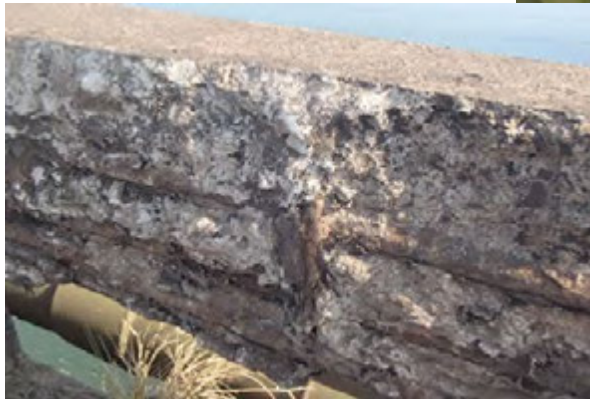
(5) Handrail	CC peeling and corroded re-bar exposed
(6) Kerb	Nil
(7) Drainage Pipe	Nil
(8) Others	It is assumed that there are many damages on superstructure although cracks were covered by guniting work and it is difficult to observe them.

Object Member	Handrail
Kind of Damage	CC peeling and corroded re-bar exposed
Sketch or Photo

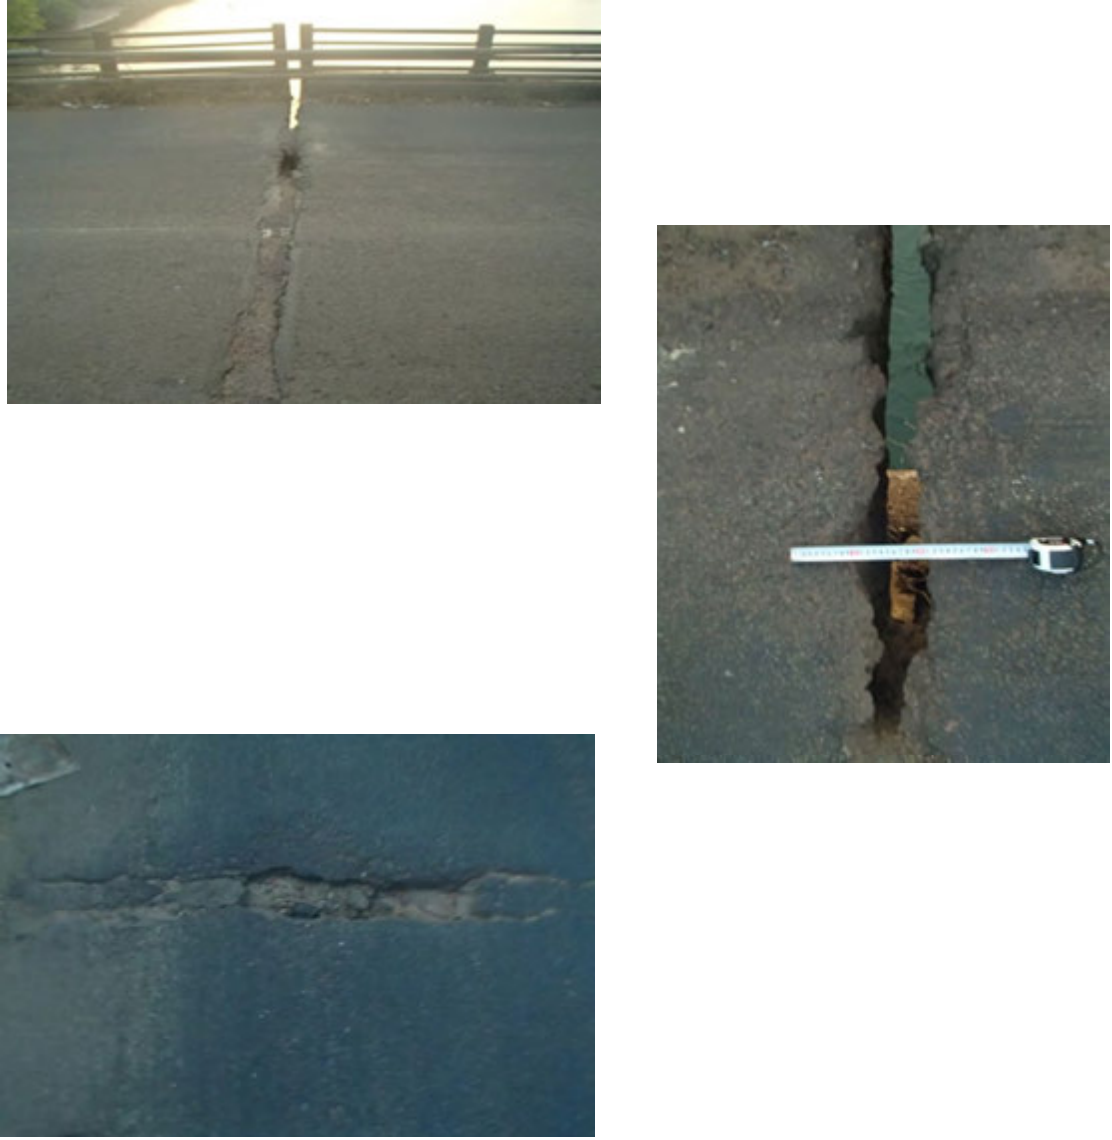
Object Member	EXP joints
Kind of Damage	Uneven gap, not functioning properly
Sketch or Photo

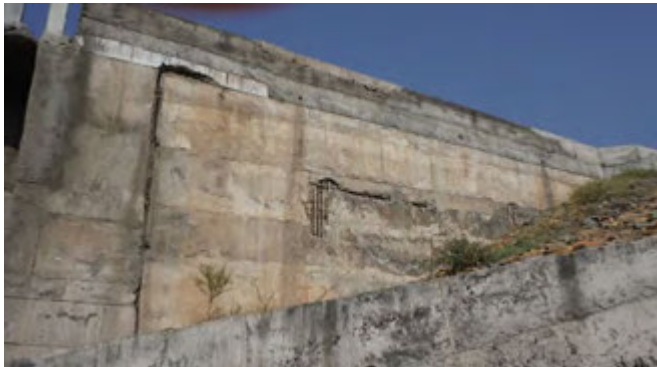
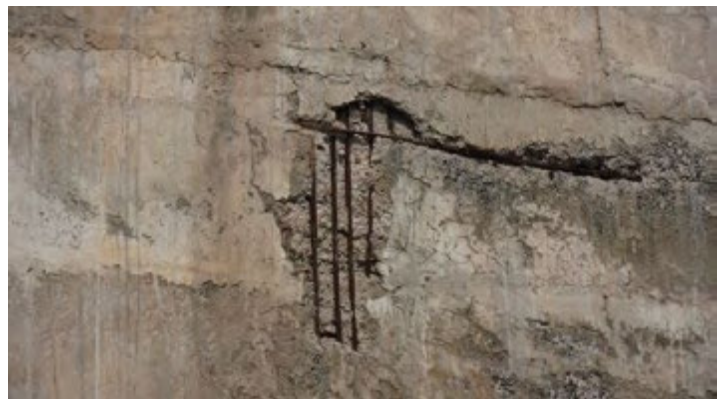
Object Member	Wing Wall (A1)
Kind of Damage	Spalling
Sketch or Photo

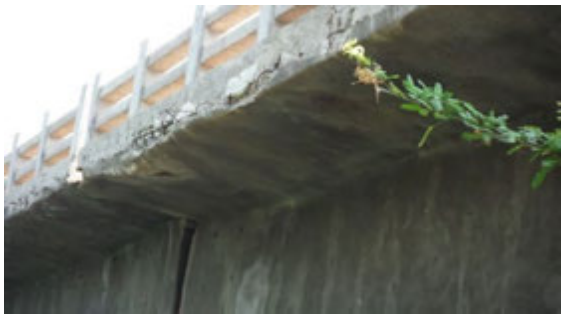
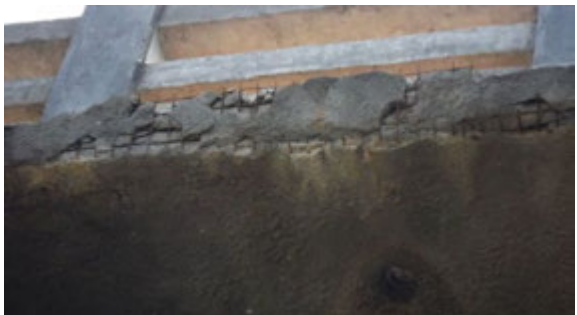
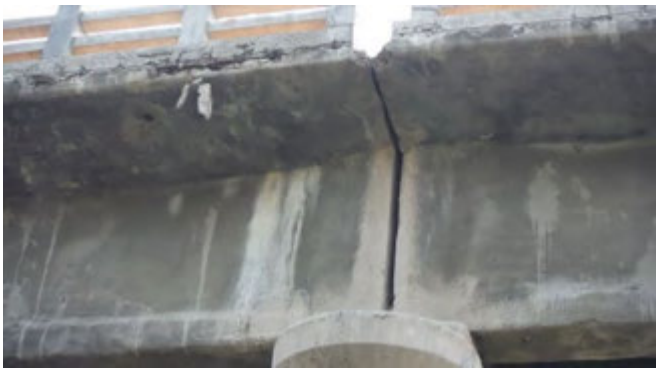
Object Member	RC T Girder
Kind of Damage	Spaliing
Sketch or Photo	<div style="text-align: center; margin-bottom: 10px;"> <p>↓ RIVER FLOW</p>

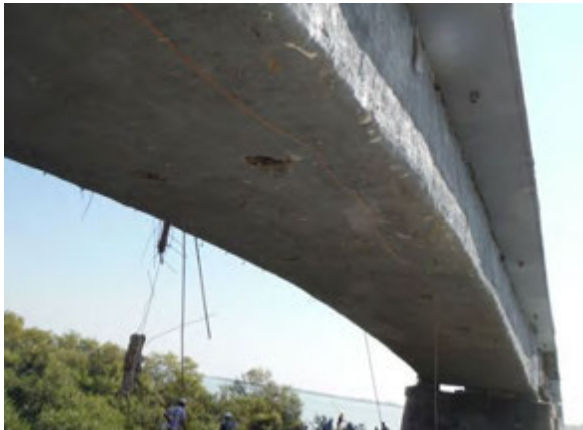
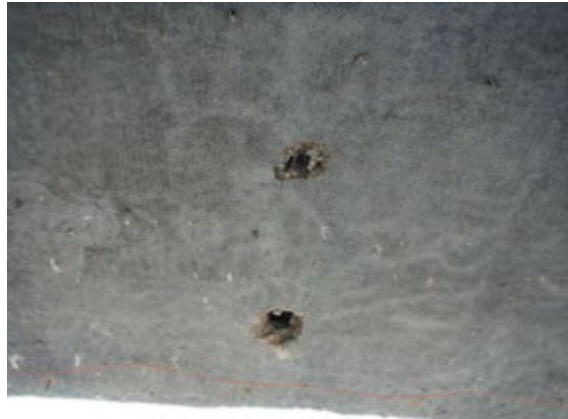
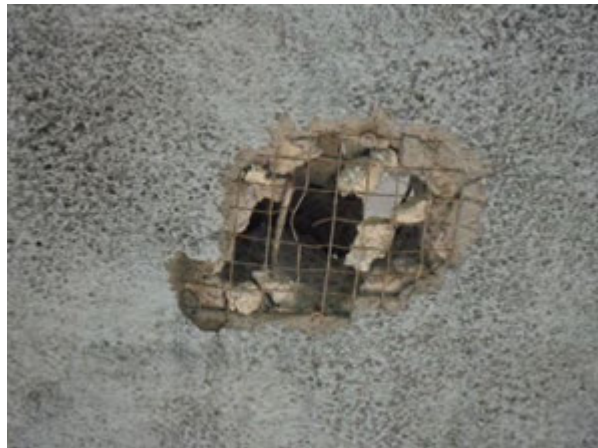
Object Member	RC Box Girder
Kind of Damage	Spalling
Sketch or Photo

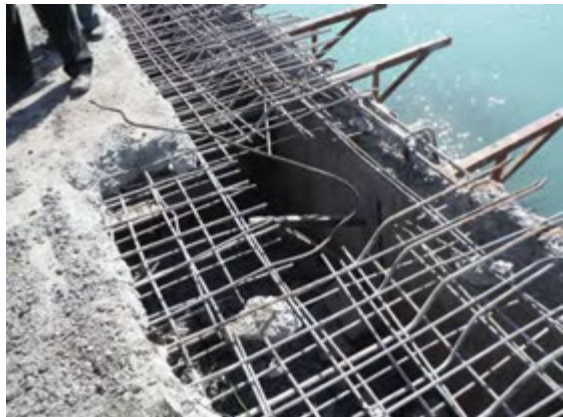
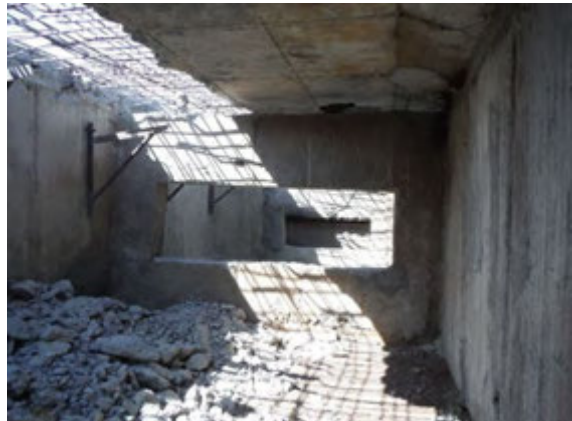
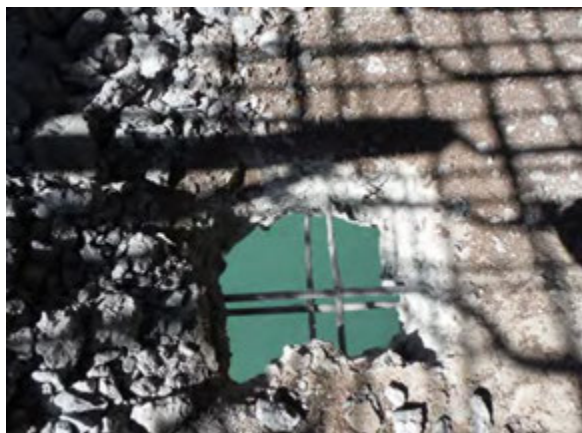
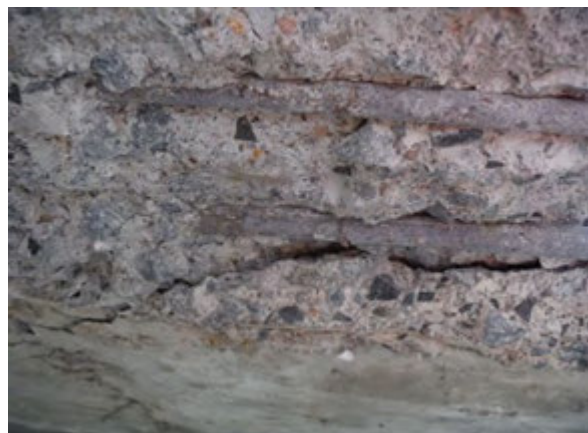
Object Member	RC Box Girder
Kind of Damage	Under Repairing
Sketch or Photo
