APPENDIX

Bridge Survey Record by Visual Inspection

Bridge No.	1	Location (State)	Assam
Bridge Name	Jia-Bharali Bridge	Road Name	NH 15 (old NH 52)
Station	Km166	Road Category	National Highway
GPS Data	N 26 ° 48 ' 36.0 "	Management Authority	State PWD
	E 092 ° 52 ' 23.6 "	Year of Construction	1962

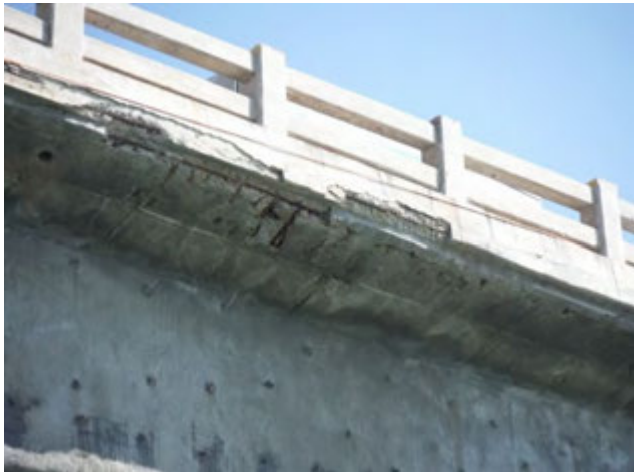
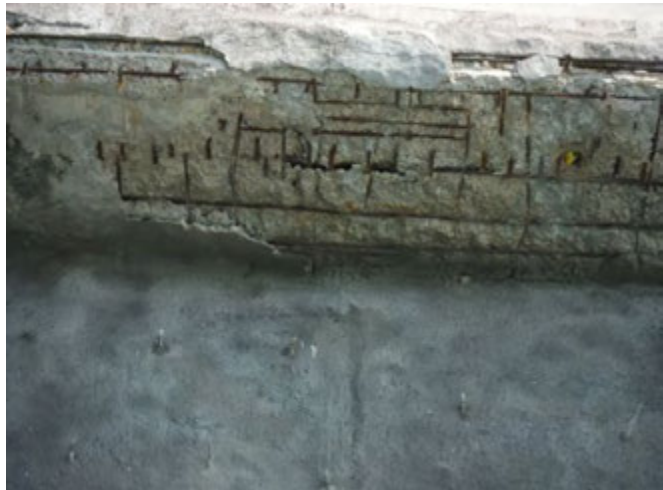
Object Member	RC Box Girder
Kind of Damage	Spalling
Sketch or Photo

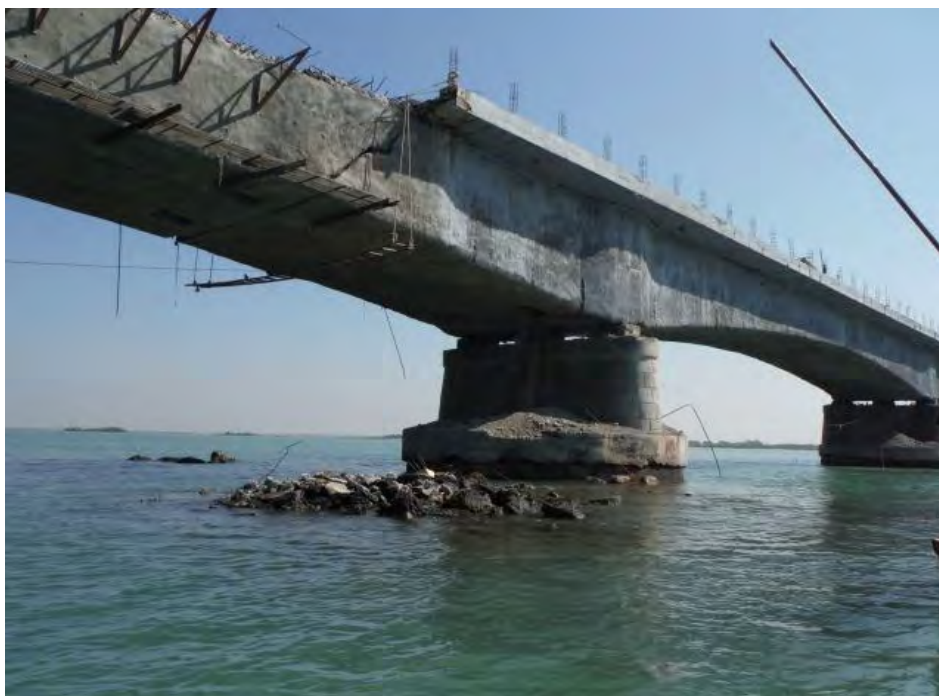
Object Member	RC Box Girder
Kind of Damage	Under Repairing
Sketch or Photo

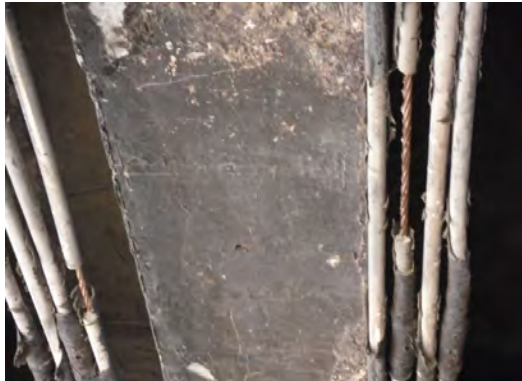
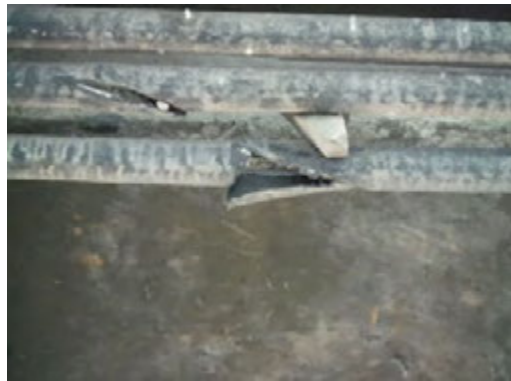
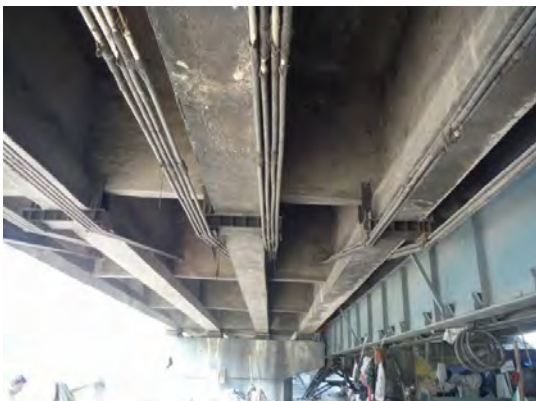
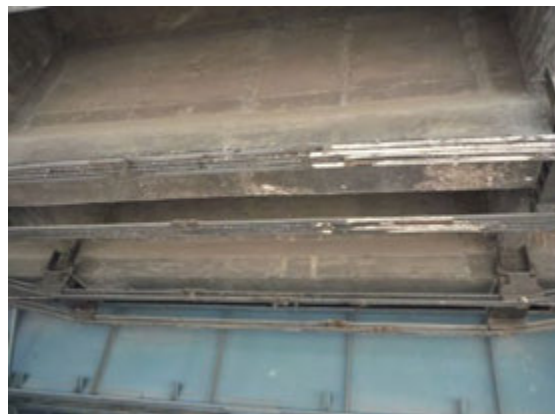
Object Member	Girder outcable (P1P2)
Kind of Damage	Boroken
Sketch or Photo

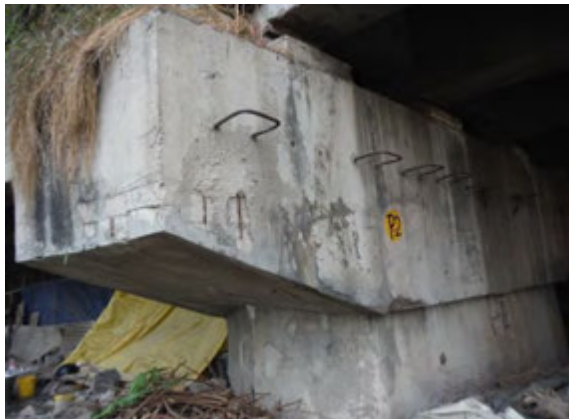
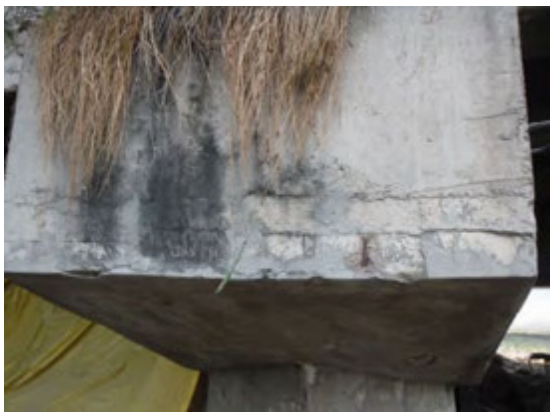
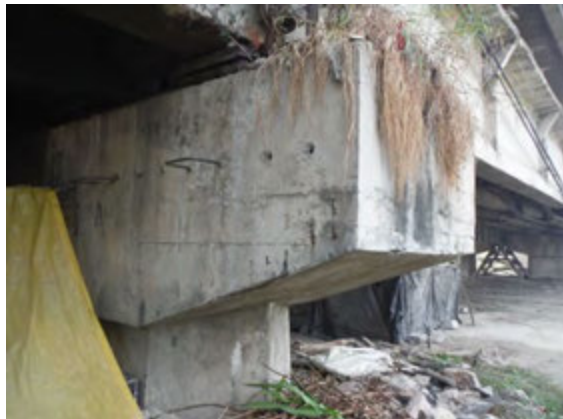
Object Member	RC Substructure (P2)
Kind of Damage	Spalling
Sketch or Photo

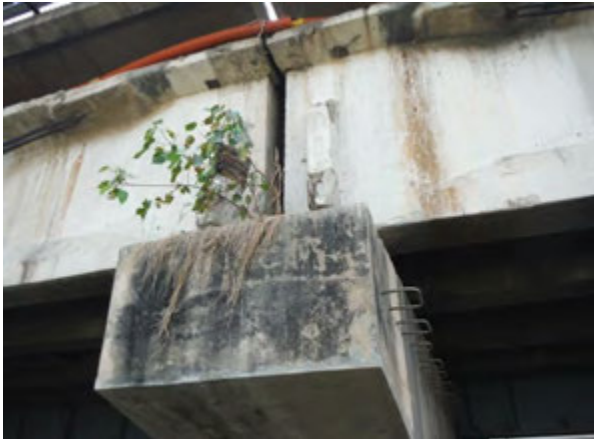
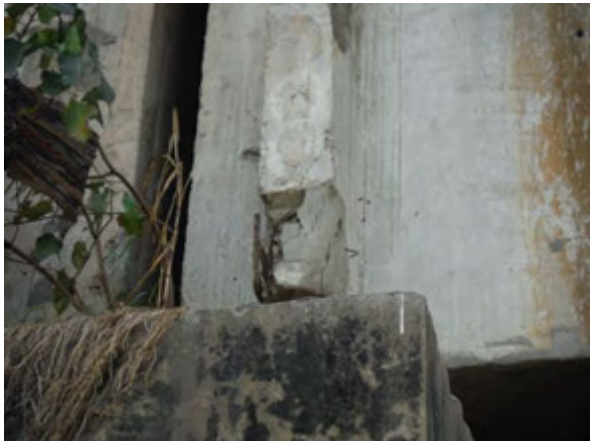
Object Member	PC T Girder (P3)
Kind of Damage	Spalling
Sketch or Photo

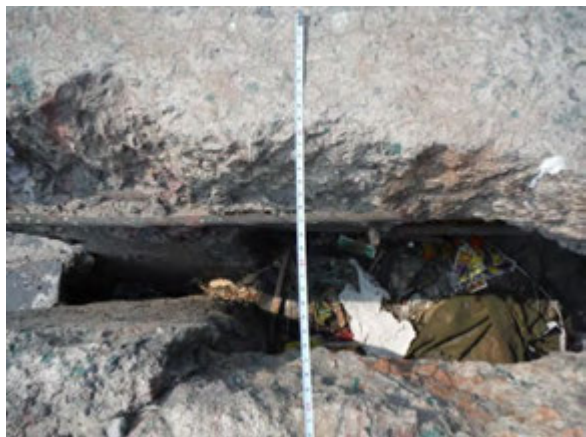
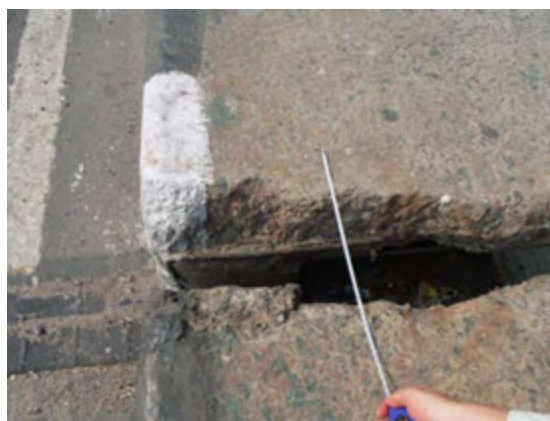
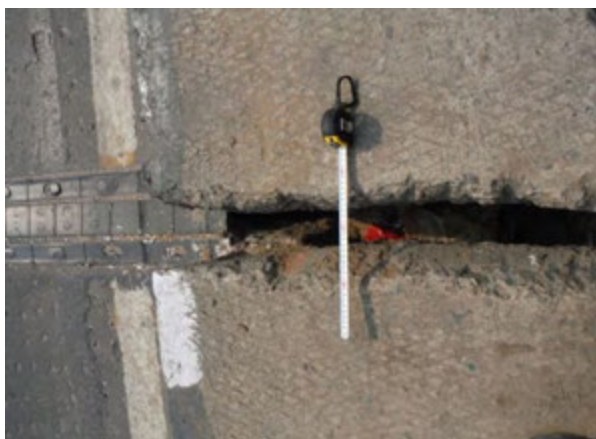
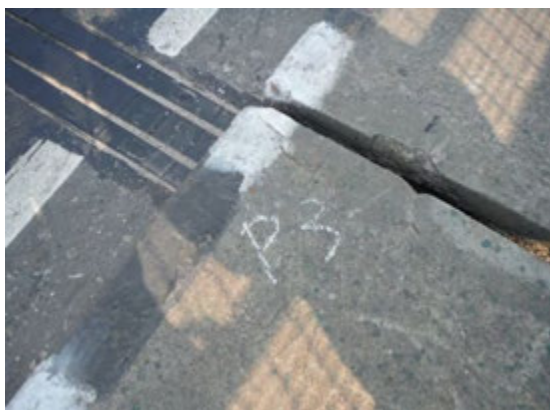
Object Member	All Joint
Kind of Damage	Clogging & Gap
Sketch or Photo

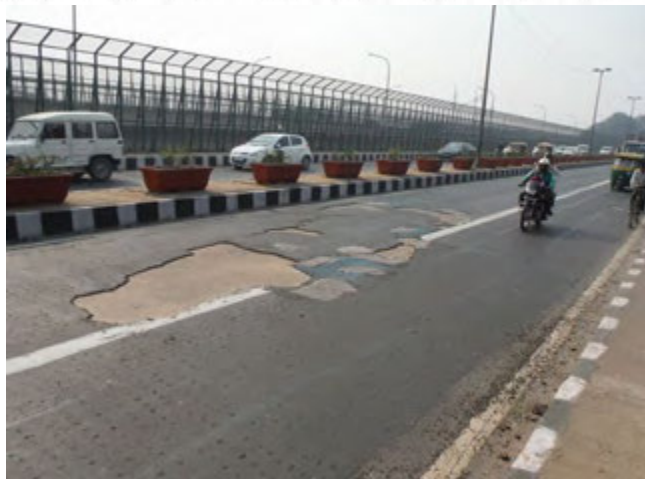
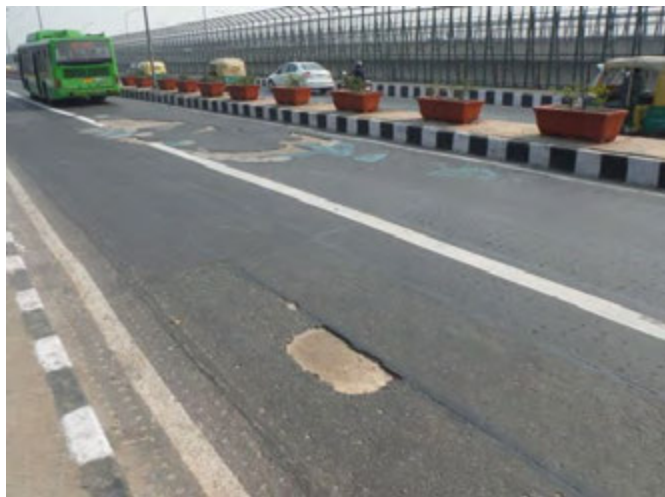
Object Member	Pavement (P8P9)
Kind of Damage	Peeling
Sketch or Photo

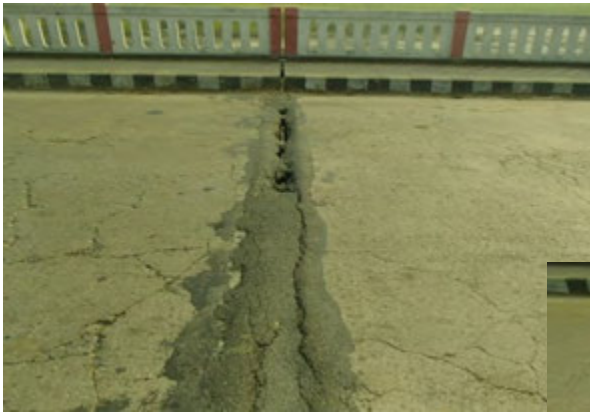
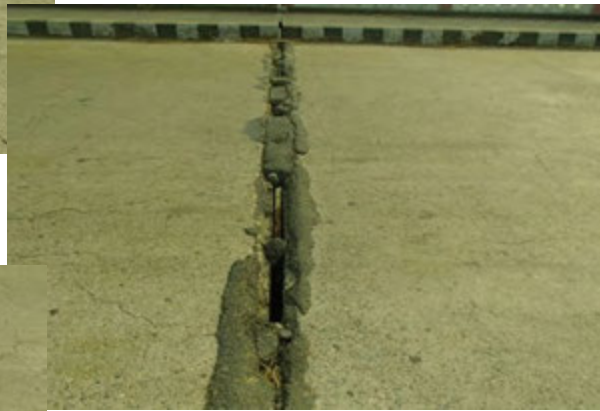
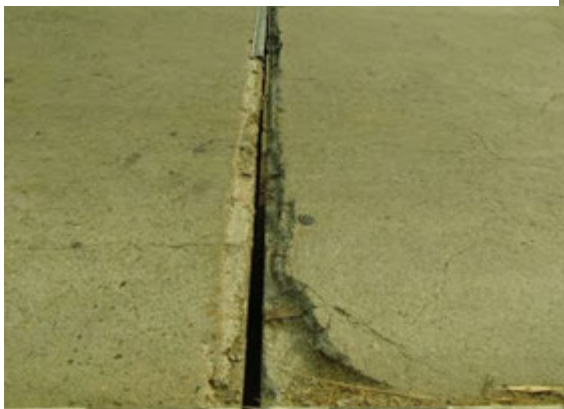
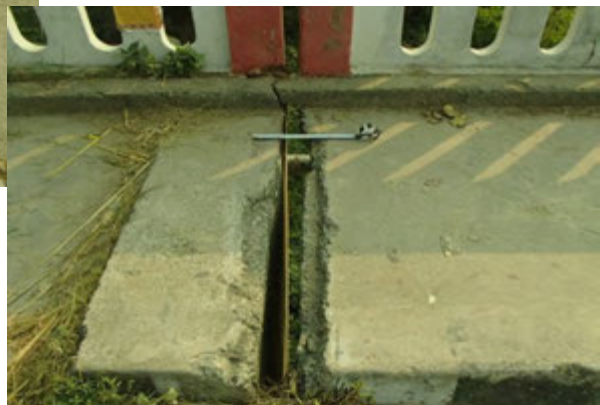
Object Member	All EXP joint
Kind of Damage	Uneven gap, broken and/or peeling
Sketch or Photo

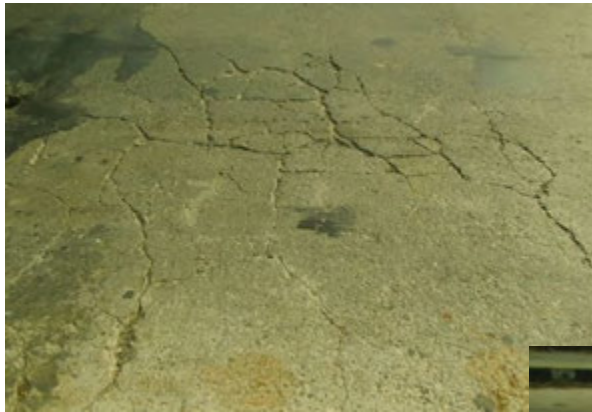
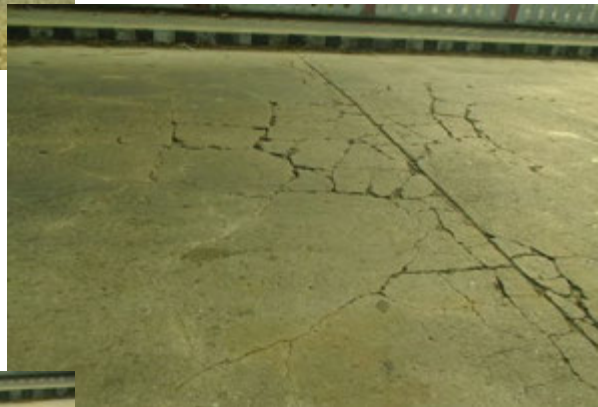
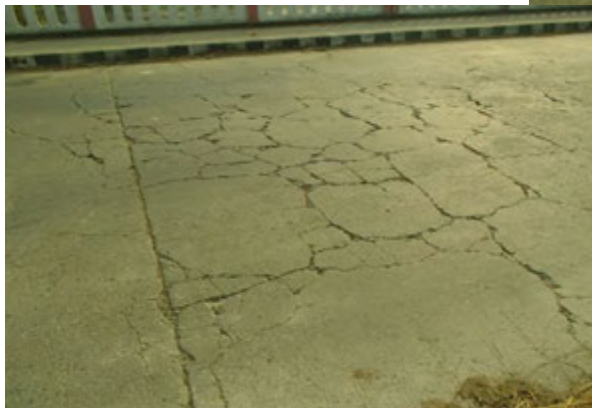
Object Member	Pavement (all portions)
Kind of Damage	Many cracks on concrete pavement
Sketch or Photo

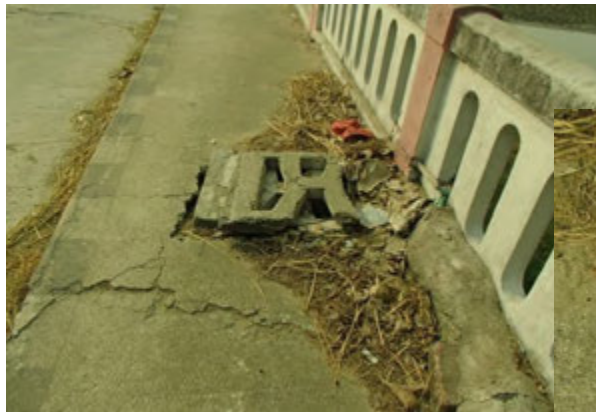
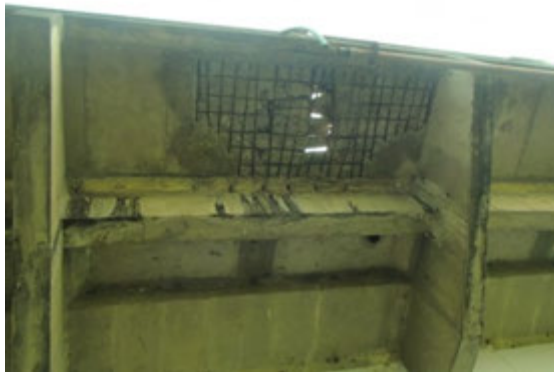
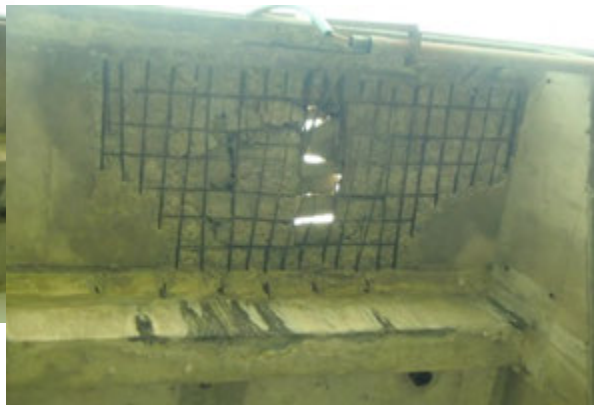
Object Member	Footway slab (P10-A2)
Kind of Damage	Falling out of footway slab
Sketch or Photo

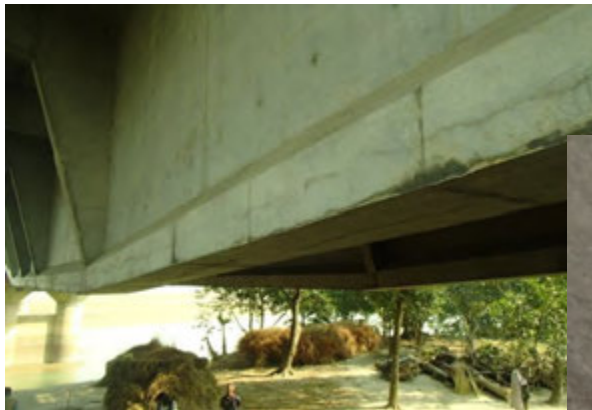
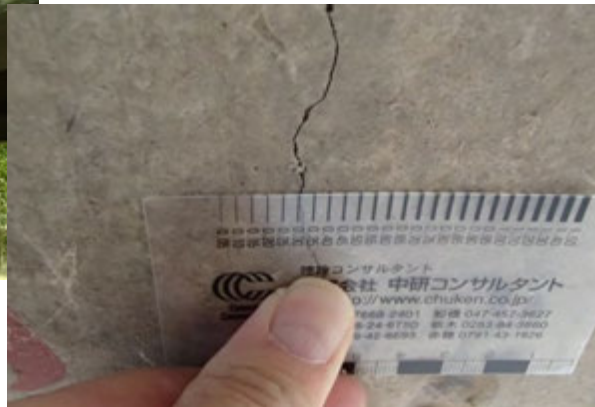
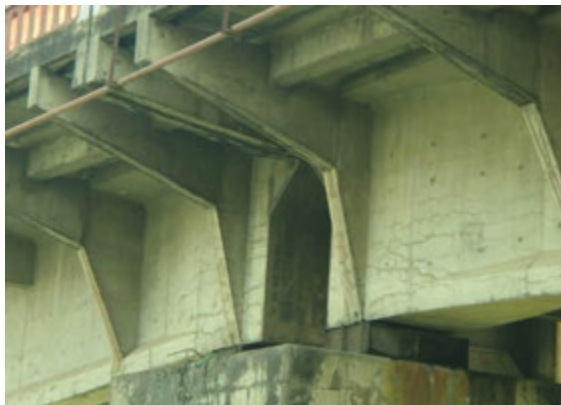
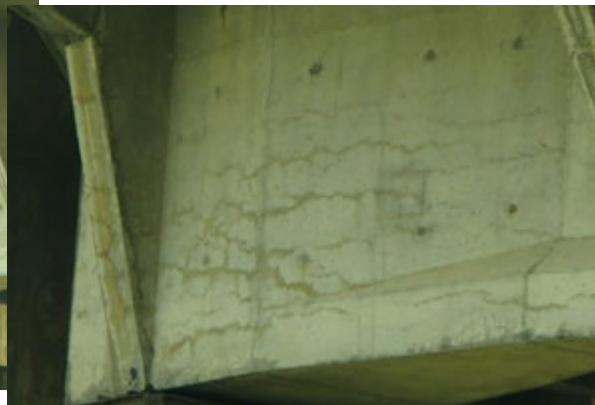
Object Member	Girder end
Kind of Damage	Small cracks on web. Some of them were already repaired in 1986
Sketch or Photo

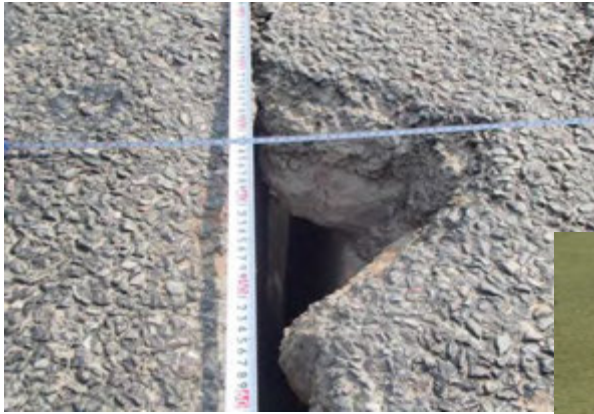
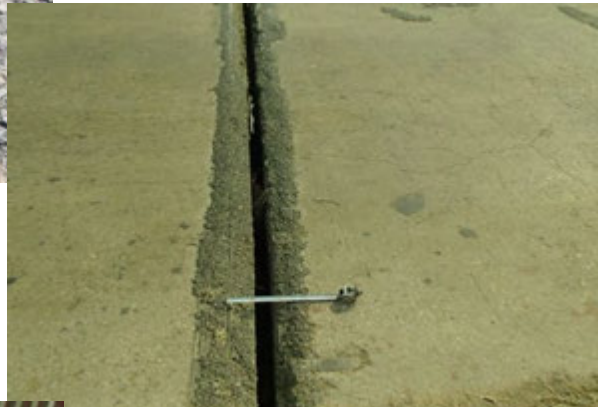
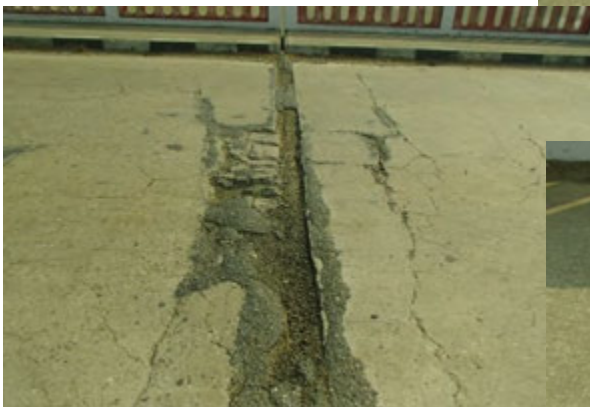
Object Member	All EXP joint
Kind of Damage	Uneven gap, broken and/or peeling
Sketch or Photo

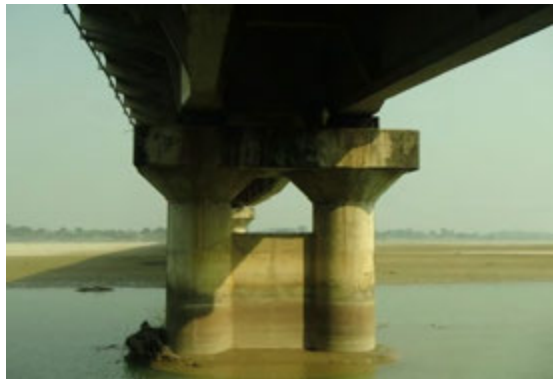
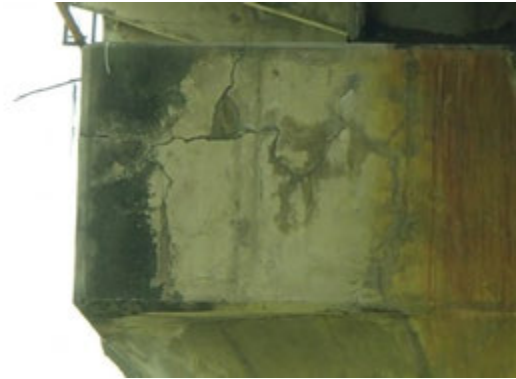
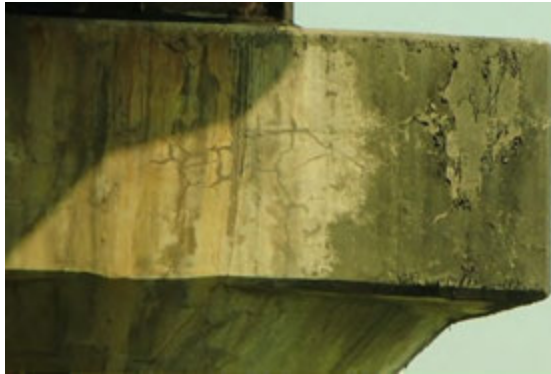
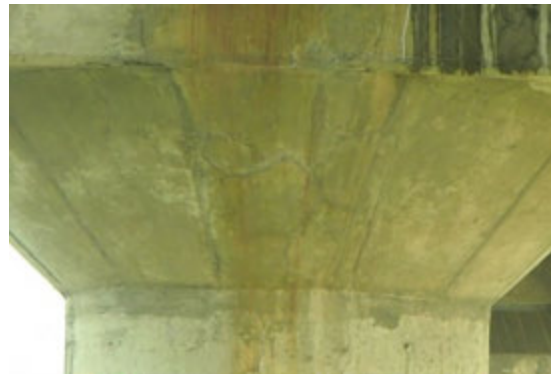
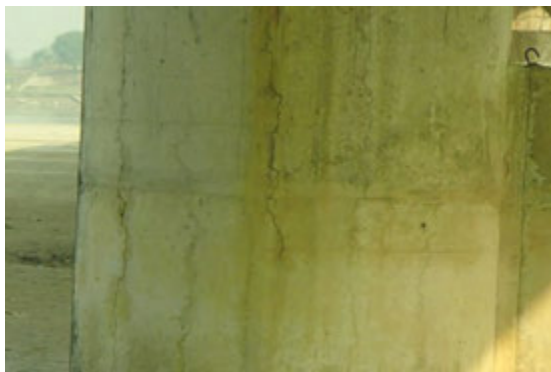
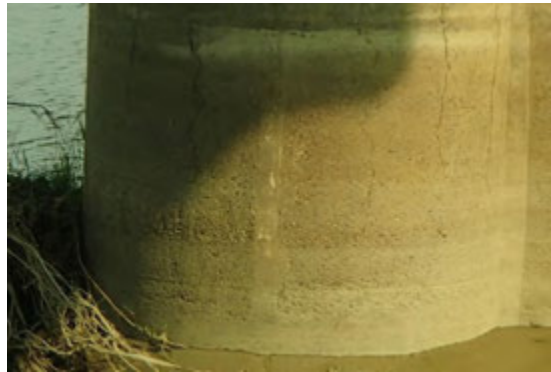
Object Member	All Piers
Kind of Damage	Cracks on pier cap and column
Sketch or Photo

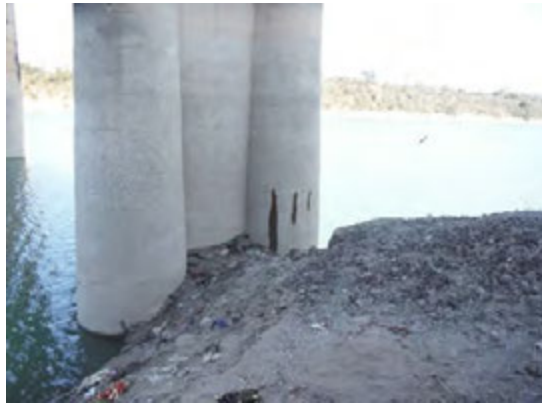
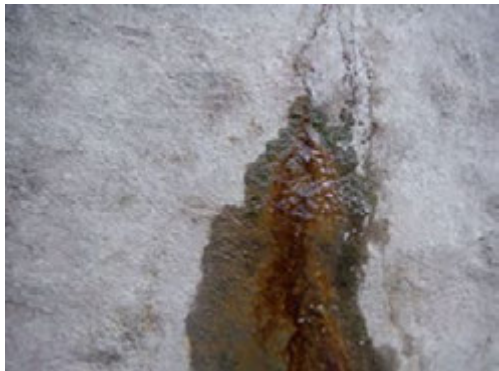
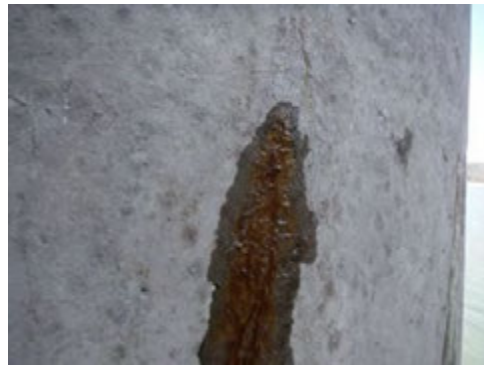
Object Member	P2
Kind of Damage	Leaking of water
Sketch or Photo

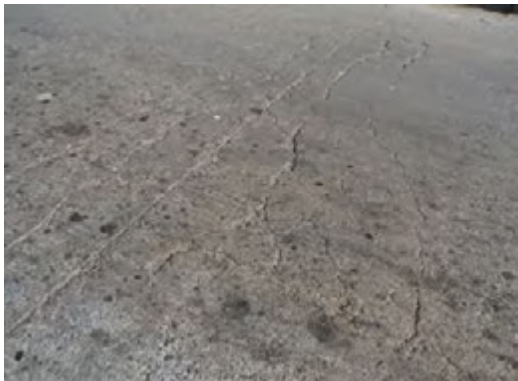
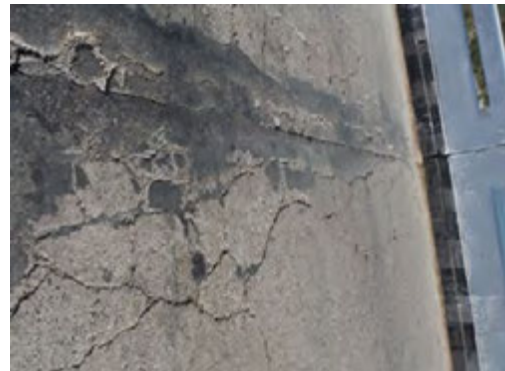
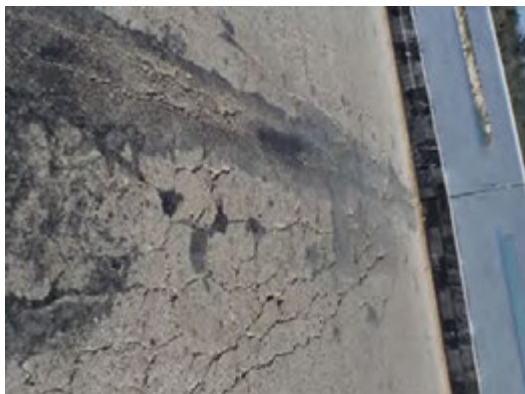
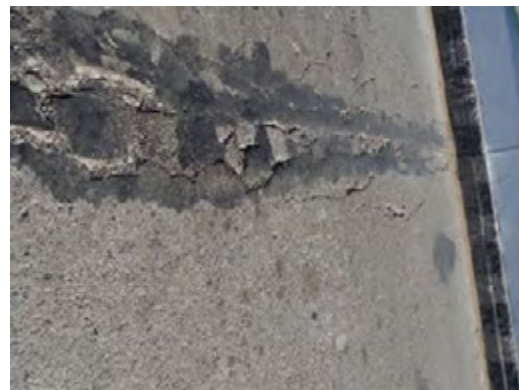
Object Member	Pavement
Kind of Damage	Cracking
Sketch or Photo

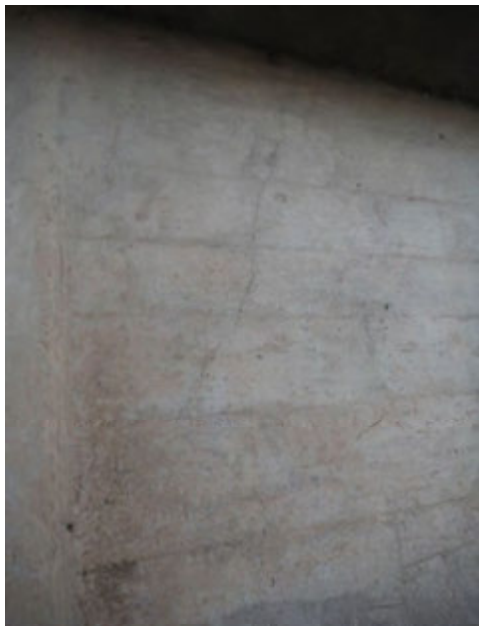
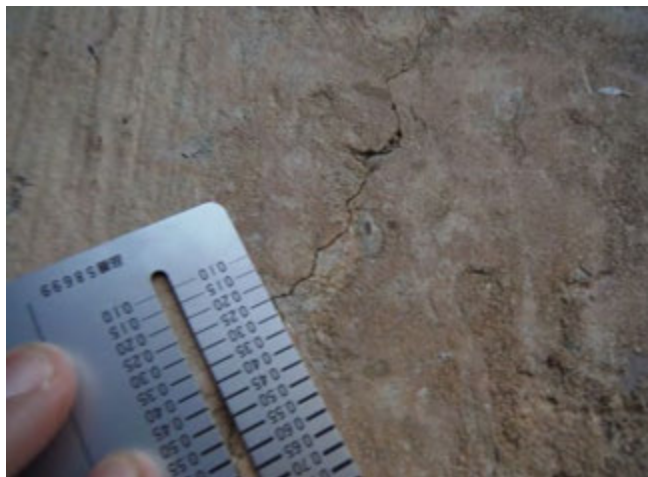
Object Member	PC T Girder (A1P1)
Kind of Damage	Cracking on web
Sketch or Photo

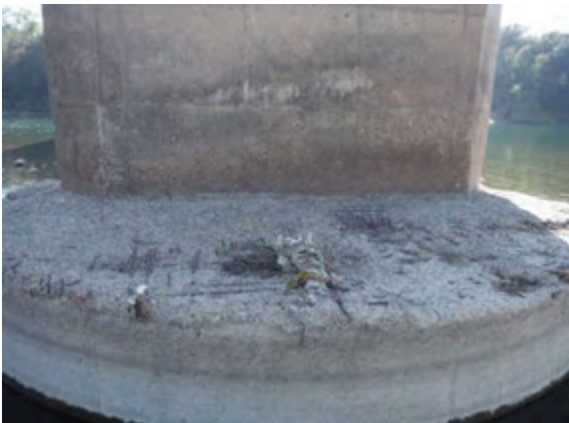
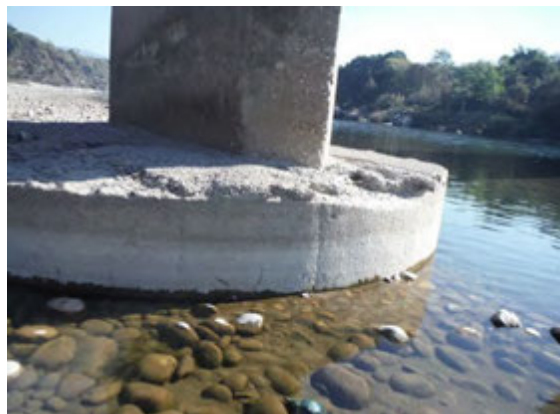
Object Member	P2
Kind of Damage	Scouring
Sketch or Photo

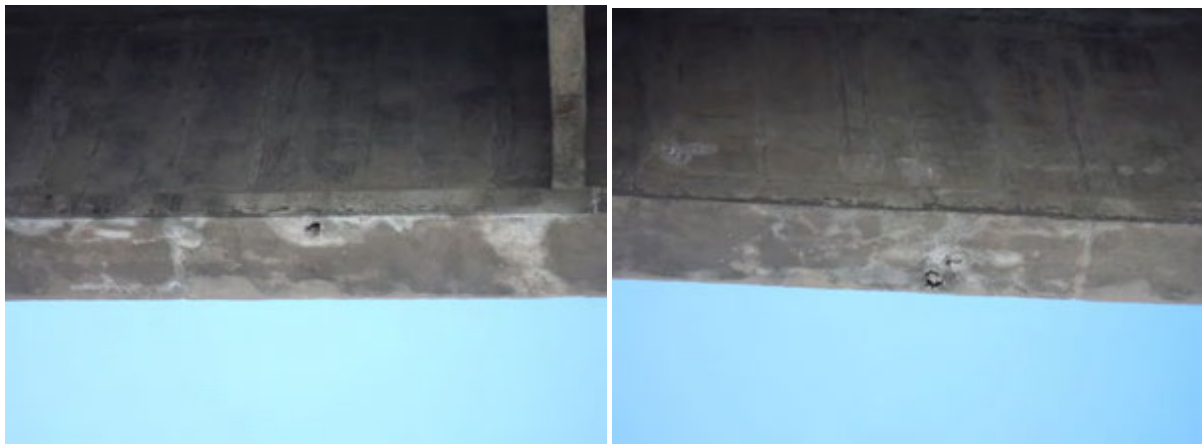
Object Member	PC T Girder (P1P2)
Kind of Damage	Honeycomb
Sketch or Photo

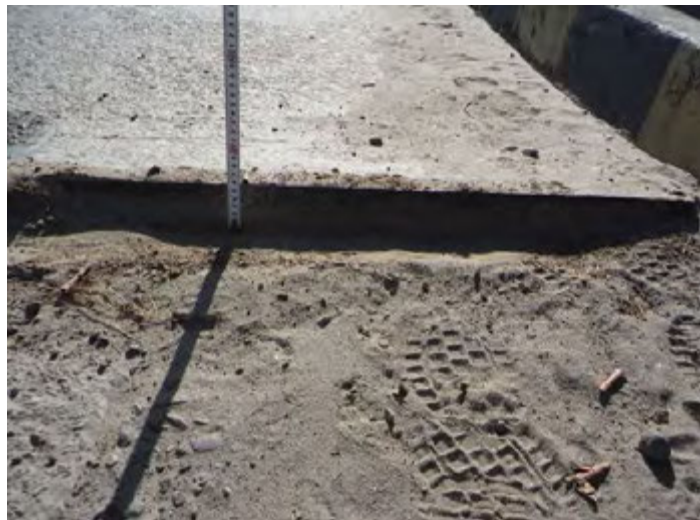
Object Member	Joint of Pavement (P6)
Kind of Damage	Level difference
Sketch or Photo

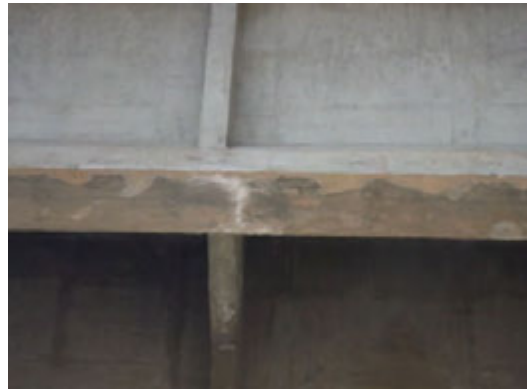
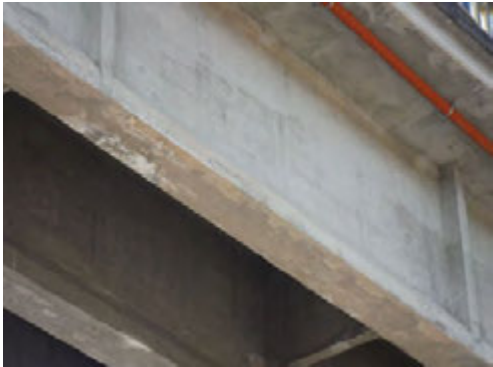
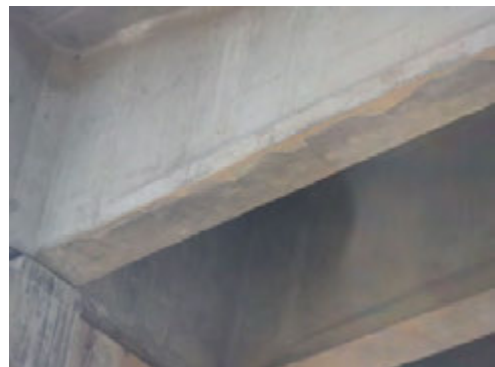
Object Member	PC T Girder (P5P6)
Kind of Damage	Efflorescence
Sketch or Photo
