Inspection and Evaluation of Port Facilities

<i>No.17</i>	<i>Name of Jetty</i>	Kaingdan No.1			
<i>Dimension</i>	Pontoon: Length 120' x Width 20' (before Nargis)		<i>Date of Inspection</i>	9 Dec,2014	
Result of Inspection and Evaluation of Port Facilities					
<i>Facility</i>	<i>General Evaluation</i>	<i>Condition of Damage And/or Deterioration</i>	<i>Measures to be taken</i>	<i>Change from Last survey in 2011</i>	<i>Reference Photo</i>
Pontoon	Good	No damage		No	Photo 2
Bridge	Fair	Timber deck is broken	Need to be repair bridge decking timber lost	No	Photo 1,4
Pier	Fair	N	N	No	Photo 1,6
Sponson	Good	No damage		No	Photo 2

APPENDIX B NAVIGATION SAFETY	B-3
B.1 On board Inspection Report of Navigation Safety of Yangon Port and Channels	B-3
B.1.1 Outline of the On Board Survey	B-3
B.1.2 Result of Inspection	B-3
B.1.3 Natural Condition	B-4
B.1.4 Current Condition of the Yangon Port and Channel.....	B-5
B.2 Evaluation for Navigation Aids	B-22
B.3 Comment for the Rating	B-23
B.4 Interview of Captain of M.S.T. Mhan Aung and Harbor Master	B-24
B.5 The Obstructions in Fairways Act Amending Law 1963	B-26

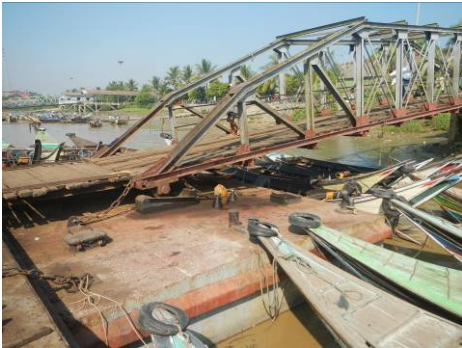
Photo 2 - Sponson

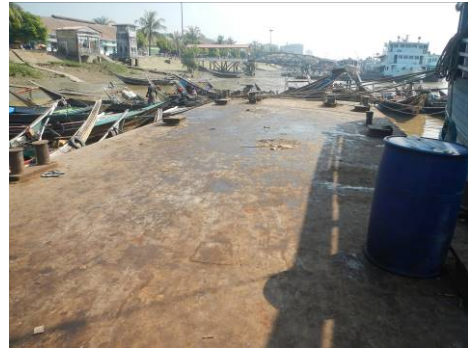
Photo 5- Pontoon

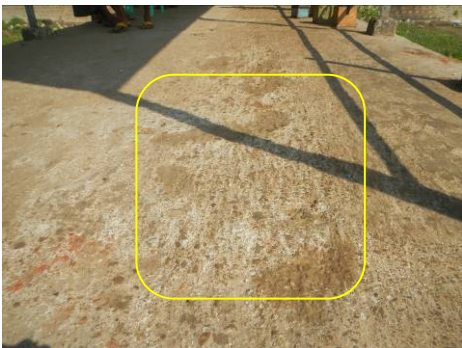
Photo 3 - Surface delaminated

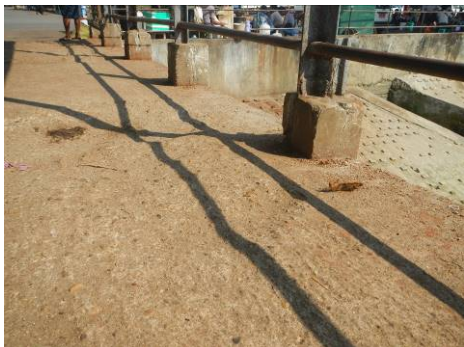
Photo 3 - Surface delaminated

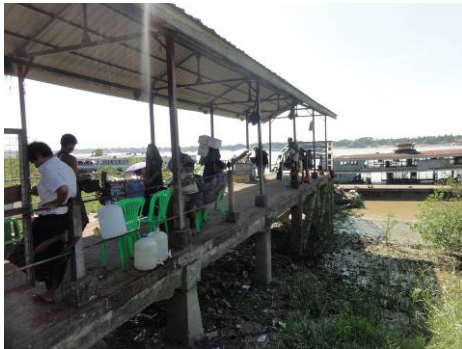
Photo 1 - General

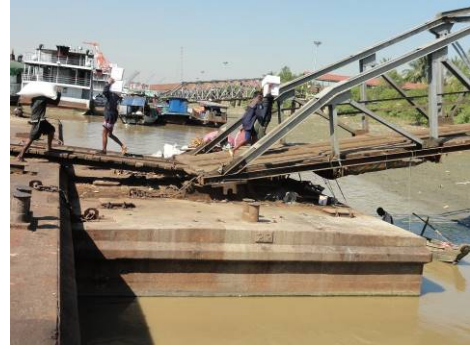
Photo 8 - Sponson

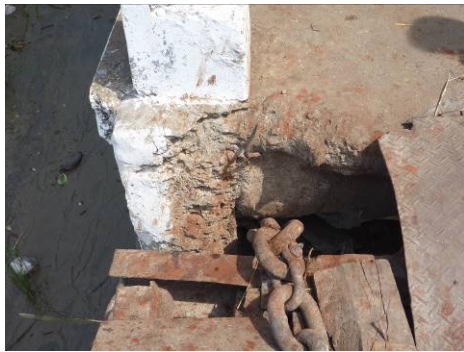
Photo 2 - Abutment

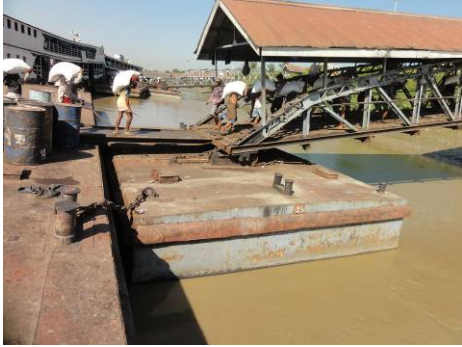
Photo 4 - Sponson

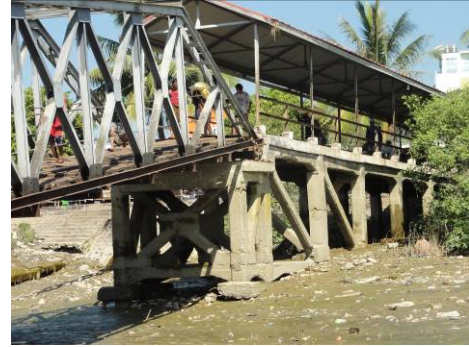
Photo 10 - Pier

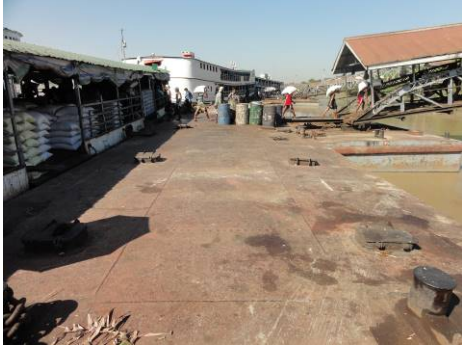
Photo 5 - Pontoon

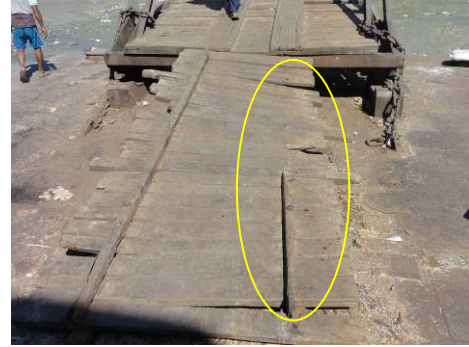
Photo 11 - Connection bridge

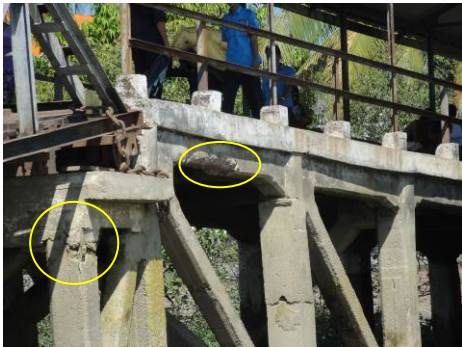
Photo 6 - Pier

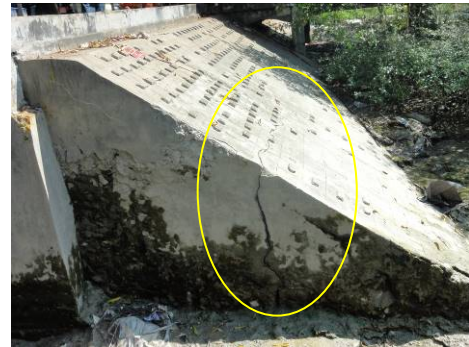
Photo 12 - Revetment

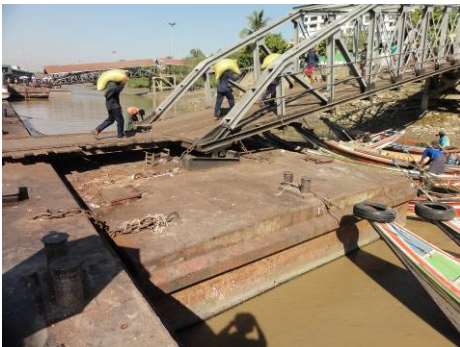
Photo 2 - Sponson

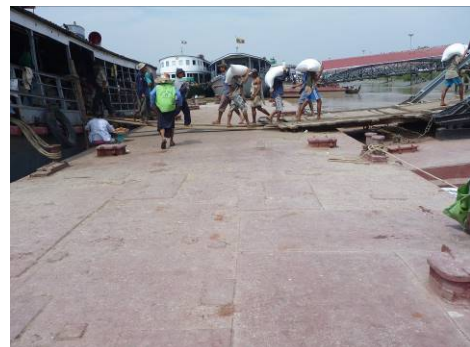
Photo 6 - Pontoon

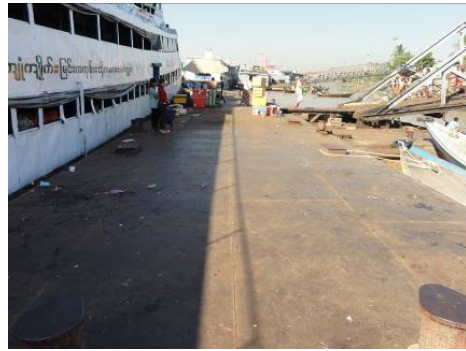
Photo 5 - Pontoon

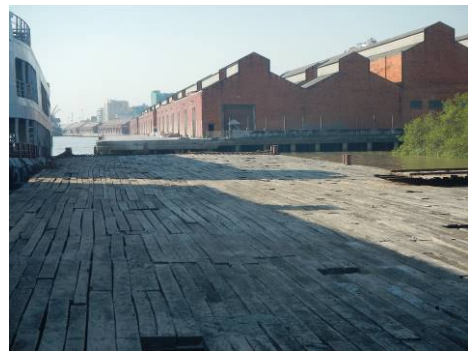
Photo 4 - Pontoon

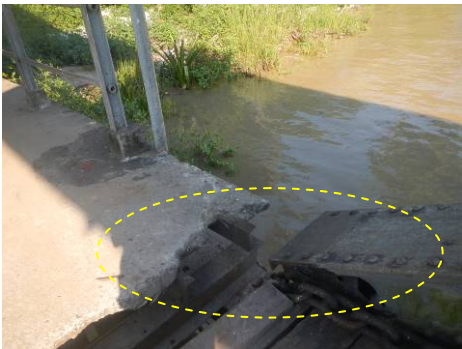
Photo 2 - Corner damage

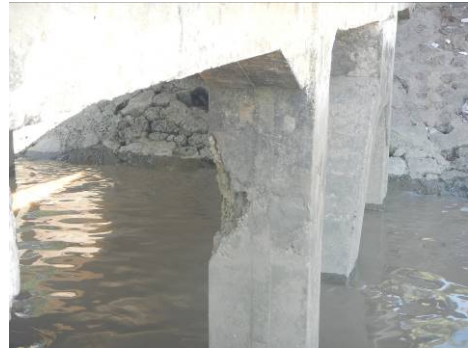
Photo 3

No.35	<i>Name of Jetty</i>	Nan Thi Da Jetty (3) Upper			
<i>Dimension</i>	Pontoon: Length 120' x Width 20' (after Nargis)	<i>Date of Inspection</i>		4 December 2014	
Result of Inspection and Evaluation of Port Facilities					
<i>Facility</i>	<i>General Evaluation</i>	<i>Condition of Damage And/or Deterioration</i>	<i>Measures to be taken</i>	<i>Change from Last survey in 2011</i>	<i>Reference Photo</i>
Pontoon	N	N	N	N	
Bridge	N	N	N	N	
Pier	N	N	Need repairing		Photo 3,4
Sponson	N	N	N	N

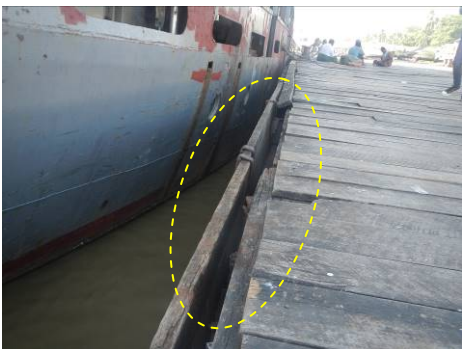
Photo 3 - Decking Damage

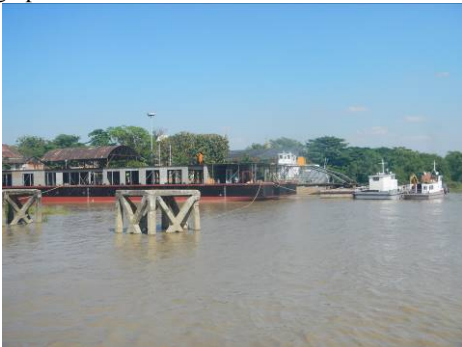
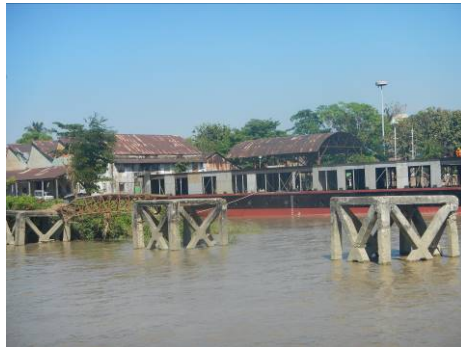
Photo 1 - General			Photo 2

No.39	<i>Name of Jetty</i>	Workshop Pontoon Jetty			
<i>Dimension</i>	-			<i>Date of Inspection</i>	4 December 2014
Result of Inspection and Evaluation of Port Facilities					
<i>Facility</i>	<i>General Evaluation</i>	<i>Condition of Damage And/or Deterioration</i>	<i>Measures to be taken</i>	<i>Change from Last survey in 20011</i>	<i>Reference Photo</i>
Pontoon	N	N	N	N	
Bridge	N		N	N	
Pier	Bad	Totally broken		N	Photo 1,2
Sponson	N	N	N	N	
<Photograph>

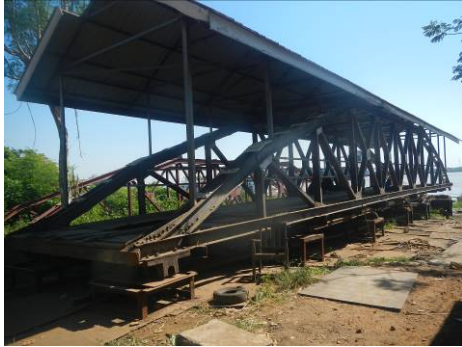
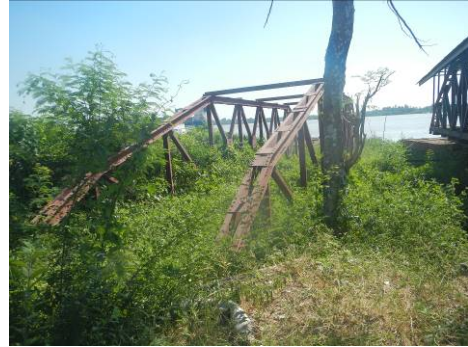
No.41	<i>Name of Jetty</i>	Botahtaung 2			
<i>Dimension</i>	-			<i>Date of Inspection</i>	4 December 2014
Result of Inspection and Evaluation of Port Facilities					
<i>Facility</i>	<i>General Evaluation</i>	<i>Condition of Damage And/or Deterioration</i>	<i>Measures to be taken</i>	<i>Change from Last survey in 2011</i>	<i>Reference Photo</i>
Pontoon	N-	N	N	No	
Bridge	Bad	Rust	Under construction	No	Photo 1,2
Pier	N-	N	N	No	
Sponson	N-	N	N	No

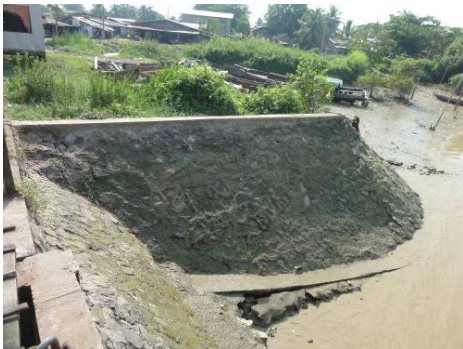
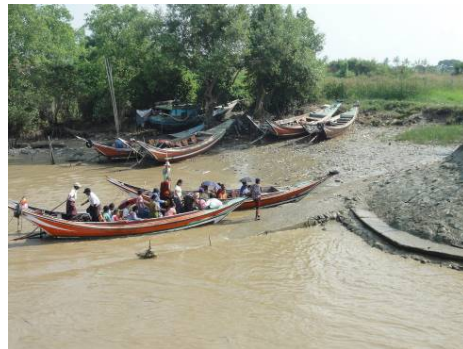
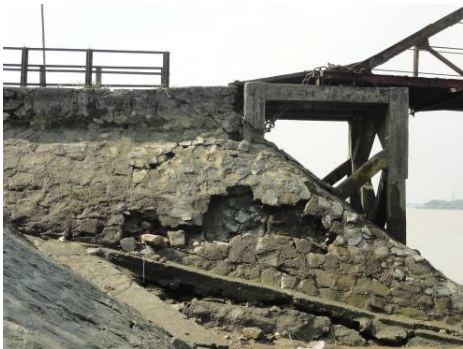
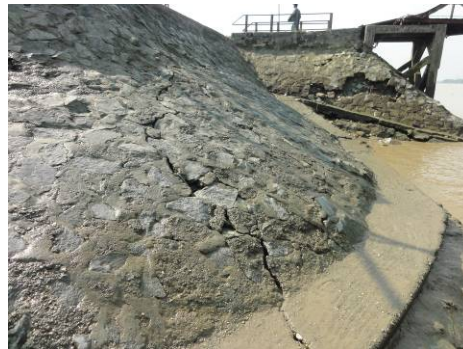
No.55	<i>Name of Jetty</i>	Min Ye Kyaw Thu Jetty			
<i>Dimension</i>	Pontoon : Length 120' x Width 20' (After Nargis)	<i>Date of Inspection</i>		10 December, 2014	
Result of Inspection and Evaluation of Port Facilities					
<i>Facility</i>	<i>General Evaluation</i>	<i>Condition of Damage And/or Deterioration</i>	<i>Measures to be taken</i>	<i>Change from Last survey in 2009</i>	<i>Reference Photo</i>
Pontoon	Fair	N	Shop or hut shouldn't be on pontoon	N	Photo 7
Bridge	Fair	Roller , rusted frame	Need to replace roller wheel, Painting,	N	Photo 3,6,8
Pier	Fair	N	N	N	Photo 2,10
Sponson	Fair	N	N	N	Photo 9
Revetment	Fair	Damage	Need Repair	N	2,4,11, 12,13,14

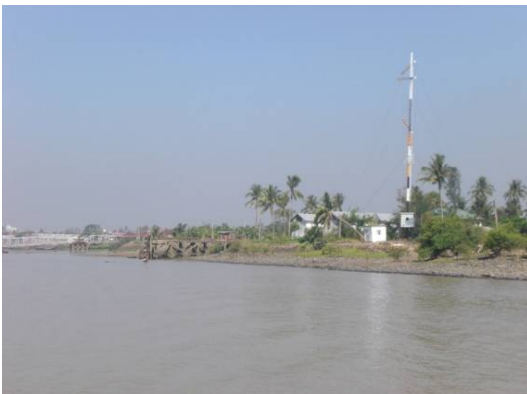
Incredible strong wind of Nargis destroyed Leading Light towers and Lights.

Photo B.4.5
Passed Monkey Point Signal Station
on her portside

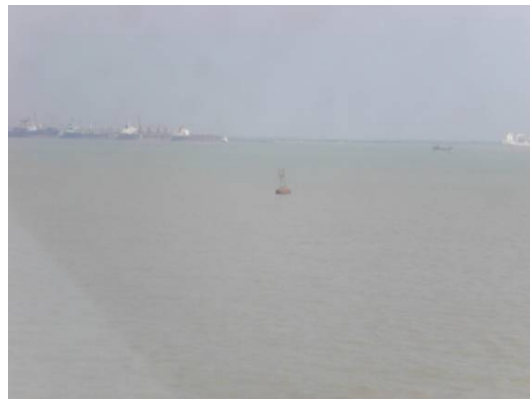
Photo B.4.14
Upper Chokey Buoy (UC Buoy)

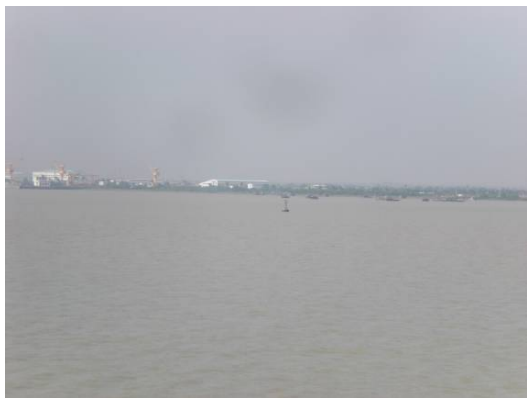
Photo B.4.15
Upper Chokey Buoy (UC Buoy)

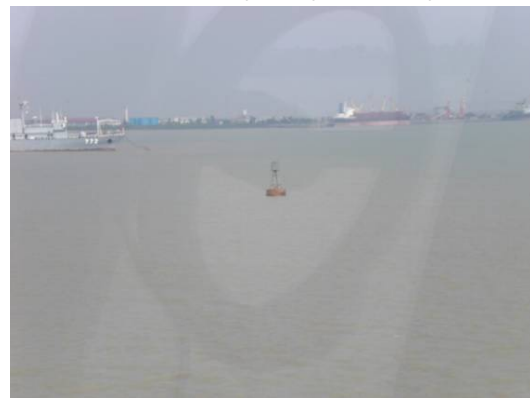
Photo B.4.16
Middle Chokey Buoy (MC Buoy)

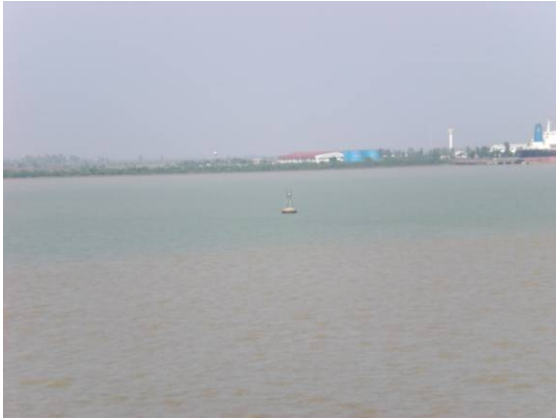
Photo B.4.19
Passed Lower Chokey Buoy(LC Buoy)
on her portside 0.2'off

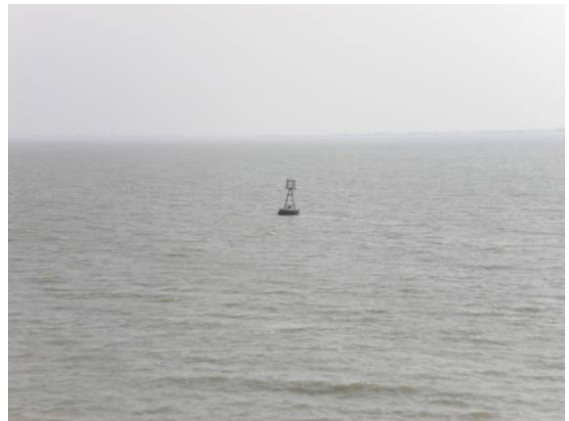
Photo B.4.22
Passed D'Silva Buoy
on her starb'dside 0.1'off

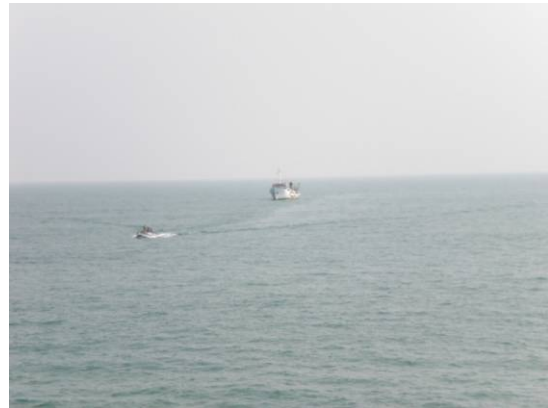
Photo B.4.38
Pilot Vessel “MAYKHARAL” and Pilot boat

We met with Pilot Vessel “MAY KHARL” at Outer Bar on 22nd March 2009. As far as checking out side condition of the vessel from bridge of our vessel “MHAN AUNG”, hull of the Pilot Vessel seemed very rusty. (Rating 2 for Pilot Vessel)

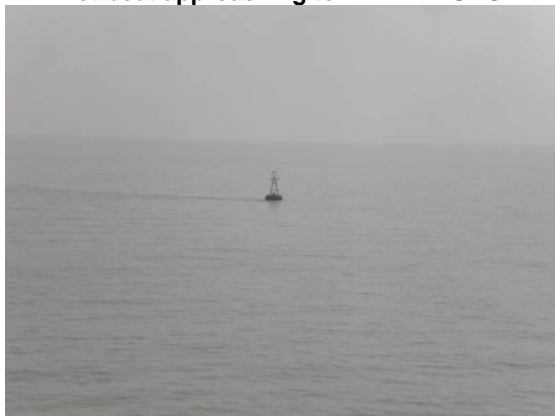
Photo B.4.41
Passed Lower Float Buoy
on her starb’ dside 0.15’ off

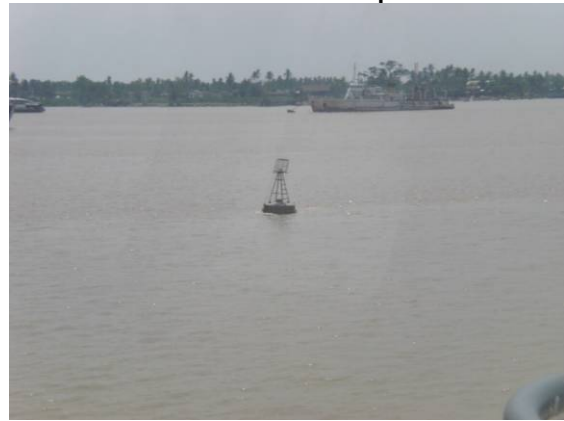
**Photo B.4.52
Passed UMP Buoy on her portside**

There are 2 navigation buoys i.e. UMP Buoy and LMP Buoy in the Monkey Point Channel to indicate southern limit of narrow channel. These buoys are very significant to avoid grounding of passing vessels. It is seemed both buoys are good condition but coloring of the buoys are same color. It is preferable to paint to Red color which means portside for entering vessels, in addition color of light introduce Red Light signal in night time. (Rating 2 for navigation buoys)

It is preferable to distinguish all navigation buoys by painting and lighting with Red or Green color in addition to install Top Mark on the top of the buoy following to recommendation of IALA. (Rating 2 for navigation buoys)

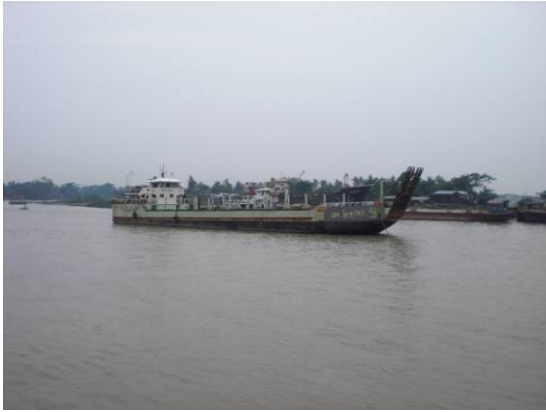
Photo C.1.8
Signal Station of Canal
In case dangerous situation by low tide, Black Ball in daytime, Red Light in night is hoisted the poll.

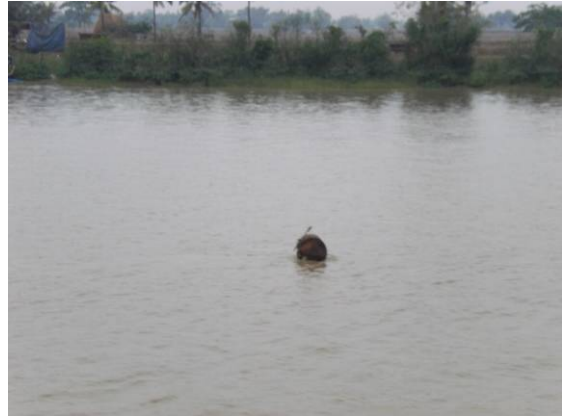
Photo C.1.14
Wreck mark buoy

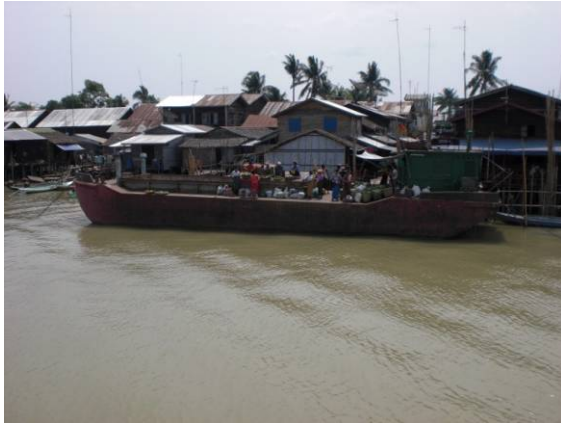
Photo C.1.25
Kyeihtaw Small ship is used as Station instead of pontoon.

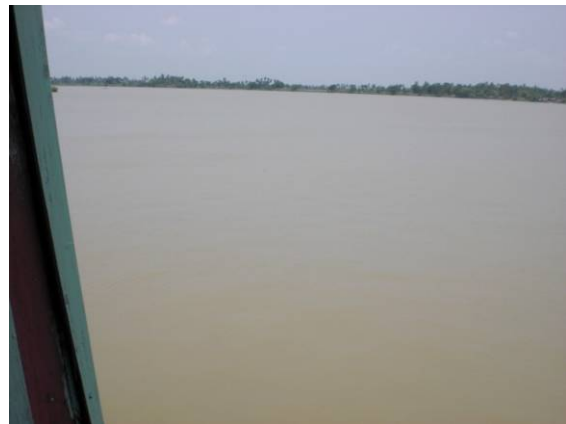
Photo C.1.28
View Riverside Maneuvering space in the river is enough

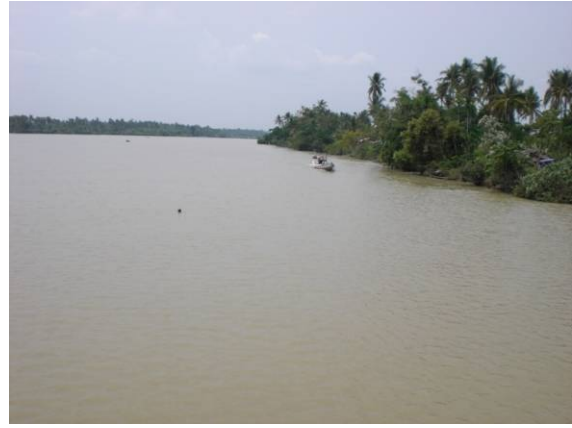
Photo C.1.30
Photoke Creek Bending part of narrow
channel, nothing any navigation aids

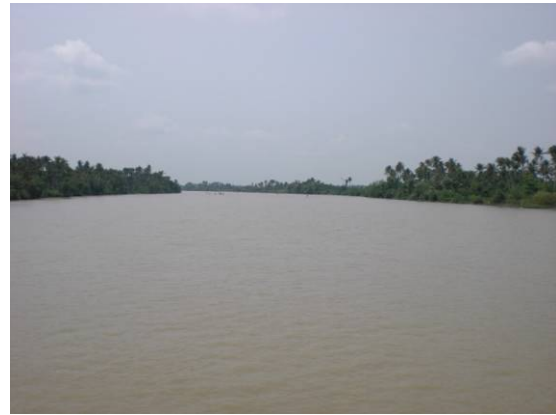
Photo C.1.32
Photoke Creek Bending part of narrow
channel, nothing any navigation aids

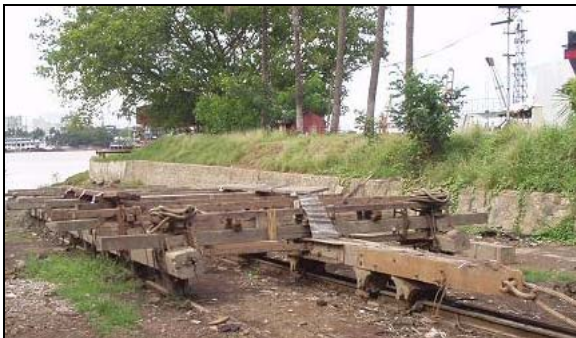
Photo C.2.3
No.3 Slipway and Cradle

<p>Damaged wooden cradle</p>			
No. 2 Slipway (Year built: 1898)			
Component	Particulars	Present Condition	Evaluation
Slipway	L=148m Max ton=205	Operational, but too old	Wooden cradles are breakable and unstable.
Hauling Winch	Pull 15.5ton, Built in 1932	Operational, but aged	
Cradle	Wooden	Operational, but unstable	
No. 3 Slipway (Year built: 1898)			
Component	Particulars	Present Condition	Evaluation
Slipway	L=140m Max.ton=205	Operational, but too old	Wooden cradles are breakable and unstable.
Hauling Winch	Pull 15.5ton, Built in 1932	Operational, but aged	
Cradle	Wooden	Operational, but unstable

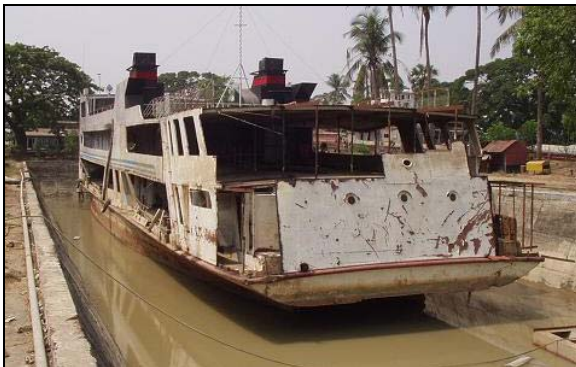
Photo C.2.5
Graving Dock

No. 4 Graving Dock (year built: 2001)			
Component	Particulars	Present Condition	Evaluation
Dock	L=90m,B=15m,D=5.4m Max ton=1400DWT	Operational	
Gate	Flap type	Damaged by Nargis, Some leakage found	Water tightness is not normal condition.
Pump	Centrifugal Pump, Dia.12"	Operational	
Gantry Crane	Not applicable	Construction suspended	Erection is expedited
<p>Some water remains on the bottom</p>

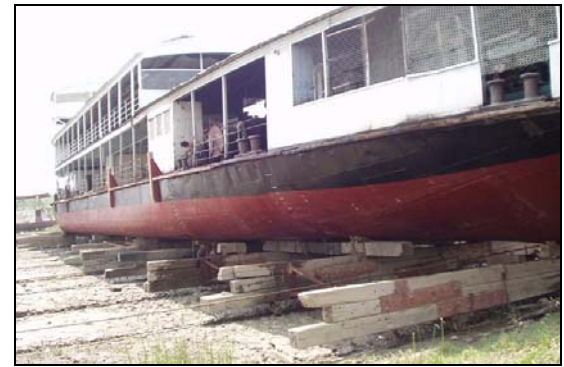
Photo C.2.6
No.7-12 Slipway

No. 7 – No. 12 Slipway (Year built: 1900)			
Component	Particulars	Present Condition	Evaluation
Side Slipway	L=83m Max.ton=468	Operational, but 2 rails missing	Some more berths required
Hauling Winch	Pull 58ton, Built in 1931	Operational, but aged, one drum disconnected	To be renewed into powered ones
Cradle	Wooden	Damaged by Nargis, now very unstable	Wooden cradles are breakable and unstable.

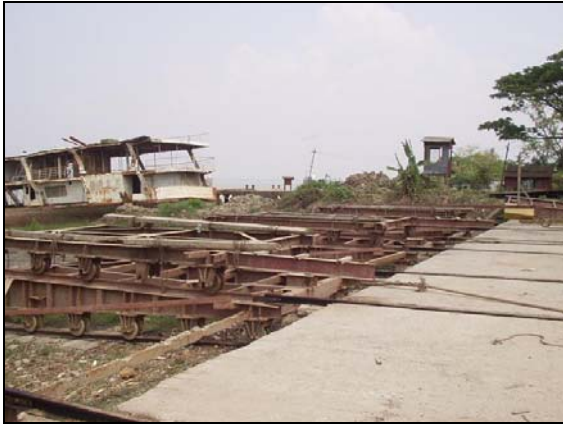
**Photo C.2.9
No.13 Slipway**

<p>Wooden Cradle</p>			
No. 13 Slipway (Year built: 1963)			
Component	Particulars	Present Condition	Evaluation
Side Slipway	L=60m Max ton=125	Operational	No.14 winch is now utilized, but very unsafely.
Hauling Winch	Not Fitted	No hauling winch	
Cradle	Steel	In good condition	
Repair Berth	44m x 35 m Concreted	In good condition	
No. 14 Slipway (Year built: 1920)			
Component	Particulars	Present Condition	Evaluation
Slipway	L=183m Max.ton=274	Operational, but too old	–
Hauling Winch	Pull 36ton	Operational, but aged	–

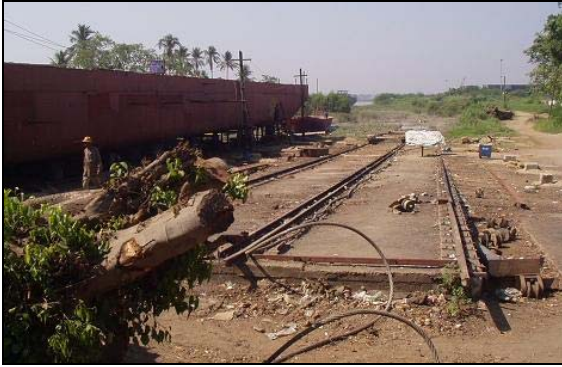
**Photo C.2.15
No.4 Slipway**

No. 4 Slipway			
Component	Particulars	Present Condition	Evaluation
Slipway	2 vsls	Operational, but winch house damaged by Nargis, Old fashioned belt driven winch	Aged winch be renewed, cradle be replaced to steel ones
Hauling Winch	150 DWT		
Cradle	Wooden

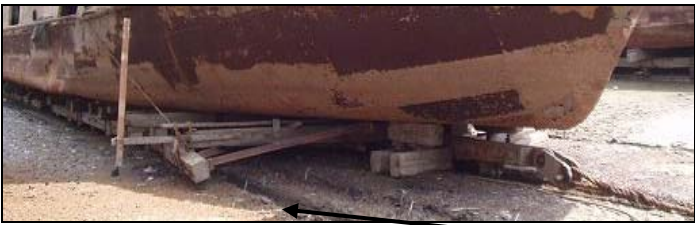
No. 1 Slipway (Year built: 1908)			
Component	Particulars	Present Condition	Evaluation
Slipway	L=180m Max.ton=274	Operational, but too old	Wooden cradles are breakable and unstable.
Hauling Winch	Pull 38ton, Built in 1931	Operational, but aged	
Cradle	Wooden	Operational, but heavily damaged

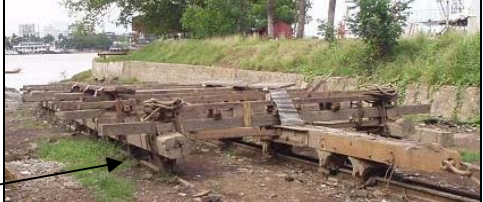
<p>Unstable wooden cradle</p>

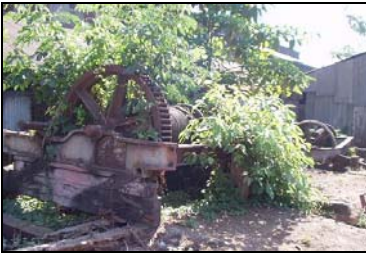
No. 1 & No. 2 Slipway			
Component	Particulars	Present Condition	Evaluation
Slipway	Not applicable	Space is utilized for new construction	To be recovered, incl. new winches
Hauling Winch	Not applicable	Out of use due to aging	
Cradle	Not applicable	Not applicable

<p>Rotten winches</p>			
No. 3 Slipway			
Component	Particulars	Present Condition	Evaluation
Slipway	2 vsls	Hauling winch is damaged, then out of use now	Winch be repaired
Hauling Winch	150 DWT		
Cradle	Wooden

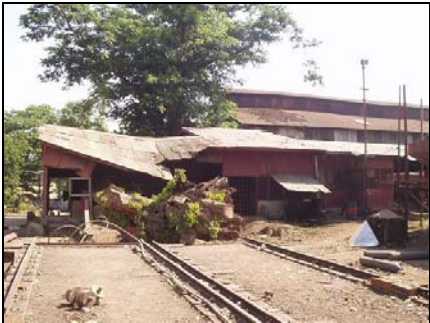
<p>Destroyed winch house by Nargis</p>
