7. Landslide Recording Sheet

# General Information Sheet (Other)

Management number	000000001	Reporter's name:	Tomoharu IWASAKI	Date of report :	June 14, 2012
Address	Temple Road, Creve Coeur	Type*	Damage of wall	latitude	-20.149417
			longitude	57.582472

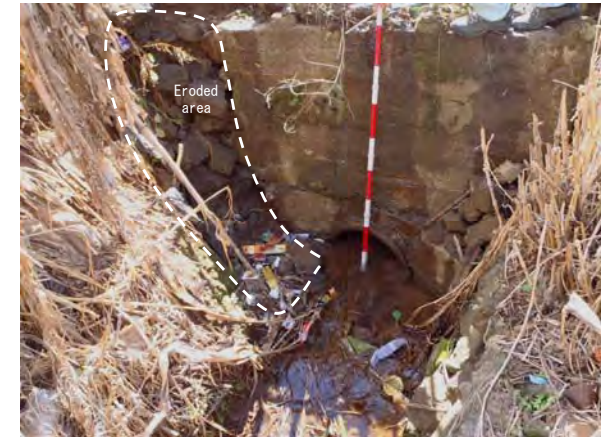
Ph-3 Upper stream

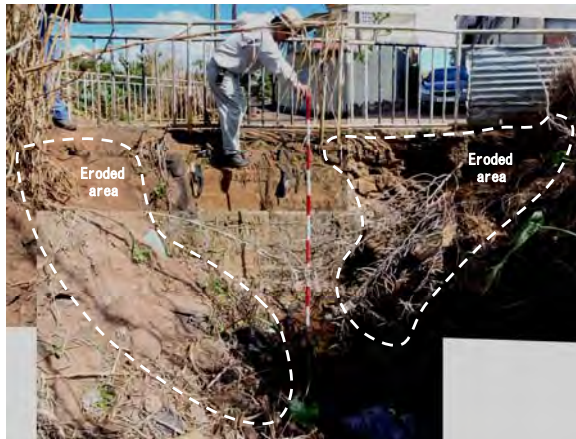
Ph-4 Down stream

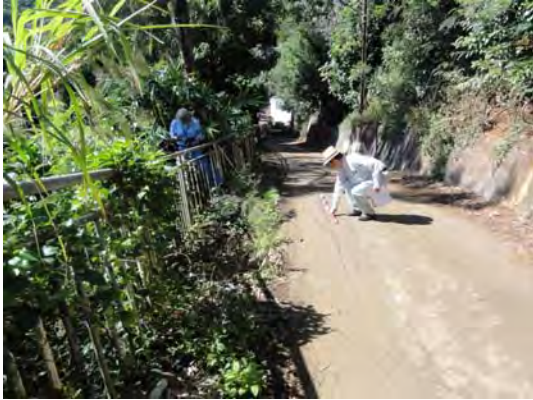
A slope failure was confirmed on the side of the road.  
 Slope failure is characterized as follows; W=2m, L=2m.  
 There is a possibility of slope failure in future.  
 It is necessary to undertake works regarding this road. And, it will be necessary to construct a retaining wall.  
 Also, there is slope failure in another site. But, the road has been already repaired.

Ph-1 Full view

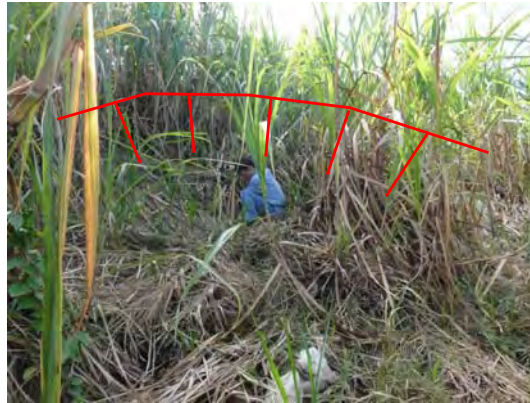
Ph-2 Main Scarp

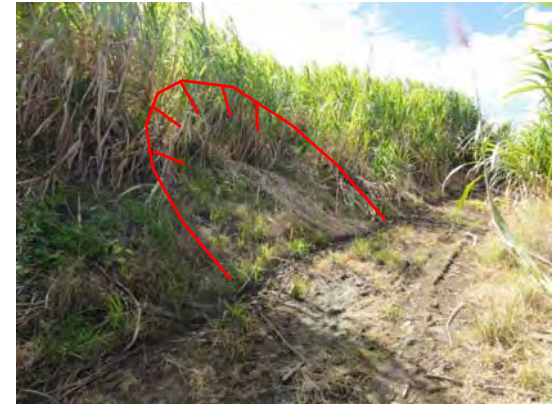
Ph-3 landslide

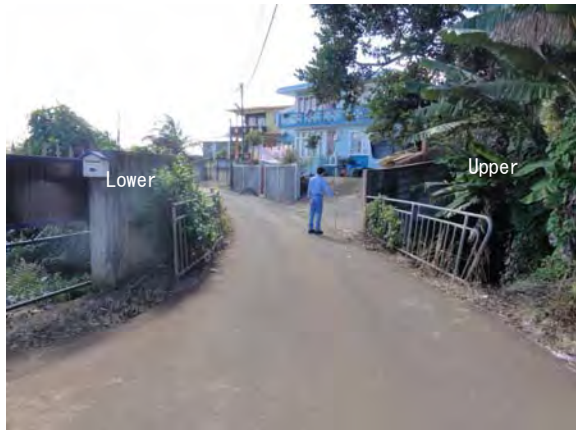
There appeared to be bank erosion on the left bank above the bridge. The upper bank has not been covered by anything while the retaining wall was constructed at the lower bank. In addition, the water level rises in the wet season causing the bank erosion.

Ph-1 Full view of the river

[Description]  
It is necessary to carry out the countermeasures in the left bank of the upper side of the bridge.

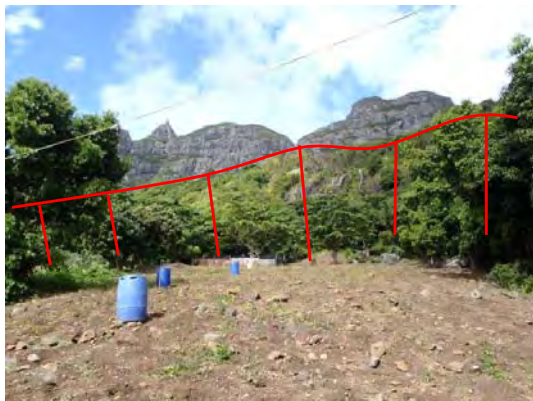
A clear landslide was confirmed in this site and the characteristics are as follows;  
 (1) Main Scarp (Horse shoe Scarp),  
 (2) Some Minor Scarps,  
 (3) Steps and Tension Cracks.

A clear landslide was confirmed. A landslide was reported to have damaged houses and a school after heavy rain in 2005. Boring investigation and monitoring have been carried out, but not sufficiently. No countermeasures have been implemented. Therefore, a detailed investigation and monitoring are necessary while the countermeasures are expected in future. L=1500m ,W=700m

Ph-1 Main scarp

None	<p>[Description]</p> <p>The Structural Measure (Hard-Component) was carried out. The landslide is not stable. Therefore, a detailed investigation and monitoring are necessary while the countermeasures are expected in future.</p>
------	--

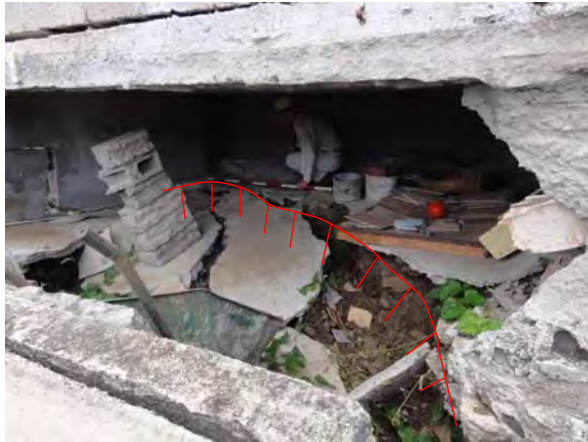
Lately, housing developments are growing rapidly in this area. A landslide boundary of 35m x 20m was clearly detected. Several houses have been damaged and some cracks were observed. The situation of the damage was also reported in the newspaper. The type of landslide is debris-slide caused by house construction in the upper slope and cut-slope at the toe. In addition, the incompleteness of the surface drainage is a problem. The landslide is not stable. A landslide investigation and monitoring are necessary while the countermeasures are expected in future.

Ph-1 Main scarp

<p>[Resident's awareness and relocation]</p> <p>[Land use restrictions in hazard areas]</p> <p>[Description]</p> <p>The landslide is not stable. A landslide investigation and monitoring are necessary.</p>
--	--

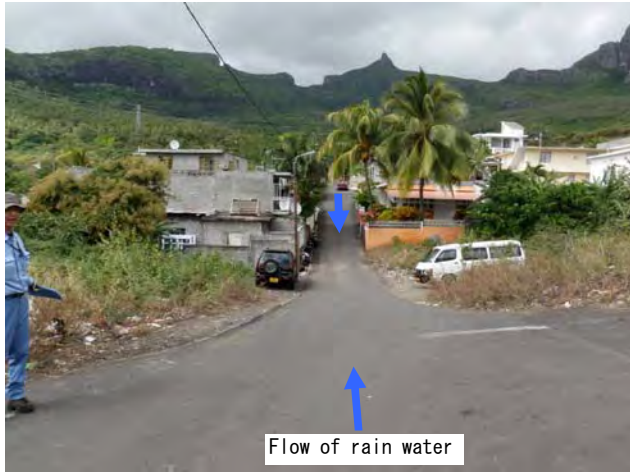
Insufficient surface drainage means rain water concentrates in low area and erodes roads and houses in its path. Damage is negligible at present, although the maintenance of the surface drainage will be necessary.

Ph-1 Full view of the depressions

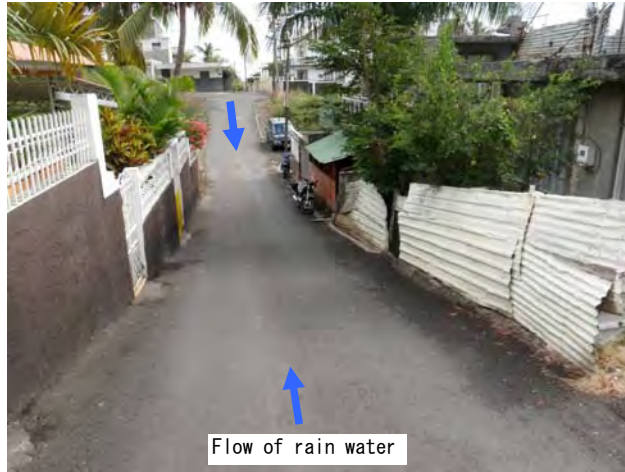
Ph-2 House around the depressions

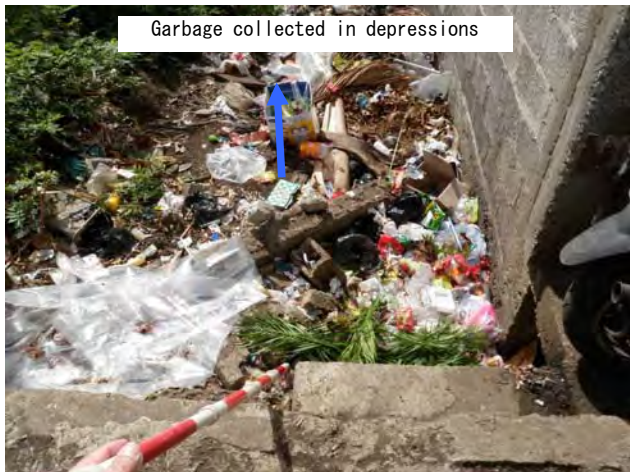
Ph-4 Channel of the depressions

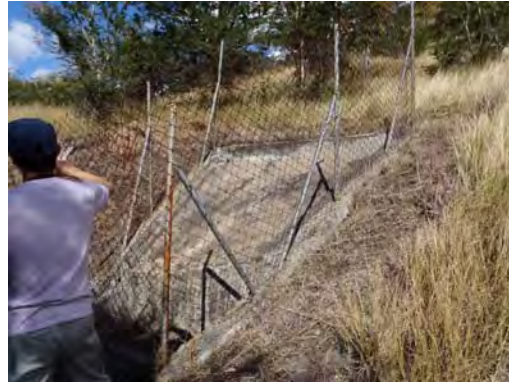
Ph-2 Horizontal drain work

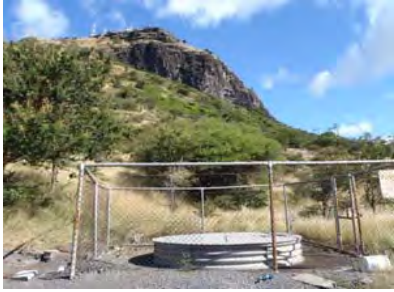
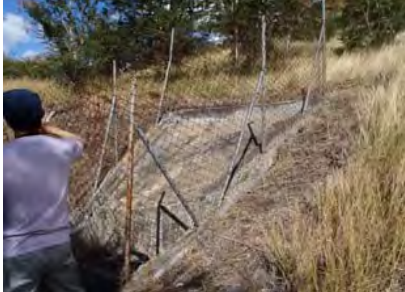
Drainage well	Horizontal drain Work				
	<p>[Description]                  The structural Measure (Hard-Component) was carried out in 1998.                  Now, the landslide is stable.                  It is not necessary to add the structural measures.</p>	<p>[Resident's awareness and relocation]</p> <p>[Land use restrictions in hazard areas]                  Non</p> <p>[Description]                  As of 2006, as for 2 of 16 extesometer, 3 of 7 inclinometers, 2 of 10 groundwater level meters, a measurement was in a possible. However, it is not measured now.</p>

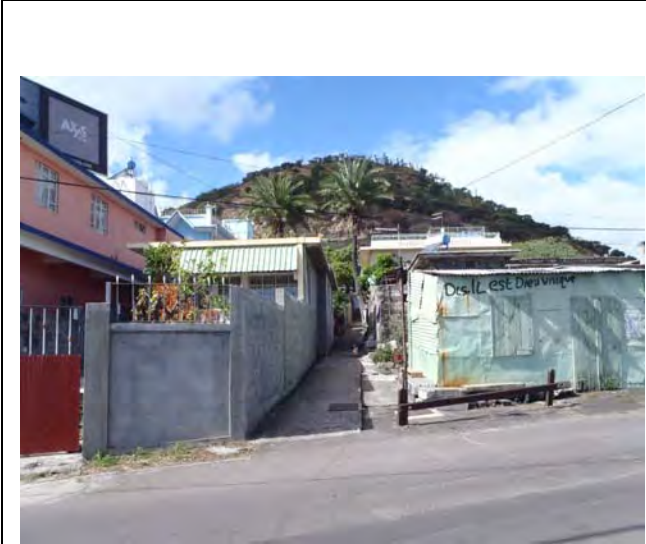
The landslide topography is not clear, but five houses and two retaining walls were damaged while the spring water was spotted in two places. There are two possible causes of this, creep transformation of weak surface soil or a shallow landslide. Therefore, landslide investigation and monitoring are necessary while the countermeasures are expected in future.

Ph-1 Full view

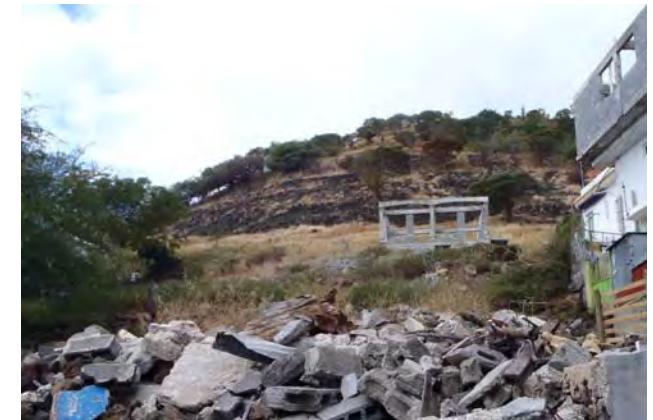
Ph-6 Main scarp

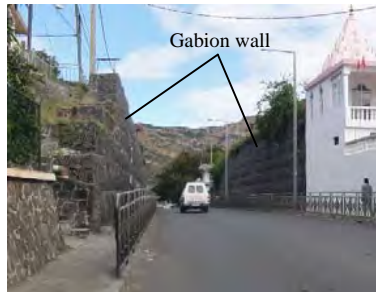
Ph-1 Full view of Gabion wall

There is no record of damage for this site but the angle of the wall is steep. Therefore, the observation of this wall is advisable.

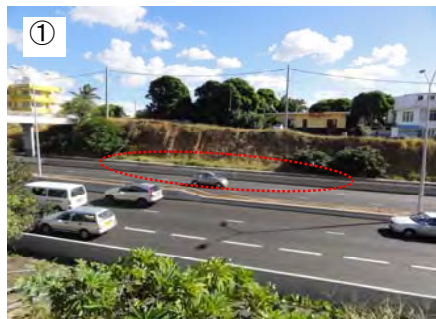
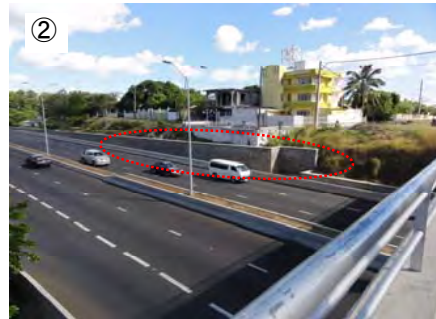
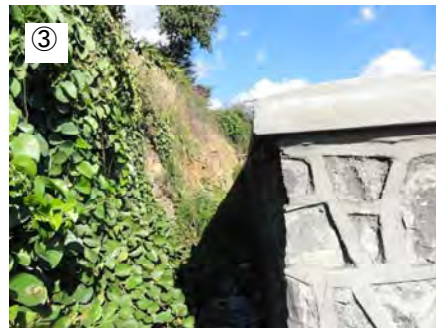
[Description]  
 The slope failure has been spotted along the cutting(5m height) at the roadside of highway. Weather on the surface layer causing the erosion it rains. The slope (①~③) is characterized as follows;  
 ①The slope has occurred shallow slope failure and has loose stones. It will be necessary to reconsider the retaining wall.  
 ②The slope is not slope failure and stability by the retaining wall.  
 ③The slope has occurred shallow slope failure. But, the retaining wall keep back rock fall.

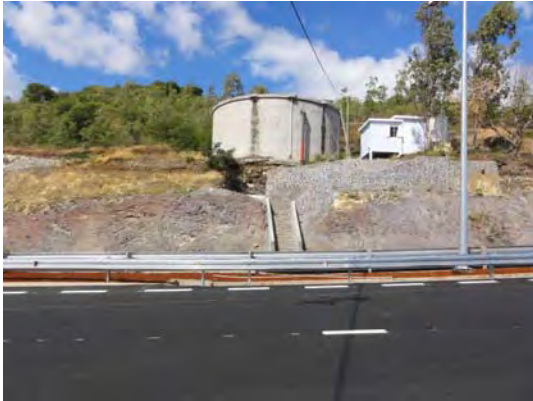
Ph-1 Full view

Insufficient drainage is causing erosion at the base of the water tank. Immediate remedial work is needed.

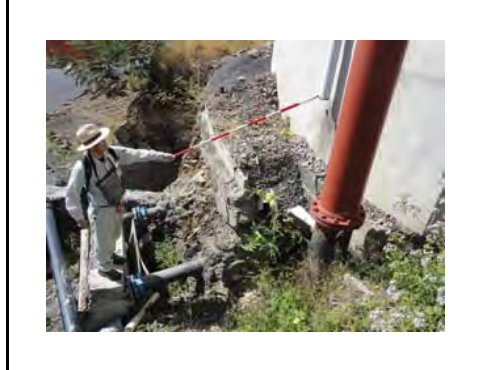
[Description]  
Imperfection of the drainage causing the erosion at the base of water tank. The maintenace will be the necessary immediately.

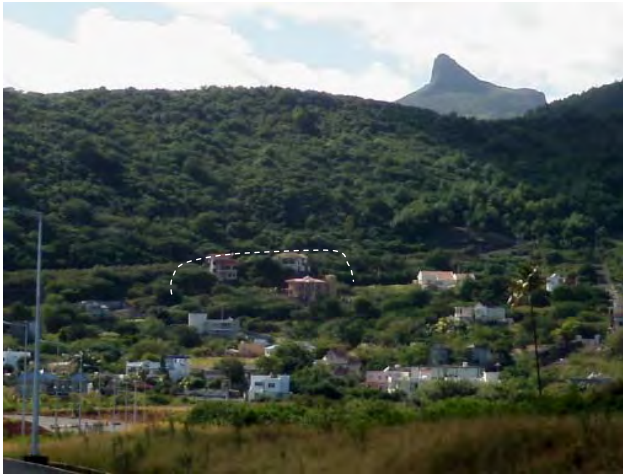
Ph-1 Full view

Falling rocks at the upper slope and shallow slope failure at the middle and lower slope occurred in an area of housing. There is only slight damage for now, although shallow slope failure and cracks have been confirmed.

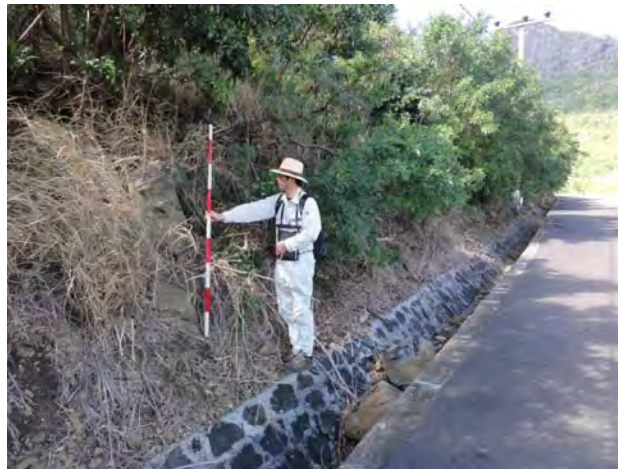
Ph-2 Rock Fall

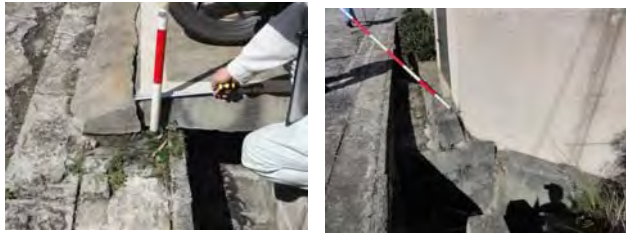
Ph-4 Damage on house

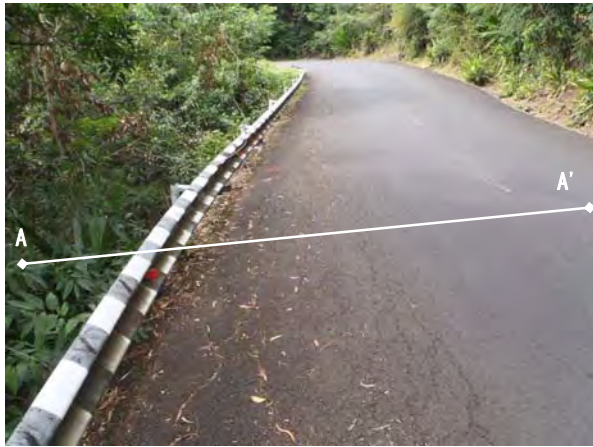
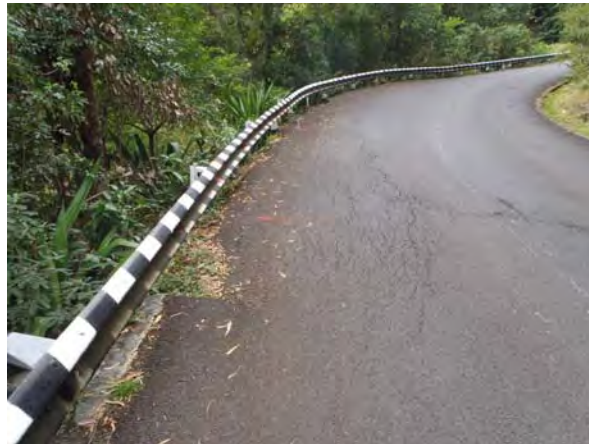
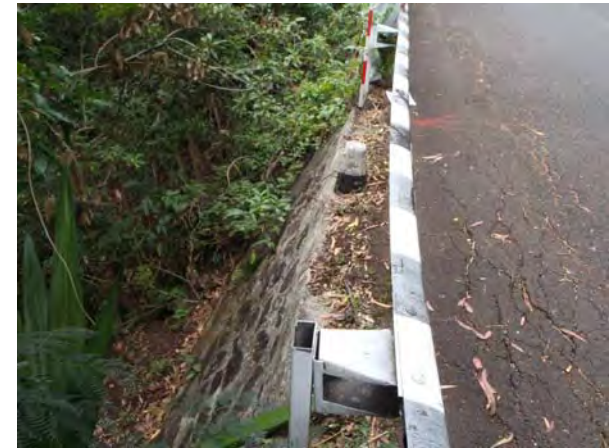
Ph-2 Retaining wall of the road shoulder (A-A' cross section)

Deformation of the road has been confirmed at the shoulder of the road due to a lack of bearing capacity.  
 The embankment of stone masonry wall and retaining wall were constructed but it is insufficient.  
 Therefore, the re-construction of the retaining wall and stone masonry wall will be necessary in the near future.

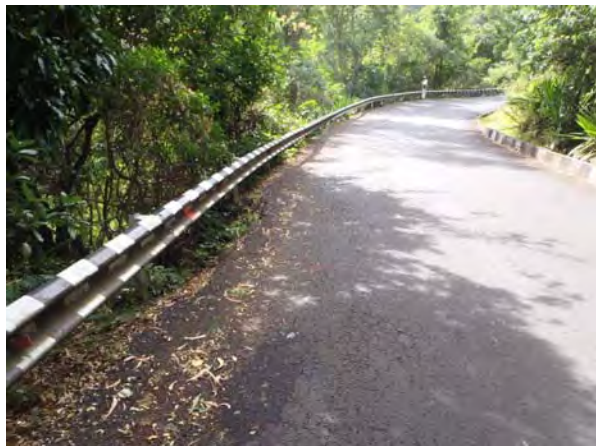
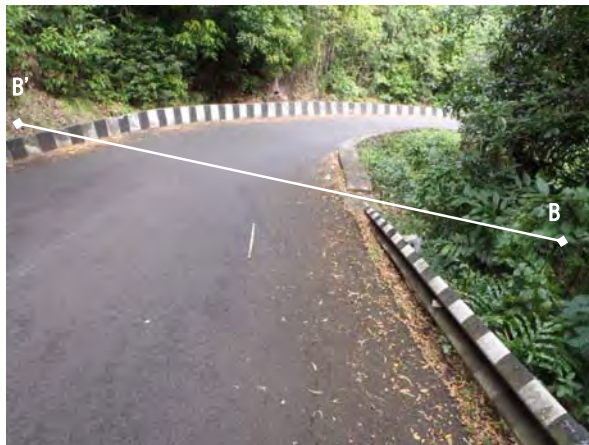
Ph-3 Stone masonry wall of the road shoulder (B-B' cross section)

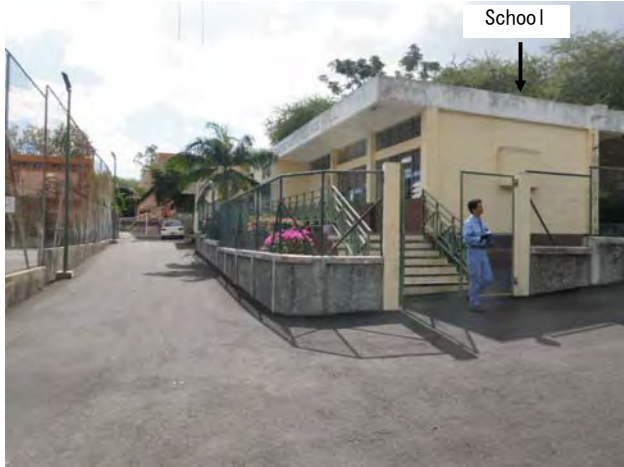
The crack at the base of village hall area and edge of concrete basketball court has been confirmed. However, the surrounding structures are not affected, therefore it is considered unlikely this damaged was caused by landslides. Rather it is likely to be caused by lack of bearing capacity of the ground or a problem with the structure itself.

Ph-1 Full view of Black River Government School

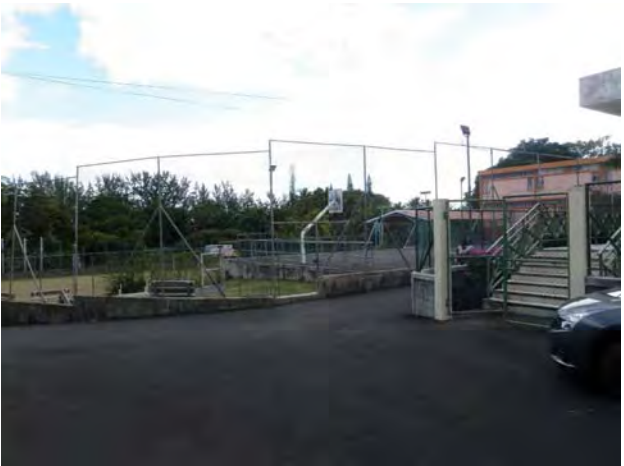
Ph-4 Full view on sea side

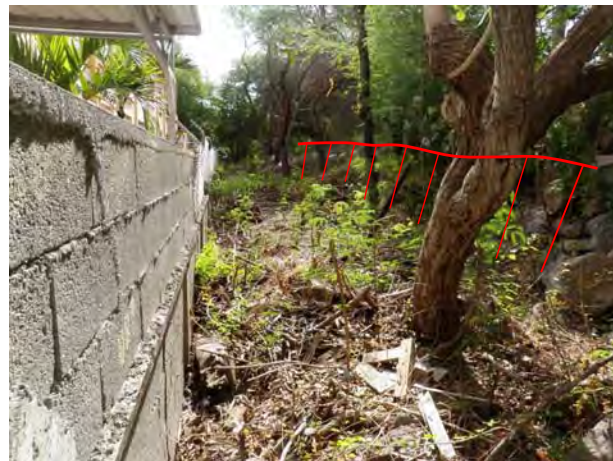
Ph-5 Non dimensions in the wall

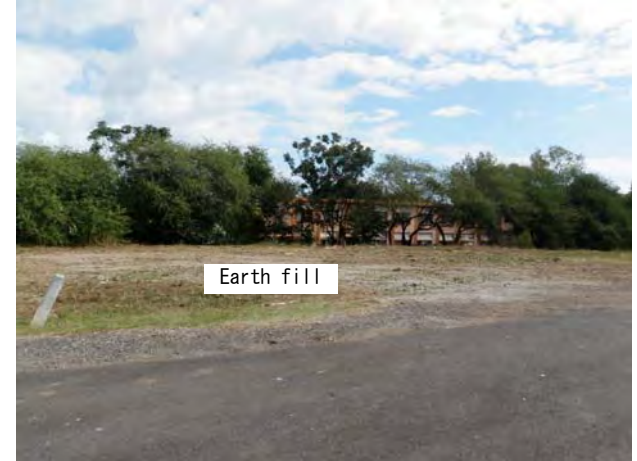
Ph-6 Sutiation in the back of School (fill-up ground)

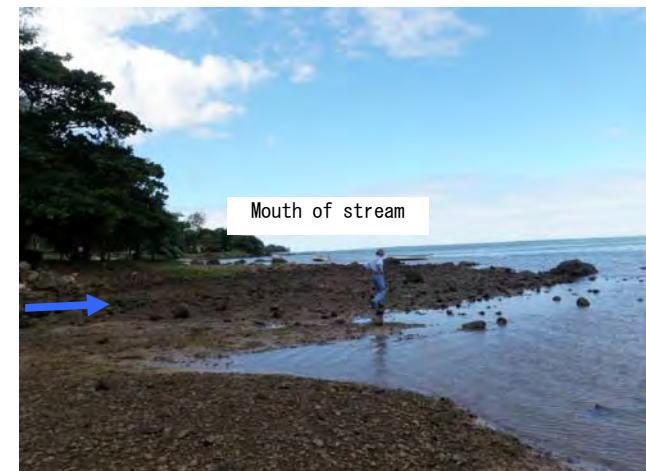
Ph-6 Discharged sediment at the mouth of stream

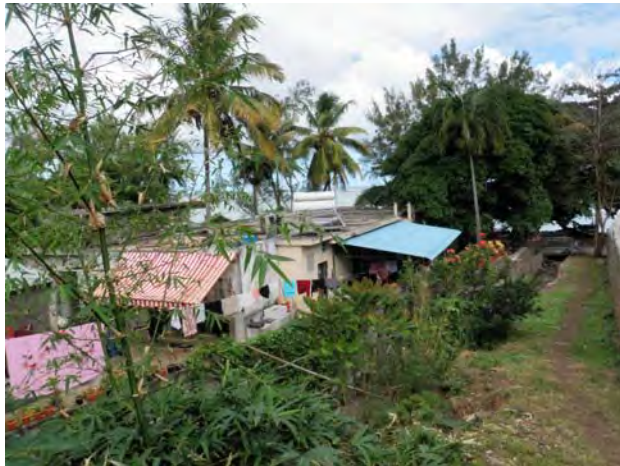
Ph-1 Full view of overcrowded house

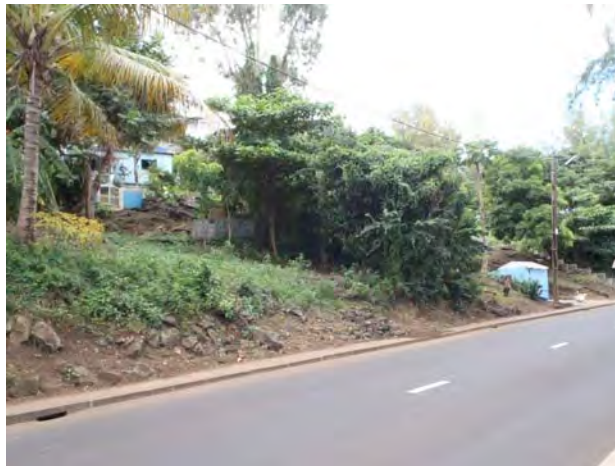
Ph-2 Shore terrace where it faces road

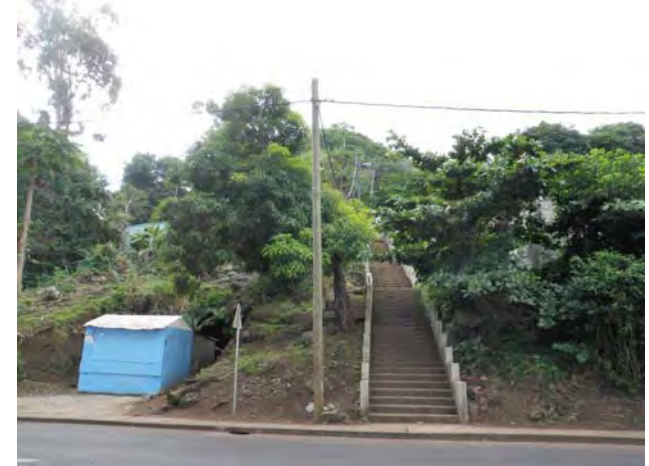
Ph-3 Shore terrace where it faces road

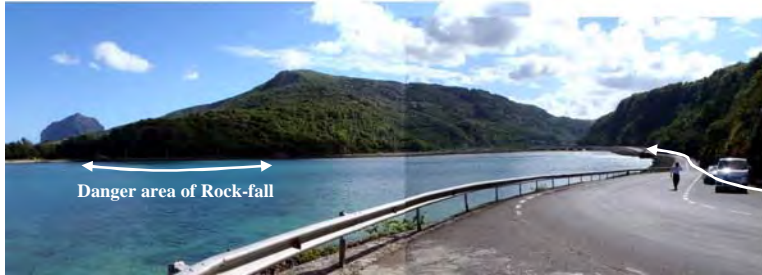
Ph-1 Full view

A new road was built to reduce the damage from rock falls. However, rock falls and small rock failures are also a frequent occurrence along the new road. The rocks are weathered, and there is a high possibility of rock fall in future.

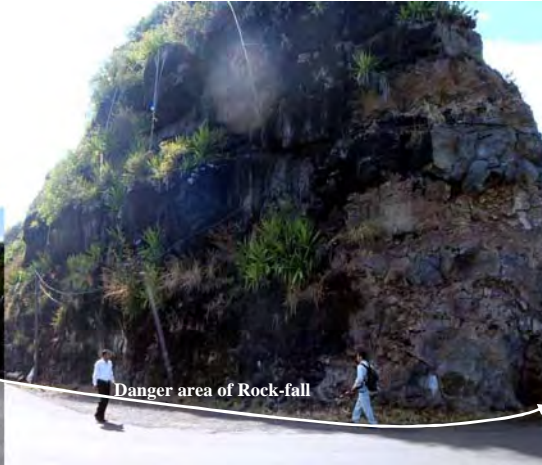
Ph-2 The rock constituting a cliff (many cracks and weathering intensely)

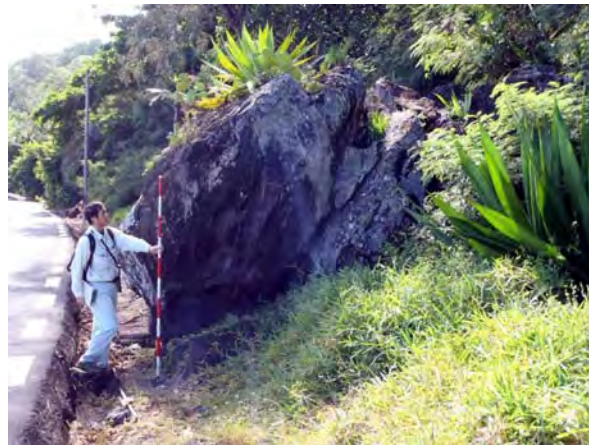
Ph-4 Rock fall

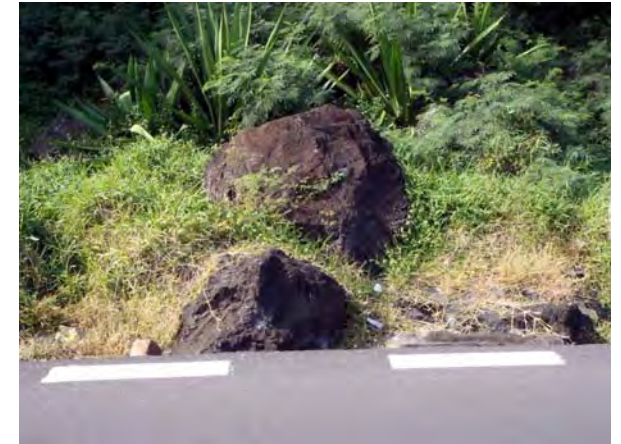
Ph-5 Rock fall

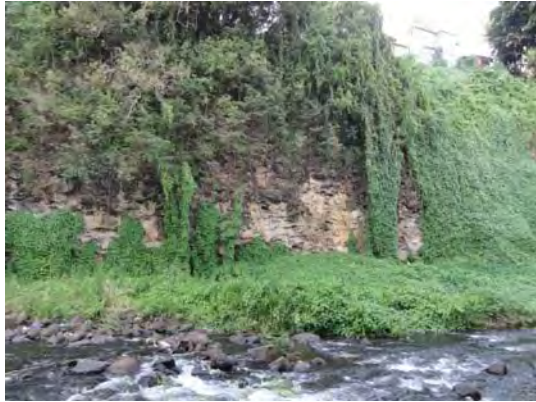
Ph-1 Full view

There are many houses built on the cliff here. The cliff is weathered severely and stream erosion occurs frequently. Therefore, the house will need to be relocated.

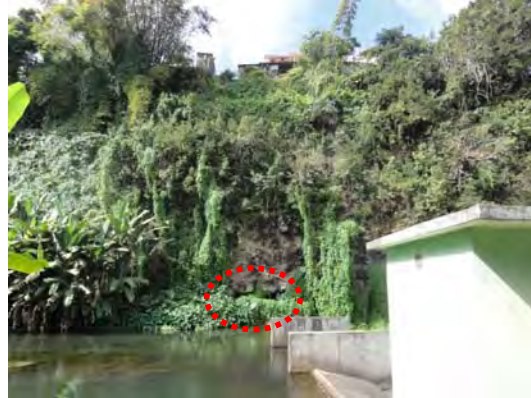
Ph-2 cave in slope

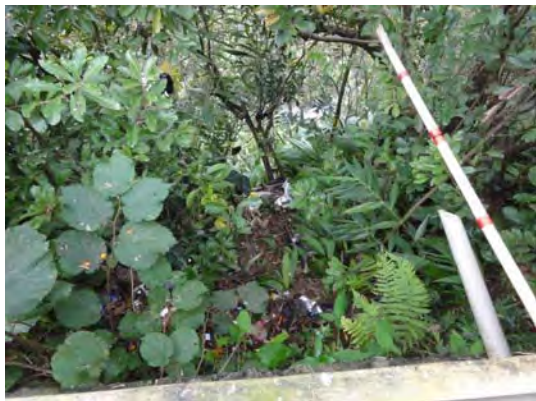
Ph-4 relation slope and house

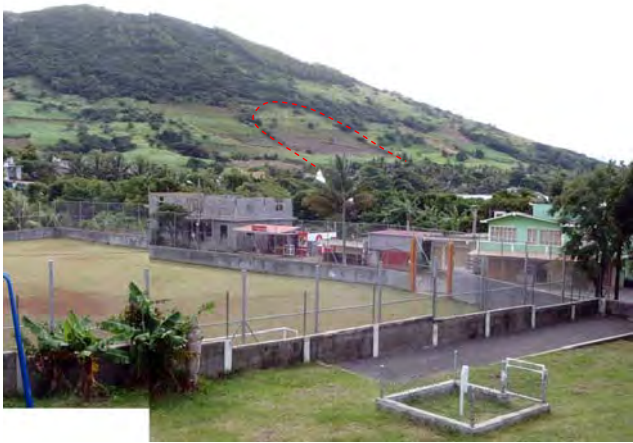
Ph-1 Full view

The groundwater level at the lower part of the landslide is high and is causing instability in the landslide. Drilling investigation and monitoring have been carried out, but not sufficiently. Further investigation and monitoring are necessary while the countermeasures are expected in future. L=350m ,W=400m

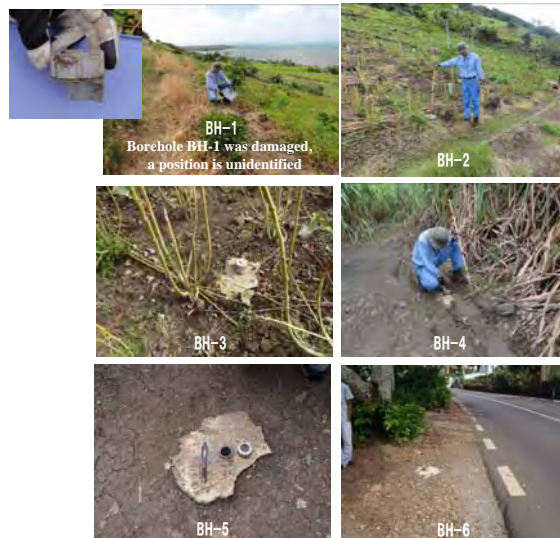
Ph-5 Existing borehole for the manual monitoring of ground water level

</div>			[Land use restrictions in hazard areas] Non			
[Description] There are 6 existing boreholes for the monitoring of ground water level (Boreohole-No. : BH-1,2,3,4,5,6), However, it is not measured now.			[Description] There are 6 existing boreholes for the monitoring of ground water level (Boreohole-No. : BH-1,2,3,4,5,6), However, it is not measured now.

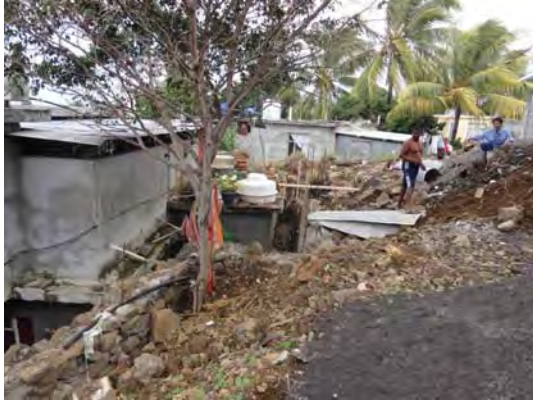
Slope failure was confirmed at the backyard of the house. No damage on the house was reported although the soil of the slope approached near the house. A retaining wall has been constructed independently.

Ph-1 main scarp

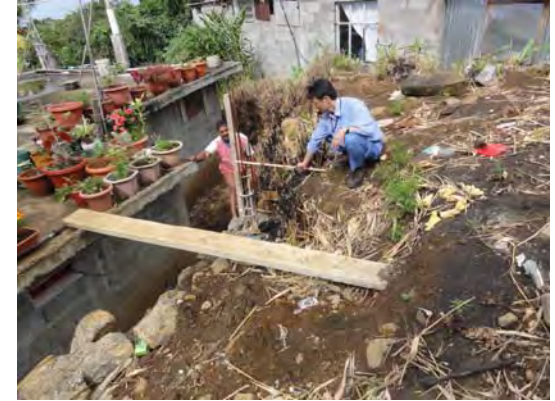
Ph-3 relation retaining wall and house

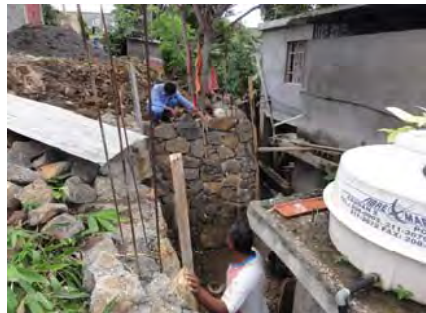
[Description]  
The retaining wall is constructed independently at the moment. It will be necessary to reinforce a retaining wall.

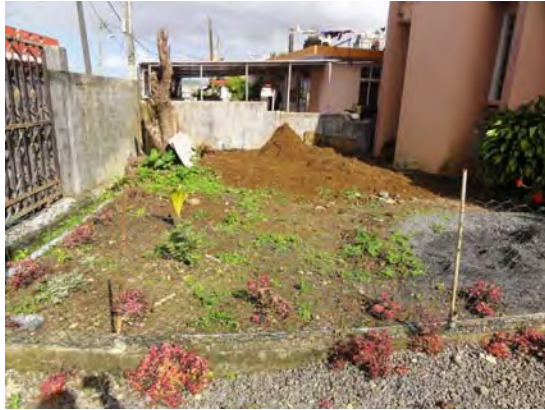
Ph-1 Full view

A cave (4m x 4m x 3m depth) due to land subsidence was observed in the residential area. No damage was caused to the houses and the cave was filled in with soil. Soakaway have to be replaced by the sewer in future. Similar situation was confirmed nearby.

[Description]  
It is important to diffuse simplified soakaway to prevent a cave occurrence. Replacement of soakaway by the sewer in future will be advisable.

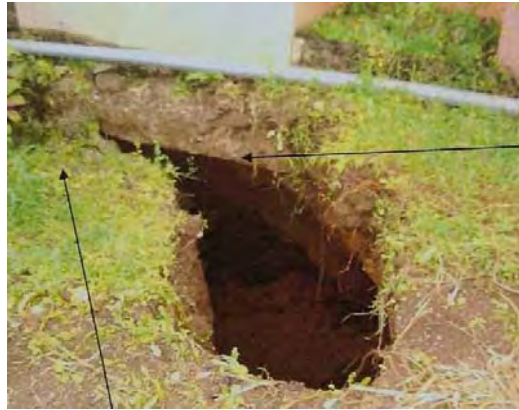
Ph-2 cave by groundwater

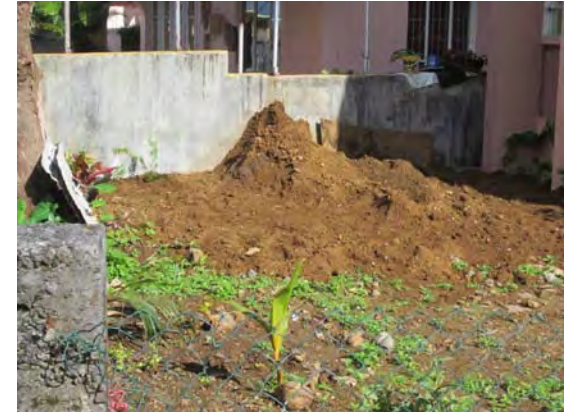
Ph-3 filled cave

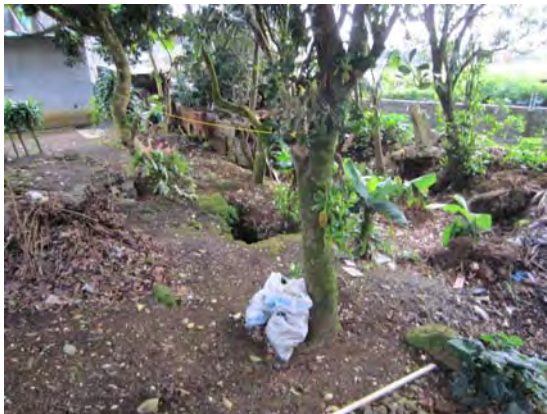
Ph-4 site of another cave

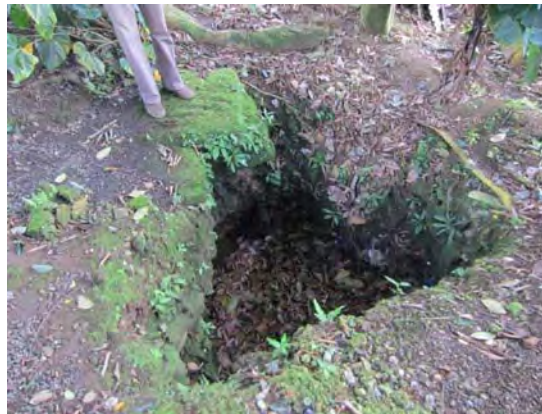
Ph-5 another cave

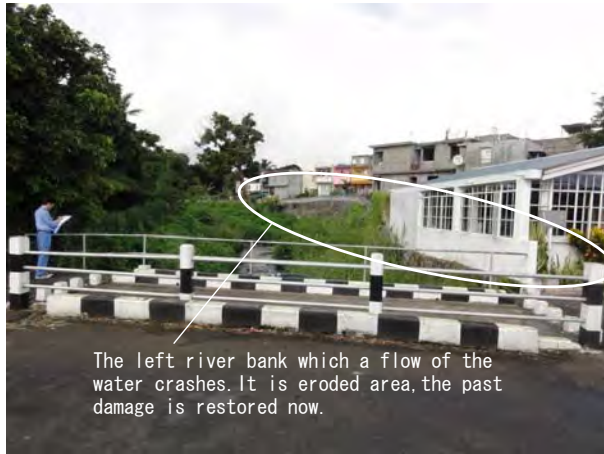
Ph-1 Full view of the river

Bank erosion and flooding is common in the rainy season when the river water level rises. There are more damage on the left side of the riverbank due to the strong collision of water. However, past damage has been restored by constructing a retaining wall.

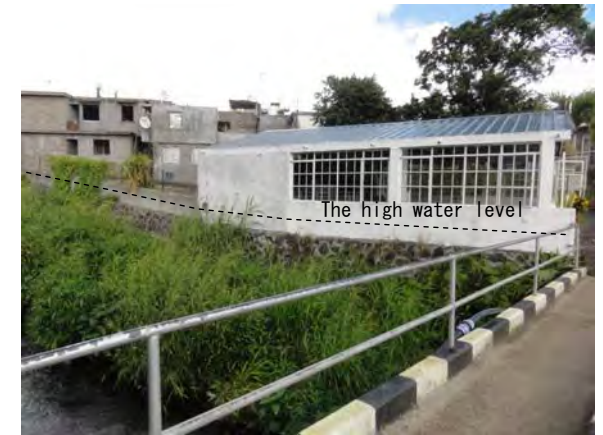
Ph-3 High water level in the rain season

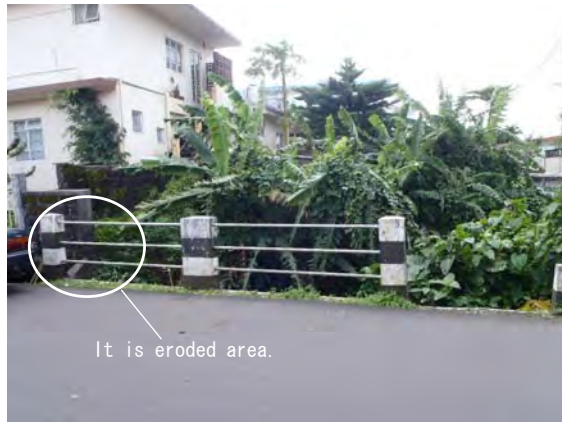
Ph-1 Full view of the river

The bank erosion and flood are common in the rainy season. The base of the houses have been eroded and the retaining wall of the houses are inclined.

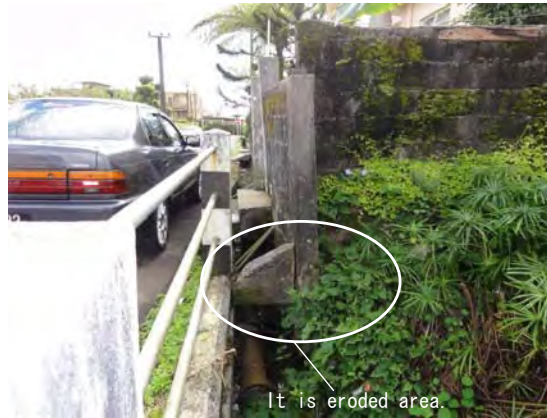
Ph-2 Eroded area

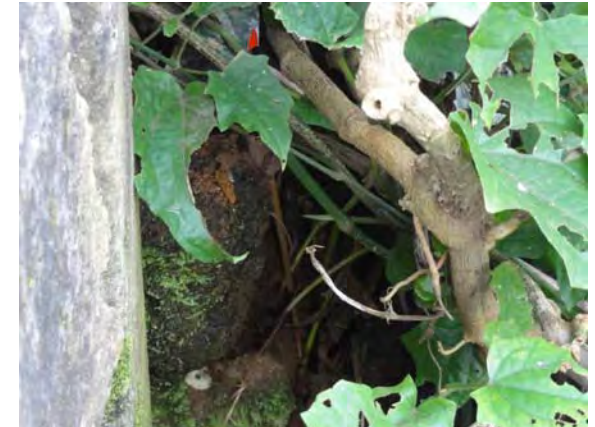
Ph-3 Eroded area (zoom up photo)

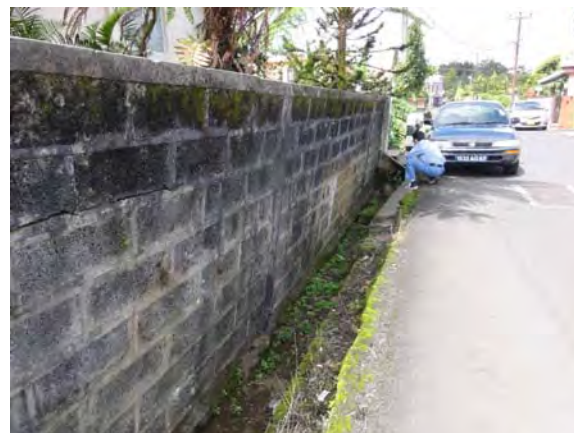
Ph-5 The inclined concrete block wall

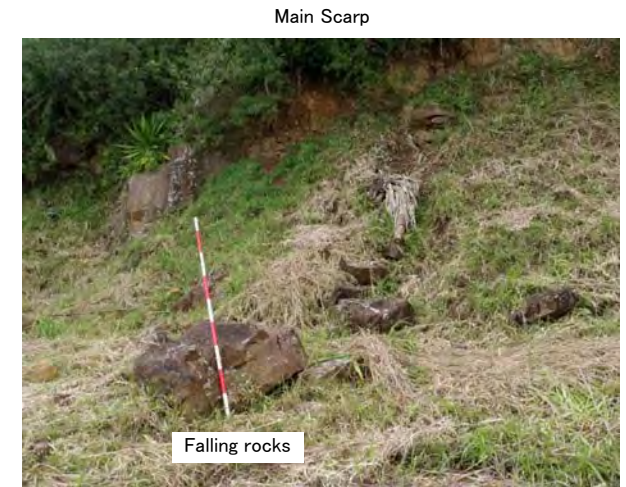
Ph-3 Falling rock

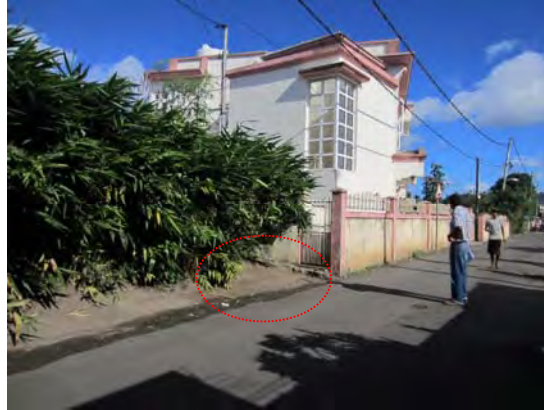
Ph-2 Full view

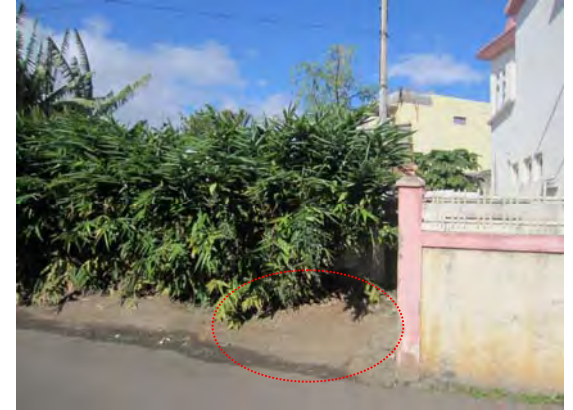
Ph-3 filled cave

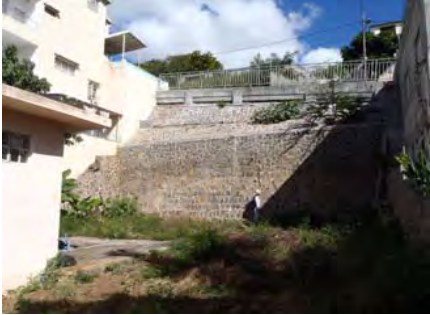
<p>A slope failure occurred and destroyed the road in 2010. A retaining wall was constructed by the local consultant(GIBB) as countermeasure. There are cracks at the upper part of stone block but it is believe to be caused by submerged soil below the stone block. No deformation at the front part of retaining wall and the retaining wall remain stable at present. Further investigation is advisable.</p>		<p>[Resident's awareness and relocation]</p> <p>[Land use restrictions in hazard areas]</p> <p>[Description]</p>

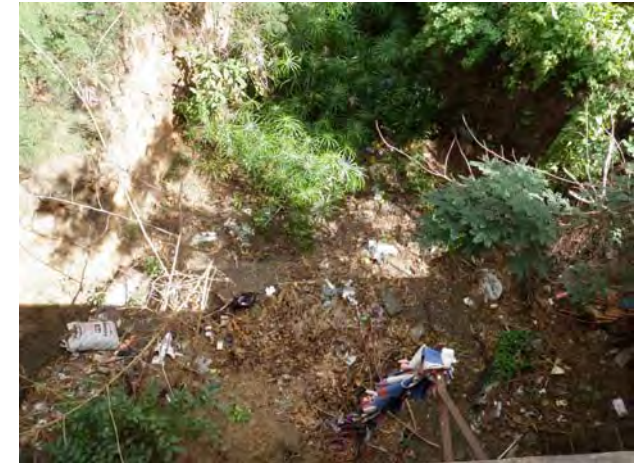
Ph-3 river bed and side erosion
