## 8. Result of Aerial Photograph Interpretation

## Regular Check Sheet

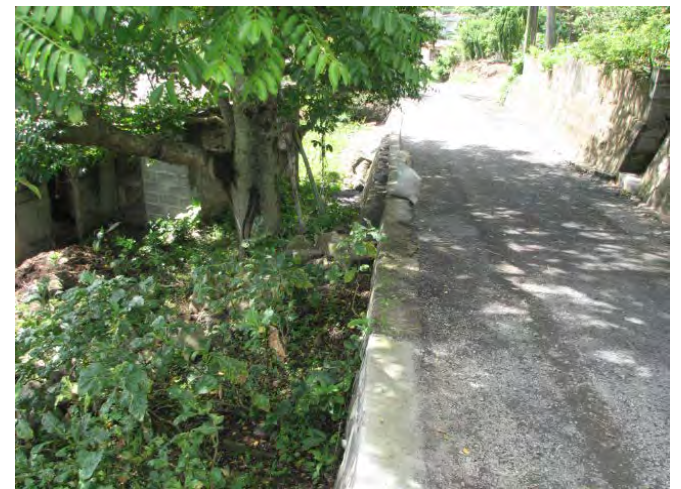
Valley side of the road

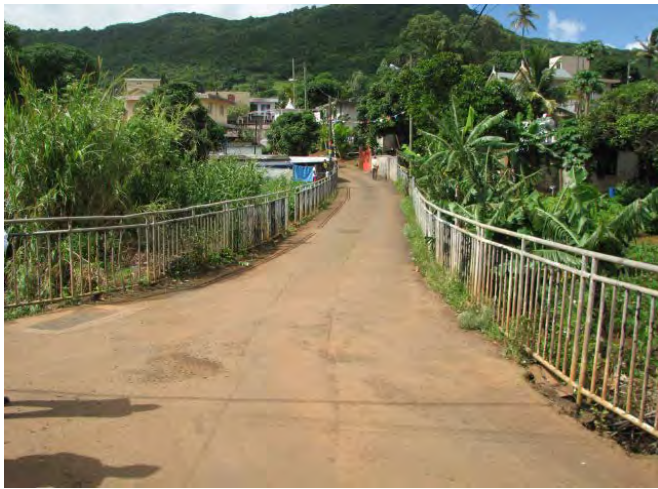
Full view

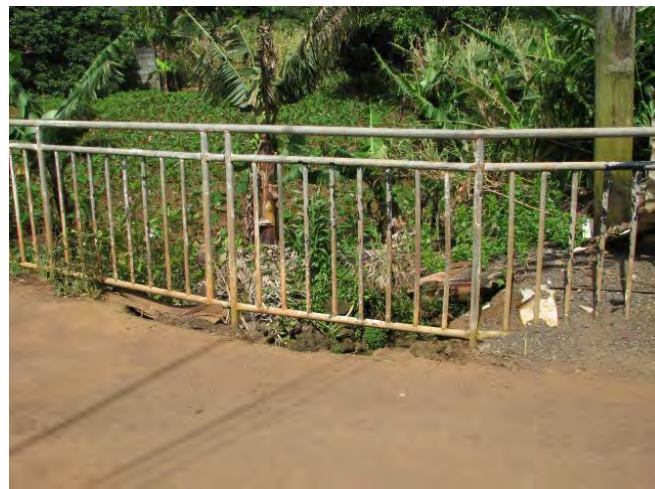
Full view of upper stream

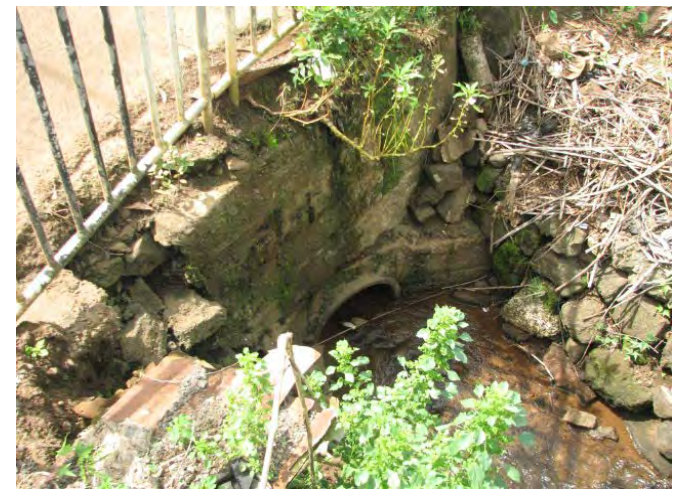
Inlet of upperstream

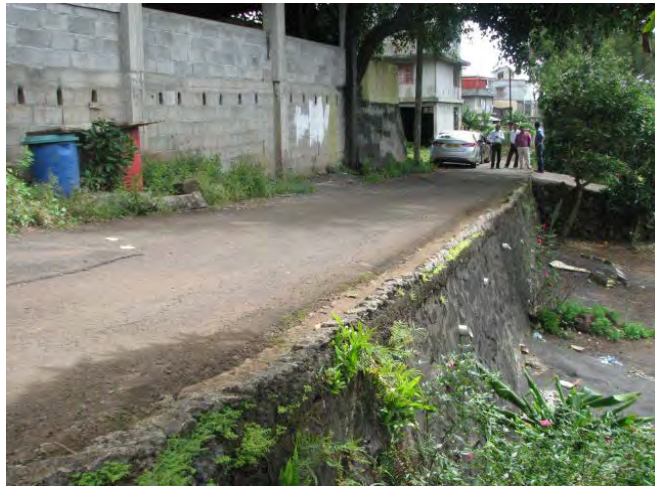
Retaining wall

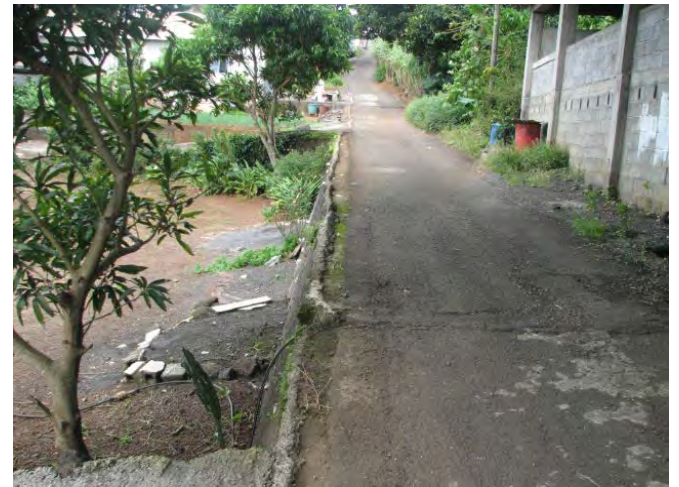
Cross section of retaining wall

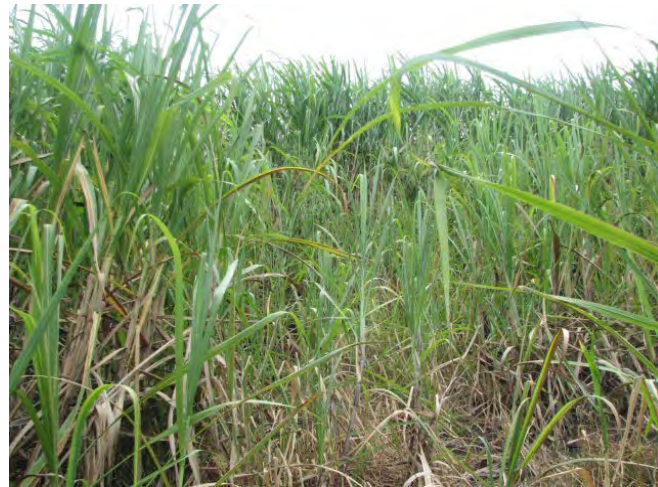
Trace of main scarp

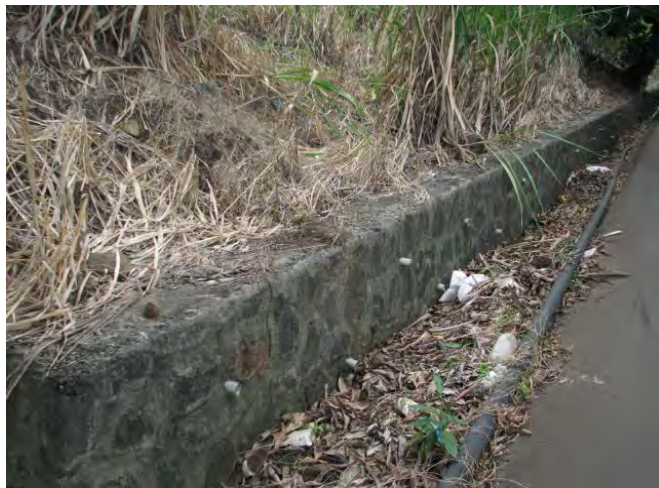
Bottom of the slope

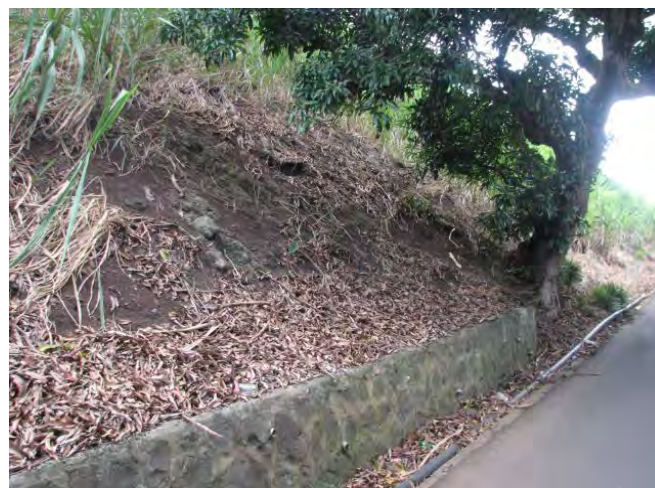
Bottom of the slope

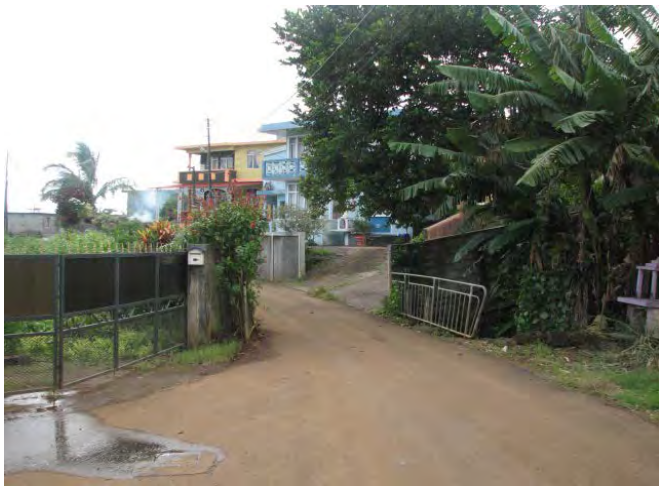
Full view of the river

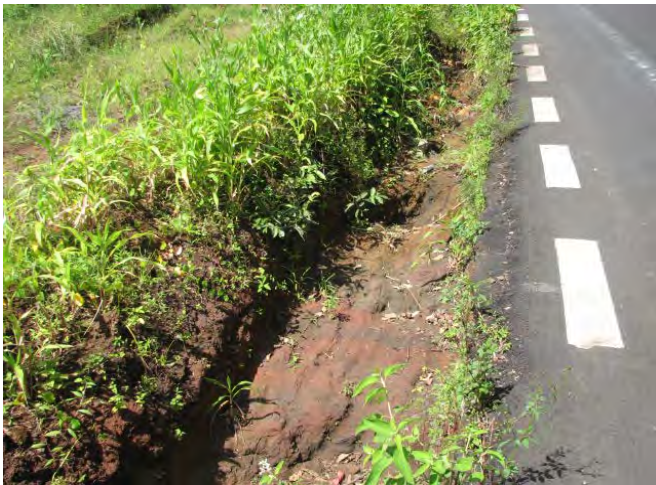
Natural ditch

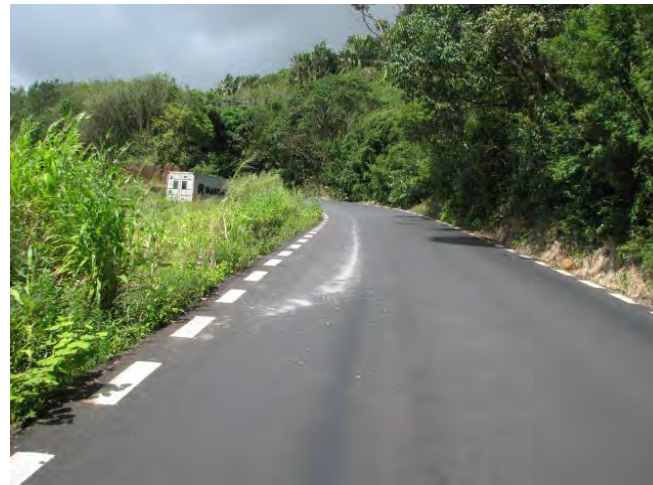
Paved road

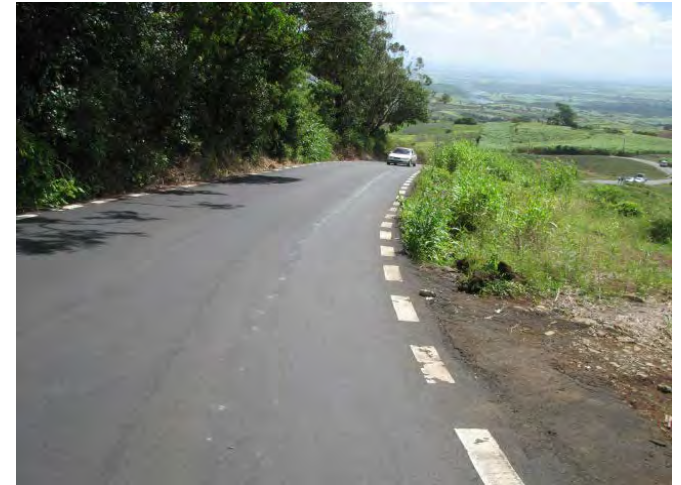
Paved road

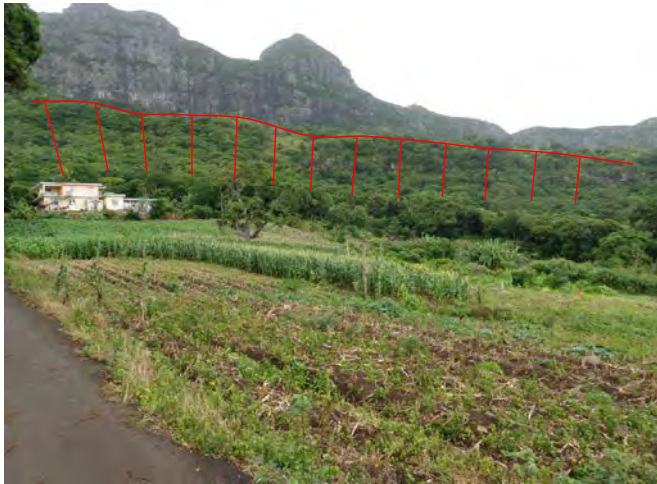
Main scarp

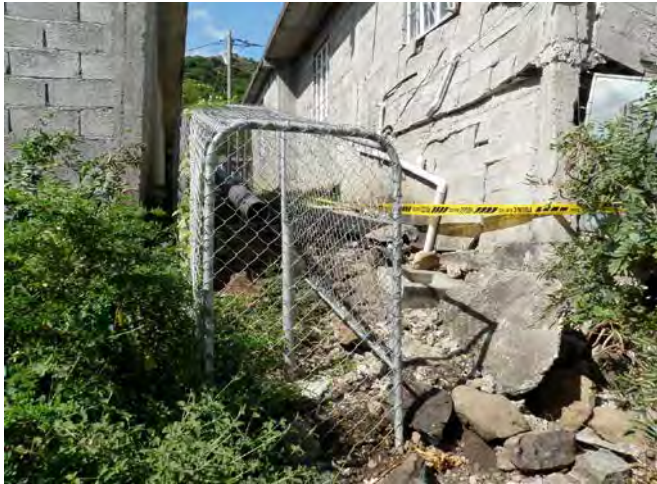
Extensometer set up next to house

Proposed action	Until the completion of countermeasures, monitoring and early warning system should be continuously implemented.						
Purpose of action

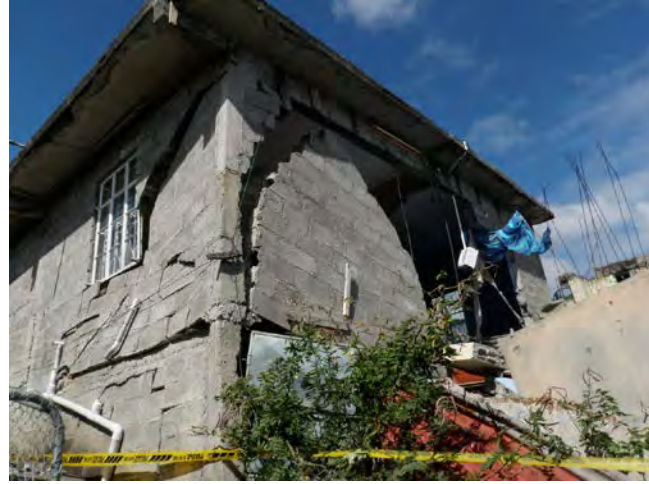
The broken house

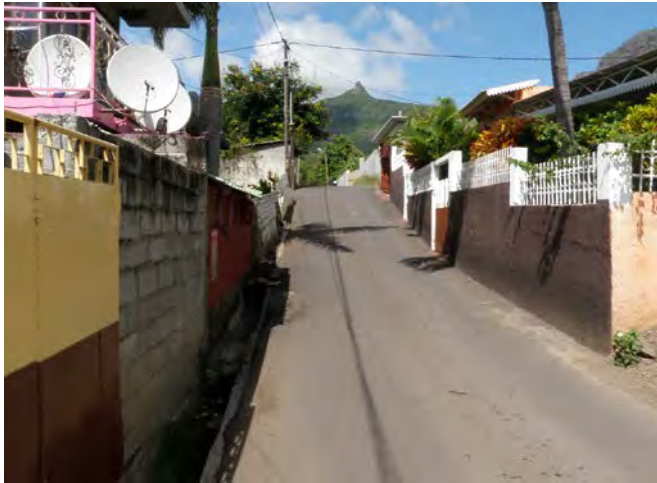
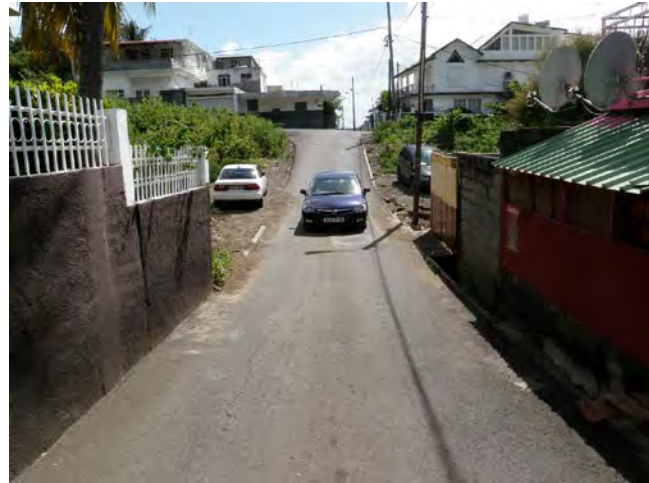
House around the depressions

Management number	010101010111	Disaster	Stream erosion	Area name	LePouce Street		
Date	April 30, 2013						
Reporter's name	Yoji KASAHARA						
Landslide /Slope failure	New failure						
	Swell slope						
	New/enlarged step/cliff						
	New/enlarged crack on slope						
Rockfall	New rockfall						
	Enlarged crack on rock slope						
	Erosion of unstable rock						
Debris flow	Filling up of debris sediment						
	Overflow of debris on road						
	Clogged culvert						
	New failure on river slope						
Spring water	Depleted/decreased spring water						
	Increased spring water						
	New spring water						
	Turbid spring water						
House/road	New/enlarged step/settlement						
	New/enlarged crack						
Counter-measure	Damage/deformation						
	Clogged drainage						
	Overflowed drainage						
Other problem							
Condition	No significant progress.						
Proposed action	It is necessary to construct the ditch of an appropriate scale.

Purpose of action	To prevent the clog of ditches and overflow

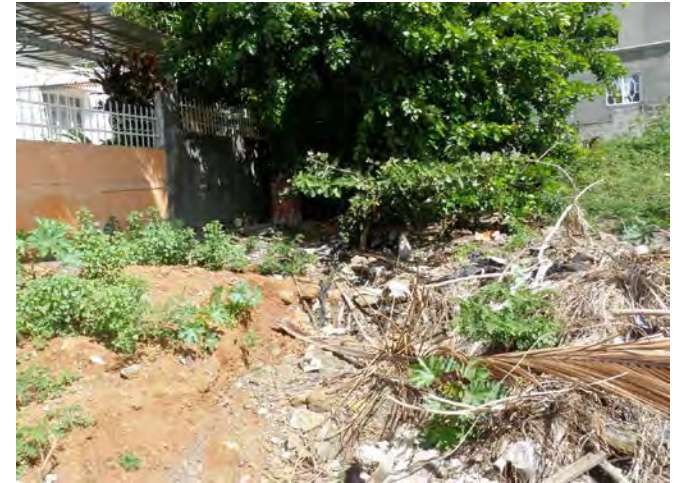
Ditch of the depressions (upstream)

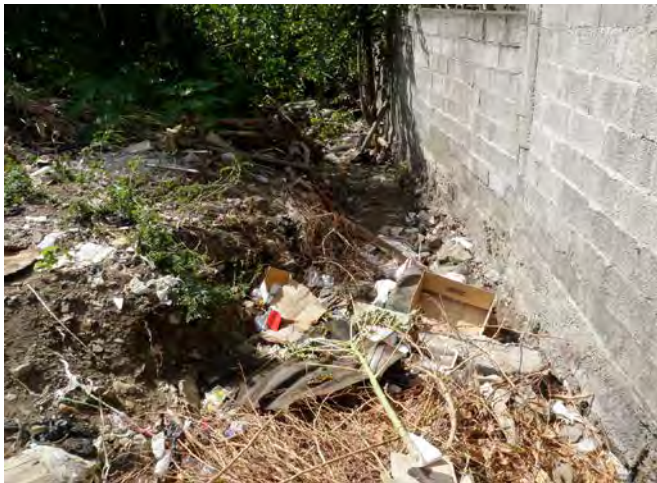
Ditch of the depressions (downstream)

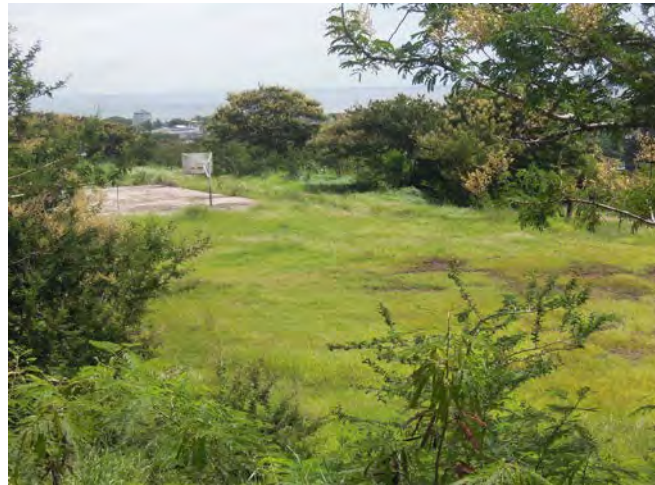
Middle slope of the landslide area. □  
No notable cracks and displacement

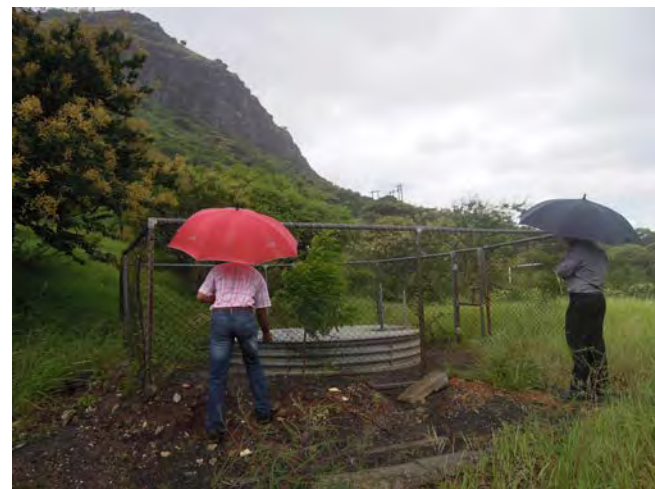
Drainage well.

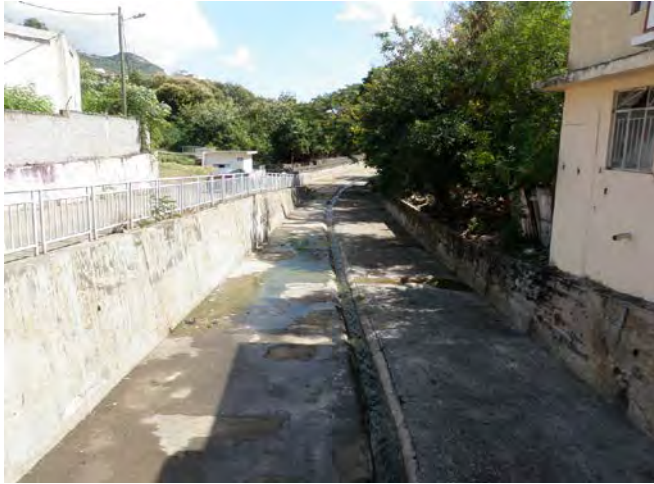
Full view of the channel (Downstream)

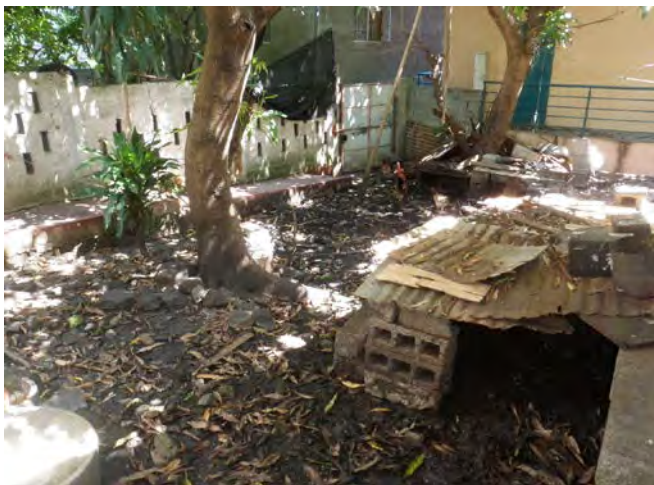
Marsh in front of house of tiptoe of the slope

Proposed action	Artificial structures (drainage, horizontal drainage, etc.) should be constructed on the house						
Purpose of action	To decrease the water level and prevent the deformation

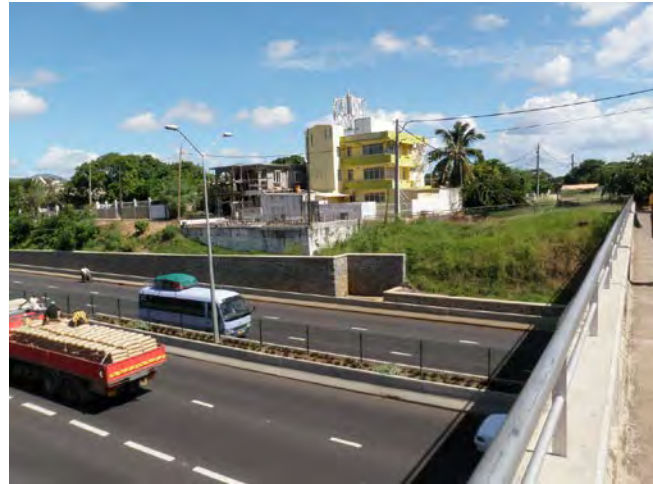
Greened cut slope (No significant progress)

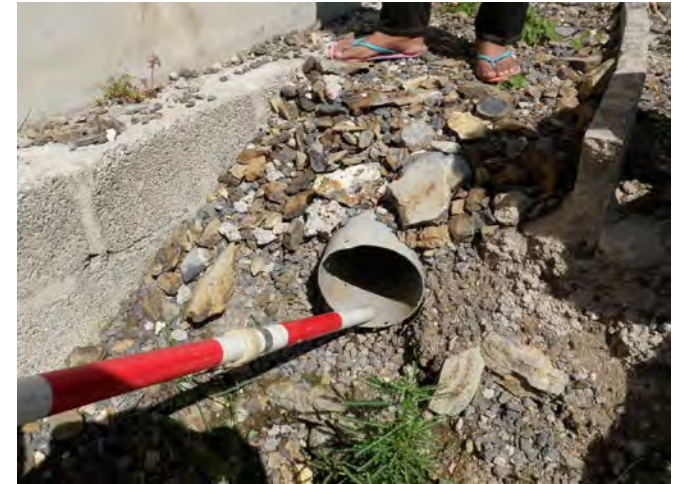
Situation of outlet

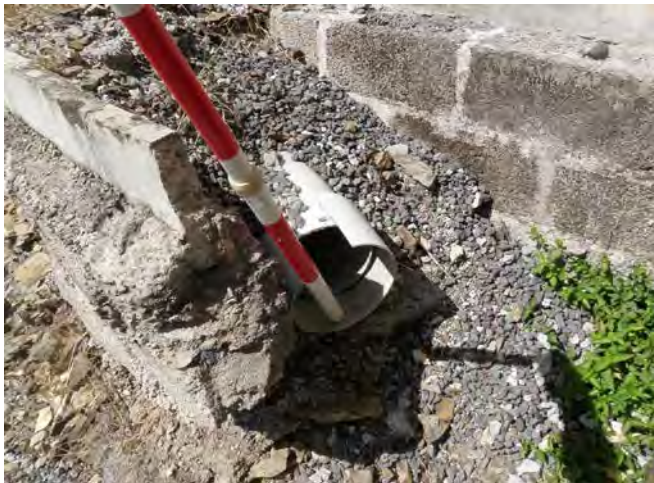
Situation of outlet

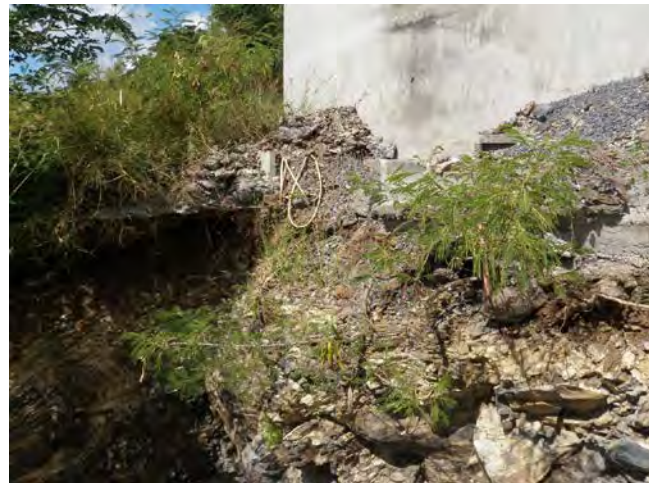
Outcrop of tank foundation

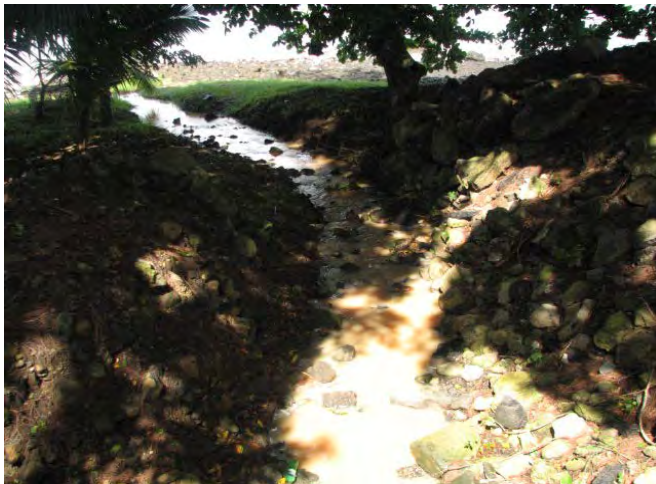
Discharged sediment at the mouth of stream

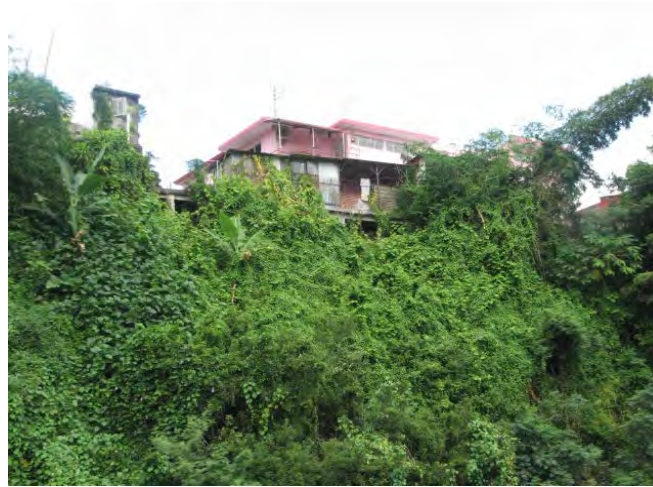
Close view of a house above the cliff

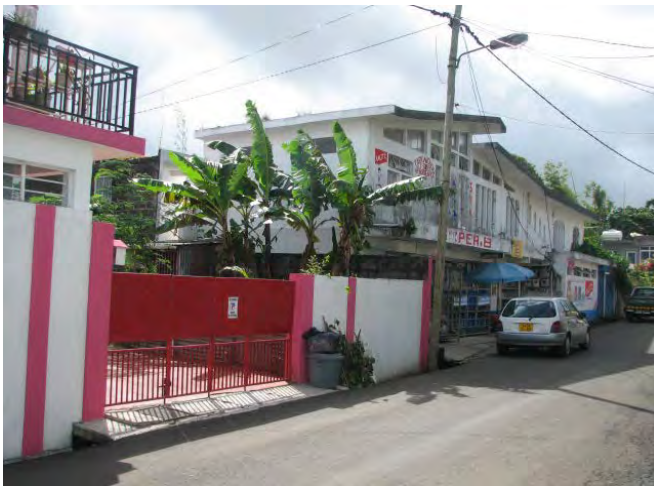
The house above the cliff

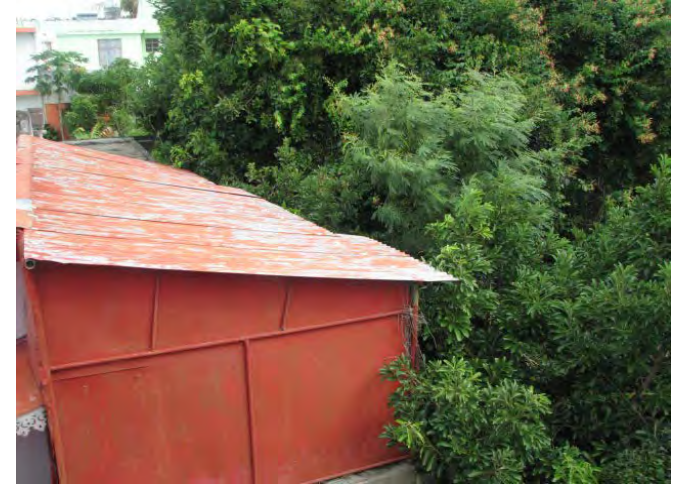
The backside of the house

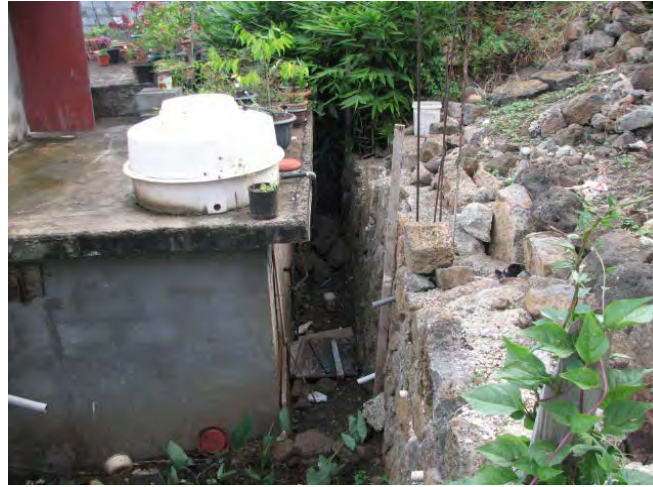
Retaining wall and house

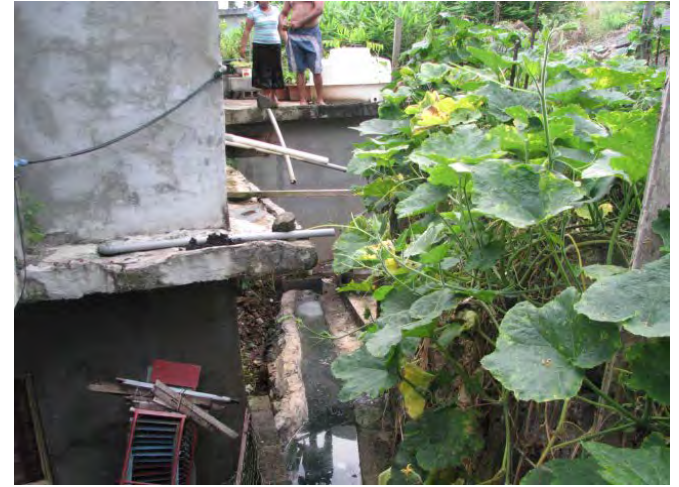
Retaining wall and house

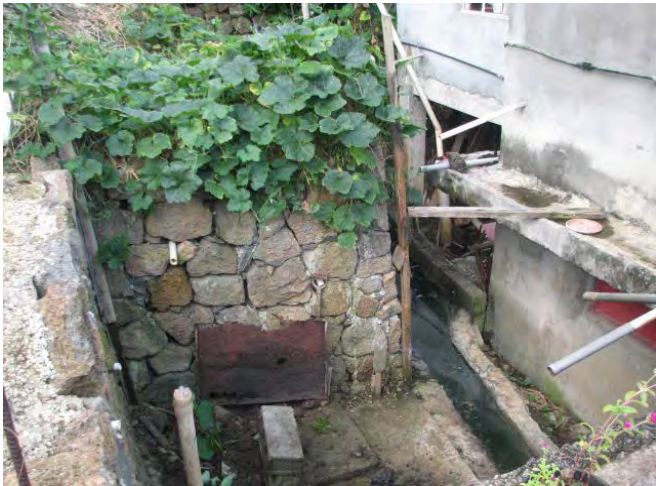
Retaining wall and house

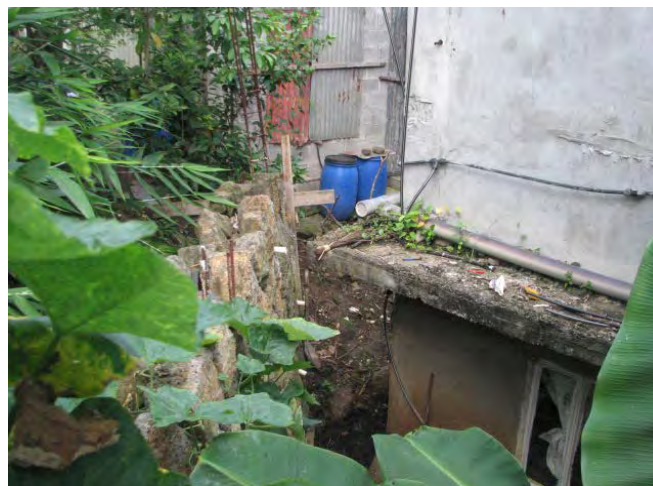
Retaining wall and house

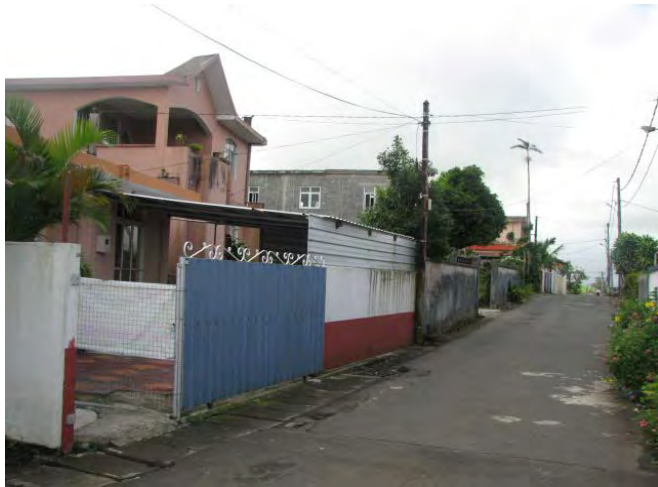
The house which had a cave

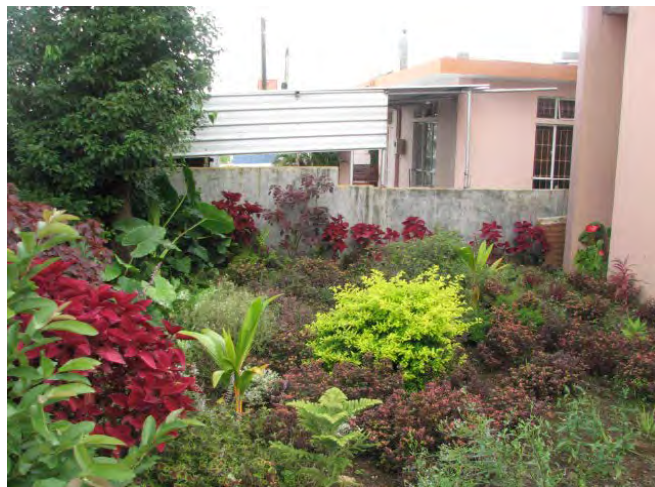
Full view of the cave  
It was already filled

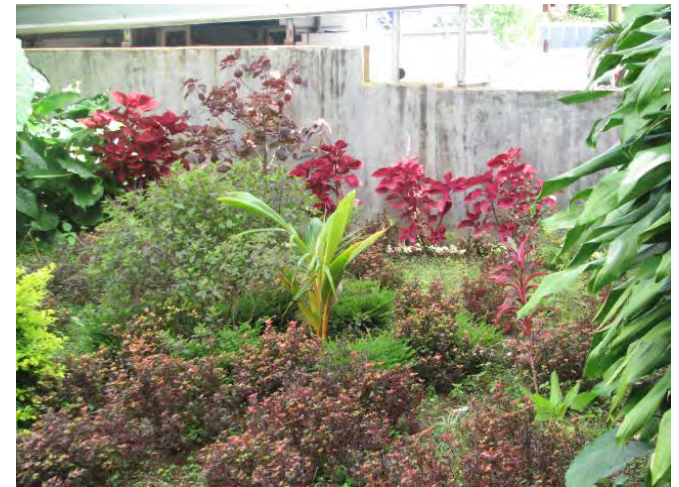
Close view of the cave  
It was already filled

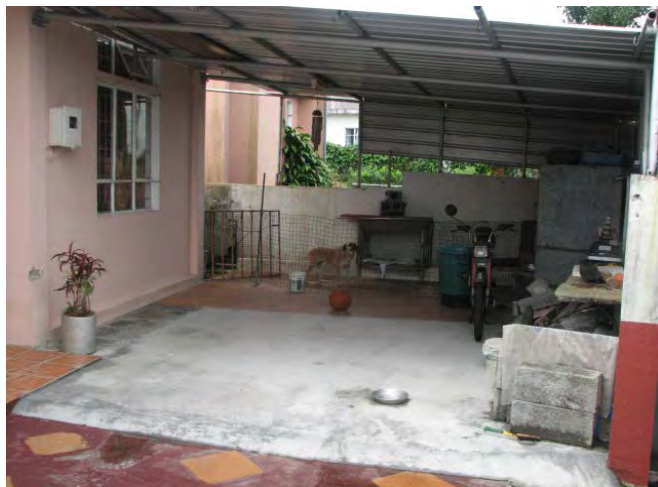
Back side of the cave area

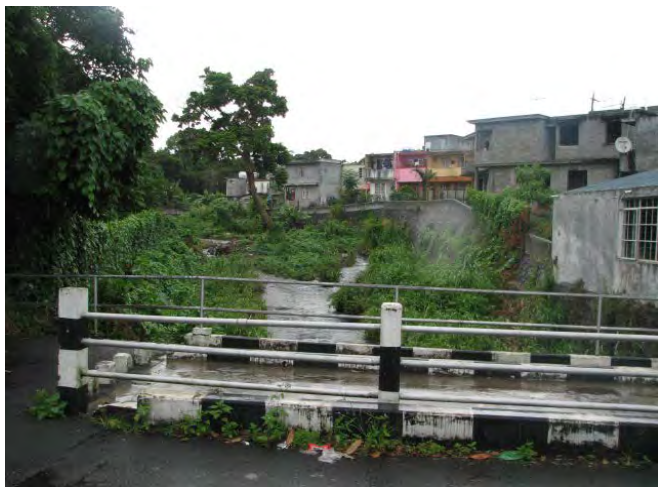
Full view of the river

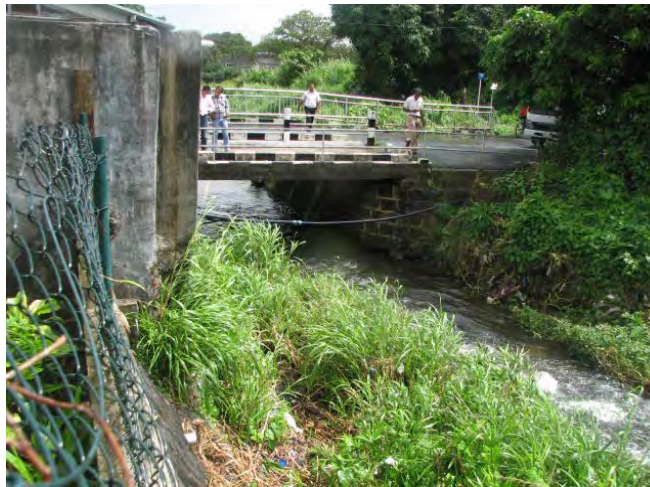
Full view from the upper side of the river

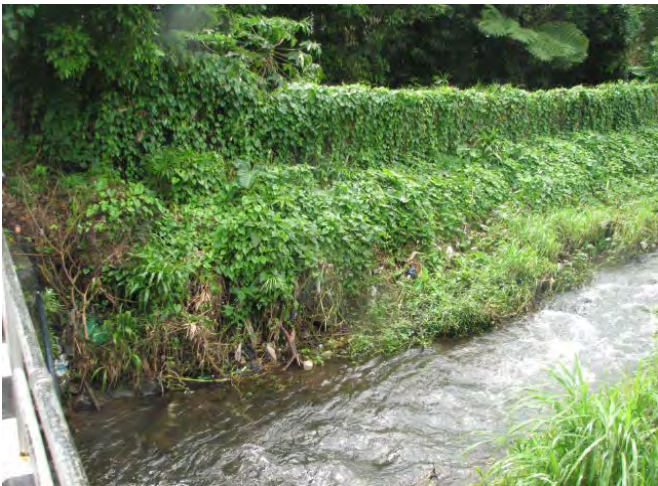
Full view of the right bank

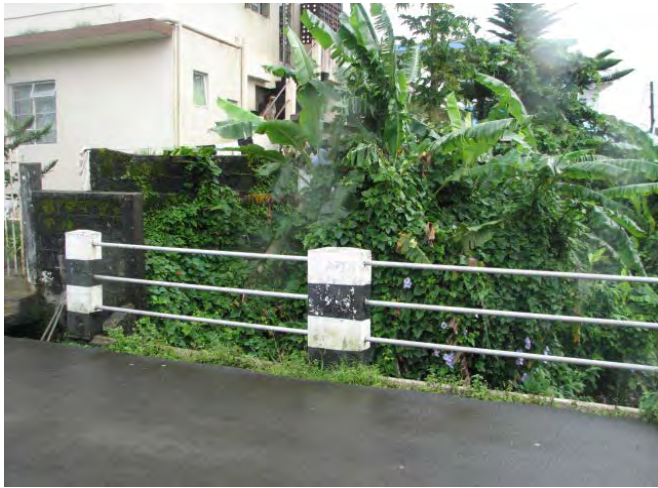
Full view of the river

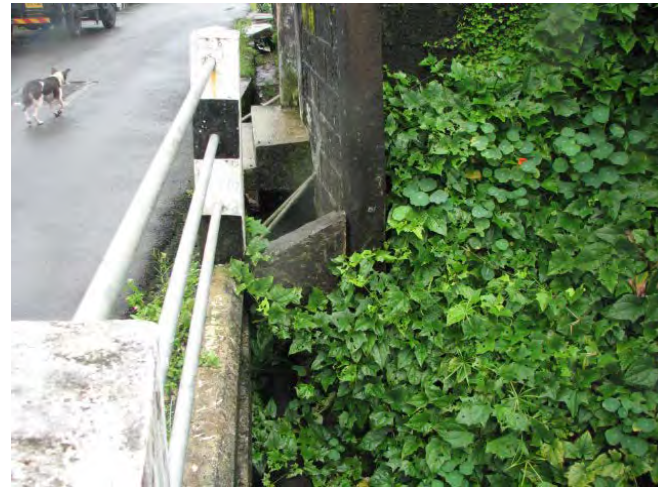
Eroded area

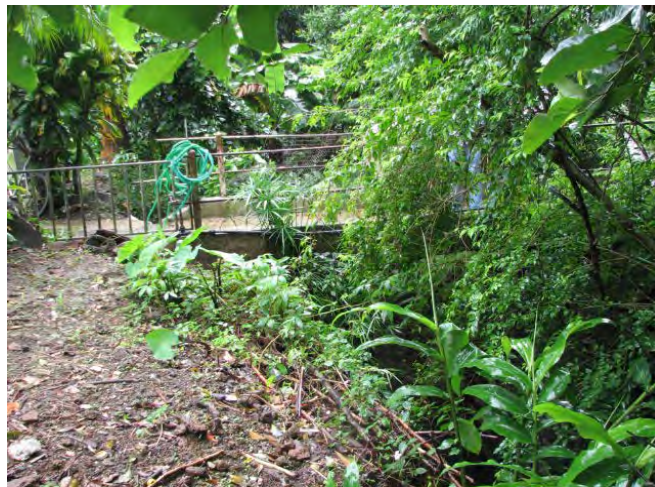
Close view of river bank of the house side

Proposed action	The retaining wall should be repaired.						
Purpose of action	To avoid further collapse on house side.

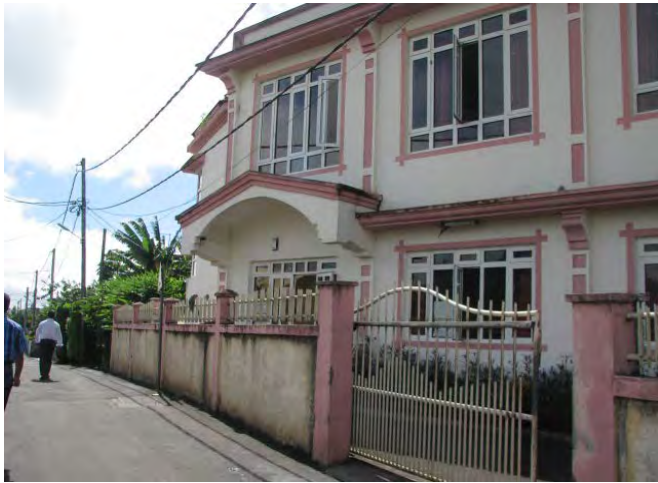
Full view

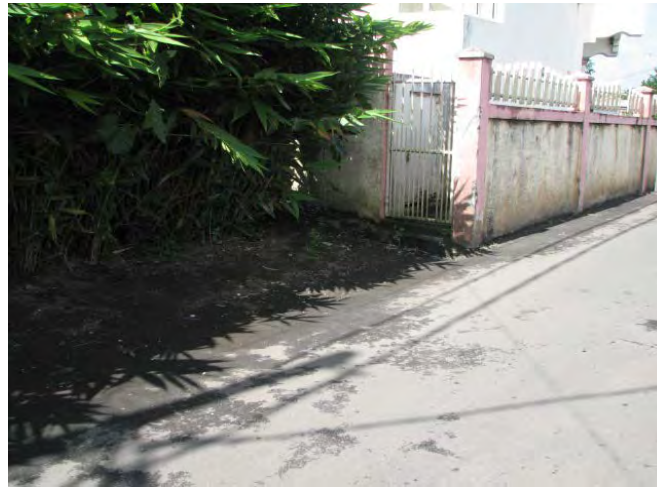
Full view

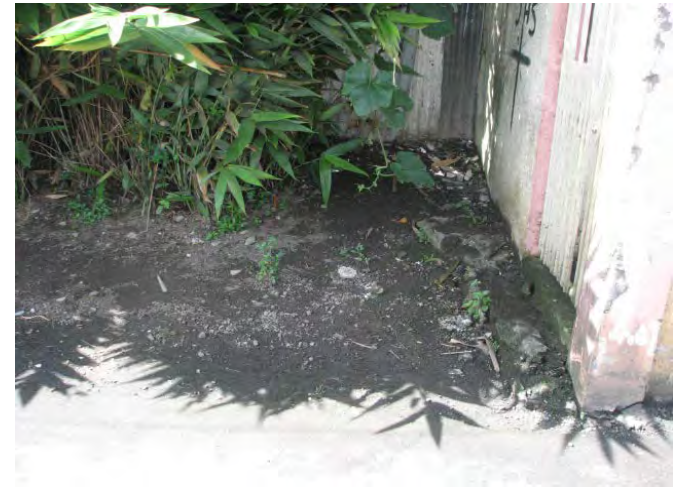
Filled cave

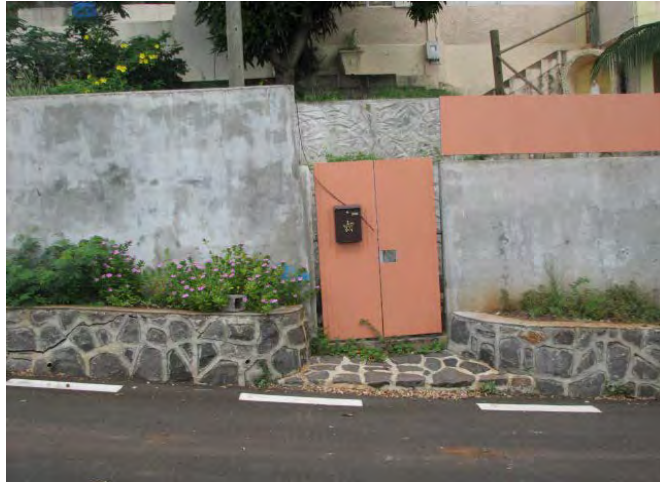
Damege on house

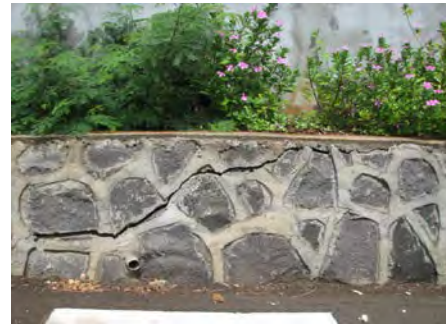
Cracks around the house
