**The Project for
Improvement of Road Technology
in Disaster Affected Area in Myanmar**

**Technical Note on National Highway
& Expressway**

(Geometric Structure & Traffic Safety Facility)

June 2015

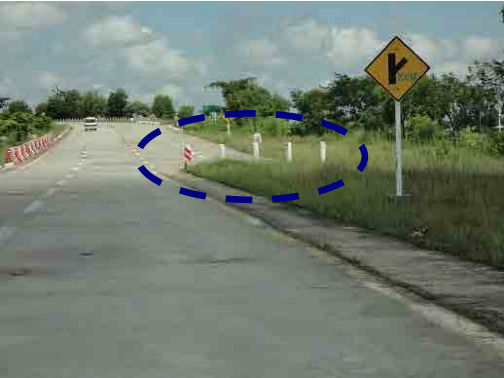
No.	Observation & Effect (If Neglect)	Photo	
1	<p>(Observation) - Concrete objects remain existed.</p> <p>(Effect) - Risk of accident (collision) will increase due to the existence.</p>

Concrete posts at beginning of ramp section.	Concrete blocks at end of widening section.

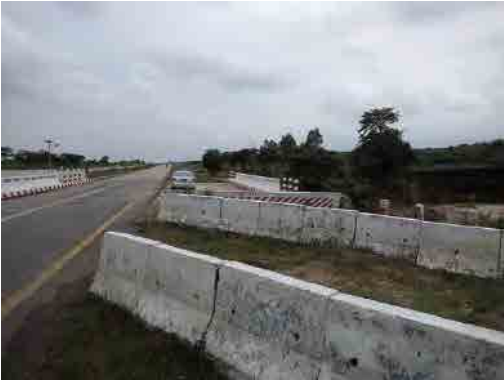
Concrete walls in front of widened bridge.	Former parking area (?)

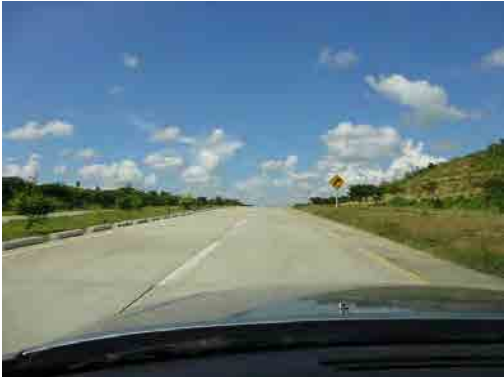
No.	Observation & Effect (If Neglect)	Photo	
1	<p>(Observation) - Insufficient sight distance.</p> <p>(Effect) - Risk of accident will increase as stated in right columns.</p>

<p>Insufficient sight distance due to small vertical curve in expressway. Risk of rear-end collision.</p>	<p>Insufficient sight distance due to inappropriate vertical alignment in National Highway No.4. Risk of a head-on collision.</p>
2	<p>(Observation) - Small horizontal curve in mountainous section.</p> <p>(Effect) - Risk of accident will increase as stated in right columns.</p>	 	 
		<p>Small horizontal curve in mountainous section. Passing with long body size vehicle is very difficult.</p>	<p>Small horizontal curve and insufficient visibility. Risk of a head-on collision and/or a fall accident.</p>

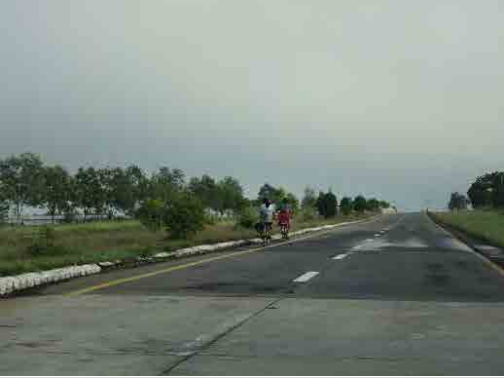
No.	Observation & Effect (If Neglect)	Photo	
1	<p>(Observation) - Road users in various categories do not comply with authorized traffic rule.</p> <p>(Effect) - Risk of secondary accident will increase as stated in right columns.</p>

<p>Riding bicycle on carriageway in expressway. Firstly, risk of accident against human. Vehicle also will be suffered secondary accident due to action to avoid bicycle.</p>	<p>Excessive numbers of passengers on open roof vehicle in expressway. Risk of accident for fallen passengers. Vehicle also will be suffered secondary accident due to action to avoid passenger.</p>

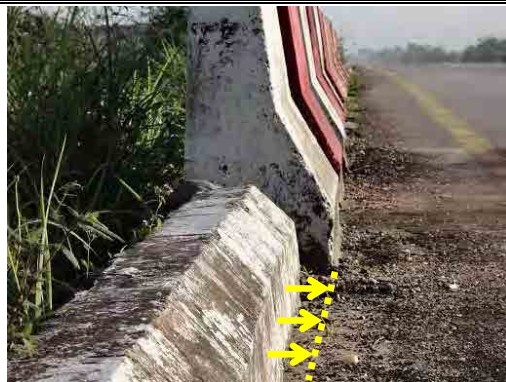
<p data-bbox="851 702 1377 726">Parapet wall and curb stone</p>

No.	Proposal	Photo	
1	<p>(Observation) - The furniture is not located in a straight line each other.</p> <p>(Proposal) - Relocate furniture to uniform front face in a straight line.</p> <p style="text-align: right;">Practicability: A</p>

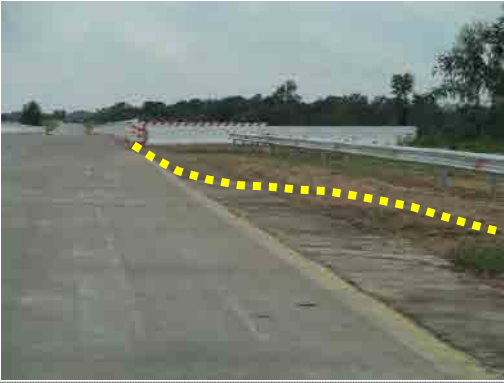
No.	Proposal	Photo	
3	<p>(Observation) - Inappropriate alignment/location of guardrail.</p> <p>(proposal) - Realignment and/or relocation of guardrail.</p> <p style="text-align: center;">Practicability: A</p>

<p style="text-align: center;">Realignment.</p>

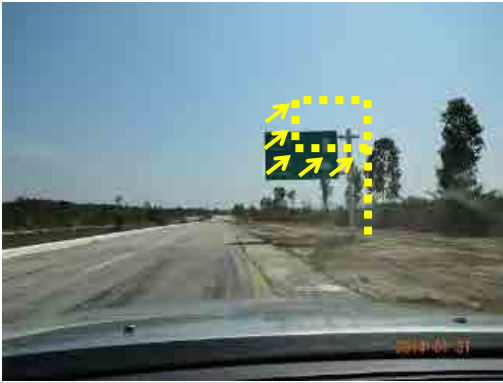
No.	Proposal	Photo	
5	<p>(Observation) - Object is installed within road clearance limit.</p> <p>(Proposal) - Relocate object to out of limit.</p> <p style="text-align: right;">Practicability: see right columns</p>

<p>Sign board. Practicability: A</p>

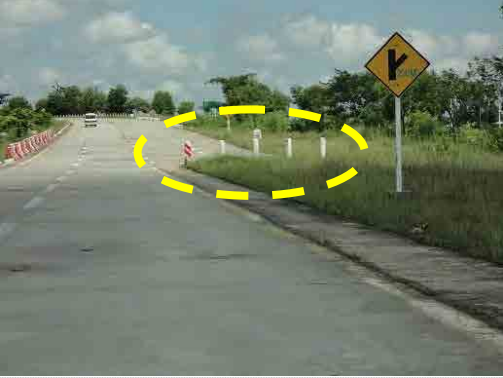
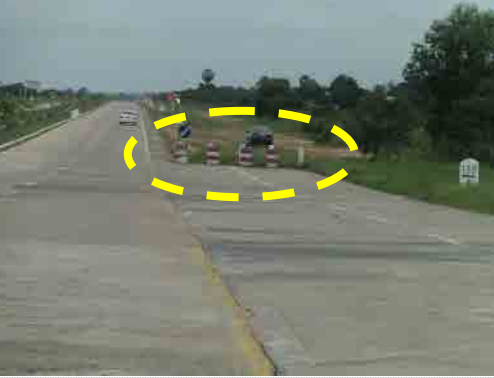
No.	Proposal	Photo	
1	<p>(Observation) - Concrete objects remain existed.</p> <p>(Proposal) - Remove the object. - Temporary barrier (non-hard material) with reflector will be installed to mitigate collision impact if indication is necessary.</p> <p>Practicability: A</p>

Concrete posts will be removed.	Concrete blocks will be removed.

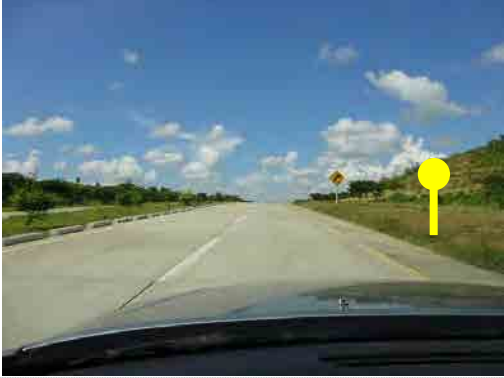
No.	Proposal	Photo	
1	<p>(Observation) - Insufficient sight distance.</p> <p>(Proposal) - Reconstruction to improve vertical alignment. (Desirable case) - Install traffic sign for warning. (Secondary case)</p> <p>Practicability: C for desirable and A for secondary</p>

<p data-bbox="853 707 1391 767">Unforeseen situation (e.g. parking car) after top of crest will be warned by the sign.</p>

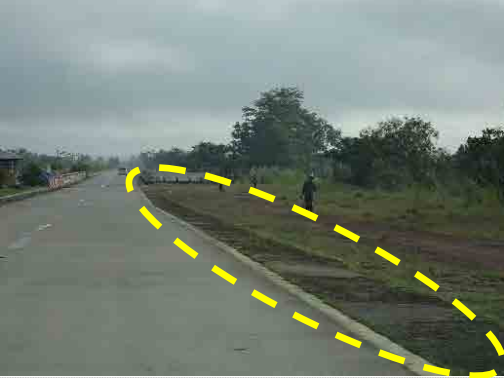
No.	Proposal	Photo	
1	<p>(Observation) - Insufficient maintenance work.</p> <p>(Proposal) - Frequent work implementation.</p> <p style="text-align: center;">Practicability: A</p>

<p style="text-align: center;">Debris clearing work.</p>

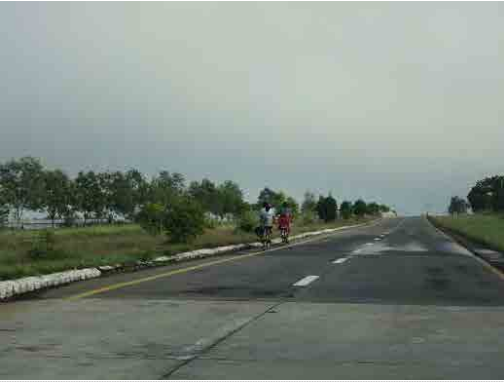
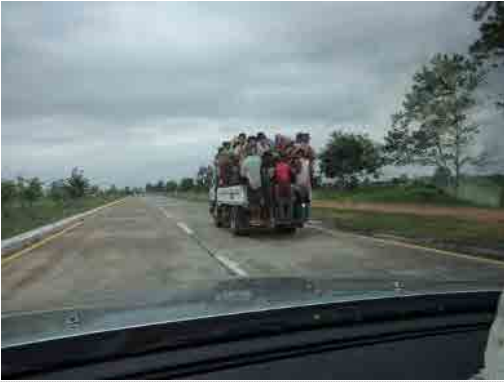
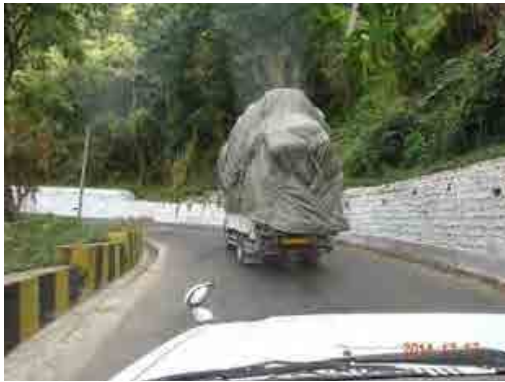
No.	Proposal	Photo	
1	<p>(Observation) - Road users in various categories do not comply with authorized traffic rule.</p> <p>(Proposal: desirable) - Reinforce penal regulation. (Difficult to obtain consensus in the parliament.) - Access control to expressway. (Construction cost for the control facility will be very large.)</p>

<p>Riding bicycle on carriageway in expressway.</p>	<p>Excessive numbers of passengers on open roof vehicle in expressway.</p>
<p>Height of cargo is too high.</p>

<p>(Proposal: secondary) - Public awareness campaign for dissemination of traffic manner to be complied by all road users through several media and/or town meeting. (Take time and cost for the campaign in moderate level.)</p> <p>Practicability: C for desirable and B for secondary</p>

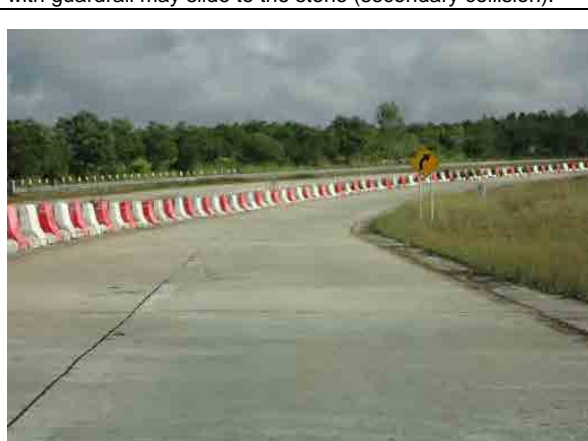
<p>Ph.15 Radius of horizontal curve seems smaller as expressway's one.</p>	<p>Ph.16 Radius of horizontal curve seems smaller as expressway's one.</p>

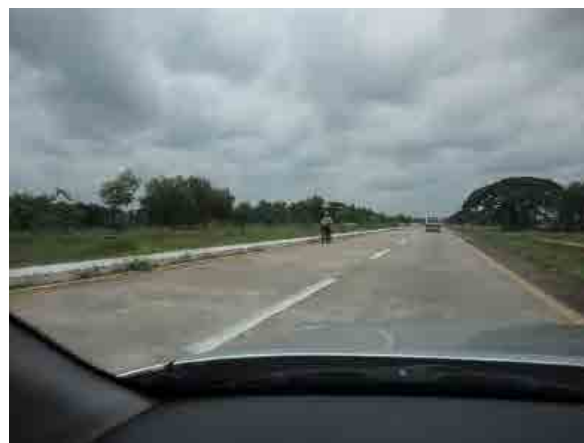
Ph.66 Prohibited traffic manner (driving motorcycle on reverse direction).

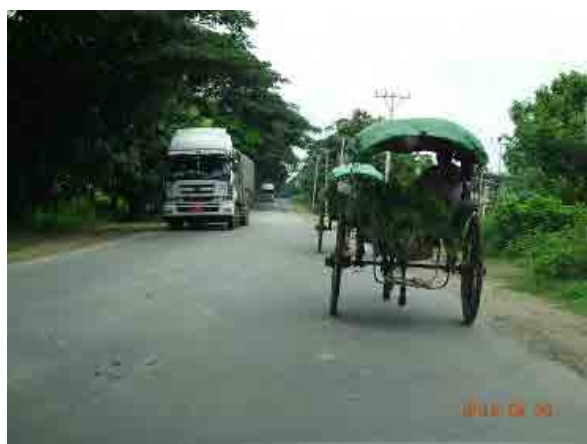
Ph.83 Large vehicles and wagons are coexisting.

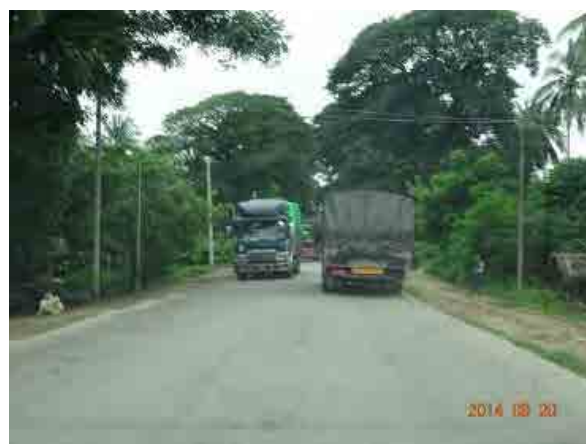
Ph.84 Large numbers of heavy vehicles.

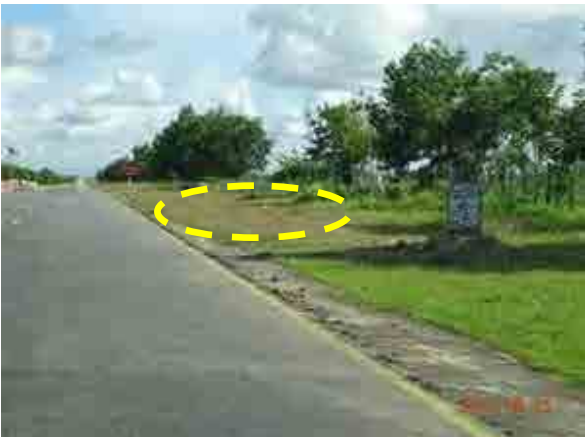
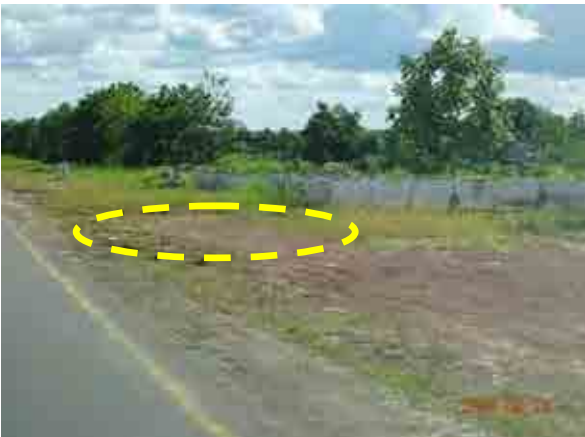
<p>Ph.131 Concrete wall was removed (good action).</p>	<p>Ph.132 Concrete wall was removed (good action).</p>

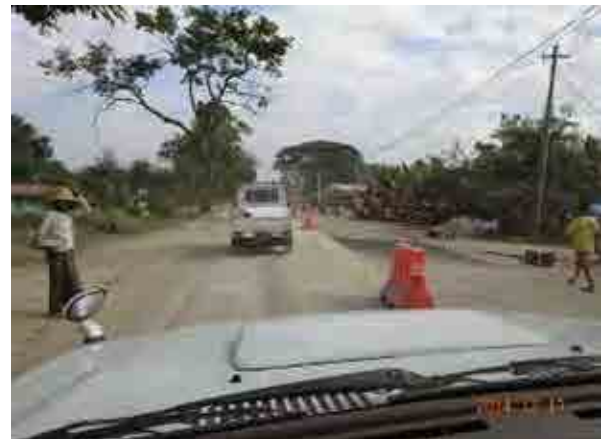
Ph.146 Pavement rehabilitation work.

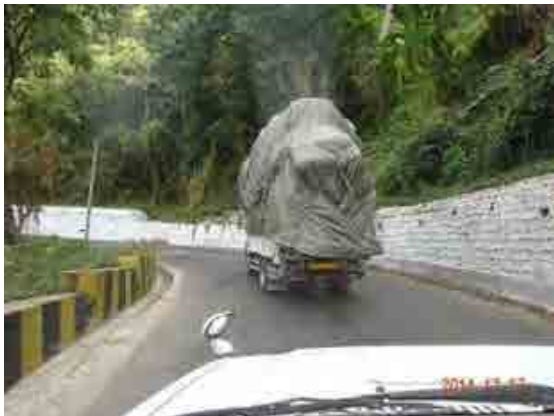
Ph.147 Height of cargo is too high.

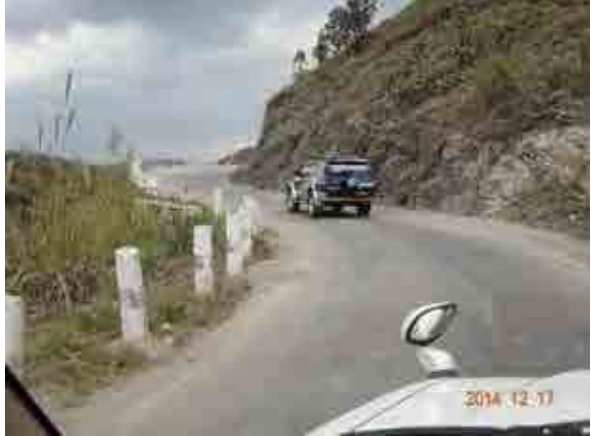
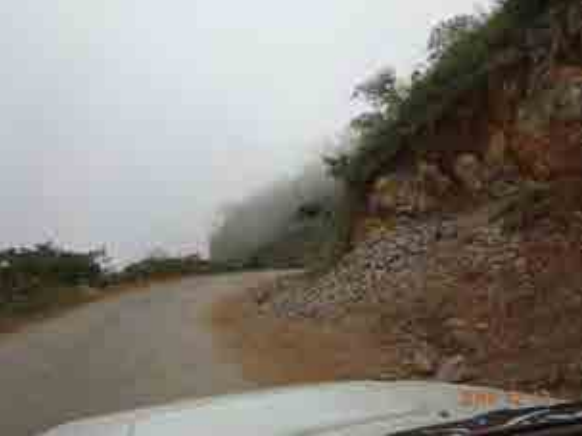
<p>Ph.151 Mountainous section requires guardrail instead of guide posts (Taunggyi – Loilem section).</p>	<p>Ph.152 No post/guardrail section may increase a risk of fall accident.</p>

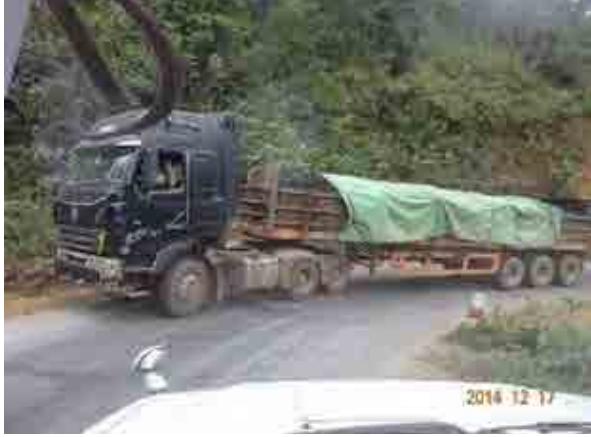
<p>Ph.153 Very difficult for passing with long body size vehicle.</p>	<p>Ph.154 This road constitutes a part of Asian Highway (AH-2). Many cargo vehicles are traveling on this road.</p>

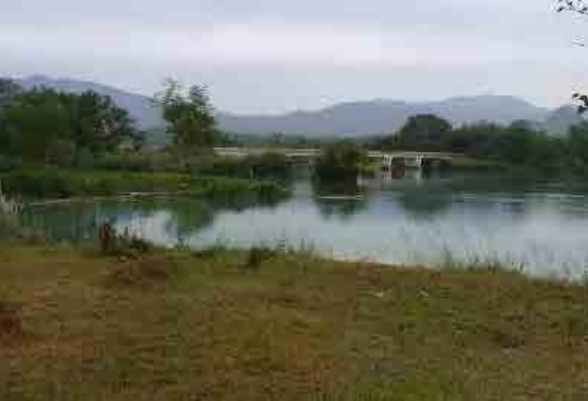
<p>Ph.165 Bridge over Nan Pun River in Kunhing.</p>	<p>Ph.166 Kunhing town area. White station wagon is the guard dispatched from police.</p>

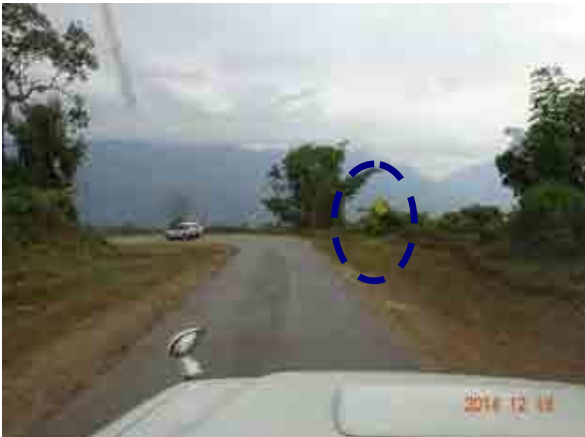
<p>Ph.167 Road (Kunhing – Takaw section).</p>	<p>Ph.168 Sight distance is not enough. Mirror should be installed on curve.</p>
