3.2. Bohol Province

3.2.1. Tagbilaran

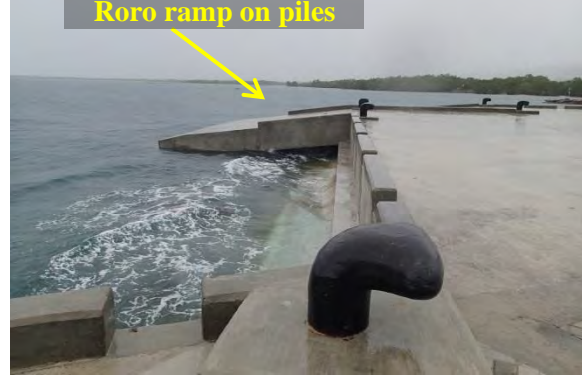
<p>Roro ramp on piles</p>
<p>Figure No.5 Back-up area paved with ILB</p>	<p>Figure No.6 Figure shows the newly rehabilitated ro-ro ramp.</p>

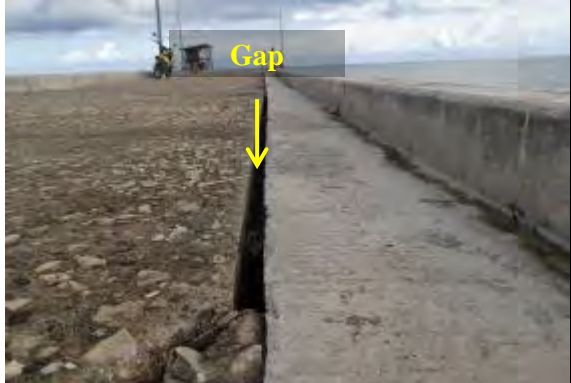
<p align="center">Figure No.4 Damaged grouted riprap at the Right side of the causeway.</p>	<p align="center">Figure No. 5 Gap between concrete pavement and curb, due to lateral movement of the structure.</p>

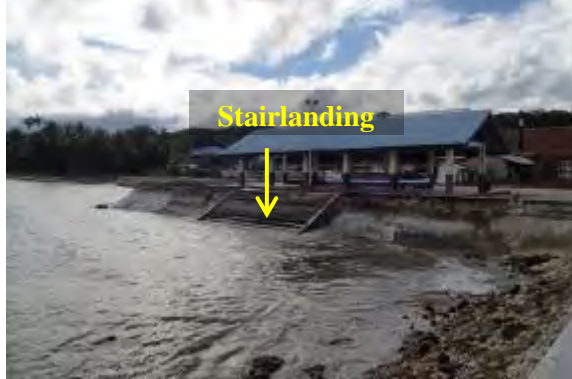
<p align="center">Figure No.8 Banca/Stairlanding in front of Market/Auction Hall</p>	<p align="center">Figure No. 9 Existing Market/Auction Hall.</p>

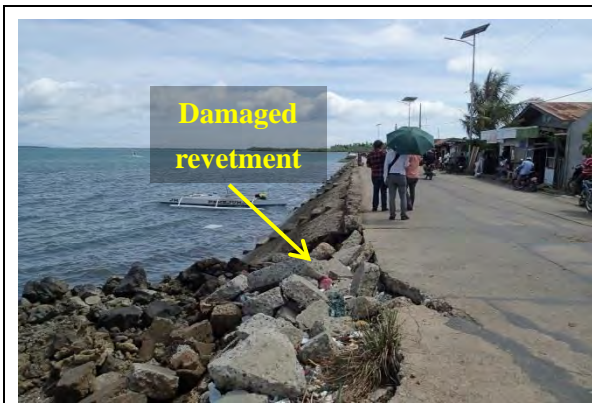
Figure No.2
Existing Causeway

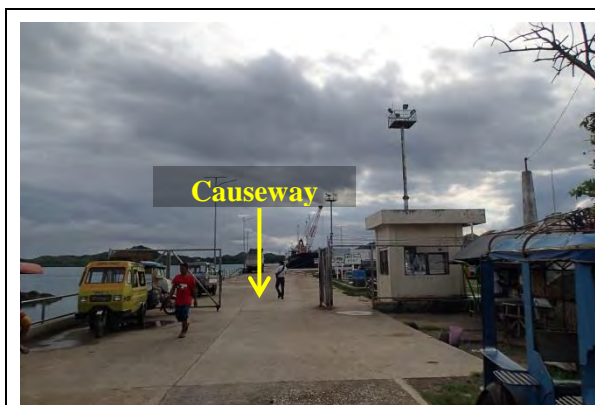
Figure No.2
Existing Causeway and the Port Entrance

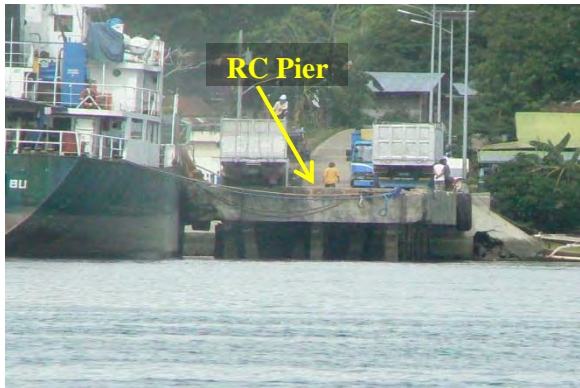
<p align="center">Figure No.12 Tip of RC Pier.</p>	<p align="center">Figure No.13 Left side elevation and tip of RC Pier.</p>

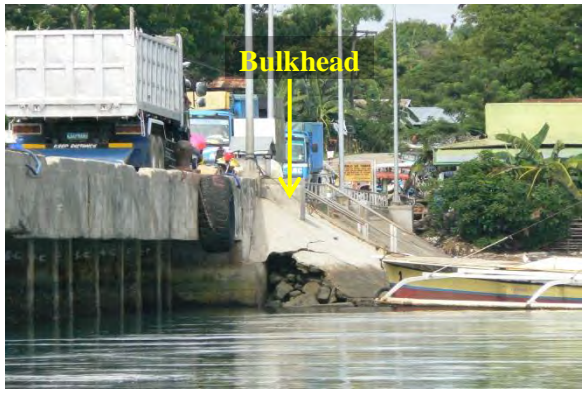
<p>Figure No.14 Bulkhead of existing causeway.</p>	<p>Figure No.15 RC Piles at the tip of RC Pier</p>

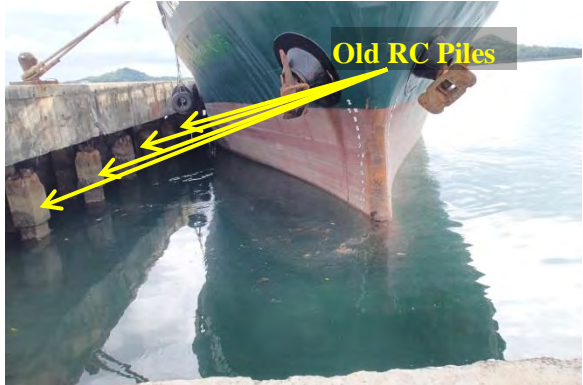
<p>Figure No.16 Old RC Piles (Condemned RC Piles) along the right side of RC pier.</p>	<p>Figure No.17 New RC Piles and Condemned RC Piles.</p>

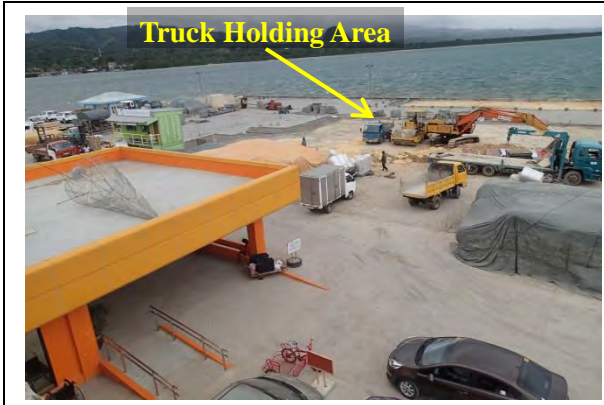
Truck Holding Area

Figure No.4
Backup area of the port.

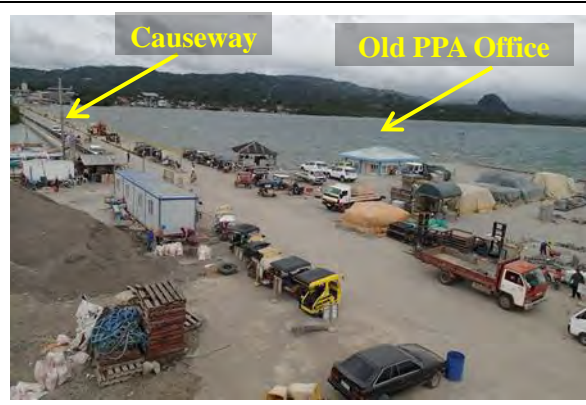
Causeway

Figure No.5
Rock causeway and the old PPA office.

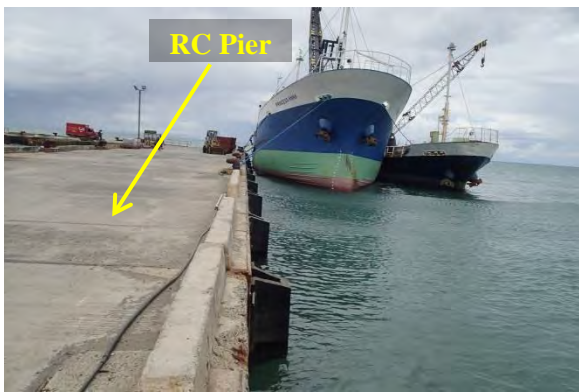
RC Pier

Figure No.6
Conventional berth (Right Side)

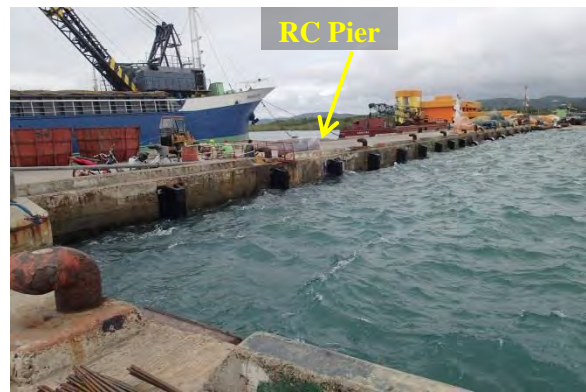
RC Pier

Figure No.7
Conventional berth (Left Side)

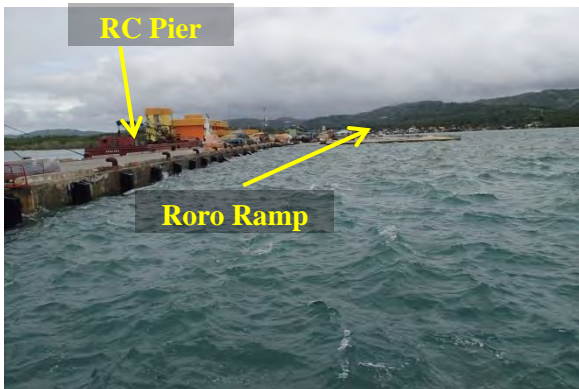
RC Pier

Figure No.8
Roro berth

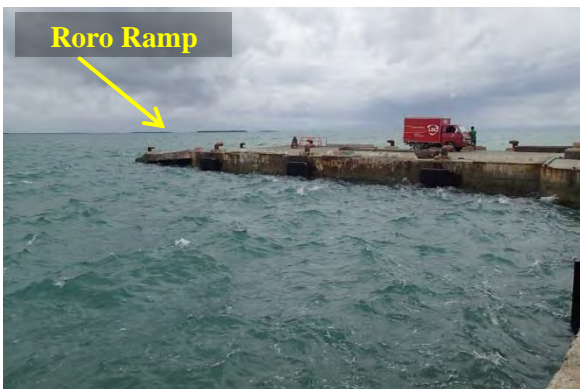
Roro Ramp

Figure No.9
Roro Berth

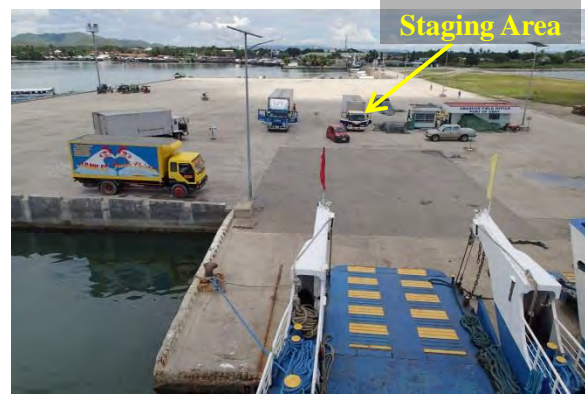
Figure No.9
Staging area/ Back –up area.

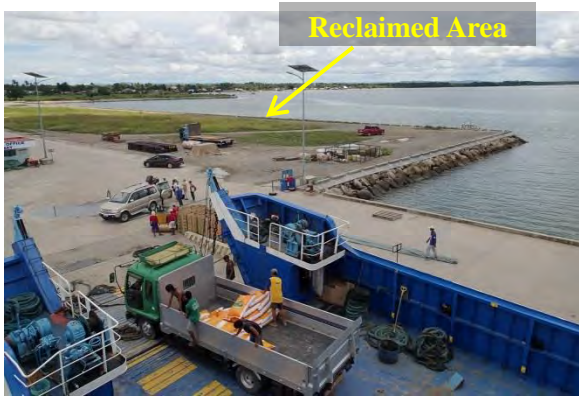
Figure No.10
Reclaimed Area

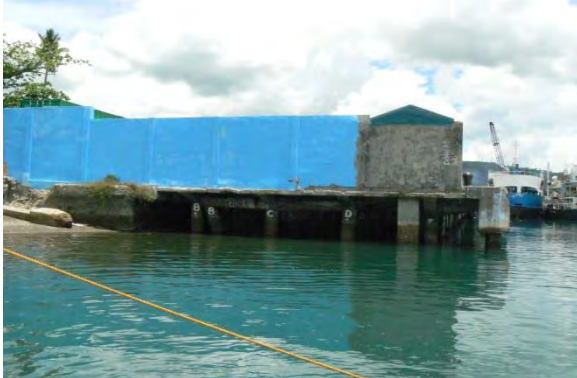
<p>Figure No.19 Photo shows the Pile foundation of RC Wharf at NE side of the port.</p>	<p>Figure No.20 Checking the inclination of the Batter Pile foundation of RC Wharf at NE side of the port.</p>

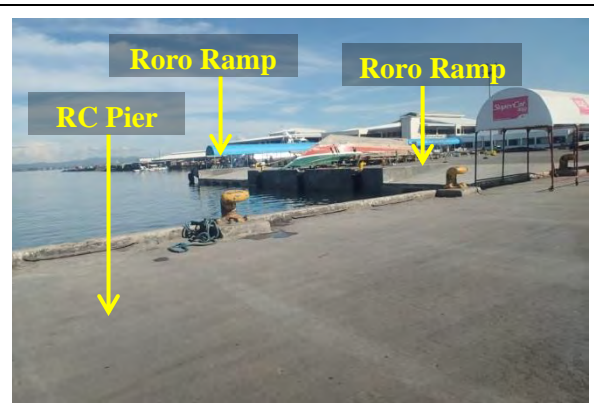
Figure No.6

Photo shows the 2-units of RoRo ramp.

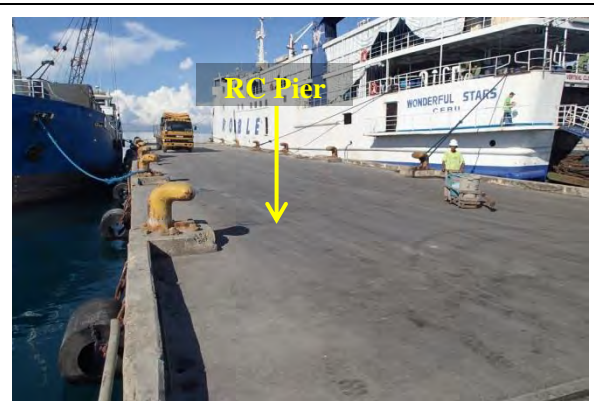
Figure No.8

Photo shows the existing RC Pier.

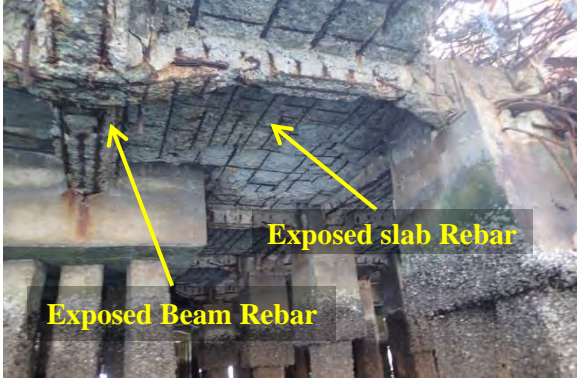
<p align="center">Figure No.13</p> <p>Photo shows exposed reinforcements of the under deck beams and slab.</p>	<p align="center">Figure No.14</p> <p>Photo shows exposed rebar of the newly repaired RC pier.</p>

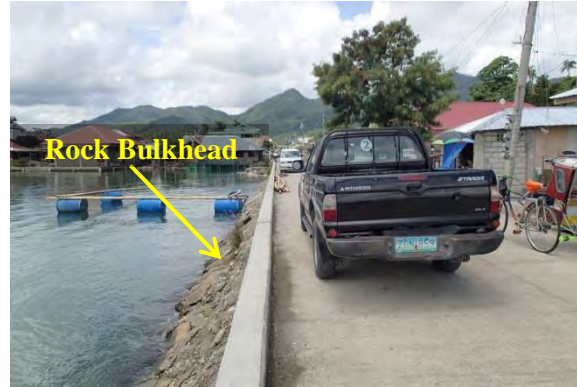
<p>Rock Bulkhead</p>

<p>Existing seawall</p>
<p>Figure No.5 Rock bulk head of the existing causeway.</p>	<p>Figure No.6 Existing seawall at the proposed new port site.</p>

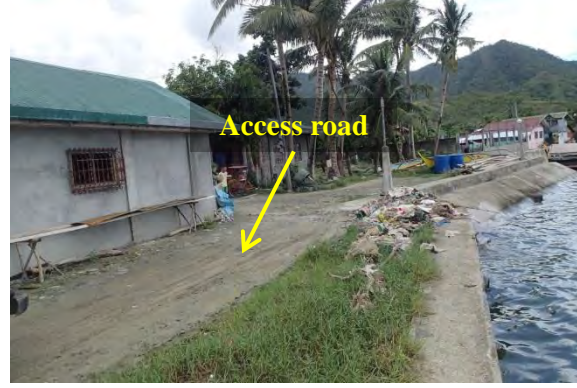
<p>Access road</p>	
<p>Figure No.7 Access road to the proposed new port site.</p>

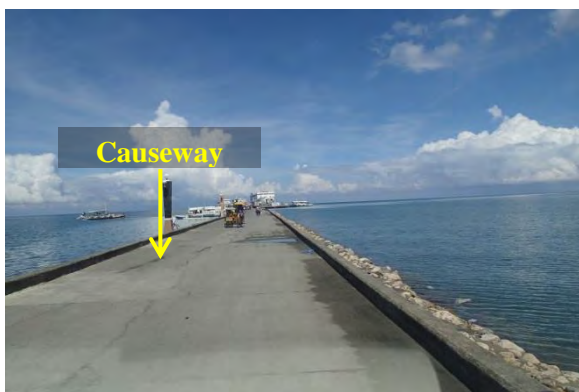
Figure No.3

Causeway

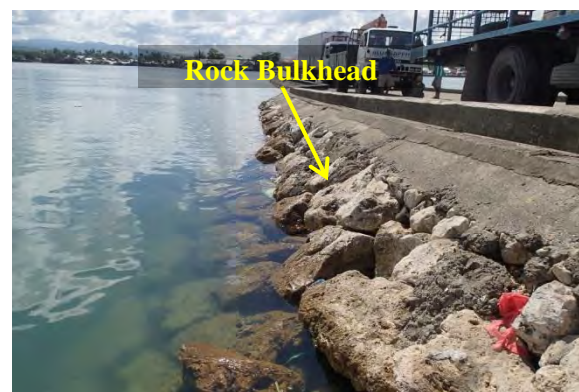
Figure No.5

Rock bulk head of the existing causeway.

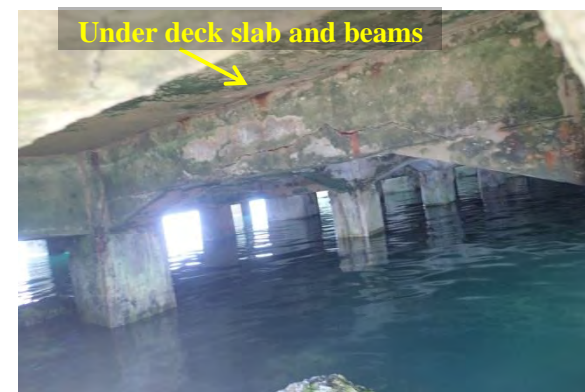
Figure No.6

Underdeck of RC pier.

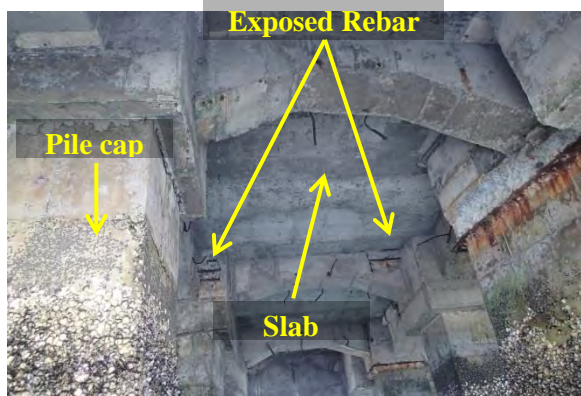
Figure No.12

Figure shows the under deck slab.

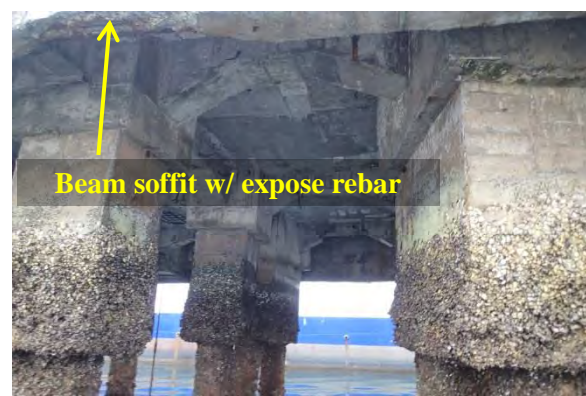
Figure No.13

Figure shows the under deck slab.

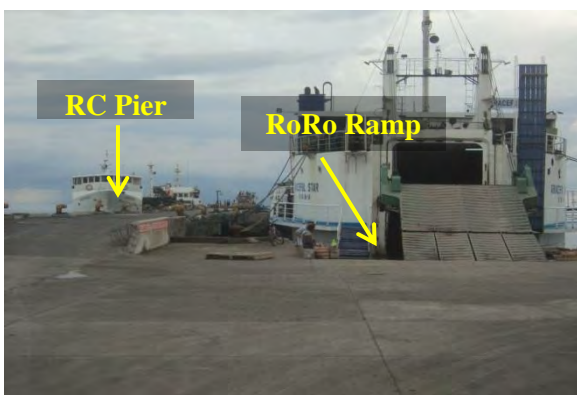
Figure No.14

Photo Shows the Rc Pier and RoRo Ramp.

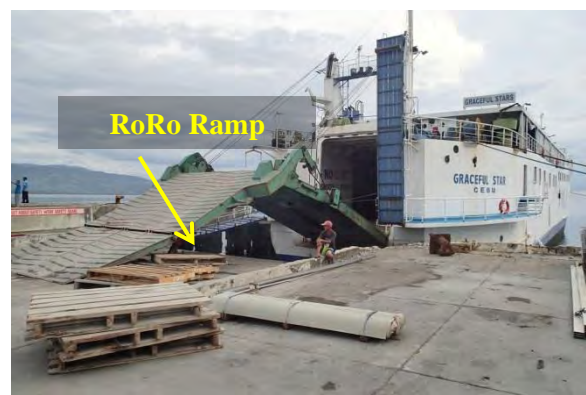
Figure No.15

The RoRo Ramp.

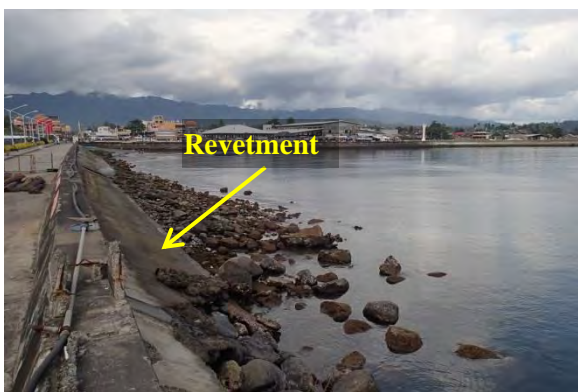
Figure No.16

Revetment at the southwest side of the port.

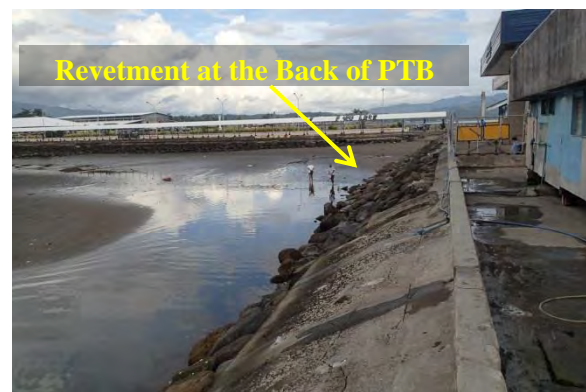
Figure No.17

Revetment at the back of PTB..

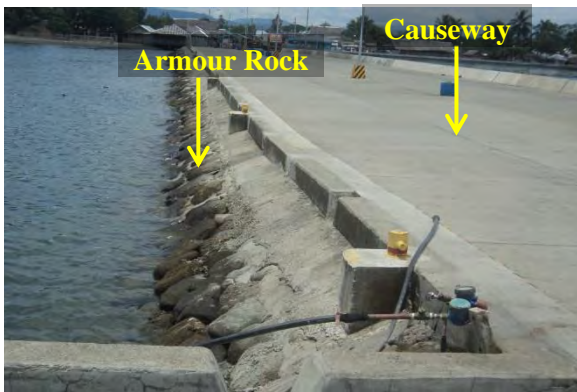
Figure No.6
Existing Rock Causeway

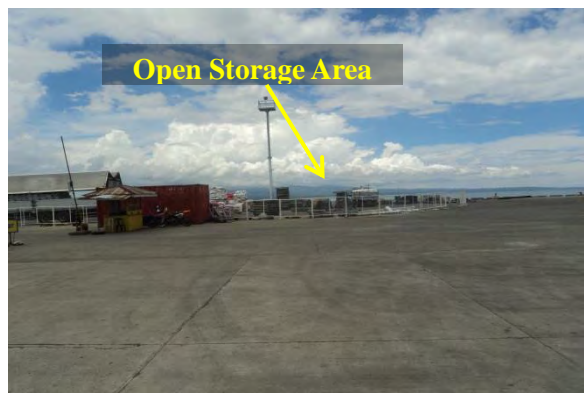
Figure No.11
Open Storage area with ILB pavement.

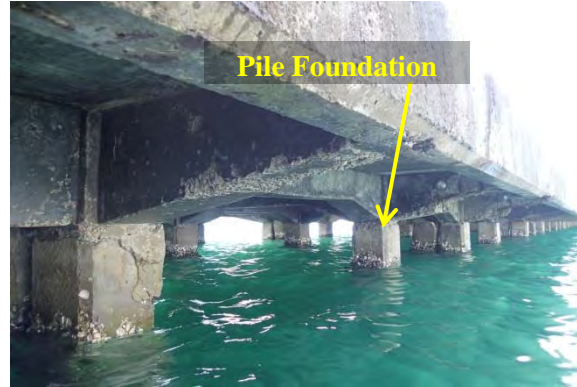
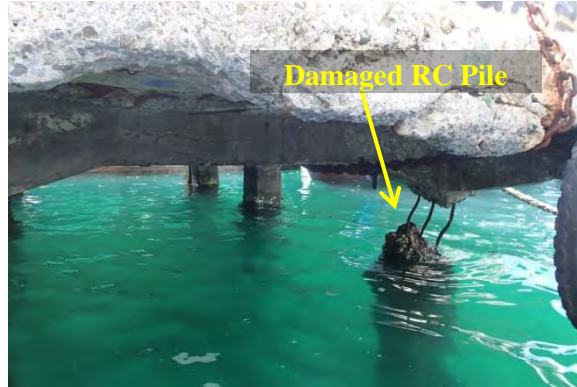
<p>Figure No.4 Photo shows the under deck slab, beams and the concrete pile foundation of the RC Pier.</p>	<p>Figure No.5 Damaged Concrete piles and curtain wall of the pier.</p>

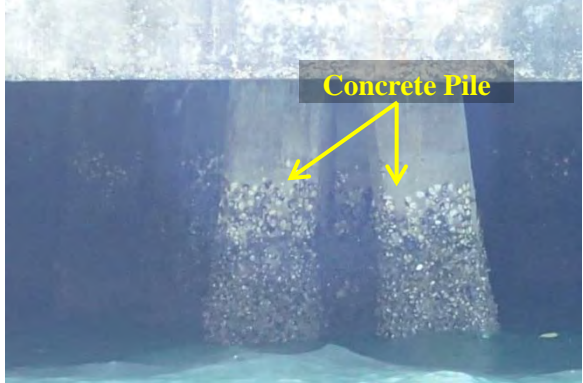
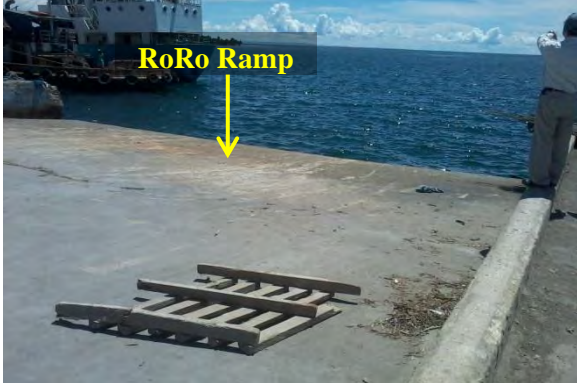
<p>Figure No.4 Existing Concrete Pile.</p>	<p>Figure No.5 RoRo Ramp.</p>

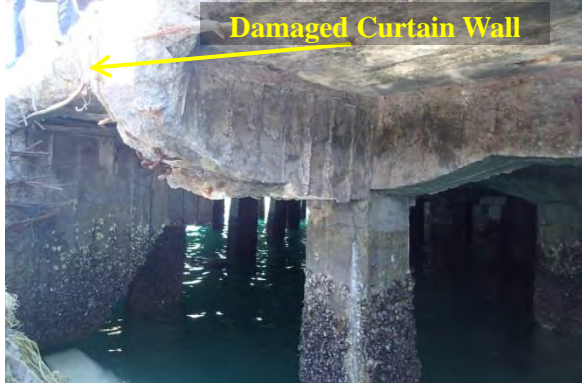
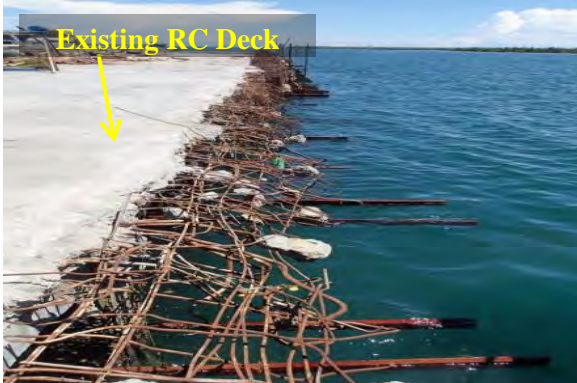
<p>Figure No.6 On-going Rehabilitation of Existing Wharf and Pier. continuous</p>	<p>Figure No.7 On-going rehabilitation of existing wharf and pier.</p>
