**The Project  
for  
Rehabilitation of Yangon Port  
and  
Main Inland Water Transport  
in  
The Republic of The Union of Myanmar  
(Follow-Up)

Final Report**

February 2016

Nippon Koei Co., Ltd. (NK)

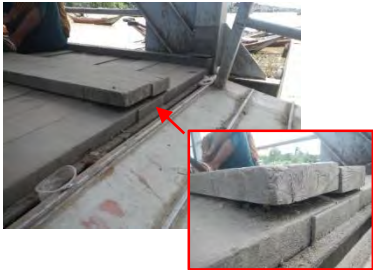
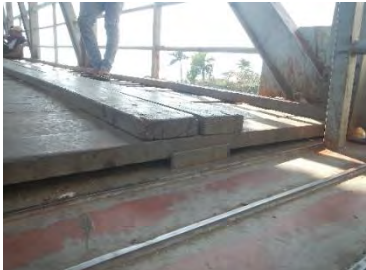
Timber floor connection is loosed and mounted.

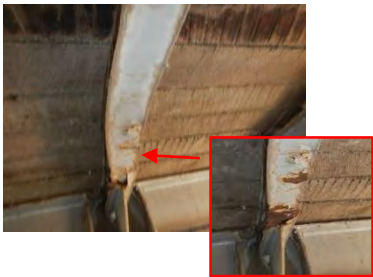
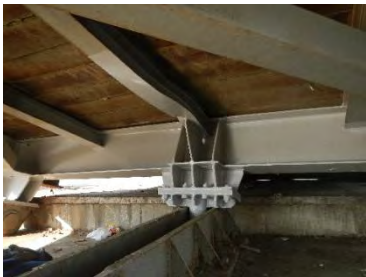
Rust and Paint defected.
East Steel Bridge

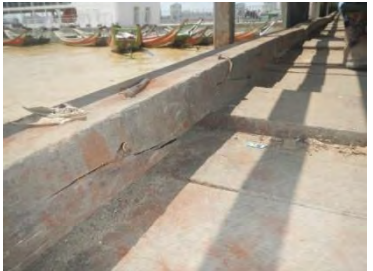
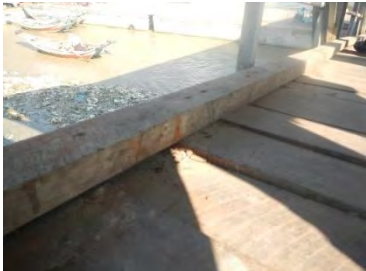
Timber floor longitudinal member is mounted and cracked.

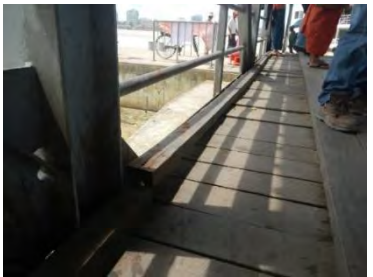
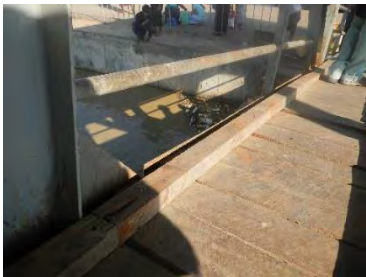
Timber floor longitudinal member is mounted.
Pontoons

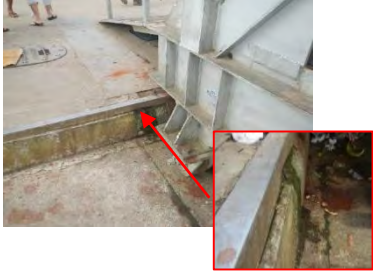
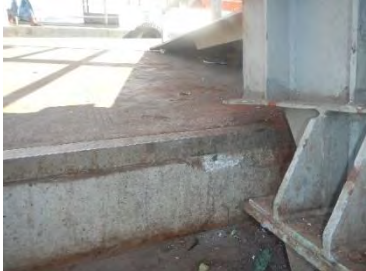
Steel angle is deformed and concrete is defected.

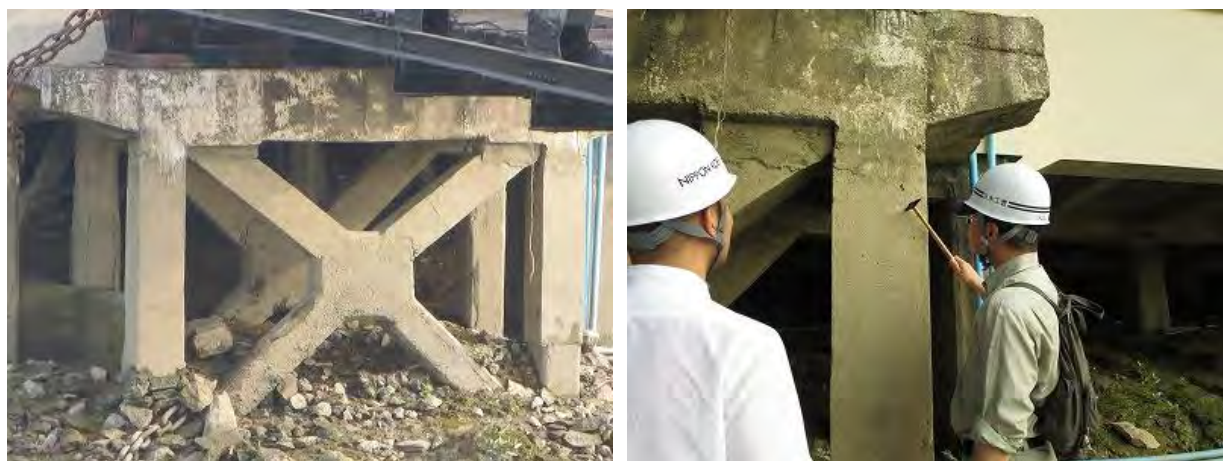
**Photo 3.1 View and Survey of Nan Thi Da 3**

A part of Nan Thi Da 3 and its condition during the survey are shown Photo 3.1. There were no cracks and peeling off of the concrete surface. The repaired part was in good condition.

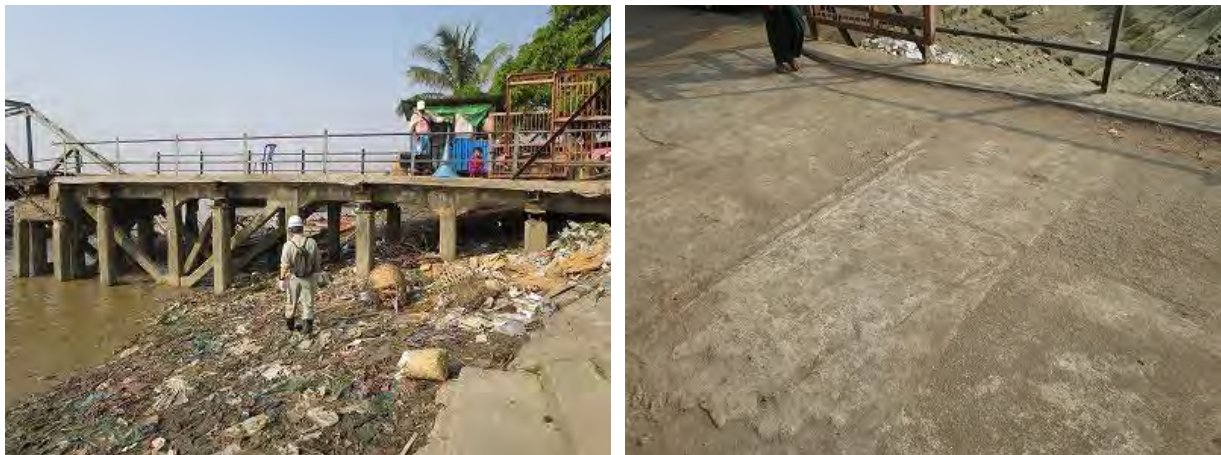
**Photo 3.7 View and Repaired Part of Sin Oh Dang 2**

A part of Sin Oh Dang 2 and a repaired part are shown in Photo 3.7. The repaired part, where new mortar was refilled, is in good condition.

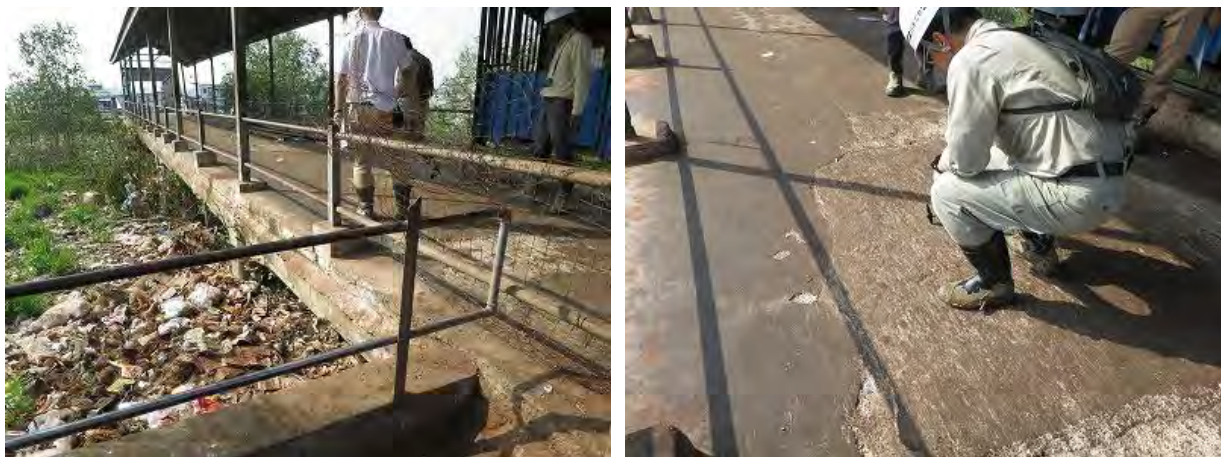
**Photo 3.9 View and Repaired Part of Hledan 2**

A part of Hledan 2 and its condition during the survey are shown in Photo 3.9. A repaired part where new mortar was refilled is in good condition (no crack).

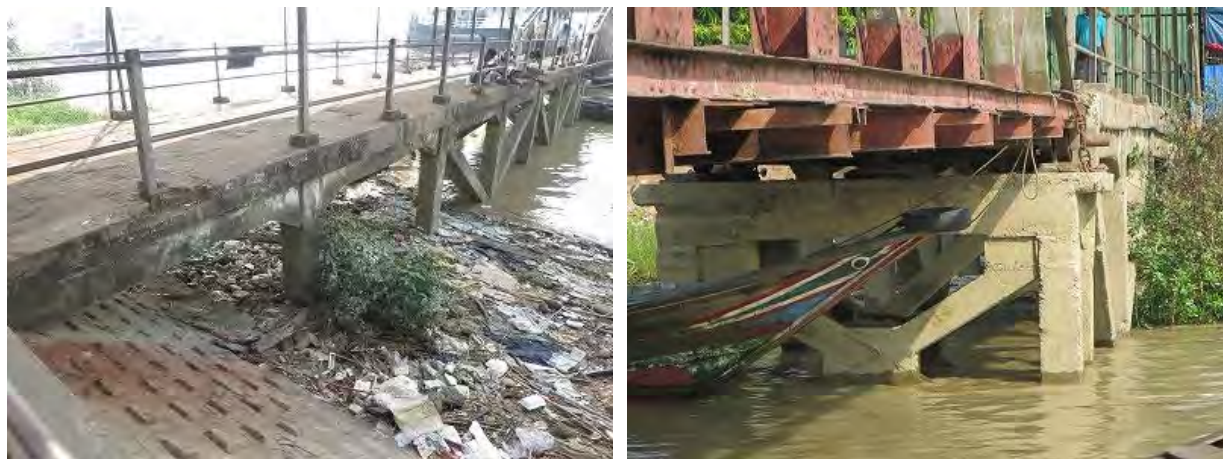
**Photo 3.11 View and Repaired Part of Kaingdon Jetty 1**

A part of Kaingdon Jetty 1 and a repaired part are shown in Photo 3.11. The repaired part that was broken due to boat collision was reconstructed. There was no crack and it was in good condition.

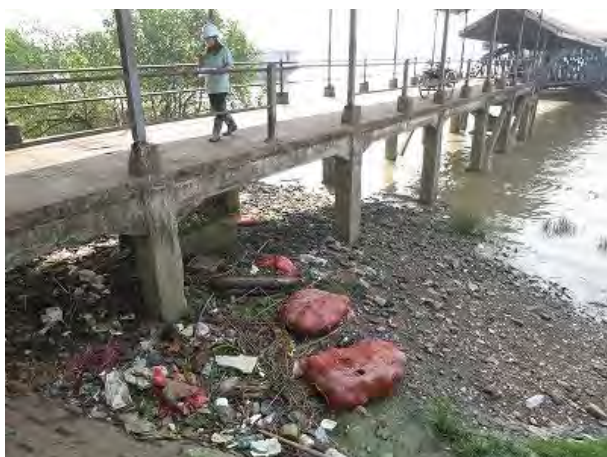
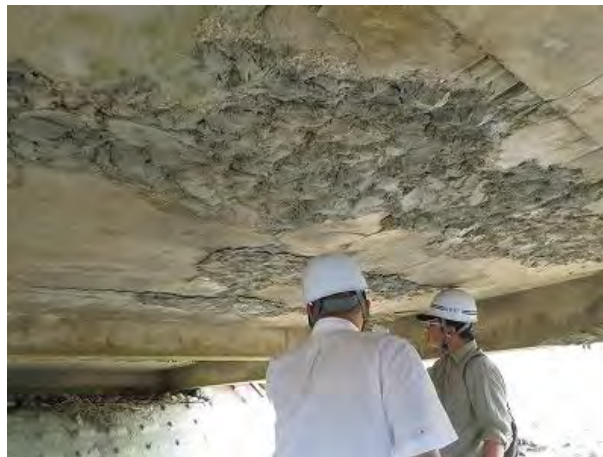
**Photo 3.13 Overall and Repaired Part of Kaingdan Jetty 1**

Jetty	Conditions	Remarks
Kaingdan Jetty 1	Many damaged parts. Repaired part is damaged again.	Please refer to Photo 3.13.
Wadan Jetty 6	Damaged part is good for the demonstration of repair.	Please refer to Photo 3.14.

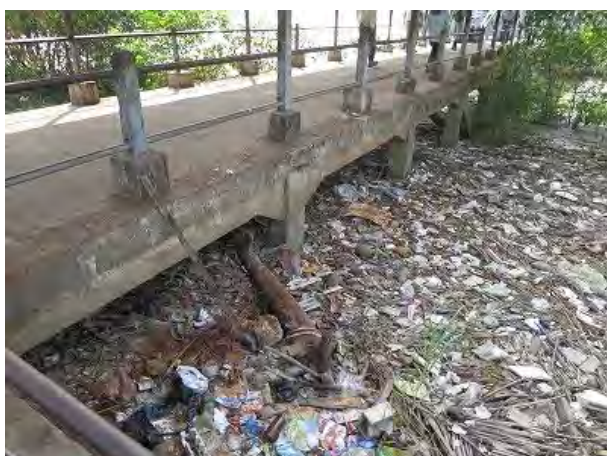
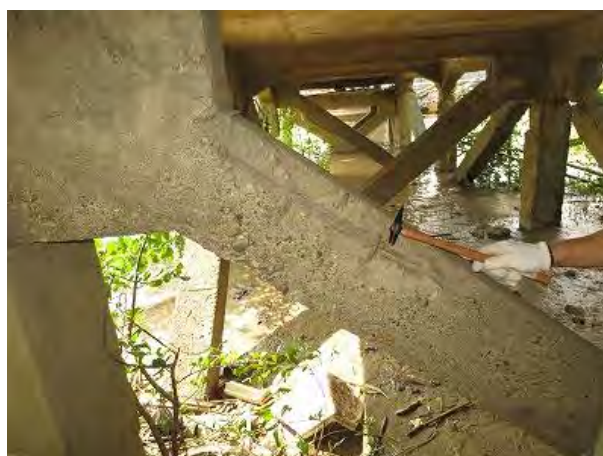
**Photo 3.14 Overall and Deteriorated Part (Rebar Exposure) of Wadan Jetty 6**

Cracks and rebar exposure occurred due to rebar corrosion at some beams at the Wadan Jetty 6. The Expert selected this jetty as a suitable site for the on-site training because the deterioration by rebar corrosion is popular in Yangon port.

The Expert removed the concrete covering and the rusted rebar, painted it with anti-rust paint, added a new rebar, and refilled new mortar. Time was limited to show how to repair the RC Beam during the training. Therefore, the Expert showed the repair process and explained the important points about the repair of the RC beam.

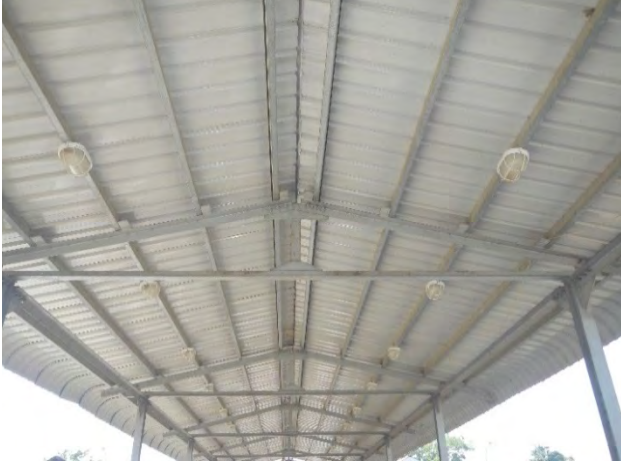
West Porter Way Roof Structure

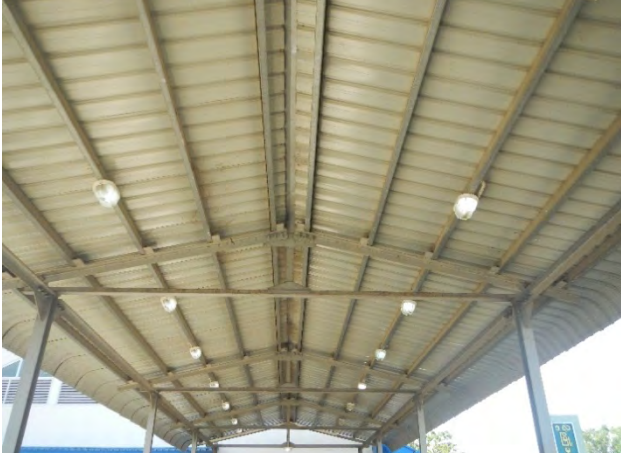
East Porter Way Roof Structure

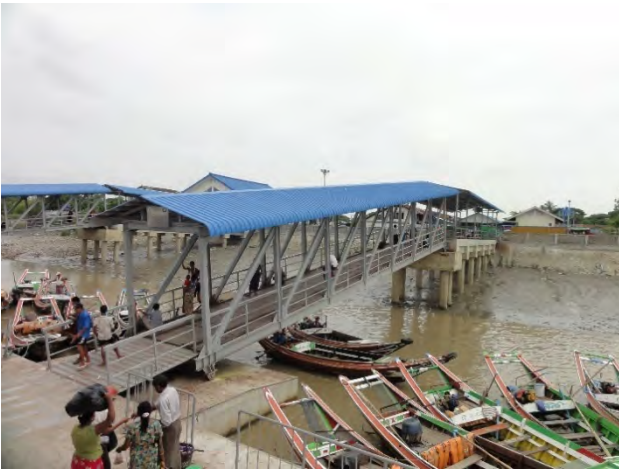
West Steel Bridge  Structure Roofing Lighting

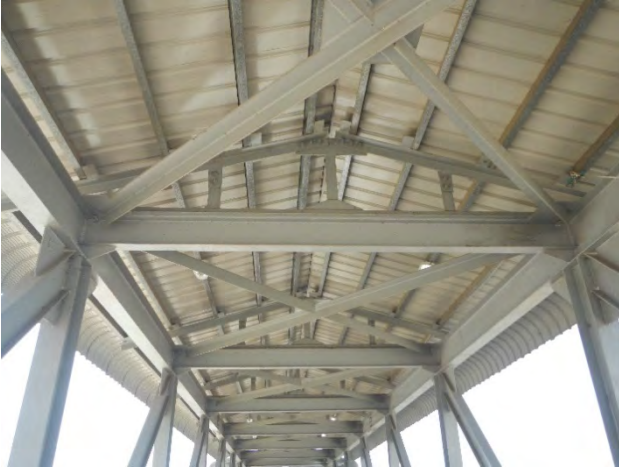
Steel Bridge Roof Structure and Lighting (West Steel Bridge)

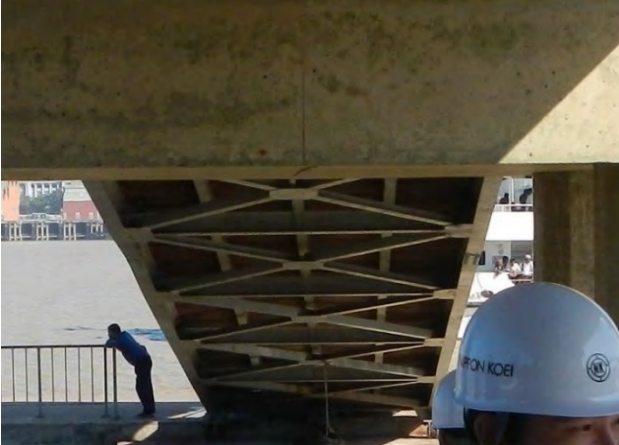
Underneath of Steel Bridge (West Steel Bridge)

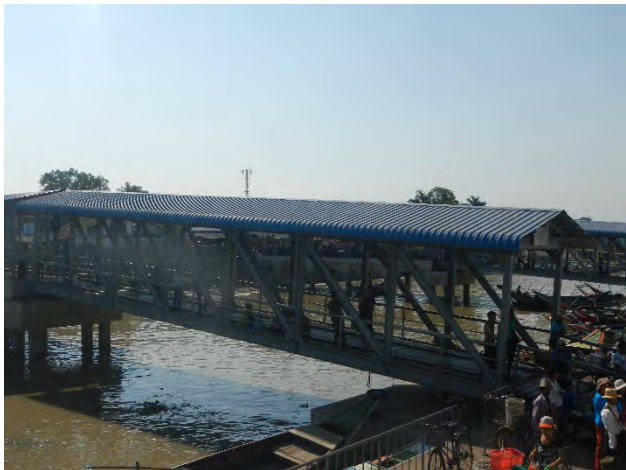
<p>East Steel Bridge</p> <p>Structure Roofing Lighting</p>

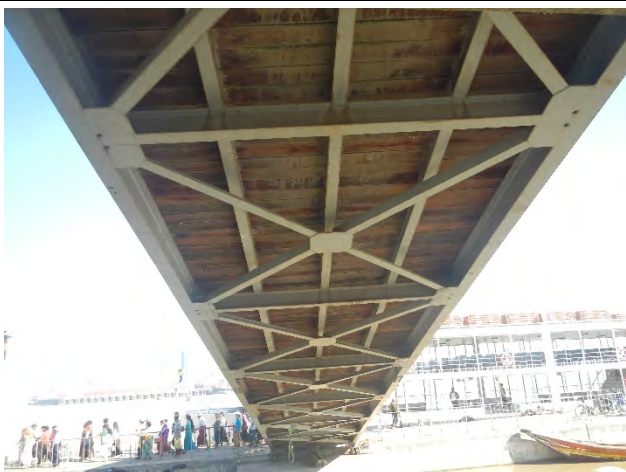
<p>Underneath of Steel Bridge (East Steel Bridge)</p>

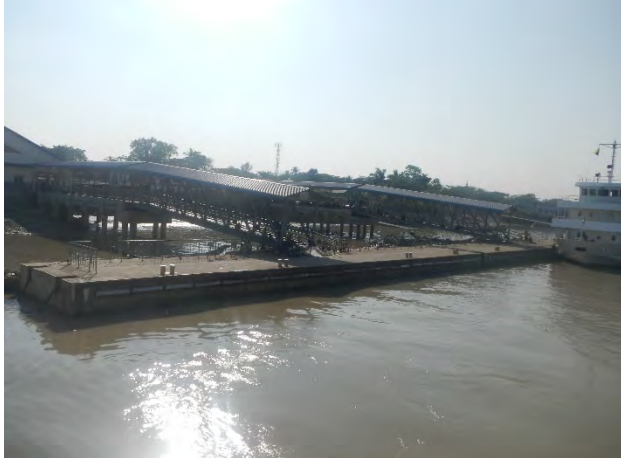
<p>Pontoons made by IWT</p> <p>Pontoon Structure Hand Rail Stainless Steel Fender Bollard Manhole Cover Anchorage</p>

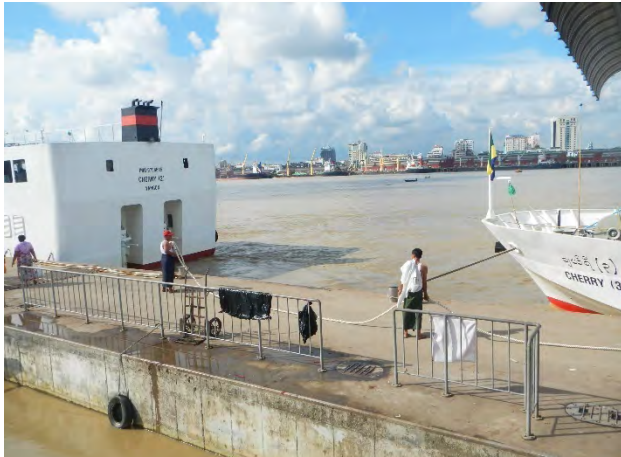
<p>Outside of Pontoon</p> <p>Pontoon Structure Hand Rail</p>

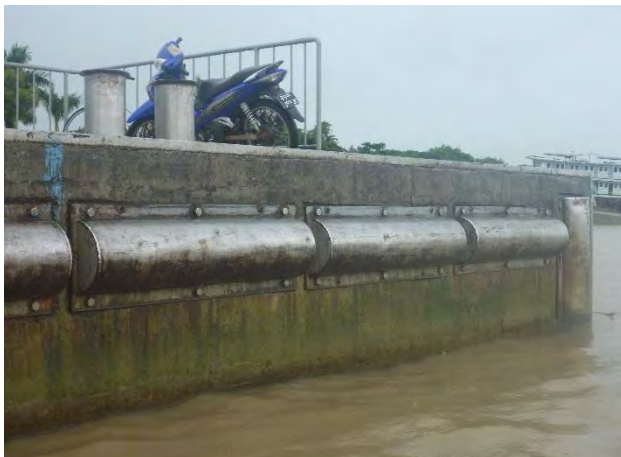
<p>Outside of Pontoon</p> <p>Pontoon Structure Bollard Stainless Steel Fender</p>

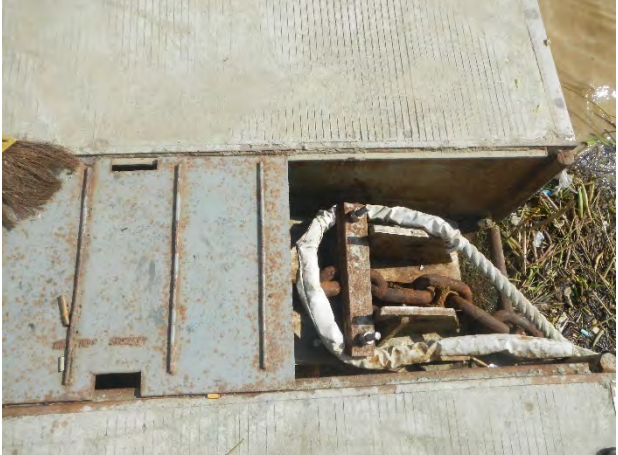
<p>Outside of Pontoon Anchorage</p>

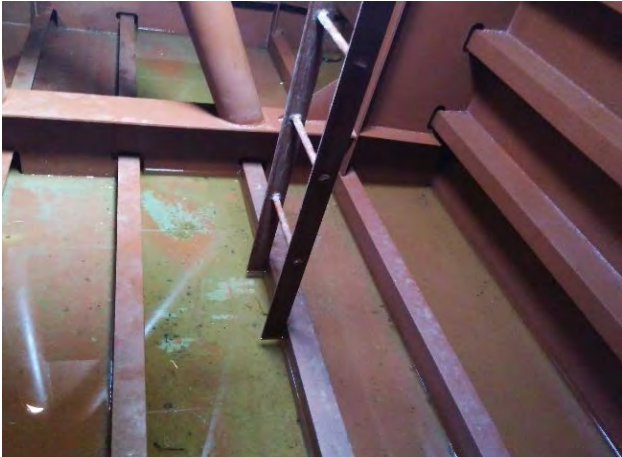
<p>Inside Pontoon (West Pontoon)</p>

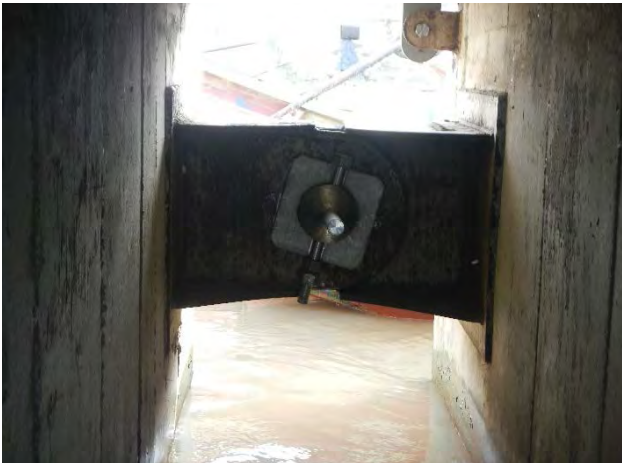
<p>Pontoon Connection (Land Side)</p>

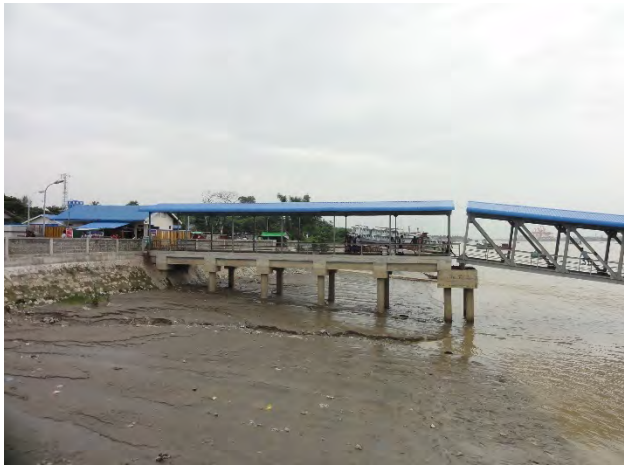
<p>Porter Way</p> <p>Pile Pile Cap Beam Slab</p>

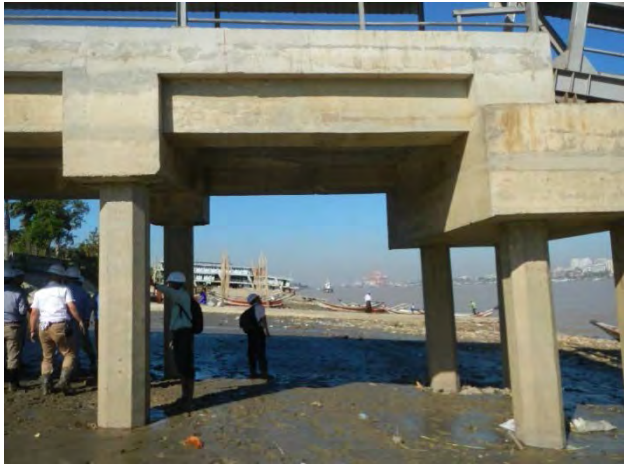
<p>Underneath of Porter Way (Pile, Pile Cap, Beam, Slab, Abutment)</p>

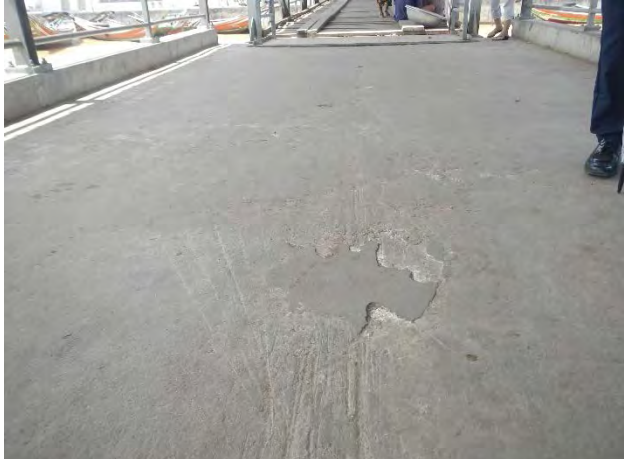
<p>Slab of Porter Way</p>

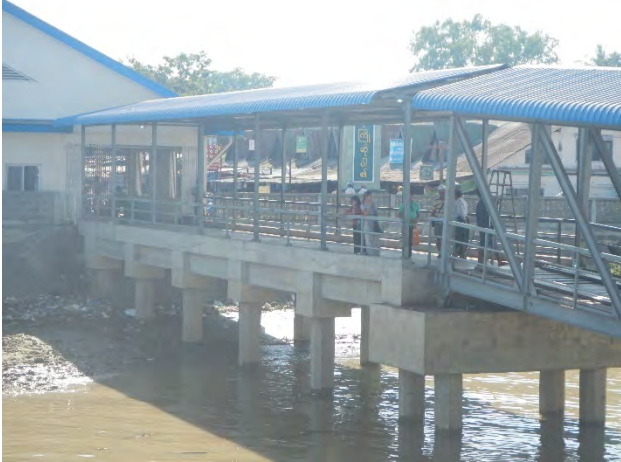
<p>Porter Way</p> <p>Pile Pile Cap Beam Slab</p>

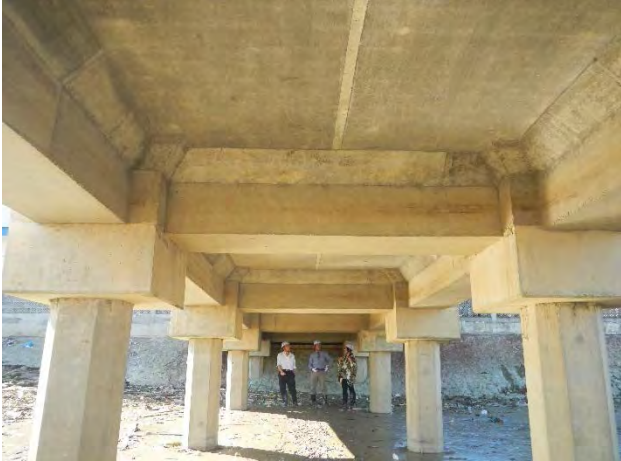
<p>Underneath of Porter Way (Pile, Pile Cap, Beam, Slab, Abutment)</p>

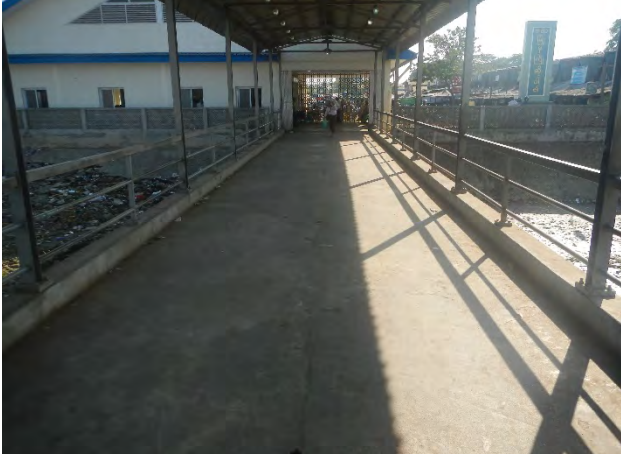
<p>Slab of Porter Way</p>

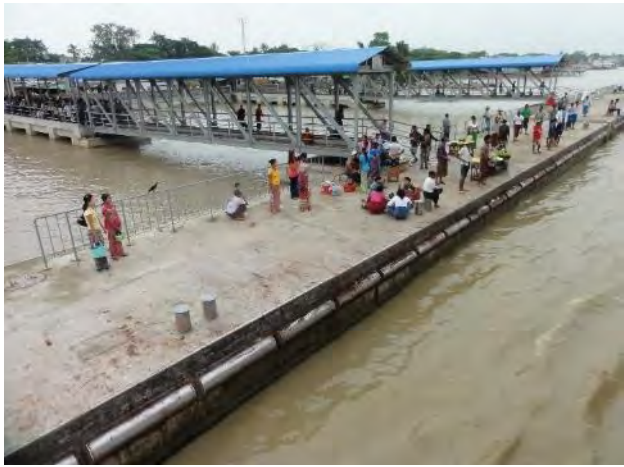
<p>Concrete Coating of Pontoon by JFE</p> <p>Top Surface                      Longitudinal Side Surfaces                      Traverse Side Surfaces</p>

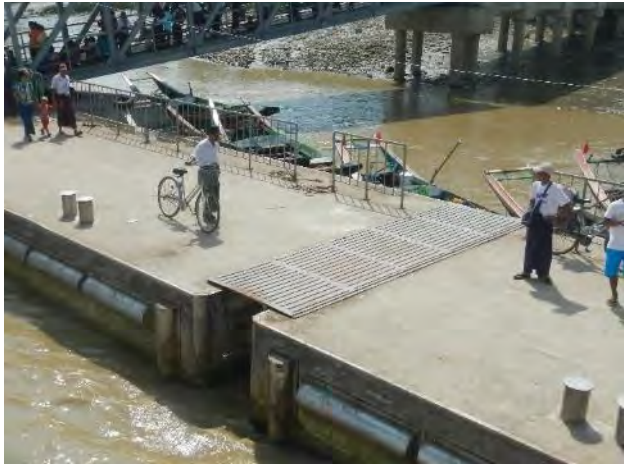
<p>Top Surface</p>

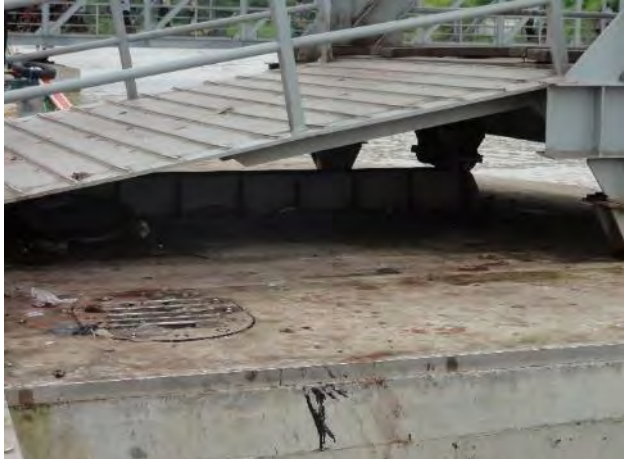
<p>Top Surface</p>

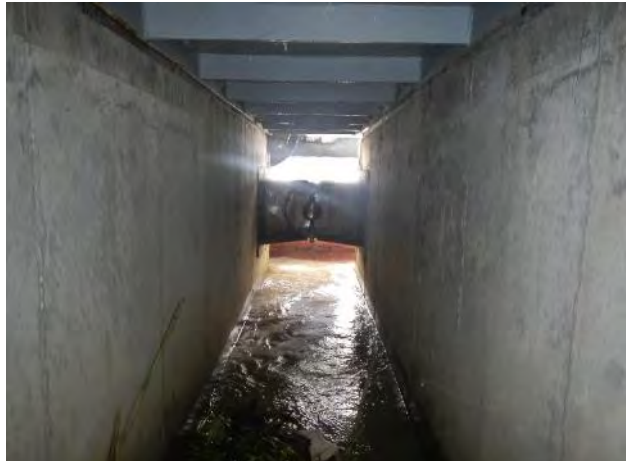
Traverse Side Surface (Inner Side)

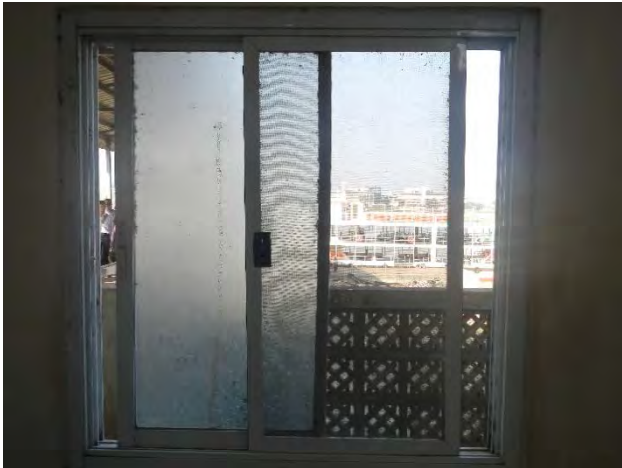
<p>Interior Facilities (Window)</p> <p>Passenger Waiting Area Passenger Service Office Manager's Office I-Pay Service Shop</p>

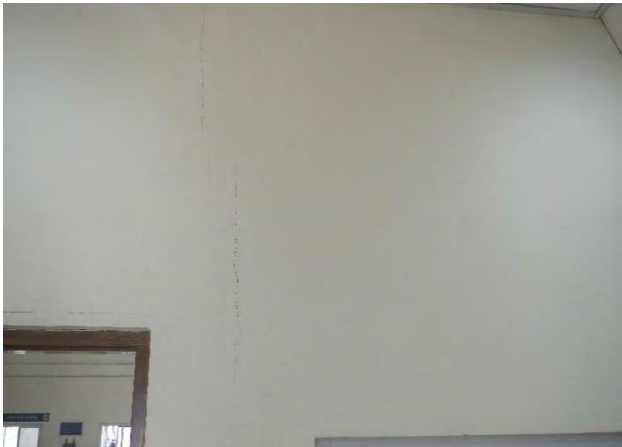
<p>Interior Facilities (Wall)</p> <p>Passenger Waiting Area Passenger Service Office Manager's Office I-Pay Service Shop</p>

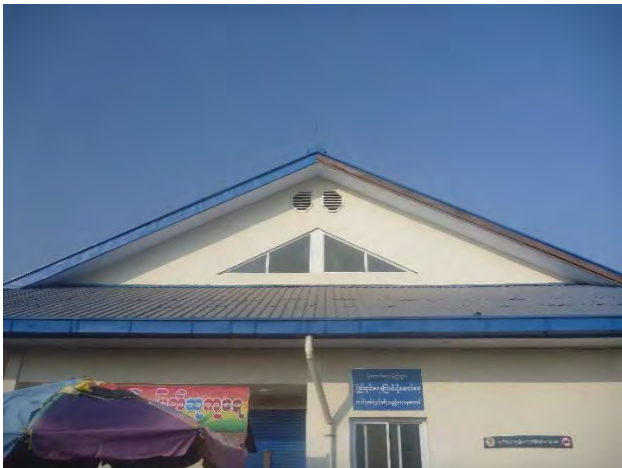
<p>Exterior Facilities</p> <p>Ventilation Louver Gutter and Downspout Roofing</p>

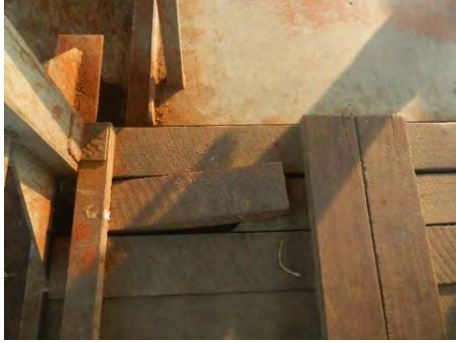
Timber plank is defected.

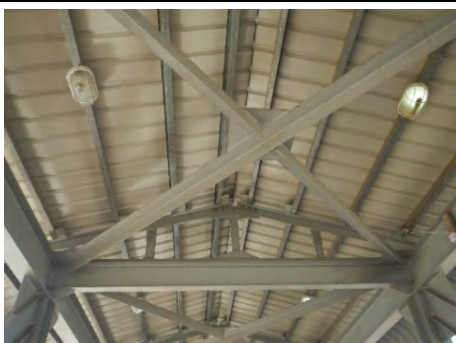
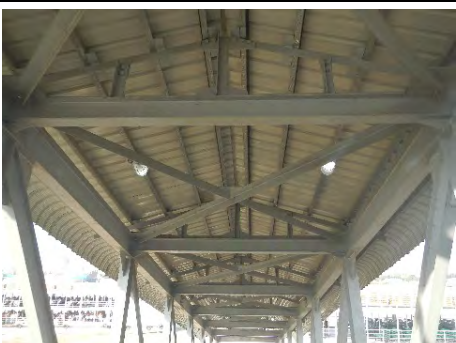
One number of light bulb is defected.

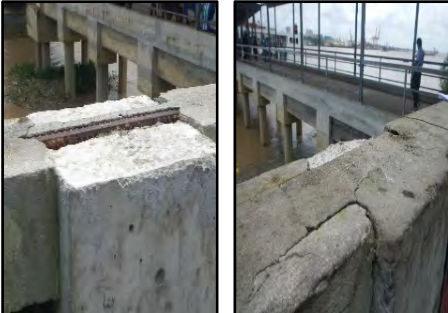
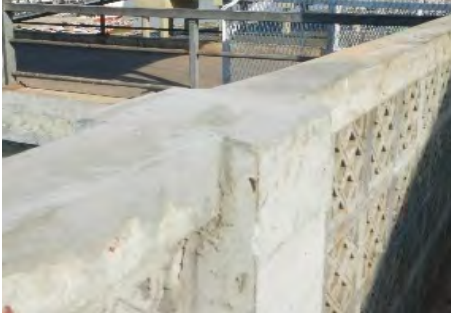
<p>Top portion of fence column is cracked and rebar is appeared.</p>

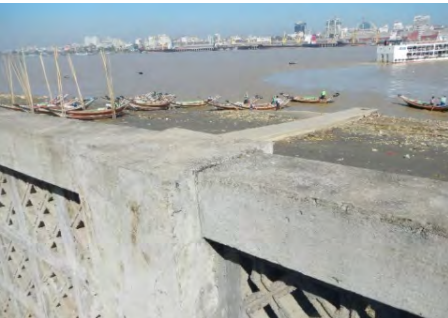
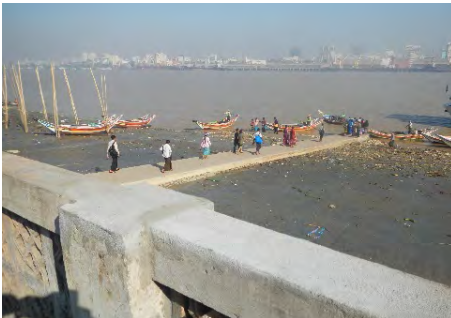
<p>Top portion of fence column is cracked and rebar is appeared (Total 4 places).</p>

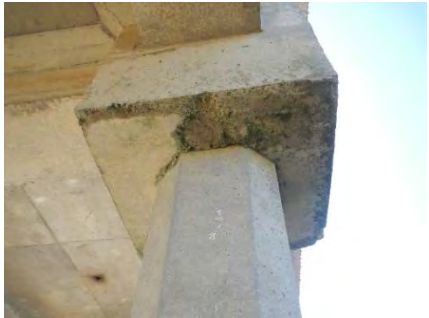
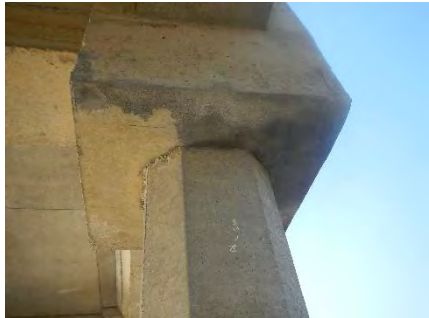
<p>Pile cap bottom surface connection is defected (Total 3 places).</p>

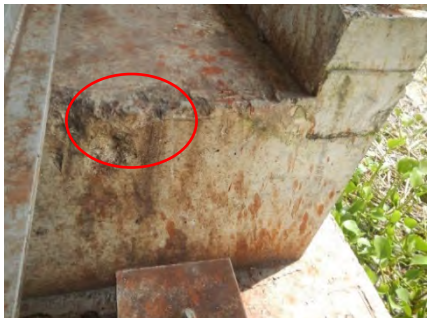
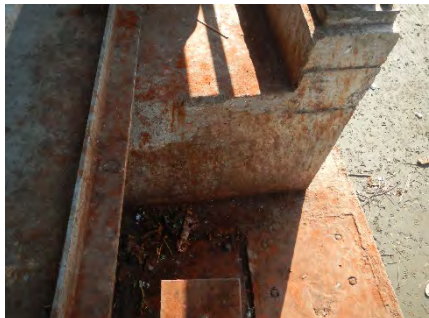
<p>Edge of Porter Way slab (vertical surface) is defected.</p>

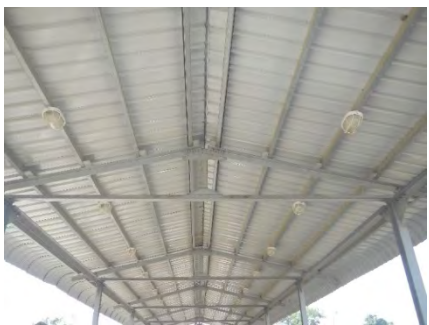
<p>All lights are not working.</p>

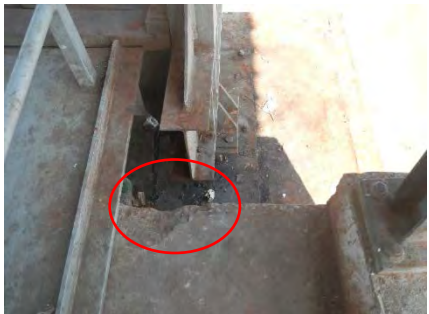
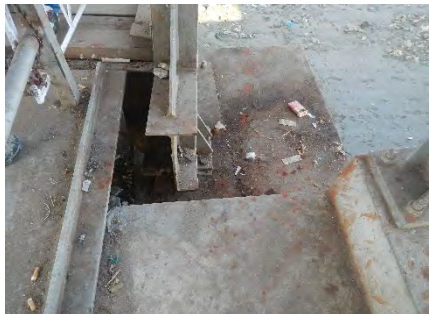
Concrete surface is defected.

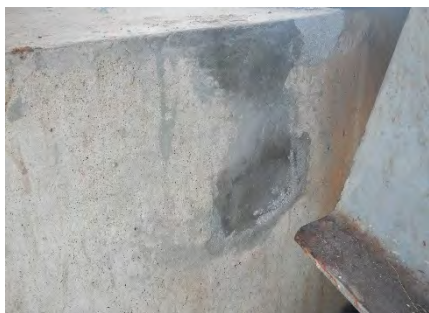
Concrete surface of abutment (vertical side) is defected.

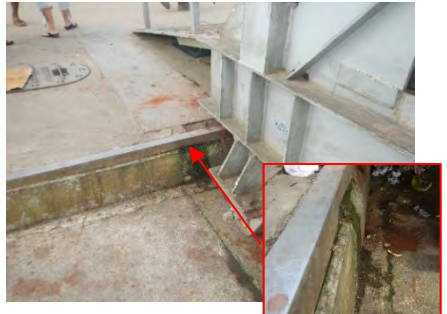
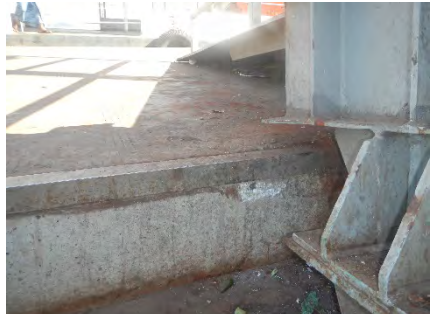
Steel angle is deformed and concrete is defected.

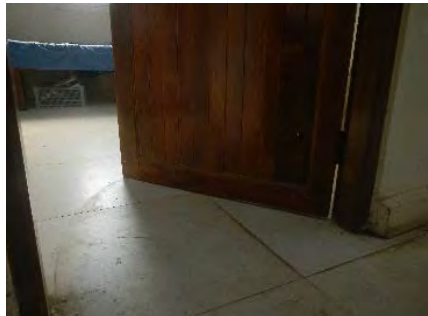
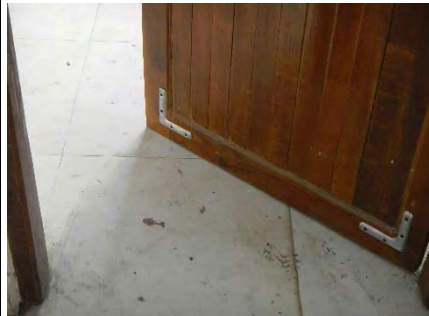
<p>Door is defected (bottom of the door close to floor level and difficult to swing).</p>

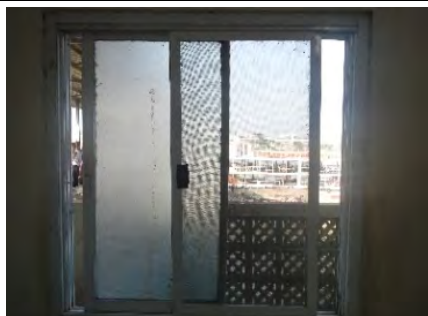
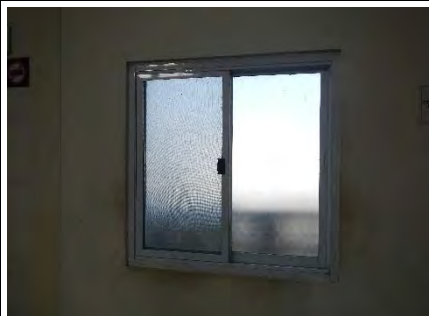
<p>6 numbers of glass window leaf are defected.</p>

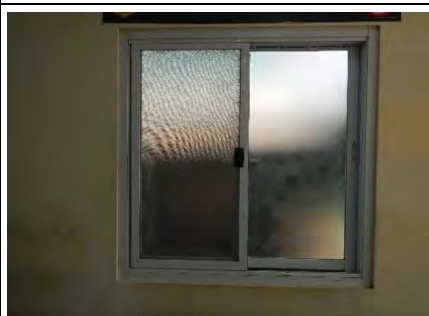
<p>Mosquito net leaf is defected.</p>

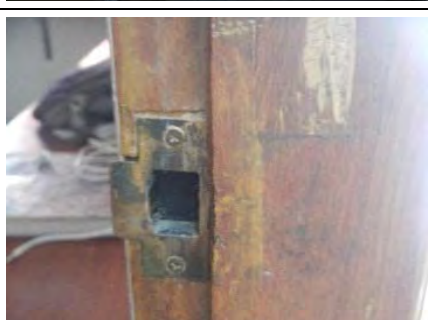
<p>Door lock is defected.</p>

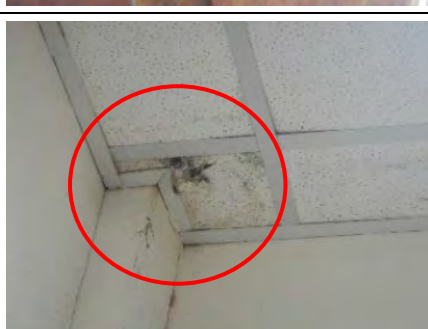
<p>Ceiling is defected.</p>

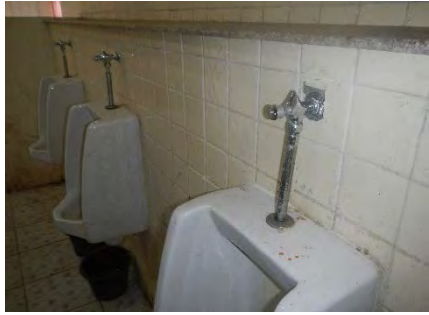
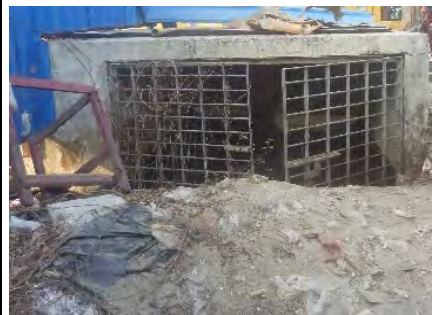
<p>The same urinal is shown after repair. The water tap is now functional and is no longer circled.</p>	<p>Urinal bowl water tap is defected.</p>

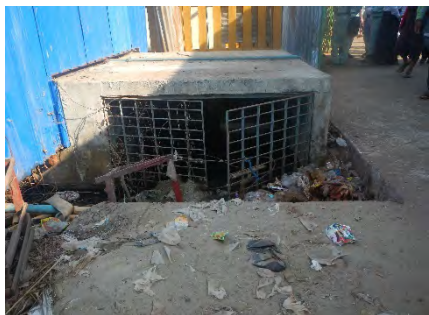
<p>The same transfer pump enclosure is shown after repair. The enclosure is now clean and free of debris.</p>	<p>One transfer pump is not working.</p>
  <p>A photograph of a building's roofline. The fascia board is circled in red, indicating it is defective.</p>

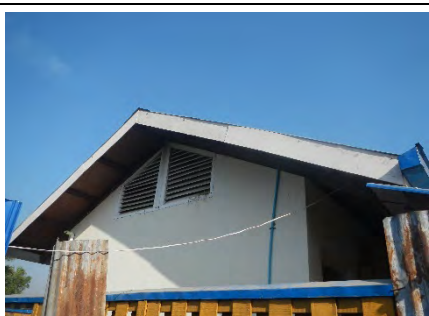
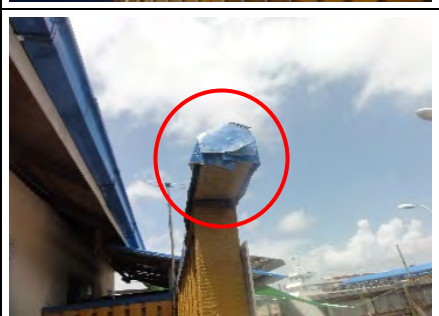
<p>The same building's roofline is shown after repair. The fascia board is now intact and is no longer circled.</p>	<p>Roof fascia is defected.</p>
