Chapter 3 Field Investigations

3.1 Basin Overview (Helicopter Survey)

3.2 River Survey

Chapter 4 Summary of Present Conditions and Issues of Flood Control and Basin Management in Nadi River

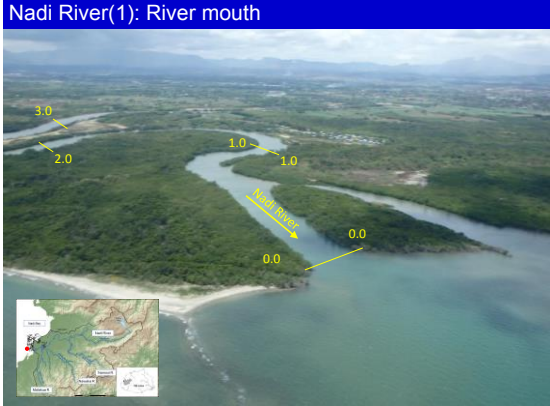
<p>Nadi River(1): River mouth</p>

The mangrove forests stretched out on the river mouth area of the Nadi River. This mangrove forests area was neither designated as National Park nor Conservatory of natural environment. Not at the river mouth area, but nearby coastal area, there was recreational facility under development.

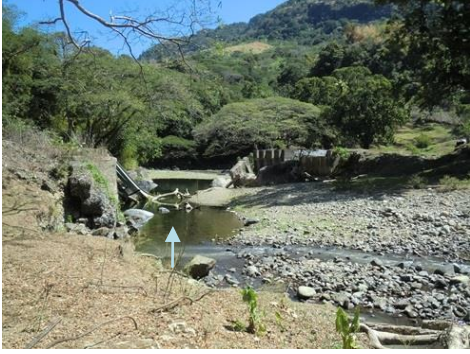
<p>Nadi River Up-stream Abandon Bridge (P-08)</p>	<p>Retention Dam Filled by Sand at Namosi River (P-11)</p>

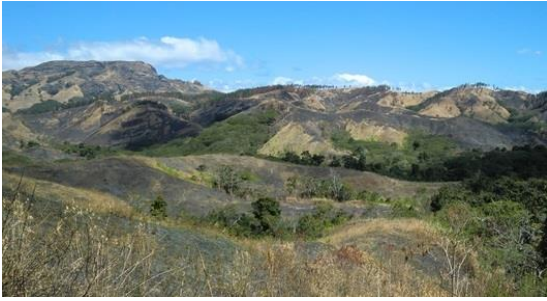
Up-stream was mountainous area. There was a mountain event, and eroded slopes were observed. Trees could be found only at low altitude area along the river (see Figure 3-2, and P-09).

<p>Up-stream of Nadi River Mountain-Burning Events (P-09)</p>	<p>Namosi River Retention Dam Under Construction (P-12)</p>

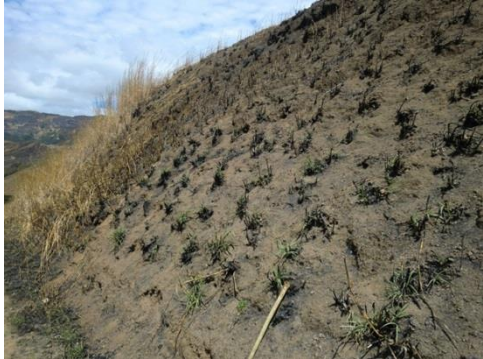
<p>Up-stream of Nadi River Mountain-Burning Events (P-09)</p>	<p>Sedimentation on River-bed of Namosi River Up-stream (P-013)</p>

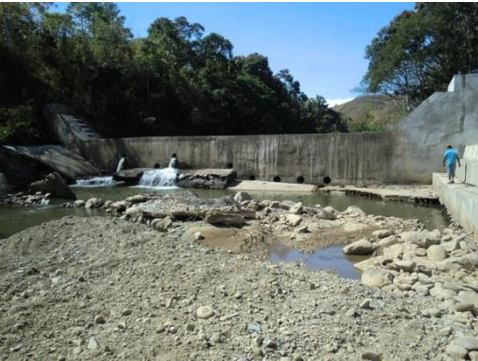
At five (5) kilo-meters from confluence, and ten (10) kilo-meters from confluence, there were retention dams. The apron of the retention dam at upper stream was left collapsed. This collapse was caused by the flood of 2012 (see Figure 3-2, and P-14, P-15).

<p>Retention Dam at Nawaka River (10km :P-15)</p>	<p>River-bed of Malakuwa River mid-stream (P-19)</p>

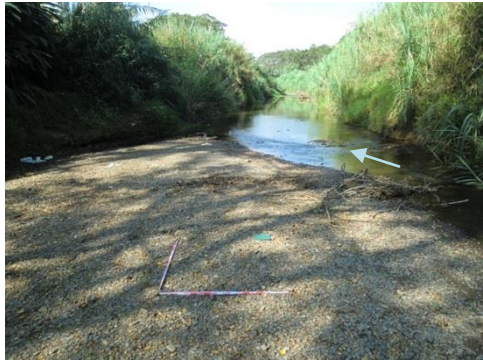
Texture grades of sand to medium gravel were widely found on the river-bed of mid-stream and up-stream of Malakua River (see Figure 3-2, and P-19).

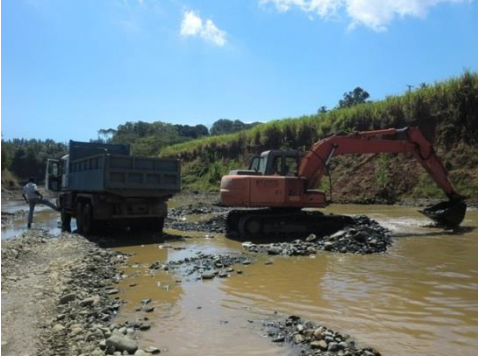
<p>Gravel Mining at Nawaka River (8km :P-16)</p>	<p>Vaturu Dam (60km : P-20)</p>

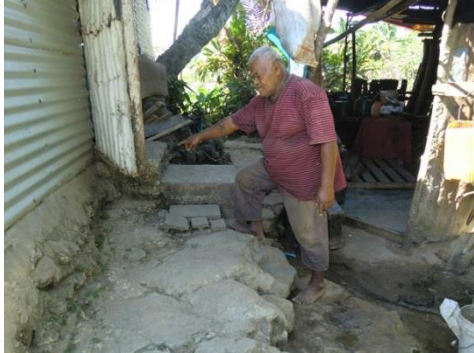
<p>Settlements (Bunayasi Village) Along the Malakuwa River (P-18) The water reached below the floor level (2012 Flood)</p>

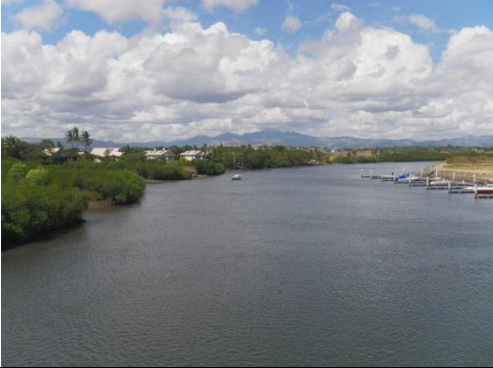
From entrance of Denarau Area, branch of Nadi River could be reached. The depth of channel was around one (1) meter. At the left bank of channel, there were cottages. At the right bank there were mangrove forests. Since there was a slash in the mangrove forests, the JICA Expert team could not reach to the Nadi River (see Figure 3-4, and PS-09). Steel sheet piles are utilized for the revetment of the tributary near the Denarau Area's entrance.

<p>Deranau Area: Tributary Stream of Nadi River (PS-09)</p>	<p>Deranau Area: Port During Low Tide (PS-10)</p>

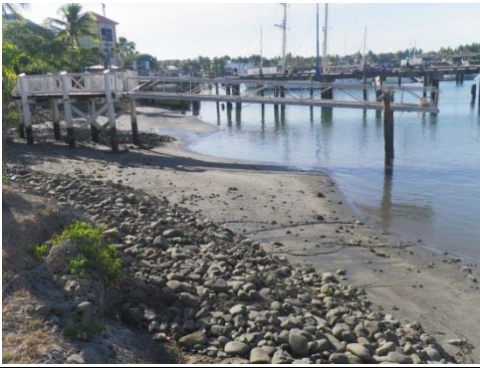
At Naisoso area, a housing developer brought in white sand to nourish the beach (see Figure 3-4, and PS-06). The Naisoso area (Naisoso island resort) was in its second stage of expansion project. There was pleasure boat harbor in the inner bay and stone bank protection was placed along the shoreline until the port entrance. The sea area in front of Nadi International Airport's runway had poles of course lights and power poles. The accretion of the sand has become serious, that it is unnavigable even for the small size vessels during low tide.

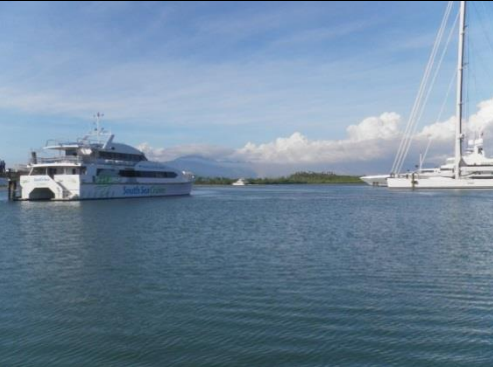
<p>Deranau Area: Sand Bank at Left Side of the Bay Entrance (PS-11)</p>	<p>Deranau Area: Beach Near by the Regent Hotel (PS-12)</p>

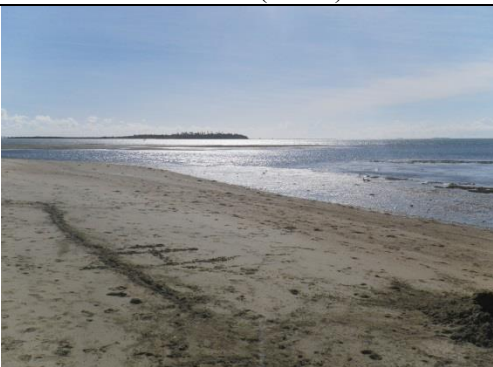
<p>Deranau Area: Beach Near by the Regent Hotel (PS-13)</p>	<p>Deranau Area: Sea Weeds Drift Down on the Beach (PS-14)</p>

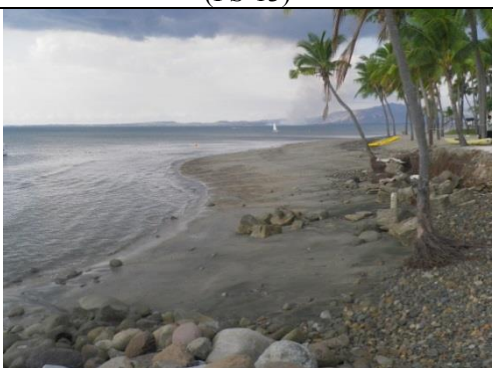
<p>Deranau Area: Beach Near by the Sheraton Hotel (PS-15)</p>	<p>Deranau Area: Beach Near by the Sheraton Hotel (PS-16)</p>

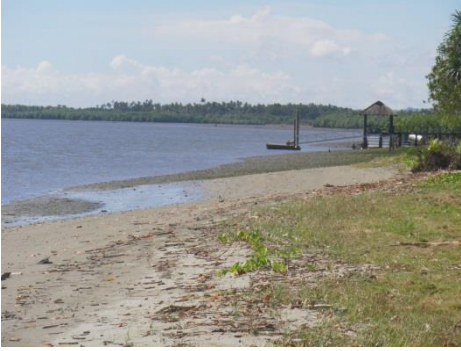
<p>Sonaisali Island: Landing Bridge at Inner Bay (PS-17)</p>	<p>Sonaisali Island: Cottage Under Construction (PS-18)</p>

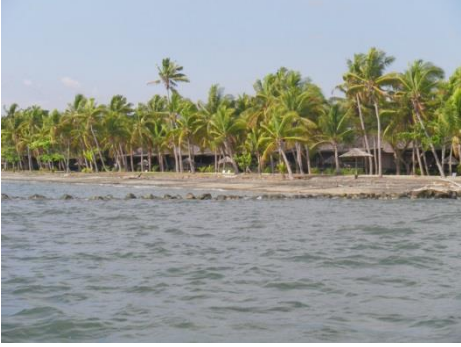
<p>Muanatirau Reef: Resort Area Facing Ocean (PS-19)</p>	<p>Muanatirau Reef: North Side of Resort Area Facing the Ocean (PS-20)</p>

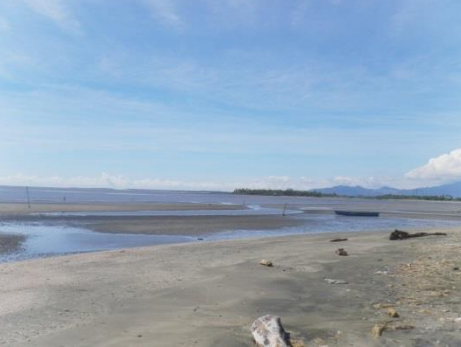
<p>Muanatirau Reef: North Side of Inner Beach (Tidal Wetland) (PS-21)</p>	<p>Muanatirau Reef: South Side of Inner Beach (PS-22)</p>

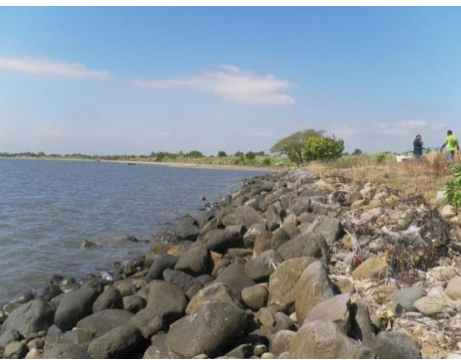
<p>Muanatirau Reef: View of North at South Edge (PS-23)</p>	<p>Muanatirau Reef: Nadi River Mouth (PS-24)</p>

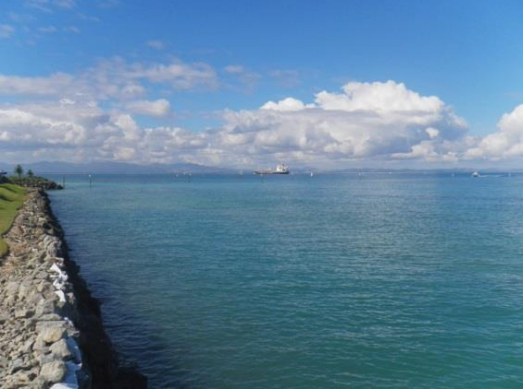
The Vuda Point Area, at northern part of Nadi Bay, is shallow water area facing the ocean. Many pleasure boats were mooring at Vuda Port protected by the stone bank protection from ocean wave. There is a boat slip for landing and loading petroleum. The breakwater is placed at the entrance of boat slip and the boat slip is protected by stone bank.

<p>Picture-1(1) : Shore Protection of Vuda Pt. to Port Mouth</p>	<p>Picture-1(2) : Shore protection of Vuda Pt. to the hotel nearby</p>

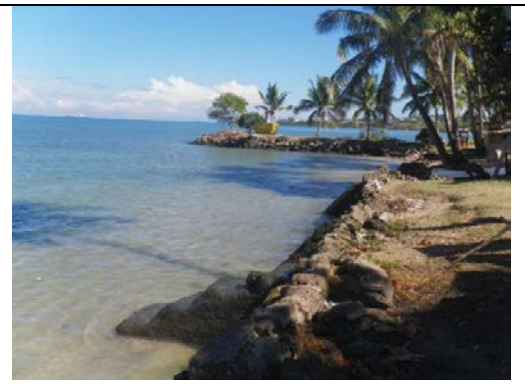
<p>Picture-3(1): Shore protection, north side of Veiseisei Village</p>	<p>Picture-3(2): Shore protection, south side of Veiseisei Village</p>

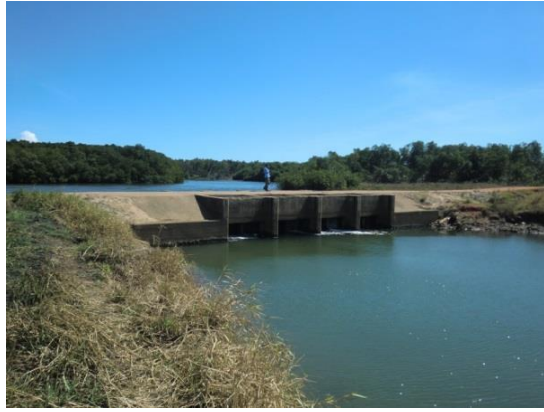
Picture-6(1): Flood gate, next to the Fantasy Island

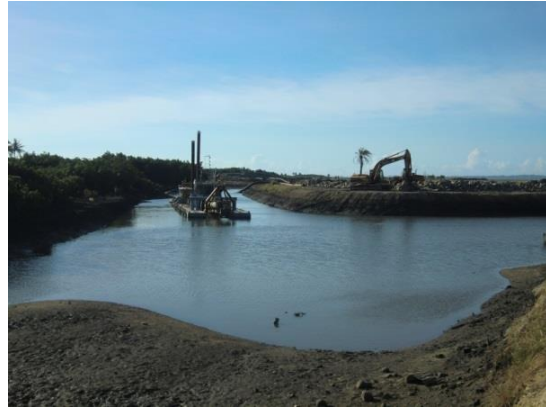
Picture-6(2): Ships for reclamation in Fantasy Island

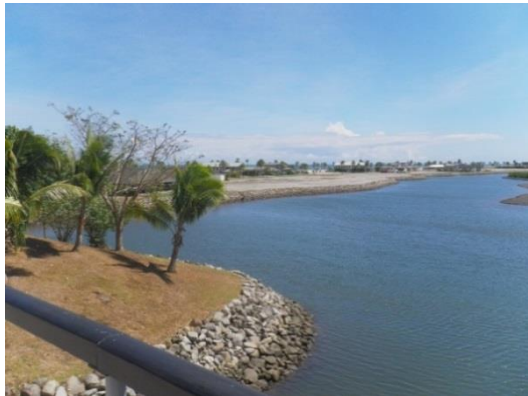
Picture-7(1): Nadi River branch in Denarau Port

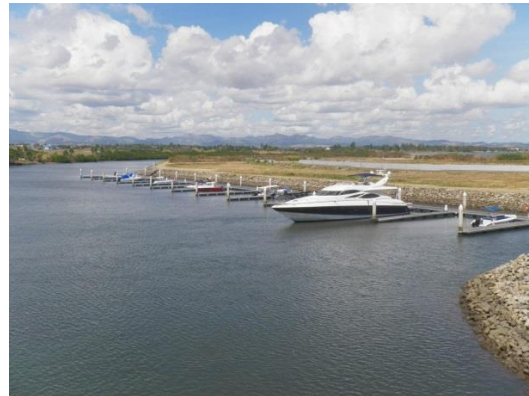
Picture-7(2): Nadi River branch in Denarau Port

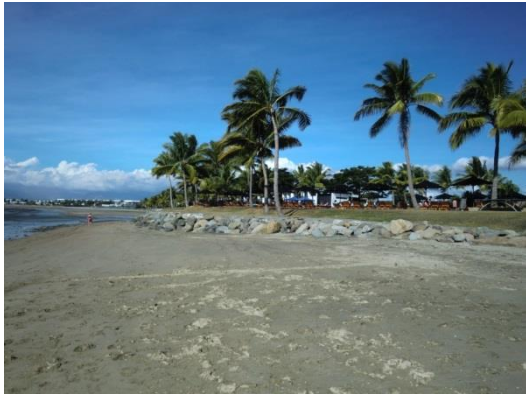
Picture-8(1): Hilton Hotel in Denarau Island

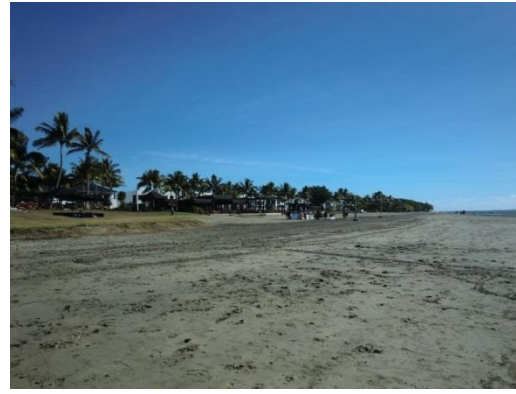
Picture-8(2): Hilton Hotel in Denarau Island

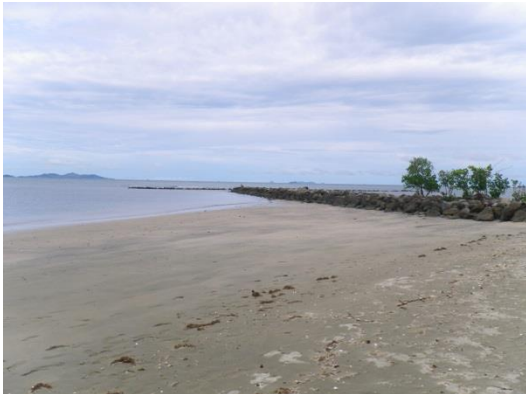
Picture-9(1): Sheraton Hotel in Denarau Island

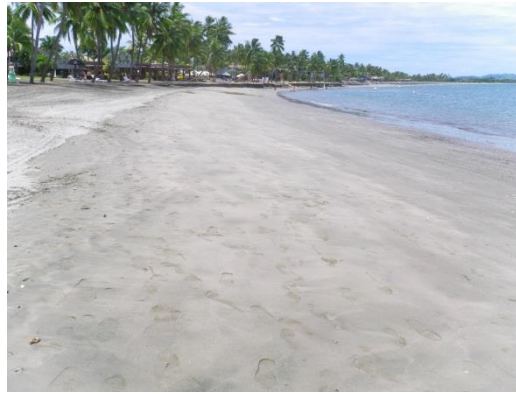
Picture-9(2): Sheraton Hotel in Denarau Island

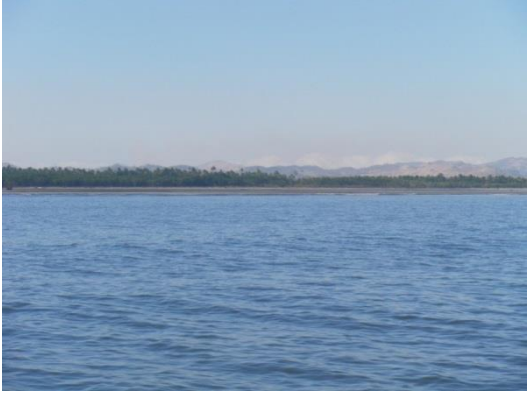
<p>Picture-10(1): Northern area of Sonaisali (Ocean side)</p>	<p>Picture-10(2): Southern area of Sonaisali (Ocean side)</p>

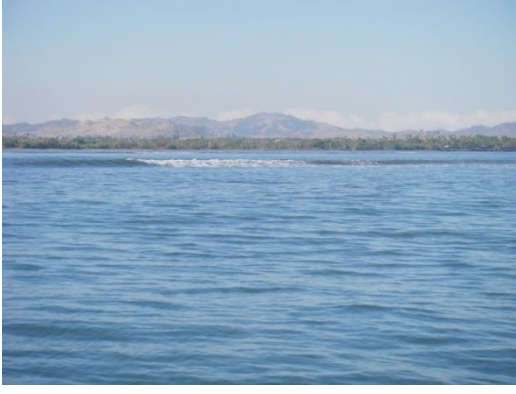
In Sonaisali Area, the front of the hotel facing the ocean had stone bank protection. It is meant to protect the reclaimed land from erosion by ocean wave. At nearby Mulonitubei Reef, southern part of Sonaisali Area, stone bank protections win the area the sugar cane transportation tram is built. It is meant for protecting the railroad from erosion.

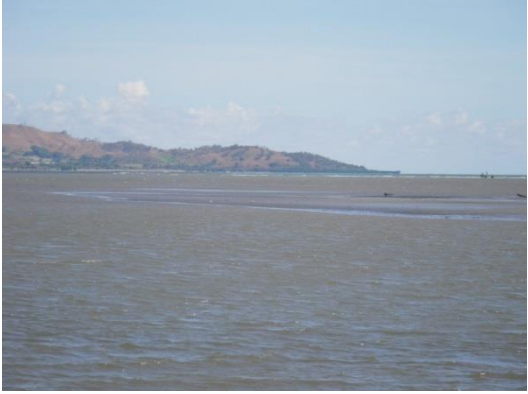
<p>Picture-11(1): Muanatirau Reef</p>	<p>Picture-11(2): Shore protection for railway</p>

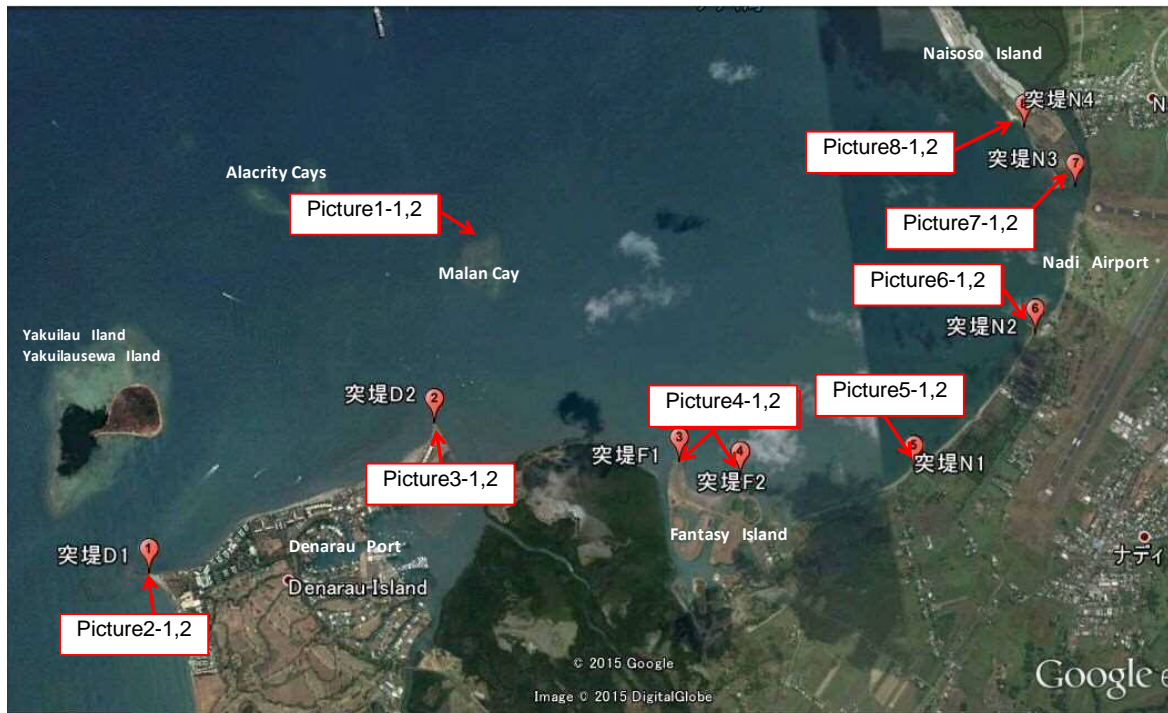
Figure 3-6 Position of Jetties

In Denarau Area, continuous coastal revetment was in place. In addition, jetties were in place to reduce ocean wave load.

The following figure (Figure 3-6) shows jetties found in the site survey. The result of the survey is also compiled as inventory of coastal structures in Appendix-3.

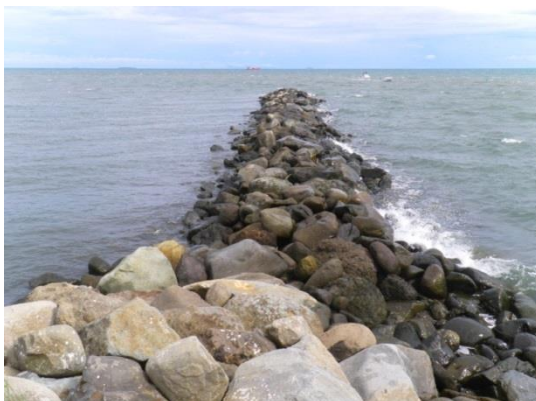
Picture3-1 Stone Jetty at Denarau Peninsula

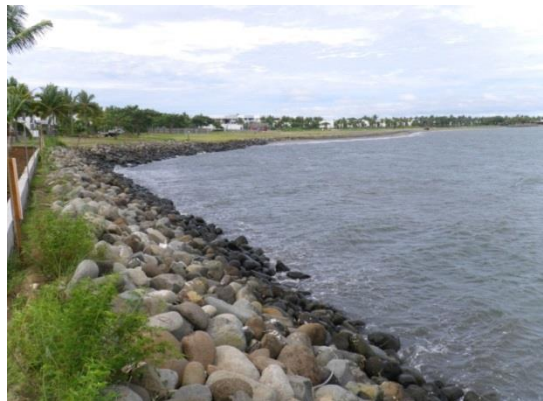
Picture3-2 Stone Jetty at Denarau Peninsula

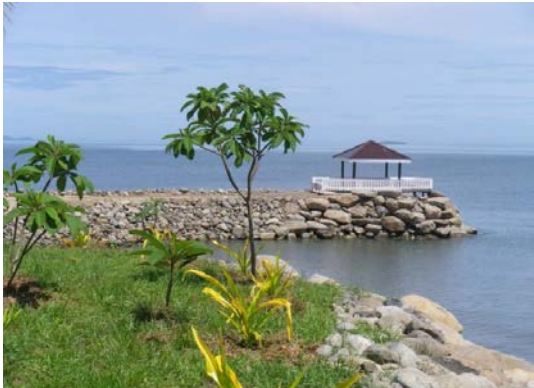
Picture4-1 F1 Stone Jetty at Fantasy Island

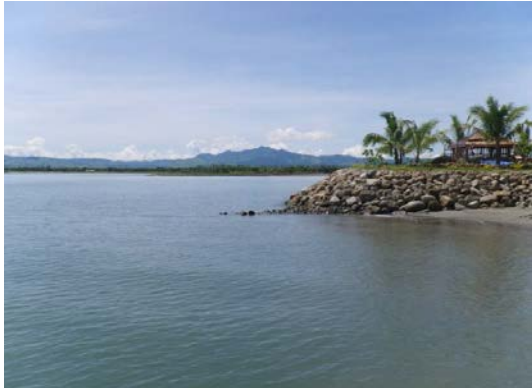
Picture4-2 F2 Stone Jetty at Fantasy Island
