エジプト国
橋梁設計（スエズ運河架橋建設計画
カウンターパート研修）
フォローアップ協力（調査）

調査報告書

平成 28 年 10 月
（2016 年）

独立行政法人
国際協力機構（JICA）

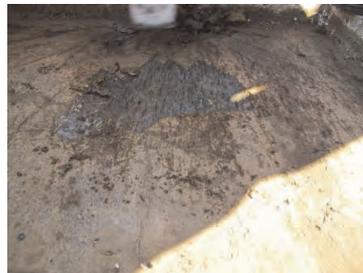
鋼床版の錆（2012年調査）

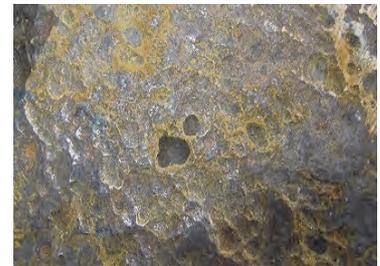
鋼床版表面（2012年調査）

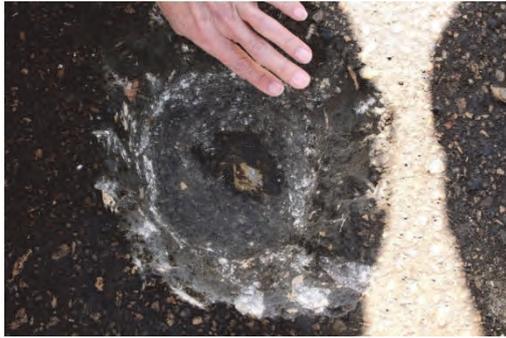
3. 舗装状況はかなり良好である。鋼床版の上面に錆は確認されない。鋼床版の黄色の部分プライマーの Zinc Chromate である。

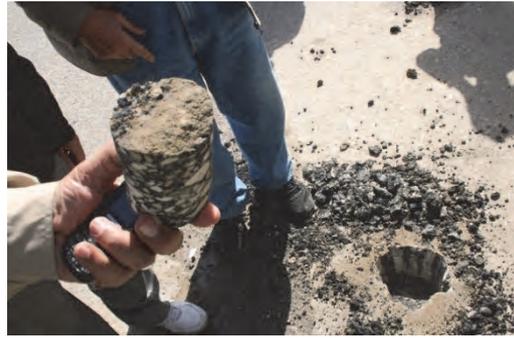
4. コア抜きされた舗装。良好である。

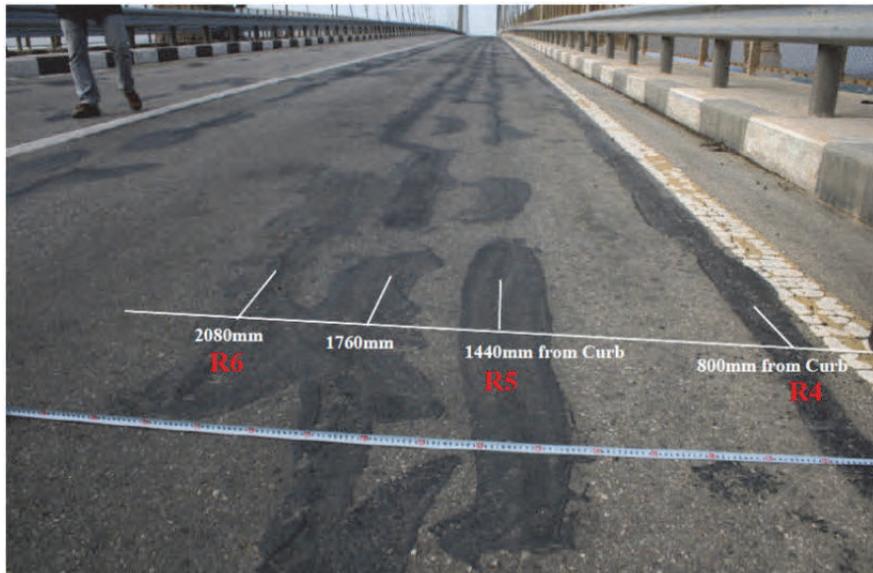
図 2.3.2 補修された舗装クラック位置とU リブ位置の関係

図 2.3.1、2.3.2 に示すように舗装クラックは、概ねタイヤの通過位置と一致する。また、舗装クラックはUリブ内の中央または2つのUリブの間で発生している。この事は、舗装クラックが補強のリブプレートのない鋼床版の上面で発生していることを示す。これは、2012年調査の報告書にも記載されている。

舗装クラックは、Uリブ内の中央、および2つのUリブの間の無補剛位置にて、鋼床版の変形によって生じていると推察される。

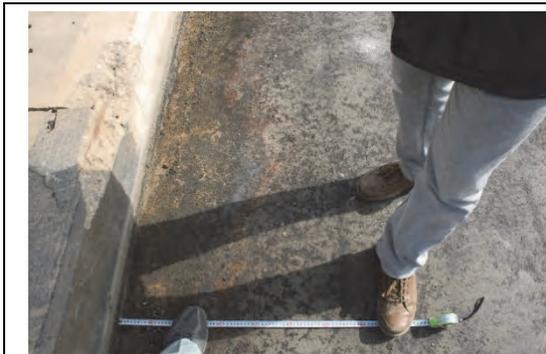
鋼床版のR4 Uリブの溶接位置は路肩端から64cmで写真の沓の位置である。

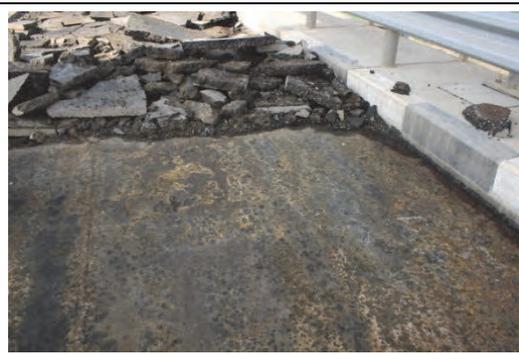
西側主塔近傍の錆状況。このあたりが最も錆が多い区間と思われる。

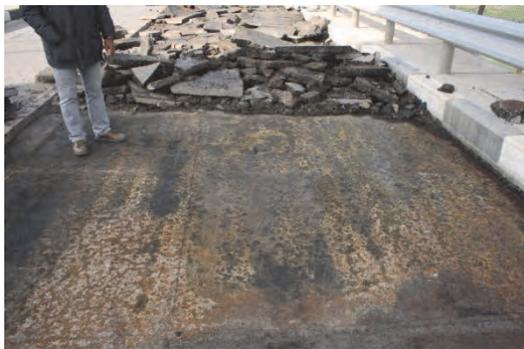
北側車線、西側主塔近傍の錆

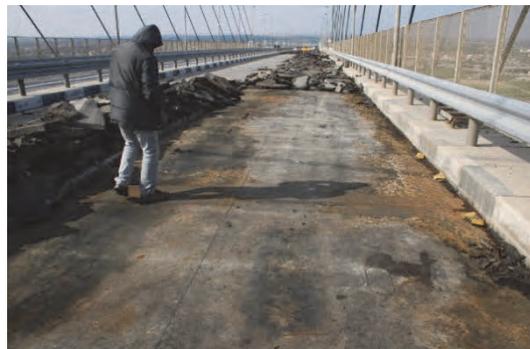
錆の発生位置は舗装クラックの発生位置の両サイドである。中央部分は良好である。

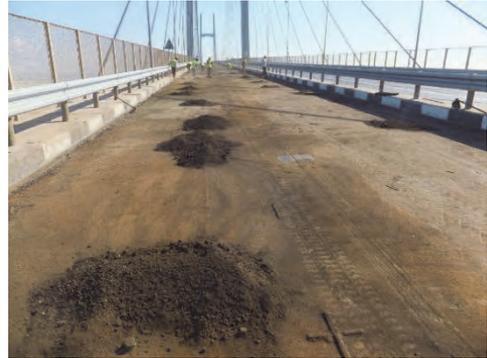
2. 白い部分は比較的良好。錆は両サイド及び中央に多く発生している。

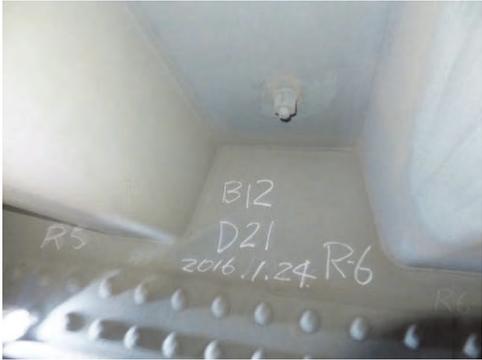
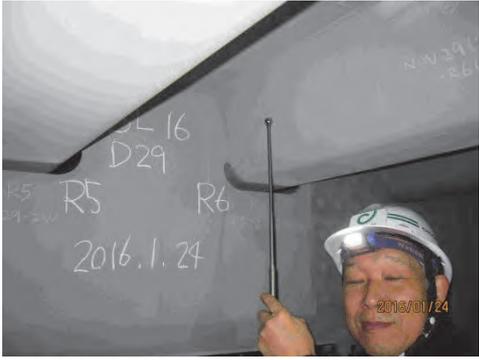
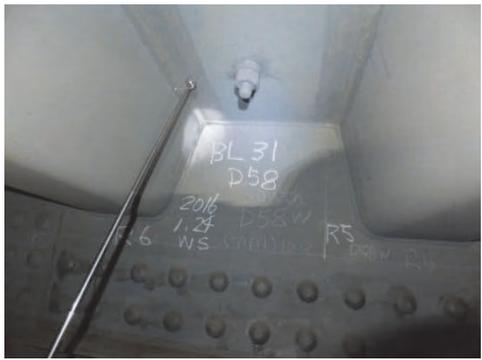
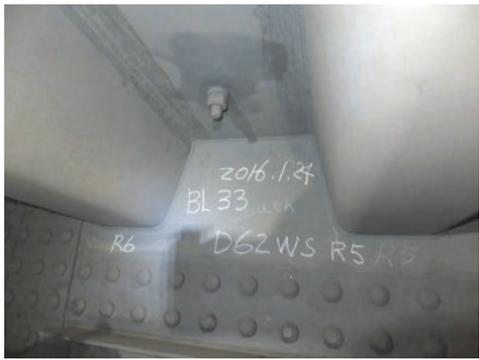
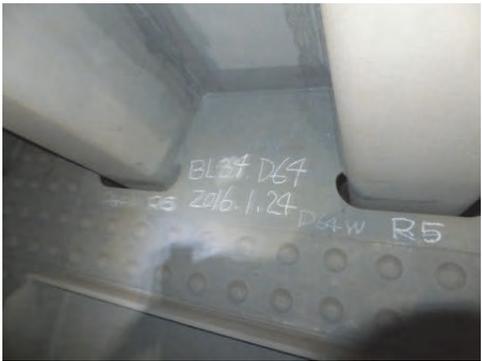
調査チームは箱桁内に入り、2012年に調査された図2.3.4の5か所の調査を行った。もしクラックが確認されれば、これは2012年以降に発生したことになる。R6とR5を中心に調査を行ったが、疲労クラック発生兆候となるペンキの割れは認められなかった。

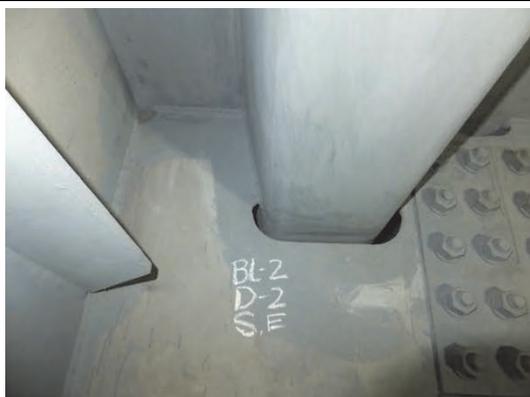
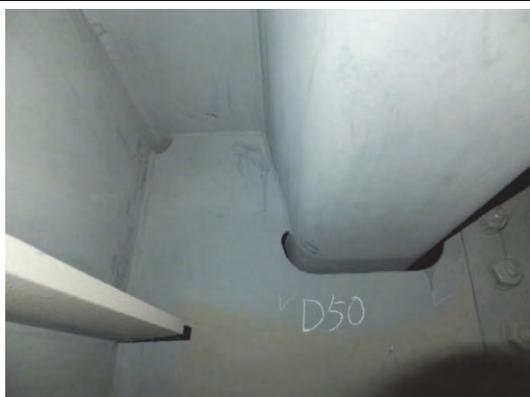
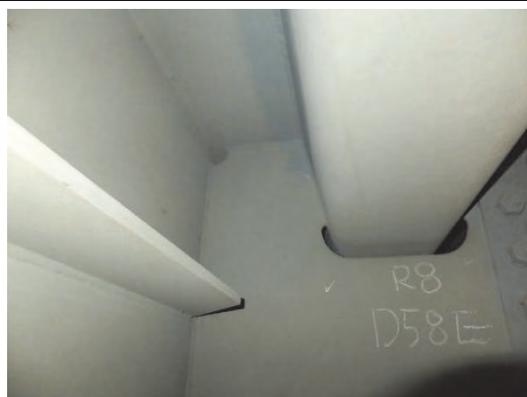
調査チームは加えて、R8のUリブまわりの調査を行った。調査は西側サイドスパン全体と中央スパン西側半分の北側R8、南側R8で行った。疲労クラック発生の兆候となるペンキの割れは認められなかった。

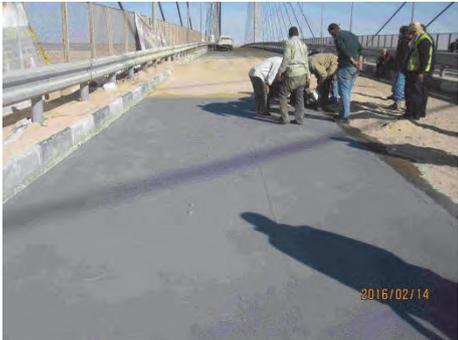
<p>2016/02/13</p>
<p>3. サンドブラスト後</p>	<p>4. サンドブラスト後 (錆の多い部分)</p>

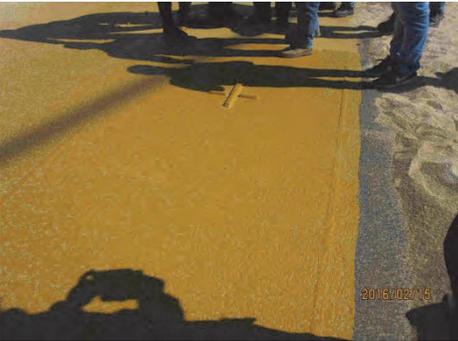
<p>2016/02/16</p>
<p>5. サンドブラスト後</p>	<p>6. プライマー塗布(Zinc Chromate)</p>

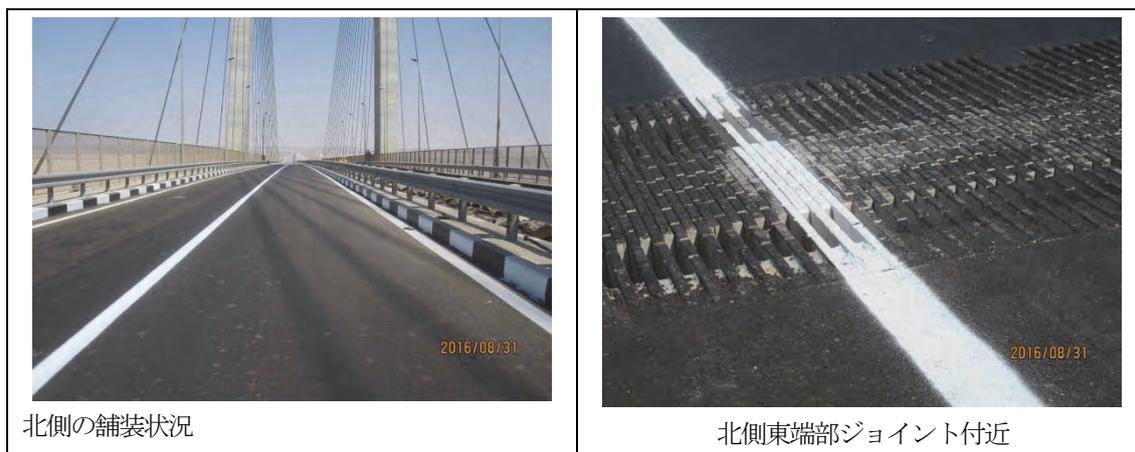
北側の舗装工事は 2016 年 8 月に完了し、交通解放されていた。舗装状況は良好であった。一方、今後、引き続き舗装の状況調査は行う必要がある。

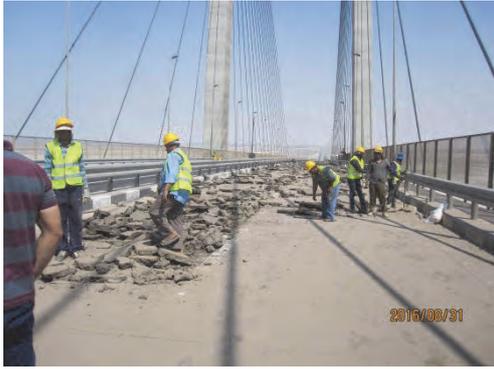
既存舗装の撤去は、作業員が北側で経験済みであったため、非常にスムーズに行われた。また北側で鋼床版の切削キズを生じていたが、南側では、鋼床版の上 2 cm で、カットを止めたため、鋼床版表面の切削キズは発生しなかった。

舗装撤去

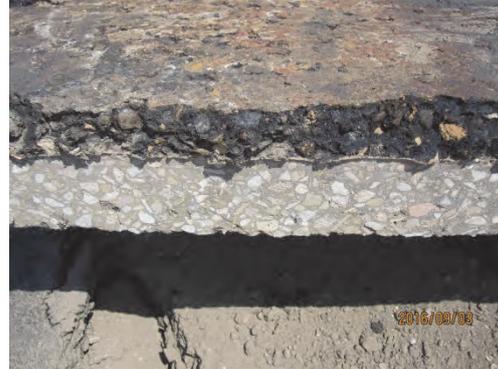
舗装切断面 (鋼床版から 2cm 上まで)

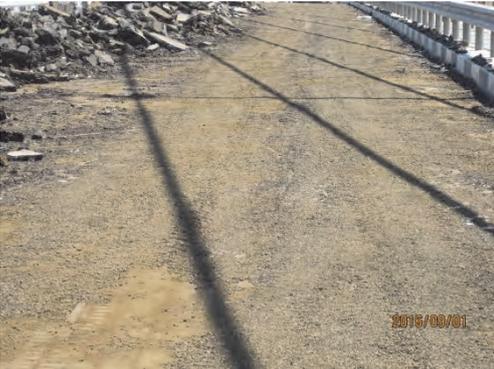
線状の錆は貫通した疲労クラックの発生可能性を示唆するが、線状クラックは認められなかった。しかしながら、線状の錆がないことが、疲労クラックがないことを保証するものではない。疲労クラックの確認は鋼床版下面の U リブまわりを調査下した。（3.2.3 参照）

鋼床版表面 (清掃前)

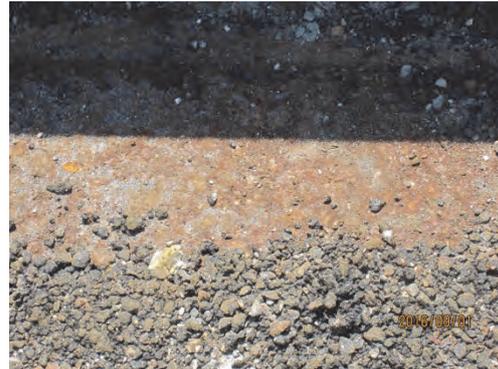
南側道路端の錆 (清掃前)

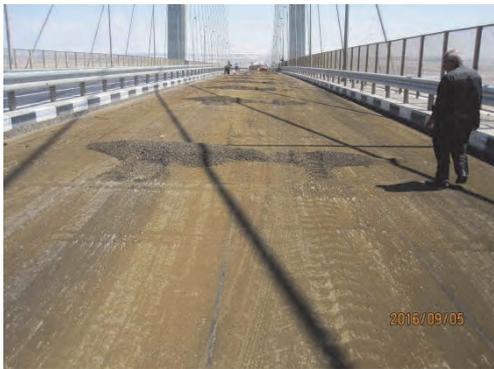
鋼床版表面 (清掃後)

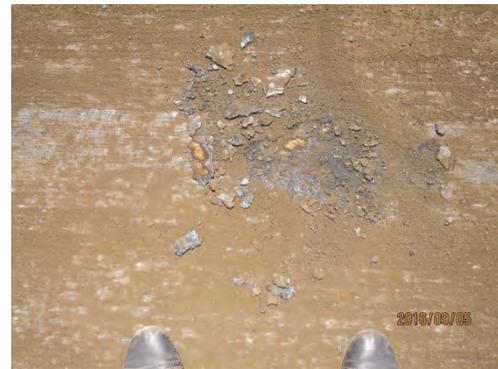
大きな錆 (清掃後)

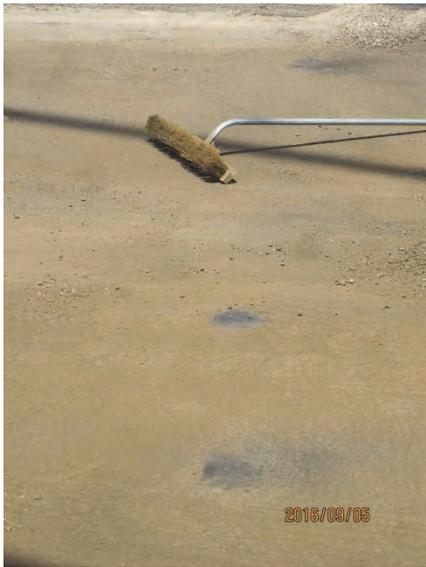
横断方向の測定点

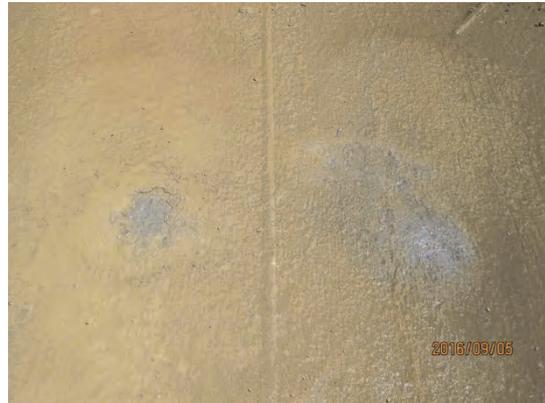
清掃後の測定予定点

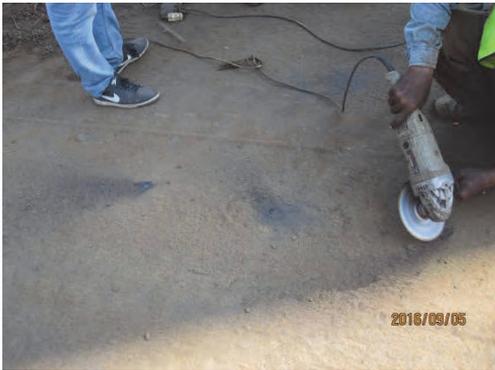
グラインダーがけ

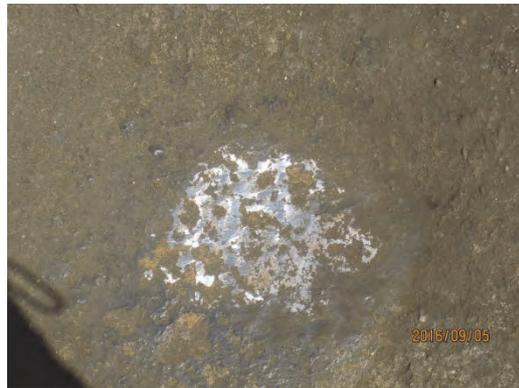
グラインダーがけ後の表面

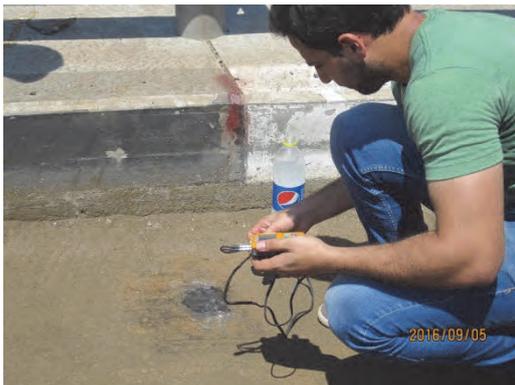
測定作業

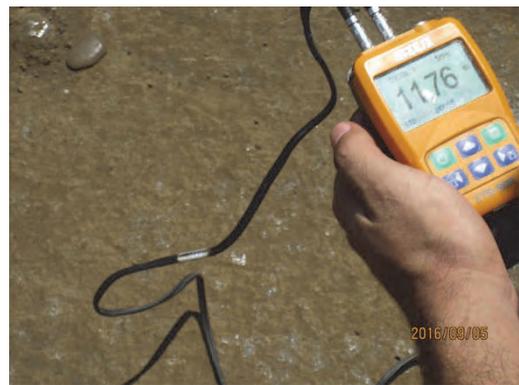
測定結果例

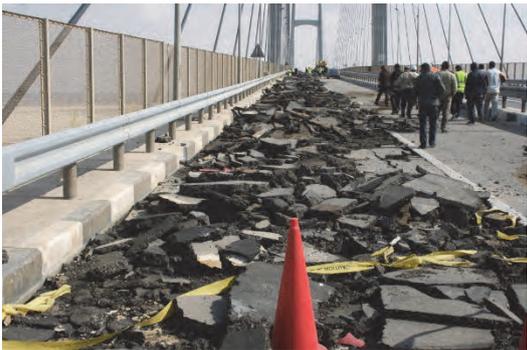
<p>2. 1車線分が舗装撤去。舗装表面のチェック。表面清掃後では、疲労クラックが確認しづらいため、その前に目視検査を行う。</p>

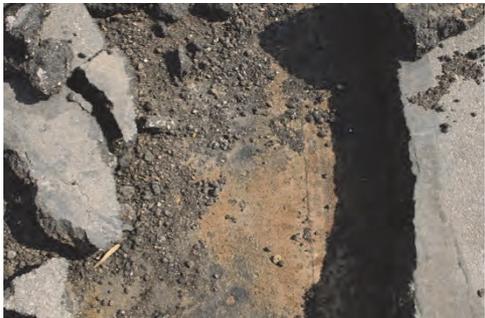
<p>3. 錆の発生が確認されるが、さほど進んではない。</p>

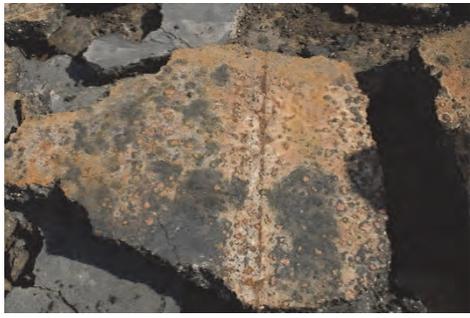
<p>4. 鋼床版に接している面の状況。</p>

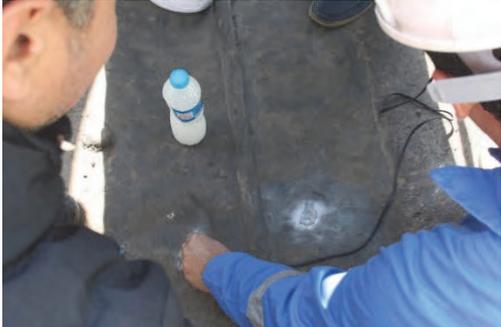
<p>5. 鋼床版板厚測定に際して、現地エンジニアはグラインダーで平面に仕上げたが、鋼床版にとって、好ましくないため、最小限にするよう指示。</p>

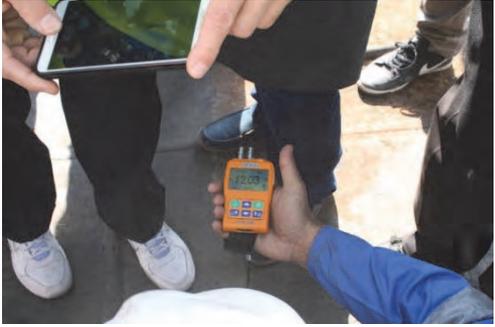
<p>6. 板厚測定状況。ここでは、12mmを示している。</p>

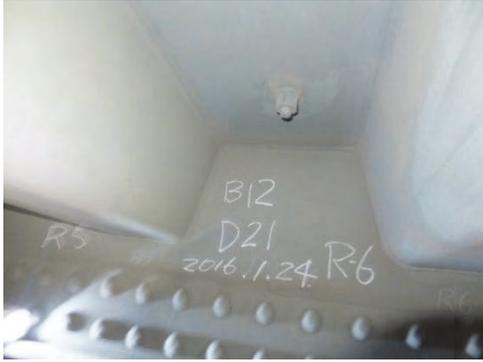
1. L1 Position

調査チームは箱桁内に入り、2012年に調査された図2.3.4の5か所の調査を行った。もしクラックが確認できれば、これは2012年以降に発生したことになる。R6とR5を中心に調査を行ったが、疲労クラック発生の兆候となるペンキの割れは認められなかった。

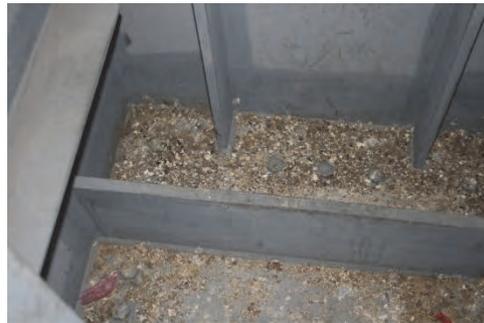
6. 箱桁の入り口。鳥の糞が散乱している。

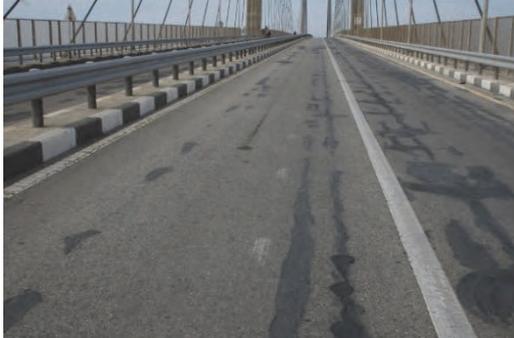
1. 北側車線の東側。西側を望む。舗装の補修状況が確認される。

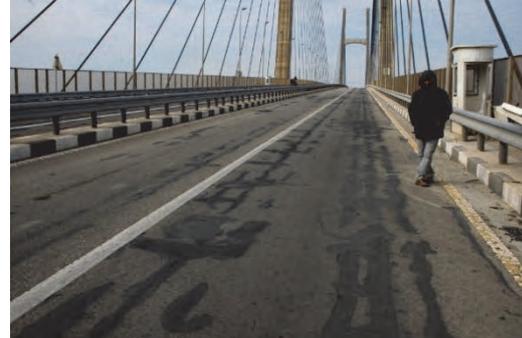
2. 走行車線で、5線の補修が確認される。これらはUリブの中央および、Uリブ間に一致する。

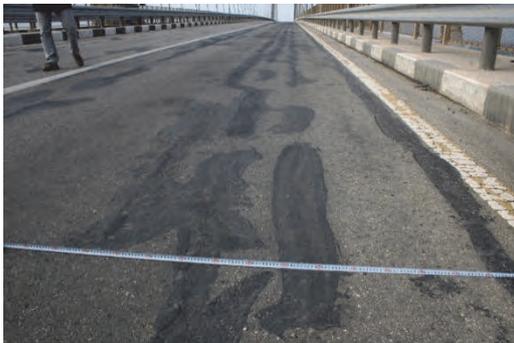
3.ここでは、車線端部に舗装修正が確認され、これはR4リブの中央に一致する。しかしながら、走行車両のタイヤ位置とは一致しないため、原因は不明瞭である。

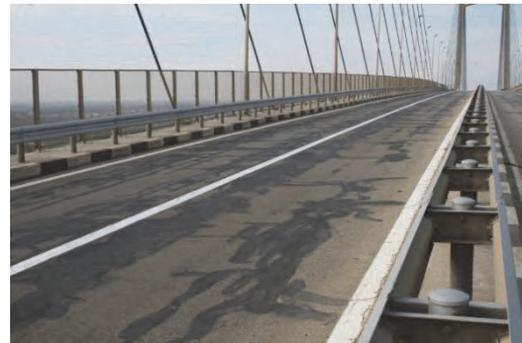
4. 南側の舗装補修状況。

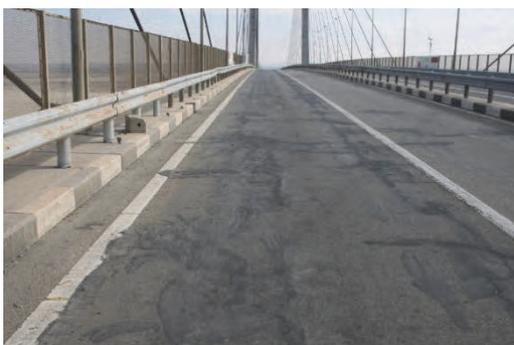
5. 橋梁中央付近の舗装補修状況。

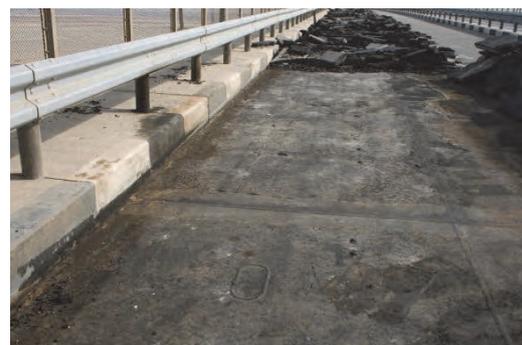
6.主塔付近での舗装撤去後の状況。

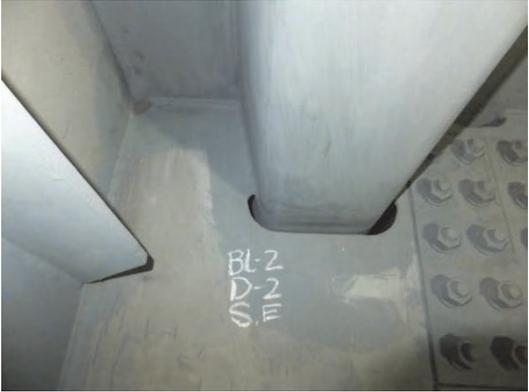
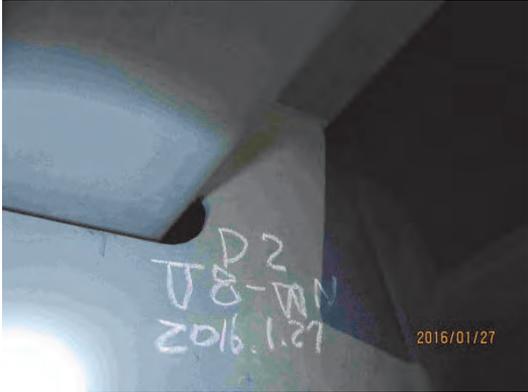
<p data-bbox="320 983 703 1014">1. R8 and D2 diaphragm, East face.</p>

箱桁内の R8 U リブを主体に調査を行った。調査は西側スパンを対象とし、北側、南側とも R8 U リブ周りをチェックした。疲労クラックの兆候である塗装のクラックはなかった。

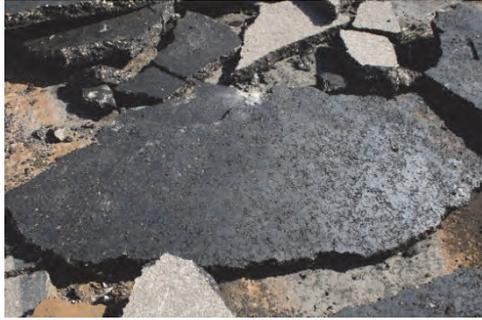
3. 北側西再度の撤去舗装。黒い表面は鋼床版に錆が発生していないことを示す。

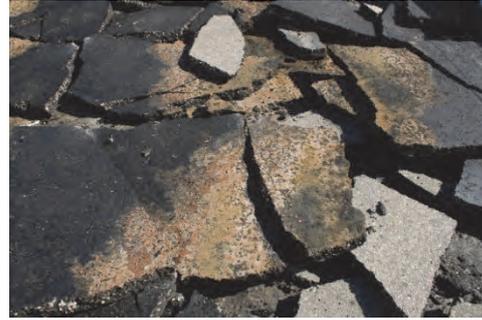
4. 撤去舗装の裏面が赤いのが、錆の発生を示す。

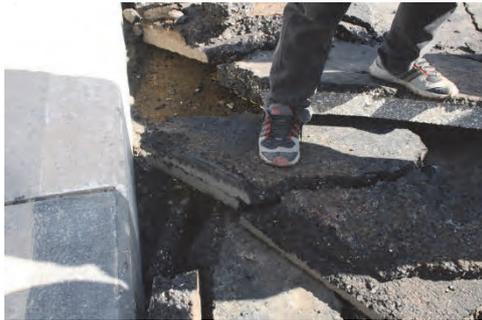
5. 北側地覆付近の錆状況。

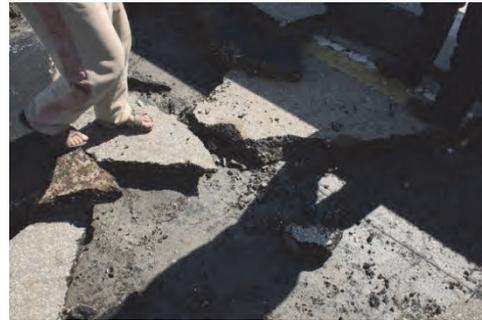
6. 車線中央部状況。錆は発生していない。

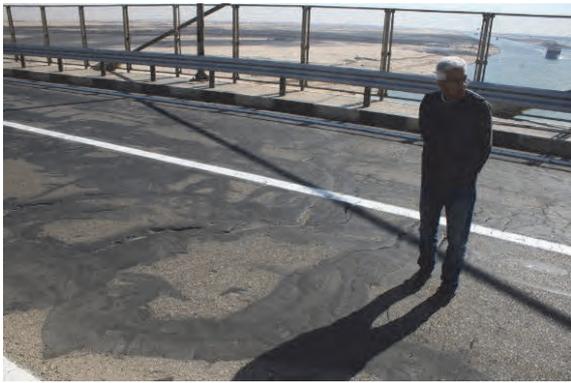
南側、スパンセンター西側の D30 から D64 の R8 U リブを主体に調査。疲労クラックの兆候はなし。
舗装クラックの大きい D58 付近を念入りに見たが、疲労クラックの兆候はなかった。

1. 南側の大きな舗装クラック。ダイヤフラム D58 付近。 .

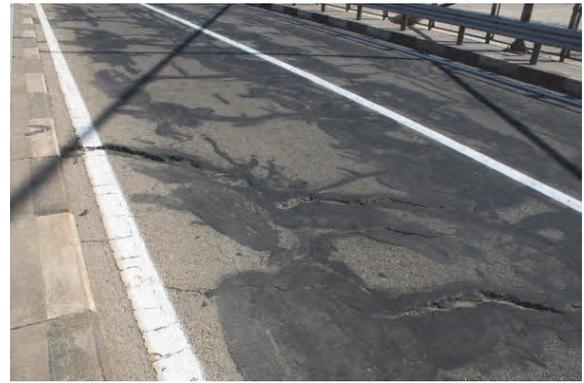
2. 南側の大きな舗装クラック。

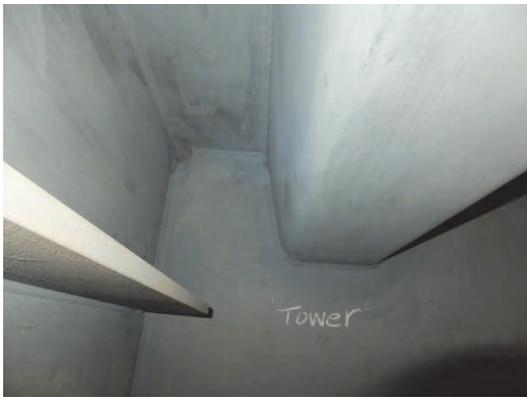
3. 南側 D30、R8 Uリブの状況。ペンキのクラックは発生していない。

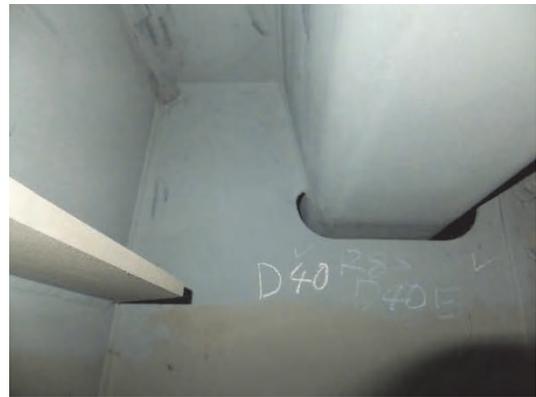
4. D40 ダイヤウラム、クラックなし。

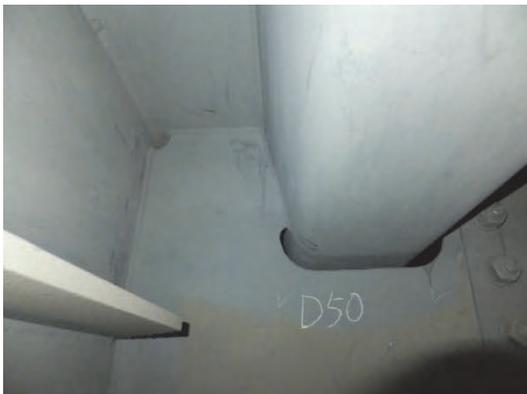
5. D50 ダイヤフラム。クラックなし。

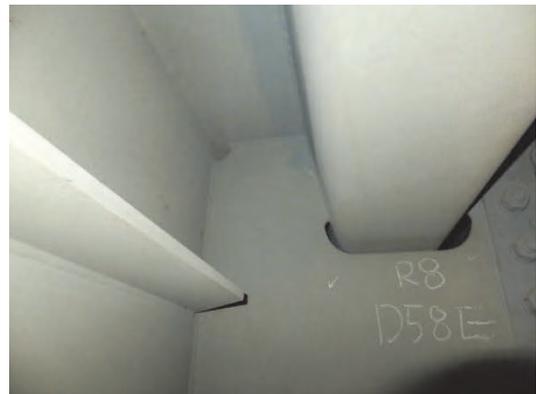
6. D58 ダイヤフラム。クラックなし。

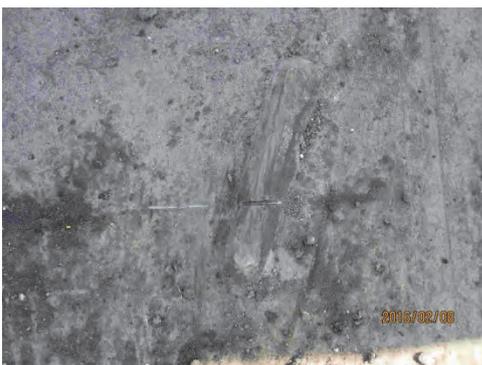
3. 鋼床版表面のオーバーカッティング。

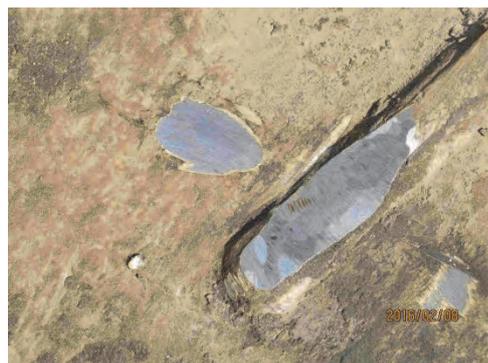
4. サムコによるオーバーカッティングの処理。

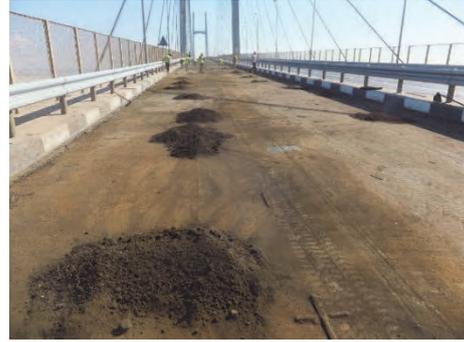
2. 白色部分は錆の発生が相対的に少ない部分。

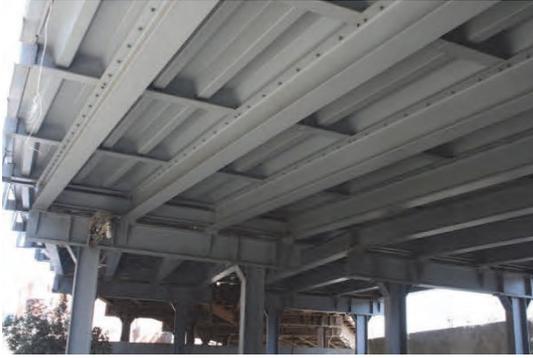
5. Panels of orthotropic steel deck were fabricated at the shops and transported to the site and assembled. One panel is about 8m long, if lateral rib spacing is 2m, and consists of 6 U-ribs. The U-rib directly above the longitudinal beam is not a U-rib but it consists of two inclined plates. The south side lane consists of two panels and the north side lane also consists of two panels.

But the longitudinal stiffness of the Maasara Bridge seems to be higher than that of the Suez Bridge, because the space of two U-ribs are supported by two longitudinal beams. (Photo 5)

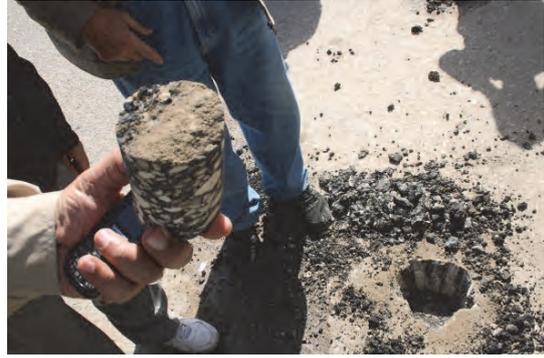
18. Drilled core. The pavement is healthy.

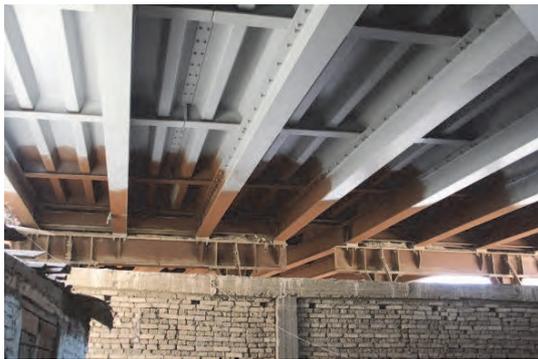
19. In 1994, both sides of the bridge was painted by Zinc Rich Paint. But Subway Company refused to paint the center of the bridge. It is said that the weathering steel was adopted for this bridge. Then it was not needed to paint.

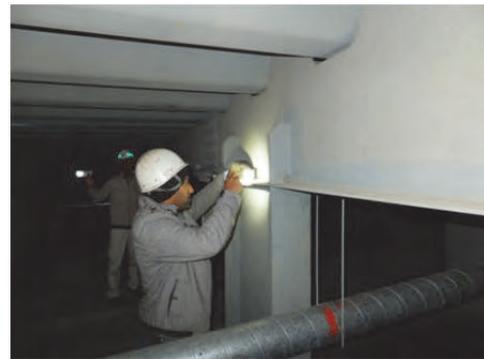
20. スエズ運河橋のUリブサポートスパンは大きい。

But the space of the longitudinal web of the Suez Bridge is much longer. (Photo 20)

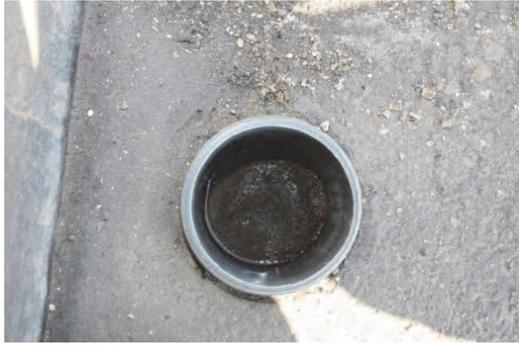
1 P11、水が確認できる。底は膨れ上がっている。

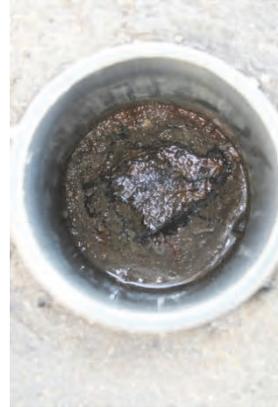
2 P11、底の表面ははがされていて、鋼床版の錆が見える。

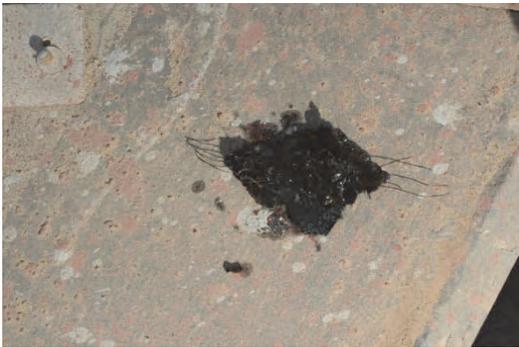
3 P11、底のゴム板

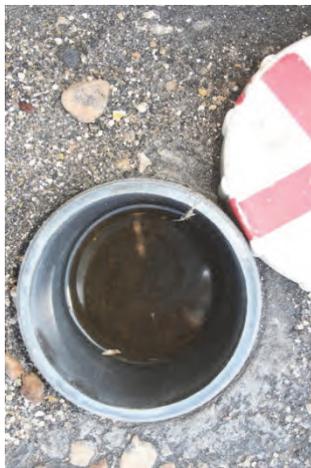
5 P12、他に比べ水位が高い

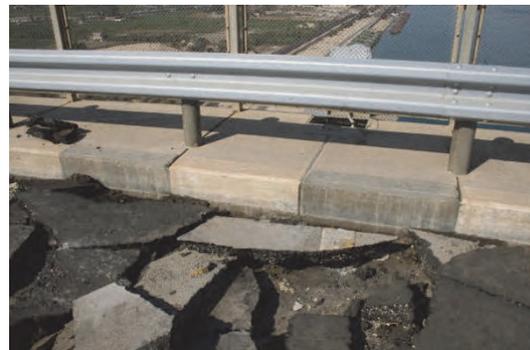
6 P13、撤去され t 舗装と舗装上のキャップ

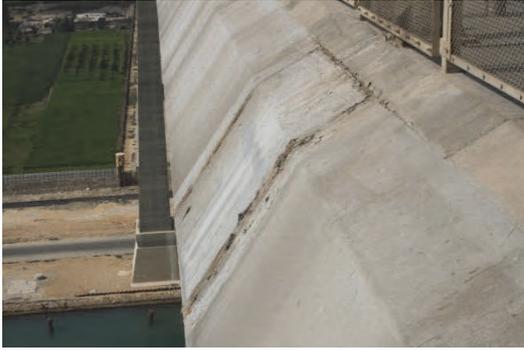
7. 現場溶接部のフェアリングに甚大な錆が発生している

ただし、写真に示すように南側の外側フェアリングに大きな損傷が確認された。フェアリングは構造部材でないため橋の安全性にかかわるものではないが、早急に錆を除去し、補強することを提案する。

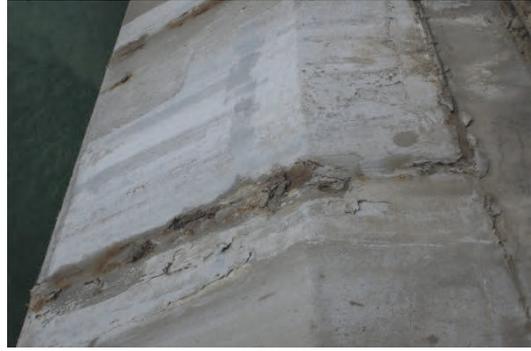
8. フェアリングの錆は構造上問題ないが、錆を除去し補強することが望ましい

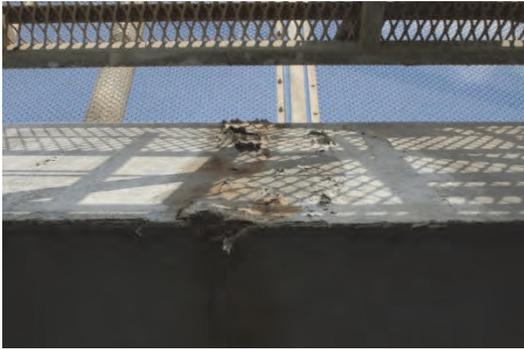
9. フェアリングの錆

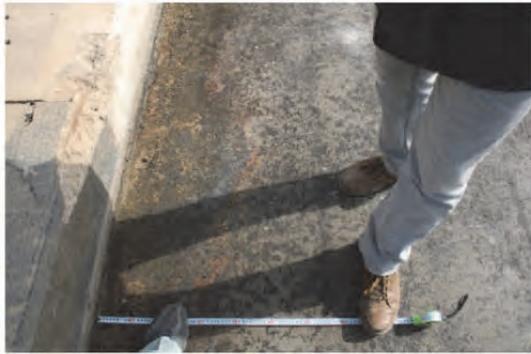
7. The welding line of R4 U-rib below the steel deck, which is 64cm apart from the curb is visible on the left of the brown shoes.

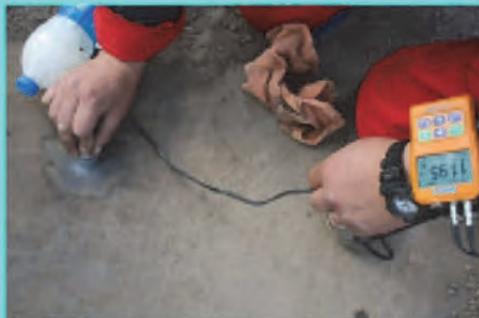
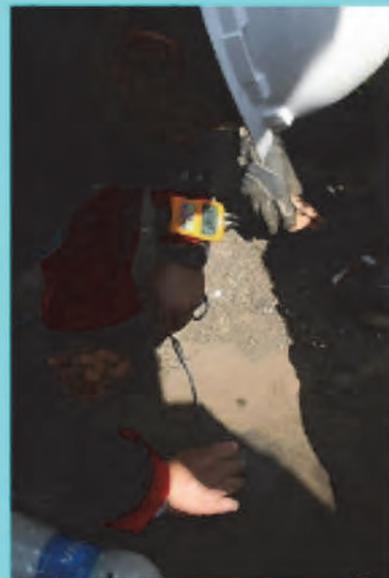
Deck plate thickness was measured at site.

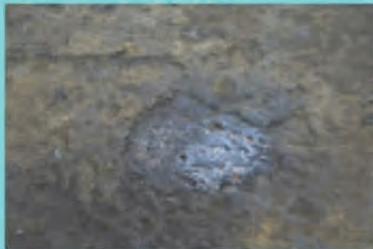
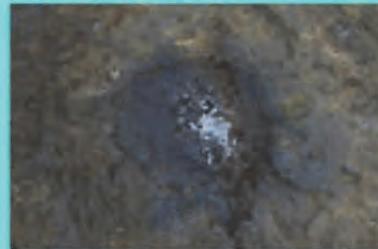
Measurement of D6, First & Second Measurement

First measurement 11.97mm

Second measurement 11.66mm

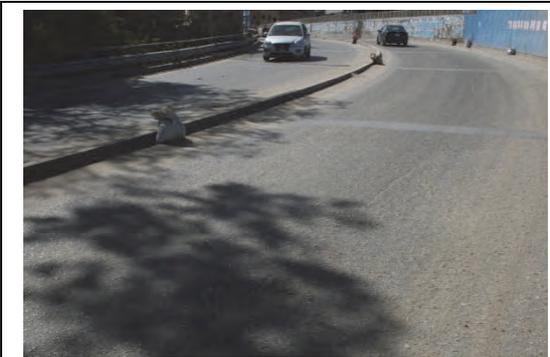
1. The Maasara Bridge over Subway. On the right is the South Lane.

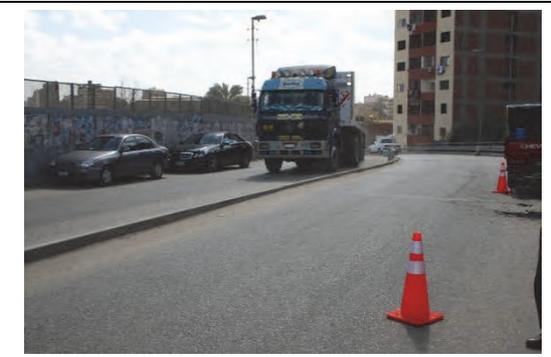
2. The traffic volume is not large but sometimes lager trucks pass.

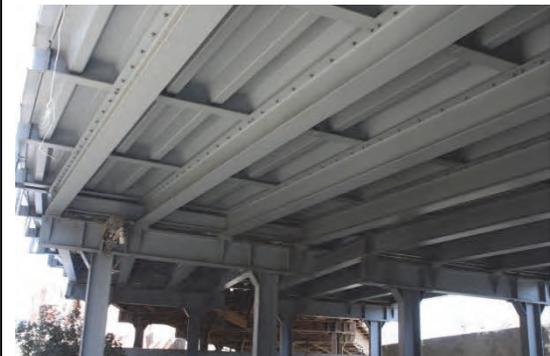
3. Panels of orthotropic steel deck were fabricated at the shops and transported to the site and assembled. One panel is about 8m long, if lateral rib spacing is 2m, and consists of 6 U-ribs. The U-rib directly above the longitudinal beam is not a U-rib but it consists of two inclined plates.
