**FOLLOW-UP COOPERATION STUDY  
ON  
THE BRIDGE DESIGN  
(COUNTERPART TRAINING FOR THE SUEZ  
CANAL BRIDGE PROJECT)**

**FINAL REPORT**

**JAPAN INTERNATIONAL COOPERATION AGENCY**

**ORIENTAL CONSULTANTS GLOBAL CO., LTD.  
CHODAI CO., LTD.**

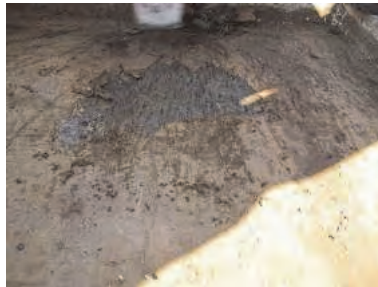
Photo1.2.2 Corrosion of Steel Deck plate

By visual inspection, some water was found entering the lower side of the bonding layer and rust was found on the surface of the steel deck plate in all inspected areas.

The thickness of the steel deck plate reduced by rust was measured by ultrasonic method after carefully removing pitted corrosion attached to the upper surface.

The thickness reduction was different depending on the investigated positions. The corrosion found on the driving lane of south section had progressed considerably compared to the north section. Steel plate thickness reduction by corrosion was less than 1 mm and most parts were about 0.5 mm.

Reduction of thickness due to corrosion may not be a big problem at the moment in terms of structure. However, if no measures are taken, fatigue cracks may occur from the top deck plate and threaten the structural soundness. To confirm the structural safety of the Bridge, the stress of the longitudinal ribs of the steel deck plate was calculated and analysed for the case where the thickness of the steel deck plate was reduced to 11.5 mm or 10.0 mm from the original thickness of 12.0 mm. As a result of the analysis, even if the plate thickness becomes 11.0 mm, the stress changes are small and less than 1%. Therefore, it was concluded that there is sufficient margin for the allowable stress.

In conclusion, it is indispensable to repair the existing pavement and the bonding layer on the entire surface of the steel deck plate using appropriate repair methods after removing the rust on the surface of the steel deck.

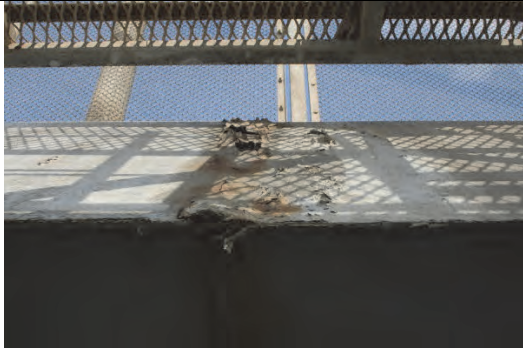
Corrosion

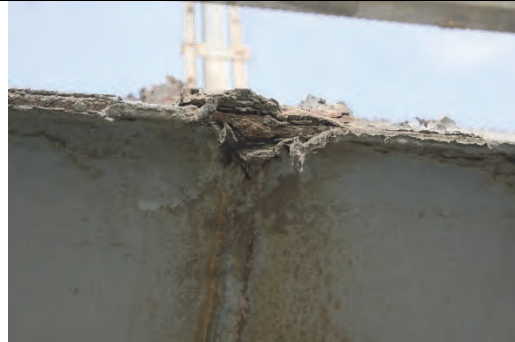
Severe corrosion

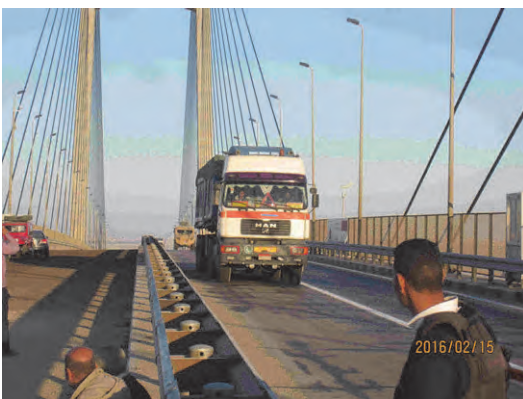
Total weight is estimated approximately 60 ton. For the soundness of the bridge especially for the pavement and the Steel Deck plate, axle loads of the tracks of army must be limited to less than 13 tons and the total weight also must be limited to less than 40ton.

Heavy Track of Army

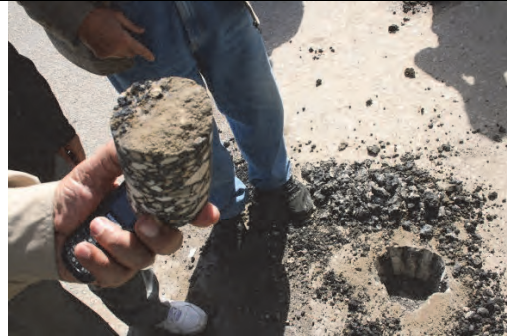
4. Drilled core. The pavement is healthy.

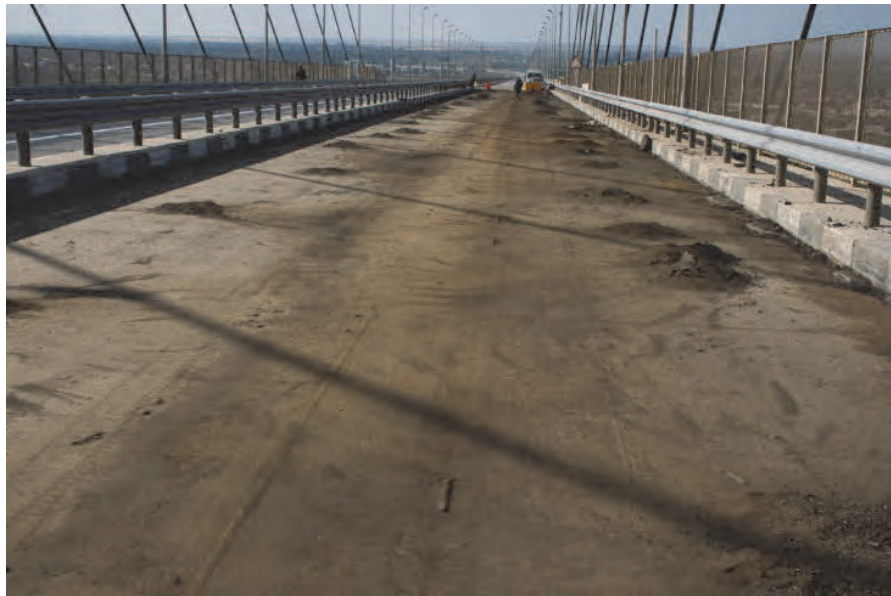
As shown in Fig.2.3.1 & 2.3.2, pavement cracks roughly correspond to the tire passing lines. Also the pavement cracks correspond to the positions of the center of U-ribs, or the center of two adjacent U-ribs. This means that the pavement cracks occur over the plates under which no reinforcing ribs exist. This can be seen from the report of 2012, too.

Pavement cracks may have been caused by the deformation of the steel deck plates over an empty space of the U-rib or an empty space between two adjacent U-ribs.

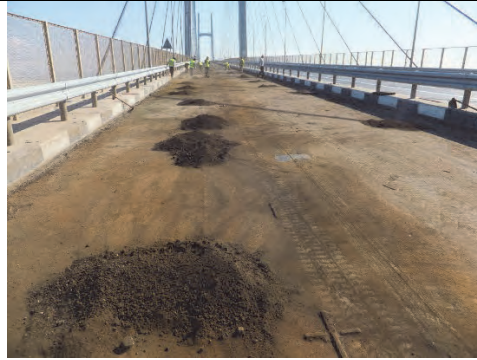
2. White area is healthier. Rust exists mainly at both ends and at the center.

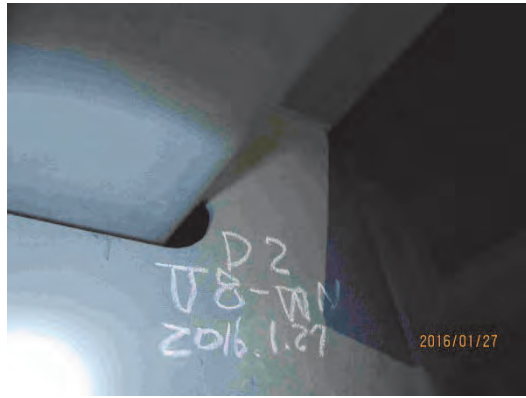
R8 and D2 diaphragm, East face.

The Study Team again inspected inside of the box girder, especially R8 U-rib areas. The inspected area is the west side span and half of center span. As a result, no paint cracks nor fatigue cracks were found.

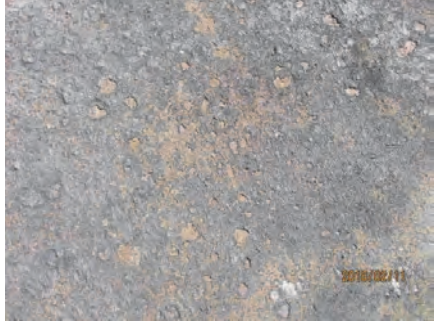
| <p>1. Testing work of sand blasting</p> | <p>2. Before sand blasting</p> |

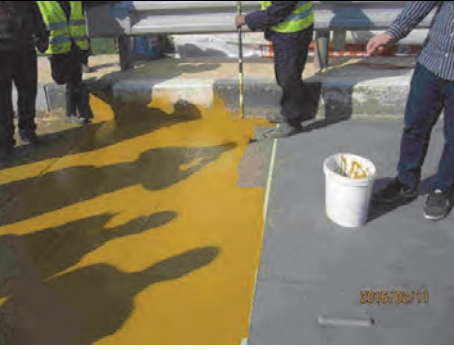
| <p>5. Painting by roller</p> | <p>6 Measurement of thickness;<br/>Approximately 0.15mm at wet condition.<br/>It will be 0.12mm after dried.<br/>A little thick, so it will be reduced more to<br/>targeted 0.05mm on actual stage.</p> |

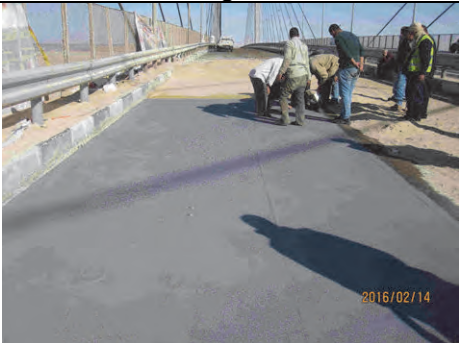
3. After sand blasting

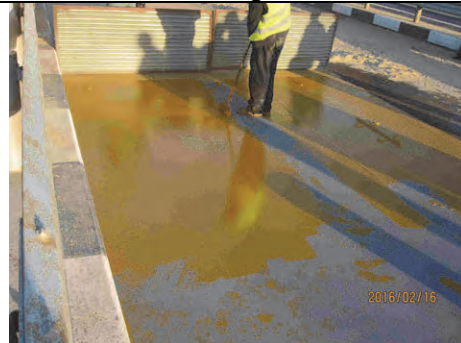
6. Painting of primer (Zinc Chromate)

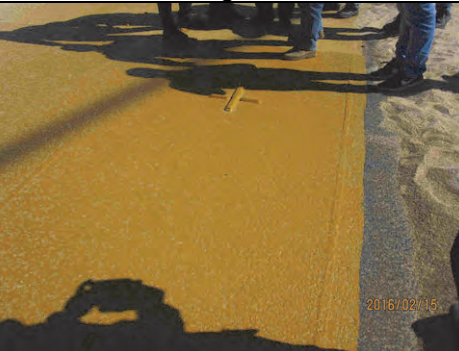
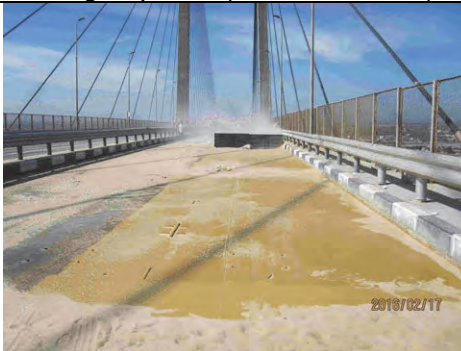
7. After painting of primer

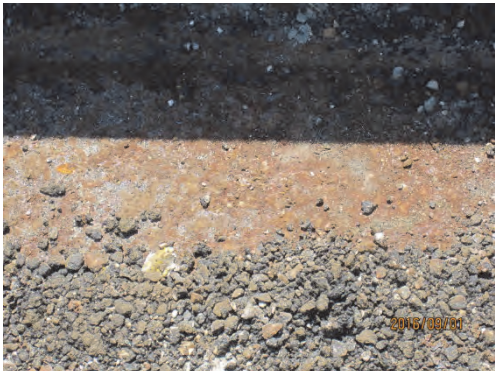
| Surface of Steel Deck (Before cleaning) | Corrosion near southern edge (Before cleaning) |

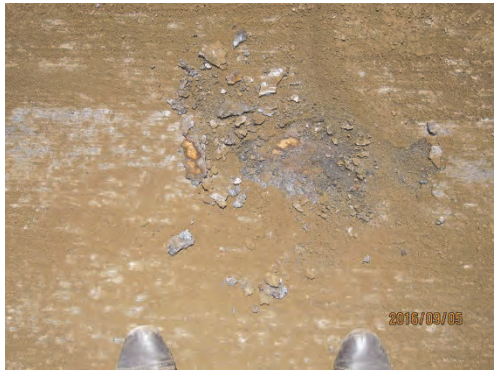
| Surface of Steel Deck (After cleaning) | Deep corrosion (After cleaning) |

The result of measurement is shown in the table below. The healthy areas show the original plate thickness of 12mm or the value close to 12mm. But the areas with some corrossions, the surface is not flat and the measurement was unstable. So the surface was ground slightly to have a small flat area for the measurement.

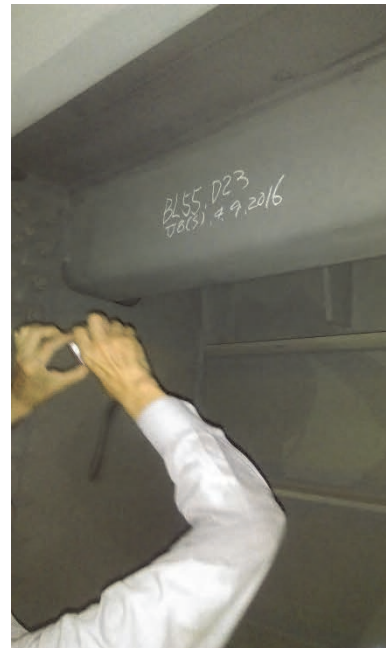
After entering the inside of the box girder, the places shown in Figure 3.2.3 were visited (from BL40 to BL65 ). R8 ribs (South & North) were examined but no indication of cracks, such as the paint cracks were found.

BL55 D23, U8 (South).

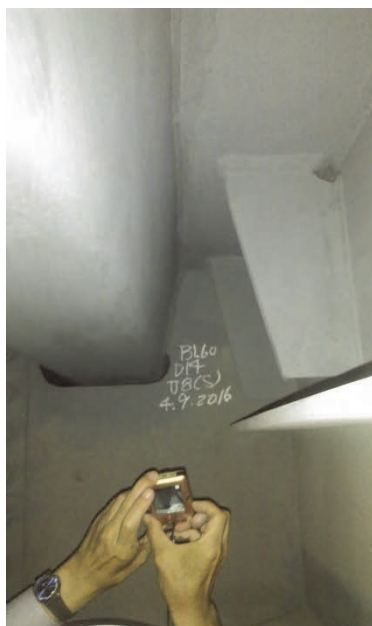
BL60 D14, U8 (South).

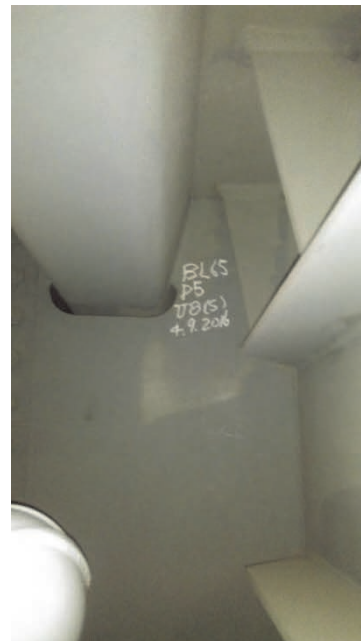
BL65 D5, U8 (South).

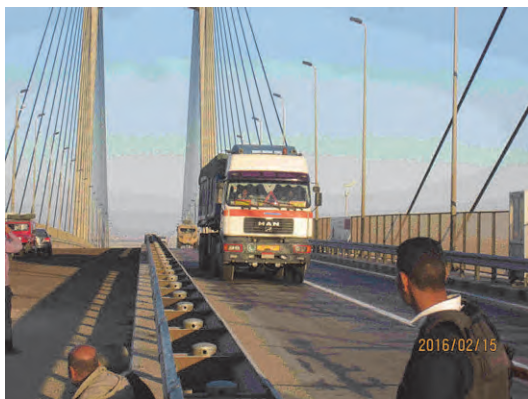
Heavy Track of Army

During the inspection, heavy tracks of army sometimes have been recognized shown in photos.

Total weight is estimated approximately 60 ton. For the soundness of the bridge especially for the pavement and the Steel Deck plate, axle loads of the tracks of army must be limited to less than 13 tons and **the total weight also must be limited to less than 40ton.**

Total weight is approximately 60 ton.  
(2.5m\*2.0m\*5m\*2.0+10.0ton(self-weight)  
=60ton)

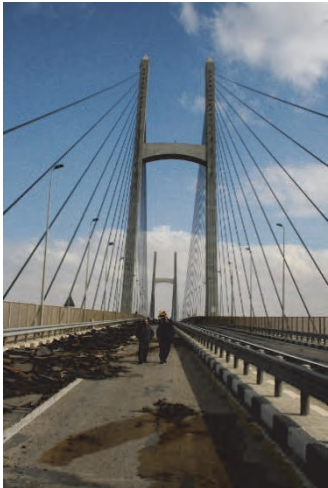
| <p>1. Bridge and pavement removal</p> | <p>2. One lane of pavement is removed. The condition of the steel deck surface is checked. If blasted, it is difficult to find fatigue cracks so that the steel deck surfaced was checked before blasting.</p> |

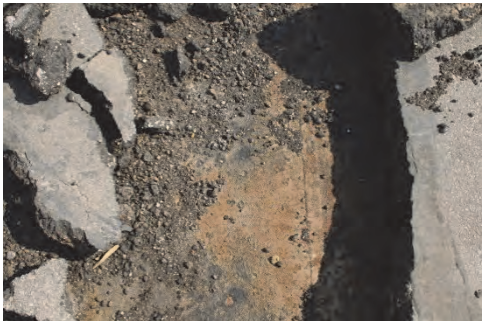
| <p>3. Some rust is found but not so severe.</p> | <p>4. Removed pavement surface directly attached to steel deck.</p> |

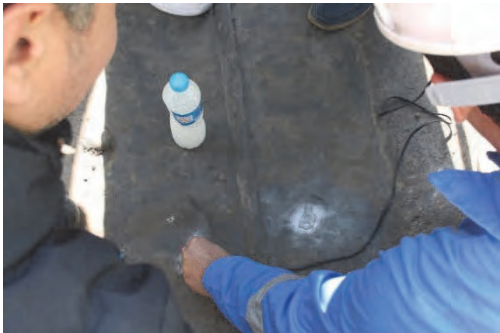
| <p>5. Spot rust after rust removal. A technician tried to flatten surface by grinder but JICA team stopped grinding, because healthy plate must not be ground.</p> | <p>6. Plate thickness next to spot rust. There is 12mm.</p> |

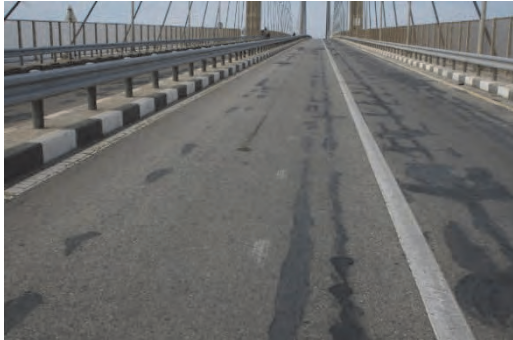
1. East side of the bridge and north lanes. Looking towards West on Overtaking Lane. Line repairs of pavements are visible.

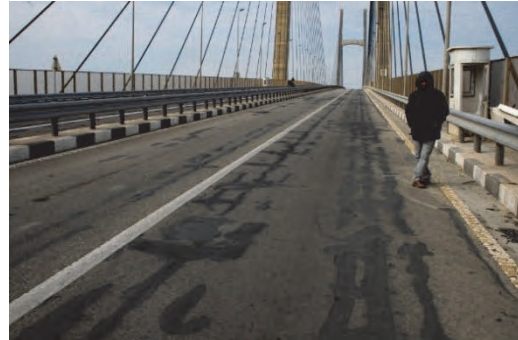
2. Driving Lane and 5 lines of pavement repair are visible. These lines correspond to the center of the U-ribs or the center of two adjacent U-ribs.

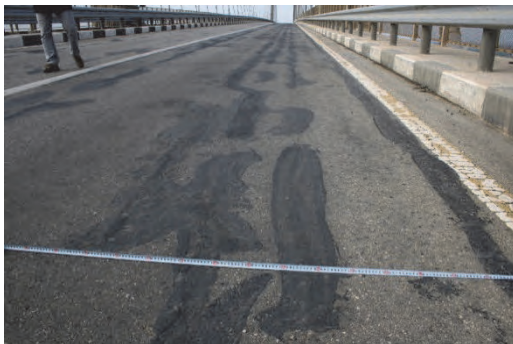
3. In this area, a repair line near the right white line, which is at the center of R4, is visible. But over this line, tires do not run so often and the reason of the crack formation is unclear.

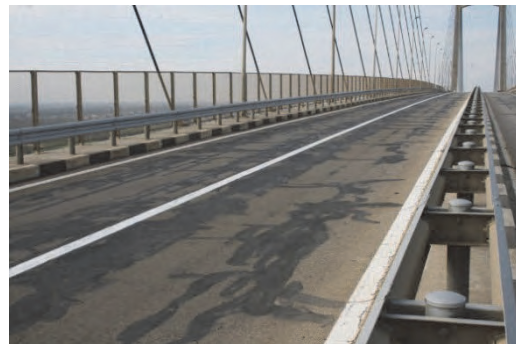
4. On the south lane, the pavement crack over R4 U-rib is not formed.

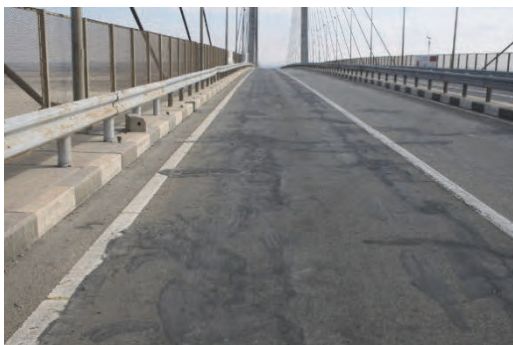
5. Near the bridge center, a crack line over R4 is not formed.

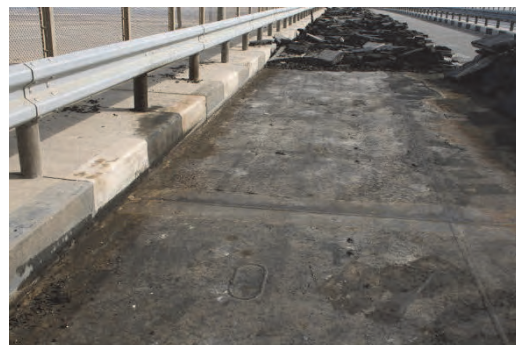
6. Near the tower, pavement materials were removed and the starving horse is visible. A temporary hand hole is between R4 and R5.

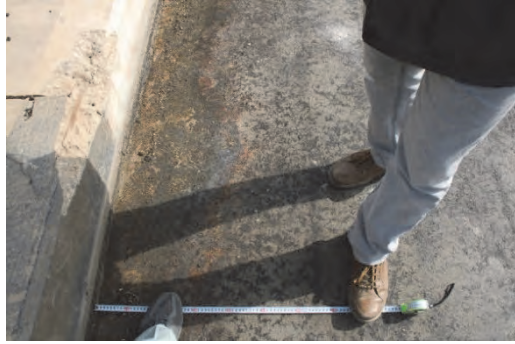
7. The welding line of R4 U-rib below the steel deck, which is 64cm apart from the curb is visible on the left of the brown shoes.

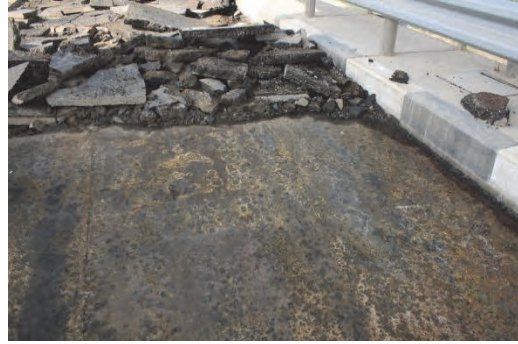
8. Corroded area near the west tower. This may be worst corroded.

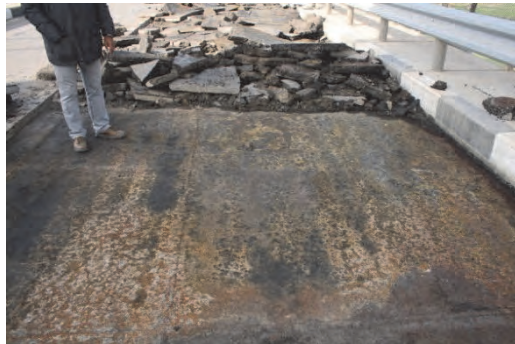
9. Corrosion near the west tower and on the North Lane.

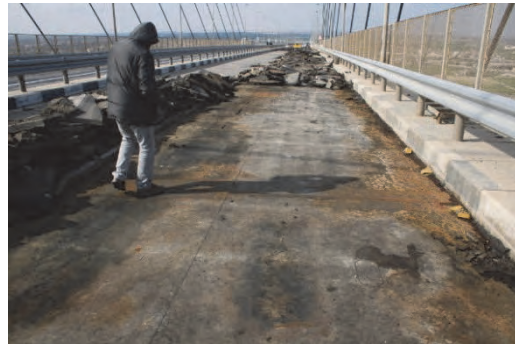
10. The corroded areas are on both sides which are below the cracked pavement areas. The center area is healthier.

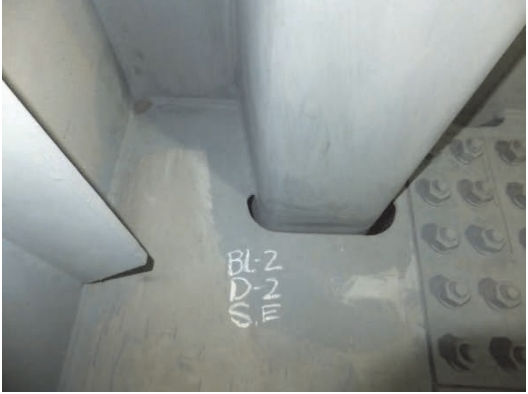
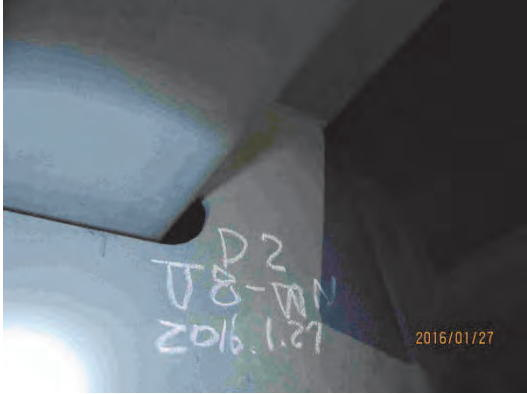
The Study Team visited the Bridge Site at 10 AM and inspected the inside of the box girder, especially R8 U-rib areas. The inspected area was the west side span and the welding beads of north and south R8 U-rib were inspected. No paint cracks were found.

| Welding bead of South Side R8 U-rib | Welding bead of North Side R8 U-rib |
|---|---|
| <p data-bbox="320 943 703 976">1. R8 and D2 diaphragm, East face.</p> | <p data-bbox="888 943 1272 976">1. R8 and D2 diaphragm, East face.</p> |

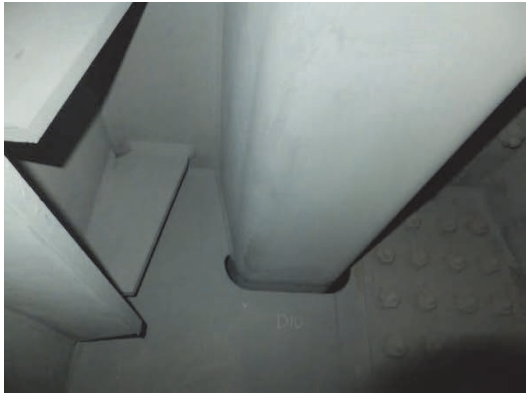
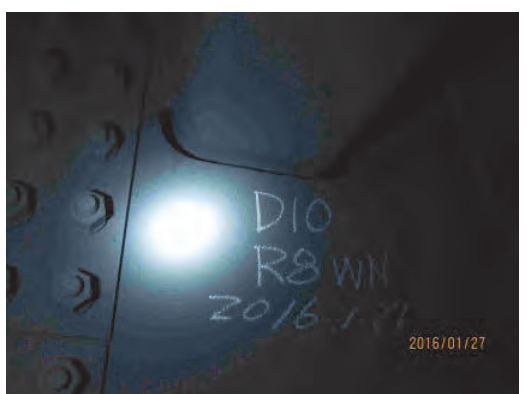
| Welding bead of South Side R8 U-rib | Welding bead of North Side R8 U-rib |
|---|---|
| <p data-bbox="320 1411 703 1444">2. R8 and D10 diaphragm, East face.</p> | <p data-bbox="888 1411 1272 1444">2. R8 and D10 diaphragm, East face.</p> |

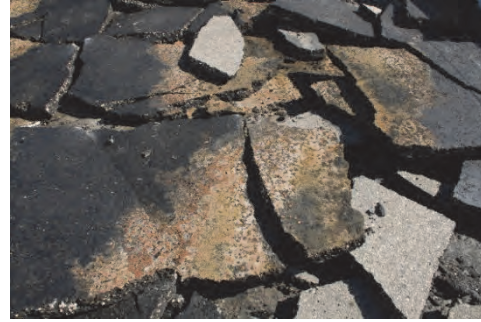
4. Back side of removed pavement. This red color shows steel deck corrosion.

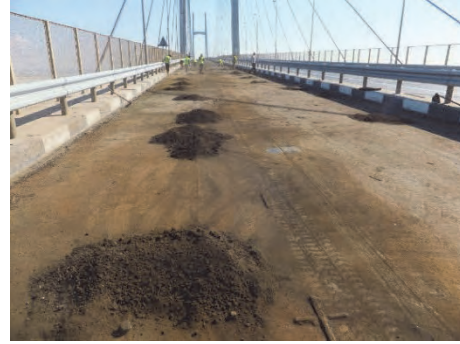
2. White area is healthier. Rust exists mainly at both ends and at the center.

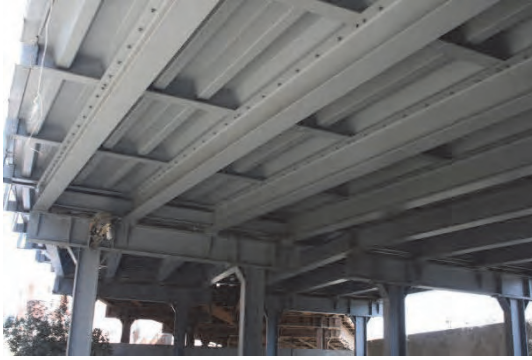
5. Panels of orthotropic steel deck were fabricated at the shops and transported to the site and assembled. One panel is about 8m long, if lateral rib spacing is 2m, and consists of 6 U-ribs. The U-rib directly above the longitudinal beam is not a U-rib but it consists of two inclined plates. The south side lane consists of two panels and the north side lane also consists of two panels.

But the longitudinal stiffness of the Maasara Bridge seems to be higher than that of the Suez Bridge, because the space of two U-ribs are supported by two longitudinal beams. (Photo 5)  
But the space of the longitudinal web of the Suez Bridge is much longer. (Photo 20)

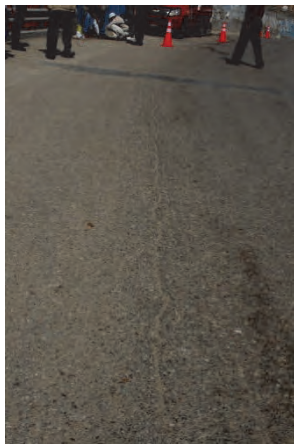
9. Cracks on the pavement. These cracks seem to correspond to the position of two panel connection, because two panels can move independently to some extent.

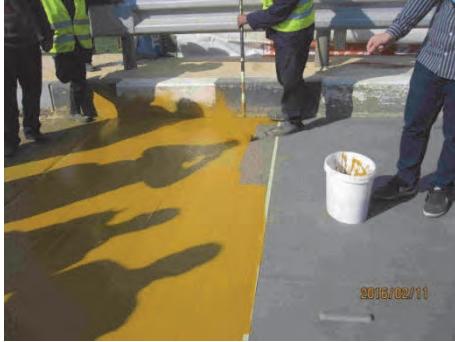
5. Painting by roller

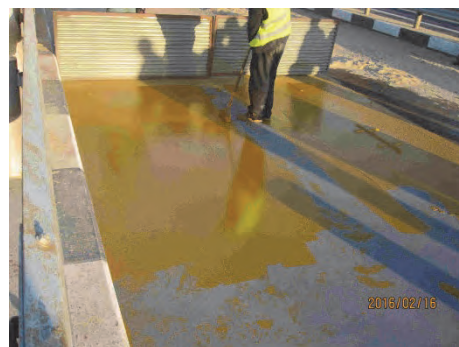
6. Painting of primer(Zinc Chromate)

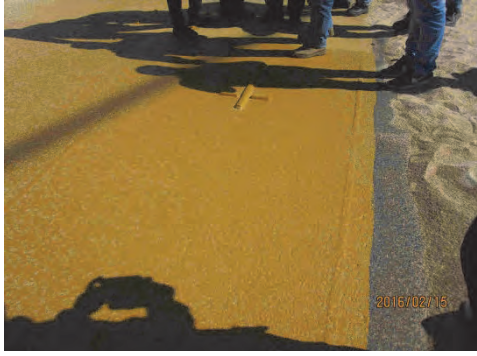
7. After painting of primer

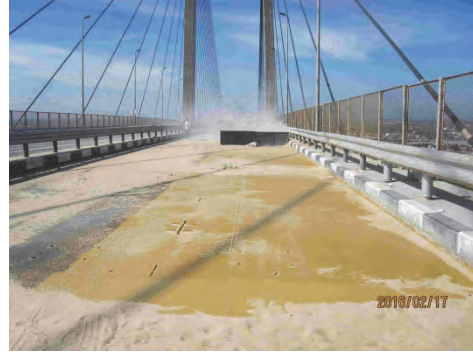
8. After painting of primer

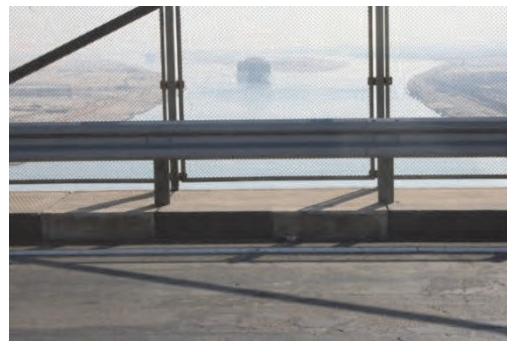
4. P12, a cap remains.

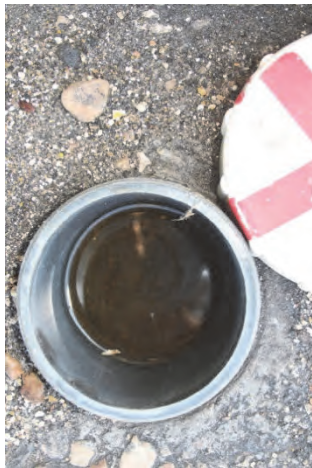
5. P12, higher water level than others.

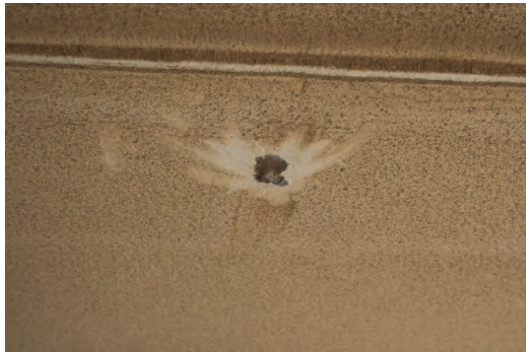
1. Spot rust

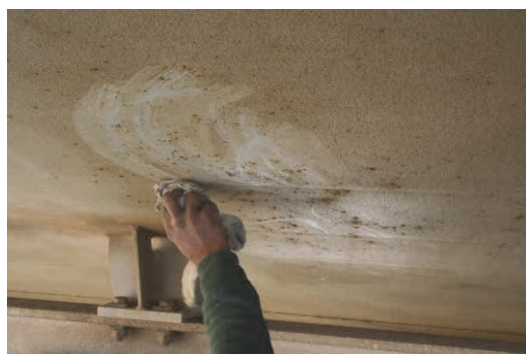
5. Some rust.

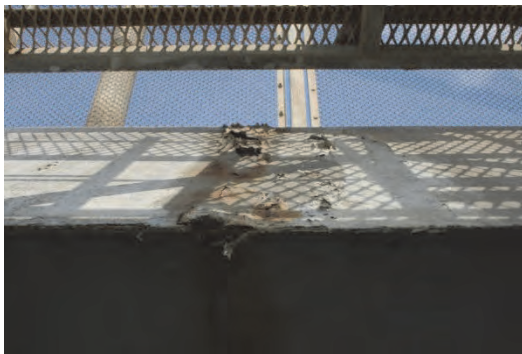
9. Corrosion

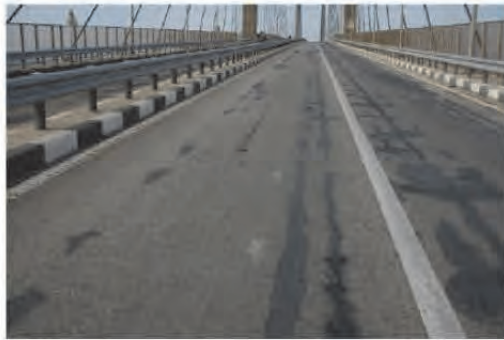
1. East side of the bridge and north lanes. Looking towards West on Overtaking Lane. Line repairs of pavements are visible.

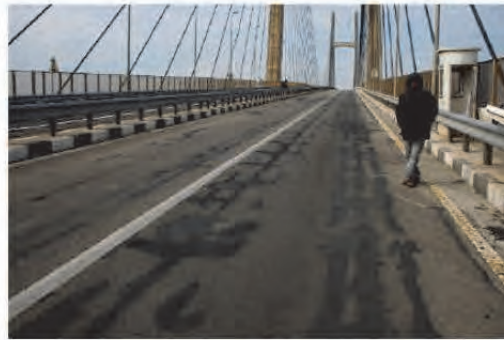
2. Driving Lane and 5 lines of pavement repair are visible. These lines correspond to the center of the U-ribs or the center of two adjacent U-ribs. This will be explained in detail, later.

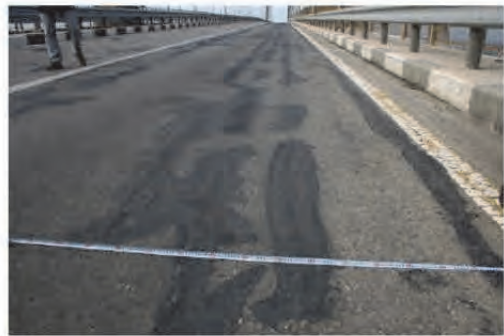
3. In this area, a repair line near the right white line, which is at the center of R4, is visible. But over this line, tires do not run so often and the reason of the crack formation is unclear.

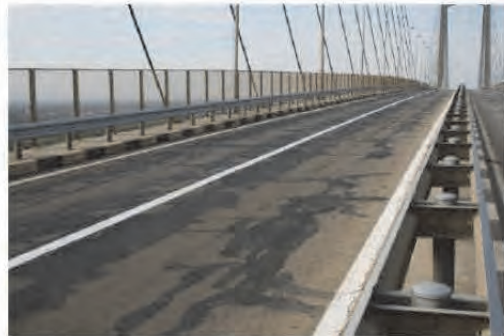
4. On the south lane, the pavement crack over R4 U-rib is not formed.

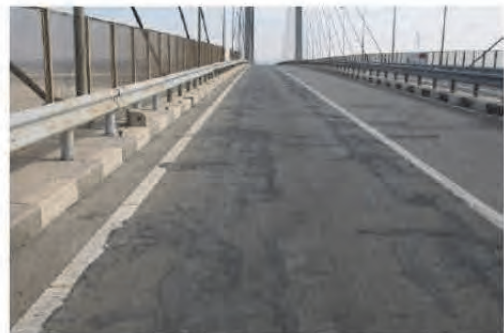
5. Near the bridge center, a crack line over R4 is not formed.

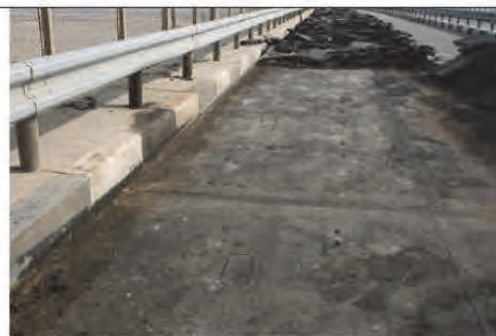
6. Near the tower, pavement materials were removed and the starving horse is visible. A temporary hand hole is between R4 and R5.

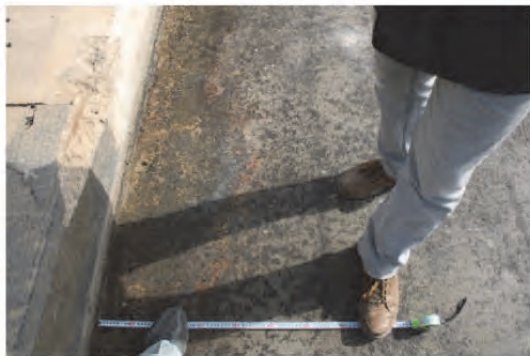
7. The welding line of R4 U-rib below the steel deck, which is 64cm apart from the curb is visible on the left of the brown shoes.

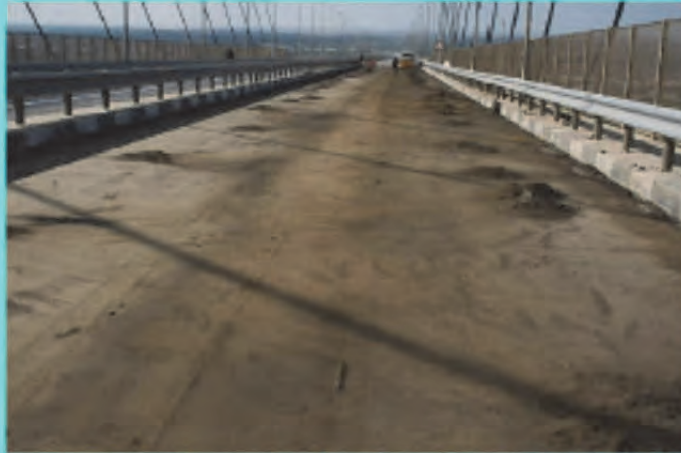
Lines of rust were not found. A line of rust can indicate the existence of penetrated fatigue crack initiated from inside of the deck plate. Non-existence of lines of rust does not assure non-existence of fatigue cracks inside. Fatigue cracks around U-shaped rib under deck plate need to be checked. White areas above are generally healthy. Red areas are rusty to some extent. Both ends of the road surface and the center are often rusty. The average reduction of thickness is not large.

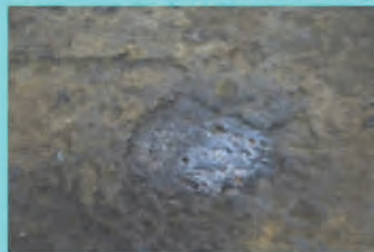
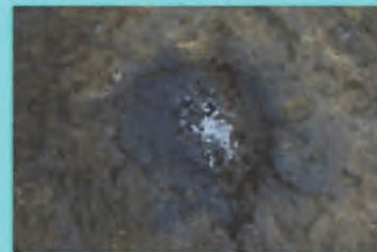
**Measurement of D6, First & Second Measurement**

**First measurement 11.97mm**

**Second measurement  
11.66mm**

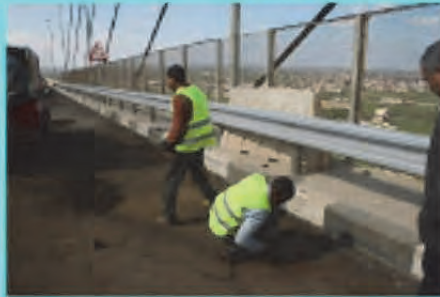
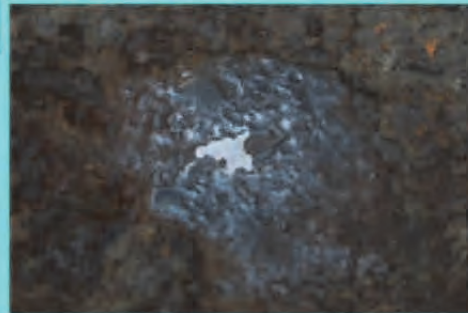
### Measurement of Extra1, Rustiest spot

Thickness 11.21mm

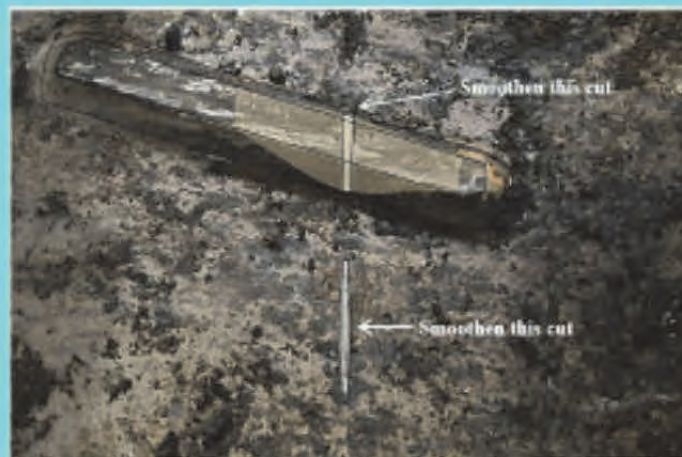
When the thickness was measured, two small cuts on the remaining of the lifting piece and the deck plate were found. it was requested to smoothen the cuts at the site, but SAMCO engineer proposed to do so later because a smaller grinder was easy to do so. This kind of cut should be avoided as far as possible.
