CHAPTER 16

ENVIRONMENTAL AND SOCIAL CONSIDERATIONS

16.2 Environmental Baseline Conditions of the Project Area-1 Baluchaung No.1 Hydropower Plant

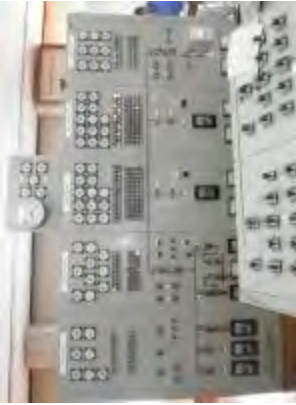
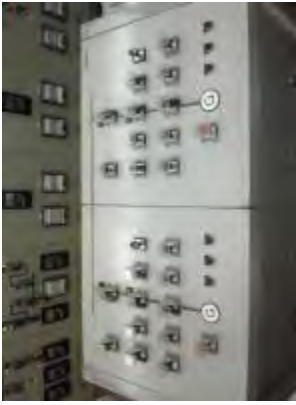
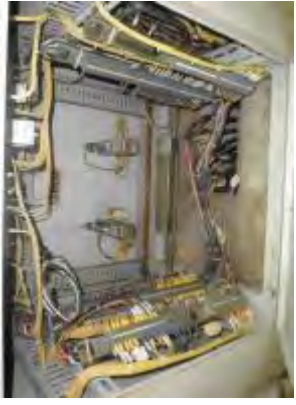
NO.	(Control Equipment) Overall	(Control Equipment) Details	(Control Equipment) Details	Remarks
CON 1

<ul style="list-style-type: none"> - Mechanical type meter and operation switch - Manufactured in 1988 (28 year-old) - No inspection record after COD - Trouble record of "77E" switch of unit 2 - Dusts accumulation - Aging degradation
CON 2

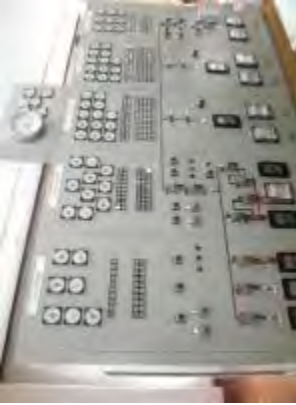
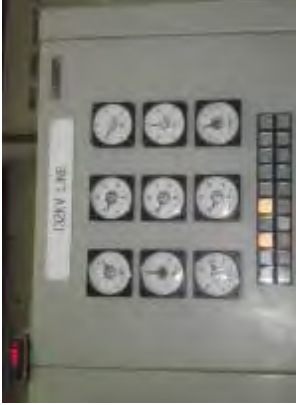
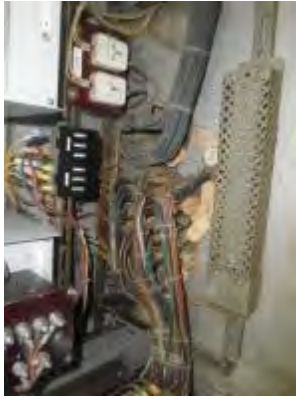
<ul style="list-style-type: none"> - Mechanical type meter and operation switch - Manufactured in 1988 (28 year-old) - Dusts accumulation - Aging degradation
CON 3

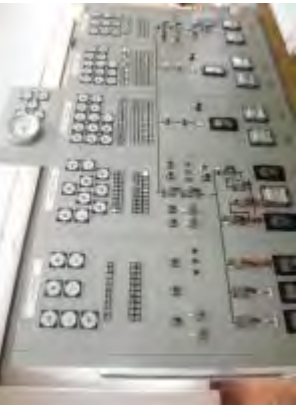
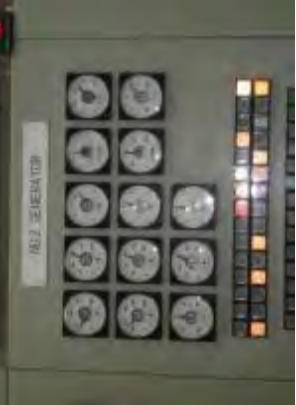
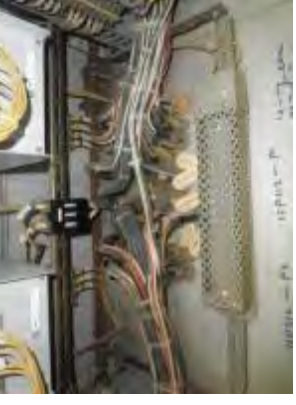
<ul style="list-style-type: none"> - Mechanical type meter and operation switch - Manufactured in 1988 (28 year-old) - No inspection record after COD - Dusts accumulation - Aging degradation
CON 4

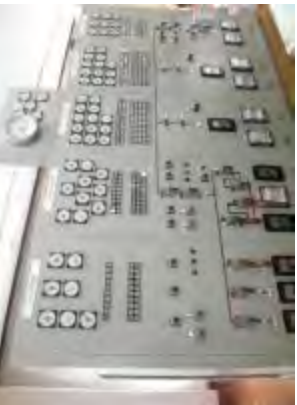
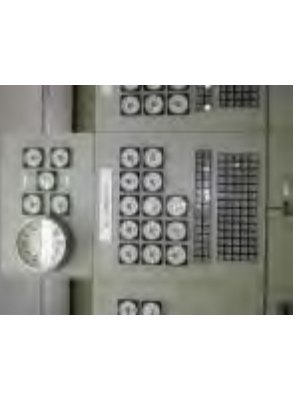
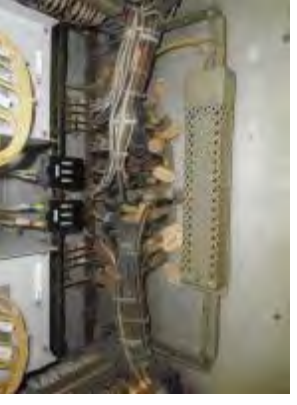
<ul style="list-style-type: none"> - Mechanical type meter and operation switch - Manufactured in 1988 (28 year-old) - No inspection record after COD - Dusts accumulation - Aging degradation

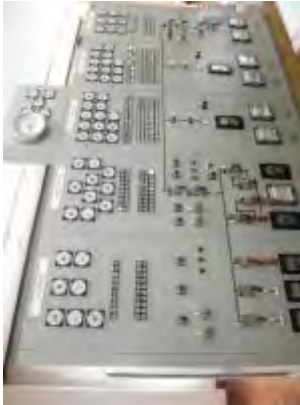
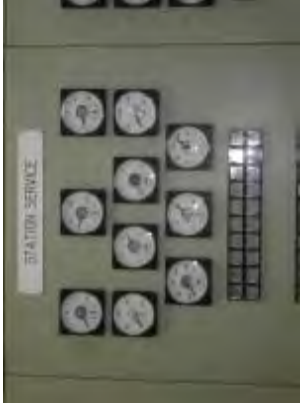
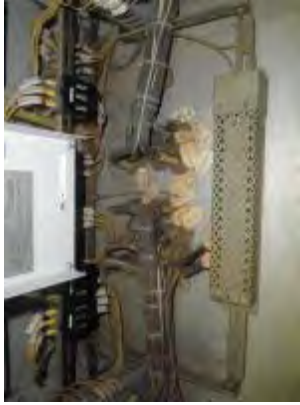
NO.	(Control Equipment) Overall	(Control Equipment) Details	(Control Equipment) Details	Remarks
CON 5

<ul style="list-style-type: none"> -Mechanical type meter and operation switch -Manufactured in 1988 (28 year-old) -No inspection record after COD -Dusts accumulation -Aging degradation
CON 6

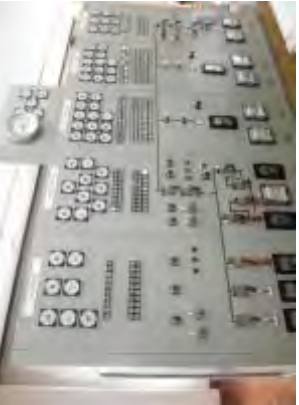
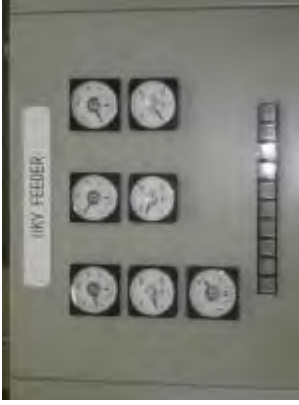
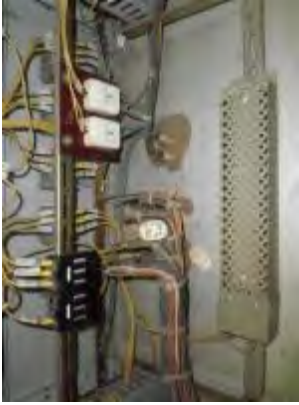
<ul style="list-style-type: none"> -Mechanical type meter and operation switch -Manufactured in 1988 (28 year-old) -No inspection record after COD -Dusts accumulation -Aging degradation
CON 7

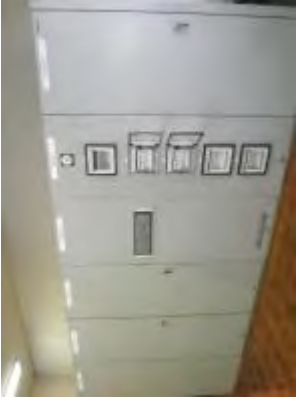
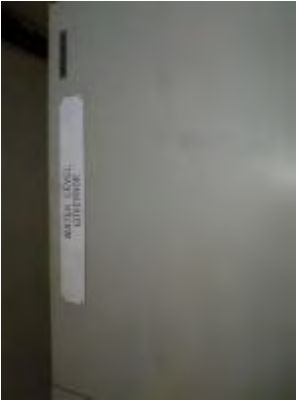
<ul style="list-style-type: none"> -Manufactured in 1988 (28 year-old) -No inspection record after COD -Dusts accumulation -Aging degradation of timer and auxiliary relays
CON 8

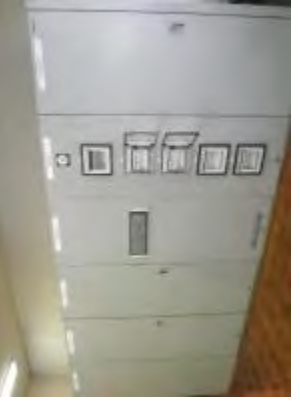
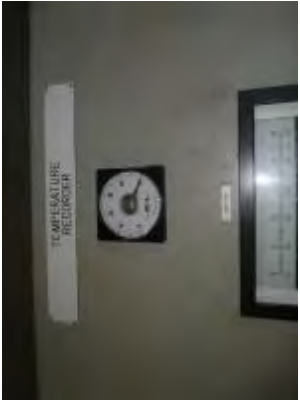
<ul style="list-style-type: none"> -Manufactured in 1988 (28 year-old) -No inspection record after COD -Dusts accumulation -Aging degradation of timer and auxiliary relays

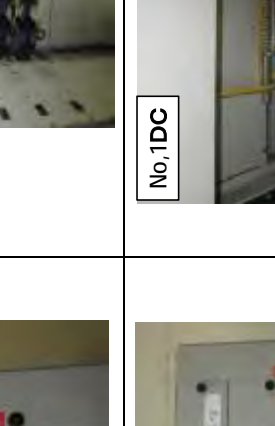
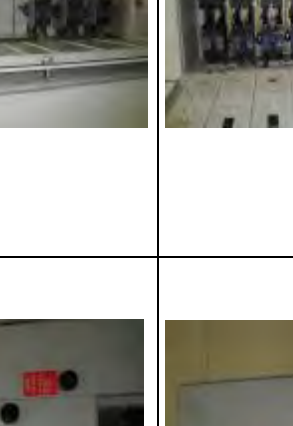
<ul style="list-style-type: none"> - Manufactured in 1988 (28 year-old) - Dust accumulation on wires, terminals and control cables

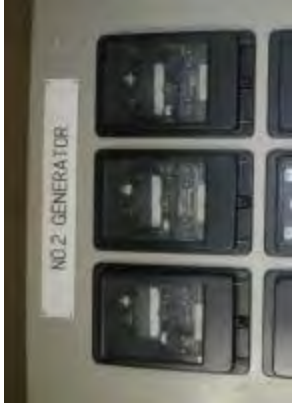
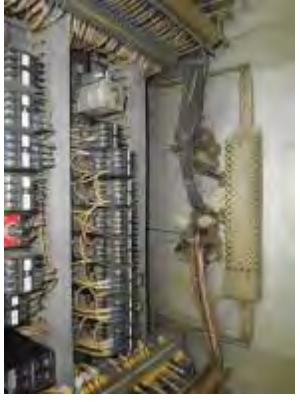
<ul style="list-style-type: none"> -Analog type relay unit -Manufactured in 1988 (28 year-old) -Dust accumulation on overall relay units. -No maintenance record after COD -No spare part for each relay unit -Aging degradation

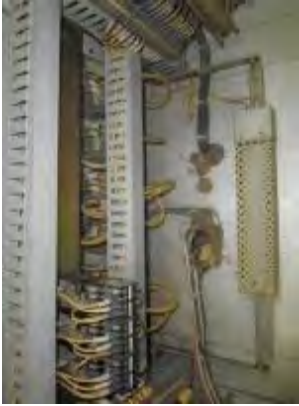
<ul style="list-style-type: none"> •Analog type relay unit •Manufactured in 1988 (28 year-old) •Dust accumulation on overall relay units. •No maintenance record after COD •No spare part for each relay unit •Aging degradation
MPR 6

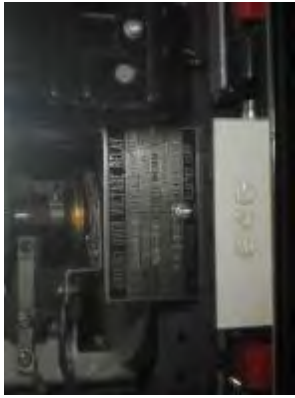
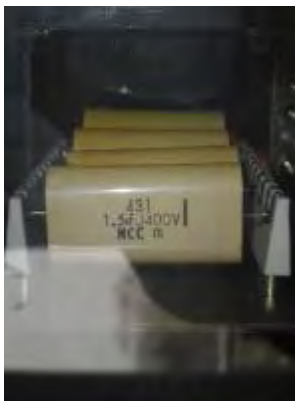
<ul style="list-style-type: none"> •Manufactured in 1988 (28 year-old) •Oil leakage from electrolytic capacitor •Analog type relay unit •Aging degradation

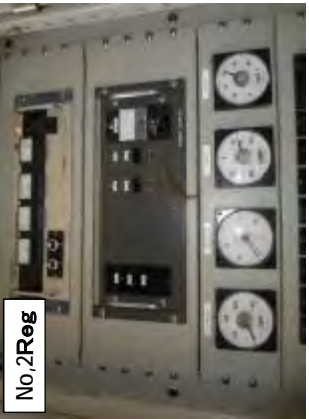
No.2Reg

No.1Reg	<ul style="list-style-type: none"> -Manufactured in 1988 (28 year-old) -Small animal in Gov-Reg Panel -Replaced No.1 power unit (in 1994) -No spare part for detecting unit
Reg 2

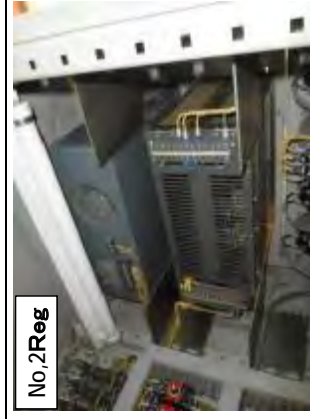
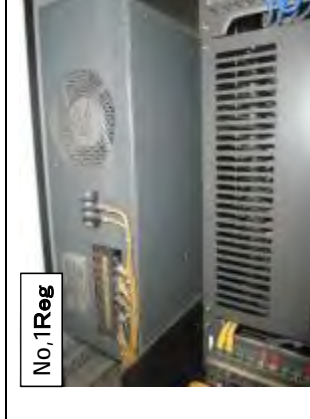
No.1Reg	<ul style="list-style-type: none"> -No.1 regulator; manufactured in 1994 (22 year- old) -No.2 regulator; manufactured in 1988 (28 year- old) -Electrolytic capacitor and cooling fan in power unit exceeding the durable life.
Reg 4

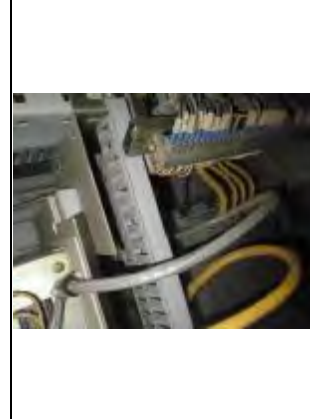
<ul style="list-style-type: none"> -No counter measure against the small animal in the back of GOV-Reg Panel -Dusts accumulation on control cables

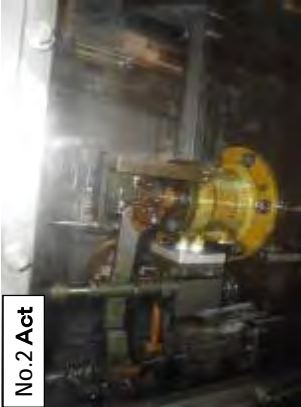
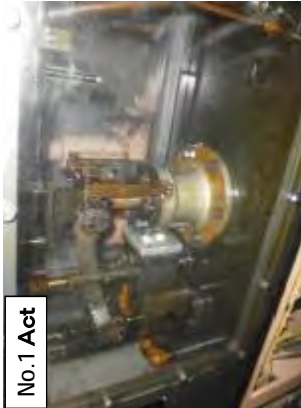
No.1 Act	<ul style="list-style-type: none"> -Grease adhering to the operation unit in actuator panel -Deterioration of operating oil
Act 2

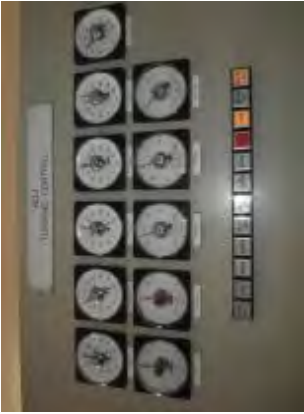
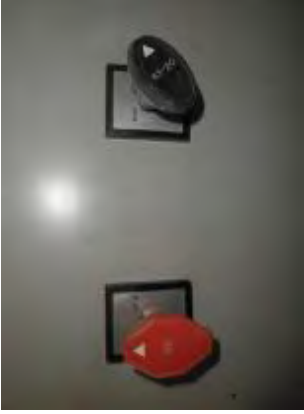
<ul style="list-style-type: none"> -Manufactured in 1988 (28 year-old) -Meters and switches exceeding the durable life -No spare part of meters and switches -Dust accumulation -No dust-proof cover
WAC 2

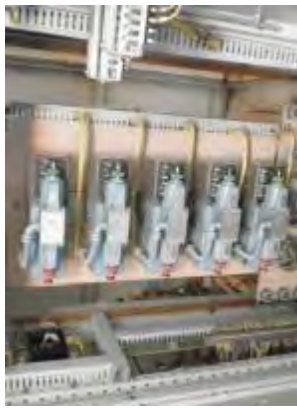
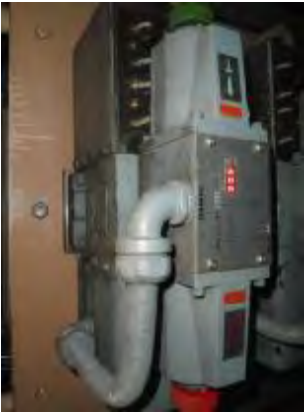
<ul style="list-style-type: none"> -Manufactured in 1988 (28 year-old) -Solenoid valve exceeding the durable life -No spare part -No dust-proof cover. -Dust accumulation
WAC 3

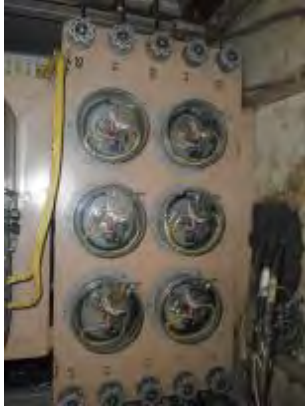
<ul style="list-style-type: none"> -Manufactured in 1988 (28 year-old) -Bourdon tube pressure gauge for hydraulic relays exceeding the durable life -No spare part
WAC 4

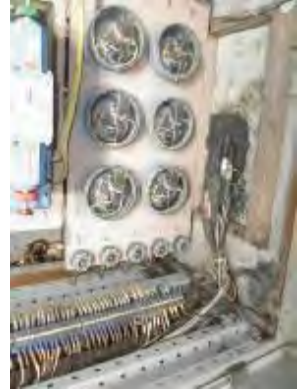
<ul style="list-style-type: none"> -Manufactured in 1989 (27 year-old) -Crowded terminal for grounding wire

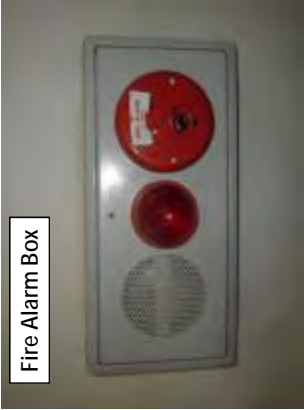
<ul style="list-style-type: none"> -Manufactured in 1987 (29 year-old) -No maintenance record after COD -Aging degradation -The connection to central control center is unknown.
FAL 3

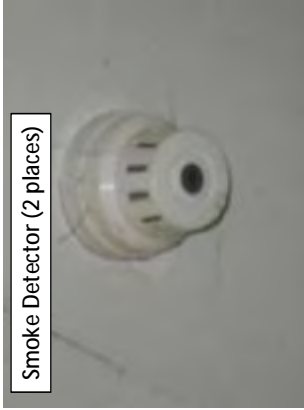
<ul style="list-style-type: none"> -Manufactured in 1987 (29 year-old) -No maintenance record after COD -Aging degradation
FAL 4

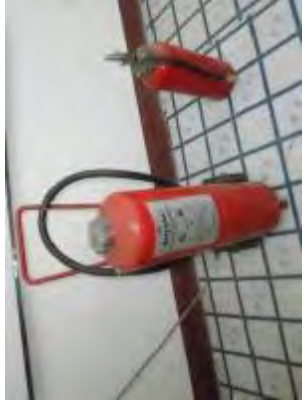
<ul style="list-style-type: none"> -Manufactured in 1987 (29 year-old) -No maintenance record after COD -Aging degradation

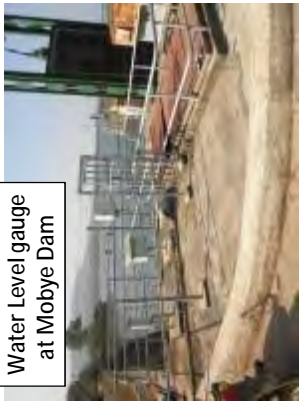
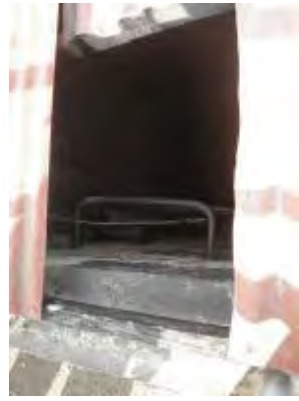
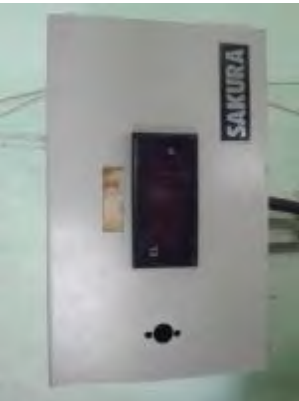
<p>Water Level gauge at Moby Dam</p>

<ul style="list-style-type: none"> - Manufactured in 1988 (28 year-old) - Missing probe - Broken water level indicator - Dust accumulation on control cables and others
WLVG 2

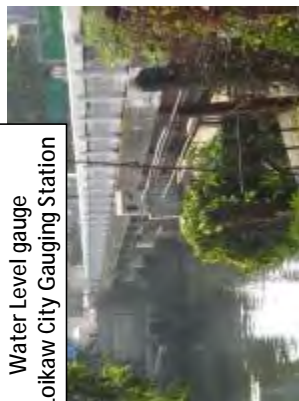
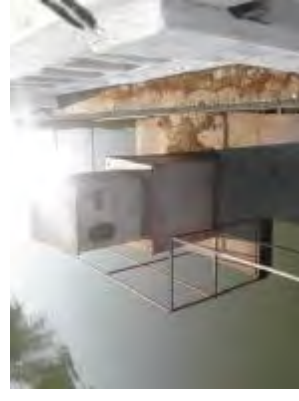
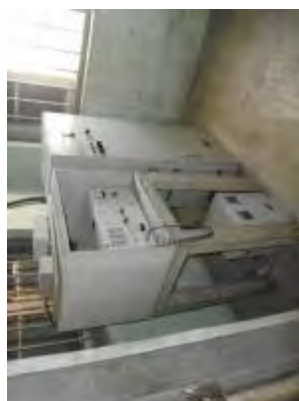
<p>Water Level gauge at Loikaw City Gauging Station</p>

<ul style="list-style-type: none"> - Manufactured in 1988 (28 year-old) - Rust on main body - No data transmission from water level gauge - Dust accumulation on control cables and others
WLVG 3

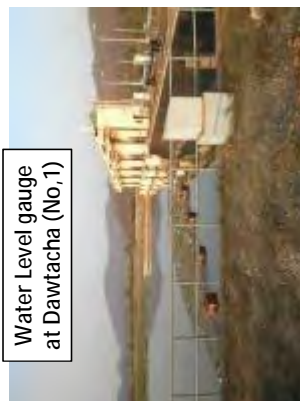
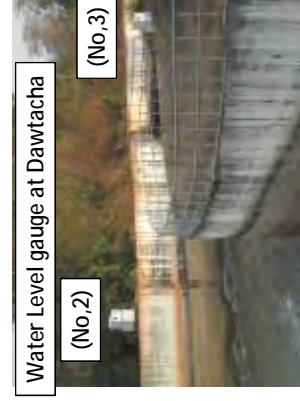
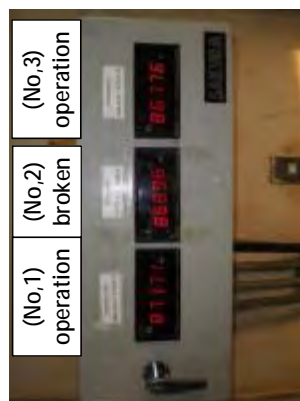
<p>Water Level gauge at Dawtacha (No.1)</p>

<p>(No.1) operation (No.2) broken (No.3) operation</p>	<ul style="list-style-type: none"> - Manufactured in 1988 (28 year-old) - Rust on main body - Broken No.2 indicator - Dust accumulation on control cables and others

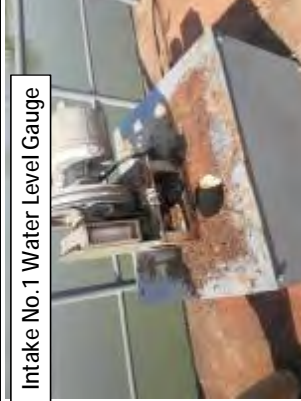
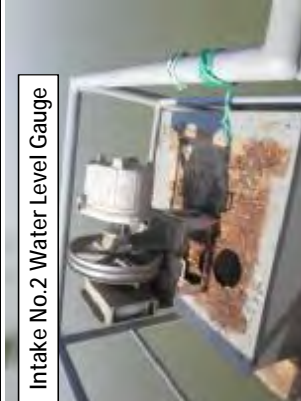
<p>Water Level gauge at Podage Intake No.1 Water Level Gauge Intake No.2 Water Level Gauge</p>

<p>Intake No.2 Water Level Gauge</p>	<ul style="list-style-type: none"> - Manufactured in 1988 (28 year-old) - Fallen off float - Corrosion and deformation - No operation as water level gauge - Dust accumulation on control cables and others

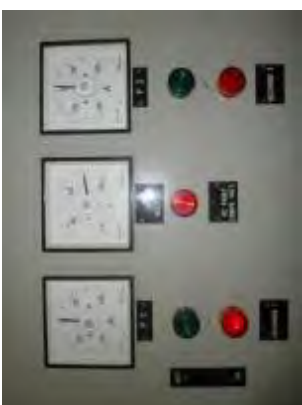
<ul style="list-style-type: none"> - Manufactured in 1985 (31 year-old) - Analog type meters of voltage and current - Mechanical operation switches - Aging degradation
HADC 2

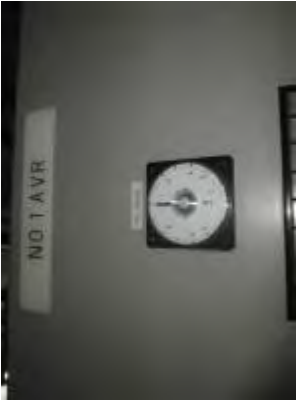
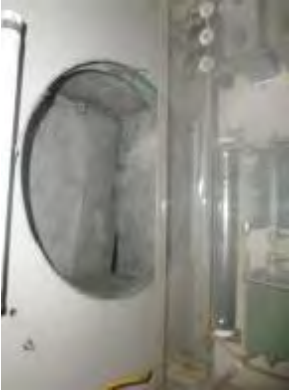
<p>AVR Panel</p> <ul style="list-style-type: none"> -Manufactured in 1985 (31 year-old) -Analog type meters exceeding durable life -Removed cooling fan because of failure -No dust- proof cover -No spare part
AVR 2

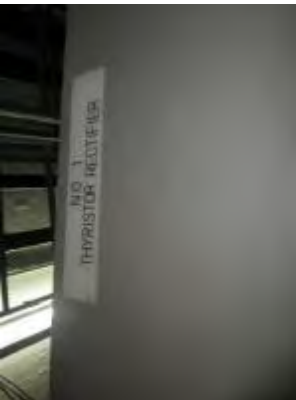
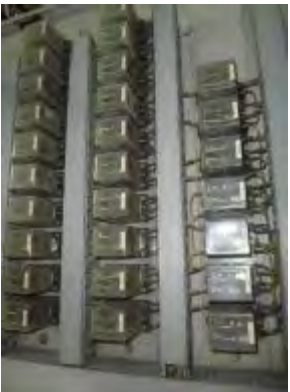
<p>No.1 Thyristor Rectifier</p> <ul style="list-style-type: none"> -Manufactured in 1985 (31 year-old) -Thyristor exceeding the durable life -Black smoked auxiliary relays -No spare part
AVR 3

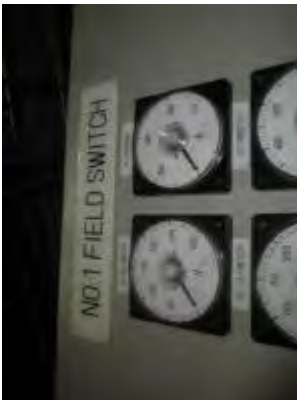
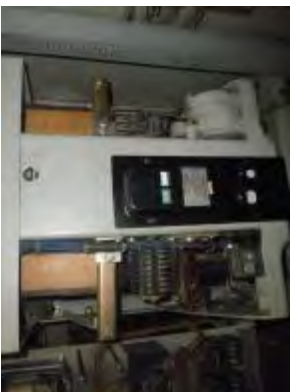
<p>No.1 Field Switch Panel</p> <ul style="list-style-type: none"> -Manufactured in 1985 (31 year-old) -Spring type field CB whose arc-extinguishing chamber is vitreous enamel resistor type -Dust accumulation on control cables

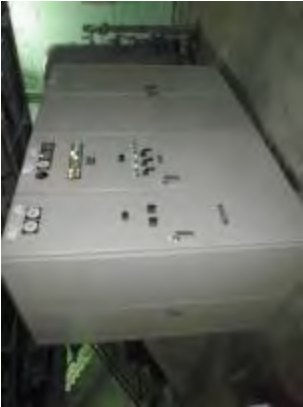
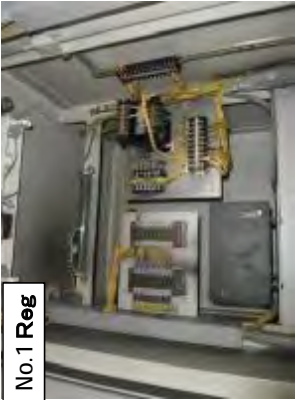
No.1 Reg

No.2 Reg	Power unit -Manufactured in 1985 (31 year-old) -Aging degradation -No spare part of power unit -Dust accumulation
Reg 2

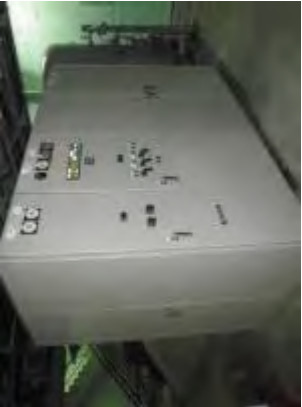
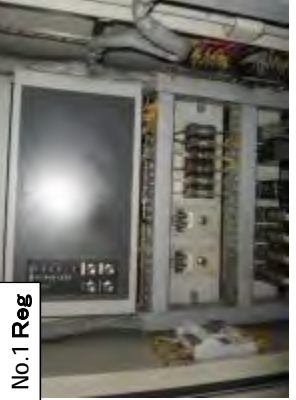
No.1 Reg

No.2 Reg	Regulator setting device -Regulators of variable resistor, exceeding the durable life -Operation switches, timers and auxiliary relays exceeding the durable life
Reg 3

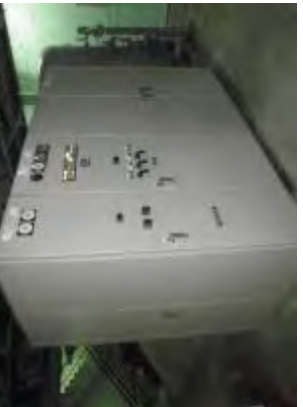
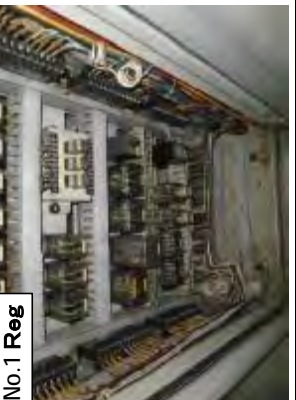
No.1 Reg

No.2 Reg	Internal wires and control cables -Dust accumulation

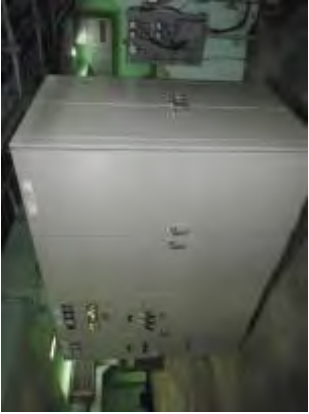
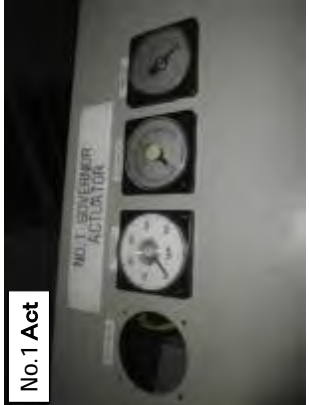
No. 1 Act

No. 2 Act	<p>Governor Actuator Panel</p> <ul style="list-style-type: none"> -Manufactured in 1985 (31 year-old) -Removed power meter because of failure -Incorrect value indicated by speed meter at the position "0"
Act 2

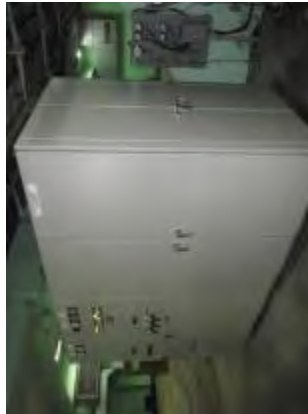
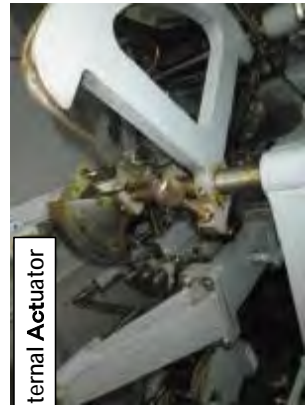
Internal Actuator

<p>Governor Actuator Panel</p> <ul style="list-style-type: none"> -Grease adhering to the operation unit in actuator panel -Oil leakage -Degraded operation oil
Act 3

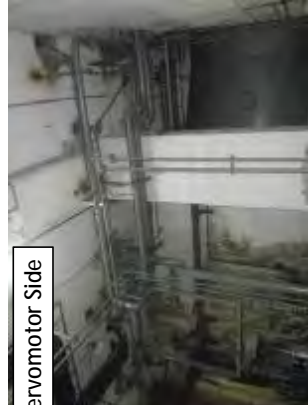
Servomotor Side	<p>Return Unit</p> <ul style="list-style-type: none"> -No maintenance record of coupling and return units in actuator panel after COD
Act 4

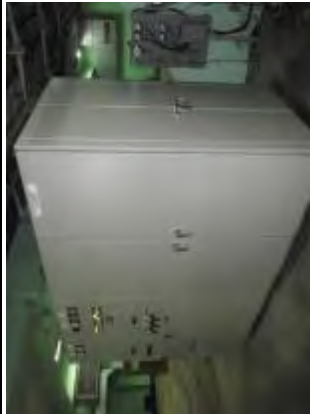
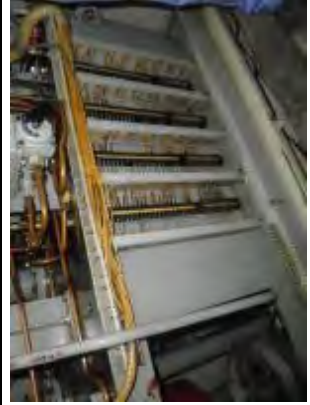
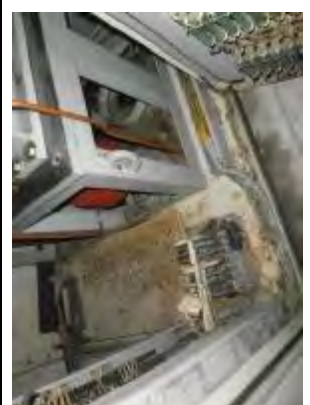
<ul style="list-style-type: none"> -Internal wires and control cables -Dust accumulation

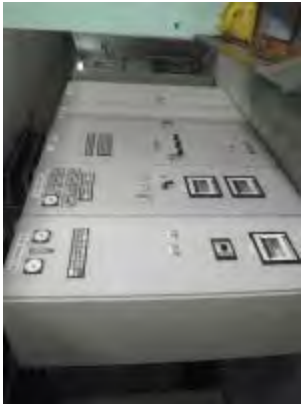
Photo	(Turbine Control Cubicle) Overall	(Turbine Control Cubicle) Detail	(Turbine Control Cubicle) Detail	Remarks
WAC 1	 	 	 	<ul style="list-style-type: none"> -Manufactured in 1985 (31 year-old) -Meters and auxiliary relays exceeding the durable life -Broken recorder -No spare part on meters and switches -Dust accumulation
WAC 2

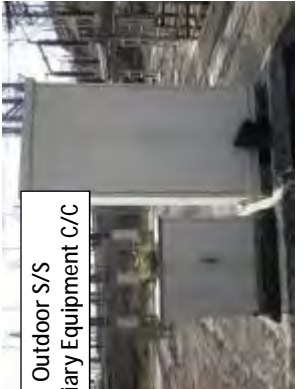
Outdoor S/S Auxiliary Equipment C/C

Outdoor S/S auxiliary equipment control center -Manufactured in 1985 (31 year-old) -Aging degradation of MCCB, timer, switches and auxiliary relays -Dust accumulation

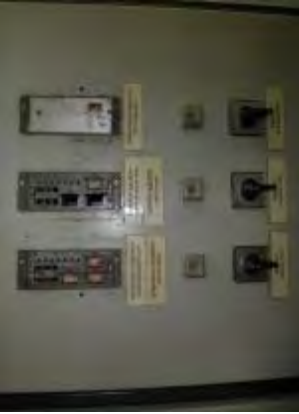
<p>Air-conditioning control panel -Manufactured in 1985 (31 year-old) -Dust accumulation on wires, terminals and control cables. -Both are broken. -All electrical components in the cubicle do not work properly because of aging degradation.</p>
AC 3	<p>Nozzle on the Ceiling of Control Room</p>  	 	 	<p>Ventilation duct and nozzles in control room -Manufactured in 1985 (31 year-old) -Dust accumulation in the ventilation duct -Remote operation is not available from control panel</p>
AC 4	<p>Air-conditioning System in Rectifier Room</p> <p>Rectifier</p>

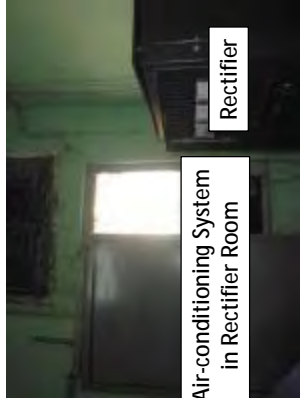
<p>Air-conditioner in rectifier room (1 unit) -Manufactured in 1985 (31 year-old) -Broken machine -No air-conditioning equipment in rectifier room</p>

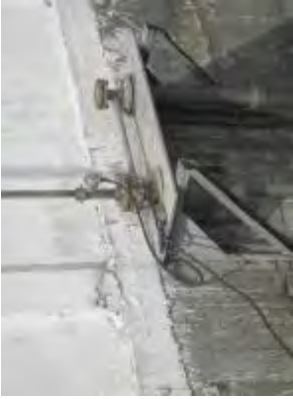
<p>Water level gauge at dam intake ・Manufactured in 1985 (31 year-old) ・No data transmission from water level gauge ・Dust accumulation on control cables ・This is maintained by ministry of agriculture and irrigation ・Bulkwork is made by stainless steel.</p>
<p>WLVG 2</p>

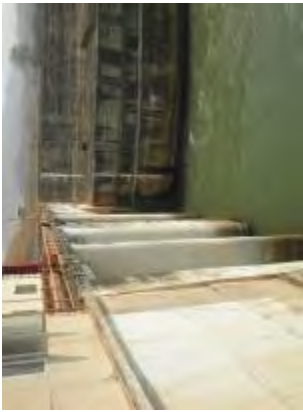
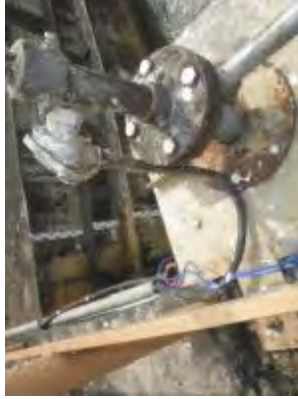
<p>Water level gauge for tailrace ・Manufactured in 1985 (31 year-old) ・No data transmission from water level gauge ・Dust accumulation on control cables ・This is maintained by ministry of electric power ・Bulkwork pipe is made by stainless steel.</p>

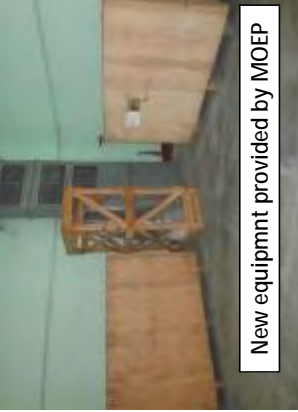
<p>New equipmnt provided by MOEP</p>	<p>Telephone System</p> <ul style="list-style-type: none"> -Not been used since 2007 -Manufactured by foreign company -Maintained by ministry of electric power -Dust accumulation
TC 2

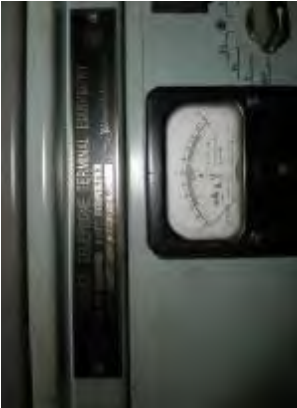
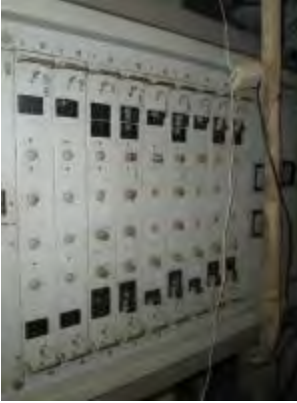
<p>Telephone System in Control Room (1 unit)</p> <ul style="list-style-type: none"> -Manufactured in 1963 by HITACHI -It does not work as communication tool -Dust accumulation
TC 3

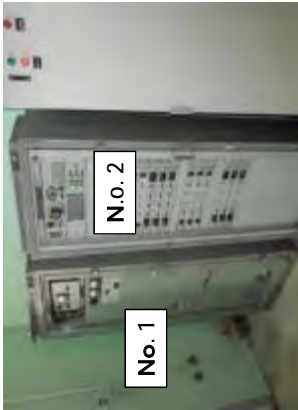
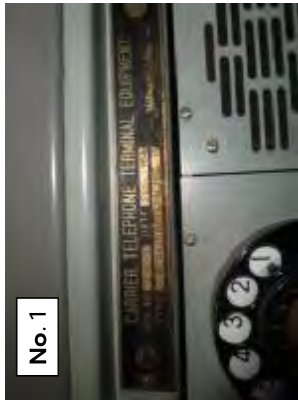
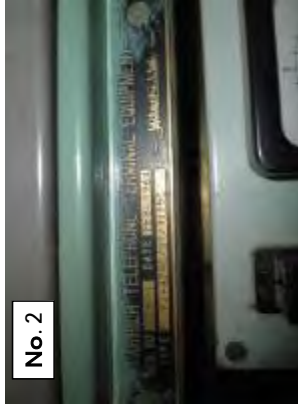
<p>No. 2</p>	<p>Telephone System in Power Room (2 units)</p> <ul style="list-style-type: none"> -Manufactured in 1964 by HITACHI -It does not work as communication tool -Dust accumulation
TC 4

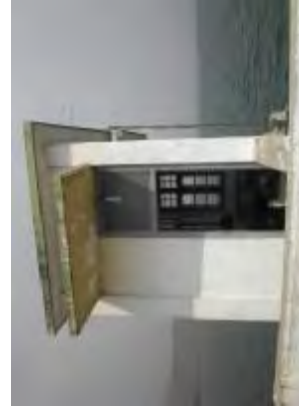
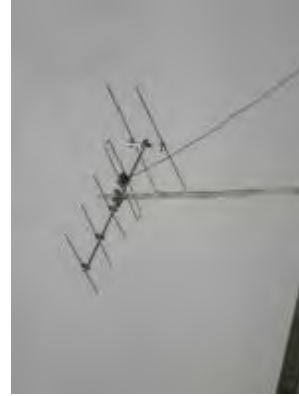
<p>Antenna for transmission of dam water level</p> <ul style="list-style-type: none"> -It does not work as communication tool -The result of visual inspection is not accepted.

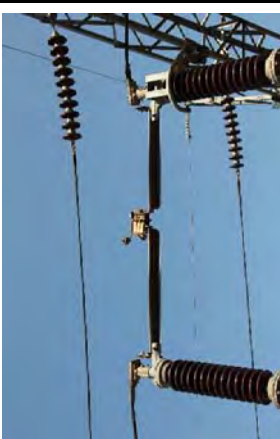
<p>B-34 132 kV Disconnectors Ironware check</p>

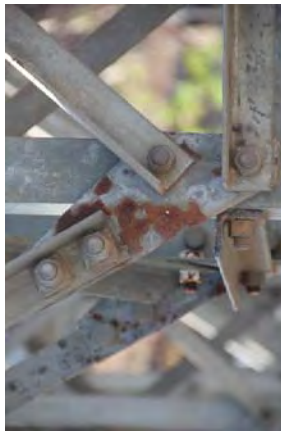
<p>B-35 132 kV Disconnectors Contract parts check</p>

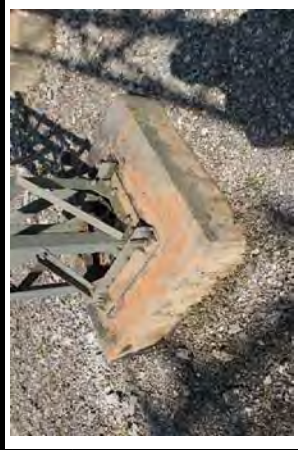
<p>B-37 132 kV disconnectors Foundation check</p>

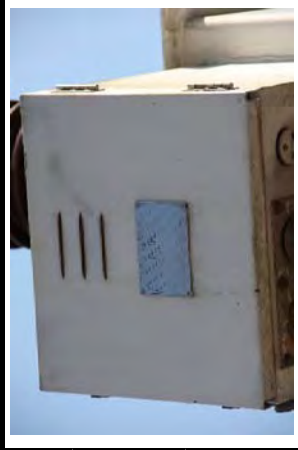
<p>B-38 132 kV CVT Name plate</p>

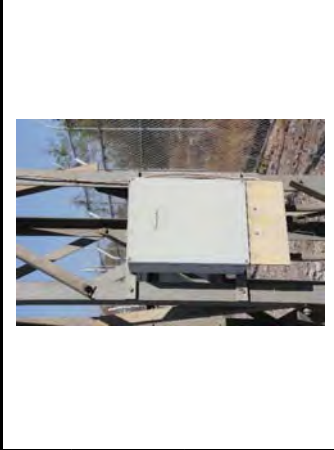
<p>B-40 132 kV CVT Ironware check</p>

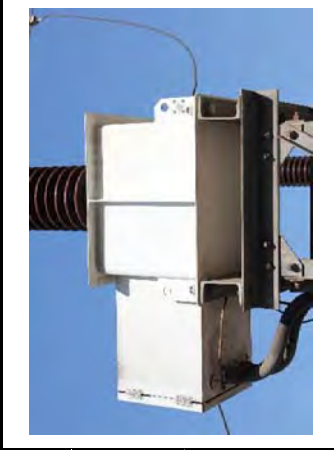
<p>B-41 132 kV CVT Tank check</p>

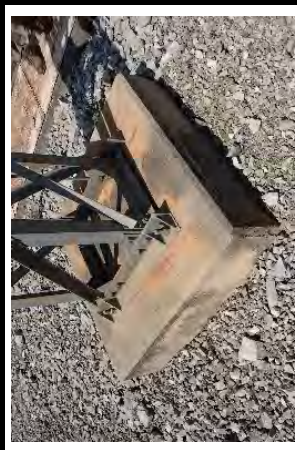
<p>B-45 132 kV surge arrester Foundation check</p>

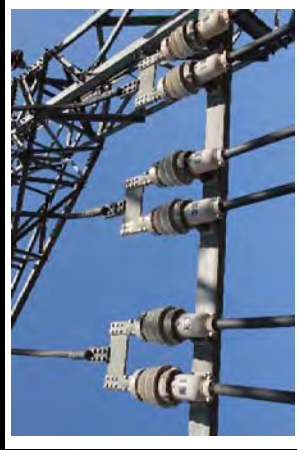
<p>B-46 11 kV cable Appearance check</p>

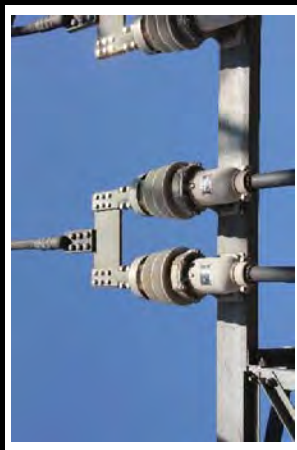
<p>B-48 11 kV cable head Appearance check</p>

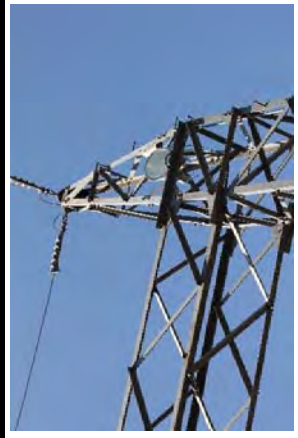
<p>B-49</p> <p>Gantry structure.</p> <p>Appearance check</p>

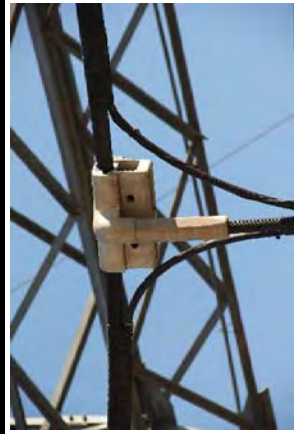
<p>B-50</p> <p>Cable clamps</p> <p>Appearance check</p>

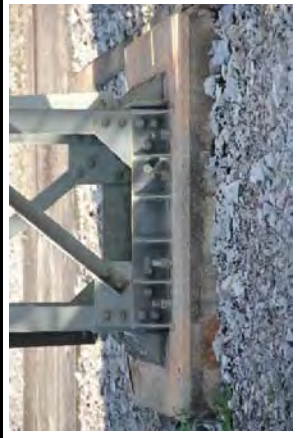
<p>B-52</p> <p>Gantry structure</p> <p>Foundation check</p>

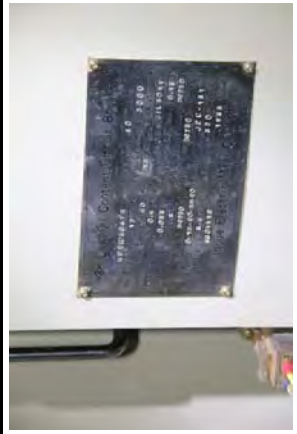
<p>B-53</p> <p>11 kV circuit breakers</p> <p>Name plate</p>

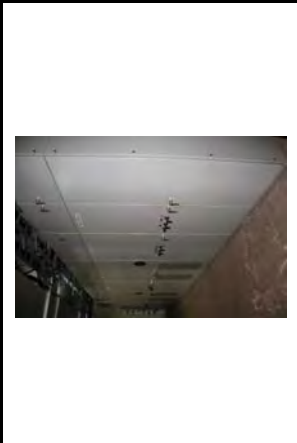
<p>B-54</p> <p>11 kV cubicle</p> <p>Appearance check</p>

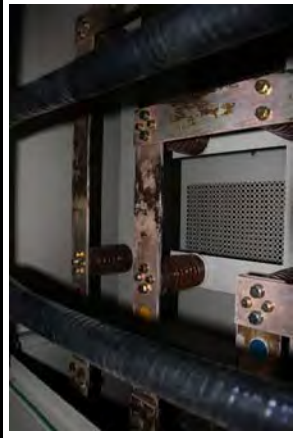
<p>B-55</p> <p>11 kV busbar</p> <p>Appearance check</p>

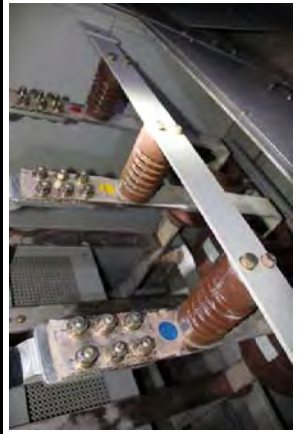
<p>B-56</p> <p>11 kV insulators</p> <p>Appearance check</p>

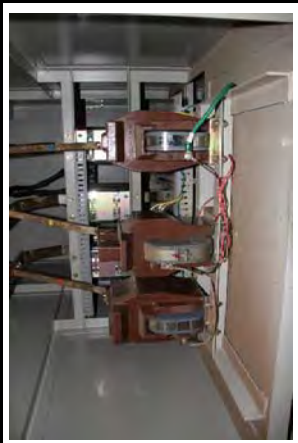
<p>B-57</p> <p>11 kV VT</p> <p>Appearance check</p>

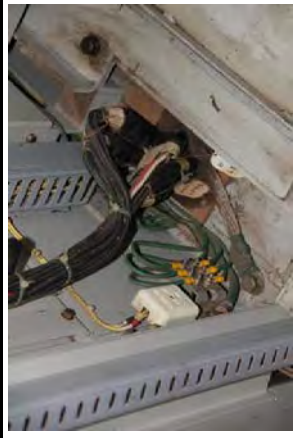
<p>B-58</p> <p>11 kV cable and terminals</p> <p>Appearance check</p>

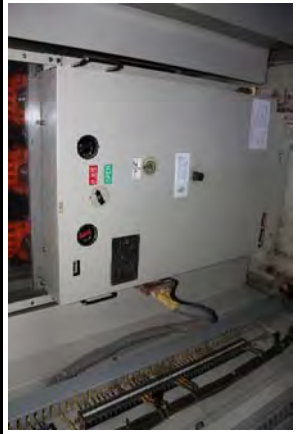
<p>B-59</p> <p>11 kV circuit breakers</p> <p>Appearance check</p>

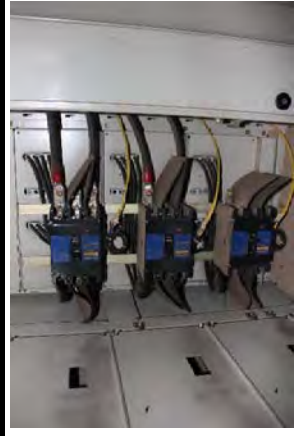
<p>B-74</p> <p>DC panels</p> <p>Appearance check</p>

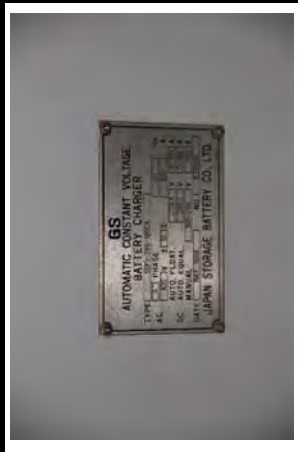
<p>B-75</p> <p>DC battery charger</p> <p>Name plate</p>

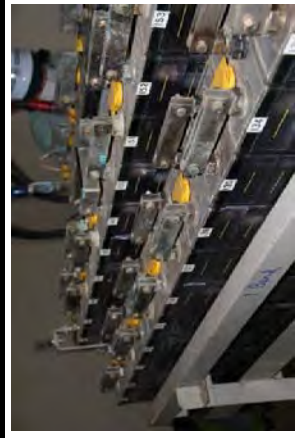
<p>B-76</p> <p>DC batteries</p> <p>Appearance check</p>

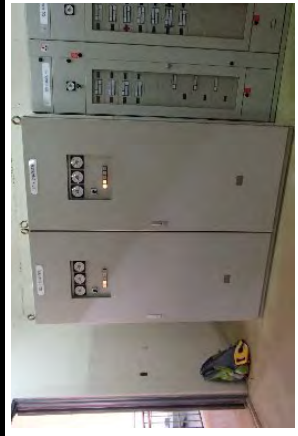
<p>B-77</p> <p>DC battery charger</p> <p>Appearance check</p>

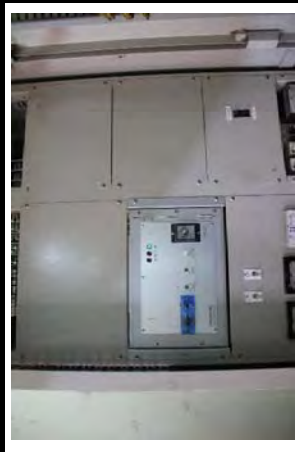
<p>B-78</p> <p>DC battery charger</p> <p>Appearance check</p>

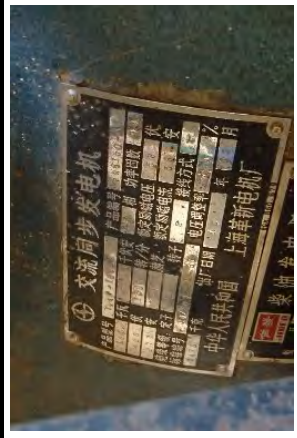
<p>B-79</p> <p>Emergency DG set</p> <p>Name plate</p>

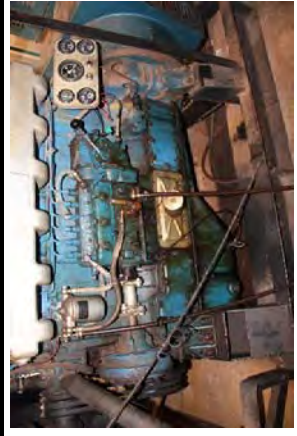
<p>B-80</p> <p>Emergency DG motor</p> <p>Appearance check</p>

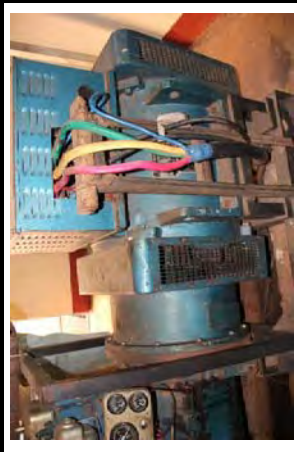
<p>B-81</p> <p>EDG Generator</p> <p>Appearance check</p>

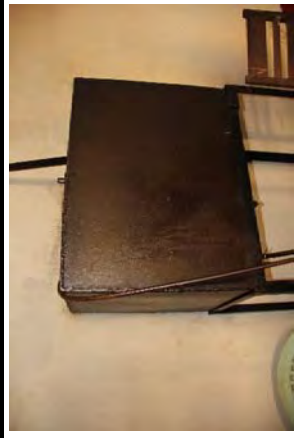
<p>B-82</p> <p>EDG oil tank</p> <p>Appearance check</p>

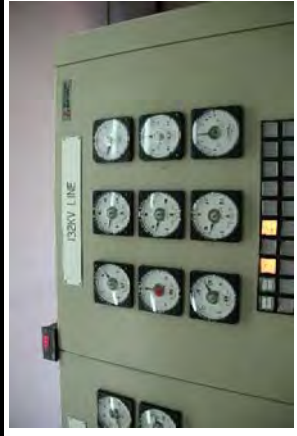
<p>B-83</p> <p>TL control panel</p> <p>Appearance check</p>

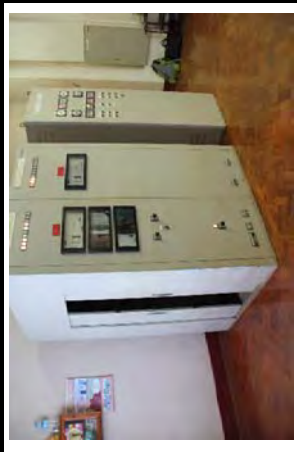
<p>B-84</p> <p>TL protection panel</p> <p>Appearance check</p>

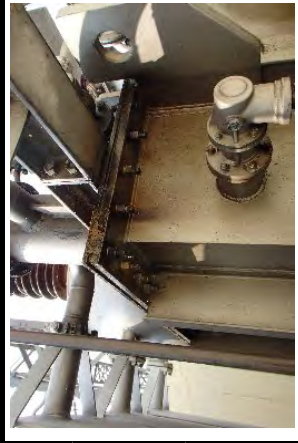
<p>S-2 132/11kV Main Tr. Oil leak check</p>

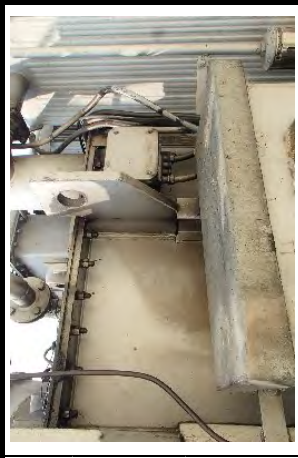
<p>S-3 132/11kV Main Tr. Oil leak check</p>

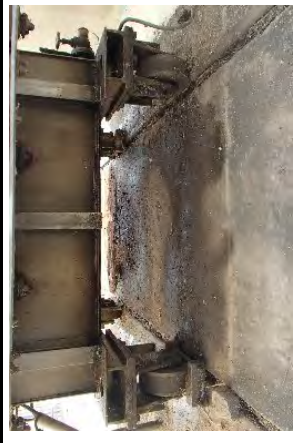
<p>S-4 132/11kV Main Tr. Oil leak check</p>

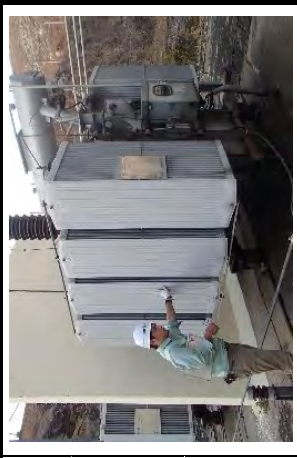
<p>S-6 132/11kV Main Tr. Vibration and noise check</p>

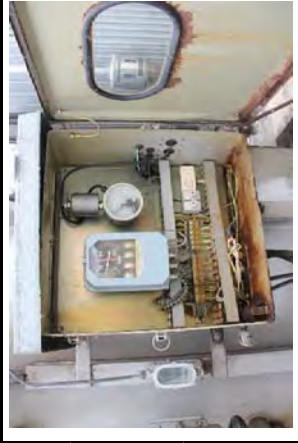
<p>S-8 132/11kV Main Tr. Temperature meter</p>

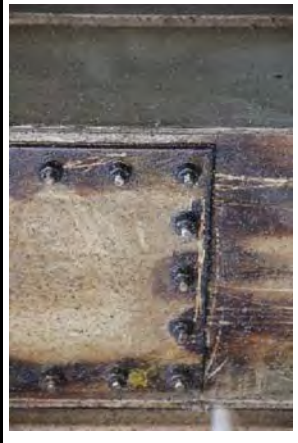
<p>S-19</p> <p>11/11 kV Tie Transformer</p> <p>Oil leak check</p>

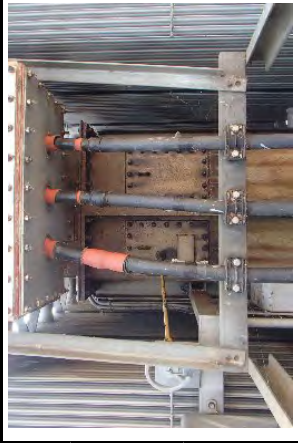
<p>S-24</p> <p>11/11 kV Tie Transformer</p> <p>Insulator</p>

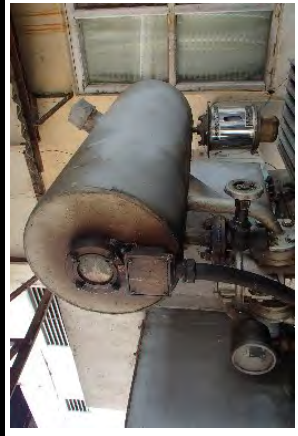
<p>S-26 11/0.4 kV Station Tr. Oil leak check</p>

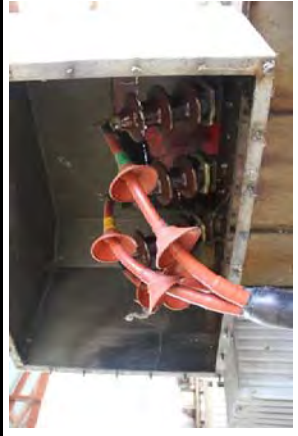
<p>S-31 11/0.4 kV Station Tr. Cable connection</p>	 	<p>S-32 11/0.4 kV Station Tr. Insulators check</p>

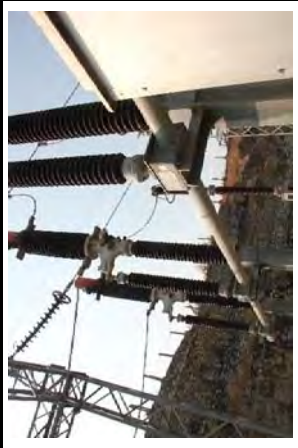
<p>S-36 132 kV Circuit breakers Tank check</p>

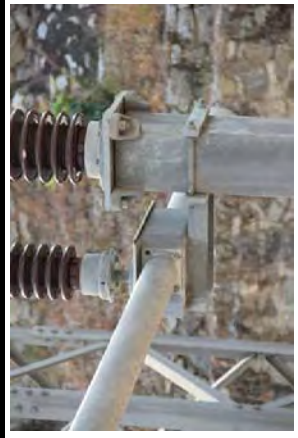
<p>S-37 132 kV Circuit breakers Ironware check</p>

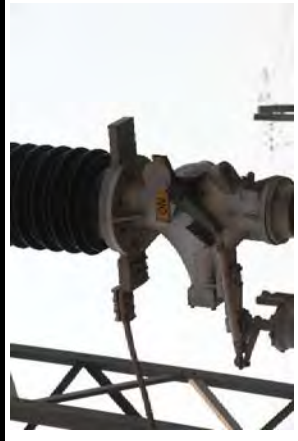
<p>S-38 132 kV Circuit breakers Terminal area check</p>

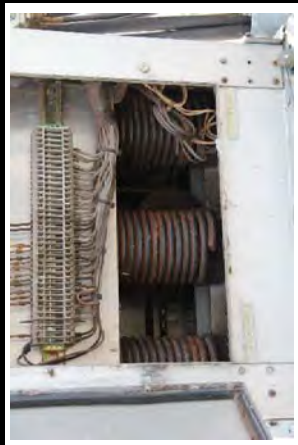
<p>S-39 132 kV Circuit breakers Spring motor check</p>

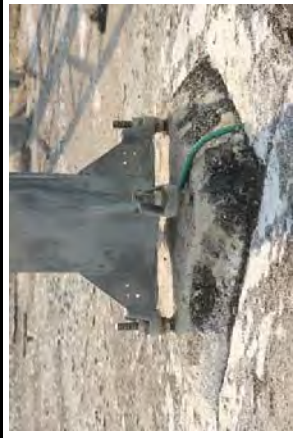
<p>S-40 132 kV Circuit breakers Foundation check</p>
