ムンバイ市跨線橋架替えプロジェクト説明資料

Data Collection Survey on Road/Railway Bridge Sector

Explanatory Material of Reconstruction Project of ROBs in Mumbai

**August 2016
Mumbai**

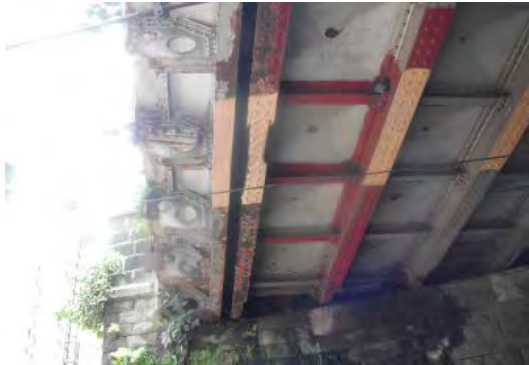
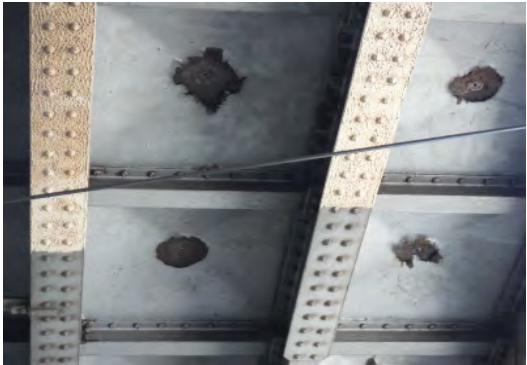
Object Member	Steel I-Girder
Kind of Damage	Rusting
Sketch or Photo	<div style="display: flex; justify-content: space-around;">

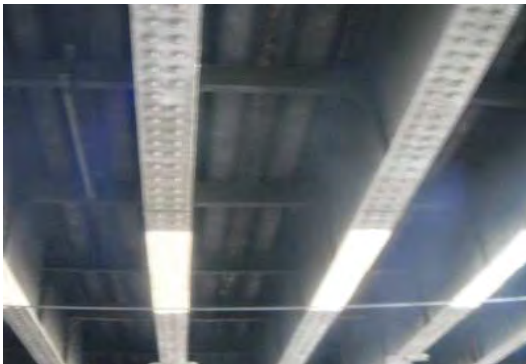
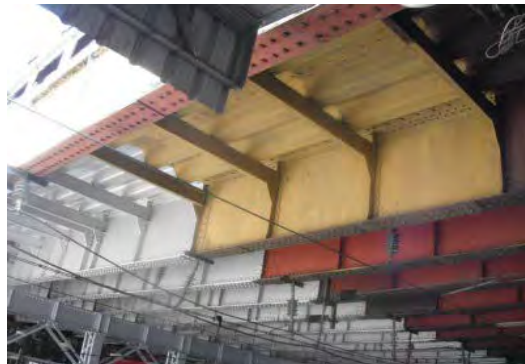
Object Member	
Kind of Damage	Good Condition
Sketch or Photo

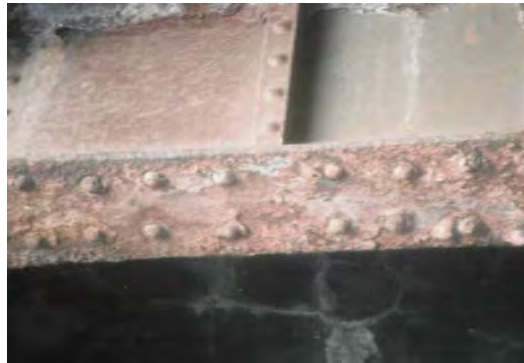
Object Member	Cross Bream
Kind of Damage	Runsting
Sketch or Photo

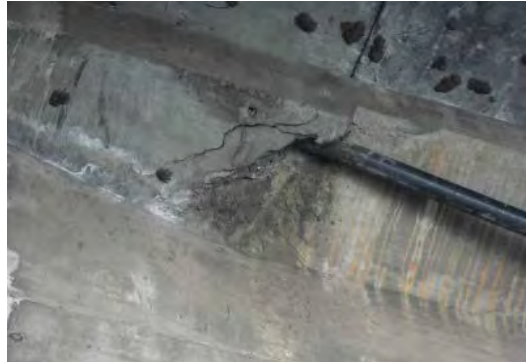
Object Member	PC I-Girder and RC slab
Kind of Damage	Spalling
Sketch or Photo

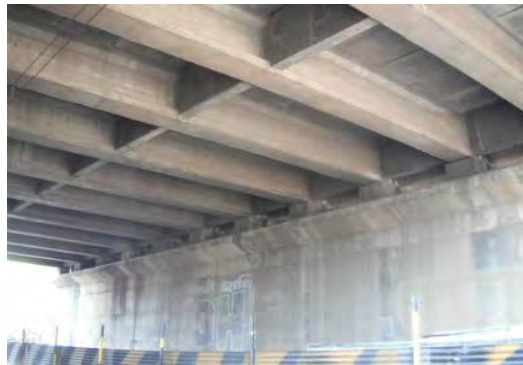
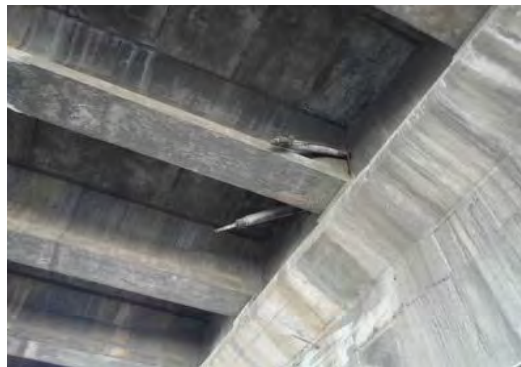
Object Member	
Kind of Damage	Good Condition
Sketch or Photo

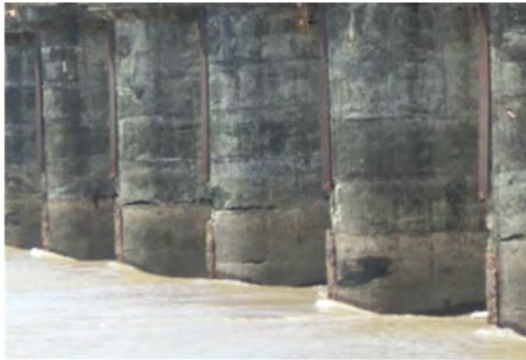
Object Member	Pier
Kind of Damage	Cracking
Sketch or Photo

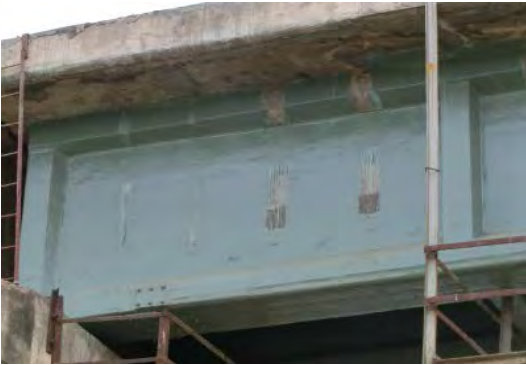
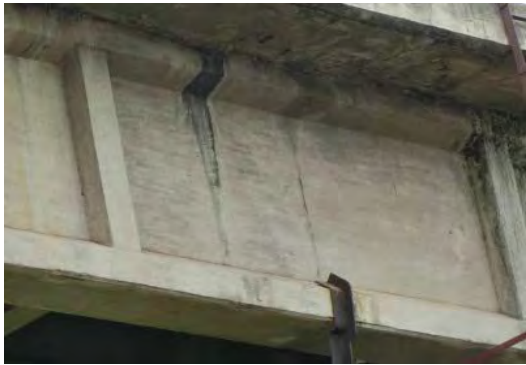
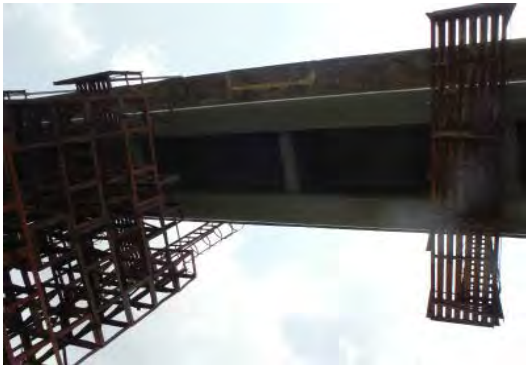
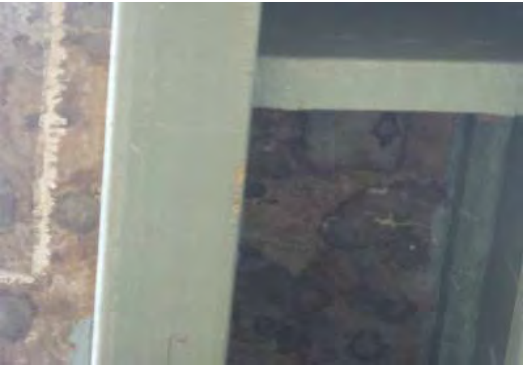
Object Member	Prestressed I-Girder
Kind of Damage	After Repairing CFRP, Now in Good Condition
Sketch or Photo	<div style="display: flex; flex-wrap: wrap; justify-content: space-around;">

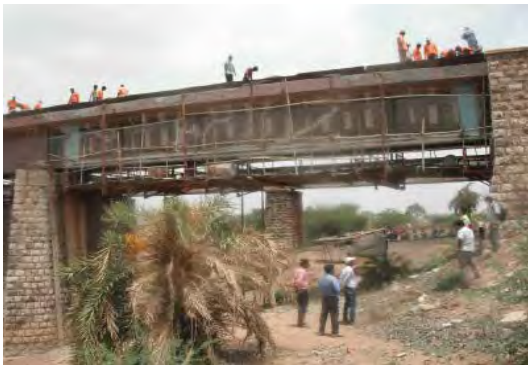
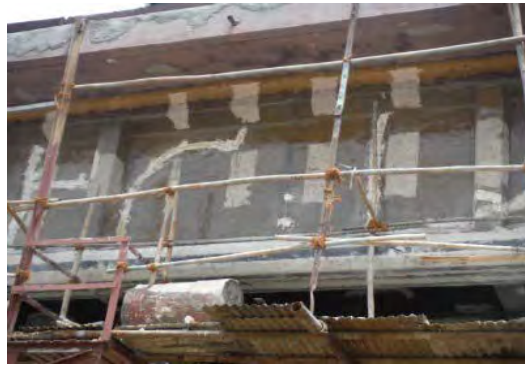
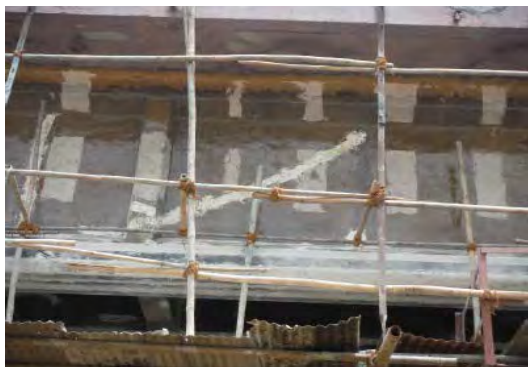
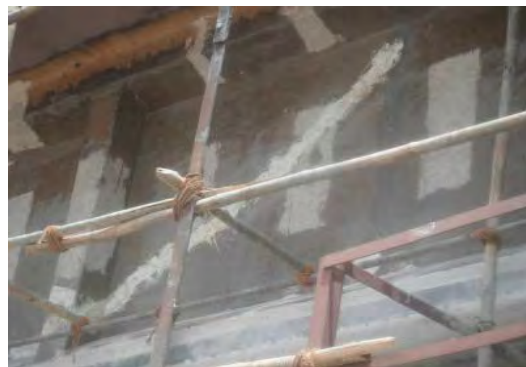
Object Member	Prestressed I-Girders
Kind of Damage	After Repairing CFRP, Now in Good Condition
Sketch or Photo
