APPENDIX 6

Damaged Bridge Survey Record Managed by Western Railway

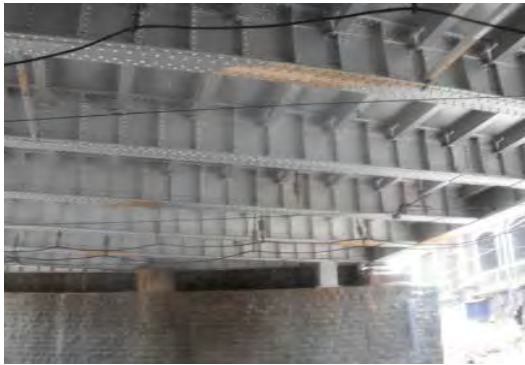
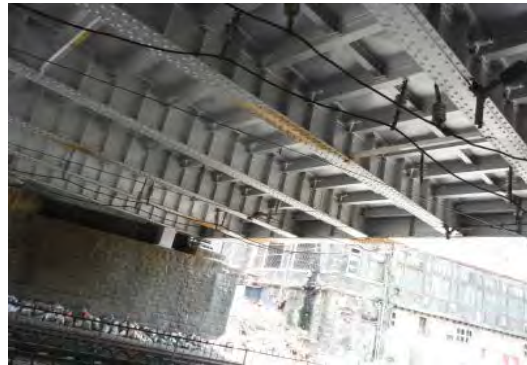
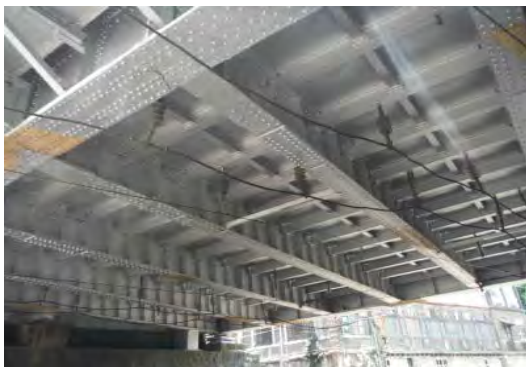
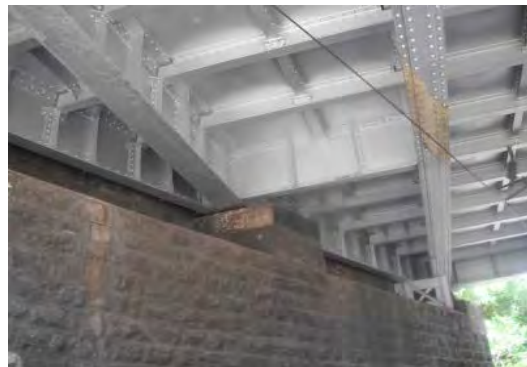
Object Member	
Kind of Damage	Good Condition
Sketch or Photo

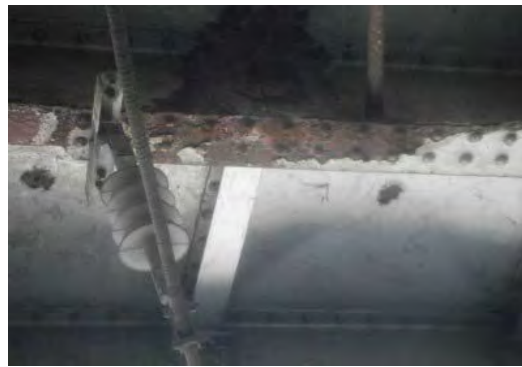
Object Member	Steel I-Girder
Kind of Damage	Rusting
Sketch or Photo

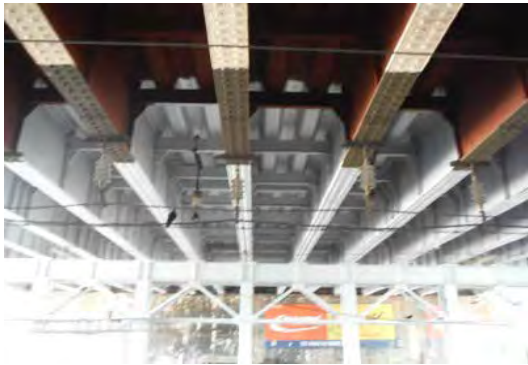
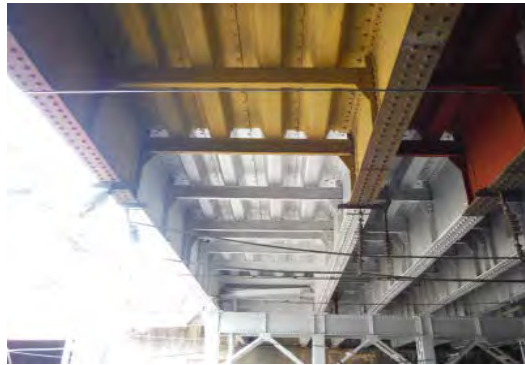
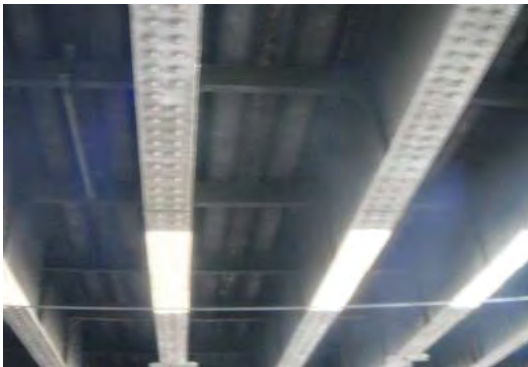
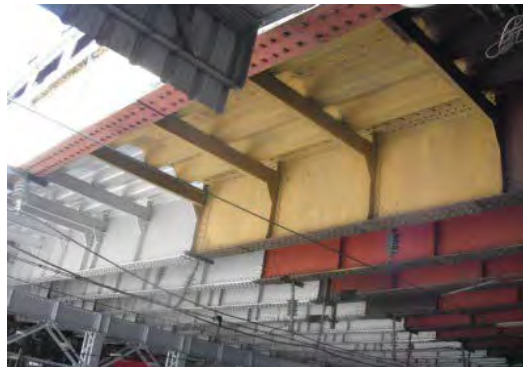
Object Member	
Kind of Damage	Good Condition
Sketch or Photo

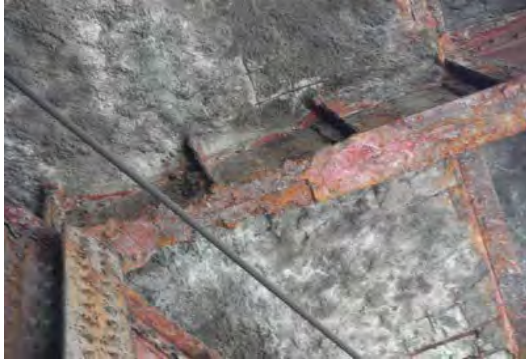
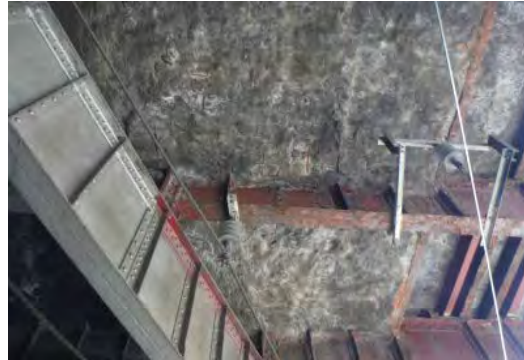
Object Member	RC Slub
Kind of Damage	Spalling and exposed Rebar
Sketch or Photo

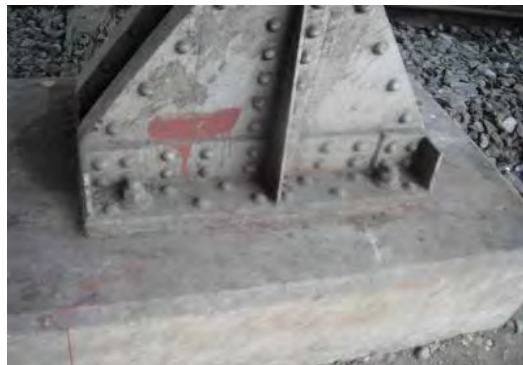
Object Member	Concrete Base
Kind of Damage	Cracking and spalling
Sketch or Photo

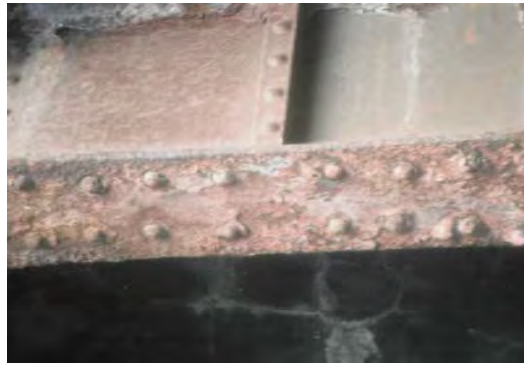
Object Member	Cross Bream
Kind of Damage	Runsting
Sketch or Photo

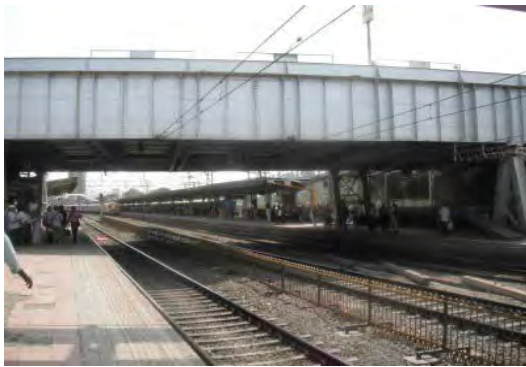
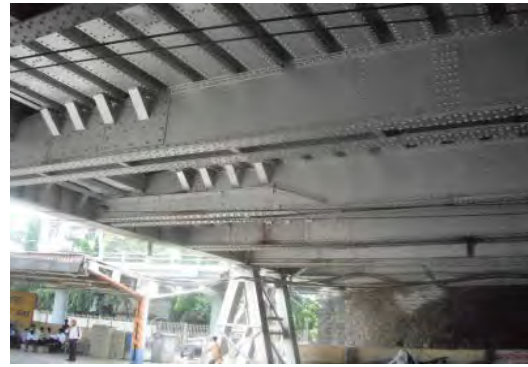
Object Member	
Kind of Damage	Good Condition
Sketch or Photo

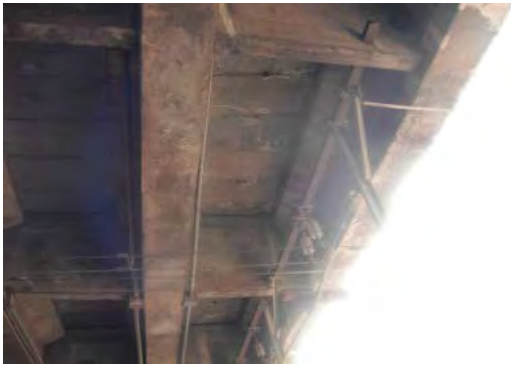
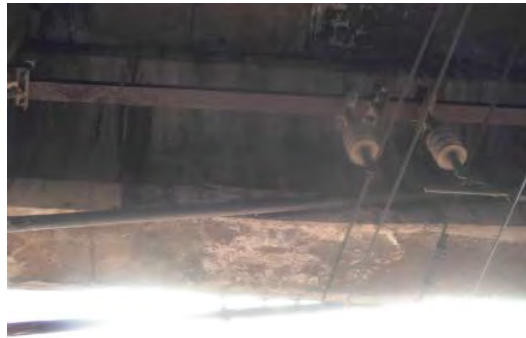
Object Member	PC I-Girder and RC slab
Kind of Damage	Spalling
Sketch or Photo

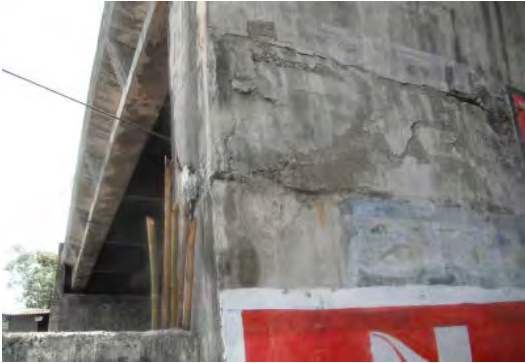
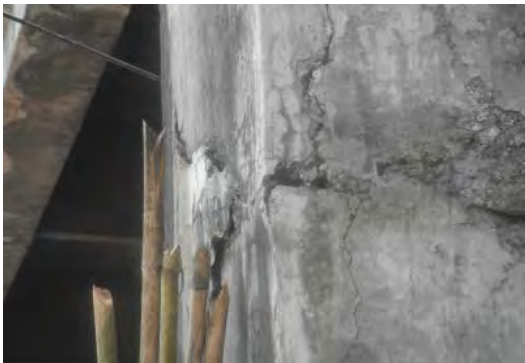
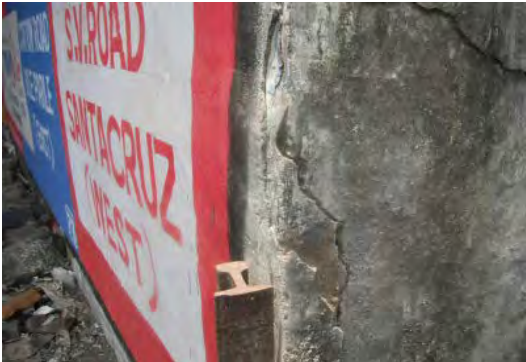
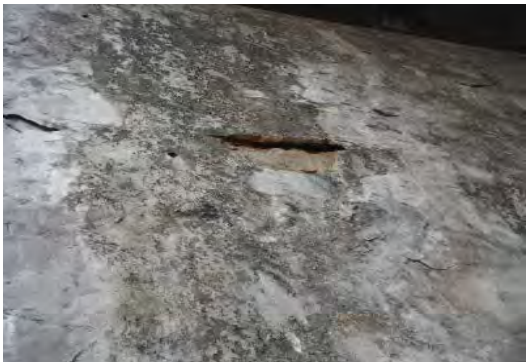
Object Member	RC Pier
Kind of Damage	Cracking and Spalling
Sketch or Photo	<div style="display: flex; flex-wrap: wrap; justify-content: space-around;"> <div style="width: 45%; text-align: center;">

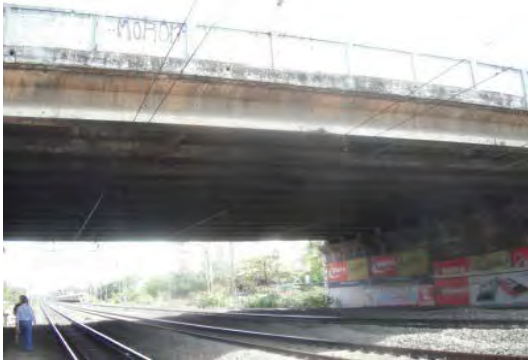
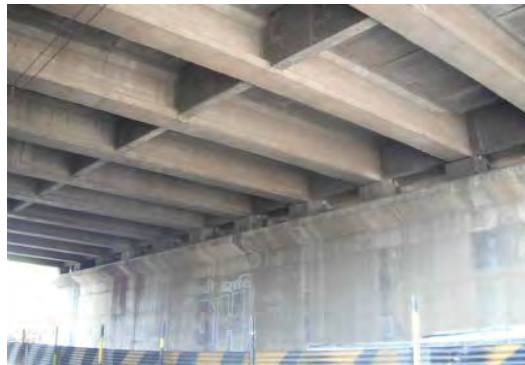
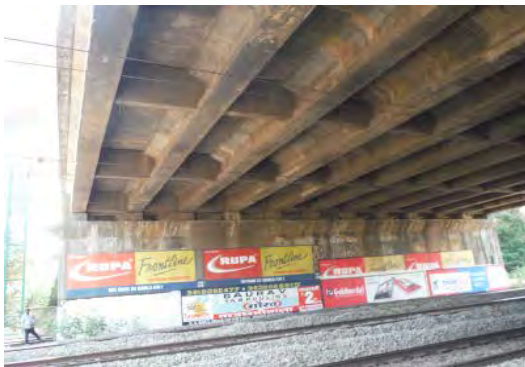
Object Member	
Kind of Damage	Good Condition
Sketch or Photo

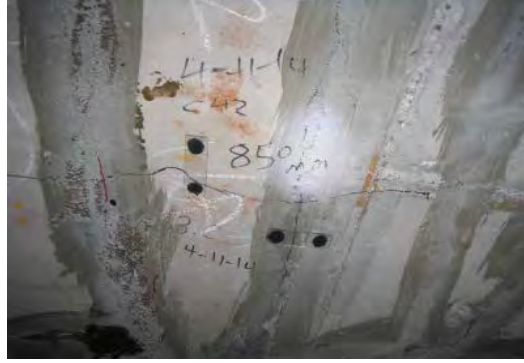
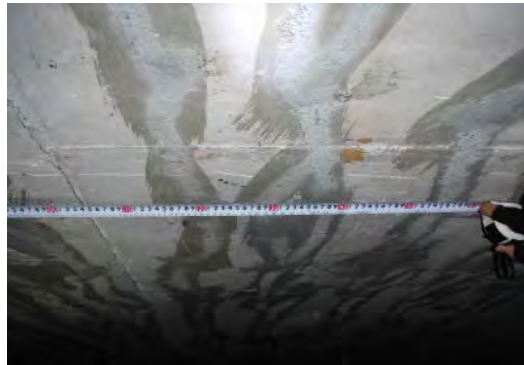
Object Member	Deck Slab
Kind of Damage	Repair Work for Cracking
Sketch or Photo

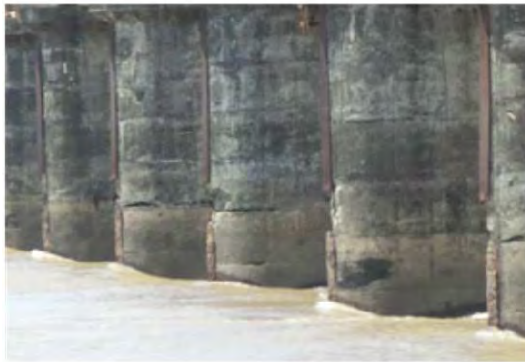
Object Member	Pier
Kind of Damage	Cracking
Sketch or Photo

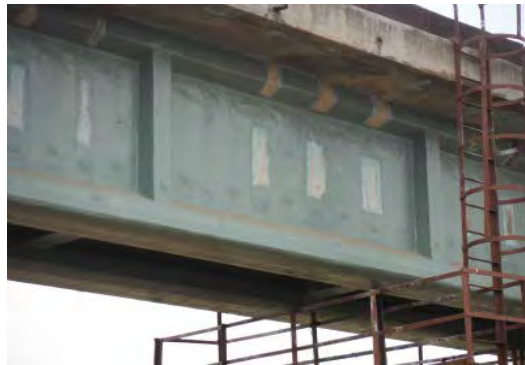
Object Member	Prestressed I-Girders
Kind of Damage	After Repairing CFRP, Now in Good Condition
Sketch or Photo

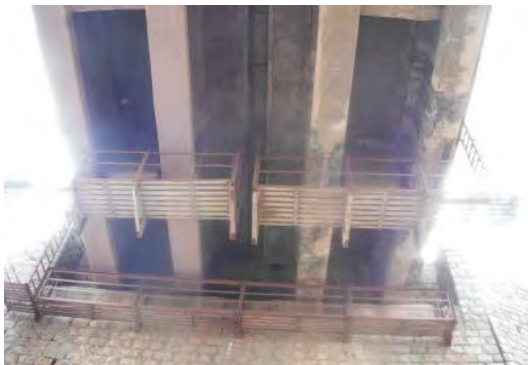
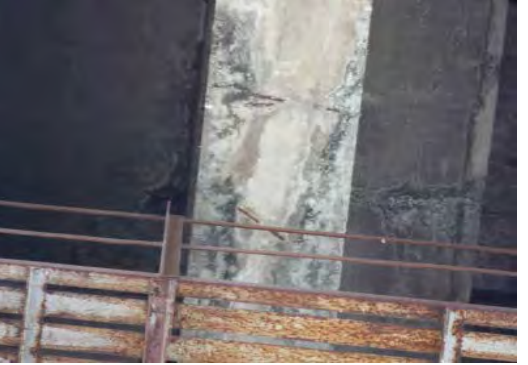
Member	Kind of the Damage
	Ex. Concrete : Cracking, Spalling, etc. Steel : Cracking, Rusting, Fracture, etc.
1. Superstructure	
(1) Concrete Member	
- Girder	Cracking
- Cross Beam	Good
- Slab	Cracking , Reinforcement Bar Exposed
(2) Steel Member	N/A
- Girder	
- Vertical Girder (stringer)	
- Cross Beam	
- Sway Bracing	
(3) Bearing Shoe	No Check
(4) Drainage Pipe	N/A
(5) Others	-
2. Substructure	
- Pier	N/A
- Abutment	Good
- Wing Wall	Good
3. Miscellaneous	
- Approach Road Condition	Good
- Obstruction	-
- Scouring	N/A
4. Evaluation

Object Member	Prestressed I-Girders
Kind of Damage	Cracking
Sketch or Photo	<div style="display: flex; flex-wrap: wrap; justify-content: space-around;">
