Republic of Mauritius
Landslide Management Unit: LMU, Ministry of Public
Infrastructure and Land Transport: MPI

TECHNICAL COOPERATION PROJECT : LANDSLIDE ADVISER FOR MAURITIUS

FINAL REPORT

February 2018

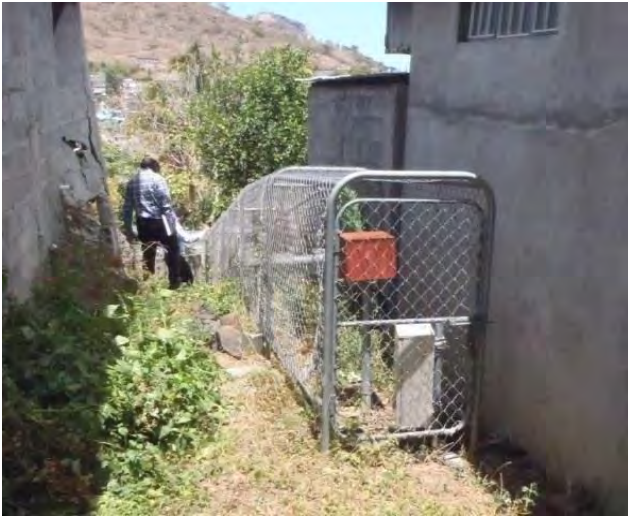
Extensometer maintained by MPI/LMU, Vallée Pitot

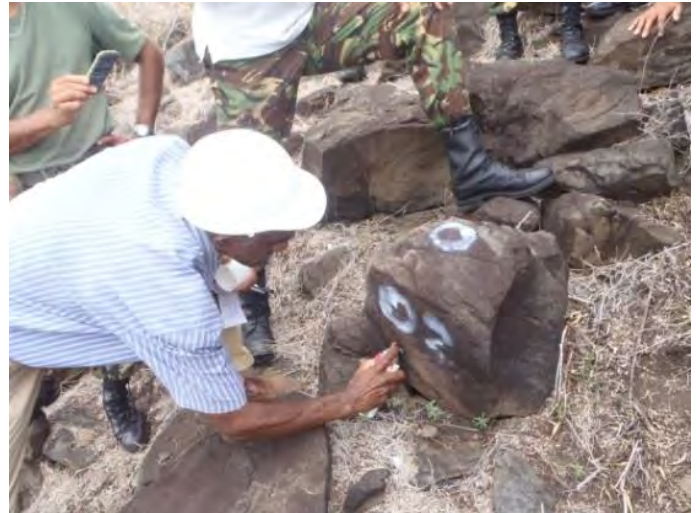
Marking the rocks, Signal Mountain

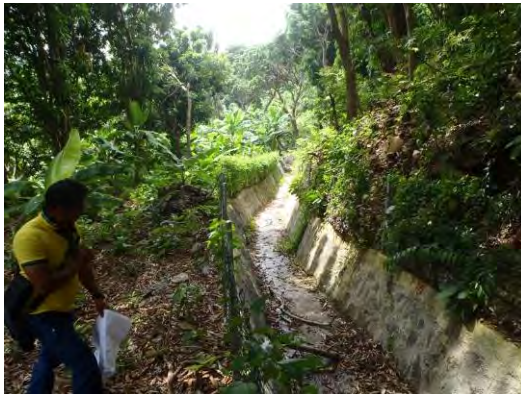
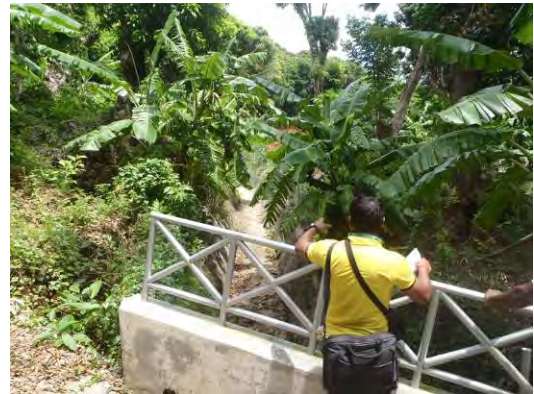
Work item		Current situation	Problems
Channel for flood	CH-1	It does not have damage nor loss, and functions normally	The obstacles which are collected at the bottom of the canals such as soil or leaves must be removed regularly to keep good condition. The inspection of the structure is required regularly. When damage is discovered, it should be repaired promptly.
Horizontal Drainage	HD-1	A groundwater is drained away from two drillings, and the trace that groundwater is being drained away is confirmed at all of the horizontal drainages (five drillings). It is estimated that there was a considerable amount of drained water during the heavy rain from the observation of these horizontal drainages.	The washing work of the drainage hole should be carried out regularly to keep good condition.
Upgrade drainage	UD-1, UD-2	It does not have damage nor loss, and functions normally.	The obstacles which are collected at the bottom of the canals such as soil or the leaves must be removed regularly to keep good condition. The inspection of the structure is required regularly. When damage is discovered, it should be repaired promptly.

Photo 1 View of landslide Countermeasure, channel for flood, CH-1, 08th March 2016
(Source: JET)

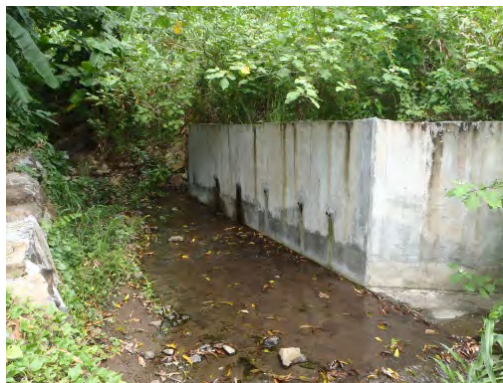
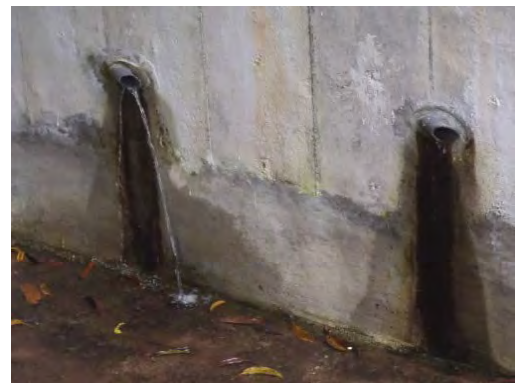
Photo 3 View of landslide countermeasure, horizontal drainage, HD-1, 08th March 2016
(Source: JET)

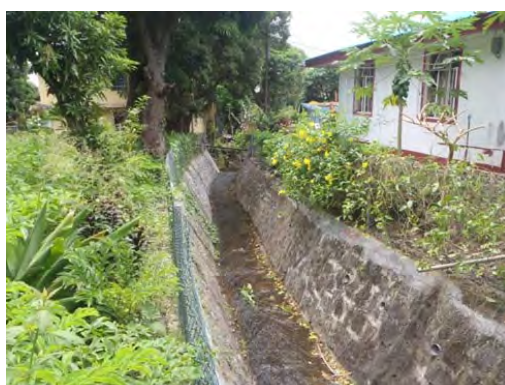
Photo 5 View of landslide countermeasure, upgrade drainage, RUD-1 and 2, 08th March 2016
(Source: JET)

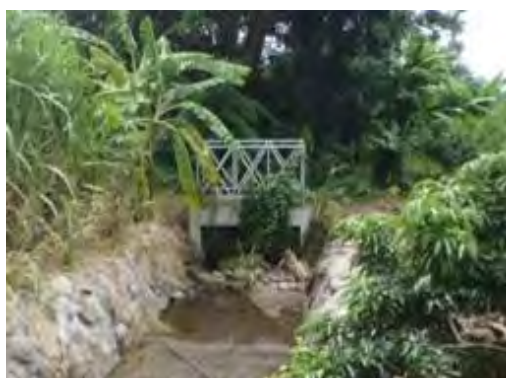
Br-4

Photo 6 View of landslide countermeasure, bridge (Source: JET)

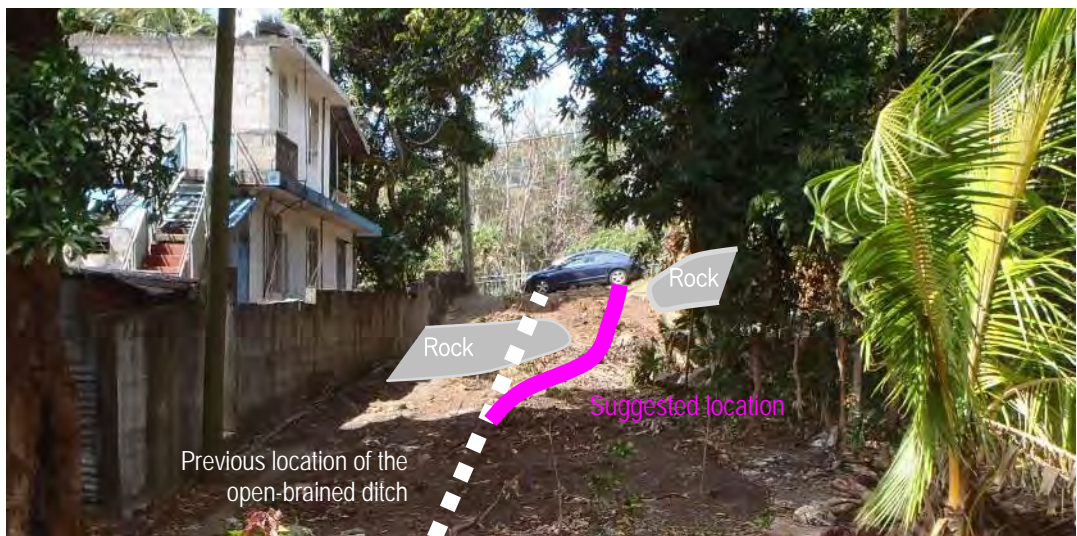
A part of Open-brained ditch, BD-1, is impeded by a big rock. Therefore, the JICA expert suggested placement of Open-brained ditch (Figure 2) which avoids the big rock (20 September 2017). There is no functional decline resulting from this option.

Figure 2 Location of open-brained ditch, BD-1 (Source: JET)

Photo 2 Location of open-brained ditch, BD-1 (Source: JET)

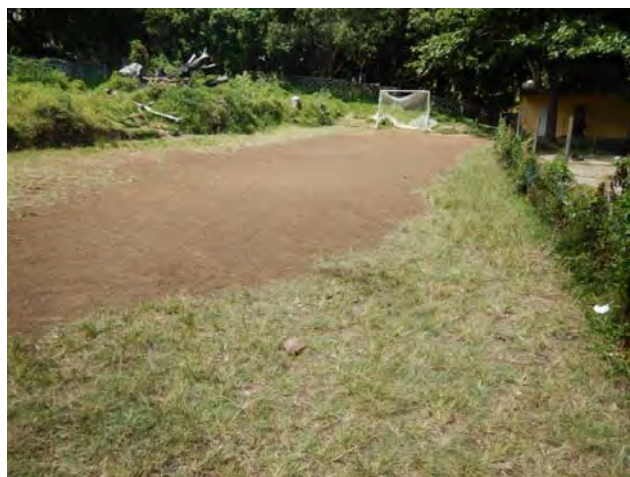
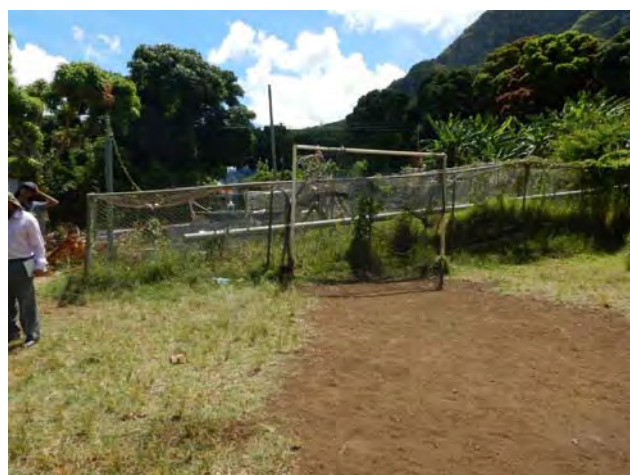
Photo 1. Full view of the site (Source: JET)

- ✓ The distance between the mini football ground and the existing extensometer should be more than 2m.
- ✓ The mini football ground should be surrounded with a fence of more than 4m.
- ✓ Surface drainage around a mini football ground should be constructed as shown in Figure 2, and it should be connect to the existing drain located on the road side.

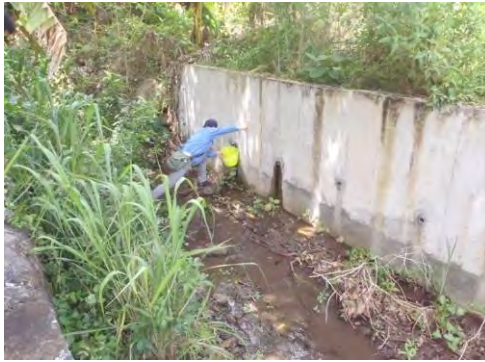
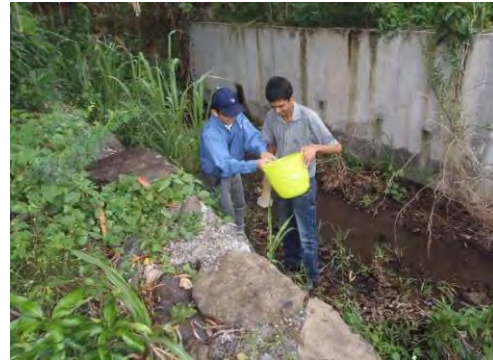
Groundwater was draining from two holes of the five drilling holes. Although there was no rainfall, because the weather was clear on 6 March 2017 when site inspection was carried out, according to the local people, the amount of drainage from horizontal drillings increase

around 2 or 3 times during heavy rain. All of this drained water is caught by the reinforced upgrade drainage, RUD-1. The quantity of flow of this horizontal drainage was 1.8 litres a minute (refer to table 1).

Photo 2 Measurement for horizontal drainage HD-1 (Source: JET)
