Work plan for evaluation of the landslide countermeasure in Chitrakoot

Slope inventory

MPI and JET have visited 18 sites of slope failures, rock falls, and debris flows, and surveyed the current conditions of each slope during this project. As a result of the investigation of the 18 sites, slope investigation sheets and a slope inventory were made by MPI and JET.

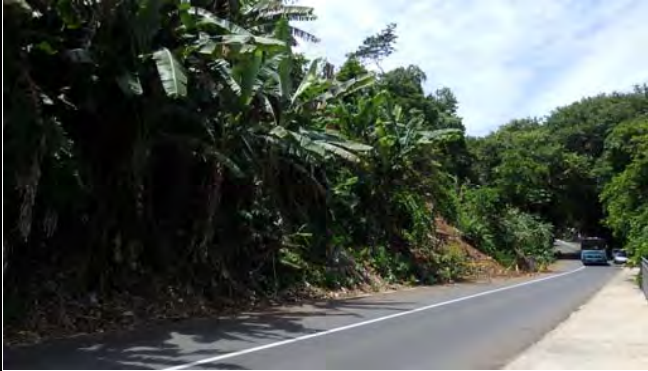
Photo-1 Full view. Scarps of the slope failure. After discussion between LMU and JET, structural slope protection were designed.

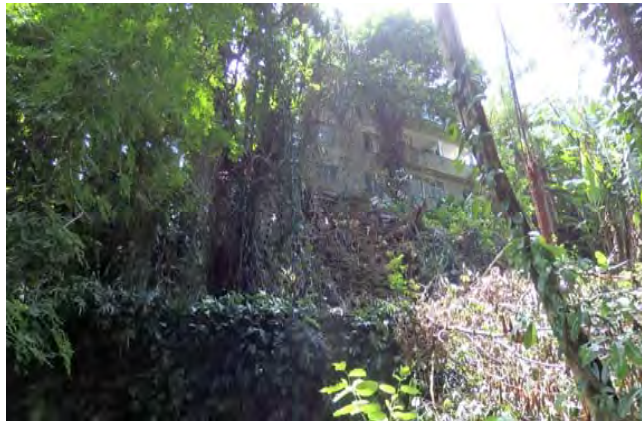
Photo-5 Some houses stand on the edge of the slope.

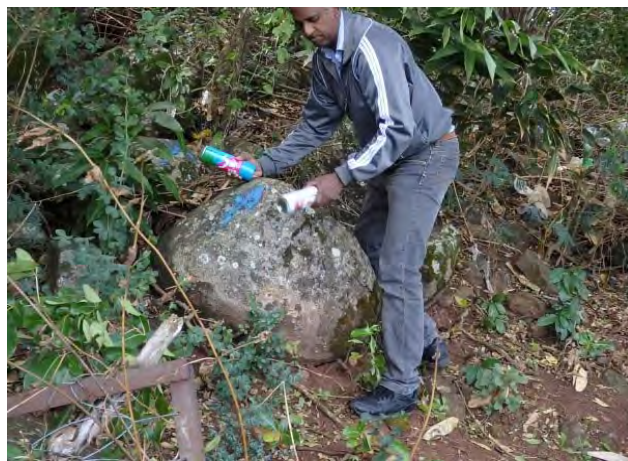
Blue paint: Stabilization

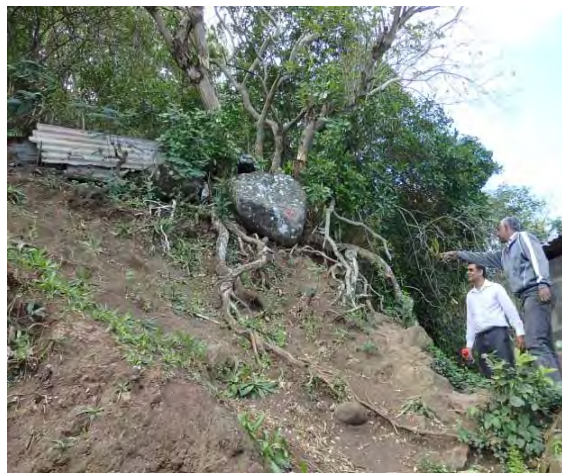
Red paint: Removal

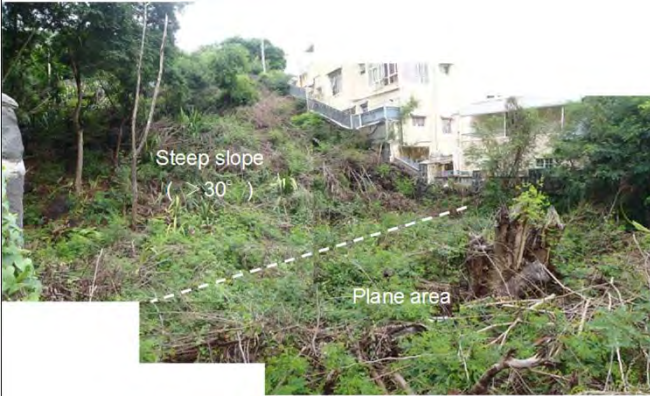
Full view of the site

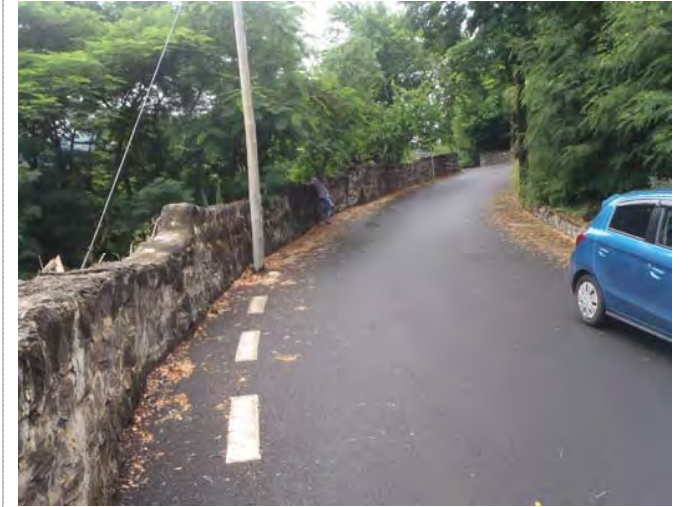
The view of the upper road

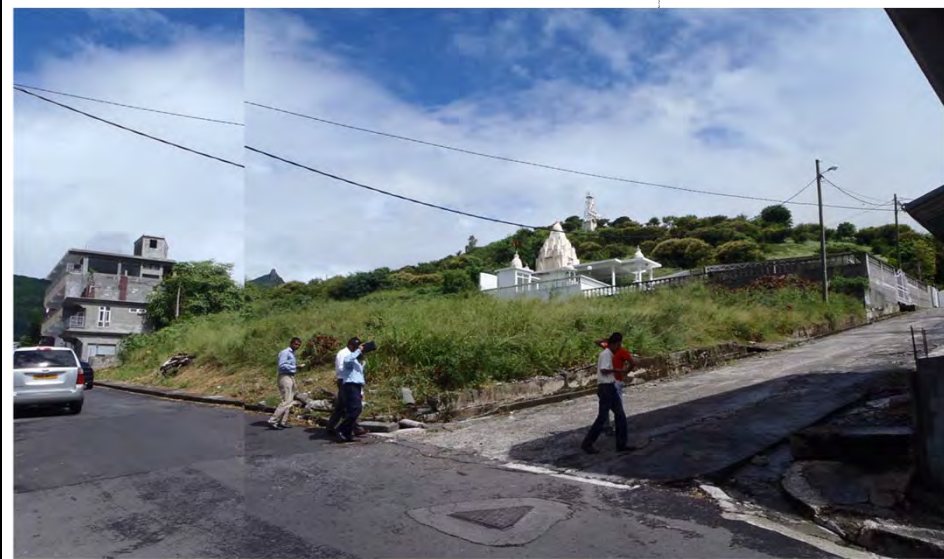
Full view of the site

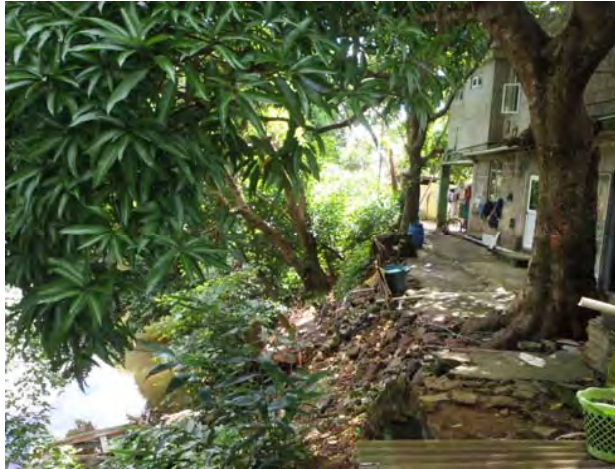
Full view of the site

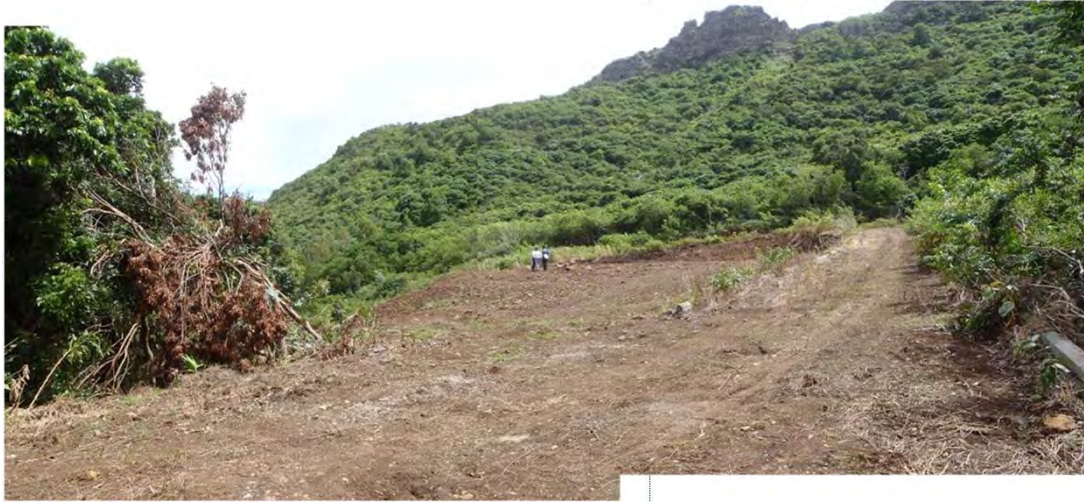
Full view of the site

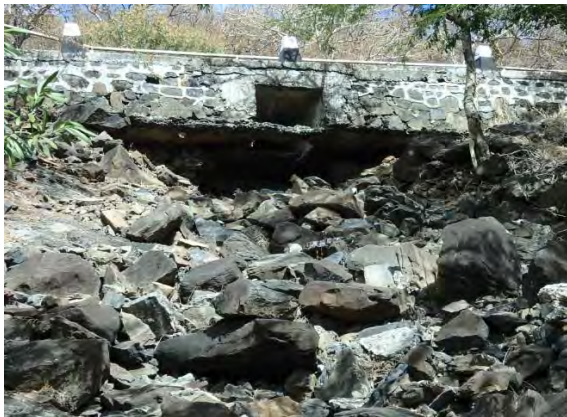
Photo-4 Base of the culvert was eroded and culvert is hanging. LTU and JET proposed to be replaced by strong one unit culvert and filling sufficient concrete base.

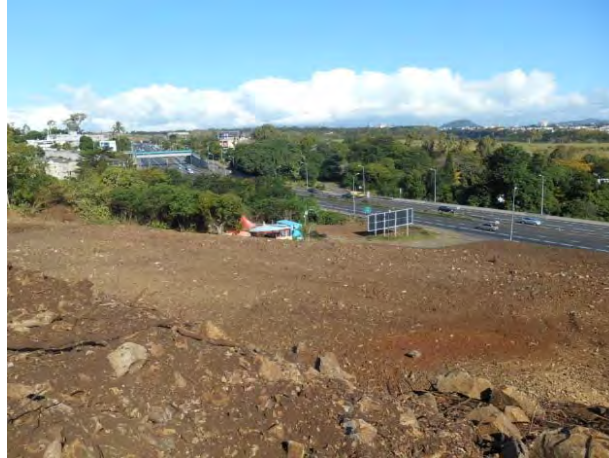
Photo-2 Middle of the development area is flattened.

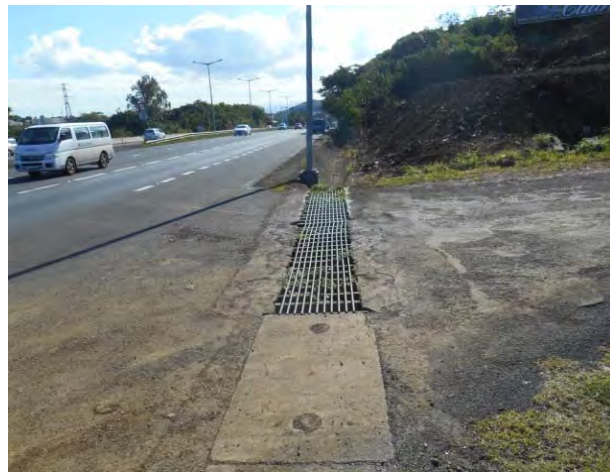
Photo-4 Development area is very close to the M1.

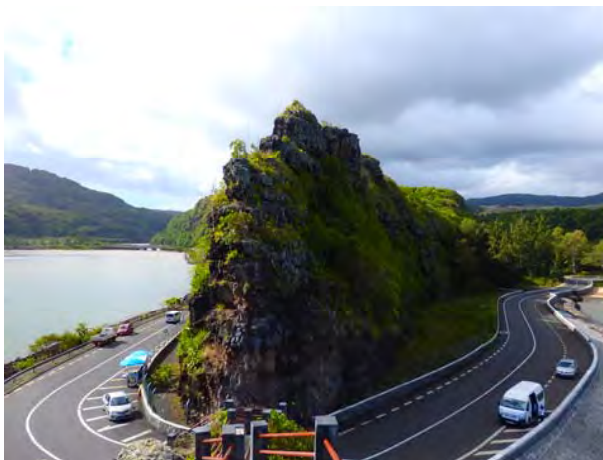
This slope is located at the cape of Mocande on the south coast of the island. The slope(cliff) consist of hard basalt lava and the layers of crinker. Many cracks develop on the surface of the hard lava layers. Most of the rock fall were from the basalt part cliff. In July and August 2014, RDA carried out the work of rock removal which were unstable and close to the road. A new road(shift of alignment) was built to reduce the damage from rock falls. However, rock falls and small rock failures are also a frequent occurrence along the new road. The rocks are weathered, and there is a high possibility of rock fall in future.

Photo-1 Total view of the Cape Mocande.

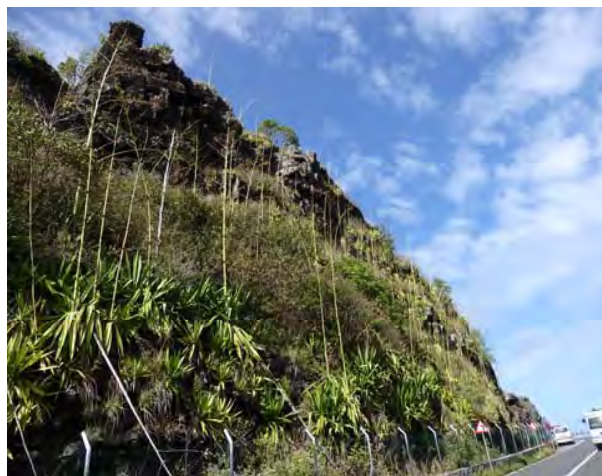
Photo-2 West site of the cliff

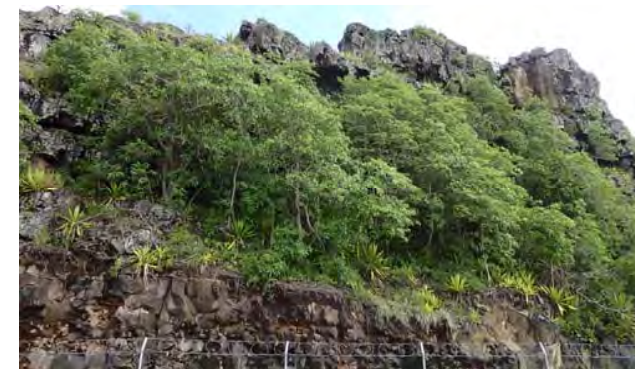
Photo-3 East side of the cliff. Road alignment was shifted away from the cliff

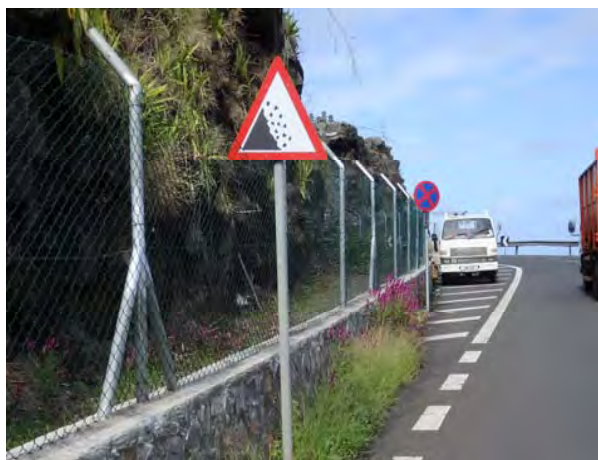
Photo-4 Rock fall fence and warnig sign

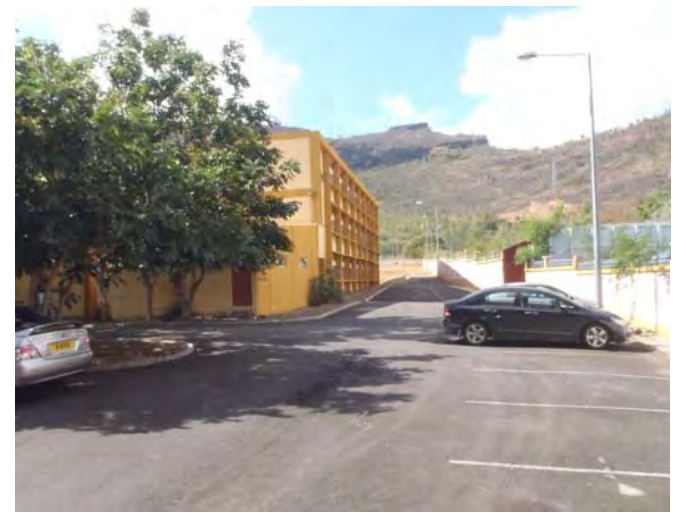
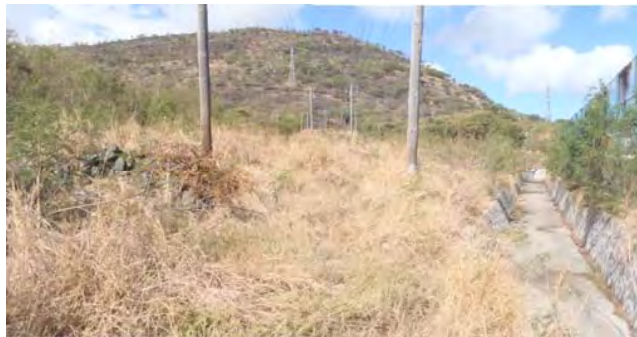
The damage by the landslide is not found on open drain behind a school.

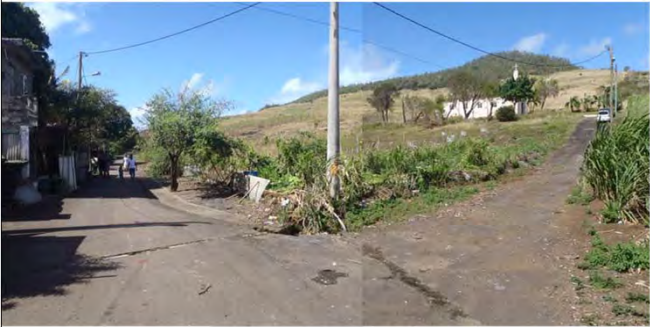
Full view of the site
No damage by landslide is found on the road surface & road side ditch

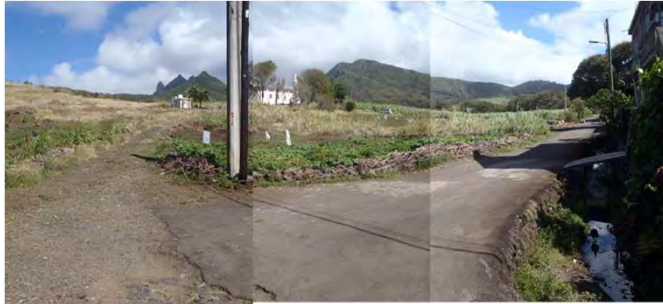
Full view of the site
No damage by landslide is found on the road surface & road side ditch

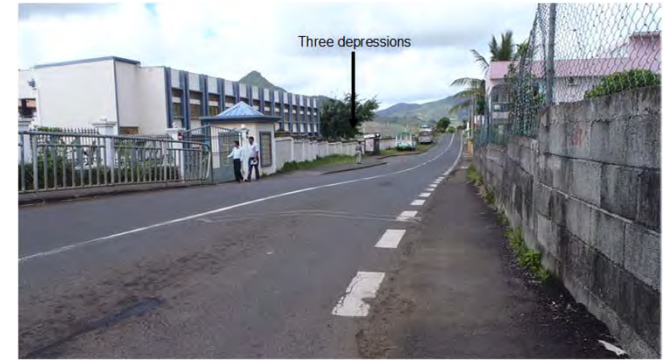
- > Three depressions appear on the green area of the site, and are located at the bottom of the dale.
- > The natural canal located at the bottom of the dale was present even before the school was constructed.
- > The green area was built on a dale and a natural canal by a filling-work.
- > From the fact mentioned above, it is estimated that the three depressions were caused by subsidence of the filling. The subsidence may be due to lack of compaction of the filling at the time of the construction. It may also be caused by sand of the filling being washed away by groundwater which flows along the original surface (dale) under the ground.
- > It is recommended that three depressions should be filled by gravel, not sand, and enough

Three depressions are located at the bottom of the dale.

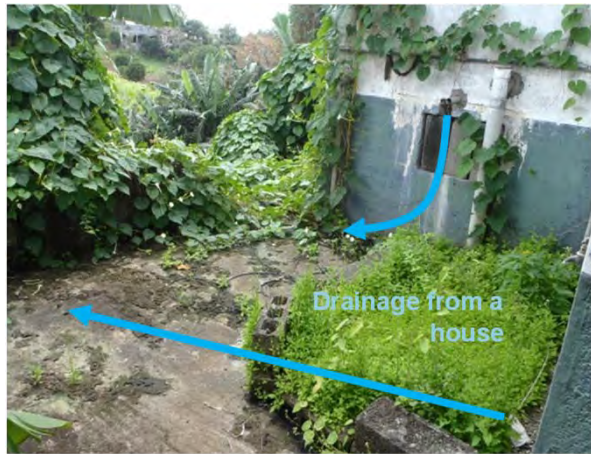
Drainage from a house accelerates erosion of the cliff

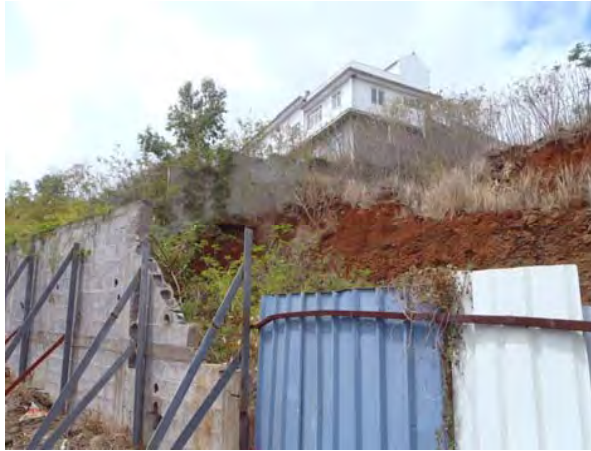
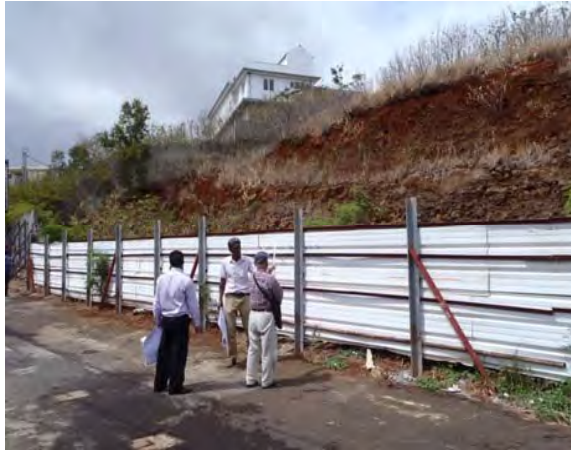
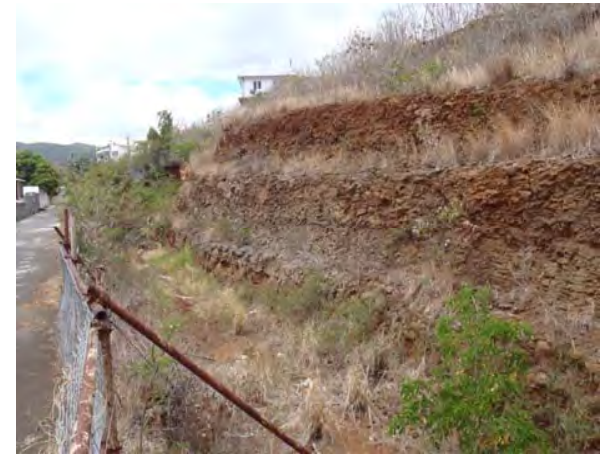
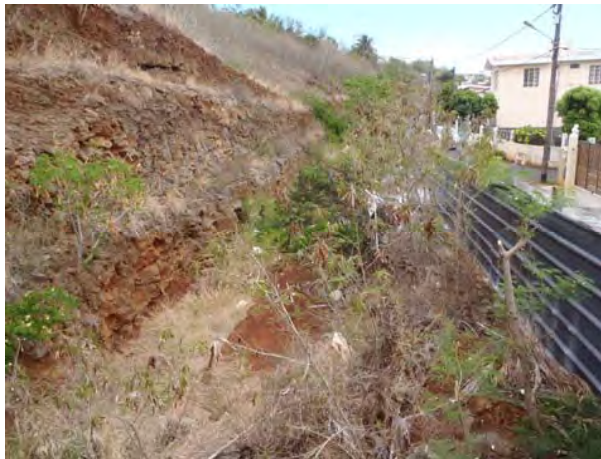
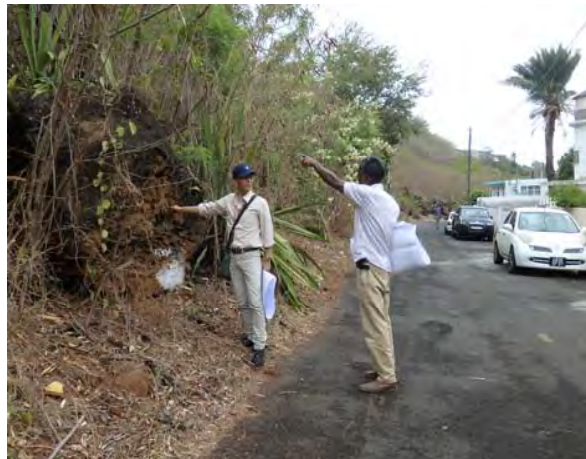
Site1

Site 1: It is the site where collapse of a boundary wall by the land development was reported recently, 2012. The slope angel is very steep and there are many unstable rocks on this slope. As a temporary countermeasure, a open drain had been excavated by the land owner where the wall collapsed. In future, Retaining wall will be installed there as a permanent countermeasure for the slope.

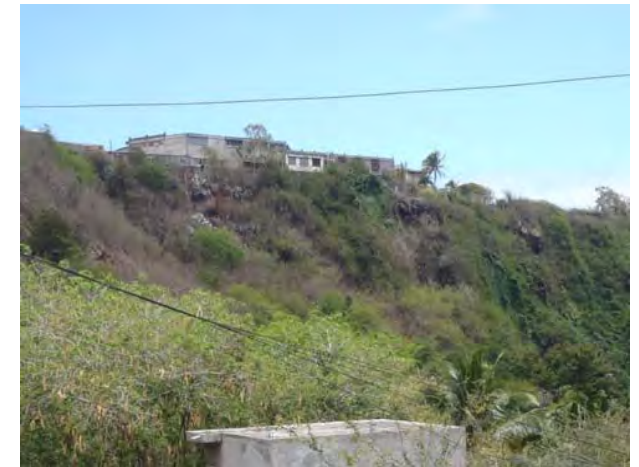
Site2

Site 2: There is significant volume of dumped materials including rock dust and boulders observed on the steep slope, terrace scarp. In future, a rock barrier (Retaining wall) will be installed there as a countermeasure to control a movement of the dumped materials.
