添付資料 9-6
工事完了証明書

1. Name of Consulting Service Assignment	The Pilot Project for Landslide and Rock fall mitigation works (Lot 1) under the Technical Cooperation for Landslide Mitigation Project
2. Performance Period	28/01/2016 – 28/07/2018
3. Contract Amount	LKR 38,268,930.00 (Final confirmed price: LKR 37,361,900.36)
4. Name of Contractor	ELS Construction (Pvt) Ltd
5. Progress of Work	As per progress report
6. Amount Payable by this Inspection	LKR 10,437,206.77
7. Note	Work progress in the report is 97.51% (Rs. 33,923,186.36) which is the progress percentage to the contract amount without contingency (10%). After this inspection on the completion of the work, defect liability period commences at the date of issuance and approval of Certificate of Completion for one year. The contractor should submit Maintenance Security to JICA for the defect liability.

CERTIFICATE OF PRACTICAL COMPLETION

Defects Liability Certificate

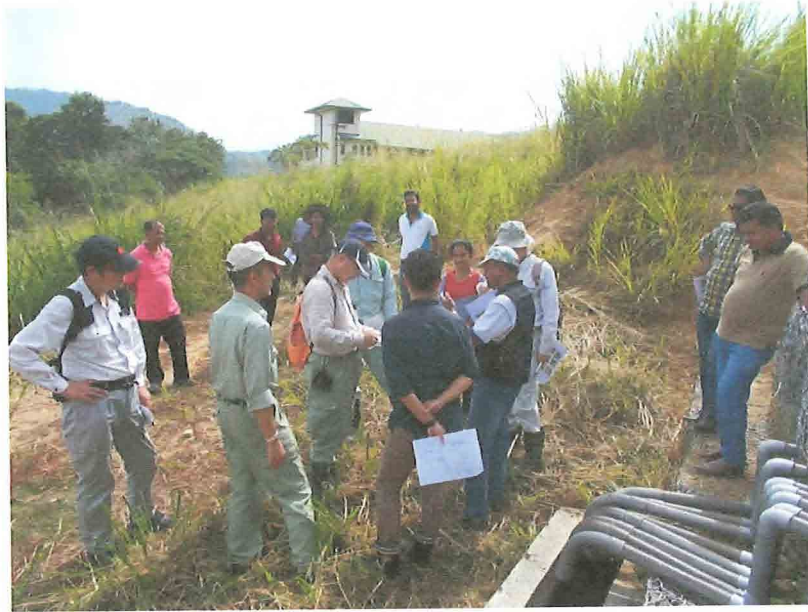
Defect Liability Inspection at the site

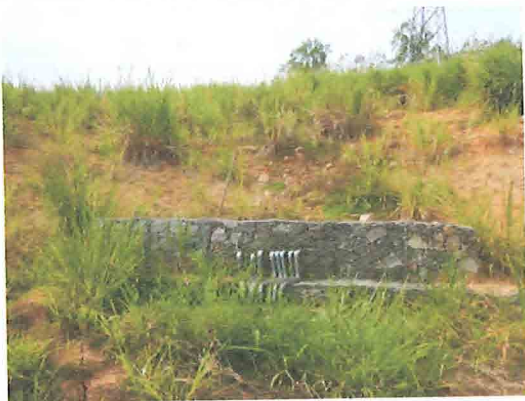
Photo 3: Small slip has been reshaped (D. P. 1)

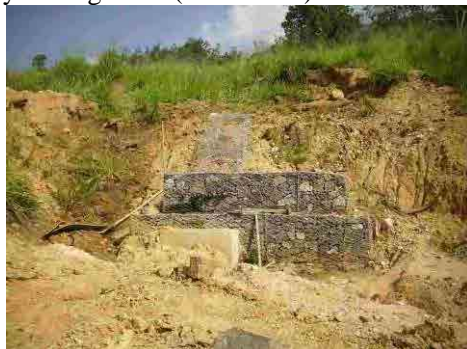
Small landslide behind the gabion wall caused by cutting work (Point No.1)

Photo 4.1 Small landslide caused by cutting work

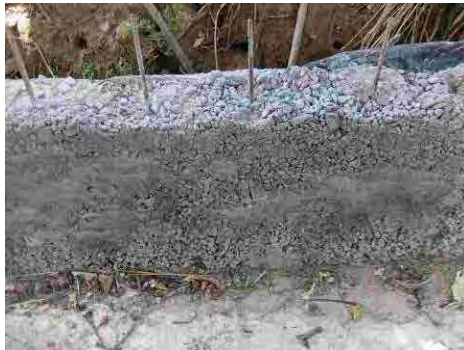
The concrete grade of the surface drainage ditch should be more than 25 grade. Otherwise, honeycombs could appear on the surface of the ditch. (see Photo 4.2) The main cause was the concrete grade and insufficient compaction with vibrator might be a cause of the honeycombs. Therefore more than a concrete grade 25 should be used for the surface drainage ditch in order to avoid such honeycombs. Also distribution of reinforce steel bars should follow the original design in order to keep the quality stipulated in the standard in Sri Lanka and the contract document (see Photo 4.3) .

Photo 4.2 Honeycombs of surface drainage ditch (already corrected)

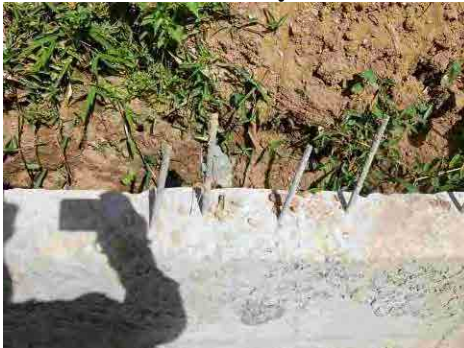
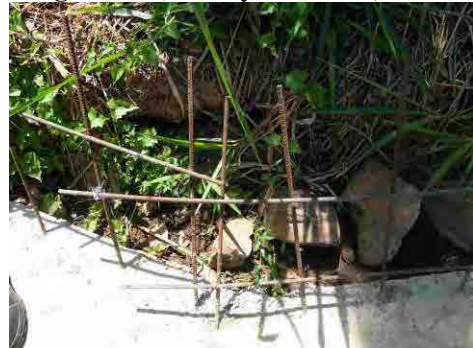
Photo 4.3 Spacing of steel bars do not follow the design (already corrected)

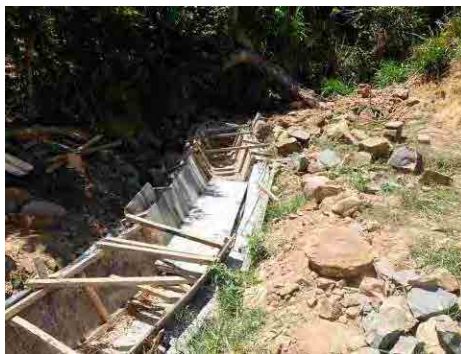
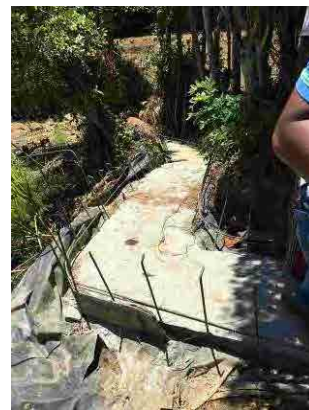
sometimes it could be difficult to follow the original design. Topographic surveys should be conducted before the construction works along the planned surface drainage ditch line and usually a cross section should be surveyed almost every 20m along the ditch line in the shop drawings. Therefore sometimes it could be difficult to follow the original drawings because the topographic survey cannot cover all of the cross sections along the ditch line. If there are so many changes of gradient of slope or sudden change of direction of stream, the Contractor shall submit a proposal of proper ditch works and an approval from the Engineer should be required. If necessary, additional cross sections should be surveyed depending on the topography along the planned ditch line in the shop drawings. (see Photo 4.4) After the discussion, these sudden curves were corrected in the pilot project. However, some parts have not been corrected completely, and sometimes water overflows at the steep slope and sudden curves. To construct such a steep slope and sudden curve should be avoided in order to avoid overflow at the sudden curve points. (see Photo 4.5) Sometimes land use was a problem to construct ditches as the original design land owners don't allow their land to be used for ditches. In this case, before the construction works, sufficient explanation and discussion should be conducted with land owners to obtain the land owner's agreement.

Photo 4.4 Sudden curves of ditch (already corrected)

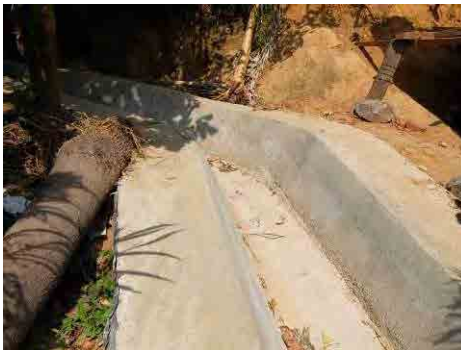
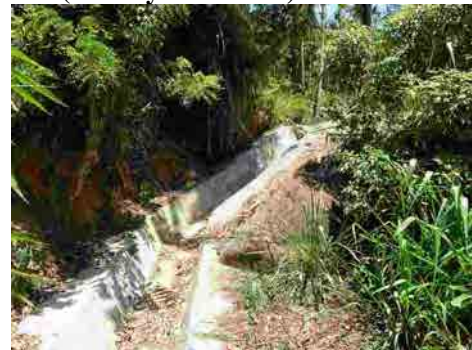
Photo 4.5 Sudden curves of ditch

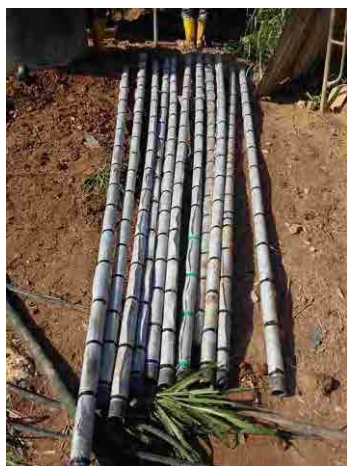
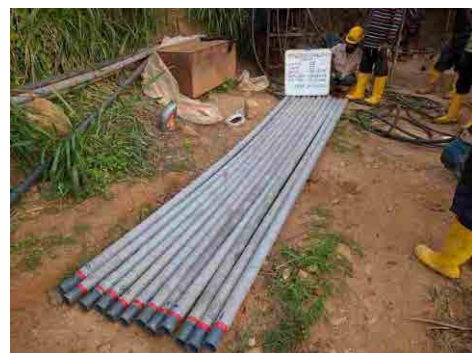
Wrapping of the geotextile in the PVC pipe is important. Sometimes the geotextile becomes unstuck because of improper wrapping. After that soil flows into the PVC pipes, and the PVC pipes might be blocked. Actually, after the change of wrapping from left to right (see Photo 4.7), PVC pipes were not blocked in the pilot project.

**Photo 4.7 Wrapping of geotextile to PVC pipes
(left: improper wrapping, right: proper wrapping)**

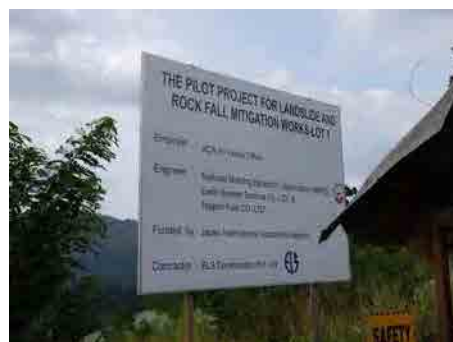
工事看板

ボーリング深度の確認を写真撮影のみで行っていたため、ホワイトボードに必要な情報(プロジェクト名、工区名、孔番、掘削長等)を記載するように指導した。

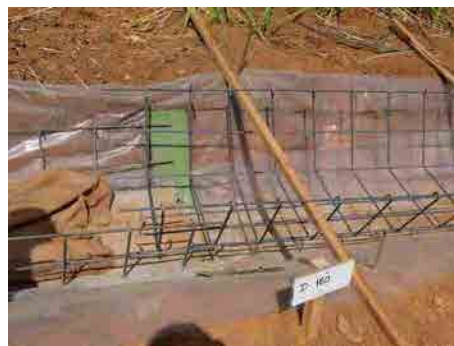
施工継目の間隔は 20m となっており、管理基準値（案）に示す 10m 間隔の検査は不可能である。したがって、NBRO とも協議して、管理基準値（案）の 10m 間隔を 20m 間隔に変更する。

施工継目

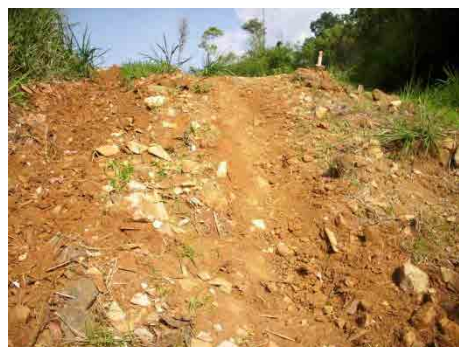
水路工形式の変更予定箇所

管理面では安全ミーティングを2～3日に1回実施して安全意識の向上を計っている。削孔作業の状況を確認できたが、ヘルメット、保護靴の使用は徹底されていた。7月分の出来型から水路工について数箇所確認を行ったが、基準内のサイズであることを確認した。ただし、データ管理シートの整理が現状では不十分であり、今後は検査直後に記載しファイリングを行っていくことをコントラクターおよびNBROサイトエンジニア（テクニカルオフィサー）に指導した。また、水路工施工箇所のうち勾配の急な区間についてはカスケード方式とする提案があり、予定箇所を確認した。プロポーザルについては後日提出される予定である。

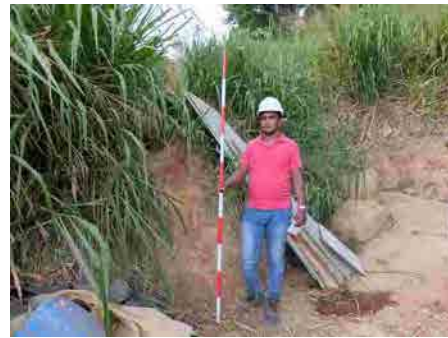
c については、NBRO 及びコントラクターからカスケード式の水路の提案がなされた。コントラクターの提案箇所を確認したところ、全ての箇所においてカスケード式の水路が必要とは考えられず、1 箇所については必要と判断された。ただし、NBRO との協議の結果、カスケード方式ではなく、急勾配の箇所の上下に柵を 1 箇所ずつ設けることを提案した。

急勾配の斜面 (約 30 度)

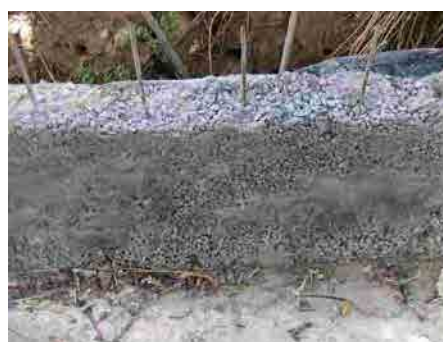
ハニーカムの状況

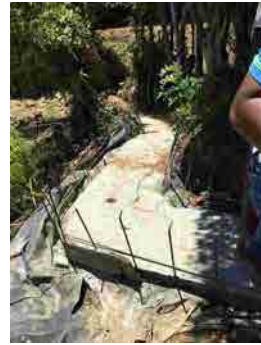
c については、**NBRO** からカスケード式の水路の提案がなされた。現地を確認したところ、それほど急勾配ではなく **15-20** 度程度であった。提案箇所の下方には集水枿が設置予定であったため、それによって流速の減衰効果は期待できるものと考えられたため、カスケード式水路の設置は不要と考えられる。以上について、現地で **NBRO**、業者と確認した。

ほぼ直角に曲がる水路

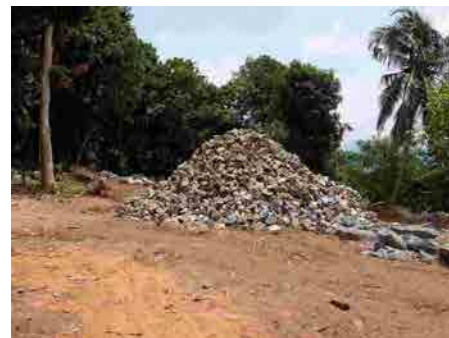
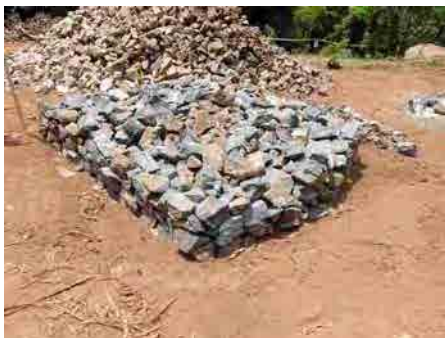
以前は、破碎した岩塊を所定の形状にまとめて数量の確認を行っていたが、数量が増えてきたため、管理が総量を把握できるような管理ではなくなっていた。したがって、現地視察時に総量が把握できなくても、視察時にそれまでの数量を確認できるように写真で記録するように指示を行った。

現在の状況

現在の確認状況

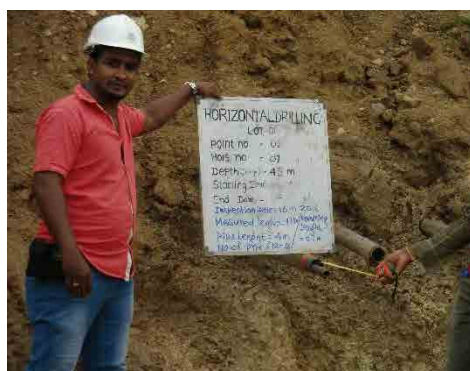
No.1 検尺状況 (挿入完了)

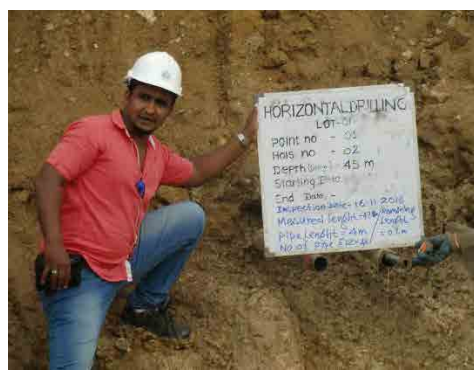
No.2 検尺状況 (挿入完了)

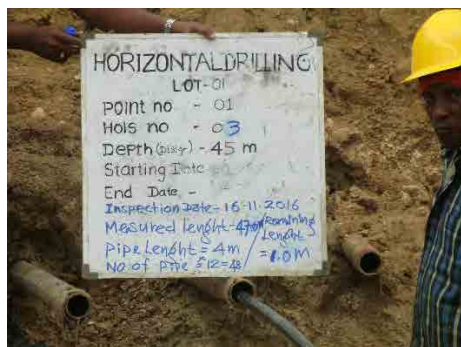
No.3 検尺状況 (挿入完了)

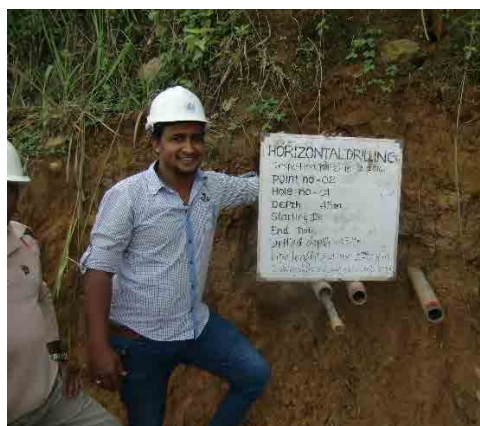
No.1 検尺状況 (挿入完了)

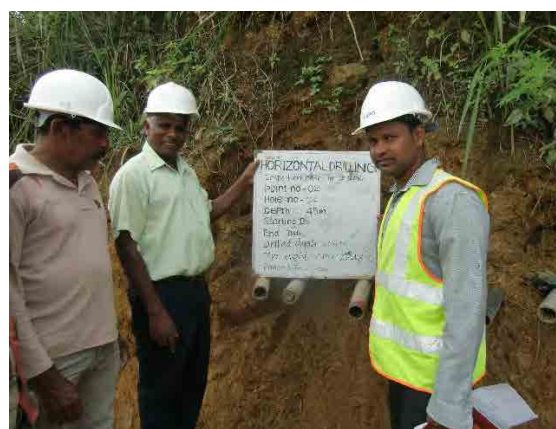
No. 2 検尺状況 (挿入完了)

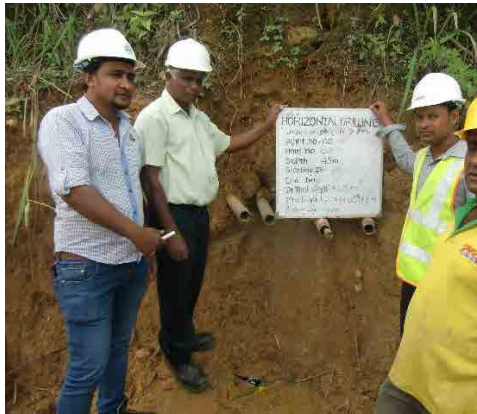
No. 3 検尺状況 (挿入完了)

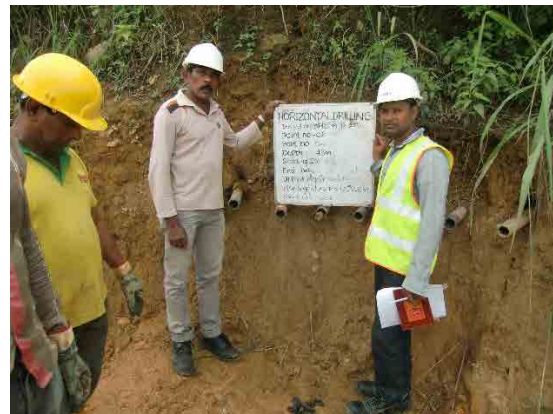
No. 4 検尺状況 (挿入完了)

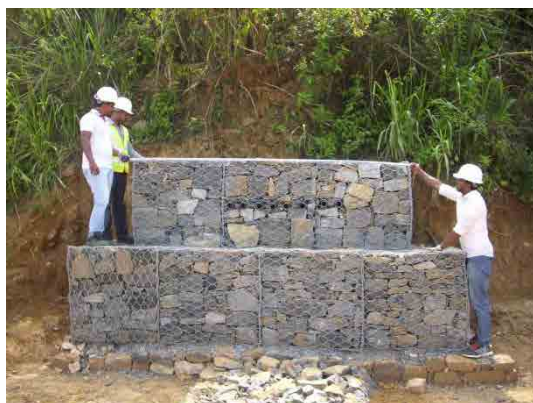
Point 2 および Point3 のガビオン工が完了している。1 か所あたりのガビオン個数は（1 m3/1 個×10 個=10m3）を標準としているが、掘削範囲、埋戻し材料等を考慮して必要最小数量の7m3/箇所とすることについて施工業者、NBRO、TCLMP 間で合意している。以下に ガビオン工の出来形確認時の状況写真を示す。

Point2 出来形確認

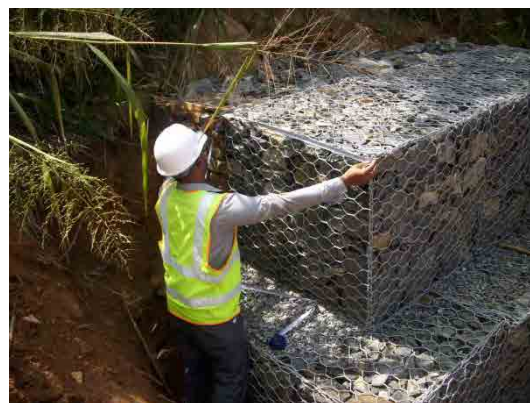
Point3 出来形確認

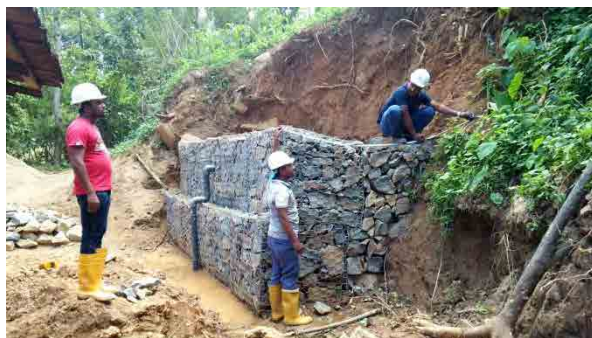
削孔およびパイプ挿入は 11 月までに完了しており、孔口部のガビオン工が施工され出来高計上 (10 m³) がなされた。水平ボーリングからは継続して良好な地下水排水状況を示しており、10 孔を合計した排水量は 90/分であった。12 月下旬には連続した降雨日があったことから、前月の約 50/分から大きく増加したとみられる。

ガビオン工形状確認

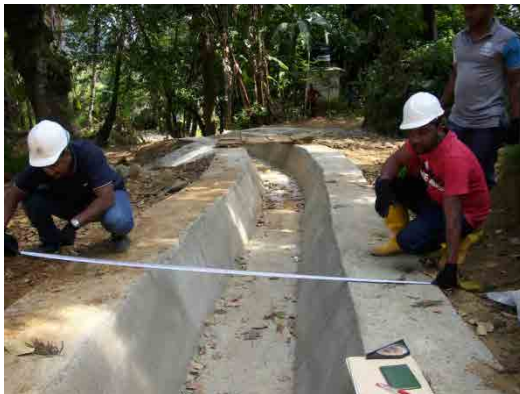
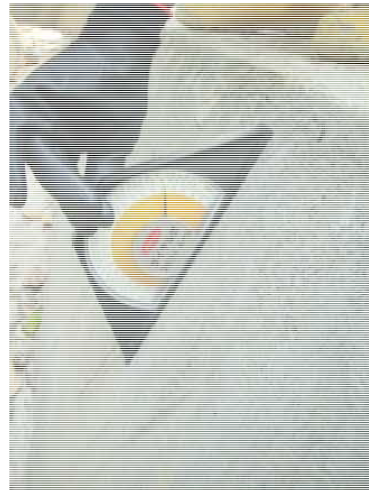
以前に課題が指摘された施工不良に関わる課題は、補修工事により対応がなされている。この課題については、NBRO ジオテク部門のマドラング氏が、定期的の確認・指導を行っており、12月19日に現地確認・指導がなされている。現地の修復対応はほぼ終了しており修復完了・確認区間より、順次、出来高として計上がなされており、12月分も水路工掘削、コンクリート打設について、施工完了区間の数量計上がおこなわれた。

水路工施工状況

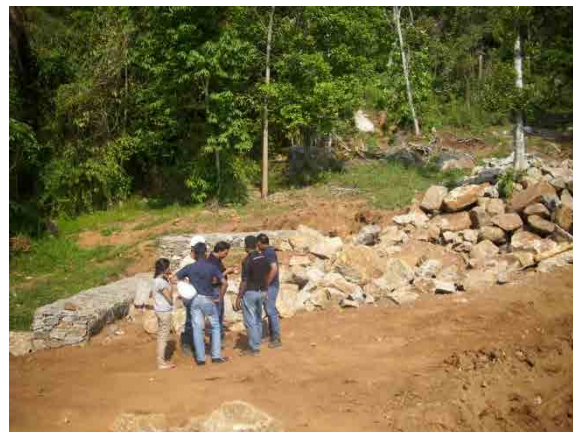
開水路予定箇所の確認立会

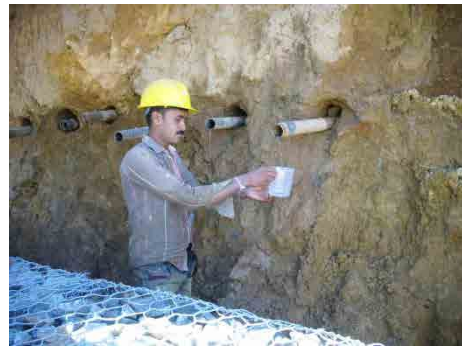
Point 5(BH-5)の削孔深度確認を2月13日に行なった。全9孔ともに計画延長の60mを超過しており、累計掘削延長540mを1月出来形数量として承認した。排水量は9孔計で2ℓ/minであった。

排水量確認

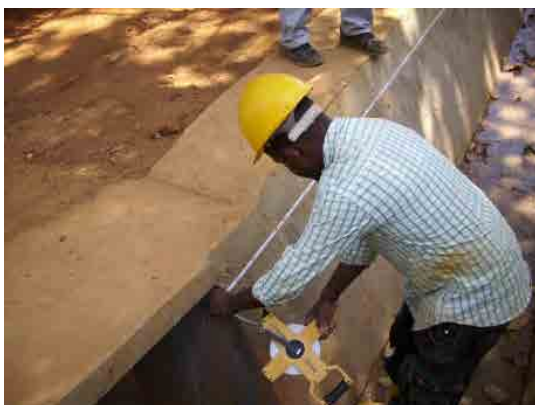
水路工延長確認

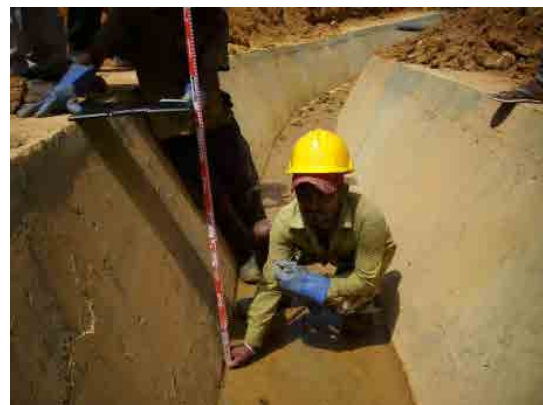
水路工 (TypeA) 形状確認

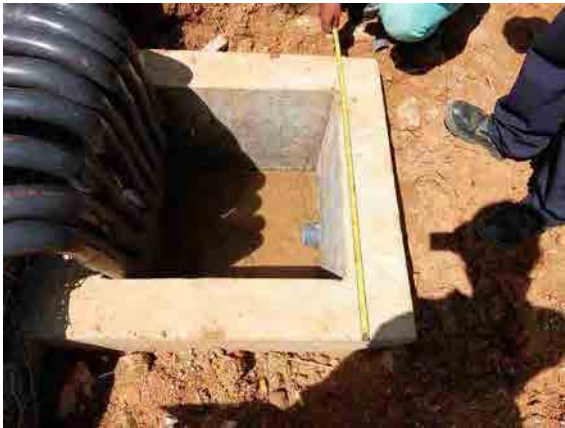
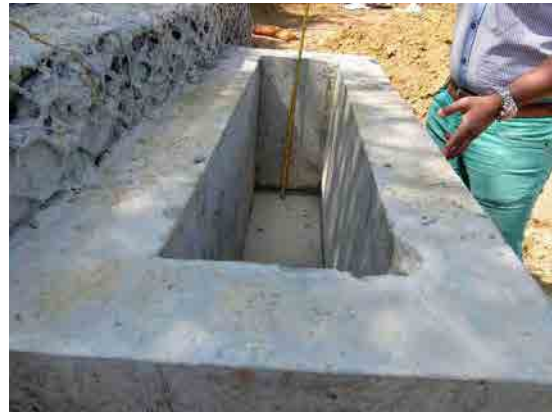
（左：Point 3、右：Point 2）

コンクリート打設が完了した水路区間は各水路タイプ別に完成数量が計上・報告された。また、水路工の急勾配区間を挟んで計画されていた集水柵については承認レターが発出されており出来形数量として承認された。ガビオン工の前面に設置する集水柵工についても追加施工対象として承認されたので、Loc1～3 の3箇所については出来形数量として確認した。ただし、集水パイプの配置により集水柵の形状が異なっている。形状に合わせた構造図を添付したレターを最終的には提出するようにコントラクターに依頼済みである。

布団カゴ前面の集水柵の設置状況（集水パイプの配置にあわせて形状が異なっている）

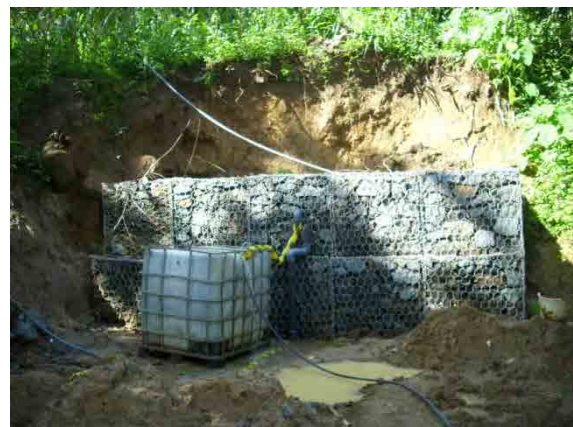
ガビオン工全景

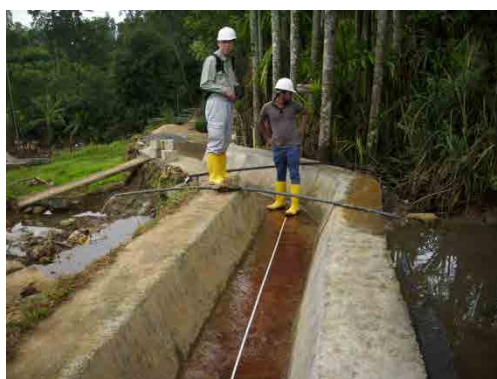
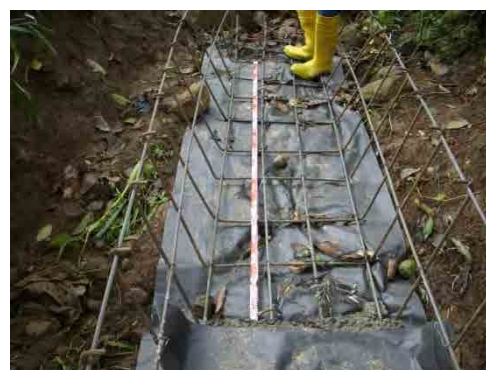
施工不良に関わる課題は継続して補修工事により対応がなされている。この課題を含めて、NBRO ジオテク部門のマドランガ氏が、定期的に現地視察を行っており、2月9日に同氏の現地確認・指導がなされている。よって、NBROの指導にしたがって品質基準を保った水路工の施工がなされており、1月分の出来形としてTypeAおよびTypeBの施工数量が計上されている。

水路工施工状況

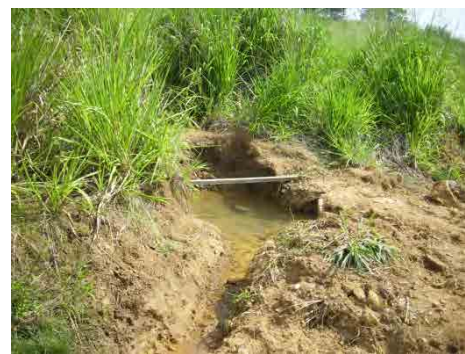
また、施工済みの水平ボーリング PointNo.1 の背後斜面も幅 15m、長さ 20m 程度の地すべり現象を生じており不安定な状況であり、さらに背後斜面からの湧水の浸出が恒常的に認められた。この現象を放置すると PointNo.1 周辺の不安定化が進行することが懸念されたため水路工の施工によって湧水を既設の水路工に導くことが NBRO の指導により計画された。現時点では地表面を仮掘削して水路工のラインを設定し、ある程度の湧水を既設水路工に導いている。なお、PointNo.1 の向かって左側端部は前述の湧水の流下影響により不安定化が進行している。この部分についてはガビオン擁壁を延長することで対応が計画されている。

PointNo.1 背後斜面の湧水

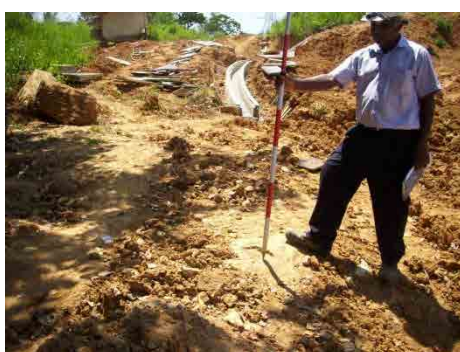
Type E 水路工の流末付近、TypeB 水路工との接続箇所(集水桝設置)に至る予定ルート内には大きな岩塊があることがコントラクターによって確認された。したがって、この岩塊を避け最短区間での接続を行うことが工法、施工日数、コスト的に妥当であることをコントラクター、NBRO, TCLMP で現地確認をおこなった。本件については水路延長の変更であるため BoQ の変更で対応可能と考えられる。

TypeE 水路予定区間の岩塊

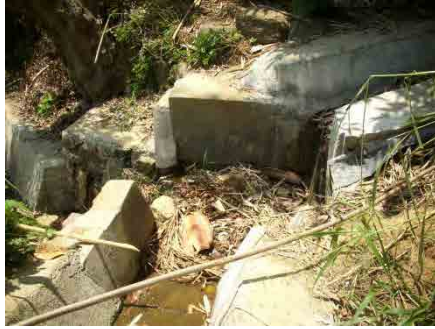
③については土砂や植物等の堆積が確認されたが、集水桝の機能は保たれている。

以上のことから完成検査後にとくに大きな異常は生じていないと判断されるが、③の堆積物については増加が予想されることや瑕疵検査期間内においてさらに大きな降雨の影響を受けることも予想されるので定期的な水路工清掃の指導、継続的な監視、モニタリングが必要である。NBRO の地すべりモニタリングや巡回結果についても確認をおこなう必要がある。

集水枡内の堆積物

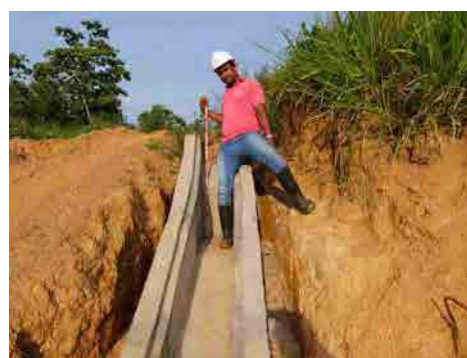
TypeE 水路急勾配部

また、本 Type E 水路の上流部の急勾配箇所、50cm 程度の落差が水路に設けられていた。施工上止むを得ずこの形状にした、とのことである。流水の減勢の役割も果たすため、施工自体に問題は無い。断面形状が異なるものの、Type E とみなし変更扱いとはしないこととした。

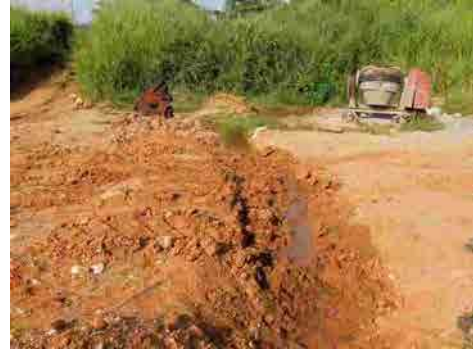
Type E 最上流部において、特に湧水や湿地等も認められないことから、施工の必要性が特に認められないことが確認された。一方で、ボーリングポイント No.4 上方斜面に湧水が認められ、湿地化していることが確認されたため、この部分に水路工を設置して排水を行うことを提案し、Progress Meeting で合意された。これらの変更は BoQ の変更は伴わないものの、当初設計の変更となる。同様にコントラクターにレターの提出を依頼した。

Type E 水路周辺 湧水と湿地

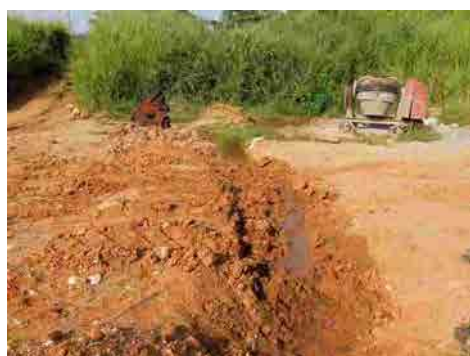
なお、上述のように雨量が少ないことに加えボーリング Point No.4 の効果もあり、先月に比べて今月は湧水量が大幅に減少した。先月との比較写真を示す。

Type E 水路周辺 湧水と湿地（5月）

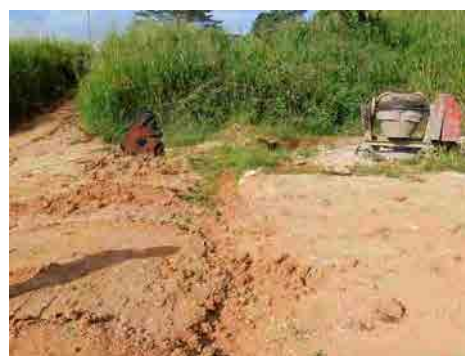
Type E 水路周辺 湧水と湿地（6月）

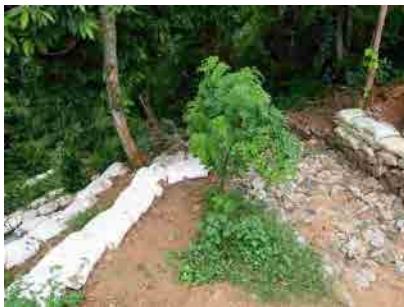
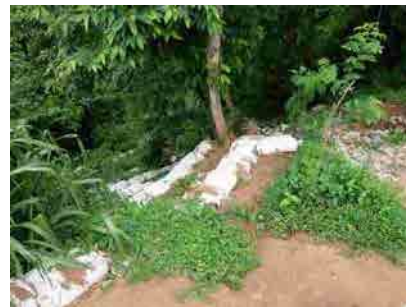
水路工側部に設置された土のう (左:5月、右:6月)

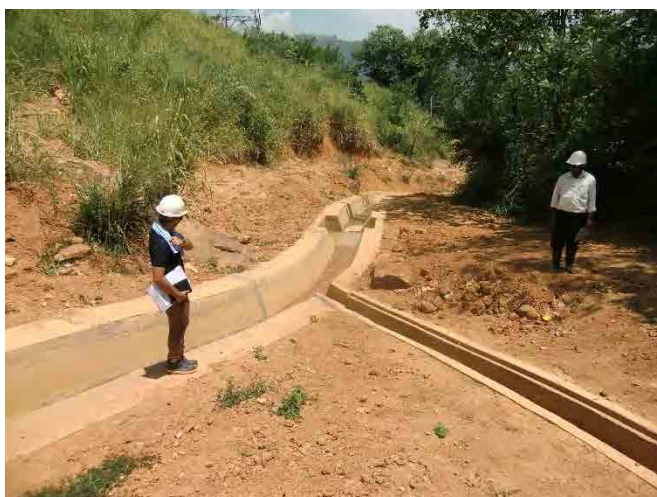
(注)Type3は移設工事の実施を前提に、条件付き検査合格とした

Type3 集水柵 (水路合流点への移設工事を実施予定)

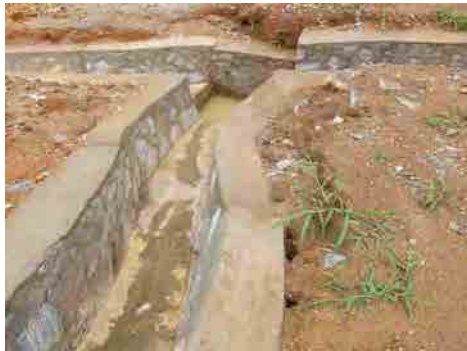
概して上方斜面で水路脇の侵食等が確認され、斜面中部～下部では、水路や集水柵への土砂の流入が認められる。

上部斜面における水路側部の侵食状況

今後もモニタリングを継続し、侵食の拡大や土砂による水路の閉塞が確認された場合は、対策を行う必要がある。

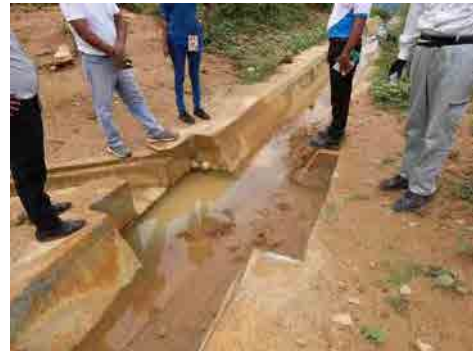
最下部の柵への土砂の流入状況

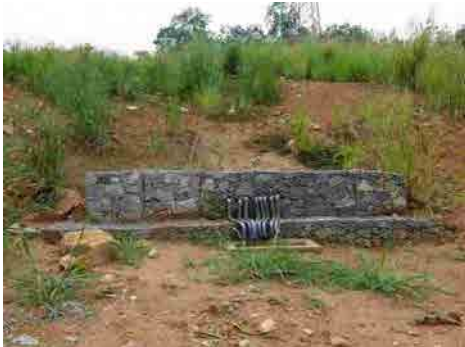
Point No.1 の状況

Point No.1 で、背後斜面から土砂が侵食されて流出している状況にある。前回、亀裂が確認された箇所が小規模なすべりを発生していることが確認された。また、Point No.6では、集水柵に土砂が流入し、ほぼ閉塞状態にある。土砂の撤去等に関する計画をコントラクターが提出する予定となっている。

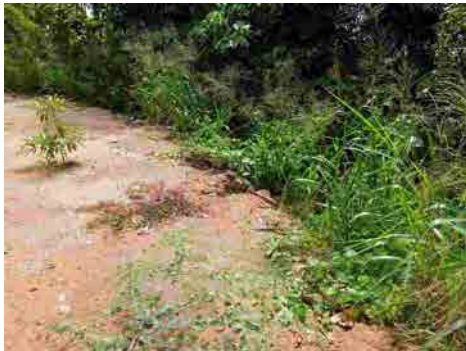
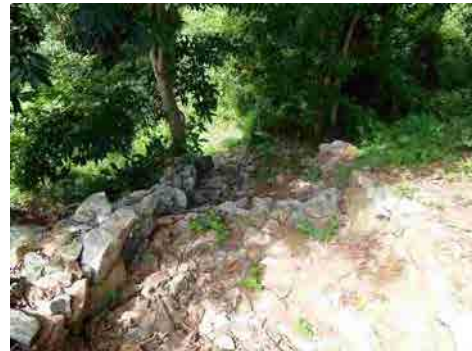
布団カゴ工前面の盛土部分の法肩に、小規模な亀裂や侵食が確認された。また、カスケード水路工が流水により、一部石が移動している状況が確認された。

盛土部法肩の侵食状況（左）と水路工の状況

以上のことから完成検査後に特に大きな異常は生じていないと判断されるが、これらの亀裂等の状況は引き続き観察を行い、必要に応じて対策を講じる必要がある。

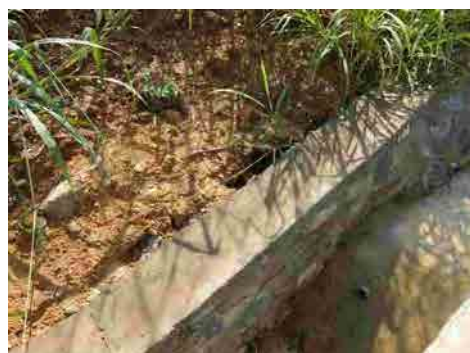
前回に引き続き、概して上方斜面で水路脇の侵食等が確認され、斜面中部～下部では、水路や集水柵への土砂の流入が認められる。特に今回はボーリング Point No.6 に多量の土砂が流入し、ほぼ閉塞状態となっていた。NBRO、コントラクターと協議の結果、コントラクターが土砂撤去や切土法面への植生を行う予定となった。

上部斜面における水路側部の侵食状況

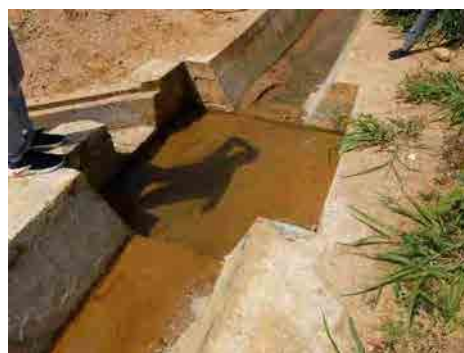
最下部の柵への土砂の流入状況

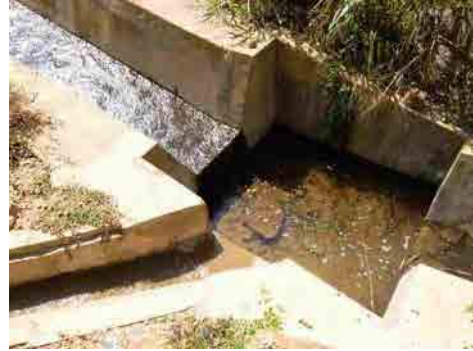
最下部の柵への土砂の流入状況

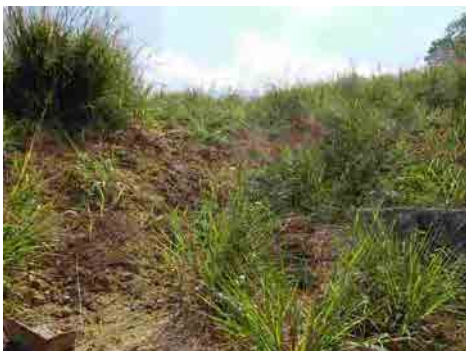
Point No.1 背後斜面の状況

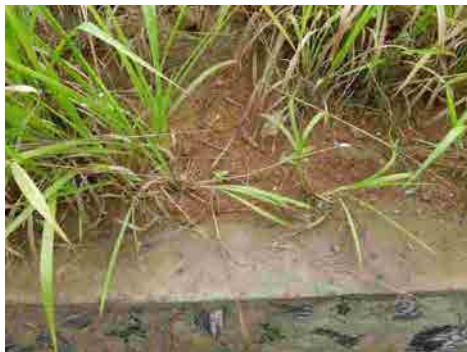
コントラクターが、前回までのモニタリング結果に基づき亀裂等の補修や土砂の撤去を行った。現時点では特に大きな問題は無くなっている。今後もモニタリングを継続し、同様に侵食の拡大や土砂による水路の閉塞等が確認された場合は、対策を行う必要がある。

侵食の補修

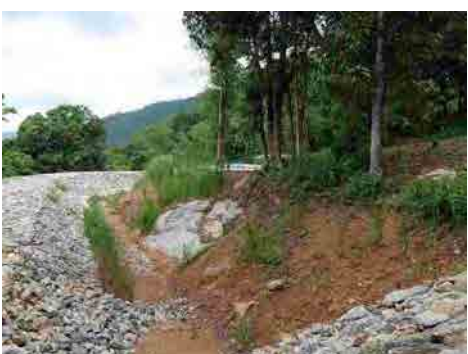
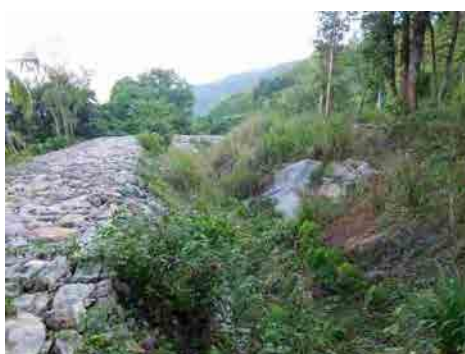
植栽工の状況 (左：2017年5月、右：2018年3月)

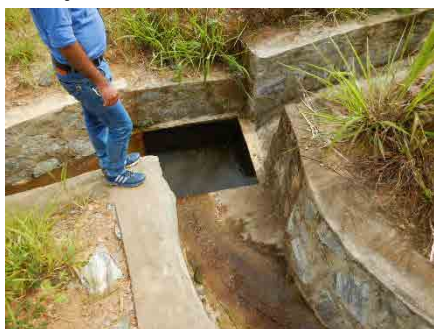
2017年7月26日に完成検査が実施された。現在は瑕疵担保期間中であるが、NBROにより定期的に集水柵に溜まった土砂の取り除き等が実施されており、水路の効果は適切に維持されている。

最上部の集水柵に堆砂は生じていない

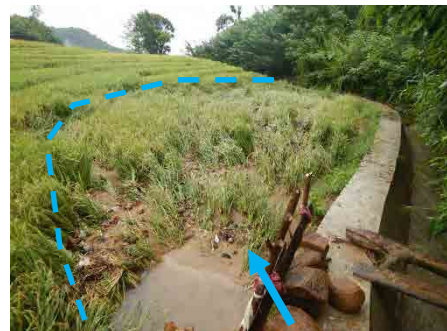
水路が急角度で屈曲している2箇所 (Location No.14 および No.15) において、水路の流水が豪雨時にあふれる現象が確認された。Location No.14 については、コントラクターが水路工上部にコンクリート壁を建設して、対策を行っているが、降雨時にはその壁の横から流水が飛び出していることが確認された。Location No.15 では水田に被害が生じているため、今後、水路にコンクリート製か鋼製の蓋をして固定する等の対策が必要である。

水路からの越流による水田の被害 (Location No.15) 2018年5月の状況

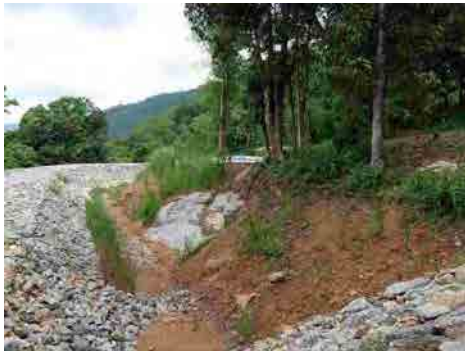
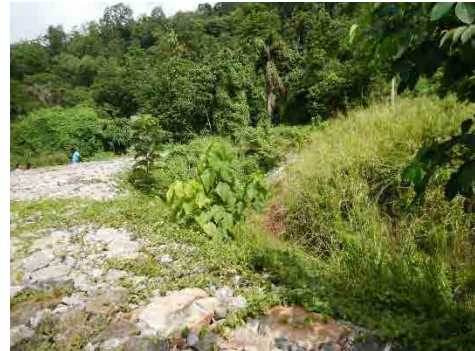
水路工の状況（変化なし）

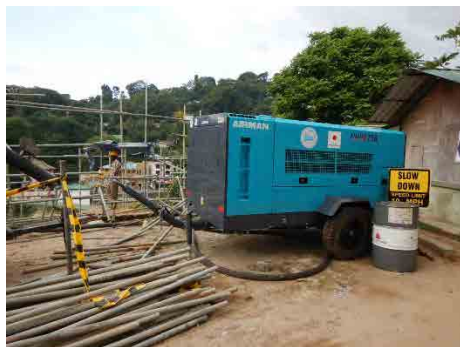
6 月の点検でもコンプレッサーも問題なく稼働していることを確認した。また、NBRO の施工監理技術者により日々のコンプレッサーの稼働記録と点検チェックシートが記入されていることを確認した。

キャンディ看護学校で稼働中のコンプレッサー
