APPENDIX-3

SITE SURVEY FOR OVER HEAD TRANSMISSION LINE

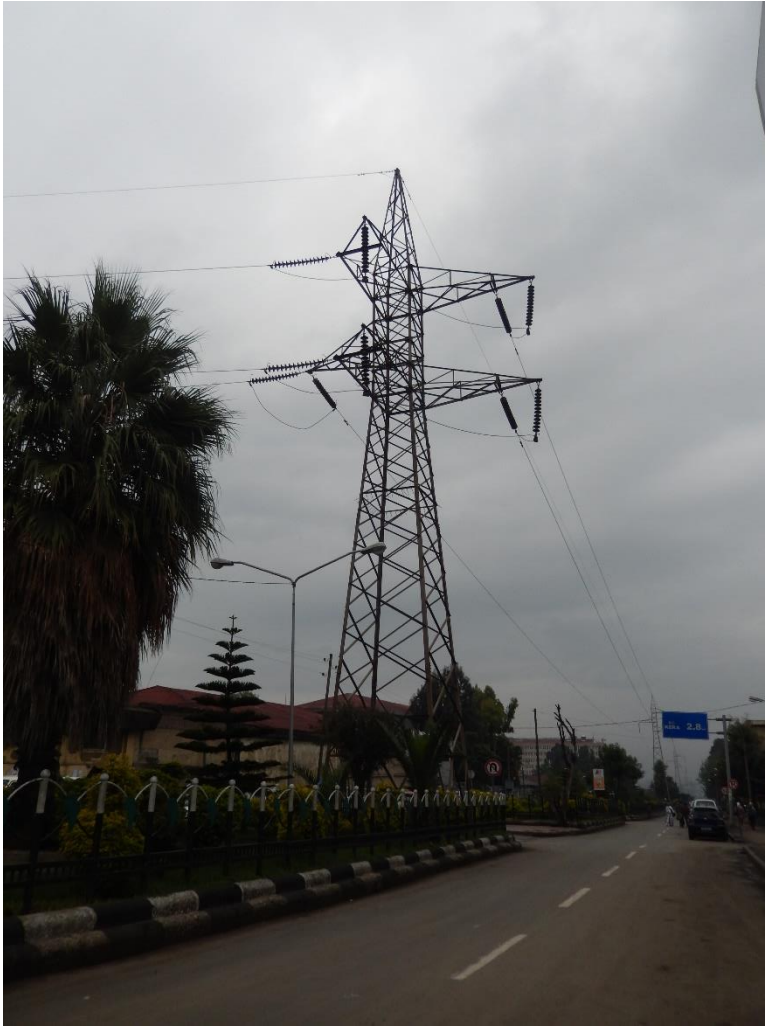
T-02 is kept in good condition.
Tower is located in median strip of two (2) lane road.

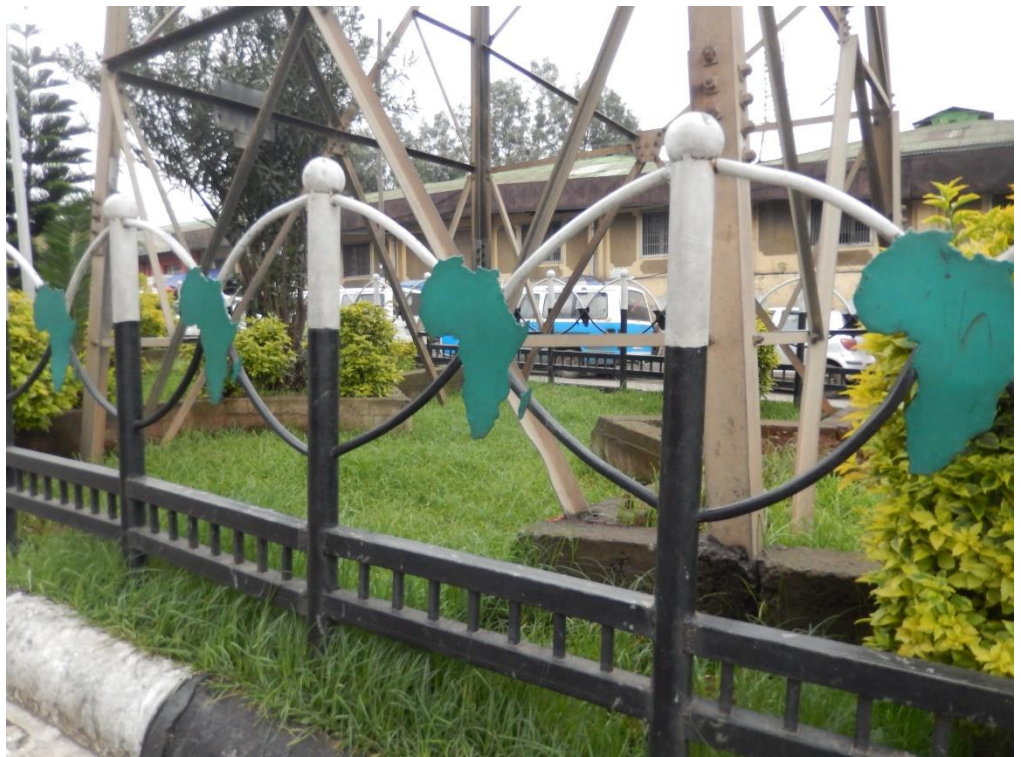
T-03 is kept in good condition.
Foundation was covered by embanked soil
due to ground level become higher
than original level.

Tower is located in median strip of
two (2) lane road.

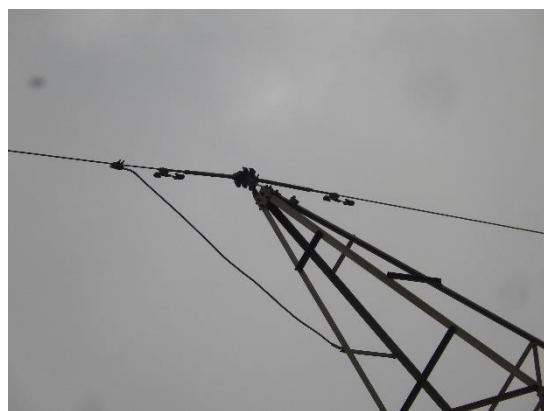
T-06 is kept in good condition.
Tower is located in median strip of two (2) lane road.

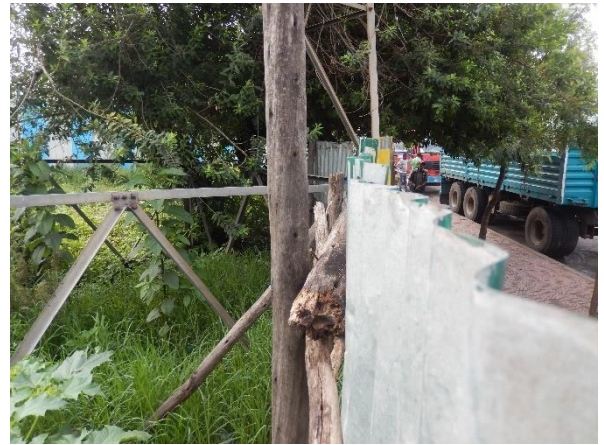
T-09 is kept in good condition.
Tower is located in main road.
One leg is located on walkway a little bit.

Tower location is fenced by party
other than EEP, access to tower is blocked.

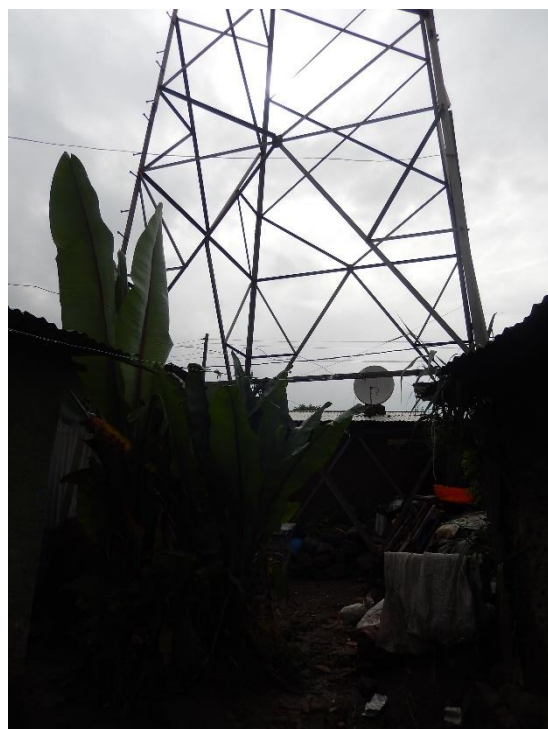
T-10 is kept in good condition.
Tower is located inside the residential area,
surrounded by houses.
No vehicle access, only foot pass access.

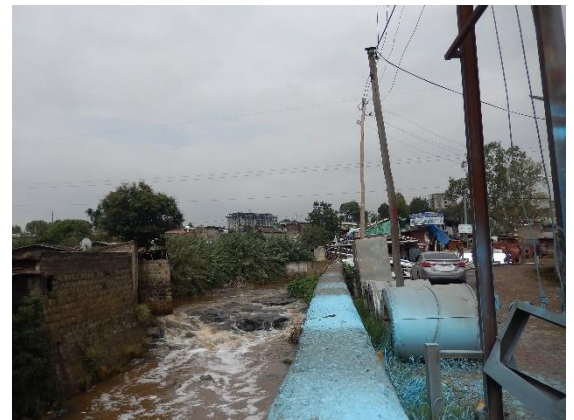
T-11 is kept in good condition.
Tower is located inside the residential area,
surrounded by houses.
No vehicle access, only foot pass access.

River crossing between T10 and T11.

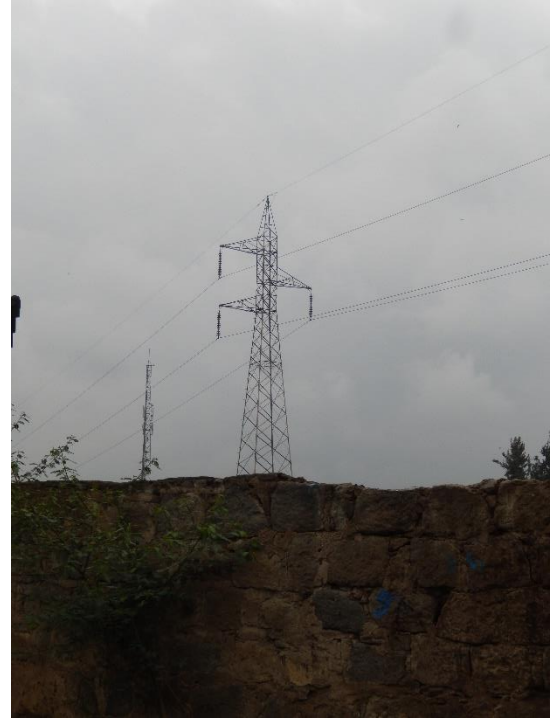
T-13 is located inside the land other than EPP.
Goat breeding area?

Access shall be made from main road through
Land user's access.

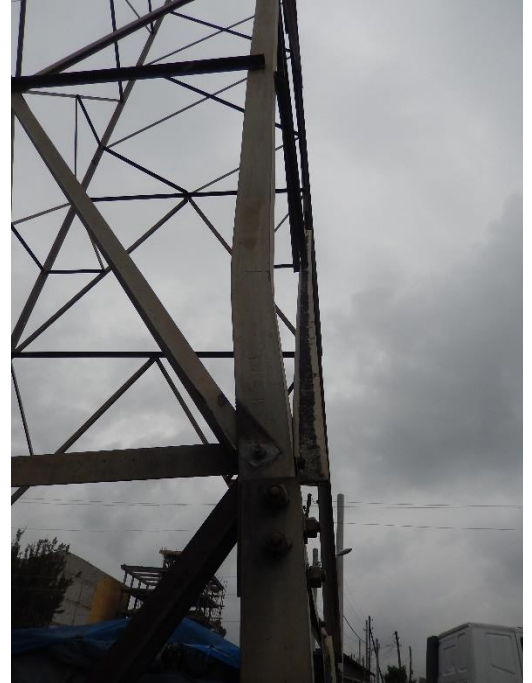
T-15 has been damaged heavy.
Damages are in critical condition,
as main legs have been twisted completely and
Secondary members of legs were out of function
due to deformation .

Damages seems to be occurred in long time ago.

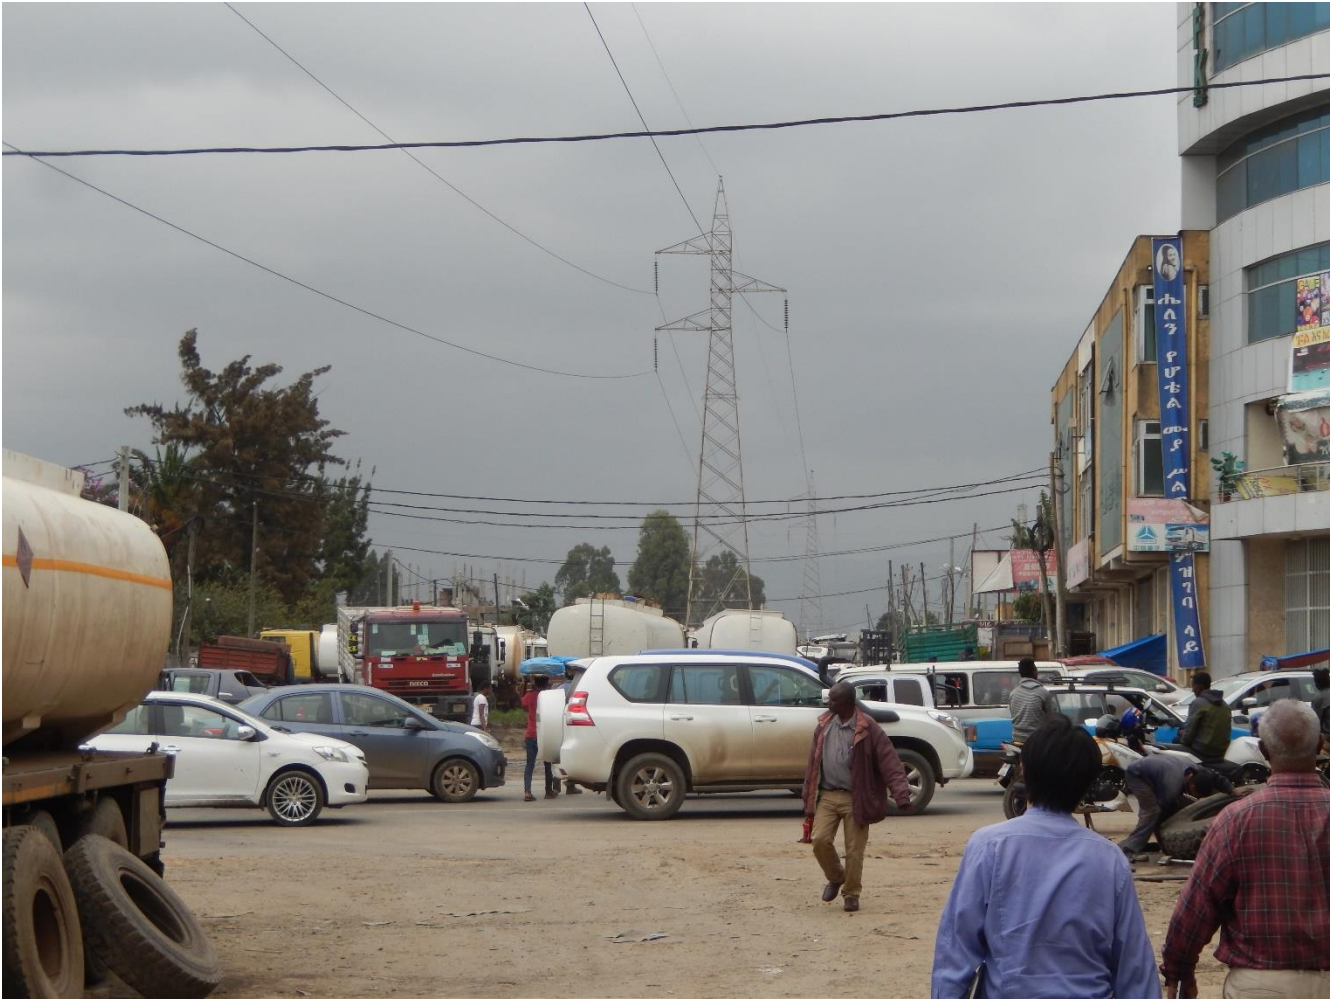
Tower 16 views from T17 side.
Road Construction is under progress on T17-T20.
T16 side is not started yet

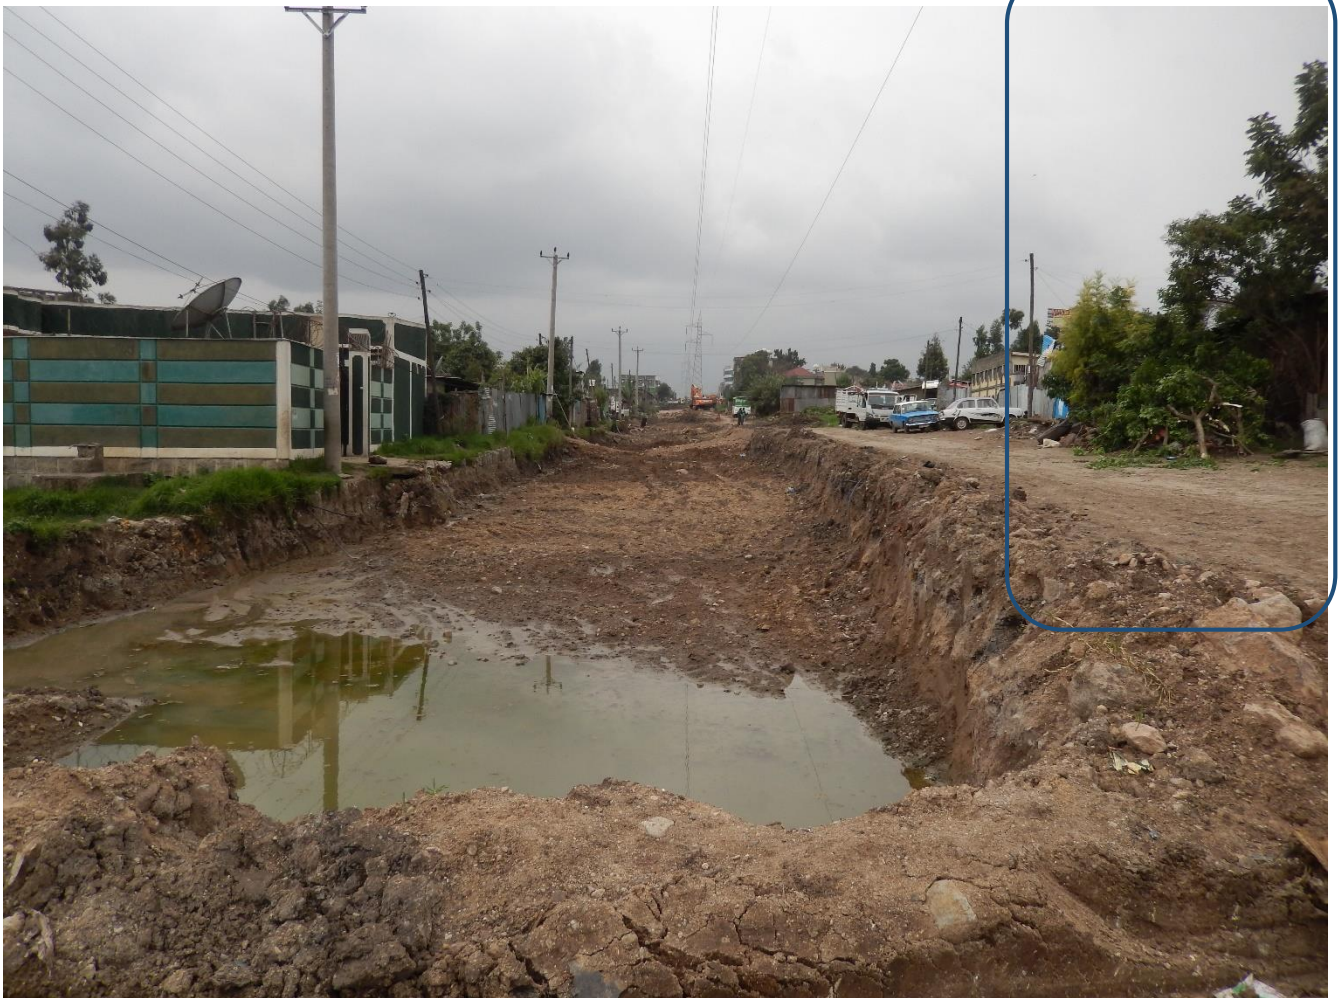
Construction of road starts on the half side of Corridor.
15kV Distribution Line will be demolished to shift it to new location outside corridor.

Parking vehicle has been removed already.
Tower foundation will be kept as original position

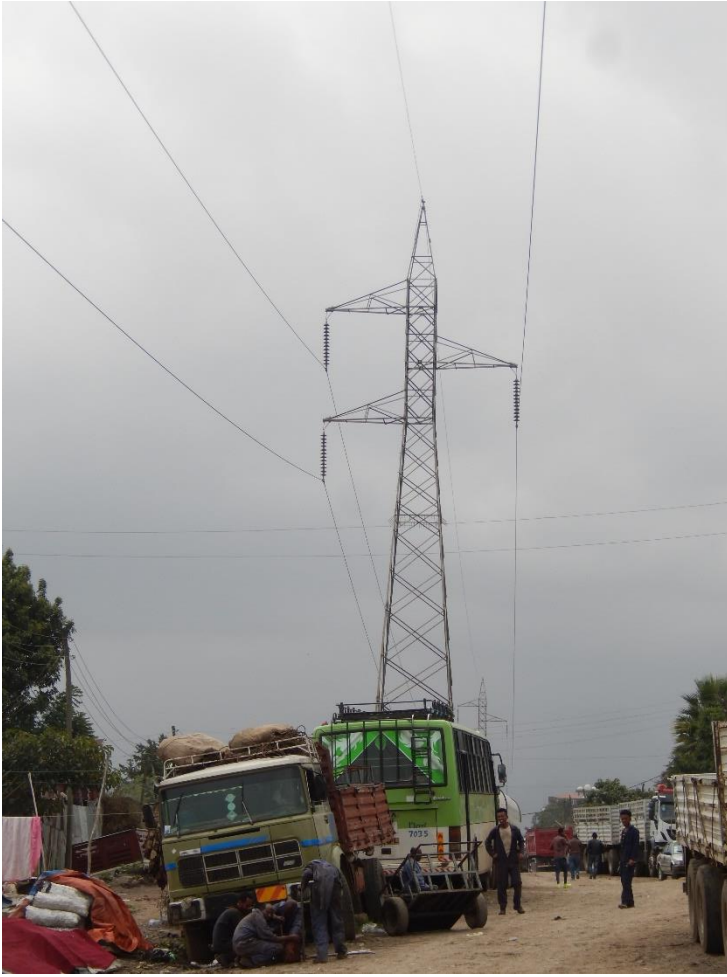
T18 Damaged Leg steels

Tower legs had been damaged heavily.
Tower inclined slightly.

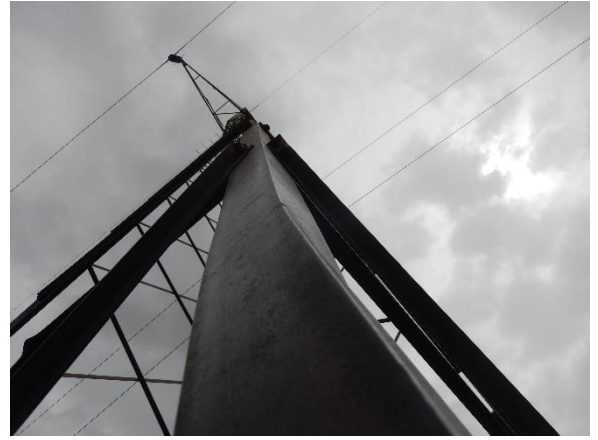
Tower T-21 from T20 side Existing road between T20 and T21.

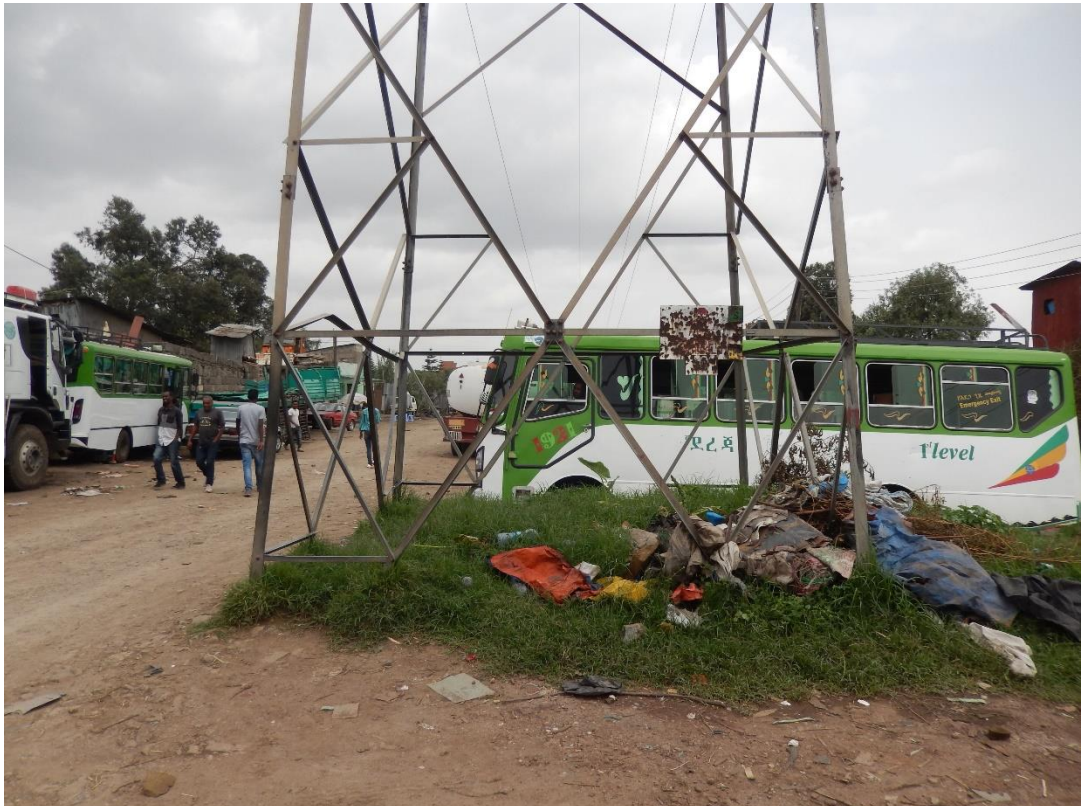
T19 Damaged Steels

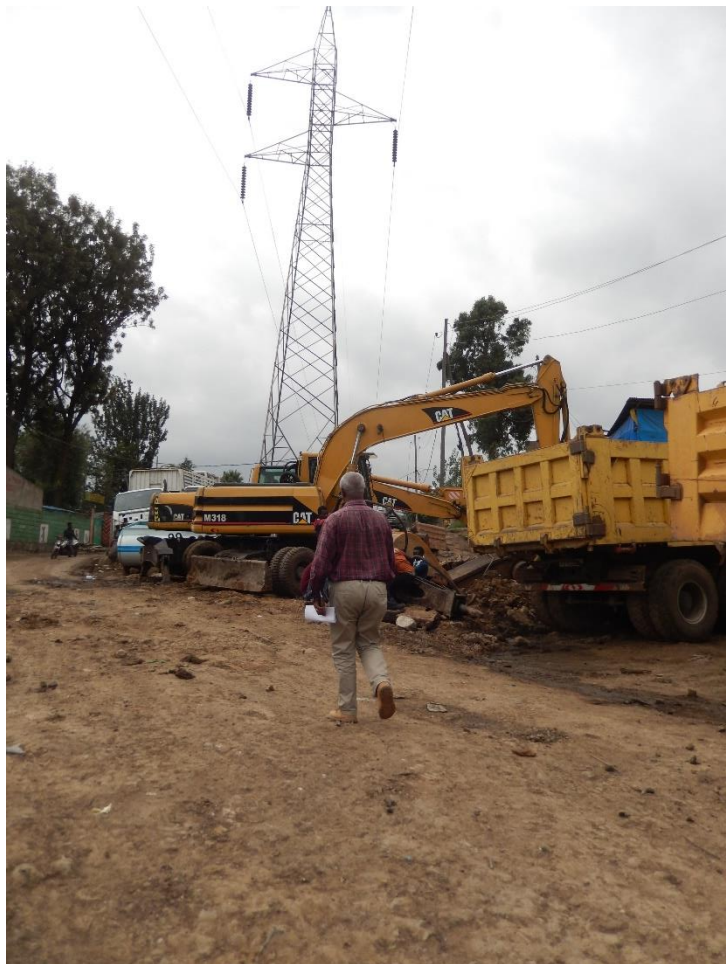
Tower T-20 from T21 side Existing road between T20 and T21.

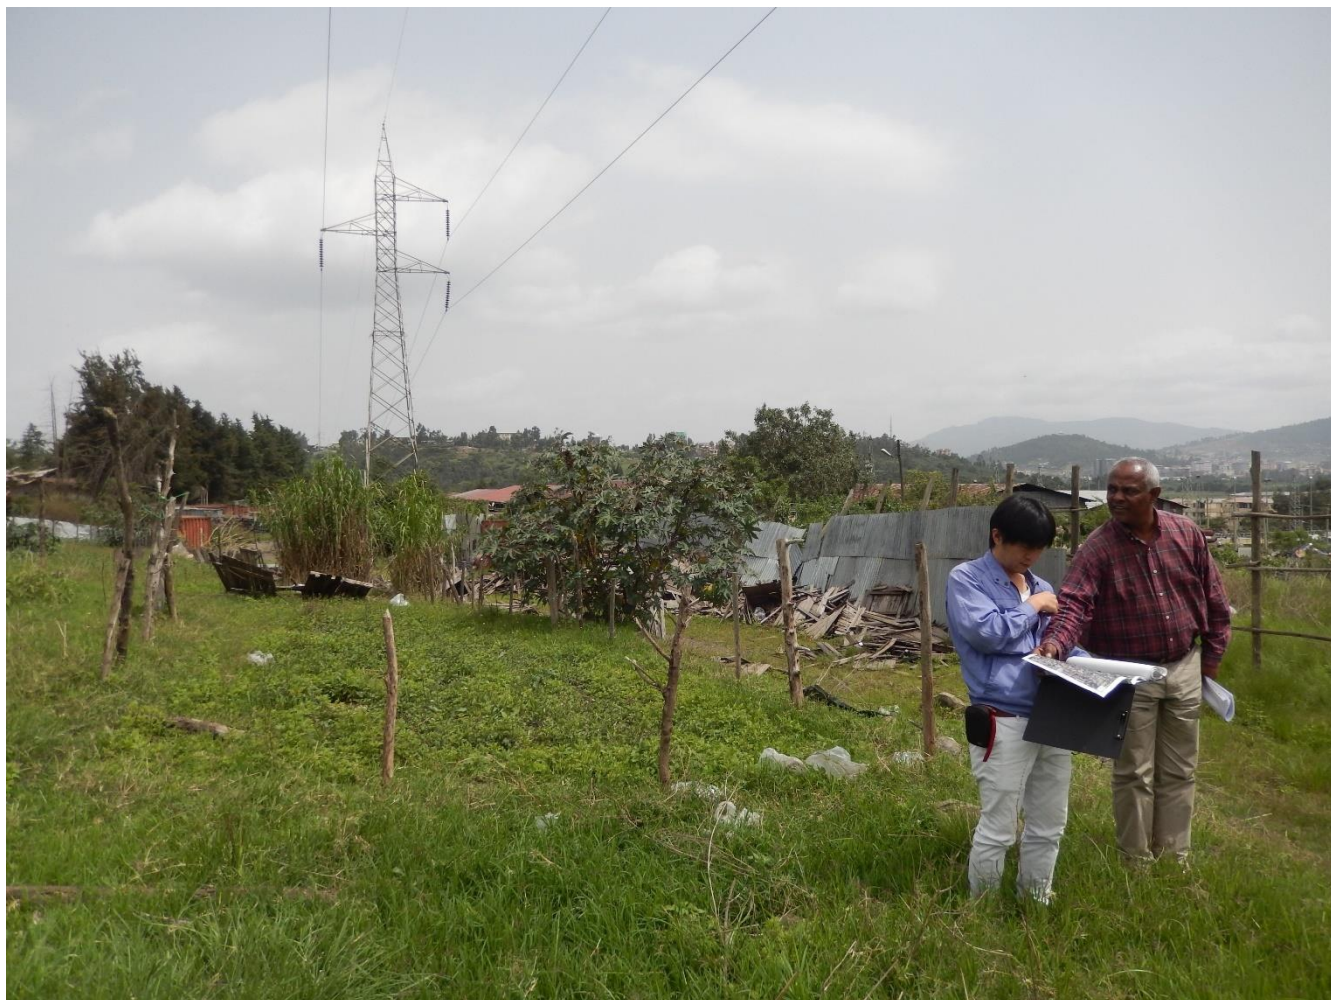
Candidate site for Cable Termination Tower (70 – 80 m from T21
Near boundary fence of EEP store.

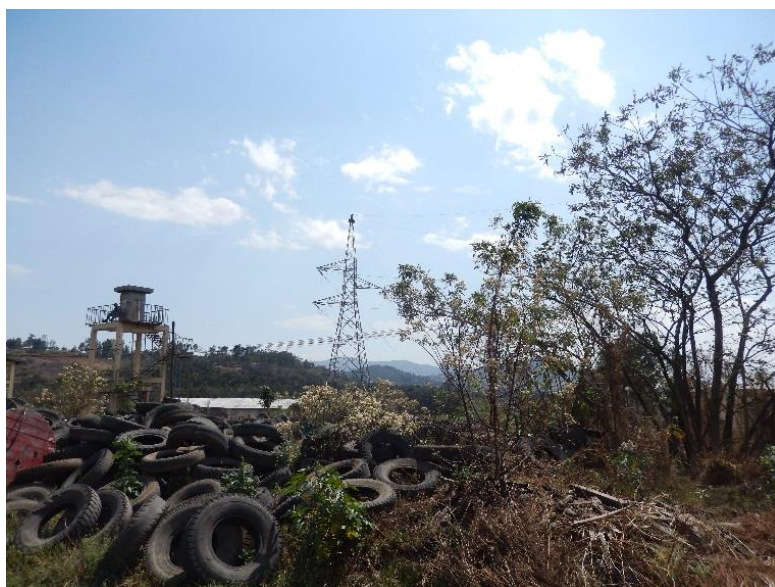
Dead-end Tower toward Mekanissa substation
DSCN0273 DE Tower

132kV Gofa Substation (Addis South II) is connected with Mekanissa Substation.

There is a plan to make T-Connection between Gofa SS at cable terminal dead-end T22. New double circuit (2cct) tower is planned to construction beside 1cct dead-end tower to Mekanissa SS.

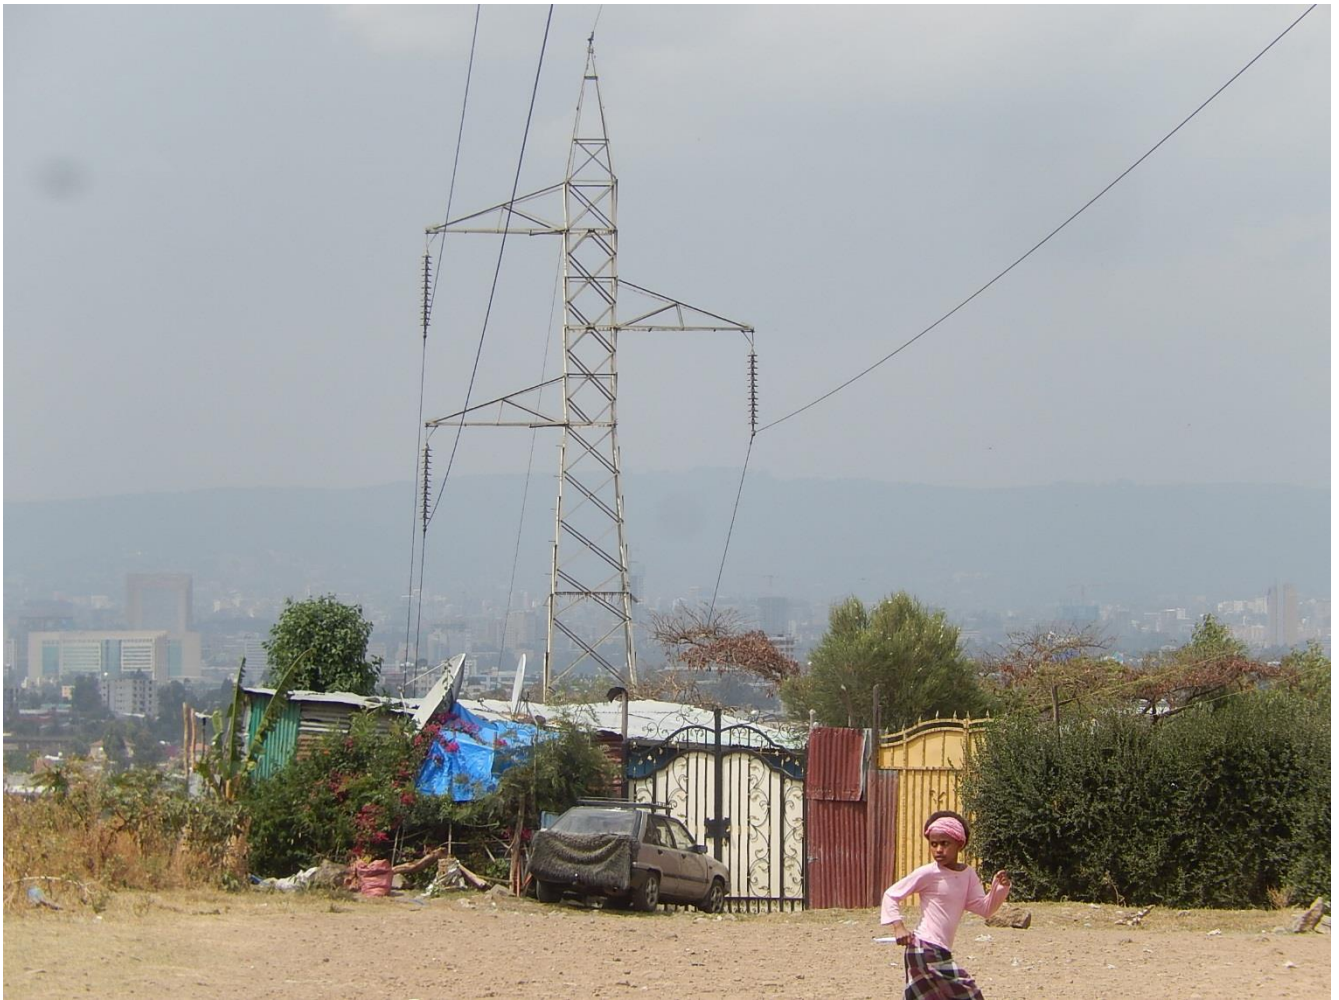
T 24
DSCN0596 T24 from T25 side 100m

Some residential houses under transmission line between T 24 and T25

T 24 is located on the top hill. Approximate 45meter elevation up from T23 toward T24.

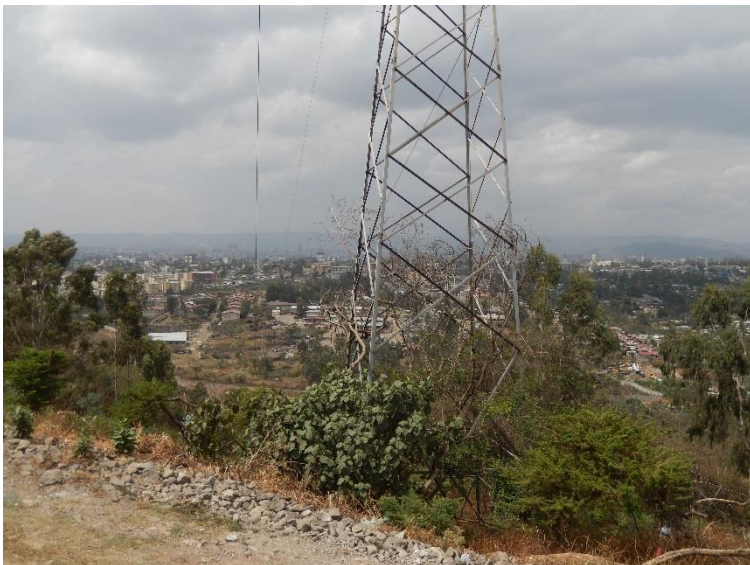
T 23
DSCN0609 T24 toward T23&T22 in store warehouse.

ROW (Corridor) is maintained between T23 and T24, however many houses were built beside the ROW.

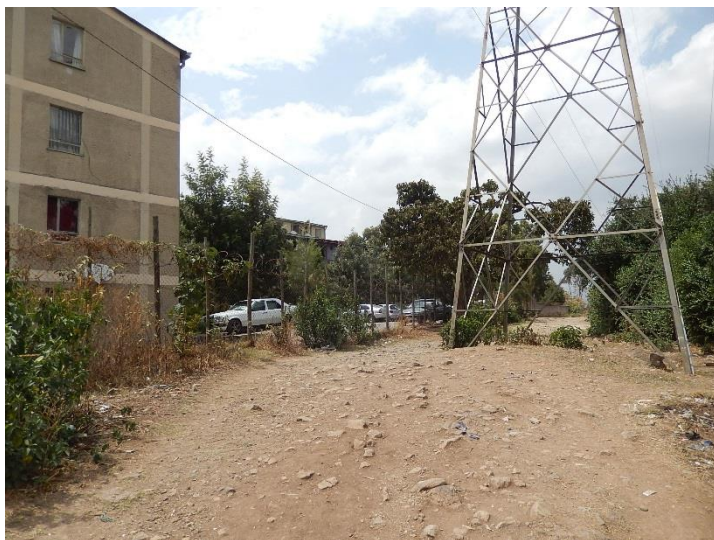
T 25
DSCN0592 T25 near existing road and fence

A road for residential peoples are passed beside the T25. A house and apartment admonitory are constructed beside tower location.

T 25 is angle deviation tower, a new lattice type tower will be constructed on the same location of existing T25.

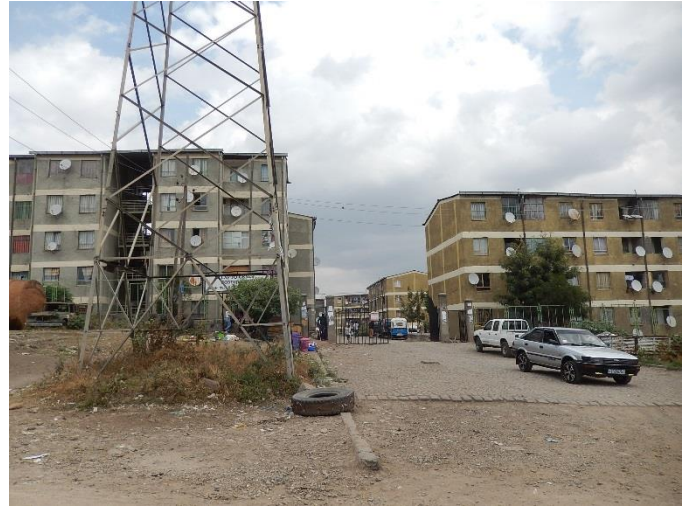
T 27
DSCN0571 T27 in front of gate to dormitory

Tower is located in front of enter gate to apartment dormitory. New tower should be shifted to avoid traffic to this dormitory.

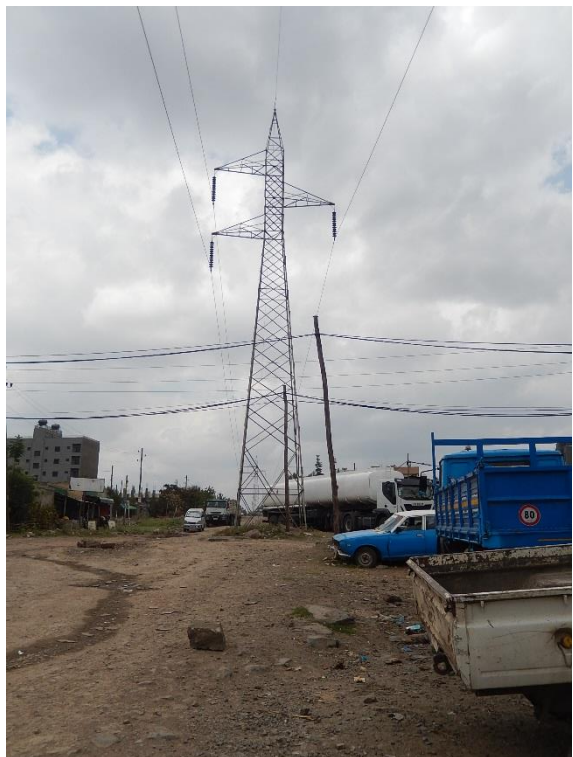
T 29
P1130589 T29 from T30 side

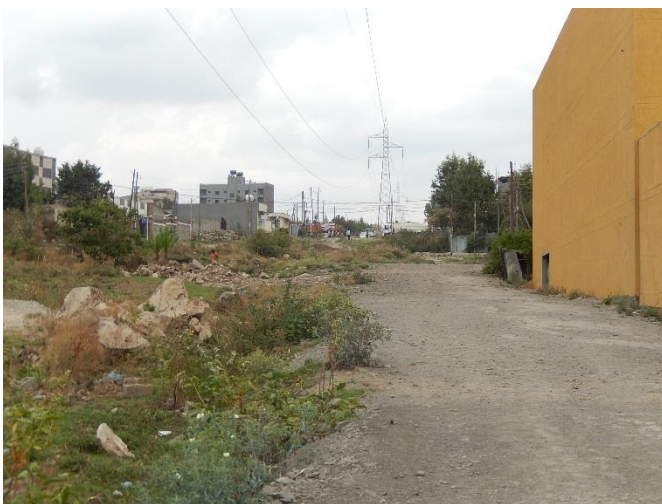
T 30
DSCN0554 ROW (Corridor) between T29 and T30

There is a plan to construct road on the ROW (Corridor) of 132kV transmission line. Between T 24/25 and T31.

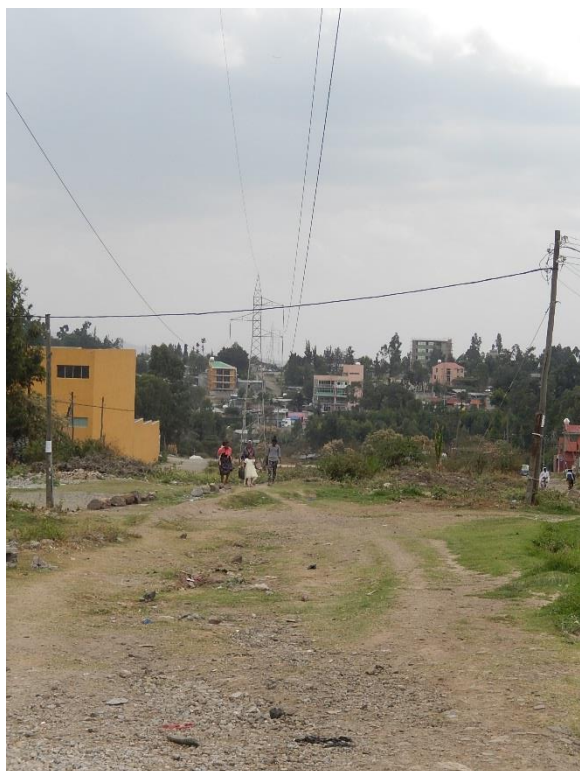
T 30
DSCN0552 T30 from T29

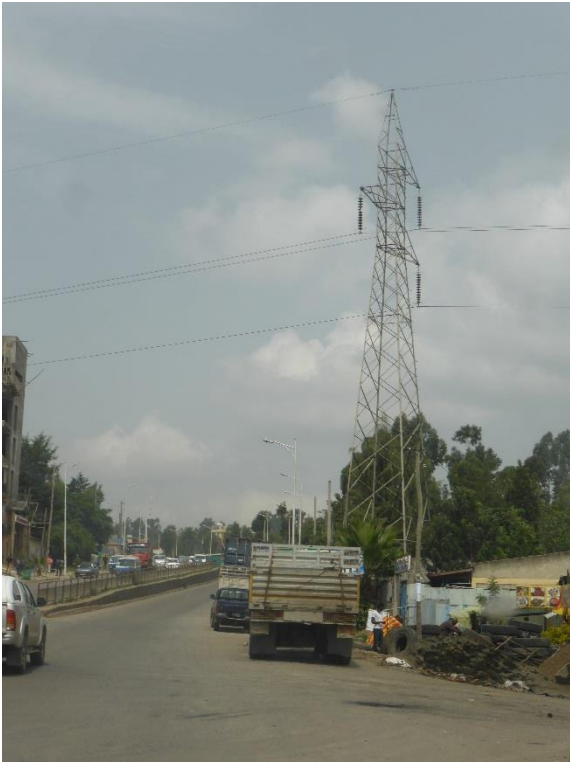
T 31
P1130595 T31 50m beside main road

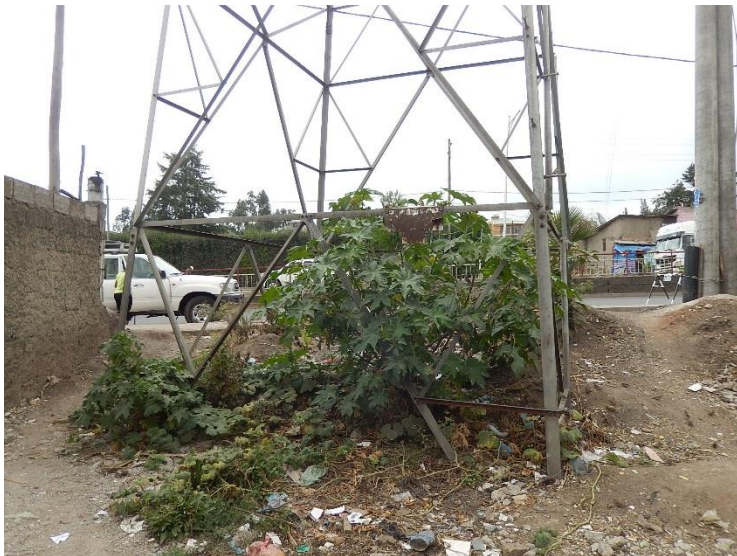
T 30
DSCN0552 T30 from T29

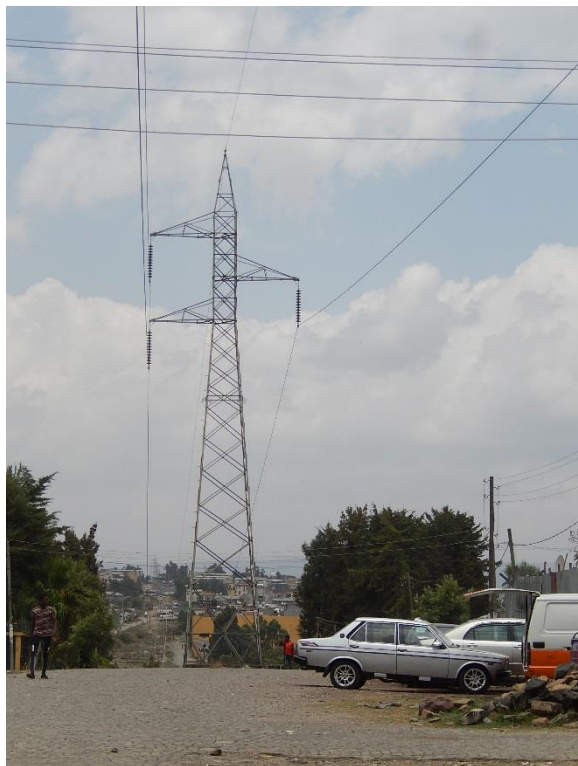
T 32
DSCN0511 T32 from T33 side

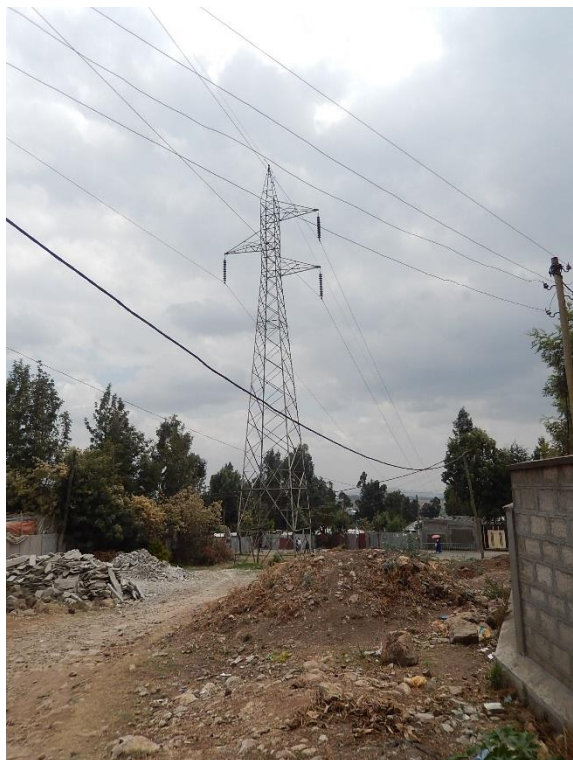
T 33
DSCN0509 T33 from T32

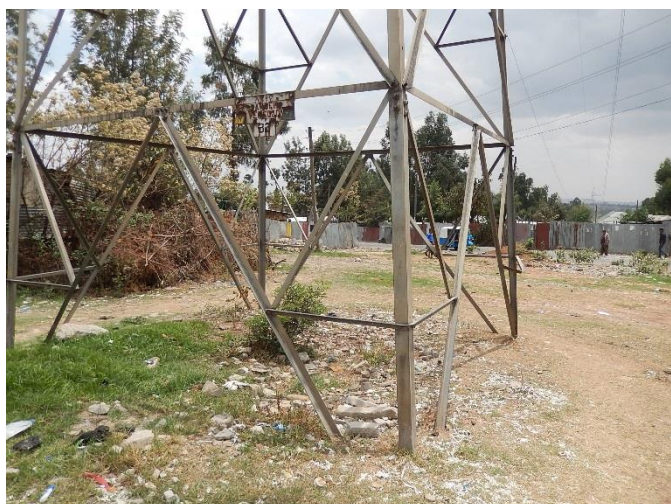
T 33
DSCN0502 T33 Bottom & to T34

This tower has been damaged by traffic vehicle on the main leg. The Tower condition is very critical .

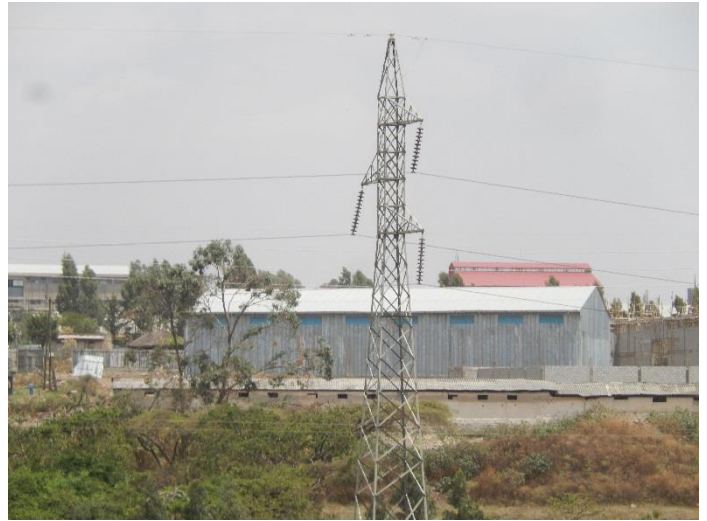
T36 is almost collapsed due to heavy damages on the leg. The suspension clamps hold conductor with unbalanced tensions. The condition of this tower is in very critical conditions.

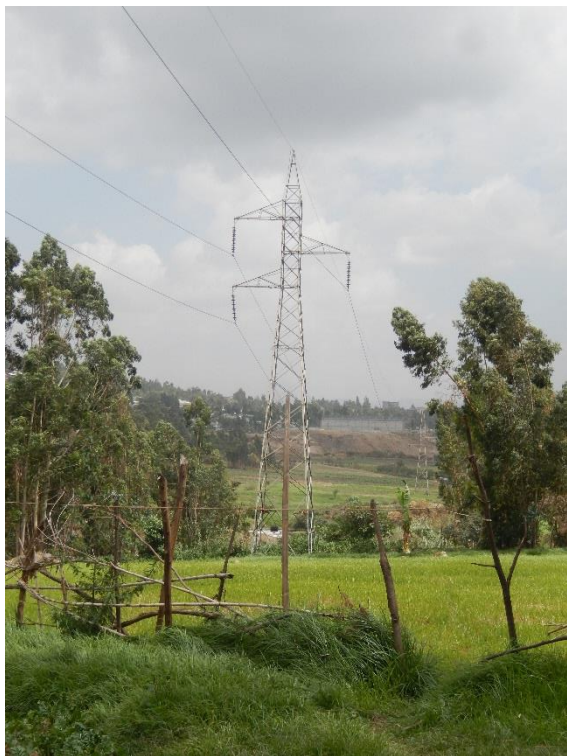
T 39
DSCN0768 T39 from T40.
T 39 – 40 -41 is transposition tower.

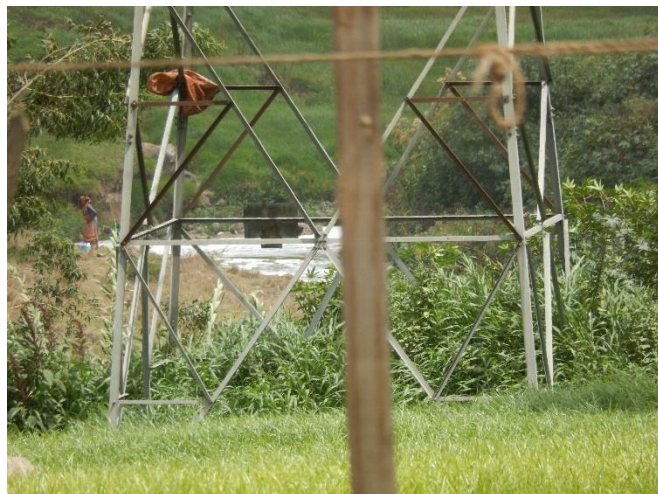
T39
DSCN0770 T39 & river.
Access bridge to cross river is for light weight only.
Vehicle is not accepted to cross.

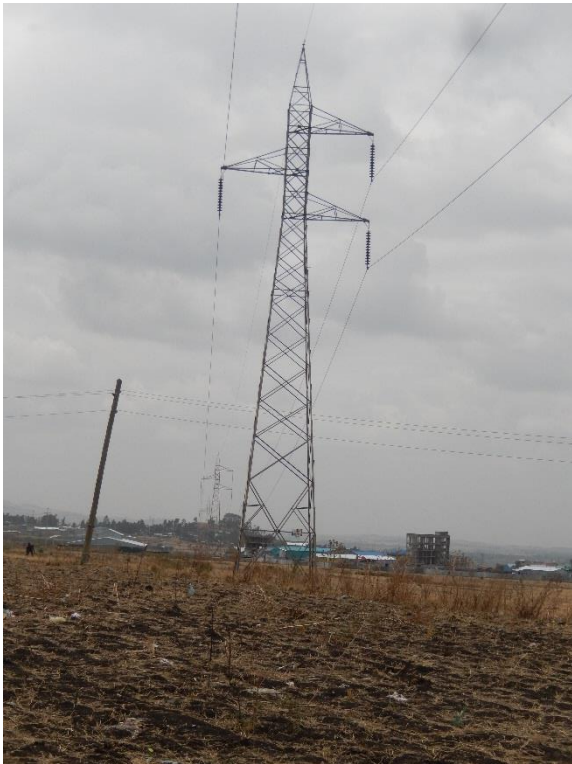
T 44
DSCN0796 T44 from T43.

Transmission line pass above the roof of
residential houses.

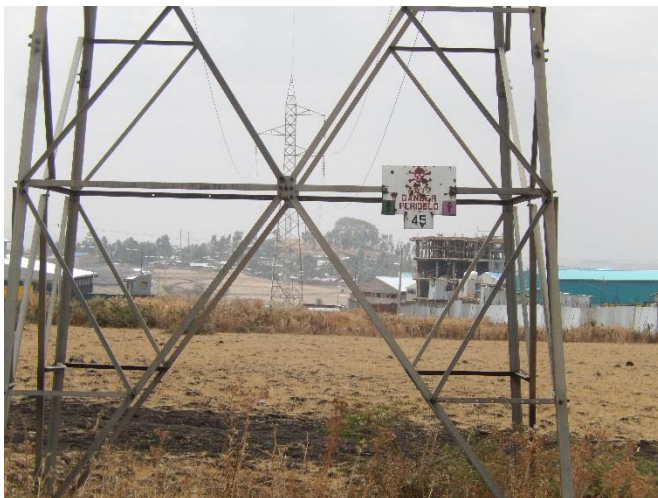
T45
DSCN0805 ROW (Corridor) is maintained.

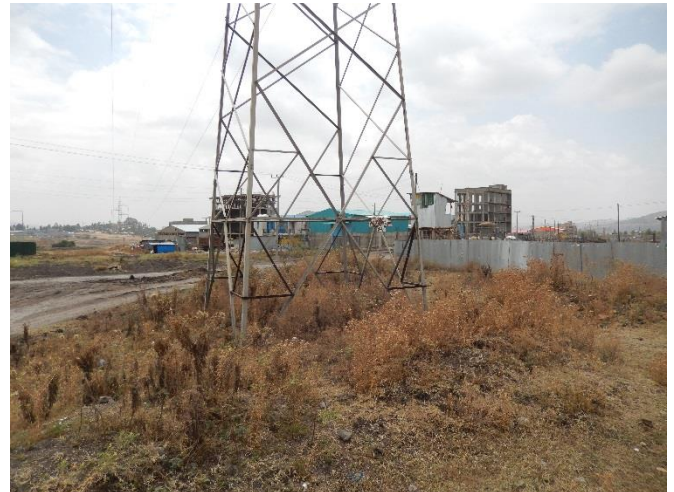
T46
DSCN0809 A view from T 46 toward T47.
ROW (Corridor) is maintained.
New factories are constructed out side the ROW.

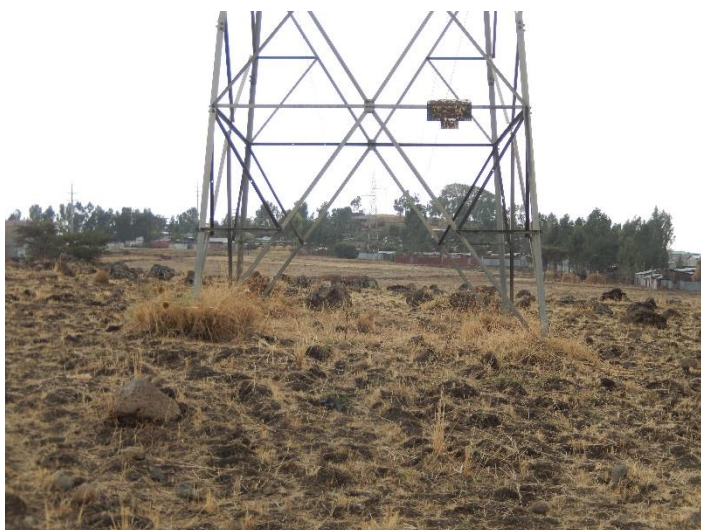
DSCN0833 T50 bottom
Residential houses are existed toward T51.

Many houses between T 50 and T51
This area is suitable for industrial area as
the short distance national road.
