APPENDIX-3

SITE SURVEY FOR OVER HEAD TRANSMISSION LINE

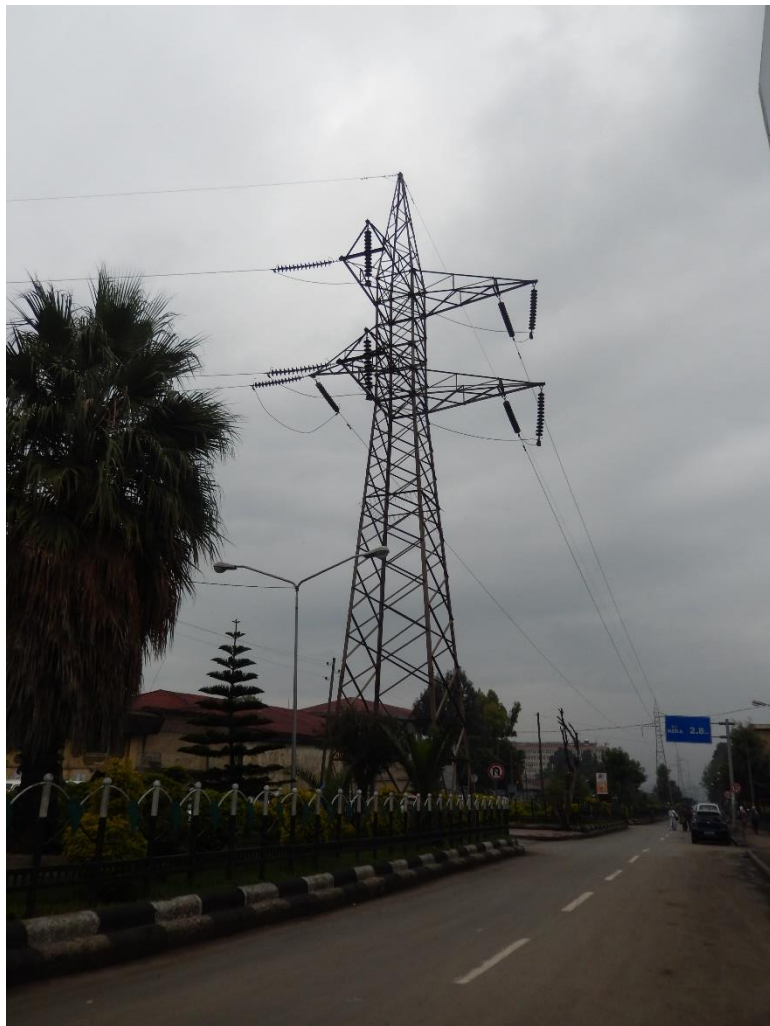
T-02 is kept in good condition.
Tower is located in median strip of two (2) lane road.

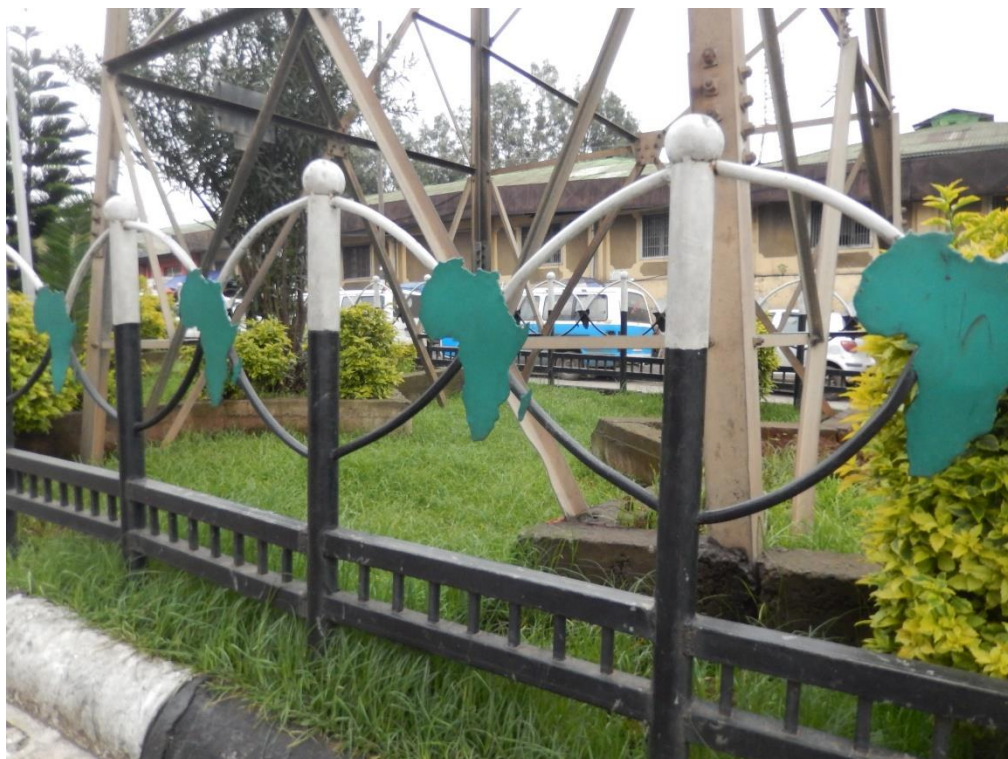
T-03 is kept in good condition.
Foundation was covered by embanked soil
due to ground level become higher
than original level.

Tower is located in median strip of
two (2) lane road.

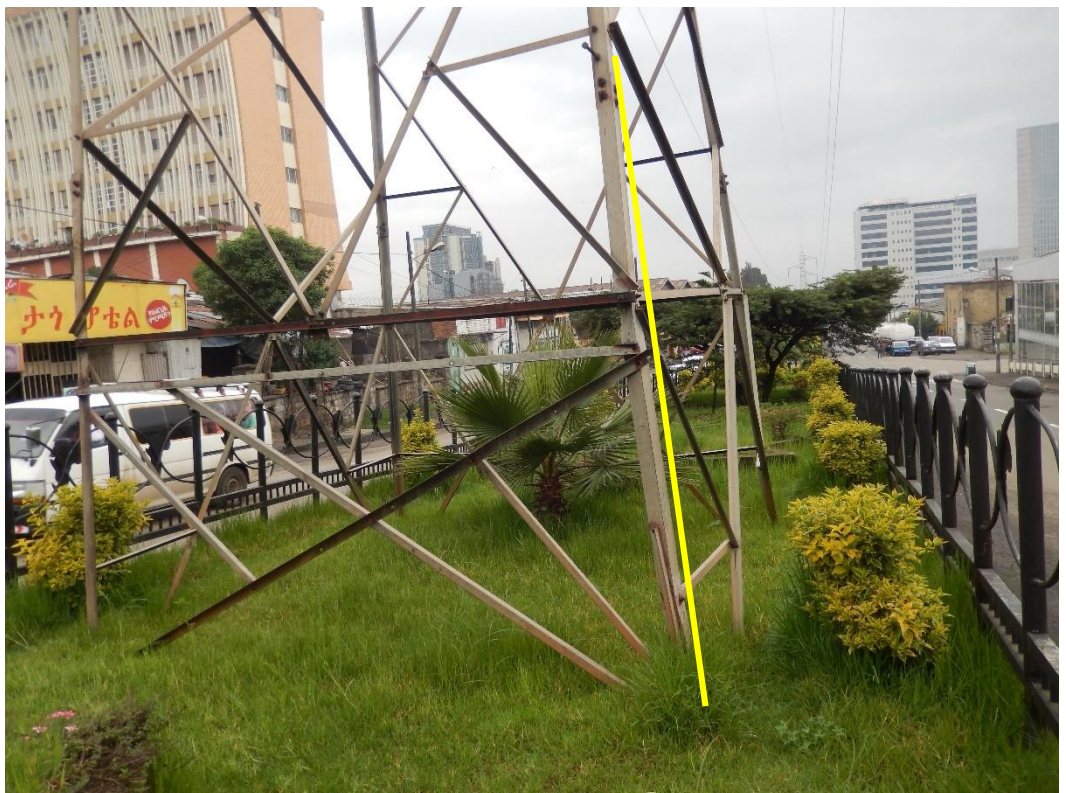
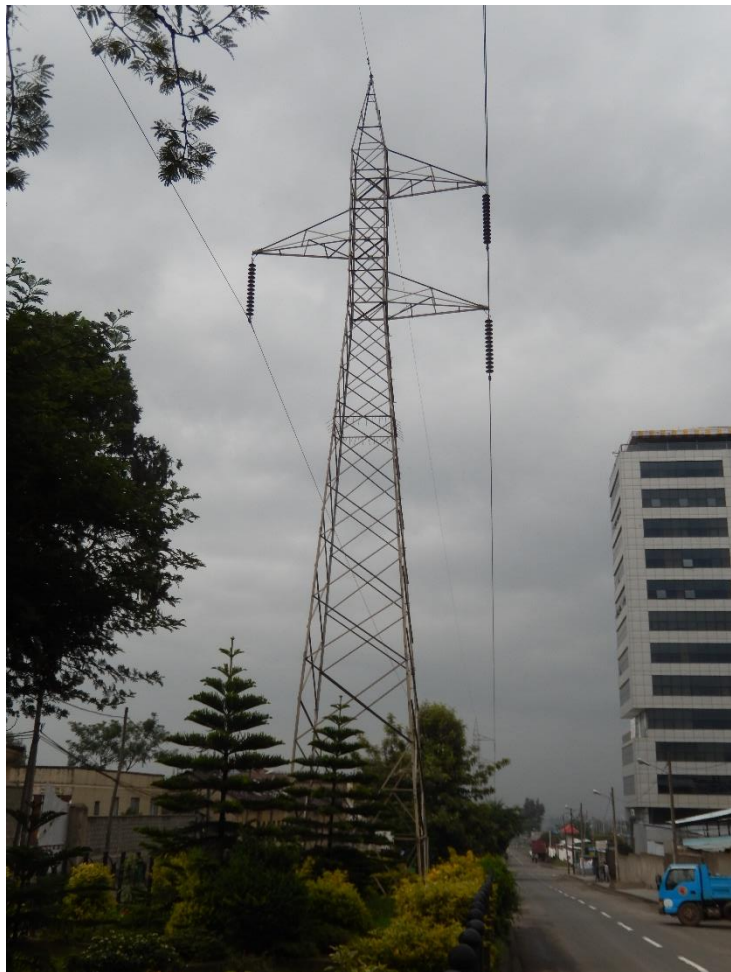
T-04 has been damaged heavy.
Damages were repaired temporary
however, tower is in critical condition,
as one of main leg has been twisted completely.

Damages seems to be occurred in long time ago.

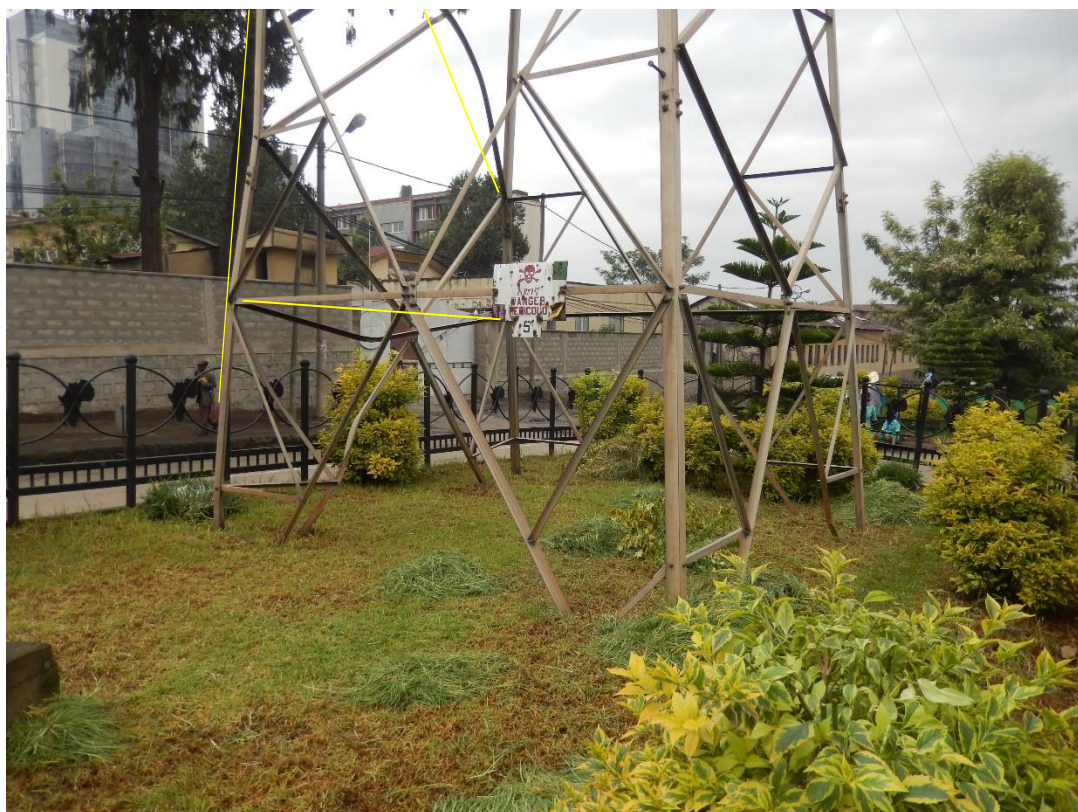
T-05 has been damaged heavy.
Damages are in critical condition,
as main legs have been twisted completely and
Secondary members of legs were out of function
due to deformation .

Damages seems to be occurred in long time ago.

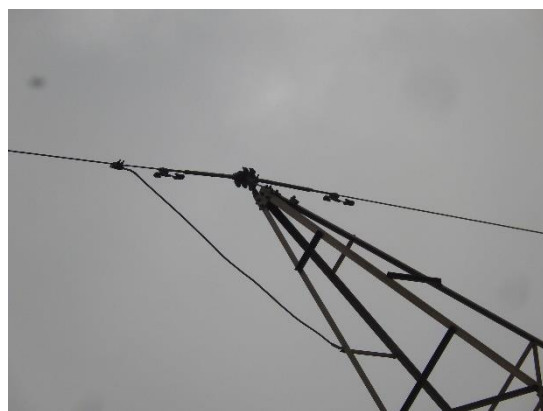
T-06 is kept in good condition.
Tower is located in median strip of two (2) lane road.

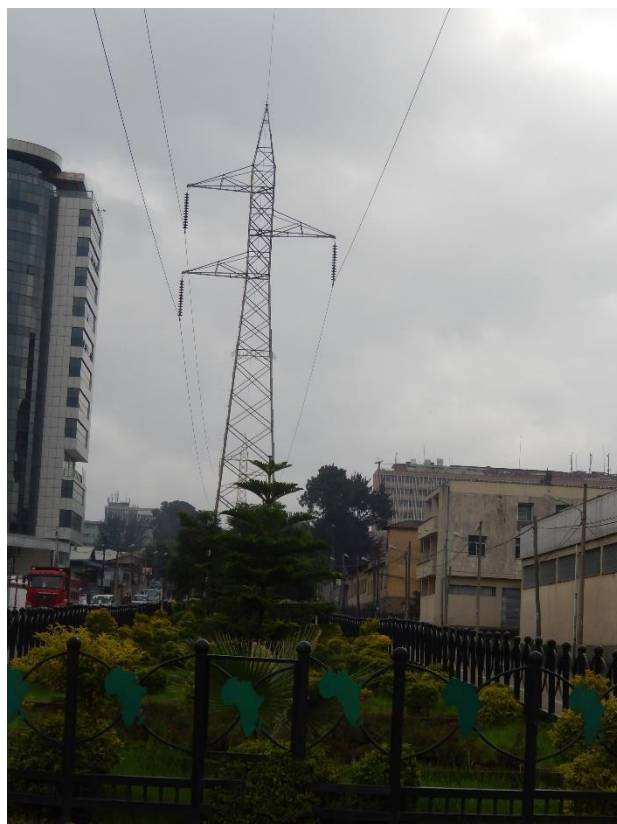
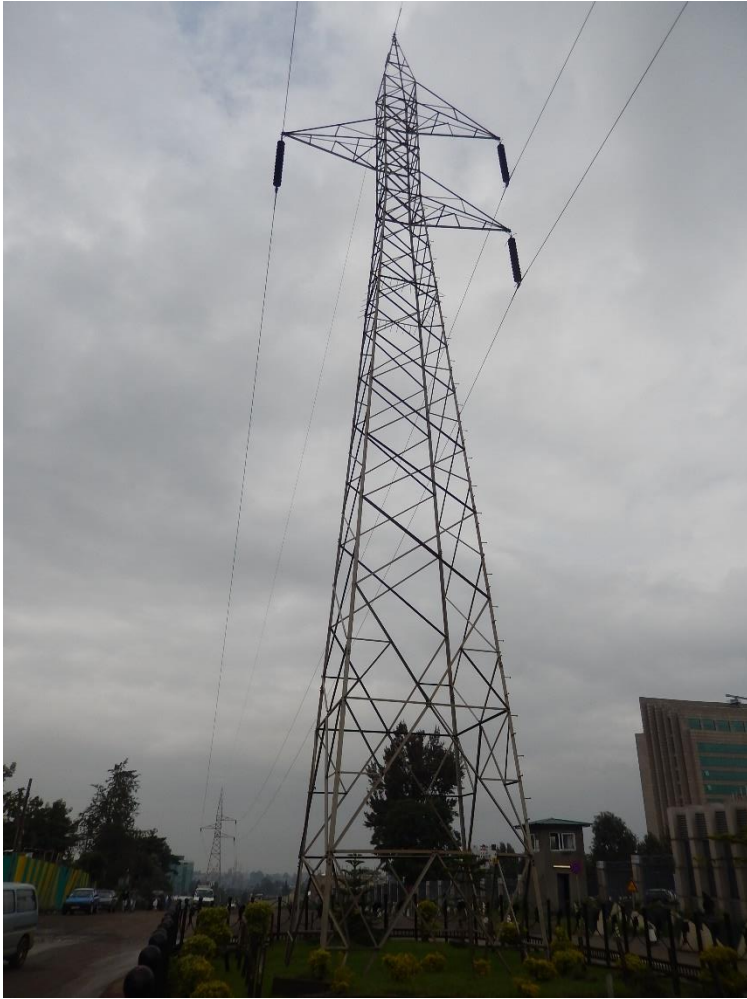
T-07 has been damaged heavy. Damages are in critical condition, as main legs have been twisted completely and Secondary members of legs were out of function due to deformation .

Damages seems to be occurred in long time ago.

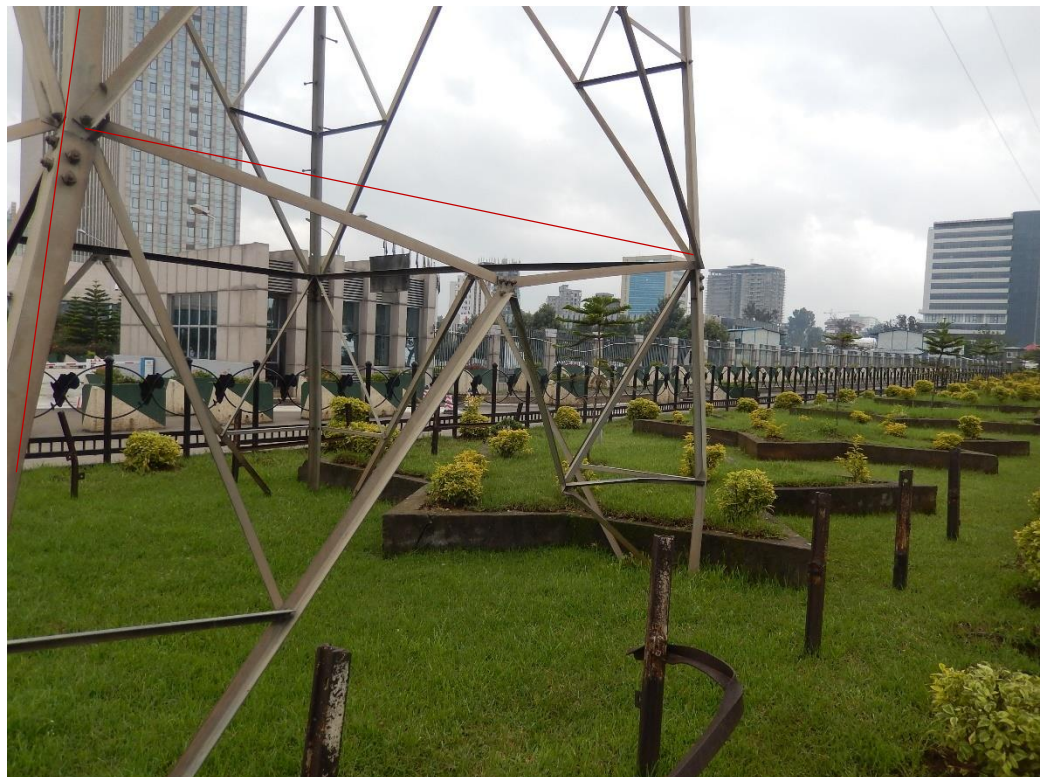
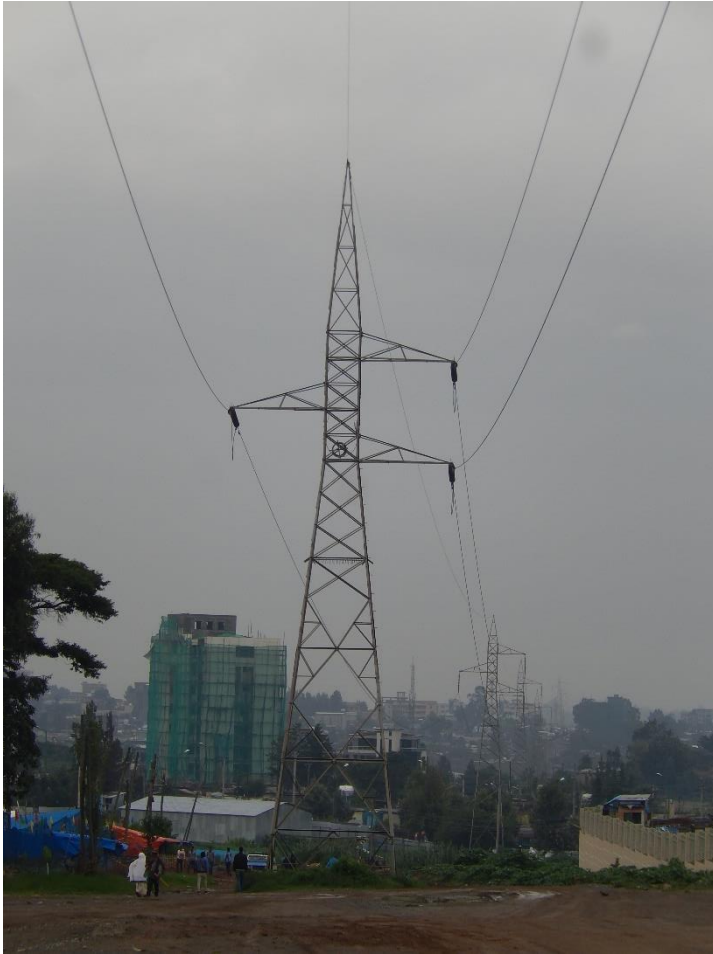
T-08 has been damaged heavy.
Damages are in critical condition,
as main legs have been twisted completely and
Secondary members of legs were out of function
due to deformation .

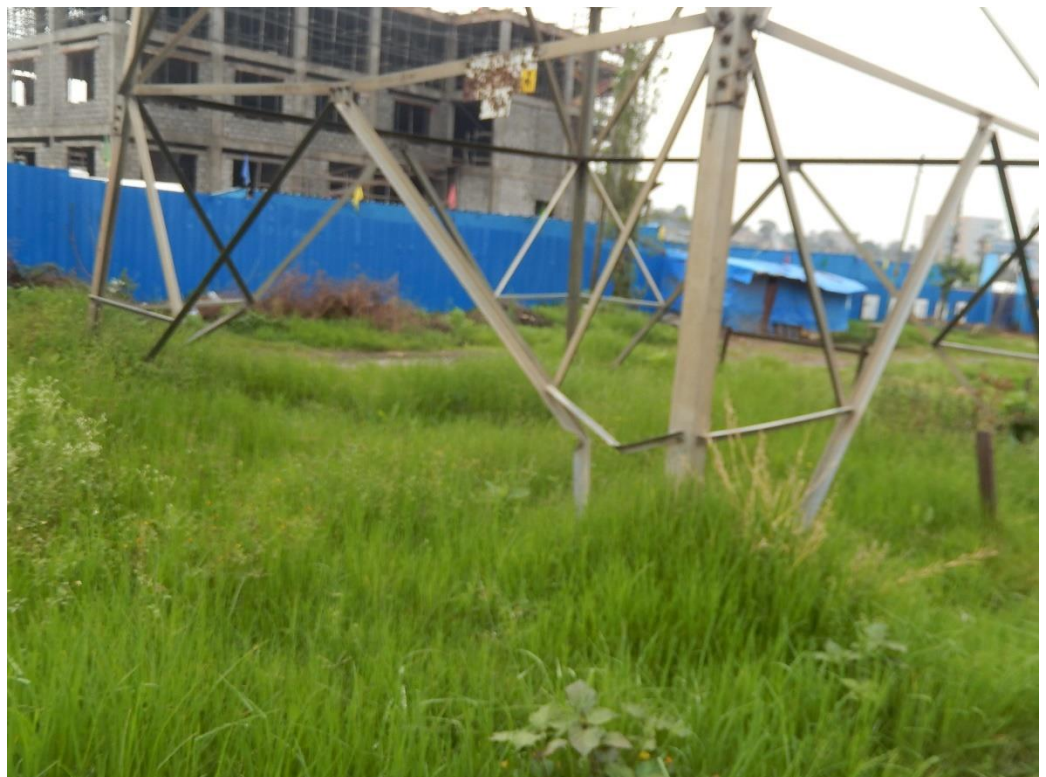
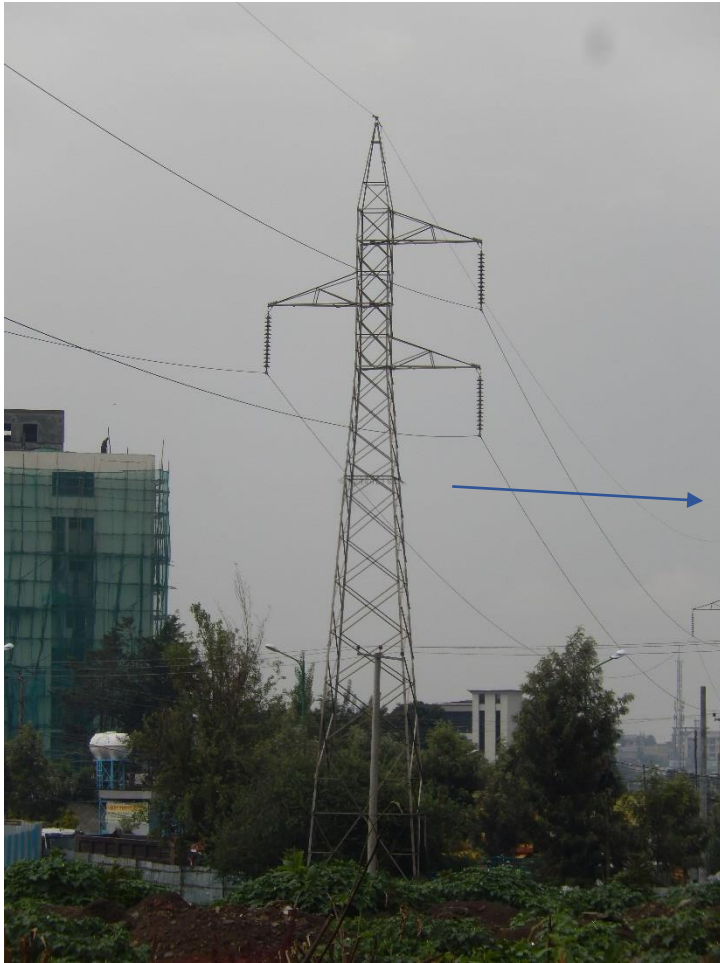
T-09 is kept in good condition.
Tower is located in main road.
One leg is located on walkway a little bit.

Tower location is fenced by party
other than EEP, access to tower is blocked.

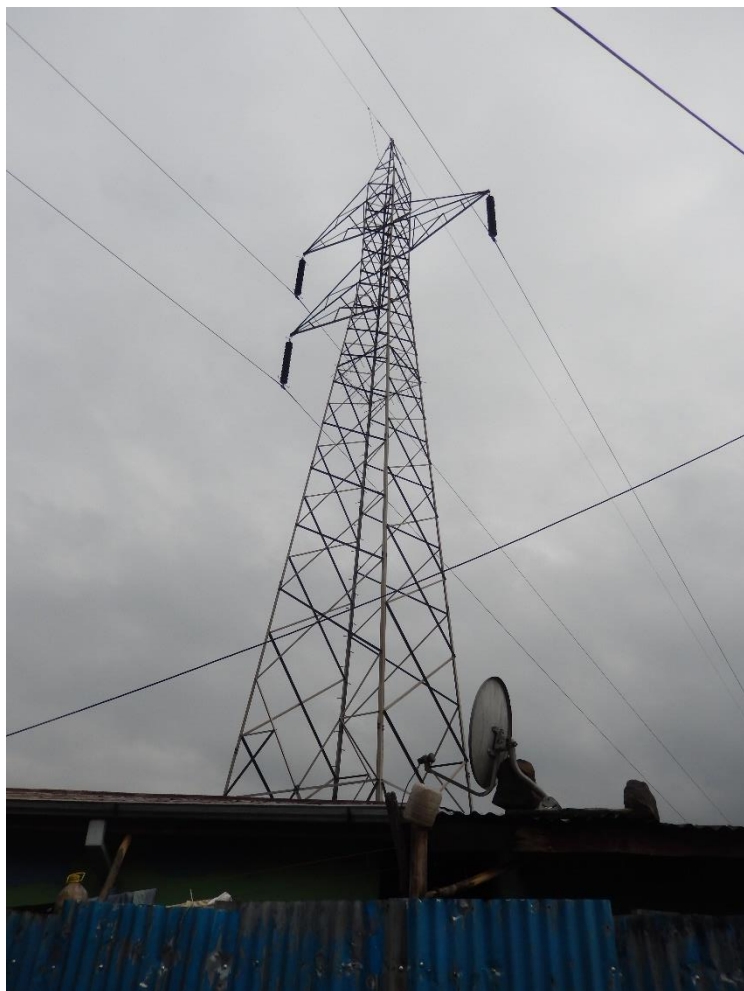
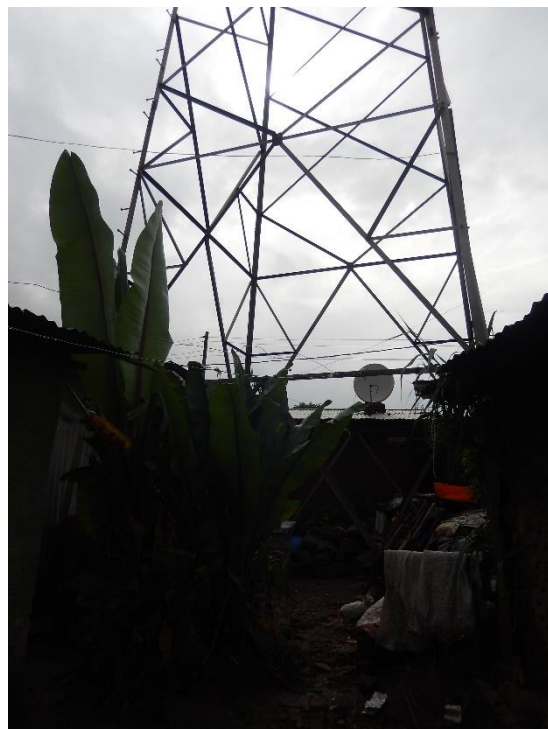
T-10 is kept in good condition.
Tower is located inside the residential area,
surrounded by houses.
No vehicle access, only foot pass access.

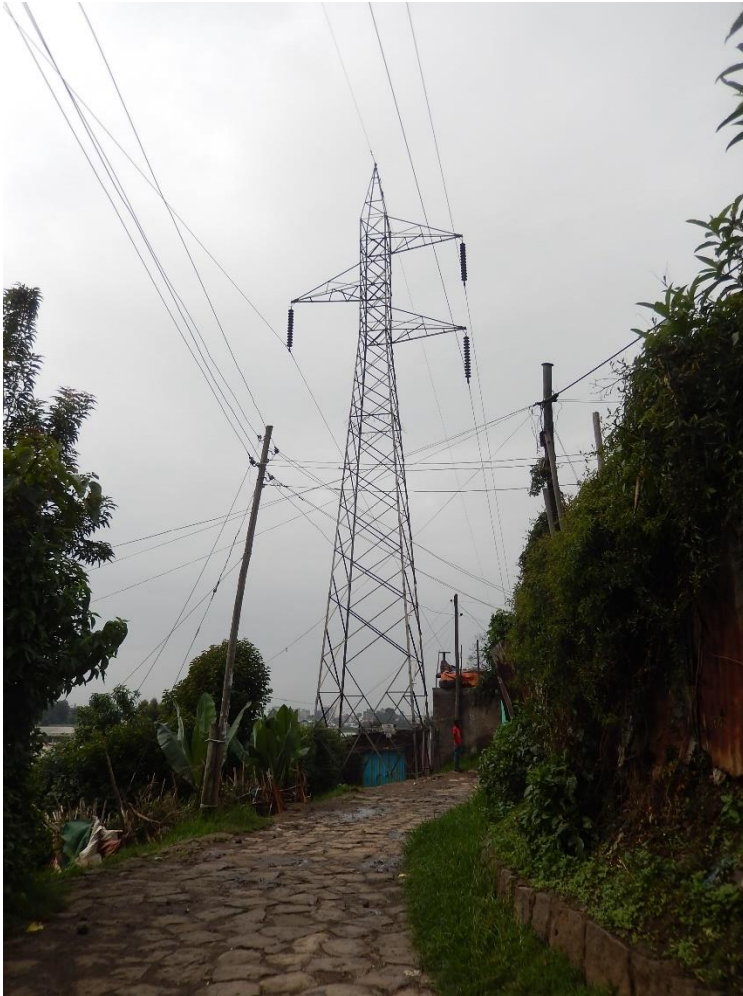
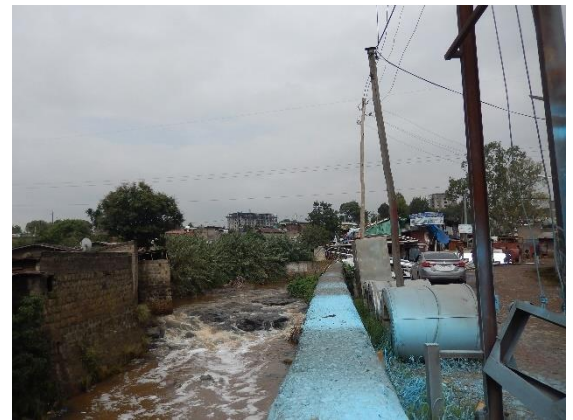
T-11 is kept in good condition.
Tower is located inside the residential area,
surrounded by houses.
No vehicle access, only foot pass access.

River crossing between T10 and T11.

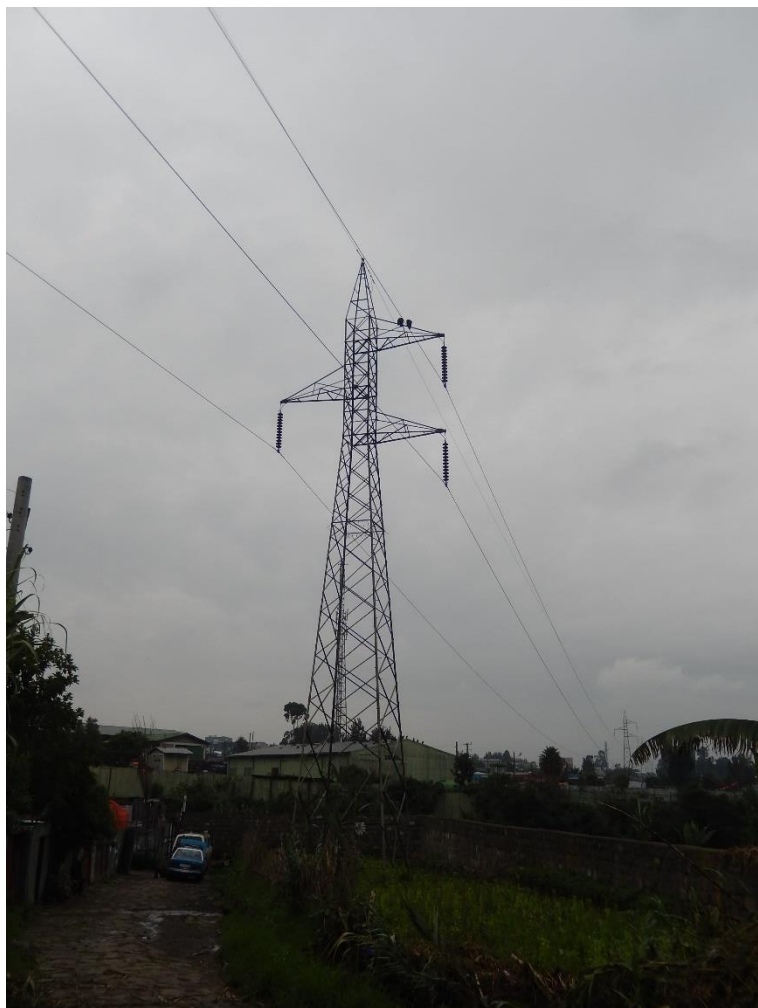
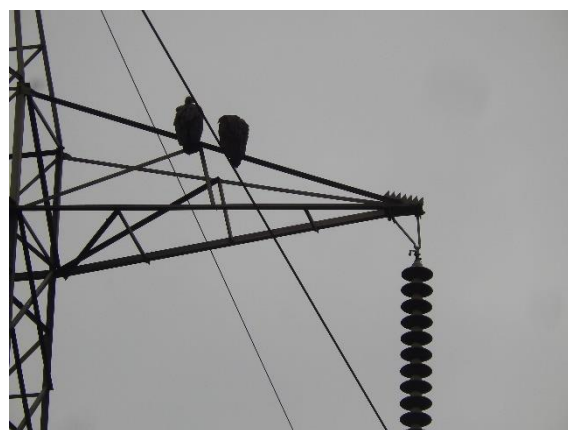
T-12 is kept in good condition.
Tower is located in residencia area.

Many birds are observed around tower.

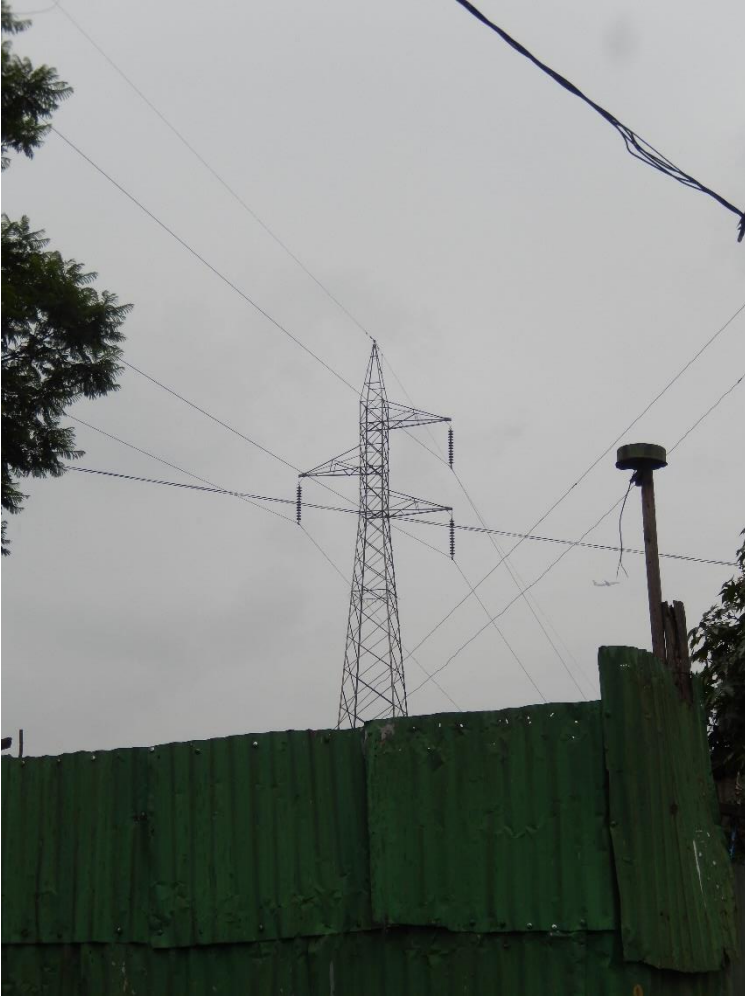
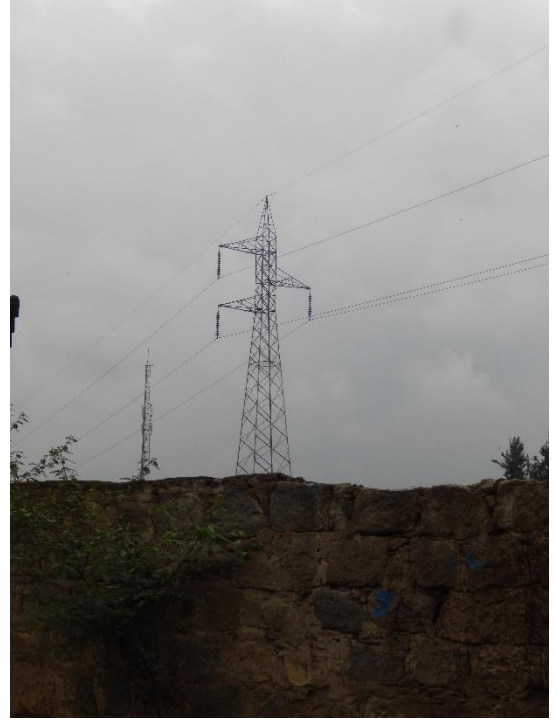
T-13 is located inside the land other than EPP.
Goat breeding area?

Access shall be made from main road through
Land user's access.

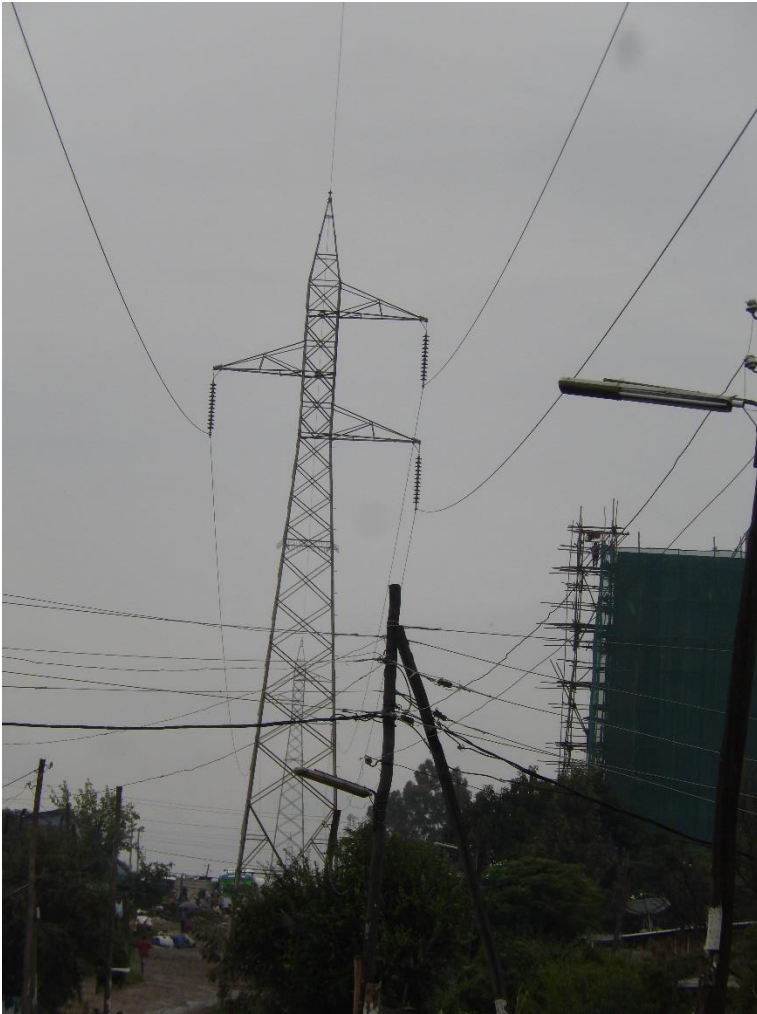
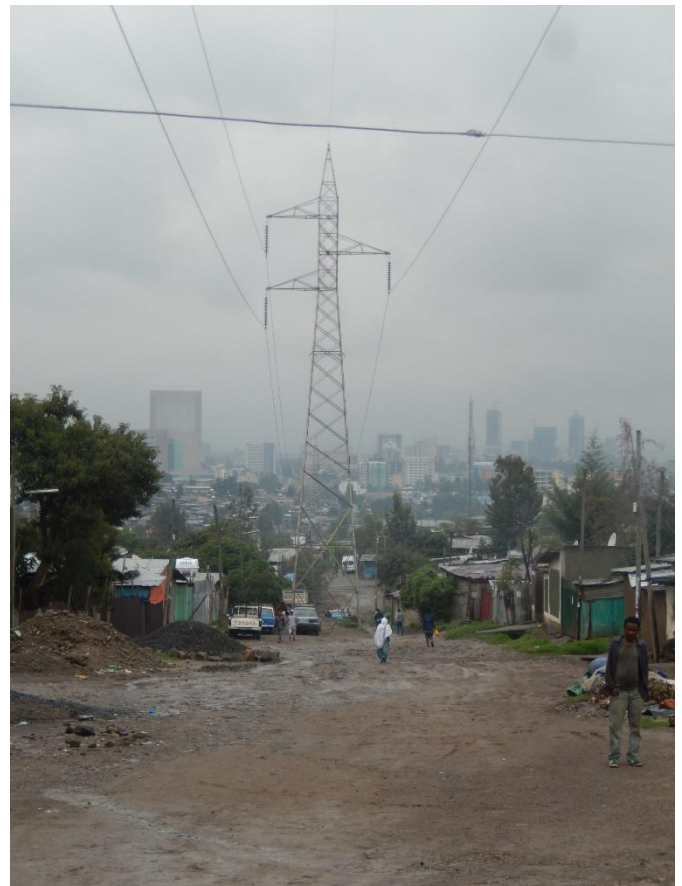
Tower is located in ROW corridor.
Tower is slightly damaged.

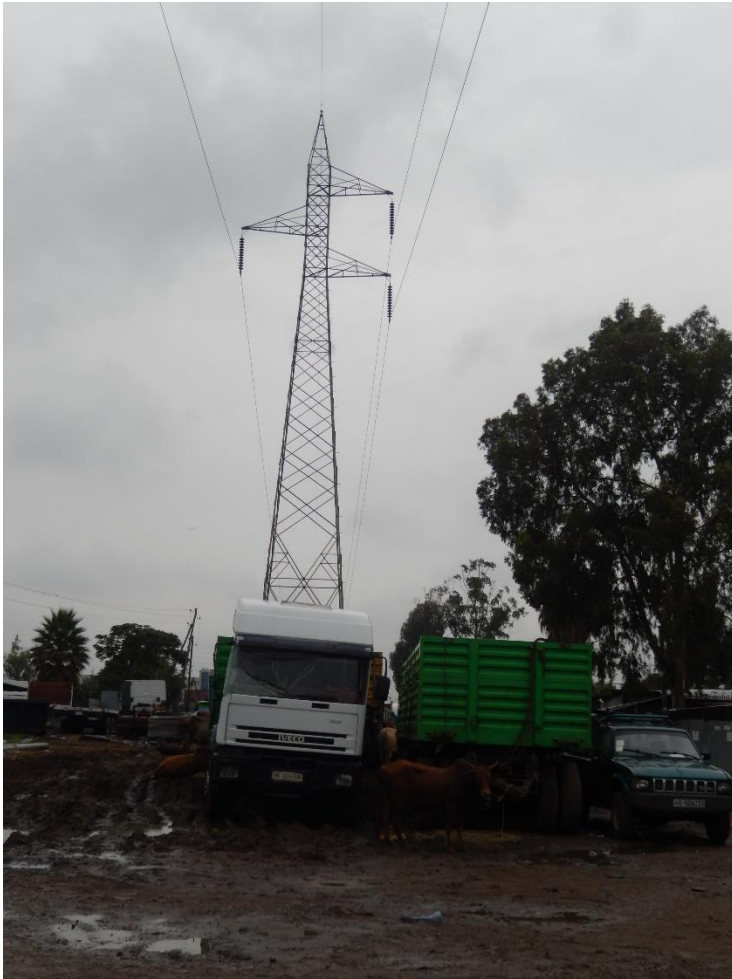
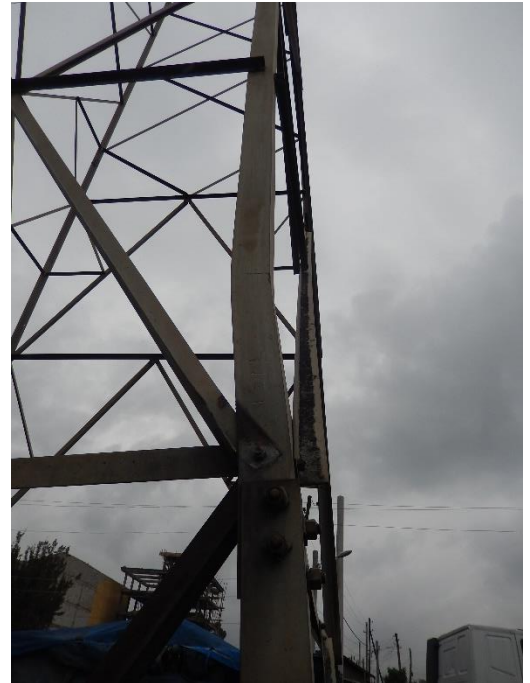
T-15 has been damaged heavy.
Damages are in critical condition,
as main legs have been twisted completely and
Secondary members of legs were out of function
due to deformation .

Damages seems to be occurred in long time ago.

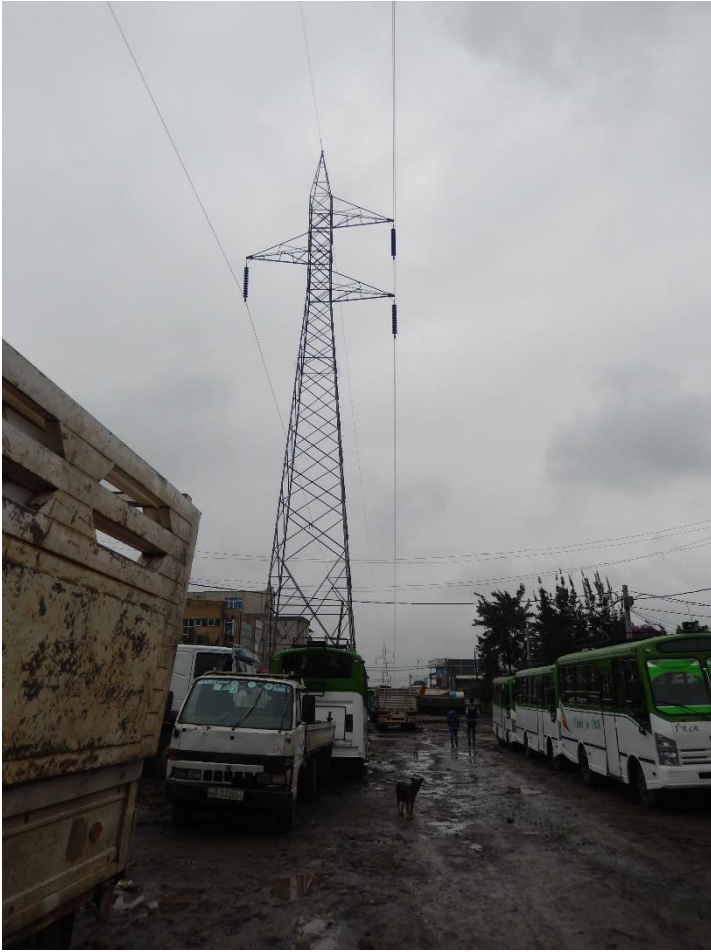
T-16 has been damaged heavy.
Damages are in critical condition,
as main legs have been twisted completely and
Secondary members of legs were out of function
due to deformation .

Damages seems to be occurred in long time ago.

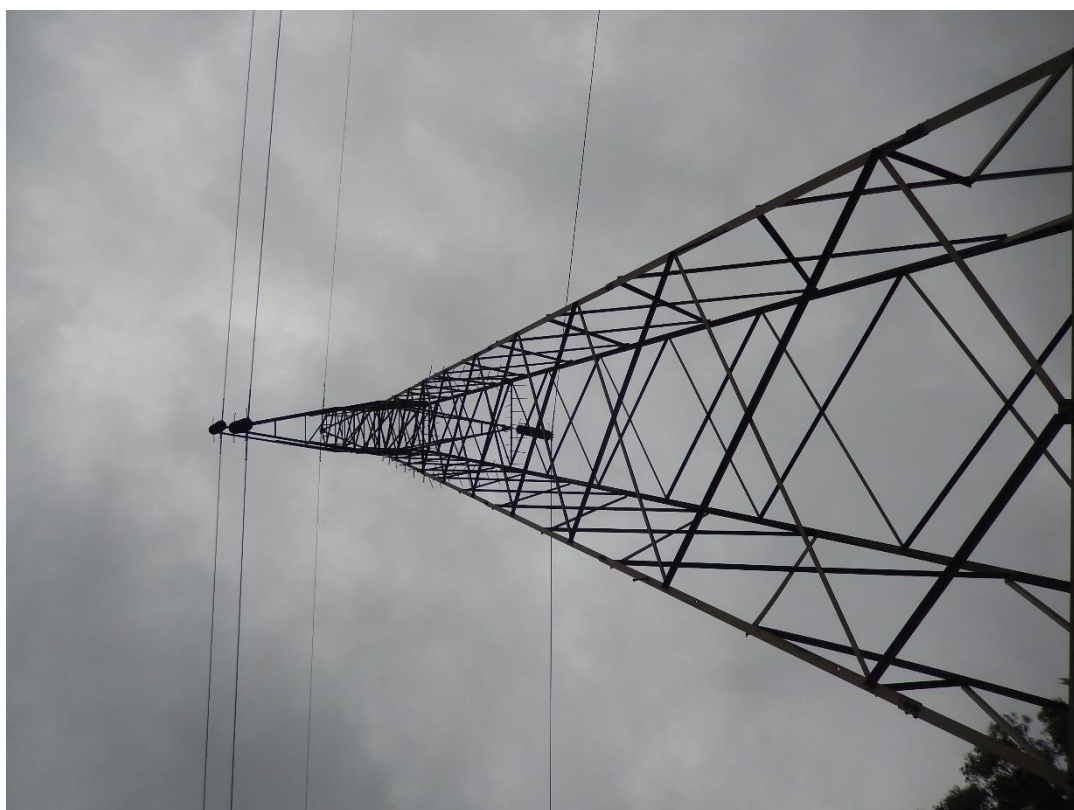
Insulator assemblies were twisted due to tower inclined.

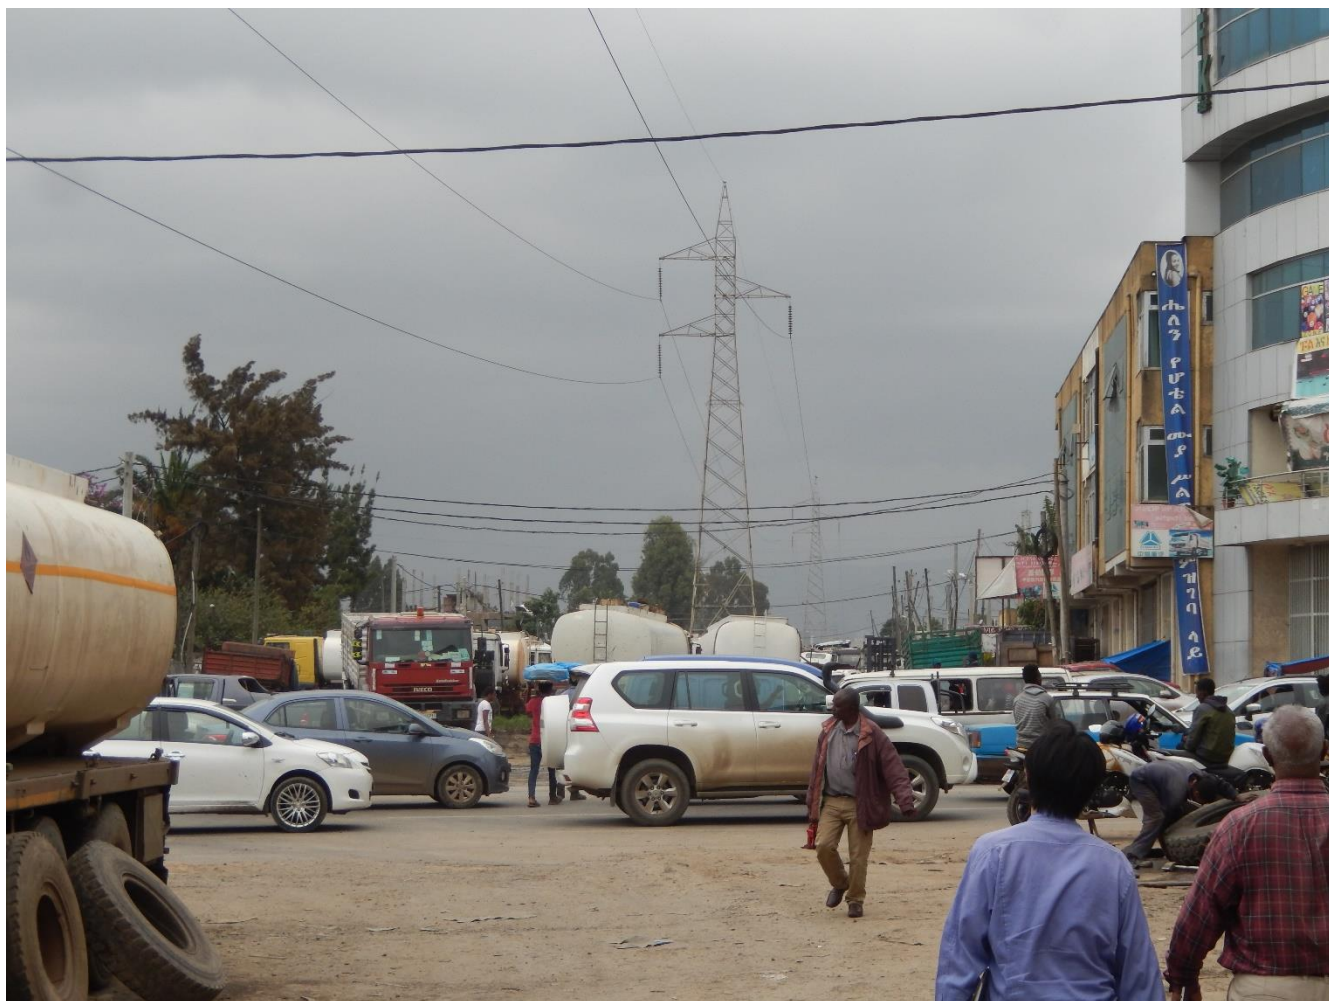
Tower 16 views from T17 side.
Road Construction is under progress on T17-T20.
T16 side is not started yet

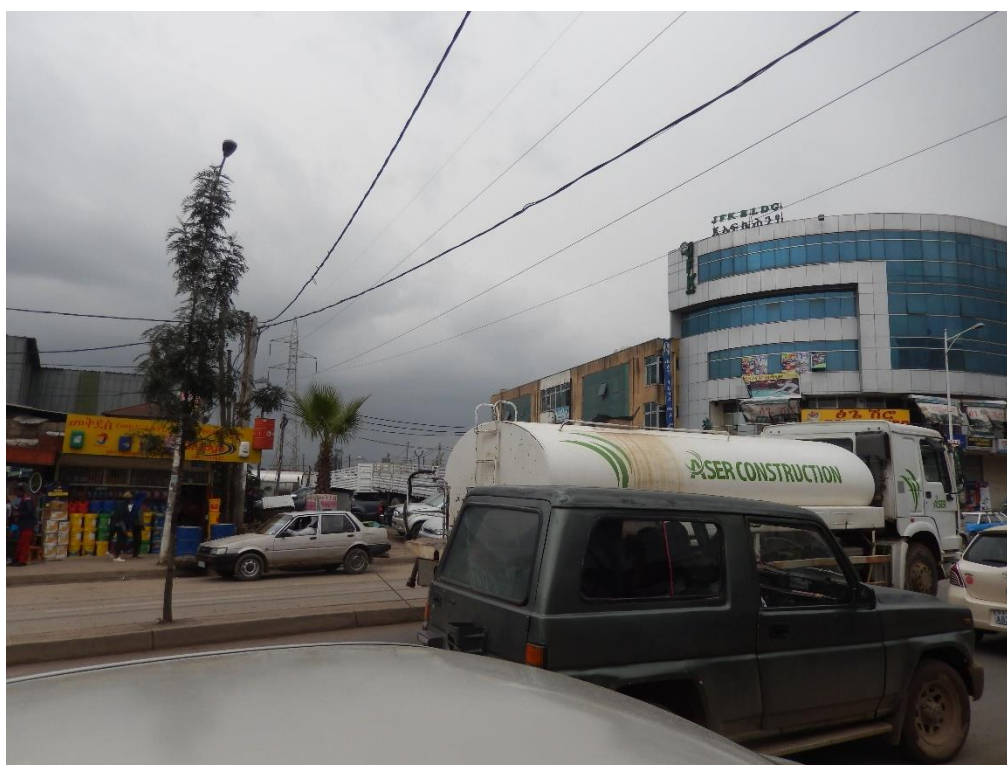
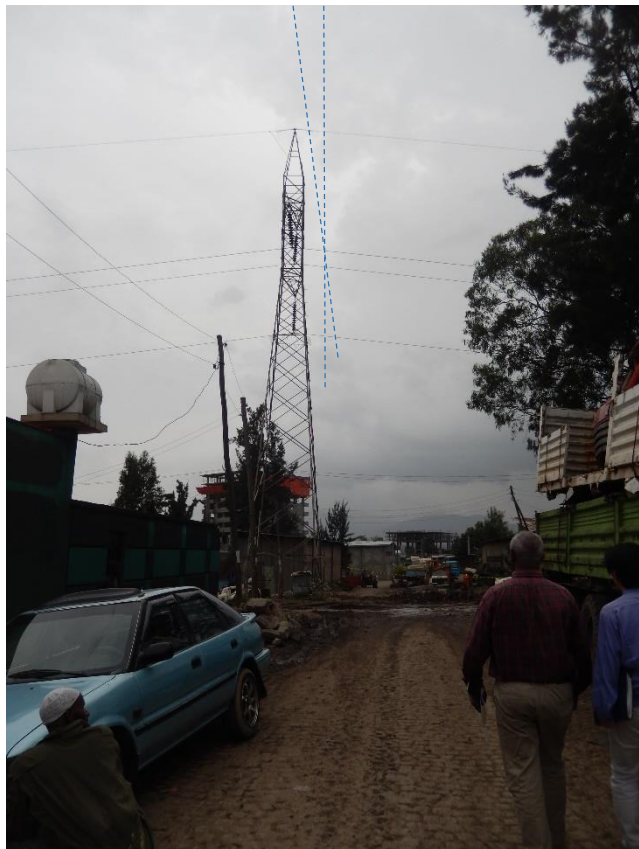
This T17 has been damaged by activities of road construction and almost collapsed.

Insulator assemblies are inclined due to tower inclination.

Now conductor supports the tower.

Tower is in dangerous condition to collapse.

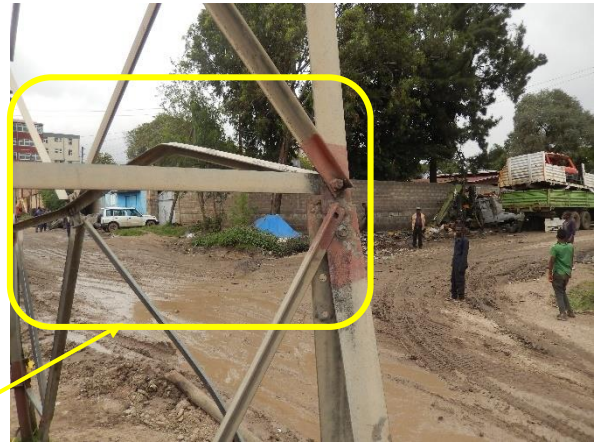
Two (2) legs were bend and does not hold the tower weight anymore.

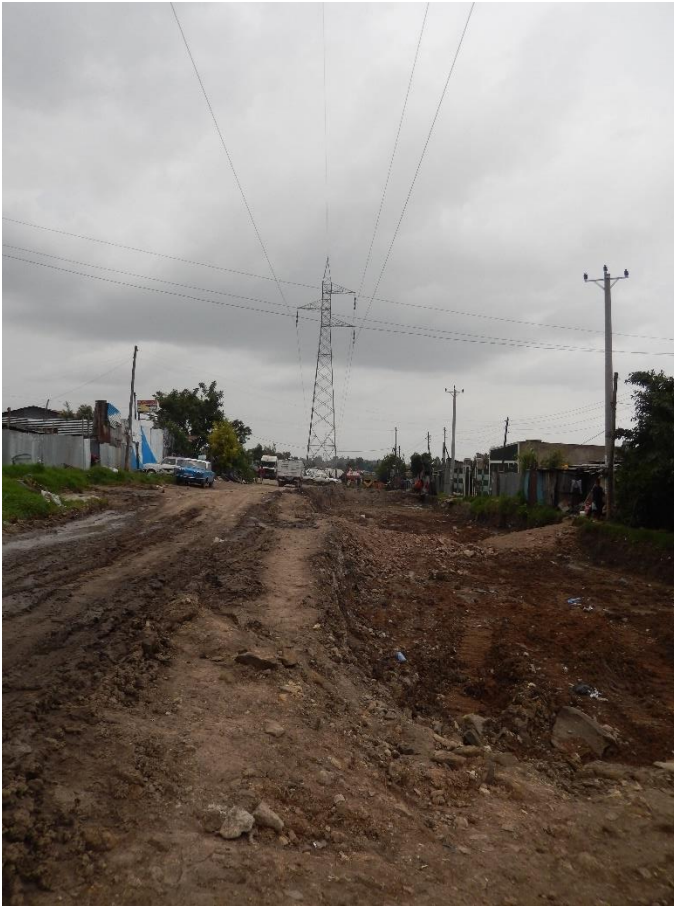
Remarks
Road Construction is under progress
between T17 and T20

Demolish existing houses under 30m corridor
(2 x 15meter both side center line)

Now excavation start on one side 15 meter

First Section of Road Construction between T17-T18.

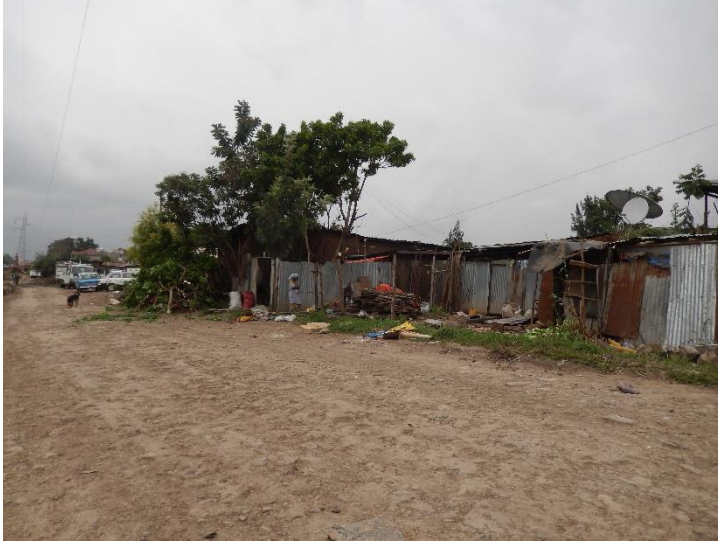
T18 to T17 Demolish and removing houses and obstruction on the Corridor.

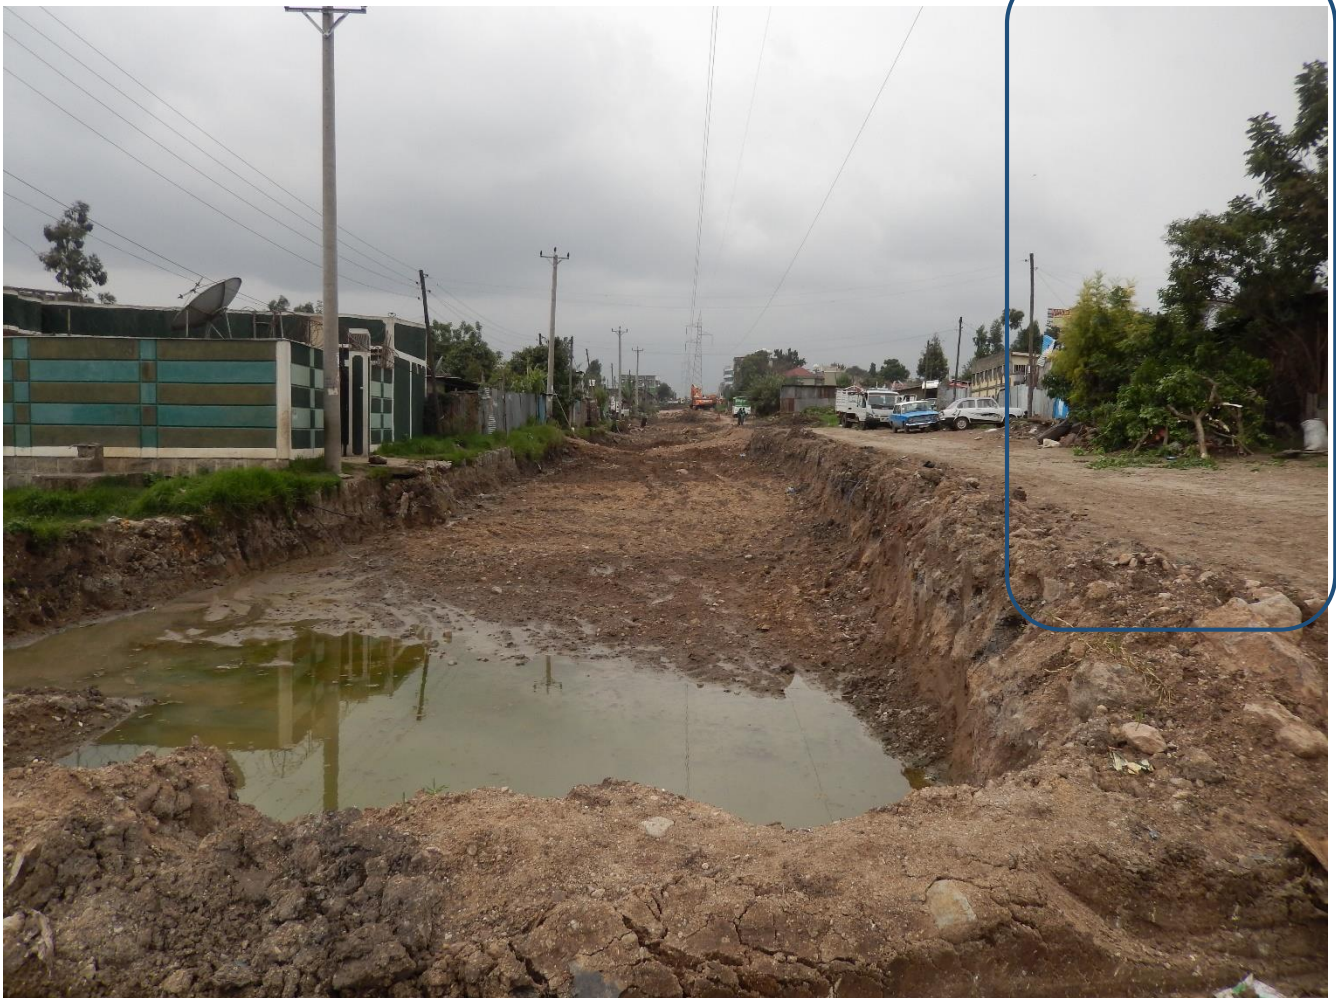
Construction of road starts on the half side of Corridor.
15kV Distribution Line will be demolished to shift it to new location outside corridor.

Parking vehicle has been removed already.
Tower foundation will be kept as original position
