APPENDIX-3

SITE SURVEY FOR OVER HEAD TRANSMISSION LINE

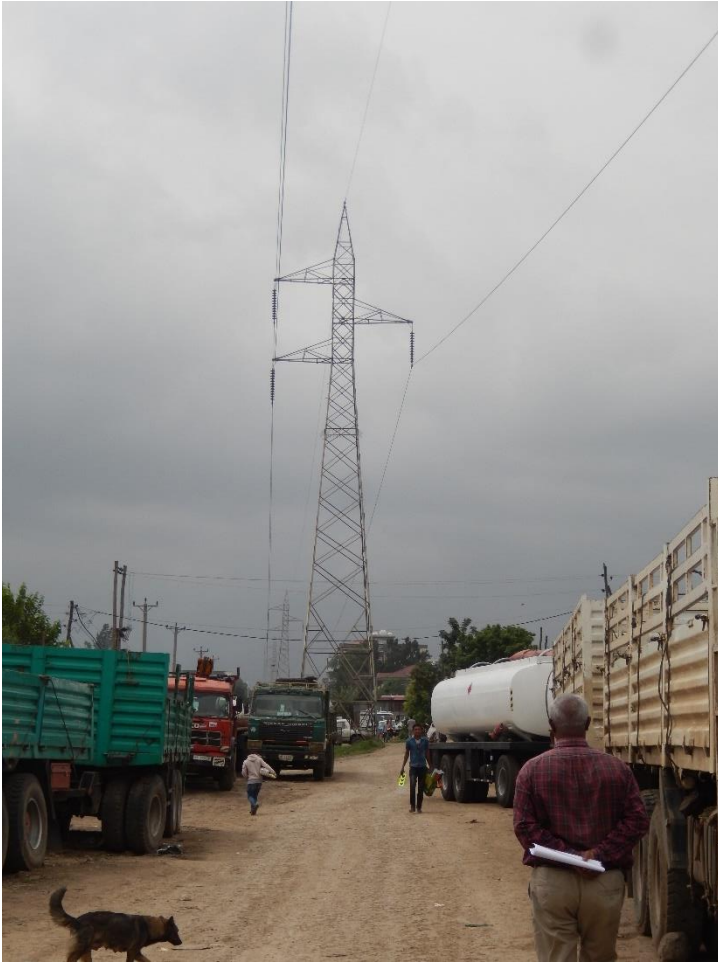
Tower T-18 from T19 side

Tower legs had been damaged heavily.
Tower inclined slightly.

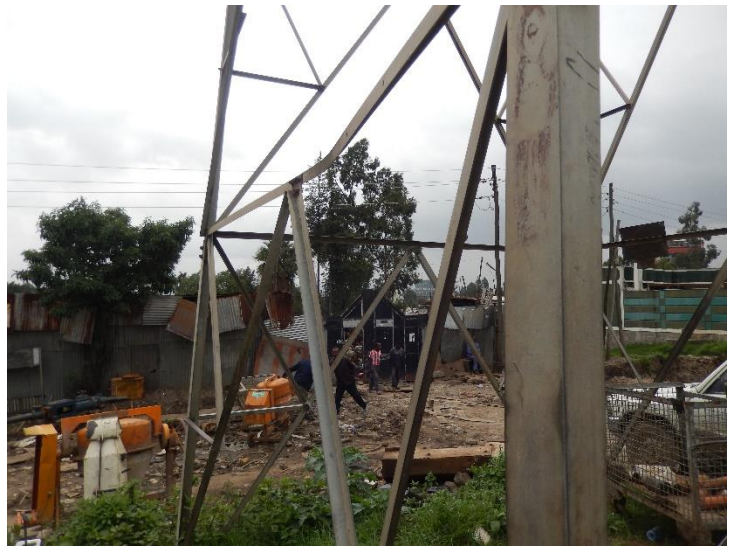
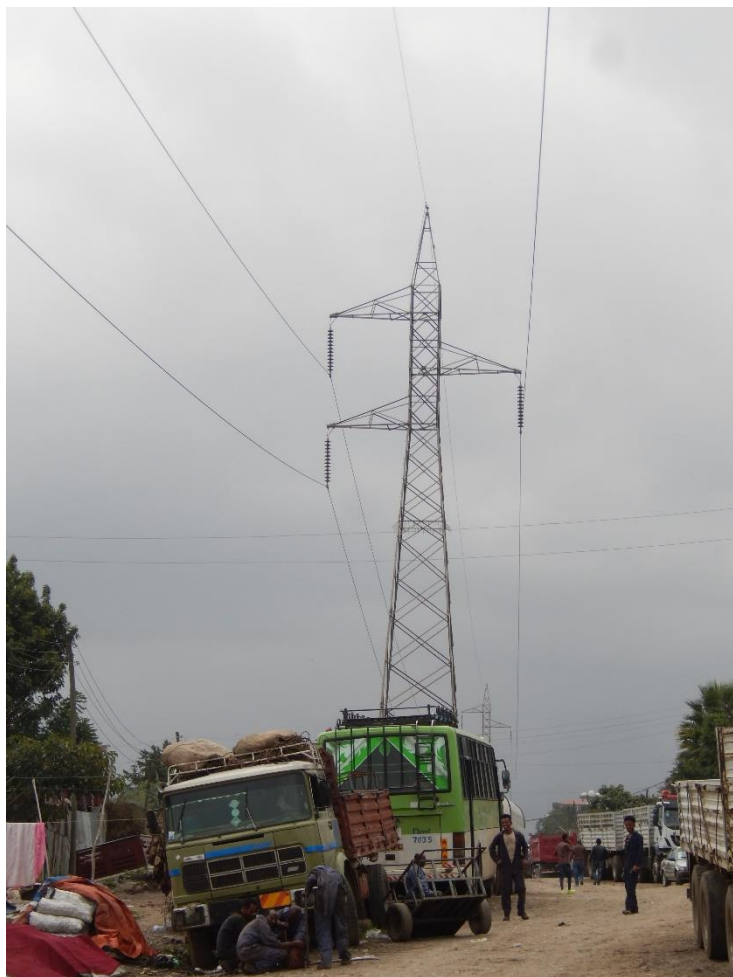
Tower legs had been damaged heavily.
Tower inclined slightly.

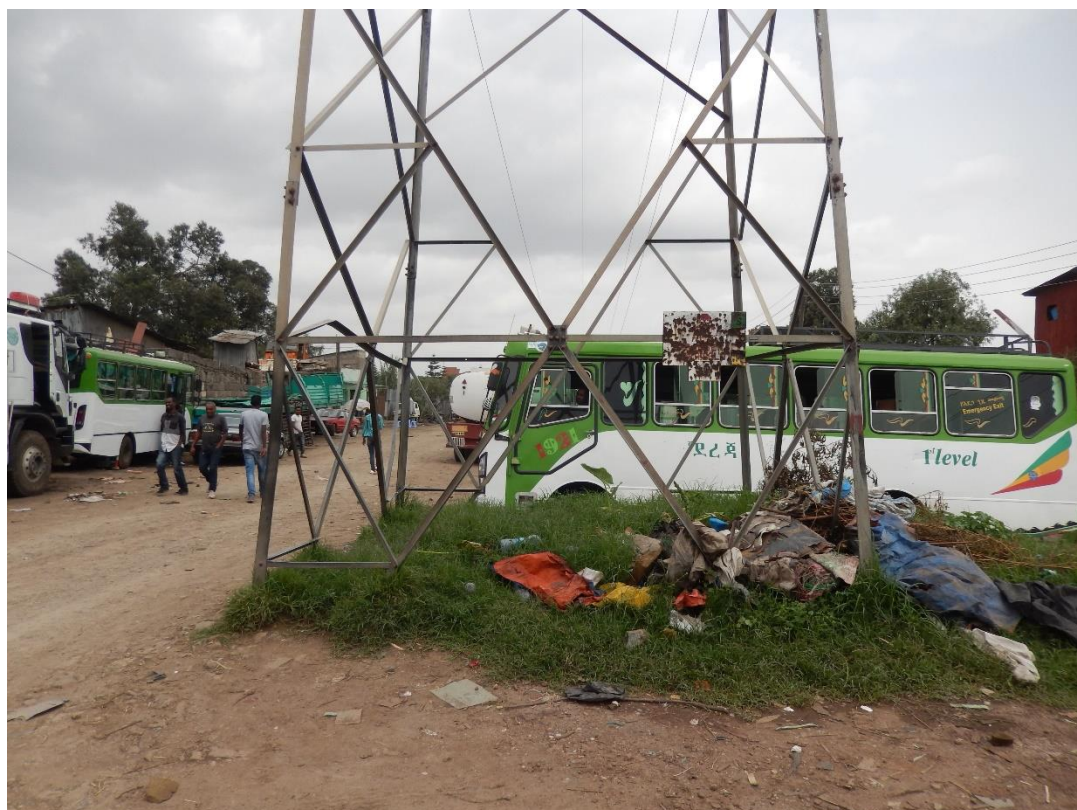
T19 Damaged Steels

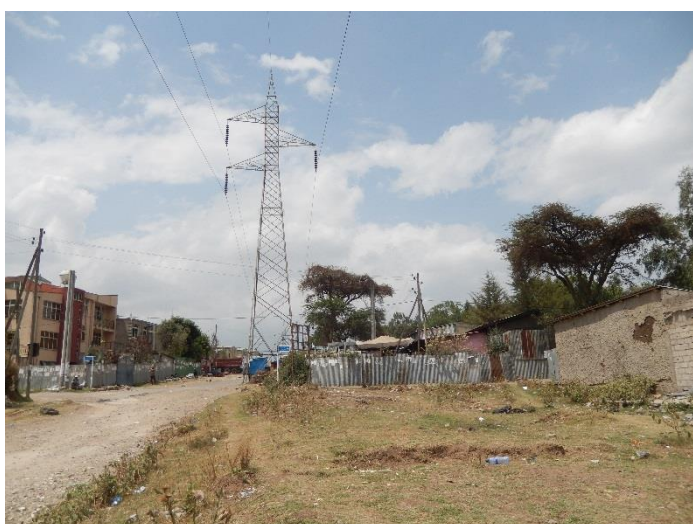
T 26
DSCN0574 T26 from T27 side ROW house

Remarks
Works Shop is constructed under the tower.

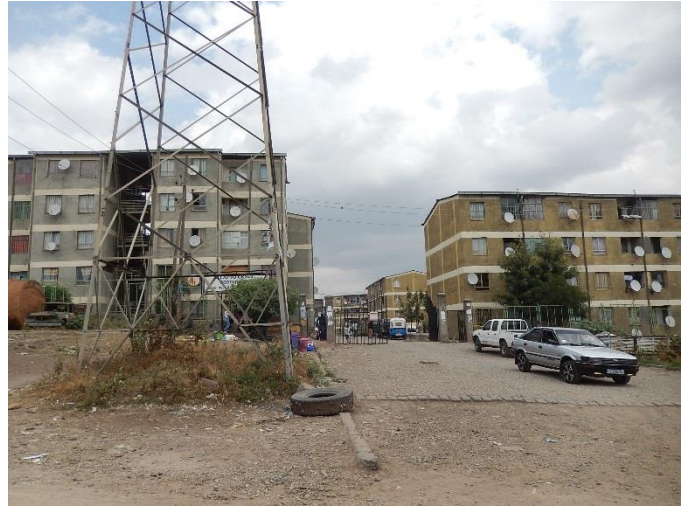
T 27
DSCN0571 T27 in front of gate to dormitory

Tower is located in front of enter gate to apartment dormitory. New tower should be shifted to avoid traffic to this dormitory.

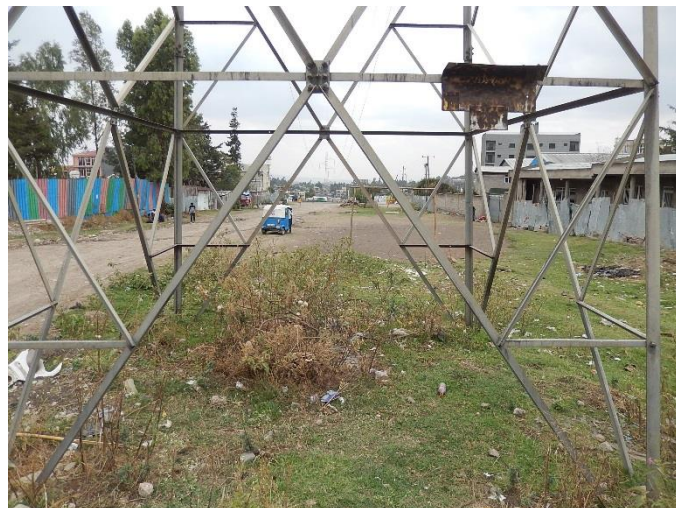
T 28
DSCN0559 T28 toward T29

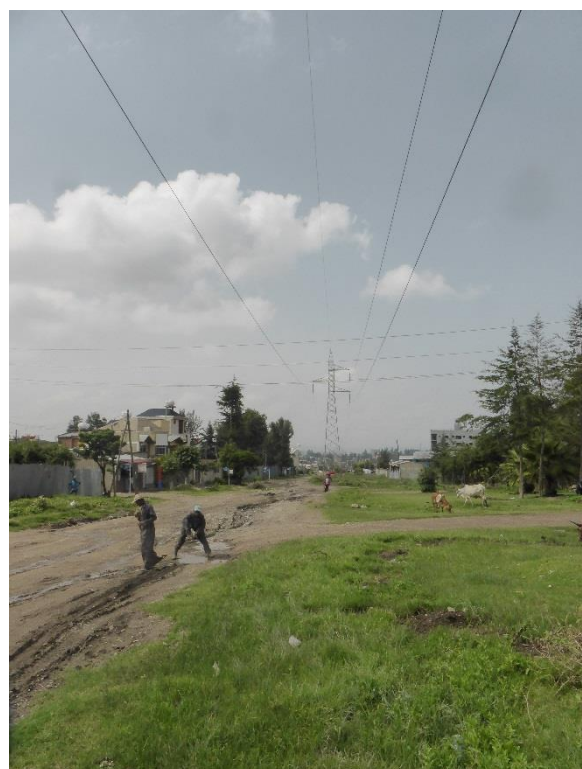
T 28
P1130586 T28 from T27

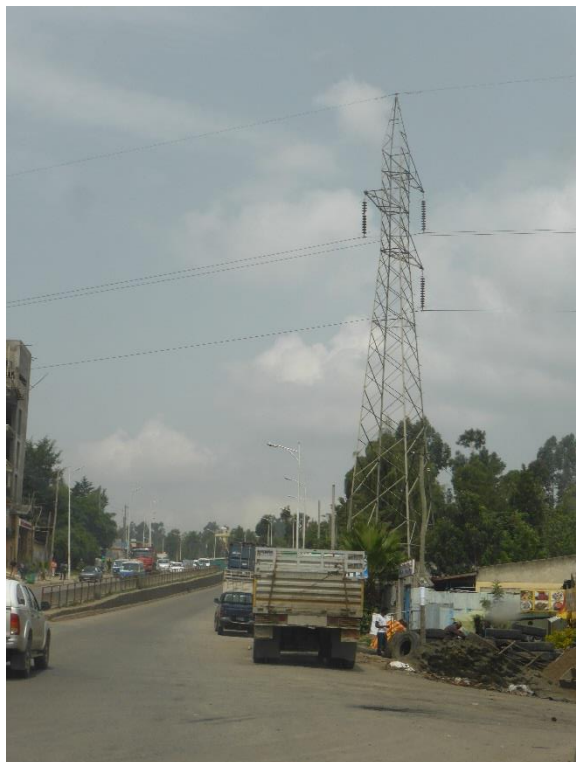
T 31
P1130595 T31 50m beside main road

Tower T31 is located in narrow space and beside road. Special tower and foundation shall be designed.

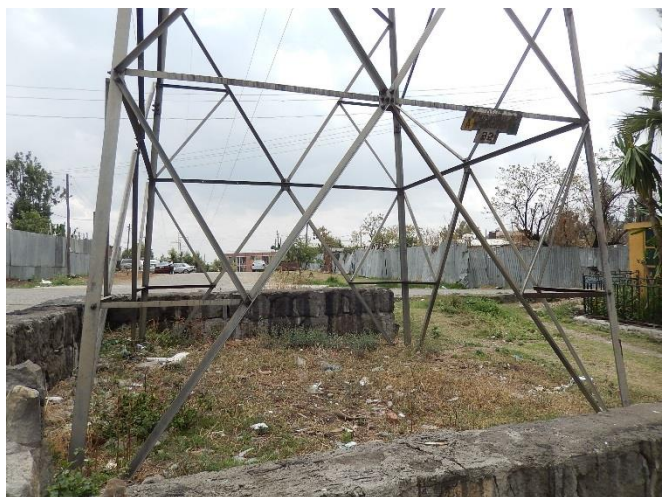
T 32
DSCN0514 T32 Bottom gard blocks

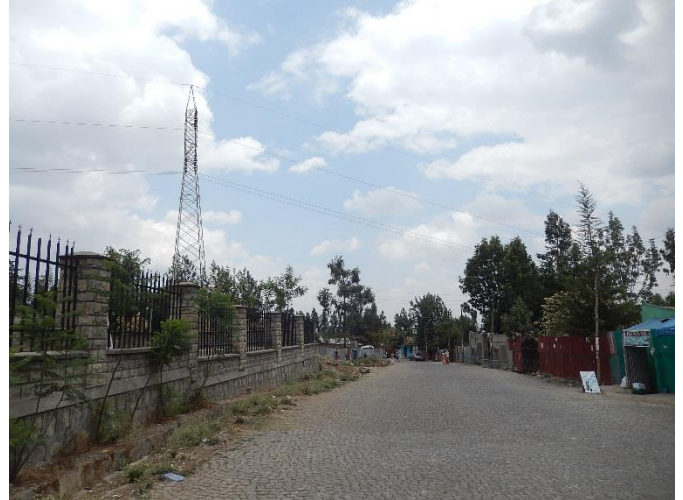
T33
DSCN0499 T33 from side 100m. Heavy weight span due to ground profile level toward T34.

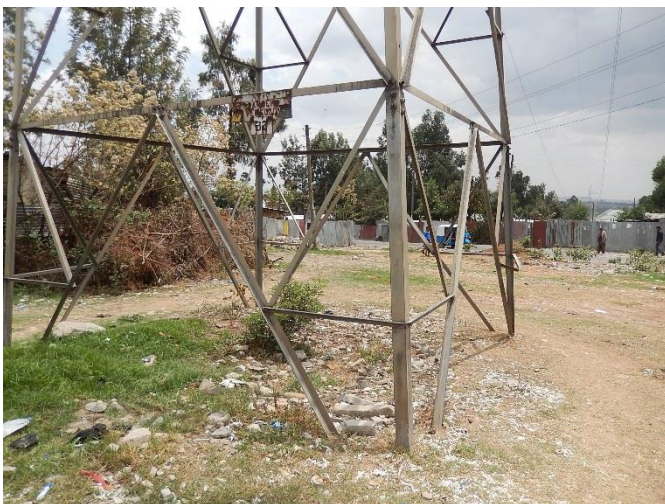
T 33
DSCN0502 T33 Bottom & to T34

This tower has been damaged by traffic vehicle on the main leg. The Tower condition is very critical .

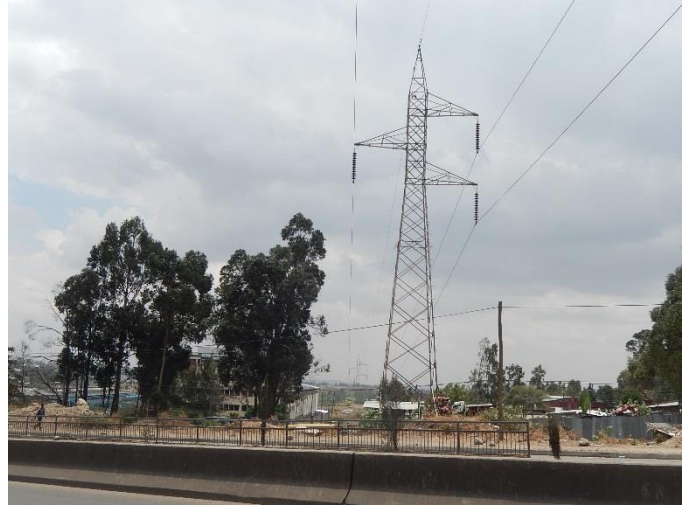
T 34
DSCN0484 T34 beside main road

T34
DSCN0494 T34 Elevation level of road is 5 meter higher than elevation of T34. Electrical clearance to road is not enough.

Elevation of road become much higher than tower foundation level, during embankment work for construction of road.

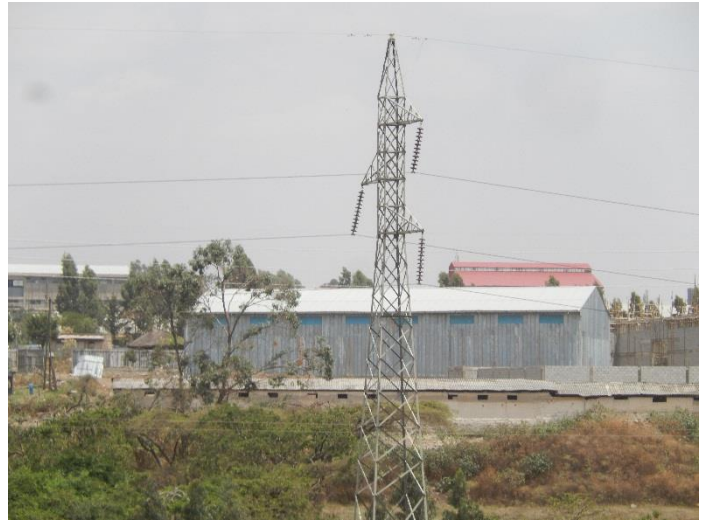
T 36
DSCN0906 T36 from T37 side.

T36 is almost collapsed due to heavy damages on the leg. The suspension clamps hold conductor with unbalanced tensions. The condition of this tower is in very critical conditions.

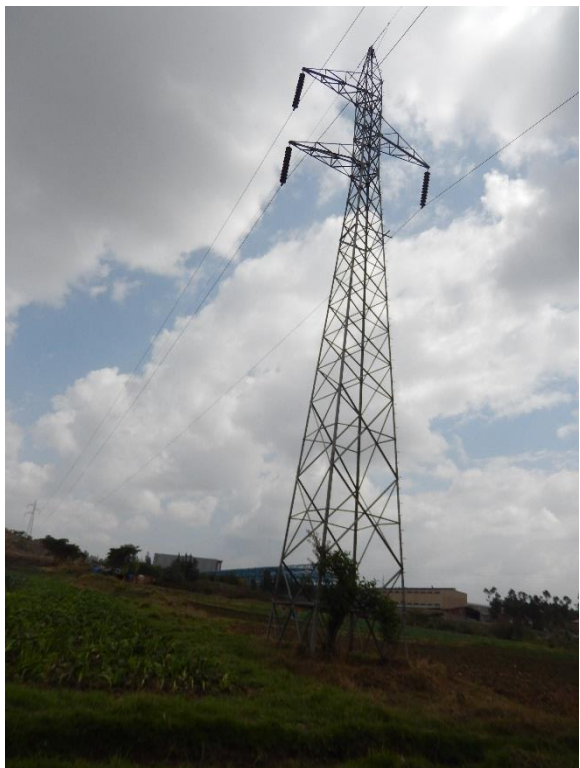
T 37
DSCN0739 T37 from T38 side .
T 36 could see at far end.

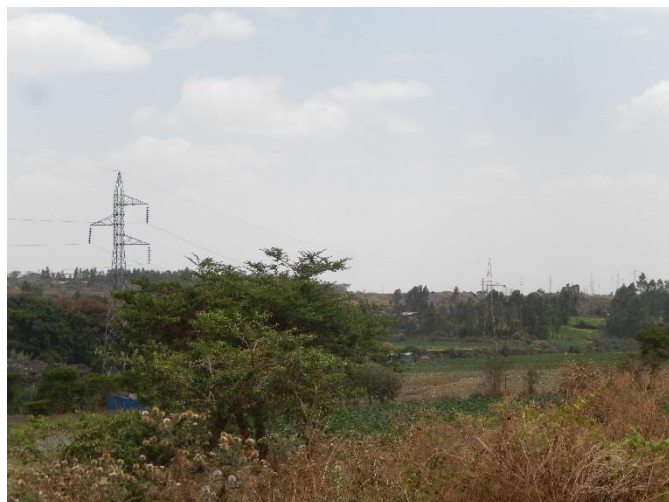
T37
DSCN0913 T37 is located in vegetable garden where
is a small stream river beside. This area may not be
industrial area in future.

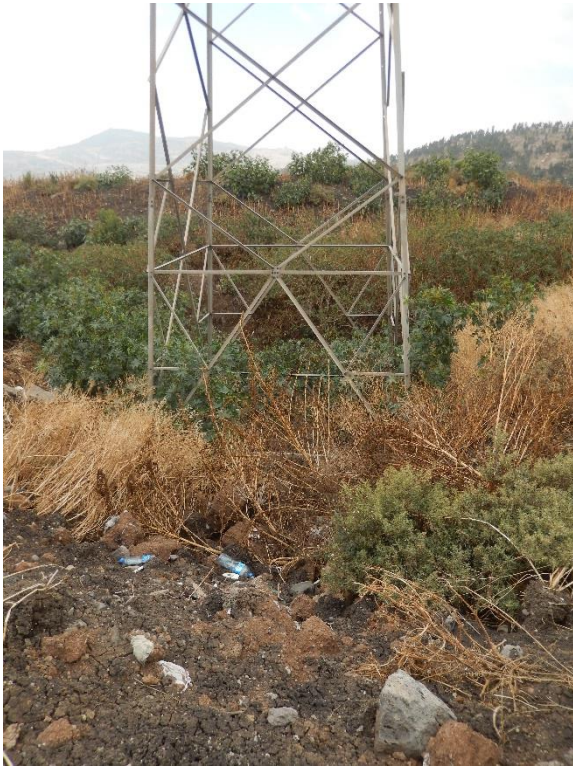
T 40
DSCN0773 T41 foundation.
Embankment works were done around tower site/

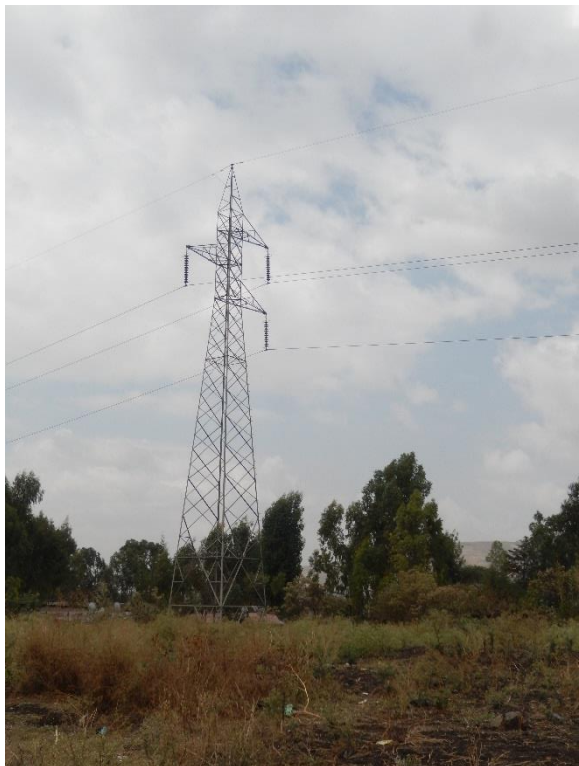
T 43
DSCN0791 T43 side residential houses.
Hoses are constructed under ROW (Corridor)
after T 42 water treatment area.

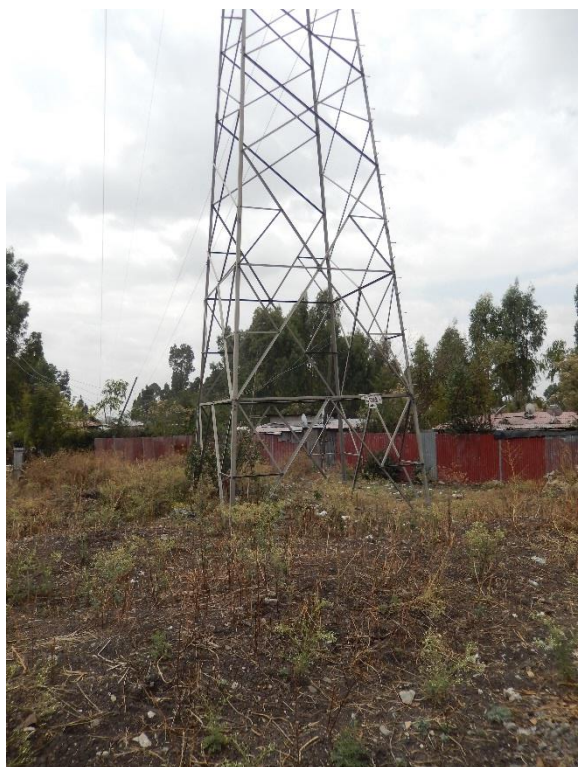
T 43
DSCN0792 T43 beside houses.

Transmission line pass above the roof of
residential houses.

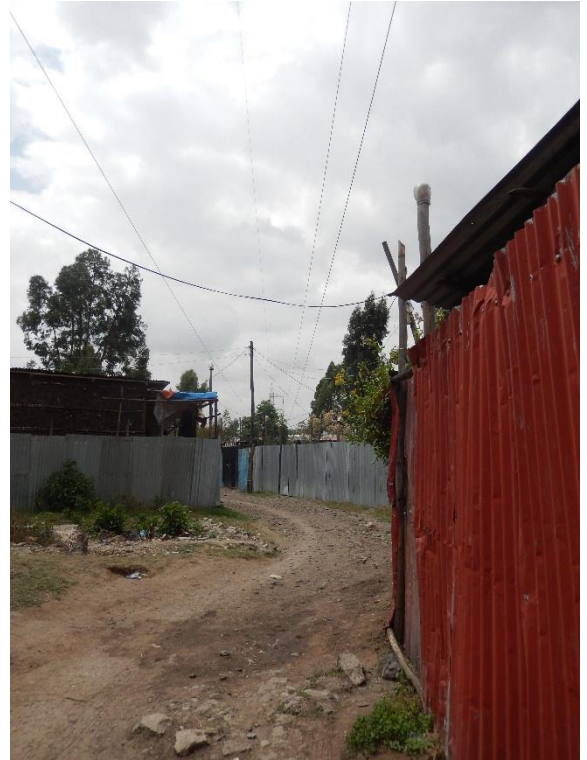
ROW under Corridor between T 43 and T44
DSCN0795 Access to T44
ROW is remained as small access.

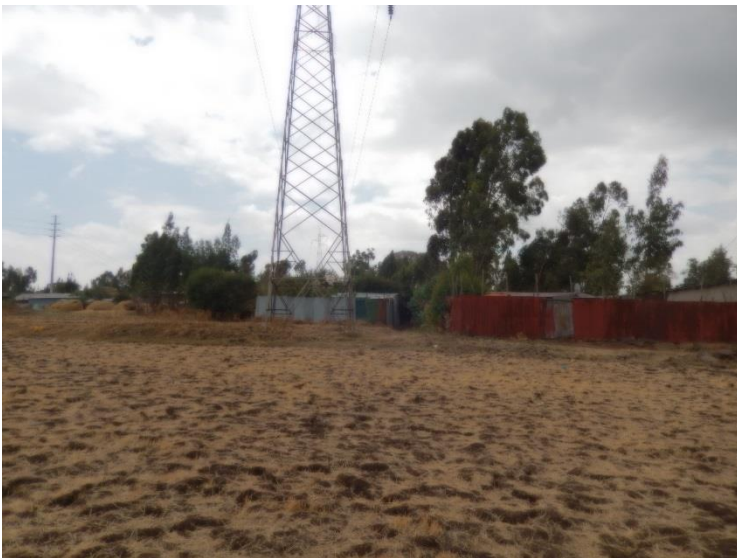
DSCN0838 T51 bottom
Residential houses are existed between T51 to T52.

Many houses between T 51 and T52
This area is suitable for industrial area as
the short distance national road.

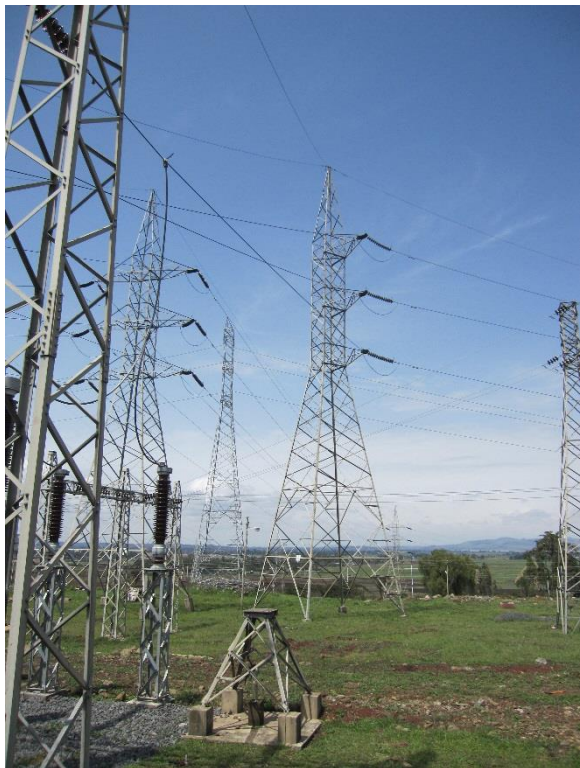
T 56
IMG_1117 T56 last tower to gantry

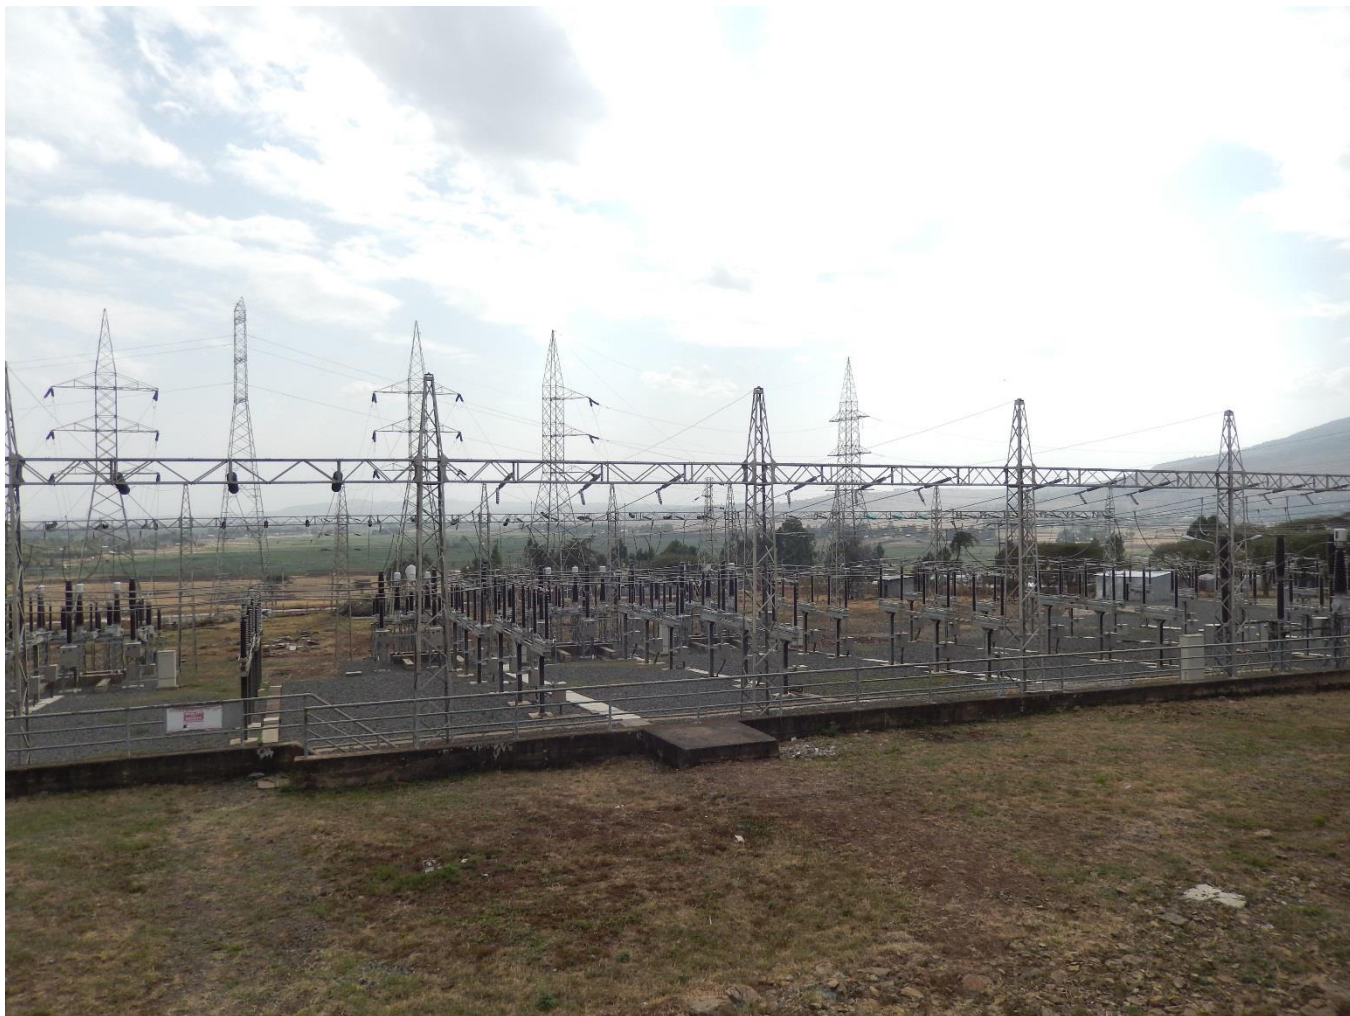
DSCN0167 Kaliti-I SS gantry

New additional feeders will be added beside existing feeder to ADC by shifting feeder bay of Mekanissa and Sebete.

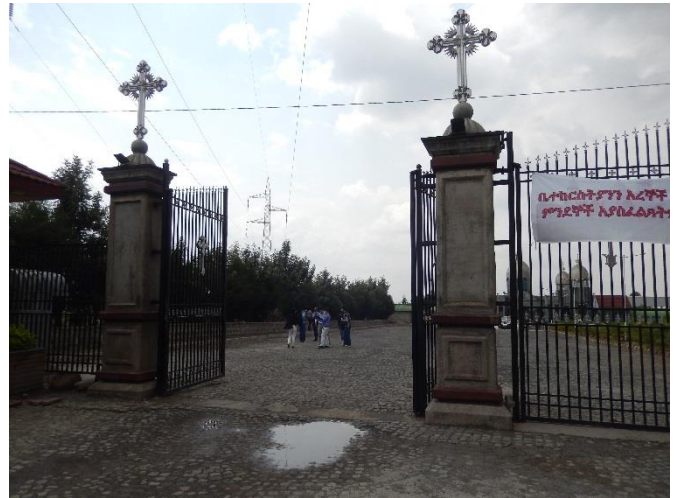
T 67
DSCN0367 New Tower will be located 30-40 meter
front of existing tower T67.

Remarks
New Cable Termination Tower will
be constructed by replacing T 67.

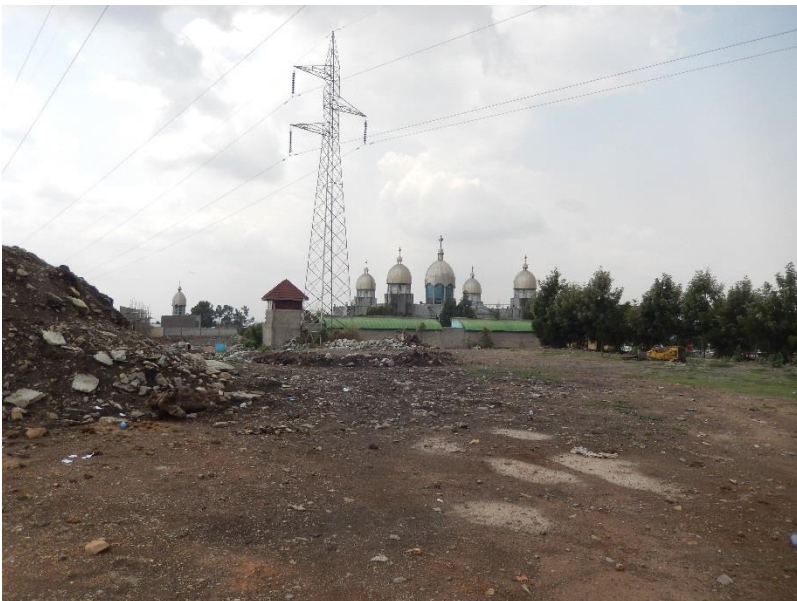
DSCN0379 T67 Second 132kV TL is just beside T67.
