斜面カルテによる調査結果

Code no.	N	1	5	-	1						
Region Office	Abbottabad										
Maintenance Unit	Balakot

Evaluation sheet (Slope failure/Rockfall)

Coordinates	Latitude				N 34°27' 49.7"						
	Longitude				E 73°19' 58.3"						
Road name	N	1	5		Km	2	8	+	4	0	0

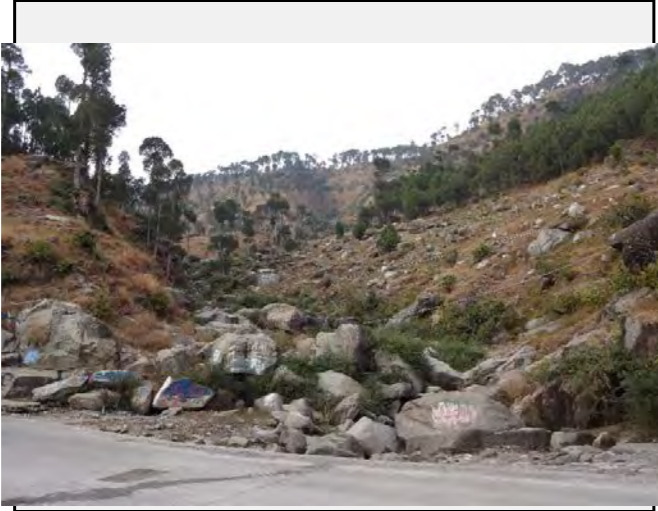
Mountain side: Large boulders are deposited on the mountain side.

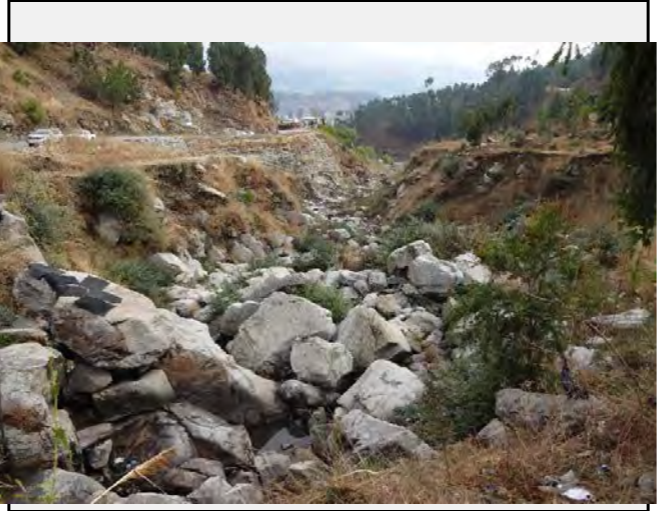
Valley side: Large boulders are deposited on the valley side.

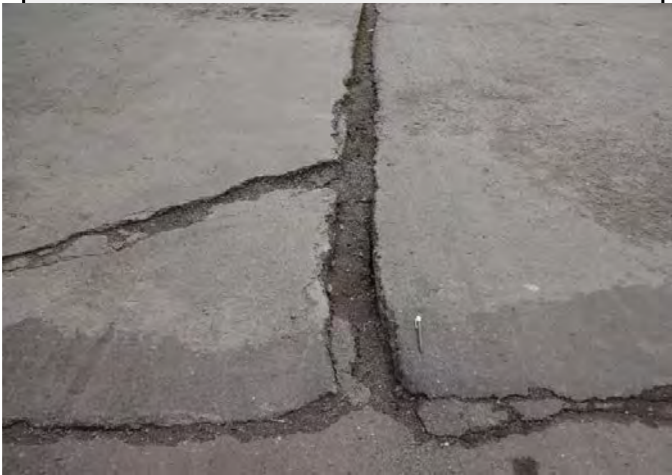
Existing anomalies: Cracks (20cm) was confirmed on the replaced portion of the road.

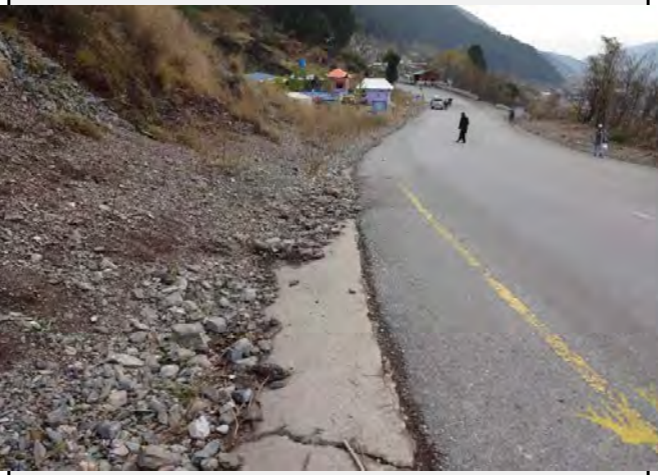
Existing countermeasures: The waterway is filled mostly by the talus.

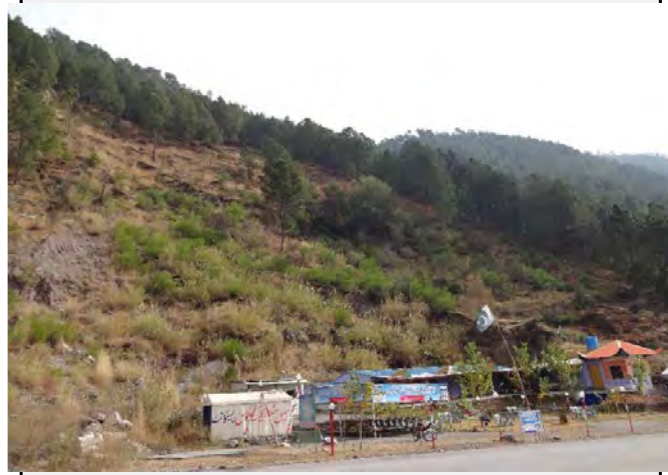
Others: A restaurant was constructed six months ago at the toe of the slope.

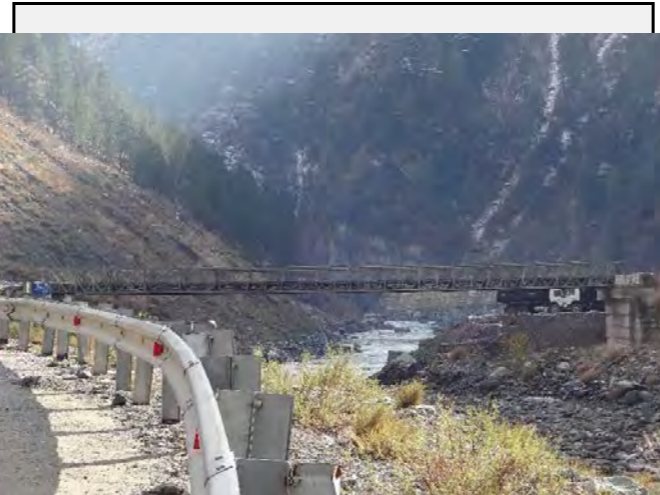
Existing countermeasures: Bailey bridge is used as temporary on the bypass road.

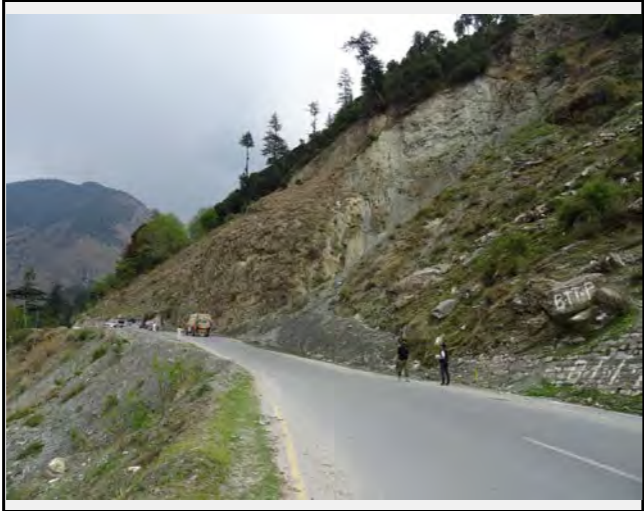
Mountain side: The mountain side is covered mostly by the talus

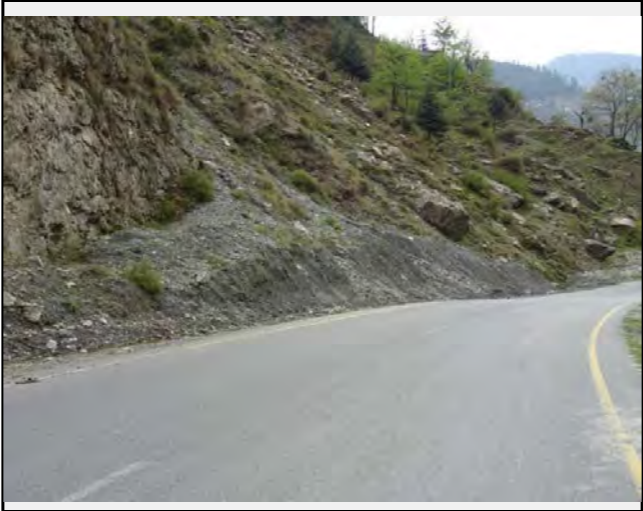
Valley side: The valley side is covered mostly by the talus and several rocks

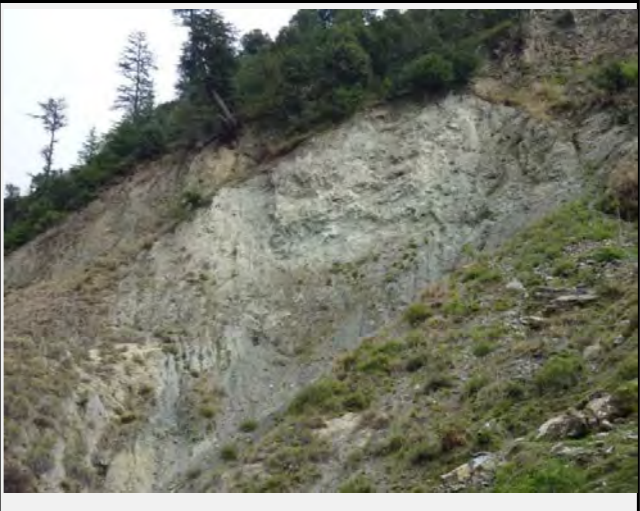
The outcrop that can be seen in the top part of the slope seems highly weathered

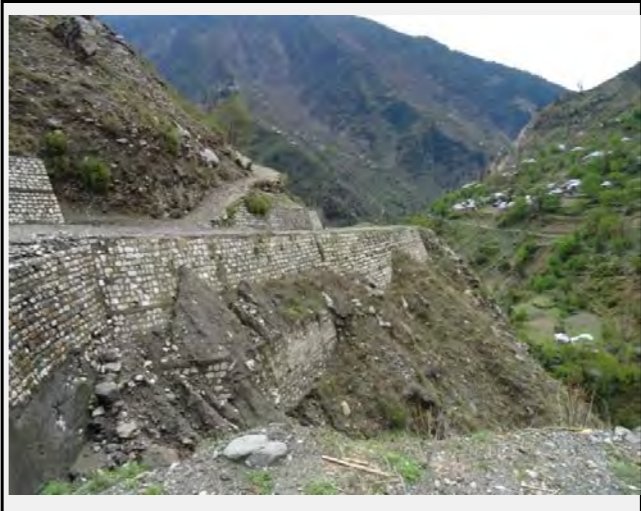
Existing countermeasures / anomalies: The exit of the retaining wall on the mountain side was re-shaped to allow the debris flow. However, this is resulting a steeper angle of the stream. The thickness of the sediment in the stream bed is around 2m

Possible countermeasures: a bridge can be constructed in the valley side of the road avoiding the debris flow stream.

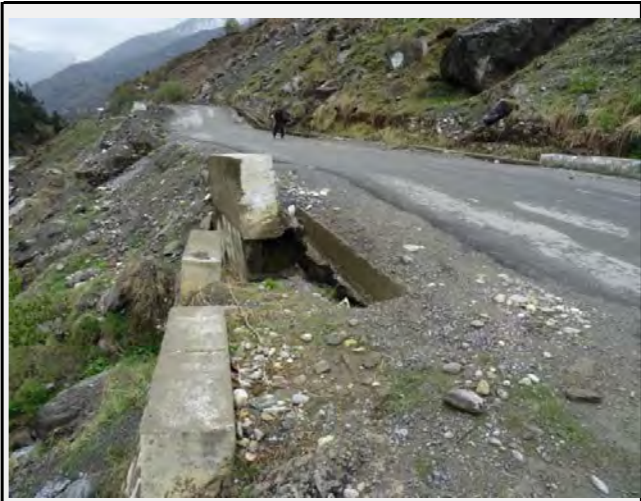
Road condition: Two area of the road subsidence was confirmed. There might be a cavity underneath the road.

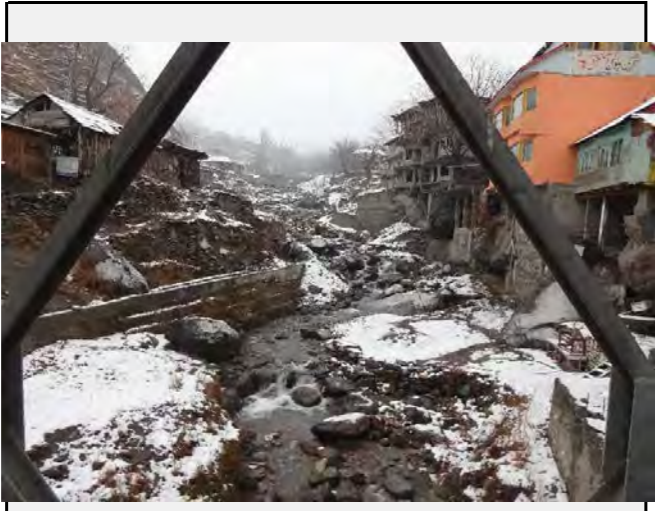
Mountain side: Boulders and debris deposited along the gentle angle of the stream.

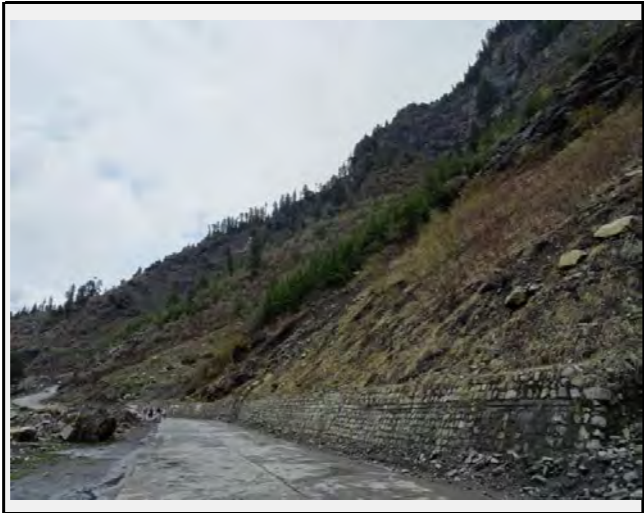
A vertical rock wall of approximately 250 m produces rock falls towards the road. The retaining wall has no effect as a countermeasure for rock falls

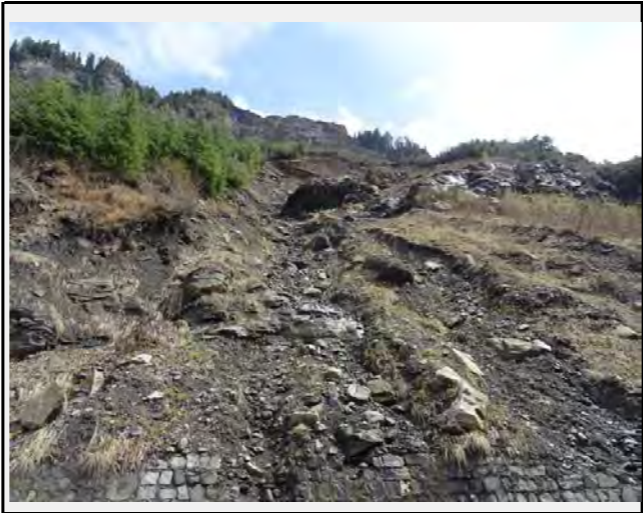
Fallen rocks that have not reached the road but may collapse and fall again can be identified throughout the slope

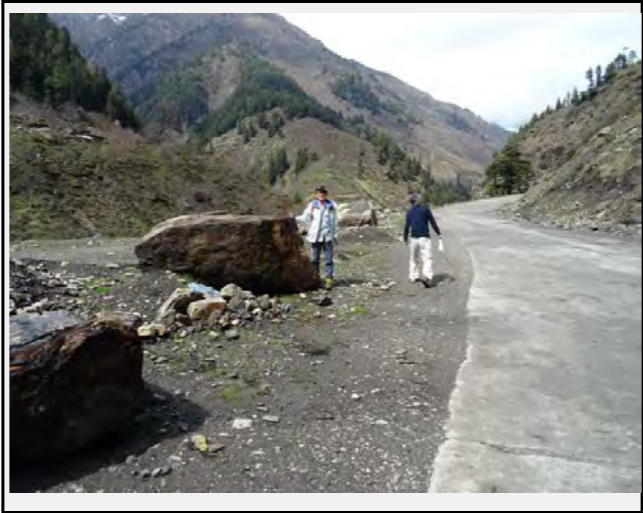
The biggest fallen rock identified (2m*1m*1m) has been pushed to the road side

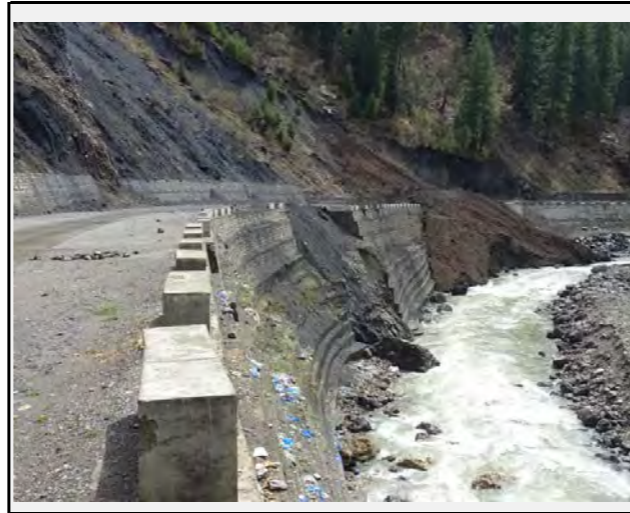
The valley side of the road is located in the outer curve of a river but it is protected by a concrete wall

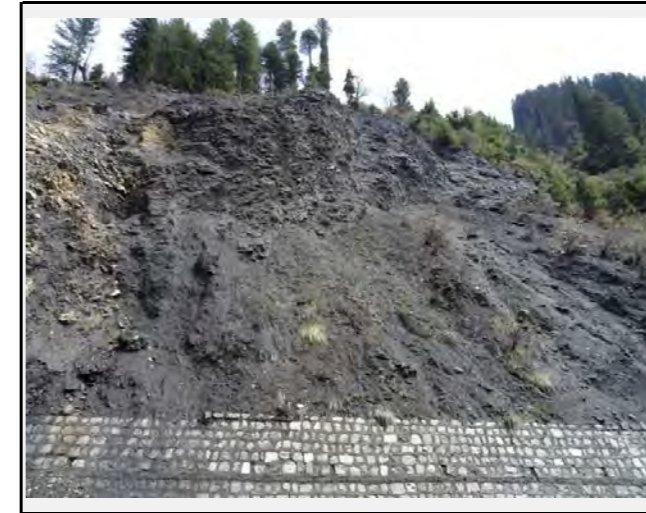
The debris and rocks detached from the highly weathered base rock surpass the retaining wall and fall on top of the road

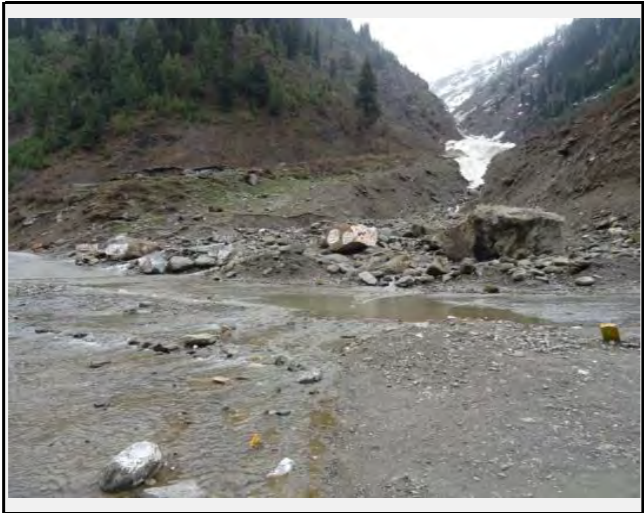
Overall view of the debris flow affecting the road

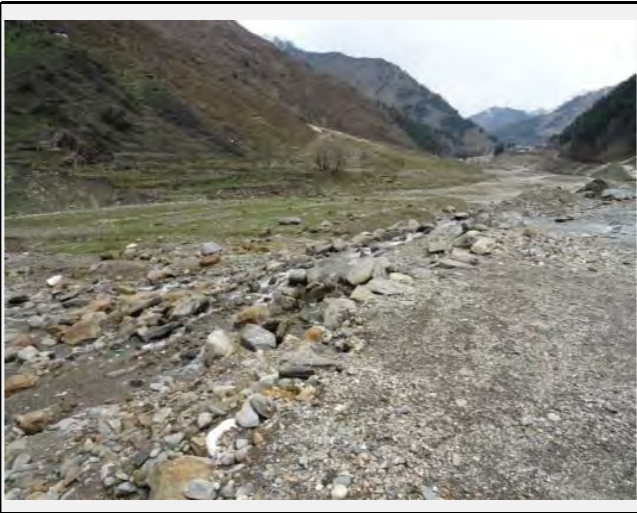
Valley side: debris flow deposits head towards the river. The geomorphology on which it lays is an alluvial fan

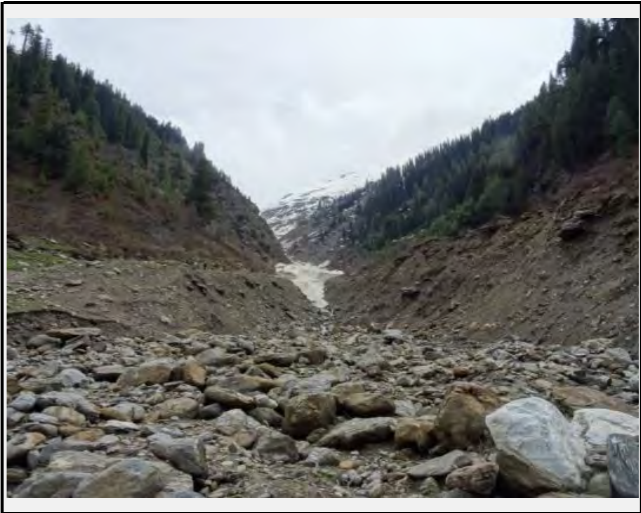
The mountainside of the road is full of debris flow deposits and a glacier can be seen at the end of the valley

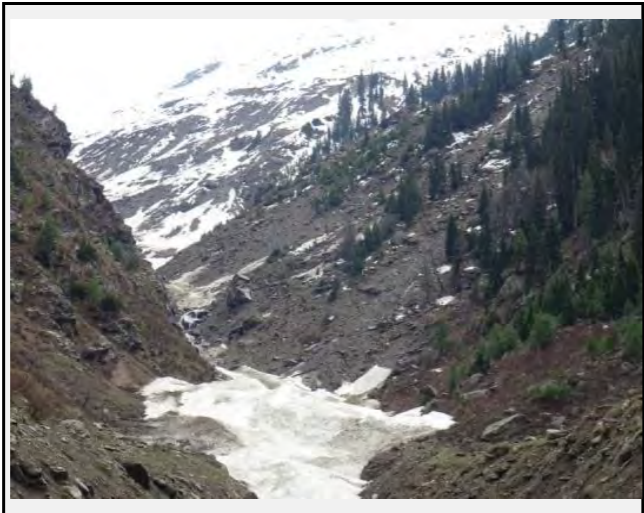
There is a big collapsed slope in the water catchment area

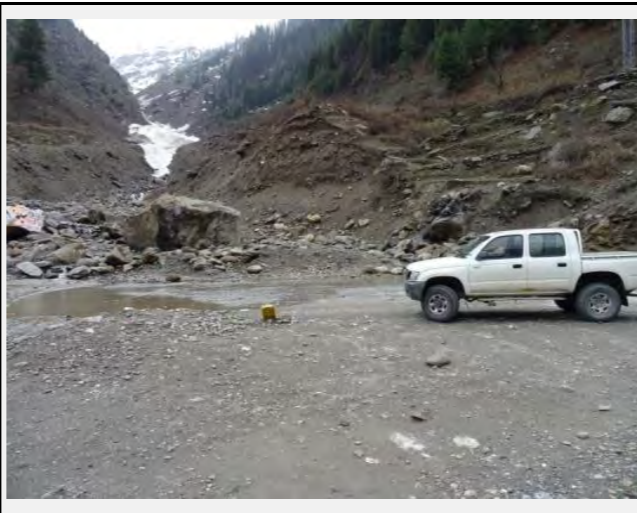
Big sized boulders (5m*8m*3m) can be seen on the stream bed. The Sides of the stream are completely bare and highly erodable

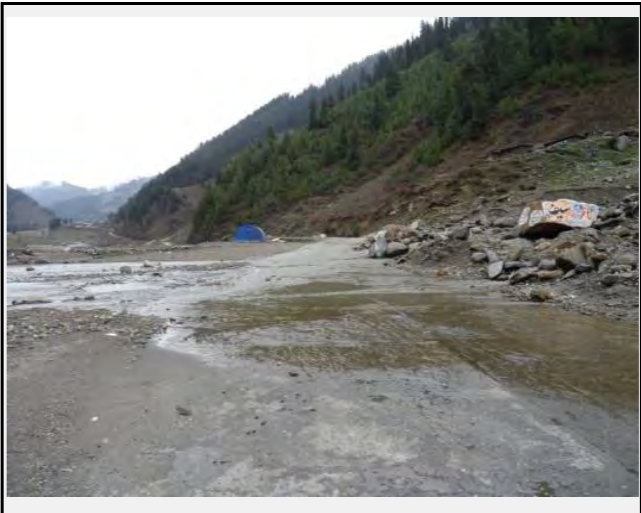
The road is flooded and partially covered by debris

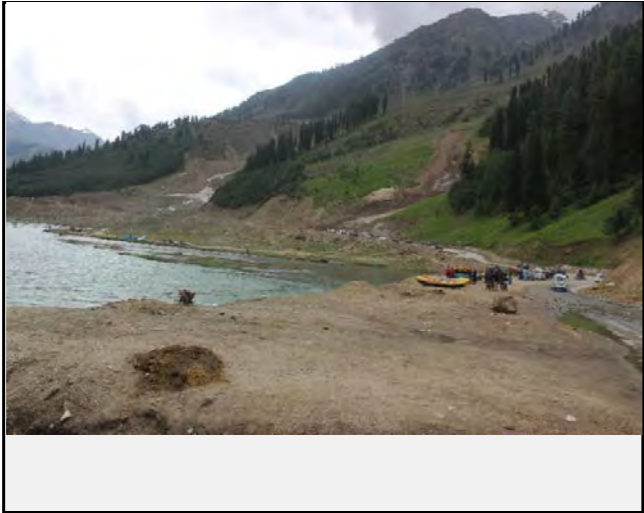
Full view of the landslide

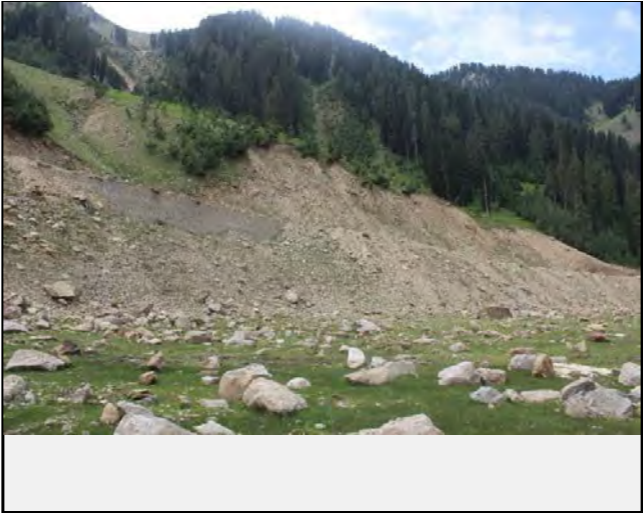
View of landslide on Valley side:

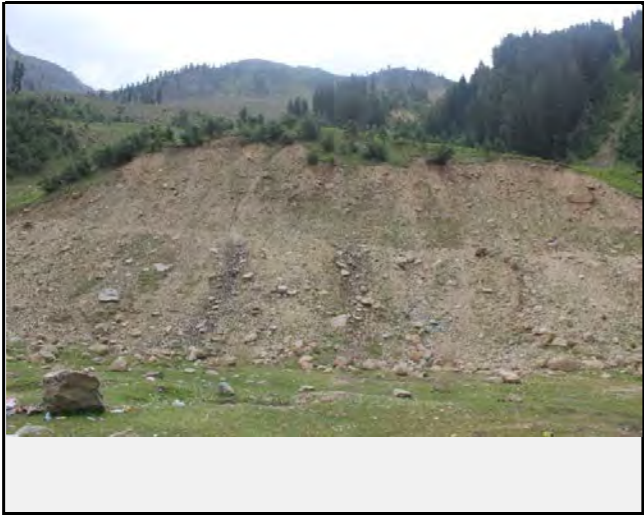
View of the Landslide at the middle point

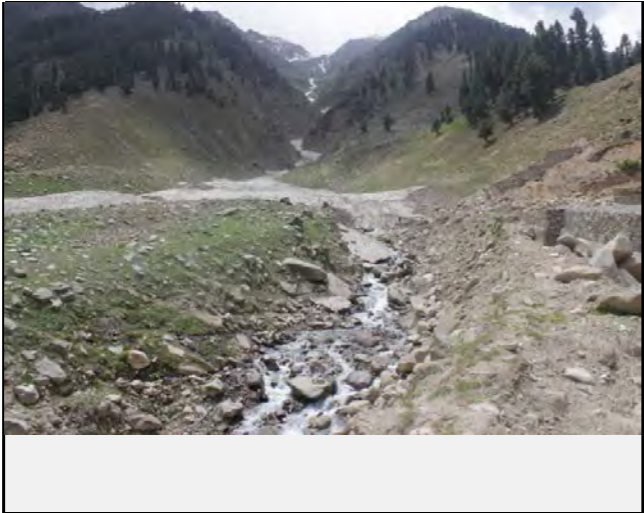
Mountain side view of the debris flow

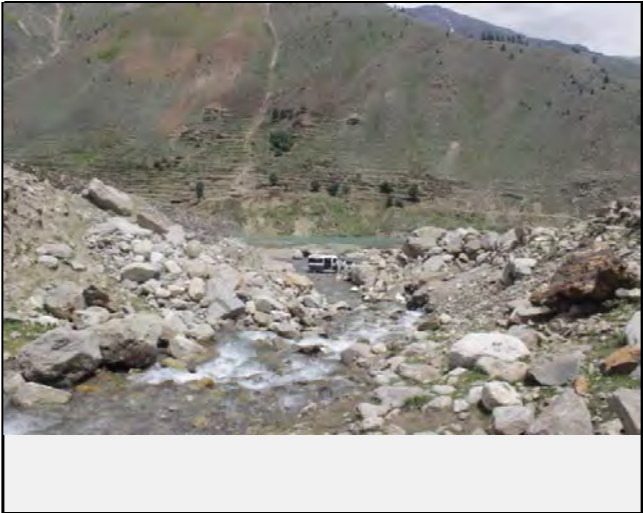
Valley side view of the debris flow

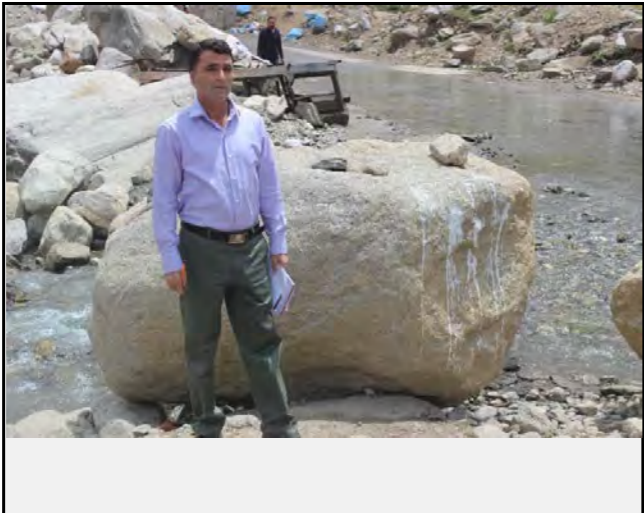
The boulder has been found along the debris flow

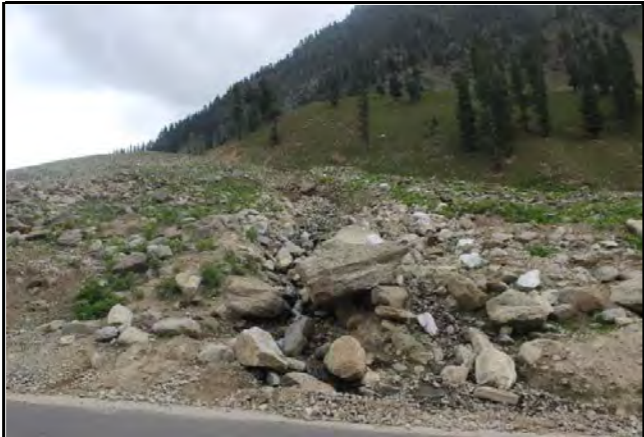
Mountain side view of the debris flow

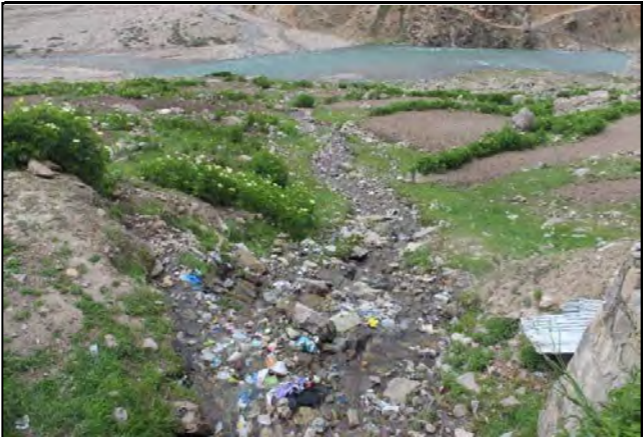
Valley side view of the debris flow

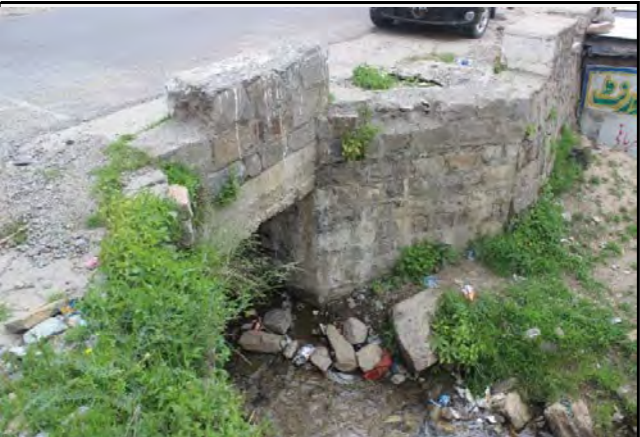
Outlet of Culvert constructed

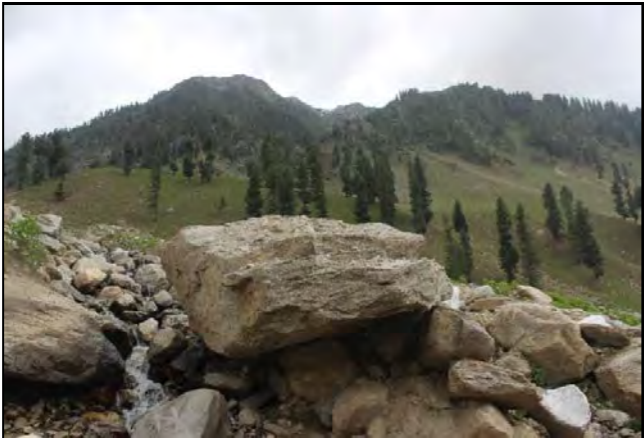
The boulder has been found along the debris flow

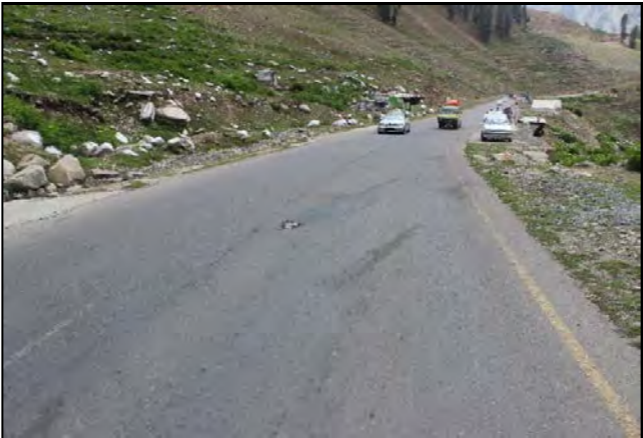
Road condition

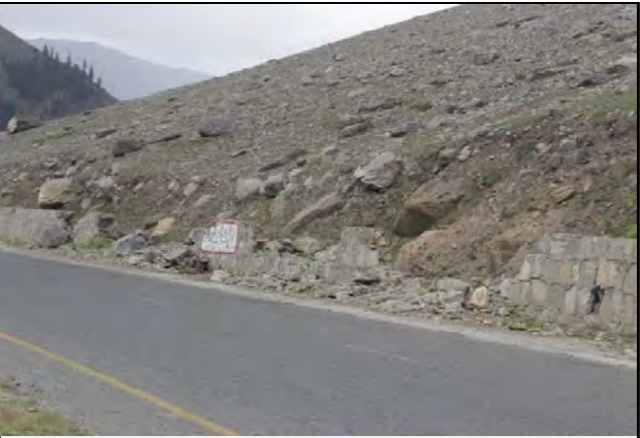
Existing countermeasures / anomalies: Retaining wall has been constructed along the Debris Flow which has been damaged by the debris material

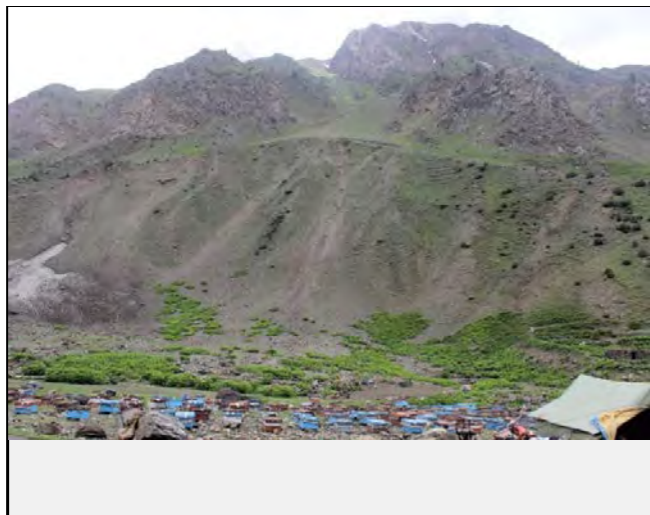
Full view of the landslide

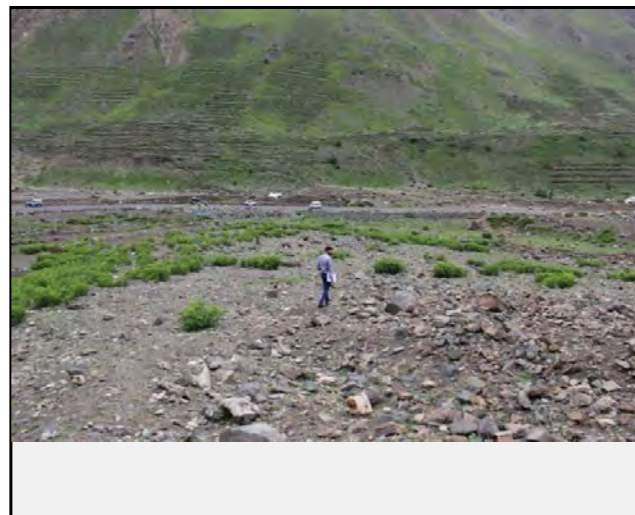
View of landslide on Valley side:

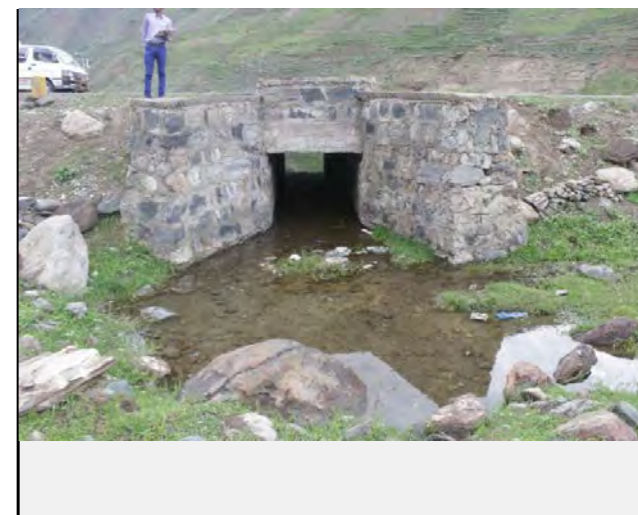
View of Box Culvert at the toe of slope

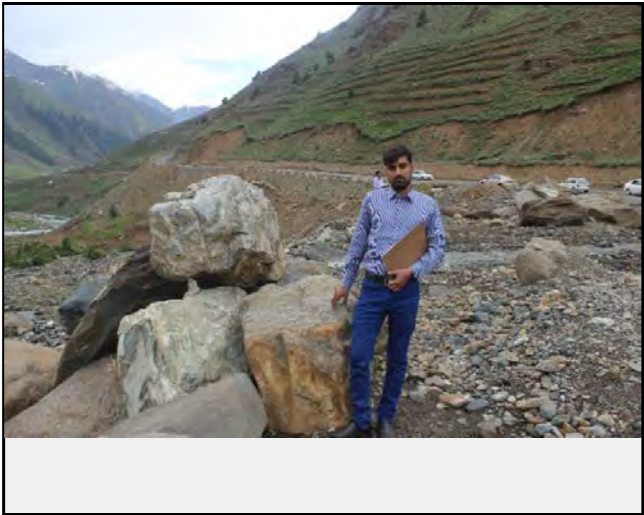
The boulder has been found along the debris flow

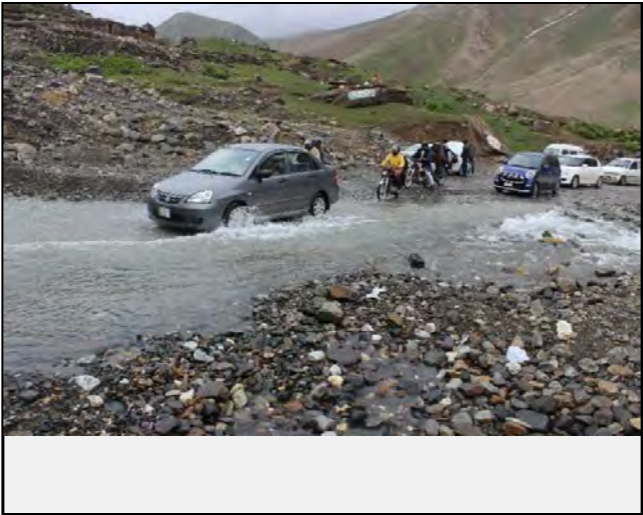
Road condition

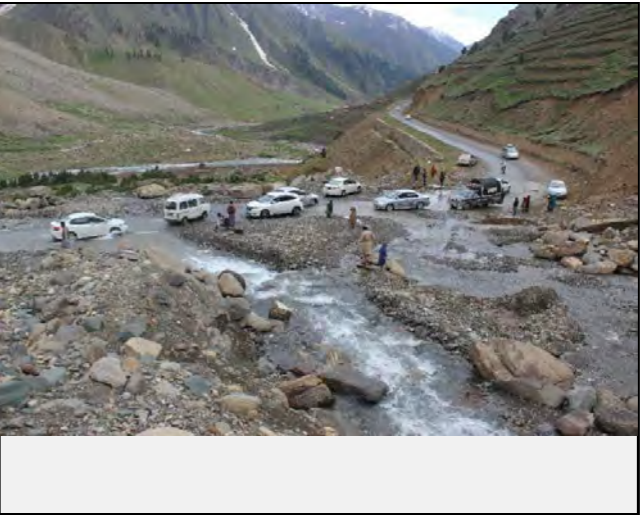
Debris flowing on road

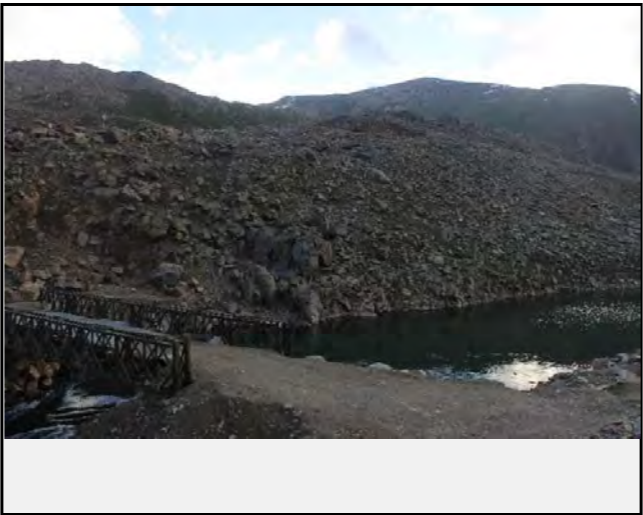
View of landslide on Valley side:

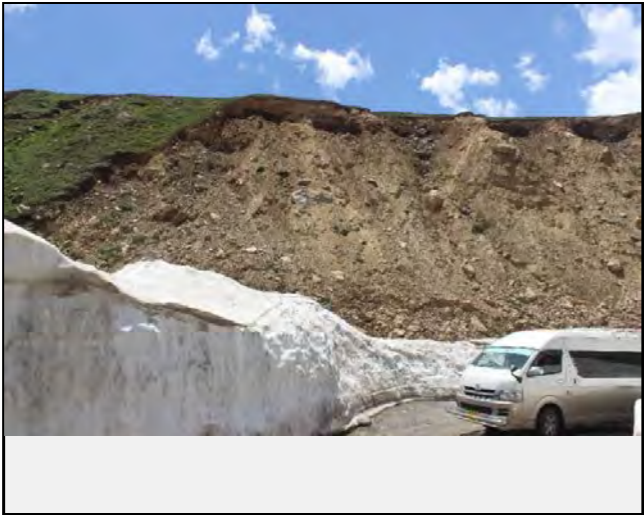
The boulder has been found along the debris flow

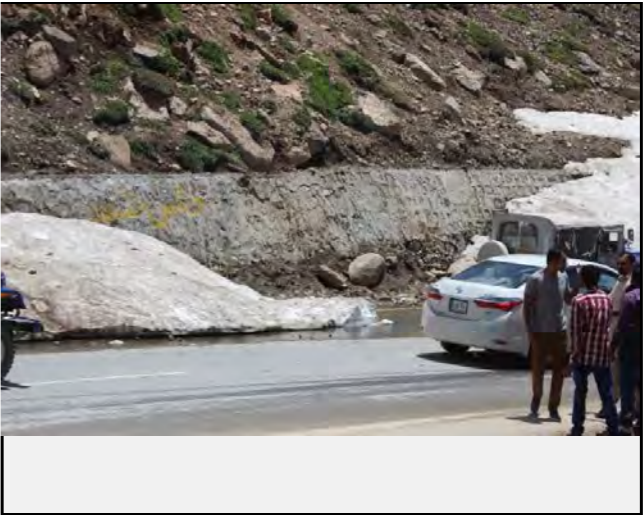
Existing countermeasures / anomalies: Retaining wall has been constructed along the Debris Flow

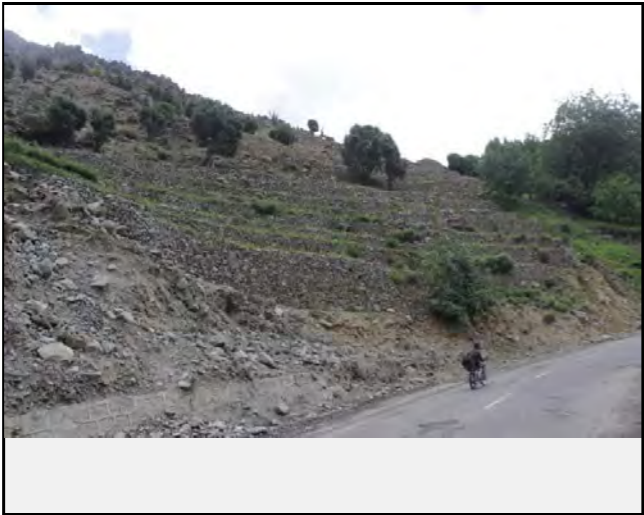
The Check dams has been built along the debris flow

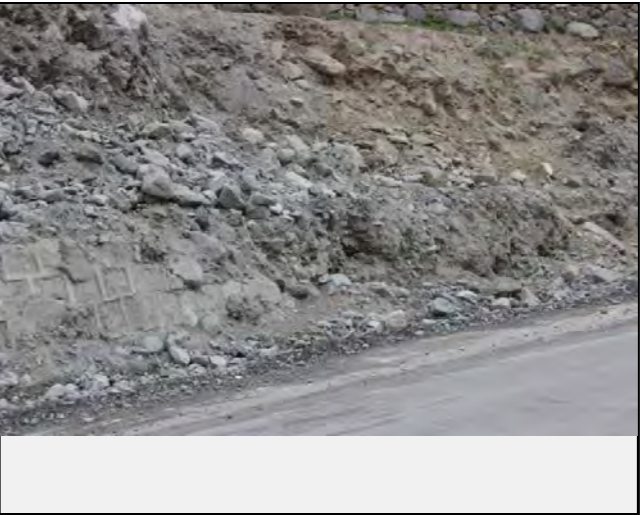
Existing countermeasures / anomalies: Retaining Wall has been constructed along the Debris Flow

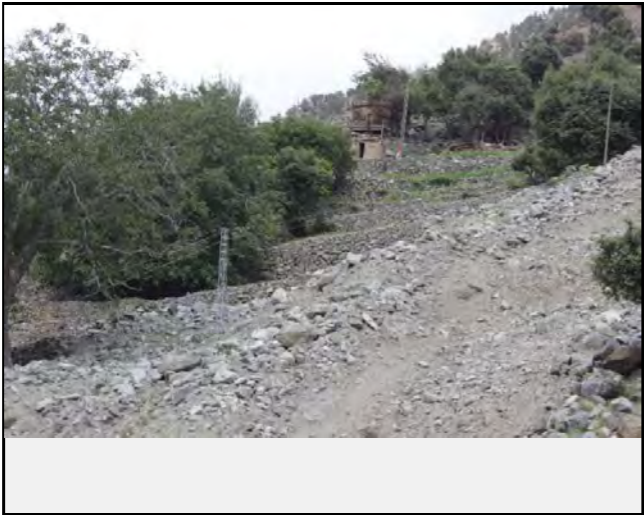
The Check dams has been built along the debris flow

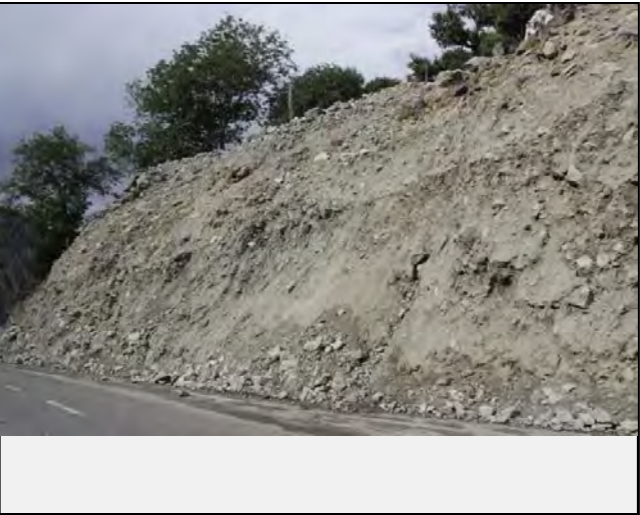
Existing countermeasures / anomalies: No Counter Measure

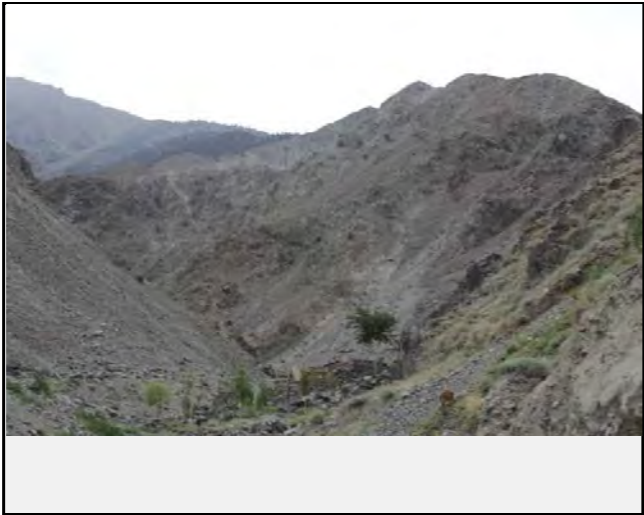
The Check dams has been built along the debris flow
