Code no.	Sat_	N	4	5	_	1			
Region Office									
Maintenance Unit

## Evaluation sheet (Slope failure/Rockfall)

Coordinates	Latitude	35° 39' 37.3"							
	Longitude	71° 45' 58.9"							
Road name					Km

Date	2018/12/4								
Inspector	Yasir, Sajid, Shafique, Basharat

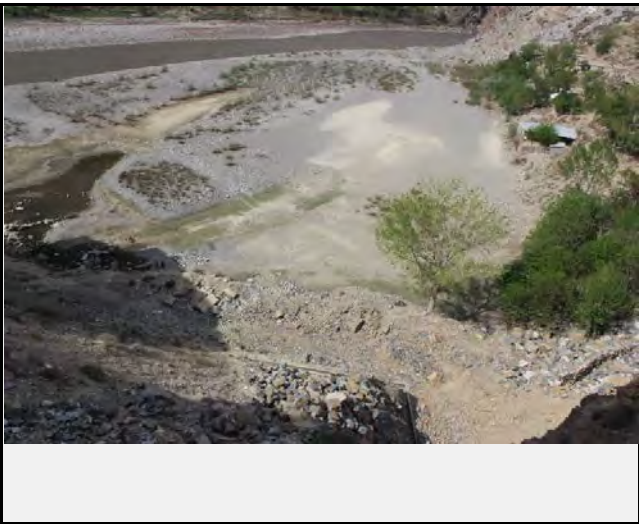
View of landslide on Valley side:

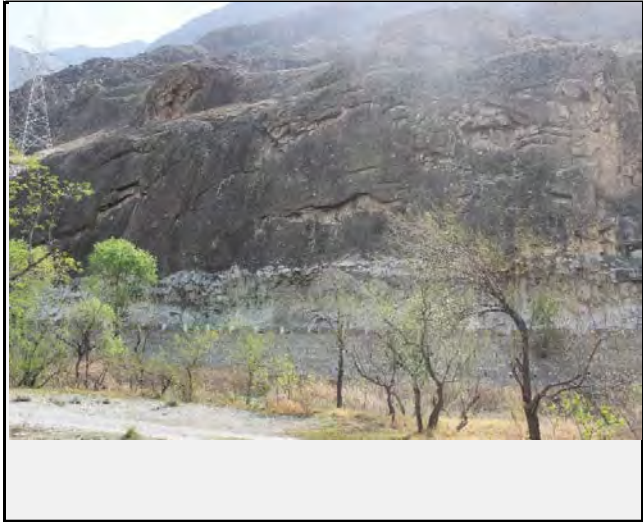
Full view of the landslide

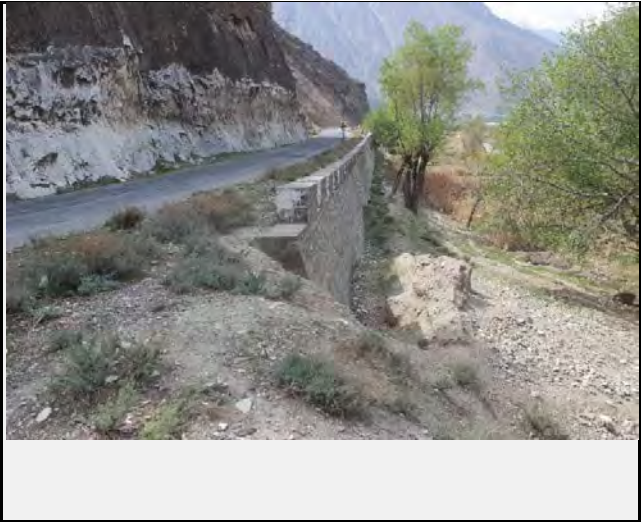
View of landslide on Valley side:

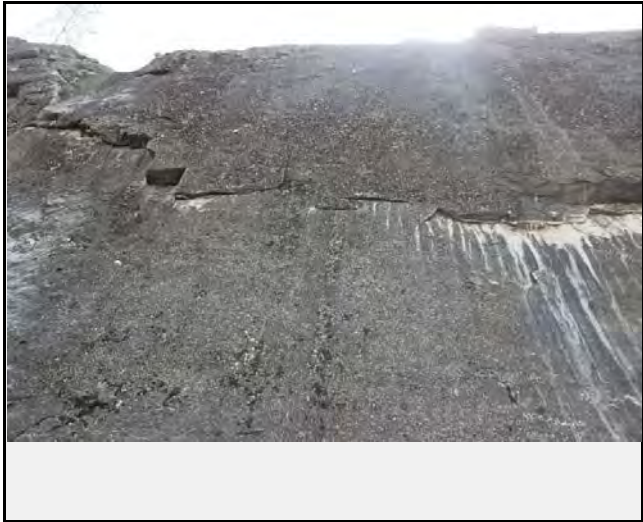
View of the slope failure at the middle point

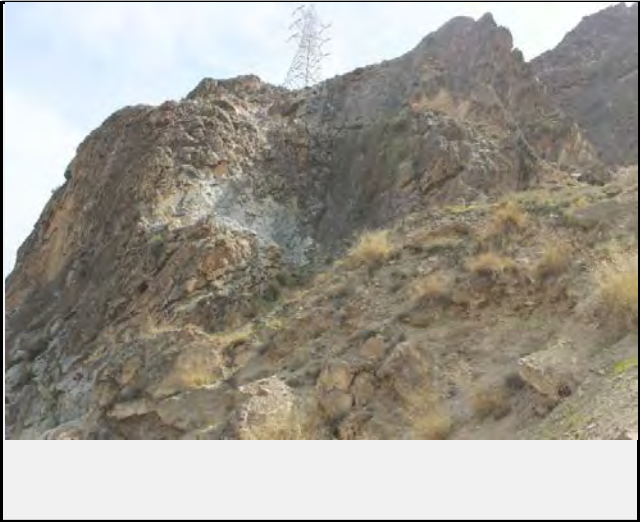
View of drainage that cuts the slope

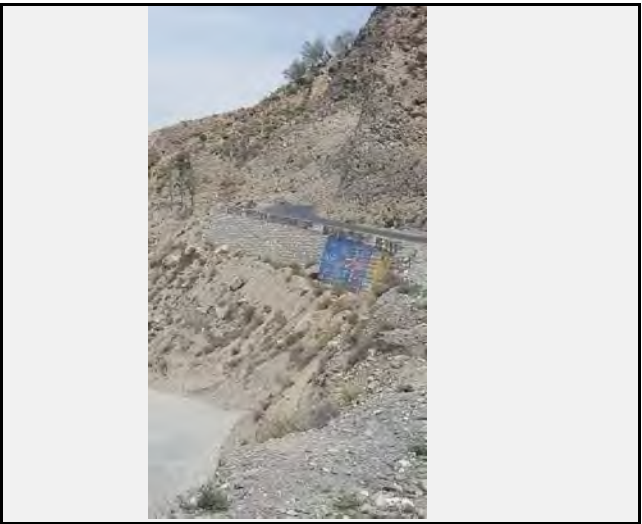
View of landslide on Valley side:

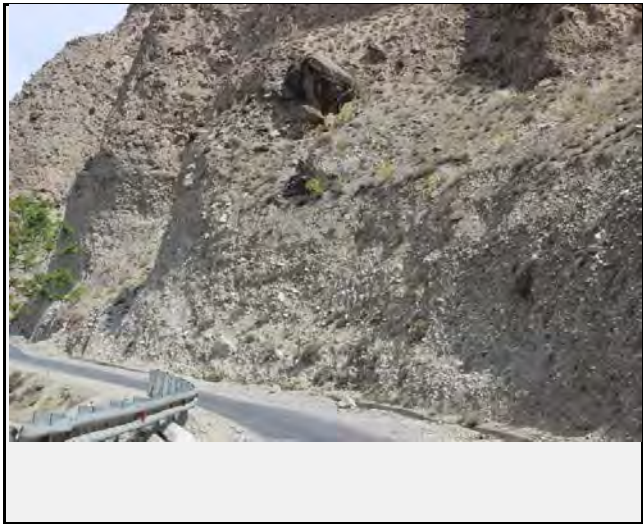
View of the slope failure at the middle point with boulder which threaten the road and traffic.

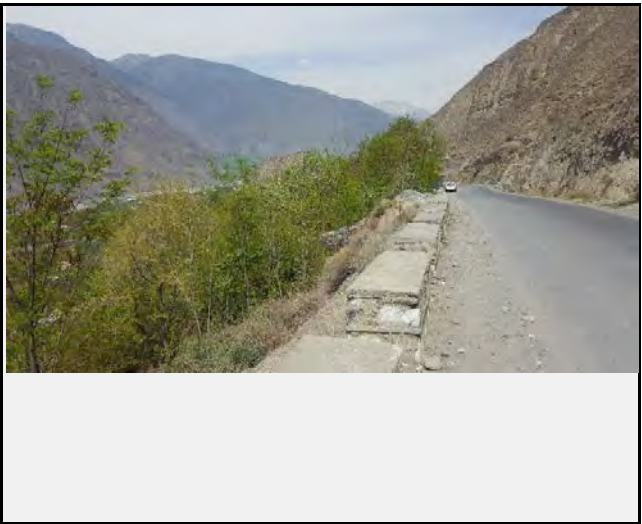
View of landslide on Valley side:

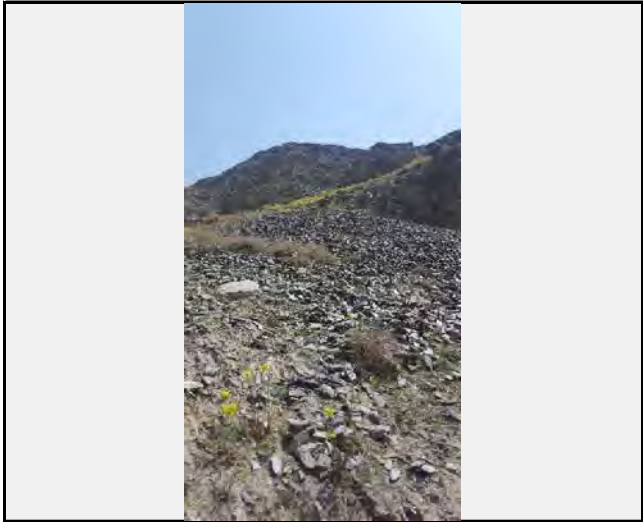
Full view of the landslide

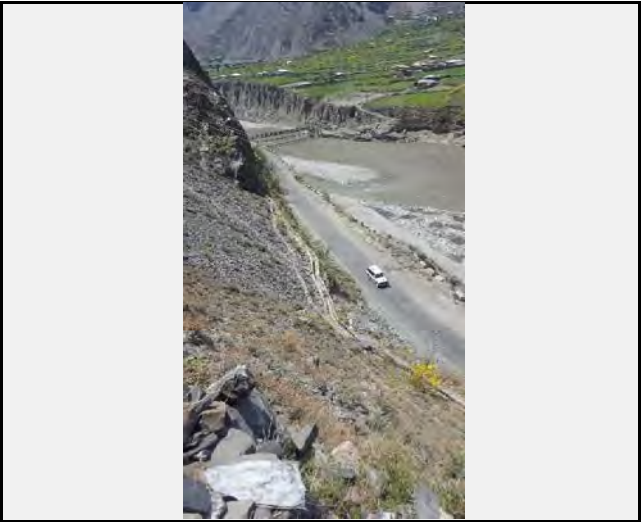
View of landslide on Valley side:

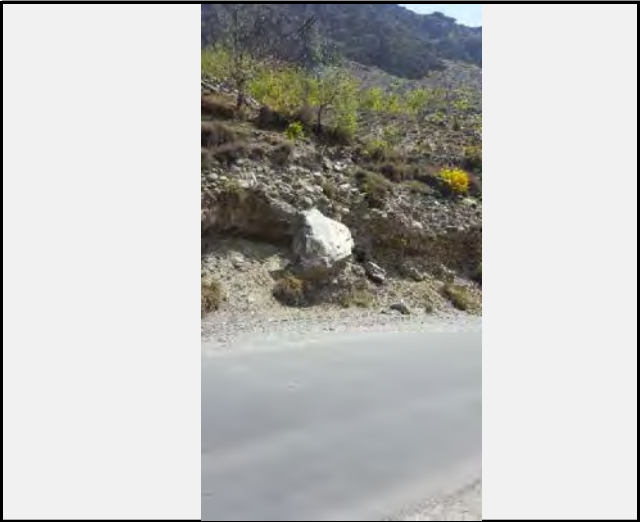
Road condition: Cut slope at the start point

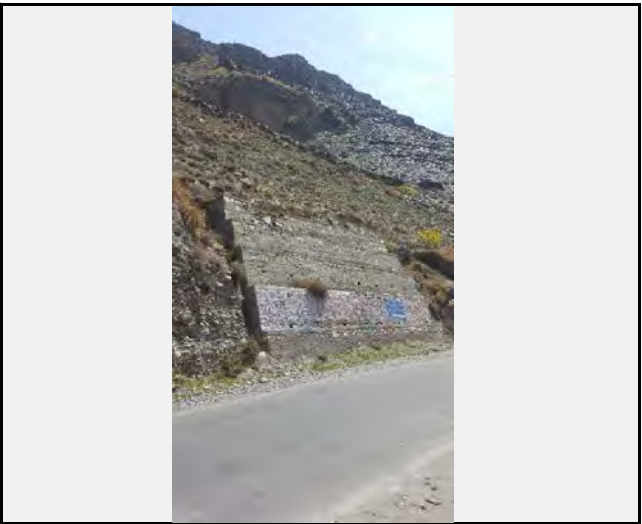
Existing countermeasures / anomalies: View of Stepped Retaining Wall as counter measure

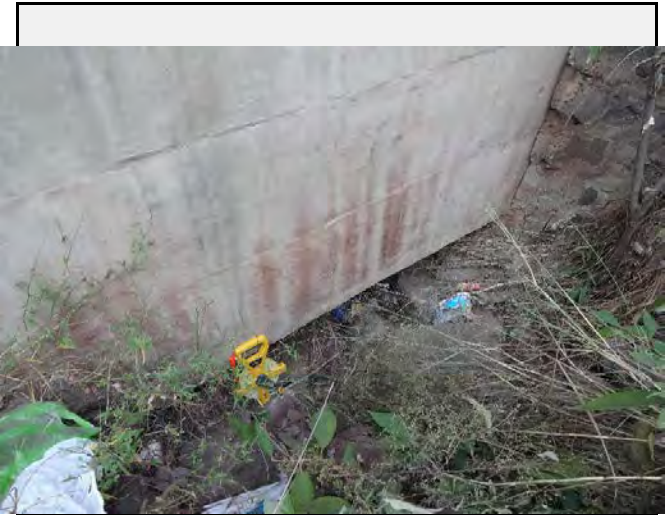
Existing countermeasures: The culvert is filled with debris and rocks which may block the waterway from the mountain area, resulting the flooding of the road.

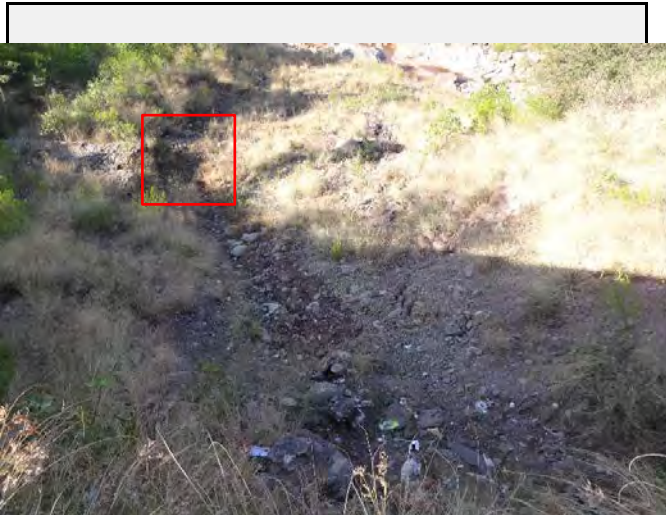
Existing countermeasures: Partial of the gabion works in the valley side was washed away by the debris. Reinforcement of the gabion work will be necessary to stabilize gradient of the river bed.

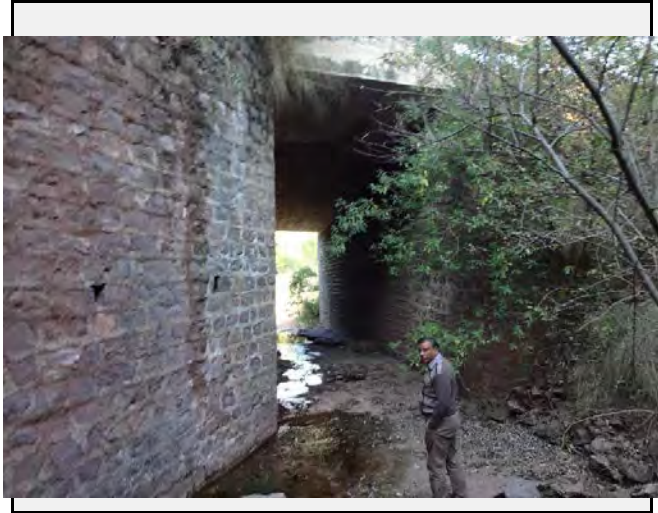
Existing countermeasures / anomalies: The box culvert are clear from any debris.

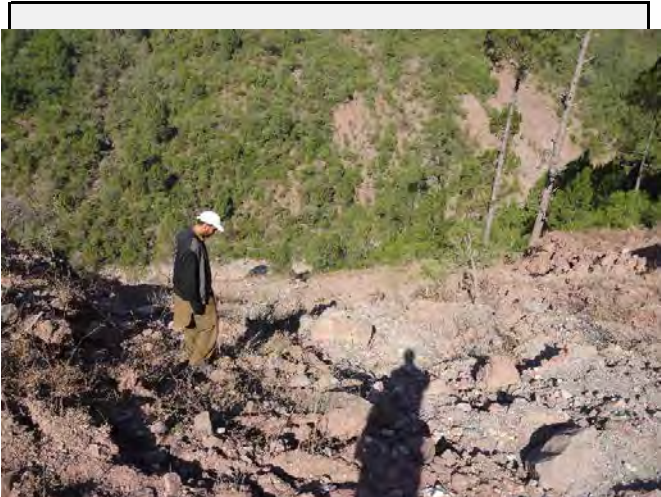
Valley side: Valley side are covered mostly by the debris and small rocks

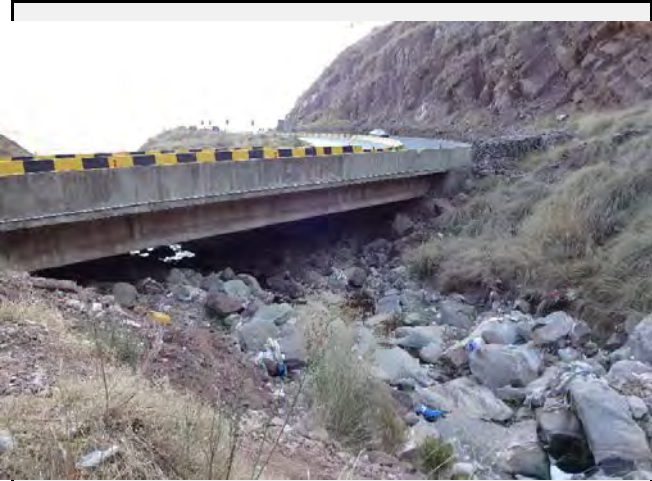
Existing countermeasures / anomalies: Dumping of the garbages around the bridge reduce the capacity to drain the debris to the valley side.

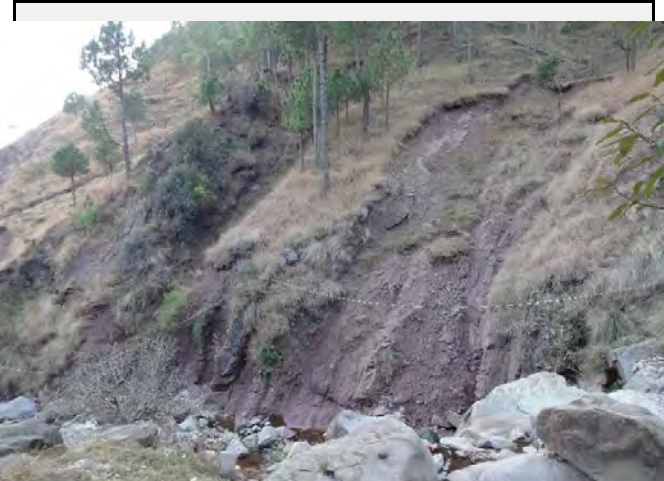
Existing countermeasures / anomalies: Several surface collapse can be observed on the west side of the slope on the mountain side.

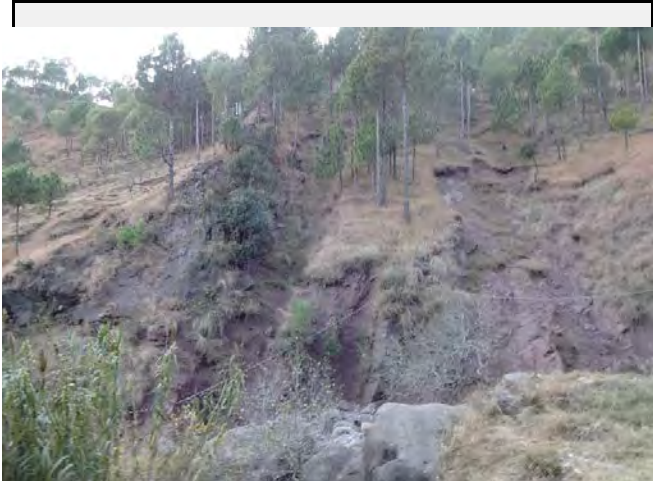
Existing countermeasures / anomalies: Several surface collapse can be observed on the west side of the slope on the mountain side.

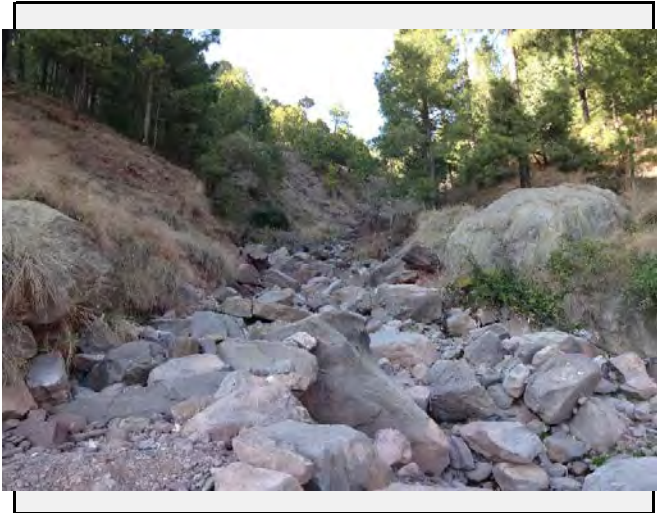
Mountain side: Stream is filled with boulders (~3m) on the mountain side.

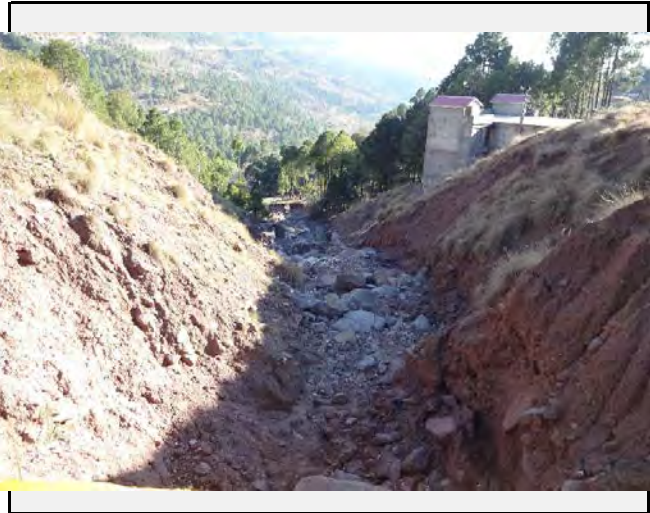
Valley side: Stream is filled with boulders (~2m) on the valley side. There is trace of erosion on the both side of the stream.

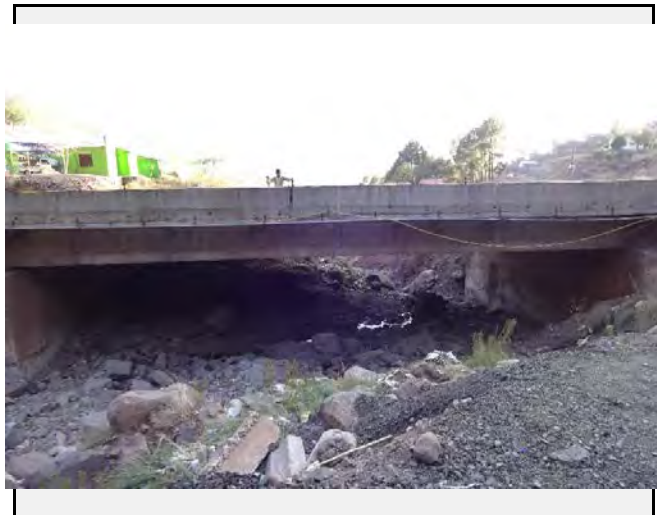
Existing countermeasures : The height underneath the bridge seems enough to clear the debris to the valley side.

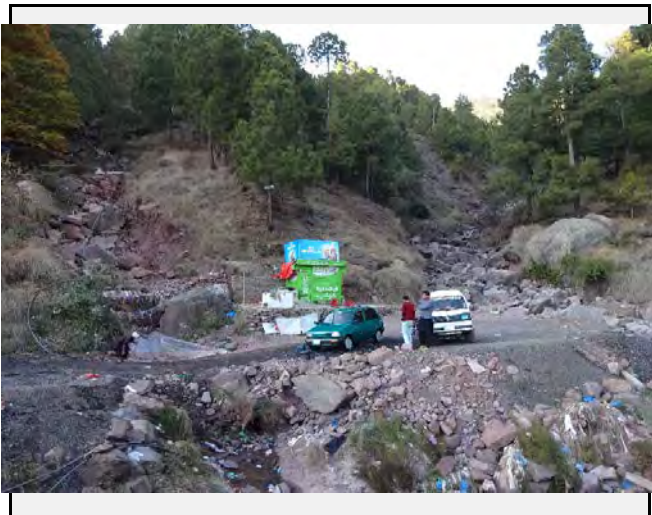
Others: Another small stream is flowing into this stream. This area is used as a carwash pit for the local people.

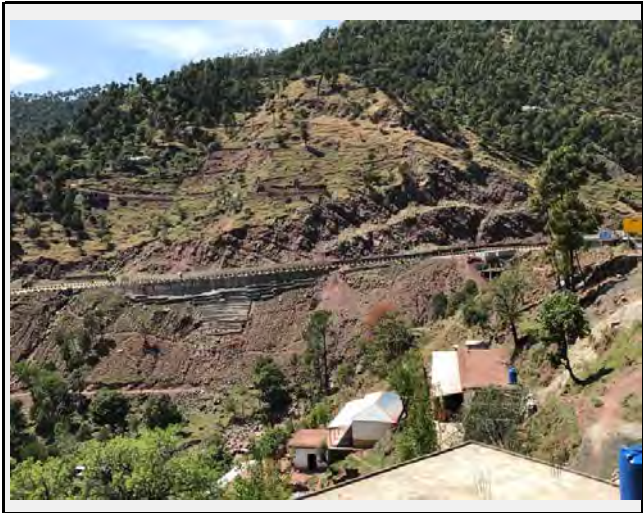
Overall view of the slope. Rock falls are expected in the mountain side and slope failure in the valley side.

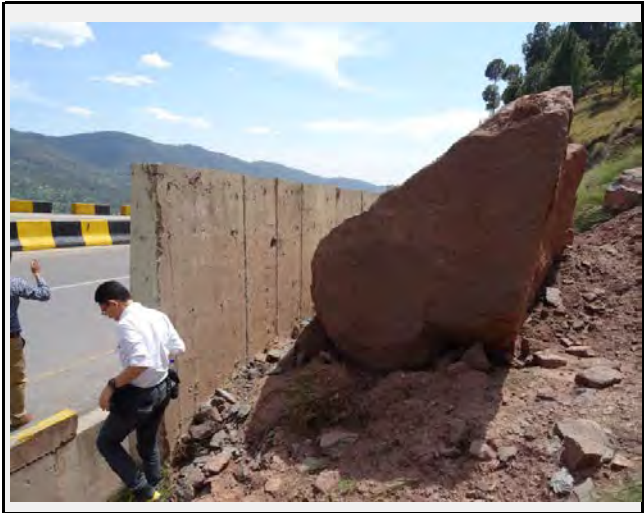
Rock falls of 2m3 have happened in the past reaching the road.

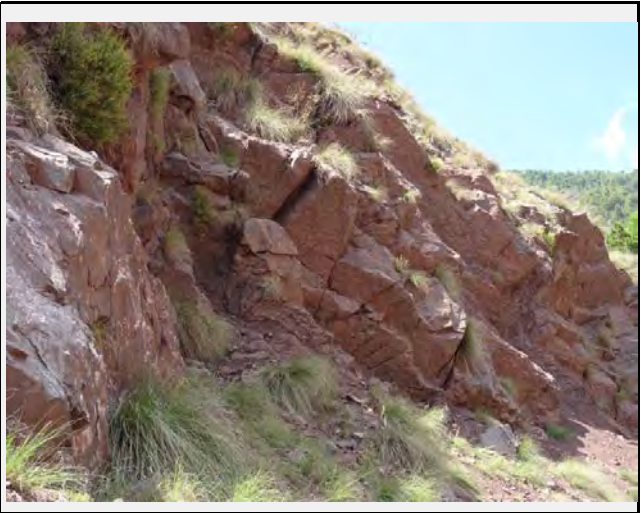
The base rock of the mountain side slope is highly fractured and some layers are highly weathered facilitating rock falls

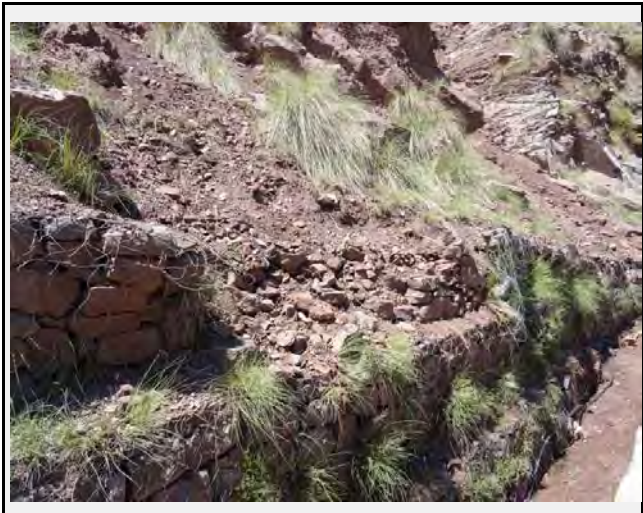
The gabion wall is damaged in many spots due to past rock falls and is thought not to operate properly as a countermeasure

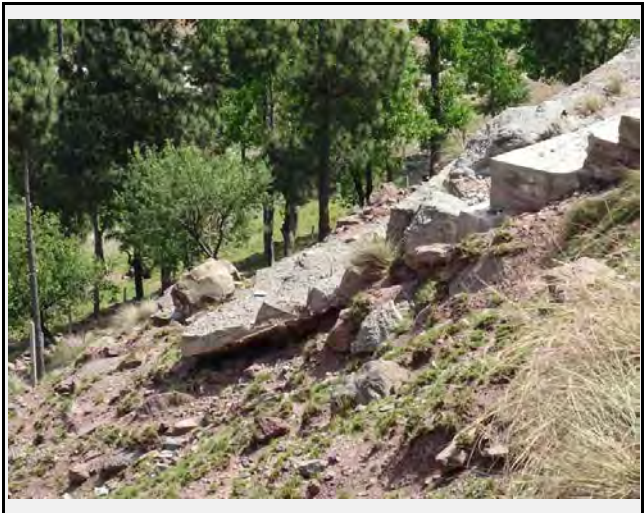
The retaining wall in the valley side is being damaged because the soil on which it is constructed is being washed away.

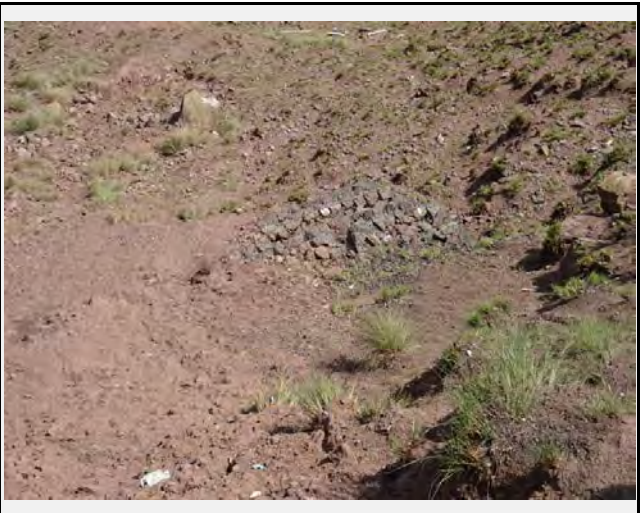
Slope failures have collapsed and damaged gabion walls constructed in the valley side as retaining walls for the embankment

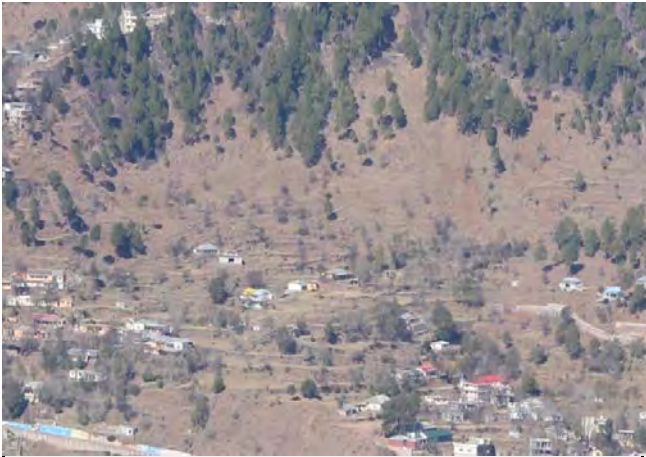
Mountain side view of landslide

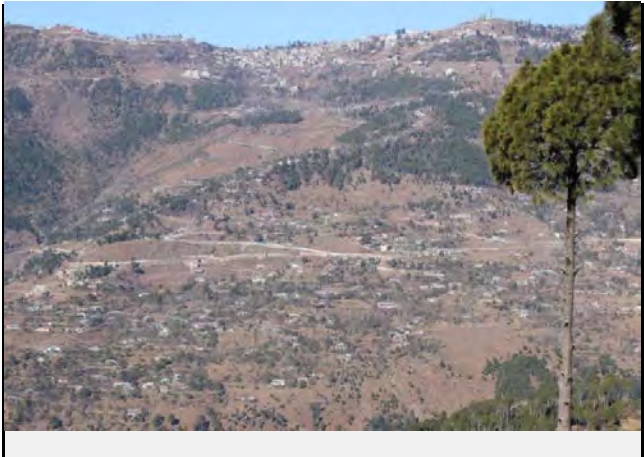
Valley side view of landslide

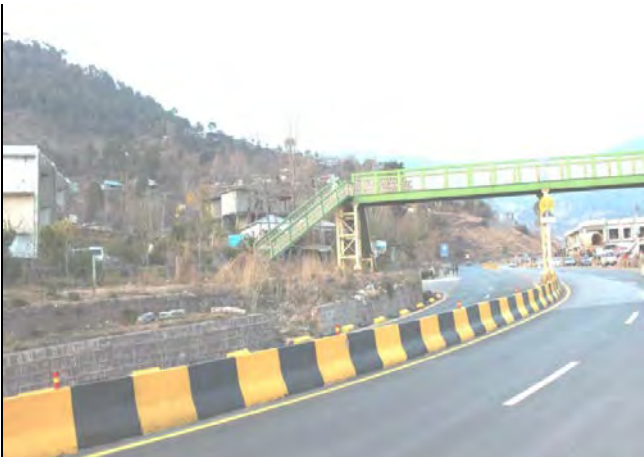
Road condition: Road is built through the landslide

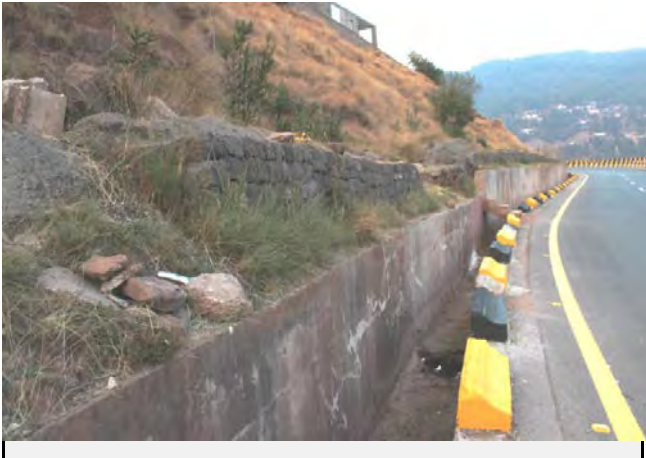
Existing countermeasures / anomalies: Retaining and gabion walls has been constructed to protect the road

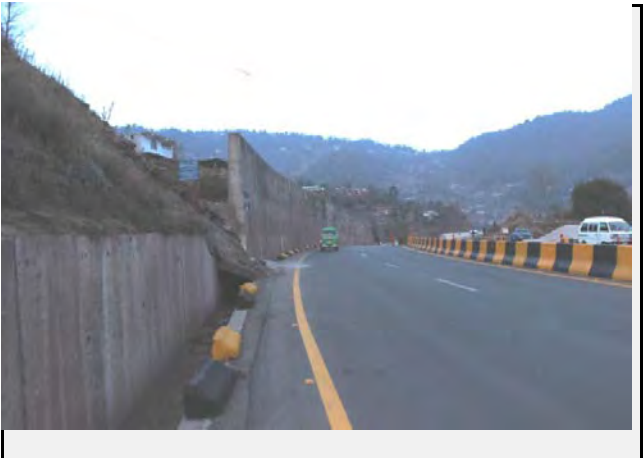
Existing countermeasures / anomalies: Retaining wall has been constructed

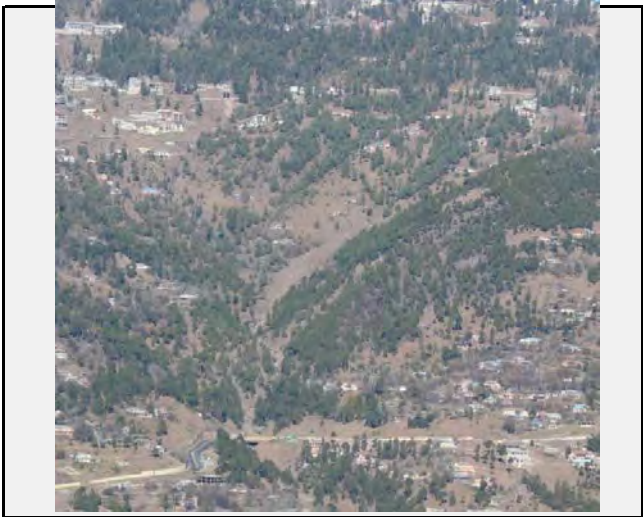
Mountain side view of the debris flow

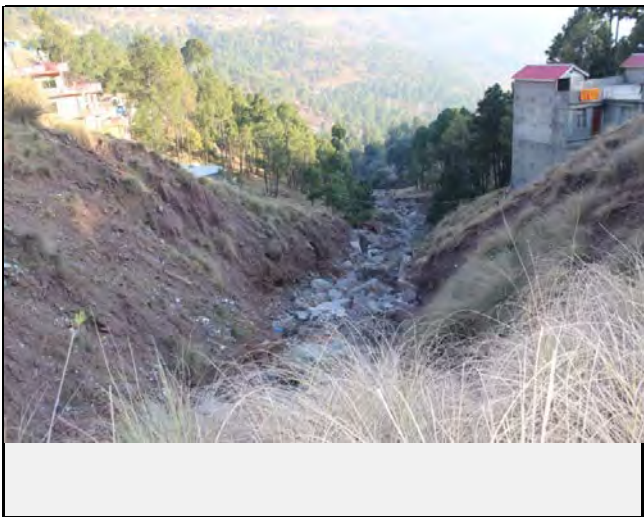
Valley side view of the debris flow

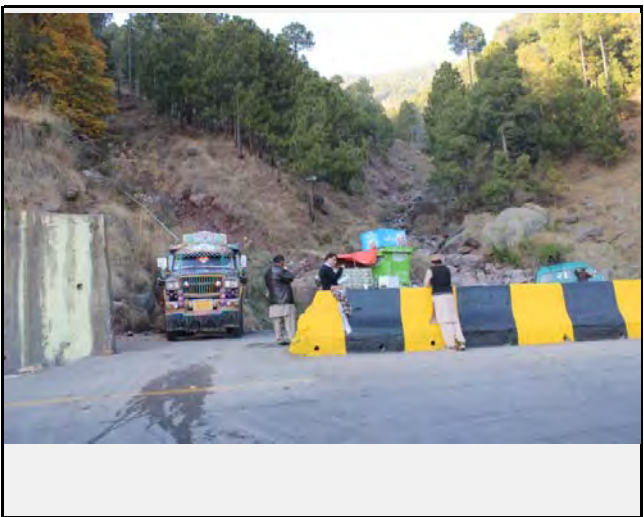
Front view of the debris flow from the road

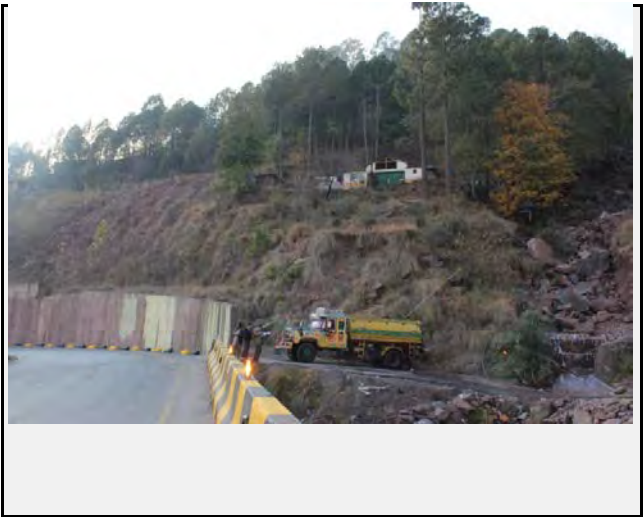
Road condition

Existing countermeasures / anomalies: Retaining wall has been constructed at the toe of the slope failure

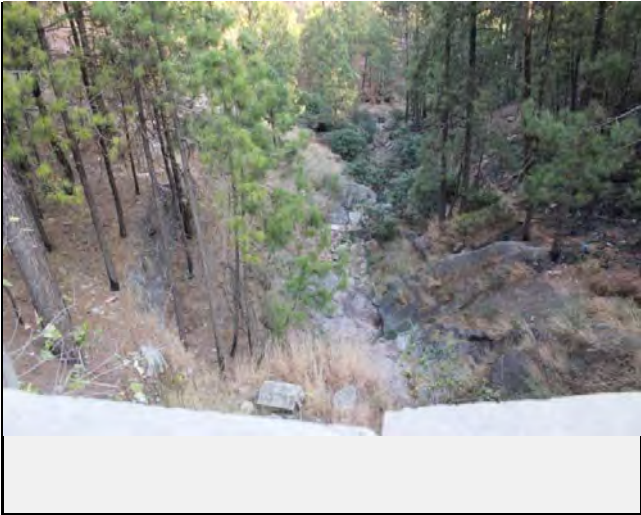
View of debris flow towards valley side

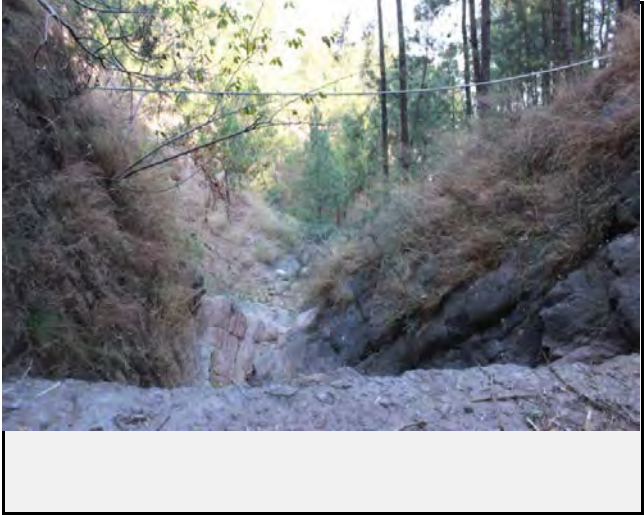
Valley side view of the debris flow

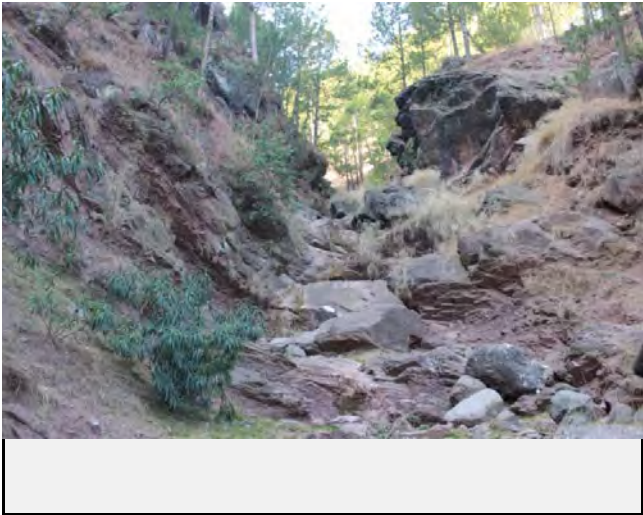
Rock bed dipping towards the channel

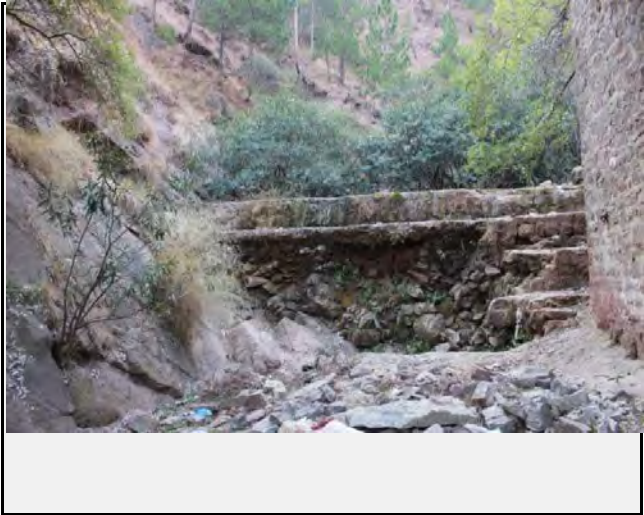
Existing countermeasures / anomalies: Benches has been made on the upstream which are been partially destroyed

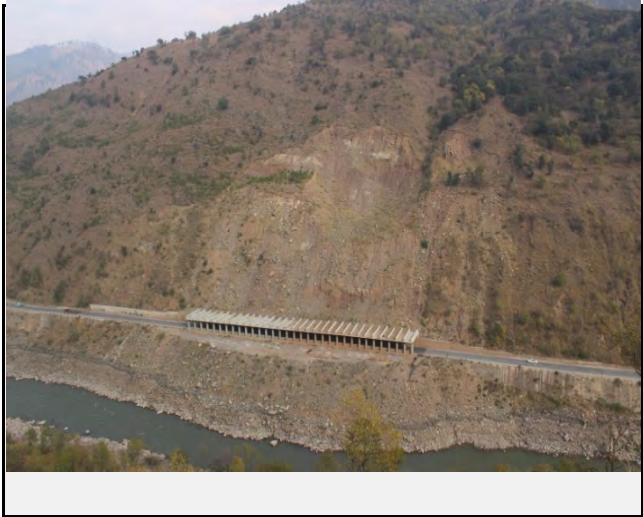
Landslide was initially triggered during 1992 flood. In March 2012, landslide was reactivated during the heavy rainfall. The landslide completely destroyed 200 meter road. The continuity of traffic along this road was disrupted more than one week during March 2012. This section is cut slope consisting of sandstone and shale. The slide is still active. There are large number of open cracks and hanging boulders. As a countermeasure NHA has constructed the shed to protect the road from debris material.

Full view of the landslide

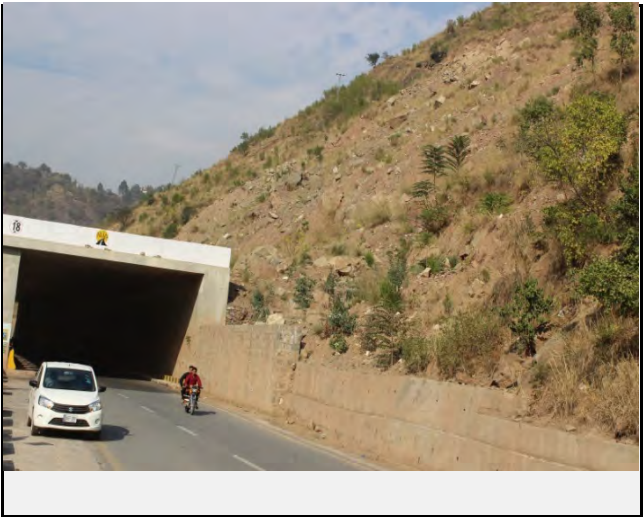
Road condition: Cut slope at the start point

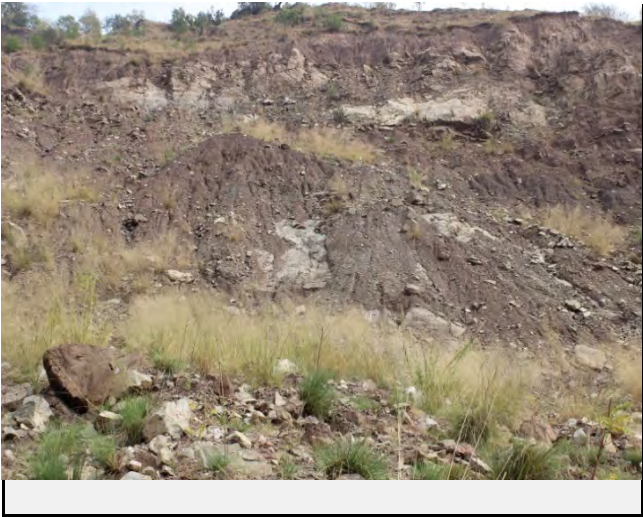
View of the slope failure at the middle point

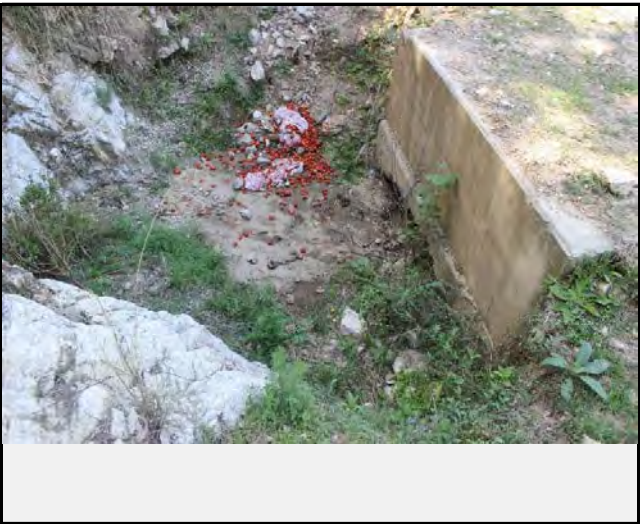
View of culvert inlet

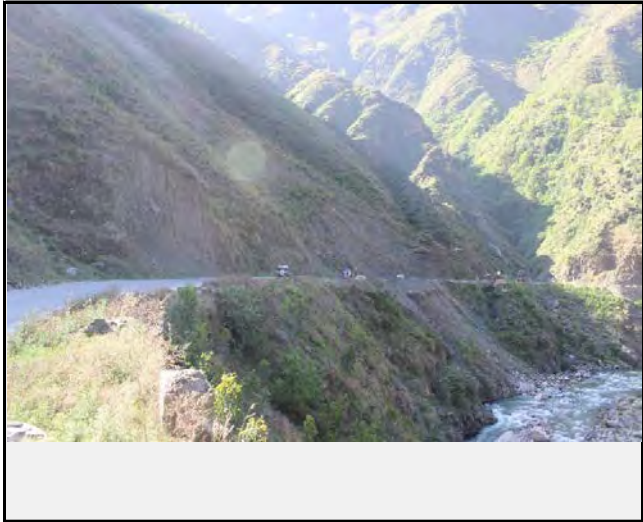
Full view of the landslide

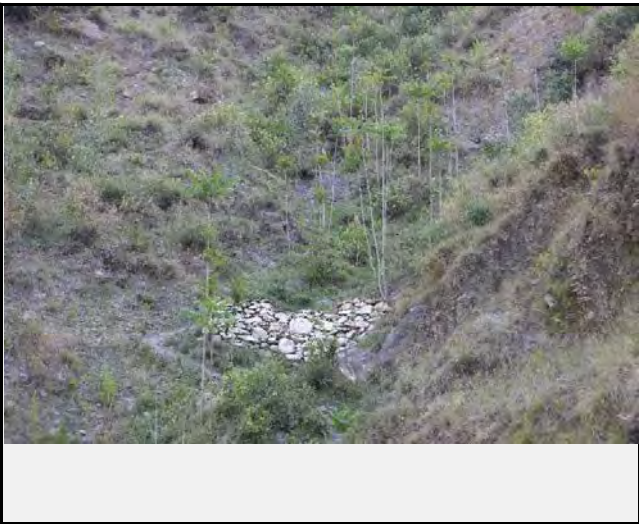
Existing countermeasures / anomalies: View of check dam as counter measure

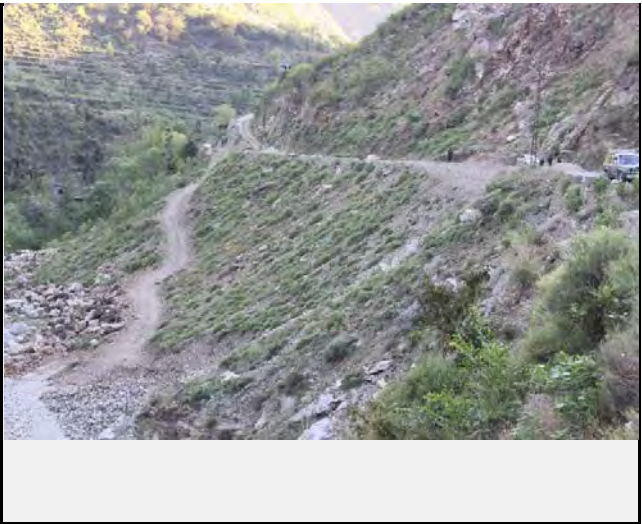
View of landslide on Valley side:

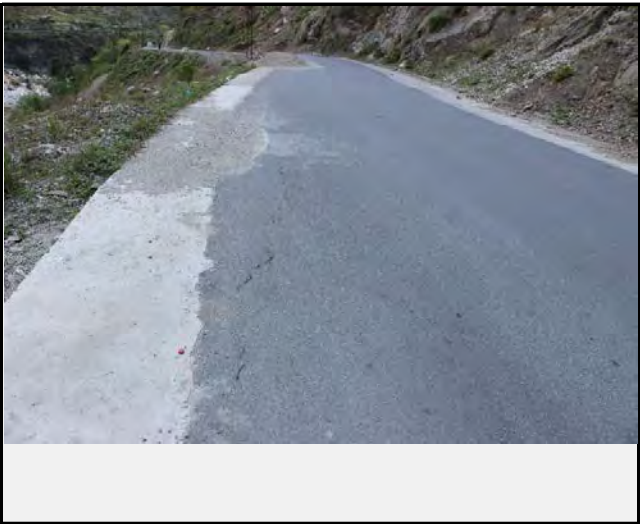
Road condition: Cut slope at the start point

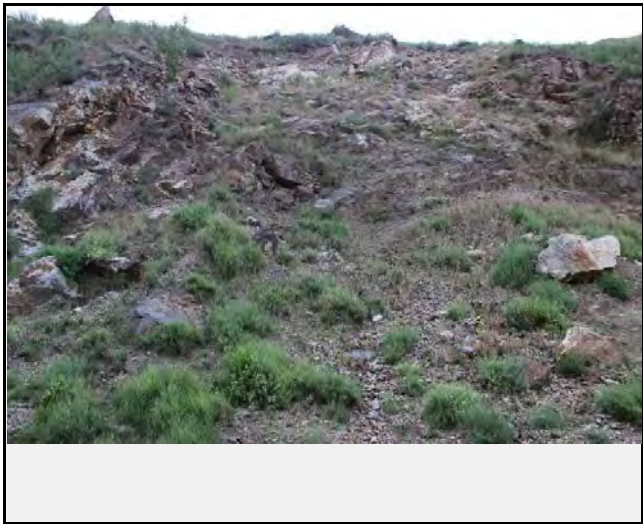
View of the slope failure at the middle point

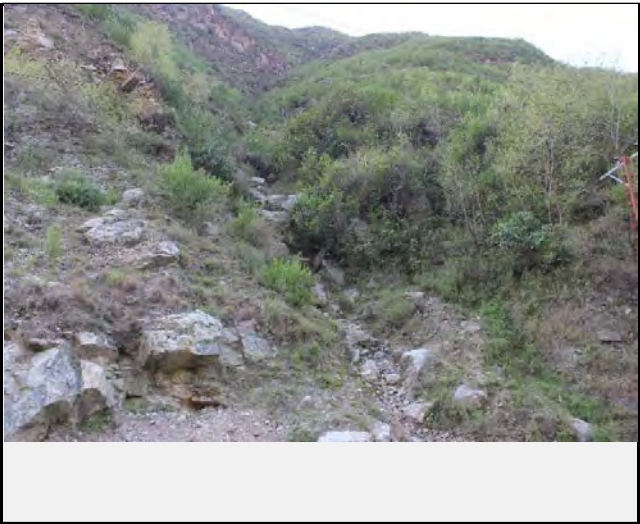
View of drainage that cuts the slope

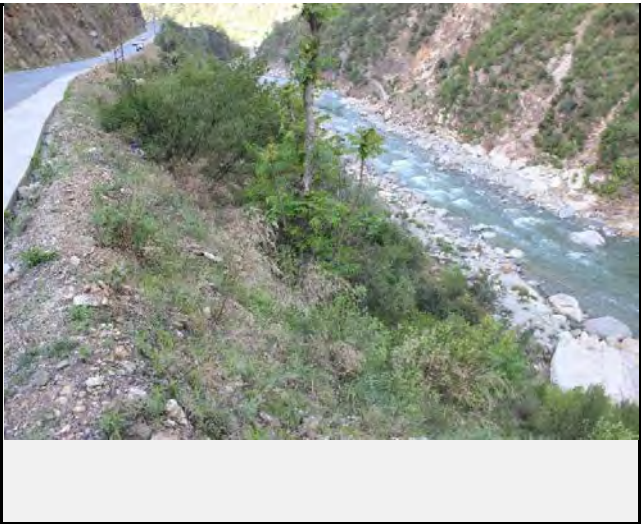
View of landslide on Valley side:

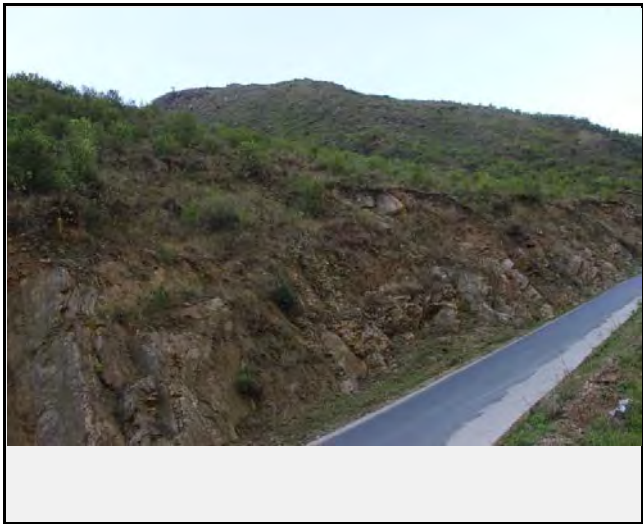
View of the slope failure at the middle point

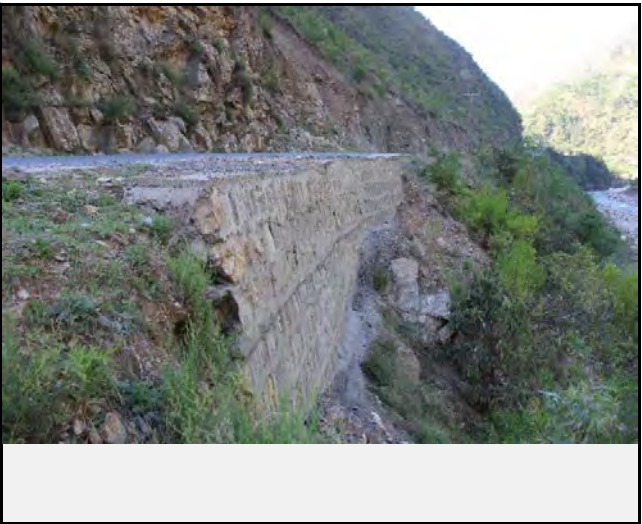
Existing countermeasures / anomalies: View of Retaining wall as counter measure

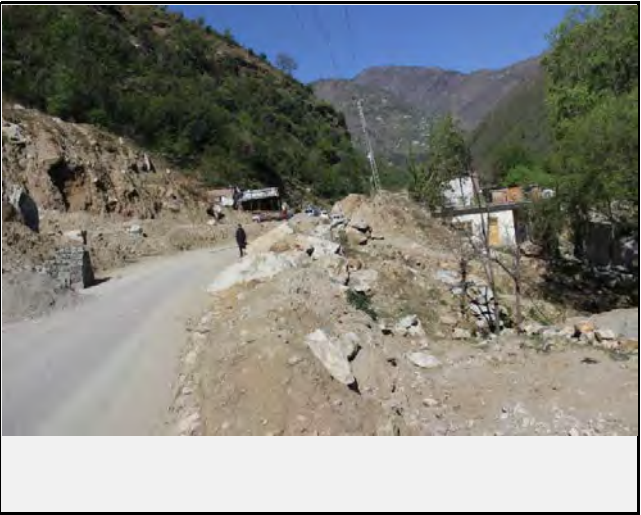
Front view of the debris flow

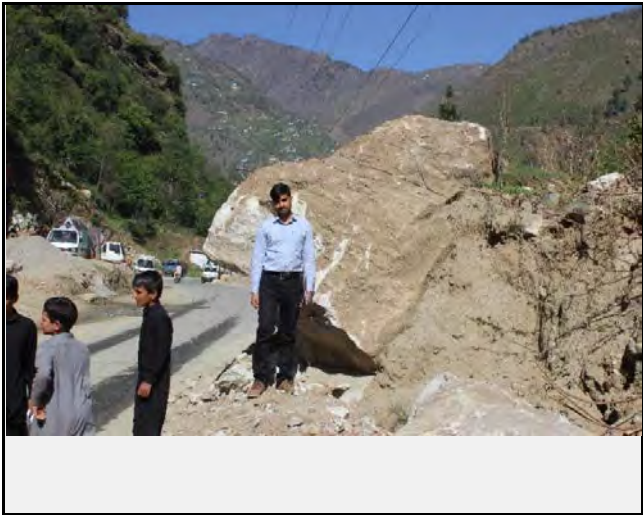
View of fallen block with the debris flow that can damage the population along the downstream.

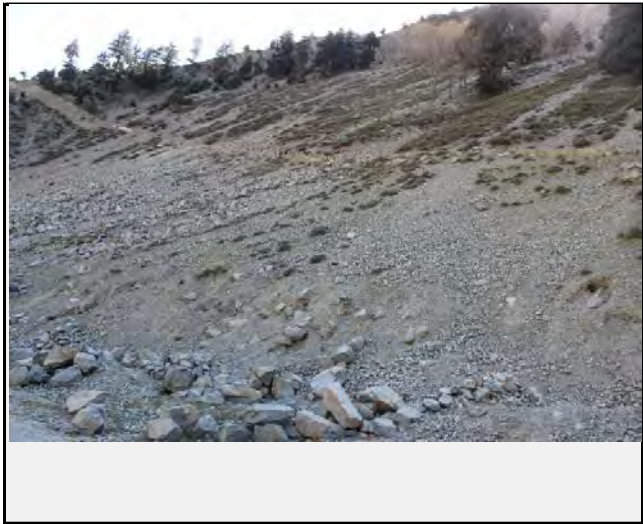
A deep seated translational landslide. Loose debris of the slide is comprised of boulders, gravels sand and silt. The slide is also prone to debris flow mainly during the rainy season. Active soil erosion on the slide leads to development of gullies on the slide. Around 15 meter of slide scarp is prone to rock fall that often reach to the road. Two road are present in the slide, one the middle of the slide and second at the slide toe. The slide has the potential to damage the road and disrupt the traffic mainly during the rainy season. No countermeasure are constructed to stabilize the slide.
---

Full view of the landslide

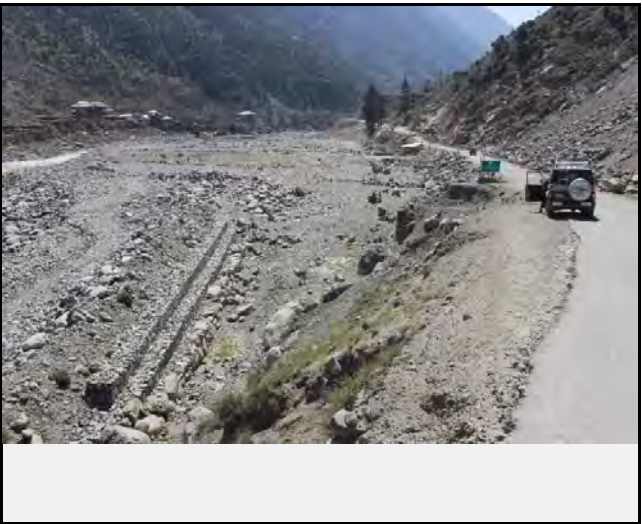
View of landslide on Valley side and a river diversion structure built on the toe of the slope failure

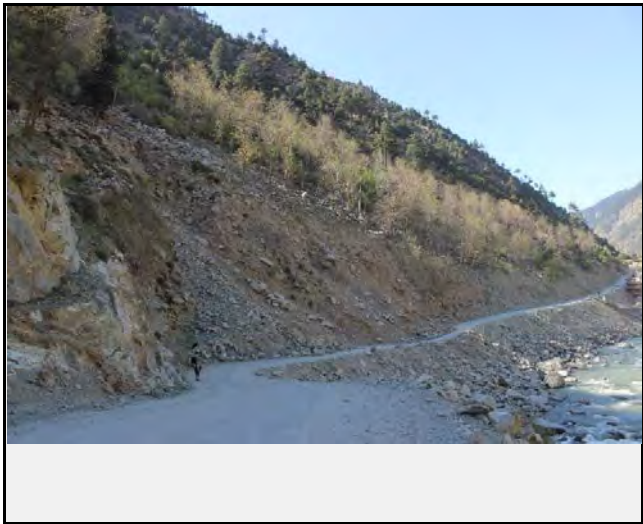
View of the slope failure at the left flank

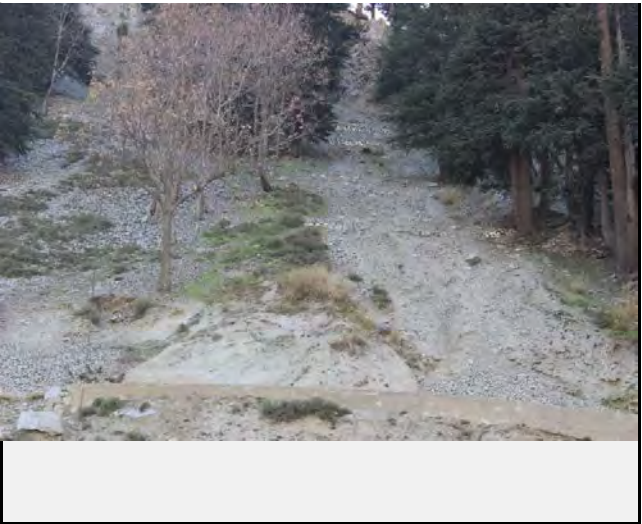
Existing countermeasures / anomalies: View of check dams as counter measure

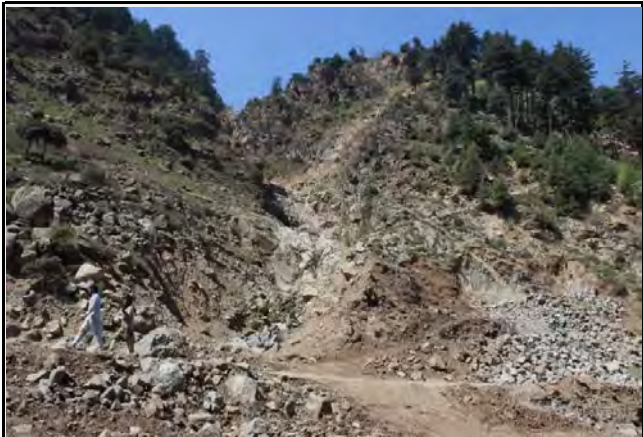
Mountain side view of the debris flow

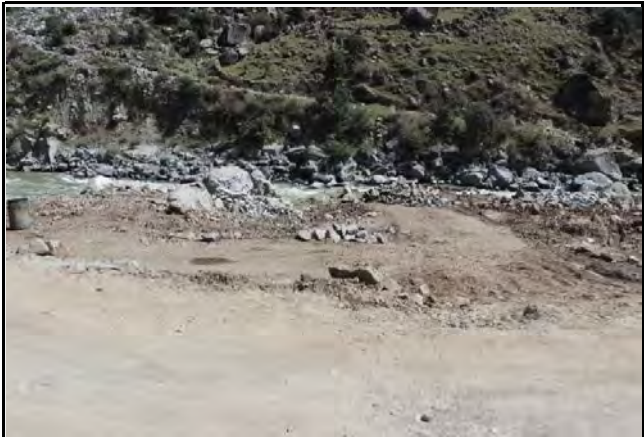
Valley side view of the debris flow

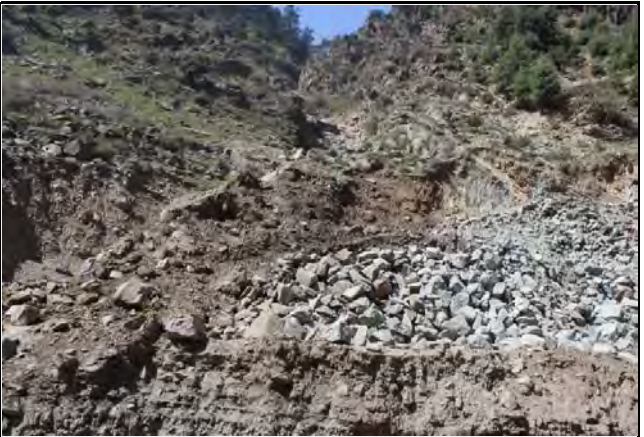
Front view of the debris flow

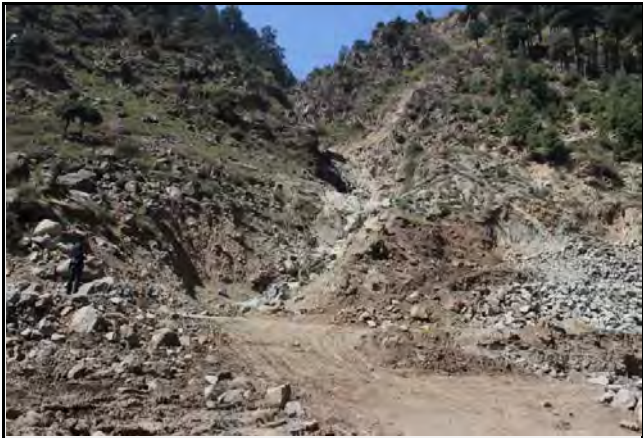
A view of slope failures along the debris flow

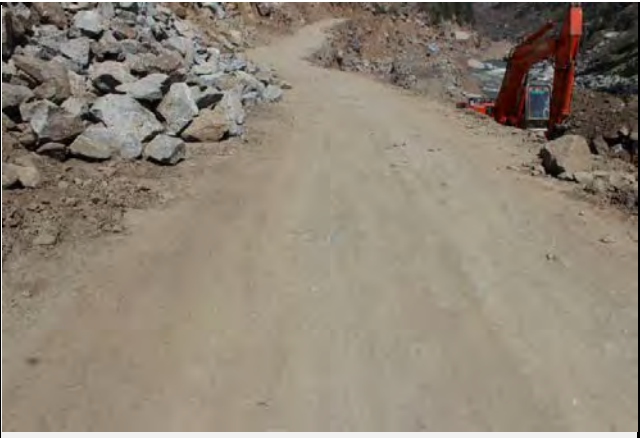
Existing countermeasures / anomalies: Retaining wall is being constructed at the toe of the debris flow
