Code no.	Sat_	N	4	5	_	1			
Region Office									
Maintenance Unit

## Evaluation sheet (Slope failure/Rockfall)

Coordinates	Latitude	35° 39' 37.3"							
	Longitude	71° 45' 58.9"							
Road name					Km

Date	2018/12/4								
Inspector	Yasir, Sajid, Shafique, Basharat

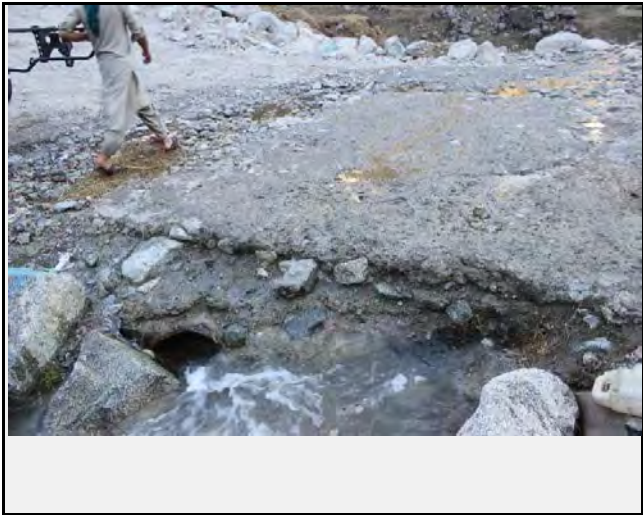
Front view of the debris flow

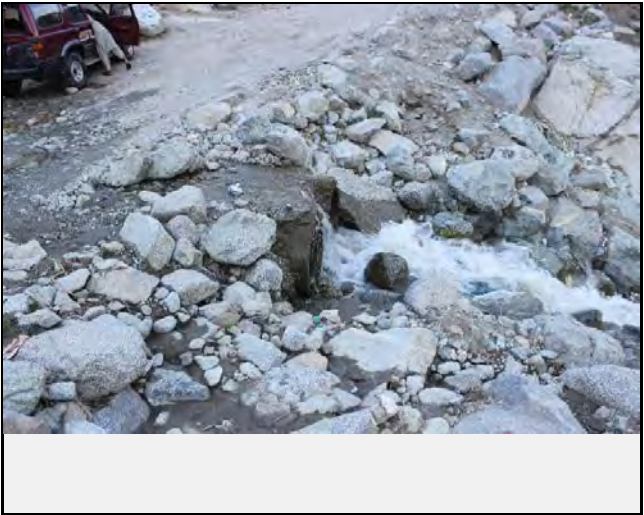
Road condition

Existing countermeasures / anomalies: Culvert / Pipes has been installed at the toe of the debris flow

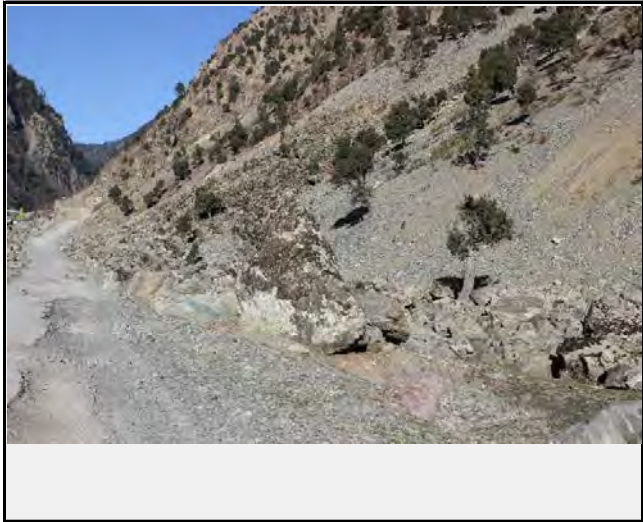
Full view of the landslide

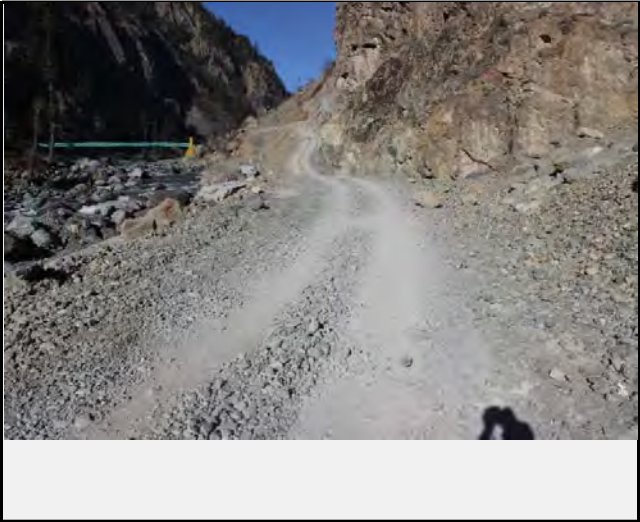
Road condition: Cut slope at the start point

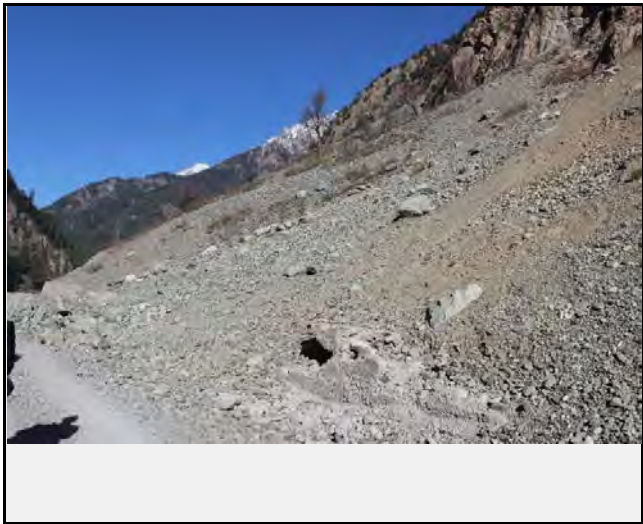
View of the slope failure at the middle point

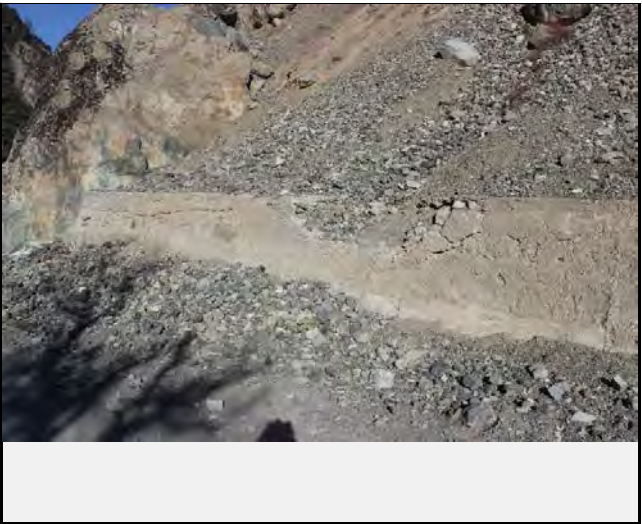
Existing countermeasures / anomalies: View of Retaining Wall as counter measure

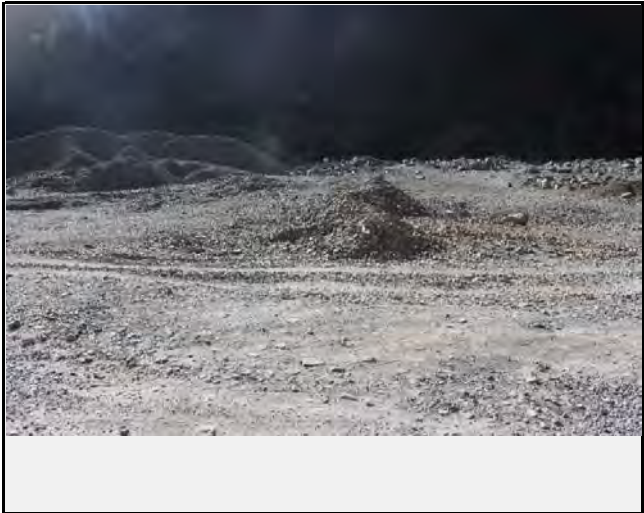
Valley side view of the debris flow

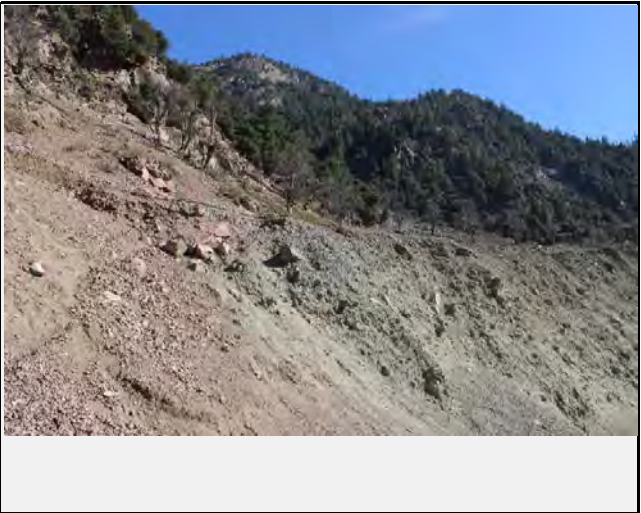
Front view of the debris flow

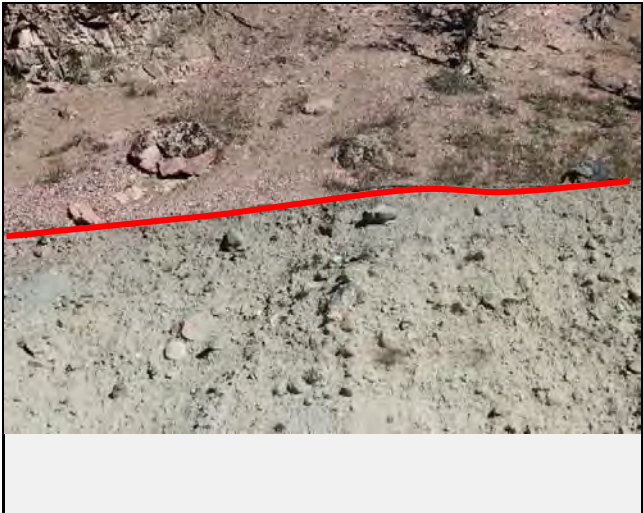
The existing road has been damaged. Red line shows the old road displaced by the debris flow.

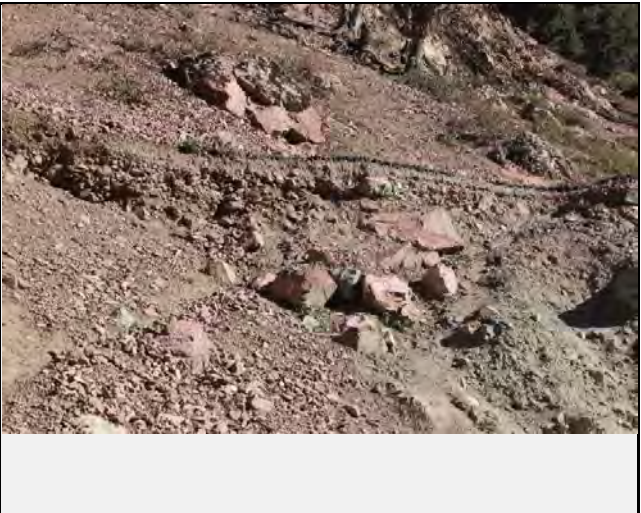
View of debris material and old road
