### 日本人制限域における調査報告書

# **SLOPE FAILURE ANALYSIS ALONG THE MAJOR ROADS NETWORK IN NORTHERN PAKISTAN**

Kokusai Kogyo Co., Ltd, Tokyo, Japan

Dr. Muhammad Basharat  
Dr. Muhammad Shafique  
Mr. Yasir Sarfraz  
Mr. Sajid Ali

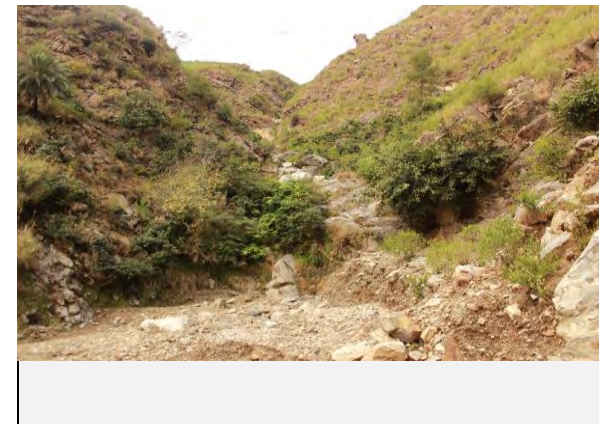
Front view of the debris flow

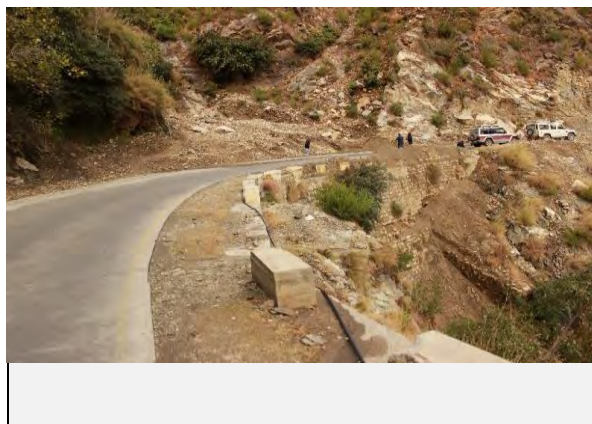
Road condition

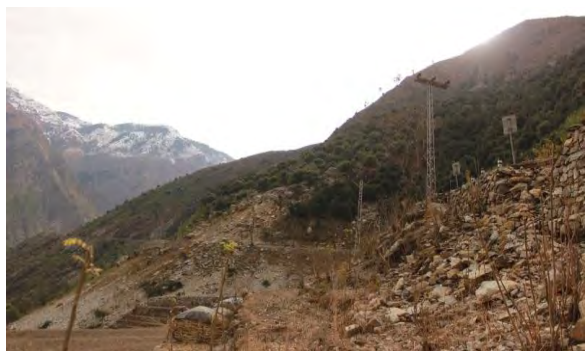
| 05 | N-35-14 | 35°00' 11.9"<br>72°53' 53.90" | Slope Failure | Construction of retaining wall | This rotational landslide is located on N35. It is historically active slope failure. The slide was mainly triggered during the 2005 earthquake and also reactivated during the torrential and prolonged monsoonal rains of 2010. The slide also become active during the rainy seasons. The scarp and upper parts of the slope is partially stable with thick vegetation. However, the portion of the landslide close to the road is still active and prone to frequent sliding and rock fall and therefore posing threats to the road. Many detached boulders and gravels are hanging on the slope posing threat to the road and traffic. No mitigation measures are constructed to protect the road from the fallen rocks or debris. Bedrock of the slide is fractured and weathered granitic rocks. Water erosion leads to development of gullies on the slide. | High |

Full view of the landslide

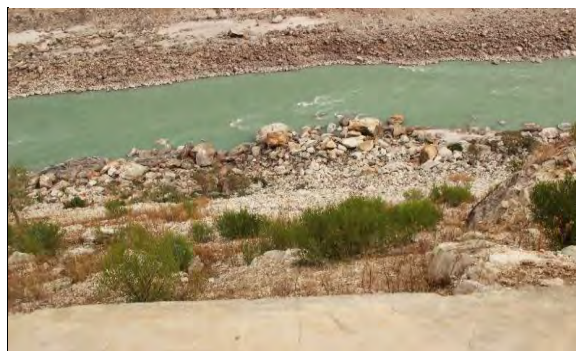
View of landslide on Valley side:

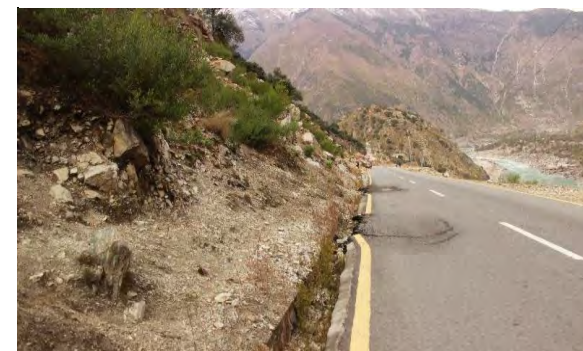
Road condition: Cut slope at the start point

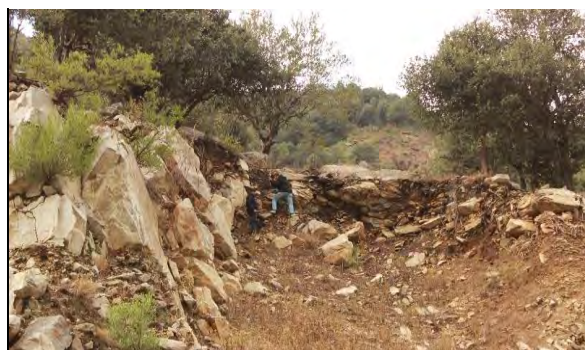
View of the slope failure at the middle point

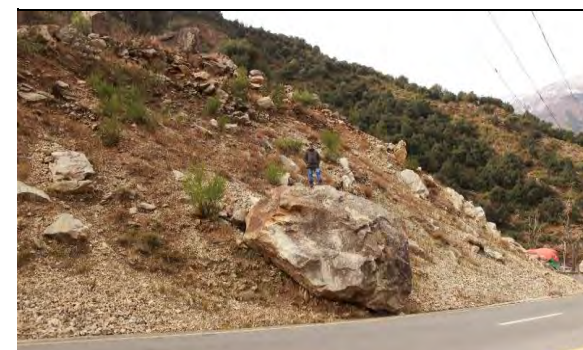
View of fallen blocks on road

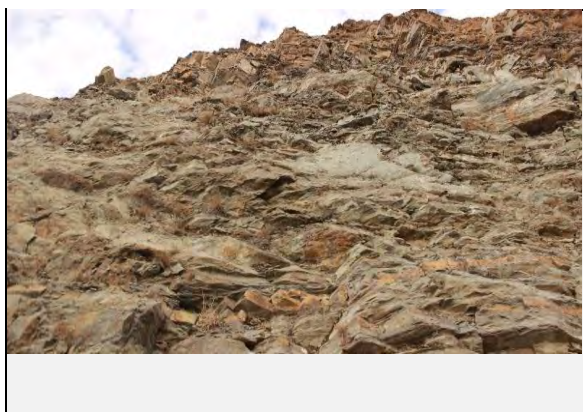
View of the slope failure at the middle point

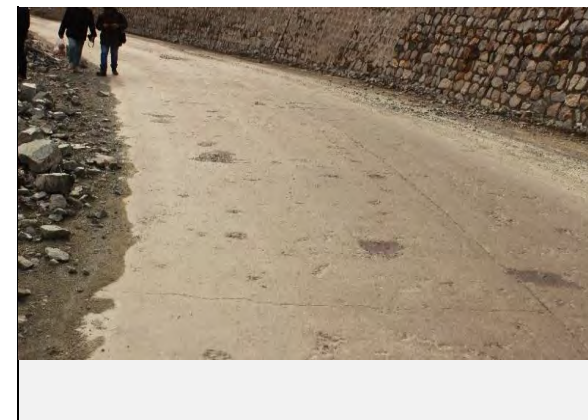
Road condition: Cut slope at the start point

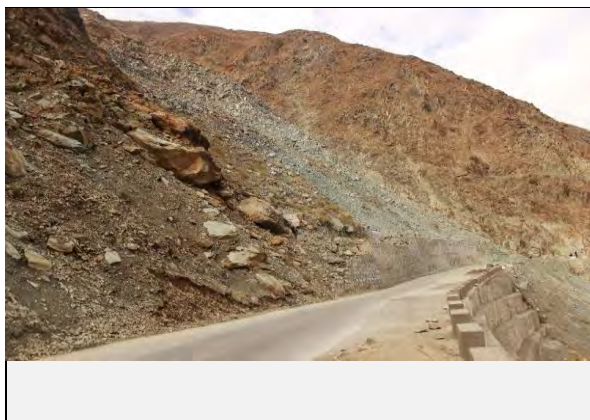
View of the slope failure at the middle point

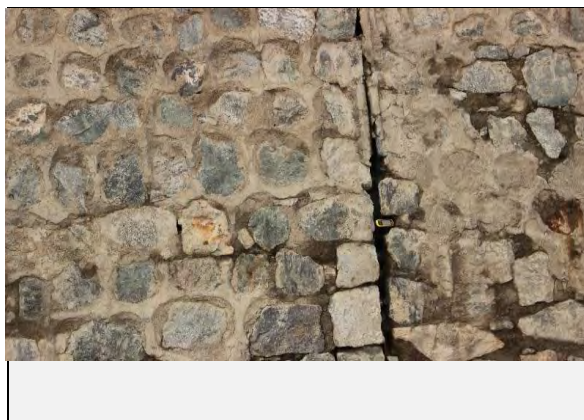
Existing countermeasures / anomalies: View of shed as counter measure

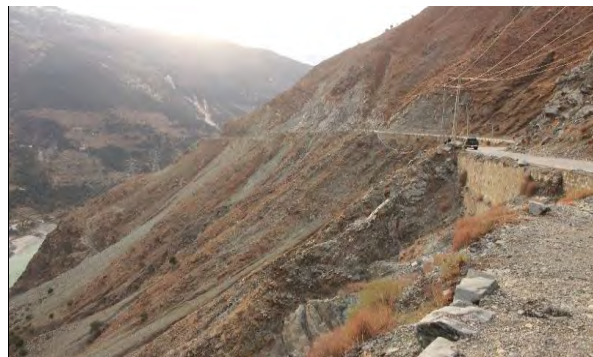
Full view of the landslide

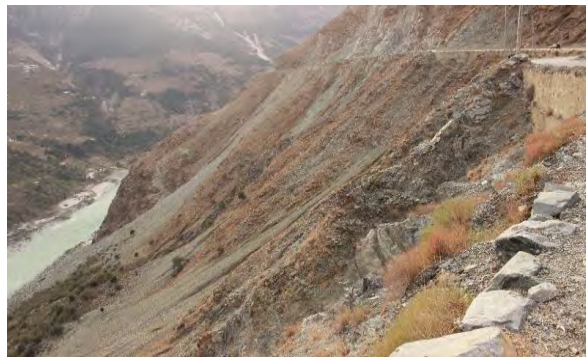
View of landslide on Valley side:

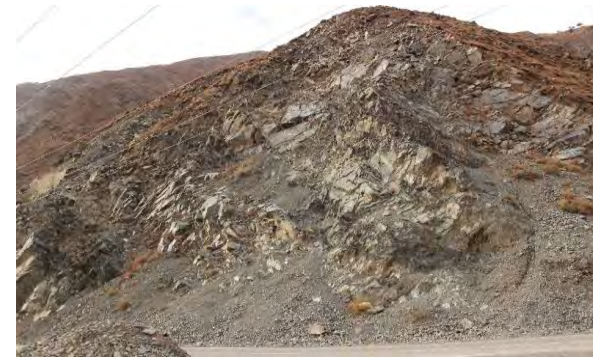
Road condition: Cut slope at the start point

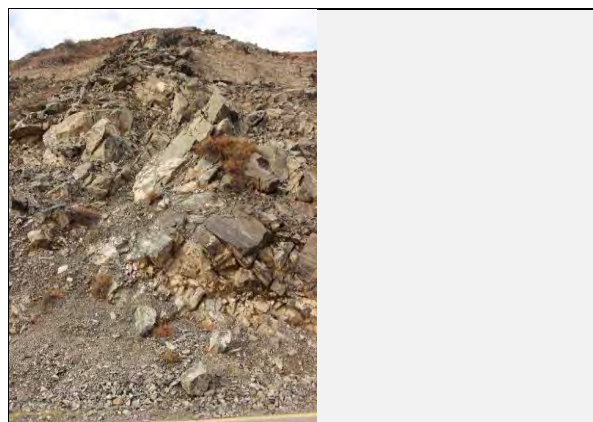
View of the slope failure at the middle point

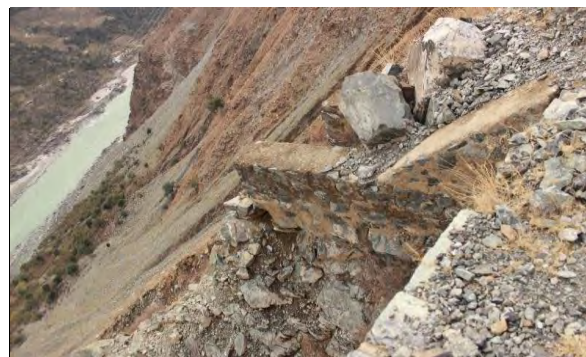
Existing countermeasures / anomalies: View of shed as counter measure

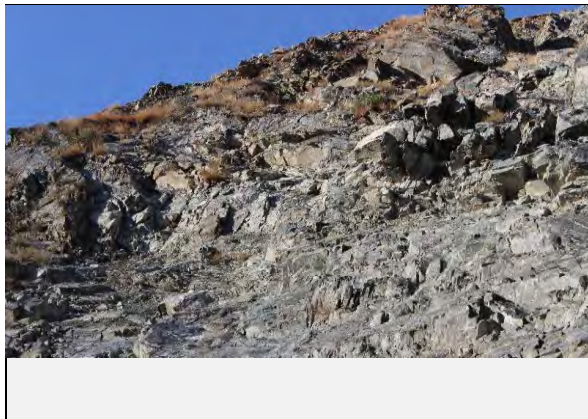
View of the slope failure at the middle point

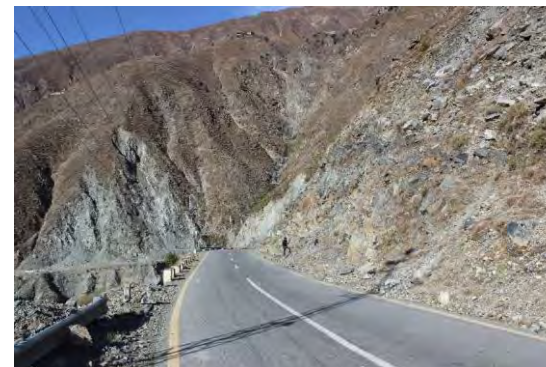
Road condition: Cut slope at the start point

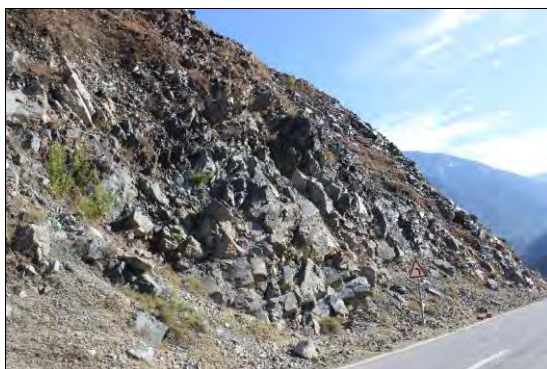
View of the slope failure at the middle point

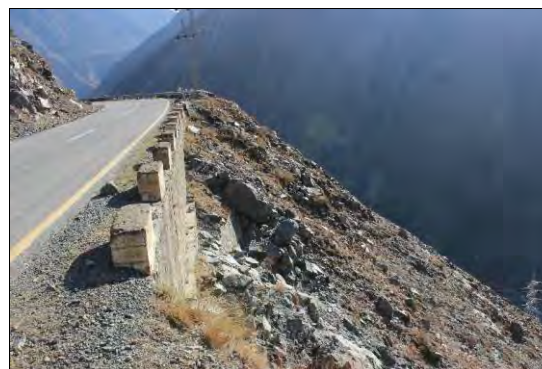
Existing countermeasures / anomalies: View of retaining wall for N-35 as counter measure

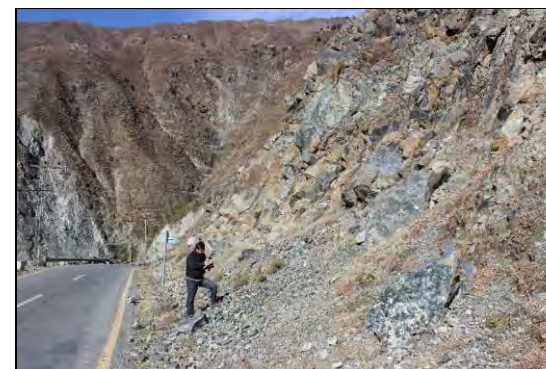
View of Large blocks fallen and talus deposit at the toe of Sloape Failure

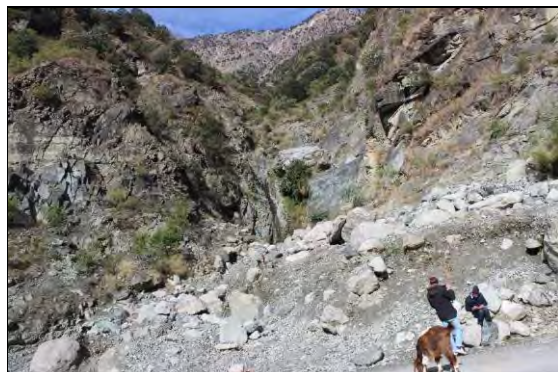
Mountain side view of the debris flow

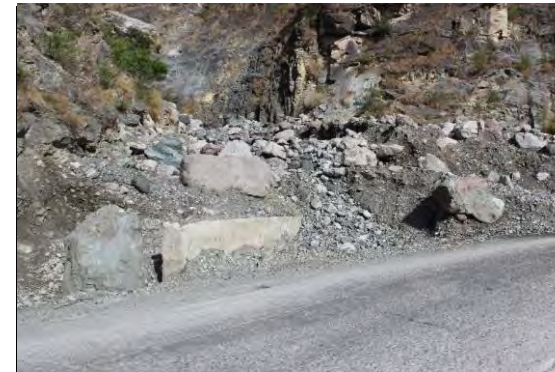
Front view of the debris flow

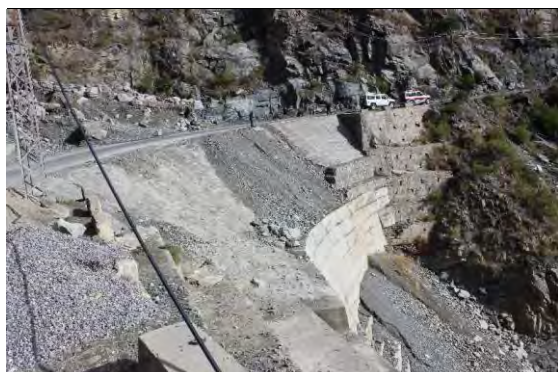
Existing countermeasures / anomalies: Sloped Retaining wall has been constructed for Debris material

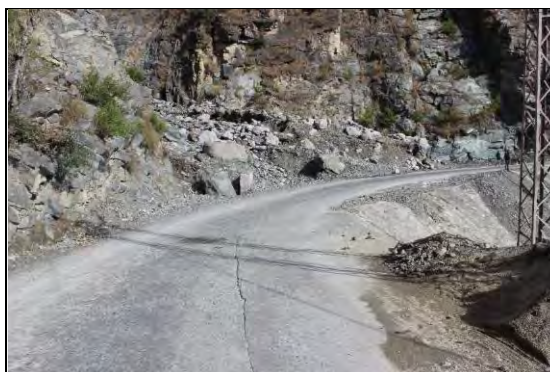
Road condition

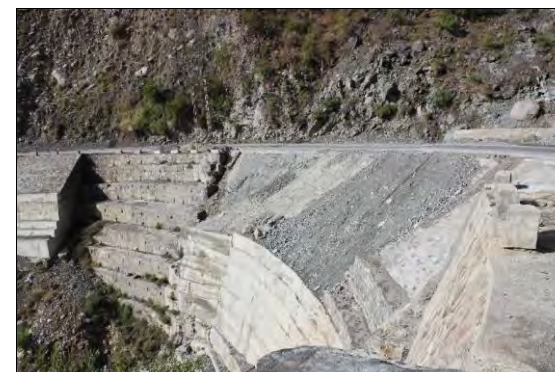
Existing countermeasures / anomalies: Retaining wall has been constructed for N-35

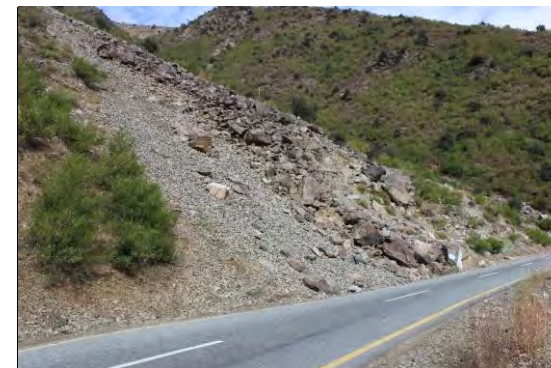
Road condition: Cut slope at the start point

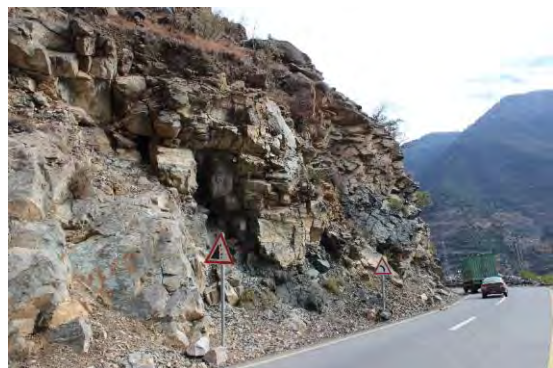
View of the slope failure at the middle point

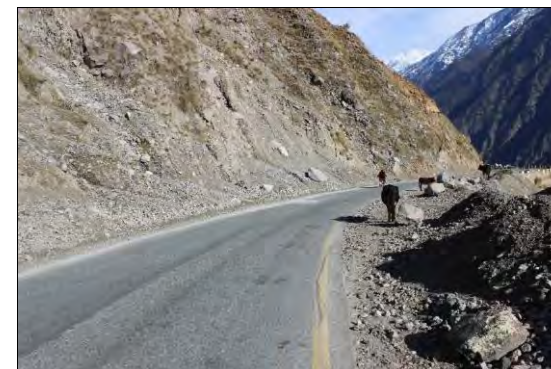
Road condition: Cut slope at the start point

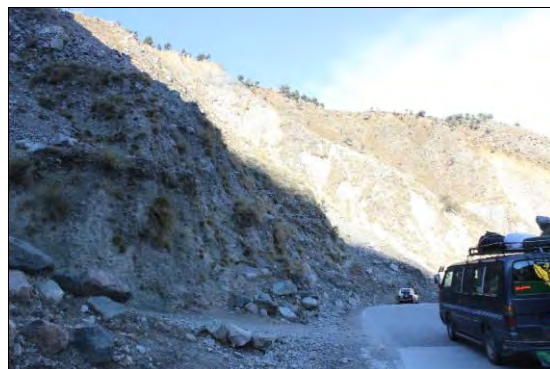
View of the slope failure at the middle point

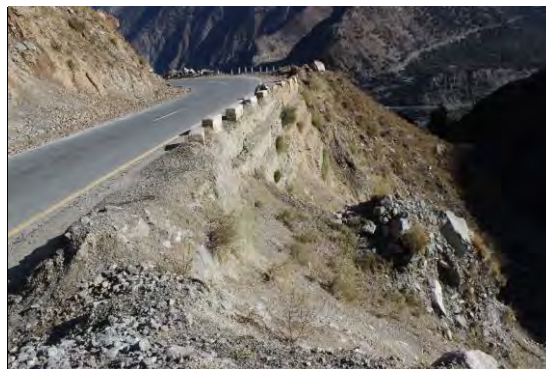
Existing countermeasures / anomalies: View of Retaining wall as counter measure for N-35

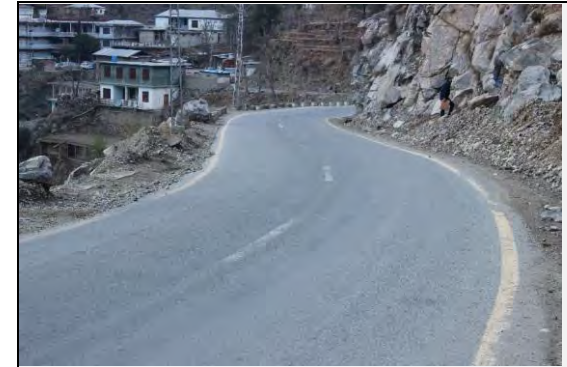
Road condition: Cut slope at the start point

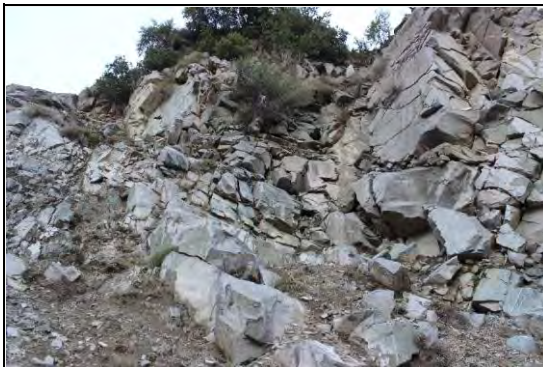
View of the slope failure at the middle point

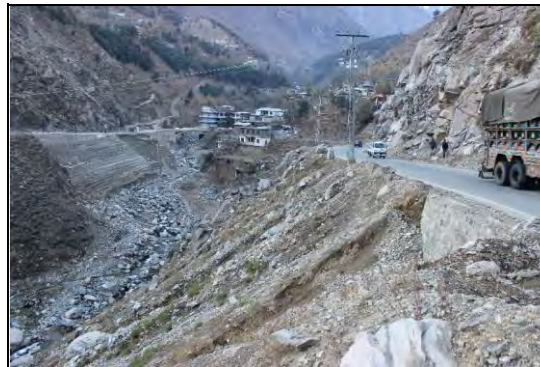
Existing countermeasures / anomalies: View of Retaining wall and benching as counter measure

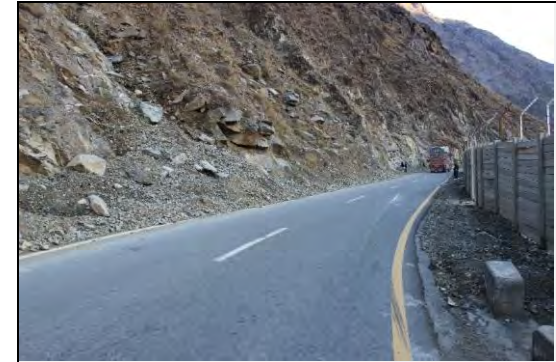
Road condition: Cut slope at the start point

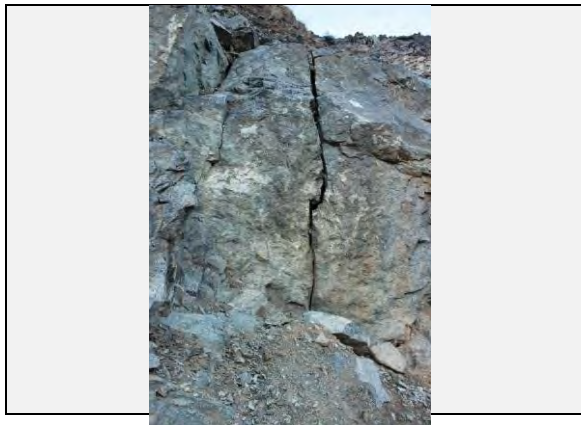
View of the slope failure at the middle point

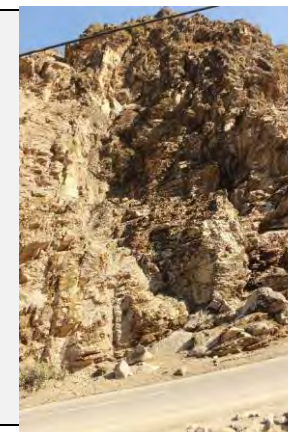
Road condition: Cut slope at the start point

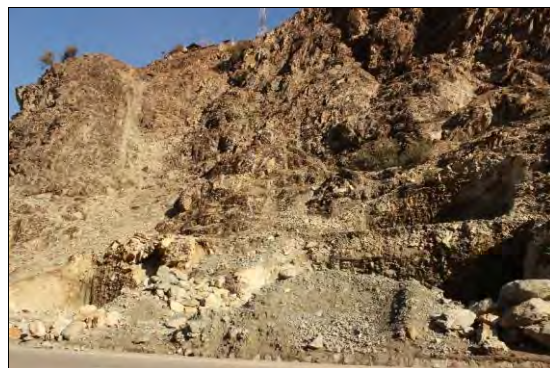
View of the slope failure at the middle point

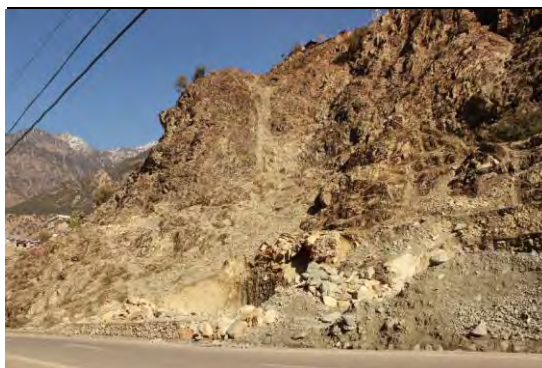
Existing countermeasures / anomalies: View of retaining wall as counter measure

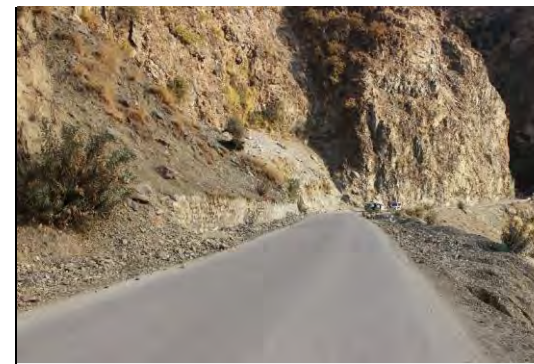
Road condition: Cut slope at the start point

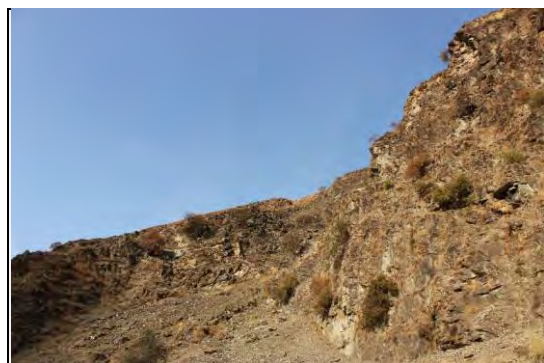
View of the slope failure at the middle point

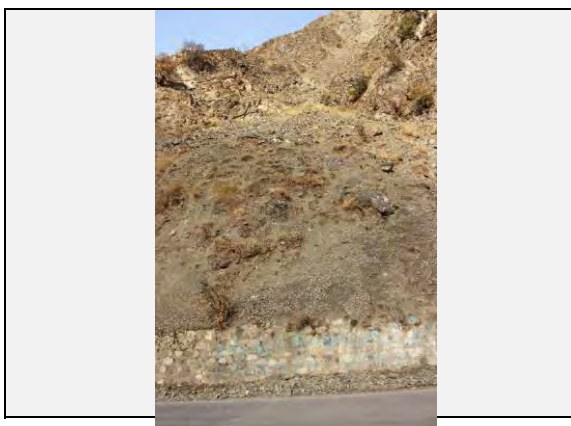
Existing countermeasures / anomalies: View of retaining wall as counter measure

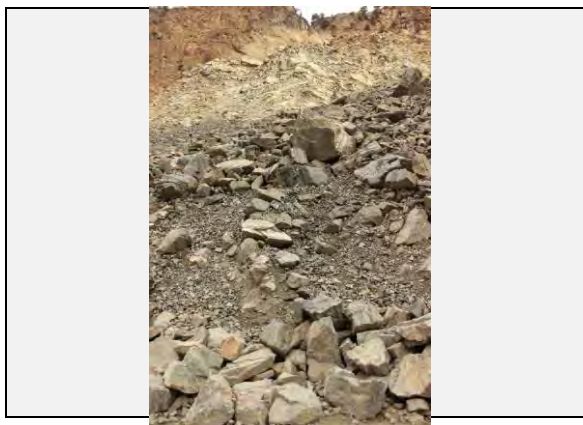
View of the slope failure at the middle point

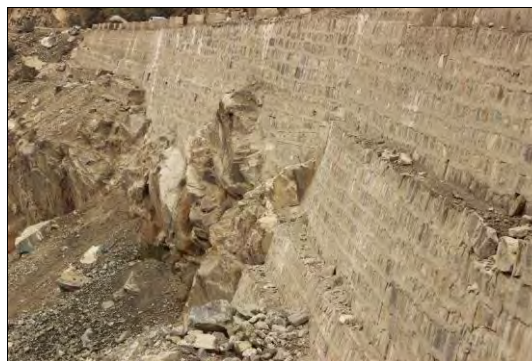
Existing countermeasures / anomalies: View of retaining wall as counter measure

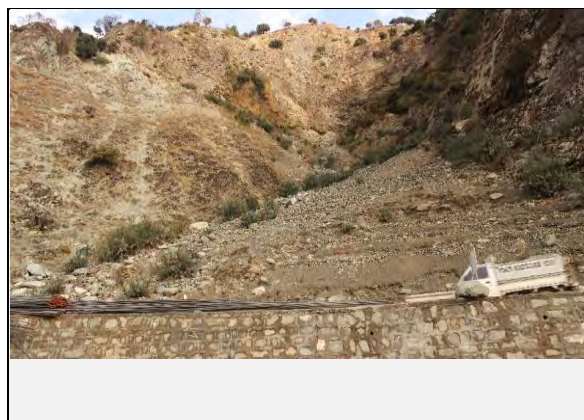
Existing countermeasures / anomalies: View of benching as counter measure

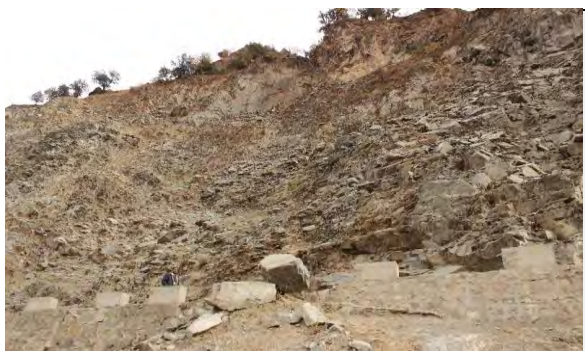
Full view of the landslide

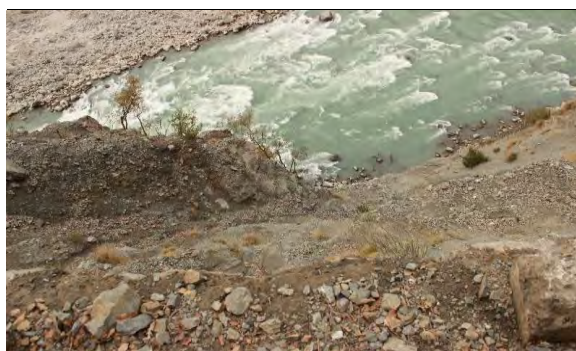
View of landslide on Valley side:

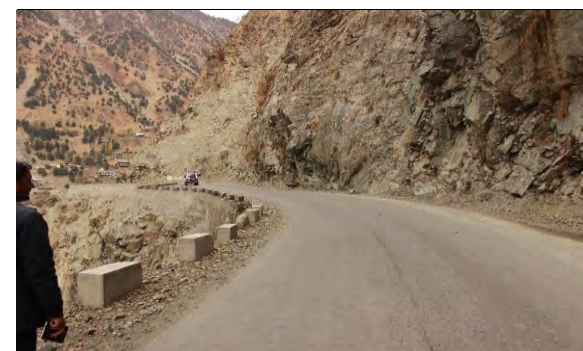
Road condition: Cut slope at the start point

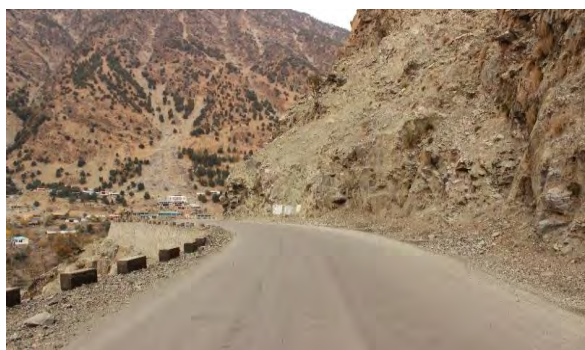
View of the slope failure at the middle point

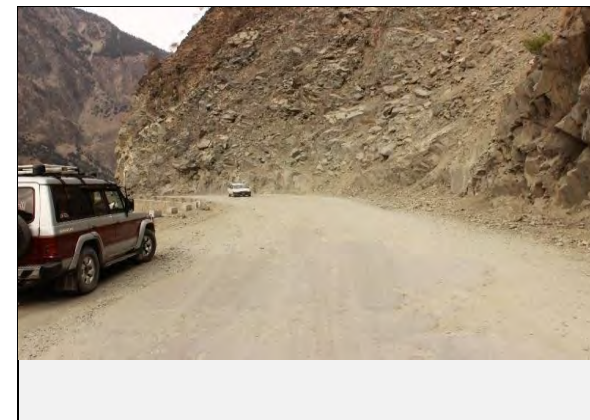
Road condition: Cut slope at the start point

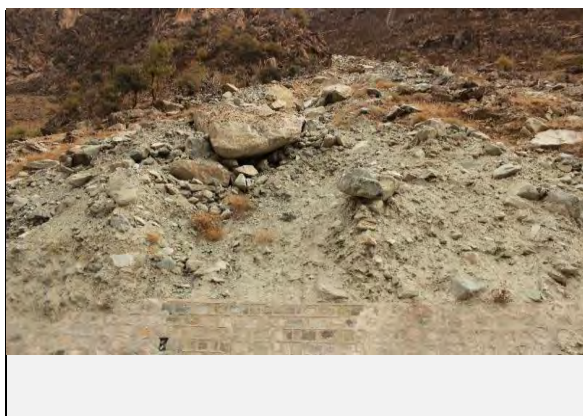
View of the slope failure at the middle point

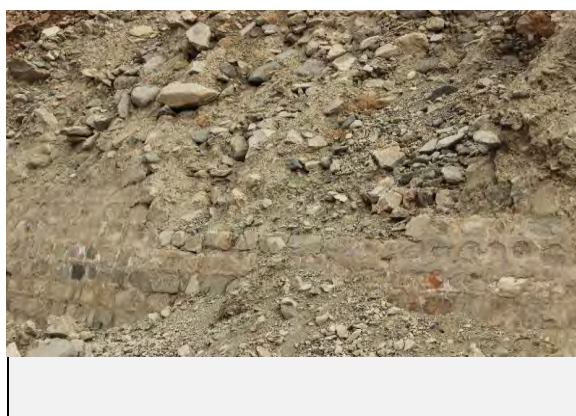
Existing countermeasures / anomalies: View of retaining wall as counter measure for slope failure

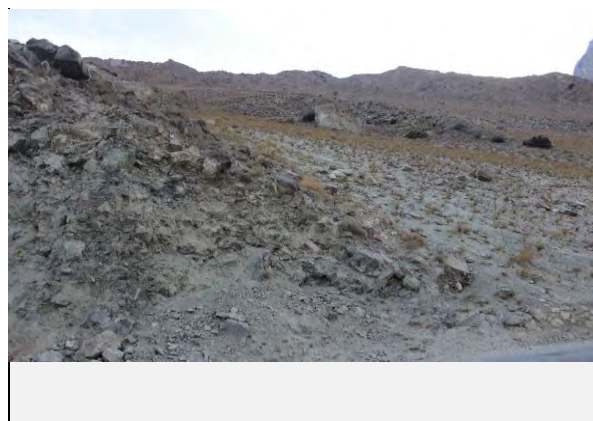
View of the slope failure at the middle point

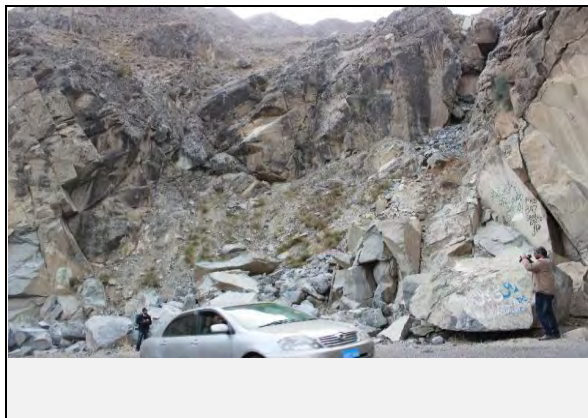
View of the slope failure at the middle point

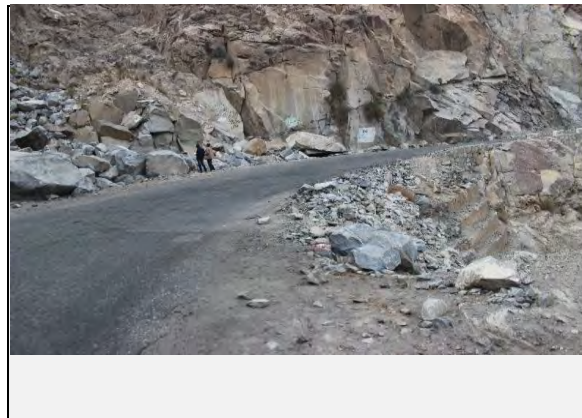
Existing countermeasures / anomalies: No Counter Measure

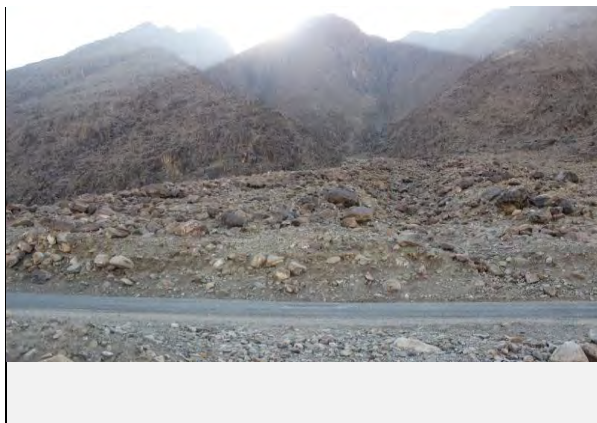
Mountain side view of the debris flow

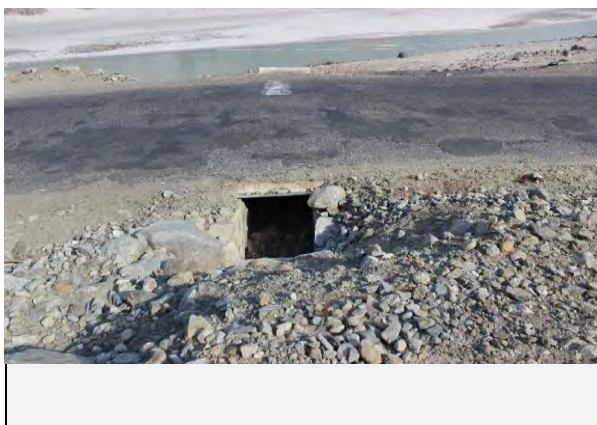
Inlet of the culvert for the debris flow

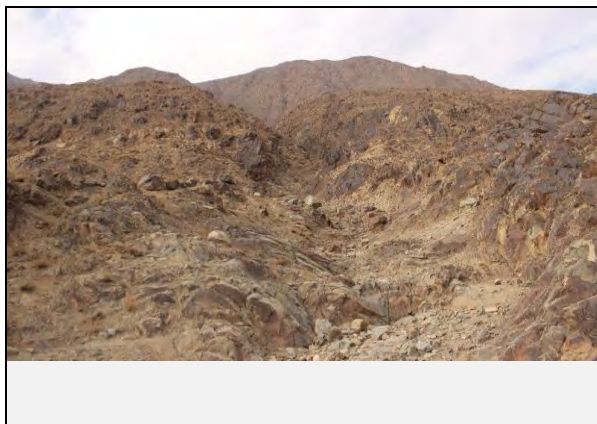
Mountain side view of the debris flow

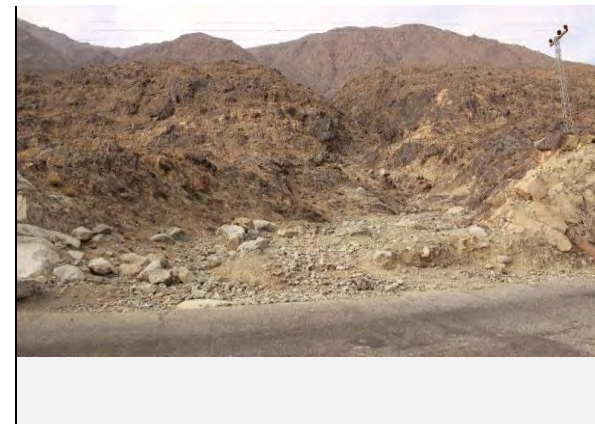
Front view of the debris flow

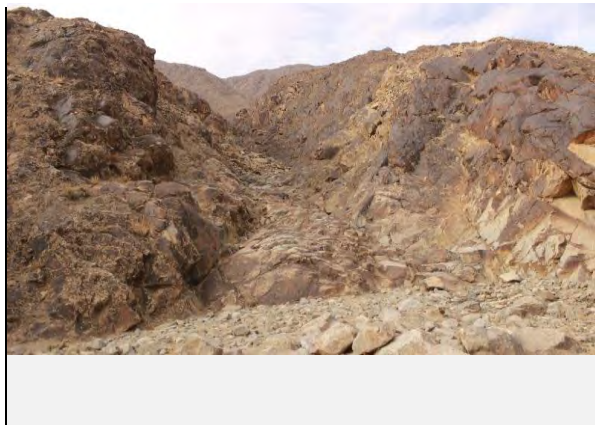
Mountain side view of the debris flow

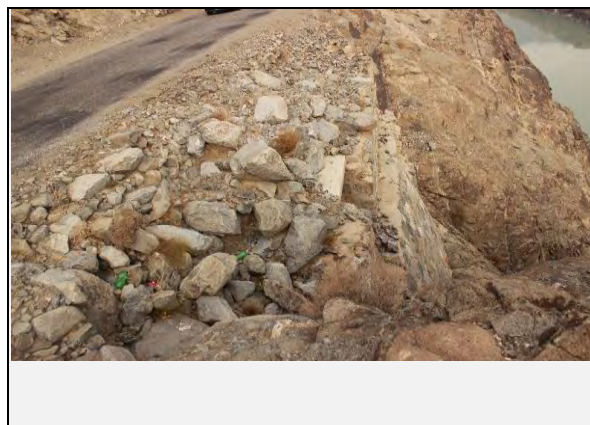
Valley side view of the debris flow

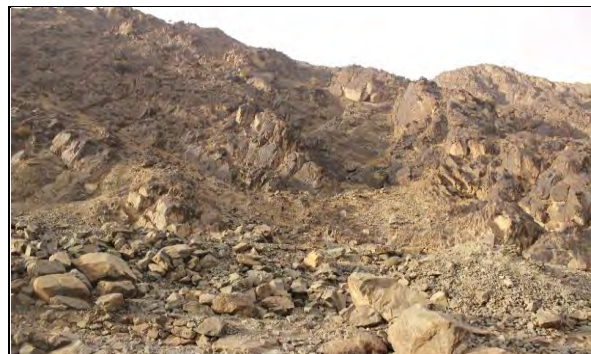
Full view of the landslide

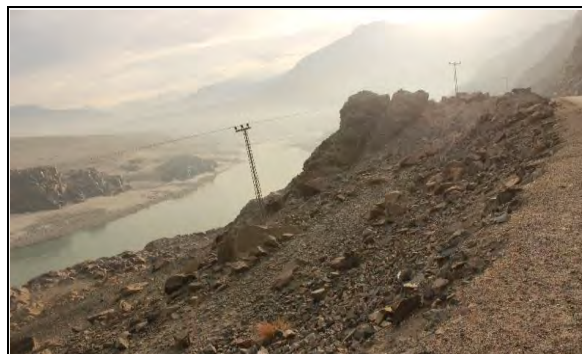
View of landslide on Valley side:

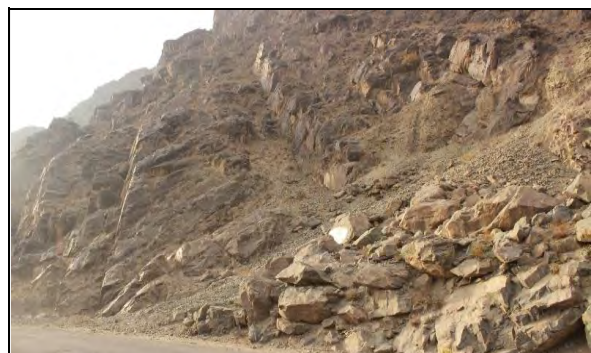
View of the slope failure at the middle point

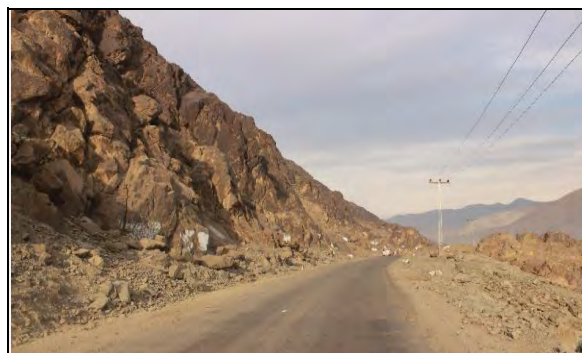
Existing countermeasures / anomalies: No counter measure
