## Evaluation sheet (landslide)

| Road Name | | | | | Km | | | | |

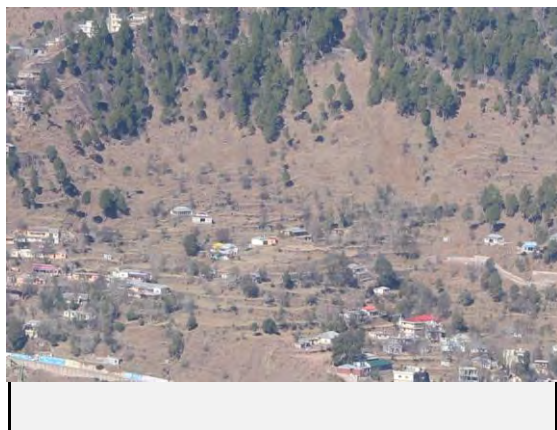
Mountain side view of landslide

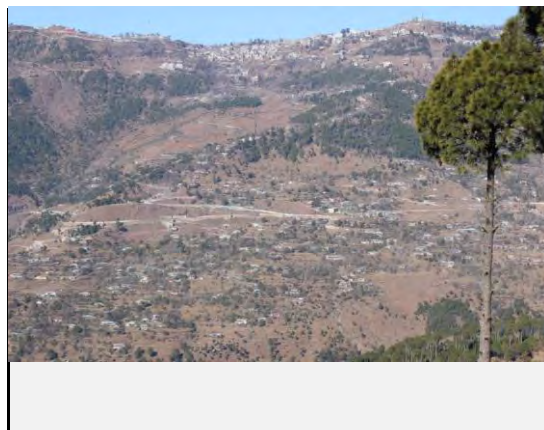
Valley side view of landslide

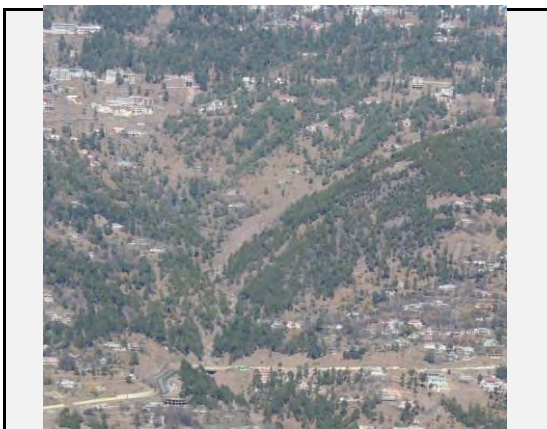
Mountain side view of the debris flow

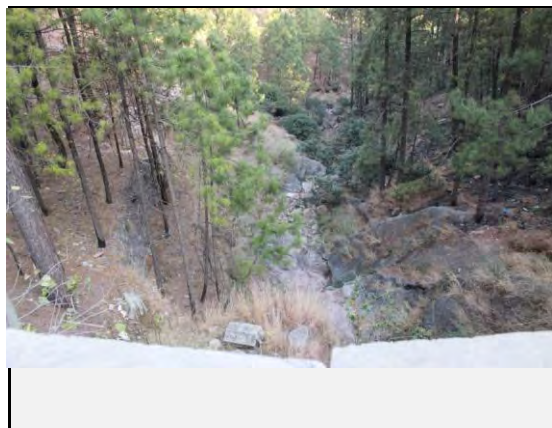
Front view of the debris flow:

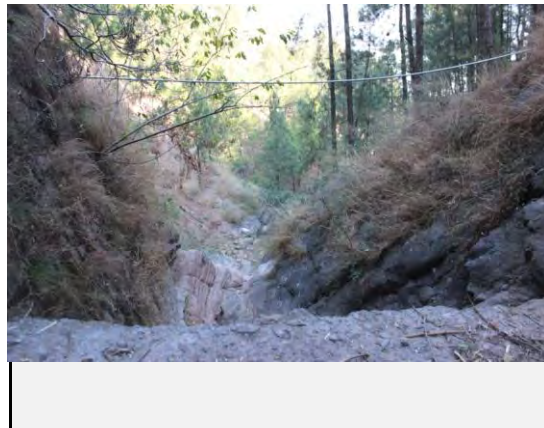
Valley side view of the debris flow

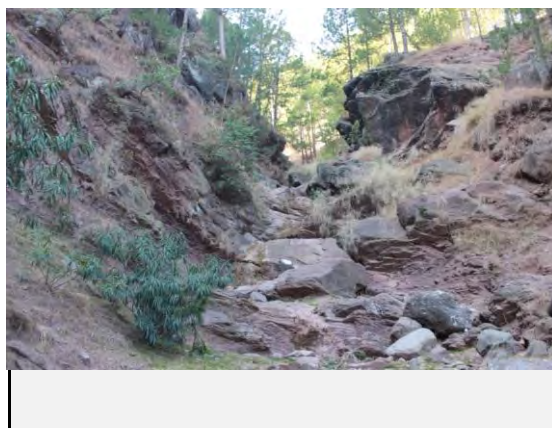
Rock beds dipping towards the channel

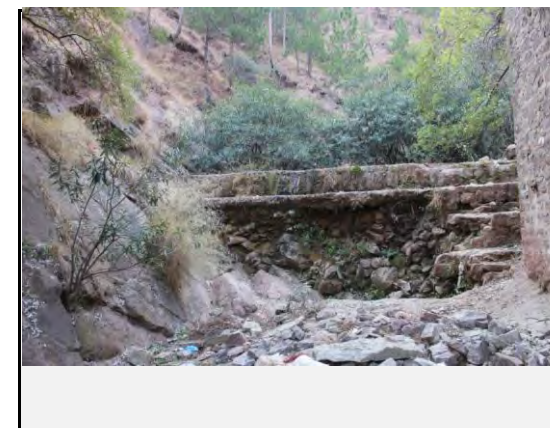
Existing countermeasures / anomalies: Benches has been made on the upstream which has been partially destroyed

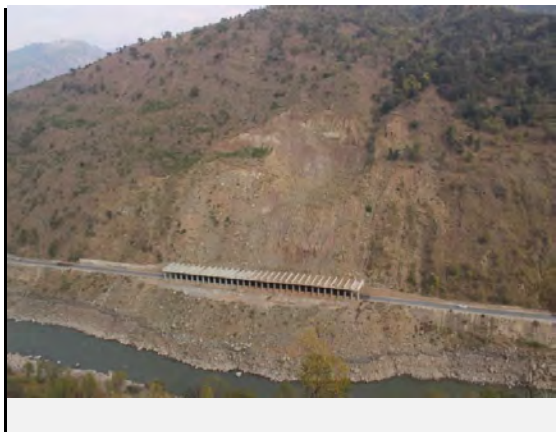
Full view of the landslide

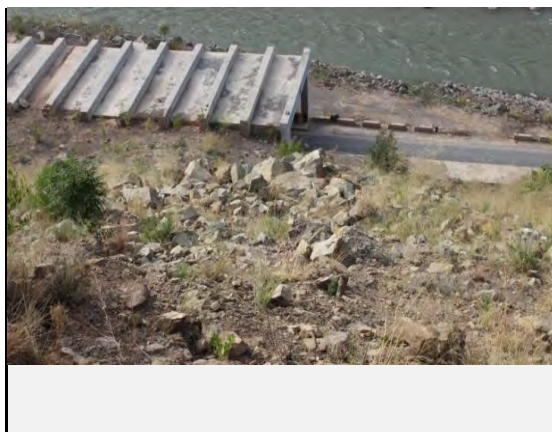
View of landslide on Valley side:

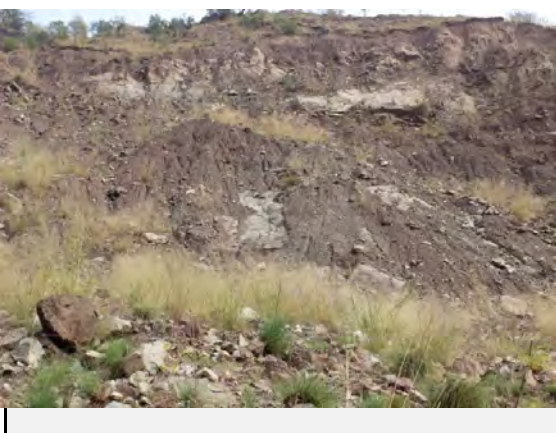
View of the slope failure at the middle point

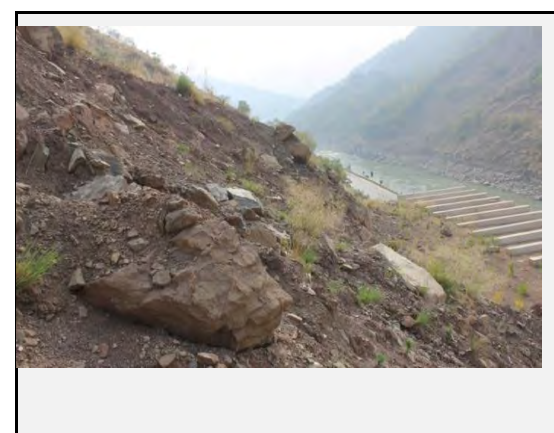
View of fallen blocks on Shed

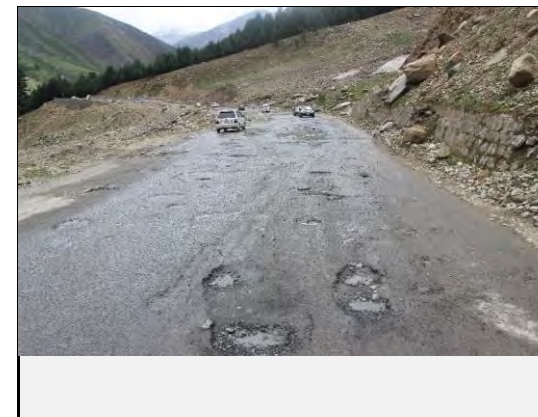
Road condition

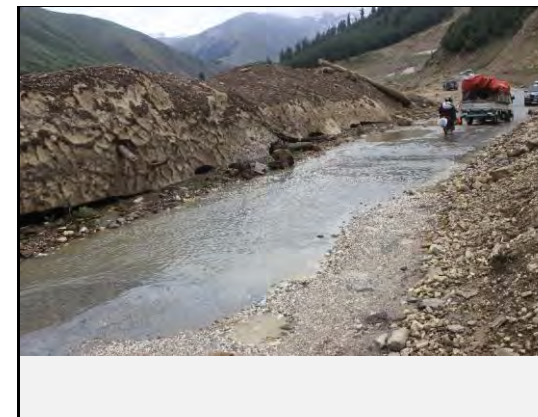
View of Glacier on the left flank of the Landslide

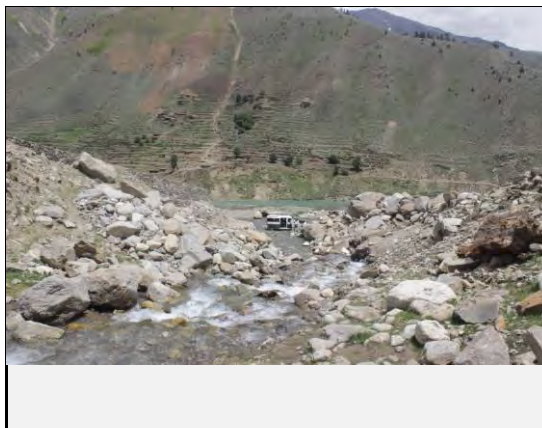
Valley side view of the debris flow

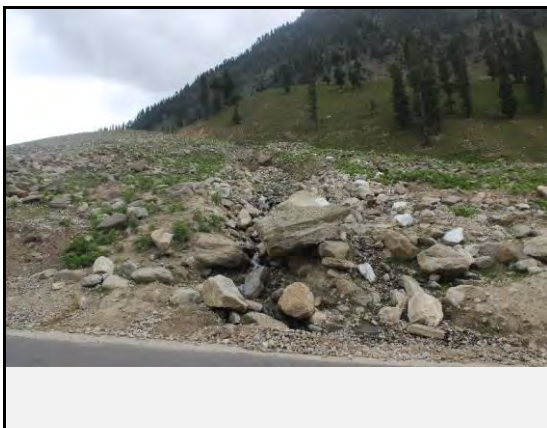
Mountain side view of the debris flow

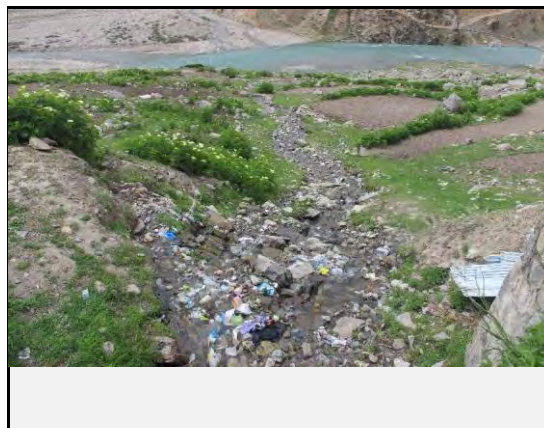
Valley side view of the debris flow

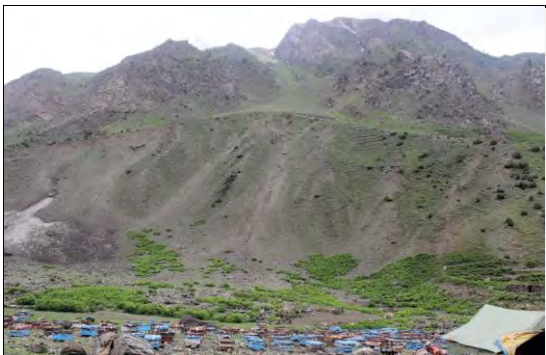
Full view of the Slope Failure

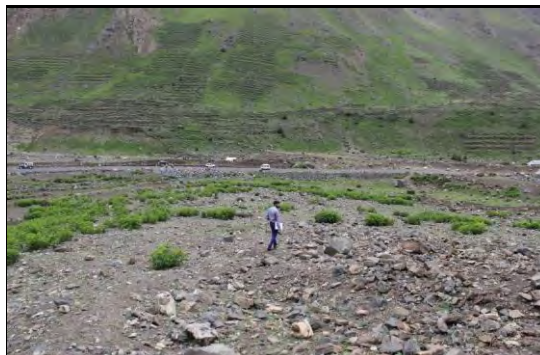
View of Slope Failure on Valley side:

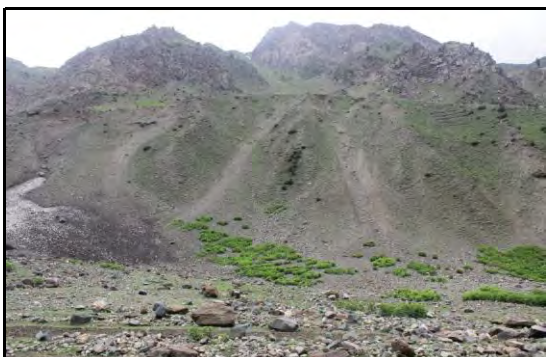
View of the slope failure at the middle point

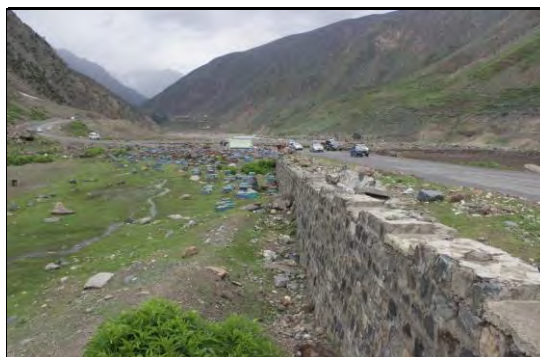
Existing countermeasures / anomalies. Damaged retaining Wall

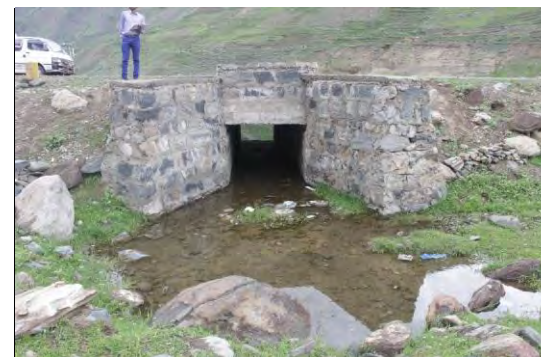
View of Box Culvert at the toe of slope

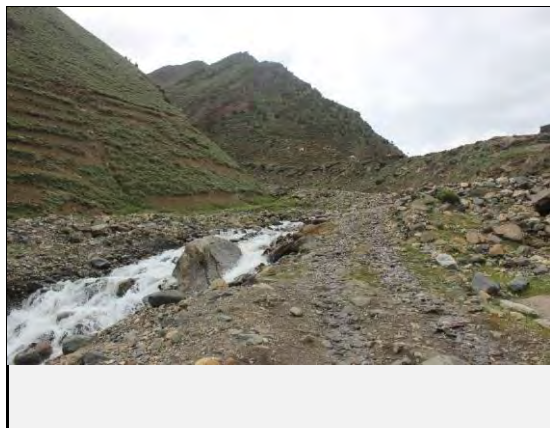
Mountain side view of the debris flow

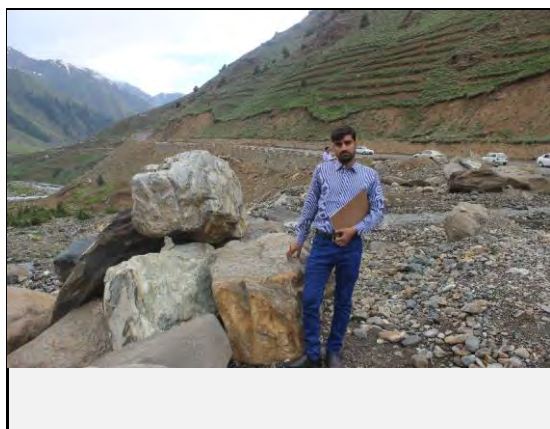
The boulder has been found along the debris flow

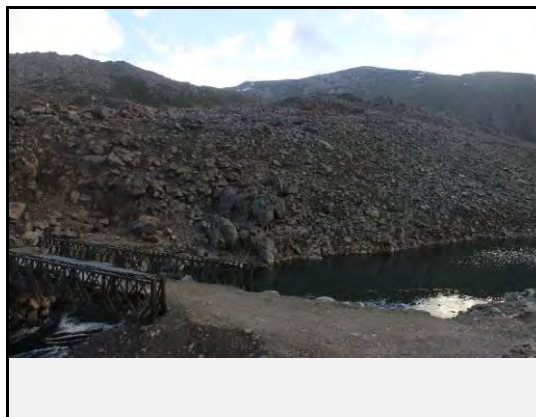
View of landslide on Valley side:

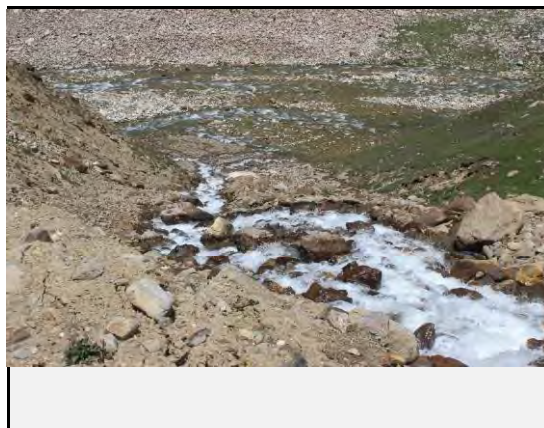
Valley side view of the debris flow

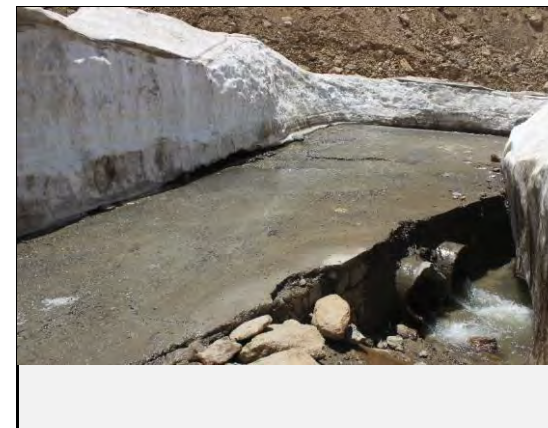
Culvert outlet

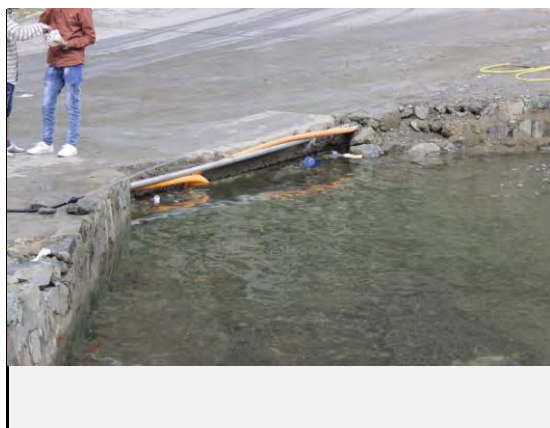
The culvert inlet along the debris flow

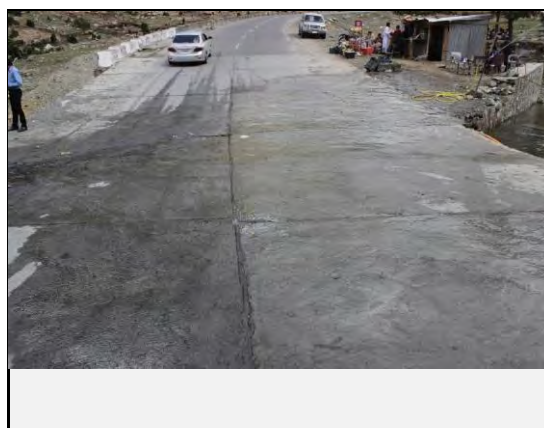
Road condition

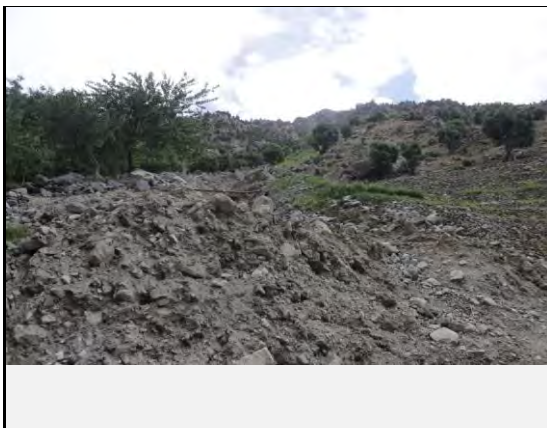
Mountain side view of the debris flow

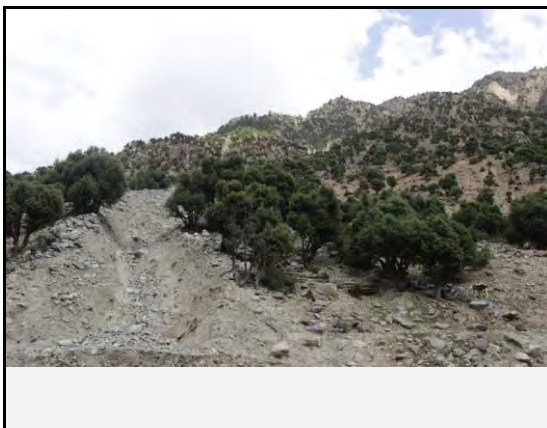
Mountain side view of the debris flow

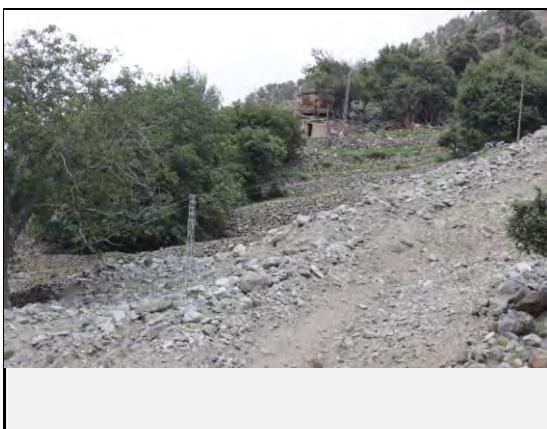
The Check dams has been built along the debris flow

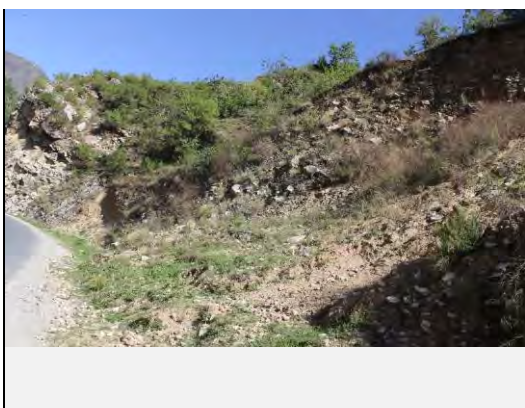
View of the slope failure at the middle point

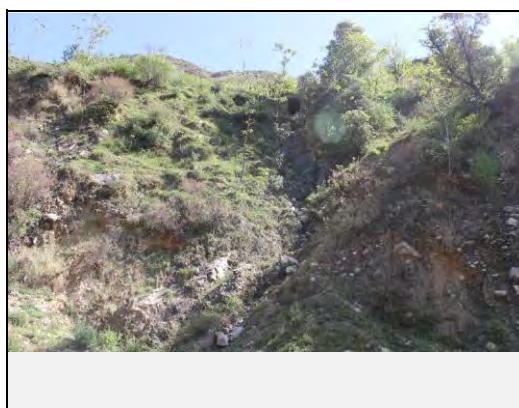
View of Gully erosion along the slope failure

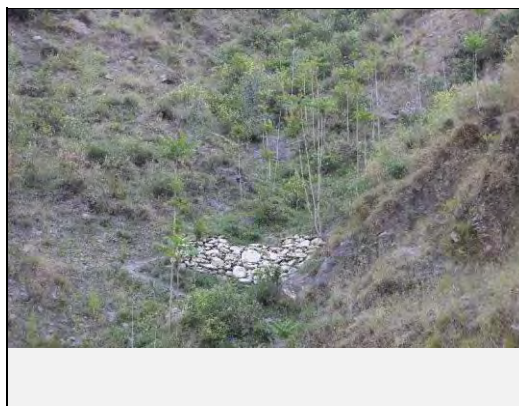
Existing countermeasures / anomalies: View of check dam as counter measure

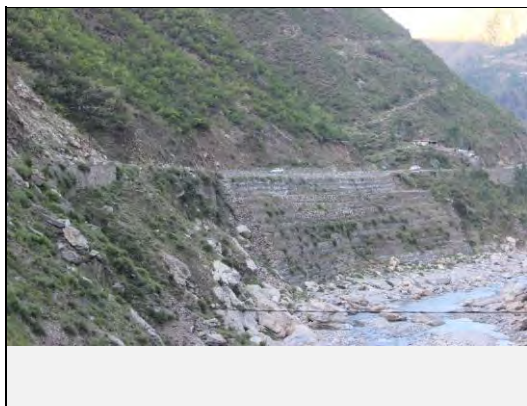
Full view of the slope failure

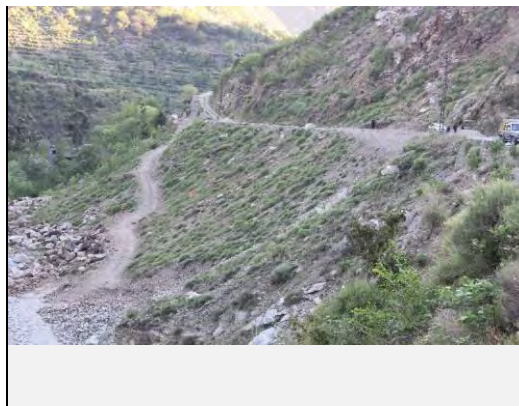
View of slope failure on Valley side:

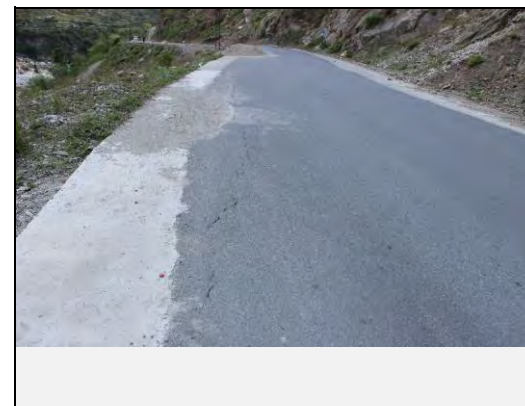
Road condition: Cut slope at the start point

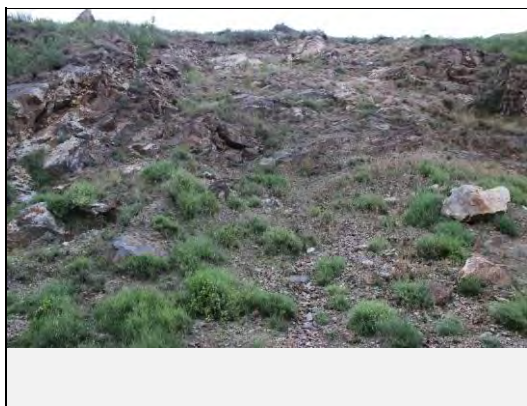
View of the slope failure at the middle point

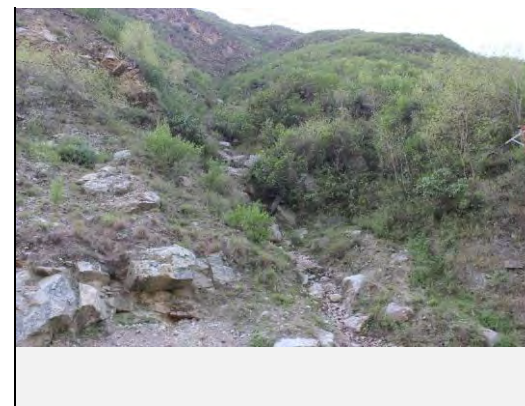
View of drainage that cuts the slope

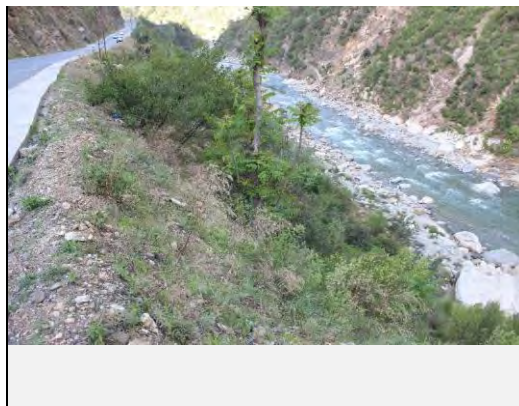
View of slope failure on Valley side:

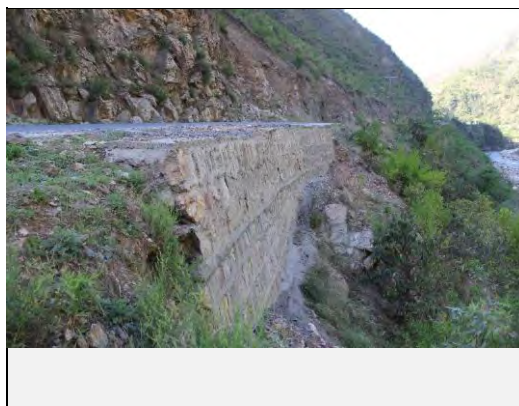
Existing countermeasures / anomalies: View of Retaining wall as counter measure

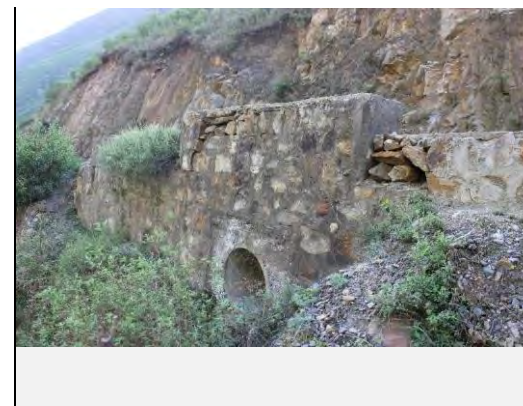
View of Drainage pipe and damaged retaining wall

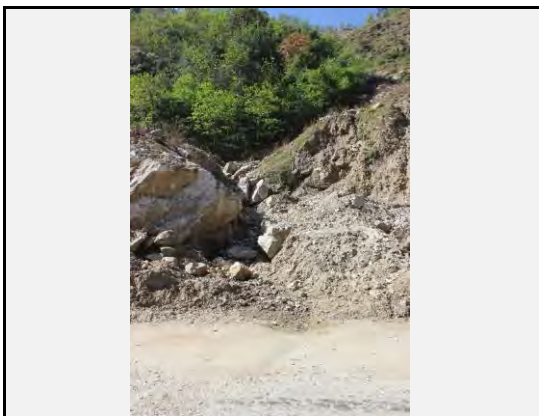
A very active debris flow mainly triggered during the intense monsoon rainfall of 2010 blocking the road for 3 weeks. The debris flow is active mainly during the rainy season blocking the road and obstructing the traffic. A channel is develop to drain the debris flow. Spring water is percolating in the slide debris. Active erosion leads to the development of gullies. Hanging boulders are also present on the slide. Two roads are passes through the slide.

Mountain side view of the debris flow

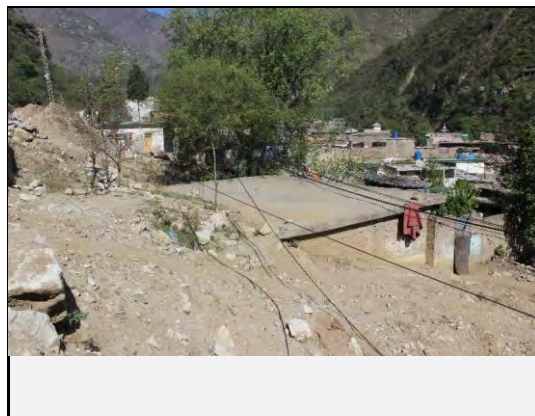
Valley side view of the debris flow

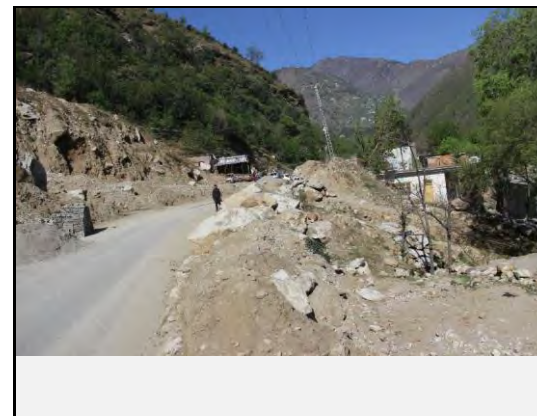
Front view of the debris flow

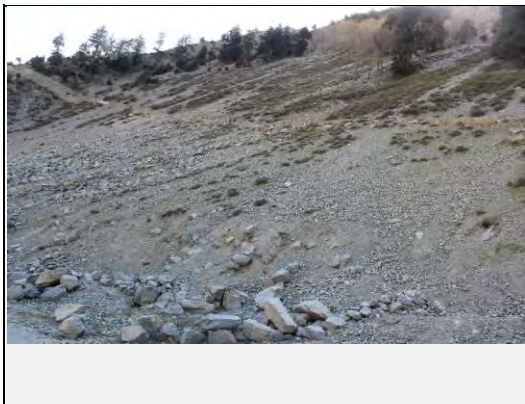
Full view of the slope failure

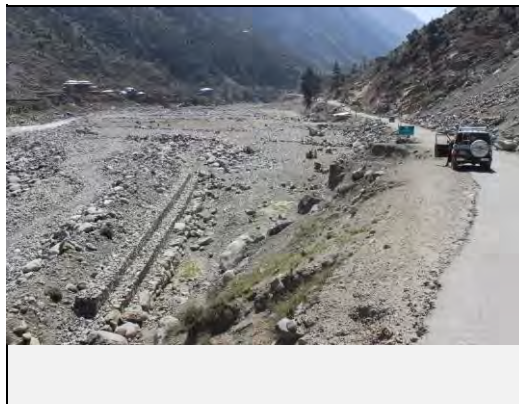
View of slope failure on Valley side and a river diversion structure built at the toe of the slope failure

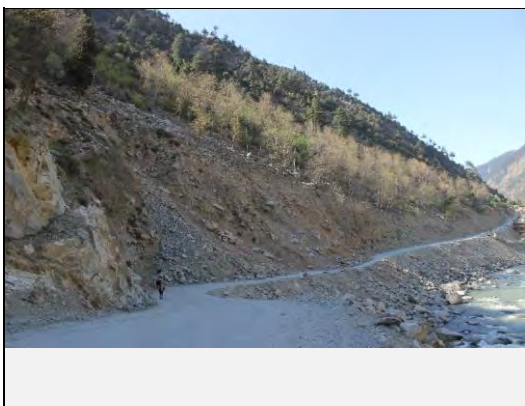
View of the slope failure at the left flank

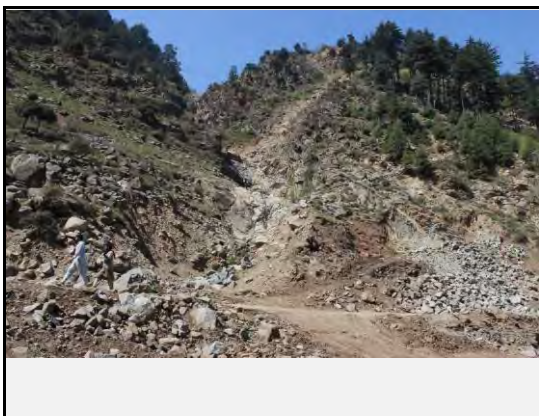
Mountain side view of the debris flow

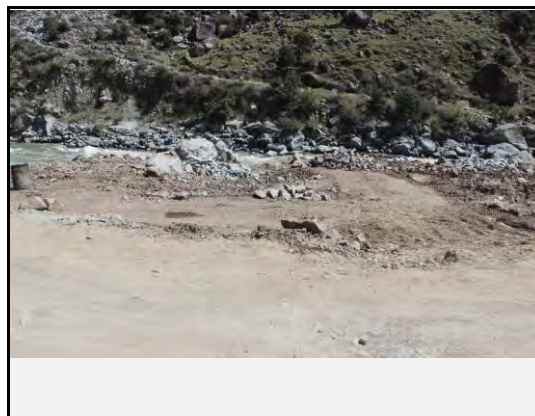
Valley side view of the debris flow

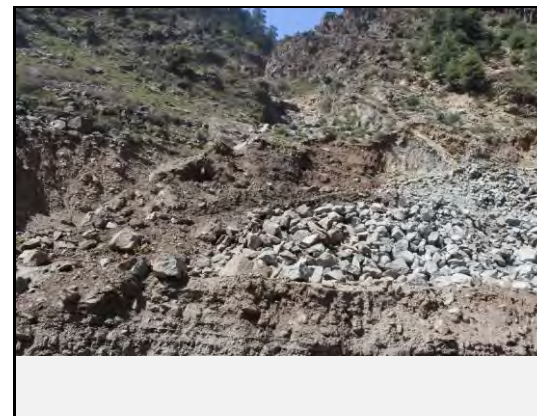
Front view of the debris flow

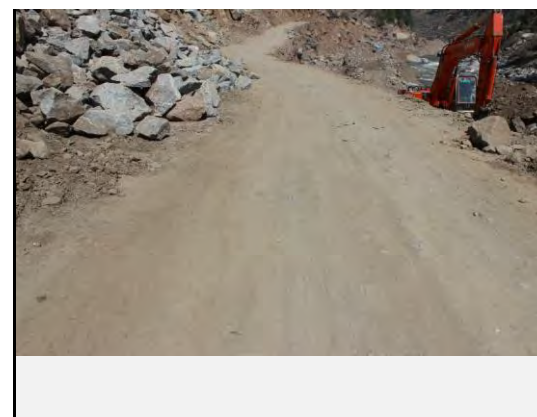
Existing countermeasures / anomalies: Retaining wall is being constructed at the toe of the debris flow

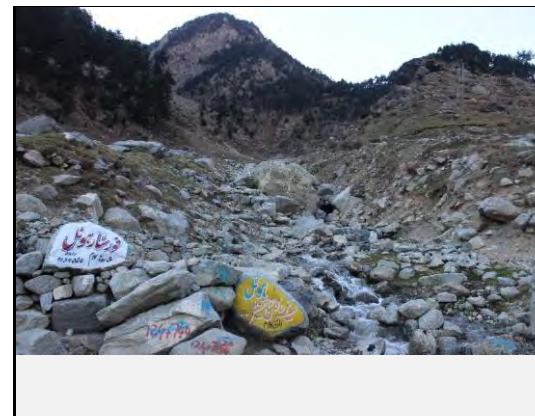
Front view of the debris flow

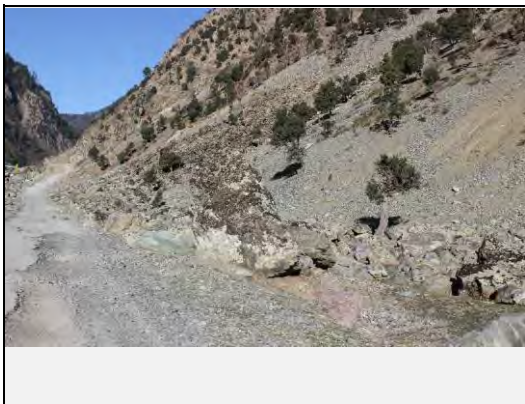
It is a complex slide comprising of rock fall and debris flow. Debris is comprised of boulders, gravels, sand and silt. Source of debris is from steep outcrop with fractured and jointed rocks. Hanging and detached boulders are lying on the debris that are prone to sliding during the rainfall. Soil erosion leads to development of water channels in the slide. The loose material on the slide is prone to debris flow during the rainy season. Excavation of the loose debris for construction material also trigger the slide. A small retaining wall is built, however, it is also damaged due to

Full view of the slope failure

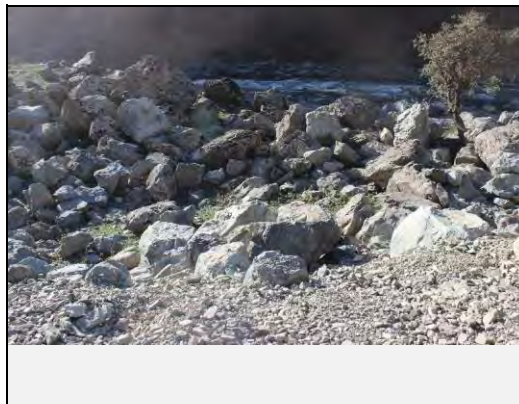
View of slope failure on Valley side:

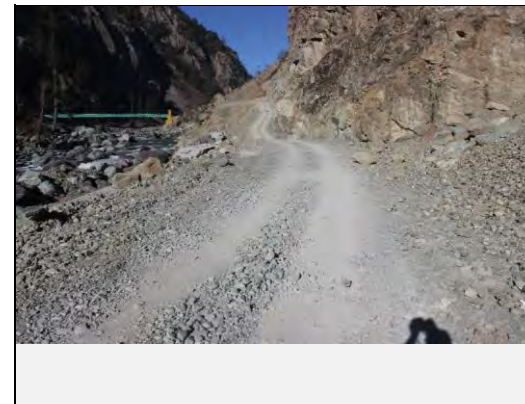
Road condition: Cut slope at the start point

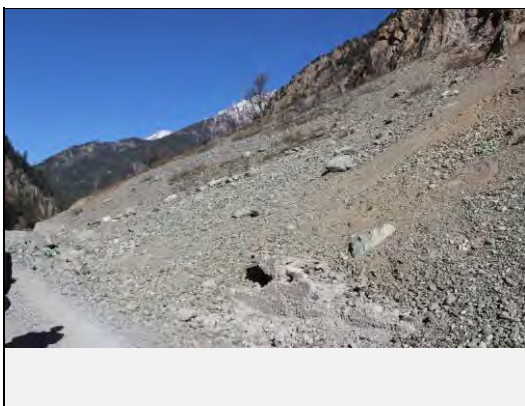
View of the slope failure at the middle point

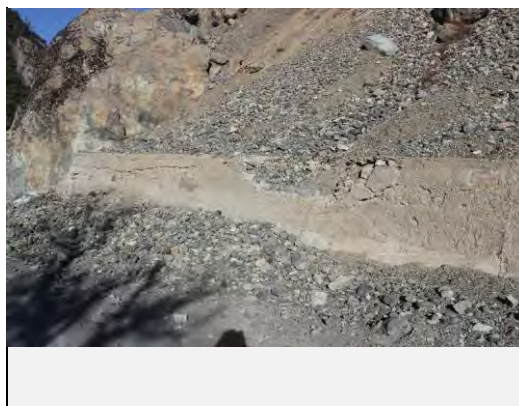
| Type of countermeasures | |
|---|---|
| Appro. 1m high Retaining wall at the toe of Slope Failure | |

Existing countermeasures / anomalies: View of Retaining Wall as counter measure

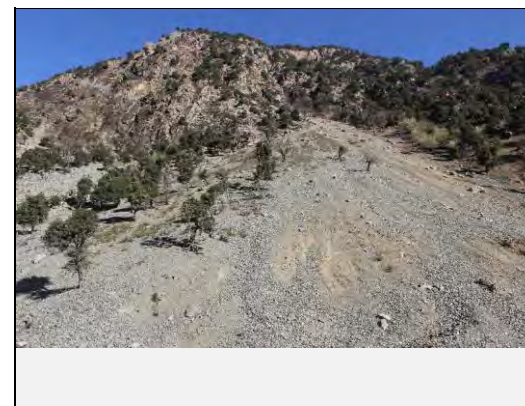
View of gully developed in the slope failure

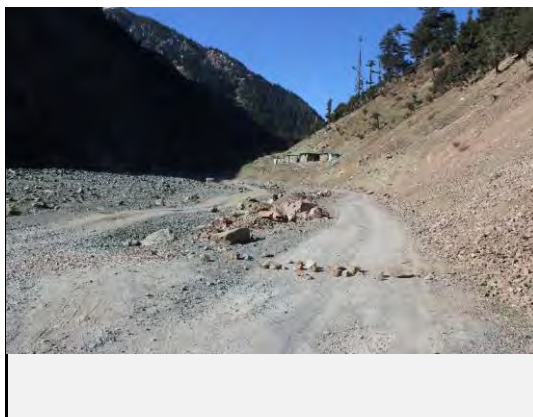
Road condition

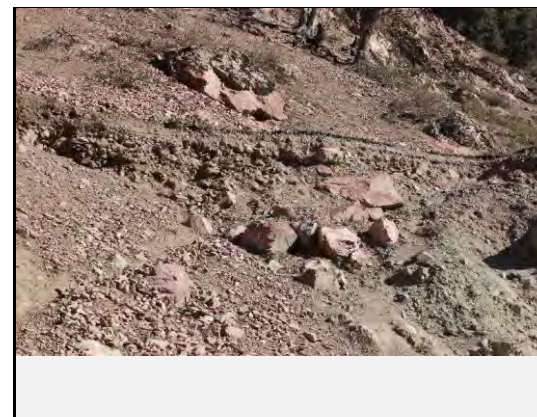
View of debris material and old road

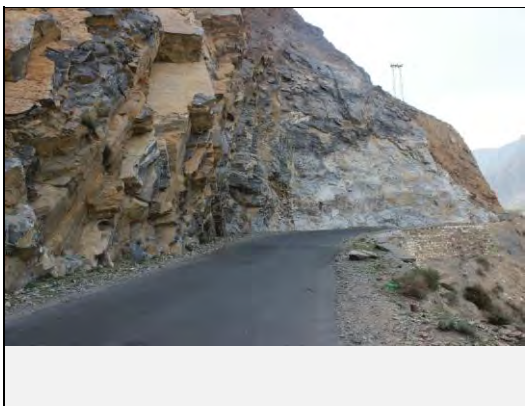
*This cut slope is generated during excavation for N-45. Marble and quartzite is exposed in this section which is jointed and cracked with a risk of over hang blocks. Clayey material is found on both sides of the rock fall. Drainage is also found on the right side of the rock fall. This site is also under consideration for the exploration of Marble for decorative stone.*

Full view of the landslide

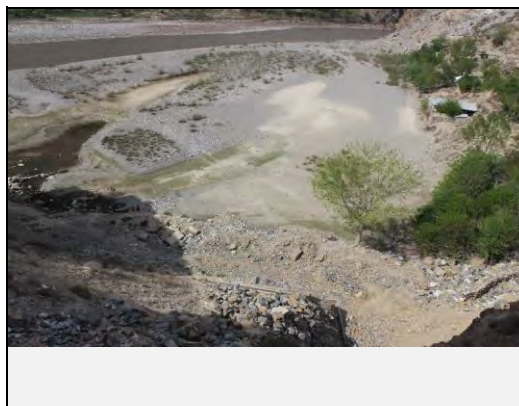
View of landslide on Valley side:

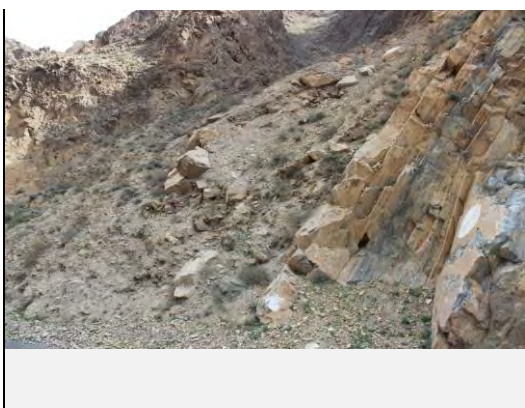
View of the slope failure at the middle point

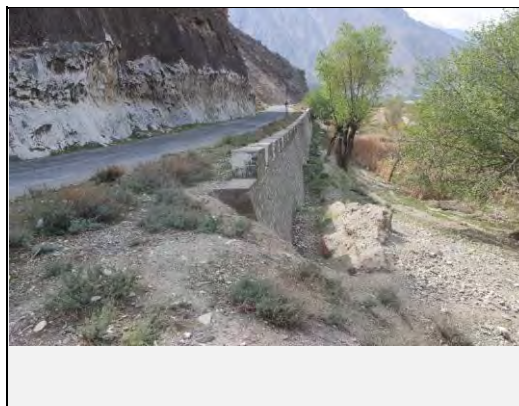
View of Slope Failure on Valley side:

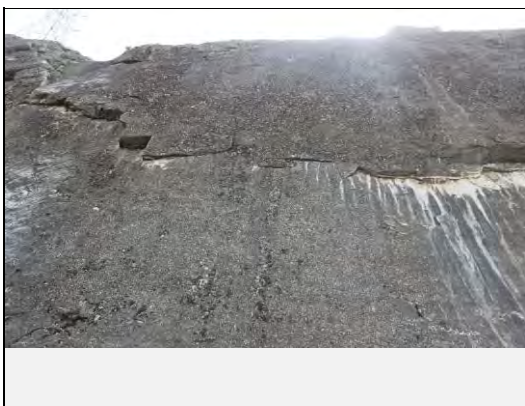
View of the slope failure at the middle point

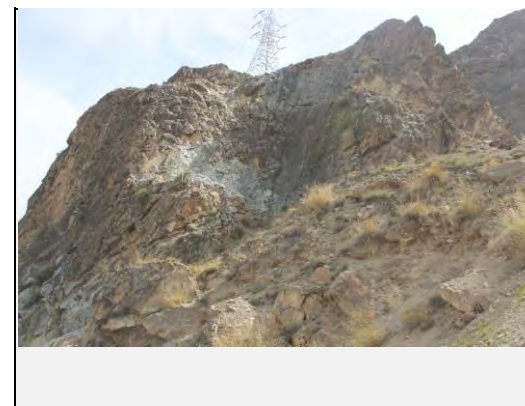
View of drainage that cuts the slope

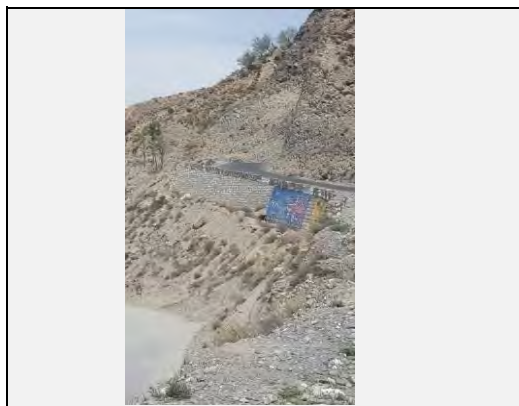
View of Slope Failure on Valley side:

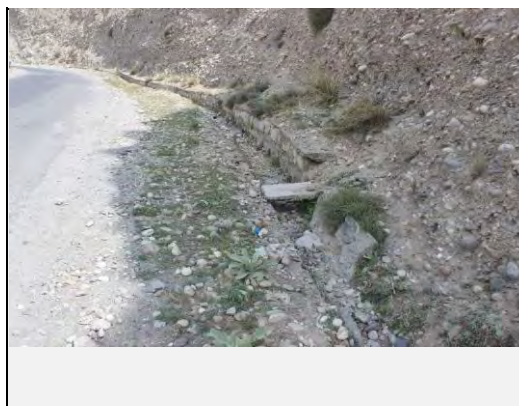
Existing countermeasures / anomalies: View of channel at the toe of Slope Failure

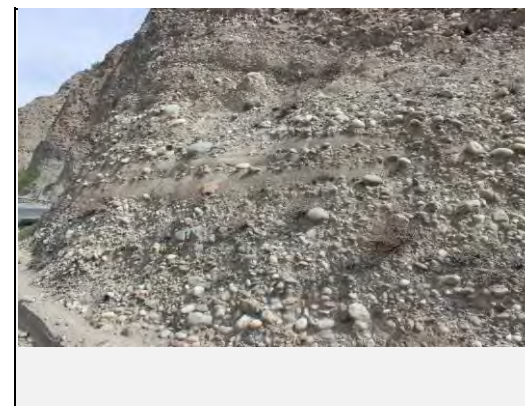
View of sandy layer in the alluvial deposits.

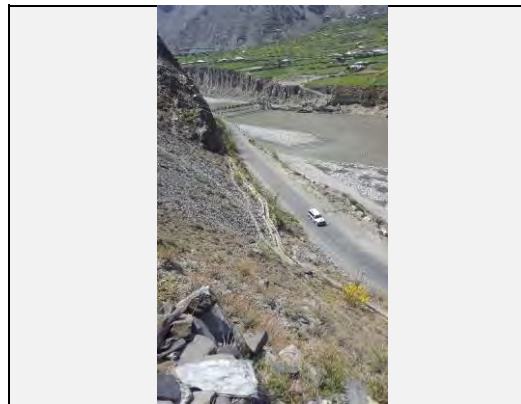
View of slope failure on Valley side:

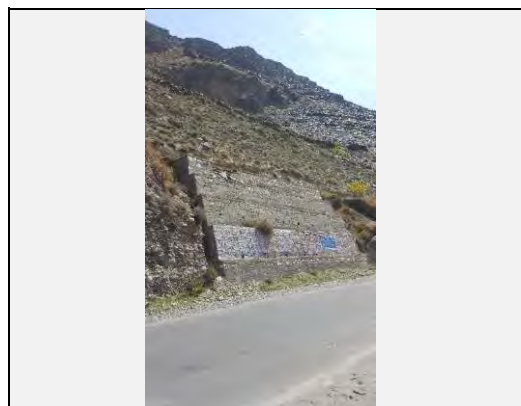
| Type of countermeasures | |
|---|---|
| Stepped retaining wall at the centre of slope failure. | |

Existing countermeasures / anomalies: View of Stepped Retaining Wall as counter measure
