Appendix 2

Survey Result of Slope Chart

Code no.	N	1	5	-	1						
Region Office	Abbottabad										
Maintenance Unit	Balakot

Evaluation sheet (Slope failure/Rockfall)

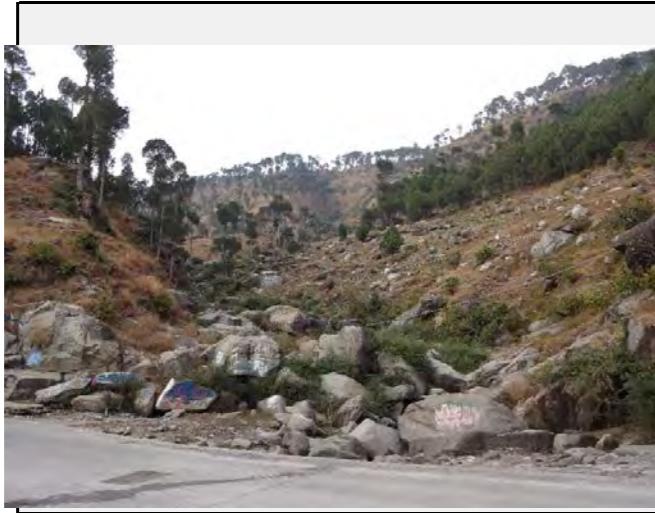
Mountain side: Large boulders are deposited on the mountain side.

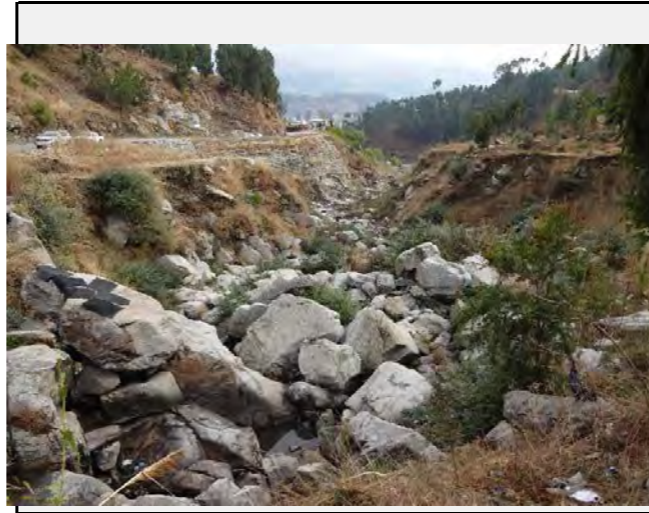
Valley side: Large boulders are deposited on the valley side.

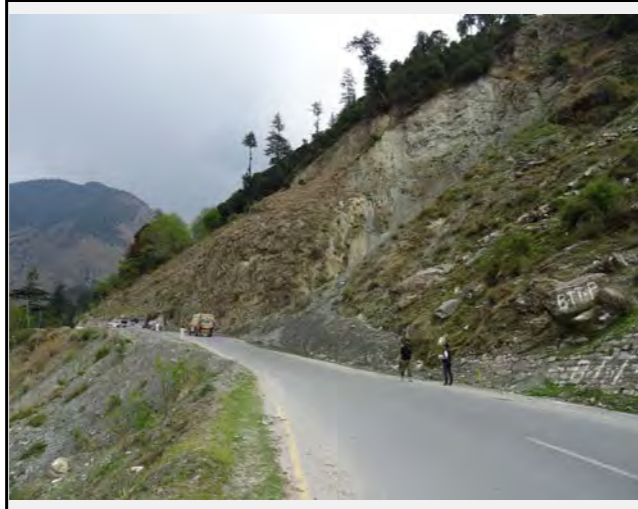
Mountain side: The mountain side is covered mostly by the talus

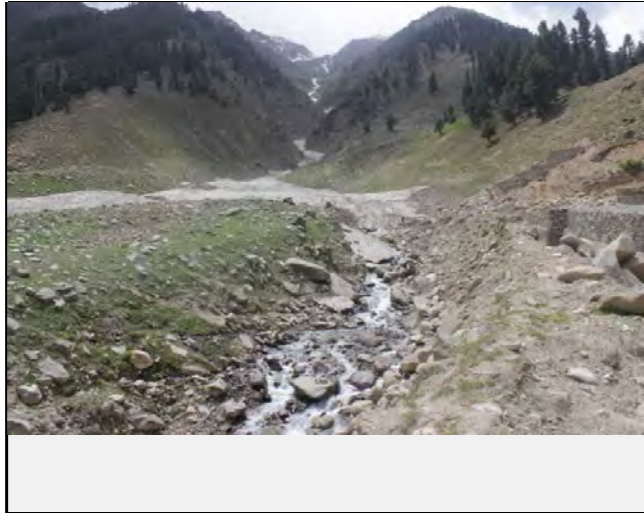
Mountain side view of the debris flow

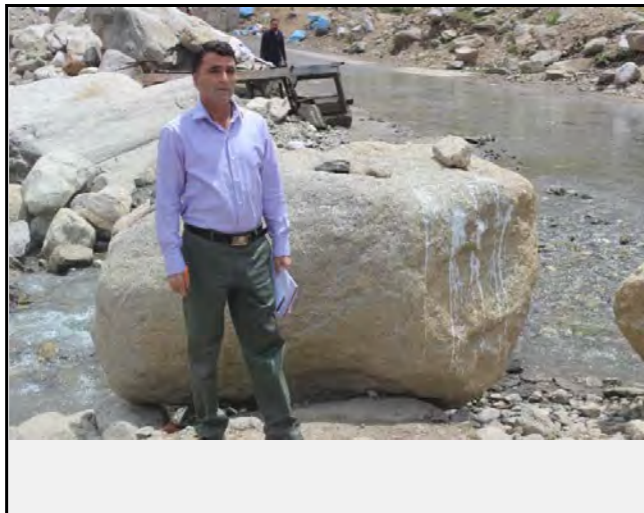
The boulder has been found along the debris flow

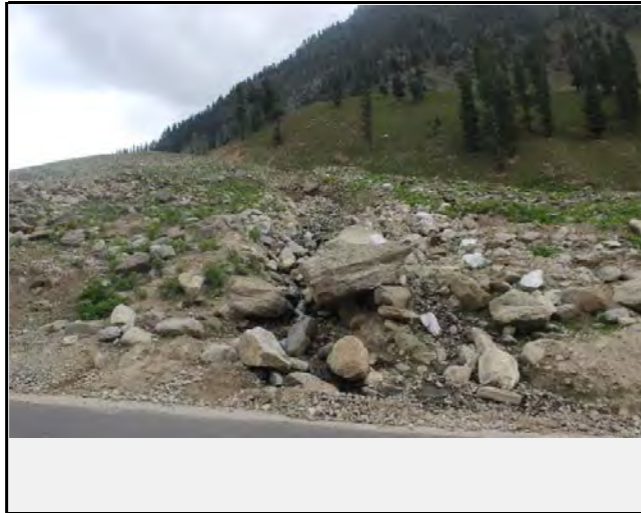
Mountain side view of the debris flow

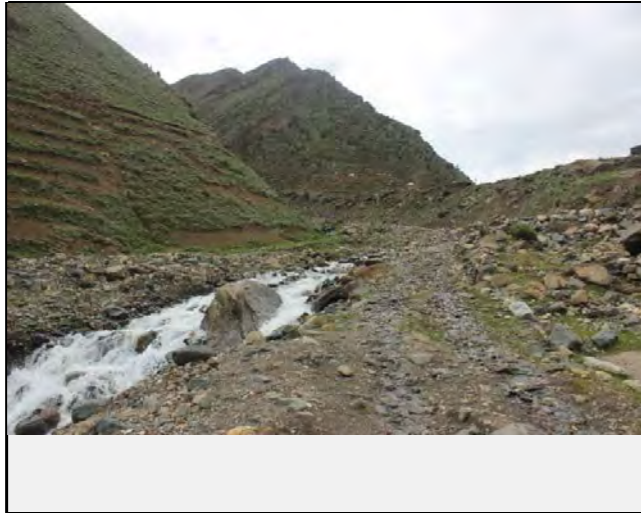
Mountain side view of the debris flow

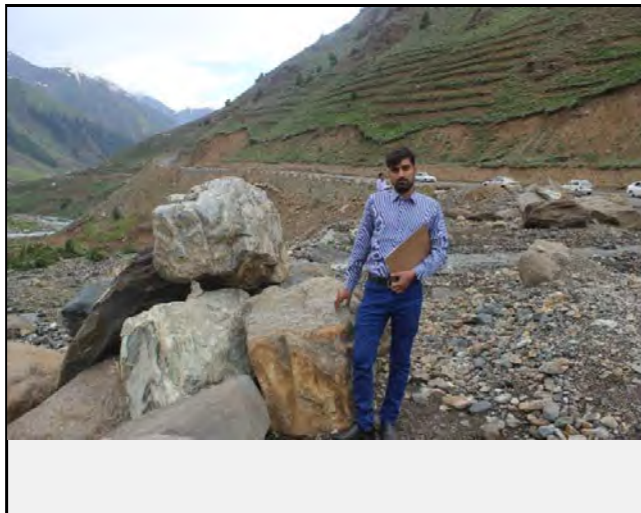
The boulder has been found along the debris flow

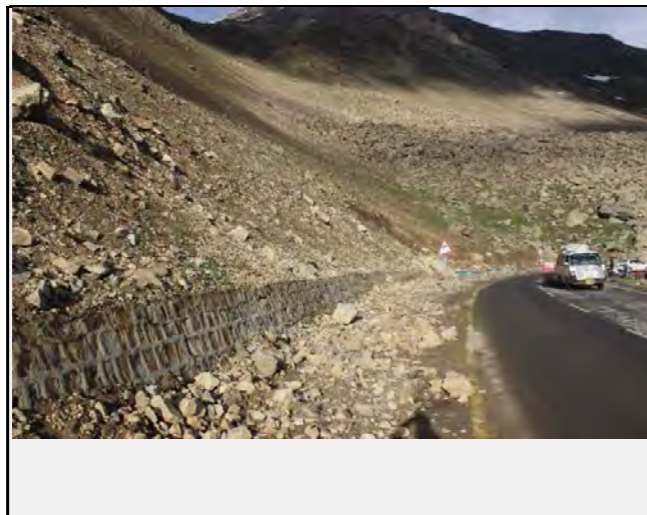
View of the Landslide at the middle point

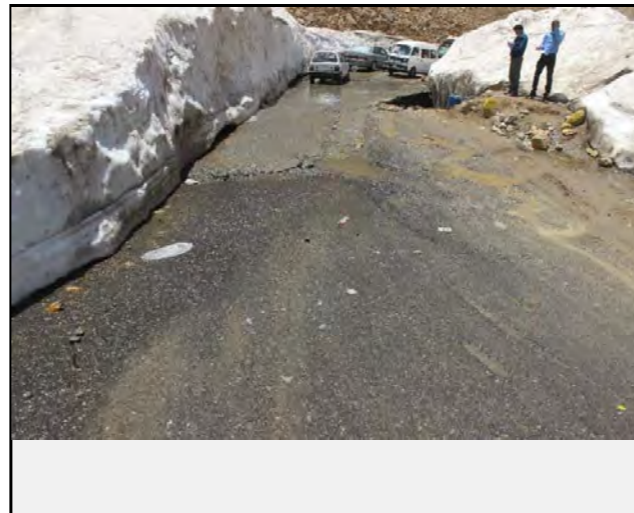
Road condition

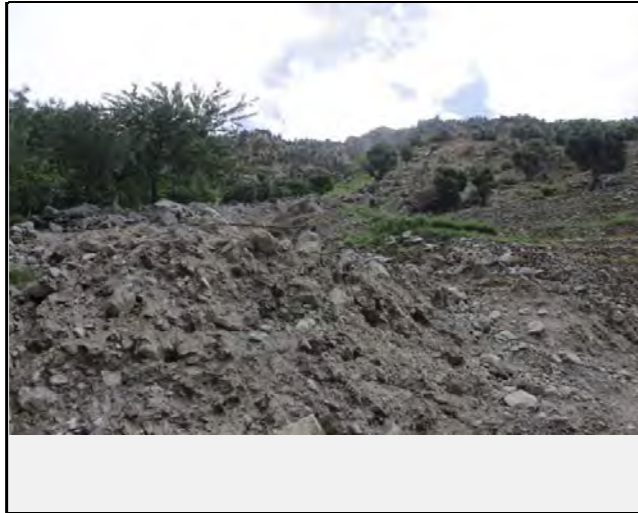
Mountain side view of the debris flow

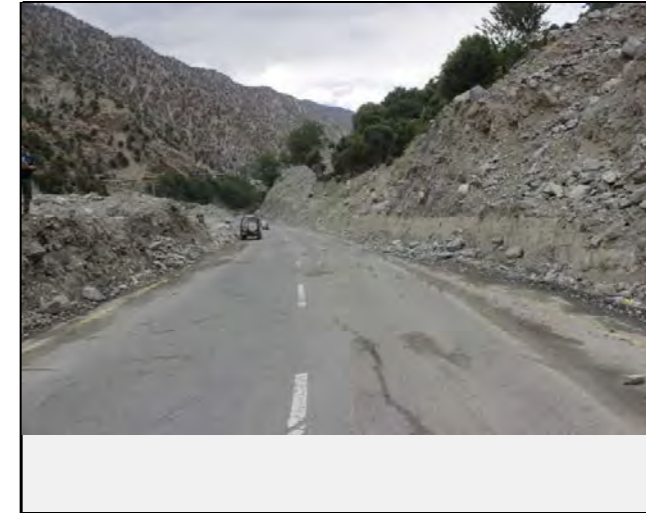
Mid view of the debris flow

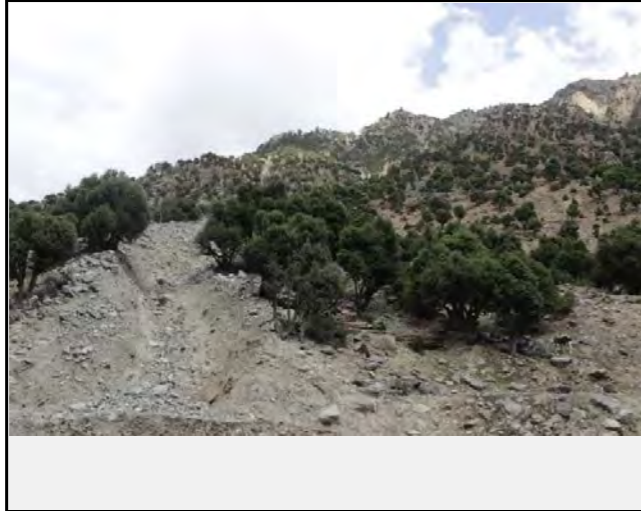
Mountain side view of the debris flow

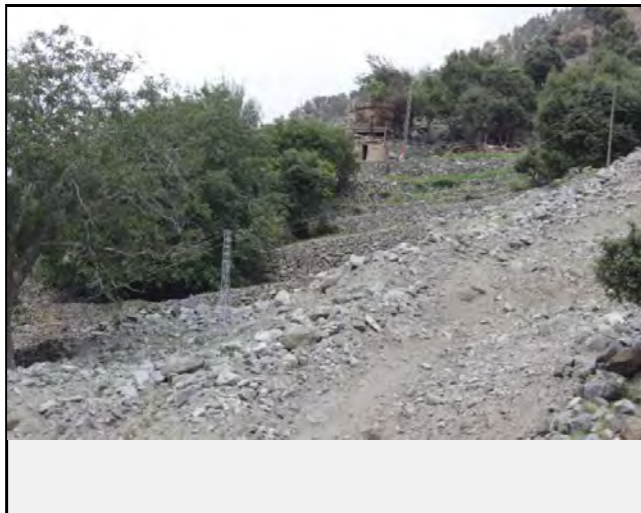
The Check dams has been built along the debris flow

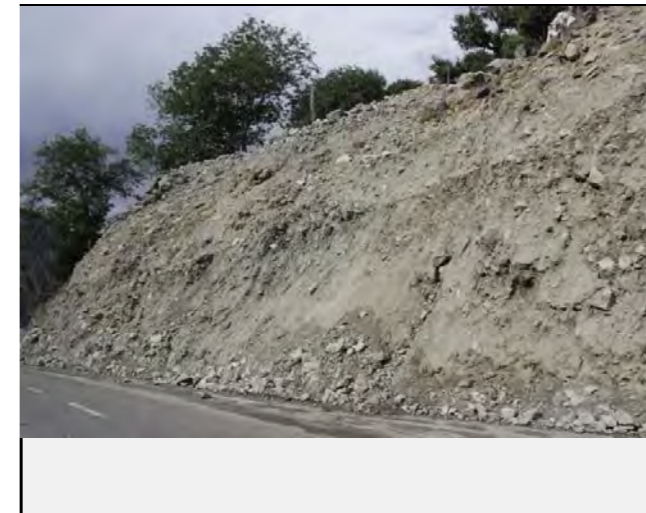
Existing countermeasures / anomalies: No Counter Measure

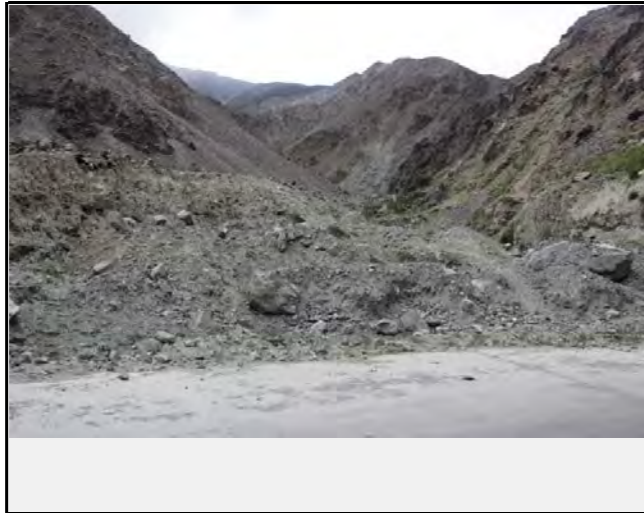
Mountain side view of the debris flow

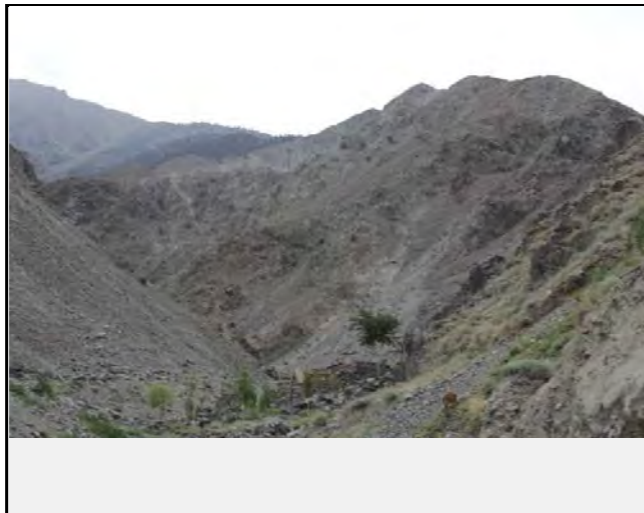
The Check dams has been built along the debris flow

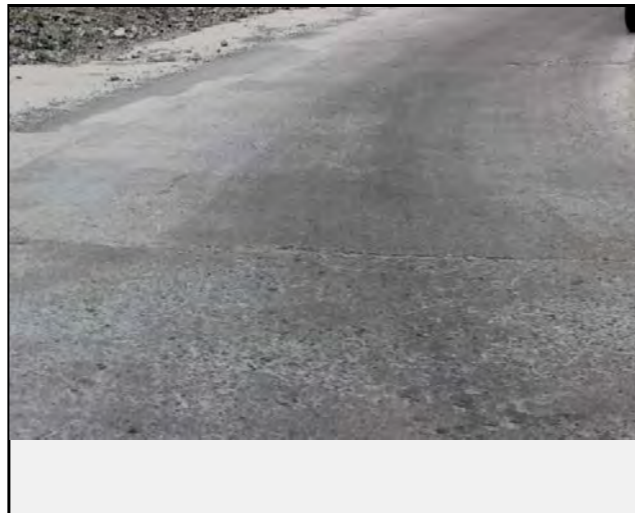
Road condition
