| Region Office | Abbottabad |

## Evaluation sheet (debris flow)

| Road Name | N 3 5 | Km 1 8 4 + 4 0 0 |

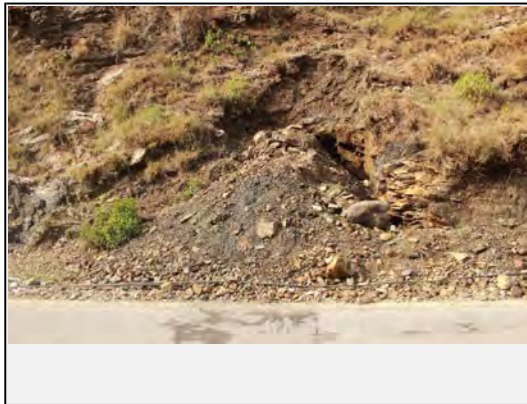
View of the slope failure at the middle point

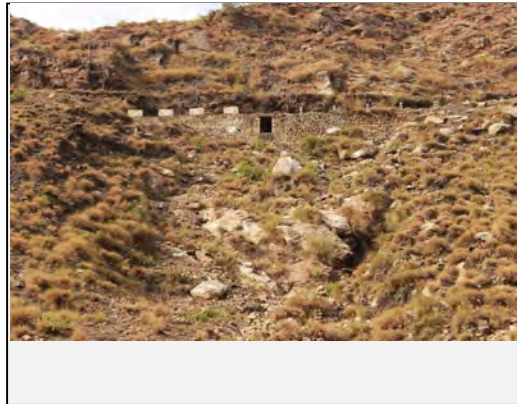
Existing countermeasures / anomalies: View of shed as counter measure

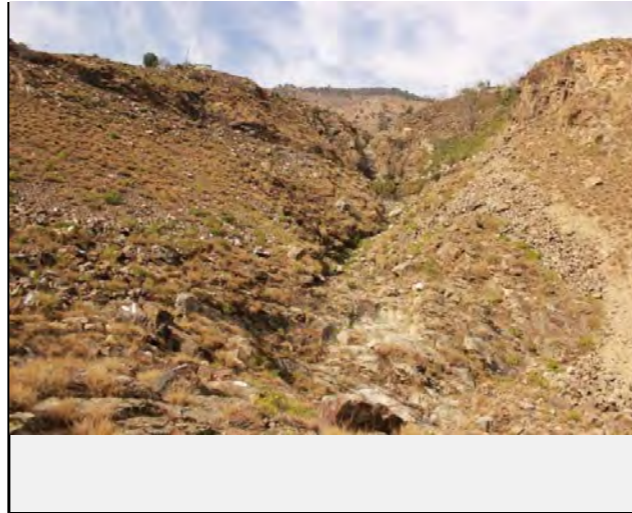
Valley side view of the debris flow

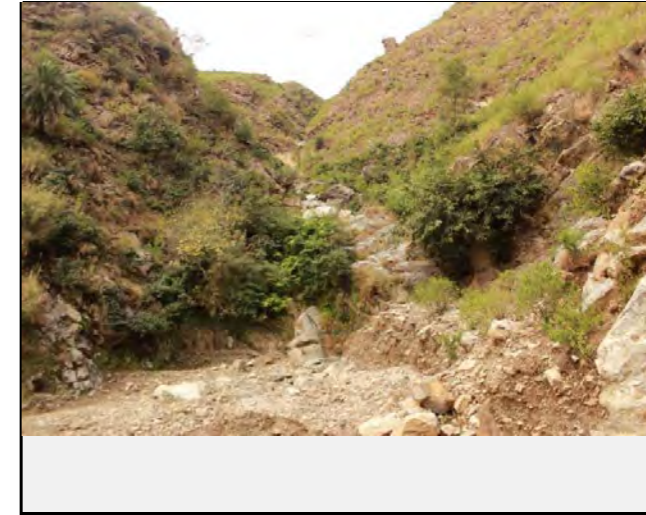
Front view of the debris flow

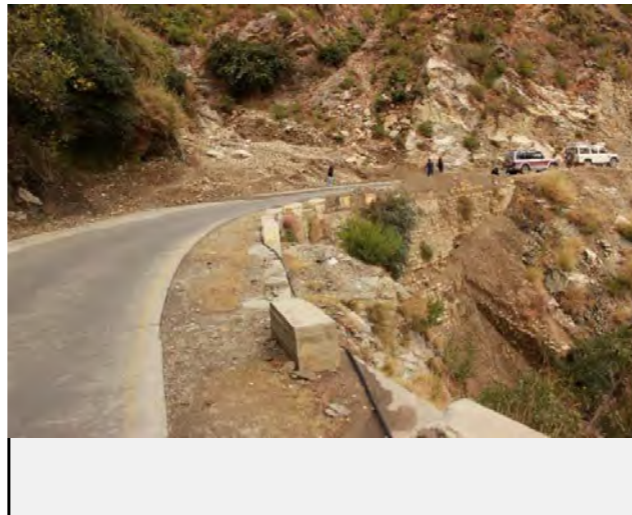
Road condition

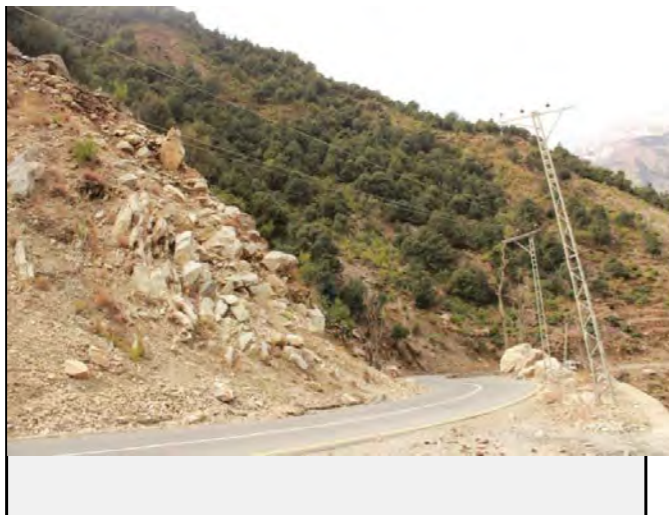
View of the slope failure at the middle point

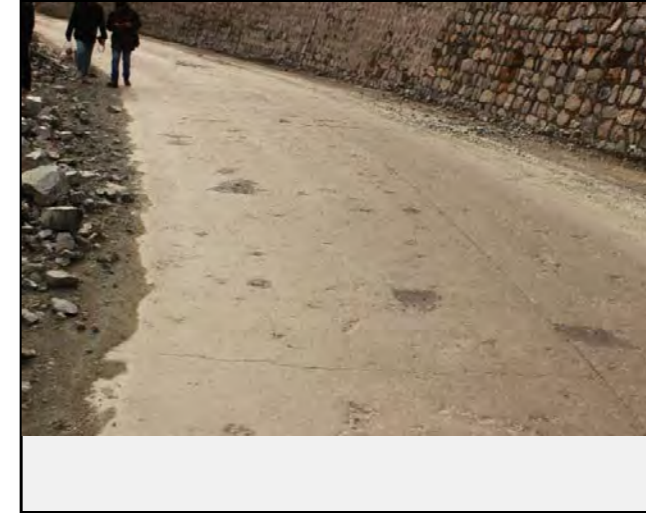
Road condition: Cut slope at the start point

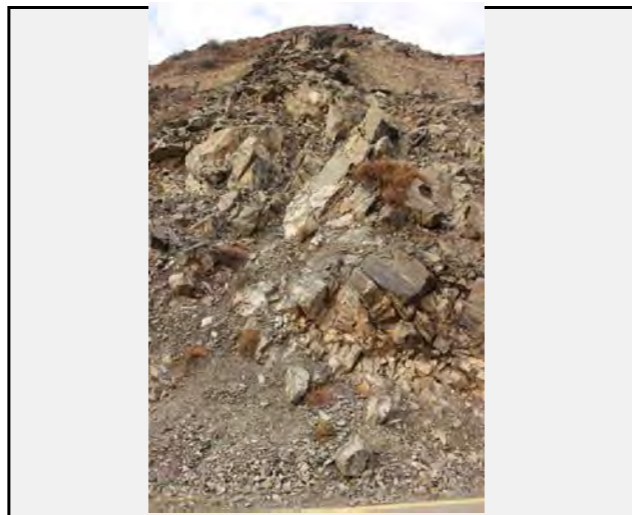
View of the slope failure at the middle point

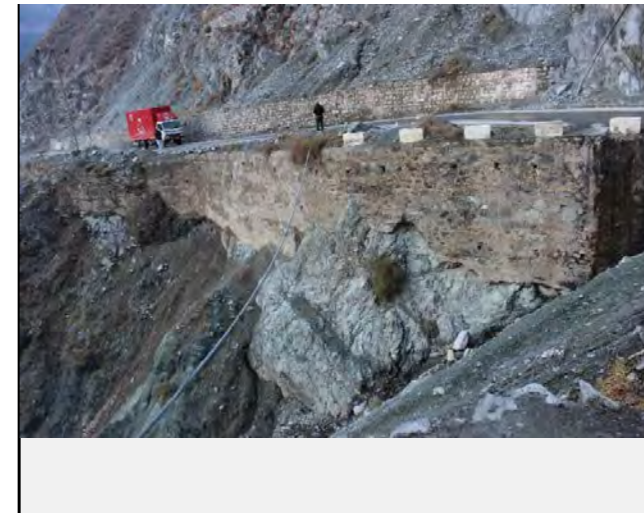
Retaining wall has been constructed as a counter measure to protect the road from the slope failure

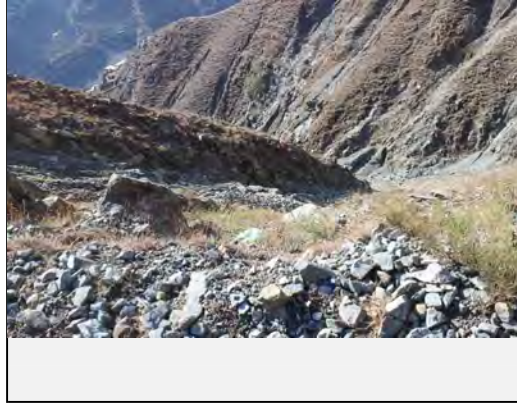
View of Slope Failure on Valley side:

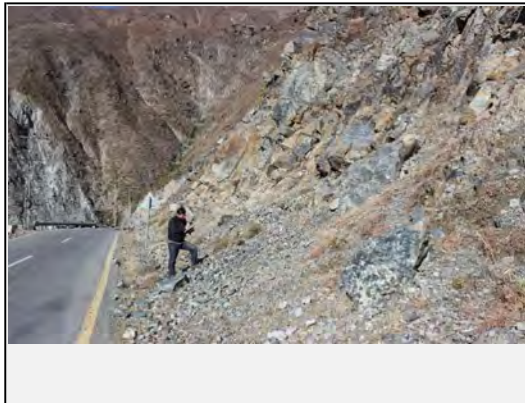
View of the slope failure at the middle point

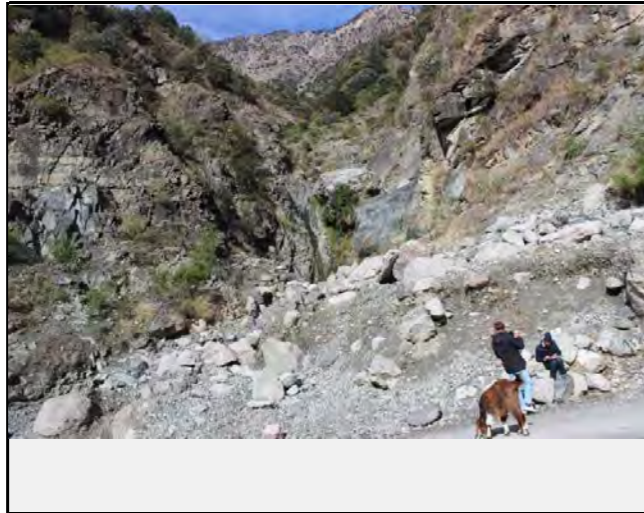
The lying debris of the DF are consists of boulders, gravels, sand and silt. The accumulated poorly sorted debris in the erosion channels are already failed and still prone to slope failure. The DF has continuous flowing water, however, the water seeps beneath the road and appears again on the valley side of the road and therefore the road is prone to a disaster. No trees are present in the source area of the DF, however, shrubs and bushes are sparsely present. Boulders are mainly of Dunite and Amphibolite. The DF is frequently affecting the road, mainly during the rainy season. A retaining wall is constructed on the valley side of the road which is also partly damaged. Part of the source area of the DF is also prone to rock fall with detached and fragmented boulders that could also reach to the road and therefore also posing threat to road and traffic.

Mountain side view of the debris flow

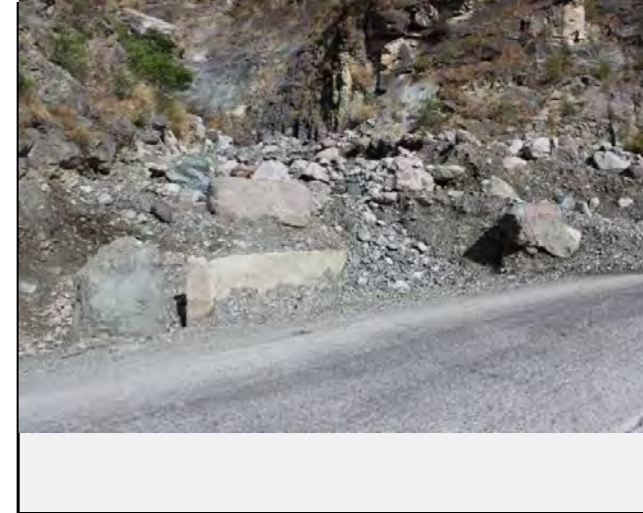
Front view of the debris flow

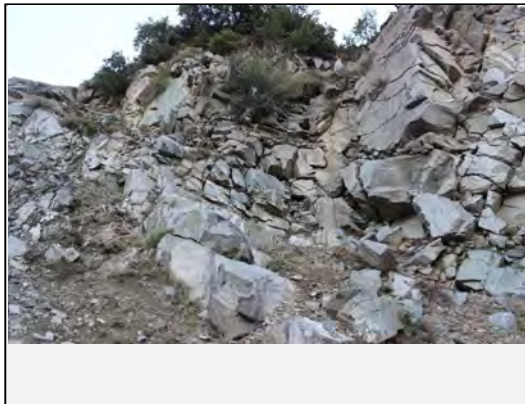
Road condition: Cut slope at the start point

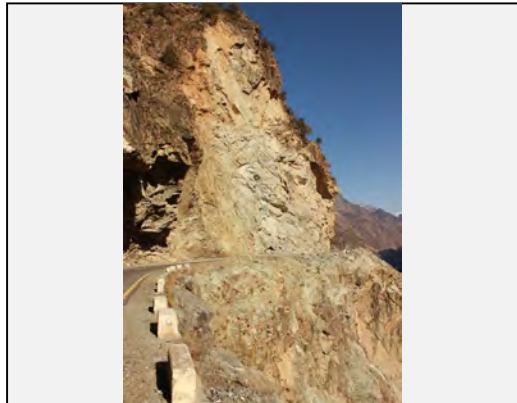
Existing countermeasures / anomalies: View of shed as counter measure

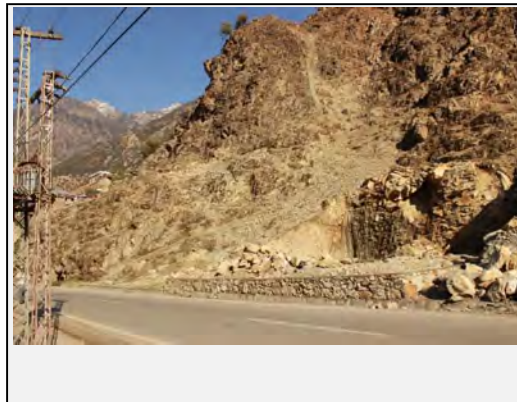
Existing countermeasures / anomalies: View of retaining wall as counter measure

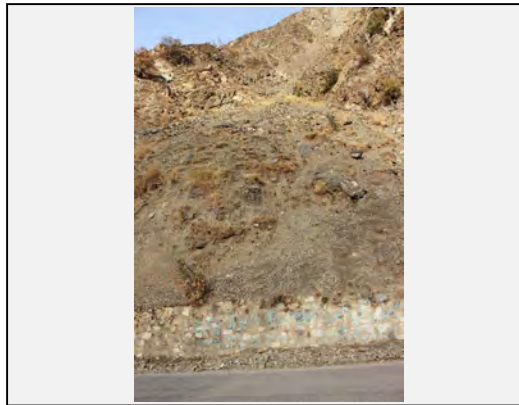
Existing countermeasures / anomalies: View of retaining wall as counter measure

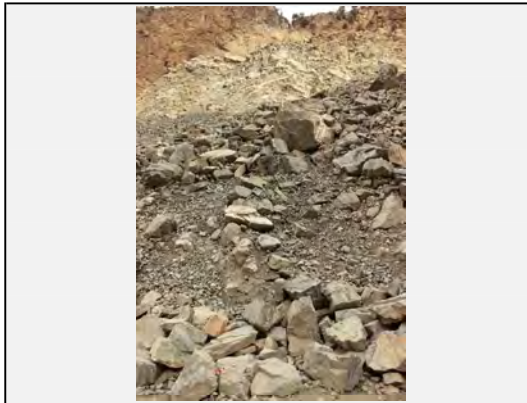
View of the slope failure at the middle point

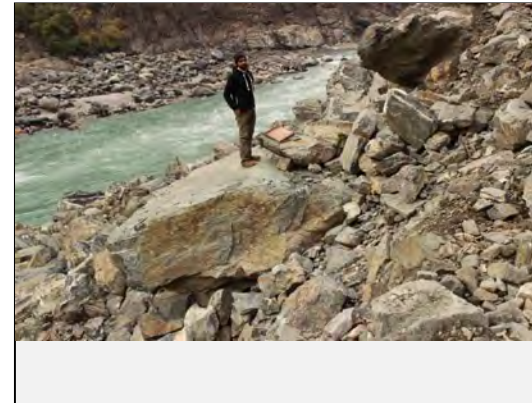
View of fallen blocks

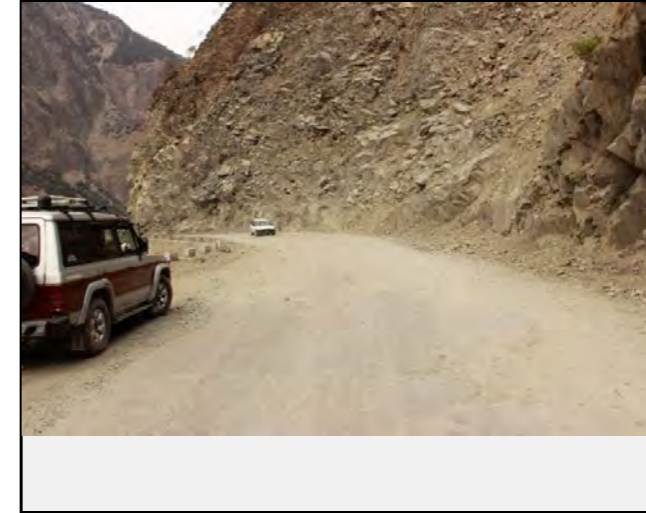
Road condition: Cut slope at the start point
