Appendix 6

Survey Result of Restricted Area

SLOPE FAILURE ANALYSIS ALONG THE MAJOR ROADS NETWORK IN NORTHERN PAKISTAN

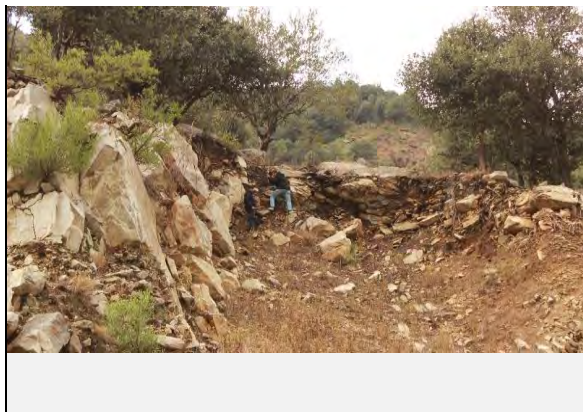
Code no.	N	3	5	1	4	
Region Office						
Maintenance Unit

05	N-35-14	35°00' 11.9" 72°53' 53.90"	Slope Failure	Construction of retaining wall	<p>This rotational landslide is located on N35. It is historically active slope failure. The slide was mainly triggered during the 2005 earthquake and also reactivated during the torrential and prolonged monsoonal rains of 2010. The slide also become active during the rainy seasons. The scarp and upper parts of the slope is partially stable with thick vegetation. However, the portion of the landslide close to the road is still active and prone to frequent sliding and rock fall and therefore posing threats to the road. Many detached boulders and gravels are hanging on the slope posing threat to the road and traffic. No mitigation measures are constructed to protect the road from the fallen rocks or debris. Bedrock of the slide is fractured and weathered granitic rocks. Water erosion leads to development of gullies on the slide.</p>	High

Full view of the landslide

View of landslide on Valley side:

Road condition: Cut slope at the start point

View of the slope failure at the middle point

Existing countermeasures / anomalies

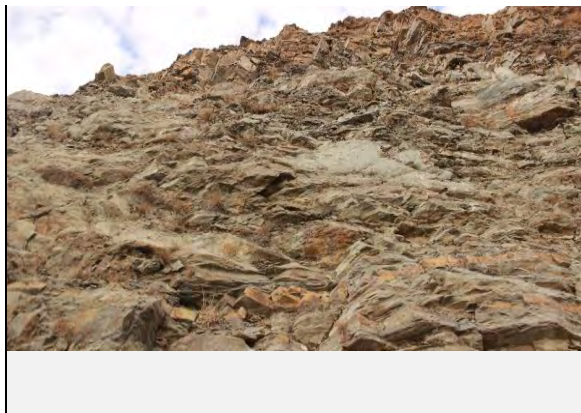
Code no.	N	3	5	_	2	6			
Region Office									
Maintenance Unit

06	N-35-26	34° 02' 19.4" 72° 52' 49.3"	Rock Fall/Slope Failure	Retaining Wall/ Rock bolting, Wire mesh	<p>The slide is active rock fall and cut slope posing great and frequent risk to road. Bedrock of the slide is highly fractured and weathered pyroxinite. The slide has hanging boulders and gravels posing threats to road and traffic. Some sections of the slide are very steep with slope of around 60 degrees. Slide is void of vegetation. During the rainy season the slide is also prone to debris flow comprising of boulders, gravels, sand and silt. Rock fall is planar in nature. Water seepages is observed on the right flank of the slide. Intersecting joints leads to wedge failure. Drainage is developed on the slope and at the stream outlets fan shaped talus are developed. No effective mitigation measures are constructed for the rock fall.</p>	Medium
07	N-35-28	35° 02' 25.7" 72° 56' 6.8"	Slope Failure	Construction of shed/ Drainage diversion	<p>This is an active slope failure and rock fall. The failure has historically affected the road. The wedge shape failure is found on the slide. Detached boulders and gravels are hanging on the slide that combine with the sand and silt leads to debris flow during the rainy season. The slide is void of vegetation. Bedrock is highly fractured and jointed pyroxinitic rocks. Drainage is developed on the slide and active weathering and erosion leads to development of gullies on the slide. Retaining wall is constructed to stabilize the slide, however, the right side of the retaining wall is already damaged. Rainfall is the major trigger for the slide and therefore leads to road damages and disruption of traffic during the rainy season. One of the trigger of the slide is also the freeze and thaw phenomenon. Since this slide is frequently damaging and disrupting the slide and therefore needs quick and comprehensive mitigation measures to minimize its impact on road.</p>	High

Full view of the landslide

View of landslide on Valley side:

Road condition: Cut slope at the start point

View of the slope failure at the middle point

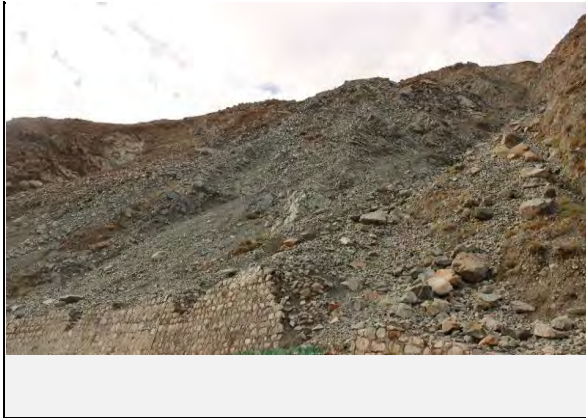
Full view of the landslide

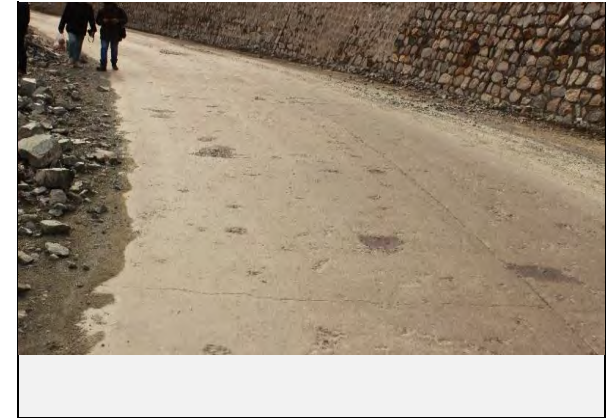
Road condition: Cut slope at the start point

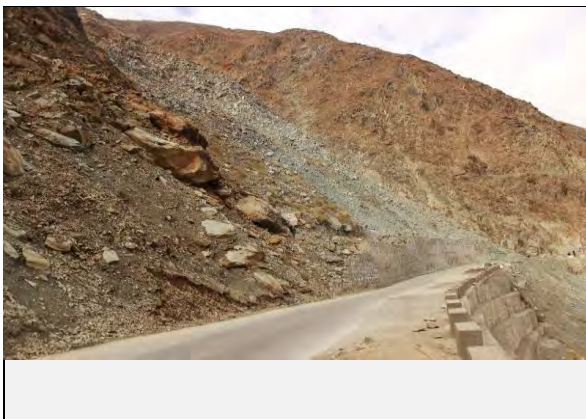
View of the slope failure at the middle point

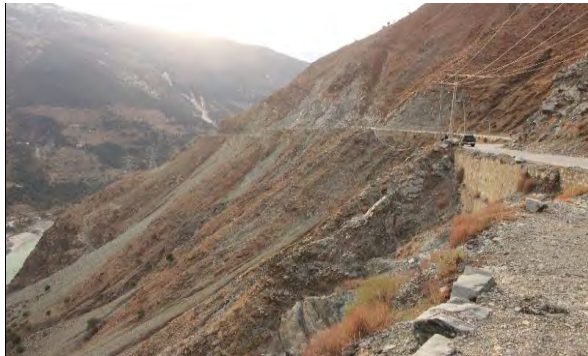
Full view of the landslide

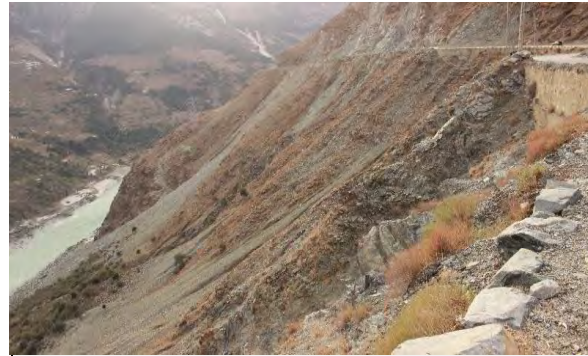
View of landslide on Valley side:

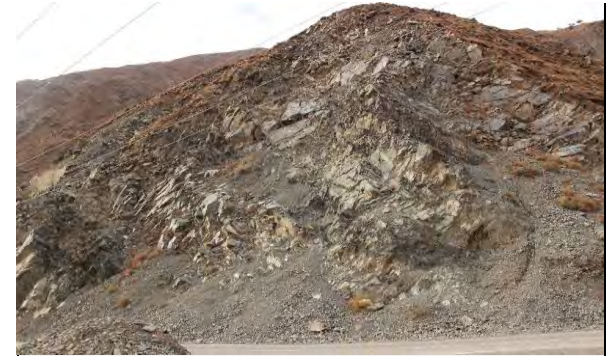
Road condition: Cut slope at the start point

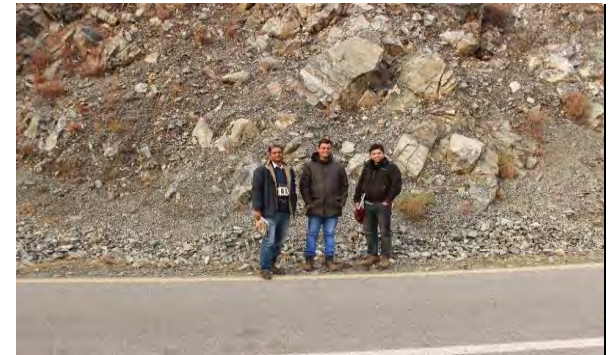
View of fallen blocks on Shed

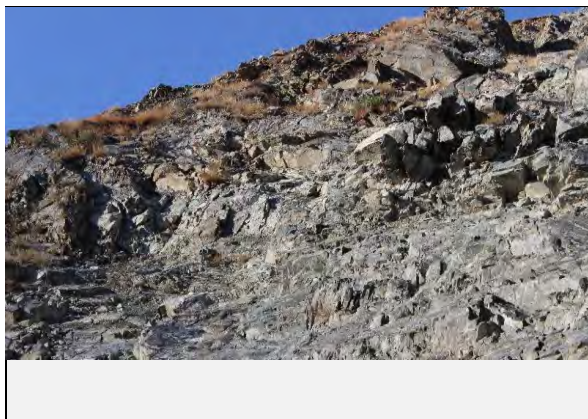
View of the slope failure at the middle point

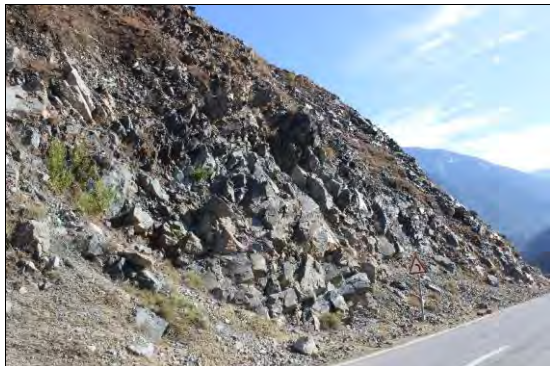
View of the slope failure at the middle point

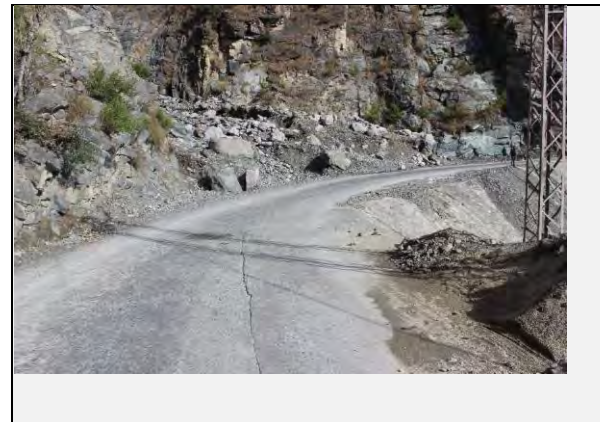
Road condition

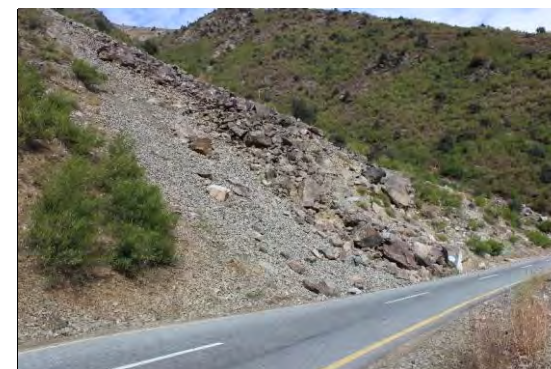
Road condition: Cut slope at the start point

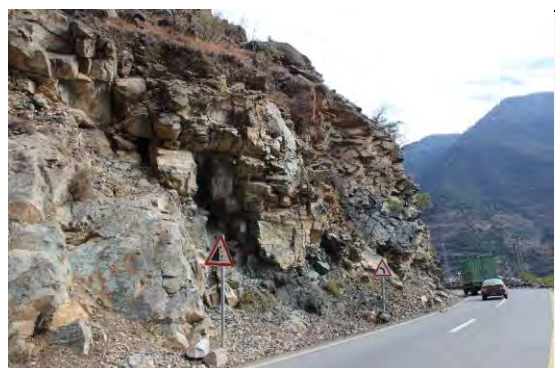
View of the slope failure at the middle point

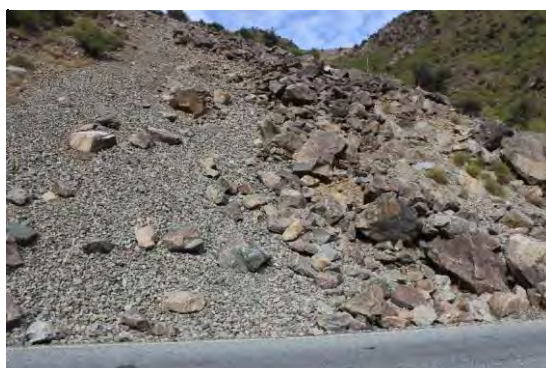
Existing countermeasures / anomalies: No counter measures

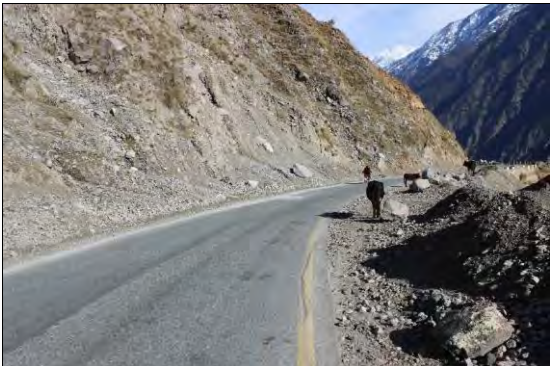
Road condition: Cut slope at the start point

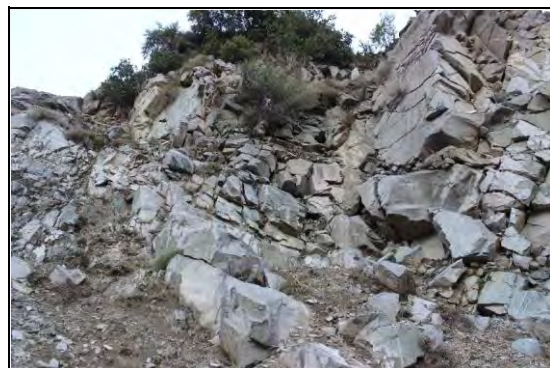
View of the slope failure at the middle point

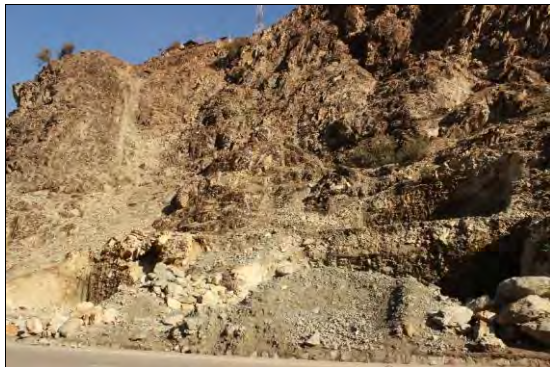
View of the slope failure at the middle point

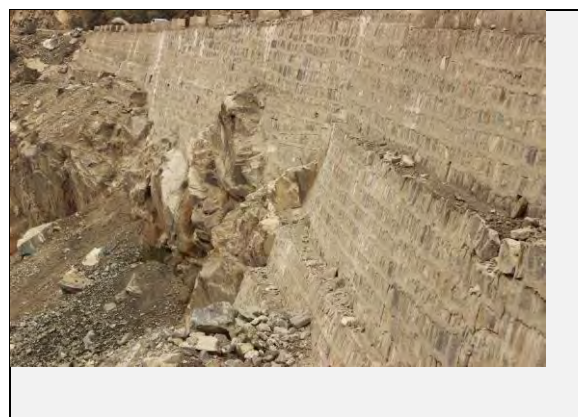
Existing countermeasures / anomalies: View of retaining wall as counter measure

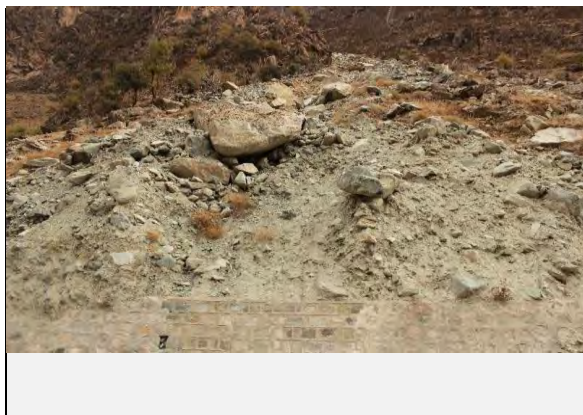
View of the slope failure at the middle point

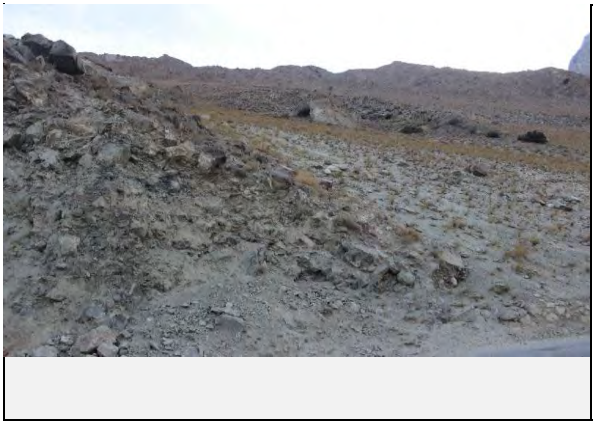
View of the slope failure at the middle point

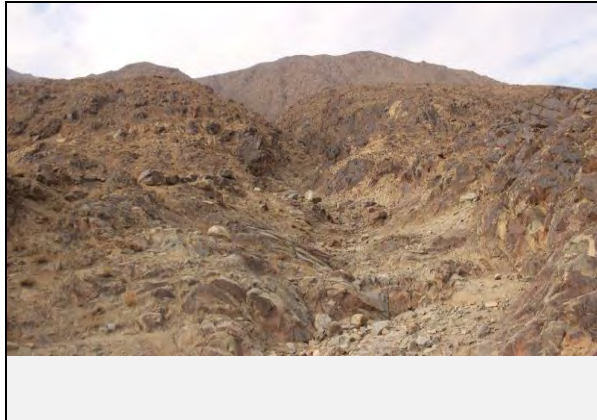
Mountain side view of the debris flow

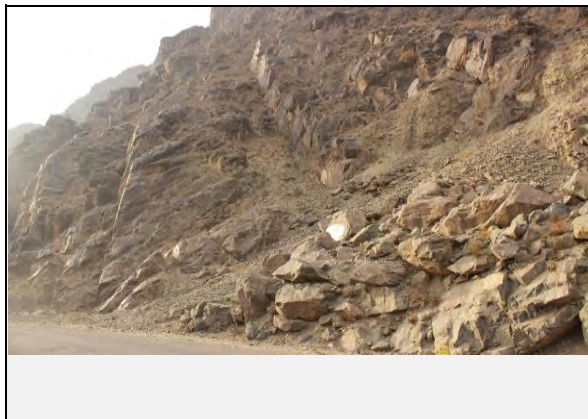
View of the slope failure at the middle point
