Evaluation sheet (landslide)

Code no.	N	7	5		7			
Region Office								
Maintenance Unit

Date	12/9/2017
Inspector	asharat, Yasir, Sajid, Shafi

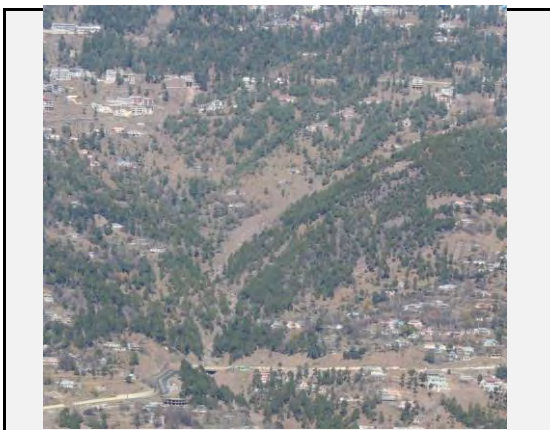
Mountain side view of the debris flow

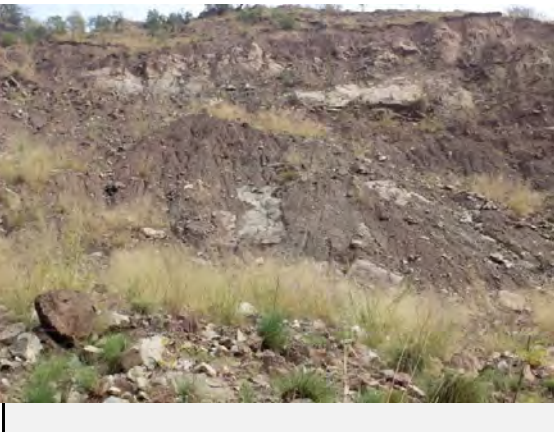
View of the slope failure at the middle point

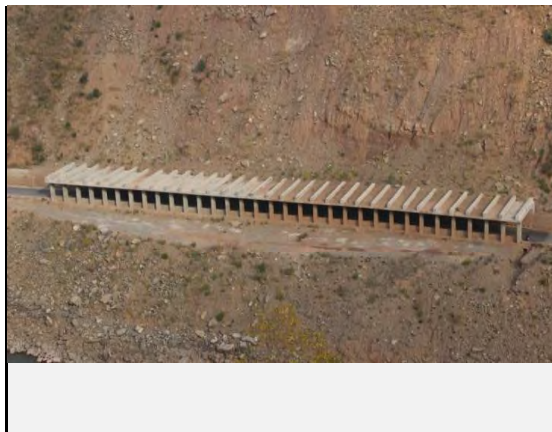
Existing countermeasures / anomalies: View of shed as counter measure

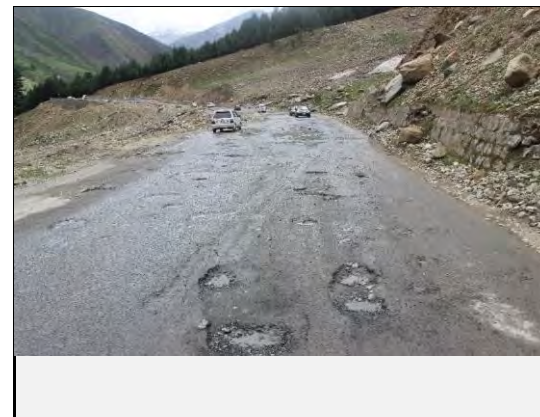
Road condition

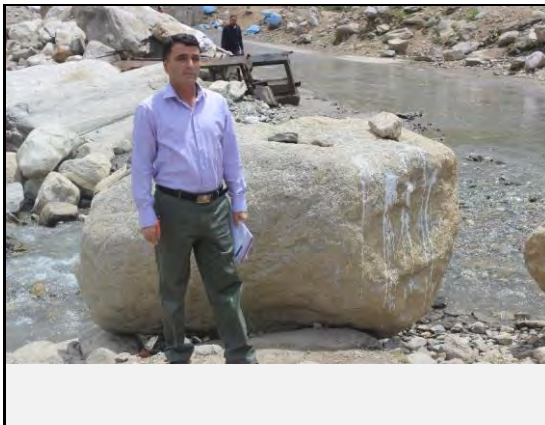
The boulder has been found along the debris flow

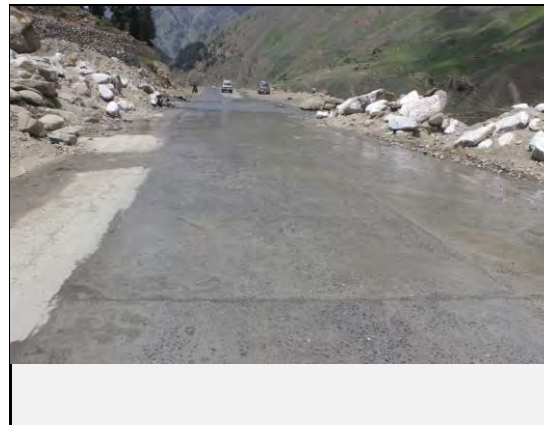
Road condition

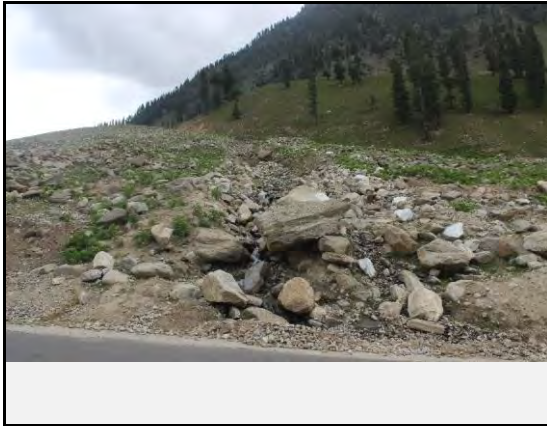
Mountain side view of the debris flow

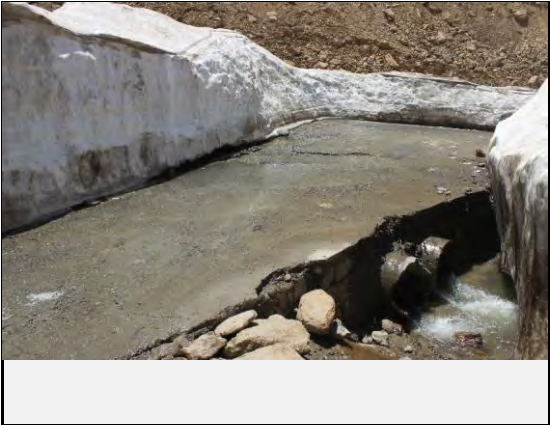
Culvert outlet

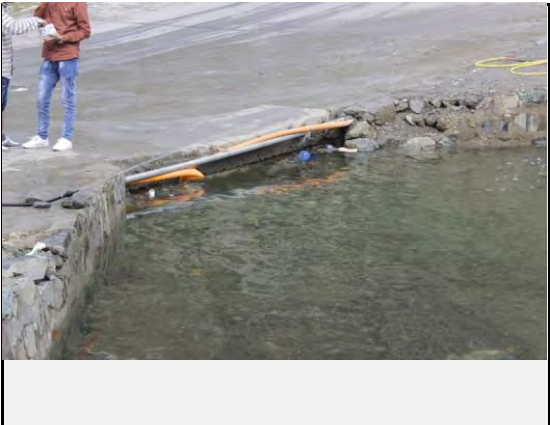
The culvert inlet along the debris flow

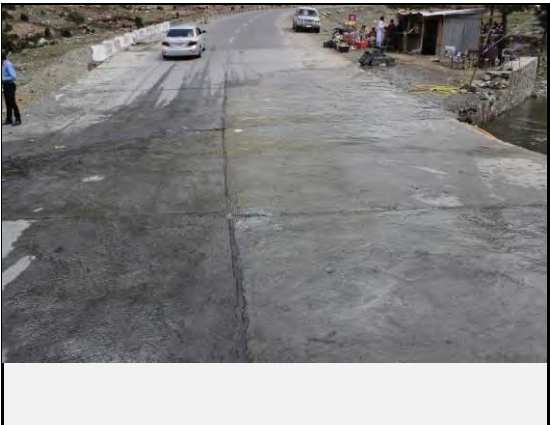
Road condition

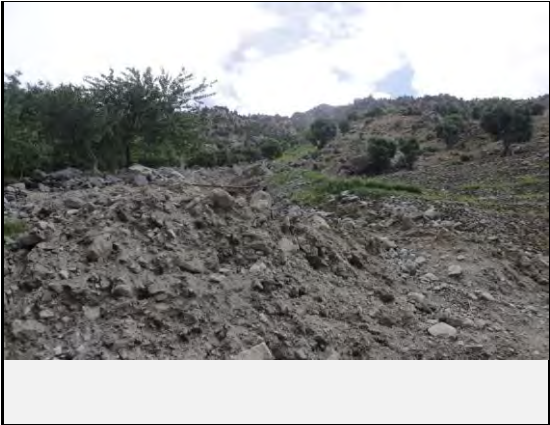
Mountain side view of the debris flow

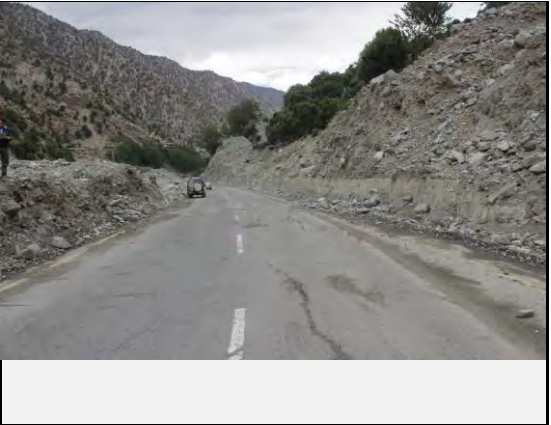
Mid view of the debris flow

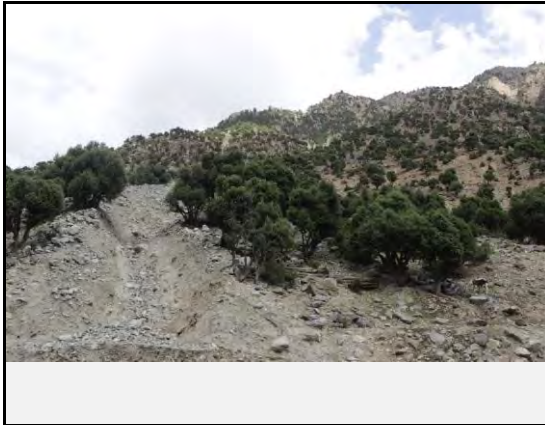
Mountain side view of the debris flow

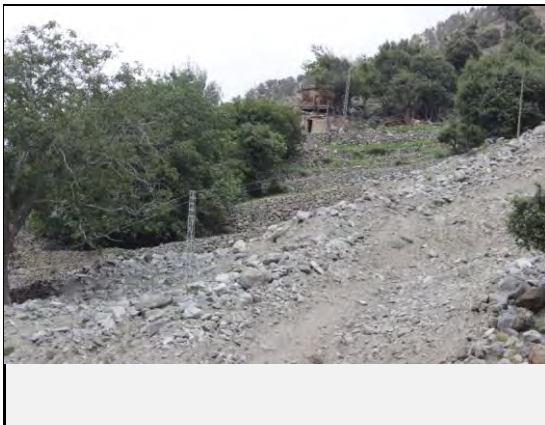
The Check dams has been built along the debris flow

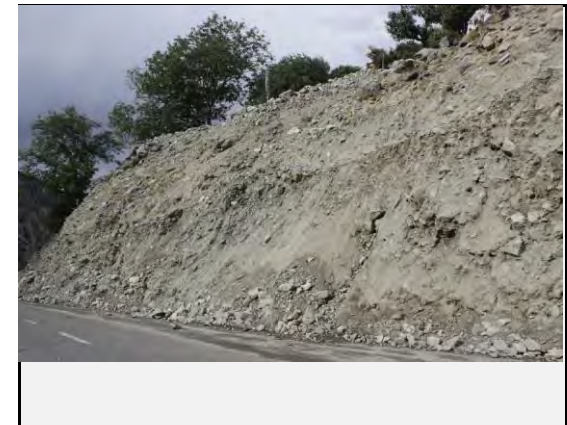
Existing countermeasures / anomalies: No Counter Measure

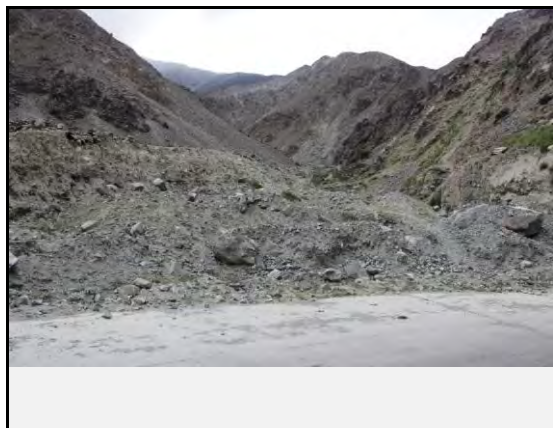
Mountain side view of the debris flow

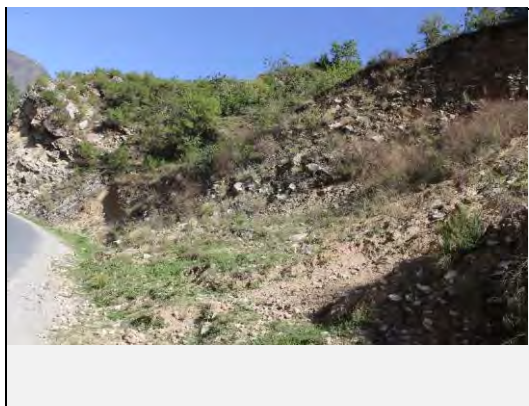
View of the slope failure at the middle point

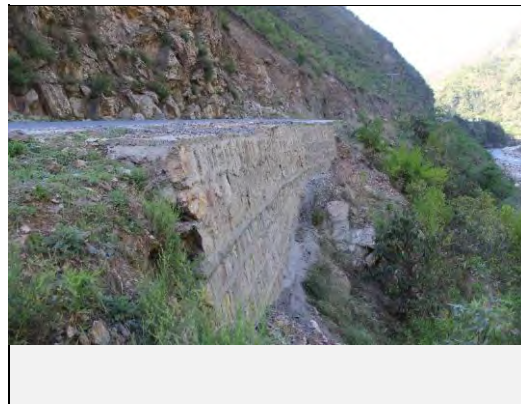
Existing countermeasures / anomalies: View of Retaining wall as counter measure

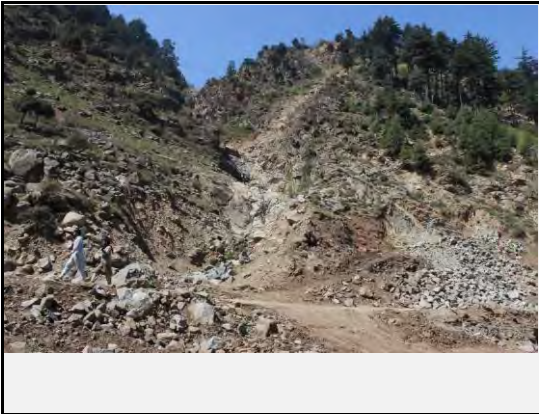
Mountain side view of the debris flow

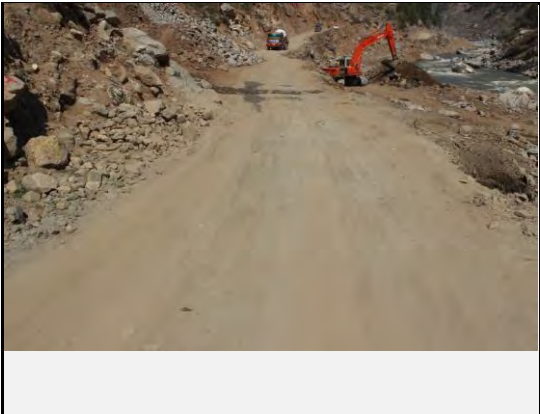
Road condition

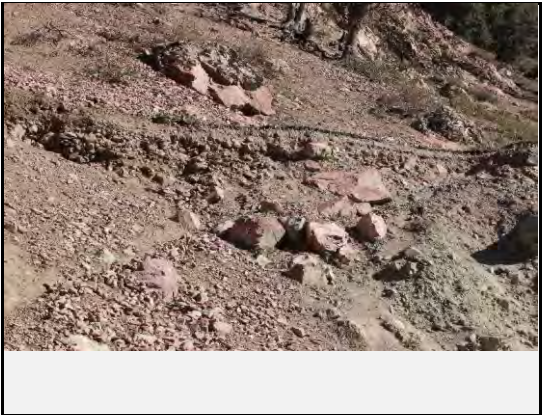
View of debris material and old road

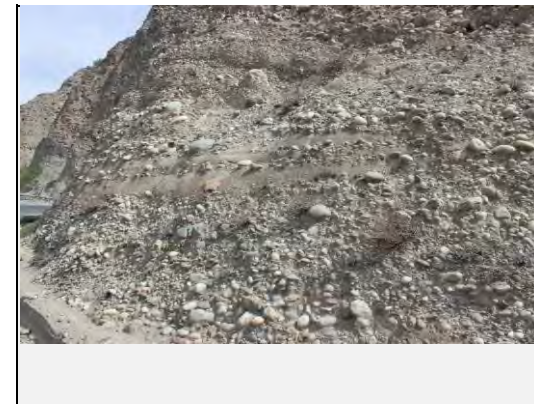
View of sandy layer in the alluvial deposits.
