DATA COLLECTION
SURVEY
ON
DISASTER RISK REDUCTION

Input from JICA for
Sulawesi Reconstruction Master Plan

FEBRUARY 2019

JAPAN INTERNATIONAL COOPERATION AGENCY
(JICA)

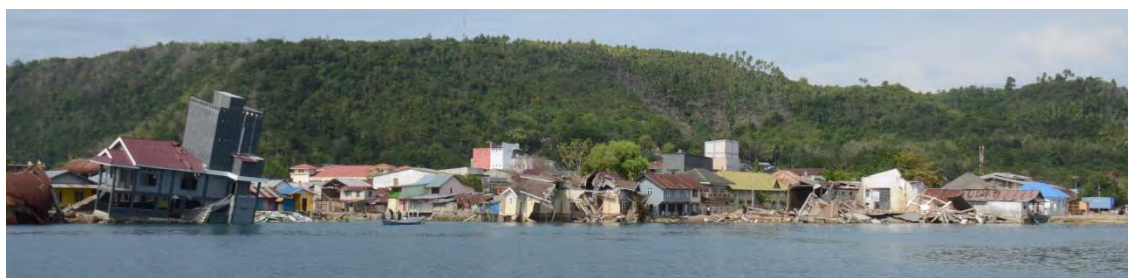
Figure 5 : Wide View of Damaged Bay Area

Ground soil settlements due to liquefaction and landslide were also observed along the east and west coasts of Palu Bay. In general, they seemed to occur on the beach or on the sea side of the coast line, and therefore did not affect the houses and buildings, except the landslide occurred near the Donggala Port. There was a significant landslide, most likely induced by liquefaction, which destroyed a number of buildings (see photo below). Immediate rehabilitation of the coastal protection structure is required. The inhabitants may need to be relocated considering the tsunami hazard.

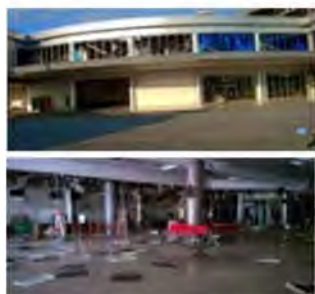
Mutiara SIS Al-Jufrie Airport

DAMPAK
Terminal Building (15196.72 m²) experience severe damage
CONTINGENCY PLAN
Passenger in emergency time will be accomodate in temporary terminal.
Follow-Up
Revitalization plan in terminal in 2018 approximated needs Rp. 75.980.000.000,-

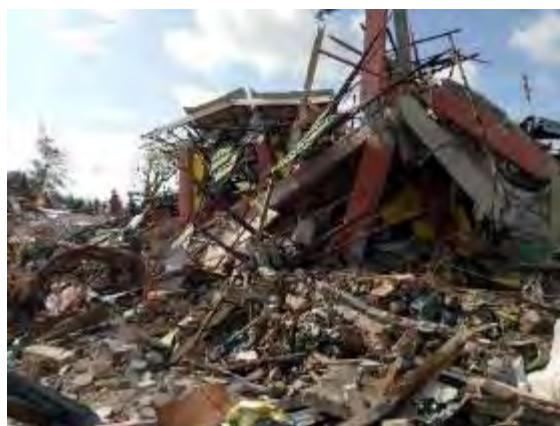
1) Primary school: SDN INPRESS BALAROA (Palu City)

After Earthquake

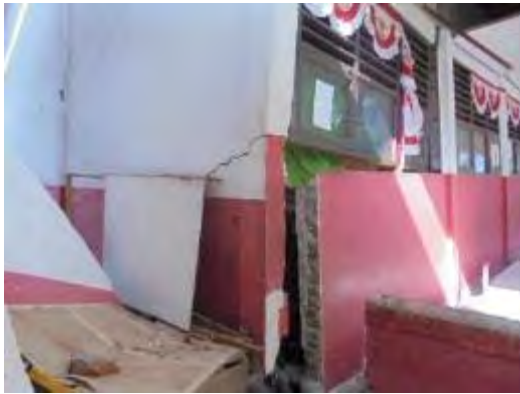
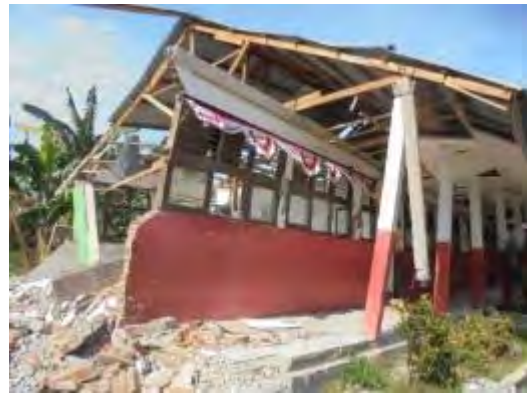
2) Primary school: SDN INPRESS JONO OGE (SIGI prefecture)

Due to earthquake and liquefaction, the school buildings had totally destroyed

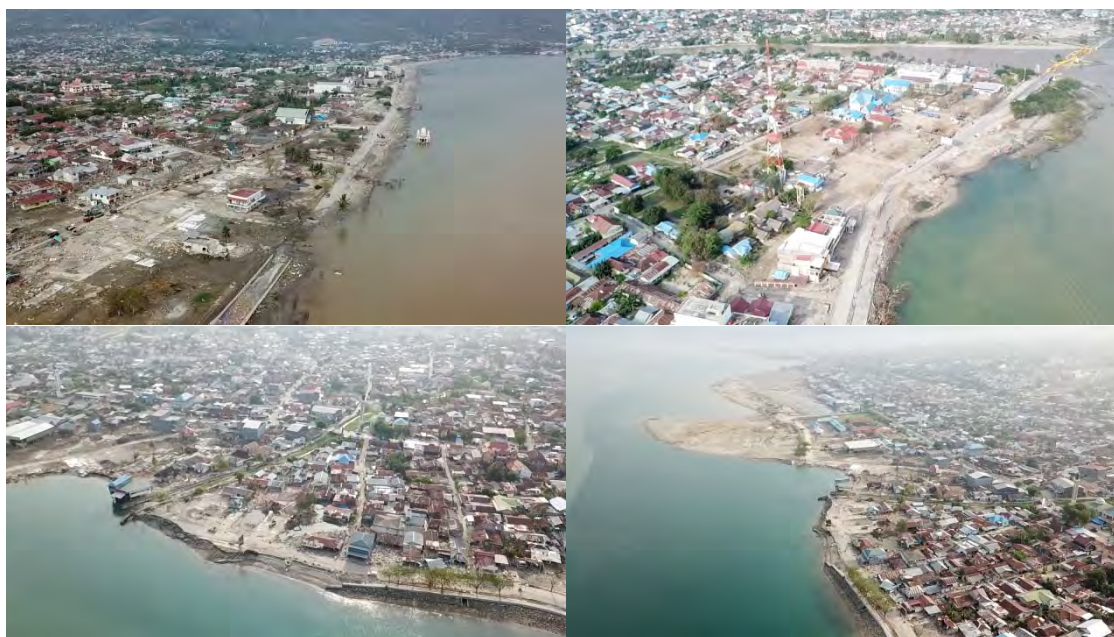
Figure 23 : Collapse by liquefaction or simple landslides occurred at many places along coastal line

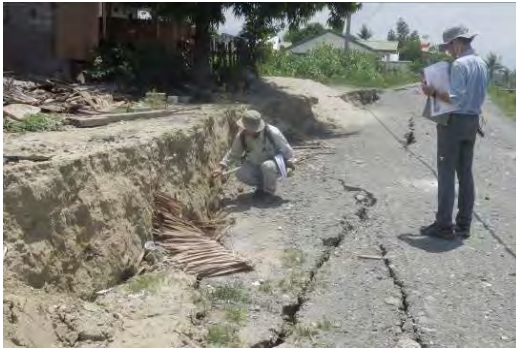
- Tensile crack initiation zone at the top: It has not reached flow (Figure 26).
- A zone where the surface layer is broken into a block of several meters in size and sliding fracture also occurs: Although it collapses, it has not reached a flow failure (Figure 27).
- Ground fluidized zone downstream from the sliding cliff: Long distance flow displacement of several hundred meters occurred, the surface ground was lost, and the lower layer from which water sprang out (Figure 28).
- Terminal flow material sedimentary zone: earth and sand and houses moving from upstream are accumulated (Figure 29)

Figure 26 : Collapse of Petobo Point Top

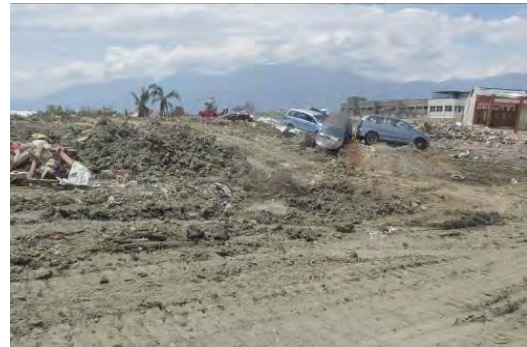
Figure 29 : End deposit part of Petobo point

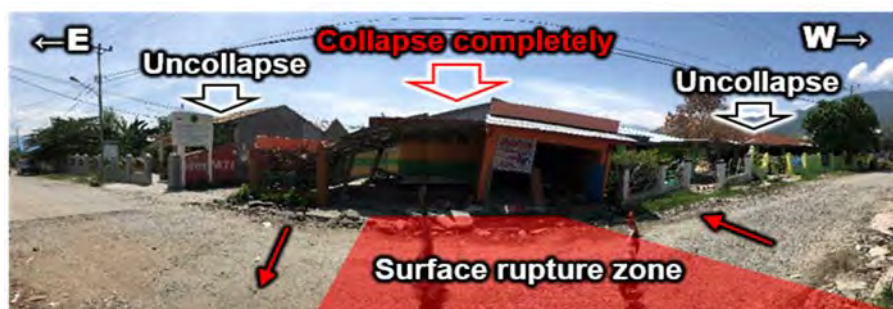
Note: Asam II str. (Lere Sub-Districts) which have left lateral displacement: 4.5m, Vertical offset: 0.4m east side up, Strike direction: N30°W

Figure 37 : Collapse of the house on the surface rupture zone at 20181103-3 site

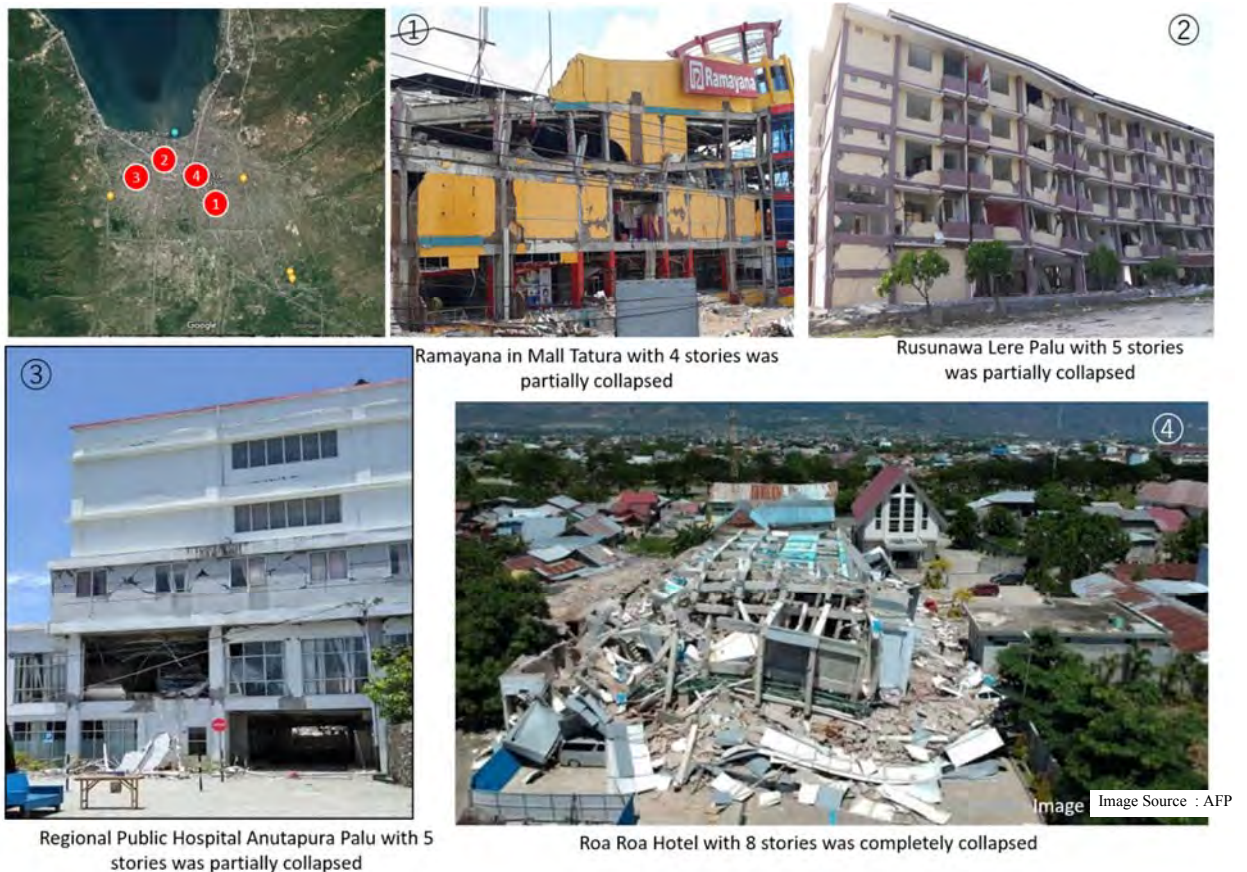
There are a lot of high-rise buildings in Palu City since it is the center location of various activity such as tourism, trading, education and culture. But the strike of shake on September 28th, 2018 made a lot of building failures and produced many victims as shown in Figure 49. The analysis to identify the cause of failure building is really important to enhance the quality of building in the future. Here we show examples of building failures after conducting building safety observation by JICA mission team.

Figure 49 : Several documentations of damage high buildings in central area of Palu City

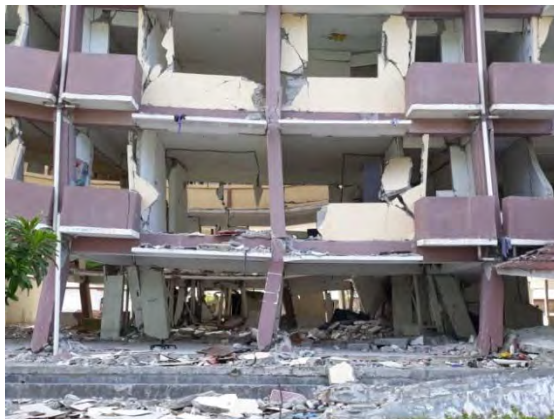
- Collapsed buildings doesn't seem to have used suitable foundation. Roa roa seems to have used Cakar Ayam Foundation which is suitable for swamp area. Rusunawa Lere seems to have used pile foundation and to have occurred "column sway", where failure mechanism occurred at column, not at beam (beam sway), and it would cause damage to the whole building (Figure 50 and Figure 51).

Figure 50 : Out-of-plane wall and column sway mechanism

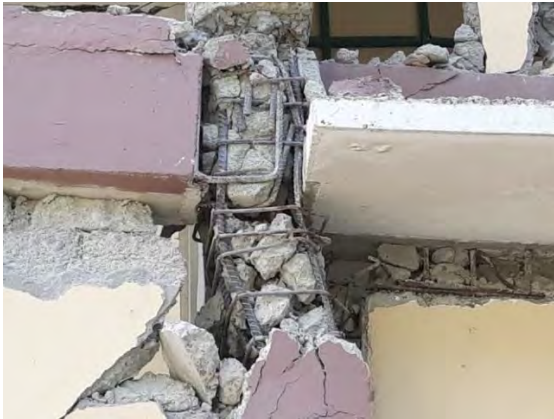
- Joint failure seems to have caused by column broken (Figure 52).
- Collapsed buildings doesn't seem to have used appropriate reinforced bars. Roa Roa hotel seems to have used very small reinforced bars narrower than 13 mm diameters, whereas in building code it should be minimum 13 mm (Figure 53–Figure 55).

Figure 52 : Joint failure

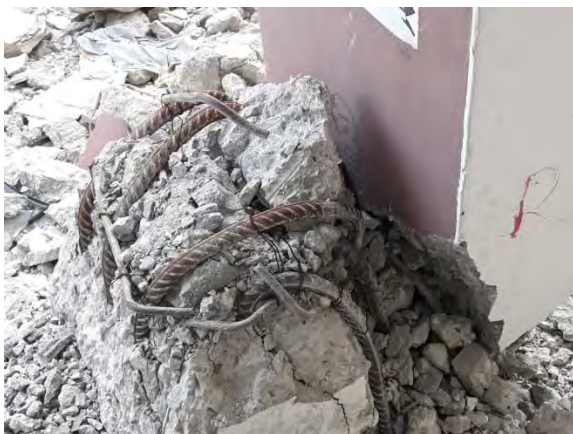
- Collapsed buildings doesn't seem to use good quality of construction material, such as inappropriate size of concrete aggregate, bad quality of brick (Figure 56).

Figure 56 : Non-deformed bars still used

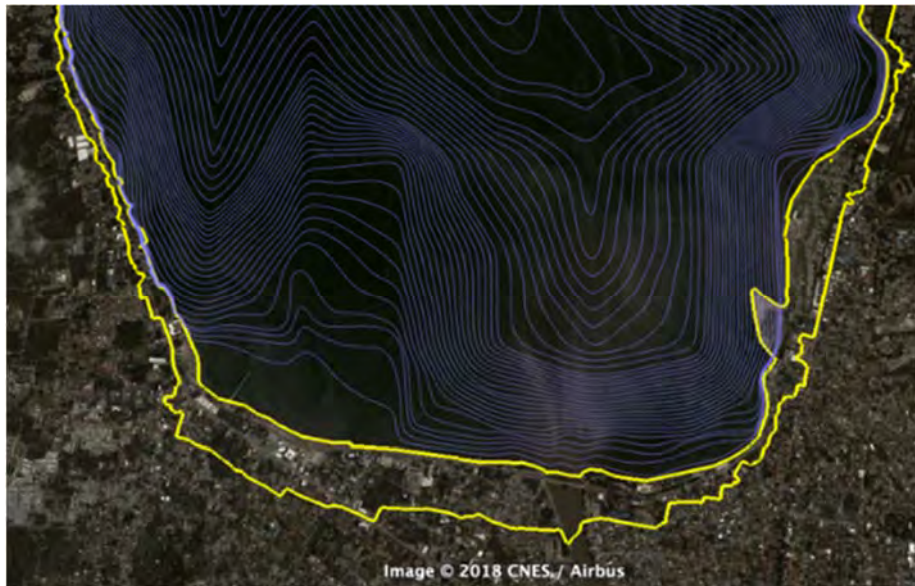
Damaged area in coastal area is confirmed by field survey etc. In coastal area, there are two type of damage. One was inundated by tsunami. The other was collapsed by landslide, which was caused directly by shake or through liquefaction phenomena by shake.

Figure 69 : Tsunami inundated area (Source: Digital Globe Open Data Program)

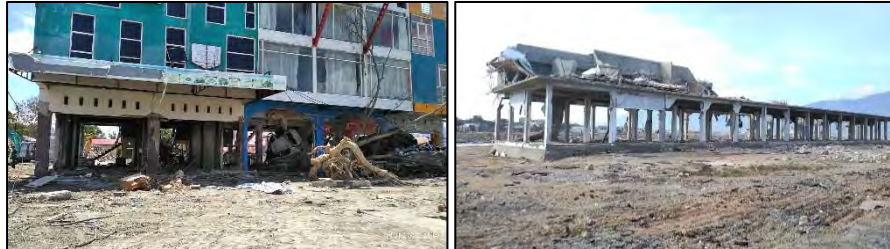
Figure 70 : Area inundated by tsunami

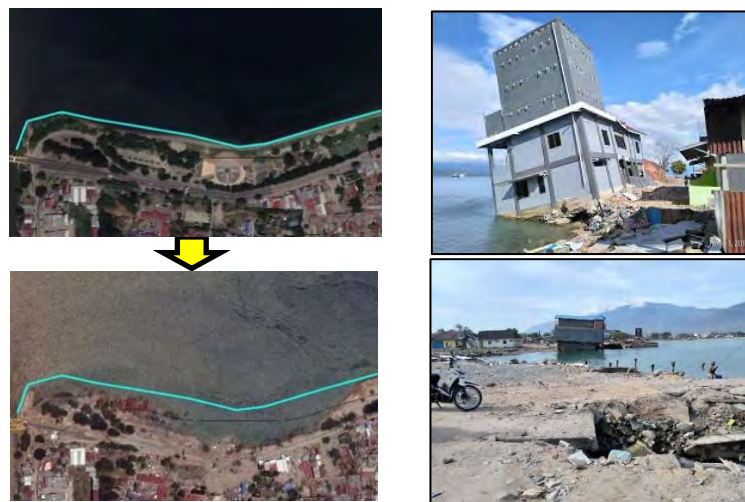
Figure 71 : Landslide area

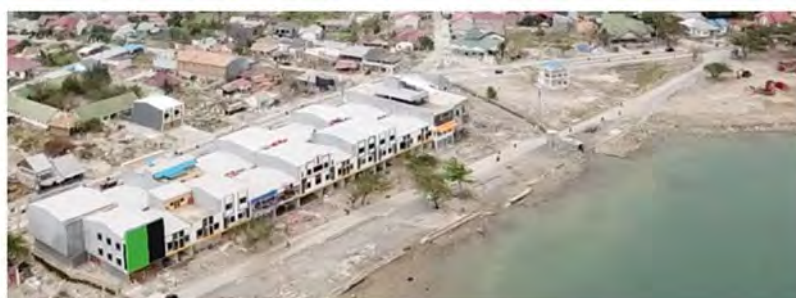
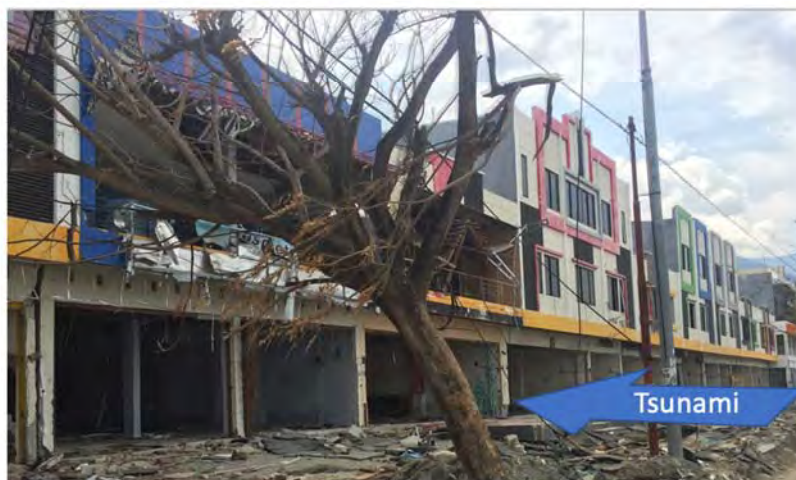
From the experience of the tsunami in central Sulawesi, the particular buildings with piloti or the commercial and residential complex building locally called as “Ruko” could stand still.

Figure 98 : Ruko type building condition in coastal area

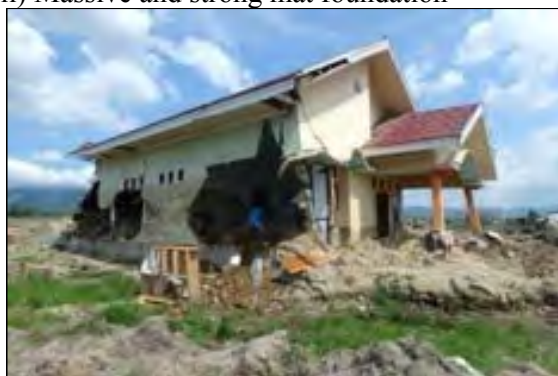
Figure 105 : Unmoved house with massive foundation in Jono Oge liquefaction damage area and image of liquefaction-landslide resistant building

For the new buildings in the liquefaction-landslide high risk area, the conditions below should be regulated.

- (i) Multiple stories for vertical evacuation
- (ii) Bed rooms should not be located on the ground floor
- (iii) Massive and strong mat foundation

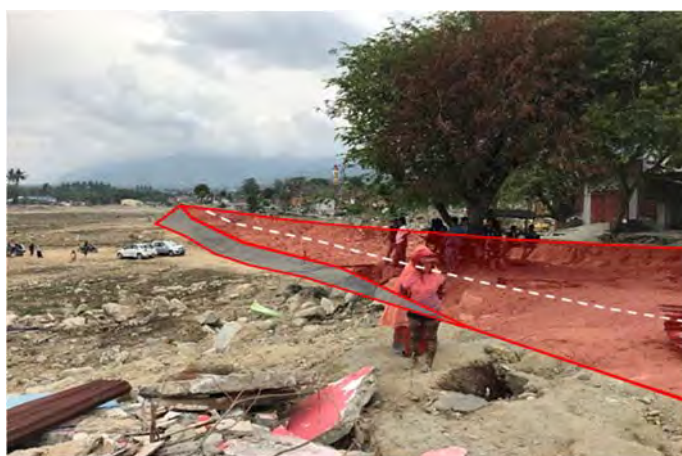
Figure 126 : Image of permanent and temporary road in Balaroa area

In the Balaroa area, large vehicles which necessary for reconstruction activities can't pass through due to liquefaction damage. Therefore, it is necessary to construct a temporary road as soon as possible. When constructing a permanent road, there is a method of reinstalling with a Rock bolt and H shape Pile and reconstruct it in its original position.

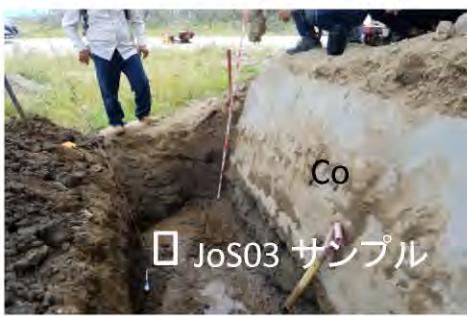
Jono Oge Trench

We confirmed that the surface soil layer of 40 cm in thickness remains under the foundation of a red house, but 2 m beside the house it is missing. Fluidization occurred at the bottom of the soil layer, and the soil layer moved in the northern region of this site, and it is thought that it was carried to the west along with the house on it.
