**Attachment 9: Kigali City Reservoir Inventory
Survey Results**

REPORT OF THE RESERVOIR SURVEY IN KIGALI

**THE PROJECT FOR STRENGTHNING OF NON-REVENUE
WATER CONTROL KIGALI CITY WATER NETWORK**

KYOWA ENGINEERING CONSULTANTS Co., Ltd/ WASAC Ltd

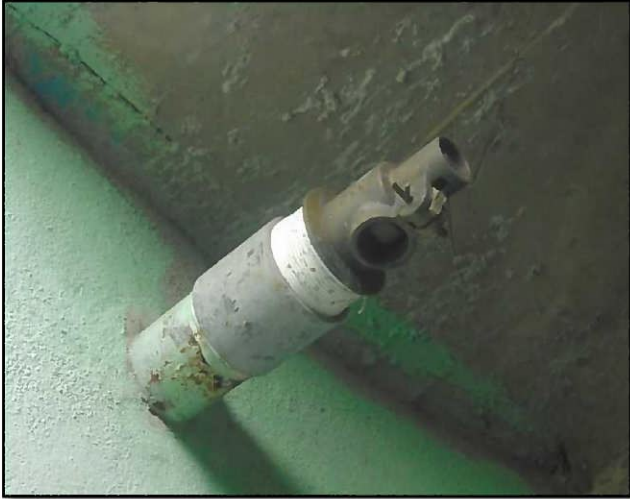
No Floater Valve

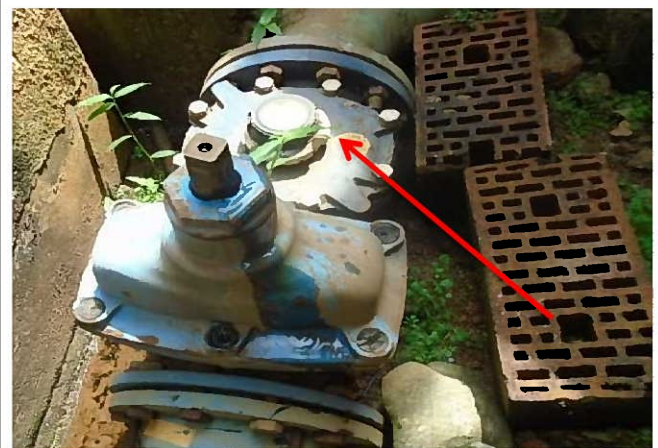
Other Information:	Inlet tank 2- Not properly working meter
	Inlet tank 1- Meter but not working
	Inlet tank 1- 2 valves leaking on top
	Tank 1: Outlet Valve DN300 defective

Meter

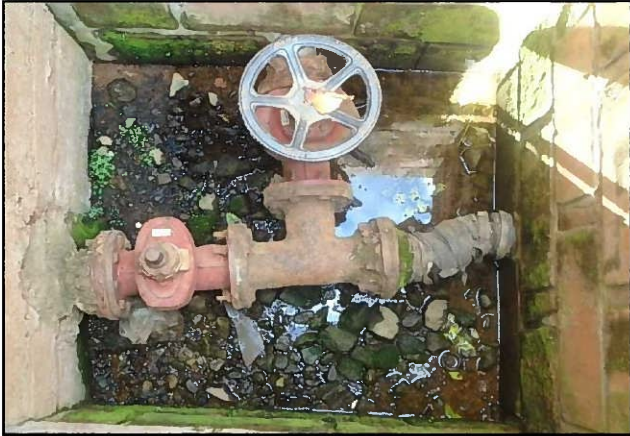
Outlet Collection Chamber DN80

Action	Requirements
<ul style="list-style-type: none">• Replacement of Inlet Valves• Replacement of the existing Collection chamber outlet valve• Wrench Key (Cle à béquille : Key for inlet pipe drainage valve)• Providing drainage for 3 other inlet valves• Drainage system for existing manholes which become flooded during rain period.• Pump outlet valve replacement• Connecting the other 2 pipes to the collection chamber• Checking the 5th inlet pipe for functionality	<ul style="list-style-type: none">• 2 Valve DN80• 1 Valve DN80• 1 key Wrench• 6 Valve DN80• 1 Valve DN80• 1 Valve DN80• Construction work

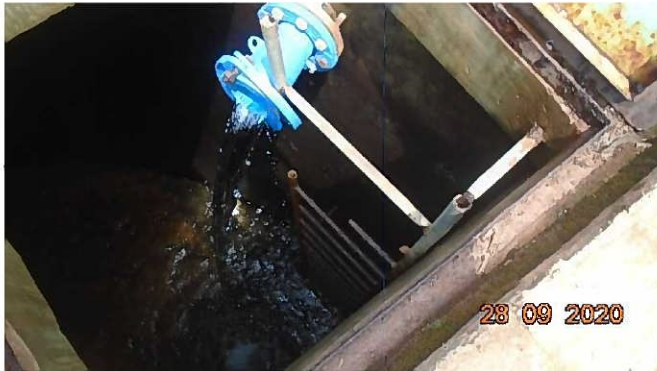
Floater needed.

Action	Requirements
<ul style="list-style-type: none">• Installation of a floater valve DN50• Installation of valve DN50 (Vanne d'equilibre)	<ul style="list-style-type: none">• 1 Floater valve DN50• 1 Valve DN50

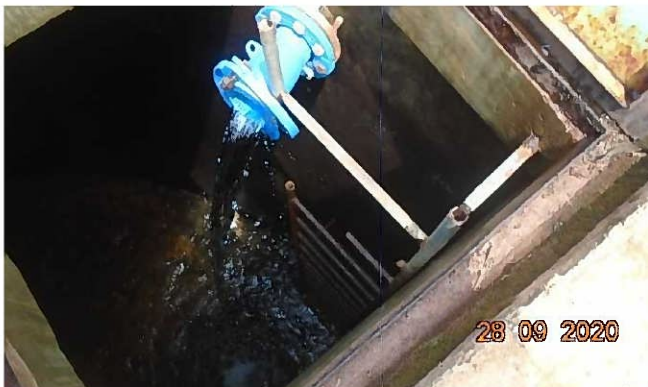
No Float Valve installed

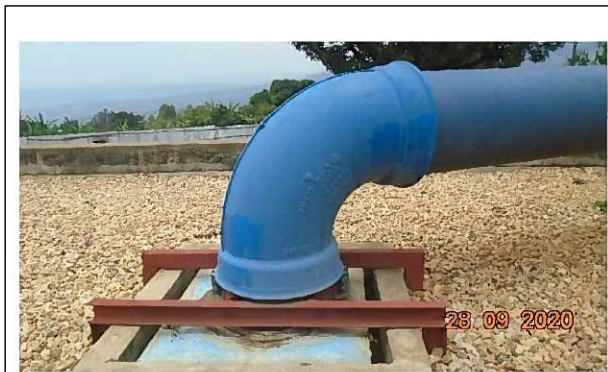
Floater on DN400 Pipe needed

Action	Requirements
<ul style="list-style-type: none">• Installation of a floater valve DN200• Installation of 90 Degree elbow DN400• installation of Reduced cone 400/200	<ul style="list-style-type: none">• 1 Floater valve DN200• 1 Elbow with 90Degree• 1 Reduced Cone 400/200

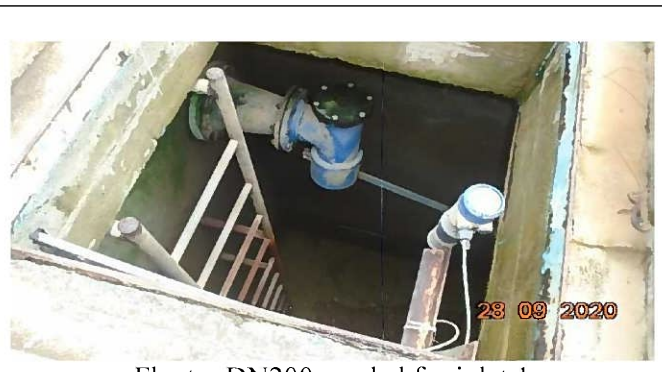
Floater DN200 needed for inlet 1

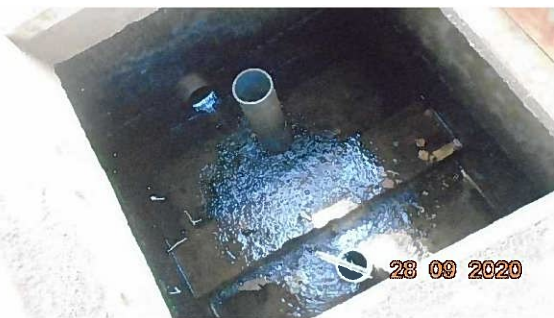
Inlet Pipe without Valve

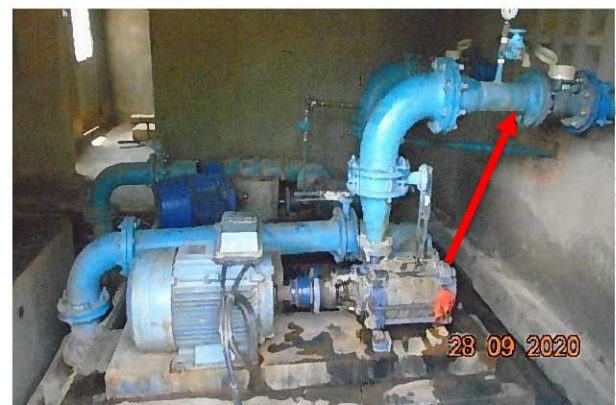
No Float Valve

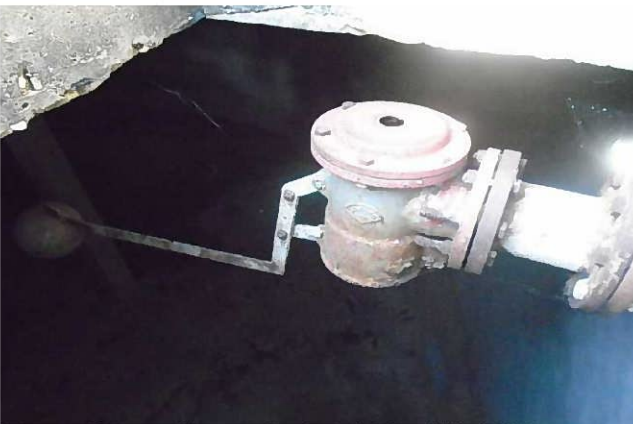
No.	Item	Details
D: Equipment		
1	Floater Valve	Malfunction , DN: 80 but defective
2	Water Level Gauge	No installation
3	Flow Meter	Mechanical, EMFM, UFM, DN: _____ , PN(bar): _____,
4	Inlet pipe No.1	SP, DN: 100 , Top
5	Inlet valve No.1	DN: 100 , Function: No information abandoned reservoir
	Inlet valve No.2 (bypass)	DN: 100 , Function: No information abandoned reservoir
6	Outlet pipe No.1	SP, DN: 100
7	Outlet valve No.1	DN: 100 , Function: No information abandoned reservoir
8	Overflow Pipe	SP, DN: 80
9	Drain Pipe	SP, DN: 100
	Drain Valve	SP, DN: 100
10	Remarks/ Issue

Float Valve

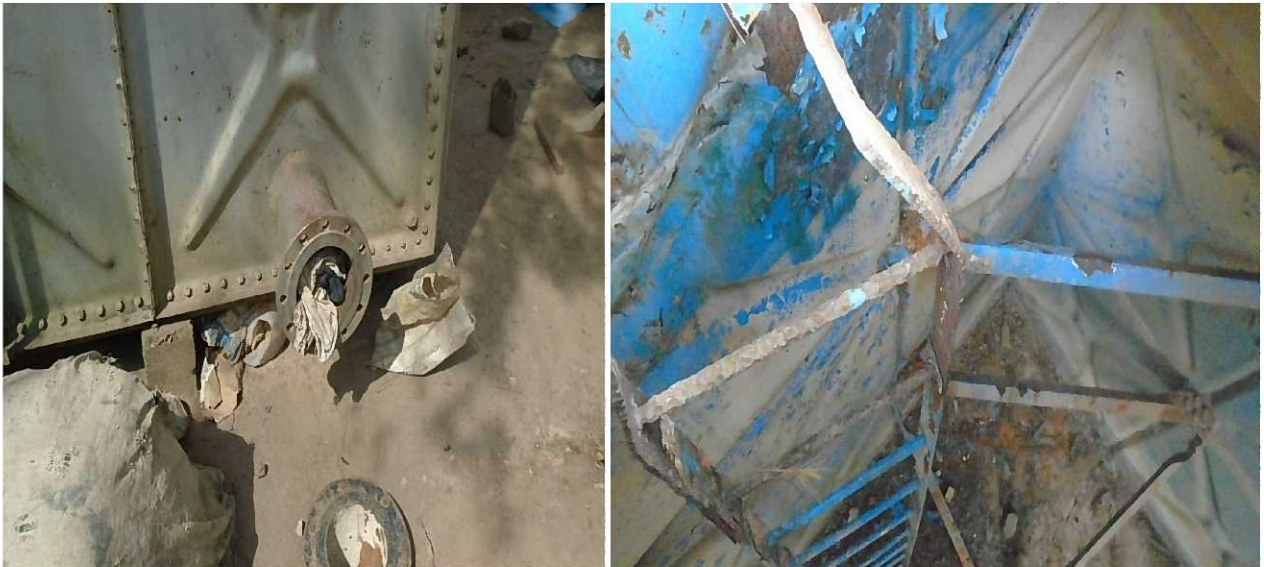
The visited spot is UTEXRWA and we found that the existing tank was abandoned completely and accessories removed.

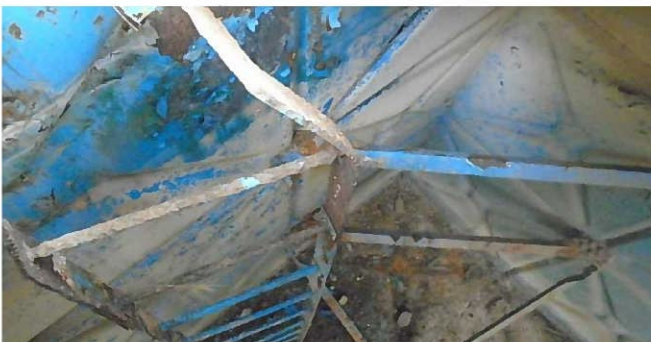
No Floater Valve (Photo: Tank inside)

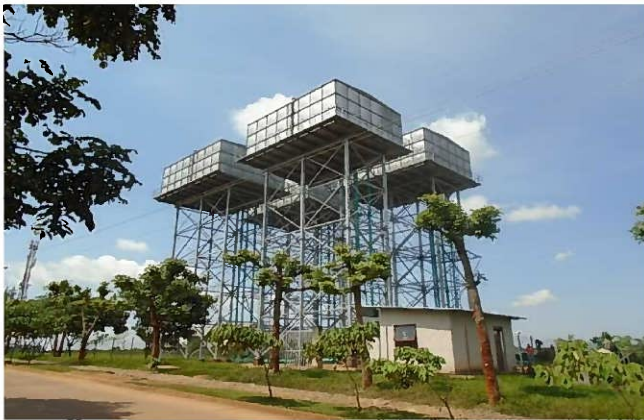
Whole View

Two (2) of them No. 70&67 have never been used since their construction (2013) even though they are storing water for rust protection, one (1) No. 68 was recently abandoned because it was leaking.

2	Foundation	Elevated
3	Structure Material	Steel
4	Inside Dimension	L: 9.76m × B: 7.32m , H: 3.66m
5	Remarks/ Issue	Not leaking, not used but storing water for its structural rust protection since 2013

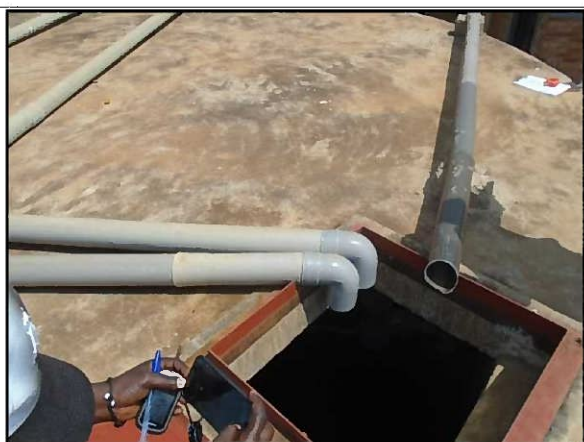
Being used for rain water harvesting

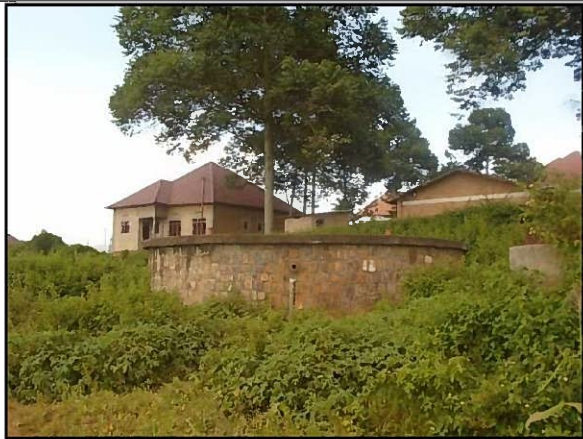
It was abandoned and bypassed

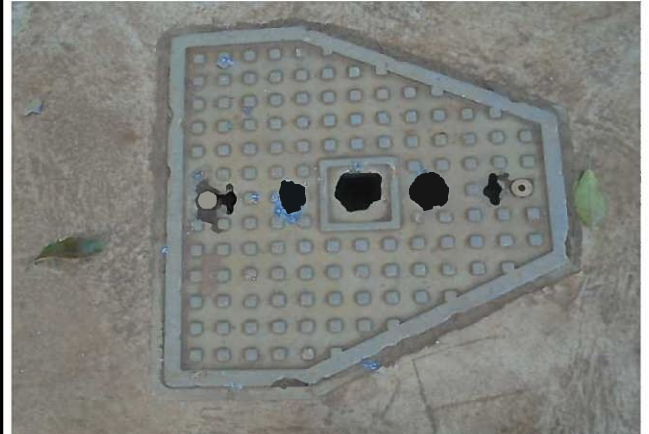
Manhole closed

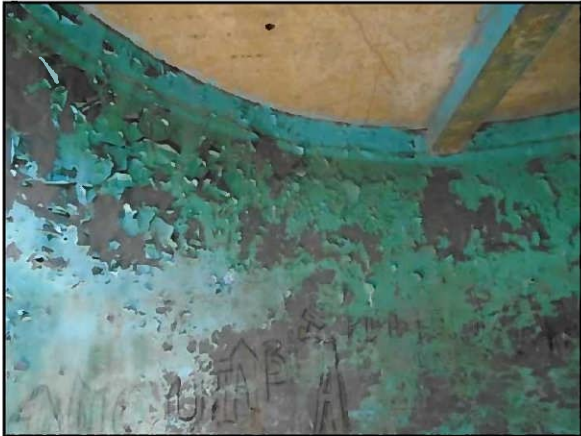
General maintenance needed

Action	Requirements
<ul style="list-style-type: none">• General maintenance or replacement,• Replacement of inlet valve• Replacement of outlet valve• Replacement of drainage valve• Installing a Floater valve	<ul style="list-style-type: none">• 3 Valve DN50• 1 Floater valve DN50• Construction

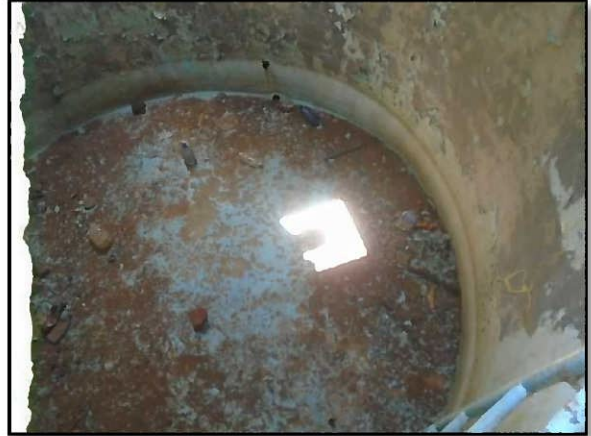
General maintenance needed

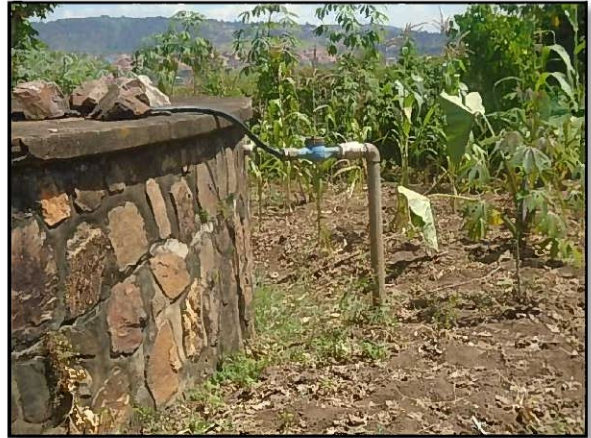
Inlet 2 reconnection

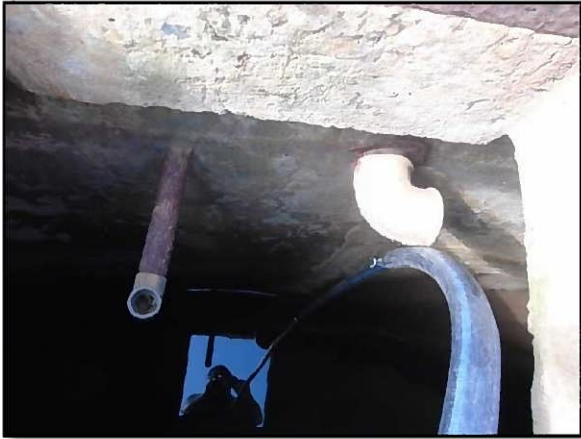
Floater valver needed

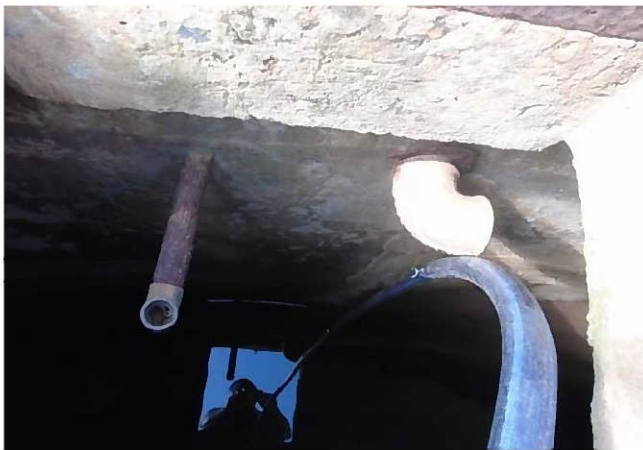
no Float Valve

Other Information:	. New accessories DN50 needed connection to the inlet and outlet, valves needed for inlet and outlet.
	. Manhole (2) needed, new covers needed
	. When at it full capacity it leaks through walls and new internal plastering is needed
	. New cover needed.

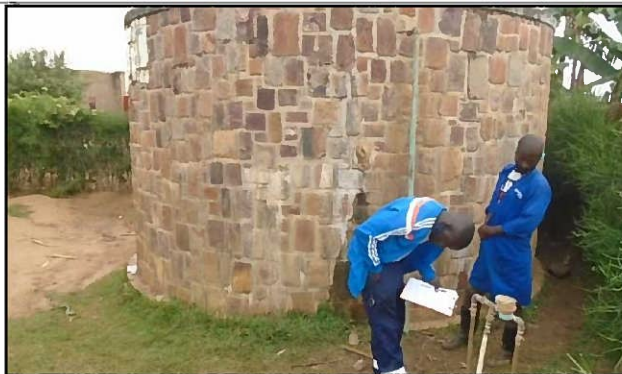
Closed we can't see the inside (under locals management.)

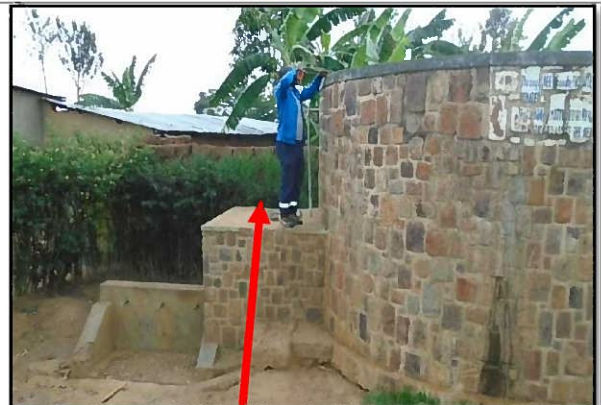
Closed

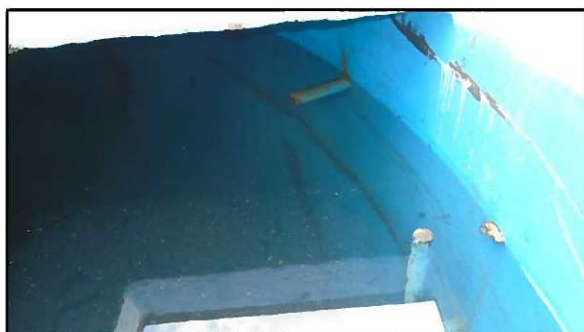
Floater needed

Action	Requirements
<ul style="list-style-type: none">• Installation of a floater valves for SP 1 1/2"• installation of outlet valve for SP 3/4"• installation of Valves for SP 1 1/4"	<ul style="list-style-type: none">• 1 Floater Valve DN100• 6 water tap valves of 3/4"• 2 Valves 1 1/4"

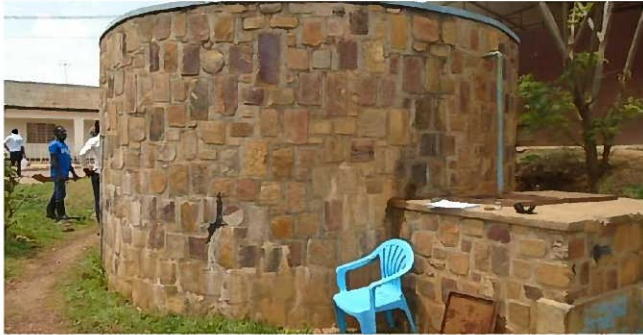
Whole View

No.	Item	Details
A: General		
1	Number of Reservoir	99
2	Name of Reservoir	Rwinyange (Rwimbogo)
3	ID Code	NYARUK2RE2
4	Ward	Sector: Nyarugunga, District: Kicukiro, Cell: Rwimbogo, Village: Rwinyange
5	Branch Office	Kanombe
6	Location	Latitude: 1.959012, Longitude: 30.140309, Altitude
7	Function of Reservoir	Kiosk Reservoir
8	Age of Reservoir	Year: No Data
9	Storage Capacity	30 m3
10	Service area of the Reservoir	Kiosk with 6 taps
B: Operational Condition		
1	Operational Condition	Operational
2	Operator Assignment	1 person
	Action against to overflow	
3	Wall Leakage	Oozed (but leaking when full)
4	Overflow observation	no data
	Phenomenon	
	Reason of overflow	
5	Bypass-flow operation	Always/ Nothing, Timing: _____
	Reason of bypass operation	
6	Inflow Condition	Source: Karengé
		Water pressure at inlet:
		Frequency and time:
7	Water level movement	Proper movement
8	Issue on Functional Condition	Leaking on walls and some valves are not operational.

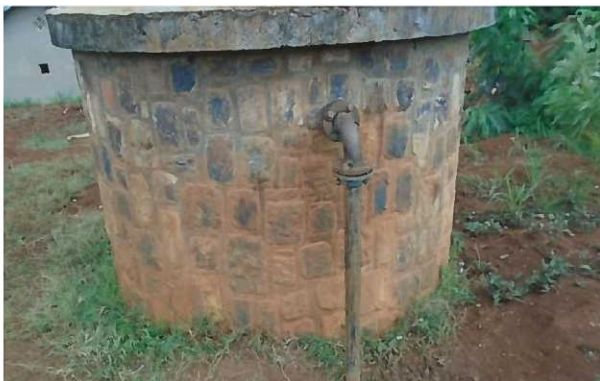
Inlet Pipe without Valve

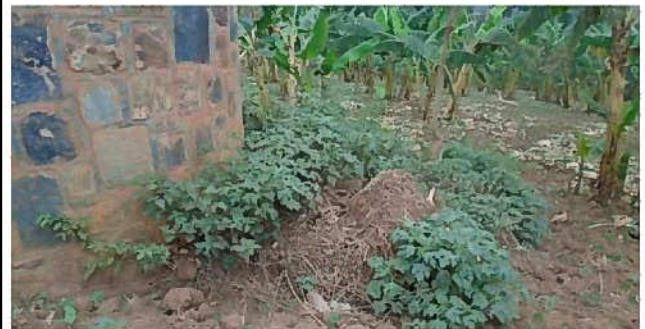
Outlet not visible

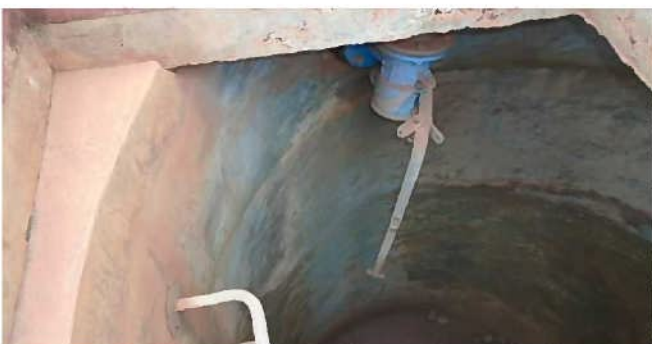
No meter

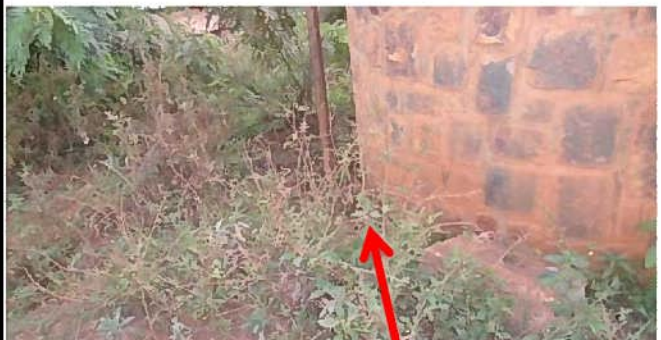
No Meter

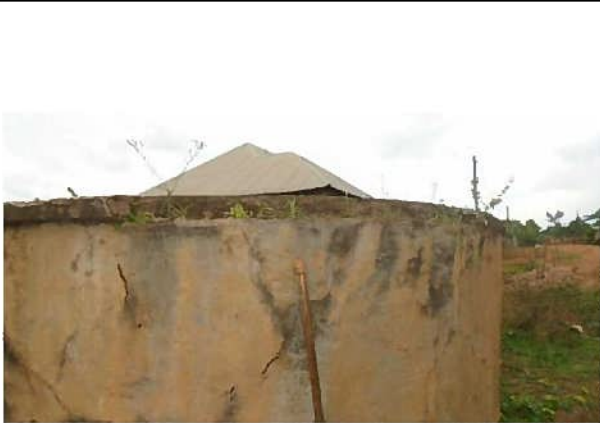
Inlet Pipe without Valve

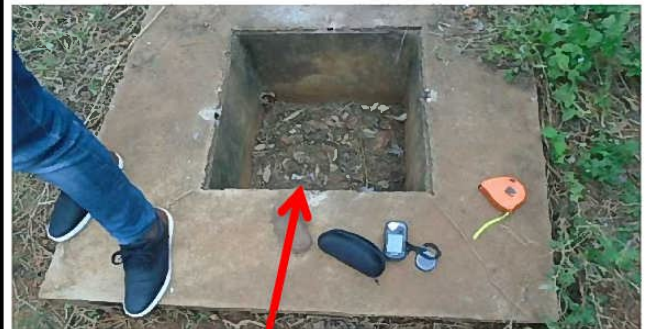
Outlet Pipe Not available

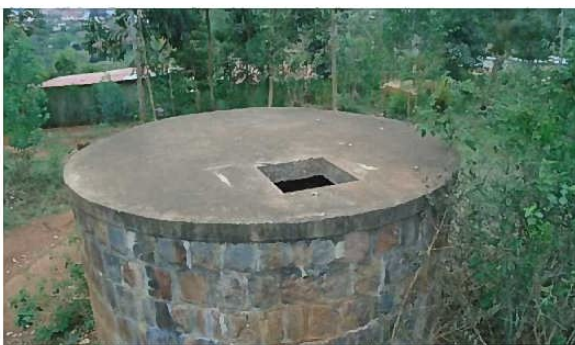
No Float Valve

No meter

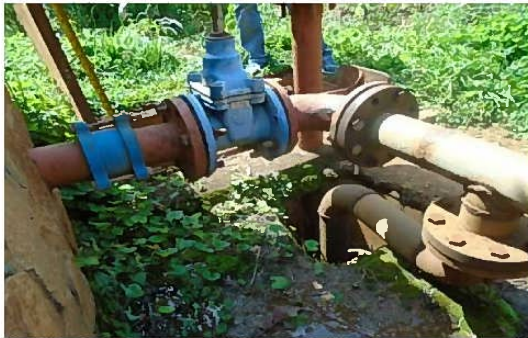
Inlet Pipe with Valve

No.	Item	Details
D: Equipment		
1	Floater Valve	No installation
2	Water Level Gauge	No installation
3	Flow Meter	No installation
4	Inlet pipe No.1	SP, DN: 80, Top
5	Inlet valve No.1	DN: 80 , Function: YES even though not in use.
6	Outlet pipe No.1	SP, DN: 80
7	Outlet valve No.1	DN: 80 , Function: Not Operational
8	Overflow Pipe	SP, DN: 80
9	Drain Pipe	SP, DN: 80
10	Remarks/ Issue	The way the outlet system is installed, it needs replacement due to valves not working, the installation was made using threaded nipples and other accessories.

1. Revised (revisit) existing installation to rectify the inlet and outlet
2. Replacing all the 4 weary valves

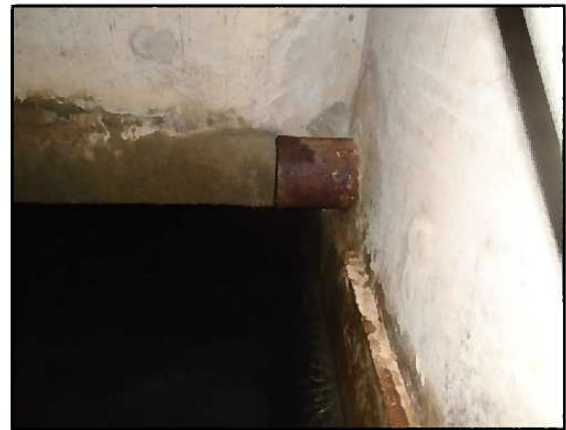
Floater valve need

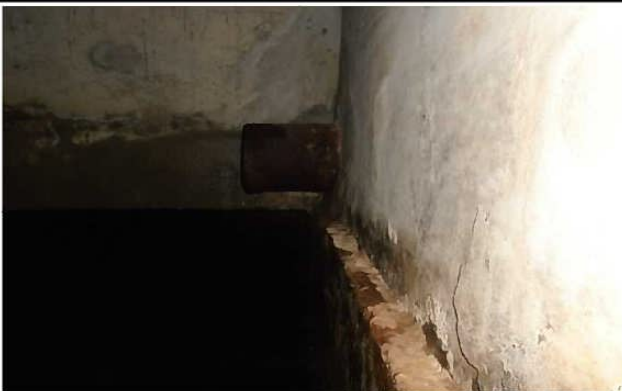
Float Valve

No float valve installed
