FINAL REPORT ON THE RESERVOIR SURVEY IN NYAMIRAMBO BRANCH

**THE PROJECT FOR STRENGTHNING OF NON-REVENUE
WATER CONTROL KIGALI CITY WATER NETWORK**

Final report of the reservoir survey in REMERA Branch/KEC Co., Ltd/ WASAC Ltd/ JICA

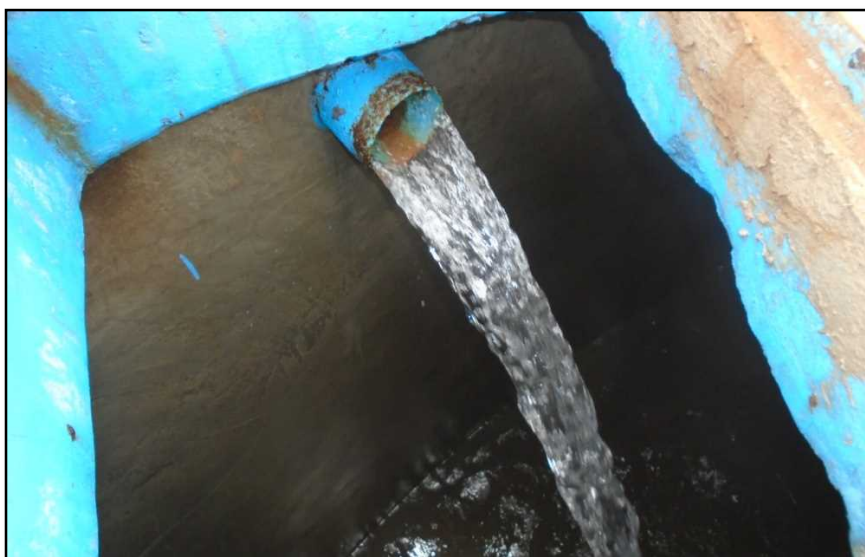
Floater is needed

Action	Requirements
<ul style="list-style-type: none">Installation of a floater valve	<ul style="list-style-type: none">1 Floater valve DN100

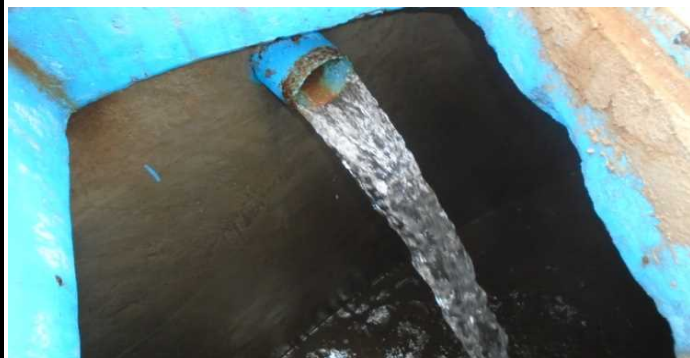
No Float Valve

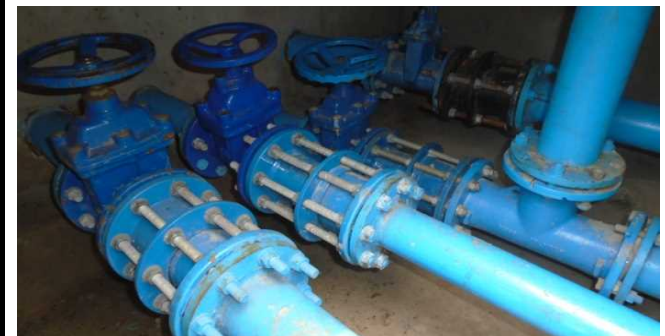
No Meter

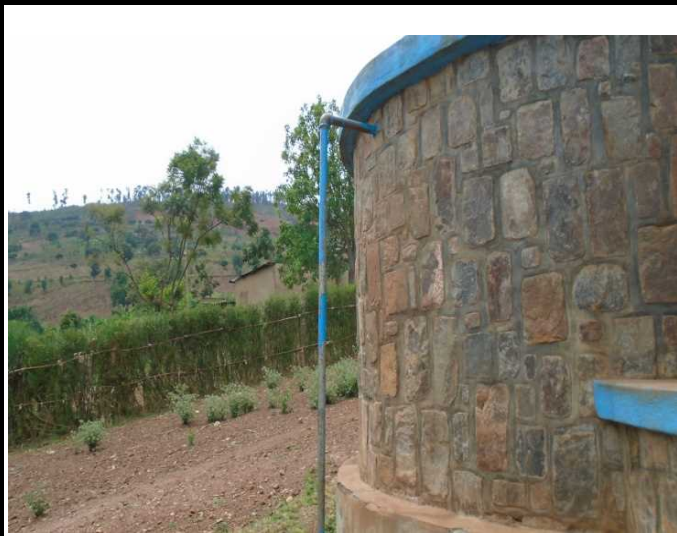
Whole View

No.	Item	Details
D: Equipment		
1	Floater Valve	Malfunction, DN: 50
2	Water Level Gauge	No installation
3	Flow Meter	No installation
4	Inlet pipe No.1	SP, DN: 50, Top
5	Inlet valve No.1	No installation
6	Outlet pipe No.1	SP, DN: 50
7	Outlet valve No.1	DN: 50, Function: YES
	Outlet valve No.2	DN: 50, Function: Defective (leaking)
8	Overflow Pipe	SP, DN: 50
9	Drain Pipe	SP, DN: 50
10	Remarks/ Issue	Reservoir Cover stolen.

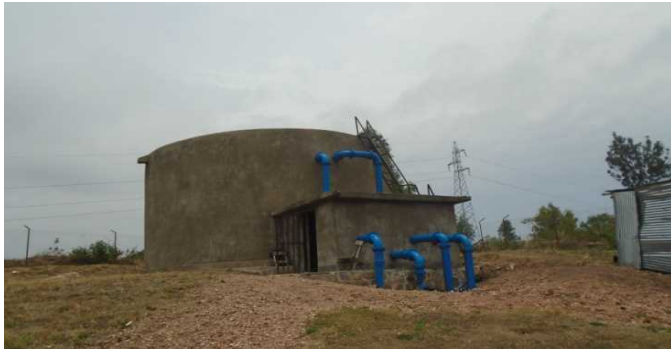
Whole View

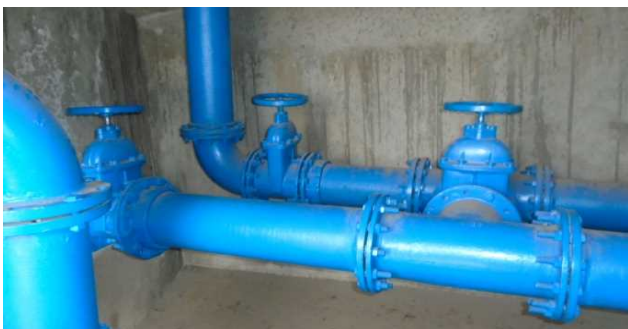
Inlet Pipe with Valve

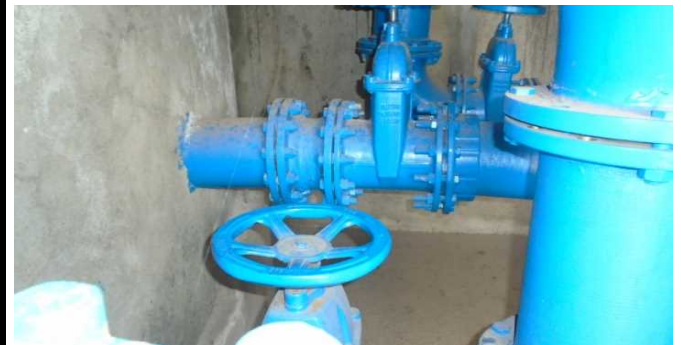
Outlet Pipe with Valve

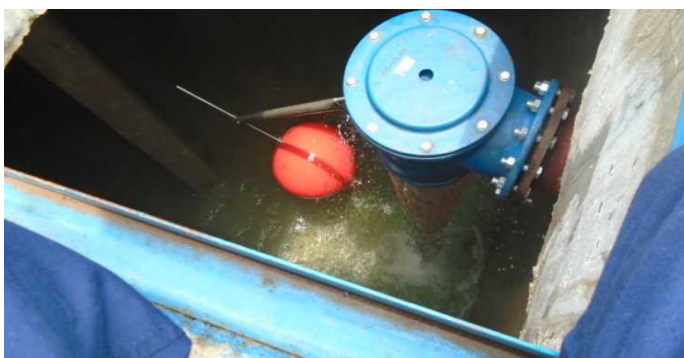
Float Valve

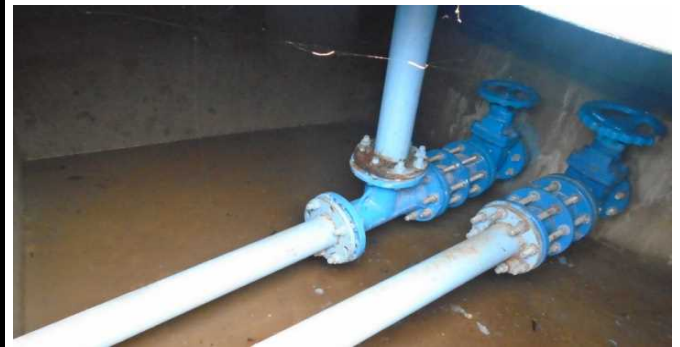
Outlet Pipe with Valve

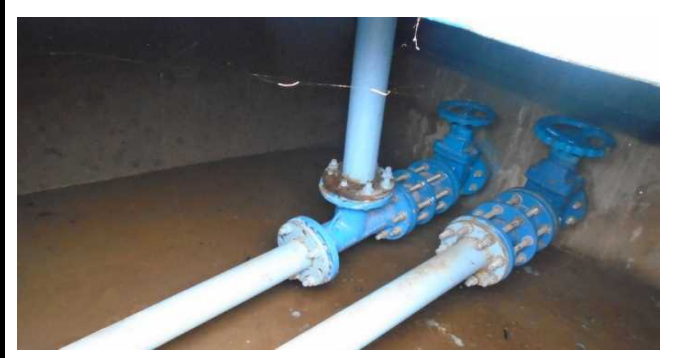
No Meter

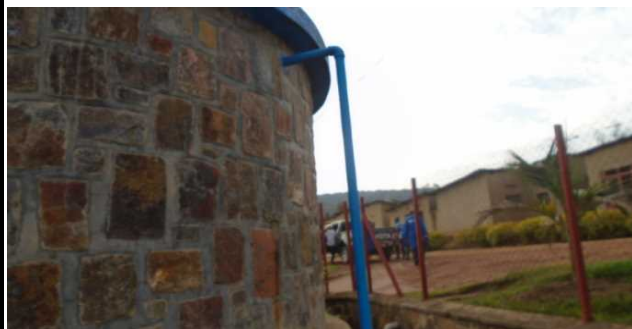
Inlet Pipe without Valve

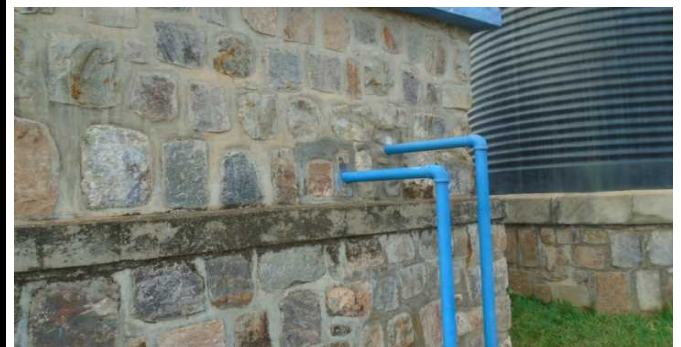
Outlet Pipe (Valve inside closed manhole)

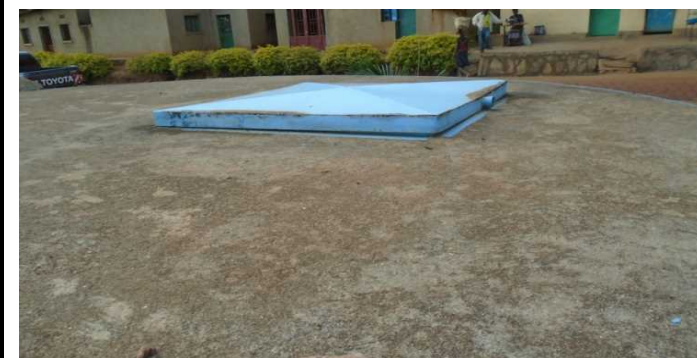
No Float Valve But can't open reservoir

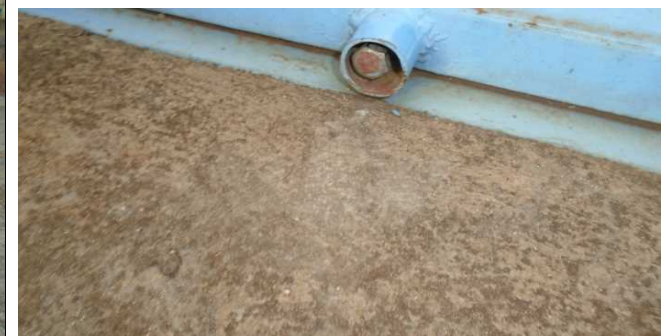
No Meter (Manhole closed)

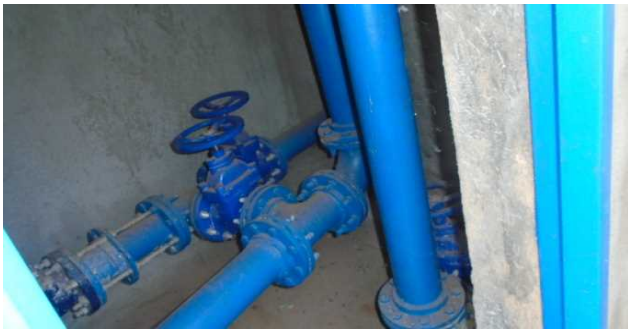
Inlet Pipe with Valve

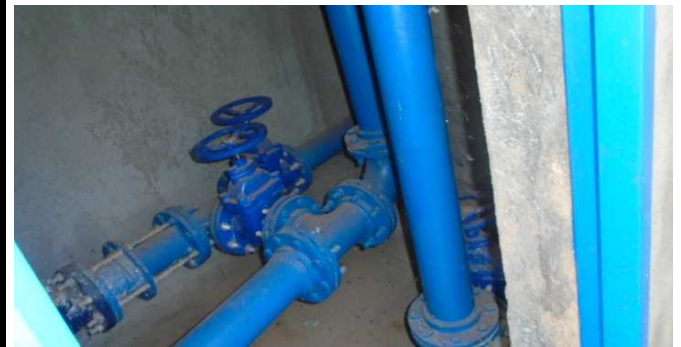
Outlet Pipe with Valve

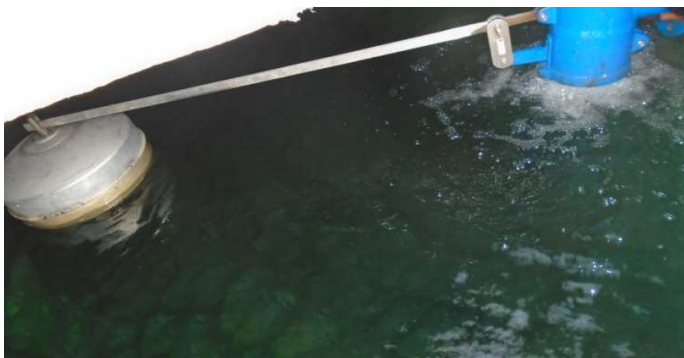
Float Valve

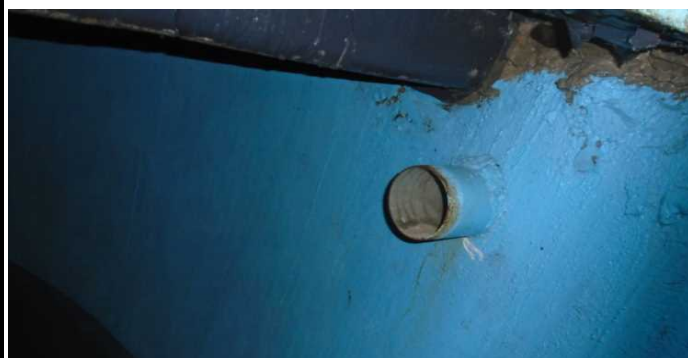
No Float Valve

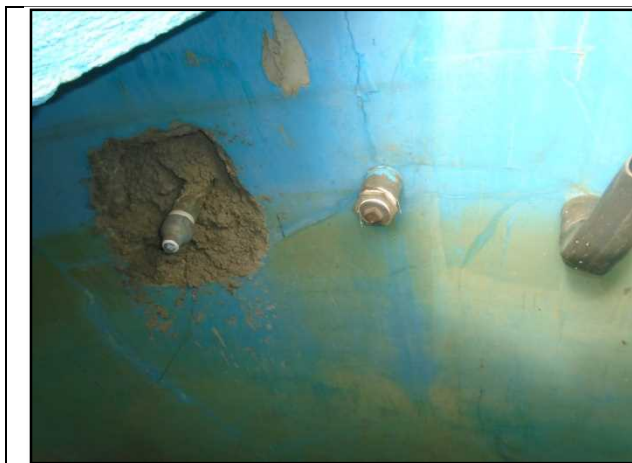
Floater valve needed

Action	Requirements
<ul style="list-style-type: none">• Install a floater valves• Install outlet valves and accessories• Install a drainage valve	<ul style="list-style-type: none">• Floater 2 ½'' and 2''• Valve 2 ½'' and 1''• Valve 2 ½''

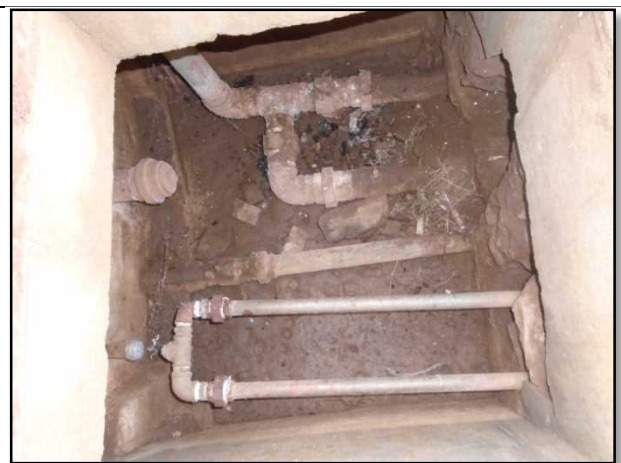
Reconnection and outlet accessories needed

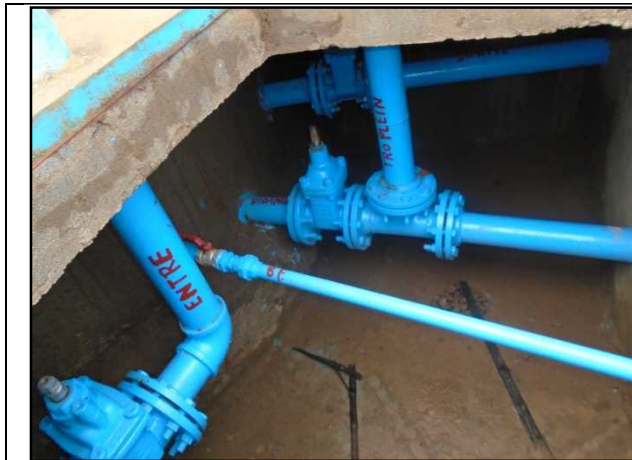
All accessories are ok

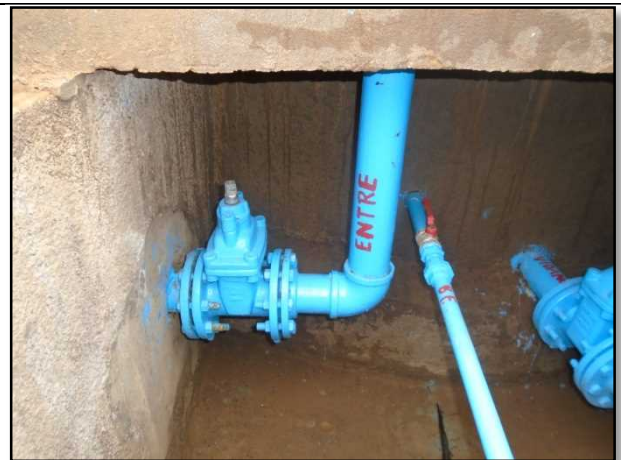
All accessories are ok

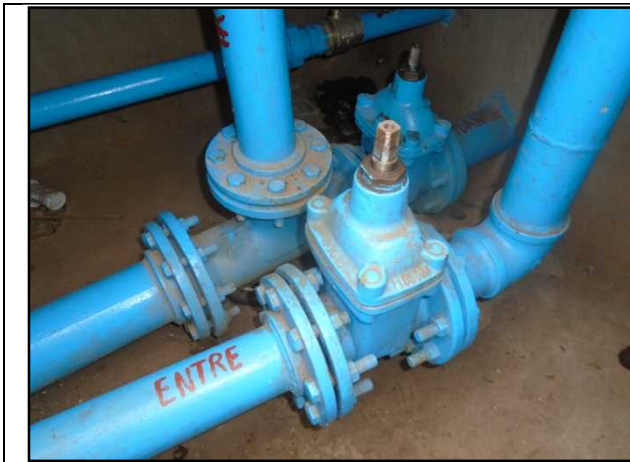
Reservoir is new and accessories are ok

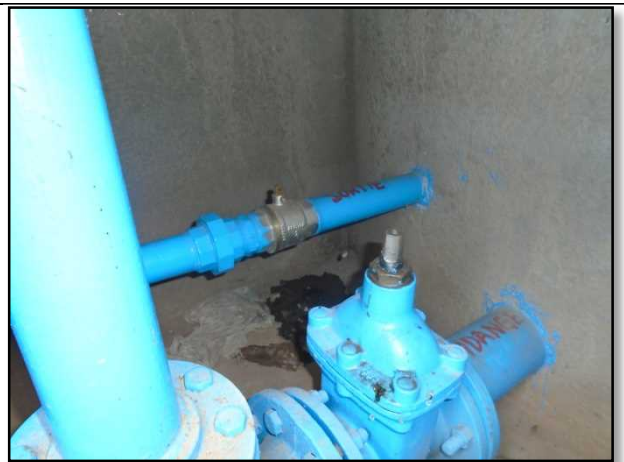
Reservoir is new and accessories are ok

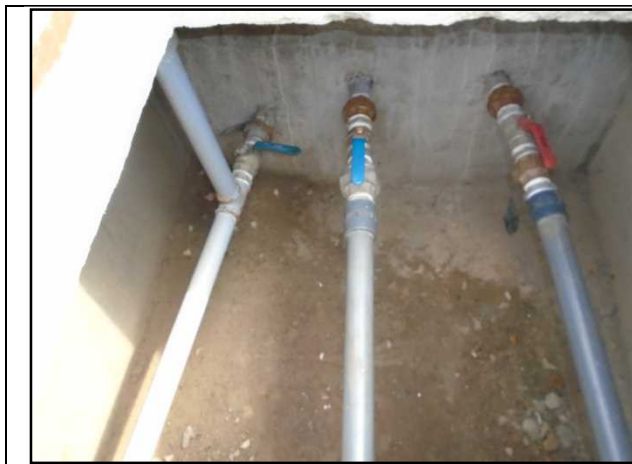
Reservoir is new and accessories are ok

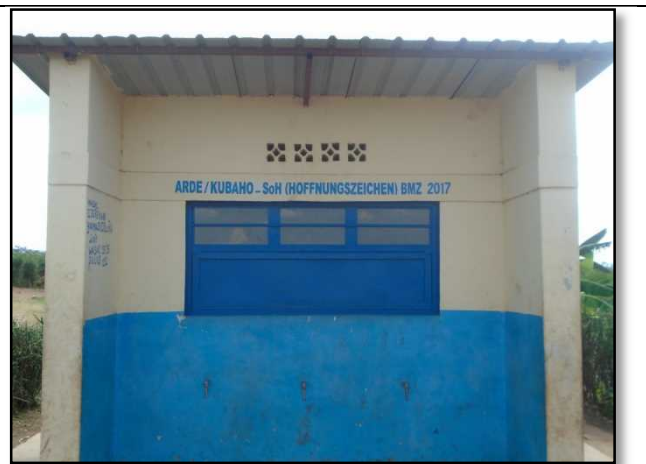
Reservoir is new and accessories are ok

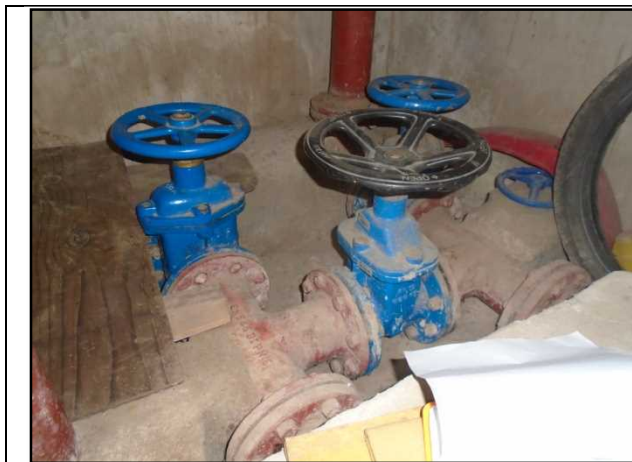
Reservoir is new and accessories are ok

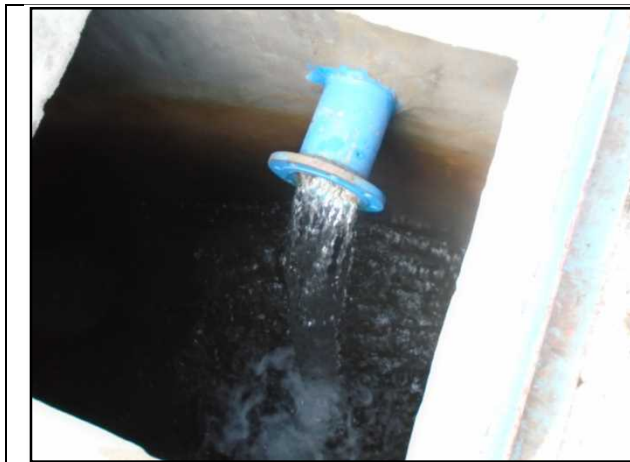
Floater valve needed

Action	Requirements
<ul style="list-style-type: none">• Floater valve needed• Drainage system for inlet manhole, and its protection during rain season.	<ul style="list-style-type: none">• Floater DN150• Drainage construction

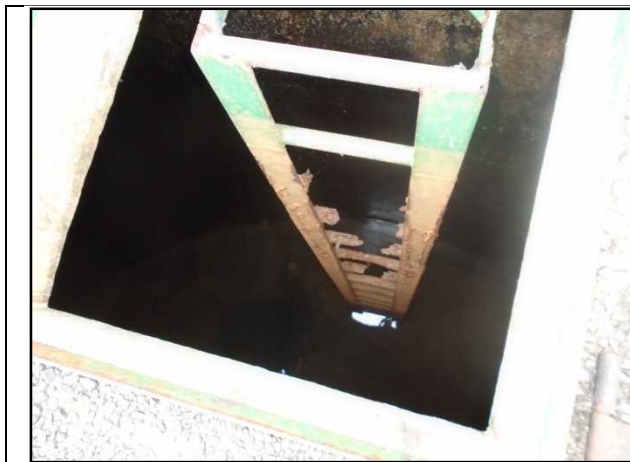
Floater valve needed

Action	Requirements
<ul style="list-style-type: none">• Floater valve needed• Support plastering for exposed steelbars protection.	<ul style="list-style-type: none">• Floater DN125• Plastering

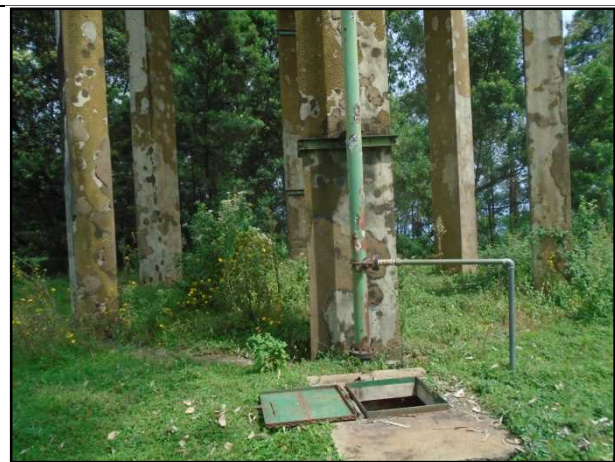
Plastering needed

Other Information:	. Plastering for support.
	. Inlet pipe very old even though not leaking.
	. Exposed column steelbars need protection.

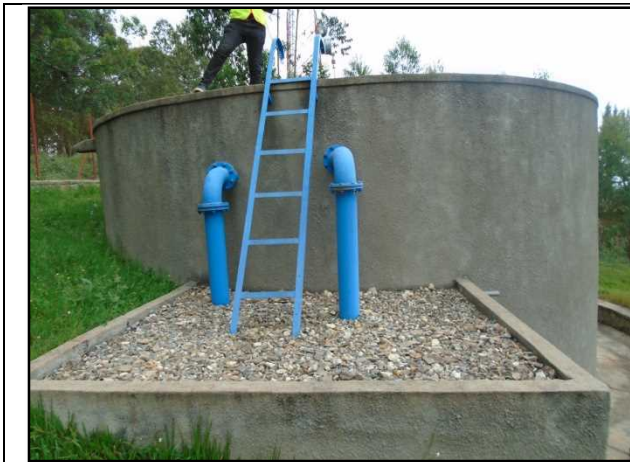
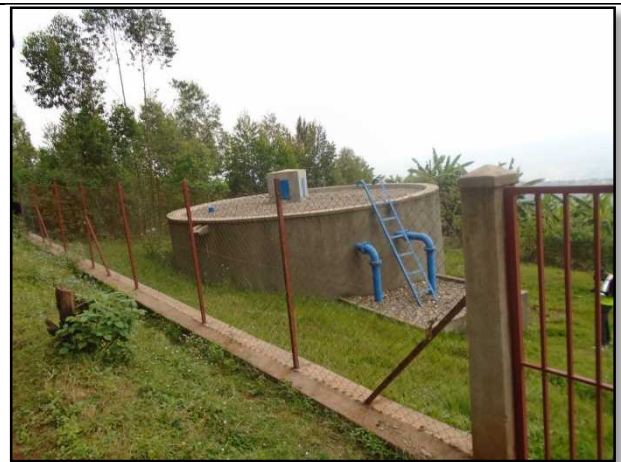
Reservoir is new and accessories are new

Action	Requirements
<ul style="list-style-type: none">Nothing

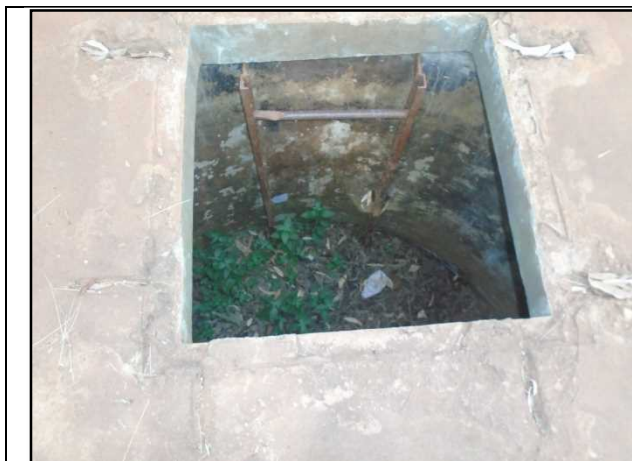
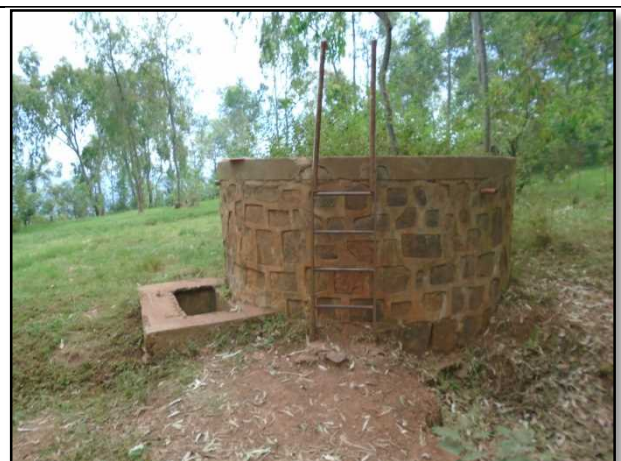
Abandoned

Action	Requirements
<ul style="list-style-type: none">• Reconstruction

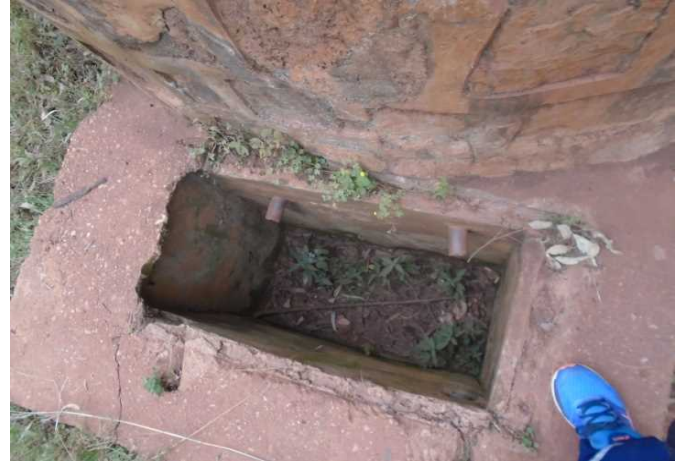
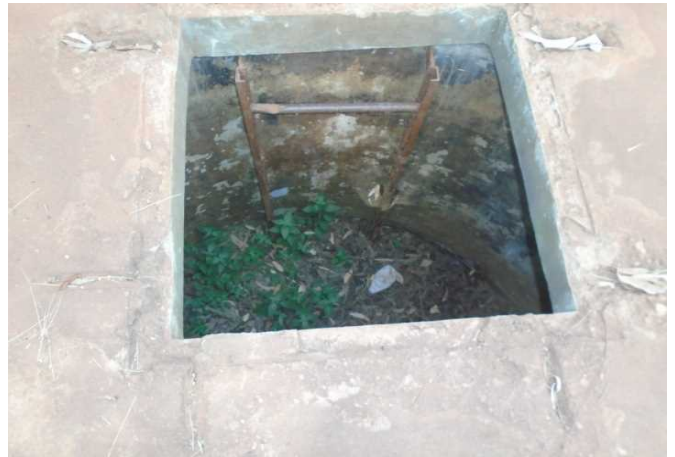
Reservoir (No accessories)

- 1- The tank was abandoned.
- 2 - Total replacement is recommended as per visual and physical assessment.

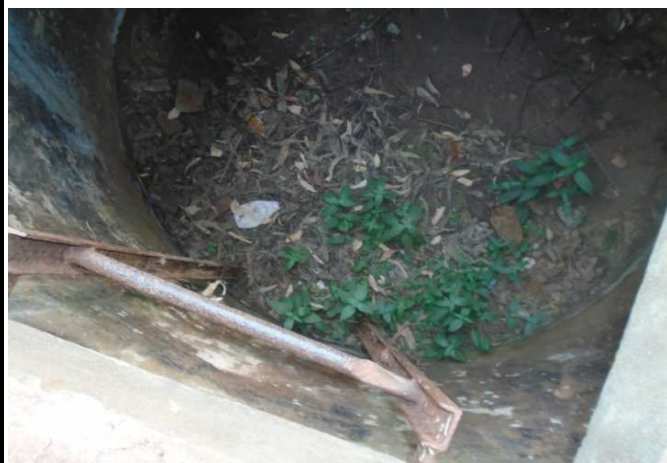
Abandoned

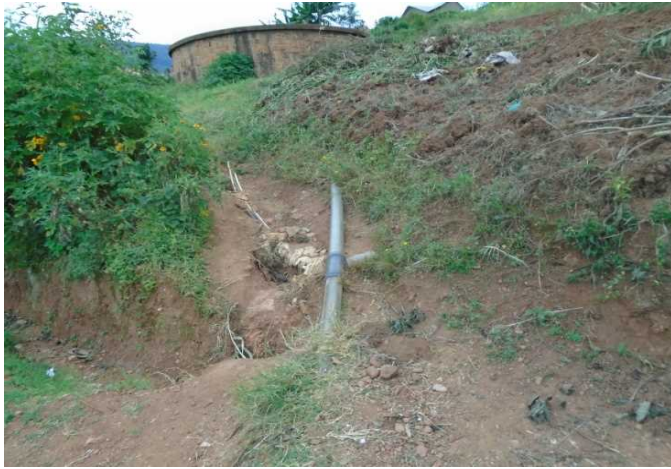
Whole View

- 1- The tank was leaking in the time it was abandoned.
- 2 - Total replacement is recommended as per visual and physical assessment.

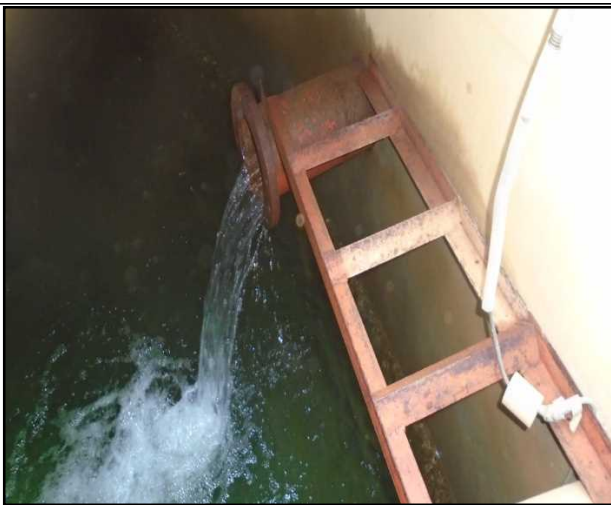
Floater Valve needed.

Action	Requirements
<ul style="list-style-type: none">• Installation of a floater valve DN200• Installation of a Valve DN200	<ul style="list-style-type: none">• Floater valve DN200• Valve DN200

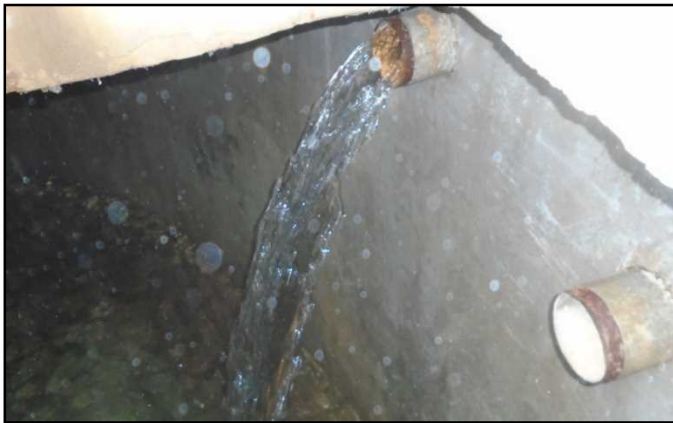
Floater valve needed

Action	Requirements
<ul style="list-style-type: none">Installation of floater valve DN150	<ul style="list-style-type: none">1 Floater Valve DN150

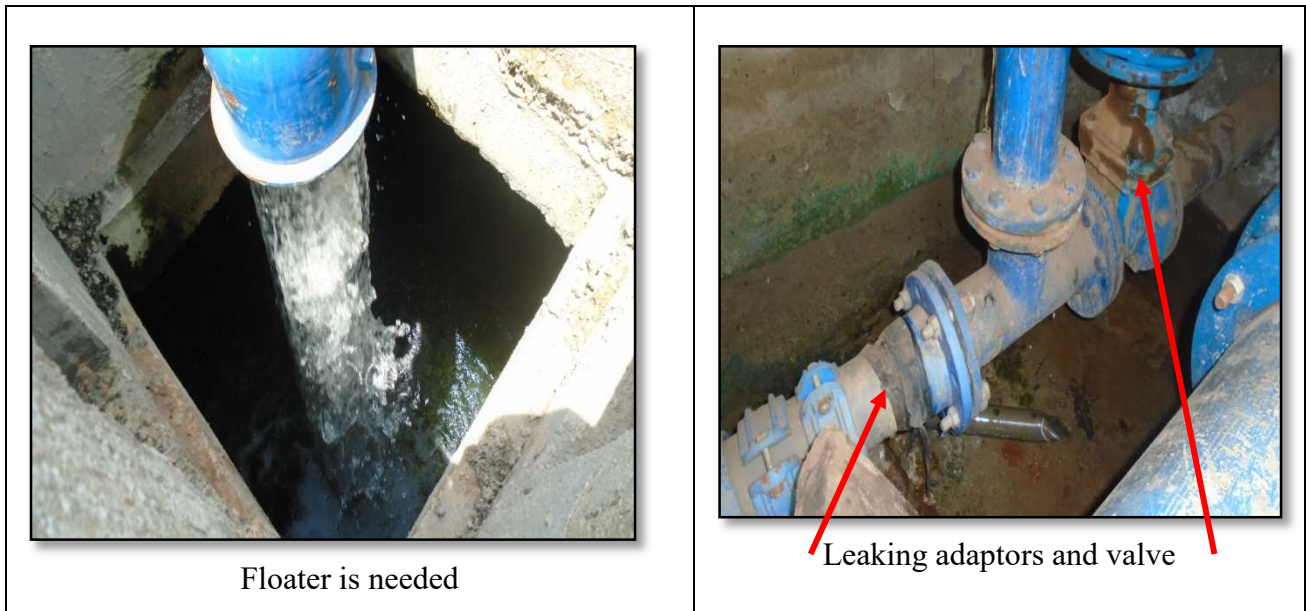
Floater valve needed, Replacement of 2 existing adaptors, replacement of 1 defective Outlet valve

Action	Requirements
<ul style="list-style-type: none">• Installation of floater valve• Installation of 60cm Straight Pipe with Double Flange DN200• Installation of 90 Degree Elbow with Double Flange DN200• Installation of 2 Adaptors DN100• Installation of Valve DN100	<ul style="list-style-type: none">• 1 Floater valve DN200• 1 Straight Pipe of 60cm with Double Flange DN200• 1 Elbow with 90 Degree with Double Flange DN200• 2 adaptors DN100• installation of Valve DN100

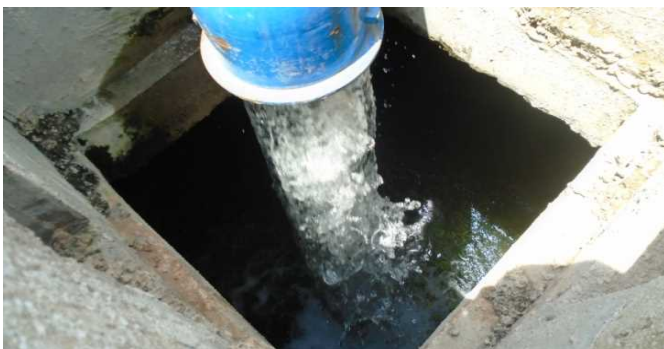
No.	Item	Details
D: Equipment		
1	Floater Valve	No installation, DN: 200 (needed)
2	Water Level Gauge	No installation
3	Flow Meter	No installation
4	Inlet pipe No.1	SP, DN: 250 , Roof
5	Inlet valve No.1	No installation (water from Culligany's new 5000tank)
6	Outlet pipe No.1	SP, DN: 200
7	Outlet valve No.1	DN: 200 , Function: YES
8	Overflow Pipe	SP, DN: 100
9	Drain Pipe	SP, DN: 100
10	Remarks/ Issue	. 2 Adaptors DN100 + Valve DN100 leaking and need replacement.

Float Valve

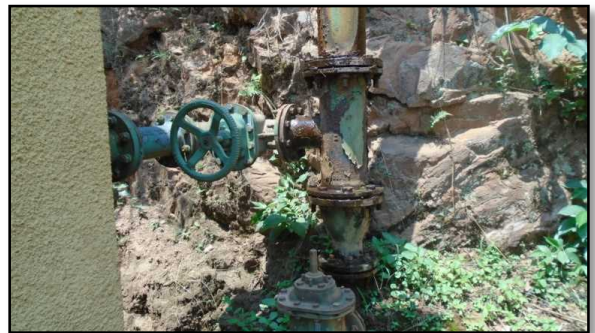
Leaking pipe to be replaced

Steel Pipe DN150 and Steel Pipe DN50 needed to modify the existing installation while replacing defective pieces,

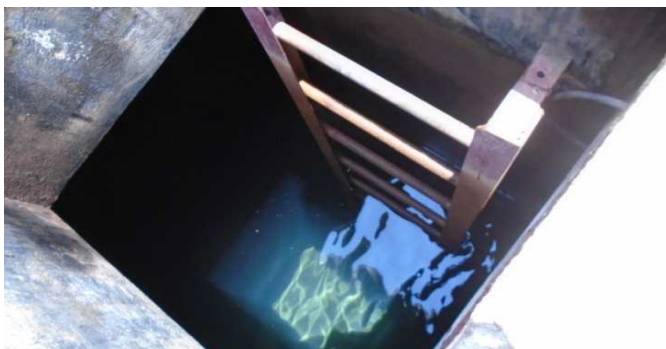
Float Valve needed (Source)

PVC Valve 110 leaking, no floater valve installed.

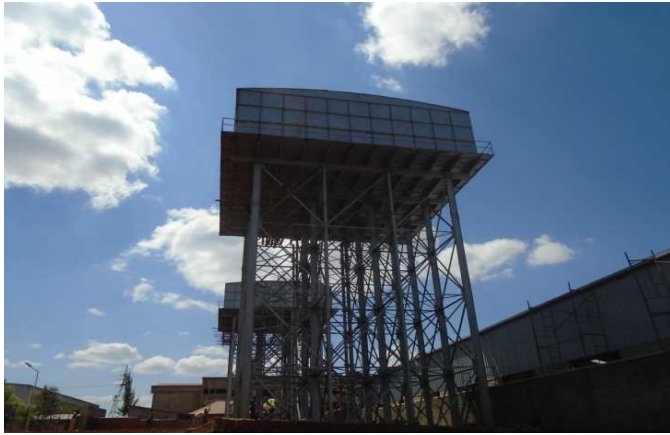
Whole View

8	Issue on Functional Condition	None
C: Structure		
1	Form of Reservoir	Rectangular
2	Foundation	Elevated
3	Structure Material	Concrete, Stones, Steel, Plastic, Other()
4	Inside Dimension	D: / L: 11m × B: 10m , H: 3m
5	Remarks/ Issue	To protect the support against rust, base concreting is needed.

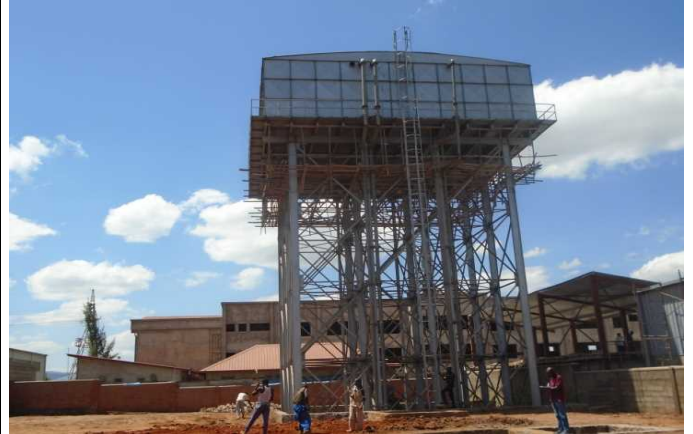
Reservoir

No.	Item	Details
D: Equipment		
1	Floater Valve	Function: Yes, DN: 150
2	Water Level Gauge	No installation
3	Flow Meter	Mechanical, DN: 200 , PN(bar): _____,
		Function: Yes
		Location: Inlet Pipe
4	Inlet pipe No.1	SP, DN: 150, Top
5	Inlet valve No.1	DN: 150, Function: YES
6	Outlet pipe No.1	SP, DN: 200, PN16
	Outlet pipe No.2	SP/ DIP/ PVC/ Others (), DN:
	Outlet pipe No.3	SP/ DIP/ PVC/ Others (), DN:
7	Outlet valve No.1	DN: 200, Function: YES
8	Overflow Pipe	SP, DN: 100
9	Drain Pipe	SP, DN: 100, PN10
10	Remarks/ Issue	Supports need protection against rust.

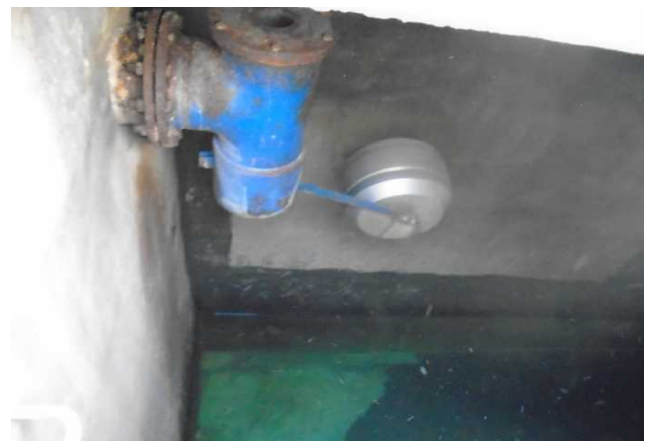
Floater Not operational

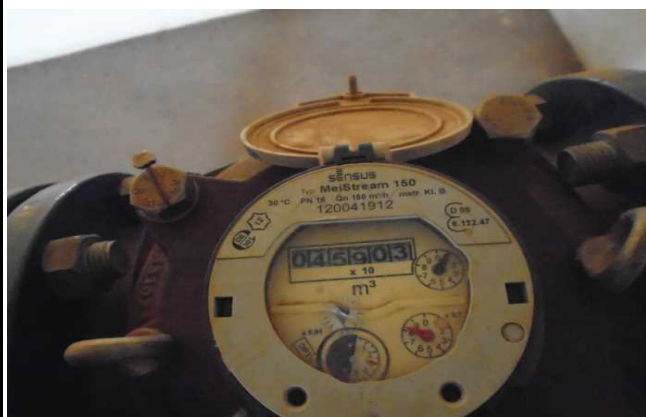
Meter (Installed on the pump outlet pipe)

No Floater

Action	Requirements
<ul style="list-style-type: none">Installation of Floater Valve at Reservoir No. 138&139	<ul style="list-style-type: none">Valve DN300
<ul style="list-style-type: none">Installation of Inlet Valve at Reservoir No. 138	<ul style="list-style-type: none">Valve DN300

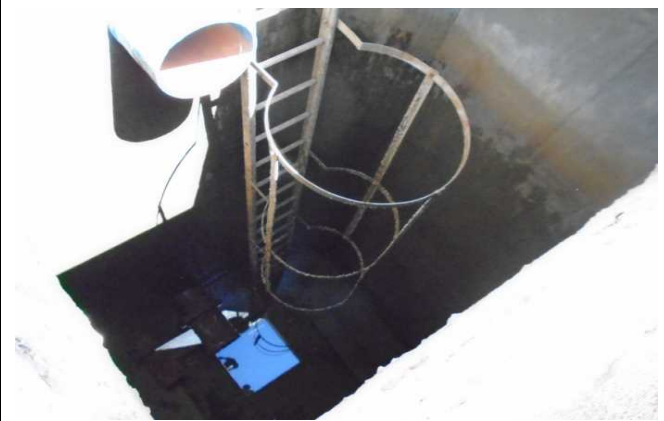
No Floater

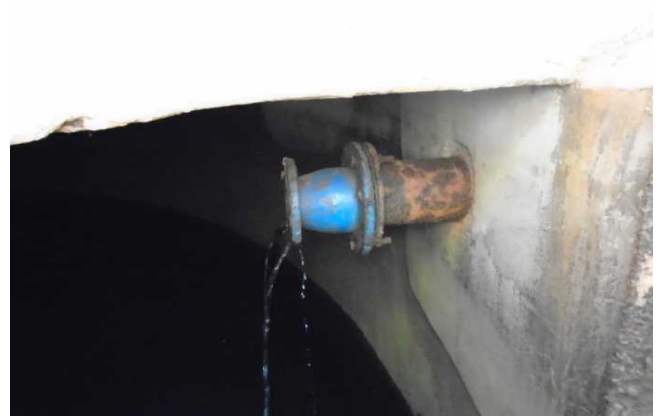
No Floater

No.	Item	Details
D: Equipment		
1	Floater Valve	No installation, DN: 150
2	Water Level Gauge	No installation
3	Flow Meter	Mechanical, DN: 80, PN(bar): _____,
		Function: YES
		Location: Inlet Pipe
4	Inlet pipe No.1	SP, DN: 150, Top
	Inlet pipe No.2	SP/ DIP/ PVC/ Others (), DN: , Roof/ Top/ Bottom
5	Inlet valve No.1	DN: 100, Function: YES
	Inlet valve No.2	DN: 150, Function: YES
6	Outlet pipe No.1	SP, DN: 150
7	Outlet valve No.1	Not available
8	Overflow Pipe	SP, DN: 150
9	Drain Pipe	SP, DN: 300
10	Remarks/ Issue	No outlet valve, Internal stairs defective and can't be used.
Other Information:		Floater Valve needed, Outlet Valve needed
