Result of the investigation on Nueva Santa Rosa

Investigation and analysis of La Guillen and Nueva Santa Rosa

Project for Control and Mitigation of Slope Disasters in the Central District
in Republic of Honduras

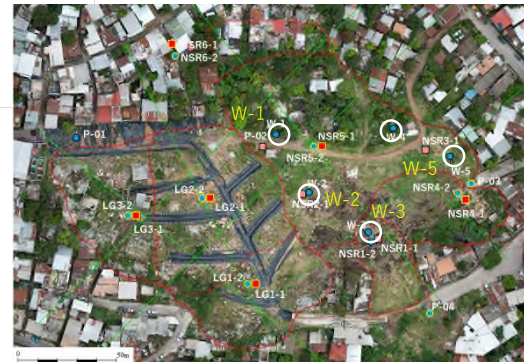
Groundwater level-Nueva Santa Rosa

Well No.	HGWL
W-1	GL-1.15m
W-2	GL-6.52m
W-3	GL-1.24m
W-4	GL-1.27m
W-5	GL-2.27m

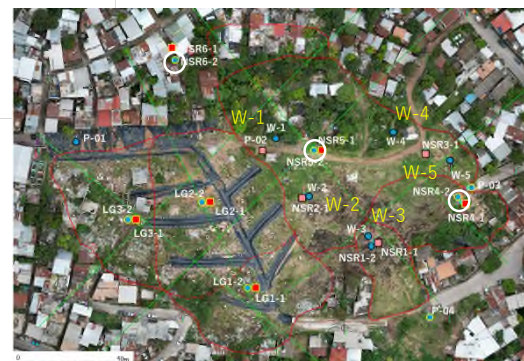
Groundwater level-Nueva Santa Rosa

Well No.	HGWL
NSR4-2	GL-0.00m
NSR5-2	GL-0.20m
NSR6-2	GL-1.45m

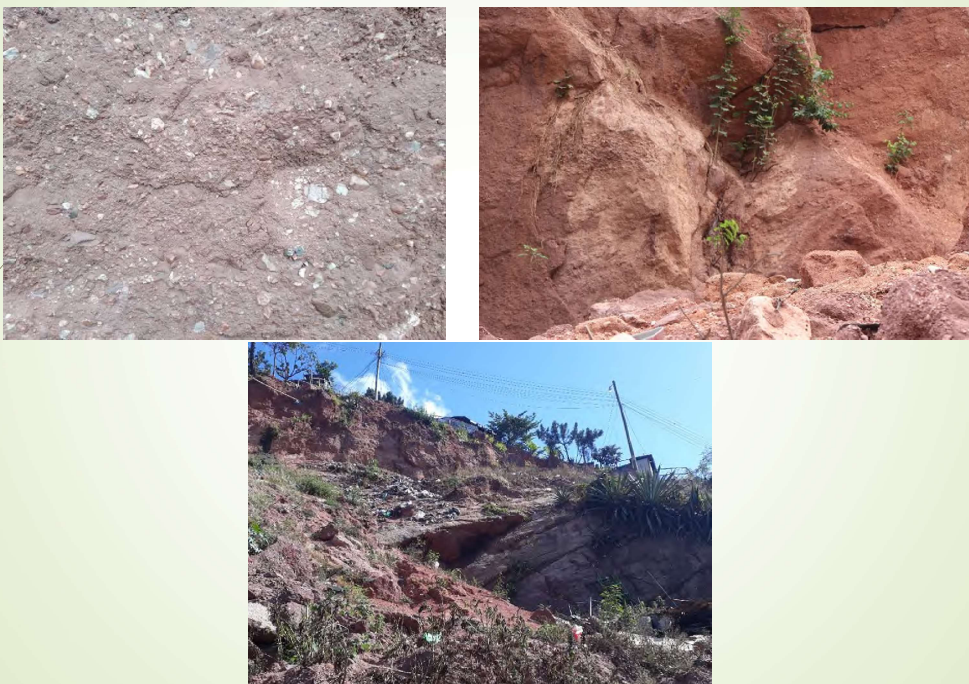
Aspecto de las rocas afectadas por el derrumbe
