Minchin Flood Bund RD 90+000

Creation Date: 3/3/2024

Province	Zone	Division	Circle
Punjab	Bahawalpur Zone	Punjnad Headworks Division	Punjnad Canal Circle
Sr. No.	River Name	River System	Bank
P-001	Indus River	Indus River	Left
Bund Name		R.D.	GPS Coordinates
Minchin Flood Bund		RD 90+000 to 100+000	29°08'78.33"N, 70°76'66.67"E
Name of Vulnerable Point	Minchin Flood Bund RD 90+000 to 100+000		
Reason for the Vulnerability	<ul style="list-style-type: none"> In 2010 flood, seepage water crossed this bund at this reach and approx. 10 feet. deep pit was formed on the country side of the bund. During 2015 flood, the River Indus impacted the same reach once again 		
Flow Condition ¹	<ul style="list-style-type: none"> There is no flow at this location due to shift in the river's direction away from the bund. River is approx. 4 km away from the said reach. 		
Site Condition in the Country Side ²	<ul style="list-style-type: none"> Cultivated land is located on the countryside side of the bund, supporting agricultural activities in the area..

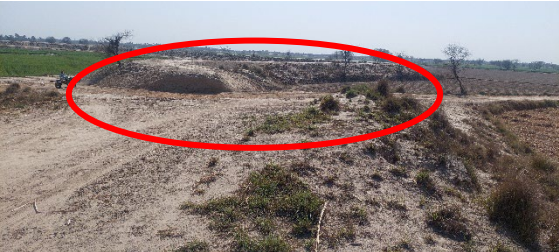
Close View of Deformation

Road crossing by cutting the bund	
Close View of Damages	
Not Applicable

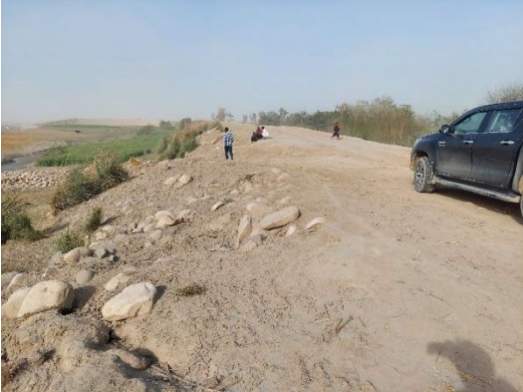
Close View of Deformation

Observation Record ⁴ (Current status, effect of countermeasure, development of erosion, deformation, and deterioration)			
DD/MM/YYYY	Inspection Type	Description and Photo	Damage ⁵
02/3/2024	Visual Inspection	<ul style="list-style-type: none"> • Extreme erosion has been observed along the flood bund at this RD. • Top level is bumpy and uneven. • 5/R Chahchran Disty. is observed towards the country side of the said RD. • Cultivated area has been observed beyond the Disty. Which 22 feet. beneath the top level of the said reach.

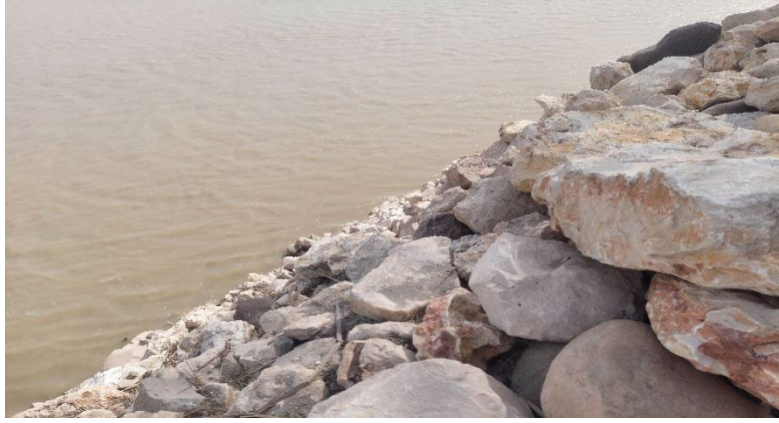
<p>Close View of Damages</p>

<p>Damaged nose portion</p>	c

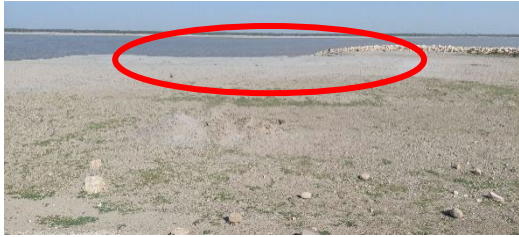
<p>Continuous Erosion observed along the allied river training structures</p>

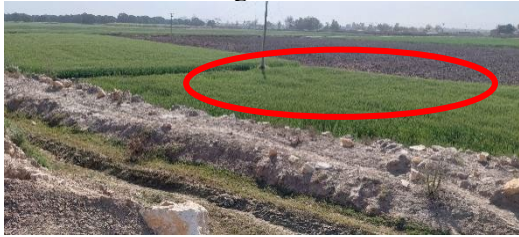
<p>Cropped area towards country side</p>

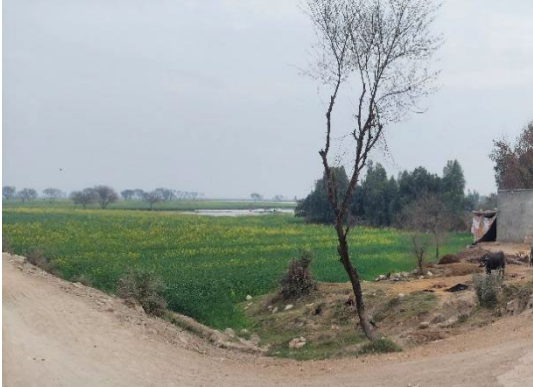
<p>Cropped area on country side</p>

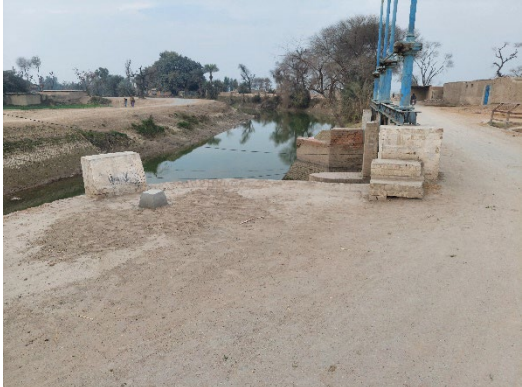
<p>Canal on the right side of the embankment</p>	a

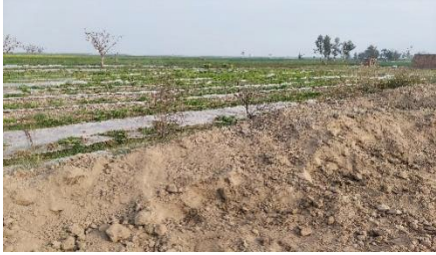
<p>Cropped area on country side</p>

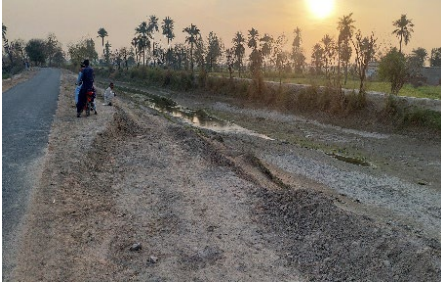
<p>Empty canal on the right side of the embankment</p>	a

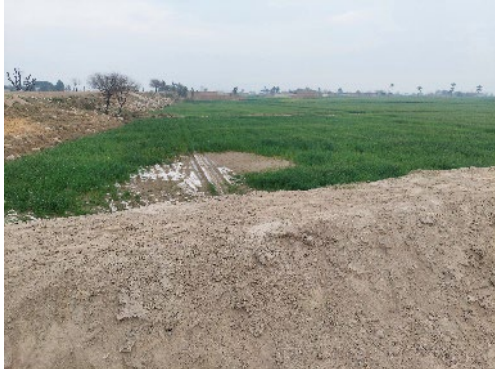
<p>Cropped area on country side</p>

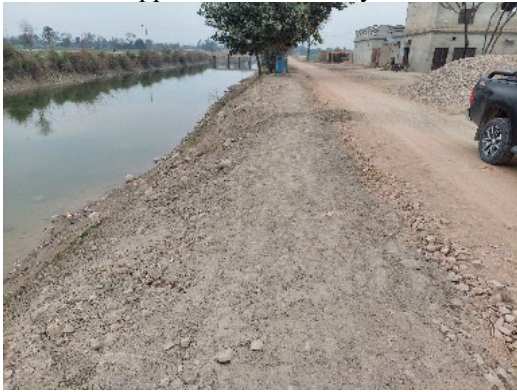
<p>Canal on the right side of the embankment</p>	a

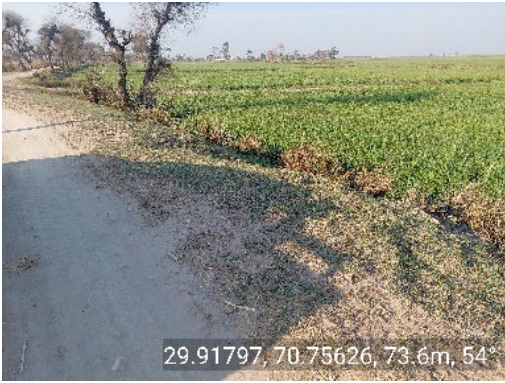
<p>29.91797, 70.75626, 73.6m, 54°</p> <p>Cultivated area on country side</p>

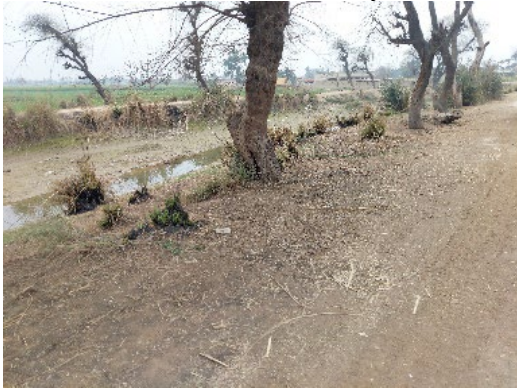
<p>Empty canal on the right side of the embankment</p>	a

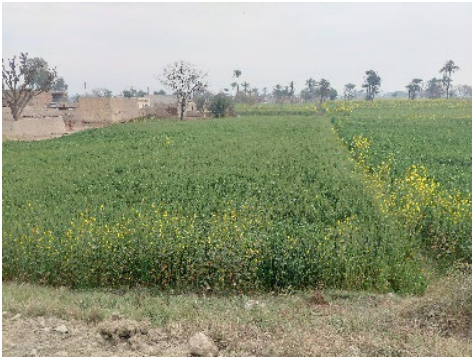
<p>Cultivated area on countryside</p>

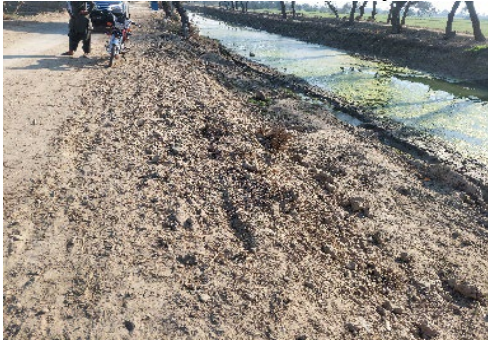
<p>Empty canal on the right side of the embankment</p>	a

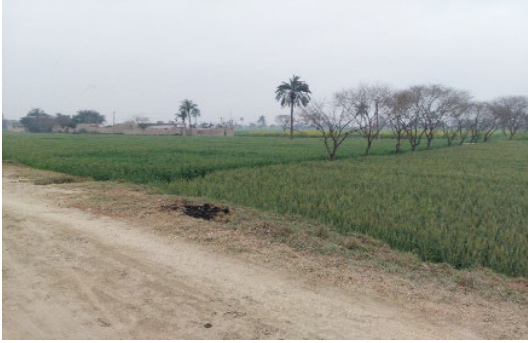
<p>Cultivated area on country side</p>

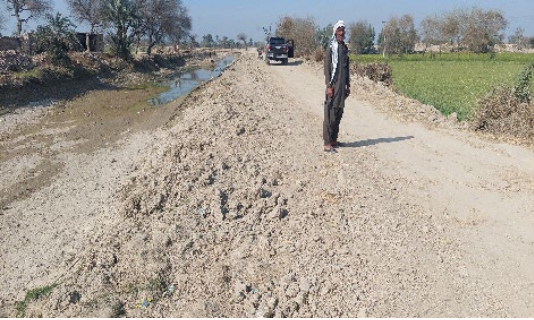
<p>An empty canal is located on the right side of the embankment</p>	a

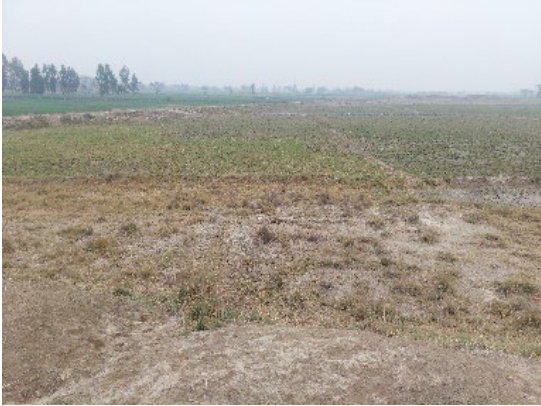
<p>Cultivated area on the country side</p>

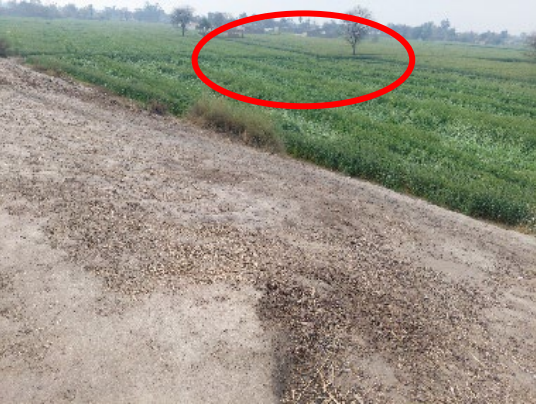
<p>Cultivated area on the country side</p>

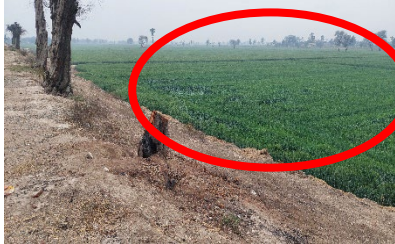
Observation Record ⁴ (Current status, effect of countermeasure, development of erosion, deformation, deterioration)			
DD/MM/YYYY	Inspection Type	Description and Photo	Damage ⁵
01/3/2024	Visual Inspection	<ul style="list-style-type: none"> • Cultivated area is present on the country side, which is approximately 18 feet below the top level of bund. • Design parameters (Top level, top width, and side slopes) of the bund was not well maintained.

<p>Cultivated area on the country side</p>

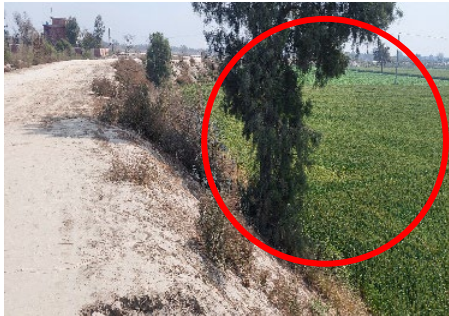
Observation Record ⁴ (Current status, effect of countermeasure, development of erosion, deformation, deterioration)			
DD/MM/YYYY	Inspection Type	Description and Photo	Damage ⁵
01/3/2024	Visual Inspection	<ul style="list-style-type: none"> • Cultivated area is present on the country side, which is approximately 10 feet below the top level of bund. • Design parameters (Top level, top width, and side slopes) of the bund was not well maintained.

<p>Cultivated area on the country side</p>

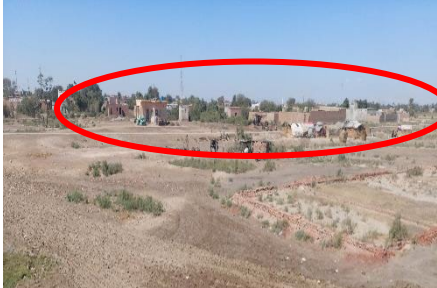
Observation Record ⁴ (Current status, effect of countermeasure, development of erosion, deformation, deterioration)			
DD/MM/YYYY	Inspection Type	Description and Photo	Damage ⁵
02/3/2024	Visual Inspection	<ul style="list-style-type: none"> • Adjoining population of Rojhan city is present on both side of the bund. • Metaled road runs along the top, connecting Rojhan to Miran Pur village. • Cultivated area are present on the river side. • There is a barren land on the country side.

<p>Adjoining population</p>

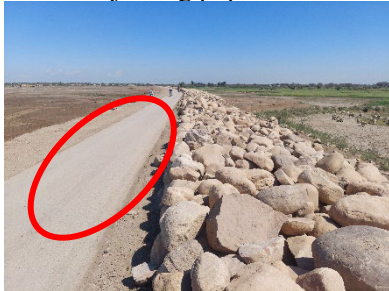
<p>Metaled road on top</p>

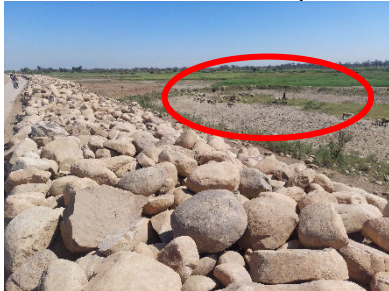
<p>Cropped area on theRiver Side</p>	a

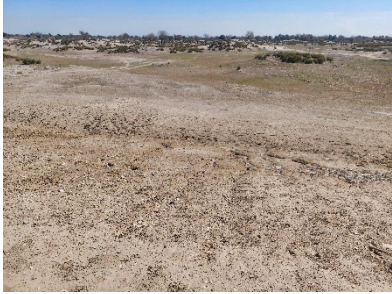
Observation Record ⁴ (Current status, effect of countermeasure, development of erosion, deformation, deterioration)			
DD/MM/YYYY	Inspection Type	Description and Photo	Damage ⁵
02/3/2024	Visual Inspection	<ul style="list-style-type: none"> • Mud lumps/heaps can be found on both sides of the bund • Adjoining population of Rojhan city is present near the reach towards the river side. • Metaled road runs on top is towards Rojhan to Miran Pur village.

<p>Mud lumps/heaps on either side of the bund</p>

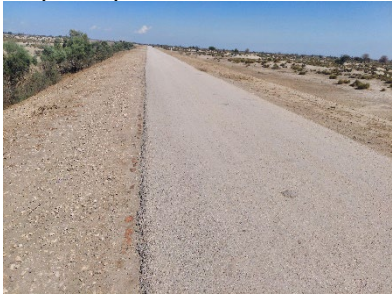
<p>Metaled road on top</p>	a
